## Insufficient Grizzly Barrier Report 2020-2025

CYE BMU 12/Knotty Pine Project Area

Submitted July 2025

## **BMU 12-Knotty Pine Project Area**

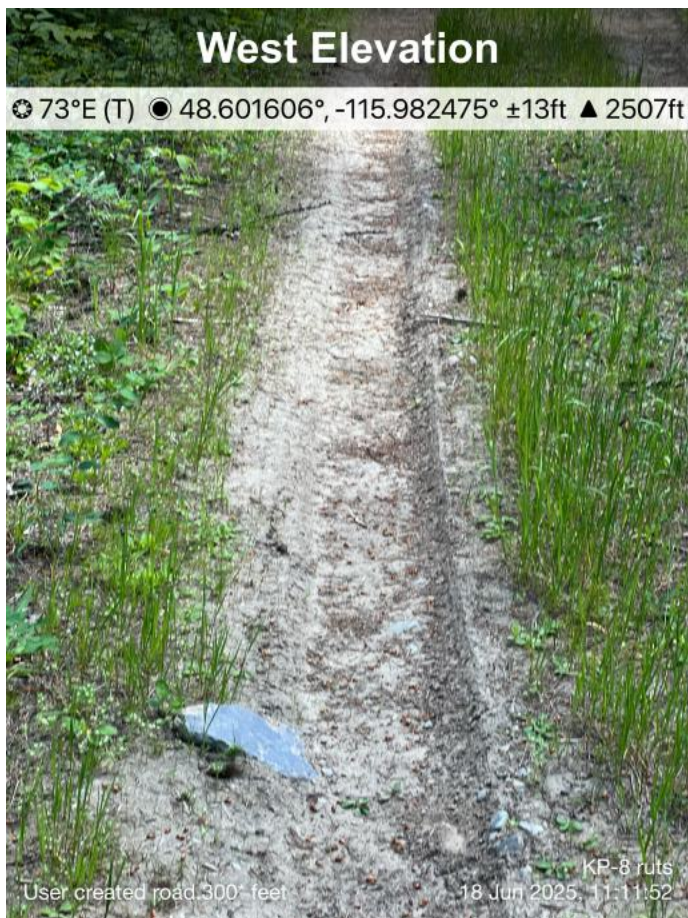
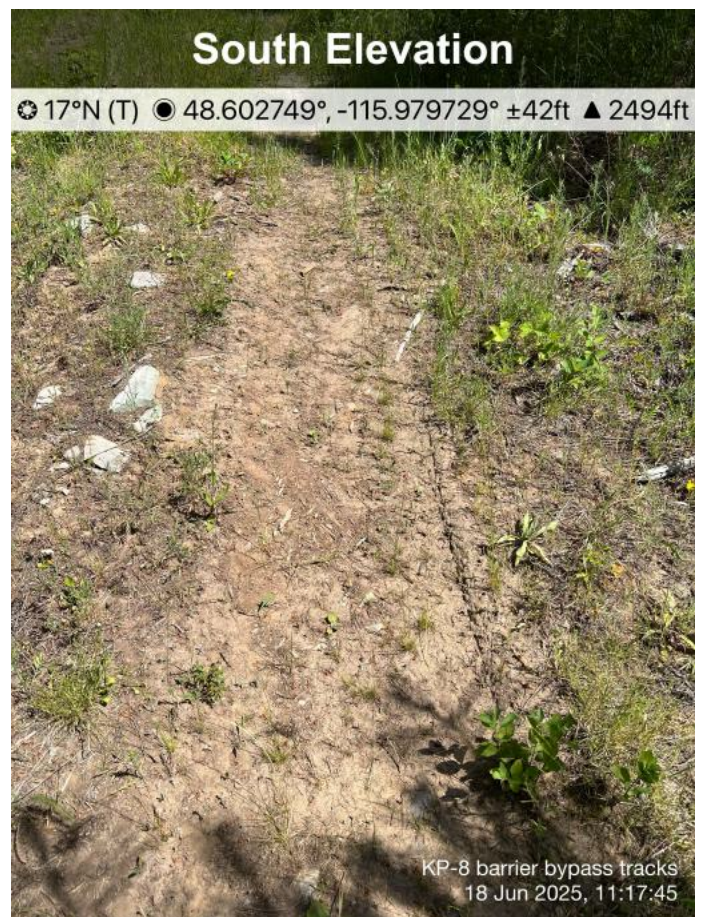
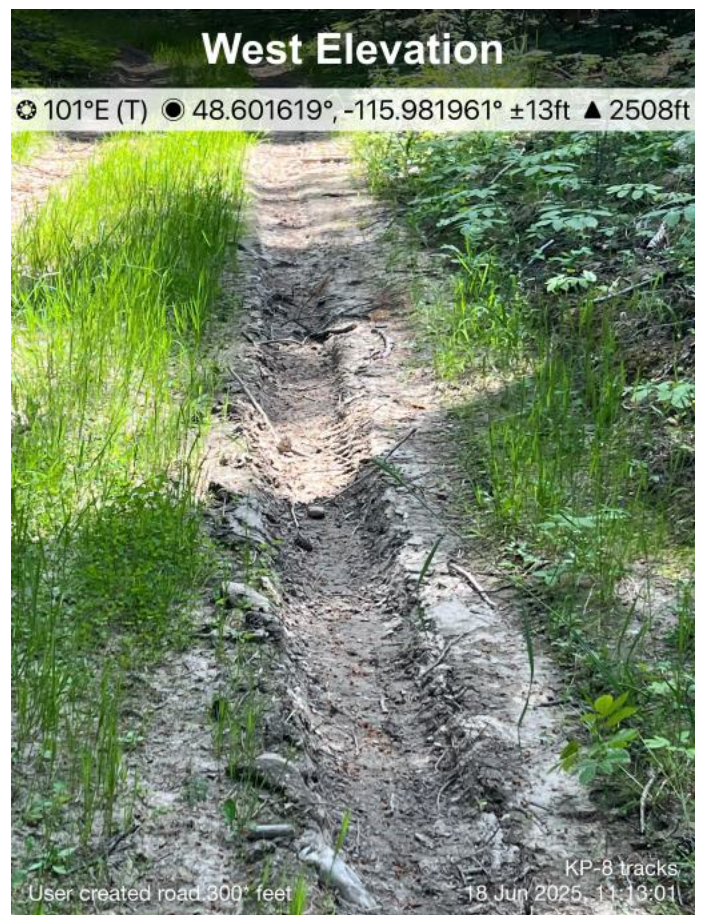
Rutted road showing evidence of trespassing toward and past the insufficient barrier.

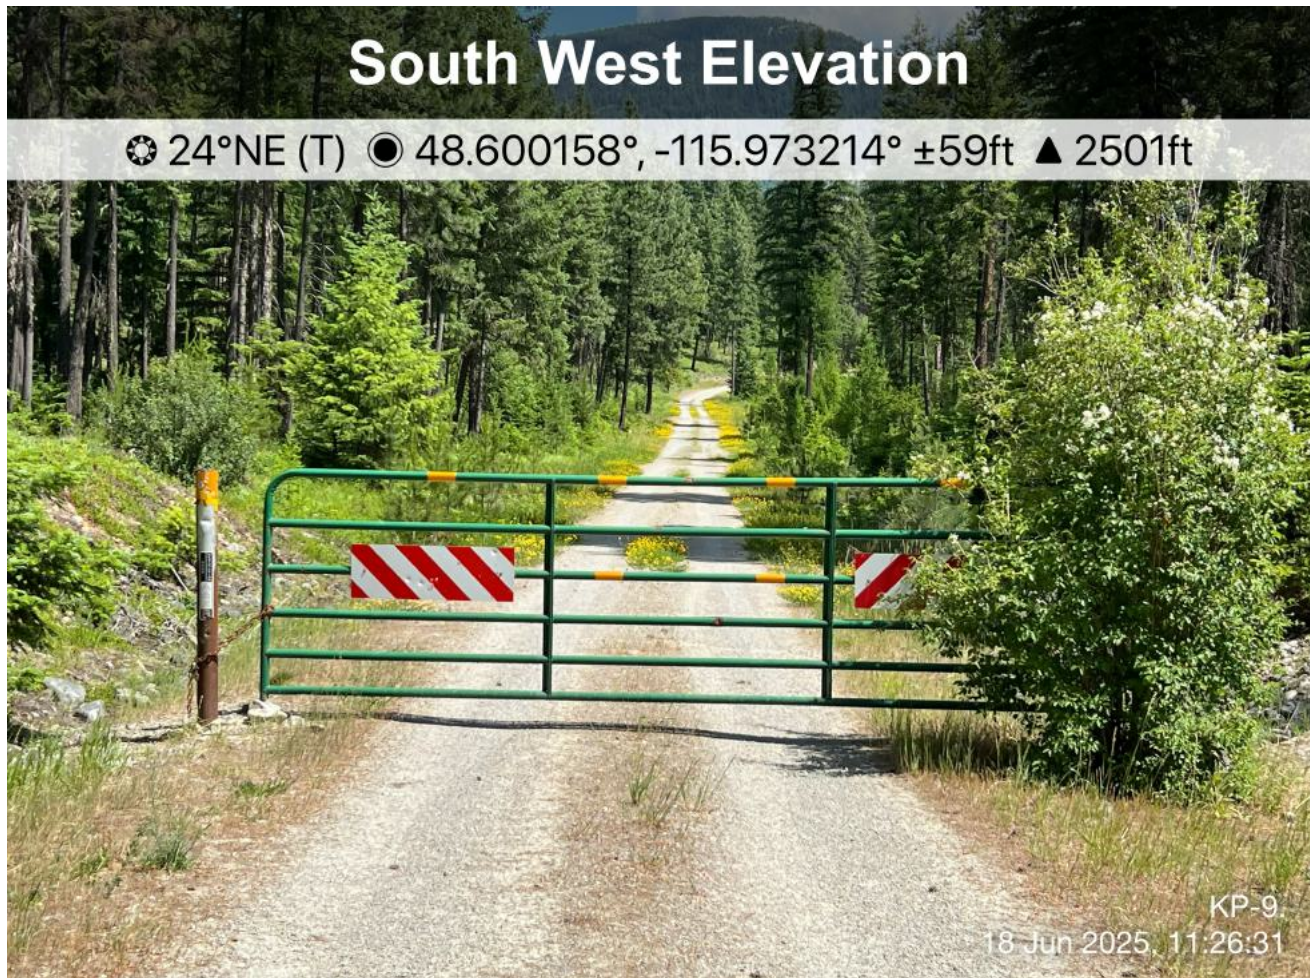
The gate on Cougar Ridge Road is ineffective at securing the road, it is passable on both sides. The road ahead is very enticing.

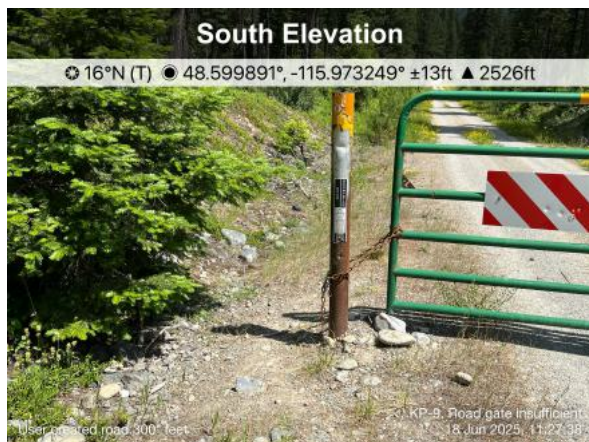
Gate bypassable, left.

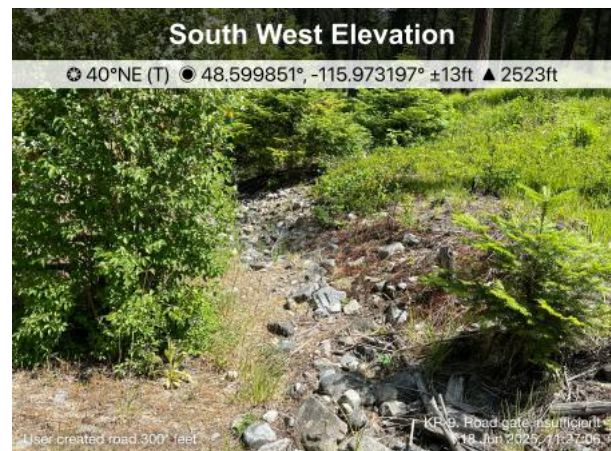
Gate bypassable, right.

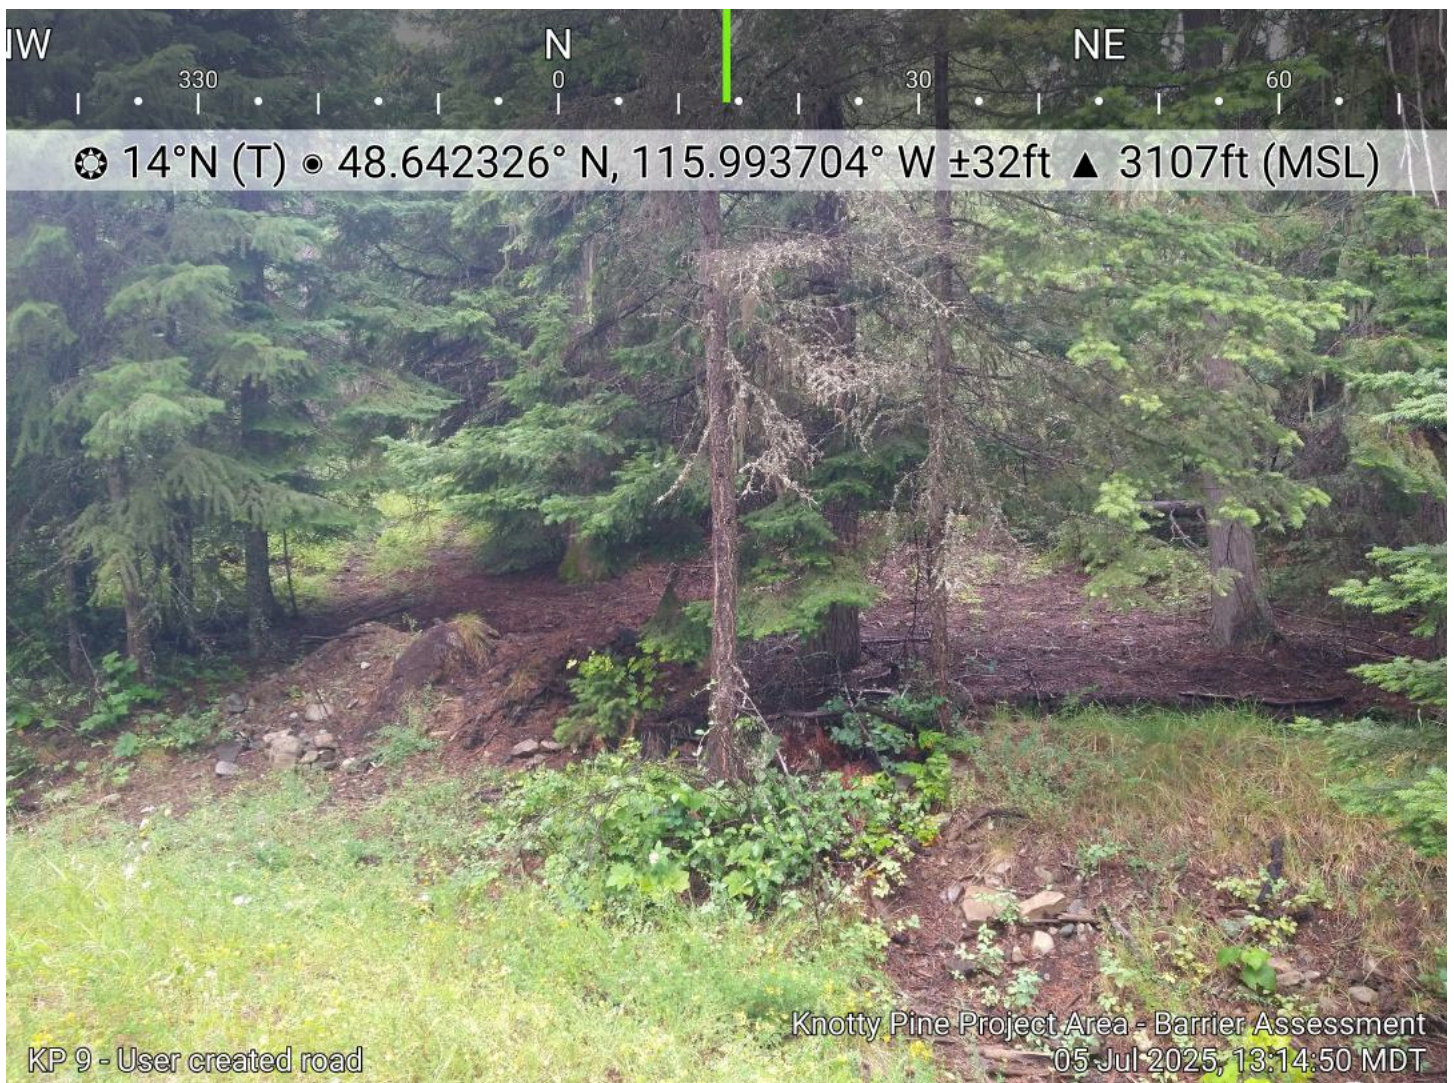
**KP 9- Coordinates: N 48.600158, W -115.973214**

The road to the right extends over\* 300 feet behind barrier.

Remedy: Additional berm-boulders, signage

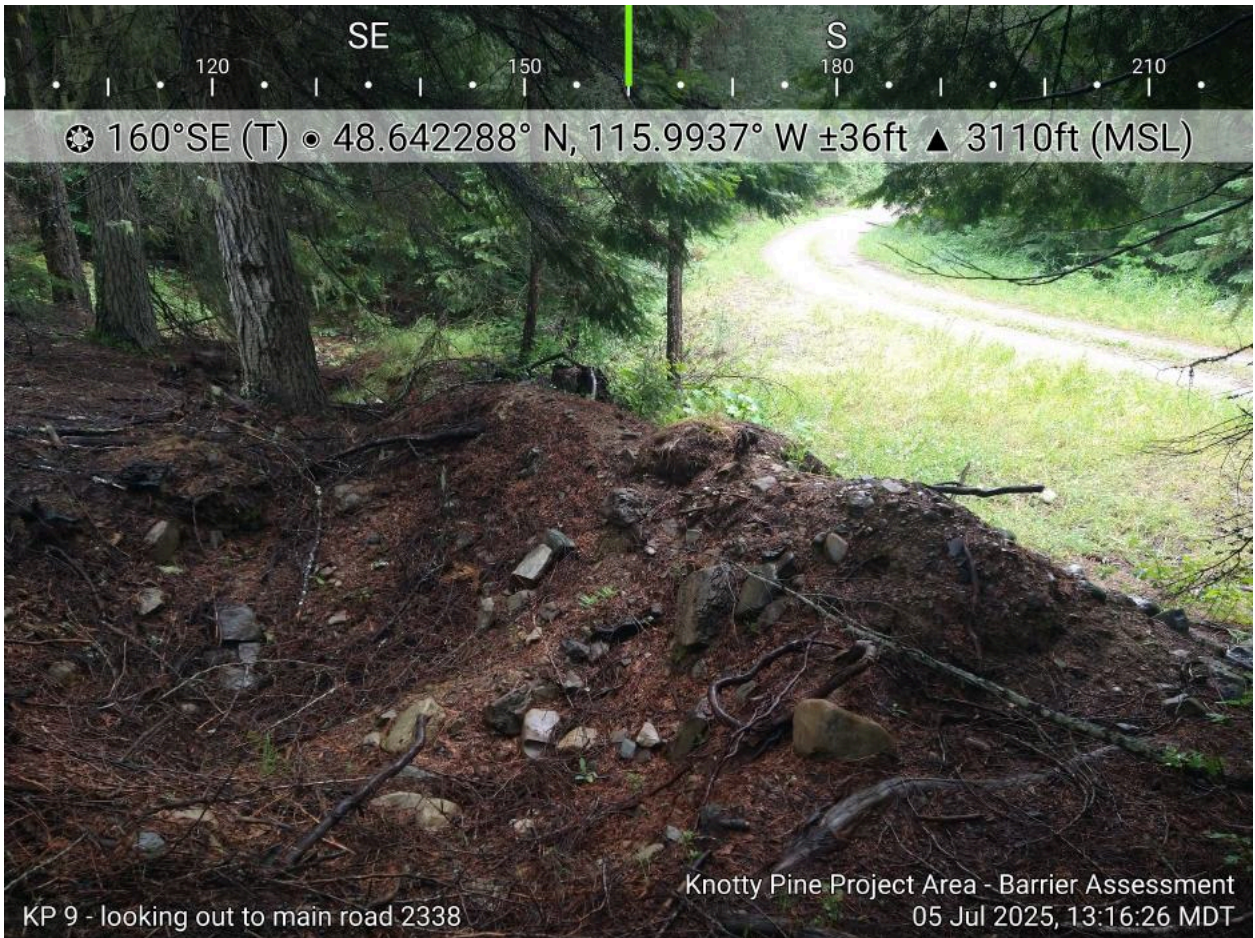
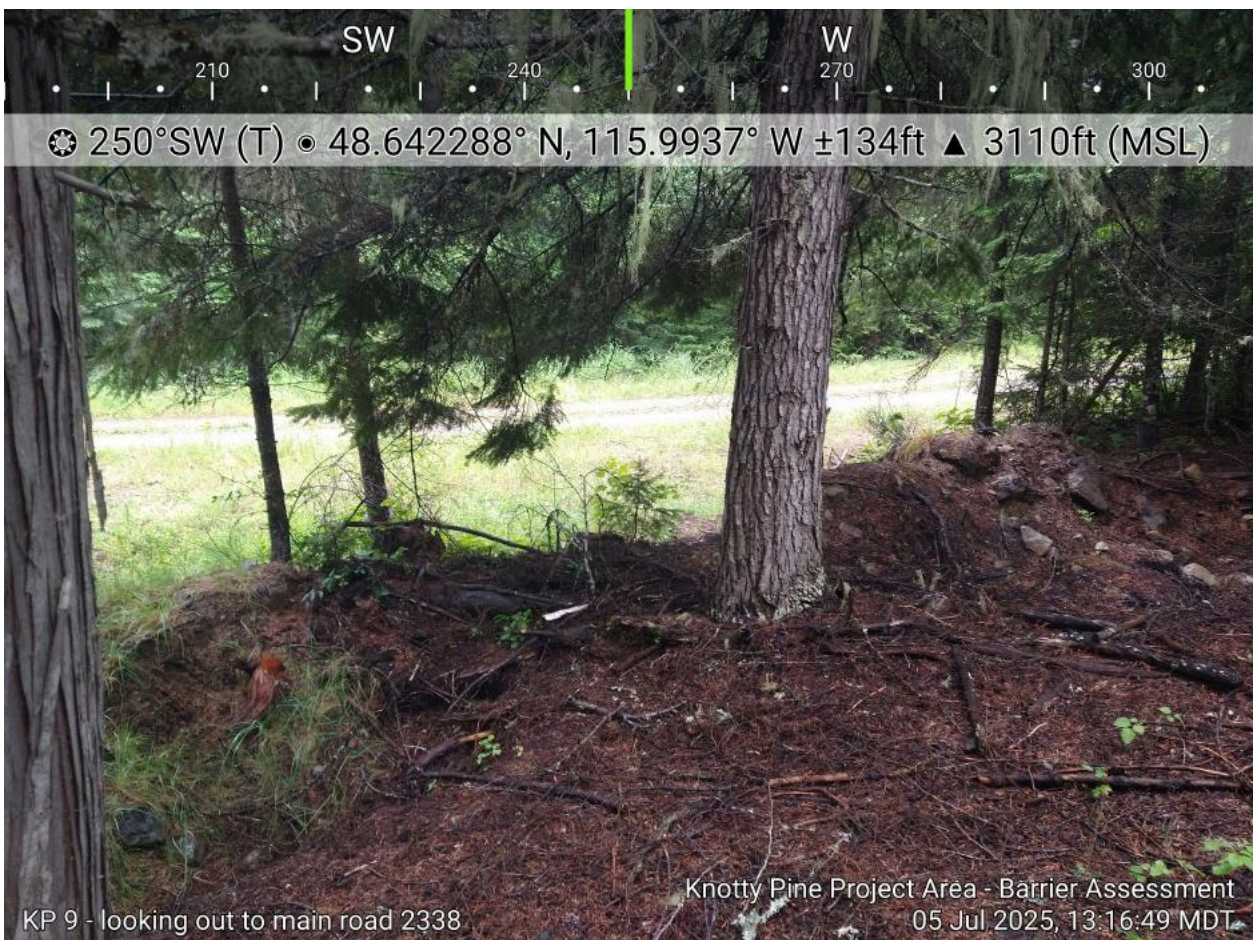
Appears to be a road for firewood cutting that exceeds 300' in length. User created road has been bermed. There is evidence of trespass over the berm as well as around the berm to the right. Visible tracks and rutting. Vegetation cleared to get access.

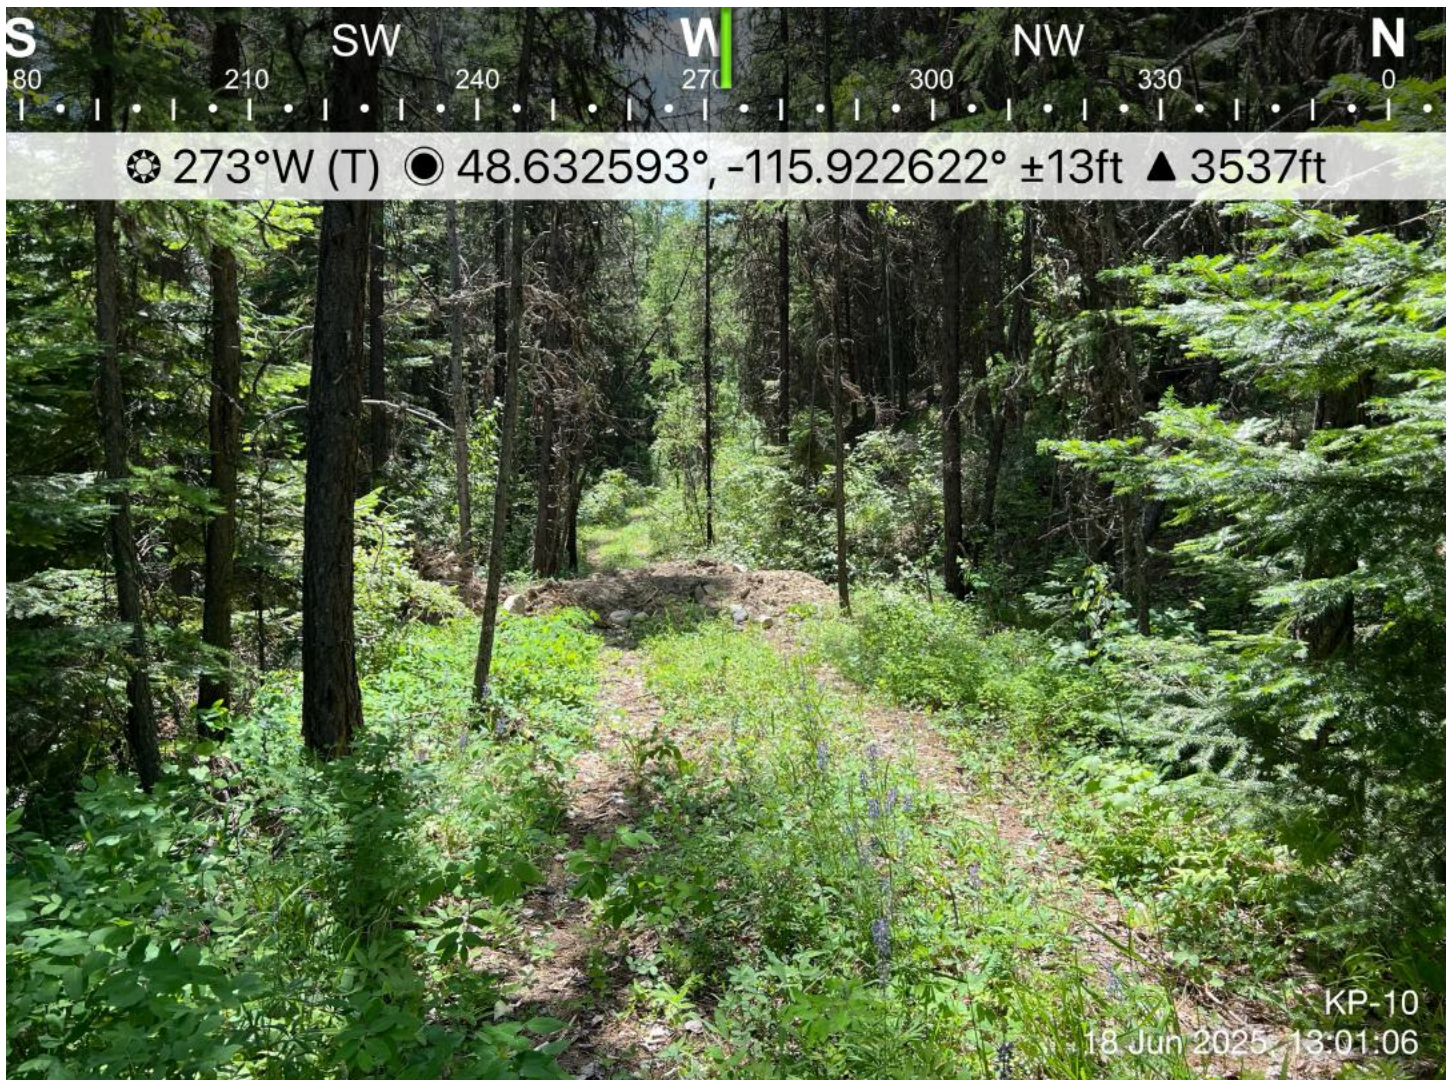
**KP 10- Coordinates: N 48.632593, W -115.922622**

Newly excavated tank trap installed. No barrier present in 2022. The barrier is currently sufficient; however, the open road extends well over 300 feet beyond the barrier.

The road to the right extends approximately\* 0.25 miles behind gate.

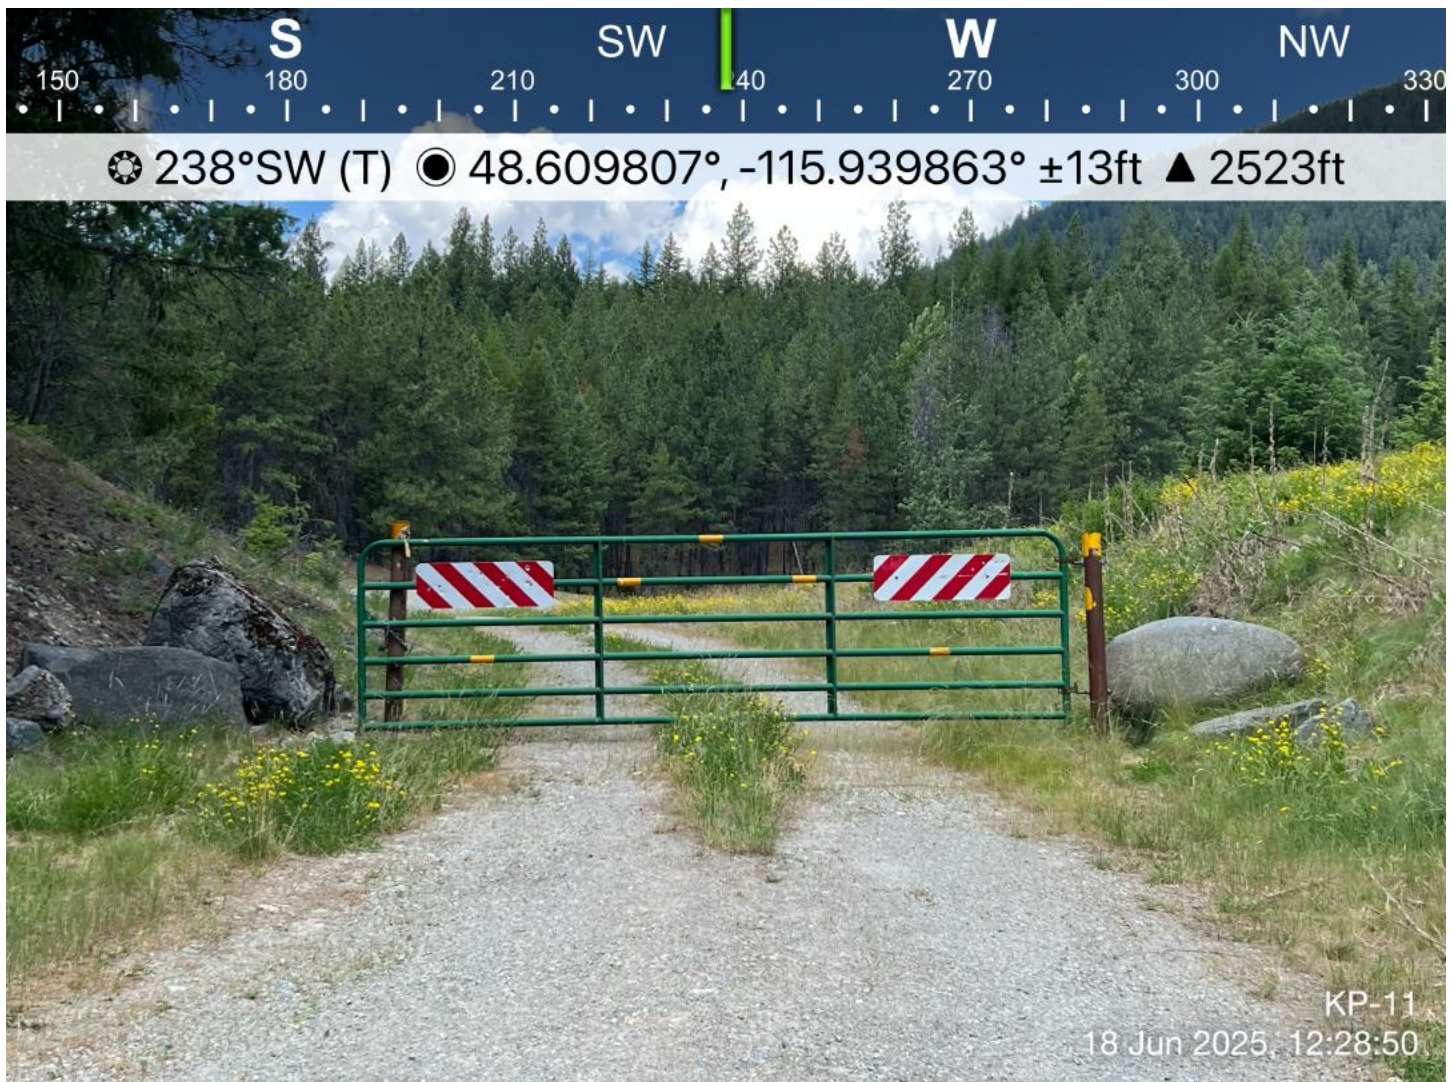
**KP 11- Coordinates: N 48., W -115.**

The gate is visible from Hwy 508. The berm to the right of the gate is passable on an ATV, side-by-side vehicle, or motorcycle. There is evidence of activity behind the gate, including tire tracks and a shooting range. Illegal motor-vehicle tracks noted behind gate. The lack of vegetation and/or trees to the side of the barrier has provided multiple options for getting around.

The road to the right extends approximately\* 1.5 miles into core grizzly bear habitat.

The gate is bypassable directly to the right of the gate and over the berm to the right of the gate. (Right and middle right)

Remedy: No Motor Vehicle Signage. Boulders, more boulders, added to the berms around the gate.

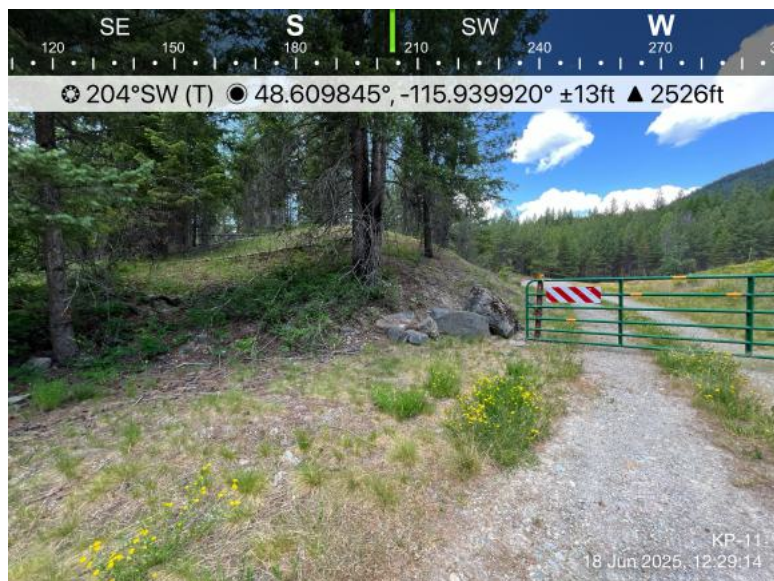
The gate is bypassable to the left over the berm.

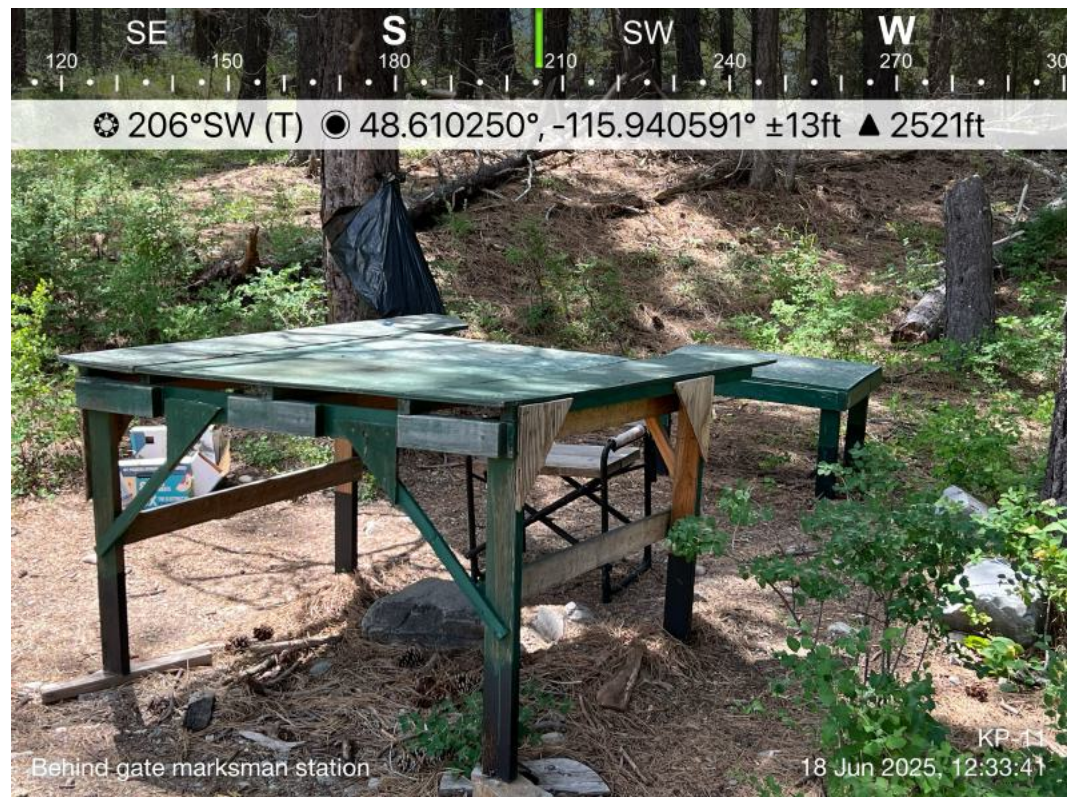
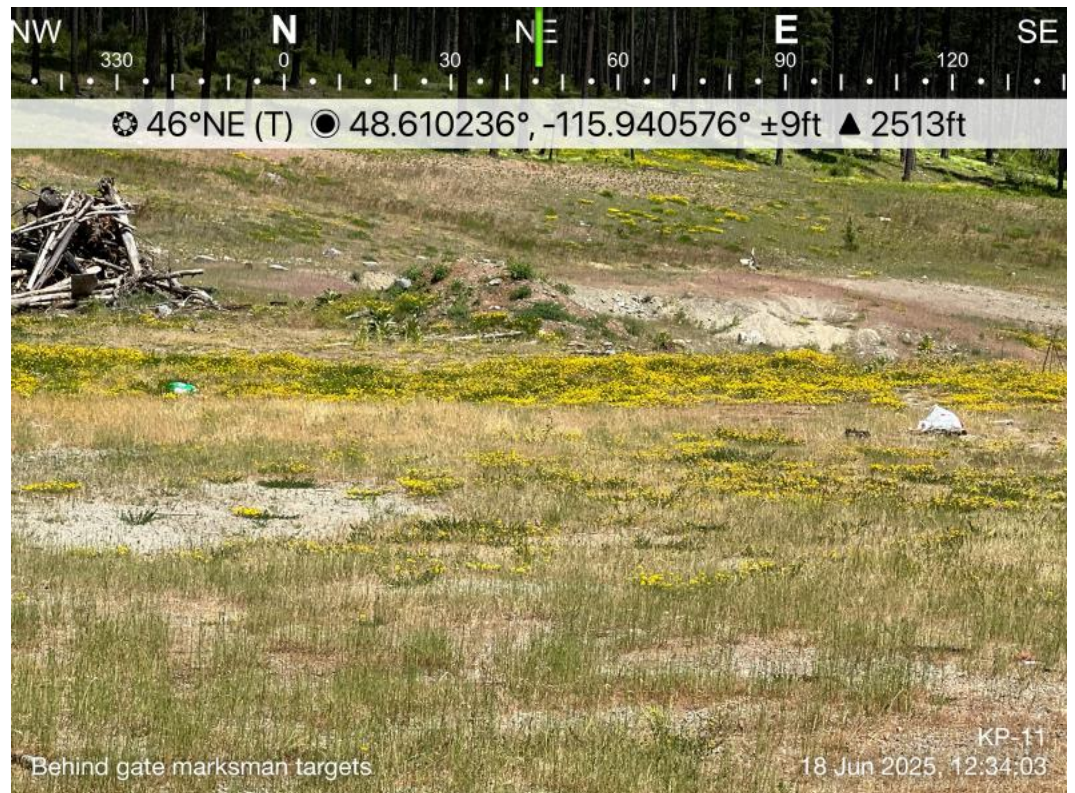
The shooting station is pictured, right.

Targets, below right.

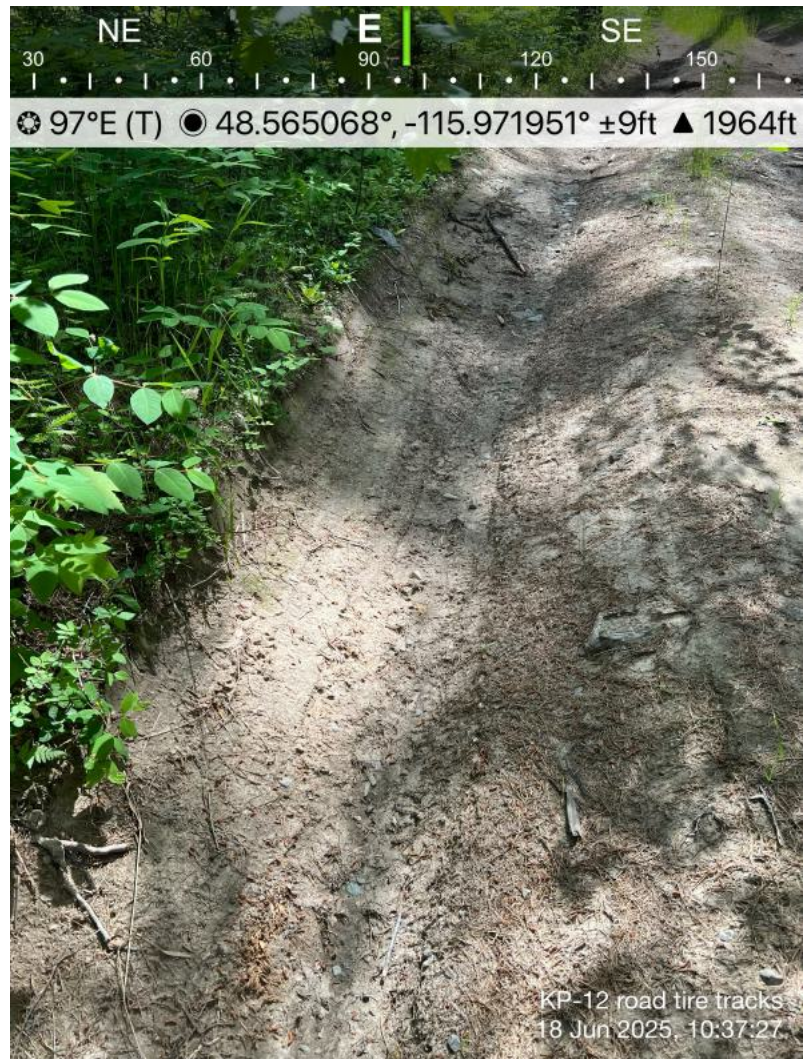
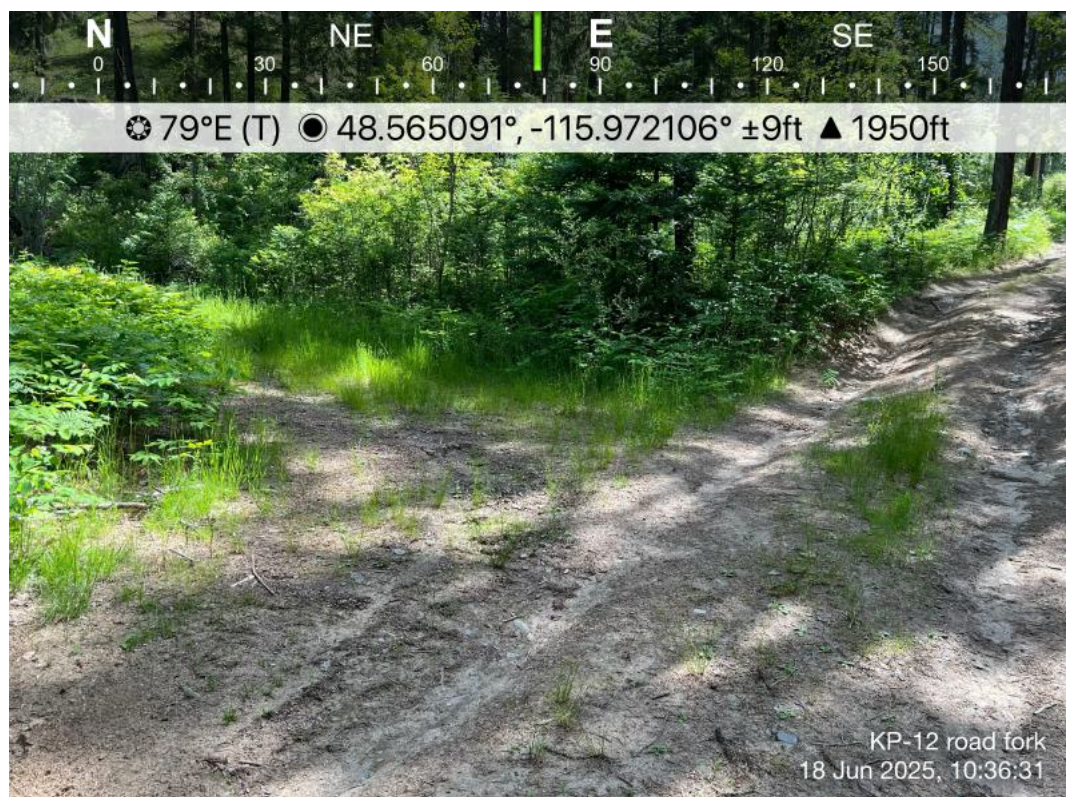
Tire tracks present  
indicate recent activity on  
the user-created roads.

Remedy: Gate, berm and No Motor Vehicle Use signage.

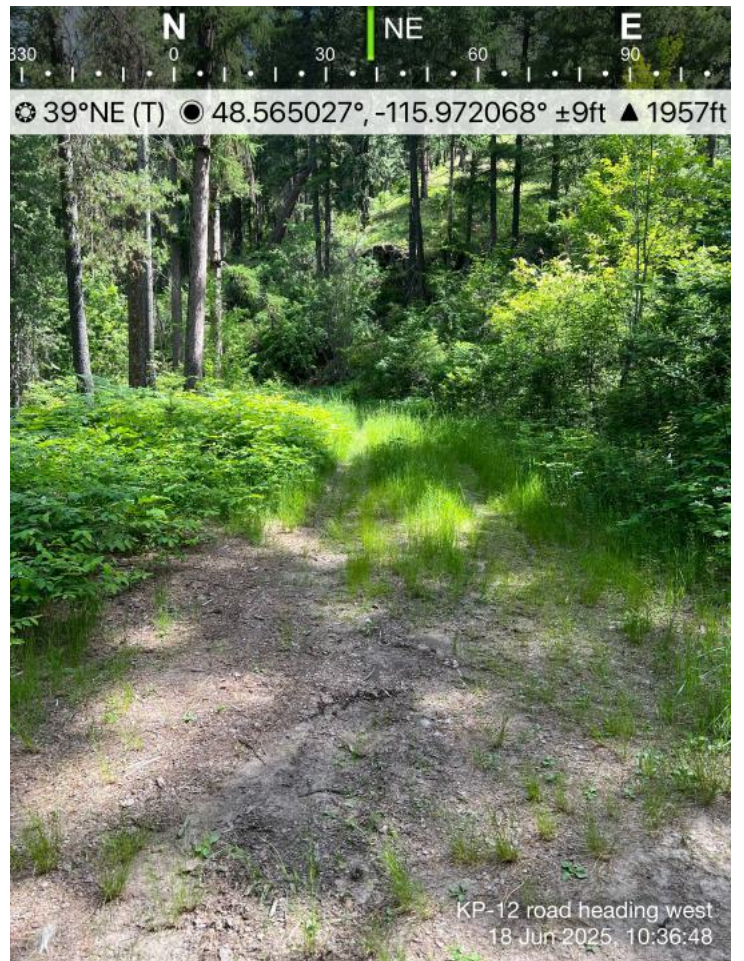
Several roads branch off from the main user-created road accessible from the highway, heading east, west, and north.

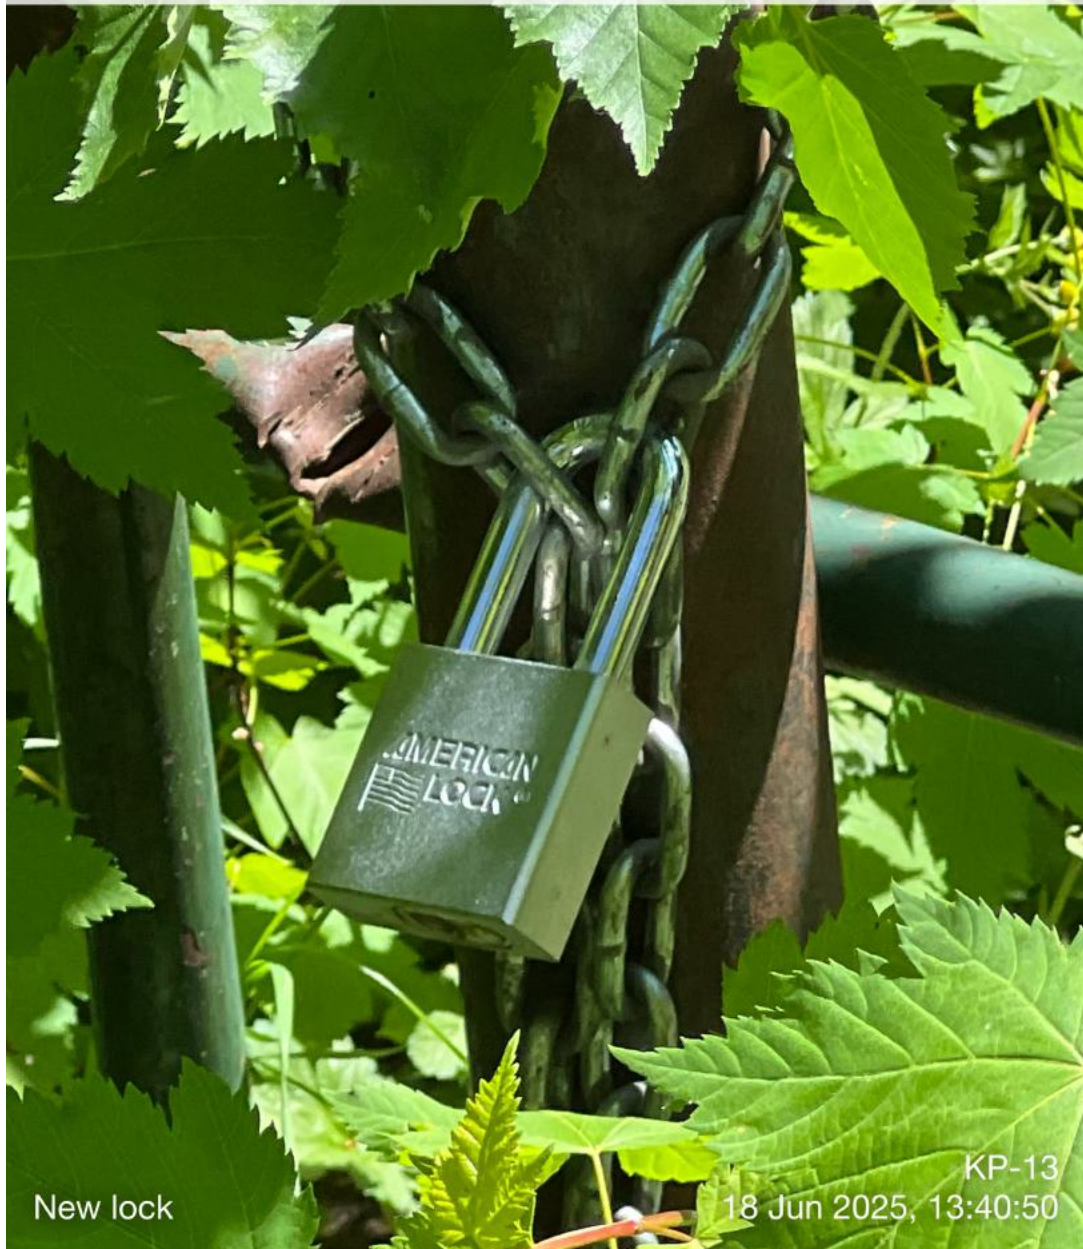
KP-13

The broken-down gate is unchanged since the last assessment in 2022. However, the lock is new.

New lock

Remedy: No Motor Vehicle Signage. Boulders, more boulders around the gate.

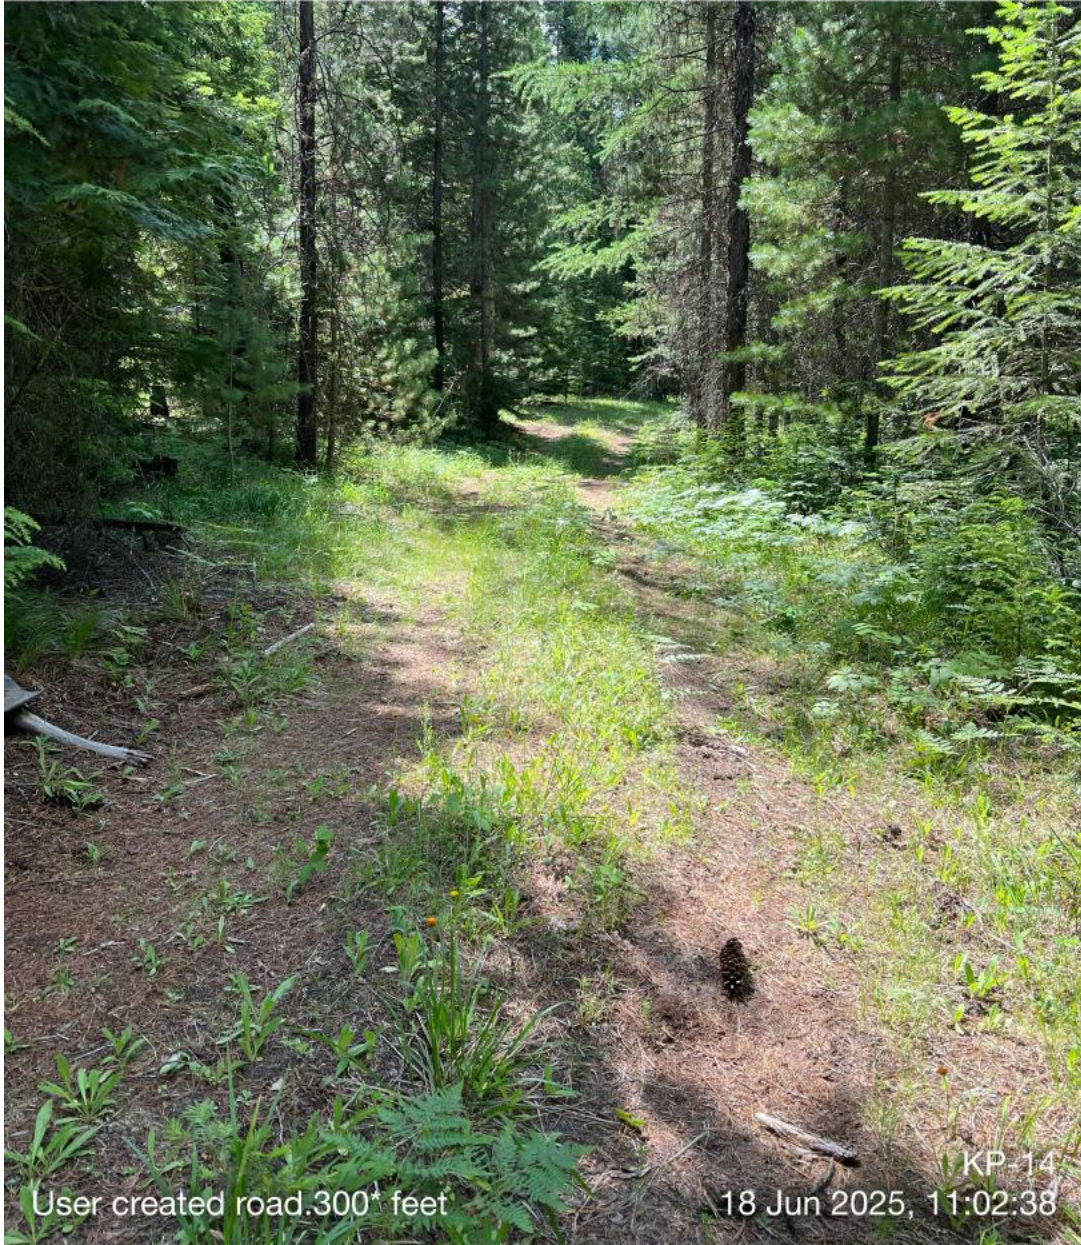
KP-14  
18 Jun 2025, 11:02:38

The user-created road extends beyond 300 feet into the core grizzly habitat.

User created road.300<sup>+</sup> feet

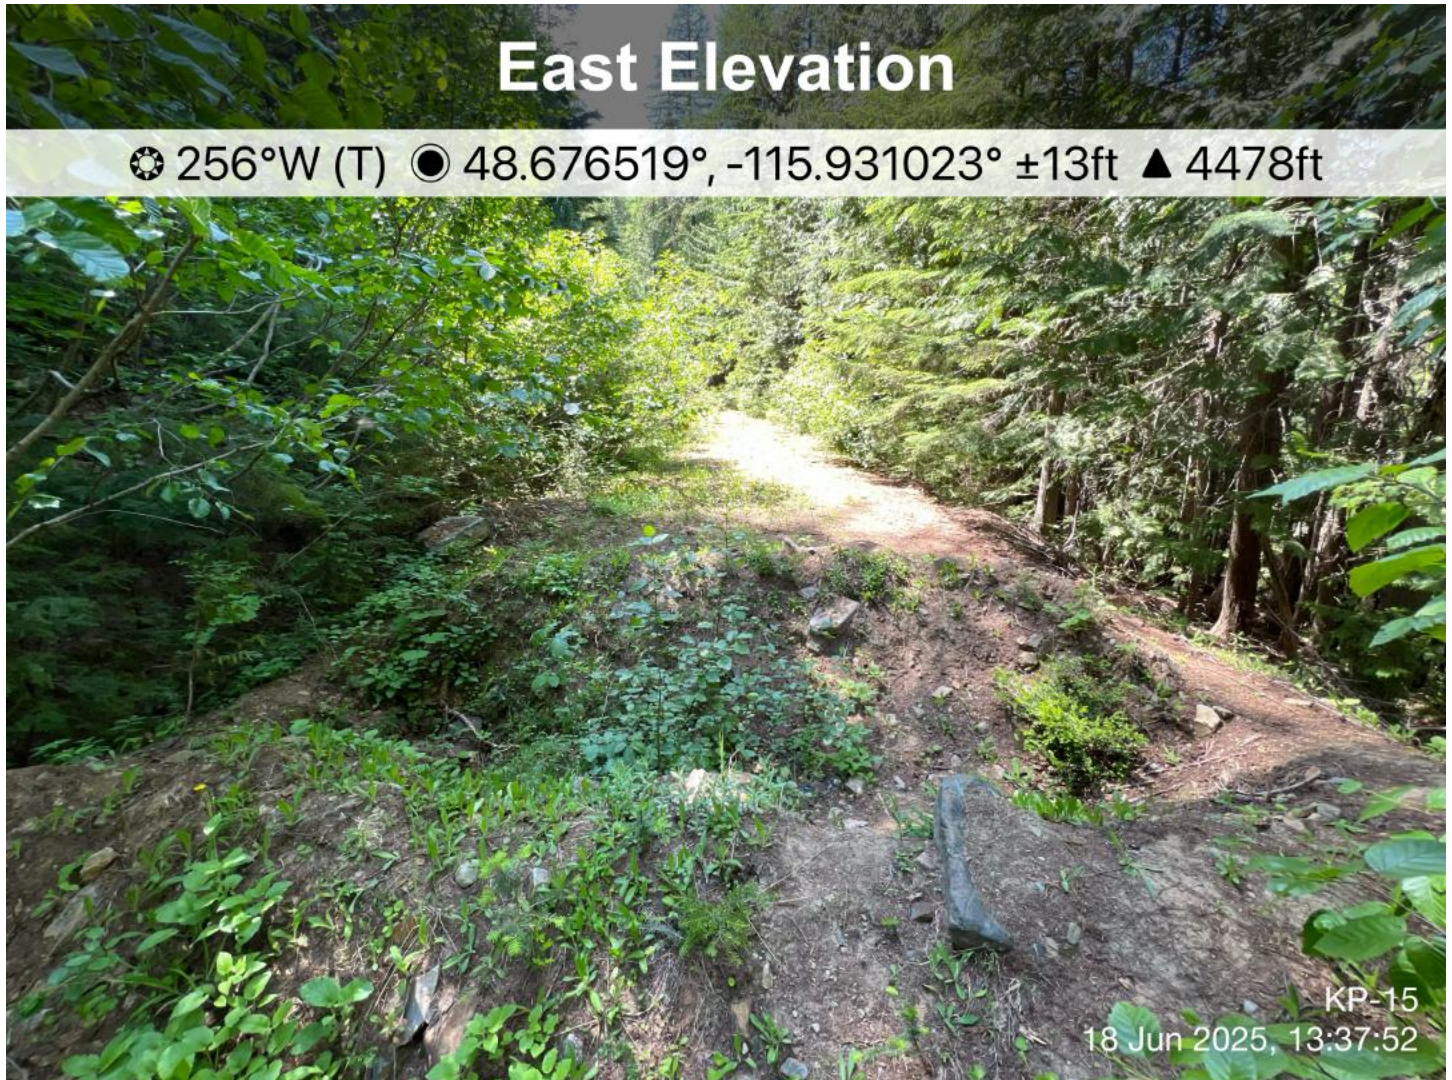
The old tank trap has a trail that accesses a hiking trail on the left. However, this trail allows access of two wheeled motor vehicles into core grizzly habitat.

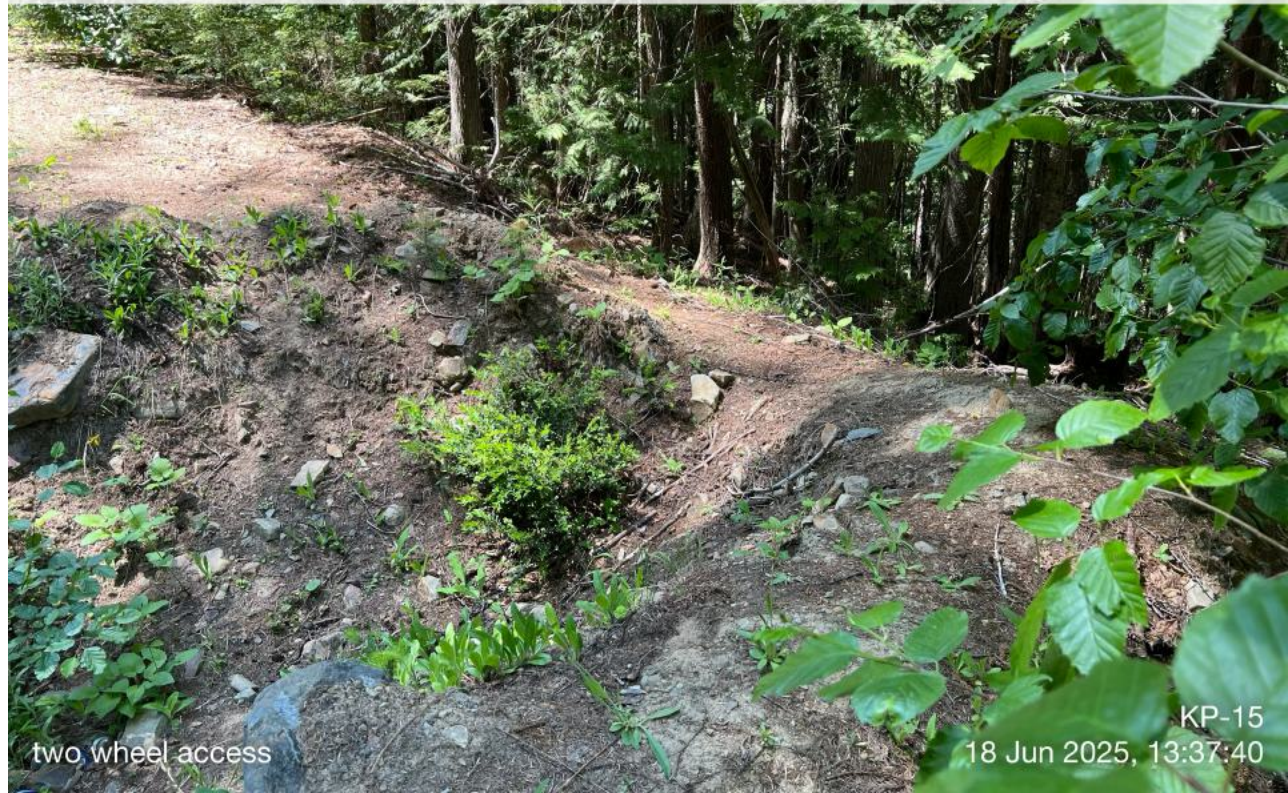
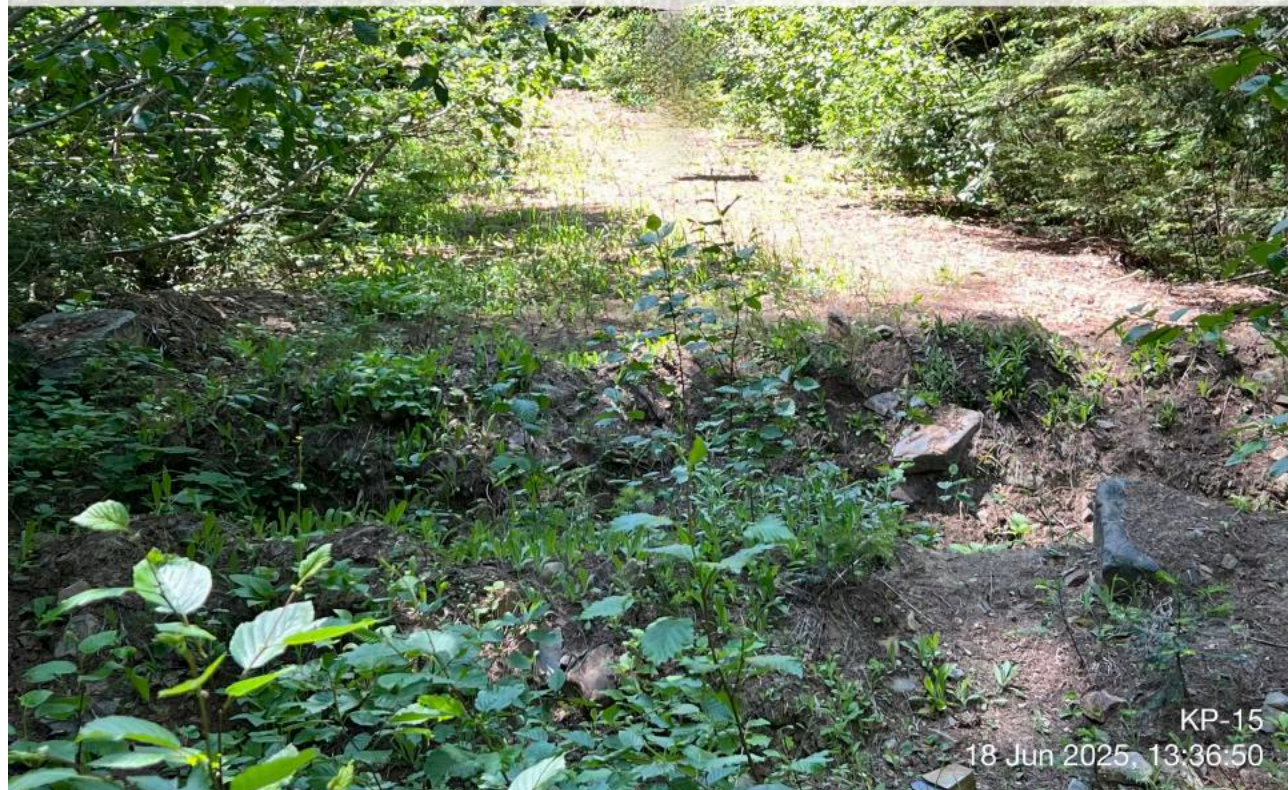
KP-15

two wheel access
