YAAK VALLEY FOREST COUNCIL

# Insufficient Grizzly Barrier Report

## 2020-2024

CYE BMUs 14-15

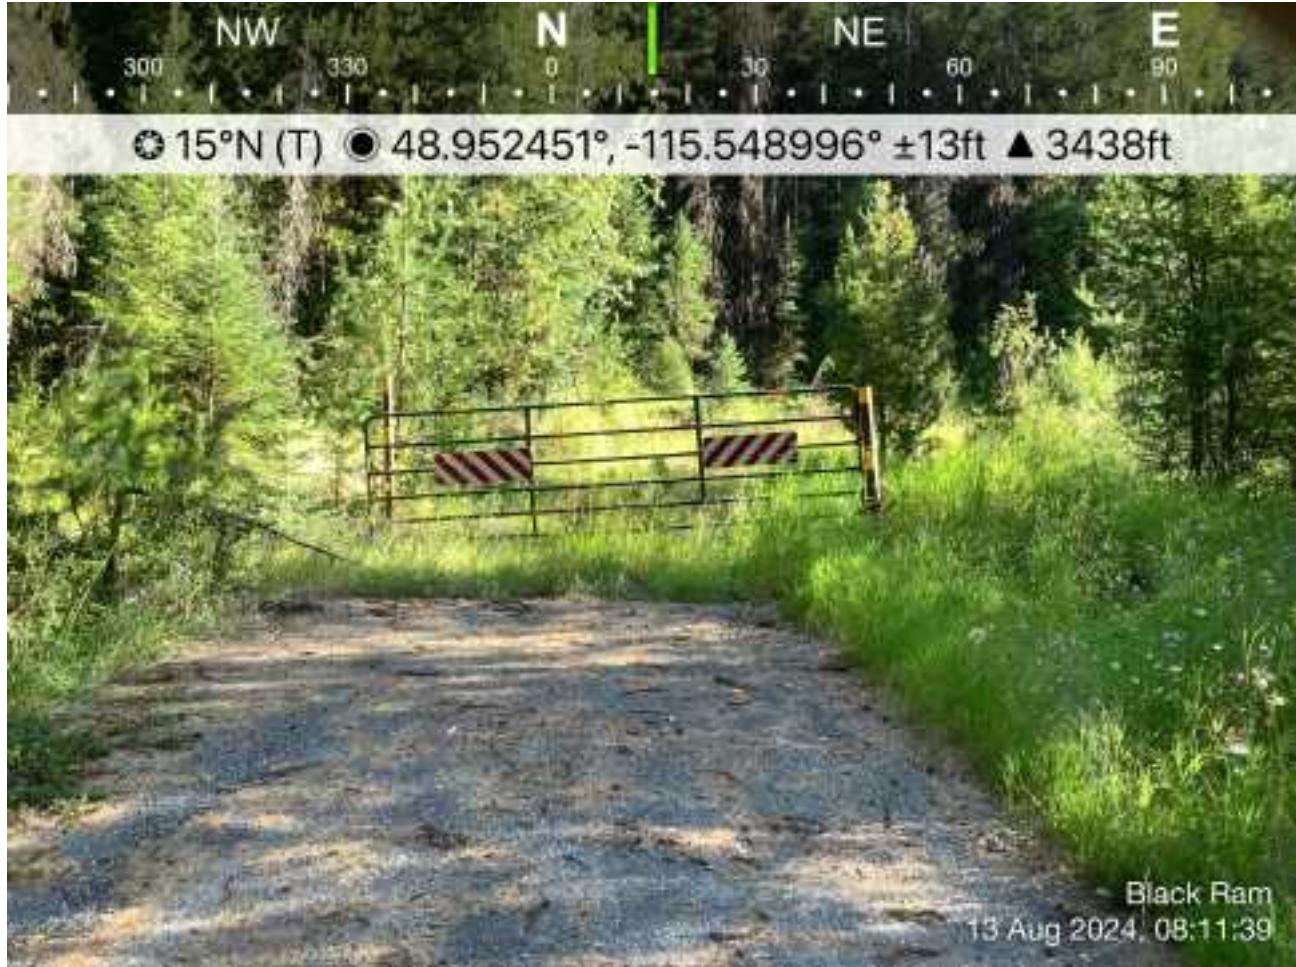
**BR 1- Coordinates: N 48.95251, W -115.54898**

Barrier ineffective 2024. There has been no visible recent activity behind the gate. A user-created

bypass is present on the left of the gate. The gap to the right of the gate is insufficient.

Remedy: berm or boulders.

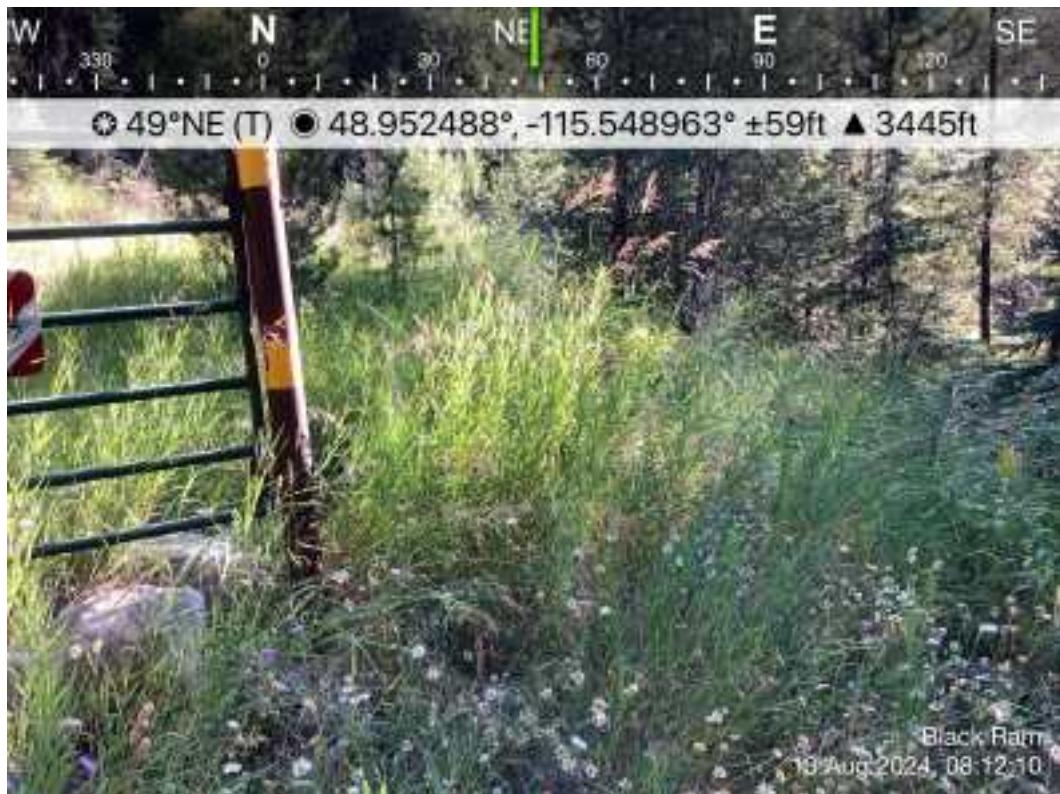
BR 1- Gate Right, passable with ATV/motorcycle

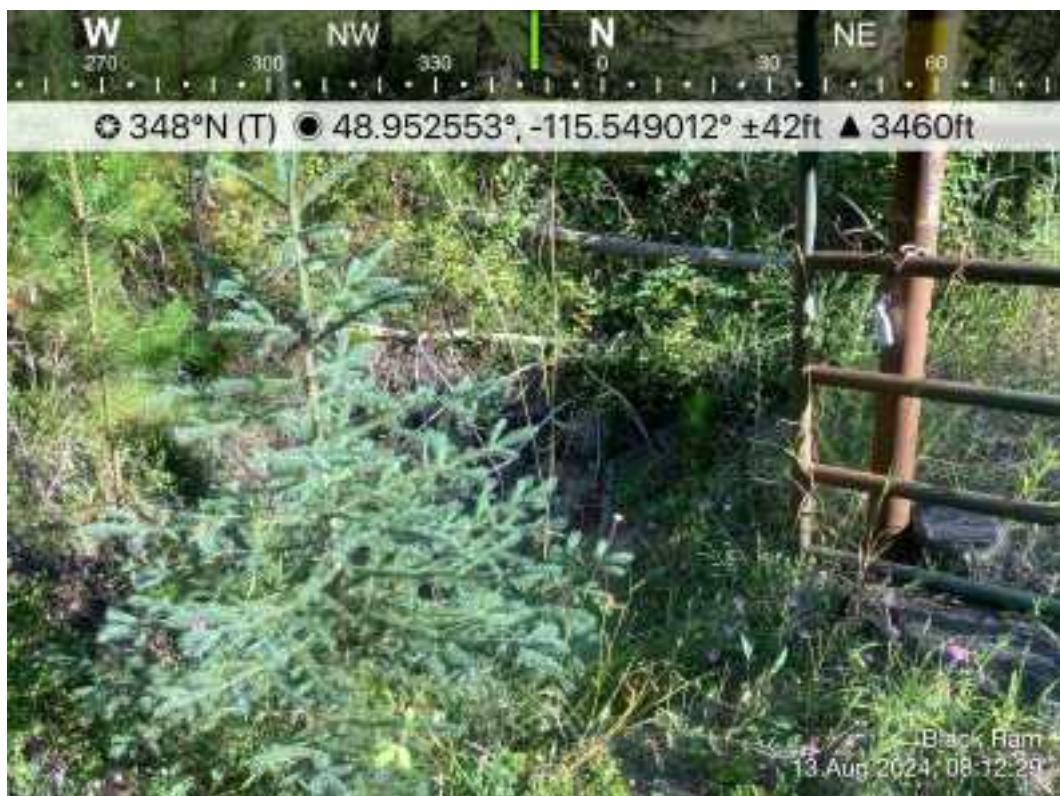
BR 1-Gate left

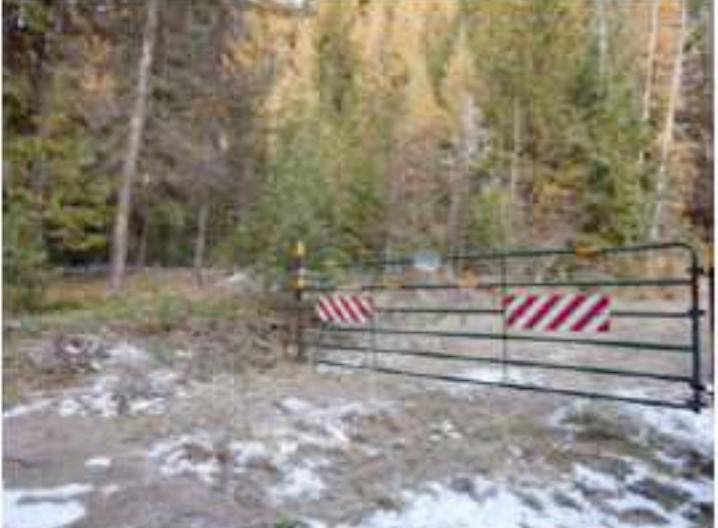
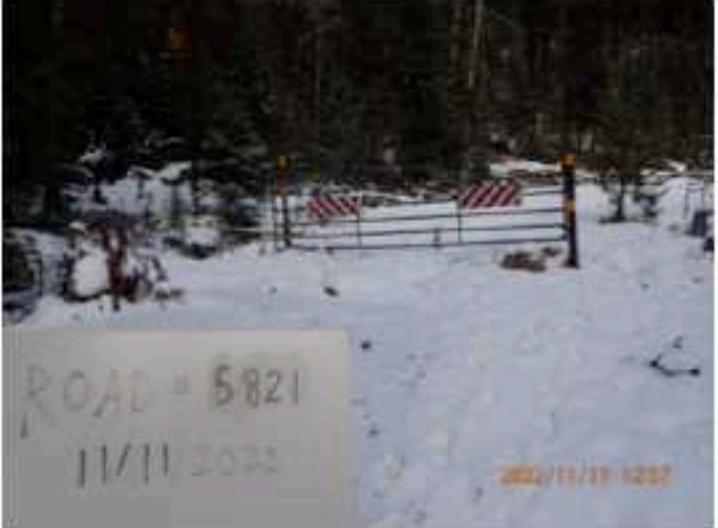
<p>ROAD # 5821 11/11/2022</p>

Site:	BR-1	
Road #, or description:	Road # 5821	
Coordinates:	48 57 08.4 / 115 32 56.4	
Site Notes:		
2020: Gate barrier. A user created bypass is located directly gate-left; approximately 8' wide passage with cleared/trampled vegetation. Grizzly bear tracks present in snow.

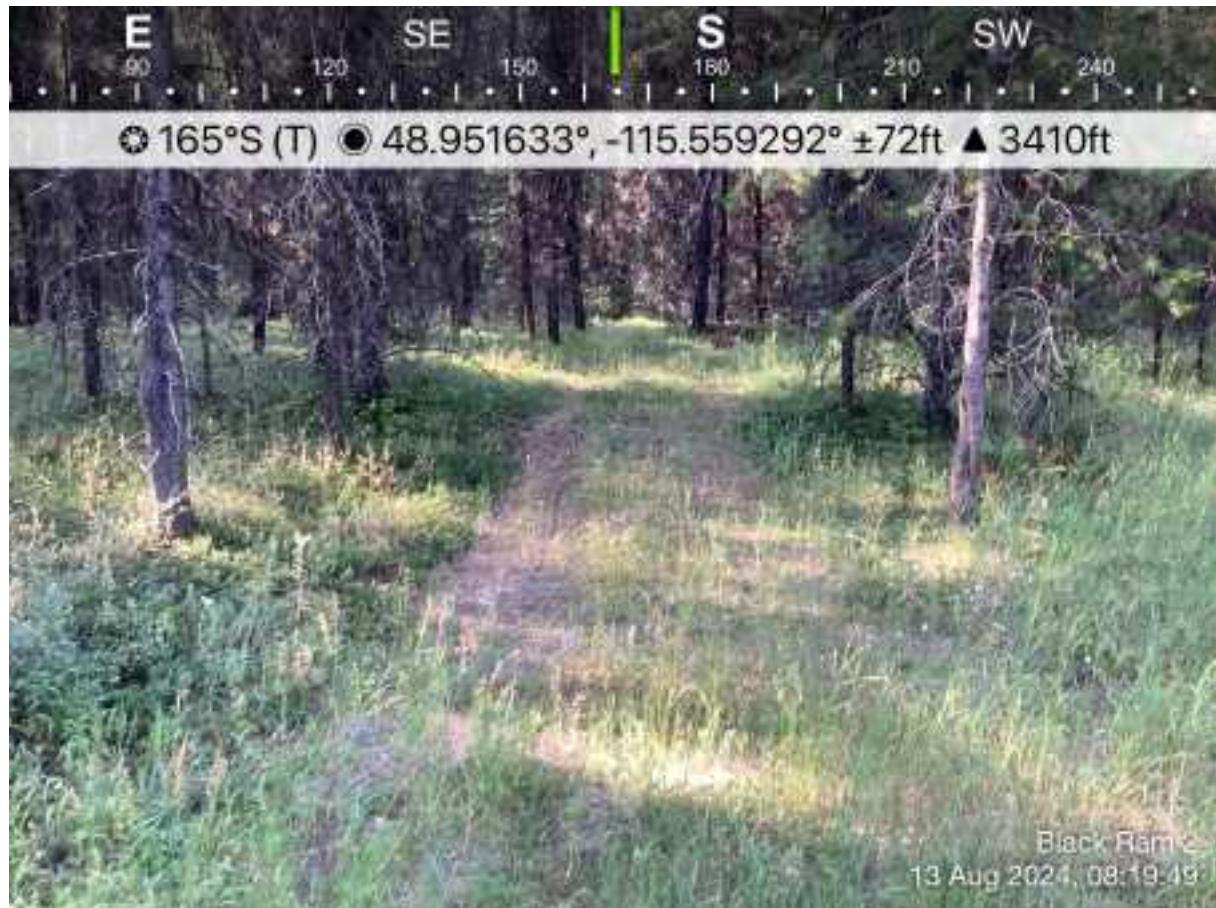
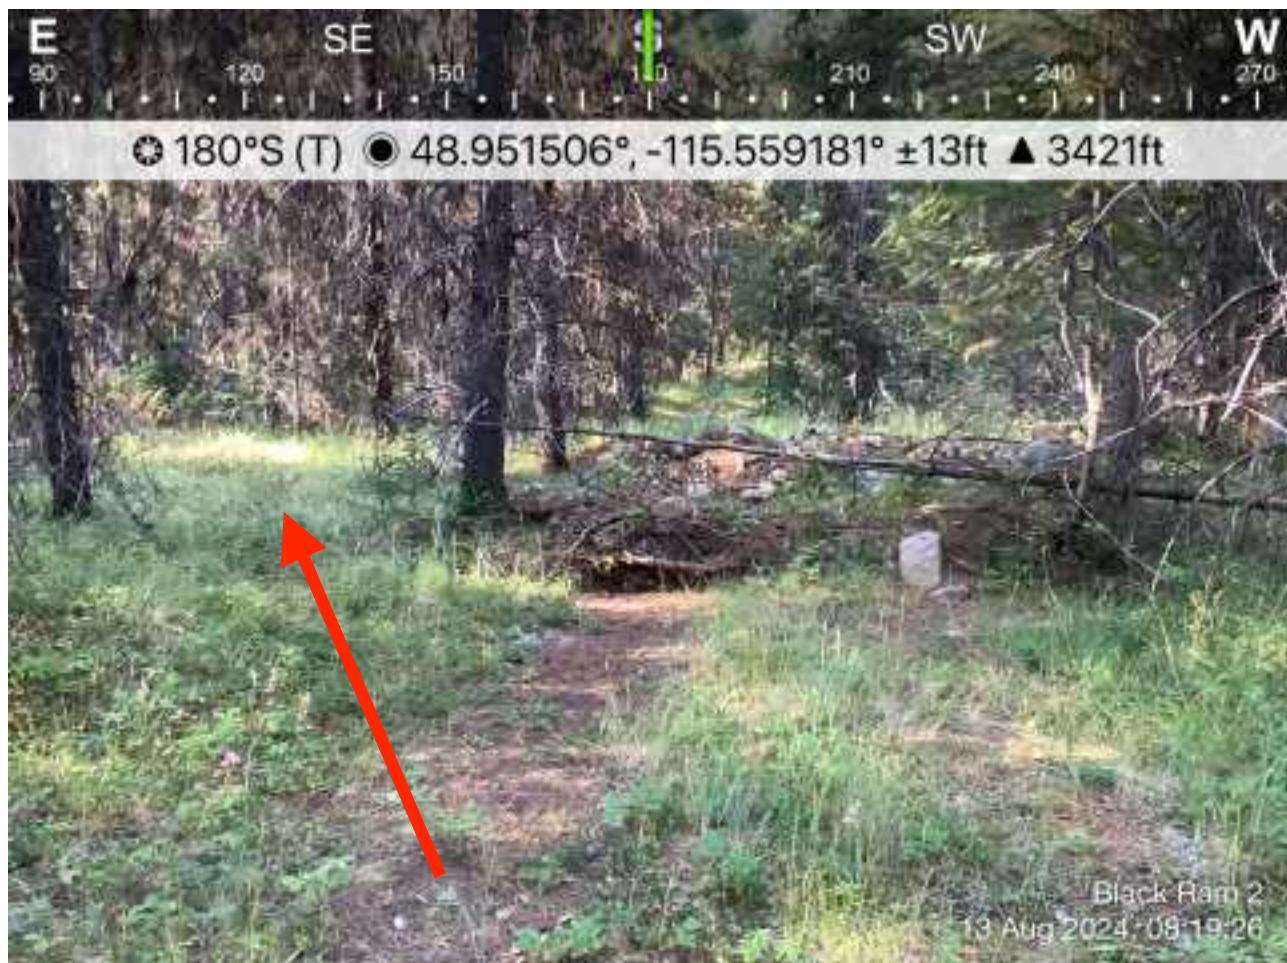
**BR 2- Coordinates: N 48.95161, W -115.55925**

Barrier ineffective 2024. No notable change since November 2023. Barrier (berm) easily passed. Evidence of new user-created trail bypassing current insufficient berm.

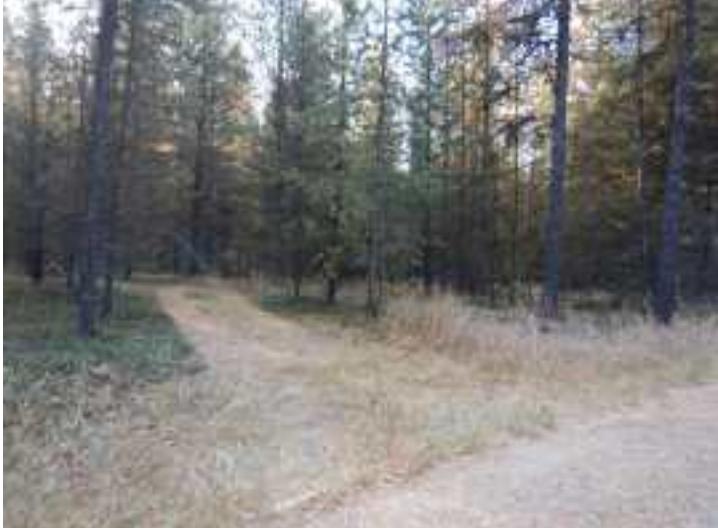
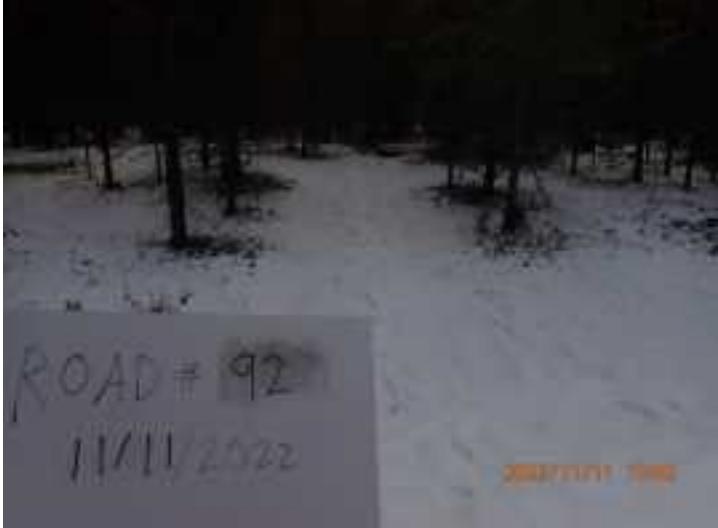
<b>Site:</b>	<b>BR-2</b>
<b>Road #, or description:</b>	unmapped user created road off of Highway 92
<b>Coordinates:</b>	48 57 05.8 / 115 33 33.3
<b>Site Notes:</b>	<p>2020: User-created road. Newberm installed-2021, can be bypassed to the barrier left and right. Takes off of highway 92, dropping down through the ditch and into a travel corridor through forest. Heavy tracksand rutting from motor-vehicle use. Miscellaneous litter along the travel corridor. Exceeds 300' in length.</p> <p>2022: This site has been bermed to prevent motor vehicle use since 2020. However, users have created a second path around the berm.</p>

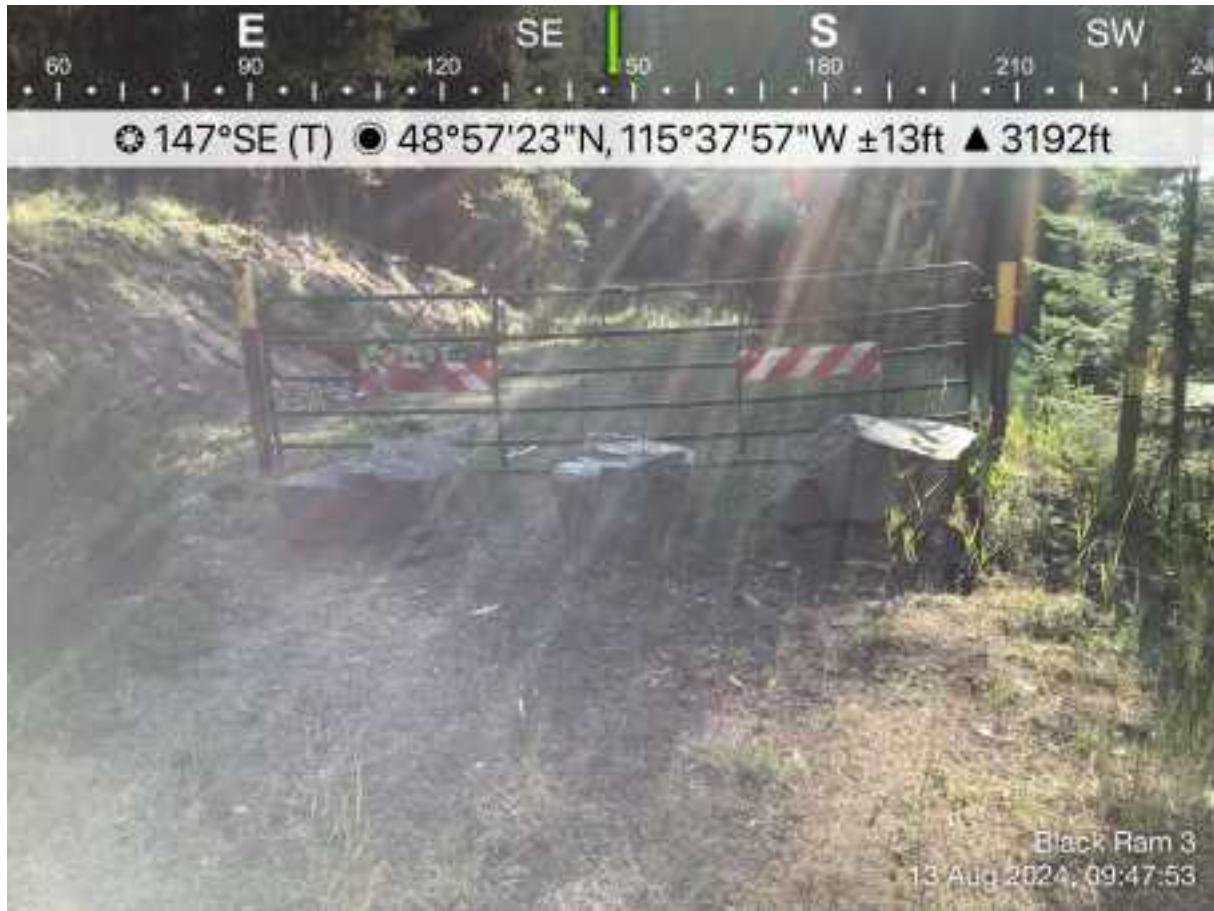
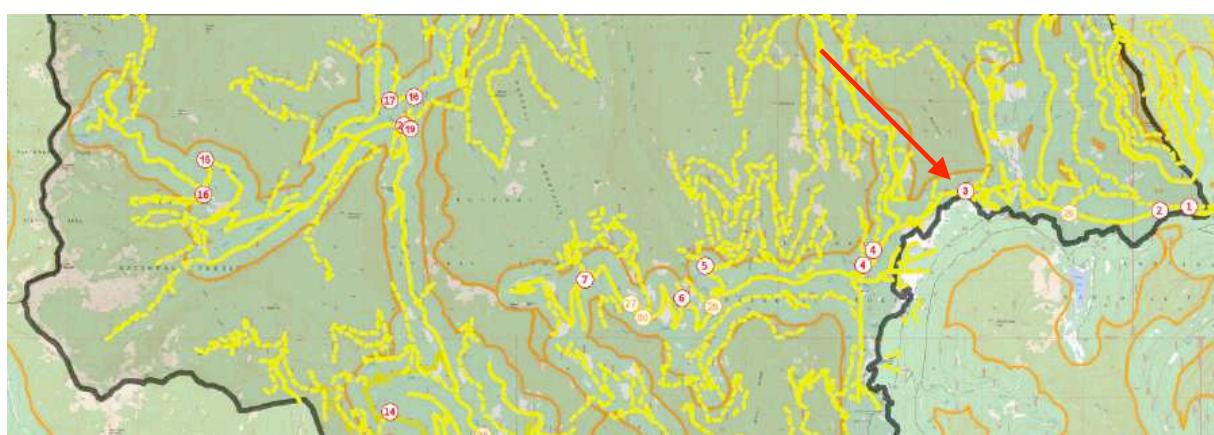
**BR 3- Coordinates: N 48.95650, W -115.63289**

Barrier ineffective 2024. Change noted in 2023, small boulders to the gate left. Easily moved/removed, easily bypassed.

Remedy - large immovable boulder placed left of the gate.

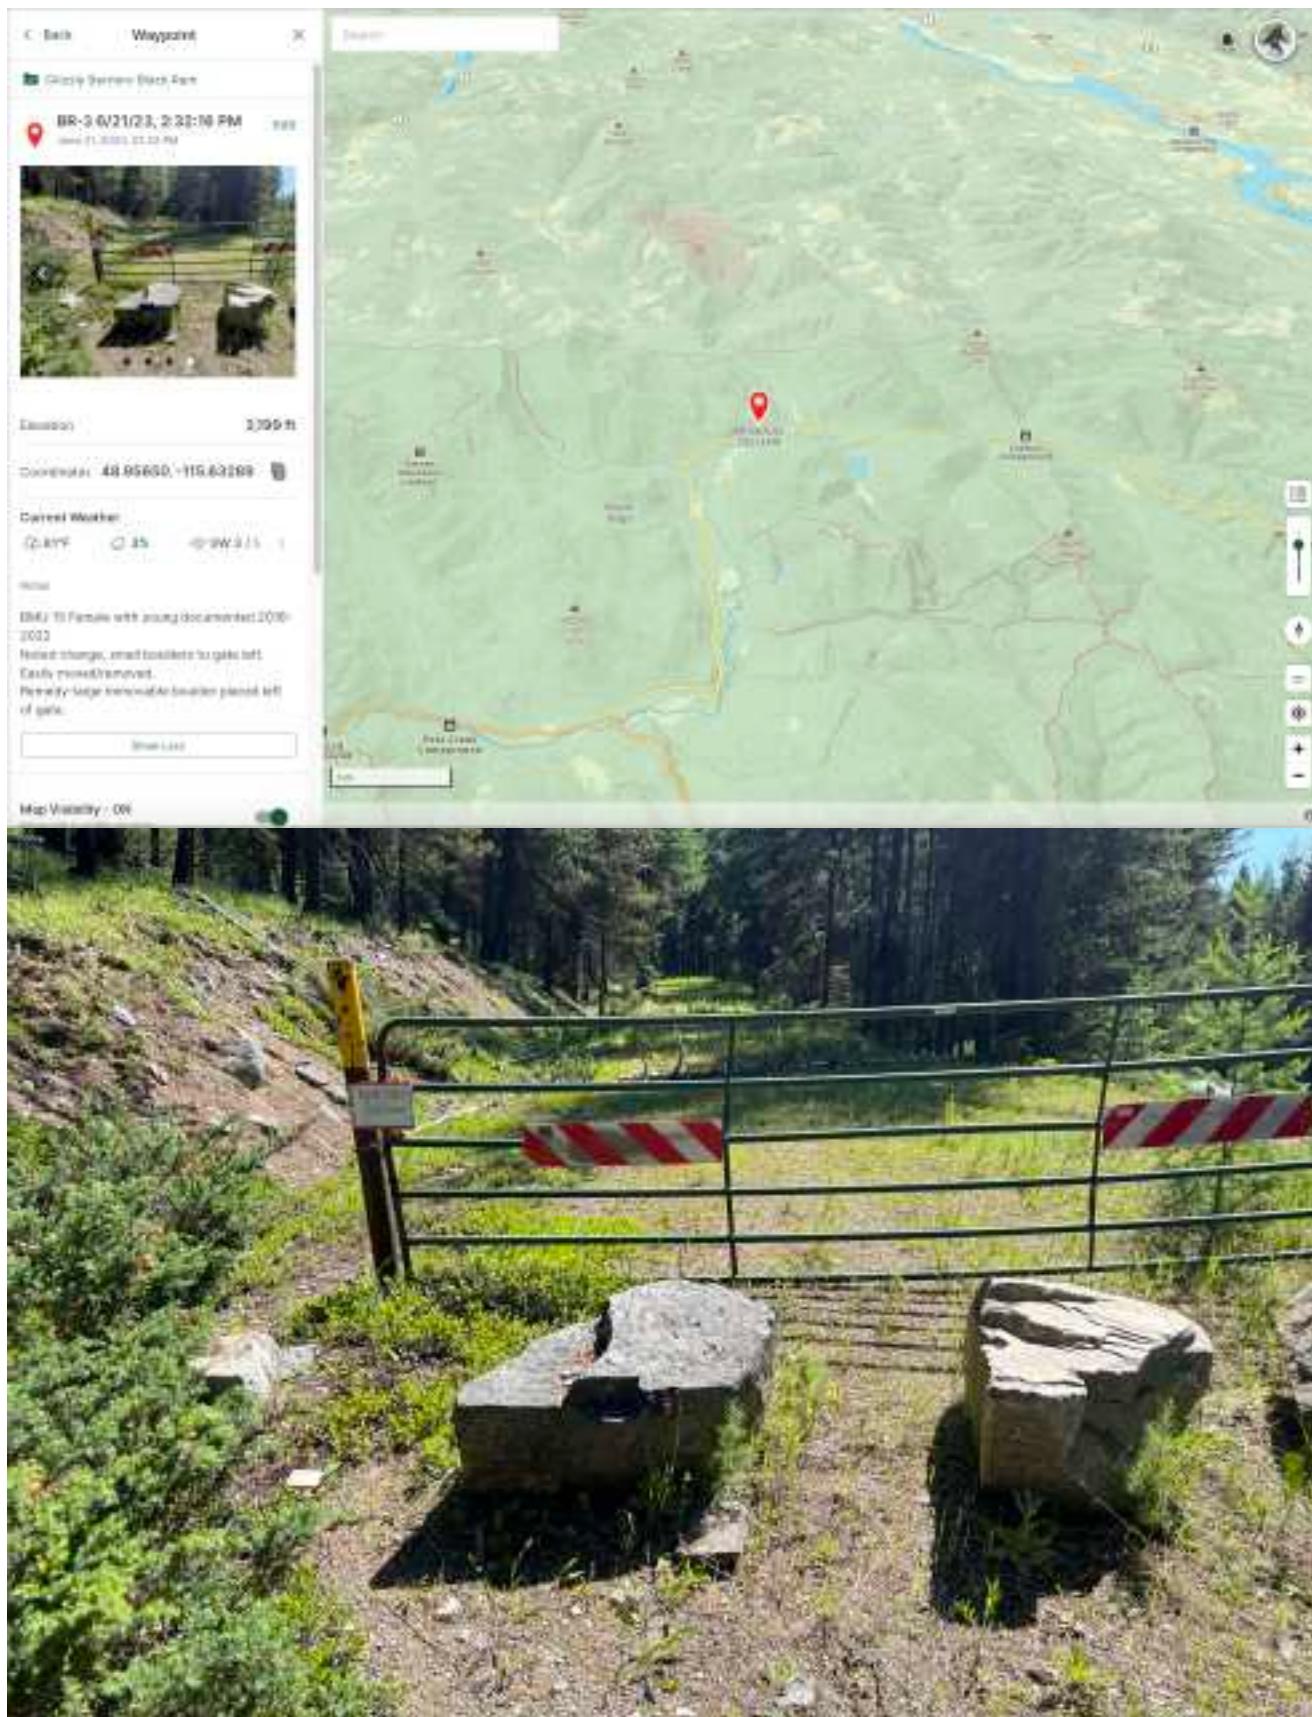
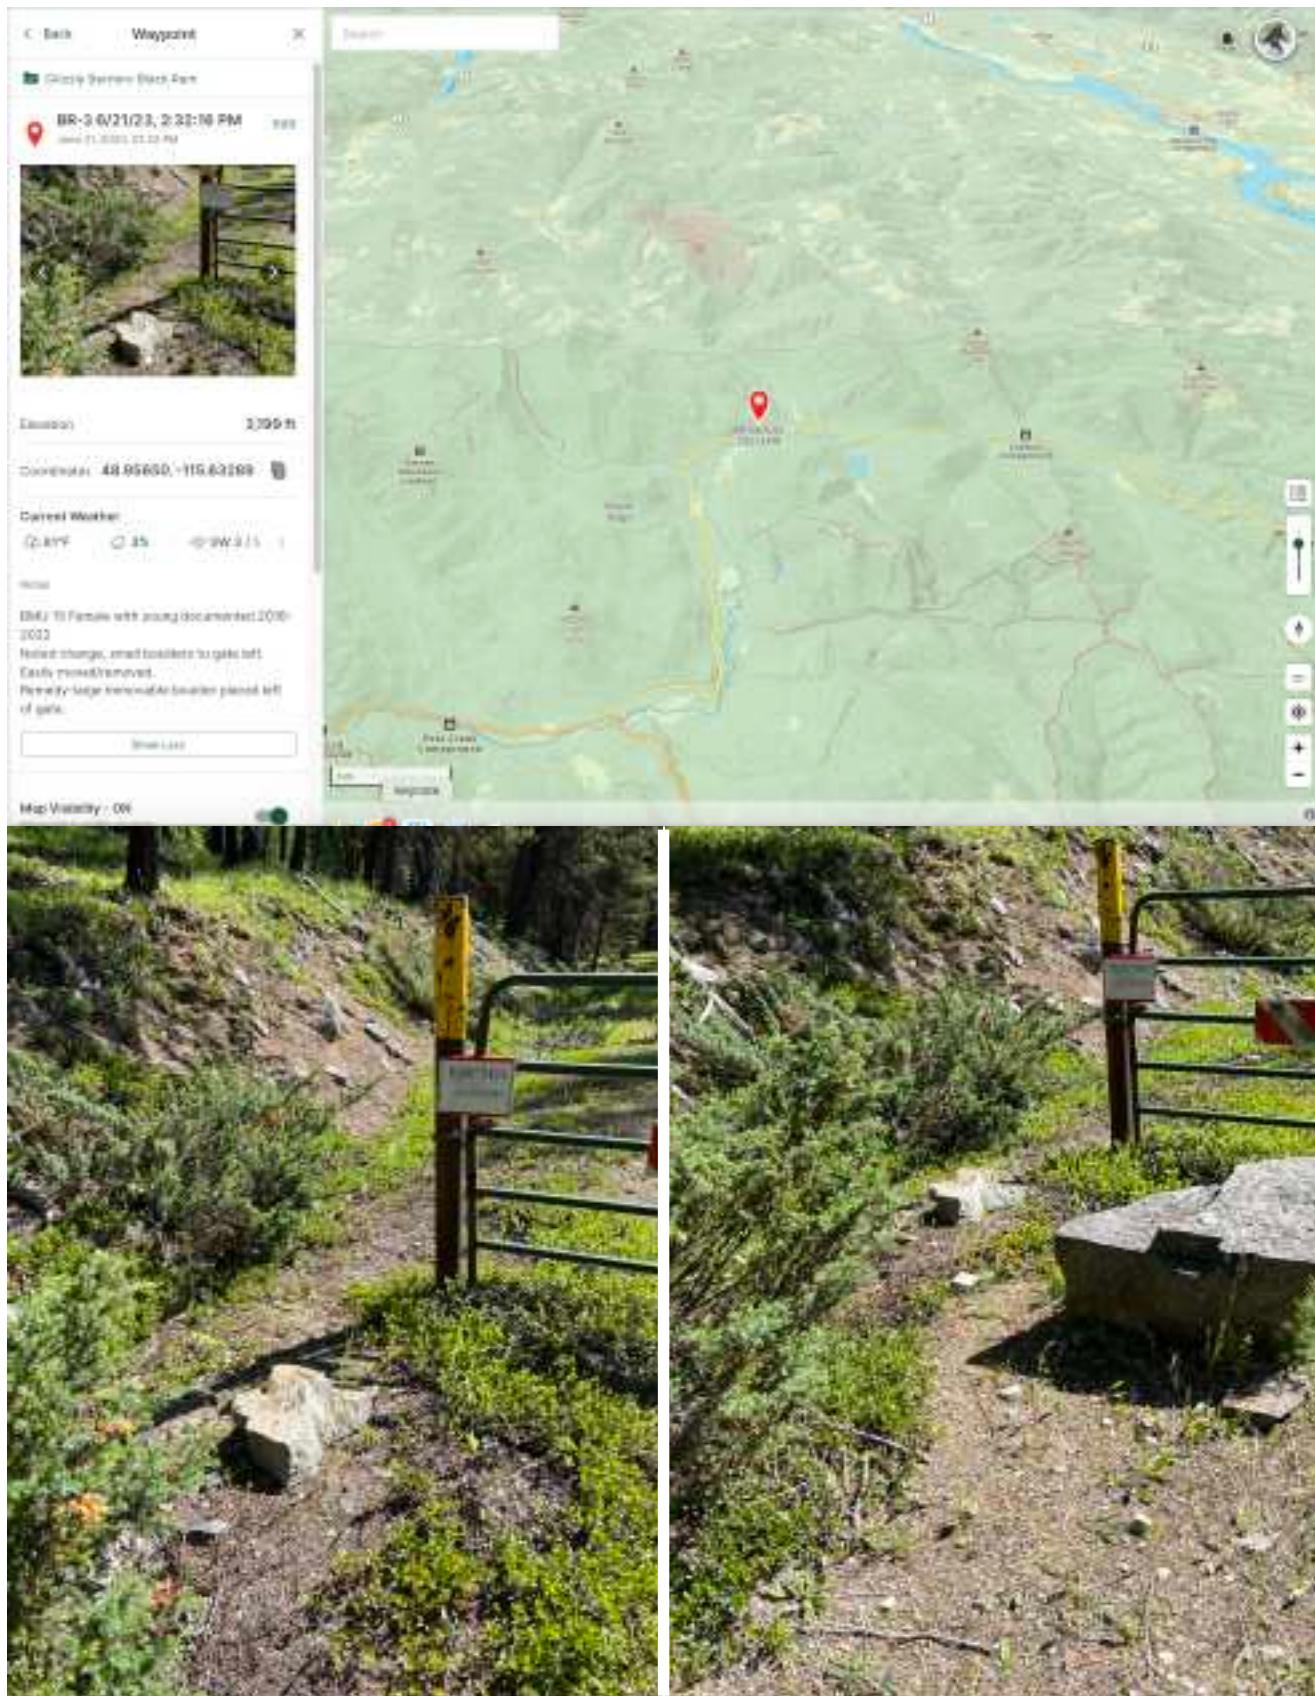
<b>Site:</b>	BR-3	
<b>Road #, or description:</b>	Road # 5835	
<b>Coordinates:</b>	48 57 23.4 / 115 37 58.4	
<b>Site Notes:</b>		
2020: Gate with small boulders. 5' wide passage directly to gate-left. Juniper shrub is not a sufficient barrier. Tire rutting and tracks behind the gate on the road bed, indicating illegal MV use.

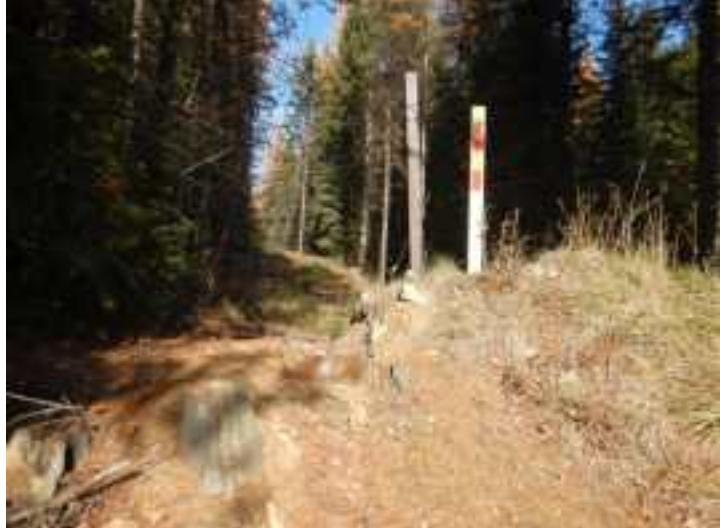
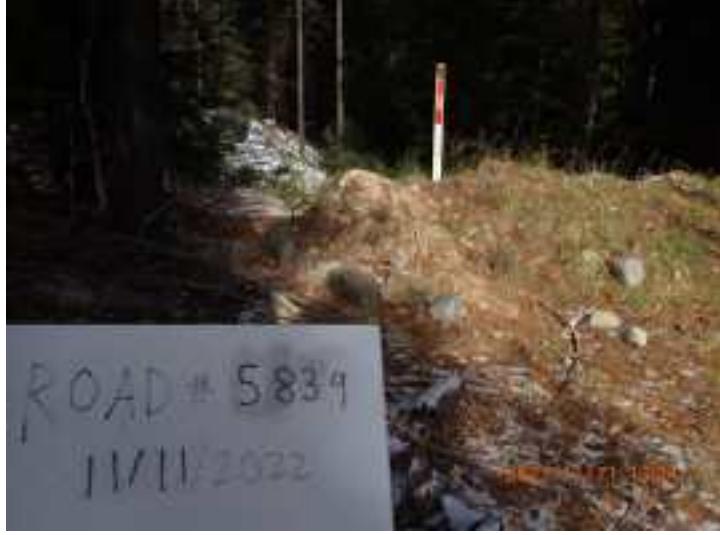
<b>Site:</b>	BR-4
<b>Road #, or description:</b>	Road # 5839
<b>Coordinates:</b>	48 56 18.9 / 115 40 10.4
<b>Site Notes:</b>	
<p>2020: Berm with signposts; no sign. A low spot passage through berm-left. Tire Ruts have reshaped the berm to be accessible via single-track /ATV.</p>

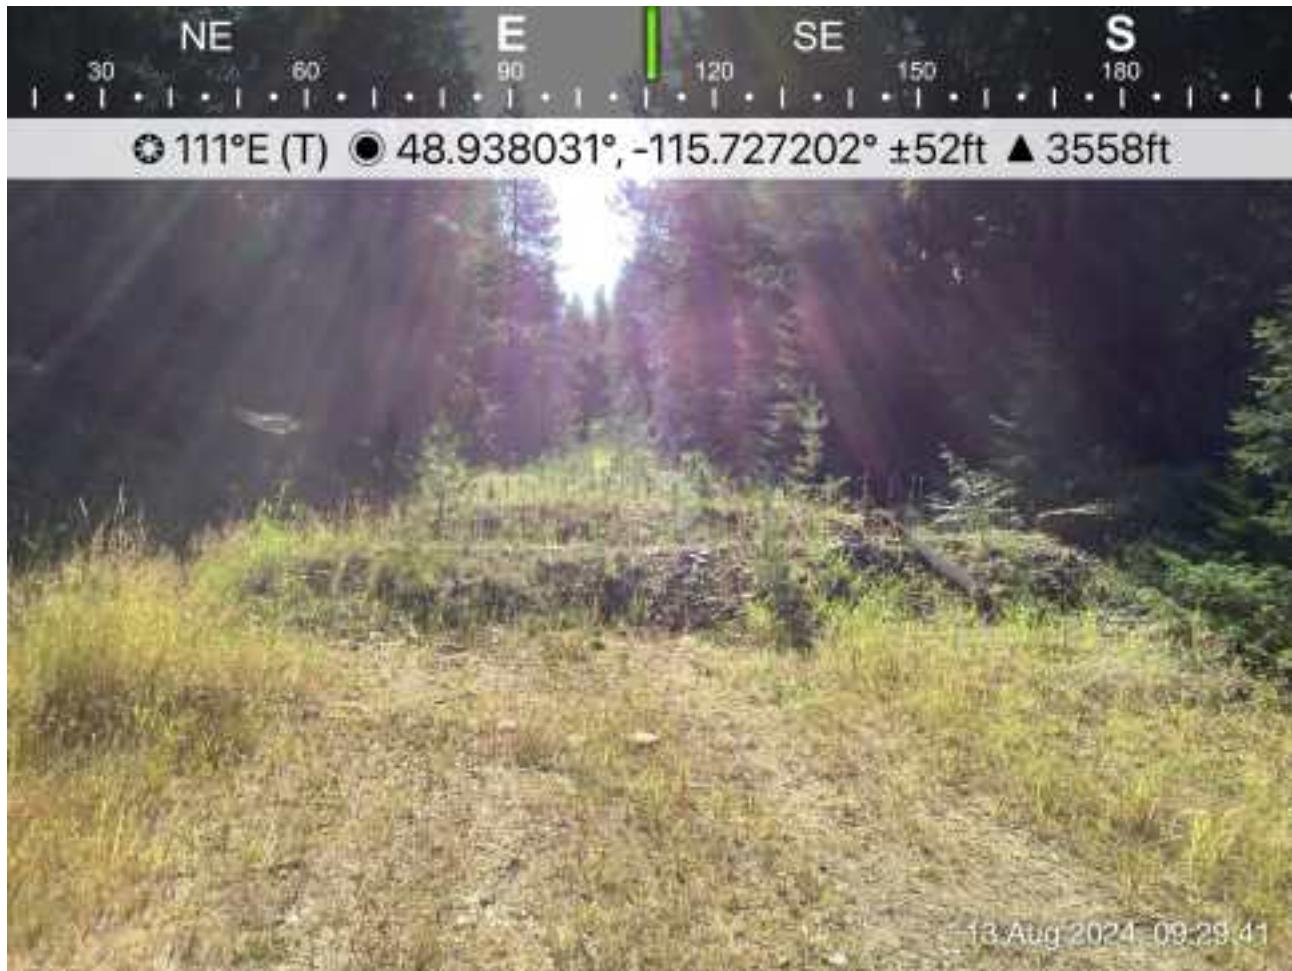
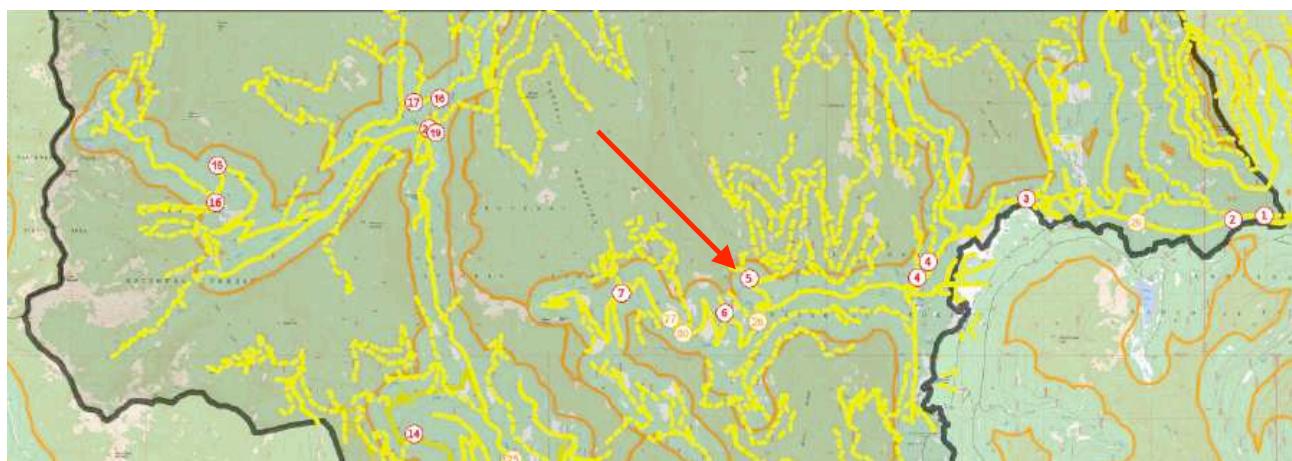
**BR 5**      **Coordinates N 48.93858, W -115.66956**

Barrier ineffective 2024. Insufficient berm. Tire tracks noted to the left of the berm, around the berm, in front of, and behind berm in 2023.

Remedy-increase berm with trench and add boulders.

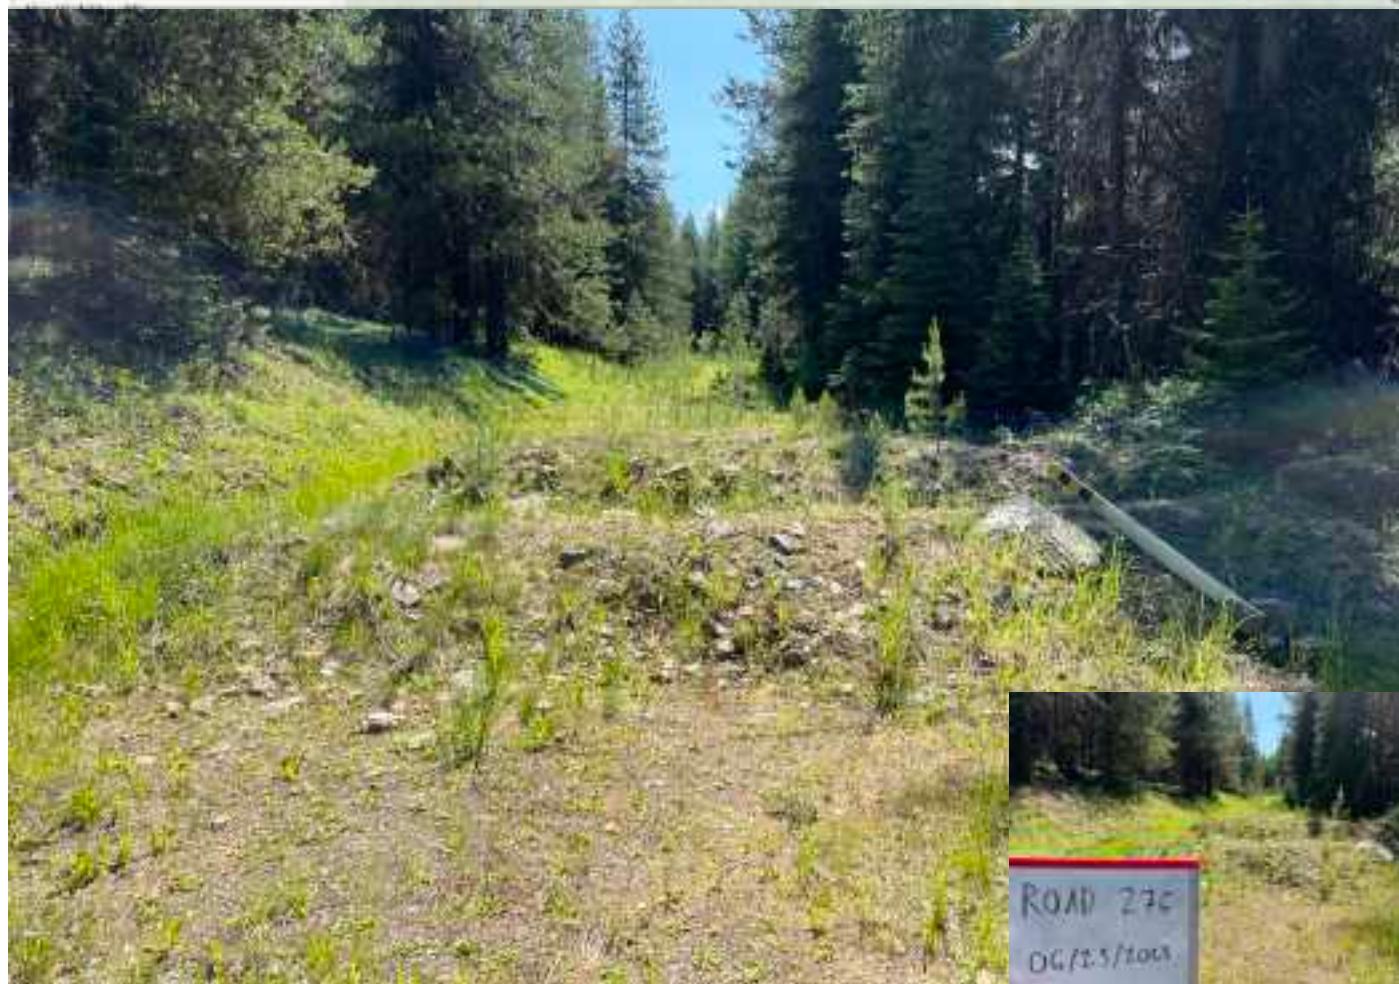
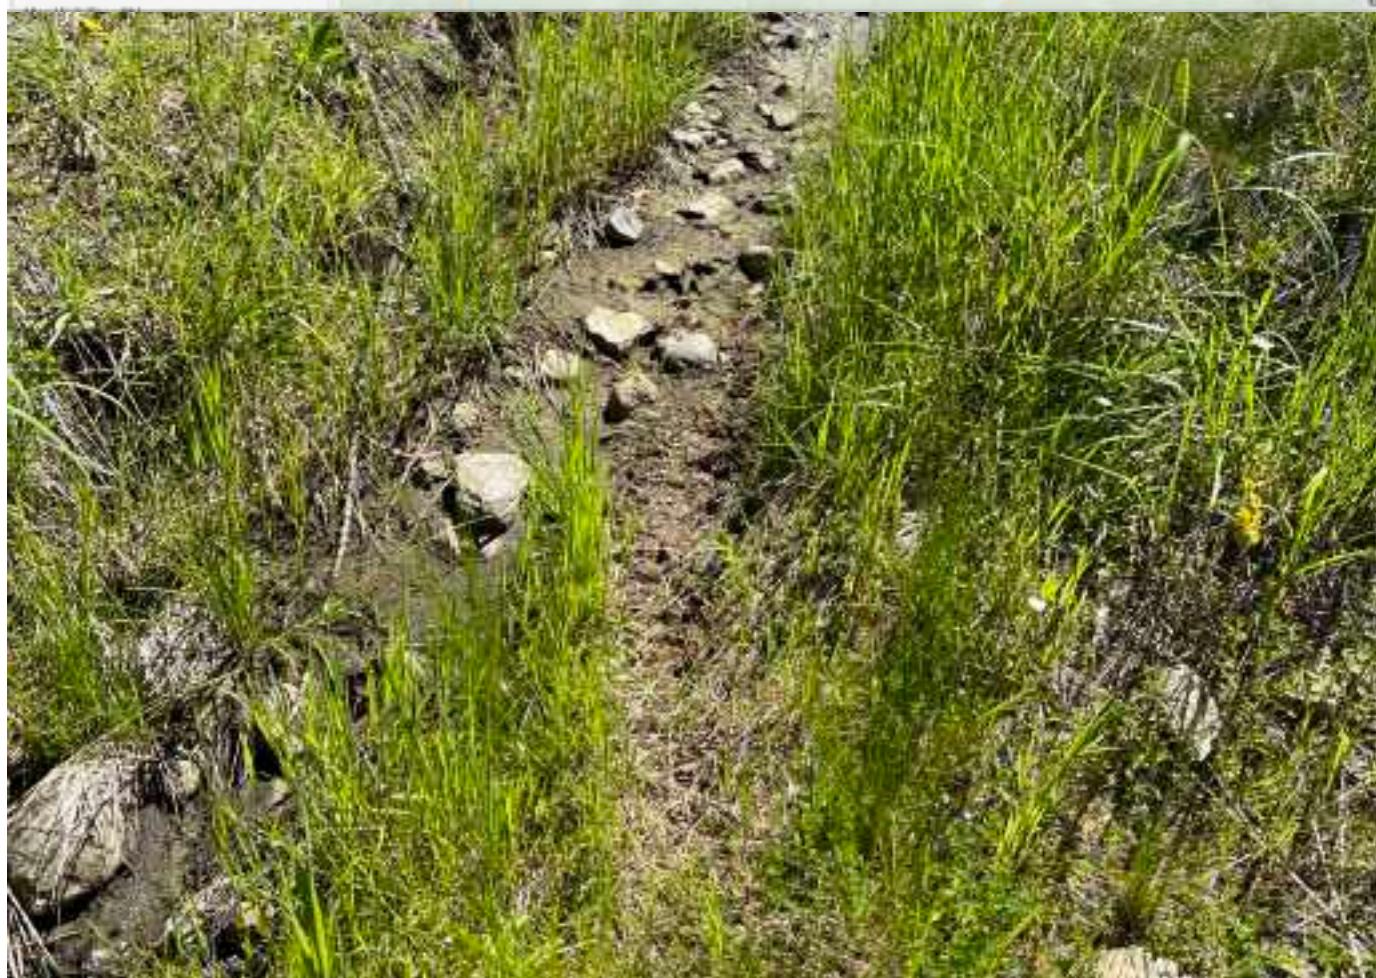
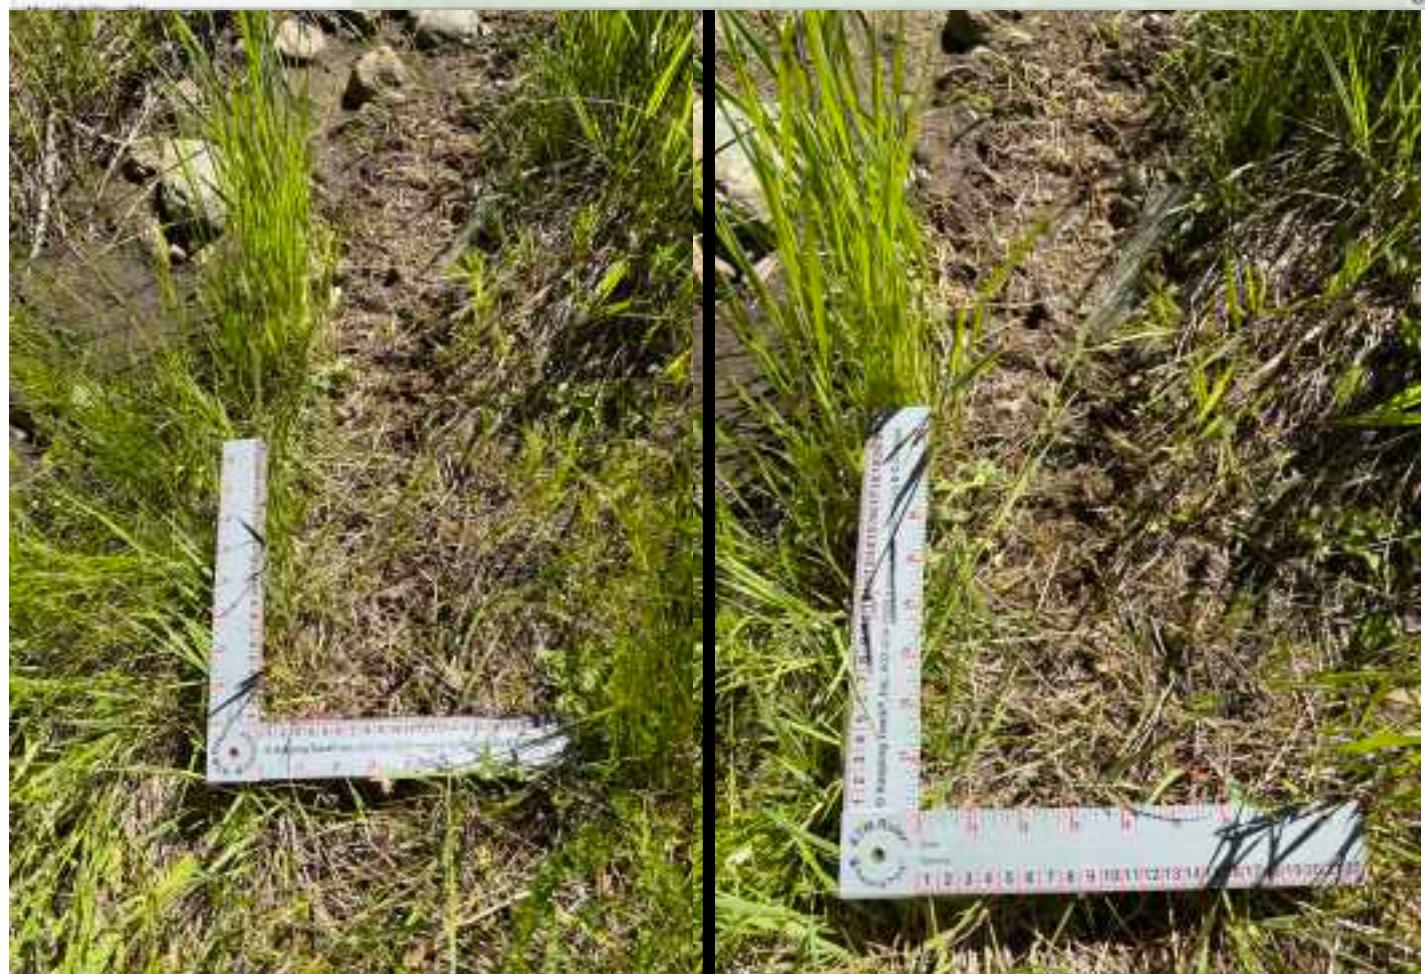
<b>Site:</b>	BR-5	
<b>Road #, or description:</b>	Road # 276	
<b>Coordinates:</b>	48 56 16.7 / 115 43 38.0	
<b>Site Notes:</b>		
2020: Berm with a 4' wide rutted passage through berm left. Looks as though it was possibly left open for ditch relief/drainage, but is being used by motor-vehicles to bypass barriers. Visible tire tracks in soil and grasses laid down from use.

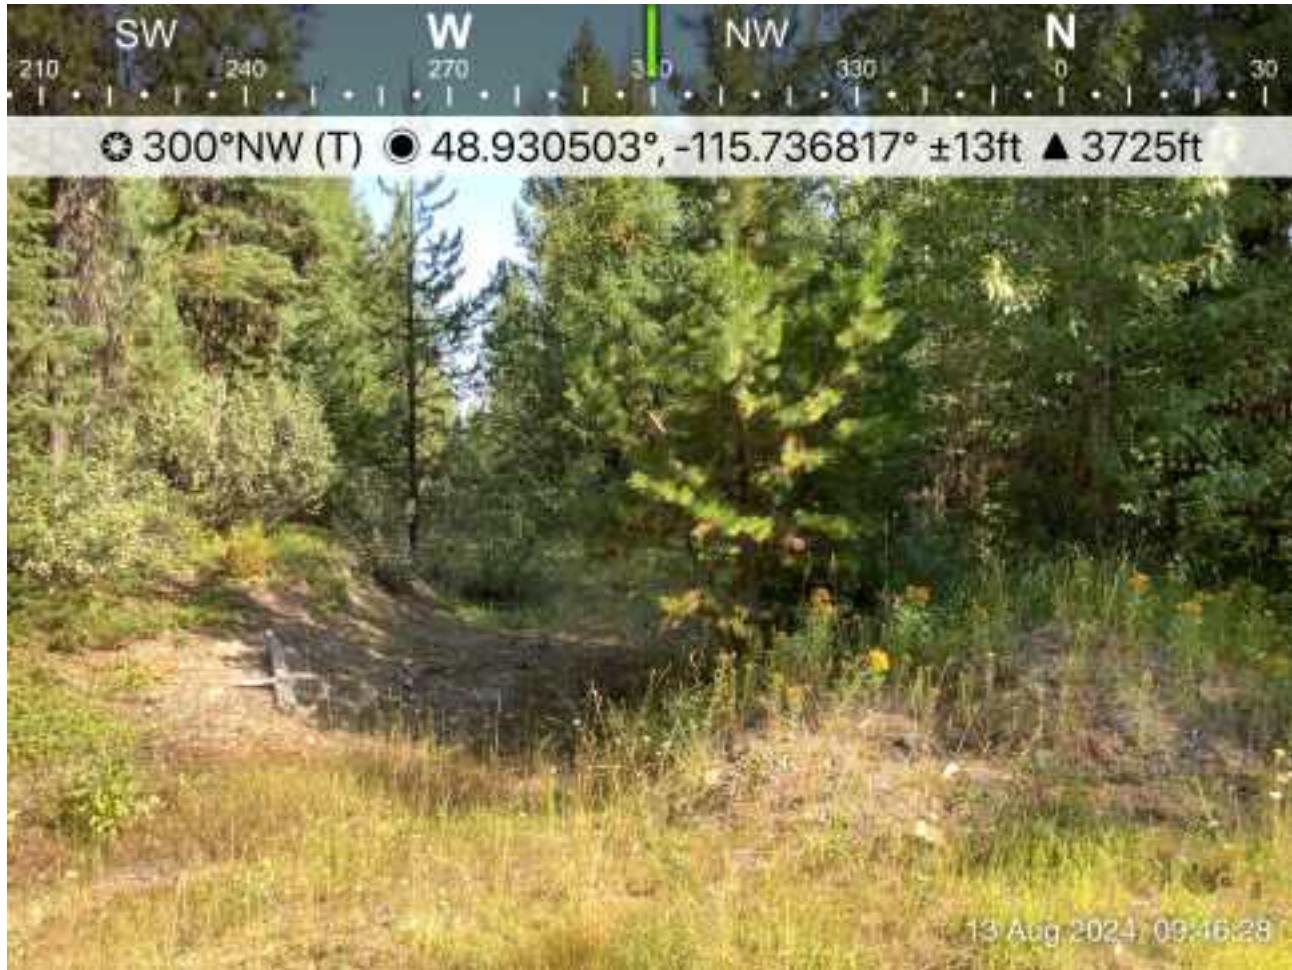
**BR 6**      **Coordinates N 48.93797, W -115.72722**

Recent rutting/tire tracks, potentially from a motorcycle visible 2023.

Remedy: Berm and or boulders or gate or all of the above.

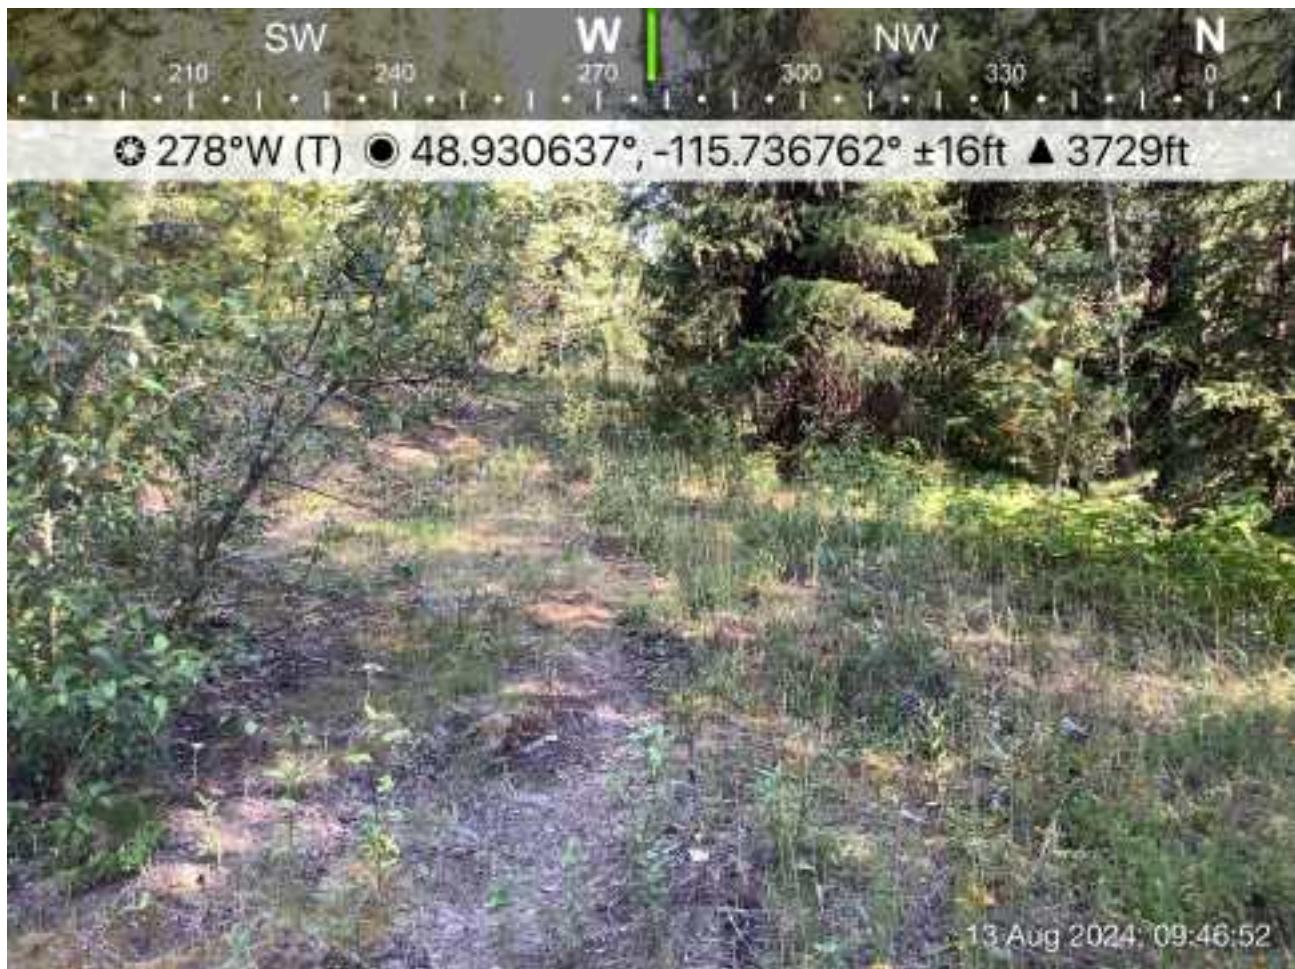
Road behind barrier is passable.
