YAAK VALLEY FOREST COUNCIL

# Insufficient Grizzly Barrier Report

## 2020-2024

CYE BMUs 14-15

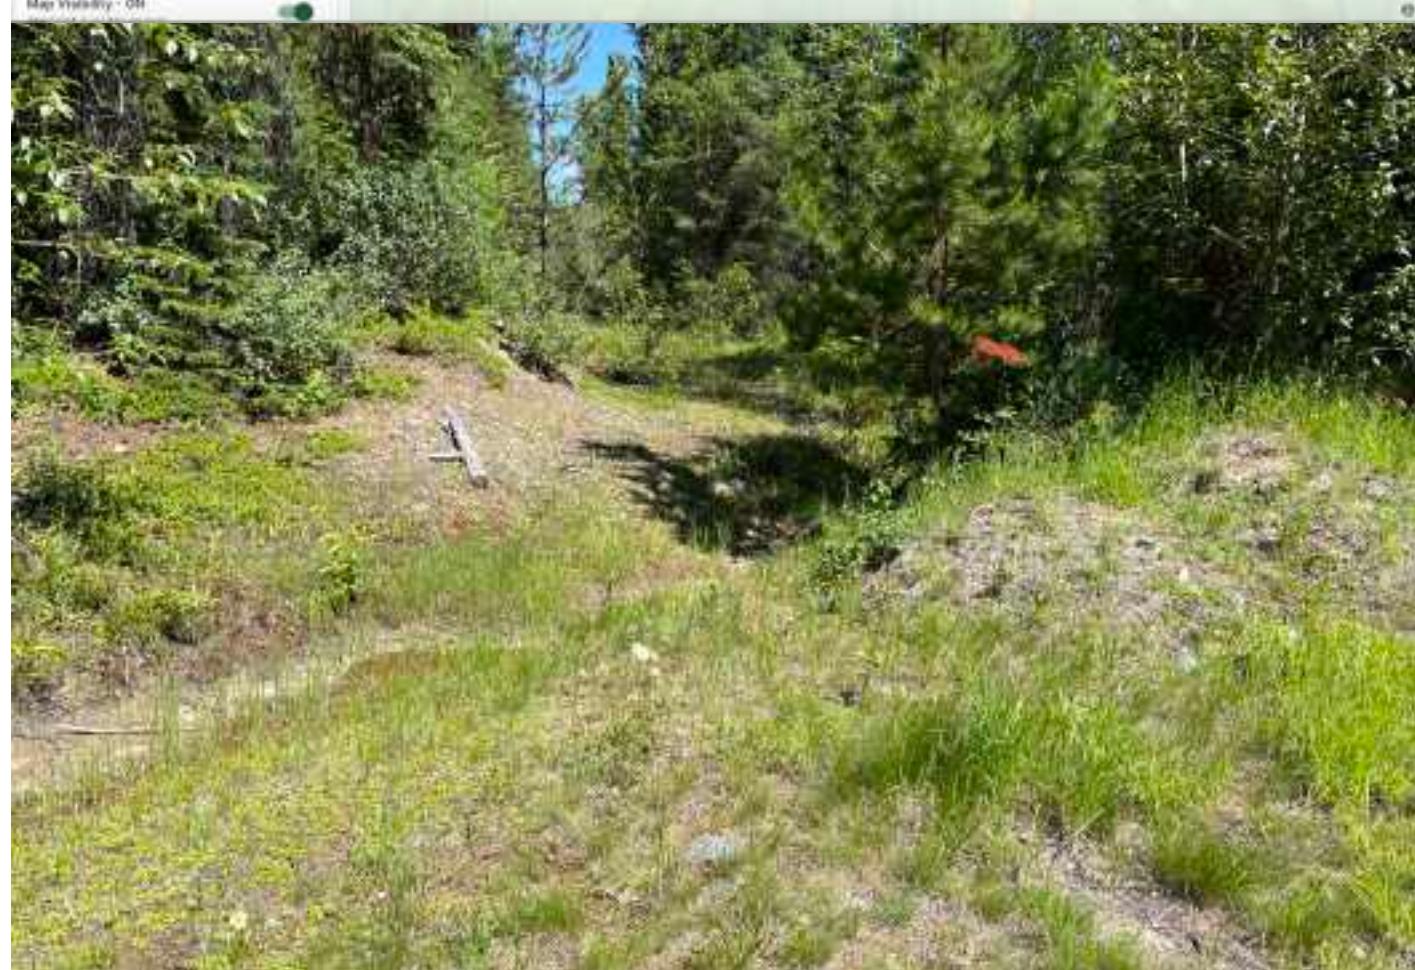
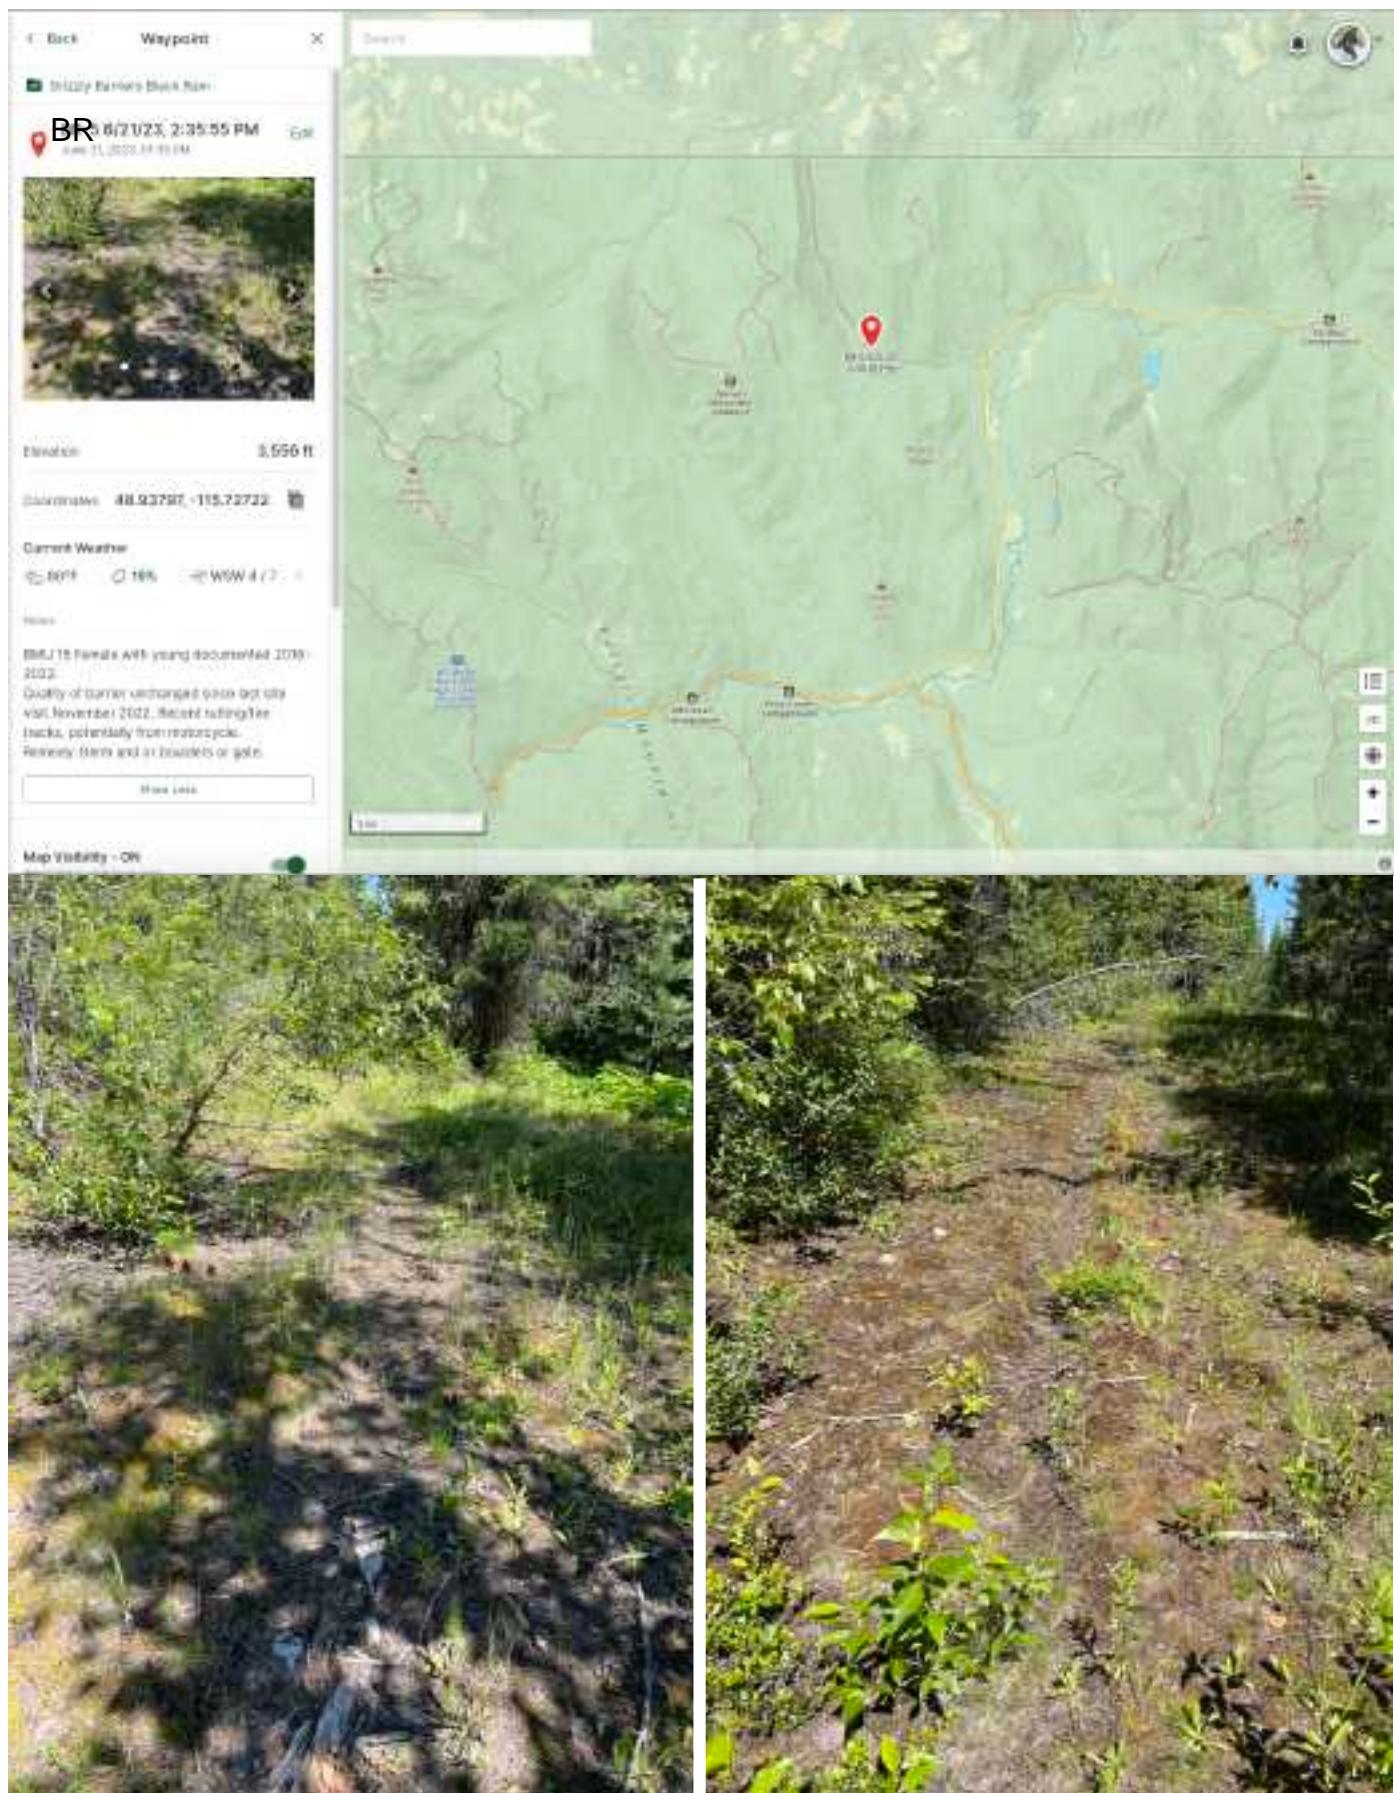
**BR 6**      **Coordinates N 48.93797, W -115.72722**

Barrier ineffective 2024. Quality of barrier is unchanged since the last site visit in November 2023.

Recent rutting/tire tracks, potentially from a motorcycle visible 2023.

Road behind barrier is passable.

Remedy: Berm and or boulders or gate or all of the above.

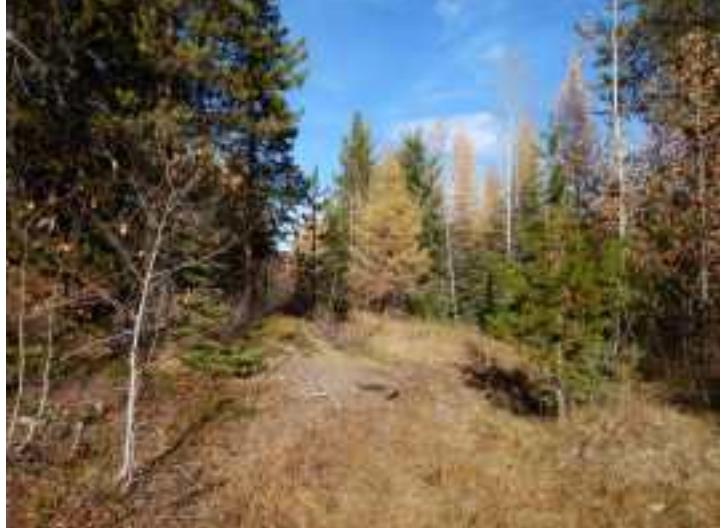
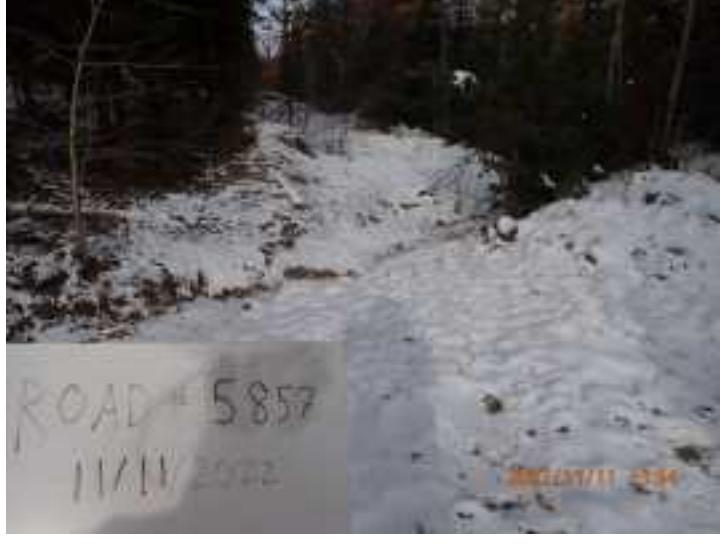
<b>Site:</b>	BR-6
<b>Road #, or description:</b>	(unmapped) User created road off of road # 5857
<b>Coordinates:</b>	48 55 49.5 / 115 44 12.1
<b>Site Notes:</b>	
<p>2020: Looks to have been bermed to the right of the user created road, but currently has no barrier to prevent passage. Tracks, rutting and signs of dispersed camping along the travel corridor. Full vehicle width</p>

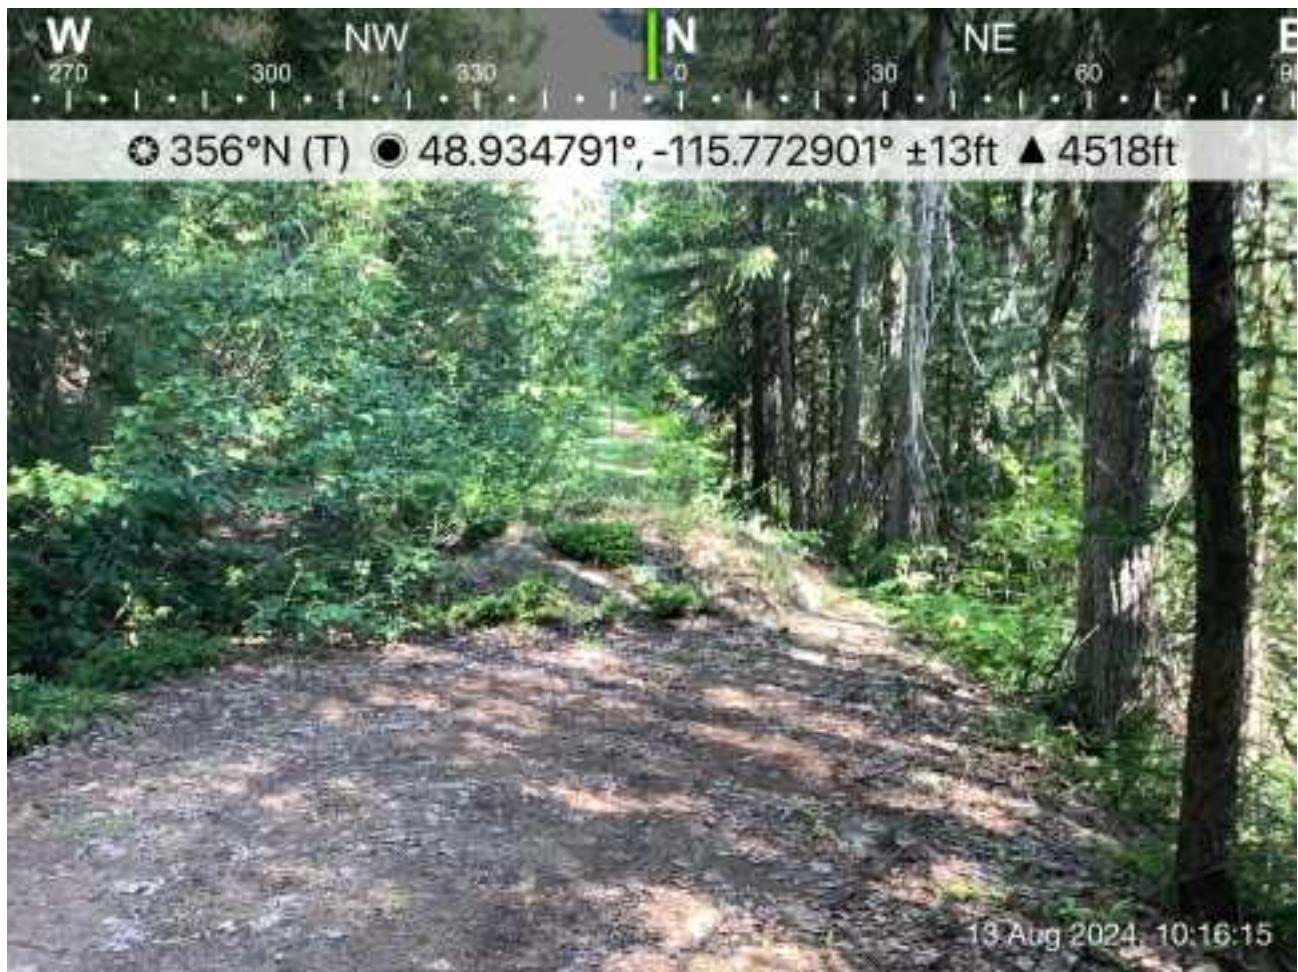
**BR 7**

Barrier ineffective 2024. No change to barrier since November 2023, no obvious recent use but still open access. Motorcycle tracks present in 2023.

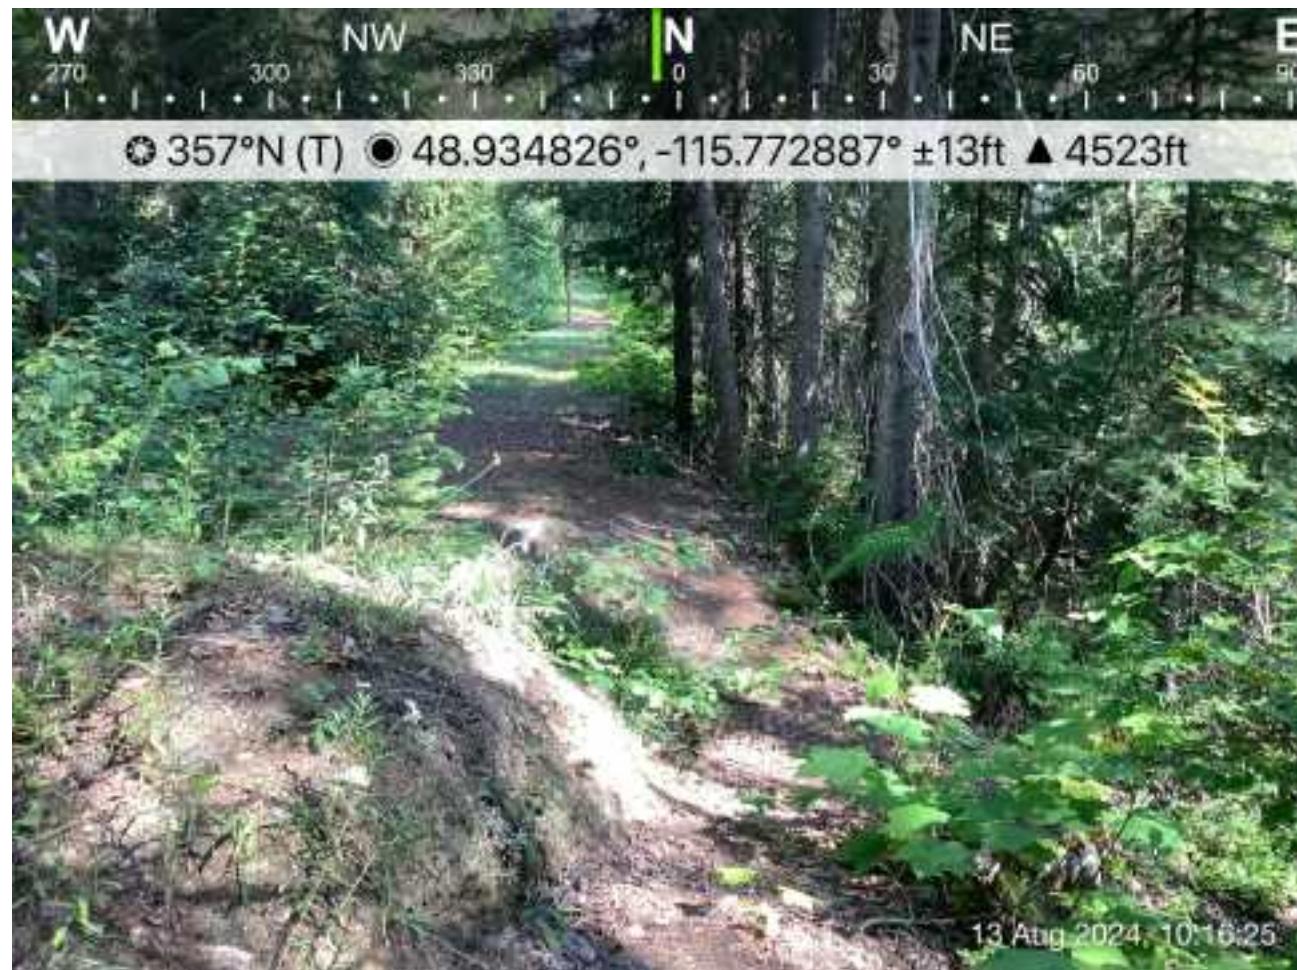
Barrier passable by ATV or motorcycle.

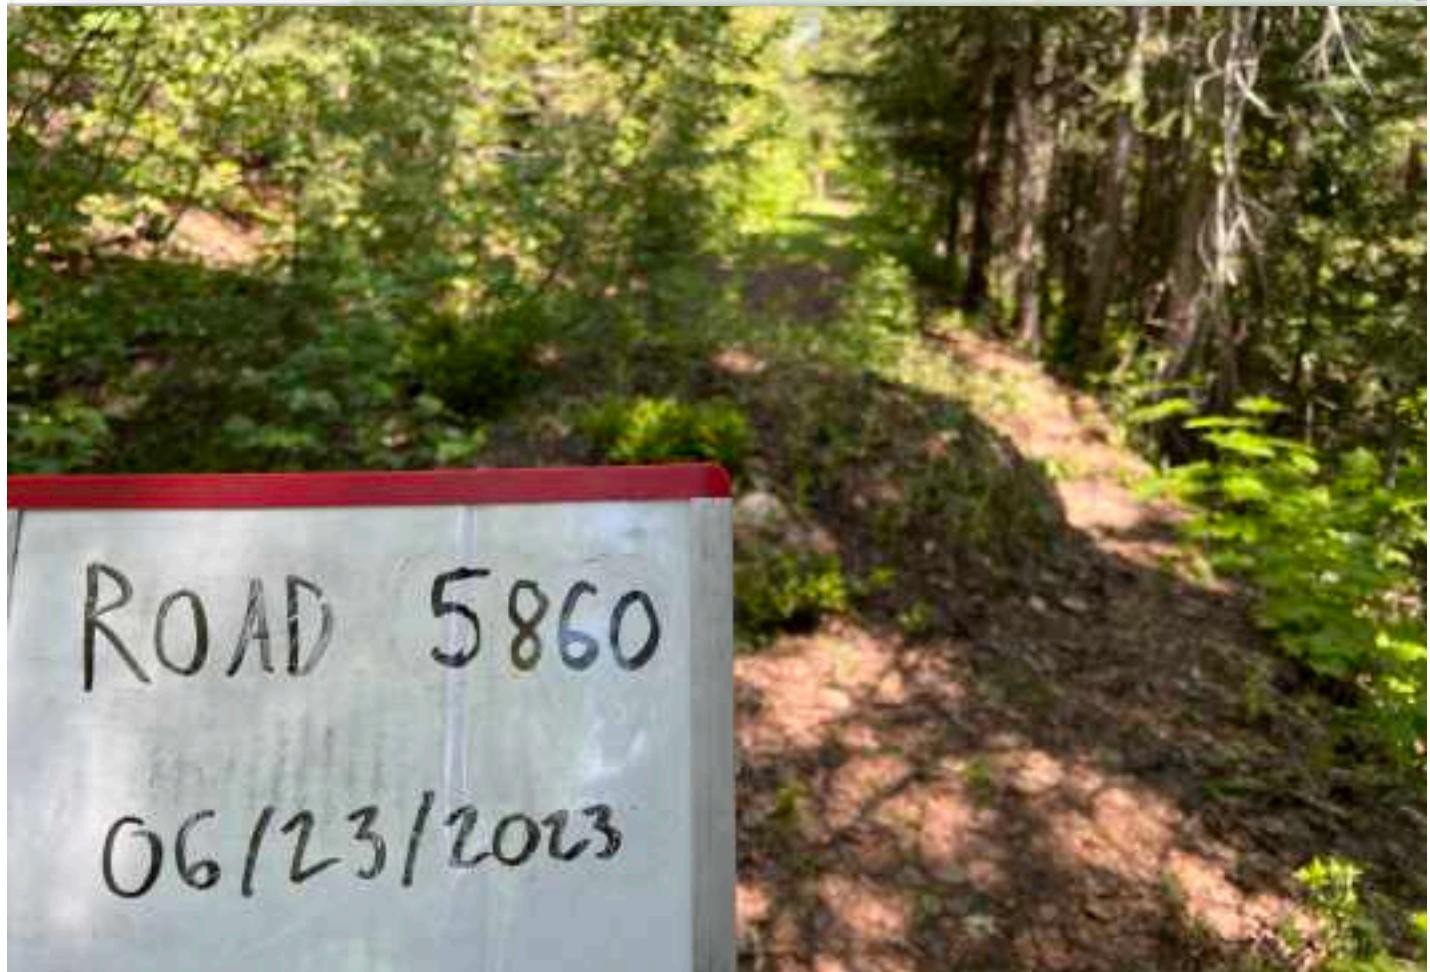
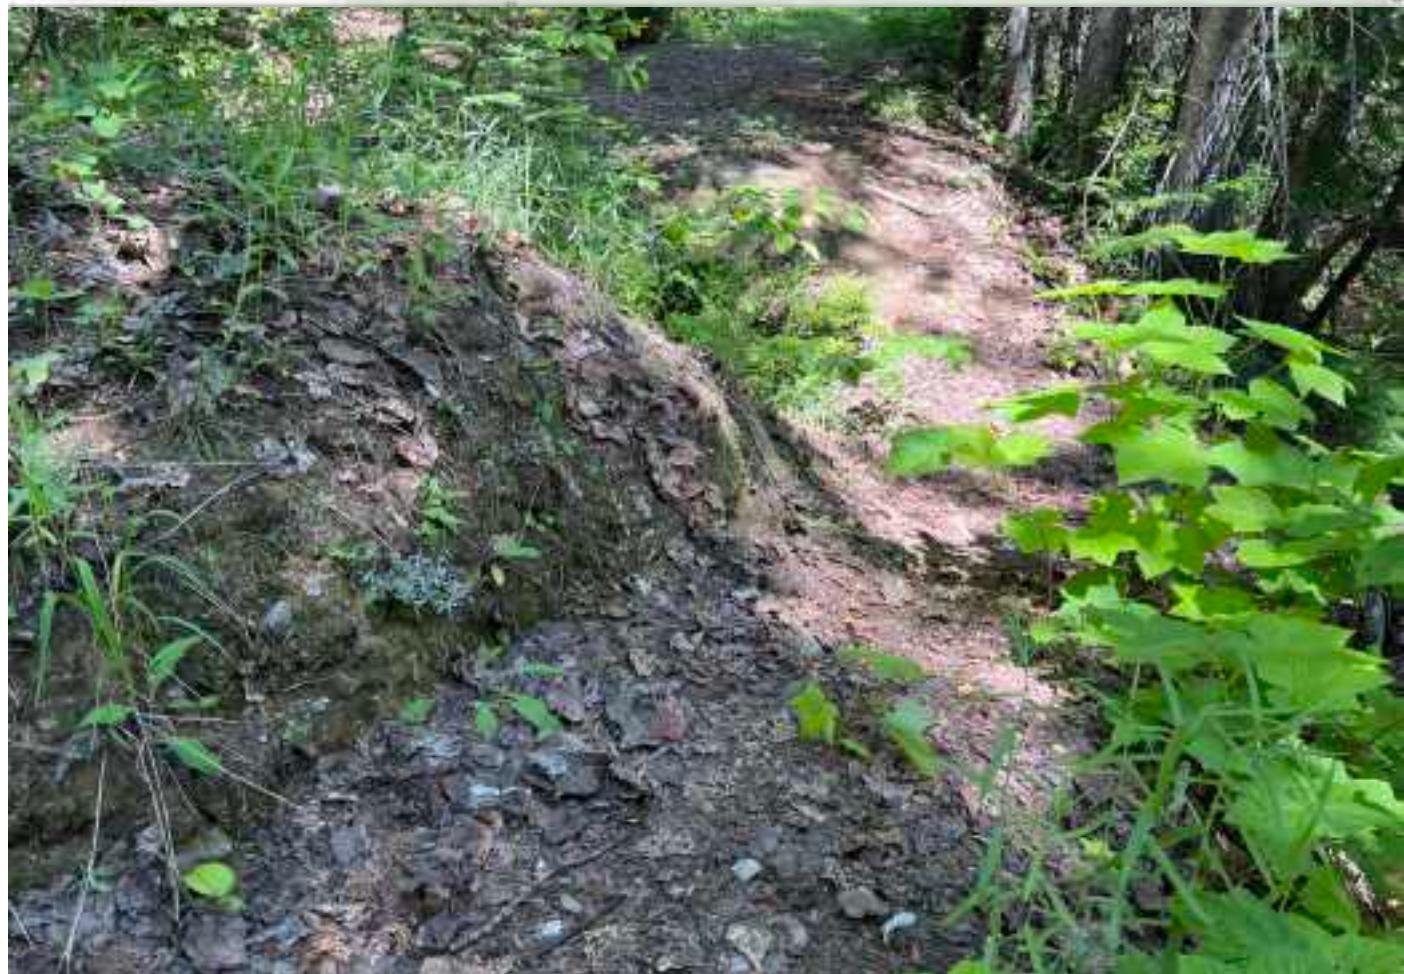
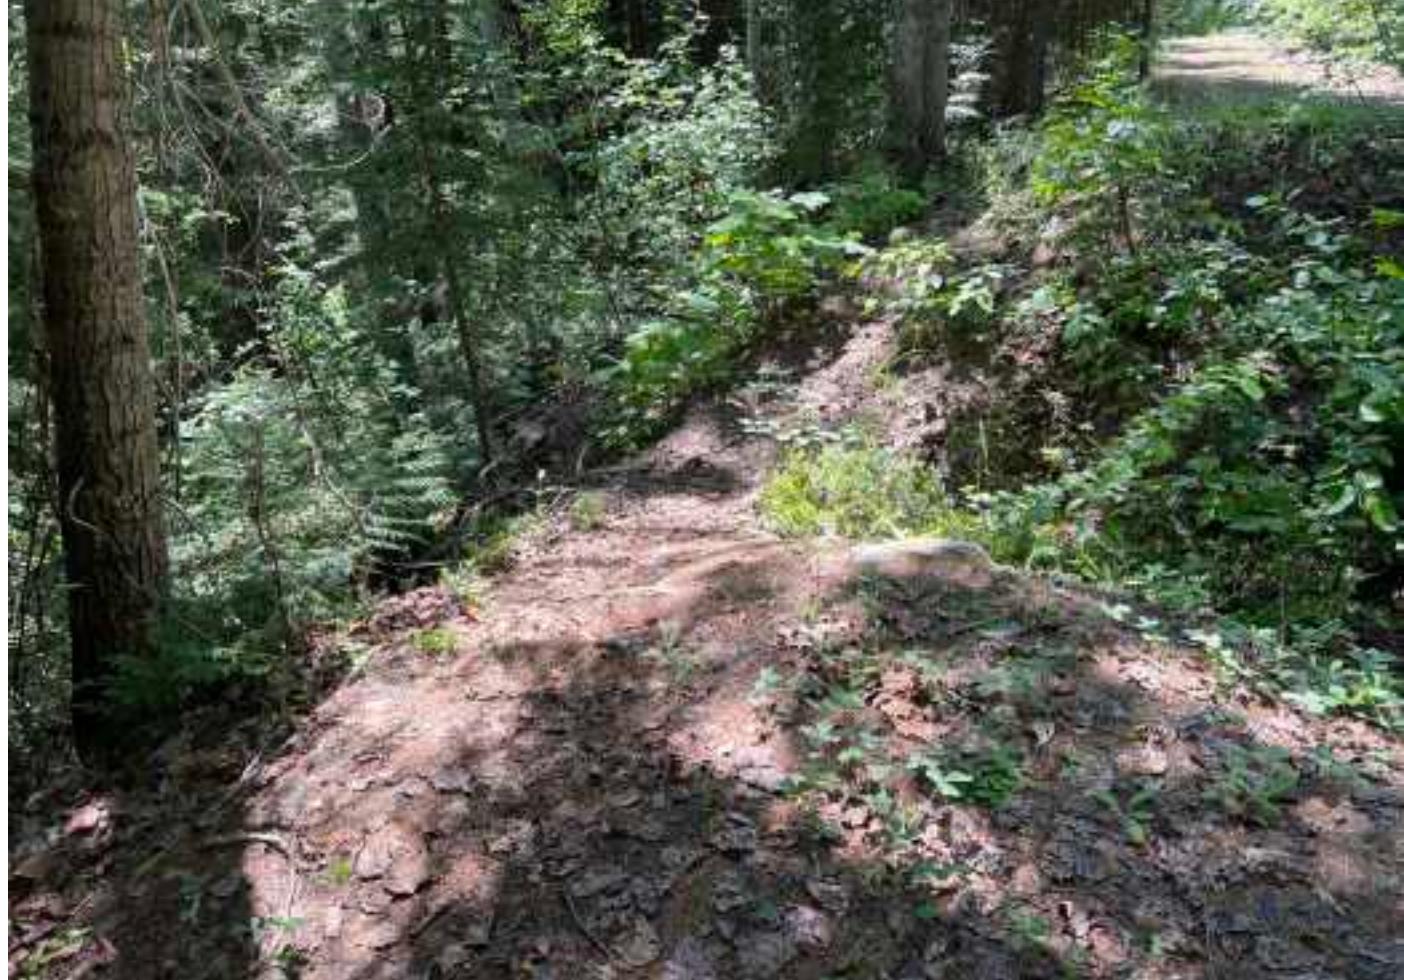
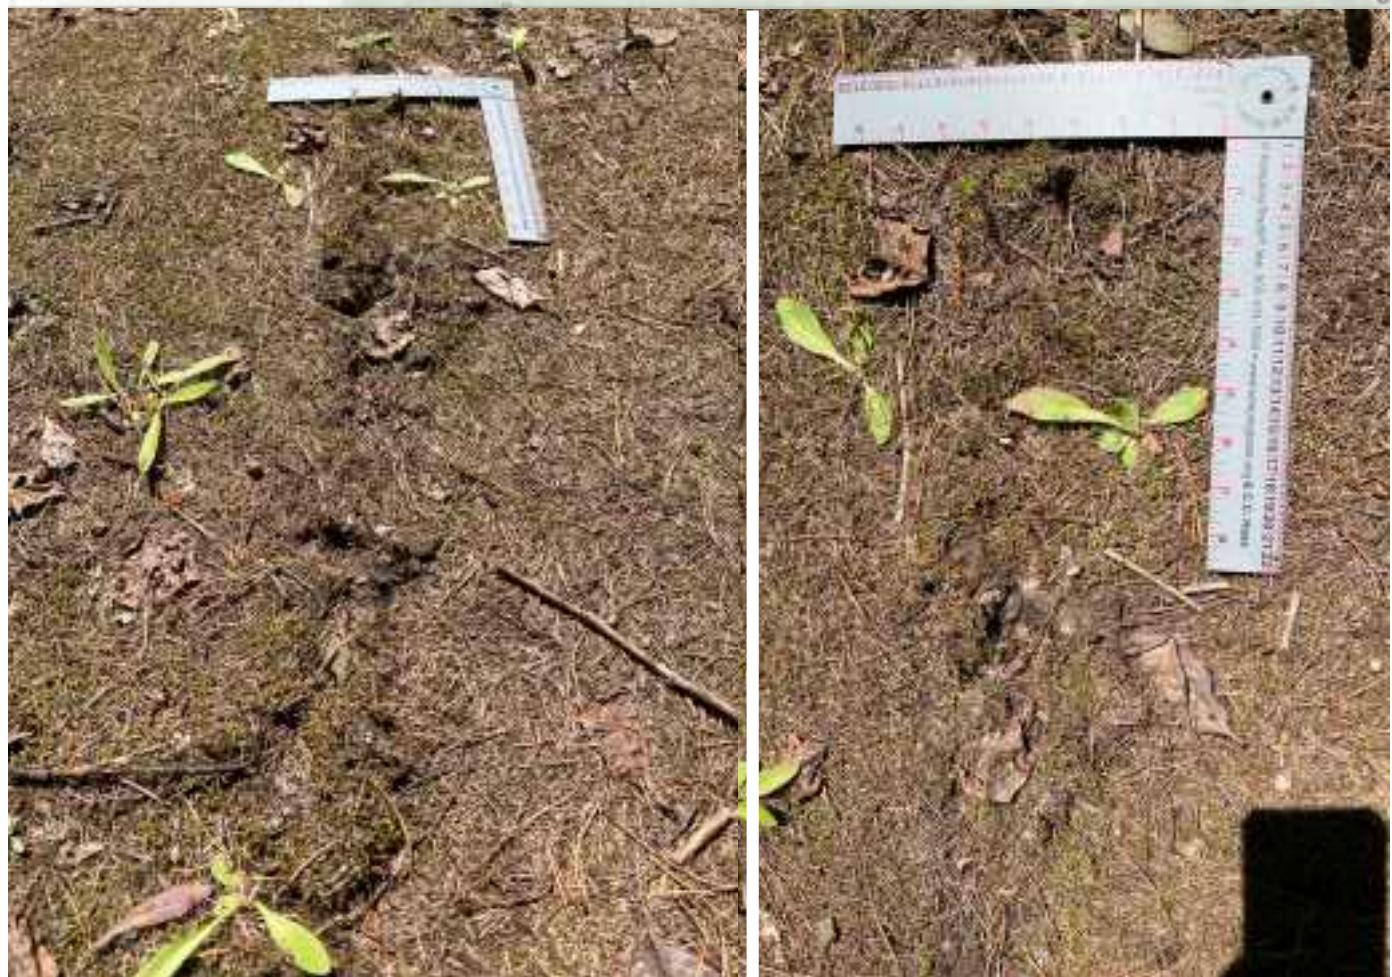
<b>Site:</b>	<b>BR-7</b>	
<b>Road #, or description:</b>	Road # 5860 / French Creek Trail # 22	
<b>Coordinates:</b>	48 56 05.2 / 115 46 22.6	
<b>Site Notes:</b>	<p>2020: The berm located at the end of road 5860, the start of the French Creek trail, has a 3.5' wide passage to the berm-right. Woody debris has been laid along the fill-slope to widen the passage. Single track rutting from MV or 'fat-tire' bike.</p>

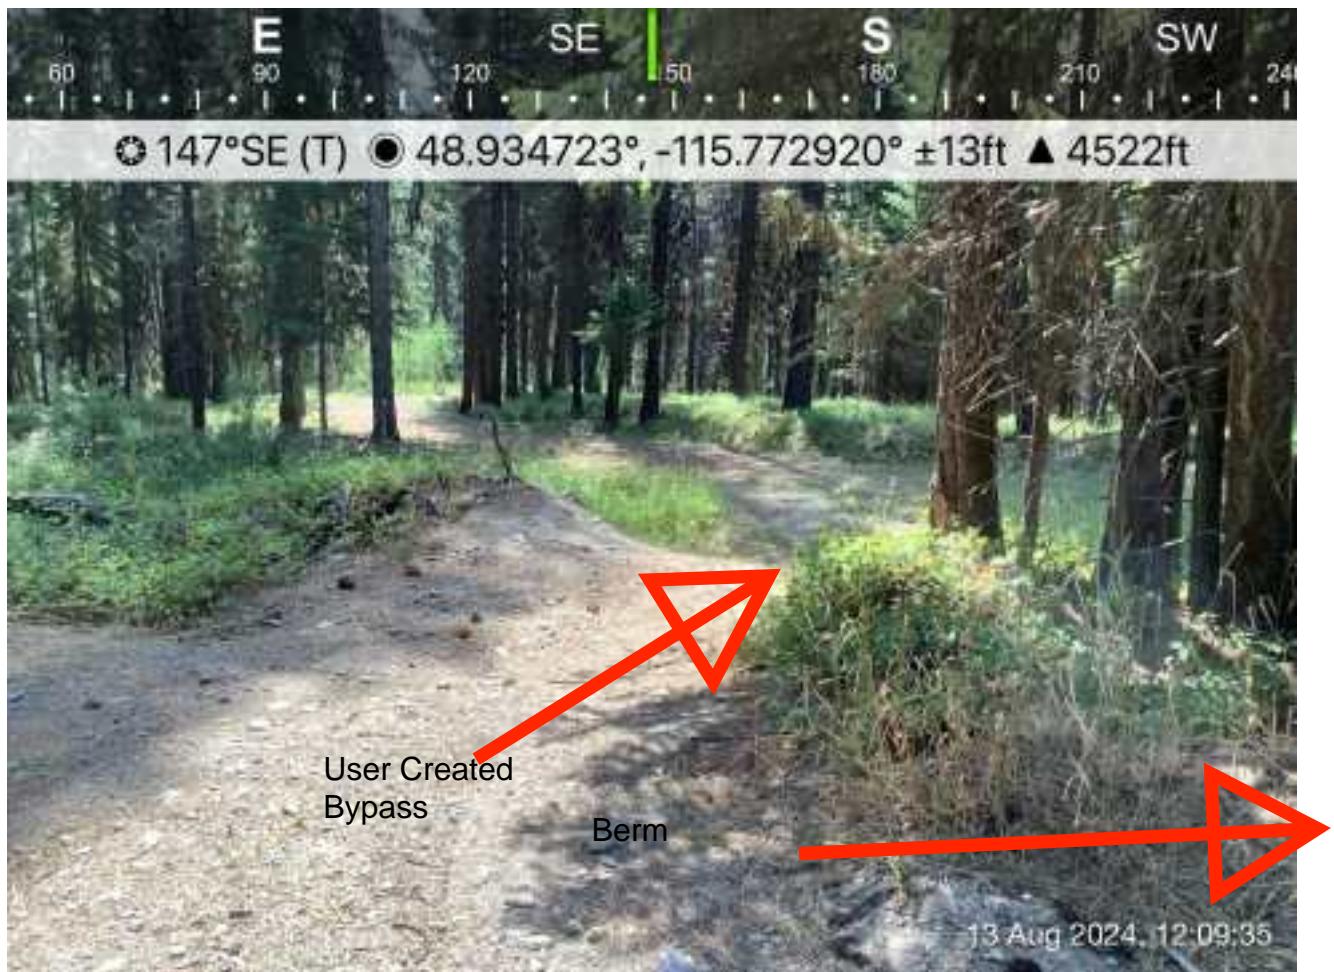
**BR 8**

Barrier ineffective 2024. No notable change in barrier since November 2023. The berm barrier is present, however, the barrier has been completely negated by the user-created road circumventing barrier. Full vehicle width, obvious and recent use.

Berm with bypass in background.

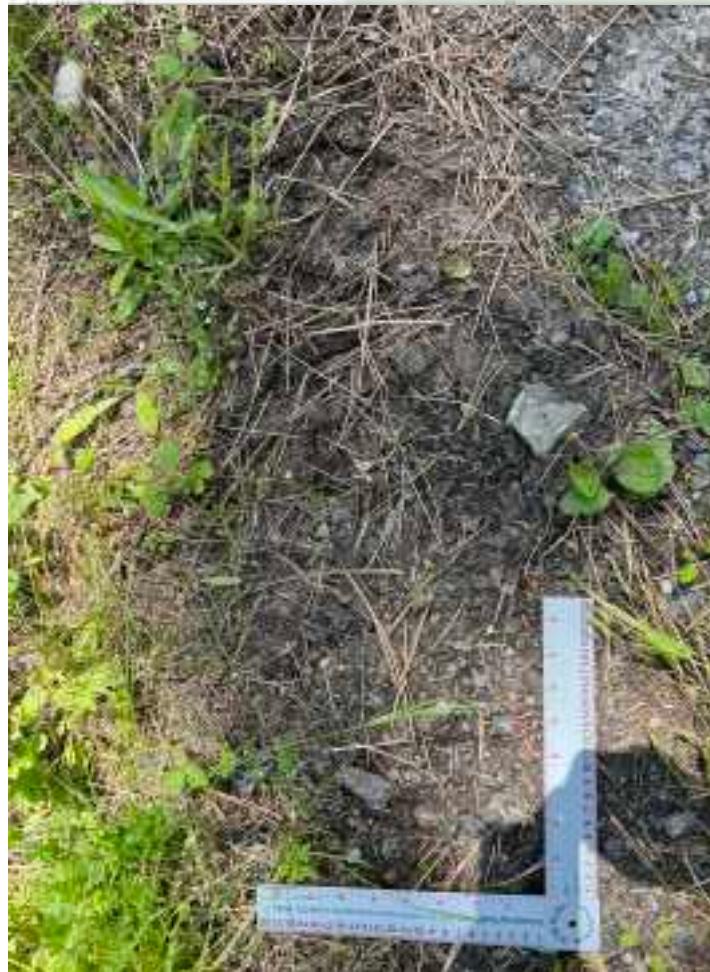
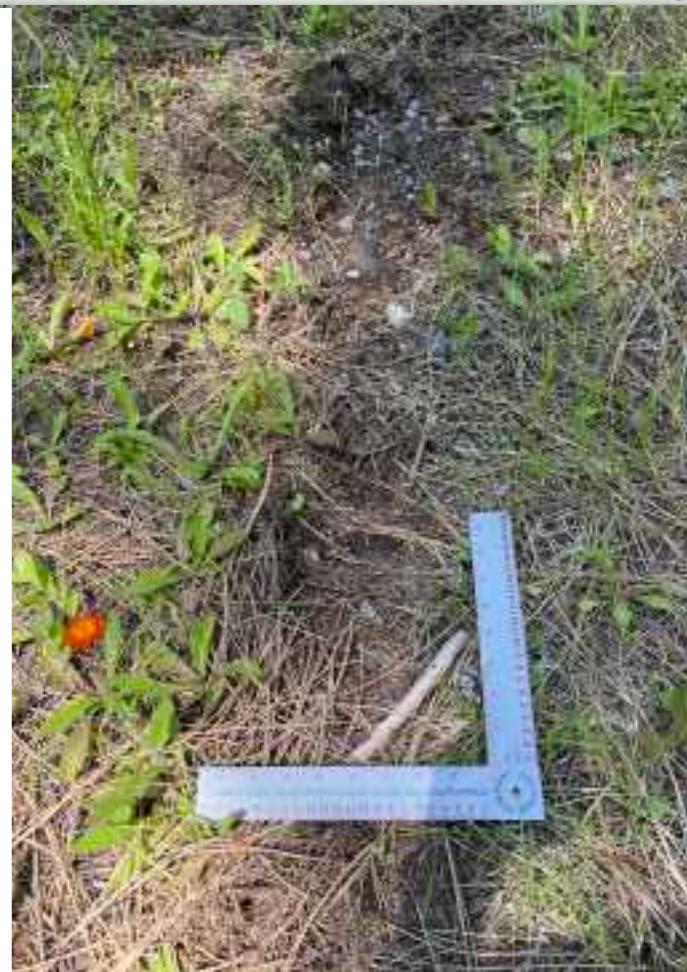
<b>Site:</b>	BR-8
<b>Road #, or description:</b>	Road # 5890
<b>Coordinates:</b>	48 50 20.1 / 115 42 44.3
<b>Site Notes:</b>	<p>2020: Shallow berm located across the road at the junction of 5892 and 5886. There is a full vehicle sized passageway approx. 50' to berm-left. Looks to be traveled frequently, major rutting and tracking from MV use. Barrier is ineffective and can be bypassed easily.</p>

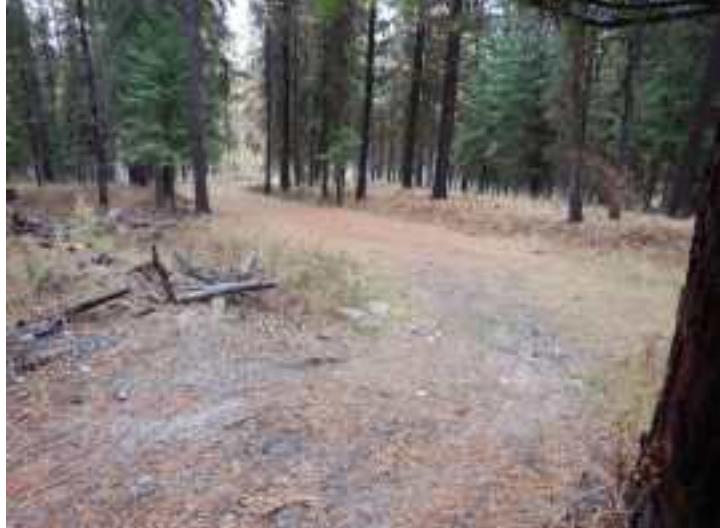
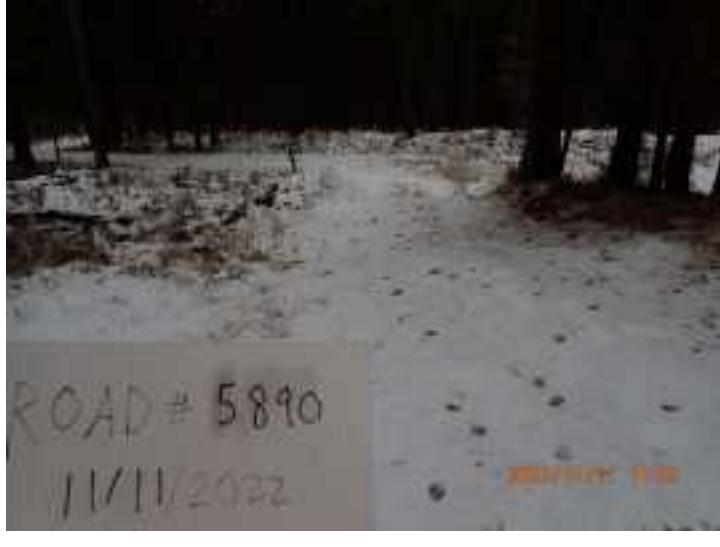
**BR 9**

Notes BMU 12 female with young documented 2016-2017. User-created road off of Hensley Pass. Not clearly used recently, signs of use fading.

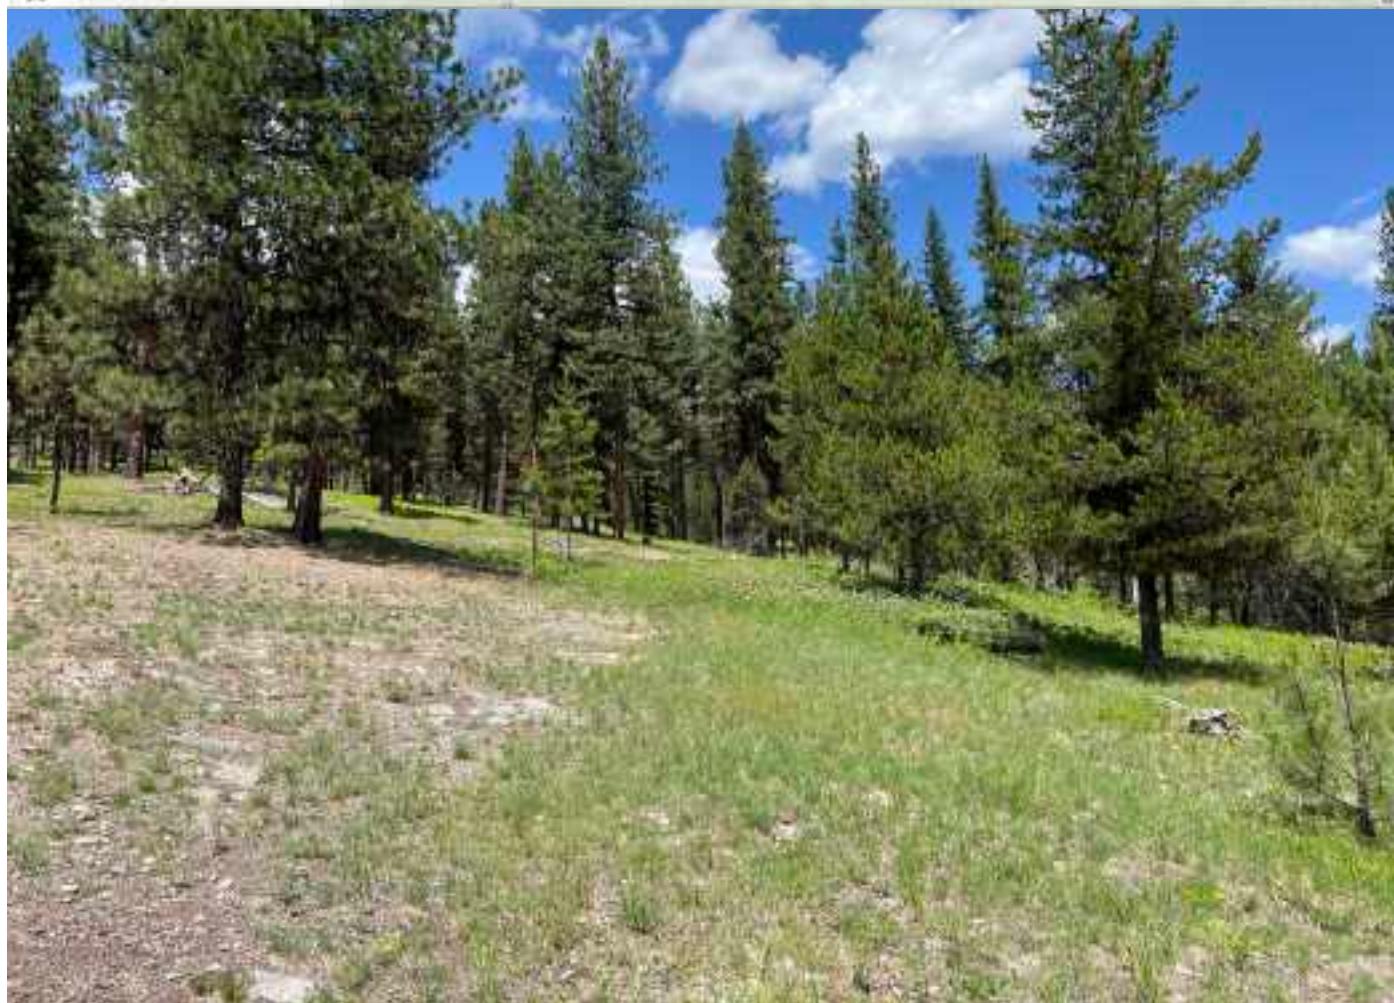
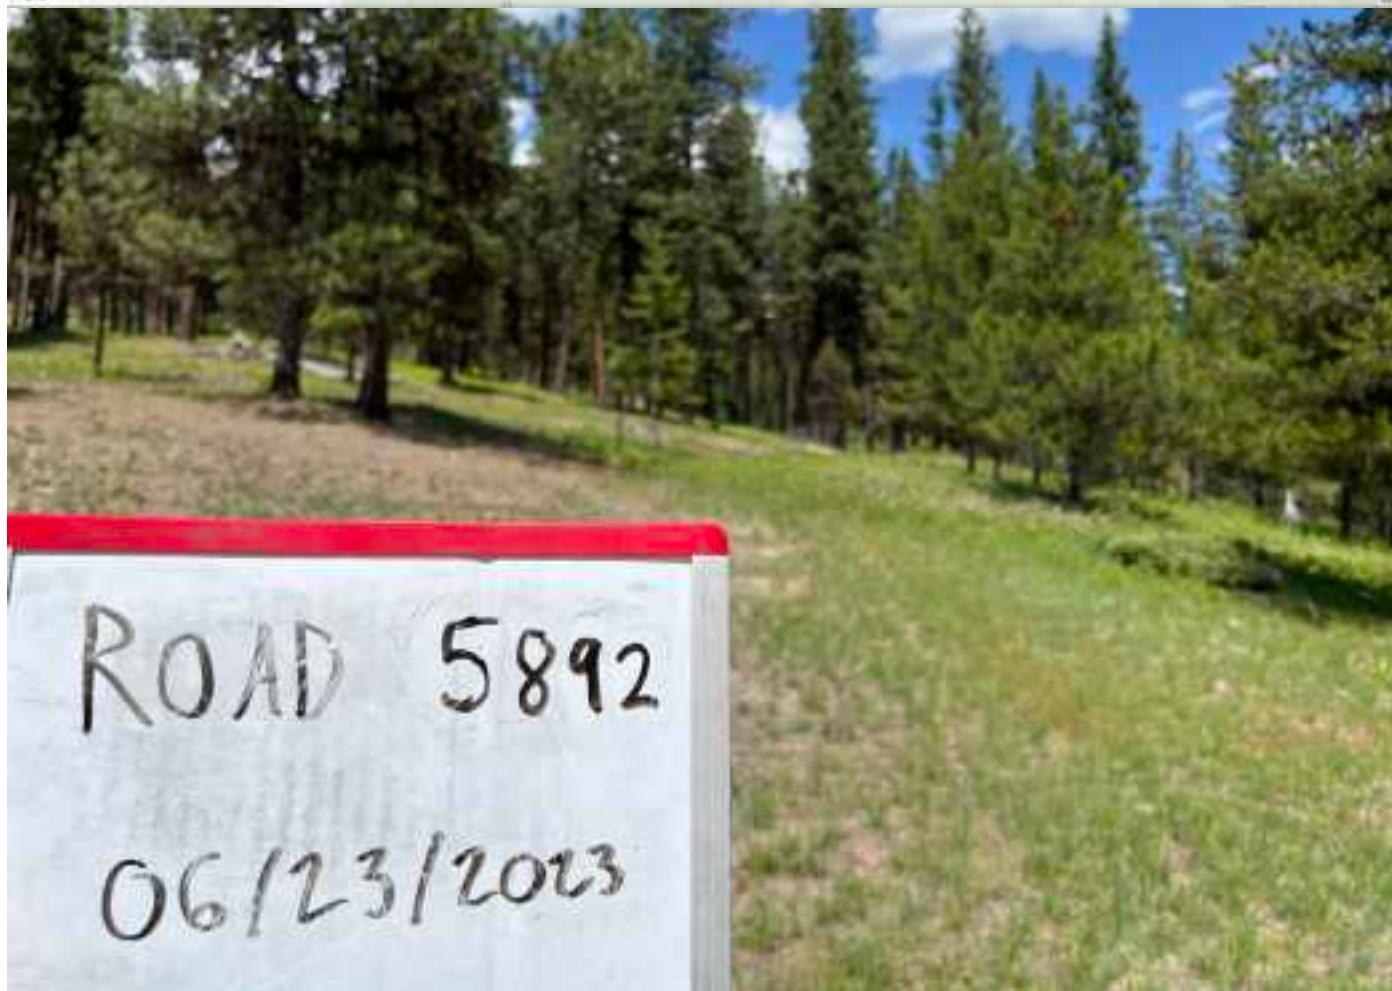
<b>Site:</b>	<b>BR-9</b>	
<b>Road #, or description:</b>	(unmapped) User created road off of road # 5892	
<b>Coordinates:</b>	48 50 25.3 / 115 42 39.0	
<b>Site Notes:</b>		
2020: User created road. Looks to possibly have been bermed in the past, but now is nothing more than a 'bump'. Ineffective barrier and can be driven over by full-sized MV. Exceeds 300' in length.

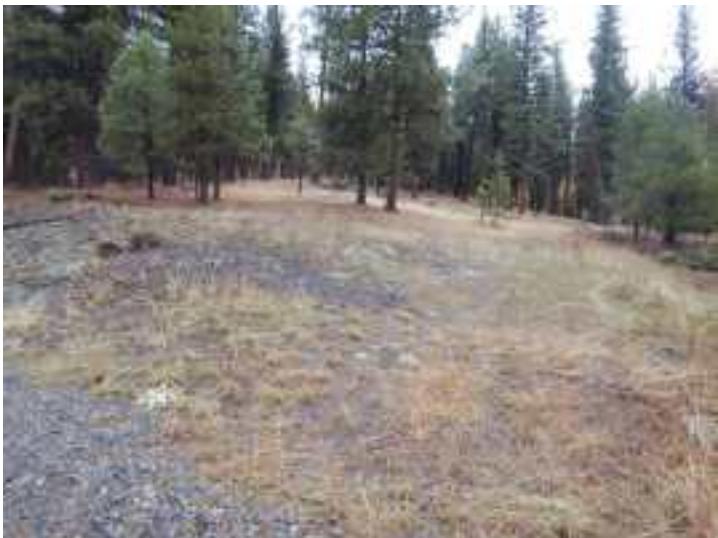
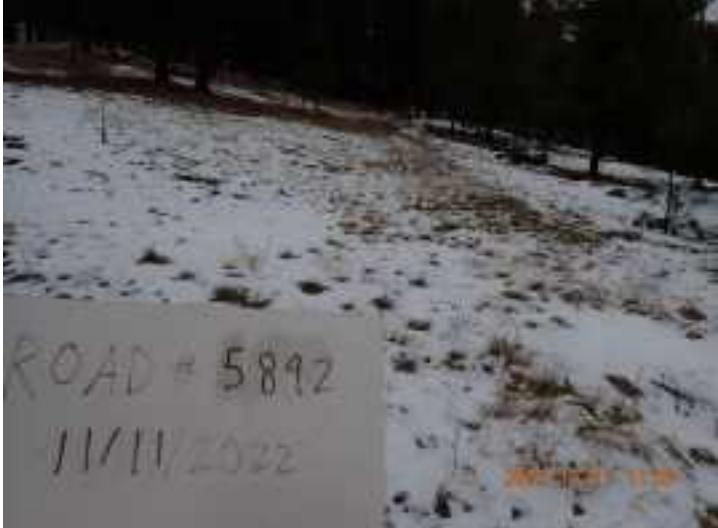
**BR 10**

BMU 15 Female with young documented 2016-2023

Barrier ineffective 2024. Insufficient berm barrier, barely a bump-passable in Subaru Outback. No impediment to motorized vehicles. Road easily accessible off of main NF Rad 5872. Remedy: Berm, boulders, gate. Barrier needs to extend uphill and downhill from gate.

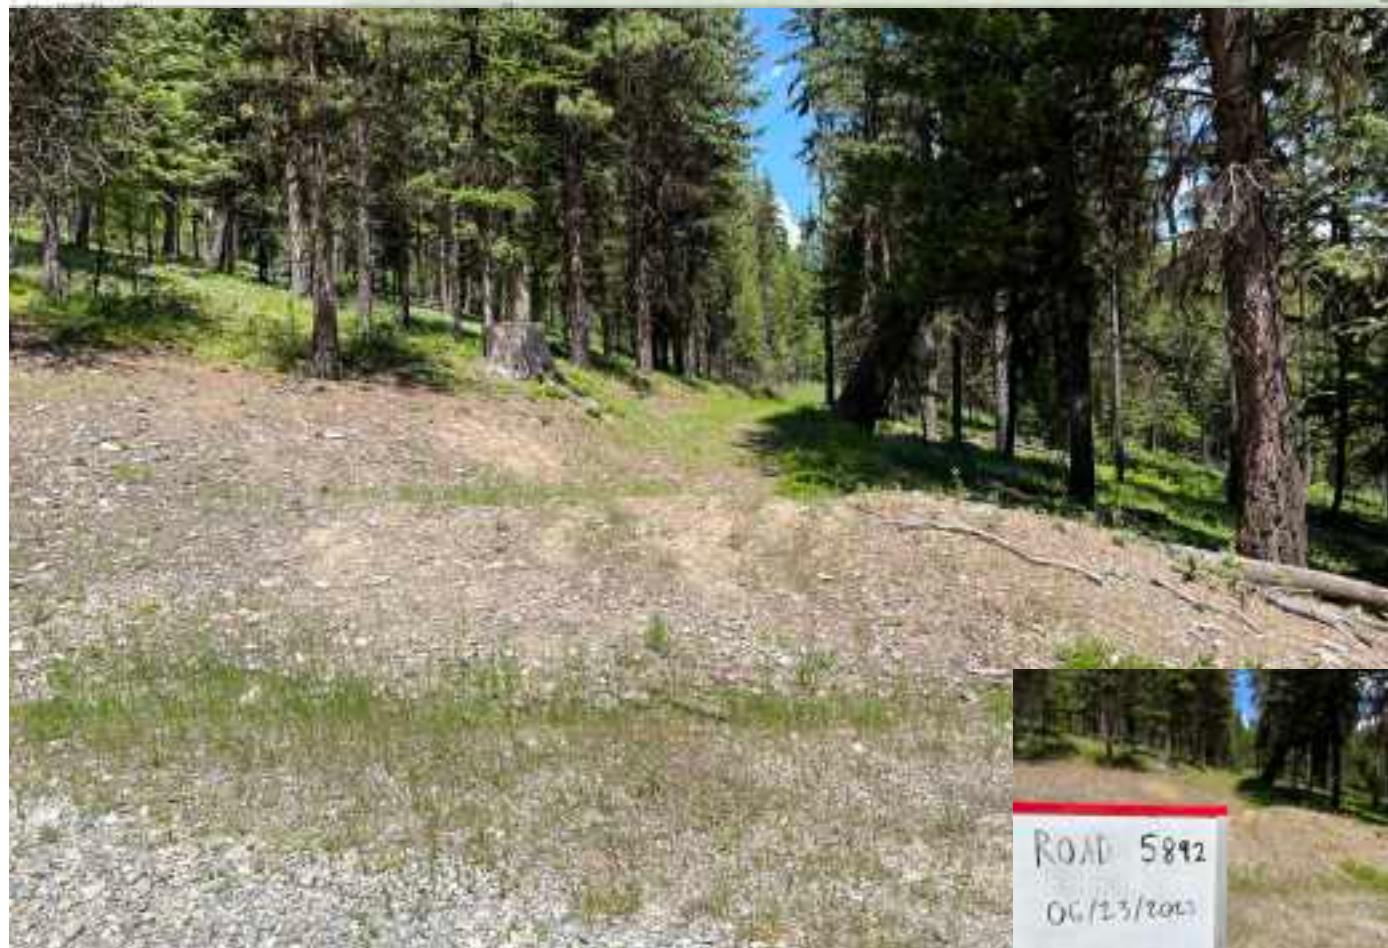
<b>Site:</b>	BR-10
<b>Road #, or description:</b>	(unmapped) User created road off of road # 5892
<b>Coordinates:</b>	48 50 34.9 / 115 42 45.9
<b>Site Notes:</b>	
	<p>2020: Insufficient berm, nothing more than a minor bump. No signage. Exceeds 300' in length. Looks driven often by full-sized vehicles.</p>

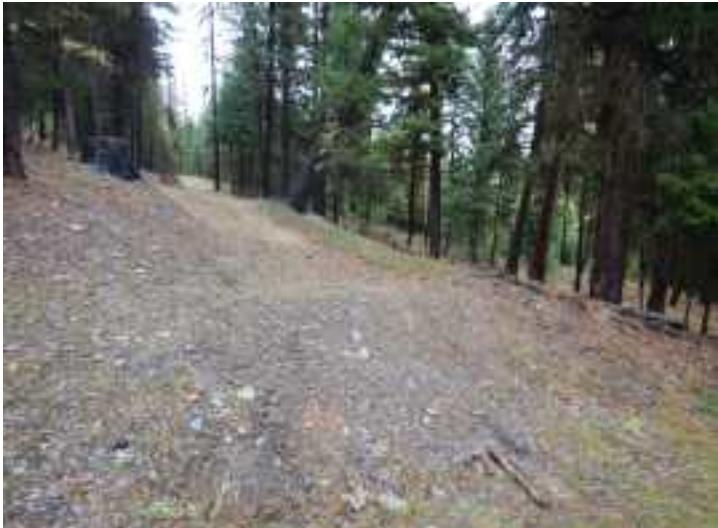
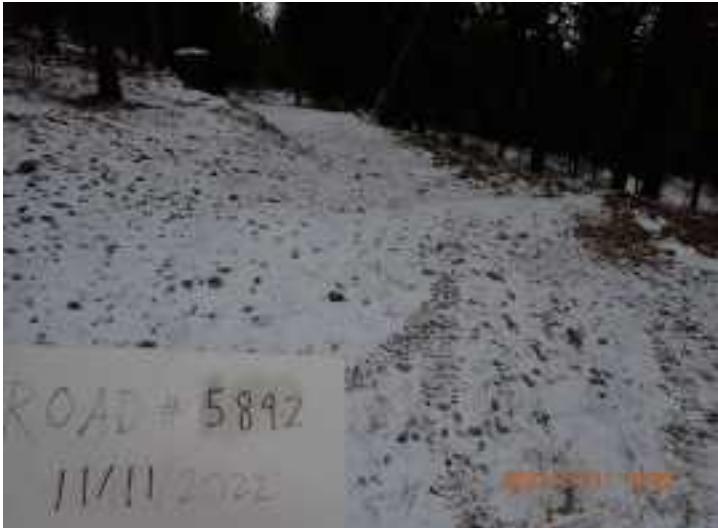
**BR 11**

BMU 15 Female with young documented 2016-2023.

Barrier ineffective 2024. No change to barrier status, still insufficient with a bypassable gap to the right of berm. No recent tracks. BR-11 is road 5886A, and 100 yards away is road 5886B (has signage posted), but not on the Motor Vehicle Use Map.
