YAAK VALLEY FOREST COUNCIL

# Insufficient Grizzly Barrier Report

## 2020-2024

CYE BMUs 14-15

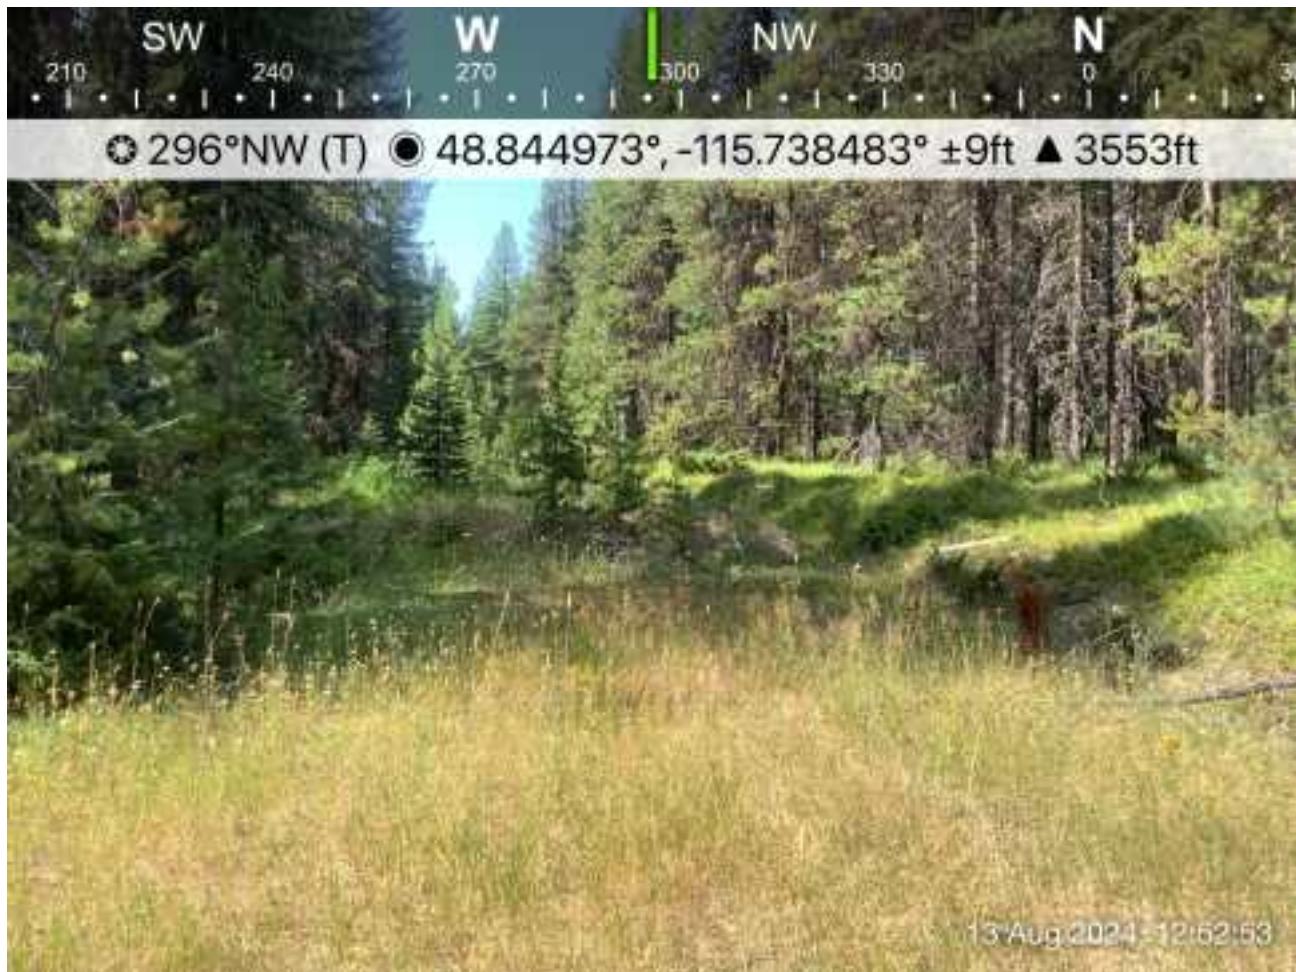
BR-11 6/21/23, 2:50:50 PM

BR-11 Female with young documented 2016-2022. No change in barrier status, still sufficient width (400 to 600 ft), no recent tracks. BR-11 is east 5880A, 100 yards west to road 5880 (barrier posted), but not in WCM.

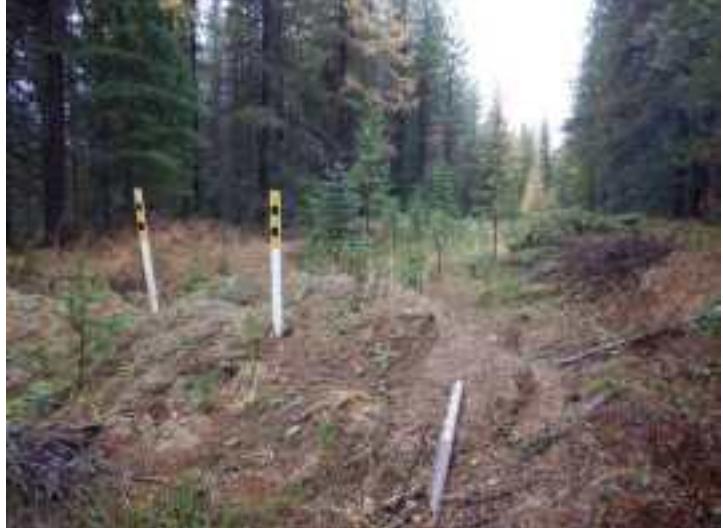
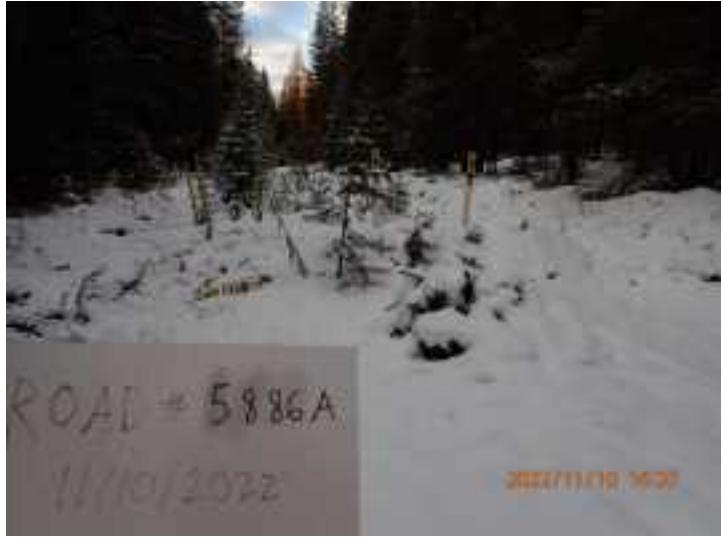
**BR 12**      Coordinates: N 48.84444 , W -115.75414

BMU 15 Female with young documented 2016-|2023.

Barrier ineffective 2024. A Berm barrier was created to prevent the use of user-created road. Berm can be bypassed on either side. Recent use was visible with truck treads to right of berm in 2023. Berm has diverted water and is overloading a culvert, eroding the road support across the road. Remedy-boulders around berm. Address erosion.

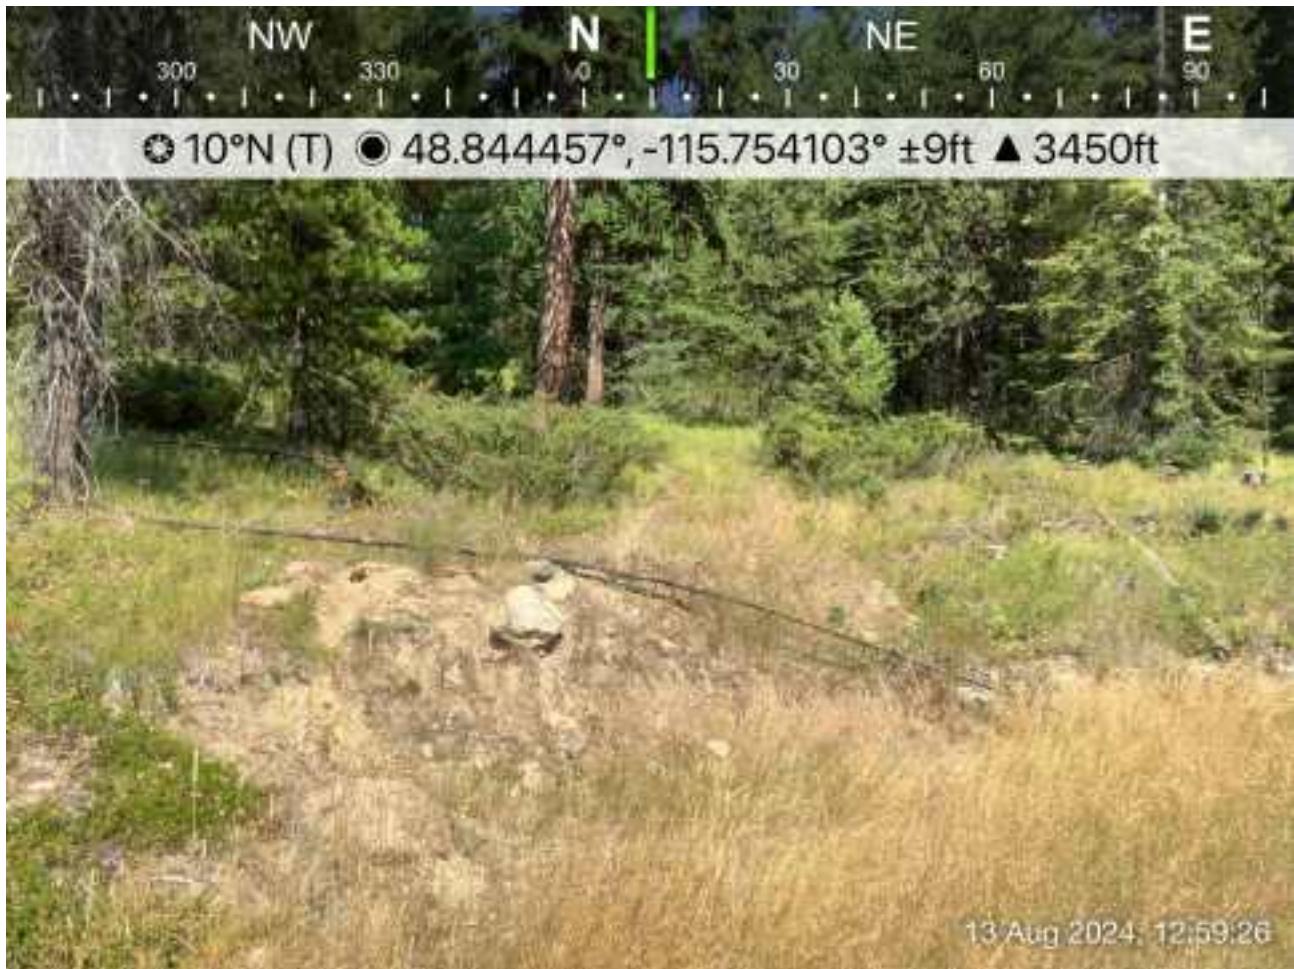
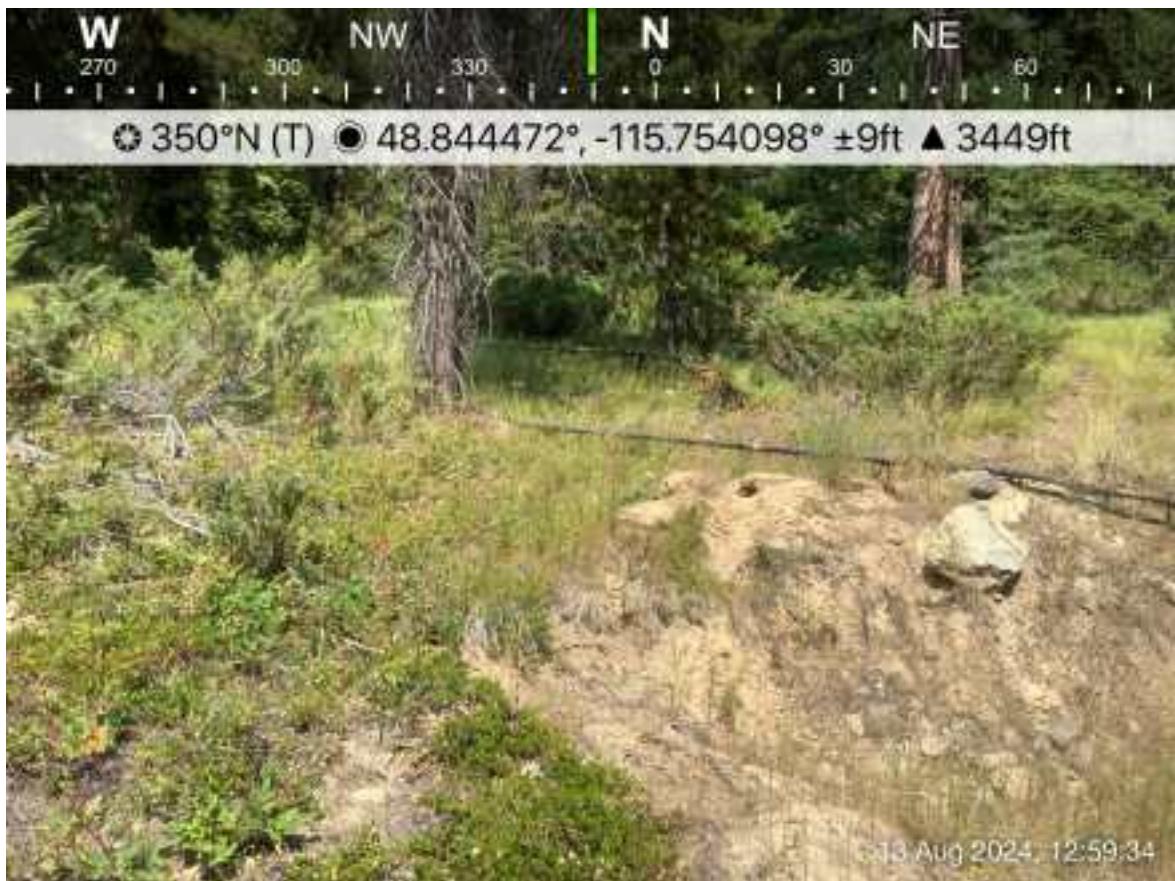
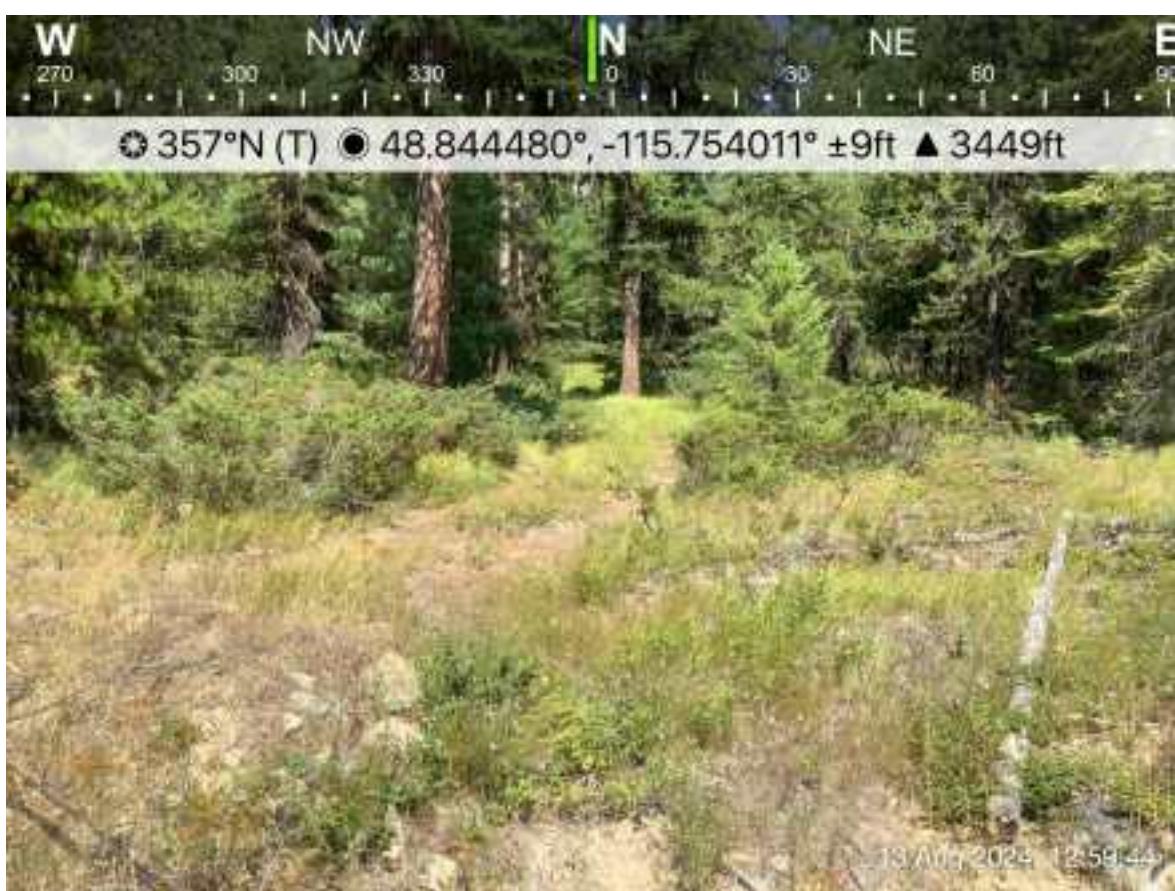
BR-12 6/21/23, 2:52:21 PM 2023  
June 21, 2023, 14:52 PM

BR-12. Fenced with young stacwired 2019-2023. Bear barrier created to prevent use of user-created road. Can be bypassed on either side of fence. Recent use visible with fresh tracks to right of road. Bear has downed willow and is carrying a cub/spring cub supporting across the road...  
Hawks/shoulder to around birth. Anti-res erosion

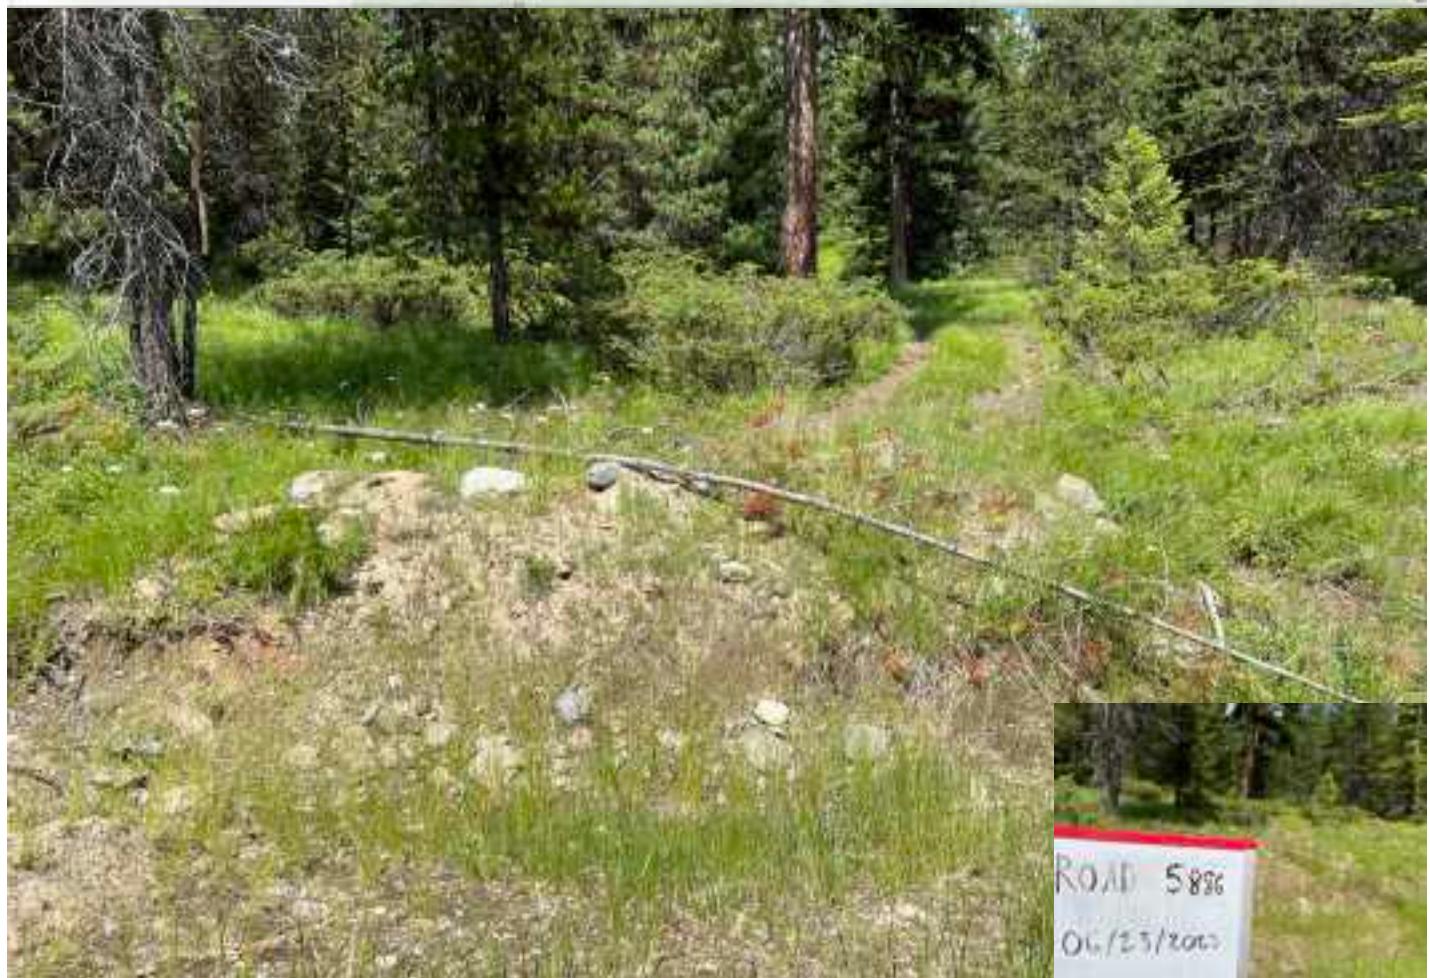
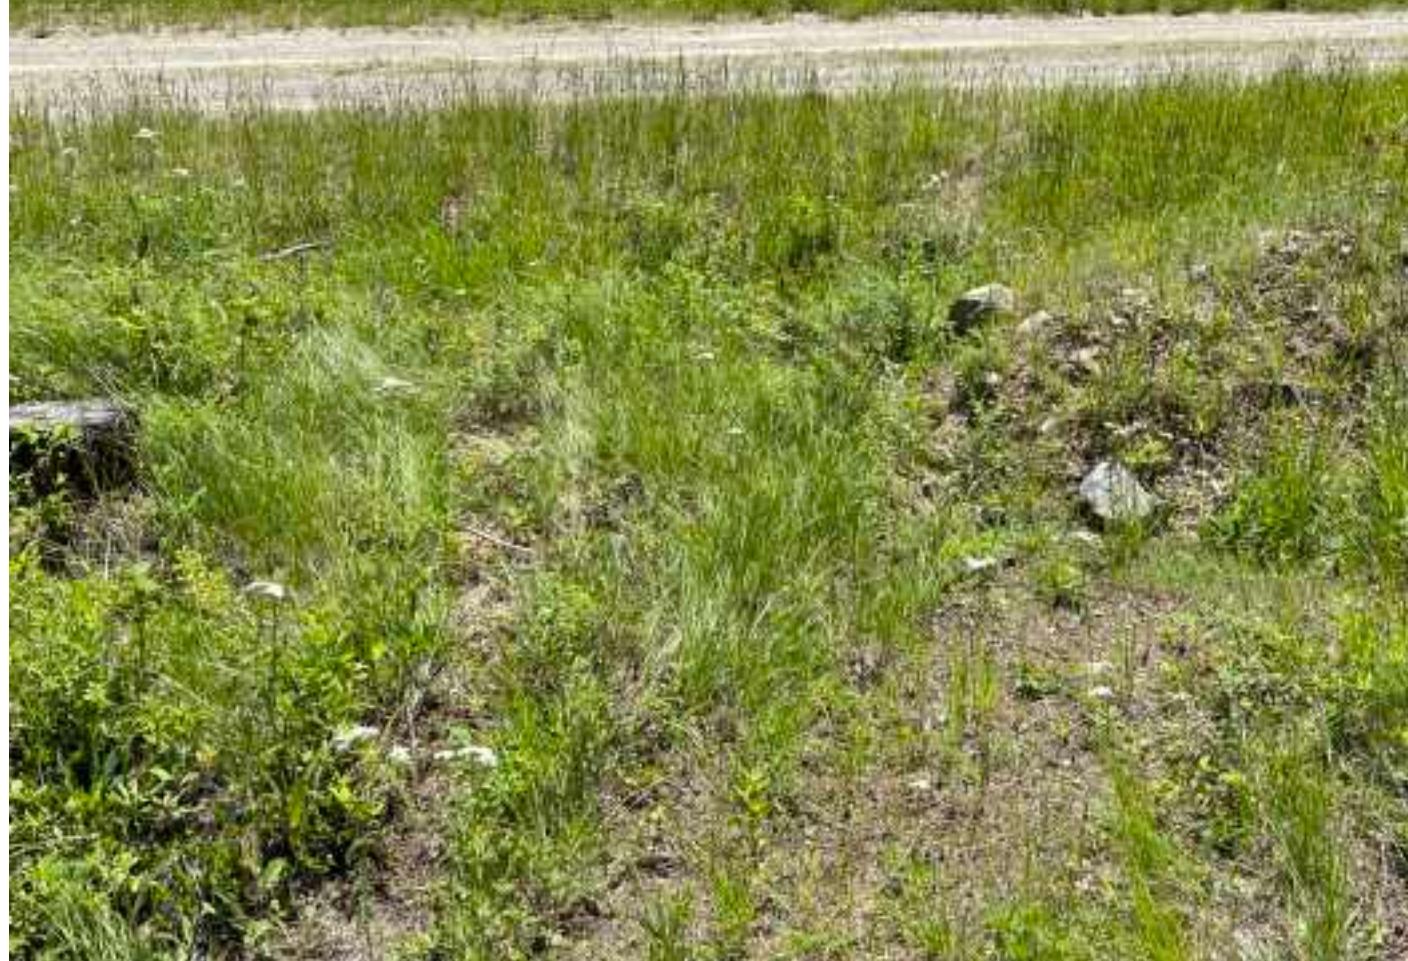
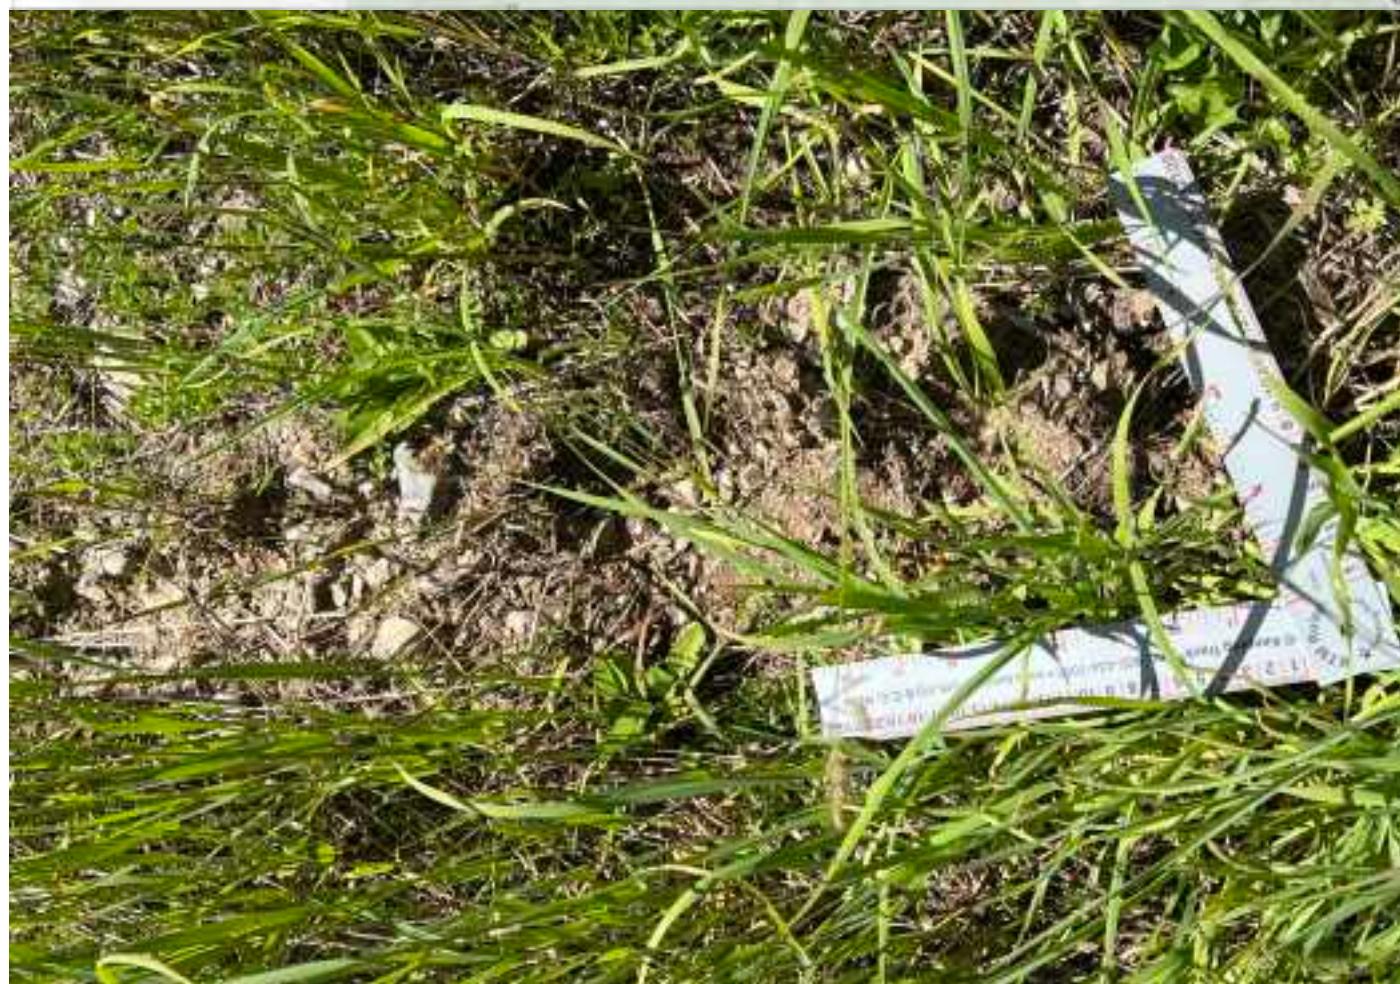
<b>Site:</b>	BR-12
<b>Road #, or description:</b>	(unmapped) User created road off of road # 5886
<b>Coordinates:</b>	48 50 40.0 / 115 4514.9
<b>Site Notes:</b>	<p>2020: A full-sized MV travel corridor that proceeds through vegetation and forest, located off of 5886 Hensley Face Road. Well established roadbed with new berm barrier installed 2021. Can easily be bypassed to barrier left and right. Exceeds 300' in length.</p> <p>2022: This is one of the sites where the Forest Service created a berm to deter illegal MV use. This user created road was bermed sometime between summer 2020 and summer 2021, when YVFC next surveyed these barriers. However, this berm can be bypassed on either side.</p>

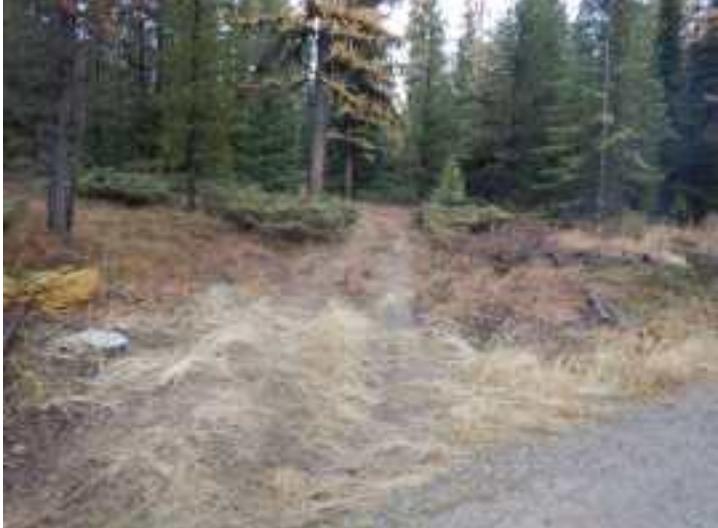
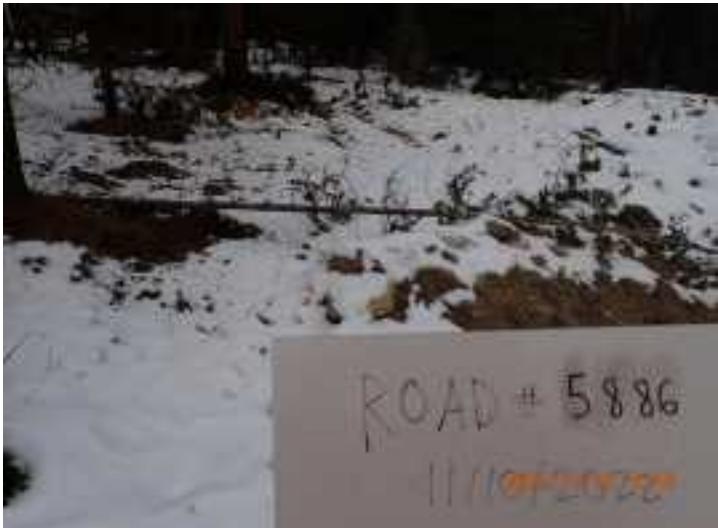
**BR 13 Coordinates: N 48.88708, W -115.74781 Date: 2024.08.02**

BMU 15 Female with young documented 2016-2023.

Barrier ineffective 2024. The barrier can be bypassed to the right gate by an ATV, side by side, or with other vehicles.

Remedy-Boulders

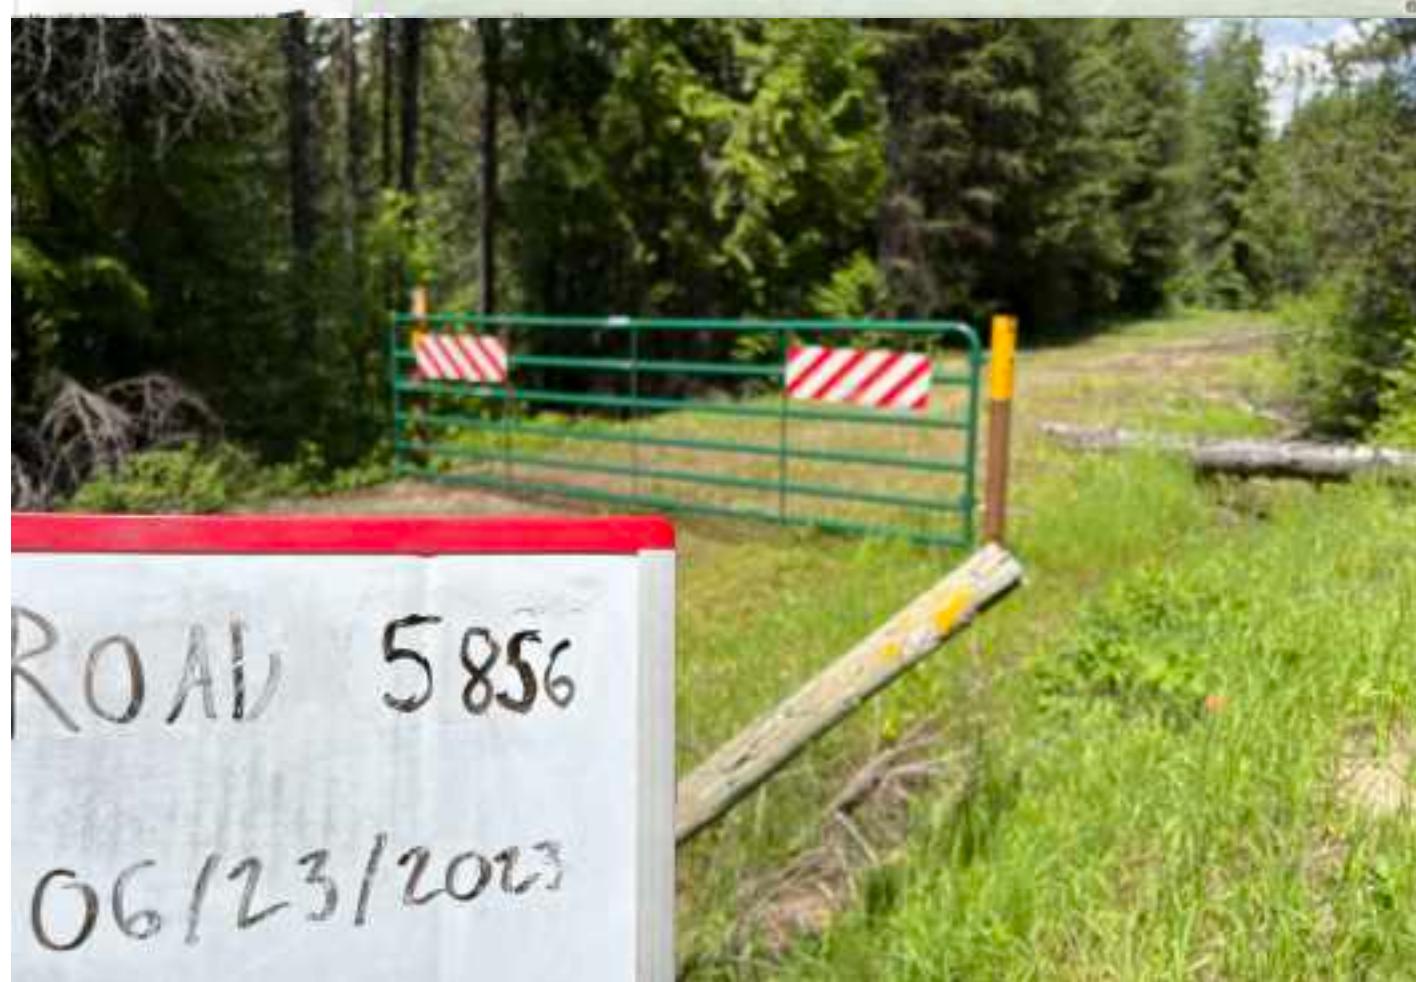
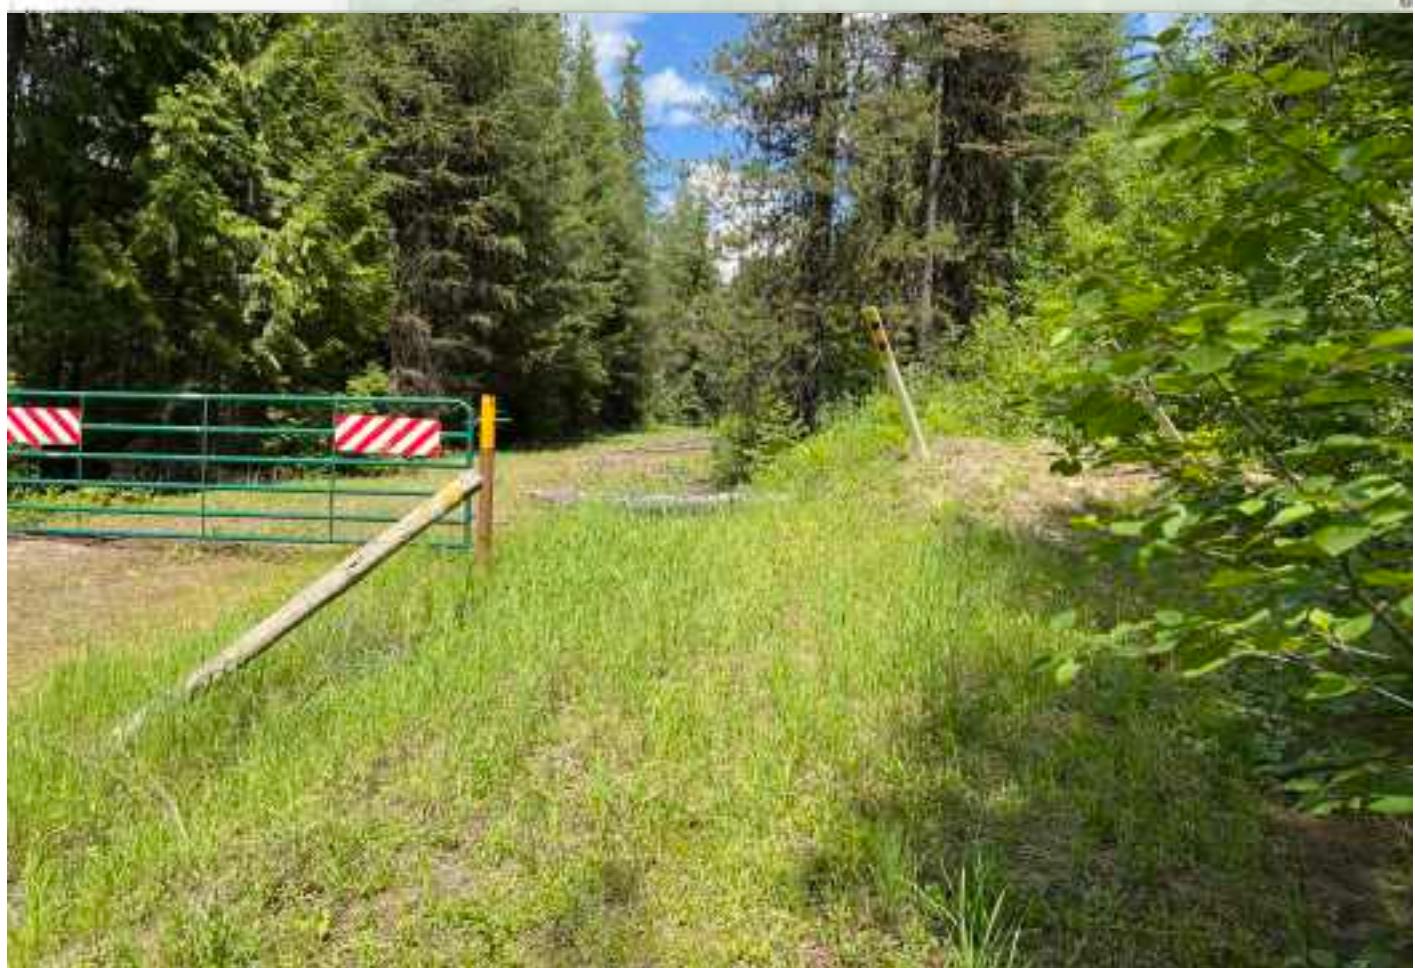
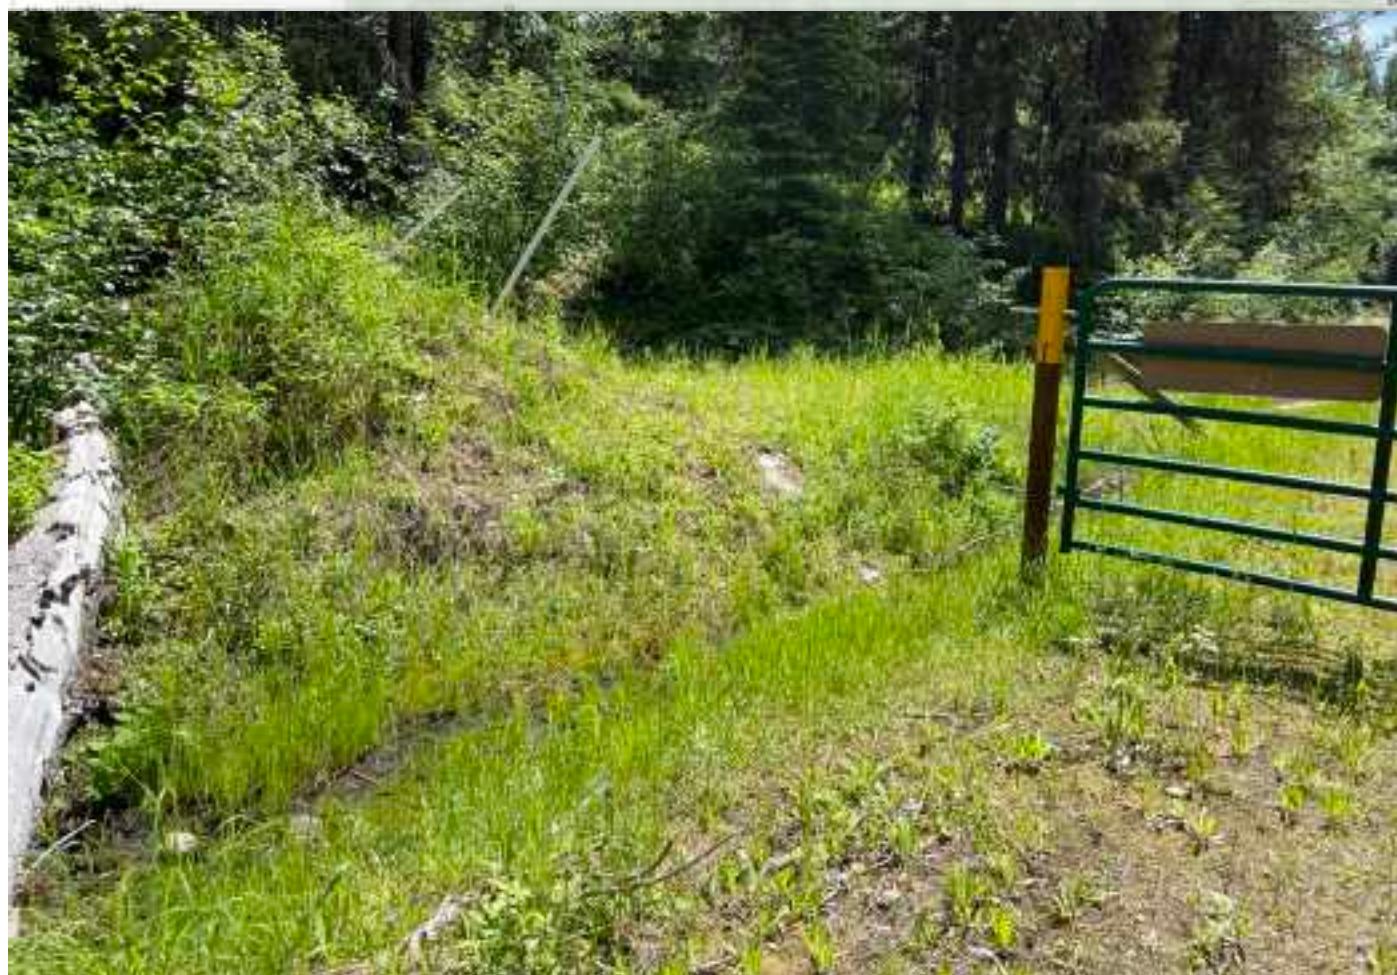
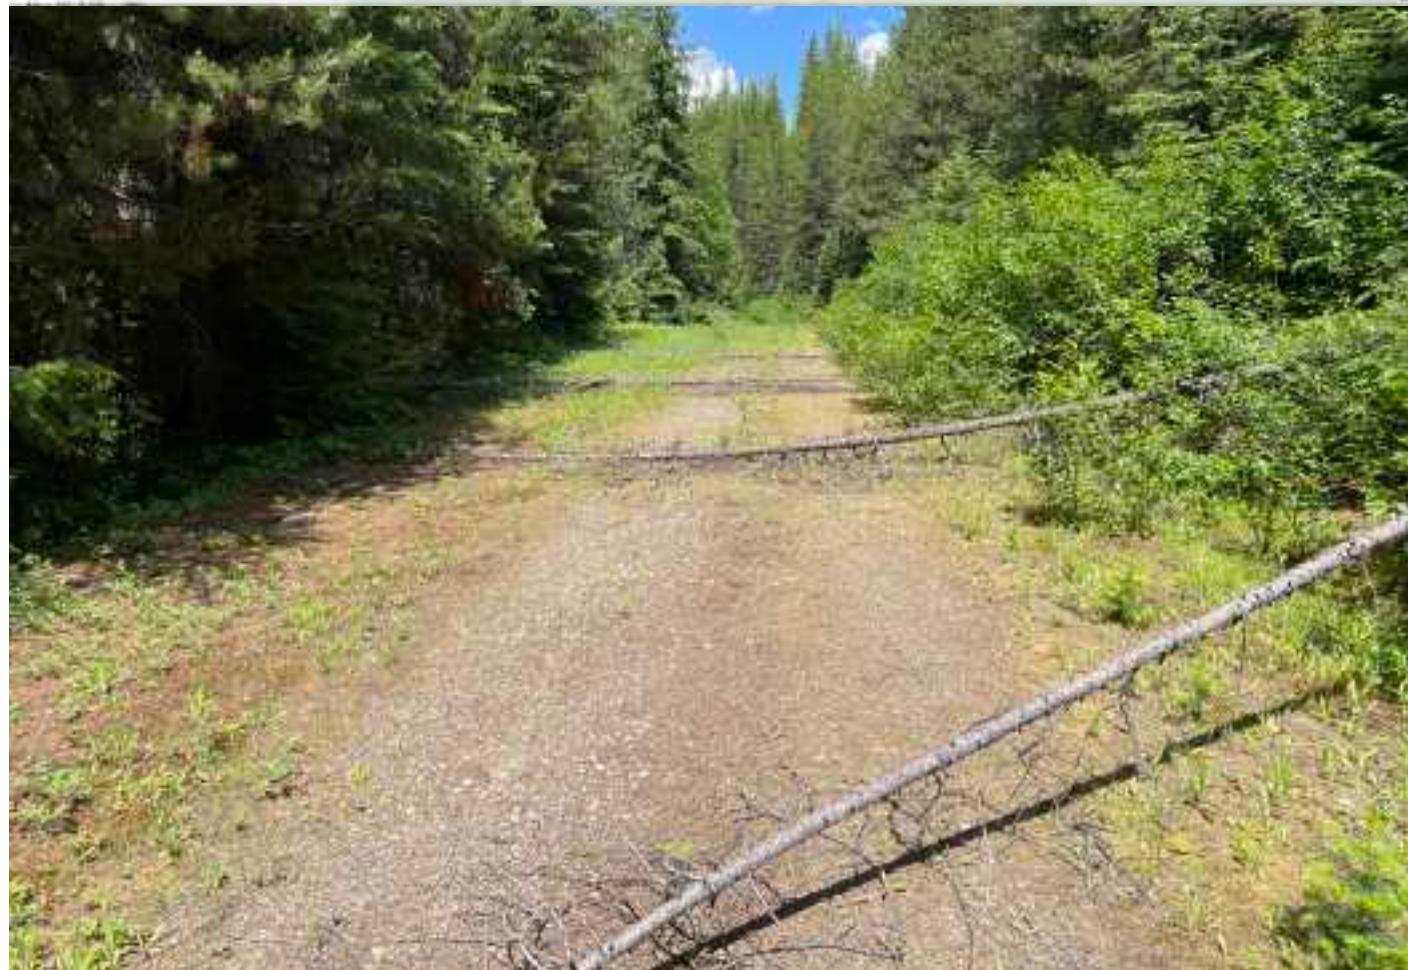
Site:	BR-13
Road #, or description:	Road # 5856
Coordinates:	48 53 13.5 / 115 4452.1
<b>Site Notes:</b>	
<p>2020: Gate barrier. Motor-vehicle bypass to gate-right, using the spur road to get around the barrier, obvious tire tracks and rutting. Lack of vegetation from being driven over. The temporary log barrier (choice firewood tree) can be easily removed so the barrier is not effective.</p>

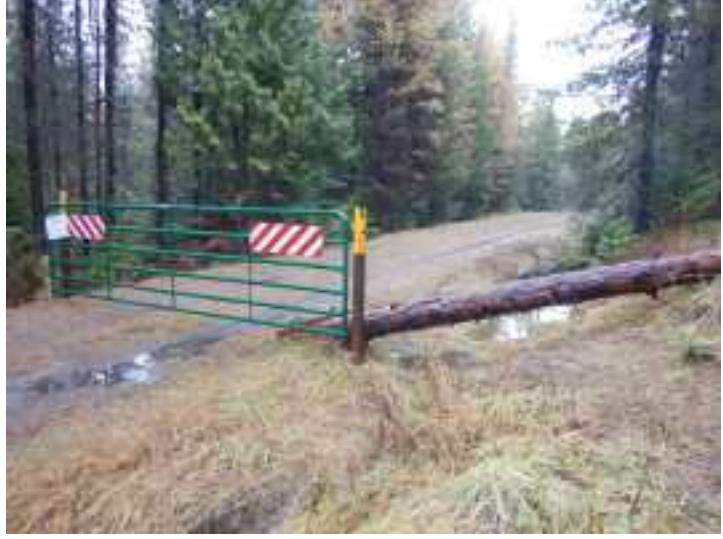
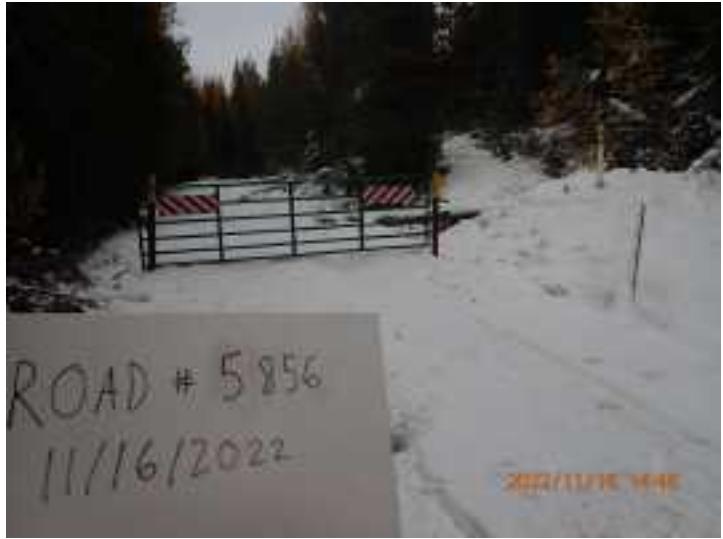
**BR 14**

Notes:  
BRU 14 female with young documented 2019-2023.  
No change noted since last report of November 2022. Bear is still习惯able to humans. The track is nearby, but no evidence of recent visit.  
Recently shown up here without and placed additional boulders.

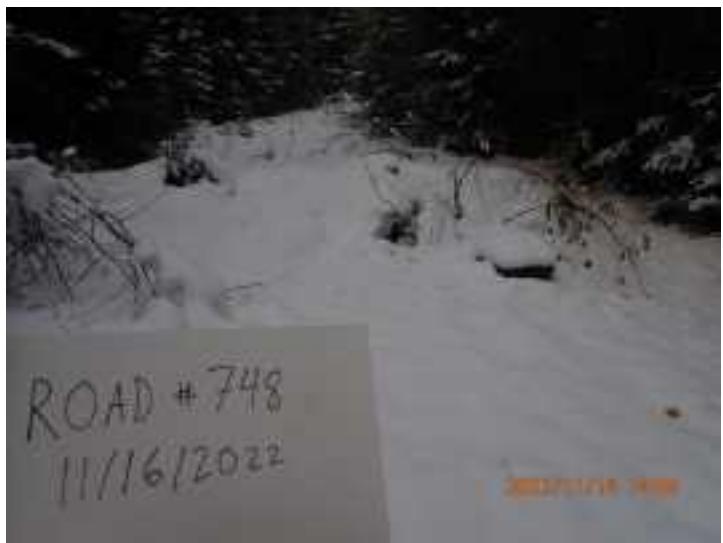
Road #, or description:	Road # 748	
Coordinates:	48 54 09.2 / 11550 43.7	
<b>Site Notes:</b>		
<p>2020: Shallow berm with poorly placed boulders.            Access to Core Grizzly Bear Area. A 5' wide            passage through berm-right provides access for            ATVs and motorcycles.</p>

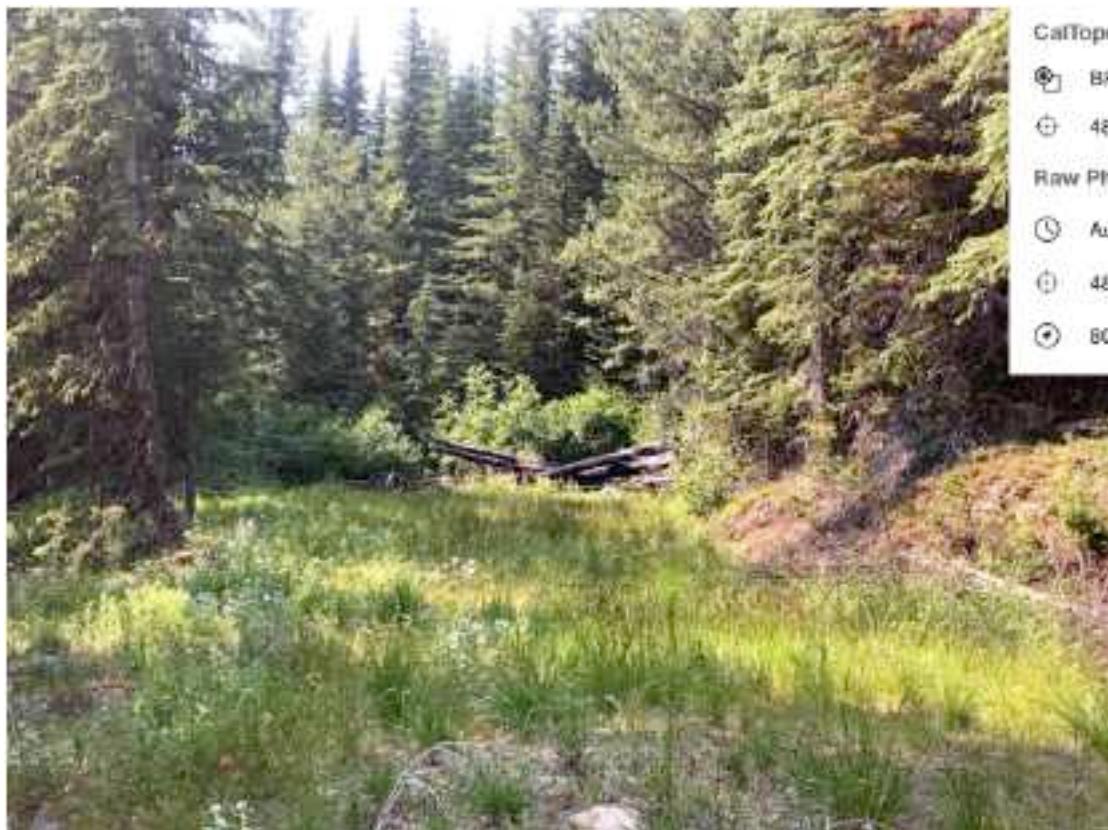
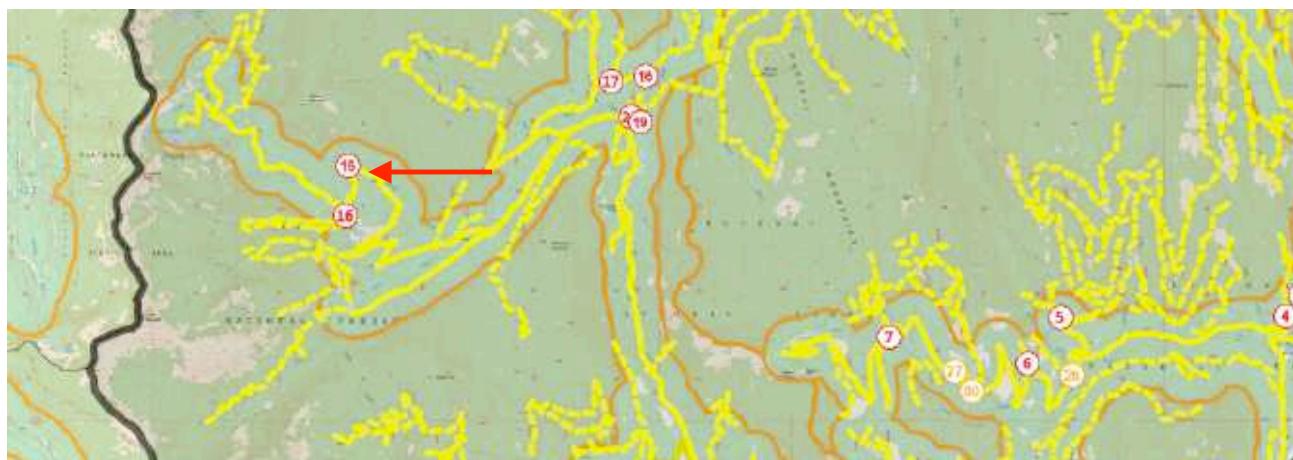
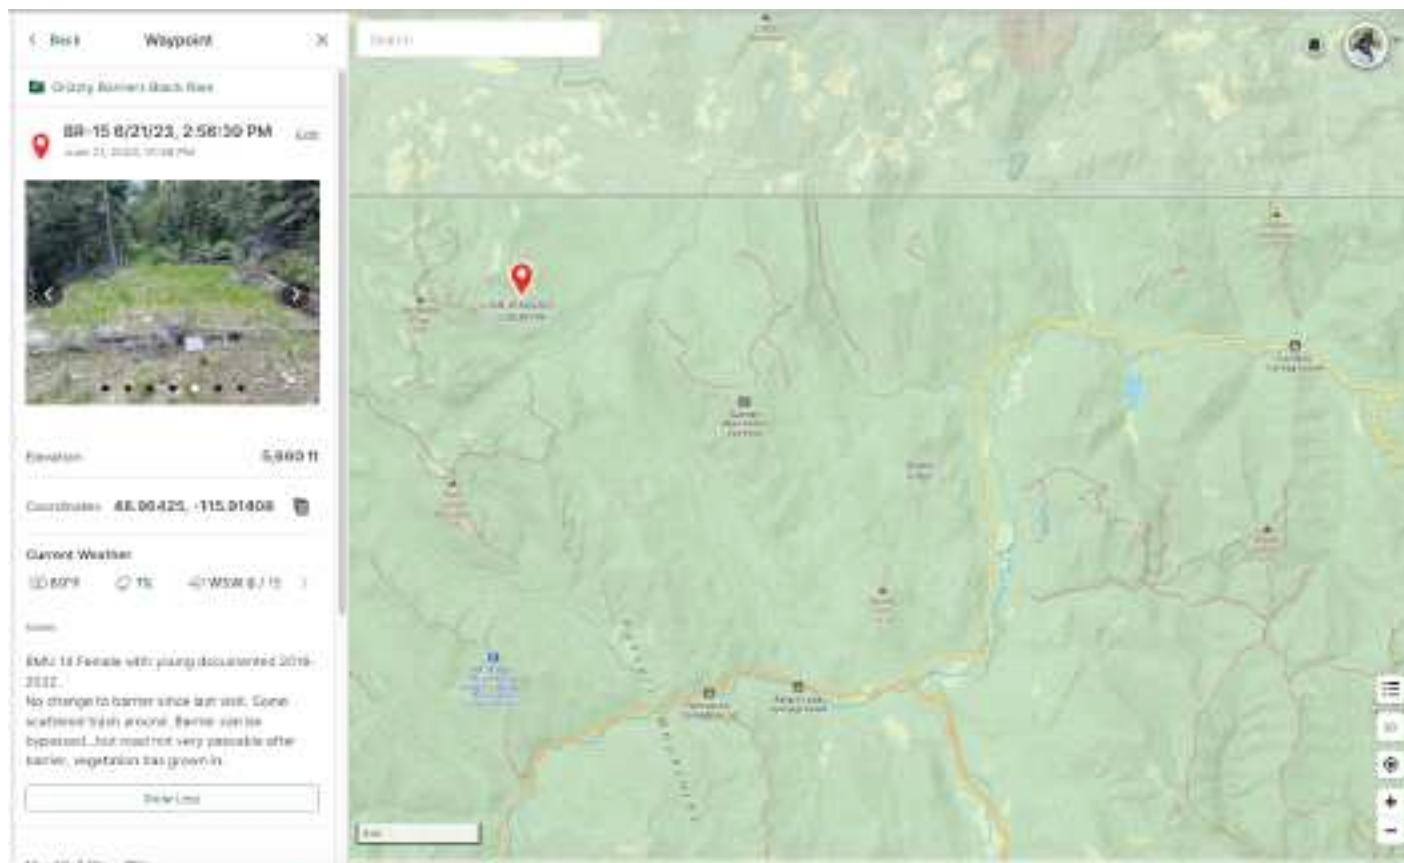
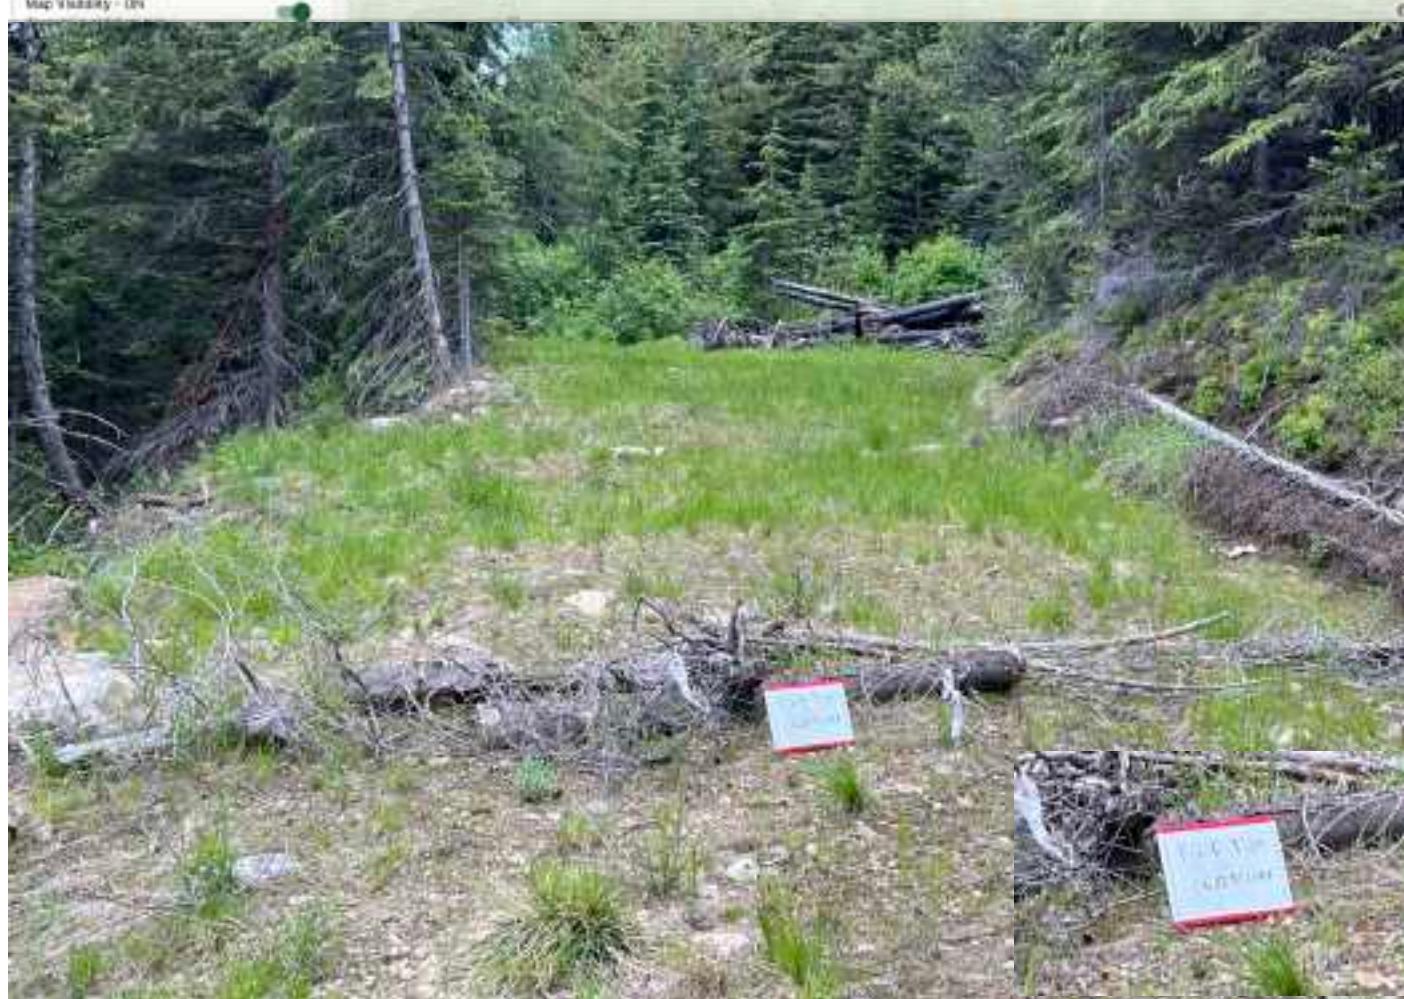
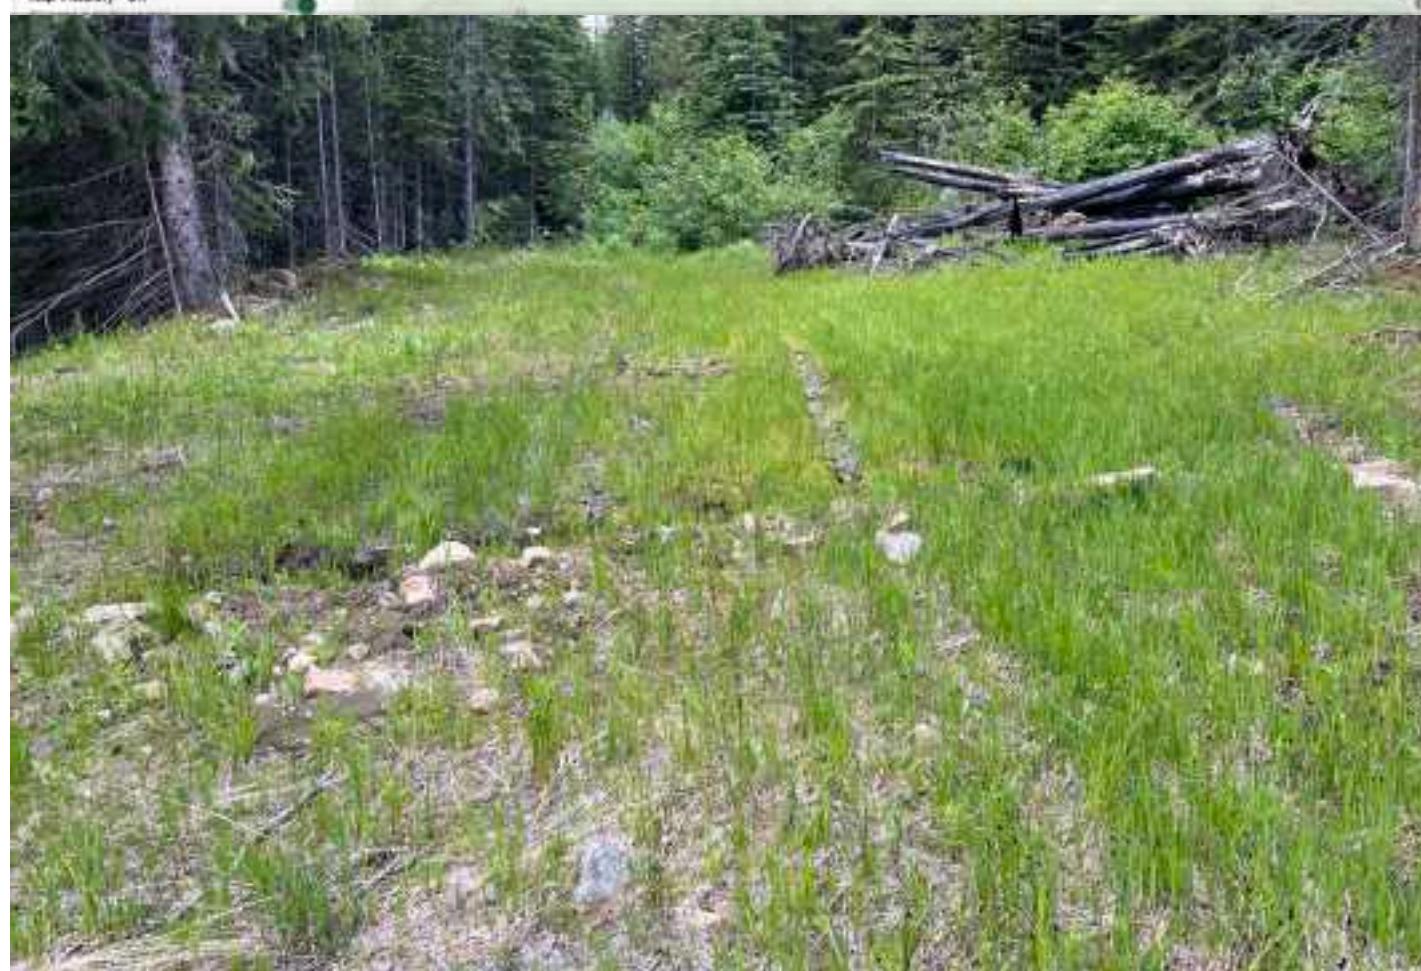
<b>Site:</b>	<b>BR-15</b>

Barrier ineffective 2024. No noted change to the barrier since 2023. Some scattered trash around the area in 2023 was removed. The barrier can be bypassed, the road after the barrier, is overgrown but passable. Vegetation is starting to reclaim the road.
