YAAK VALLEY FOREST COUNCIL

# Insufficient Grizzly Barrier Report

## 2020-2024

CYE BMUs 14-15

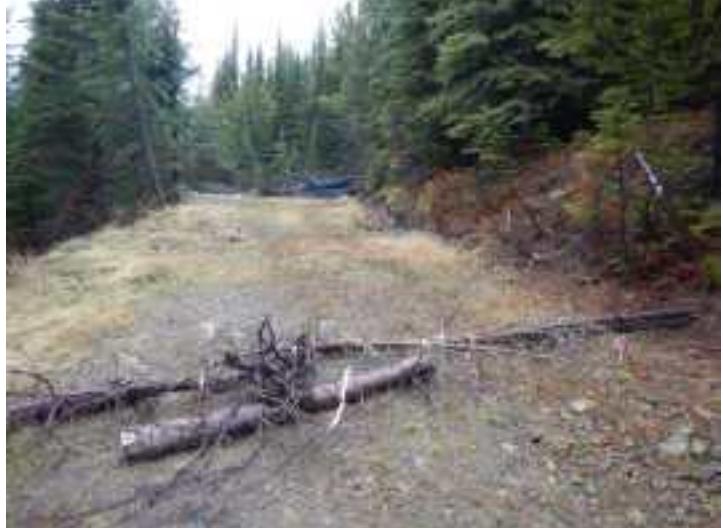
<b>Site:</b>	<b>BR-15</b>

<b>Road #, or description:</b>	Road # 338P		
<b>Coordinates:</b>	48 57 51.3 / 115 5450.7		
<b>Site Notes:</b>	<p>2020: A pile of small mixed woody debris with flagging is the current barrier. There are no signs or effective barriers. Due to wildfire activity, the soil is sensitive and major surface runoff is present.</p> <p>2022: YVFC was unable to access this location in November 2022 due to the amount of snow. A photograph from August 2022 is used here instead.</p>

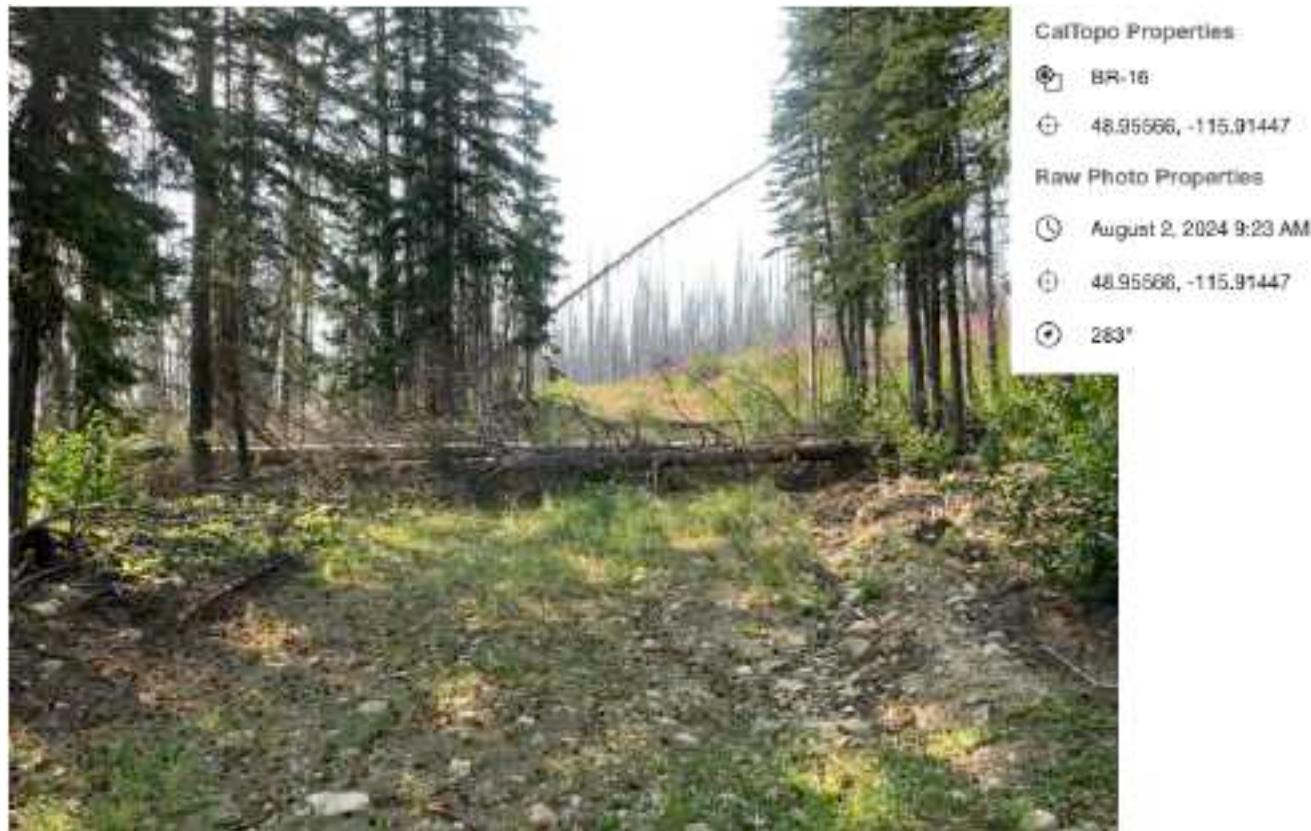
**BR 16**

Barrier ineffective 2024. Tree barriers are still lying across the road. It can be bypassed to the left or right of trees. No signs of recent trespass.

Remedy: additional blockage, boulders, or gate.

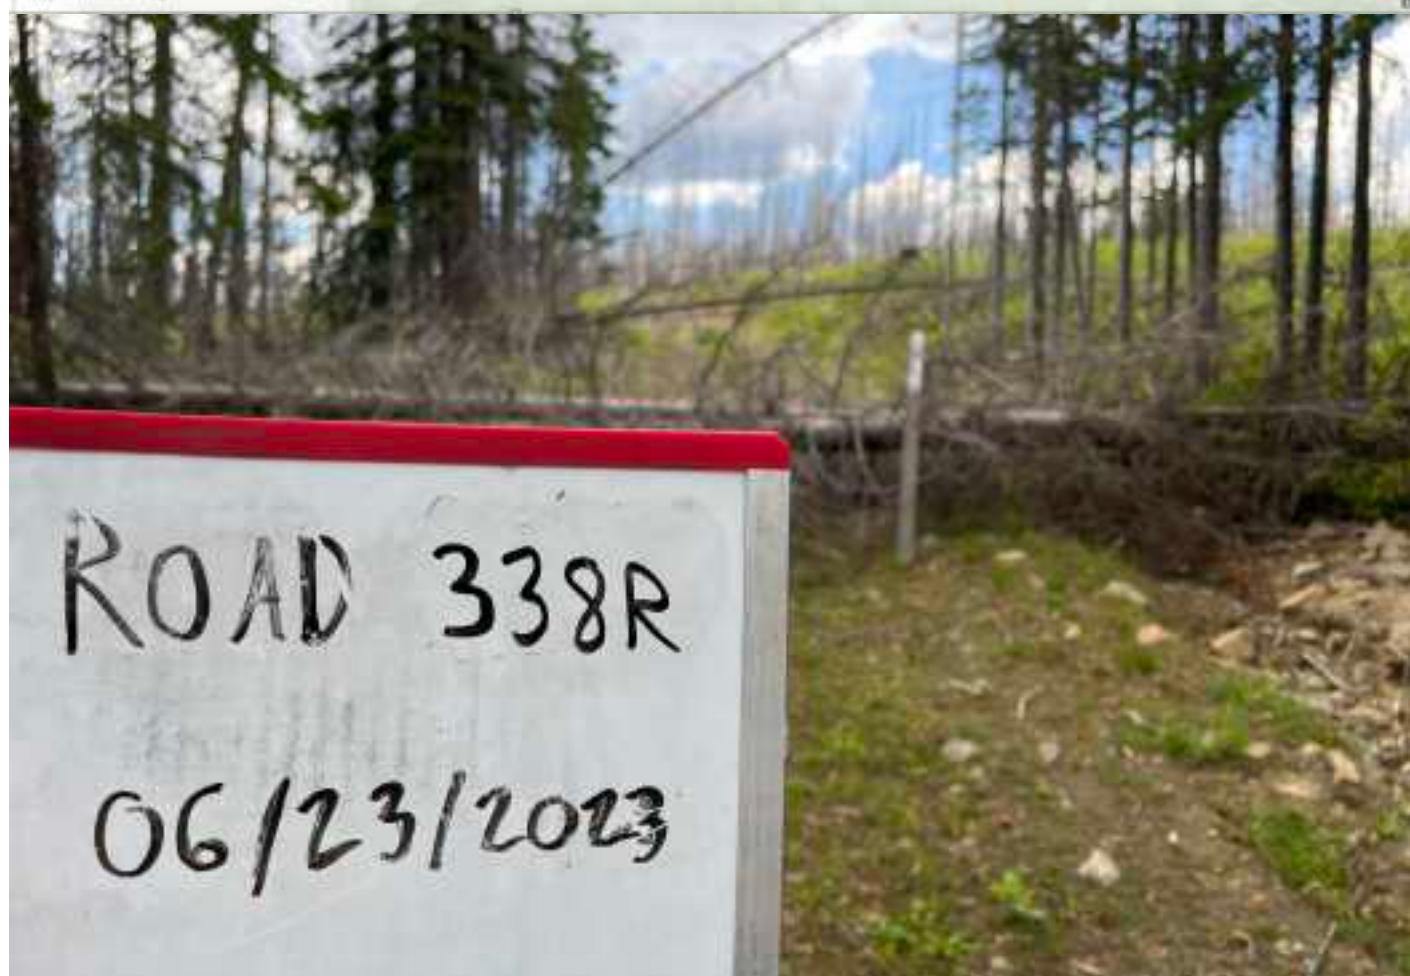
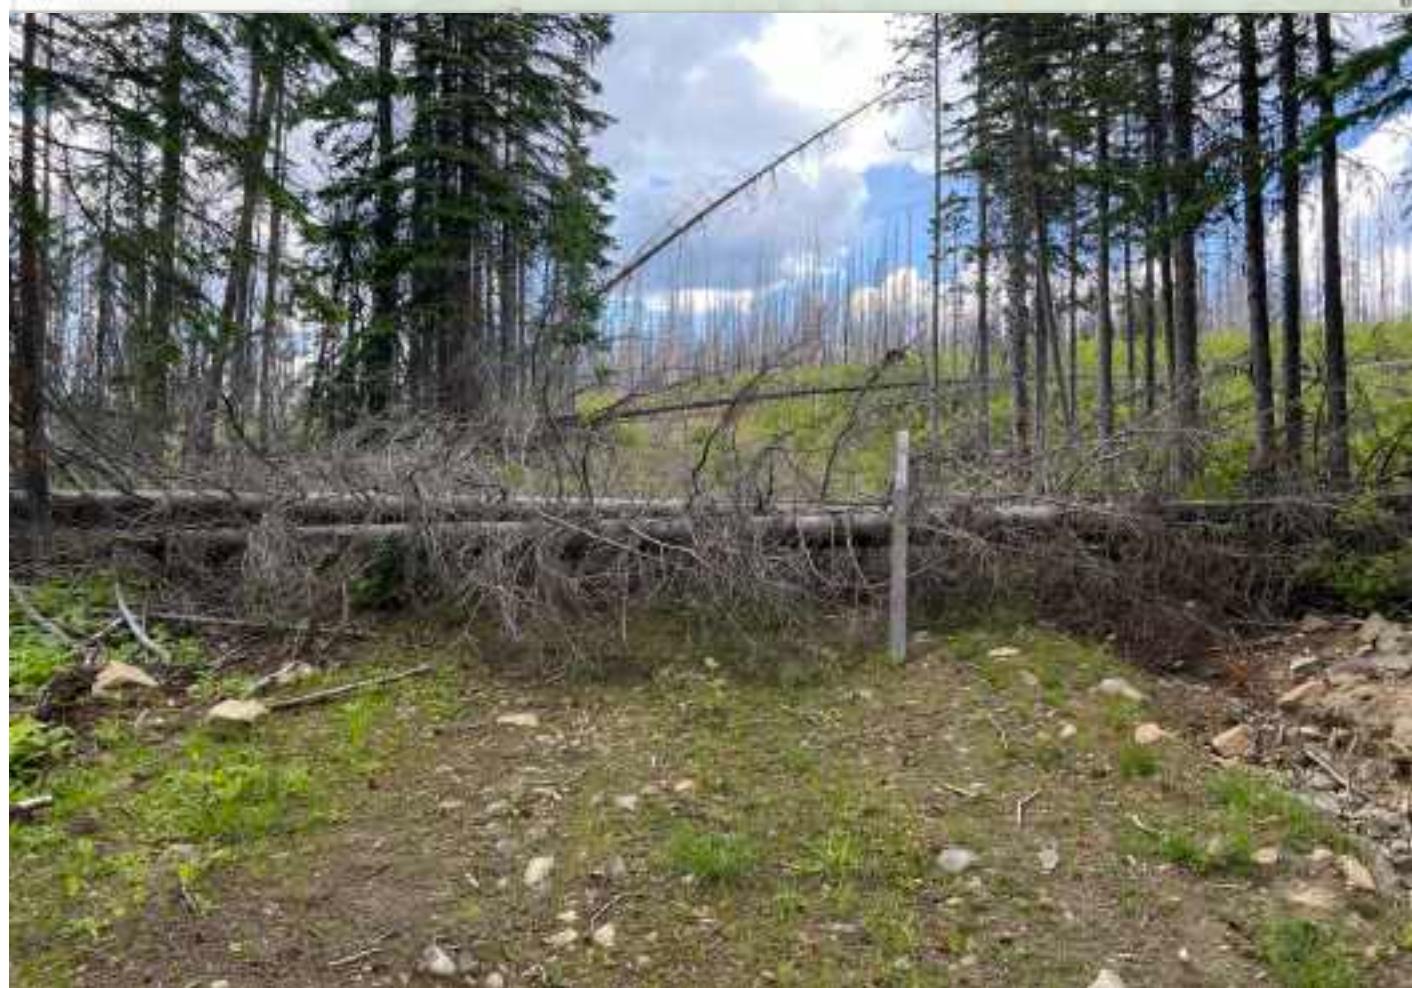
<b>Site:</b>	<b>BR-16</b>
<b>Road #, or description:</b>	Road # 338R
<b>Coordinates:</b>	48 57 20.5 / 115 54 52.5
<b>Site Notes:</b>	
<p>2020: No barrier other than two recently fallen trees. Heavy rutting and tracks from motor-vehicle use. Due to wildfire activity, the soil is unstable and major surface runoff is present. Exceeds 300' in length.</p> <p>2022: YVFC was unable to access this location in November 2022 due to the amount of snow. A photograph from August 2022 is used here instead.</p>

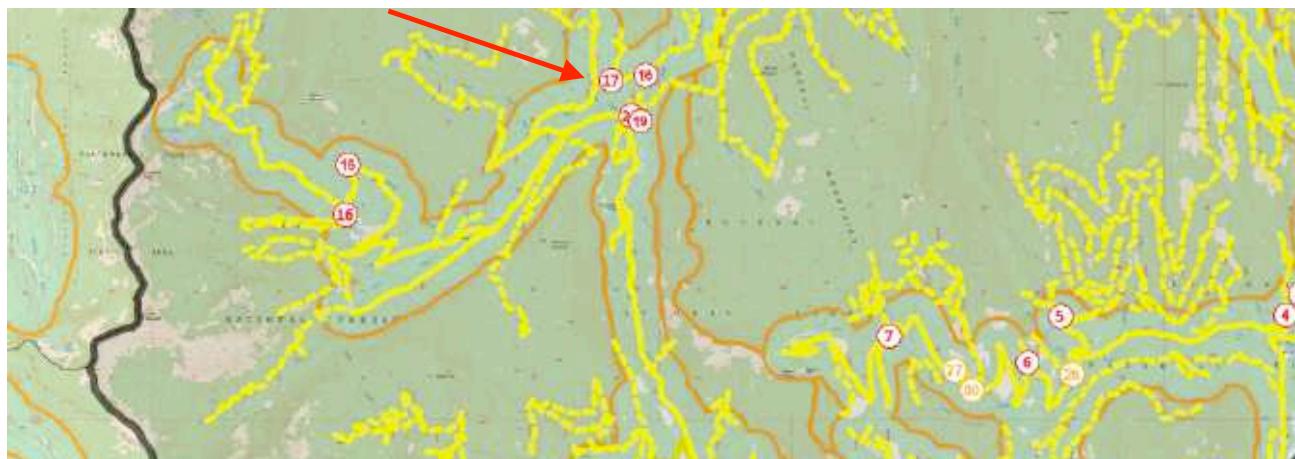
**BR 17**

BMU 14 Female with young documented 2016-2023.

Barrier ineffective 2024. Unchanged site from the original survey. No barrier, road not on the Motor Vehicle Use Map. Tracks visible entering indicating use in 2024 and 2023 surveys. Evidence of bear activity, and multiple recent scat piles nearby. Remedy-gate, boulders...

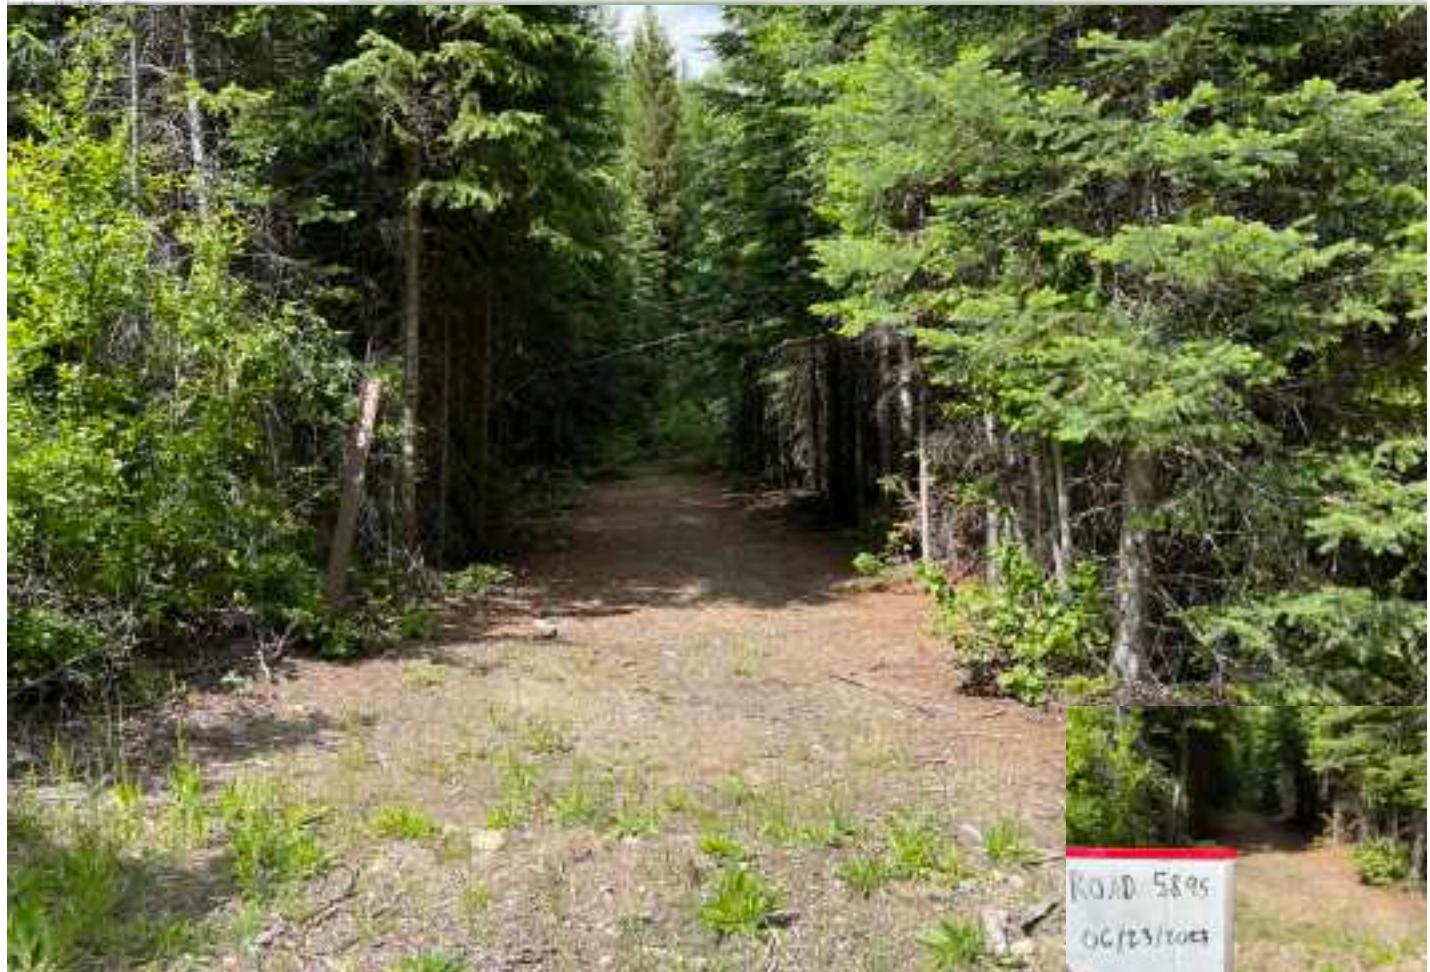
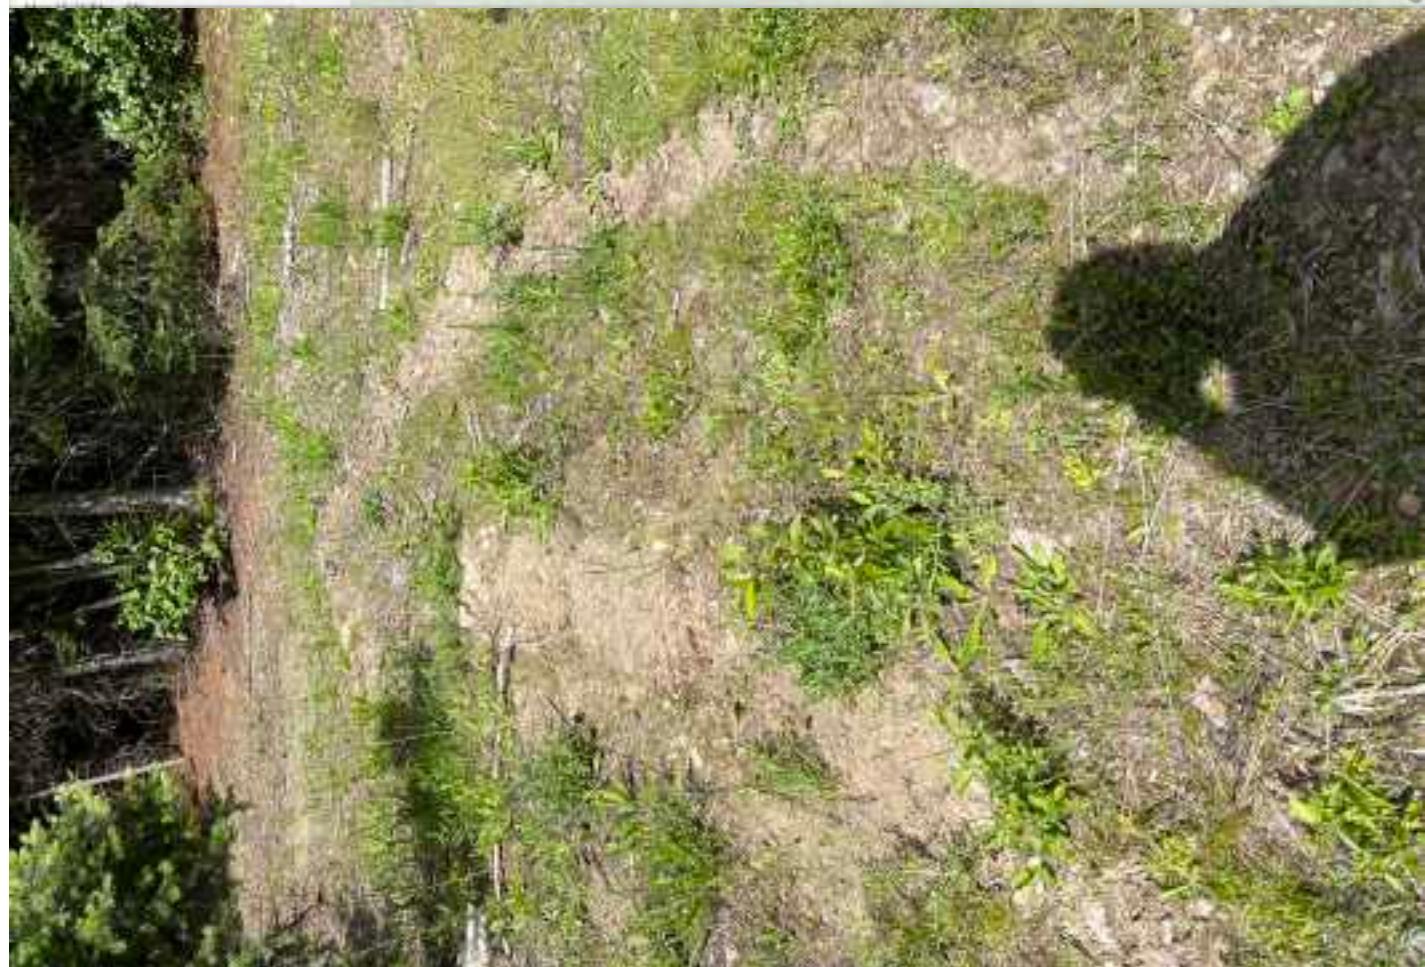
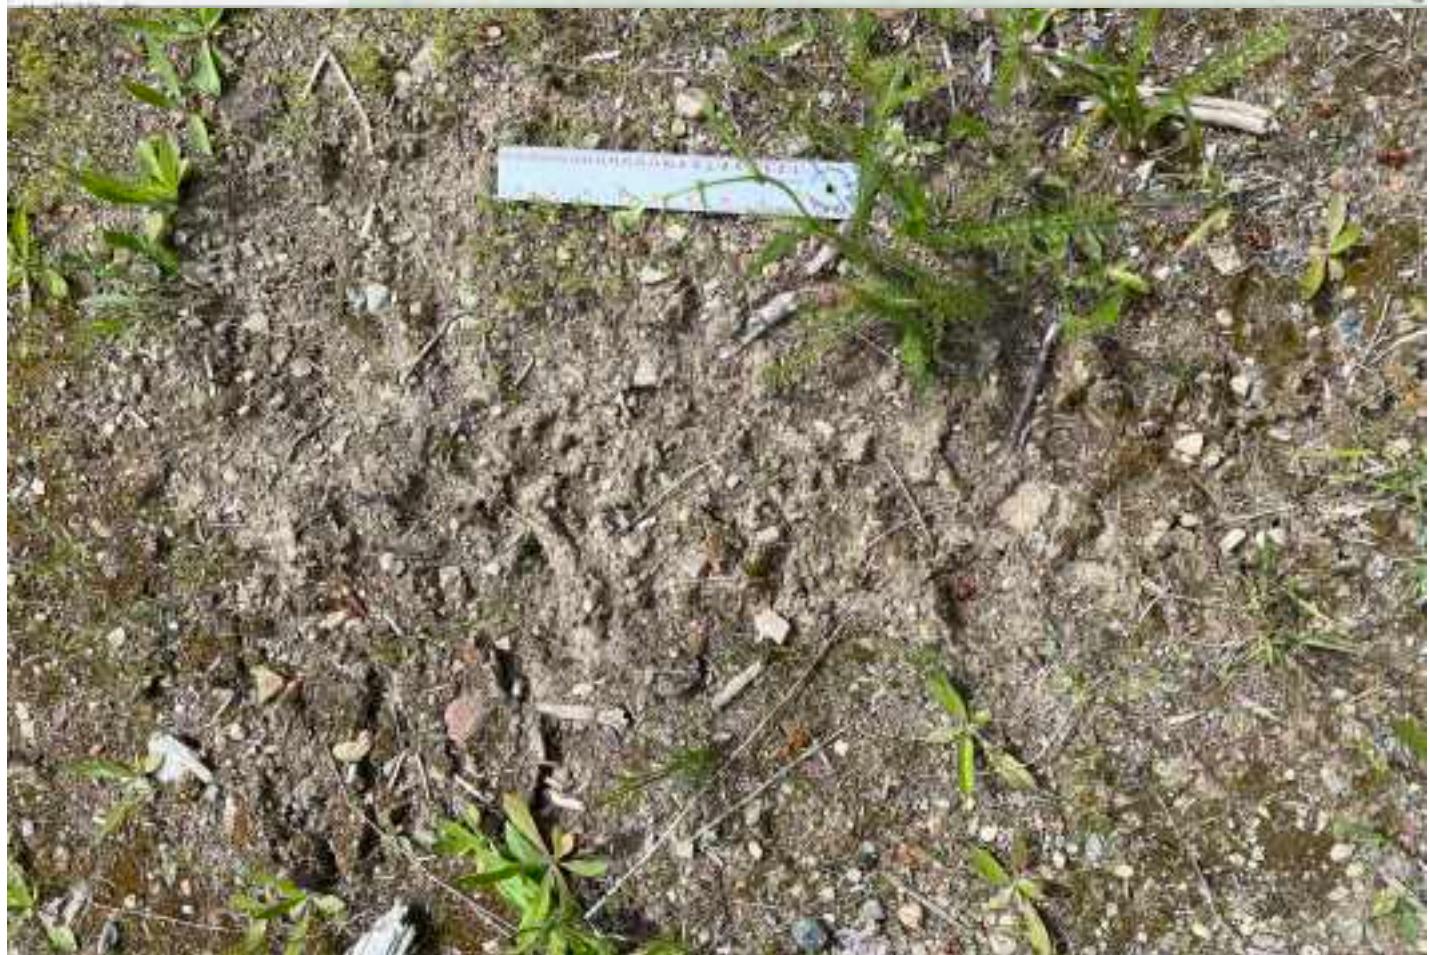
<b>Site:</b>	BR-17
<b>Road #, or description:</b>	Road # 5895
<b>Coordinates:</b>	48 58 43.6 / 115 50 43.1
<b>Site Notes:</b>	
<p>2020: No barrier. Road 5895 is not mapped as an open road, according to the MV Use Map provided by the Kootenai National Forest.</p>

BR-17. Female with young documented 2019-2022. Unchanged area from original survey. No barrier, not on MV map. Tracks visible indicating recent use. Evidence of bear activity, multiple recent trail piles nearby Remedy-gate, buildings.

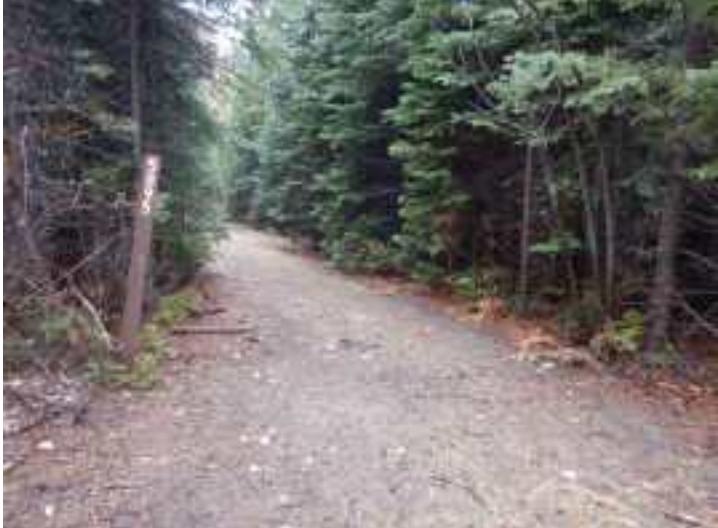
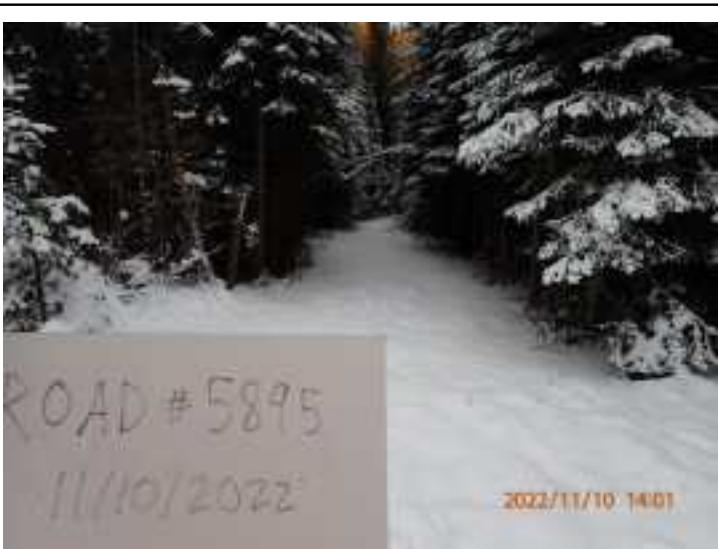
**BR 18**

Barrier ineffective 2024. Gate present, but bypassable. Tire tracks on road on both sides of gate in 2023. GATE UNLOCKED at 2023 survey.

Remedy-Lock Gate, boulders on the uphill side of the gate where it is passable by an ATV.

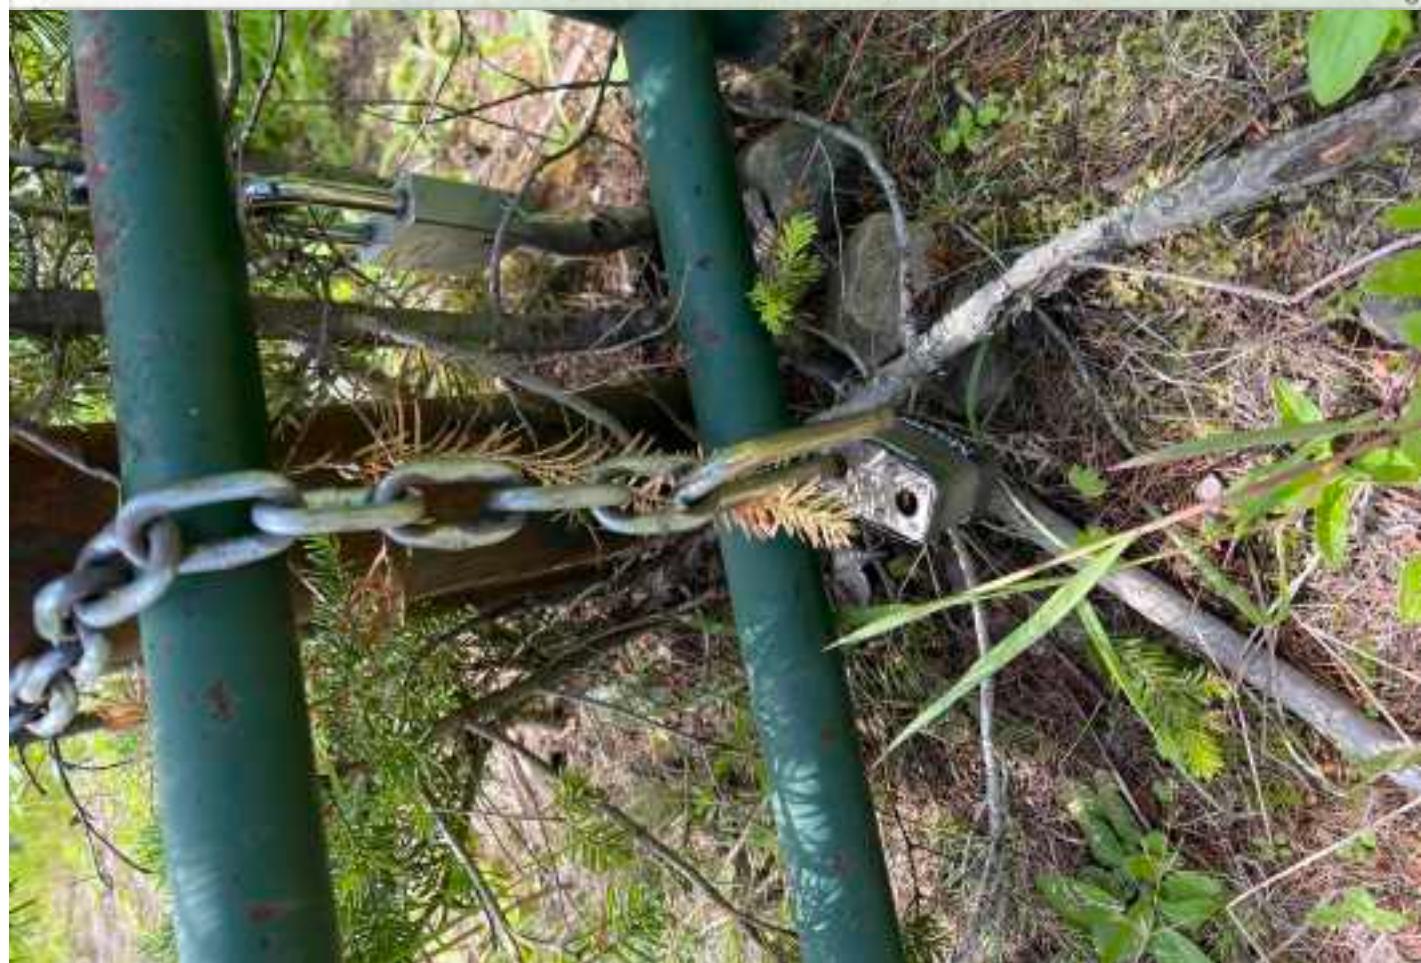
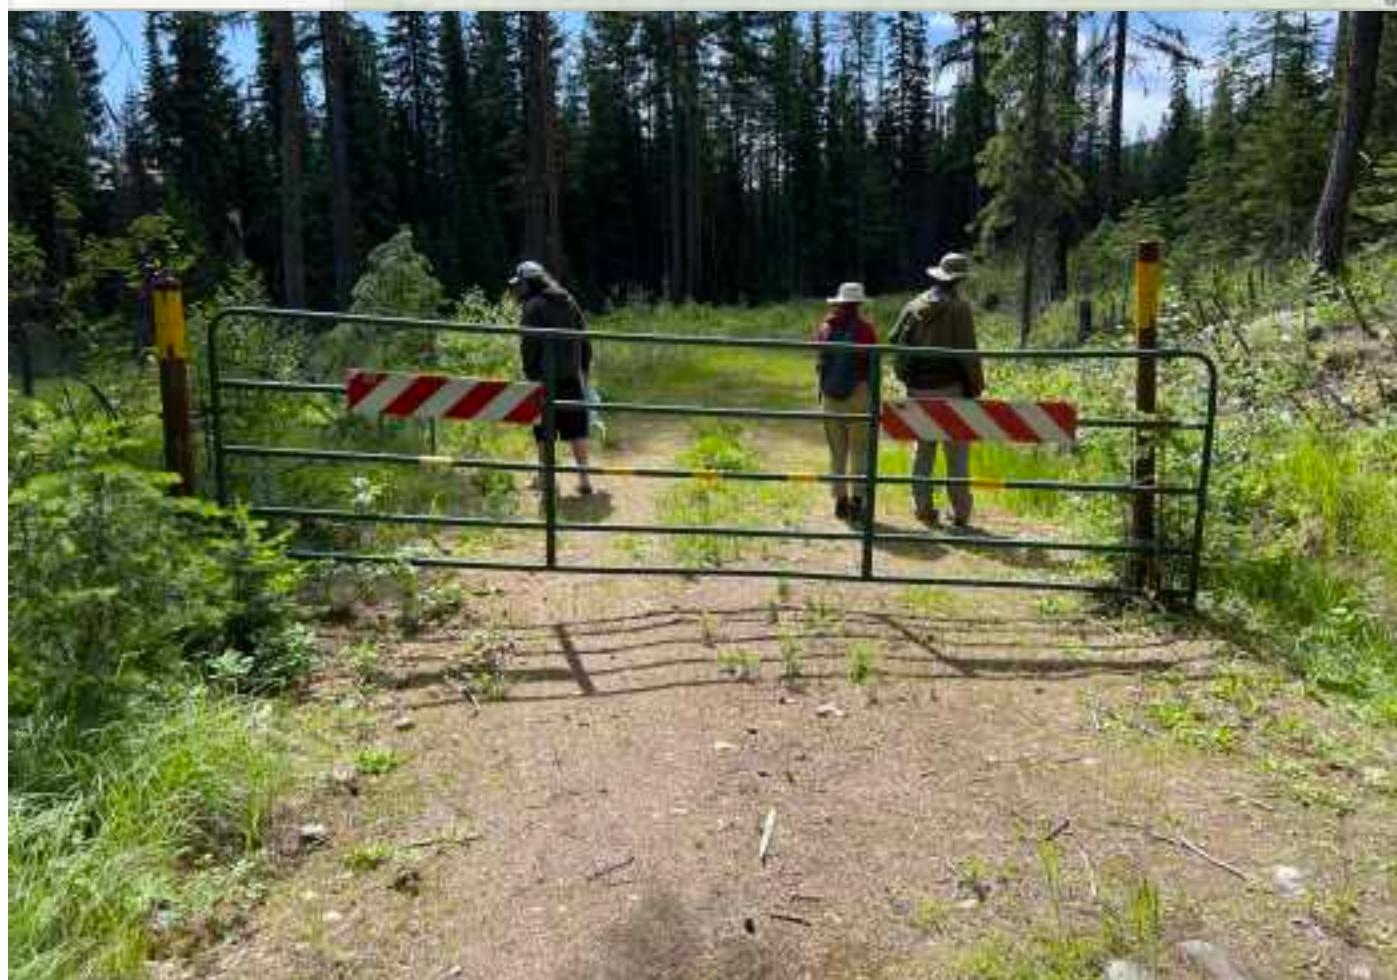
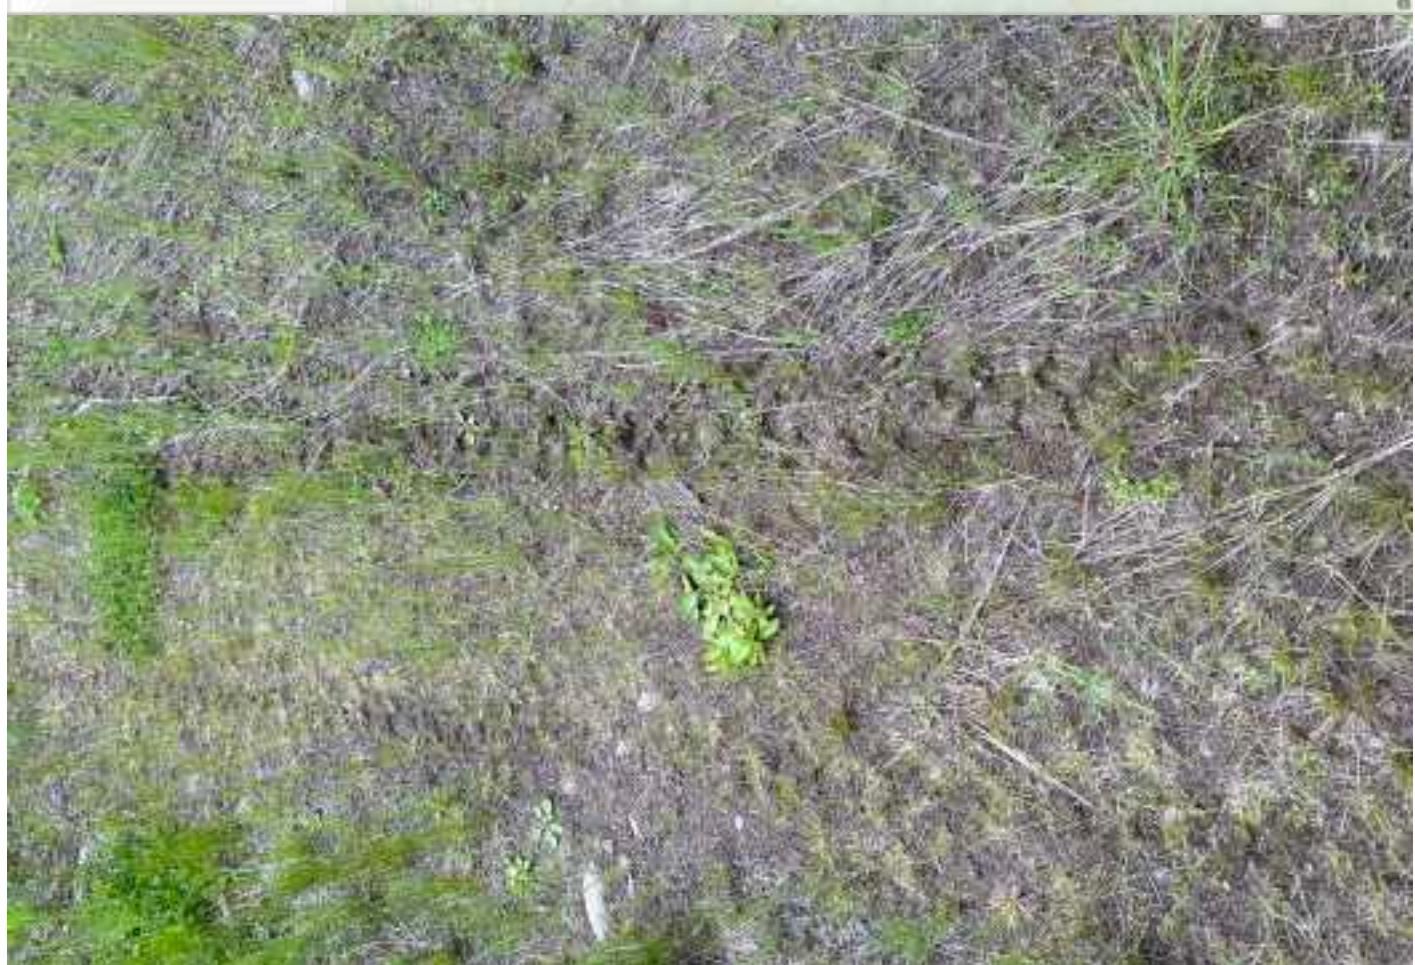
<b>Site:</b>	BR-18
<b>Road #, or description:</b>	Road # 5894
<b>Coordinates:</b>	48 58 45.9 / 115 50 11.8
<b>Site Notes:</b>	
<p>2020: Gate. 5' wide passage to gate-right. This road is accessible to ATVs and motorcycles. This ineffective barrier grants access to the Canada/USA international boundary and the sensitive Davis Wildfire fire-break.</p>

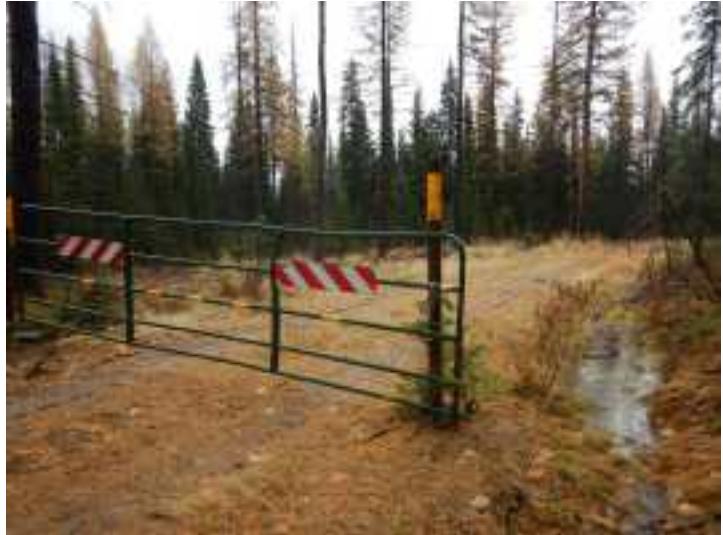
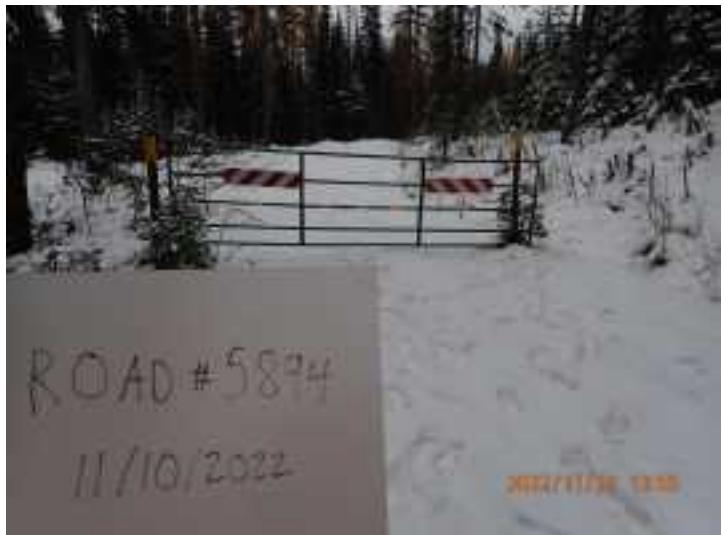
**BR 19**      **Coordinates 48.97150, -115.83906**

BMU 14 Female with young documented 2016-2023.

Barrier ineffective 2024. Barrier is unchanged since November 2023 survey. Barrier easily bypassed to berm right. Actually two different berms, both insufficiently barrier the road. Obvious evidence of clearing road behind barrier. Bush hogged extensively. Border patrol clears the road and patrols it frequently. Road is deemed closed.

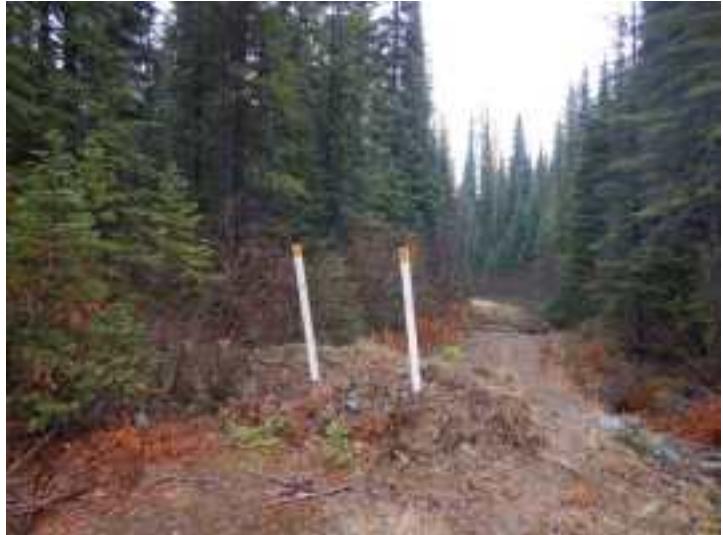
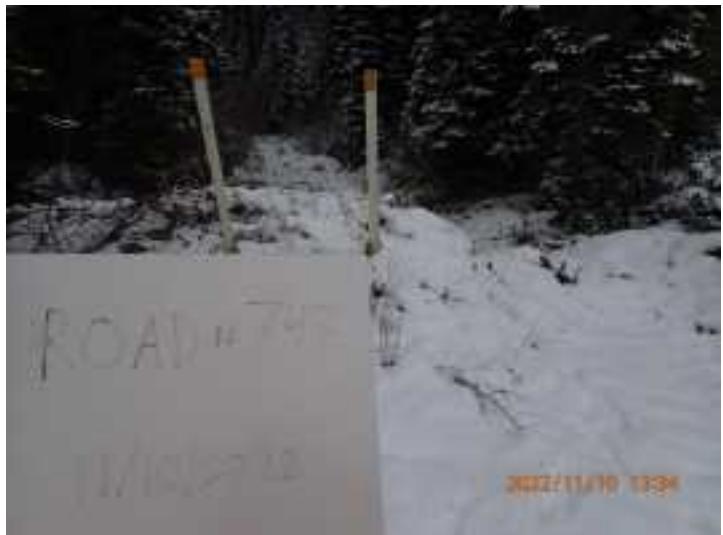
**BR 20**

BMU 15 Female with young documented 2016-2023.

Barrier ineffective 2024. Past notes state that the gate needs replacement (in 2020) but still has not been replaced (2024). Trees fell over the road both before and behind the gate. The gate can be bypassed on gate right by four-wheelers (ATVs). No recent tracks. Looks like the gate was hit by something.
