YAAK VALLEY FOREST COUNCIL

# Insufficient Grizzly Barrier Report

## 2020-2024

CYE BMUs 14-15

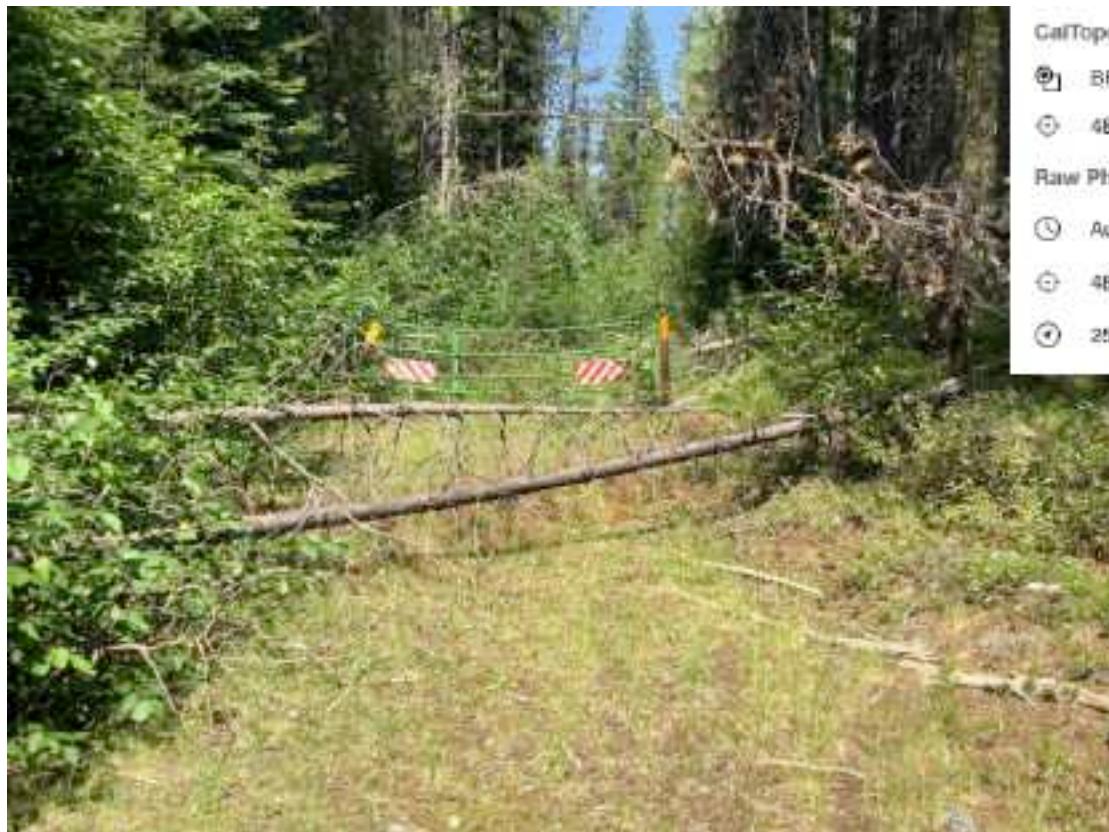
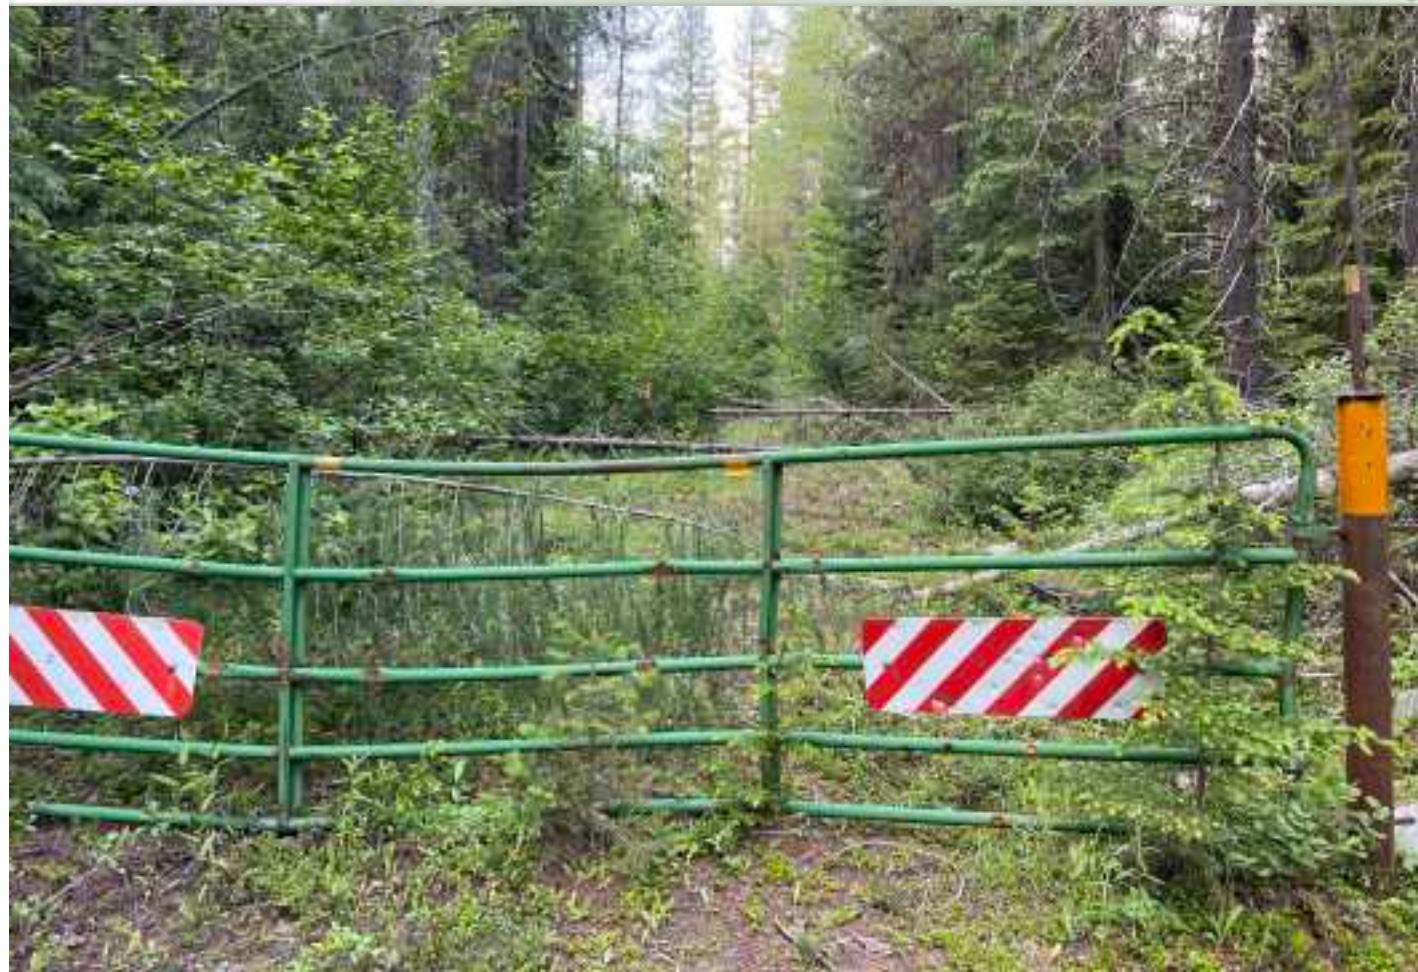
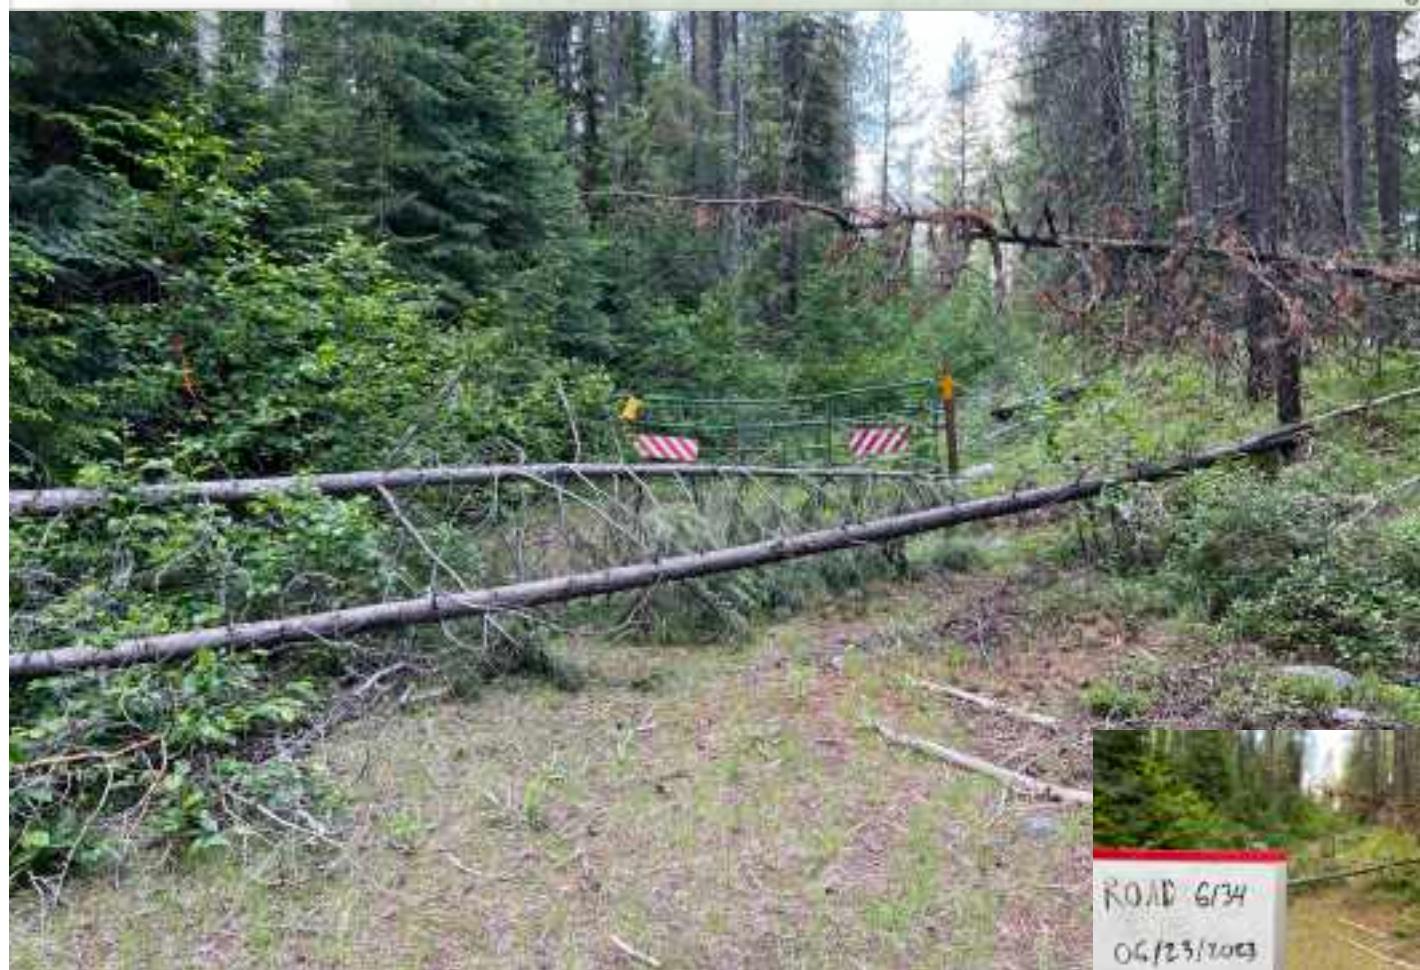
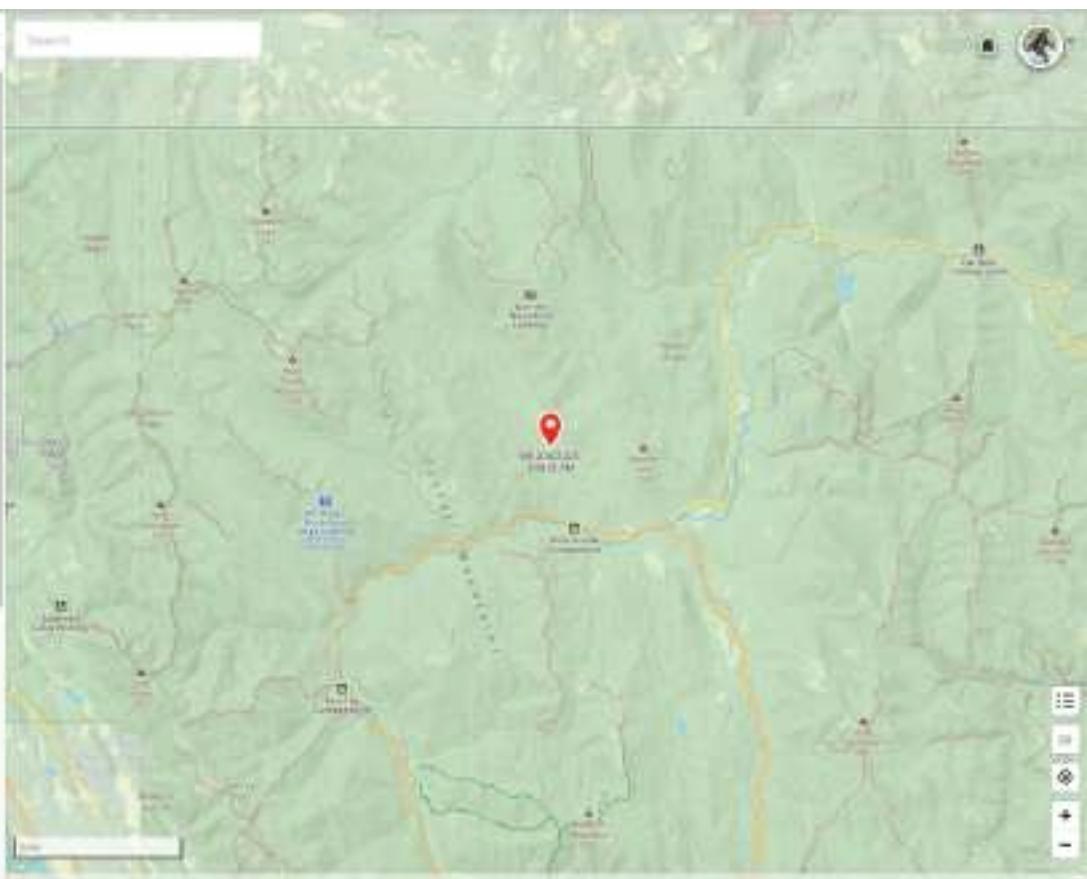
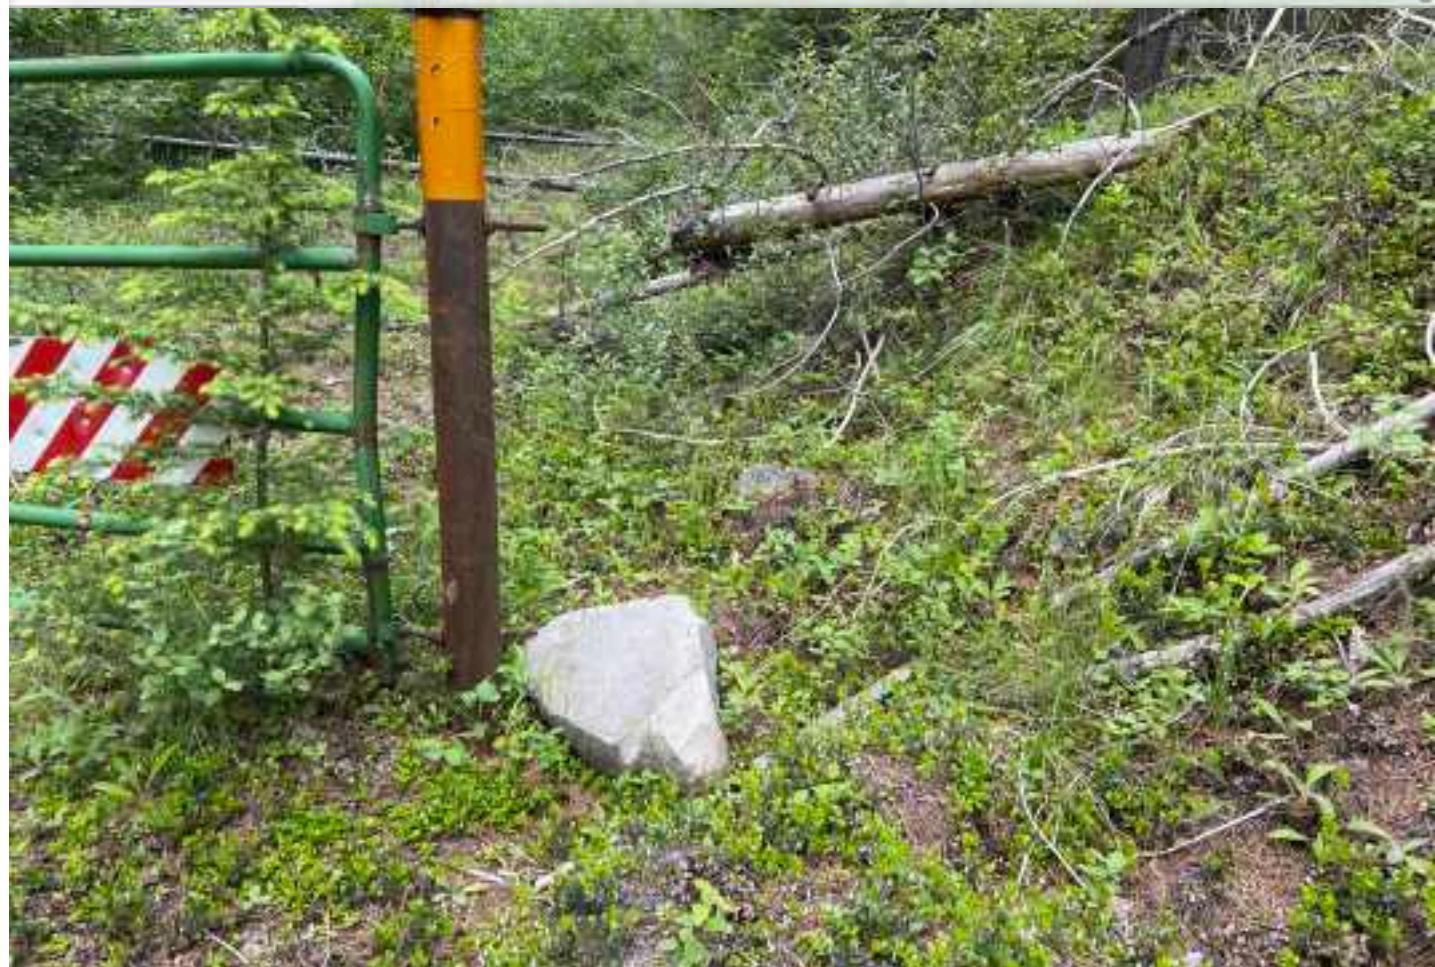
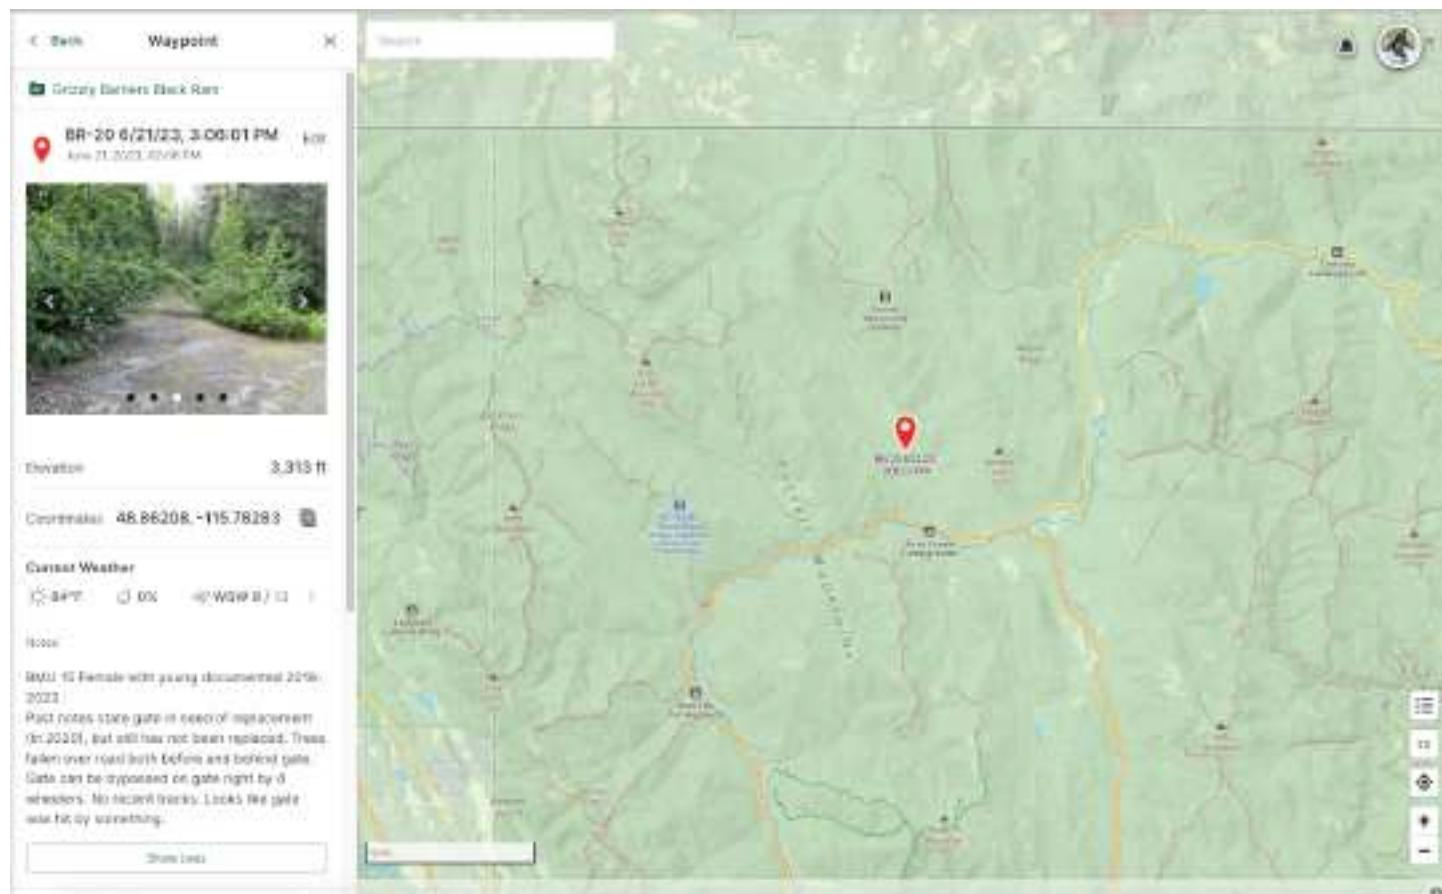
Barrier ineffective 2024. Past notes state that the gate needs replacement (in 2020) but still has not been replaced (2024). Trees fell over the road both before and behind the gate. The gate can be bypassed on gate right by four-wheelers (ATVs). No recent tracks. Looks like the gate was hit by something.

<b>Site:</b>	<b>BR-20</b>
<b>Road #, or description:</b>	Road # 6134
<b>Coordinates:</b>	48 51 43.5 / 115 46 58.2
<b>Site Notes:</b>	
	<p>2020: Gate barrier with a leaning/unstable lock post. A passage to gate-left approx. 3' allows access by motorcycles. There is a USFS marker, located gate-right, indicating the need to replace this insufficient barrier.</p>

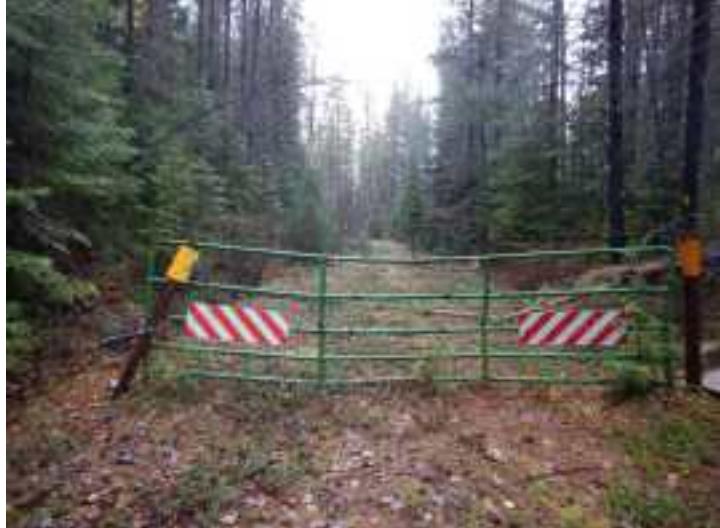
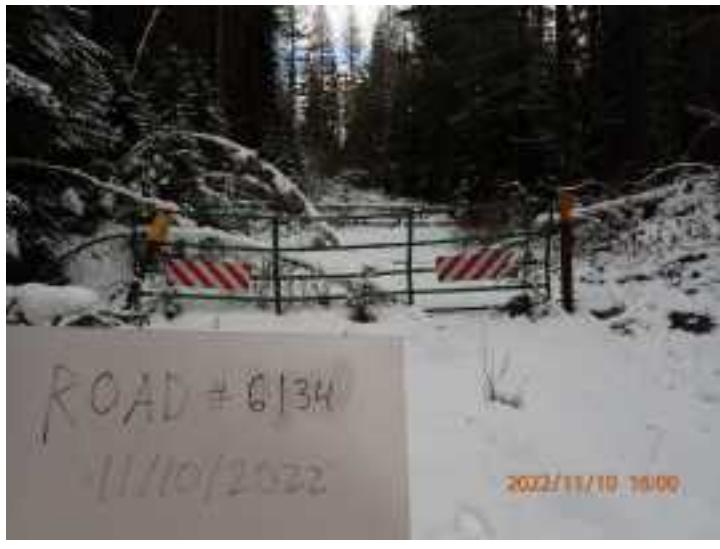
**BR 21**

Barrier ineffective 2024. KNF 5894 Road. The gate is bypassable on gate left, and the woods have been cleared to the gate left. ATV passable.

Remedy-boulders.

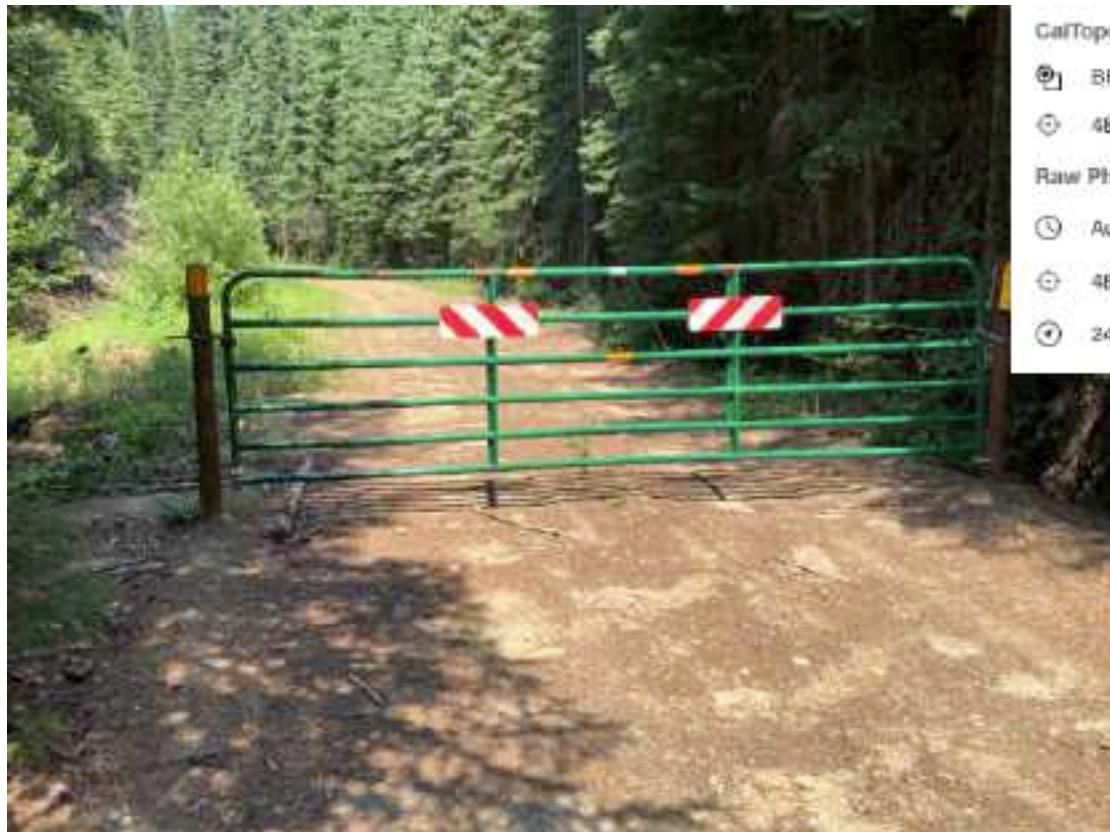
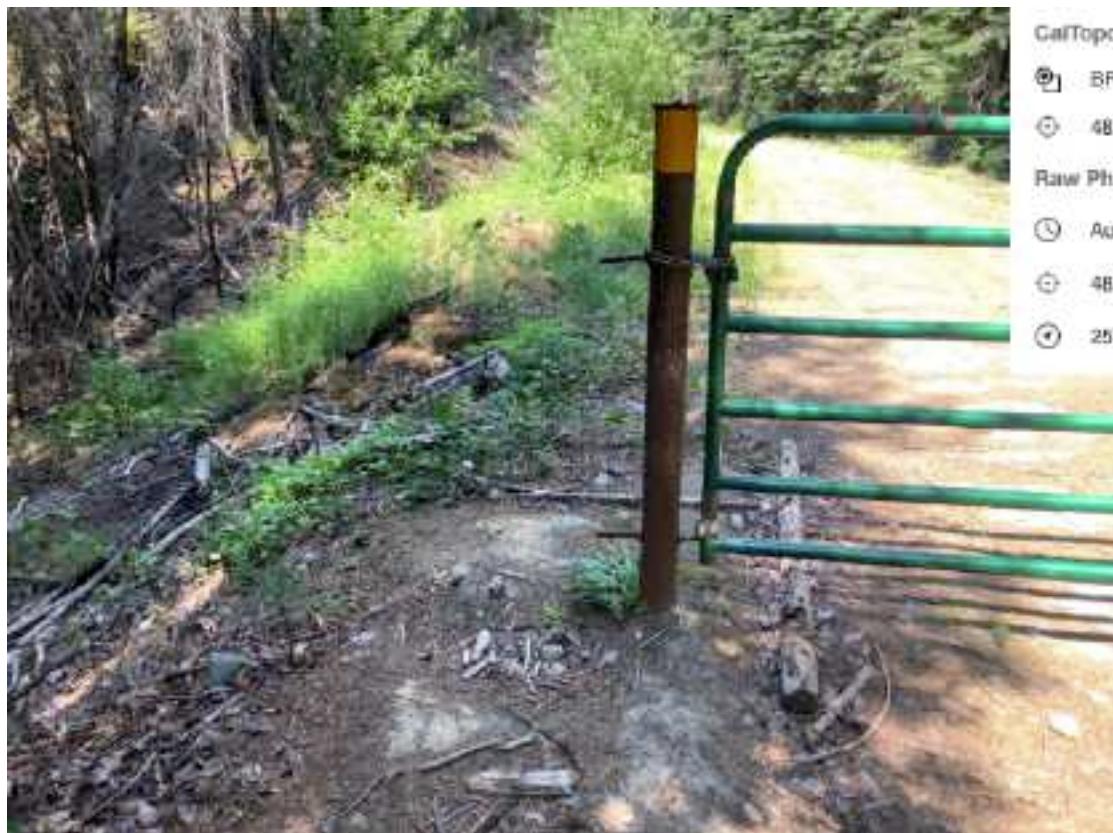
Barrier bypassable on gate left.

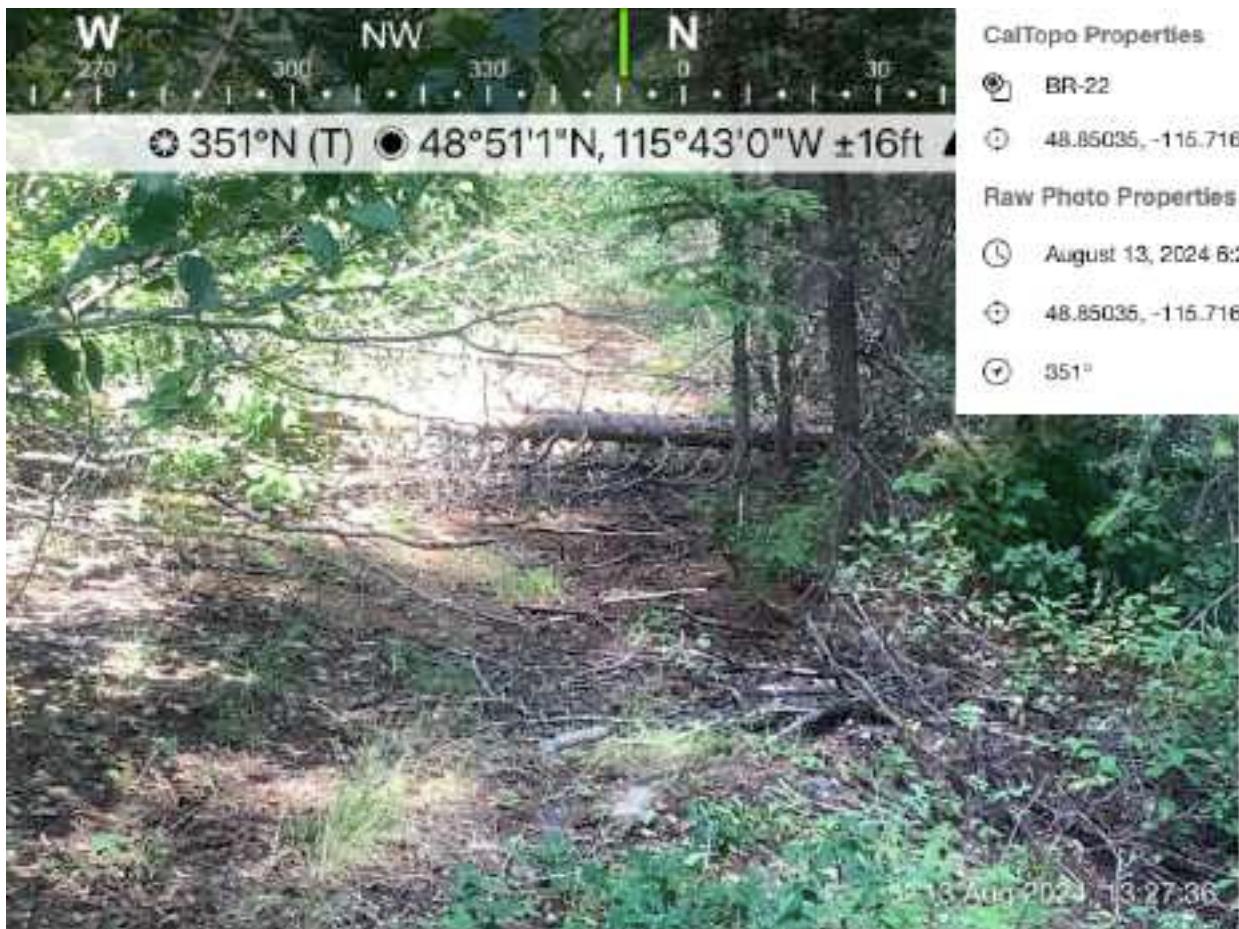
BR 22

Barrier ineffective 2024. Unbarriered road open for several hundred yards then blocked by downed tree.

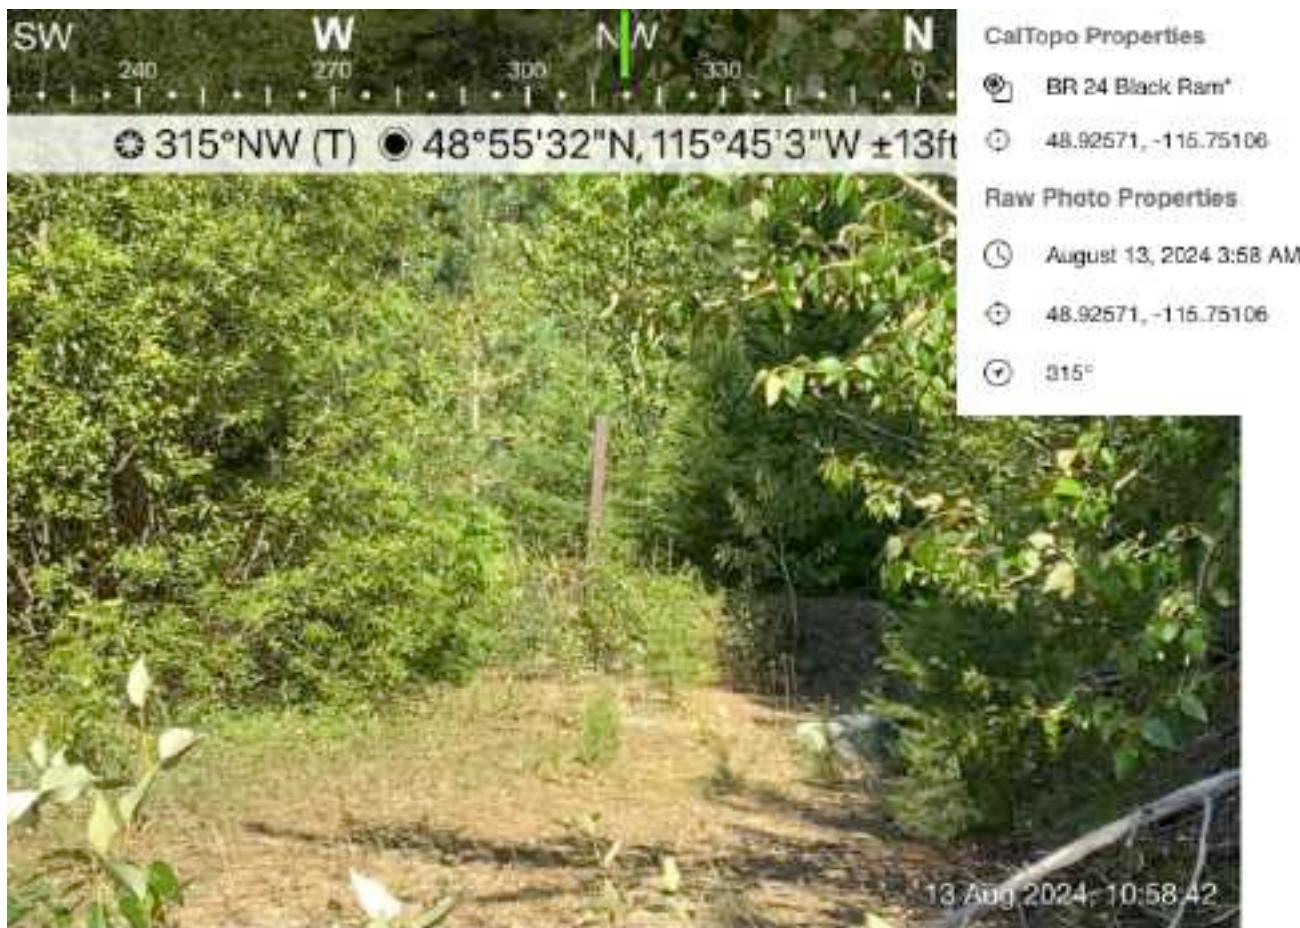
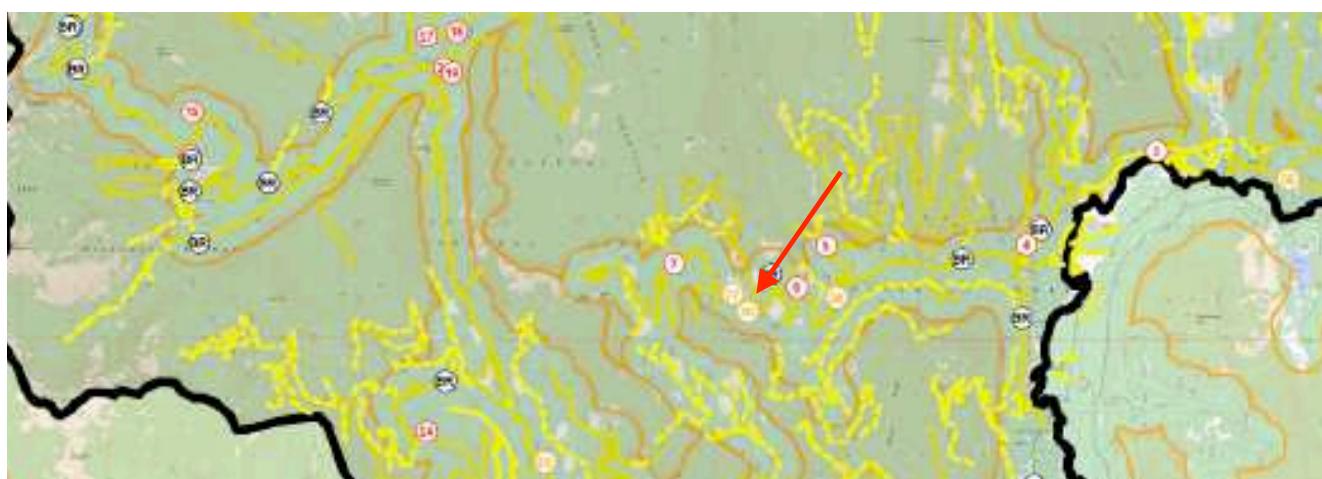
**BR 23**      **Coordinates: N 48.841520, W -115.701201**      **Date: 20234.08.02**

BMU 15 Female with young documented 2016-2023

Barrier ineffective 2024. Berm barrier, bypassable on the right side. Road open behind the barrier.

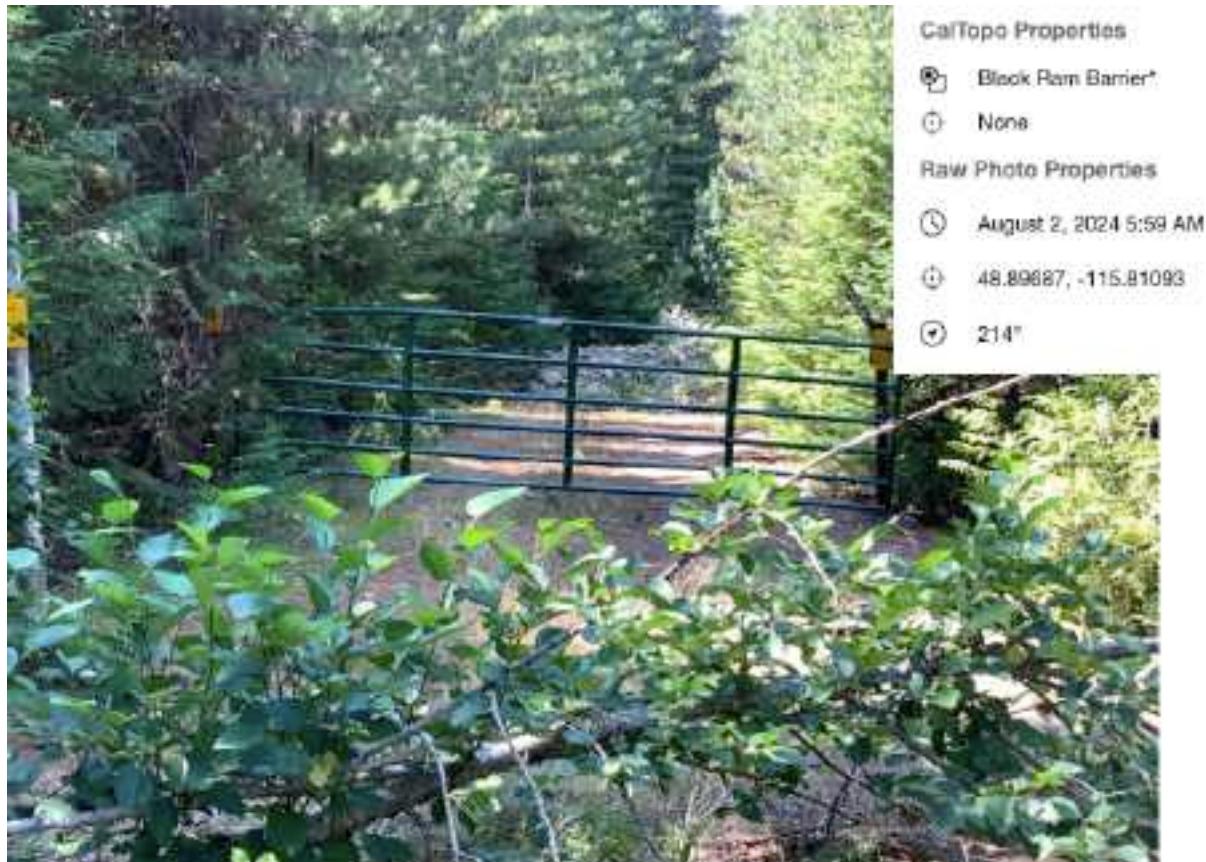
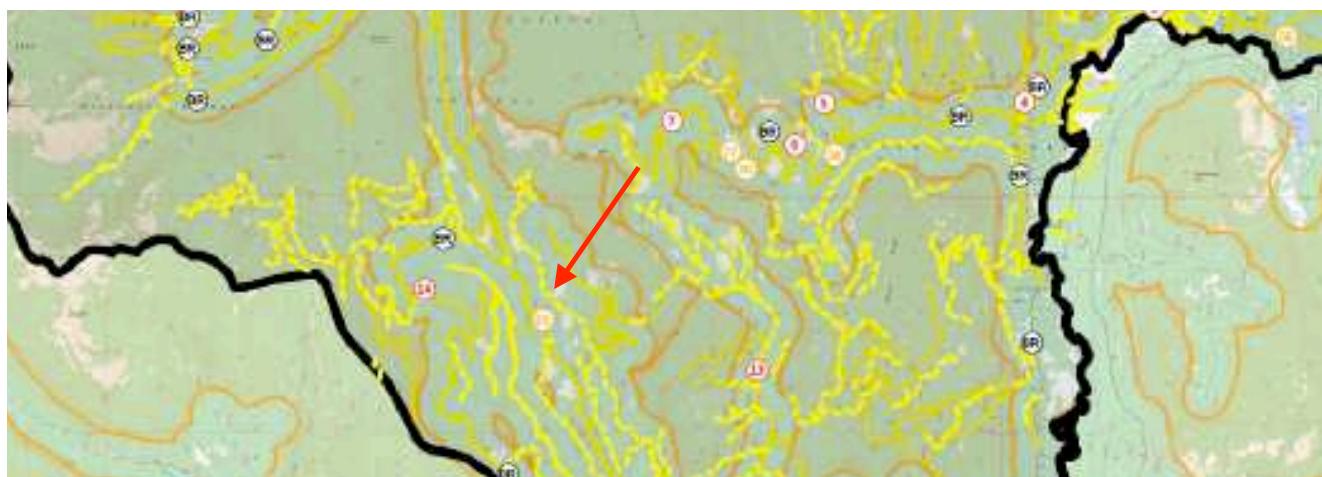
**BR 25**

BMU 14 Female with young documented 2016-2023

Barrier ineffective 2024. Road barriered with gate and berm 2024.08.02. Road open and drivable behind berms. Berms were removed with evidence of traffic for most of August 2024.

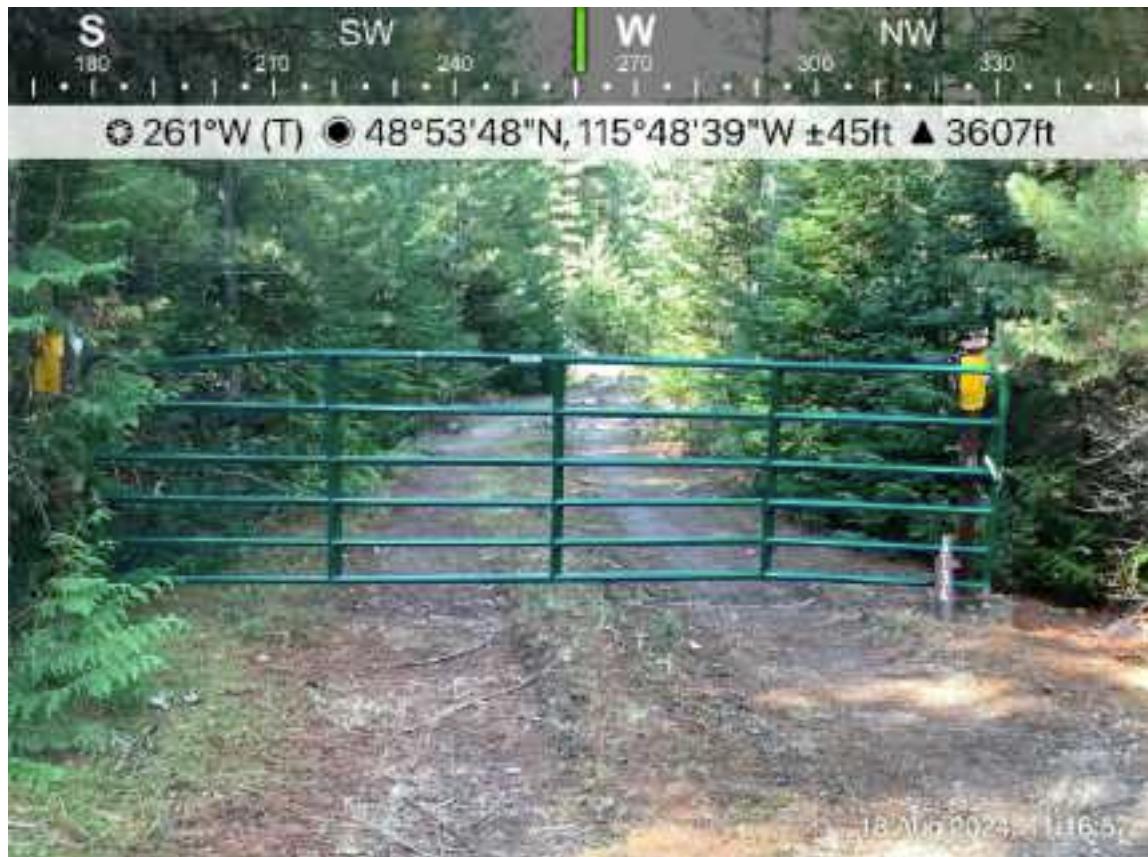
2024.08.18 Road berm barriers removed with evidence of a lot of traffic moving in both directions.

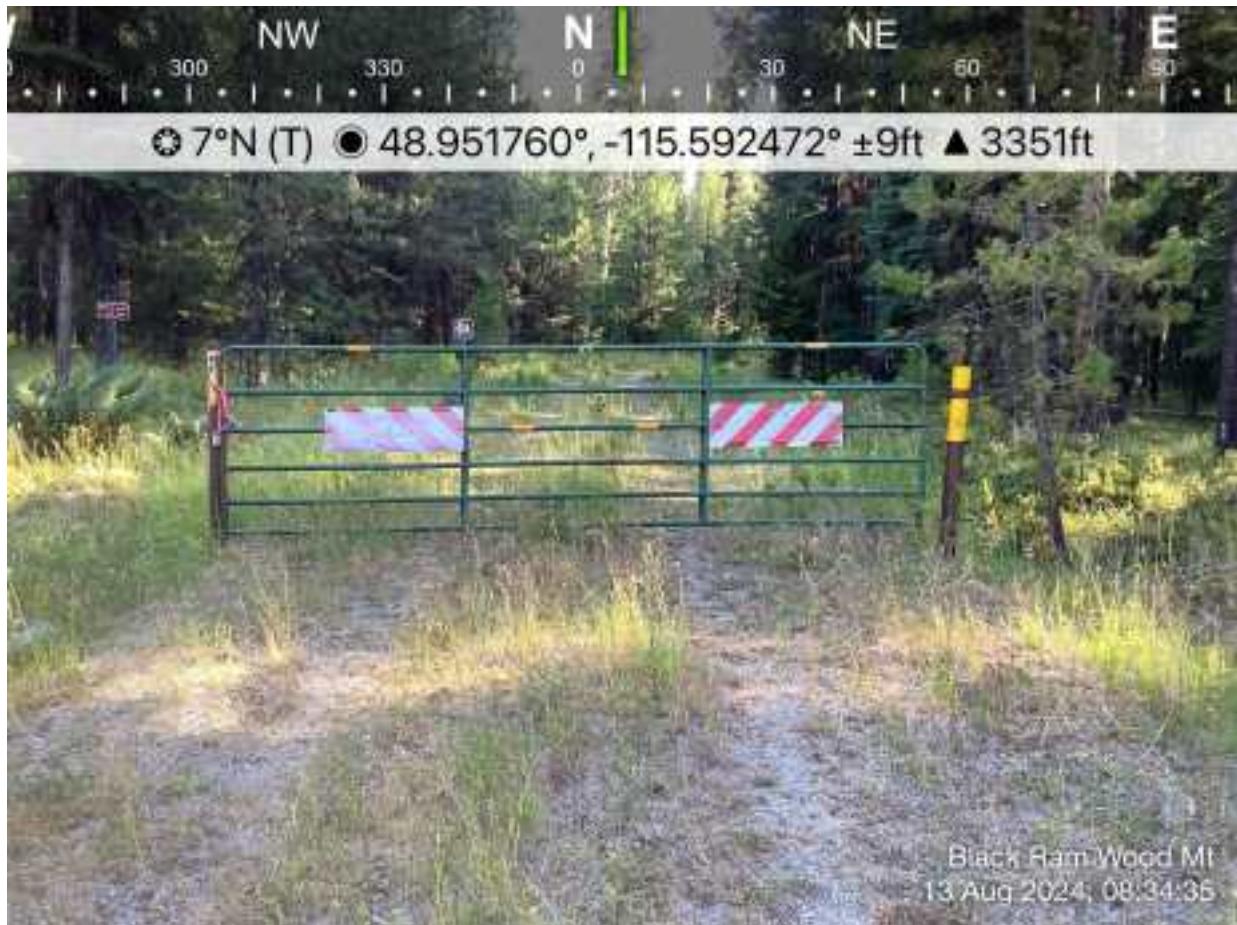
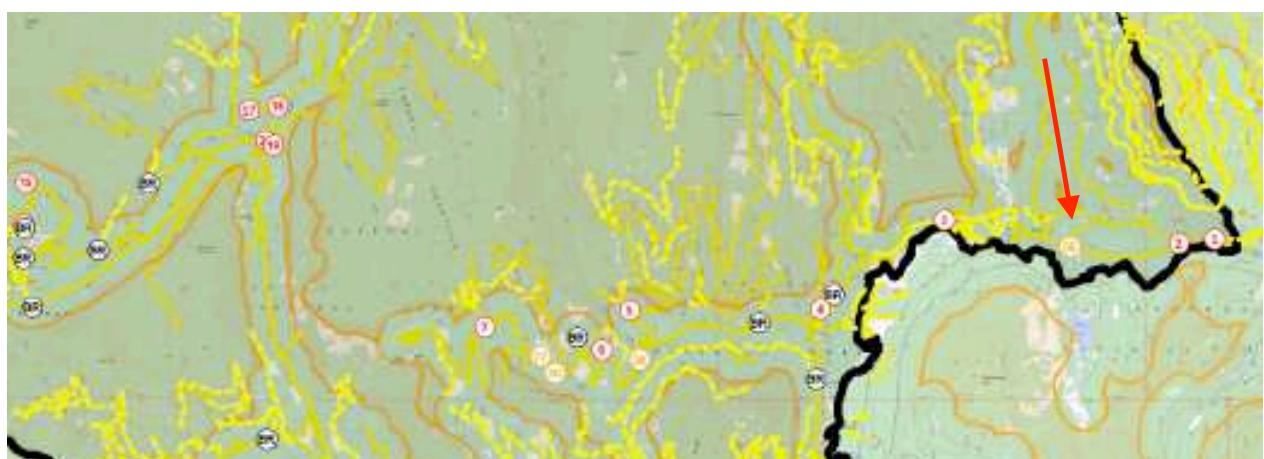
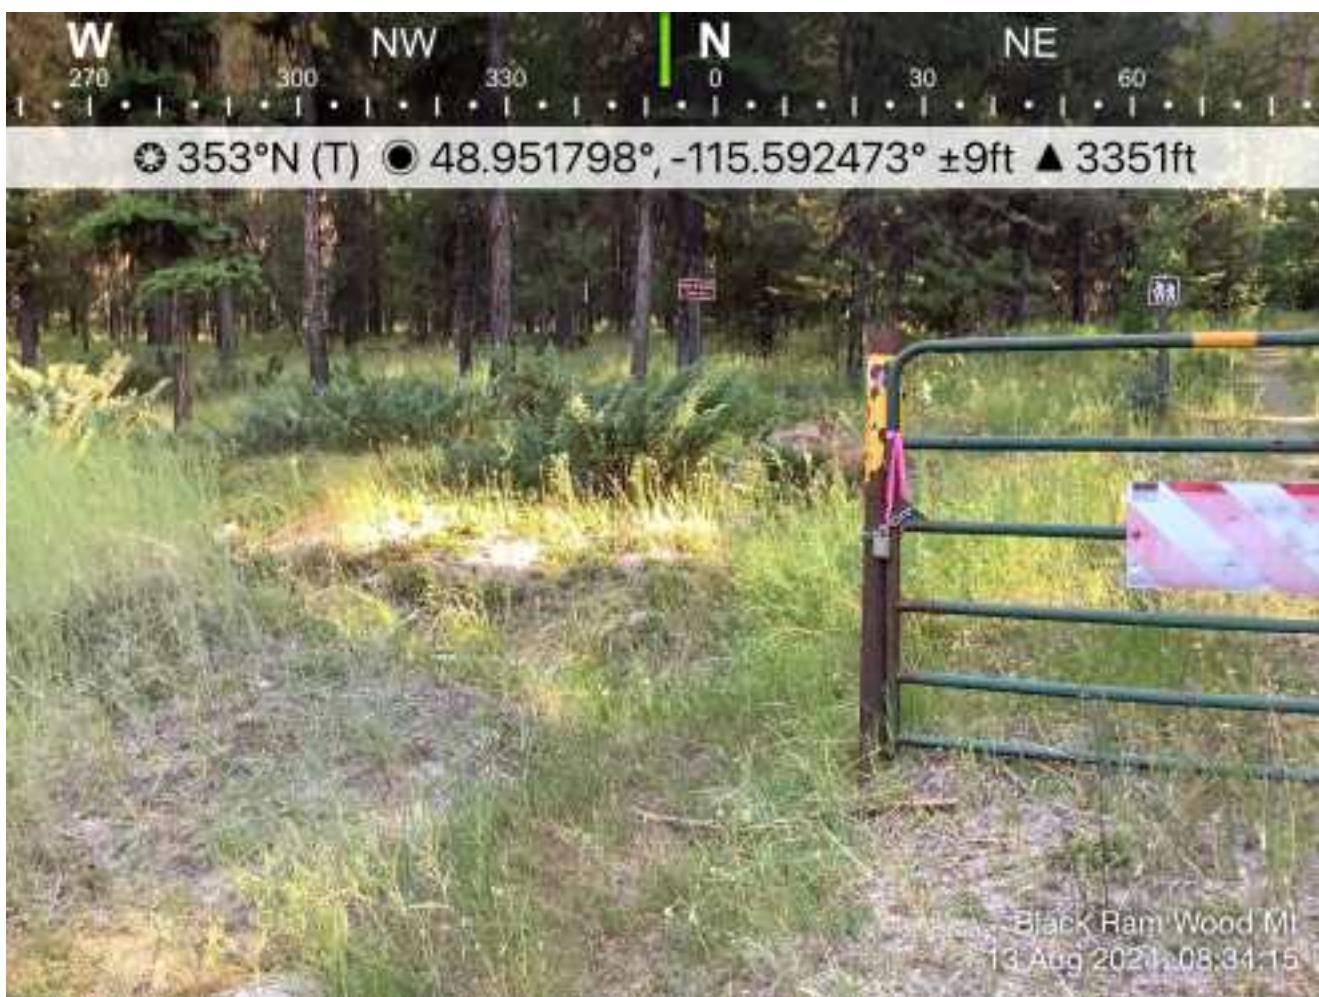
**BR 26      Coordinates: N 48.951760, W -115.592472      Date: 2024.08.13**

BMU 15 Female with young documented 2016-2023

Barrier ineffective 2024. Woods Mountain Trailhead. The gated road is bypassable on the left. Access is wide enough for ATVs, side-by-side, or small trucks. Road behind gate is drivable.

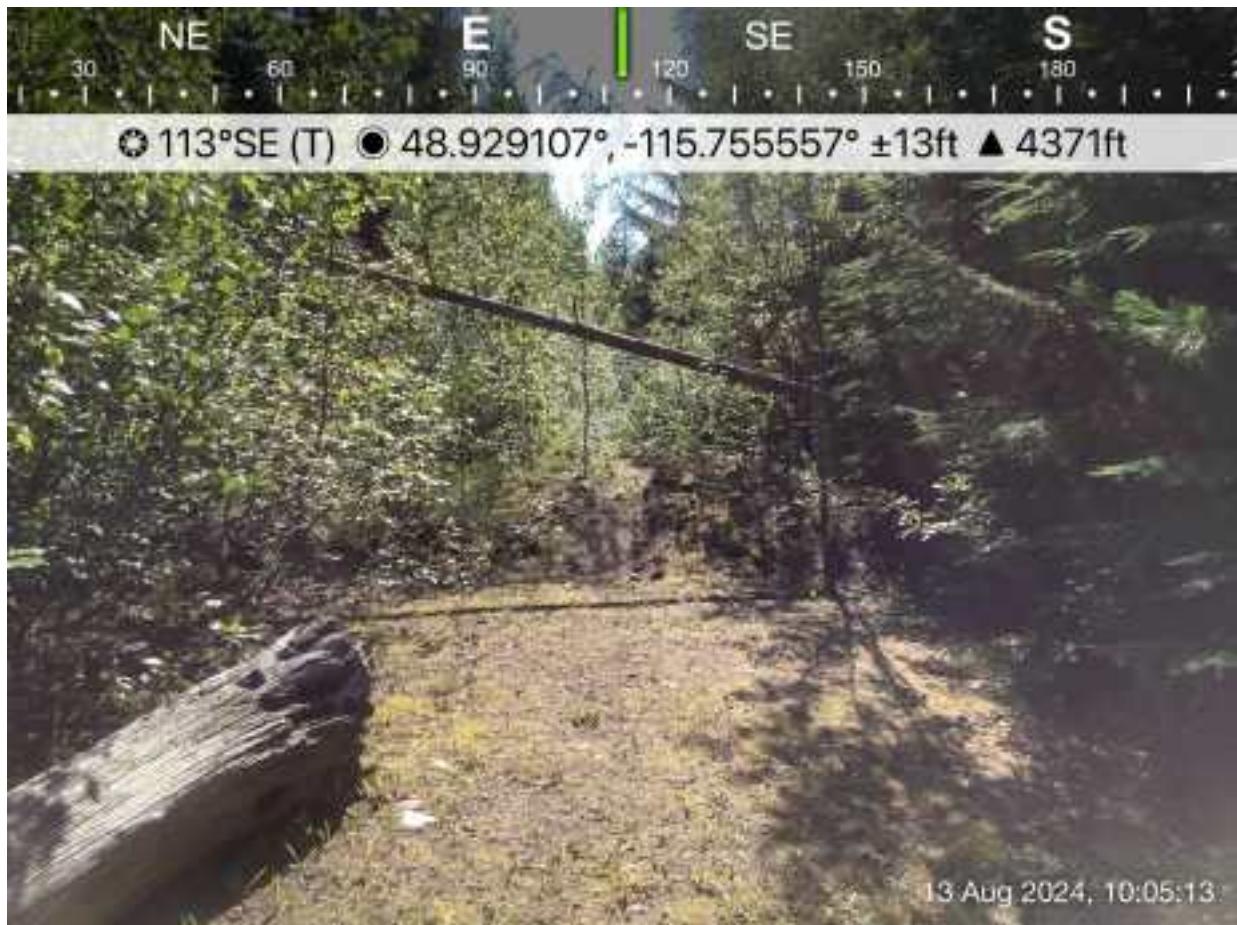
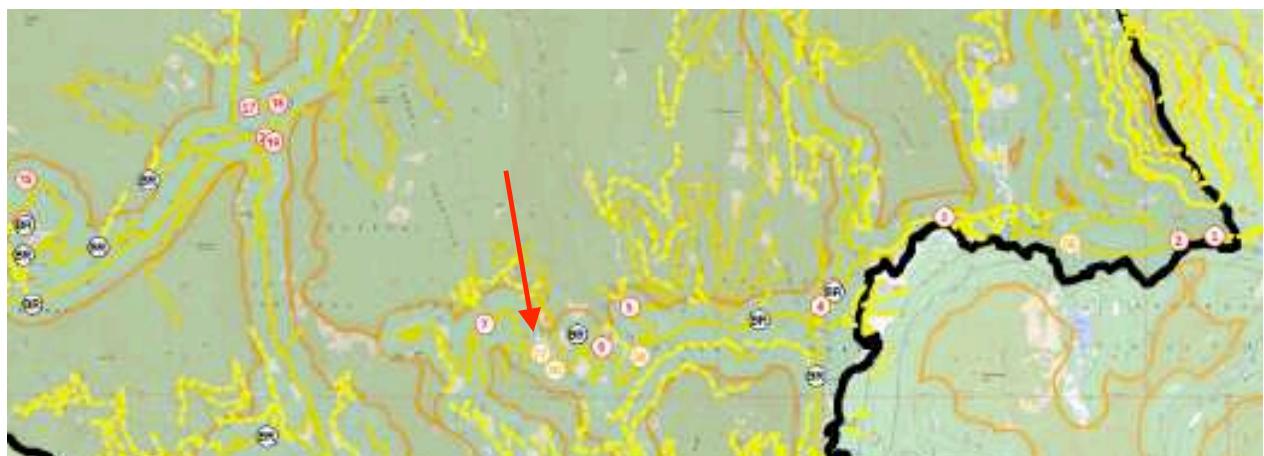
**BR 27**

BMU 15 Female with young documented 2016-2023

Barrier ineffective 2024. Bermed old road. Berm can be ridden over with a motorcycle. Road behind berm is open and passable by motorcycle or ATV.

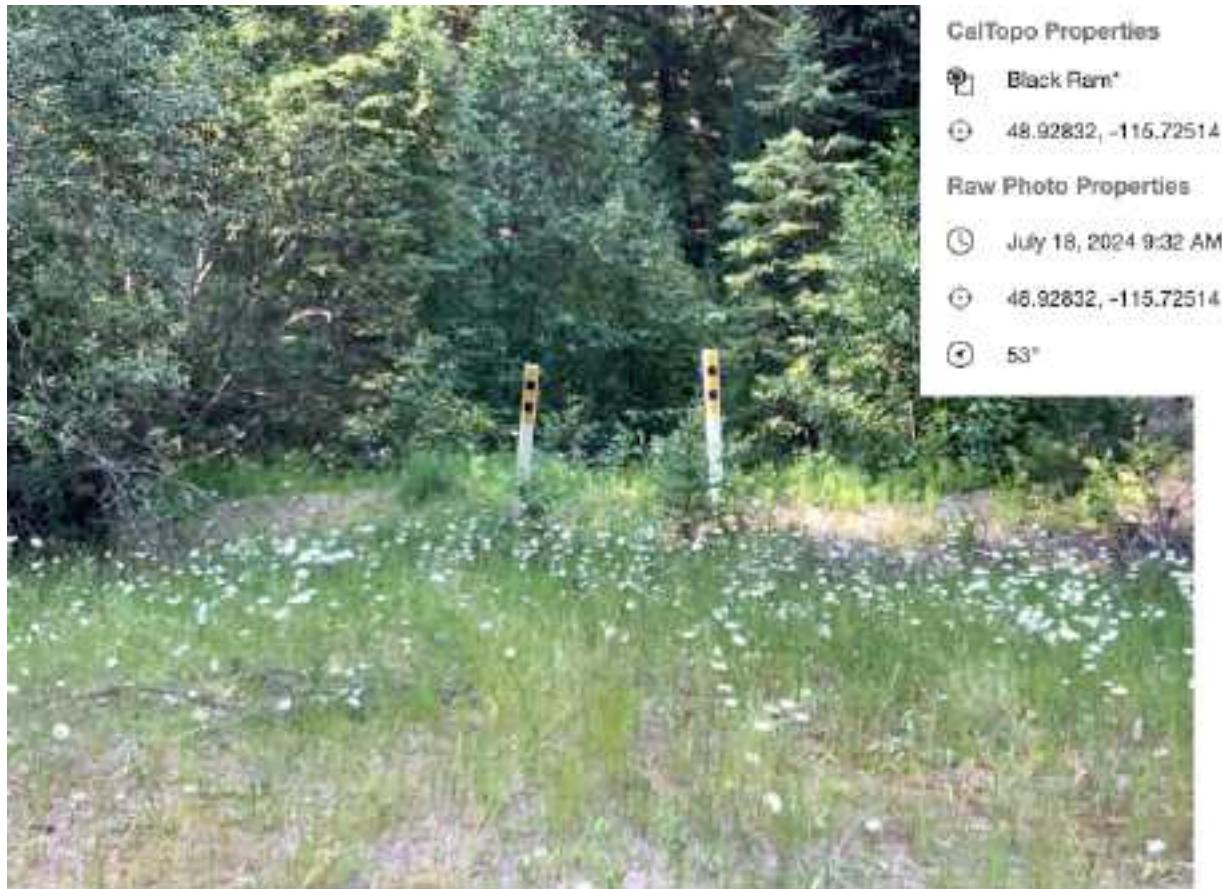
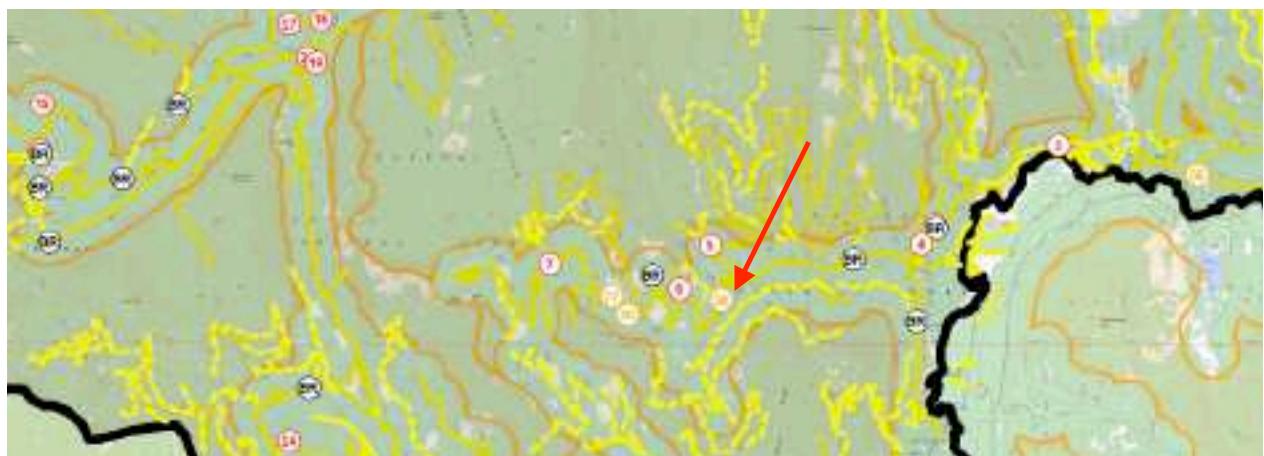
**BR 28**

BMU 15 Female with young documented 2016-2023

Barrier ineffective 2024. Old bermed road. Open trail behind berm. Berm passable and road accessible for motorcycles.
