YAAK VALLEY FOREST COUNCIL

# Insufficient Grizzly Barrier Report

## 2020-2024

CYE BMUs 14-15

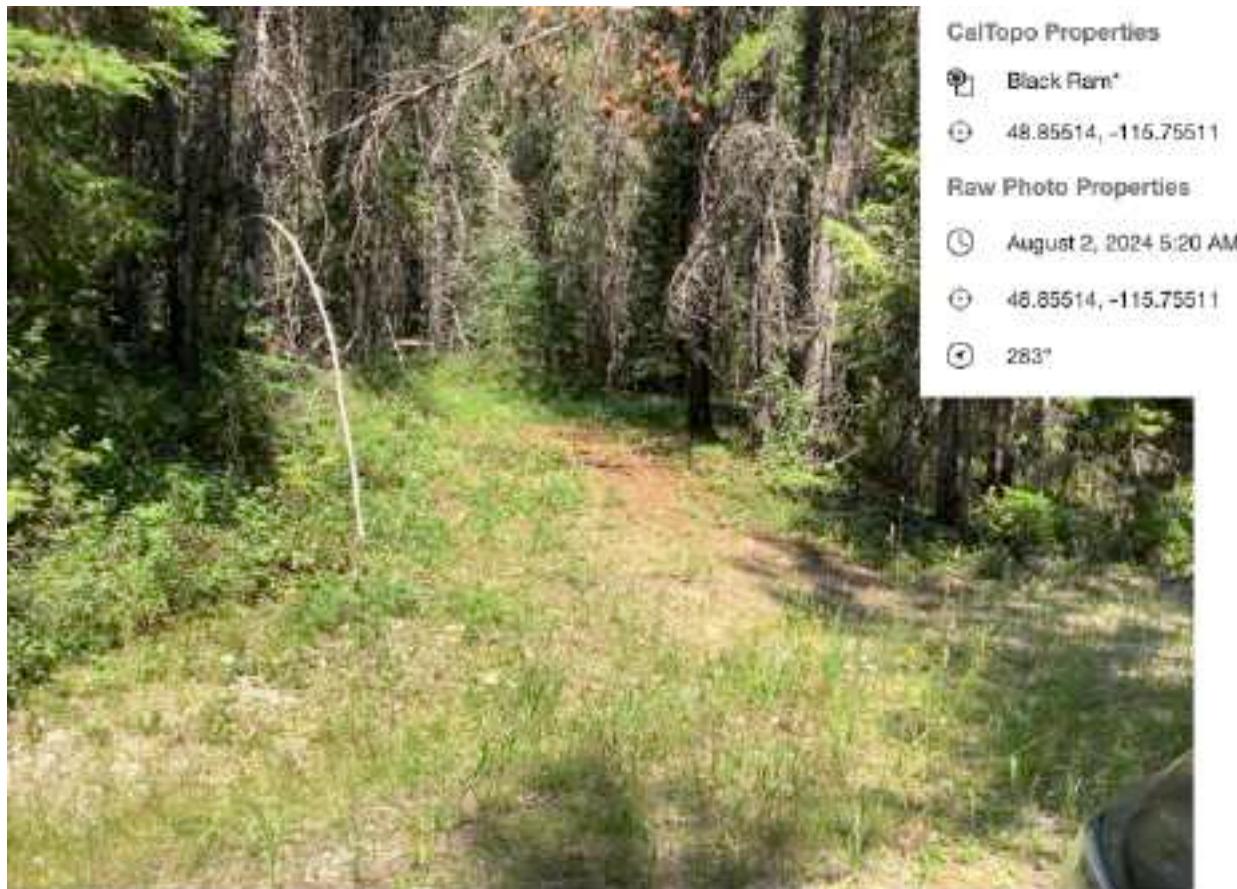
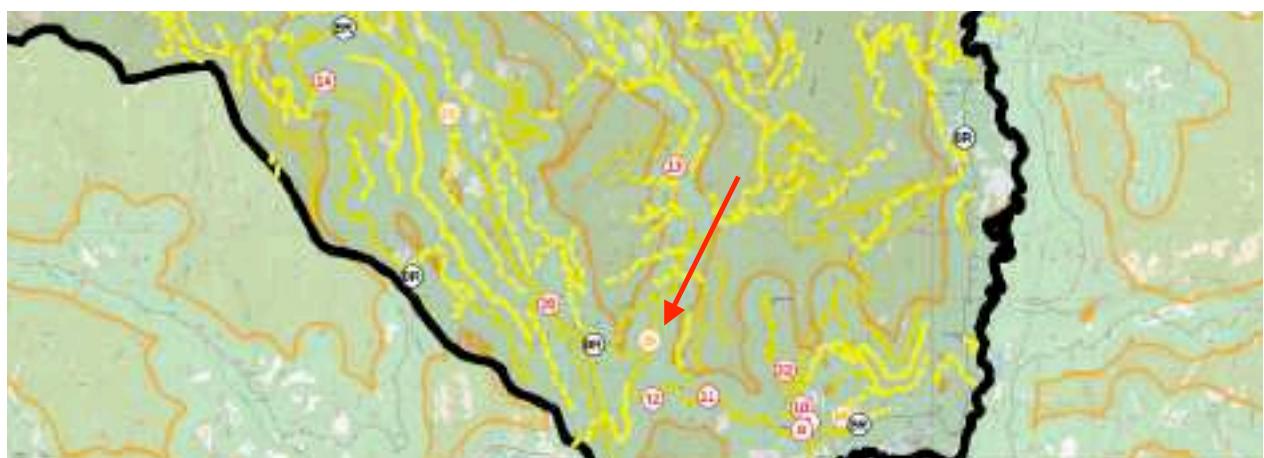
BR 29

BMU 15 Female with young documented 2016-2023.

Barrier ineffective 2024. User-created road.
