## Unstable Soils and Project Stands

### North Fork Stillaguamish Landscape Analysis Project

## Soil Resource Inventory (SRI) Natural Stability and Project Stands North Fork Stillaguamish Landscape Analysis Project

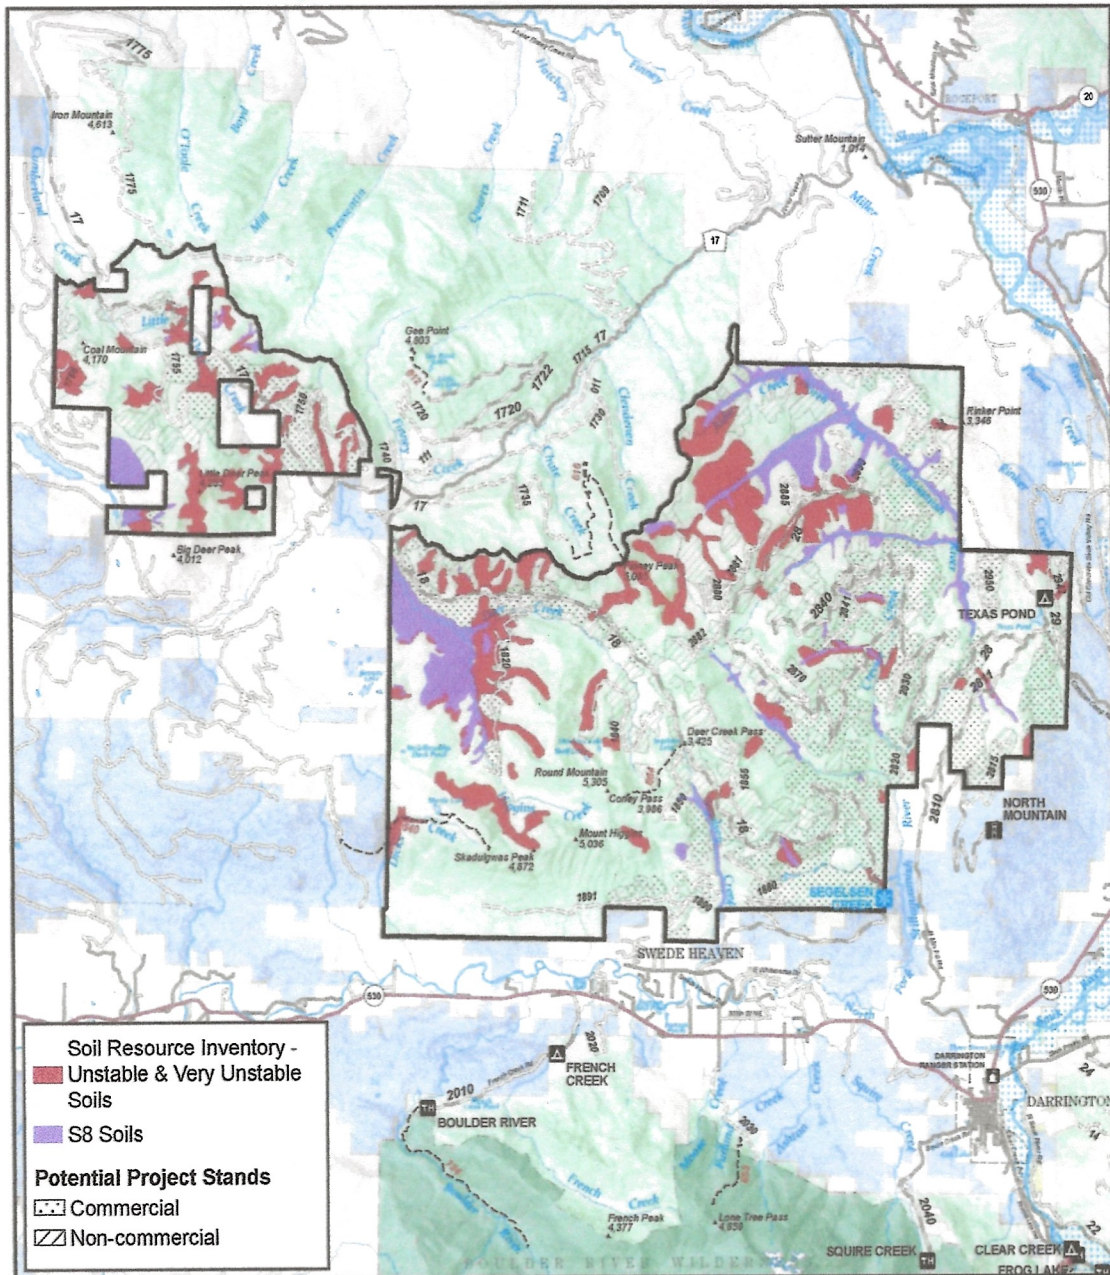
Map 2: Identified highly unstable areas. Red and purple areas are high risk areas that would not receive treatments or new road cuts in this project.

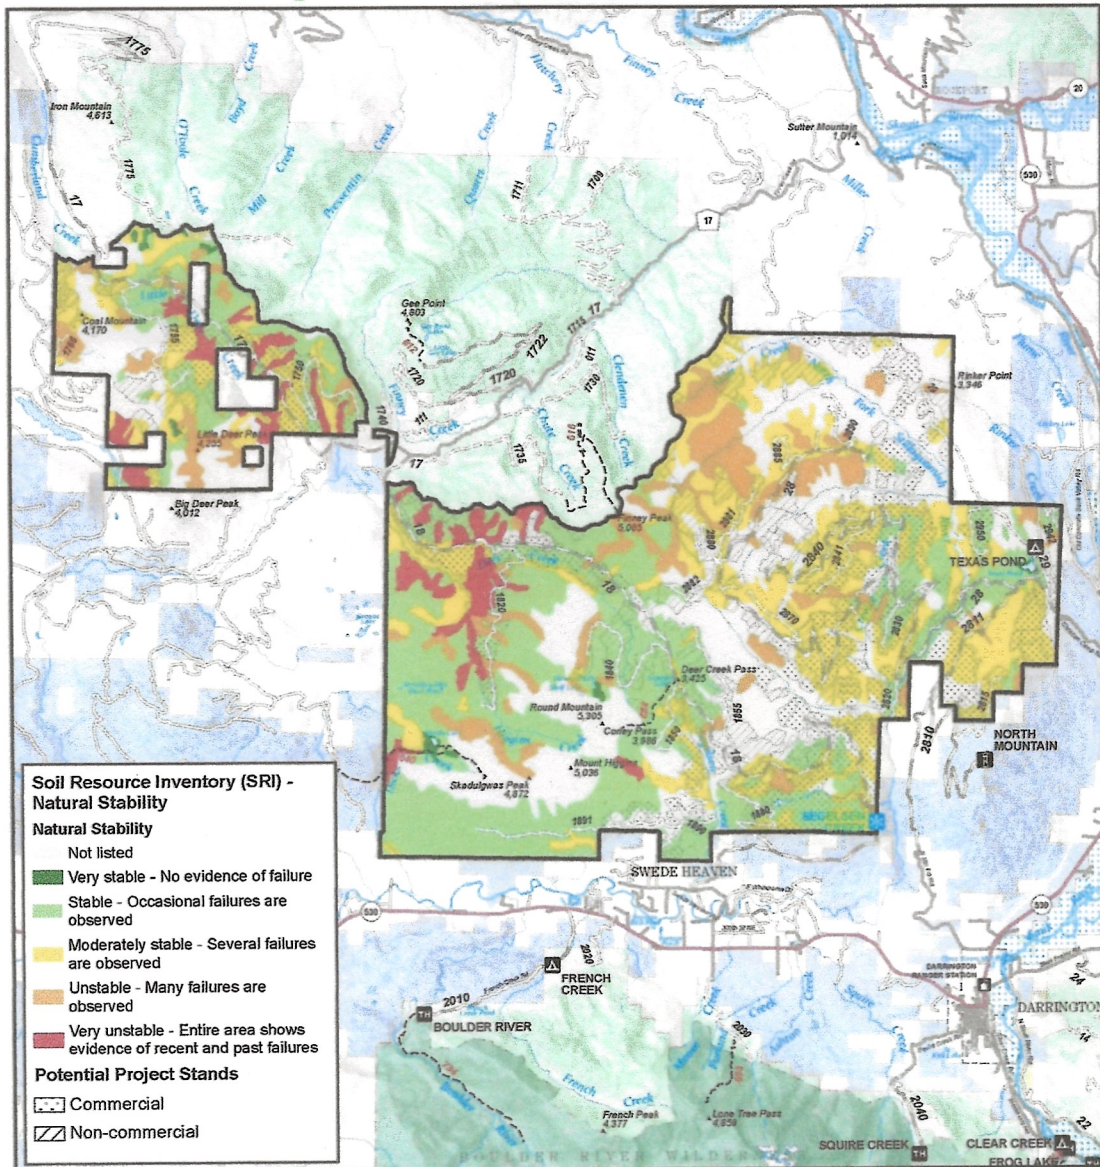
*Map 3: SRI layers were categorized as High, Moderate, and Low risks of stability. Timber stands that are located in areas that are yellow-Moderately stable and areas that are not rated will have a survey done prior to treatment implementation.*

*No timber stands are proposed for Orange/ Red – Unstable/ Highly Unstable areas.*
