EFFECT OF LOGGING ROADS ON SEDIMENT PRODUCTION RATES IN THE IDAHO BATHOLITH

Walter F. Megahan and Walter J. Kidd

USDA Forest Service Research Paper INT-123, 1972
INTERMOUNTAIN FOREST AND RANGE
EXPERIMENT STATION
Ogden, Utah 84401

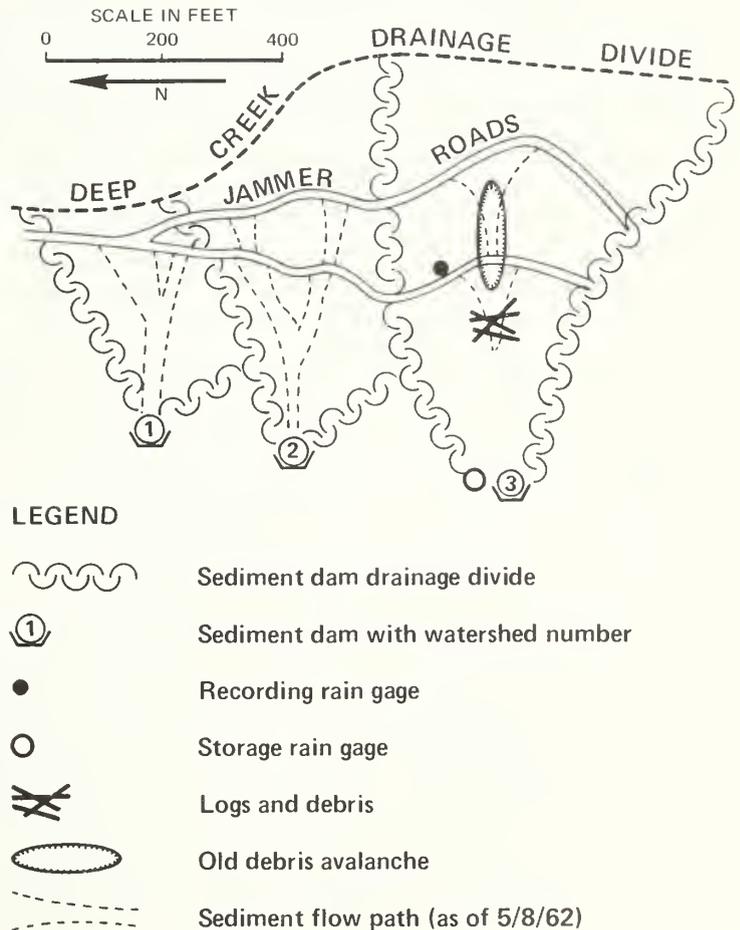
Figure 2.--Schematic map of the study watersheds.

The study area is within the confines of the Zena Creek logging study area near the head of the Deep Creek drainage, a tributary to the Secesh River. Three contiguous, ephemeral drainages comprise the 10-acre area (fig. 2). Annual precipitation at the study area averages 28.3 inches, of which about 60 percent occurs as snow.

Sediment production during the first time period after construction was extremely high on Watersheds 1 and 2 but decreased rapidly in subsequent periods. However, this didn't occur on Watershed 3. A survey of sediment flow was conducted May 8, 1962, to examine this anomalous behavior on Watershed 3. The downslope movement of sediment on each watershed was mapped from its source to its downslope terminus. This is easily done because of the light color, the coarse texture, and the uniform gradation of the eroded material in this area (fig. 3). The cause of the limited sediment production on Watershed 3 was readily apparent; a barrier of logs and debris in the drainage bottom was catching the material en route (fig. 2).

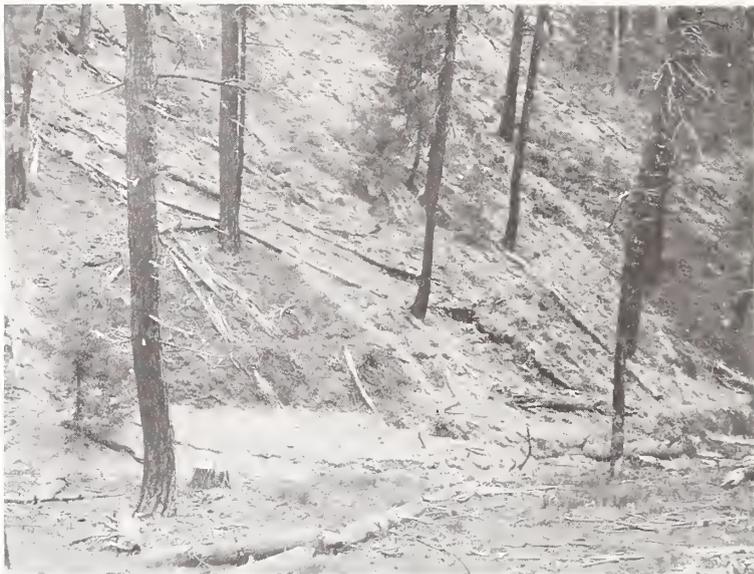
Figure 3.--Downslope sediment movement resulting from road erosion above. Sediment is easily traced because of the light color, coarse texture, and uniform gradation of the materials.

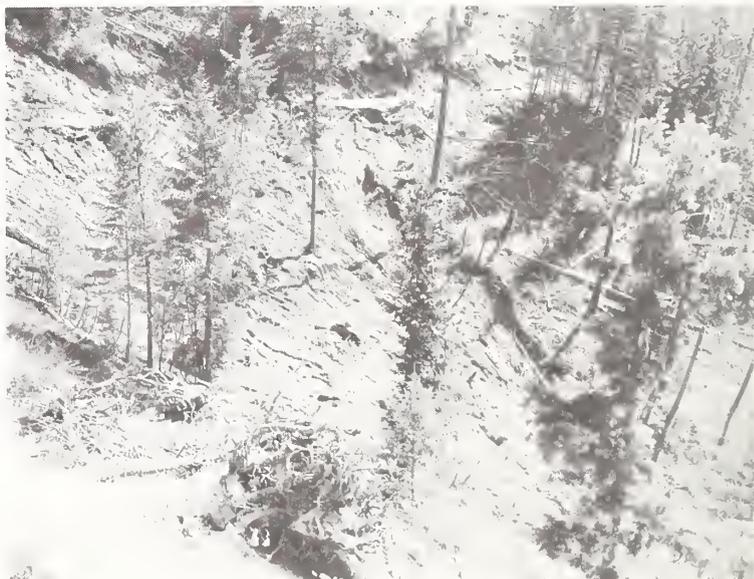
Figure 4.--View of the lower jammer road in Watershed 3, where the debris avalanche originated because of a road fill failure.

Additional erratic behavior was noted on Watershed 3. A natural landslide scarp existed on this watershed prior to road construction. This type of slide, classified as a debris avalanche (National Research Council, Highway Research Board 1958), is characterized by rapid downslope movement of soil and rock material having varying

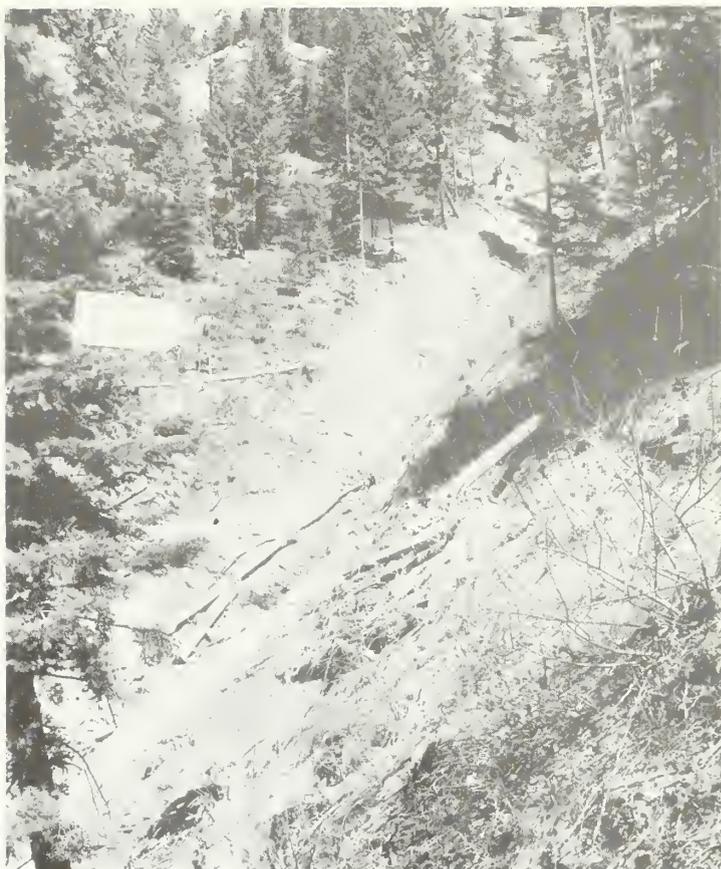
Figure 5.--The debris avalanche scoured the bottom of Watershed 3 to bedrock. The slide obliterated the sediment dam (formerly in the channel bottom) and splashed mud on top of the storage rain gage tower (see arrow).

water contents. Debris avalanches usually leave a discernible elongated scar to bedrock at the slide origin and often exhibit a characteristic downslope slide path. The lower jammer road in Watershed 3 was constructed through the old slide area without taking special precautions (fig. 2). In April 1965, a combination of rainfall and snowmelt generated a massive failure of the road fill material at the site of the old landslide (fig. 4). The slide scoured the entire length of the channel to bedrock in Watershed 3 and destroyed the sediment dam (fig. 5). Postslide measurements indicated that approximately 6,030 cubic feet of sediment moved down the channel.

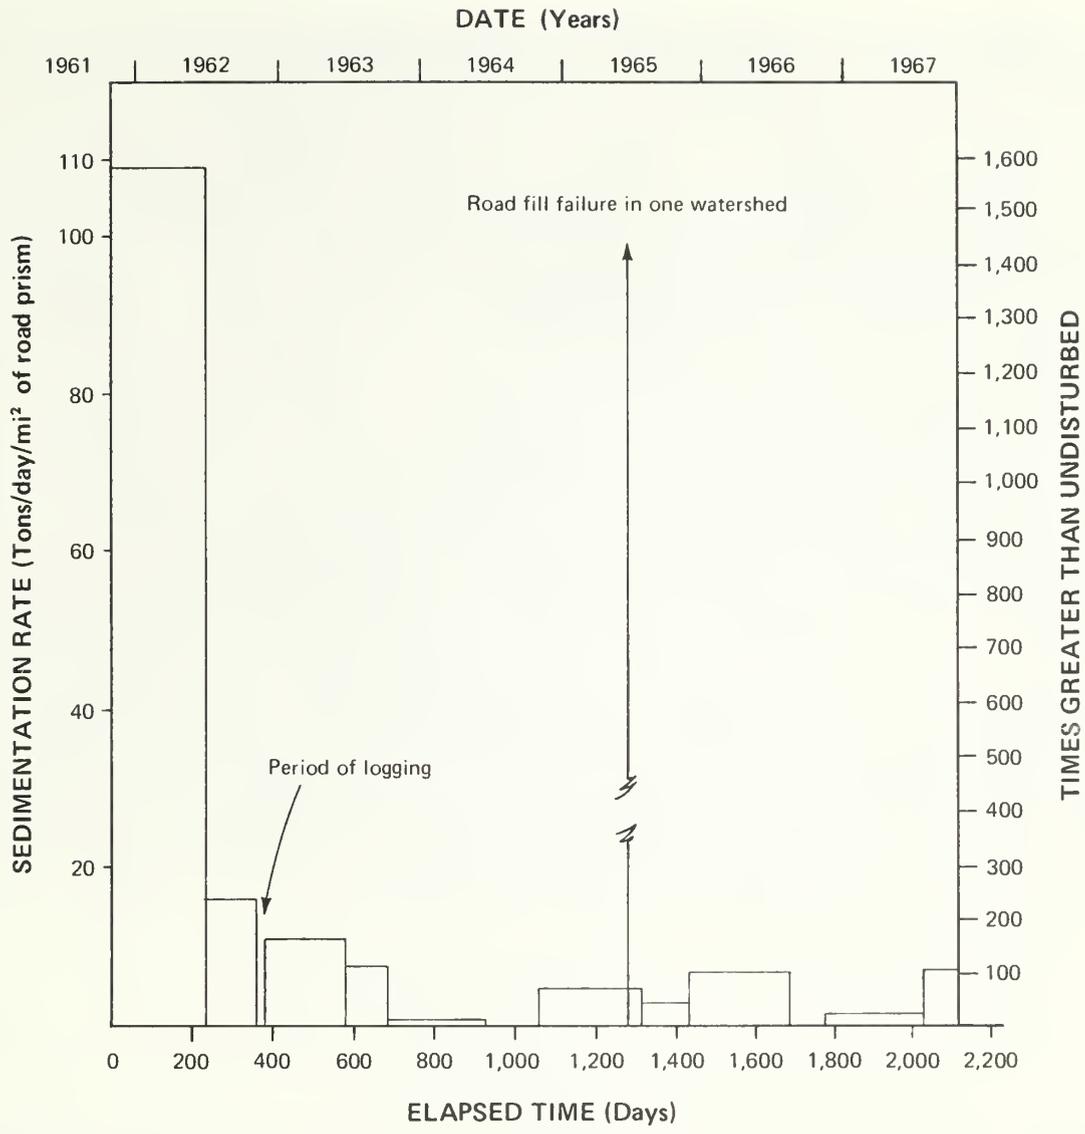
Figure 6.--Sediment production over time from surface erosion on jammer roads.

A histogram of the average sediment production data for individual measurement periods is an even more enlightening way of evaluating time trends (fig. 6). A second y axis on the right side of the figure indicates how many times sediment production from roads exceeds that from similar lands that are undisturbed. Note that sediment production during the first time period after construction averaged 109 tons per day per square mile of road--about 1,560 times greater than sediment production from similar lands that are undisturbed. Note also that this high initial rate decreases rapidly during subsequent measurement periods. As noted previously, sediment production rates resulting from surface erosion averaged about 220 times greater than the rates for undisturbed lands during the 6-year study period.

Intuitively, one can visualize how bare, unprotected material in a road prism could be subject to extremely high surface erosion immediately after construction. However, in time, the more erodible materials are removed and vegetation and litter begin to accumulate; this causes a decrease in surface erosion rates. Research data elsewhere suggest time trends in sediment production from road erosion (Rice and Wallis 1962; Reinhart and others 1963; Haupt and Kidd 1965; Vice and others 1969; Fredriksen 1970). In our study, sediment production rates had decreased progressively to zero prior to the 1964-65 measurement period. In subsequent measurement periods these ratios exhibited considerable fluctuations; ranging from zero to about 100 times greater in roaded areas than on undisturbed lands (fig. 6). Recent studies (Anderson

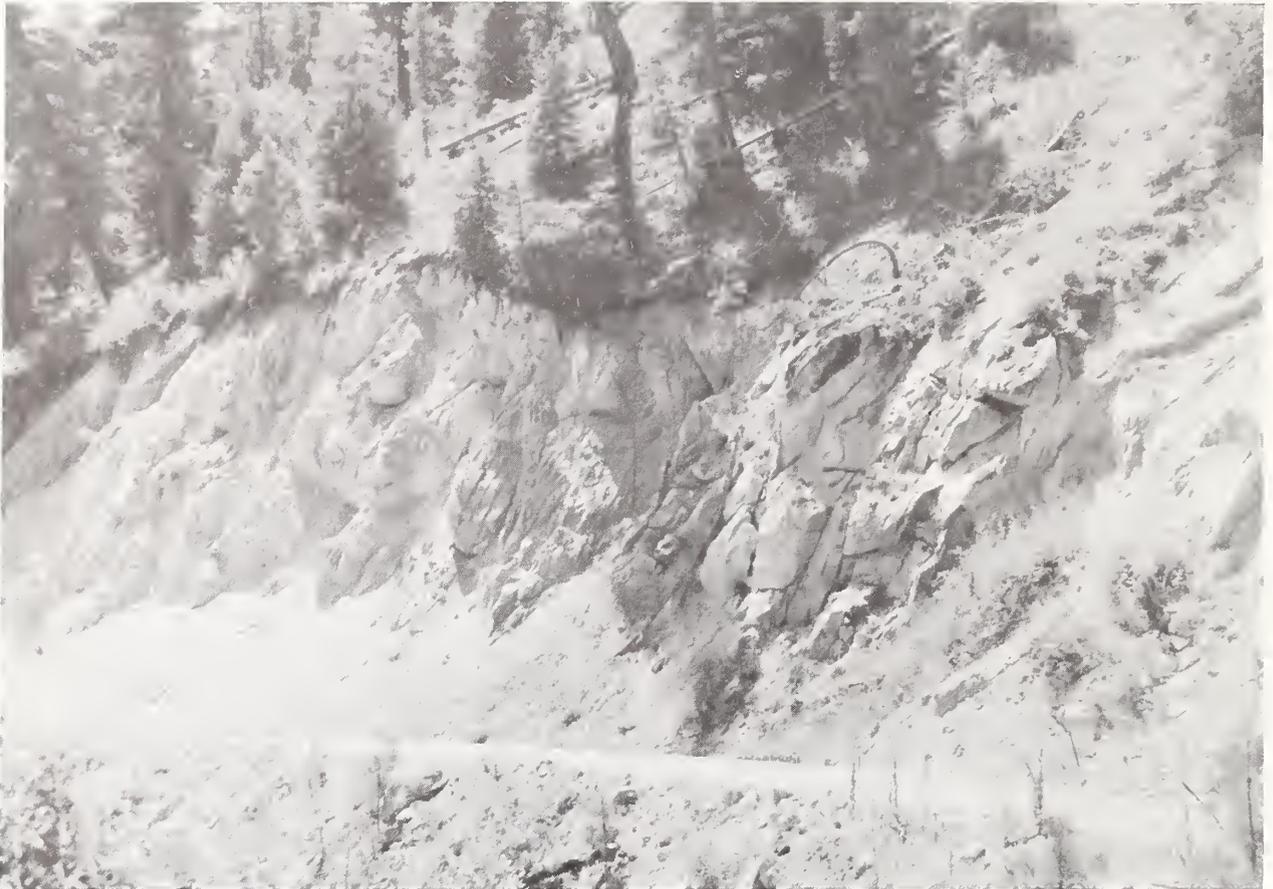
Figure 7.--Granitic rocks in the Idaho Batholith exhibit various degrees of weathering. Road cuts in the more highly weathered types continue to supply sediment for years.

Actually it is doubtful that erosion on roads in the Idaho Batholith will permanently decrease within a reasonable time to the level that existed before disturbance. The road tread and steep cut slopes in the Deep Creek area are composed of weathered granitic bedrock that continues to disintegrate after exposure faster than natural stabilization can take place (fig. 7). The material resulting from bedrock disintegration is readily transported during subsequent runoff events. Similar bedrock conditions are found throughout much of the unglaciated portions of the Idaho Batholith.

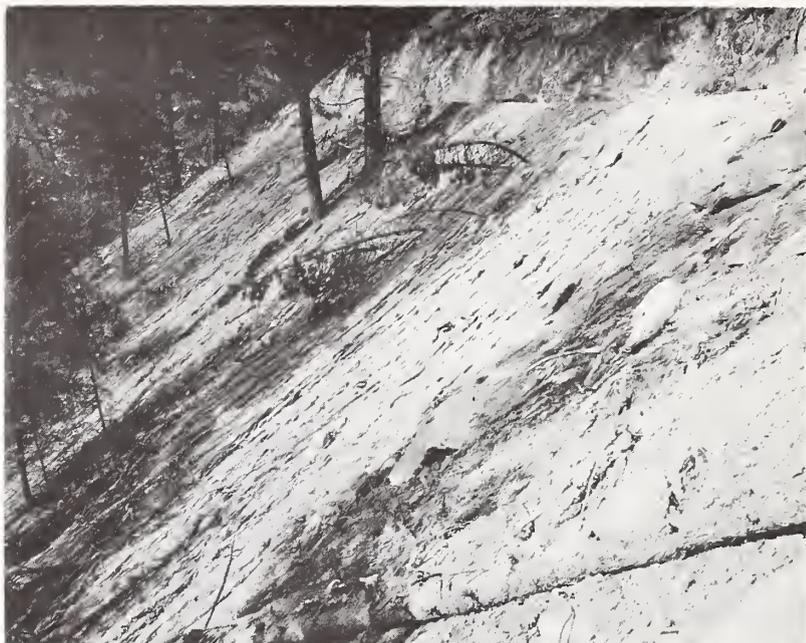
Figure 8.--Surface erosion on road fills constructed from granitic materials 1 year after construction.

Observations suggest that most of the high initial surface erosion is actually the result of erosion on exposed road fills (fig. 8). Considerable data indicate that erosion on granitic road fills can be greatly reduced by stabilization measures such as the treatments listed in table 5. Note that erosion rates on granitic road fills can be reduced up to 99 percent by such stabilization treatments. The largest proportion of surface erosion occurs during the first year and is generally the result of erosion on fill slopes; therefore, it appears to be possible to greatly reduce sedimentation caused by surface erosion on roads using these fill slope stabilization treatments.
