prepared for
Swan View Coalition

Snowmobiling's Endless Winter:

*Facilitating Physical Access Also Extends
The Snowmobile Season, Resulting In Harm
To Wildlife Security, Vegetation, Soils, And Water*

by
Keith J. Hammer

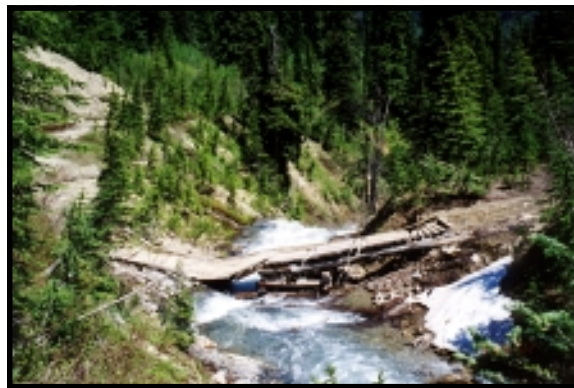
road on either side of the bridge and upland areas with and without snowpack. It is apparent the bridge has been there for a number of years. It is in fact collapsing on one side of the center pier.

This bridge over Lost Johnny Creek facilitates motorized vehicle access to an abandoned road network and upland areas.

It appears that, when the upland road network was abandoned, neither the stream banks nor the nearby road prism were returned to native contours, providing a narrower and more bridgeable gap. Portions of the road prism, and of course the stream banks, stand to be eroded should this bridge collapse and divert the stream to either side.

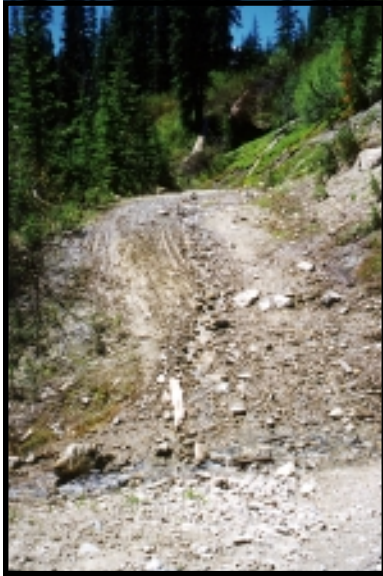
The following June 26 photo shows fresh snowmobile tracks on the bare, abandoned roadbed between the turnaround area at the end of the Lost Johnny road and the unauthorized bridge.

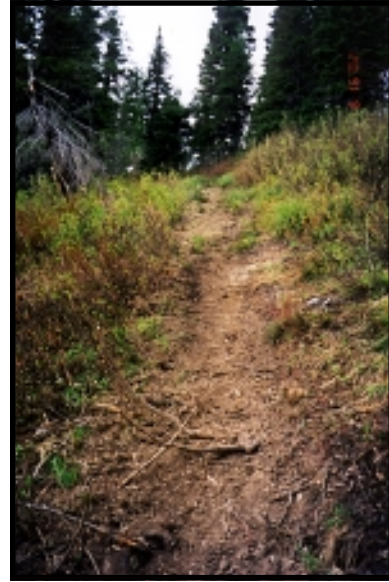
The following photo was taken June 16, 2002, above Strawberry Lake, where snowmobiles were seen on June 13 tearing bear grass and shrubs out and down into the soil while hill climbing between patches of snow.

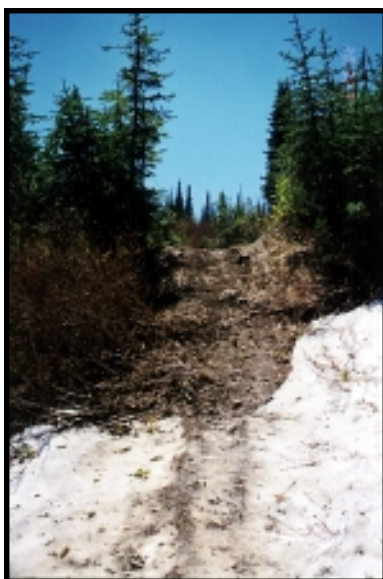
The next photo, taken several hundred yards above the bridge, shows evidence there has been substantial snowmobile use of the bridge to facilitate post-April 1 up-country snowmobiling, with a clear trail torn down through the shrubs and into soil and rock.

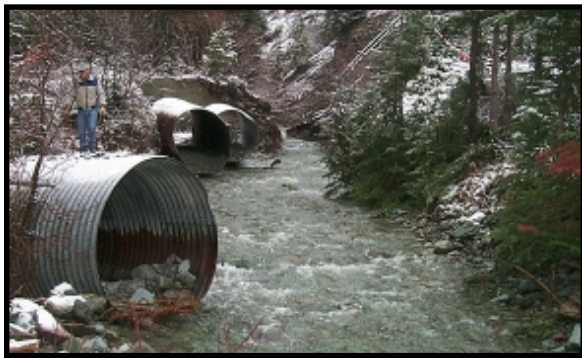
The following photo shows the 1999 washout of a 54" culvert in Nokio Creek on the Flathead National Forest, which washed some 1,000 cubic yards of Road #114 downstream.

It is precisely because culverts like this fail even on open roads, where the culverts are easily monitored and maintained, that culverts must be removed from decommissioned roads, where they are difficult to monitor and maintain. Indeed, the Forest Service's own manual on road decommissioning warns against leaving culverts and portions of road prisms in even low risk crossings by stating "it is realized that structures and embankments not removed may be inaccessible for maintenance or repair after road obliteration work is completed." [6] The potential for disaster is heightened by the fact stream crossing structures most in desire by snowmobilers are likely to be the higher risk culverts buried deeply in incised crossings with steep slopes.

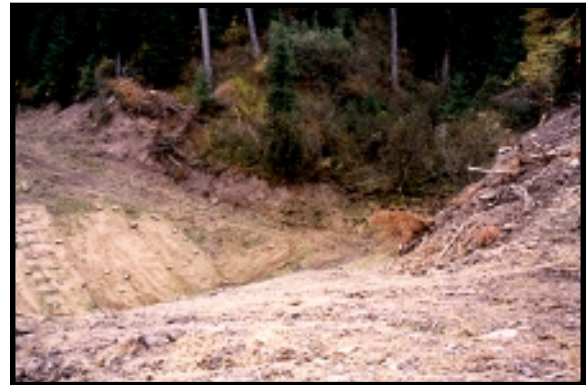
Road decommissioning conducted in 1998 on the Flathead's Coal-Mathias Road #1687 serves as an example of how leaving benched areas near streams on decommissioned roads can result in damage to streams and fish. The following photo shows benched areas left in the "recontoured" slopes following culvert removal.

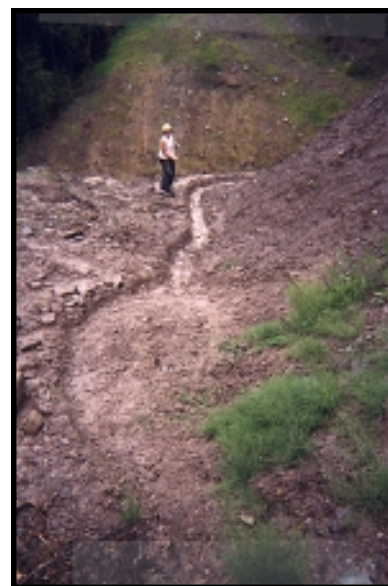
The next photo, of the same slope the following summer, shows how benches can help channel water and sediment directly to the stream channel.

While the Forest Service apparently helped channel water along the bench on the decommissioned Road #1687, doing so and leaving the bench in the first place runs contrary to Amendment 19 and the definition of "decommission" developed by the interagency Forest Ecosystem Management Assessment Team. The FEMAT defines decommission as "to remove those elements of a road that reroute hillslope drainage and present slope stability hazards." [7]

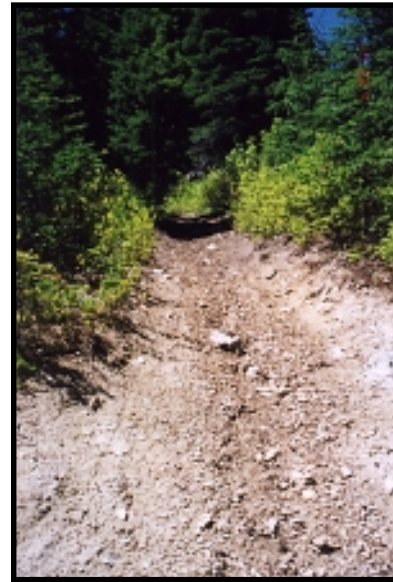
Add snowmobile use to these streamside benches and slopes and things promise to get even worse. As the photo to the right shows (as well as photos to follow) snowmobiles can dig significant ruts into the ground to channel water and sediment. This photo was taken near the end of the Lost Johnny road on June 26, 2002. The rut is of snowmobile width and shows significant use by snowmobiles.

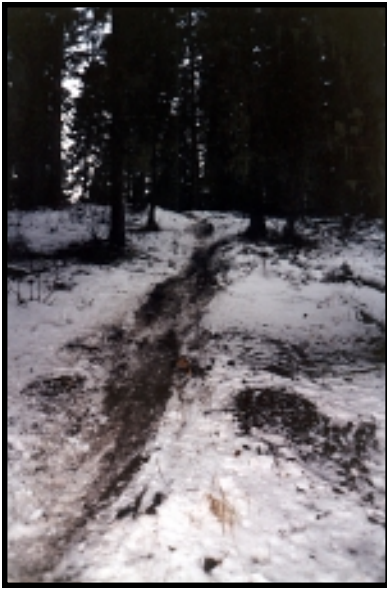
Prior removal of brush and deadfall allows snowmobile access on little to no snow.
