Comments on Phase 2 of the Cibola National Forest “Potential Wilderness Inventory and Evaluation Process”

Bear Mountains, Magdalena Ranger District

September 23, 2015

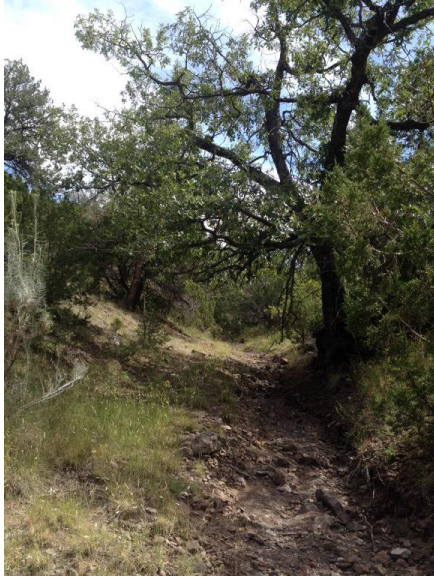
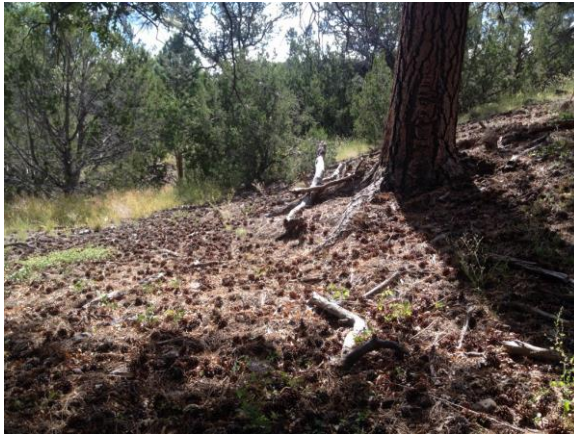
Figure 25. Wooded canyon above Scott Spring has no development. However, it does have huge gambel oaks and ponderosa pines, in addition to juniper and pinon.

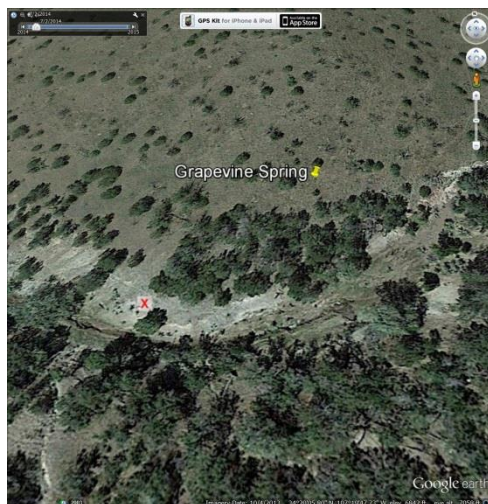
The statement “little or no development” seems contradictory to the claim that this is substantially noticeable, so it may be a mistake. Using Google Earth in the area around the FS red X and Grapevine Spring, I could discern no development.

Figure 32. Grapevine Spring area has no discernable development. GPS coordinates: 34°20'05.8"N, 107°19'47.73"W. Imagery date: 10/4/13. About 200 feet above ground.

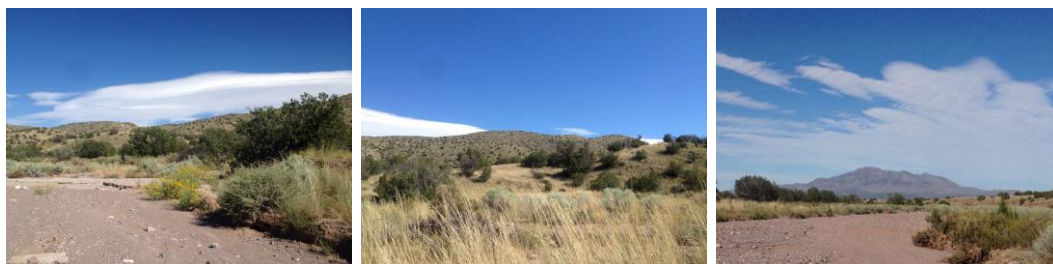
Figure 36. Flowers and grass in Deer Spring Canyon (left); Wilderness-worthy hills through tall grass (middle); and view of Sierra Ladrone (right). Photos taken 9/18/15.

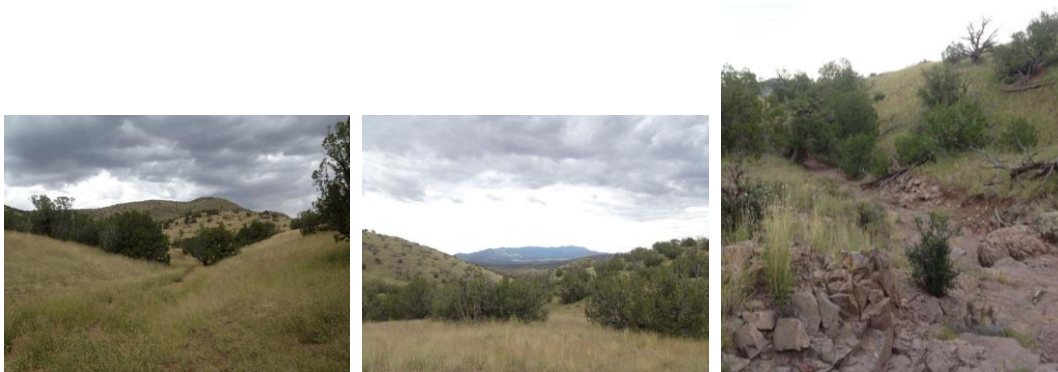
Figure 38. Left: Looking up at the south end of the bears through very lush gramma grass – no fences anywhere. This is incredibly healthy land (34°13'53.12"N, 107°18'7.09"W). Middle: View of the Magdalenas near the supposed intersection with fence from the SE, which I never found (34°14'13.37"N, 107°17'59.14"W). Right: Arroyo near 506L, where despite the proximity to private property, the vegetation and grass are still healthy (34°13'17.26"N, 107°18'18.23"W). This area was the healthiest I've seen in the Bears and is certainly worthy of wilderness protection.

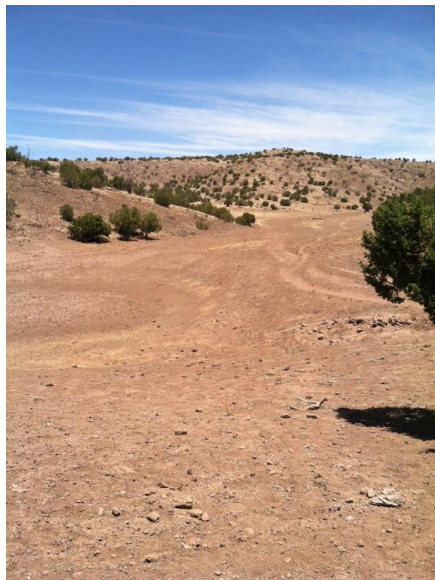
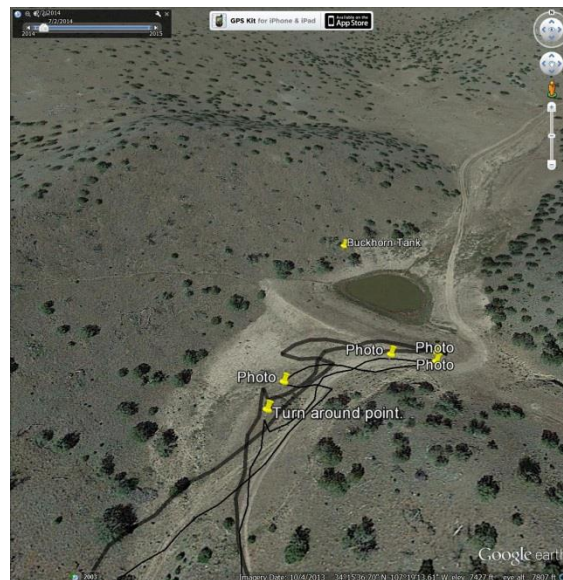
Buckhorn Tank: I hiked up 24A on July 2, 2014. It had some vehicle tracks, but no development, no PVC, excepting a large bermed stock pond about 1.6 miles from 24. Vehicular traffic from 24A did not appear possible past this point. According to Google Earth, development does not extend past this point, although there are signs of tracks in the 2013 photo.

Figure 39. Dry stockpond about 1.5 miles up 24A from 24 and Google Earth screen shot taken about a year earlier (also showing my tracks and locations of photos). GPS Coordinates: 34°15'44.08"N, 107°19'17.41". Photo date 7/2/14. Imagery date: 10/4/13.

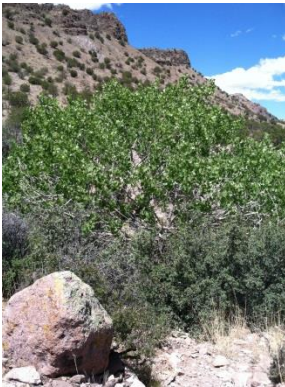
1. **Inventoried Roadless Area at NE corner adjacent to D3_5K7 that was left out of FS inventory:**

This beautiful, remote area should be included as part of the wilderness inventory. CR12A, CR12B and CR12C are accessible only by an ATV, and are slated to be closed in the TMP "proposed action." I hiked throughout this area in the summer of 2014 and found it to be free of vehicle tracks and human development, except for a couple places where the permittee has put PVC into a spring at the end of CR12C. The permittee accesses areas on horse because of the impassibility of so-called roads. Access to this area from 354E is behind a locked gate, making it easy to prevent unauthorized access. Access from the north is very difficult, up very rugged arroyos. Would

be easy to lock the gate at the forest boundary on CR12A. I saw no people during several days of hiking in the area, other than the permittee at his house (small private area about half a mile W of 354 on 354E). There are stunning canyons and springs toward the end of CR12A (see picture), and the ruins of a homestead at the end of CR12B.

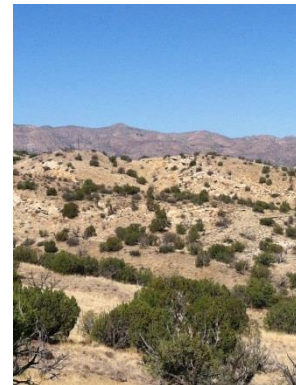
riparian area to the east of 354, with ruins of an old homestead. There is no sign of vehicle tracks (except along one fenceline for less than half mile) in the entire area south of Baca Canyon to my property and 354O. Very remote, with sandstone canyons, beautiful views of the Bears and Sierra Ladrones. I own the only private property in the area and have stipulated in my will that it be treated as wilderness after my demise.

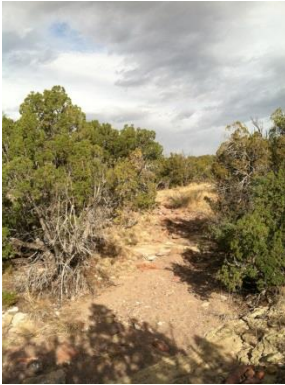
3. **Area south of my property bordering 3540 and 354:** This small area should also be included in the wilderness inventory. I own the property to the north would consider donating part of my land so as to provide contiguity. There is no development in this area, no vehicle tracks, and the land is in good condition.

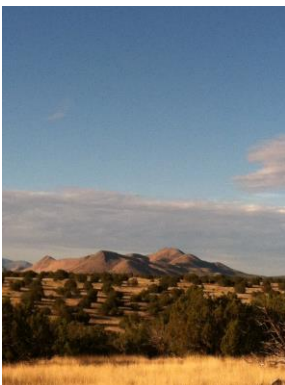
6. **General D3_5K6:** This area is rightly included as part of the Wilderness Inventory. It includes the southern section of the Bears as well as many foothills. In my opinion, it is also right to include areas for consideration that are not part of the "inventoried roadless area" as they are contiguous to it, and free of viable roads. I'll provide more detailed comments on particular areas, but want to voice general support for including this area. The photo shows some of the lovely foothills of the Bears, just N or 506.

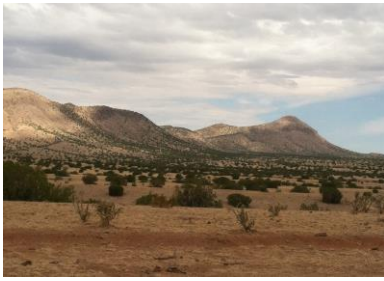
7. **Triangular Area between 354, 354L, and 506 (D3_5K6):** I support including this area for

consideration as Wilderness, with cherry stems for 354L and 354LL. The photo shows the Bears from the end of 354L. The little hills are almost untouched, beautiful, and have no development in them except as noted below. I drove and hiked all "roads" in the summer of 2014, and found that 354L becomes too rough for anything but an ATV just above the spot shown as the end of 354L on the Forest Service maps.

At that point there is some significant development -- corrals, stock tanks, etc. There is also a stock tank at the end of 354LL, but nothing past that point. I also hiked 354J and K, and found no development. After hiking, I drove up 506 and found the exit of what could have been the continuation of 354LL. However, it was so badly eroded I couldn't drive in from 506. It looks like the Bear Springs Ranch uses Bear Canyon as a shortcut to their development at the end of 354L, even though it is not a designated forest service road.

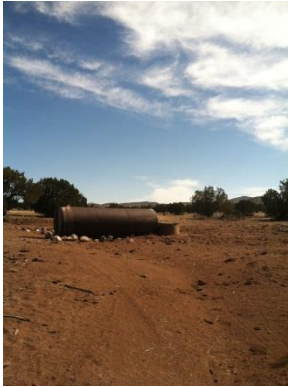
10. **Area between 169 and 506, to origin of 24:** There is quite a lot of development associated with

the Bear Springs ranch in this area near 169, including many new tracks and roads. 24C as shown on the FS map does not intersect 169, but it is definitely a track, although the only human development is a large stock tank at the SW end (shown in photo). I could find no evidence of 24CB or 24CE or 24 CA*B. However, there is a track about 200 feet in from 169 that parallels it. 506 L has a stock tank near 169 and about 2 miles in, but no other development. I'm hesitant to recommend this area for consideration of wilderness.

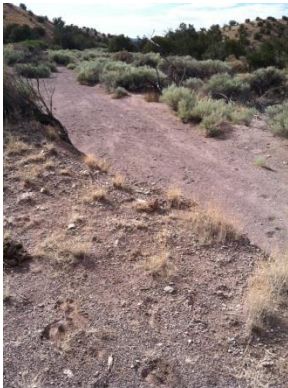
11. **West side of Bears above 24:** The western slopes and watersheds of the Bears are

appropriately designated as having wilderness potential. Other than 123F, there is very limited access to any of this territory except through private property and behind locked gates. I hiked this area in the summer of 2014, and saw no evidence of development along 24CA, or 123F after the intersection with 123FAB, nor on 123FB. 123B is completely washed out by an arroyo at 123 (shown in photo), and there is no evidence of any vehicle traffic. 123 GB is behind a locked gate, and there is no evidence of vehicle traffic where it meets 123. I can see no reason not to close 123GB and GB within the national forest, 123B, and 123F after intersection with 123FAB.
