**Independent Expert Engineering Investigation and Review Panel**

# **Report on Mount Polley Tailings Storage Facility Breach**

**January 30, 2015**

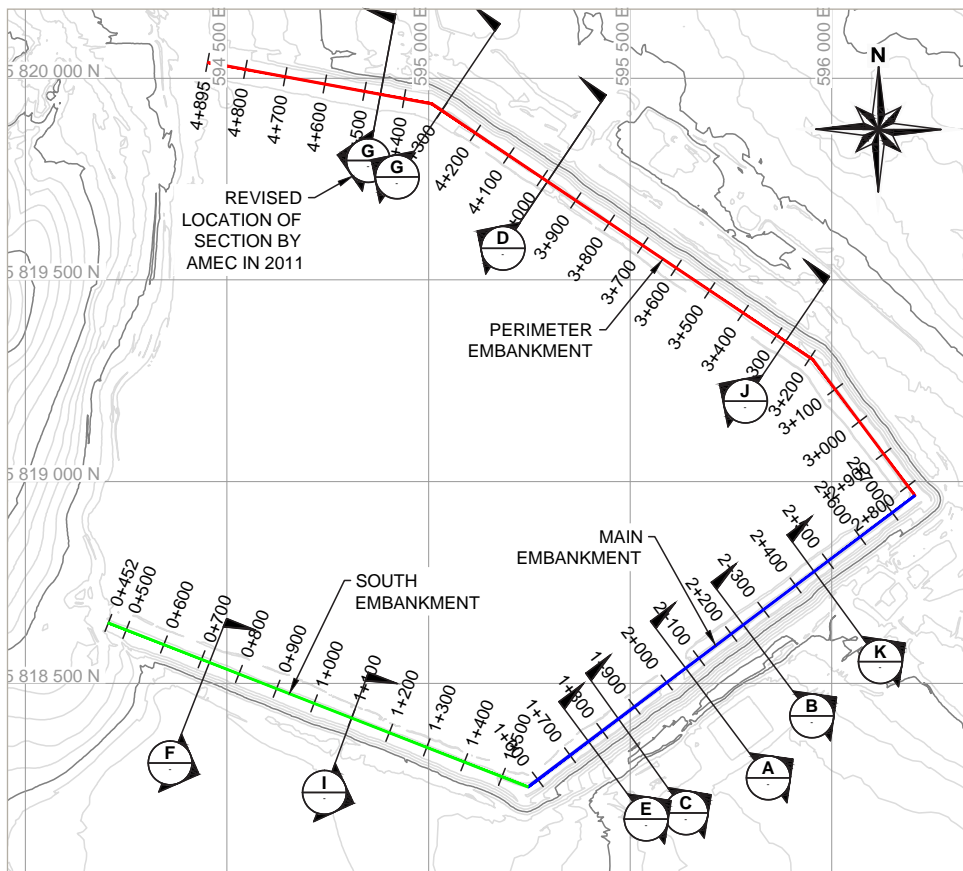
**FIGURE 3.1.1: TAILINGS STORAGE FACILITY PLAN**

**Figure 3.1.1** is a plan of the TSF adapted from the last As-Built Construction Report.<sup>1</sup> It indicates that the TSF was composed of three embankments: the Main Embankment, the Perimeter Embankment, and the South Embankment. The TSF is closed to the west by rising natural ground. The figure also indicates the location of instrumented control sections utilized by the succession of EORs. The breach occurred in the Perimeter Embankment near Section G.

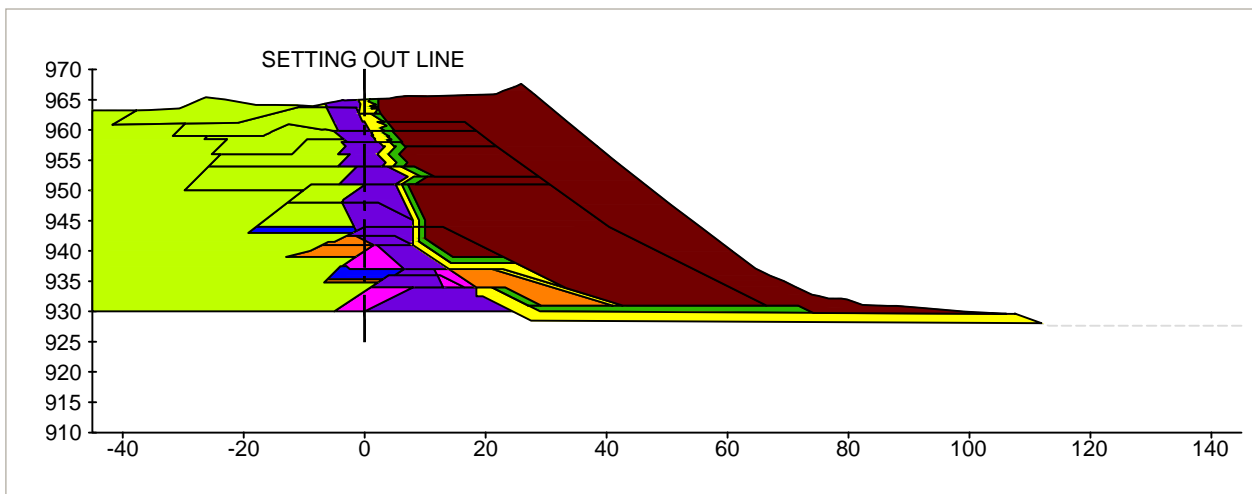
**FIGURE 3.2.2: PERIMETER EMBANKMENT AT SECTION D**

The Main Embankment and the Perimeter Embankment were the first to go into construction, with the Starter Dam completed in 1996. The South Embankment followed in later years. **Figures 3.2.1** and **3.2.2** present the sections of the Main and Perimeter Embankments at the end of the 2013 construction season. **Figure 3.2.1** is for the Main Embankment at Section A, approximately the highest section. **Figure 3.2.2** is for the Perimeter Embankment and represents the closest instrumented section (Section D) to the breach zone at the time of failure.

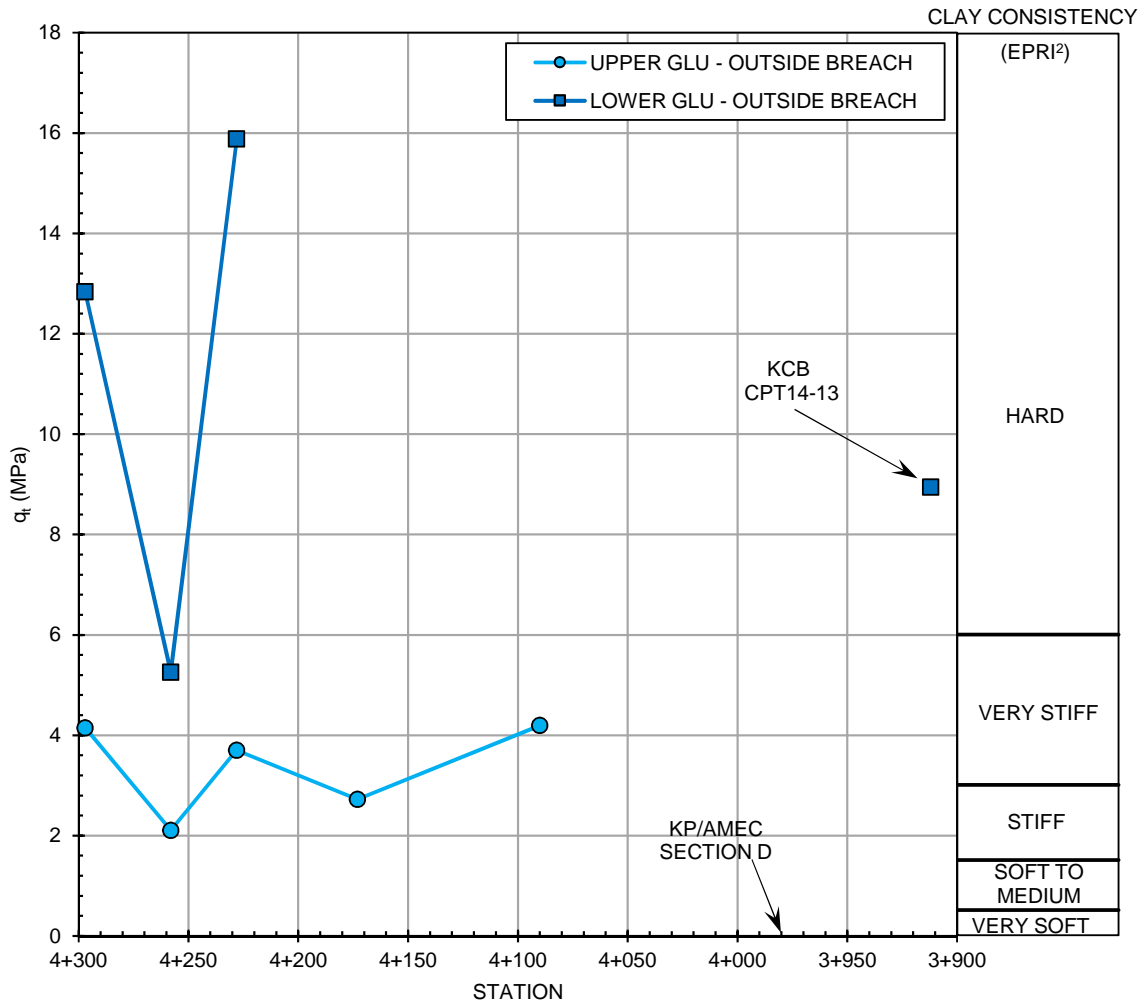
**FIGURE 5.2.4: LONGITUDINAL VARIATION IN CPT TIP RESISTANCE**

Secondly, CPT tip resistance in the two units is distinctly different. **Figure 5.2.4** shows that tip resistance  $q_t$  for the Upper GLU is less than one-half of that for the Lower GLU across the breach area. Using  $q_t$  as a measure of clay consistency, the Upper GLU classifies as stiff to very stiff, while the Lower GLU classifies as very stiff to hard.

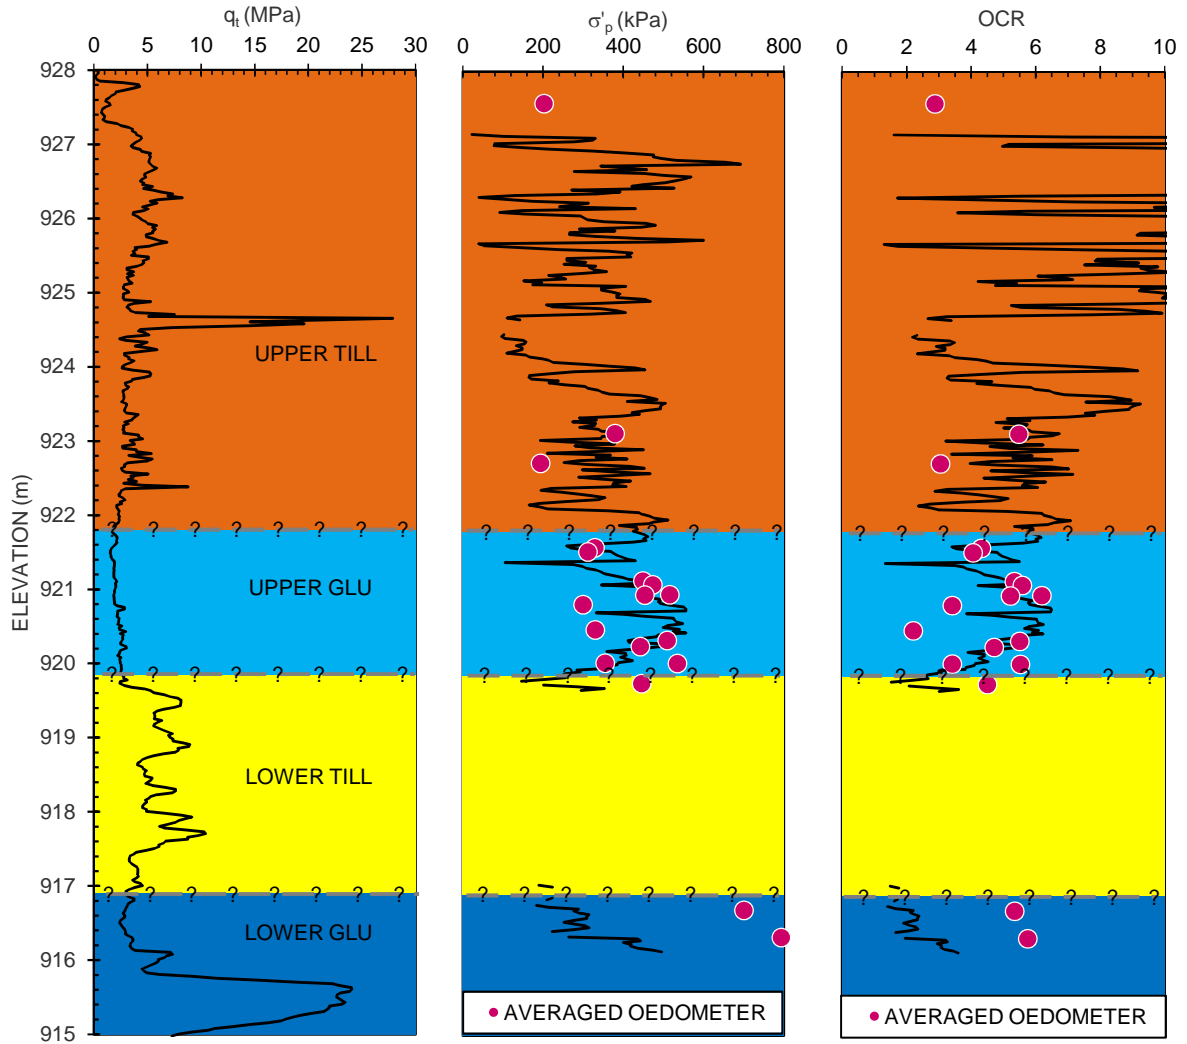
**FIGURE 5.2.5: INITIAL (PRE-CONSTRUCTION) STRESS HISTORY**

The continuous plots of  $\sigma'_p$  and OCR adopt published CPT correlations,<sup>2</sup> while the laboratory-derived data points are taken from Appendix E. From laboratory data, the average  $\sigma'_p$  for the Upper and Lower GLU units is 433 kilopascals (kPa) and 748 kPa respectively, with corresponding OCRs of 6.0 and 6.9.

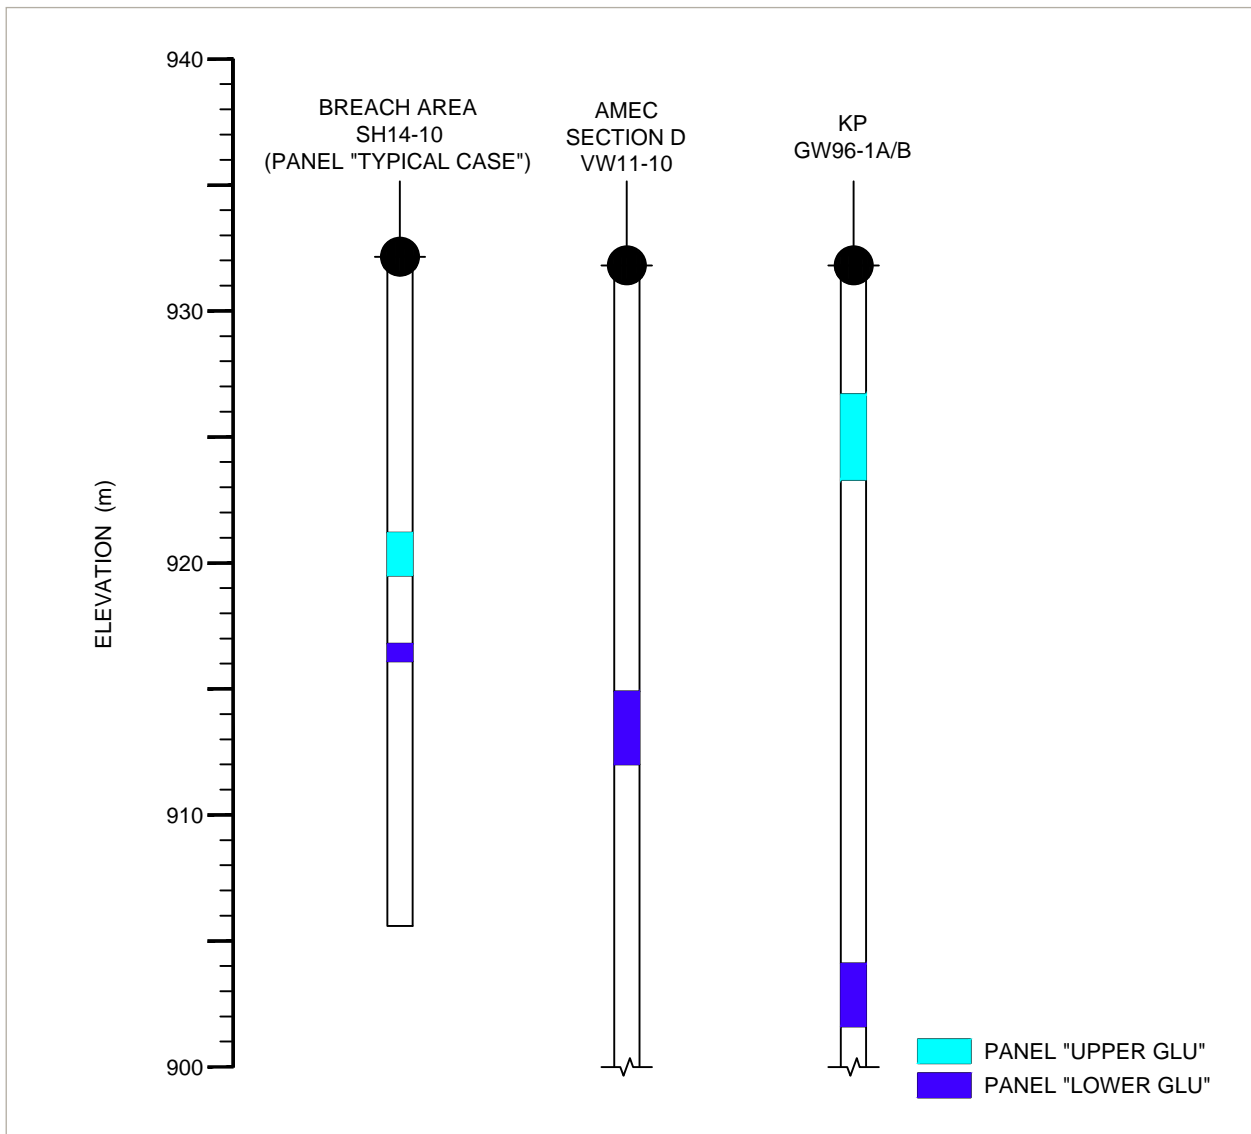
**FIGURE 5.2.7: COMPARISON OF GLU UNITS IN BREACH TO OTHER AREAS**

Stratigraphic variations on a larger scale are also apparent from **Figure 5.2.7**, which relates the Upper and Lower GLU units at the breach to glaciolacustrine soils elsewhere at boring locations presented previously in **Figure 5.2.2**. The Upper GLU at the breach shows apparent similarities to glaciolacustrine soils at similar elevation in GW96-1A that would be characterized as soft to medium-stiff according to their standard penetration test (SPT) blow count of 6. On the other hand, the uppermost GLU layer encountered in VW11-10 has an average water content of 23%, which corresponds closely to that of the Lower GLU shown in **Table 5.2.1**. Details are provided in Appendix D.

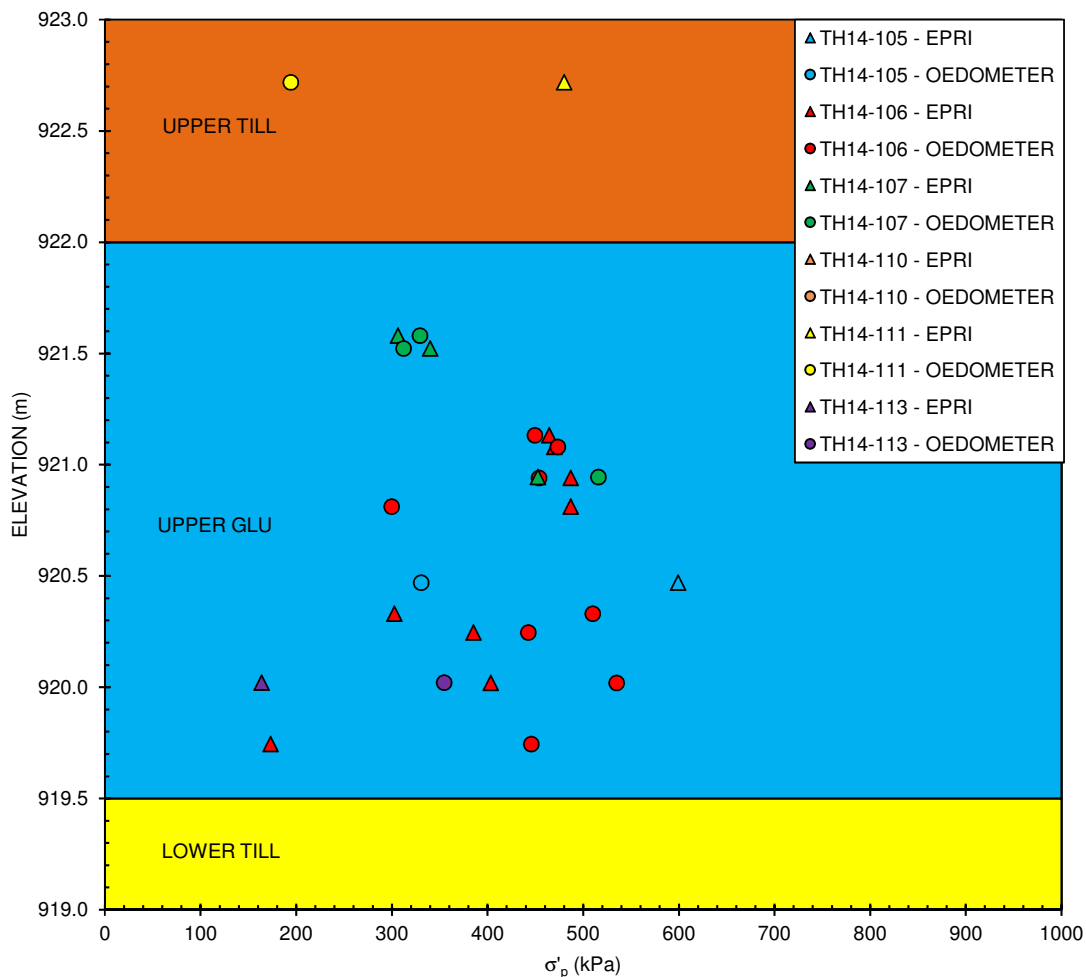
**FIGURE 5.3.3: PRECONSOLIDATION PRESSURE WITH ELEVATION**

Preconsolidation pressure can also be inferred from the CPT testing conducted as part of the Panel's site investigation. Again, only modest preconsolidation stresses have been determined. A comparison between the results obtained from the field tests with those obtained from the oedometer tests is shown in **Figure 5.3.3**, and the agreement is acceptable. As the embankment was raised to a stress level beyond the preconsolidation stresses, the underlying GLU reverted to normally consolidated behaviour.

**As the embankment was raised to a stress level beyond the preconsolidation stresses, the underlying GLU reverted to normally consolidated behaviour.**

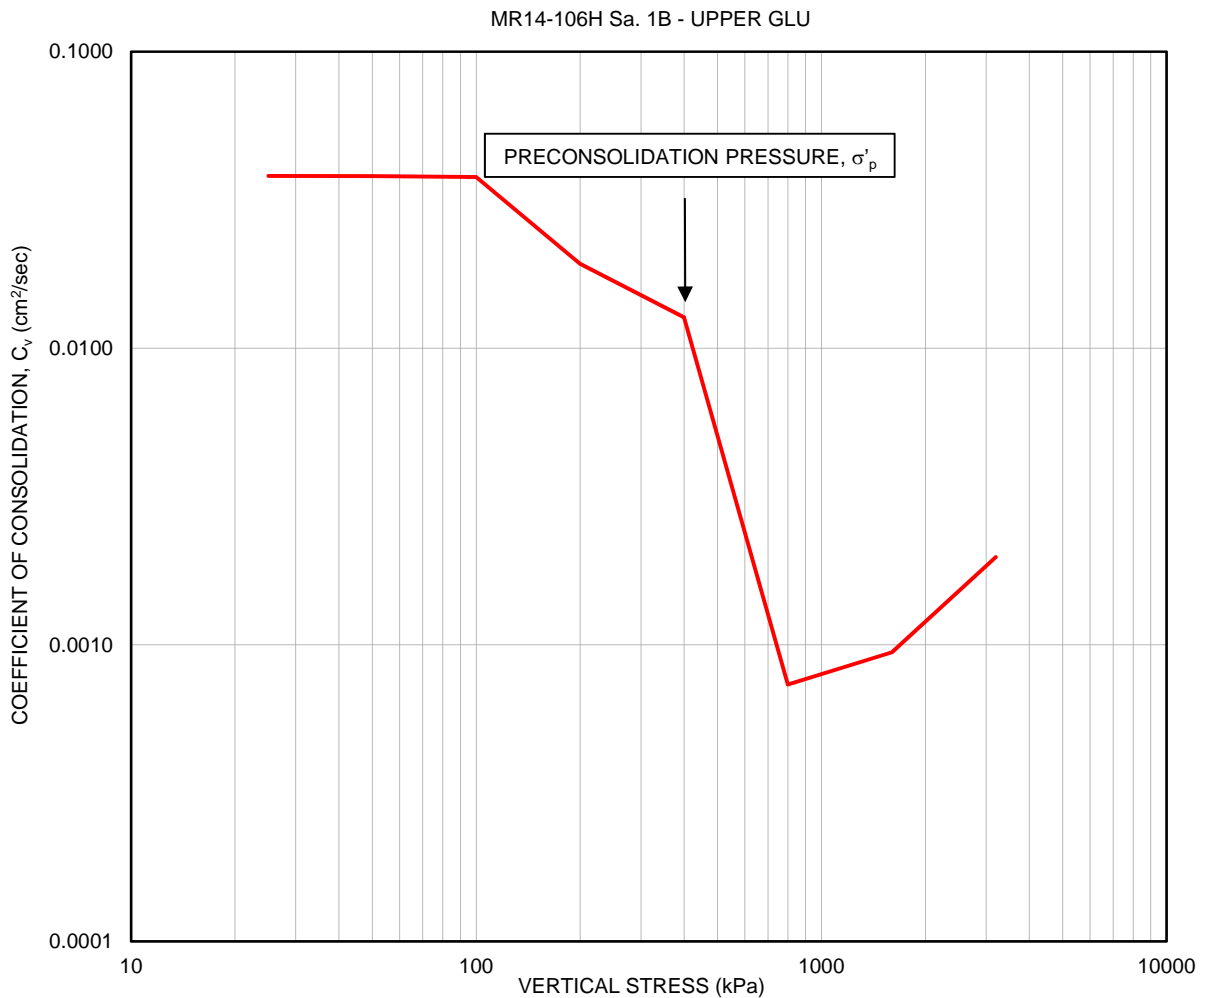
**FIGURE 5.3.4: VARIATION OF COEFFICIENT OF CONSOLIDATION WITH APPLIED VERTICAL STRESS**

The data from oedometer tests are presented in Appendix E, including information on the coefficient of consolidation that reflects the rate of pore pressure dissipation on loading. **Figure 5.3.4** provides an example of this response. The significant reduction in this value in the GLU at pressures in excess of the preconsolidation stress is noteworthy.

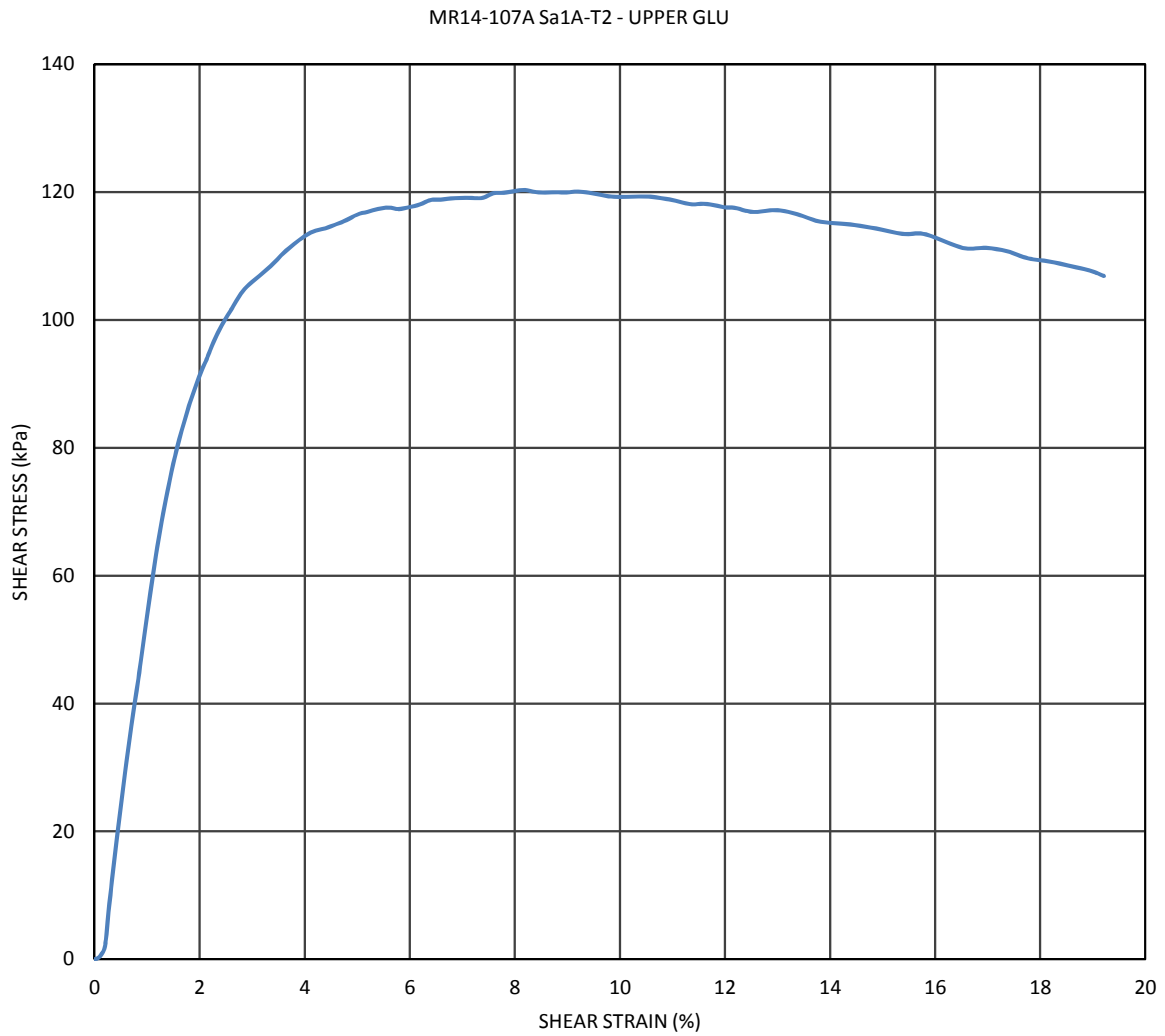
FIGURE 5.3.5: DSS TEST: GLU WITH STRAIN WEAKENING

Another important feature exhibited by this test program on GLU specimens is a decline in resistance following its peak. This is called strain weakening. An example of a test exhibiting strain weakening is shown in **Figure 5.3.5**. As will be discussed, the presence of strain weakening contributes to understanding of the sudden nature of the breach mechanism. **Table 5.3.1** summarizes test characteristics and results from the DSS test program. Complete test results, with a brief description of test methodology, are presented in Appendix E.

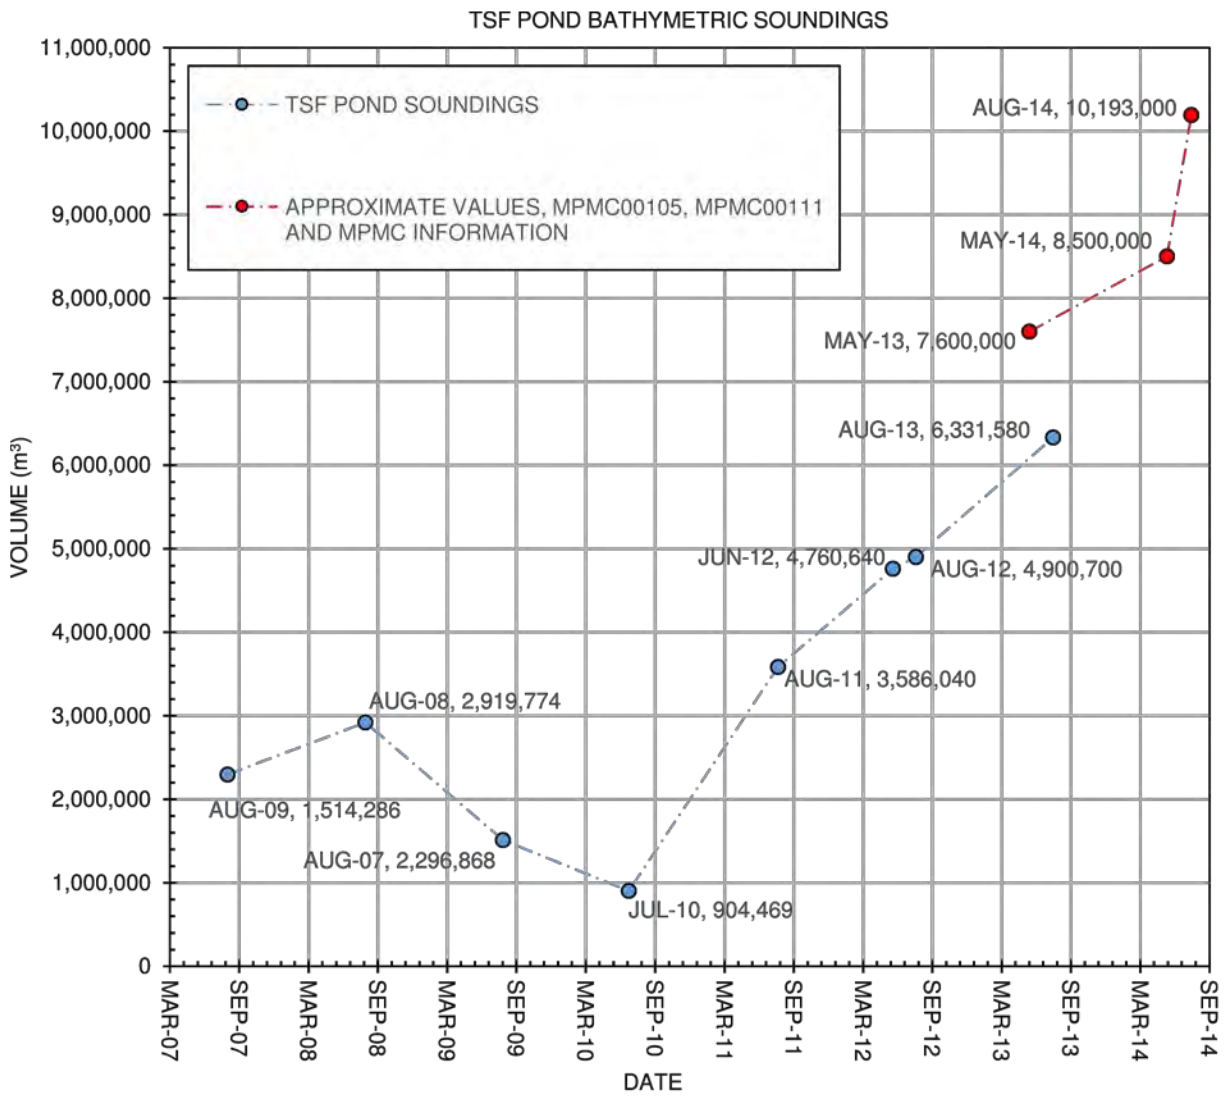
FIGURE 5.6.1: WATER ACCUMULATION IN TSF

**Figure 5.6.1** shows the accumulation of water in the TSF as determined from bathymetric surveys. The figure also shows approximate volumes reported in the records for three dates (refer to Appendix G).

MPMC was aware of the water surplus conditions at the start of Phase 2 operations. The pond volumes in **Figure 5.6.1** show that the last number of embankment raises were necessary to store water and not necessarily much higher tailings production. It is not clear to the Panel why it took so long to design and implement a water treatment strategy that would provide for a significant reduction in the amount of surplus water stored on the TSF.

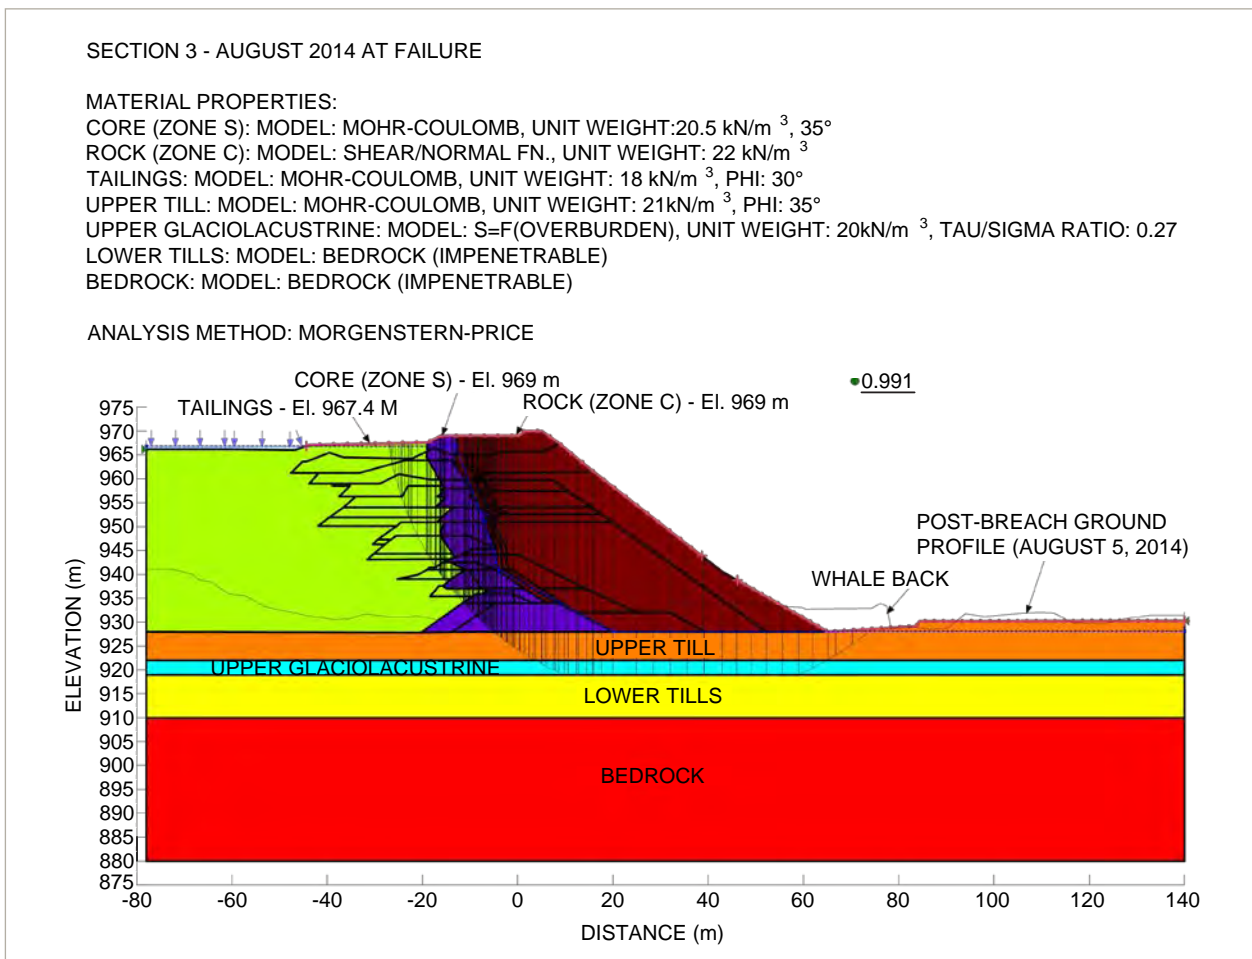
**FIGURE 6.2.1: DETAILED SECTION USED FOR LIMIT EQUILIBRIUM ANALYSIS (HIGH WATER TABLE, UNDRAINED STRENGTH RATIO 0.27)**

**Figure 6.2.1** presents the detailed section. It is based on the last LiDAR survey of the embankment prior to failure, a detailed reconstruction of the top of the structure and pond elevation based on construction inspector reports, and it includes a shallow excavation at the toe of the embankment as reported to the Panel. More details associated with the compilation of this and related sections are presented in Appendix H.

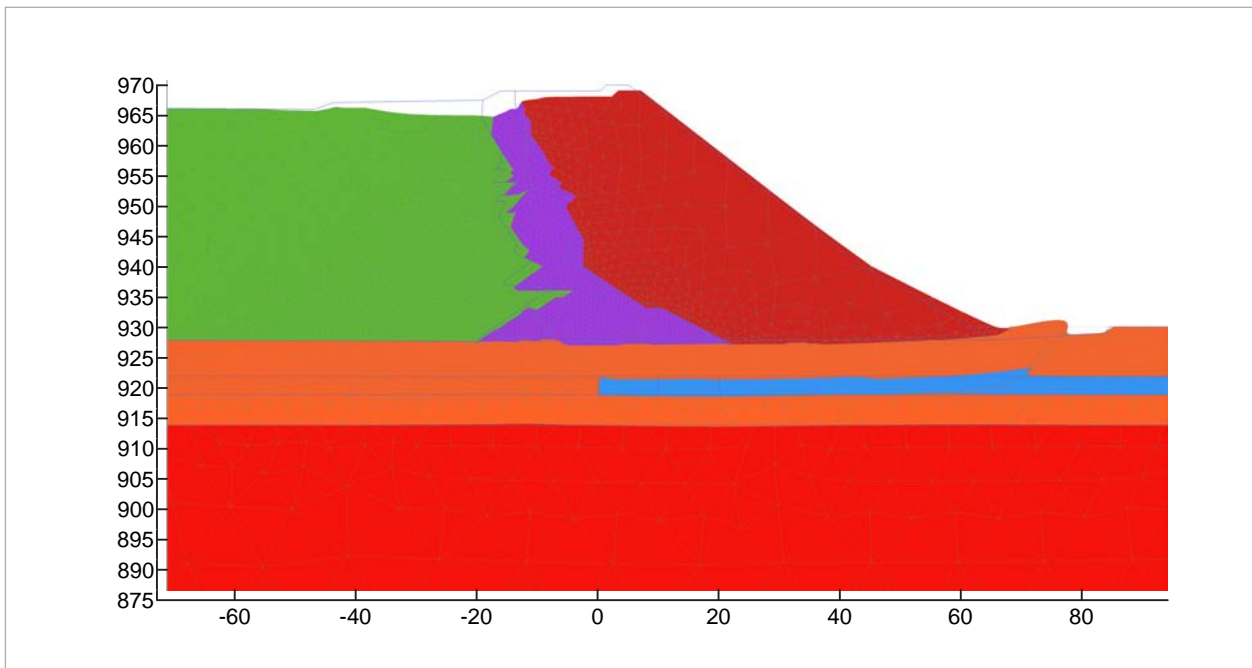
**FIGURE 6.2.4: SCALED-UP FIGURE 6.2.3 TO ILLUSTRATE DEFORMATIONS**

**Figure 6.2.3** portrays the PLAXIS model at collapse. Prior to creating collapse, the model was constructed with essentially the same input parameters as used in the limit equilibrium analyses, except for the Upper GLU that is given a high strength to avoid yielding. The strength of the Upper GLU is then reduced until a deformation mechanism forms and the embankment collapses. This provides not only a measure of the strength of the Upper GLU at which failure occurs, but also an indication of the deformed shape arising from failure. In the model presented in **Figure 6.2.3**, collapse occurred at an undrained strength ratio of 0.29, which is to be compared with 0.27 calculated from the limit equilibrium analysis that incorporates the same boundary conditions. Lower undrained strength conditions would indicate significantly larger deformations. The figure also indicates the zones of localized strain that develop to facilitate motion. Variations of continuity of the Upper GLU with respect to this case yielded similar results.

The PLAXIS analyses provide compelling support for the hypothesis that the movements of the Perimeter Embankment arose due to the undrained failure of the Upper GLU.

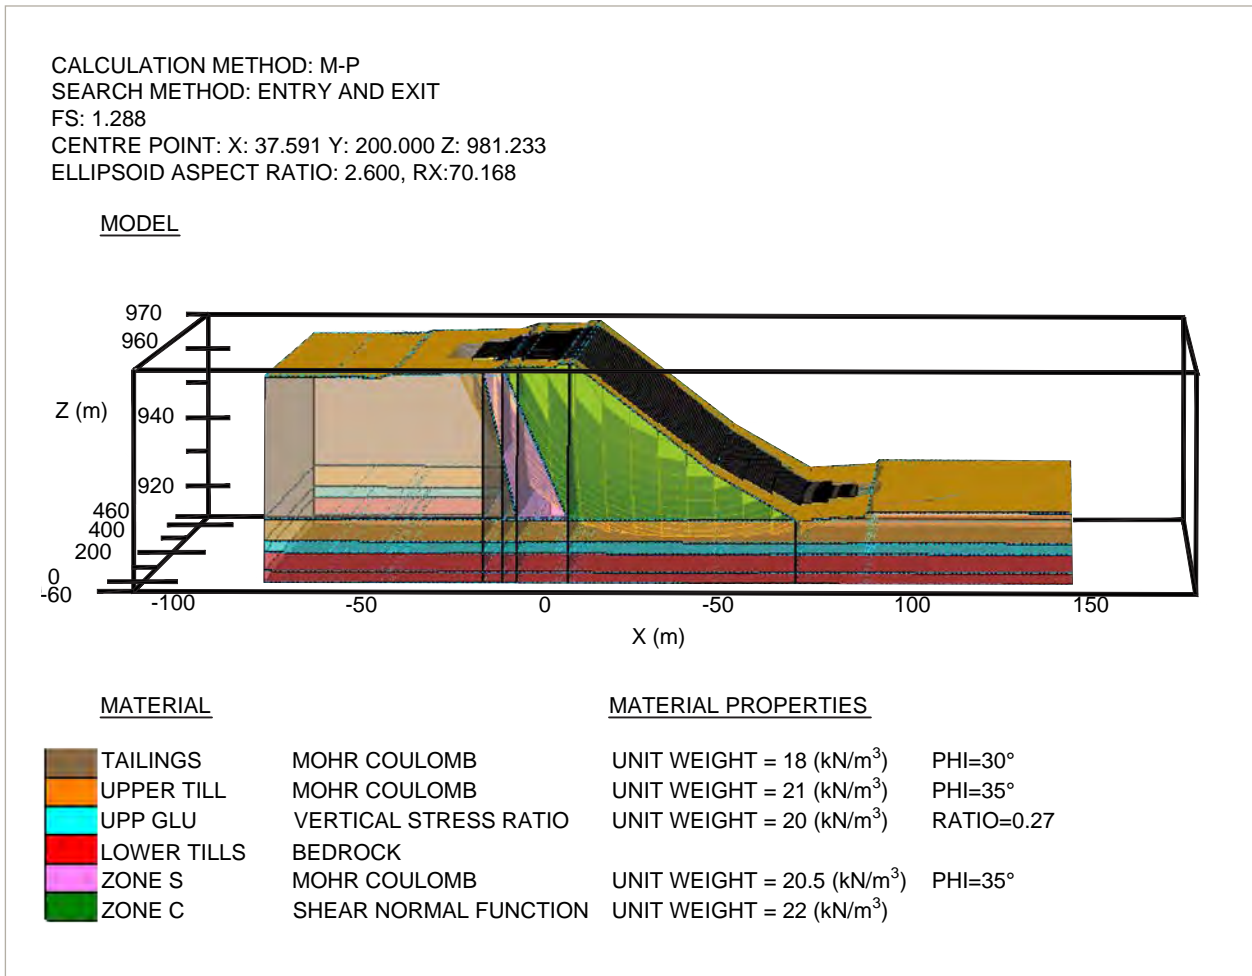
**FIGURE 6.2.5: 3-D LIMIT EQUILIBRIUM ANALYSIS (UNDRAINED STRENGTH RATIO 0.27, ASPECT RATIO 2.6, FS IS ABOUT 1.3)**

The length of the breach is relatively short compared to the height of the Perimeter Embankment at failure (~ 40 m). This is expressed as an Aspect Ratio (length/height) and is calculated to be 2.6. At this Aspect Ratio, three-dimensional restraints might be a significant factor influencing the analysis of the breach mechanism. At small Aspect Ratios, the side resistance acting on the potential moving mass increases in significance. This is ignored in the 2-D analyses described above, which are used routinely in design. Nevertheless, the Panel regarded it of value to assess three-dimensional considerations in order to fully explore the factors affecting the breach mechanism.

Three-dimensional limit equilibrium analyses have been conducted using the computer program SVSlope 3D, a widely accepted program for conducting such analyses. The geometry and boundary conditions are a three-dimensional extension of the case illustrated in **Figure 6.2.1**. All soil properties used in the 3-D analysis are the same as those employed in **Figure 6.2.1**.

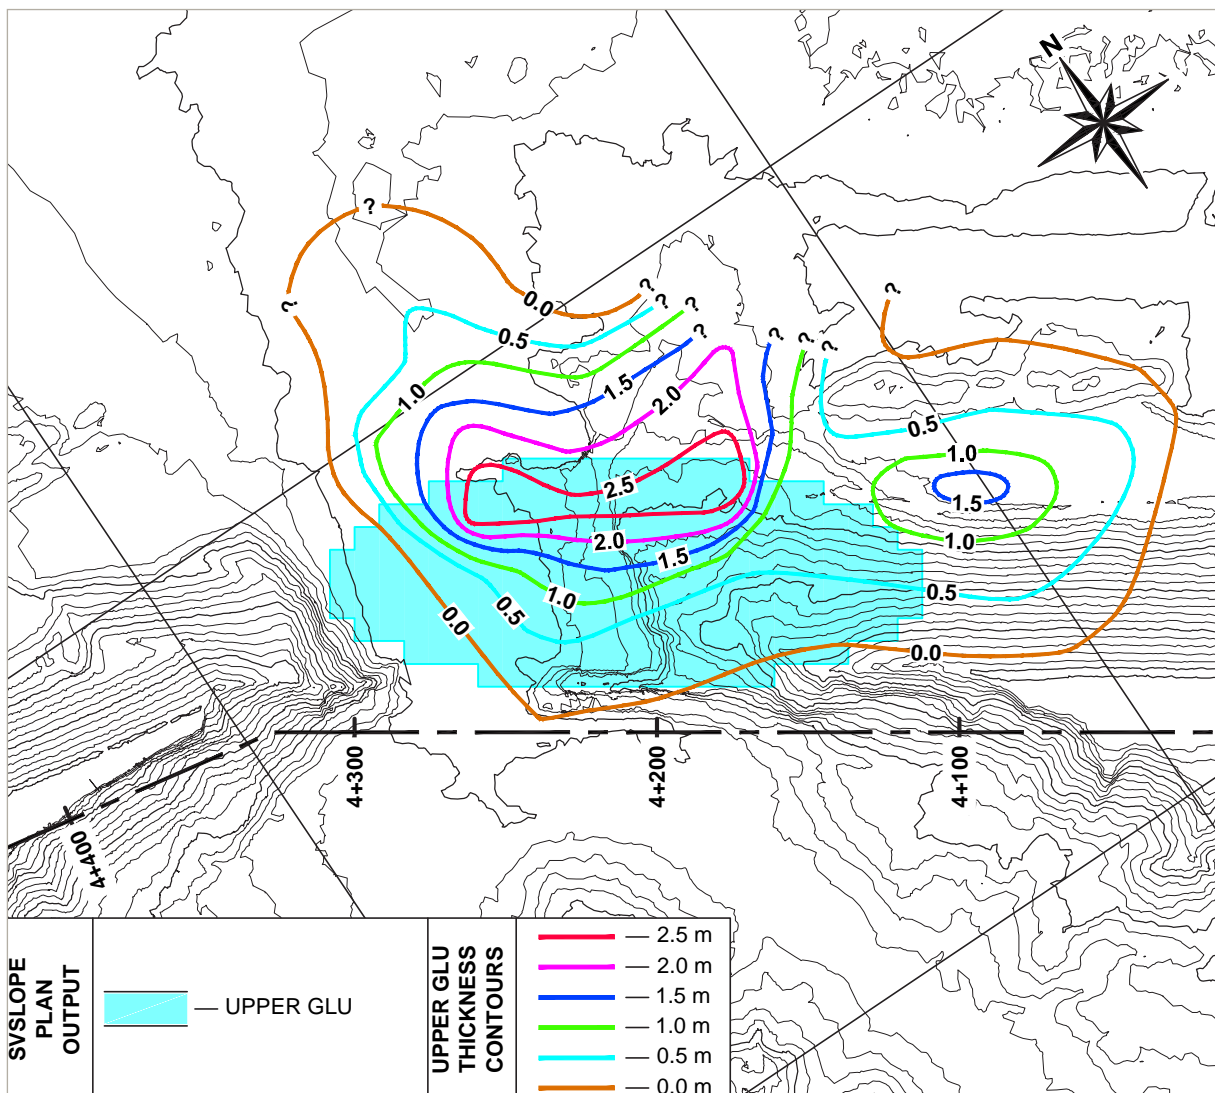
**FIGURE 6.2.7: COMPARISON OF THE 3-D ANALYSIS WITH THE THICKNESS CONTOURS OF THE UPPER GLU**

Additional support for the insight provided by the 3-D interpretation can be found by comparing the footprint of the 3-D analysis with the Aspect Ratio of 2.6 where it intersects the Upper GLU. The distribution of the thickness contours of Upper GLU is presented in **Figure 5.2.6**. This comparison is shown in **Figure 6.2.7**, which indicates a striking fit between the extent of the Upper GLU mobilized in the 3-D analysis (shown in cyan) with the extent of the deepest portion of the Upper GLU.

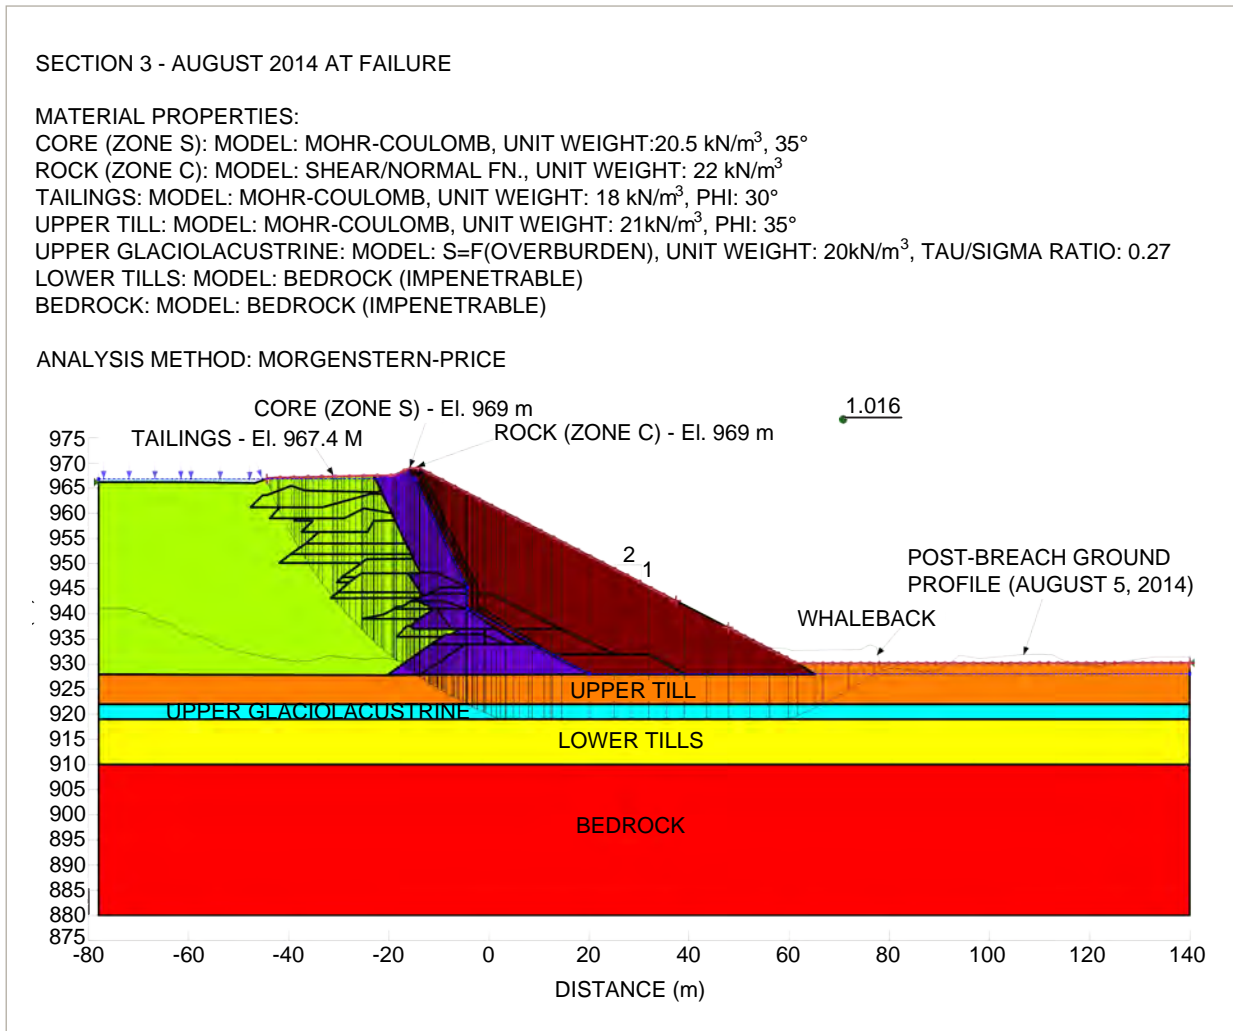
**FIGURE 6.5.1: 2-D LIMIT EQUILIBRIUM 2H:1V SLOPE TO ELEVATION 969 M (UNDRAINED STRENGTH RATIO 0.27, HIGH WATER TABLE, FS 1.02)**

At the time of Stage 4 (2006 – 2007), Knight Piésold (KP) had proposed a design for the Perimeter Embankment with a 2H:1V downstream slope and raises of the core and filter with a parallel inclined alignment to El. 965 m. This design has been projected in **Figure 6.5.1** to the core elevation at the time of failure (El. 969 m), and adopting an undrained strength ratio of 0.27 and a high water table, the calculated FS is 1.02. At El. 965 m, the FS is 1.04, much less than the design target of 1.3. Based on the back-calculated undrained strength ratio, the design was doomed to fail.

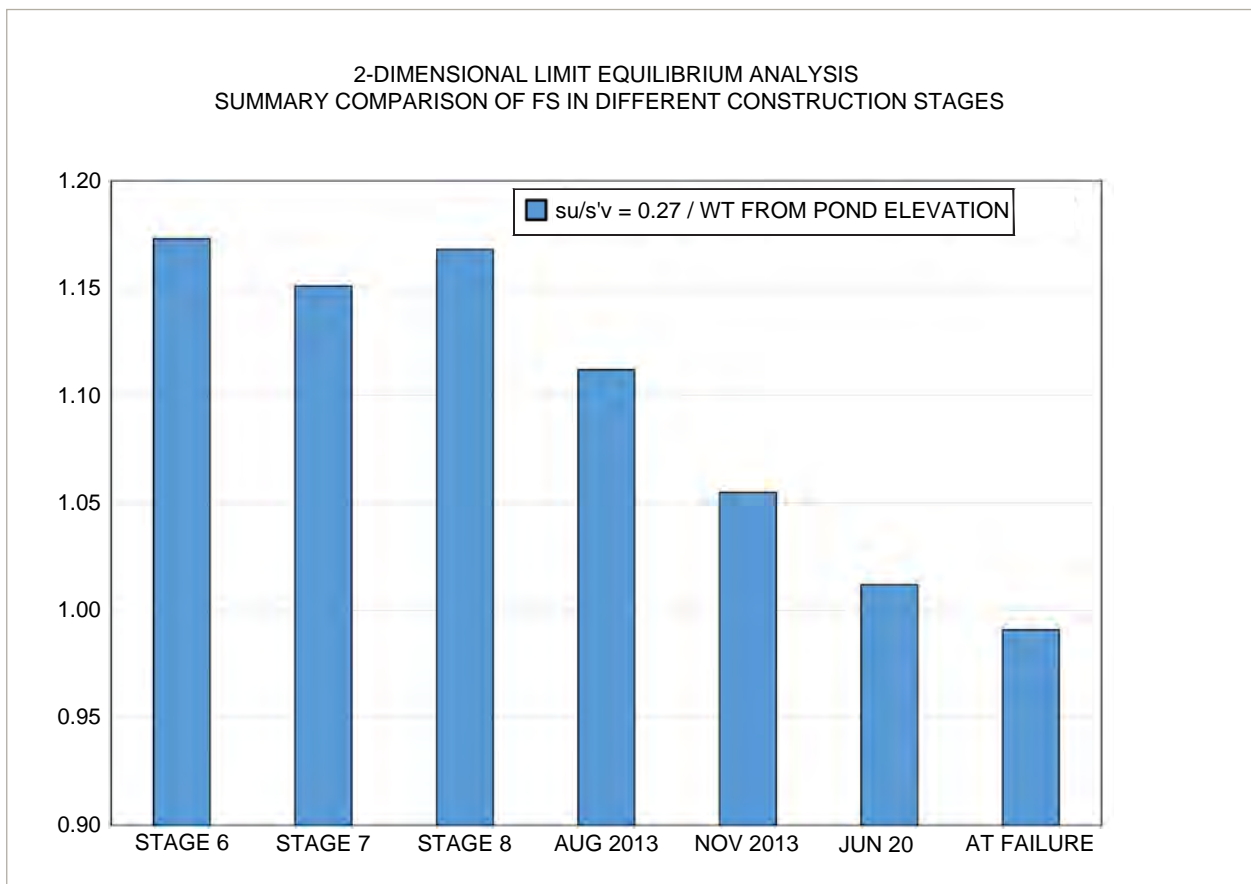
**FIGURE 6.5.2: VARIATION IN FS FOR EACH STAGE FROM STAGE 6 TO FAILURE**

**Figure 6.5.2** shows the variation of the calculated FS with each stage, from Stage 6 to failure, based on the as-built section for each stage. El. 965 m corresponds approximately to the height of the structure at the end of the 2013 construction season. At this stage, the FS is calculated to be only about 1.05, which is similar to the FS for the original design with a 2H:1V slope.

Prior to 2014, the Zone C fill began to be constructed as an angle of repose slope of 1.3H:1V. This appeared to have been an expedient measure and, as illustrated in **Figure 6.5.2**, ultimately resulted in failure of the Perimeter Embankment on August 4, 2014. If constructing unknowingly on the Upper GLU stratum, and not recognizing the potential undrained failure constituted loading the gun, building with a 1.3H:1V angle of repose slope over this stratum pulled the trigger. It appears that the 1.3H:1V

slope began as an expedient temporary measure to facilitate construction during Stage 5. It became more or less permanent for subsequent phases, although concerns had been raised before the failure. The circumstances associated with the relative permanency of the 1.3H:1V slope are not well understood by the Panel. The complex issues that prevailed during construction are summarized in section 5.4. **Figure 6.5.3** indicates that, had the downstream slope incorporating the widened crest been flattened to 2H:1V, the FS would have been 1.28. This was close to the required value of 1.3, and the embankment would not have failed. Moreover, the slope of 2H:1V was required, in any case, to support reclamation and closure criteria.

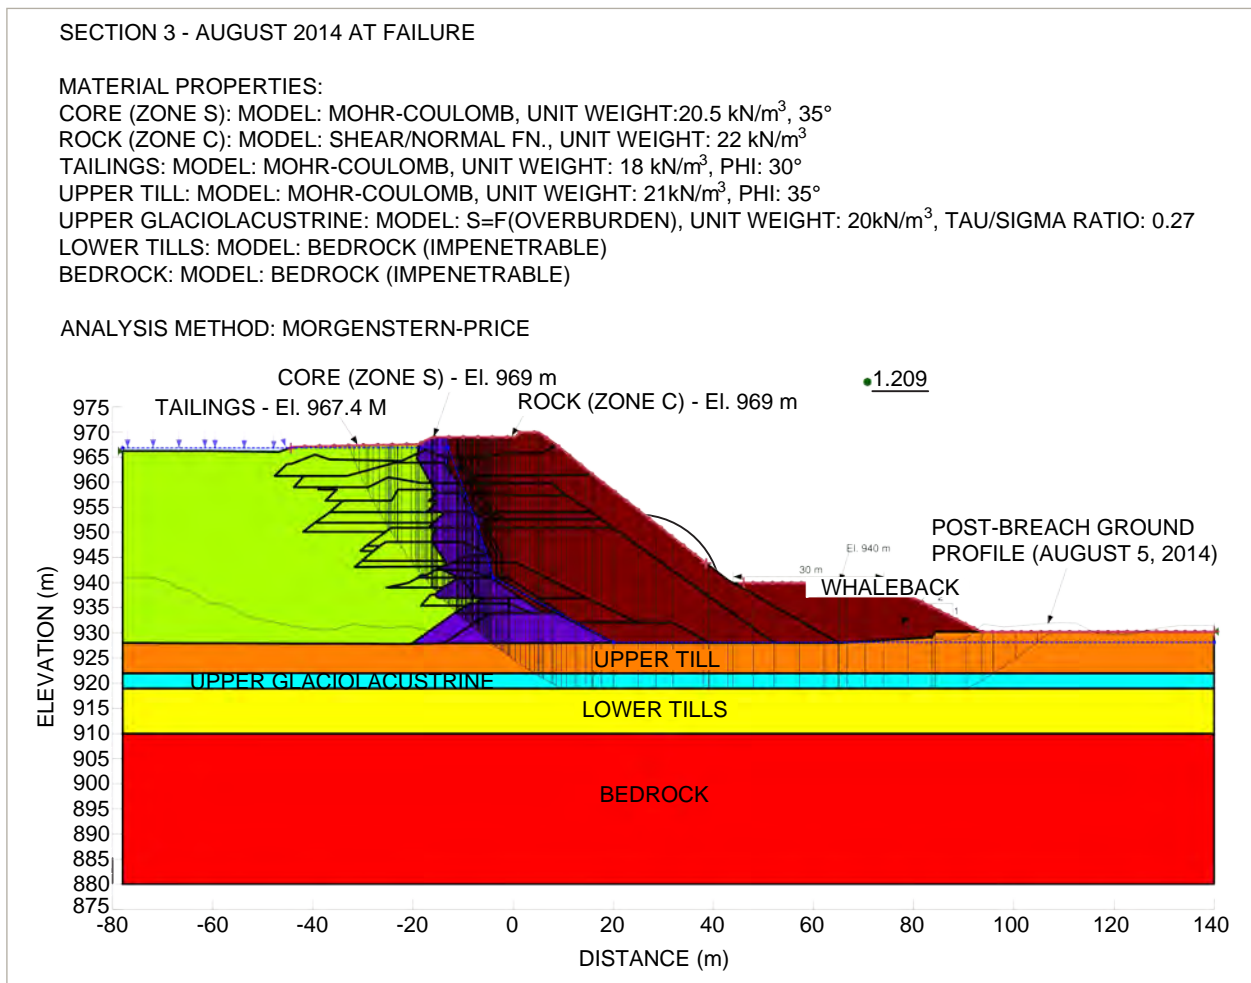
**FIGURE 6.6.1: PANEL STABILITY ANALYSIS FOR BGC BUTTRESS ON STAGE 9**

Looking specifically at the failure as documented in section 5.4, it was deemed desirable to increase the target FS to 1.5 since the TSF was operating more or less continually at full capacity. No significant progress to this end was made in Stage 9 before failure occurred. BGC’s design report for Stage 10, issued on July 25, 2014, indicated the buttress required to meet the new design objectives that they identified. Had it been in place as shown on **Figure 6.6.1**, the FS would have been 1.2 and the failure would have been prevented.
