Environmental Audit Of the Greens Creek Mine

FINAL REPORT

SRK Project 1UK005.001

March 2009

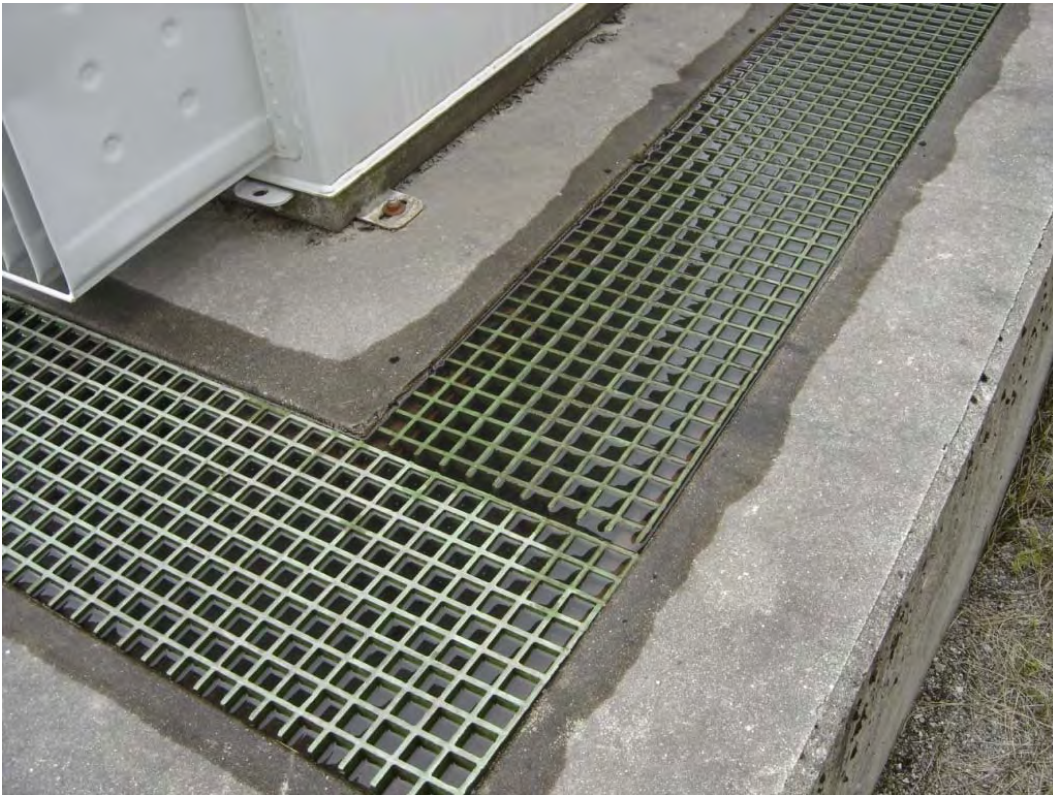
- During the surface inspection on May 8, secondary containment on the transformer located behind the old water treatment plant at the Tailings Disposal Facility was found to be full of water, eliminating the containment capacity (Photo 3). Inspections of secondary containment of transformer areas could not be verified during the audit;

- Secondary containment on the transformer located behind the old water treatment plant at the TDF was found to be full of water eliminating the secondary containment capabilities of the facility (Photo 3) – should be addressed as soon as possible.

Photo 3: Transformer Secondary Containment

- **Recommendation – Remove precipitation water from secondary containment as soon as possible.**
- Secondary containment for the tailings thickener (largest thickener closet to the tailings load-out area). As it is currently constructed, the newly install concrete containment would direct any unanticipated discharge from this thickener into the road area west of the thickener (Photo 26 and Photo 27). This is a risk area for a puncture of the thickener as indications on the side of the wall of the tank (small dents and scratches primarily) that it has been struck by equipment (presumably).

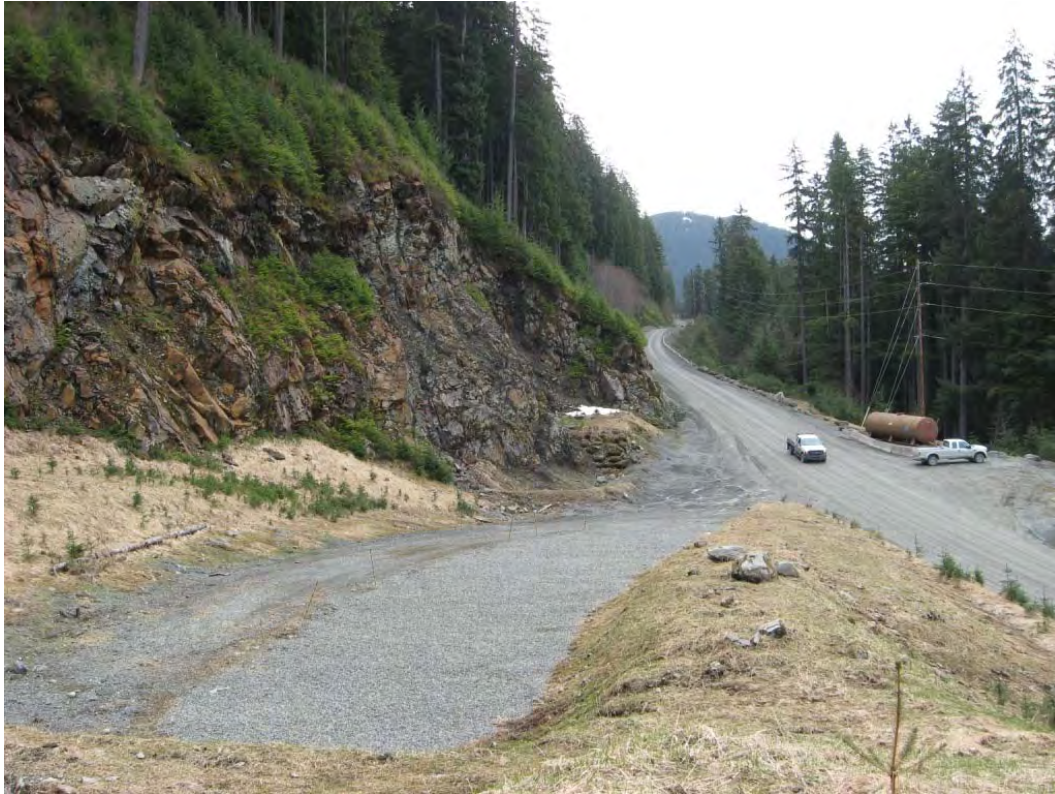
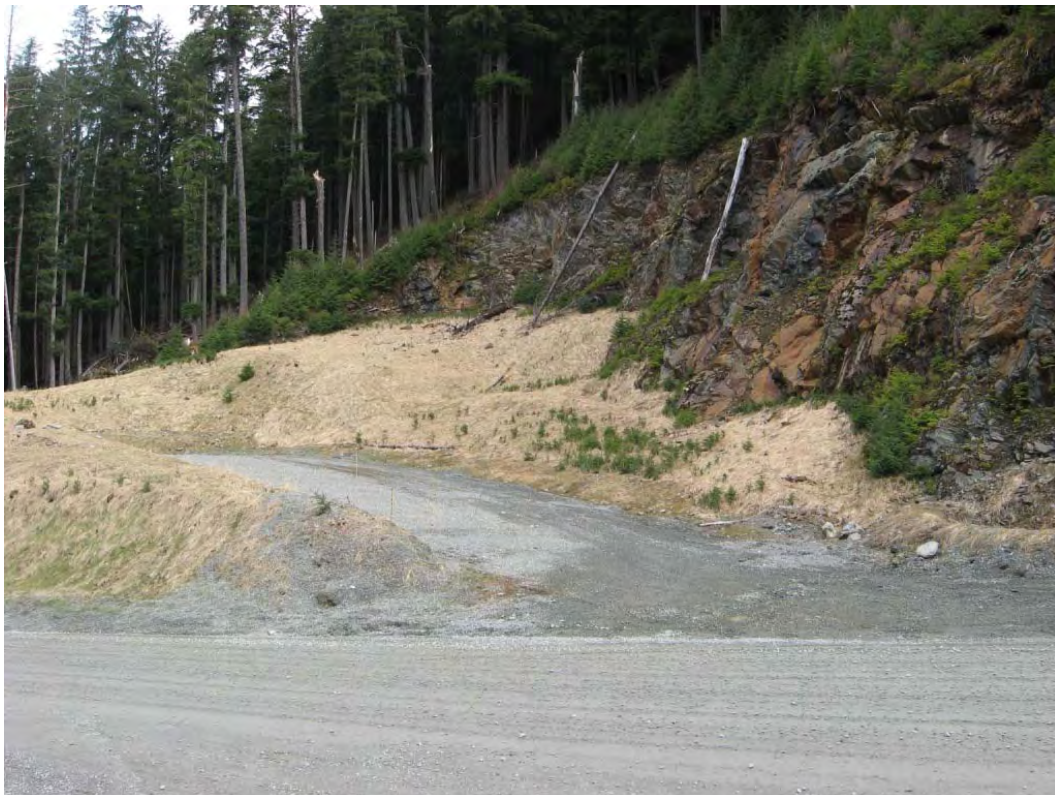
Pit 174, located at 3.3 mile on the B road, produced rock for construction of the B Road in 1987 (Photo 19 and Photo 20). There is 4,000 yd³ of pyritic quarry production rock stockpiled across the road from the pit and one third of the quarry high wall is pyritic phyllite.

Photo 19: Looking down the access ramp that overlies reclaimed and revegetated production rock in Pit 174

Photo 20: Side view of the access ramp and reclaimed and revegetated production rock in Pit 174

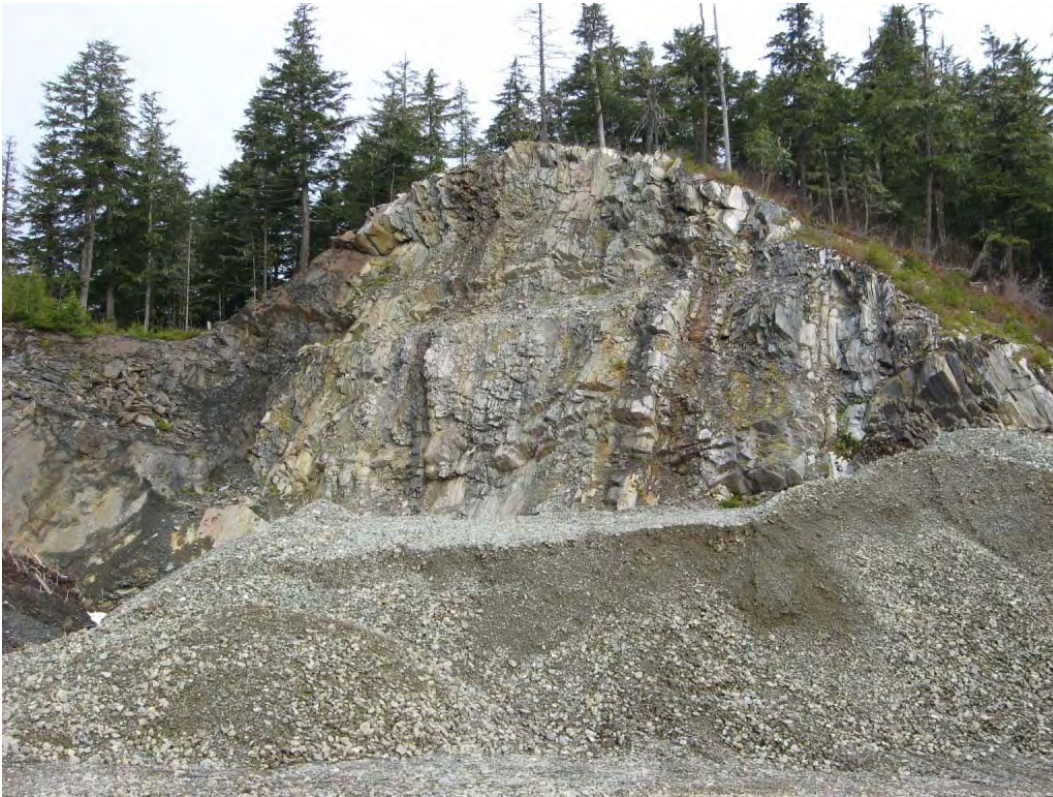
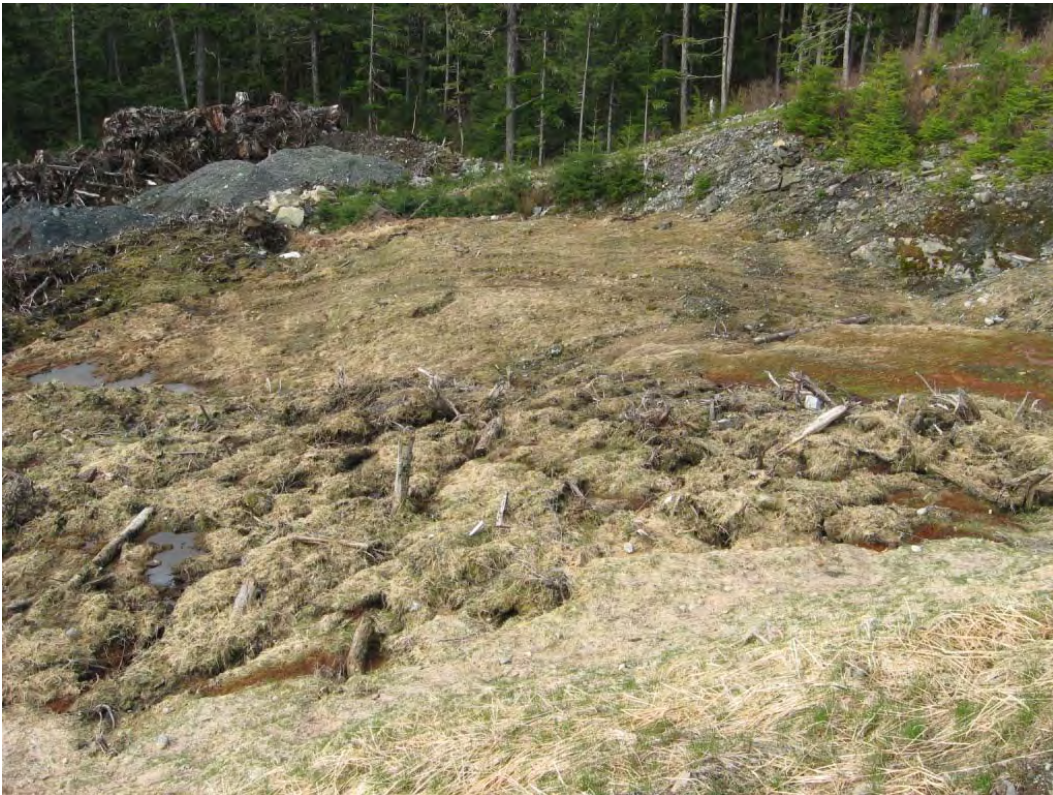
Pit 7, located at 1.8 mile on the A road, was opened in 1987 for construction of the access road and other mine facilities (Photo 21 and Photo 22). It has been partially backfilled with peat, tree debris and gravel materials from construction of the TDF and development of the 1.5 mile A road sand pit. Seepage from the pit is heavily manganese/iron-stained and has a strong sulfide odor.

Photo 21: Frontal view of the exposed bedrock backslope at Pit 7

Photo 22: At Pit 7 looking downslope over the saturated toe of what is primarily overburden hauled from the quarry at 1.5 km on the A road

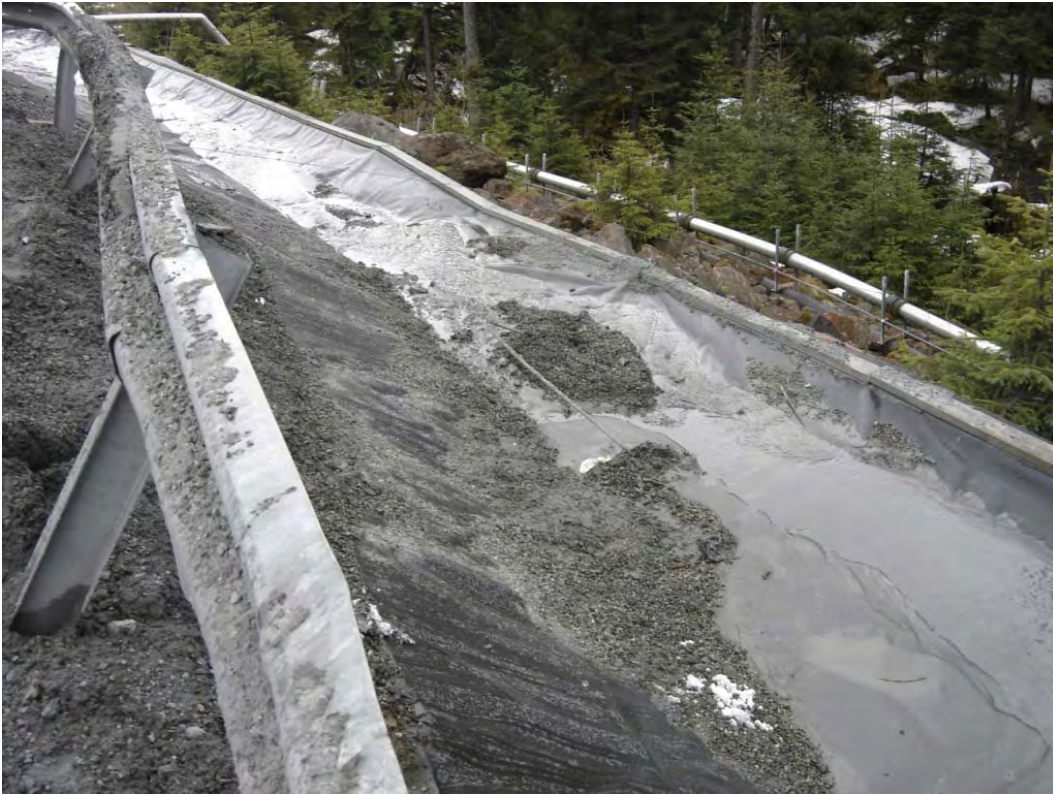
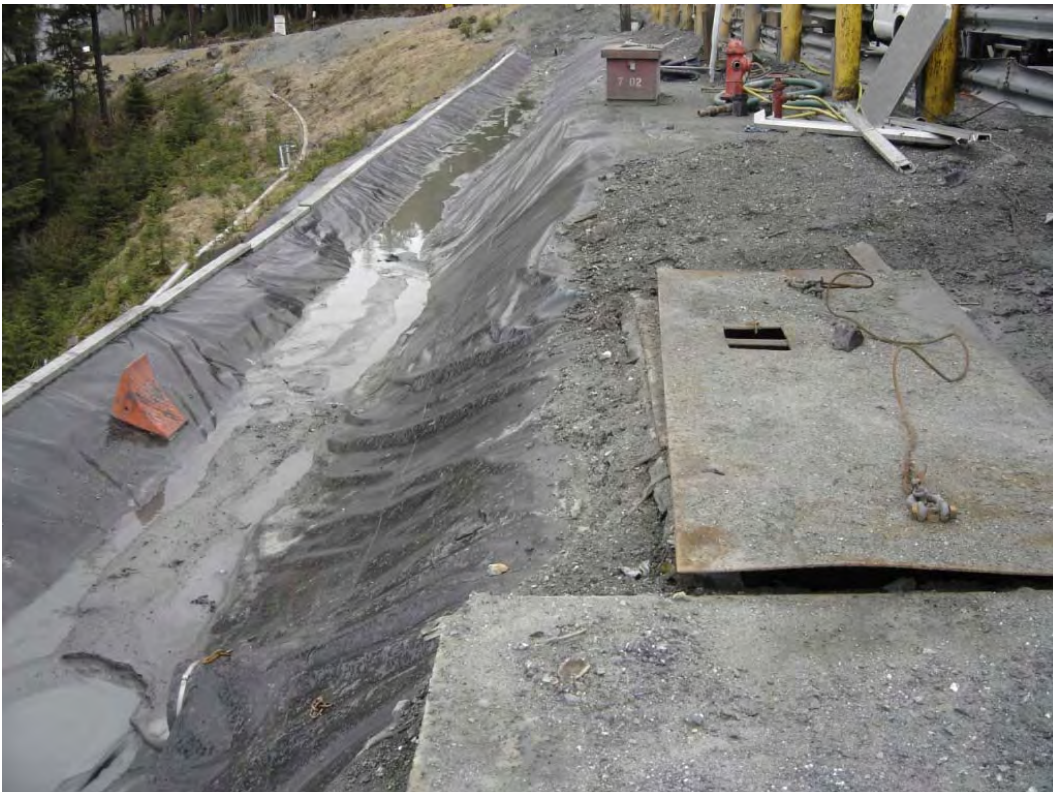
- HGCMC was not able to produce documentation from ADEC supporting their current procedure for managing the underground mine as secondary containment;
- Approximately 40 to 50% of the lined ditch immediately below the equipment wash area at the mill was blocked by gravel/sediments (Photo 23 and Photo 24), significantly reducing the capacity of the ditch;

- Lined ditch immediately below equipment wash area at the mill – approximate 40 to 50% blockage of the ditch by gravel/sediments – the current condition significantly reduces the flows that the ditch could handle (Photo 23 and Photo 24).

Photo 23: Ditch at 920 Area Looking East

Photo 24: Ditch at 920 Area Looking West

- **Recommendation – Remove blockage as soon as possible.**
- Area of construction for the temporary fresh water intake line (near the potable water treatment plant) – the area poses a high potential to impact the quality of Greens Creek due to the flushing of fines directly into the Creek upstream of the weir (Photo 25).

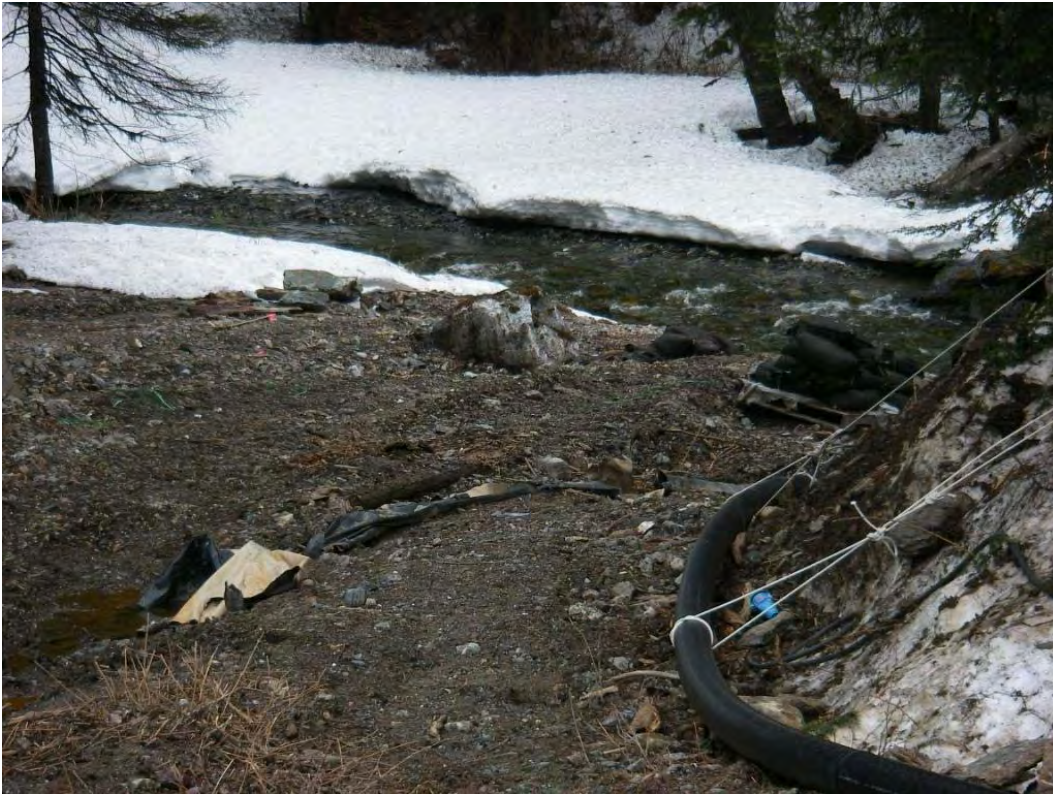
- The area of construction for the temporary fresh water intake line near the potable water treatment plant poses a potential to impact the quality of Greens Creek due to the flushing of fines directly into the creek upstream of the weir (Photo 25);

Temporary freshwater intake	<p>In anticipation of conducting maintenance on the freshwater intake grate, an area between the potable water treatment facility and Greens Creek has been cleared and work begun on the construction of a temporary water line. The area, in its current condition (disturbed with vegetation removed), presents the potential of a significant increase in the sediment load to Greens Creek in the event of a sustained or heavy rainfall event (Photo 25).</p>	<p>Immediate action should be taken to stabilize the area in order to prevent an increase in the sediment load to Greens Creek from the area disturbed by in order to install the temporary freshwater intake line</p>
Fresh water intake	<p>Area was inspected and the area was found well maintained no concern were noted</p>	
A Pond & DB-01 Settling pond	<p>The A pond liner was inspected and no concerns were noted. The pond had a minimal amount of solids and adequate freeboard was being maintained.</p> <p>Volume of the pond was not readily available from site personnel nor were site personnel able to give confident statement regard average flow into pond under normal operating conditions. Pond materials are slurried back into the mill circuit.</p> <p>Settling pond had recently been cleaned out with solids being transported to the ore storage area for inclusion in ore feed. Sufficient freeboard of approximately 2.5 m was being maintained at the time of the inspections</p>	<p>Enhanced understanding of site wide flows and containment capacities is required.</p> <p>Recommendation that a detailed and accurate site wide water balance be developed and updated on a regular basis. The site water balance must, at a minimum include: all flows, (measured contaminated and fresh water withdrawals, estimates of all leachate and contact water flows, pumping & piping capacity, individual pond capacities (with consideration for adequate freeboard) capacities and reconciliation of all volumes at least on an annual basis.</p>

Photo 25: Construction Area near Freshwater Intake

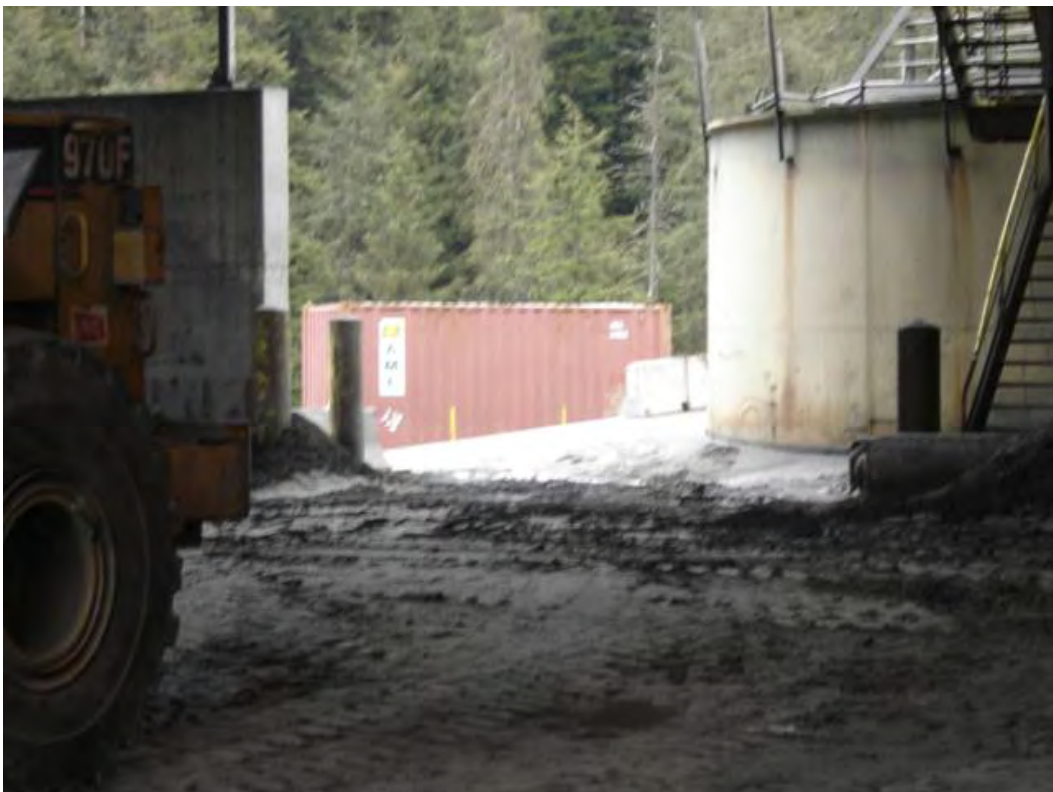
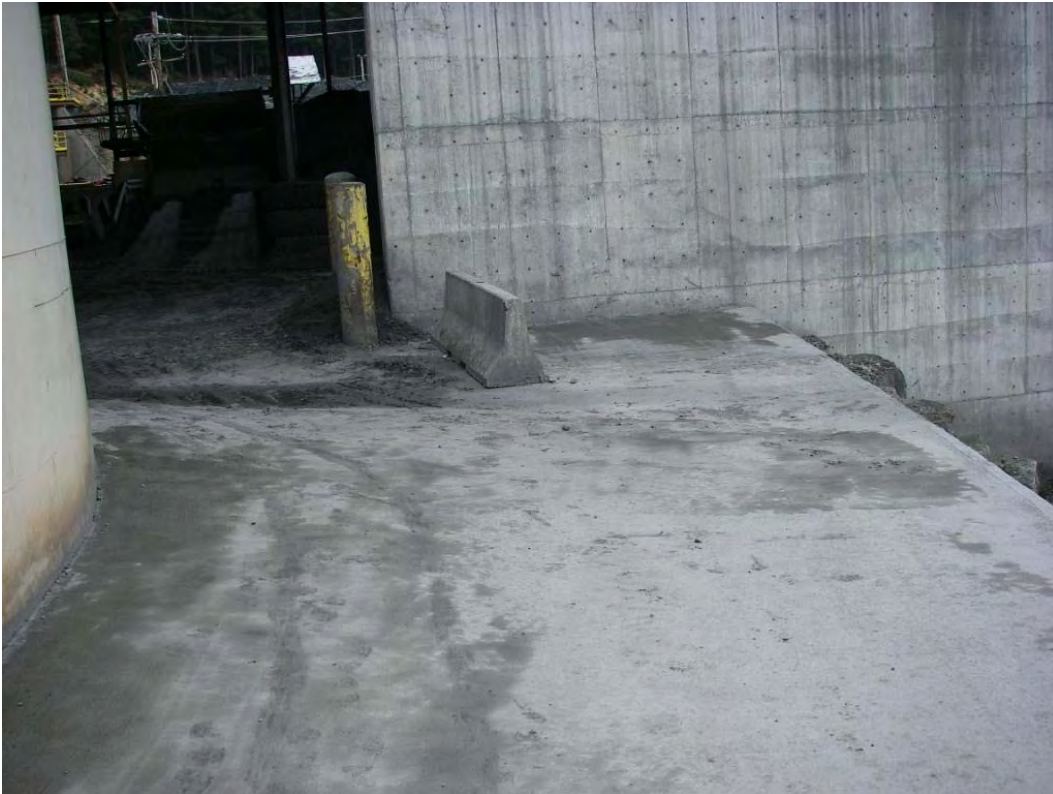
- As it is currently constructed, the concrete containment for the tailings thickener would direct unanticipated discharge from this thickener into the road area west of the thickener (Photo 26 and Photo 27);

HGCMC Site Aspect	Inspection Observations	Comments/Recommendation
Tailings thickener area	<p>Secondary containment by constructing sloping concrete pads has recently been built around the tailings and lead thickeners with overflow/ unanticipated discharges from the thickeners intended to flow to drains located at low points in the pads which in turn report into the mill at sites with appropriate sumps.</p> <p>The area between the tailings thickener and the tailings load-out facility appeared to be sloped away from the thickener and as a result would discharge to the roadway between the mill and the Creek (Photo 26 and Photo 27). This effectively eliminates the value of the secondary containment in the area. This concern was immediately voiced to William Oelklaus.</p> <p>The thickener also showed evidence of contact with equipment (likely tailings load out equipment) as there were a number of relatively small scratches and dents on the outer wall of the tailings thickener</p>	<p>Secondary containment of the tailings thickener in the vicinity of the tailing load out area should be improved as soon as possible to reduce the potential of discharge to the road area in the event of an unanticipated discharge from the tailings thickener.</p>

Photo 26: Tailings Thickener

Photo 27: Tailings Thickener Concrete Containment
