SOUTH PLATTE BASELINE STUDY

October, 2018

This report has been prepared by Carol Ekarius, Executive Director of the Coalition for the Upper South Platte (CUSP).

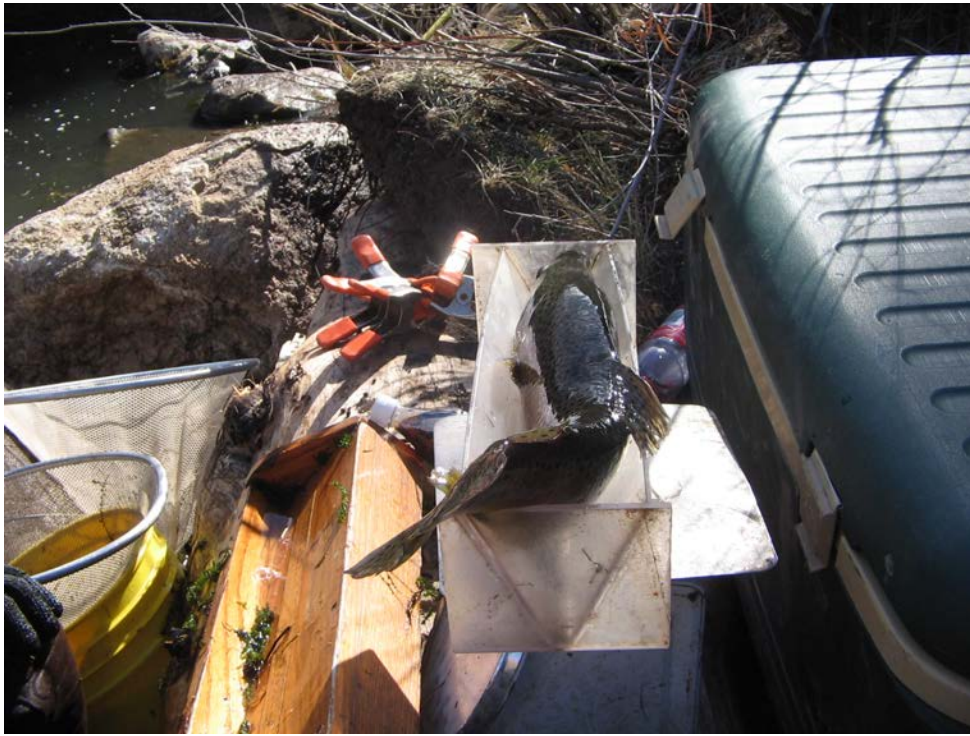
There is a reason that the Elevenmile segment is considered an important recreational site in the Upper South Platte: this lunger is being weighed and measured during fish shocking at the IFIM site (instream flow incremental methodology site) in the Canyon.

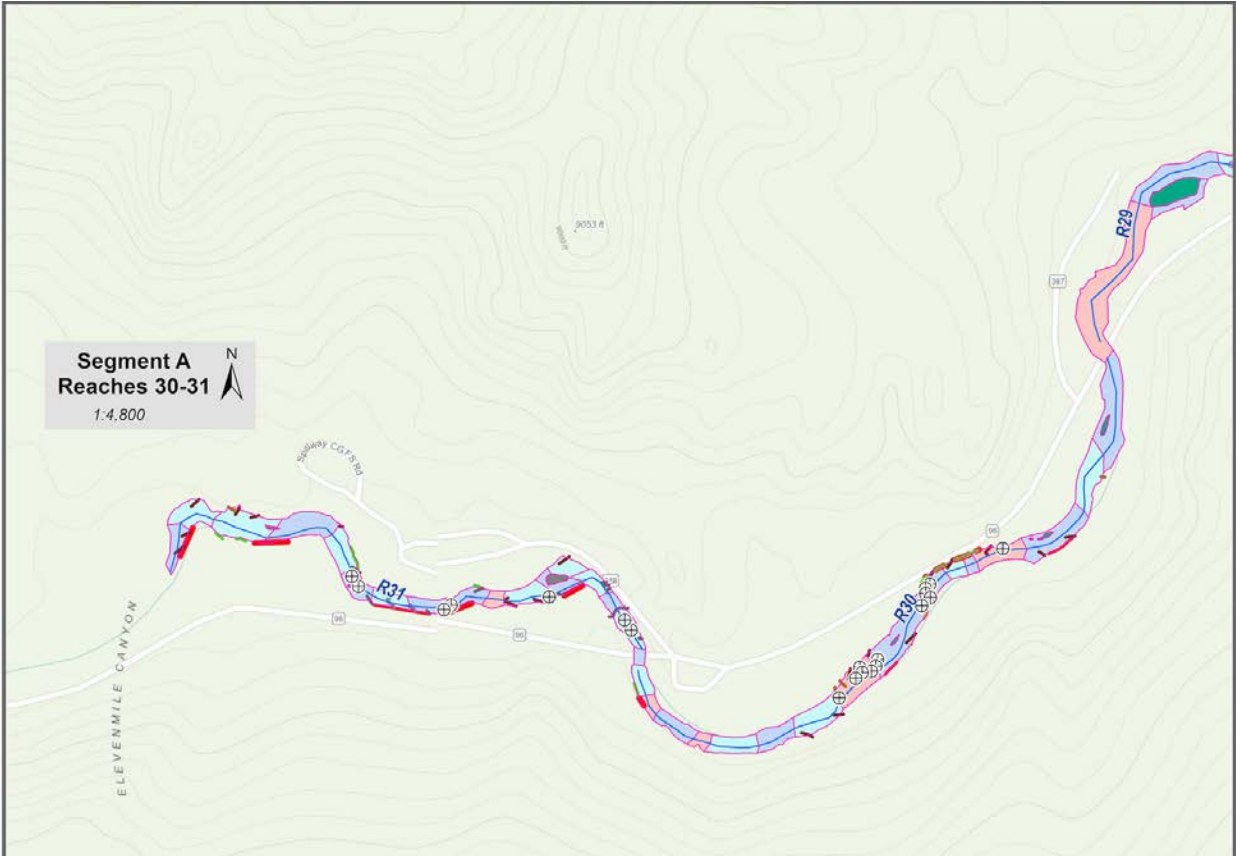
Reaches 31 and 30

Reach 31 is closest to Elevenmile Dam, beginning at the edge of the Denver Water property line below the dam. These reaches have seen significant improvement in vegetation over former periods, but still has some degradation of banks, and the parking area adjacent to 31 continues to contribute excess sediment to the river.

RECOMMENDATION: We recommend that the upper parking area receive additional maintenance. We also recommend additional monitoring to try to determine the source of nutrients that are causing algae in the Canyon.

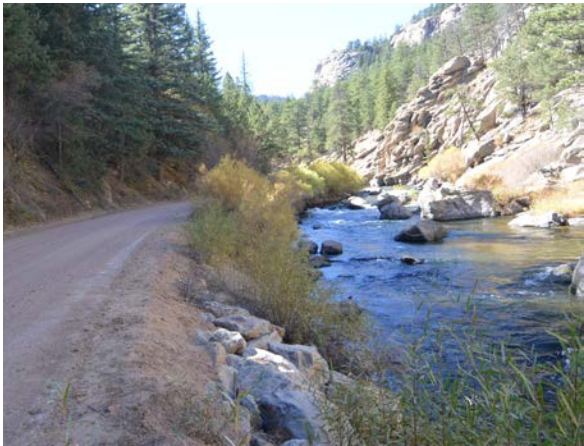
Reach 27

Although much of this reach is constrained by bedrock and rock walls right to the waters edge, this reach still has significant bank instability, and has actually gotten worse in areas as far as vegetation and bank stability goes since the last data was taken (1993 for this reach). Again, the road and fishermen access drives the instability.

RECOMMENDATION: Address bank instability and road issues.

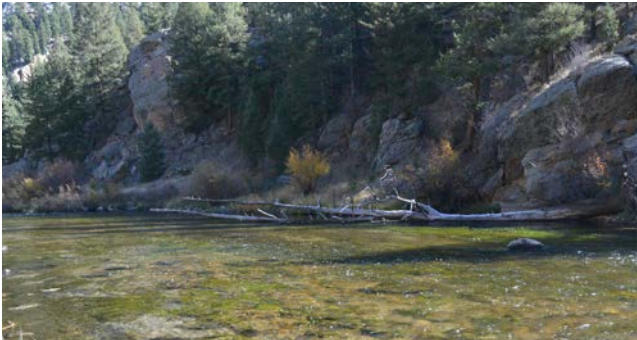
Reach 26

Excess algae is readily seen in the photo below. During water quality sampling in hot weather in the Canyon, we have had some hits for nitrates that exceed water quality standards. We still don't have a clear understanding of what is causing the nutrients or the excessive algae growth. The banks are continuing to degrade along the roadside.

RECOMMENDATION: Address bank instability and road issues. Develop a monitoring program to understand what is driving nutrients and aglae.

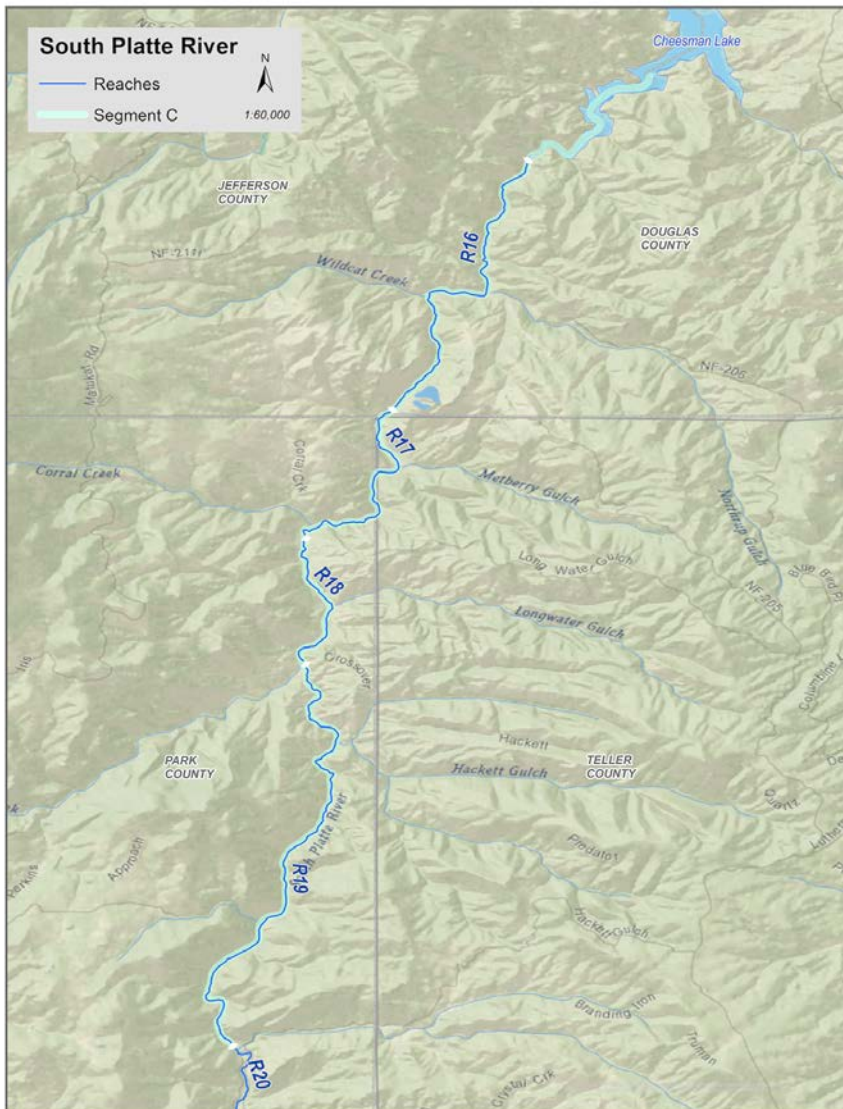
Due to the ruggedness of the terrain, several segments had no previous data, and segment 19 had no data other than photo points collected during this sampling cycle for the safety of our crew (Pete Gallagher, former Pike National Forest fisheries biologist and owner of Fin-Up Habitat Consultants; Dave Winters, former Regional Fisheries Biologist for the US Forest Service; Denny Bohon, former Biologist, Pike National Forest; and Greg Policky, former Colorado Parks and Wildlife Aquatic Biologist). Much of the segment is steep and narrow, with extremely rocky A or B channel configurations (as seen in the photo below).

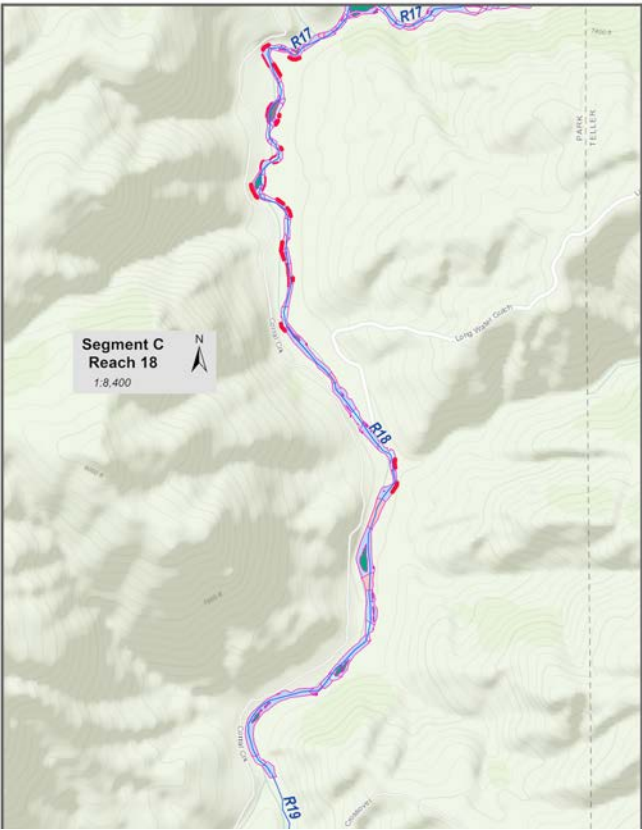
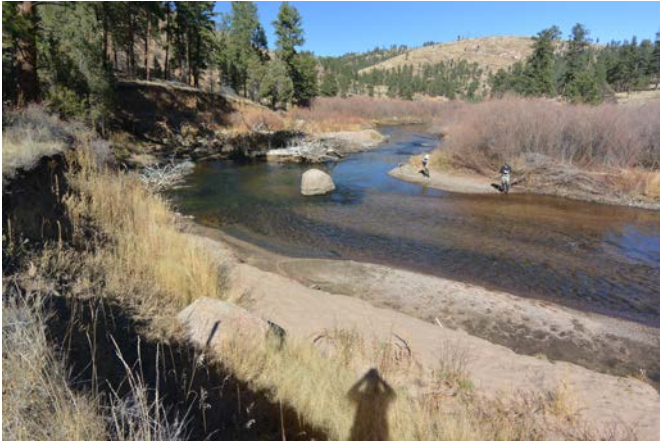
Between the closed-but-being-accessed by OHV’s portion of Corral Creek Road, and the after effects of the Hayman Fire, this reach has significant erosion and bank areas of bank instability, particularly where vehicles are entering the river.

RECOMMENDATION: Enforce and harden closure, or develop a plan to manage recreation.

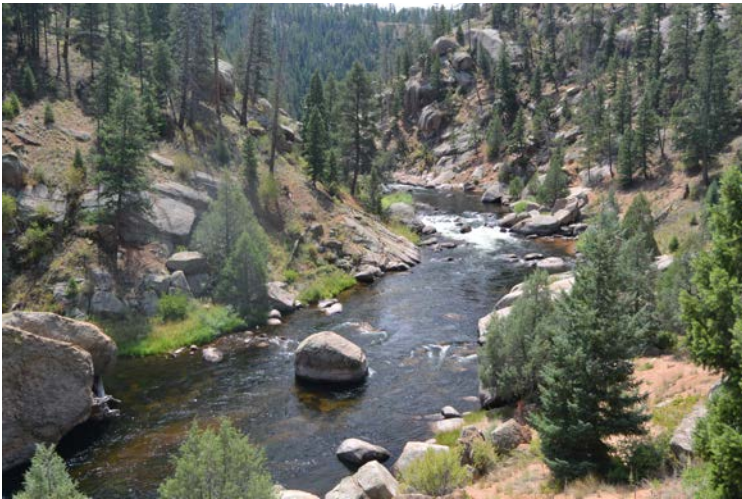
Segment D is the shortest segment, at a mere 3.1 miles, running from the mouth of Cheesman Reservoir to the upstream boundary of the Wigwam Club, and includes reaches 13 through 15. The segment's values are recreational, fisheries, and wildlife. For crew safety, data was not collected in Reaches 15 or 14 due to the steep, rocky channels, as seen in the photo below.

Generally speaking, due to the ruggedness and rockiness, this area is in a good condition, however there are social trails that contribute excess sediment to the river.

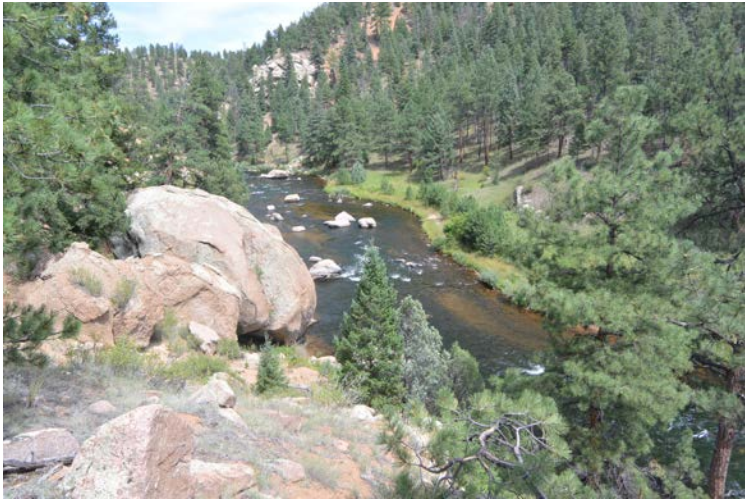
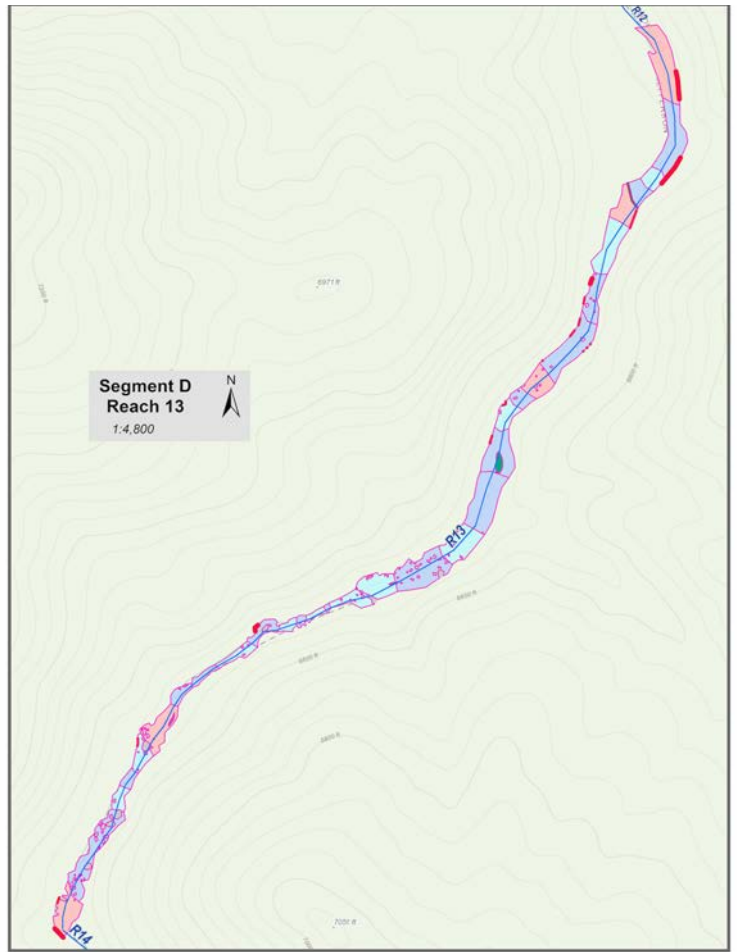
Reach 13 is generally in good shape, but does need consistent trail maintenance and reducing social trails, as well as working to increase vegetation on slopes above the river..

RECOMMENDATION: Increase trail maintenance. (Denver Water has already increased funding for more trail maintenance starting in 2019.)

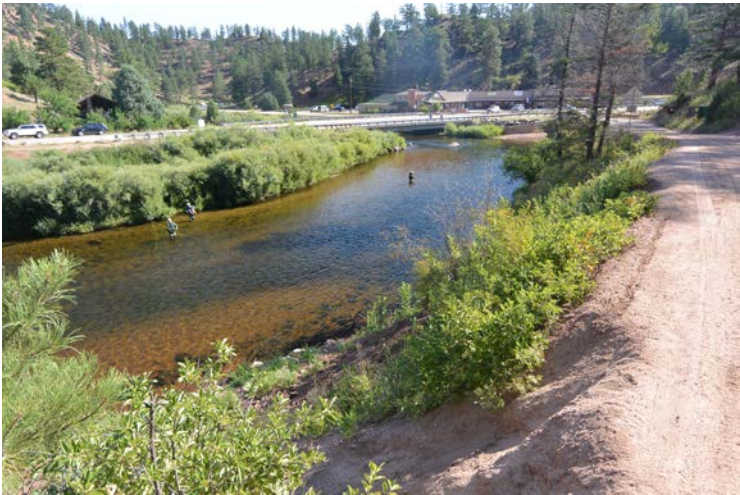
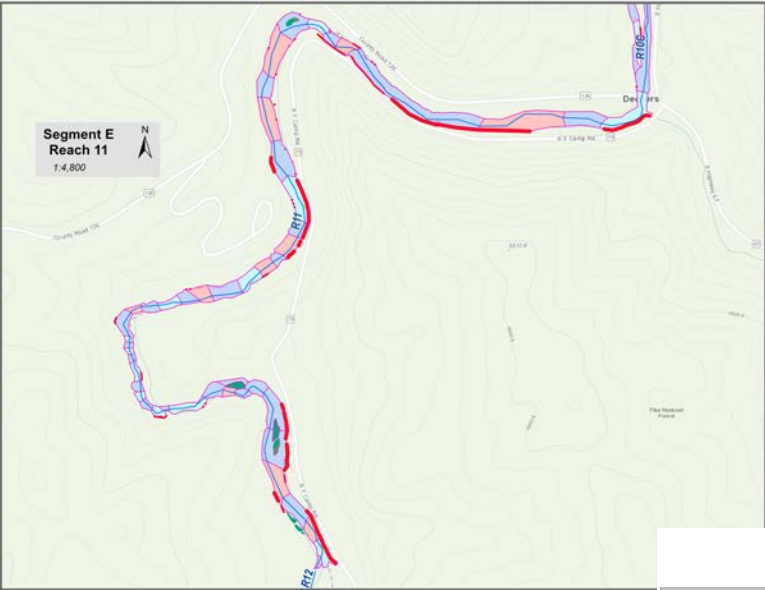
Reach 11 runs from the lower boundary of the Wig-Wam Club to Deckers. It has several areas of highly eroding bank due to the adjacent gravel road and fisherman access. CUSP, with SPEB and Trout Unlimited Funding has begun installing rock stairs for access.

RECOMMENDATION: Continue stair installation. Work with road crews to reduce erosion from the road.

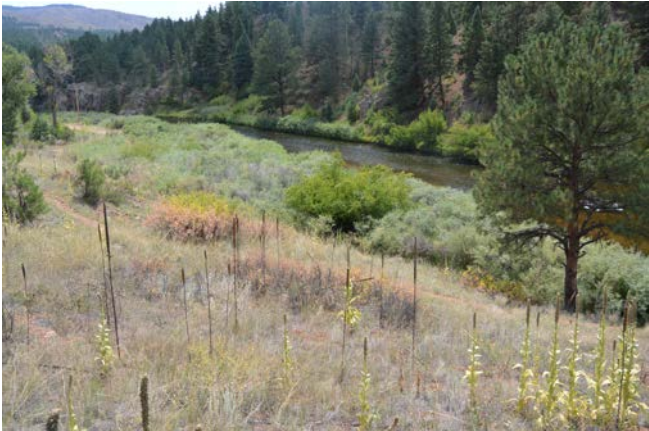
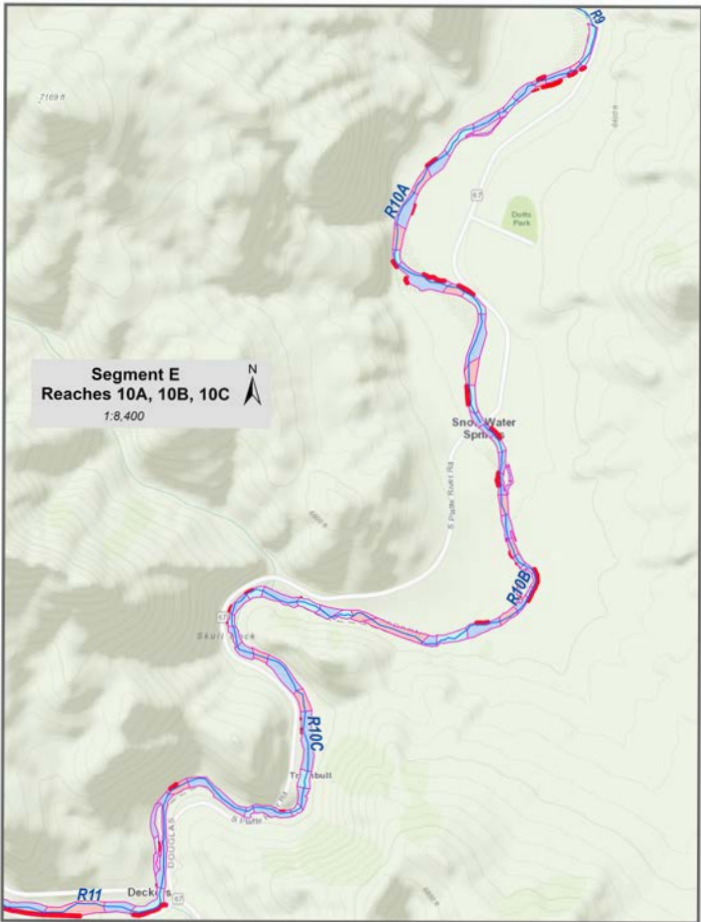
Reach 10

No data was collected prior to our project on Reach 10, which runs from Deckers to the upper boundary with Swayback Ranch. As with other areas in this segment, social trails are causing bank erosion. 10B has been impacted by drainage from the Hayman fire.

RECOMMENDATION: Work on reducing socail trails, and continue installing fisherman stairs.

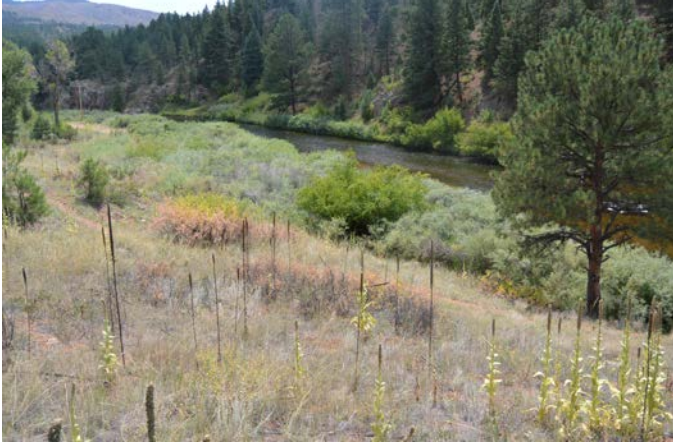
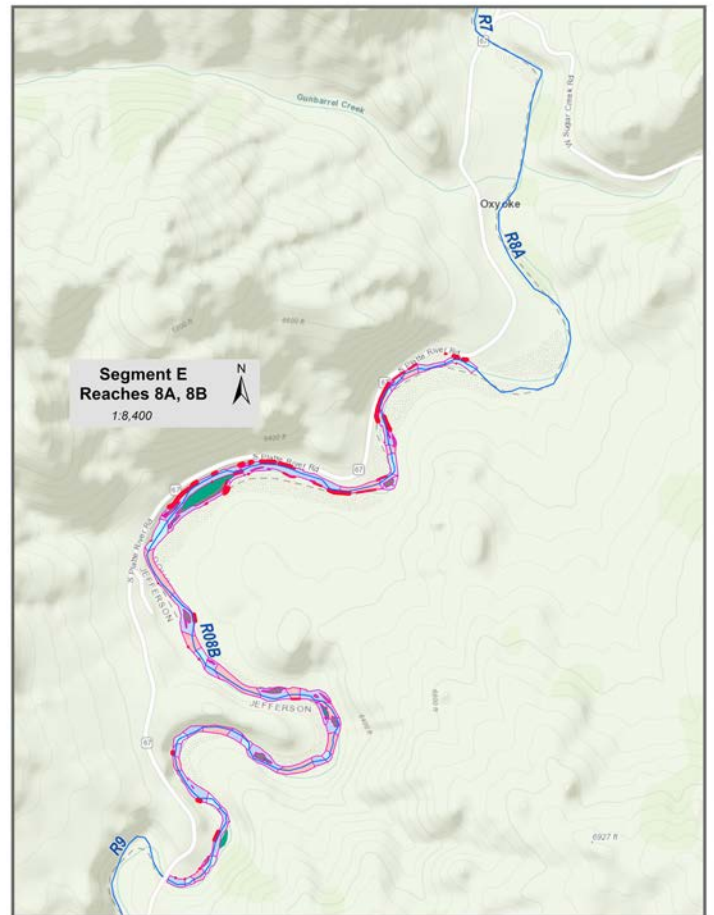
Reach 8 runs from the bottom of Swayback to private lands at Oxyoke. The road is the primary contributor to sedimentation, followed by social trails and access points.

RECOMMENDATION: Work on reducing social trails, and continue installing fisherman stairs. Work with CDOT to improve road maintenance.

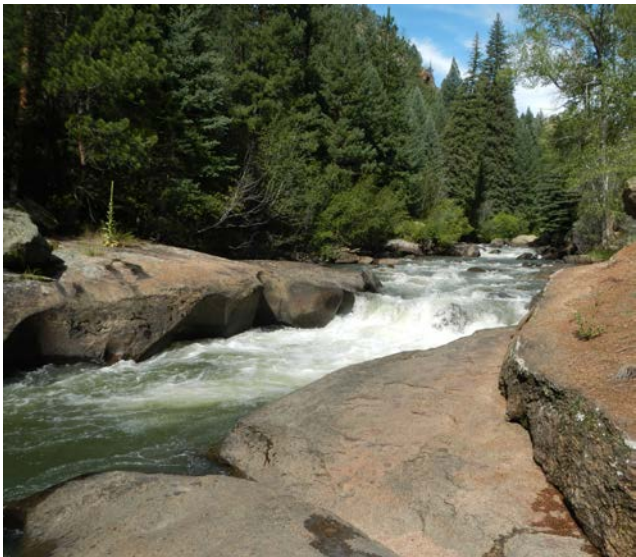
Reach 14 is representative of much of the North Fork. Data was collected in two series, 14a, and 14 b. As seen in the photo below, much of the North Fork is a constrained in narrow and rocky channels, which helps the river to remain stable.
