EXHIBIT 12

FLOYD PHOTO COMPARISON MAY 31, 2019 VERSUS JUNE 29, 2015 NORTH CAROLINA HEADWATERS OF THE CHATTOOGA RIVER

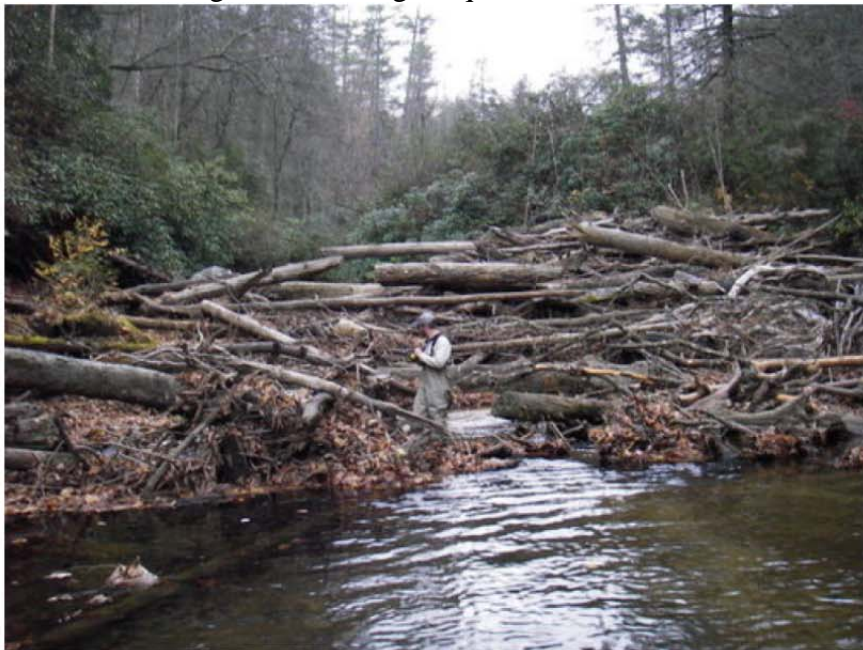
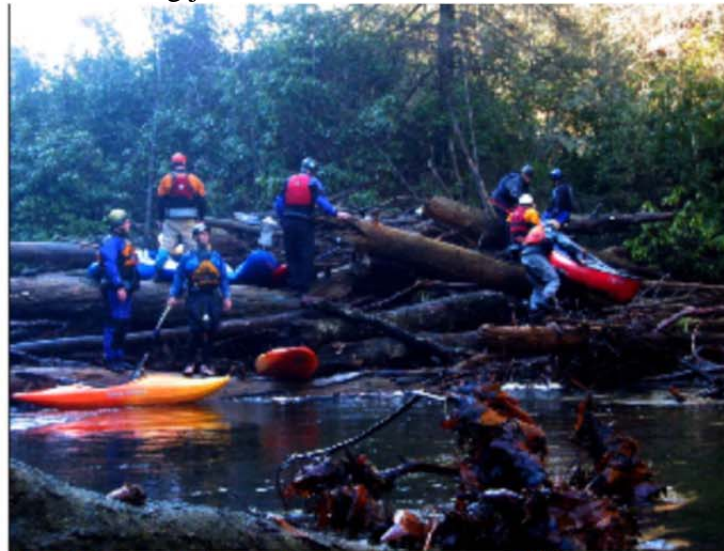
Figure 5. Boaters portaging around log jam within Chattooga Cliffs Reach.
(Photo provided by Todd Corey.)

The photo on the left is copied from Figure 2. Large Wood jam on the upper Chattooga River, North Carolina, November 2007, as published in the *Executive Summary: Large Wood in the Upper Chattooga River Watershed November 2007*, USFS Southern Research Station, C.Andrew Dolloff, Team Leader at page 4 (otherwise requested to be placed into the administrative record being compiled during the rewrite of the Land Resource Management Plan (“LRMP”) for the Nantahala National Forest as Floyd document “N-15 Executive Summary USFS LWD count Upper Chattooga Nov2007”). This 2007 study of this logjam admitted: “Wood in this jam was in various states of decay and disintegration, suggesting that it had accumulated over many years. *This jam is unique; jams of this size are unusual in the southeastern US, where as a result of past human activities most streams carry small loads of LW.*” Id. at page 4 (italics added). The photo on the right was taken in January 2007 in connection with whitewater

paddlers being allowed to paddle these headwaters as part of a visitor capacity study. This paddler field outing took place when the water flow was low—as opposed to when the river is running at higher flows which whitewater enthusiasts prefer. The ease with which these paddlers appear to be scrambling over this log jam at low water is unlikely to be achieved when the water is flowing at much higher volumes. At high water flows, paddlers would find portaging over this large log jam difficult. The above photo on the right was first published in the *Expert Panel Field Assessment Report, Phase 1 Data Collection, Upper Chattooga River*, Louis Berger Group for the United States Forest Service, Appendix C at page C-3. Both photographs constitute close-ups of this log jam. Neither photograph provides a distant or wide angle view of the log jam or of the sediments being impounded upstream of this log jam

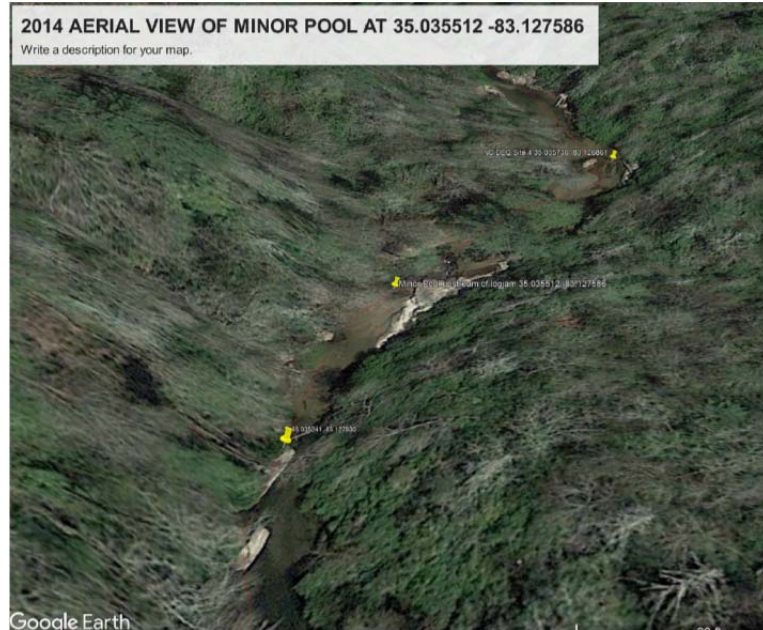
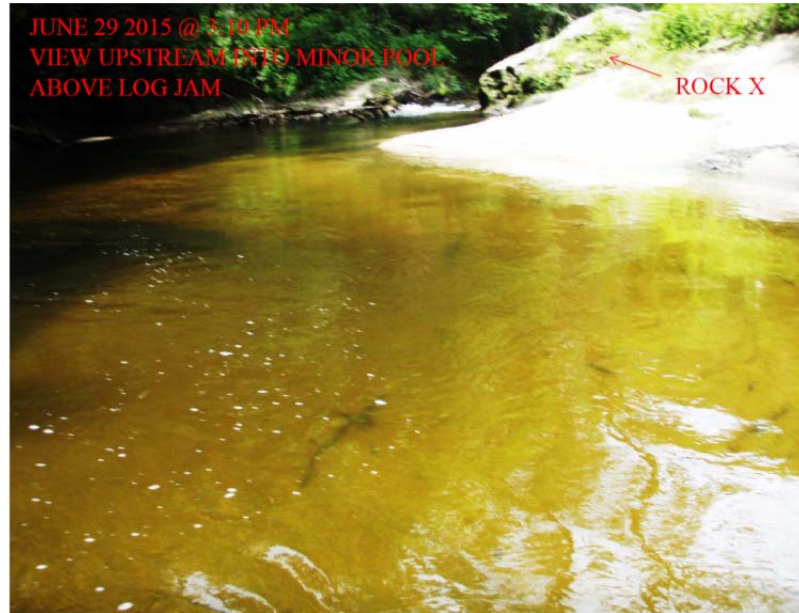
JUNE 29 2015

The following photos compare the deteriorating condition of a minor pool which once contained trout but which has now been severely degraded as suitable trout habitat because of excessive bedded sediments.

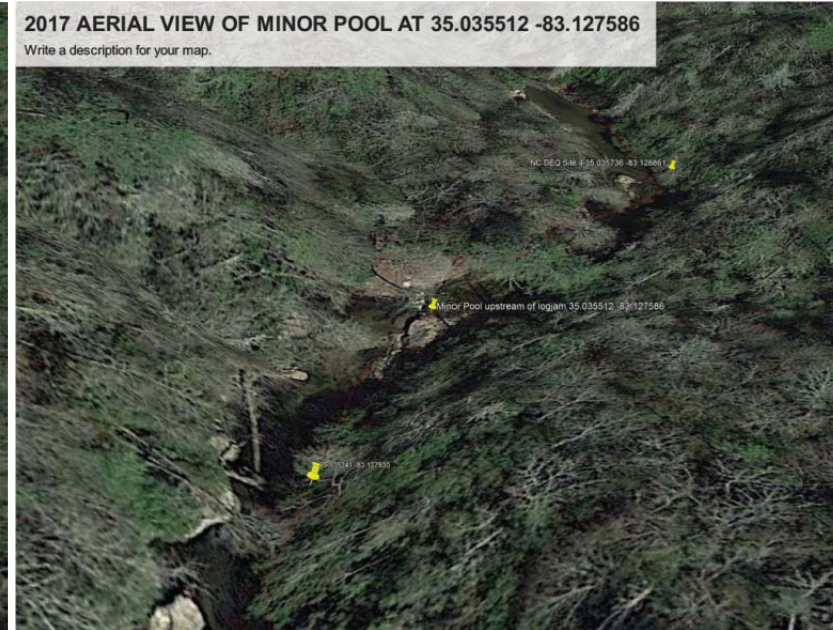
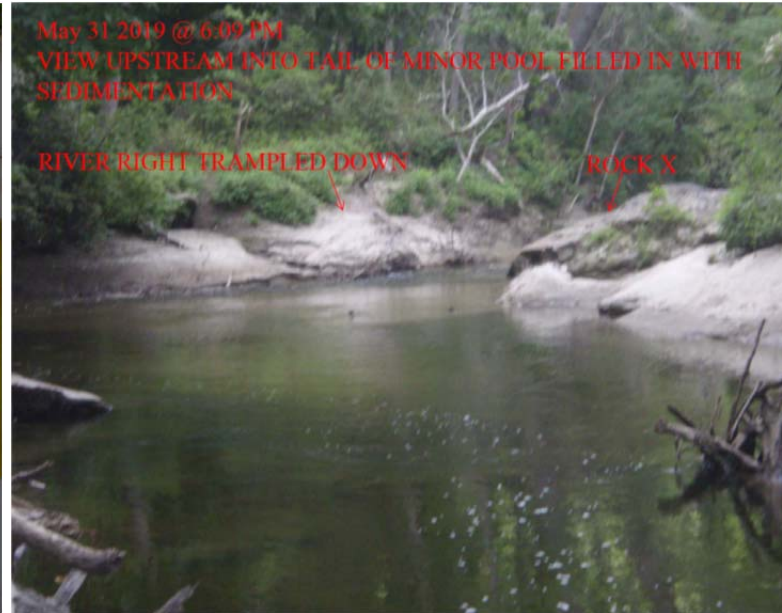
MAY 31 2019

NO IMPROVEMENT IN SEDIMENT CONDITION COMPARED TO
JUNE 29 2015 CONDITIONS: COARSE STREAM BED SUBSTRATES
NOW BLANKETED WITH FINE SANDS

These photos (taken at the same minor pool after the passage of four years of time) demonstrate (1) the non-temporary nature of the excessive bedded sediment problem being suffered on North Carolina's headwaters, and (2) how the normal sediment transport capacity of these headwaters is insufficient for alleviating this excessive bedded sediment condition over a short enough period of time.
