EXHIBIT 36

The compilation of photographs set forth below illustrate the excessive embedded sediment conditions being suffered on an extended reach (approximately 2 miles) of a stream that simultaneously carries Class B, Trout, Outstanding Resource Waters (“ORW”) water quality classifications plus a National Wild and Scenic River designation. This stream is 1 of 3 out of 12,000 bodies of water that have this status. The *specific reason* why this stream was classified ORW in 1989 was to provide for the highest intensity of the Clean Water Act’s antidegradation protection for the stream’s *then* “outstanding” trout habitat and its “outstanding” wild rainbow, brook, and brown trout fisheries—a *much narrower designated use of ORW water quality than the broader aquatic life use*. So far, efforts to have this problem recognized by the responsible federal and state agencies have not succeeded. These agencies have not yet agreed to use the *best available science* (peer reviewed)¹ for recognizing how the amount of embedded sediment shown below exceeds any reasonable minimum effects threshold for disrupting the reproductive and early life cycle needs of trout—in violation of the Clean Wa

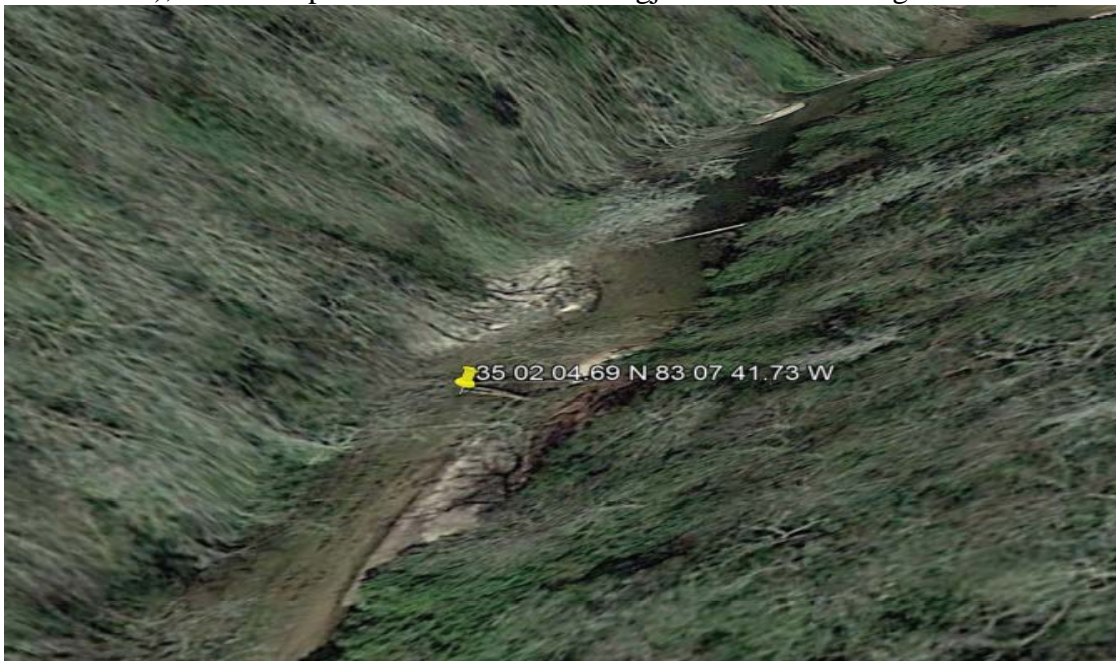
These upstream photos were taken June 29, 2015 at 35.034636, -83.128258 (35 02 04.69 N, 83 07 41.73 W), 350 feet upstream of the massive logjam. Here is a Google Earth aerial view.

The stream bed is embedded by a foot of sandy sediment which is bank to bank.

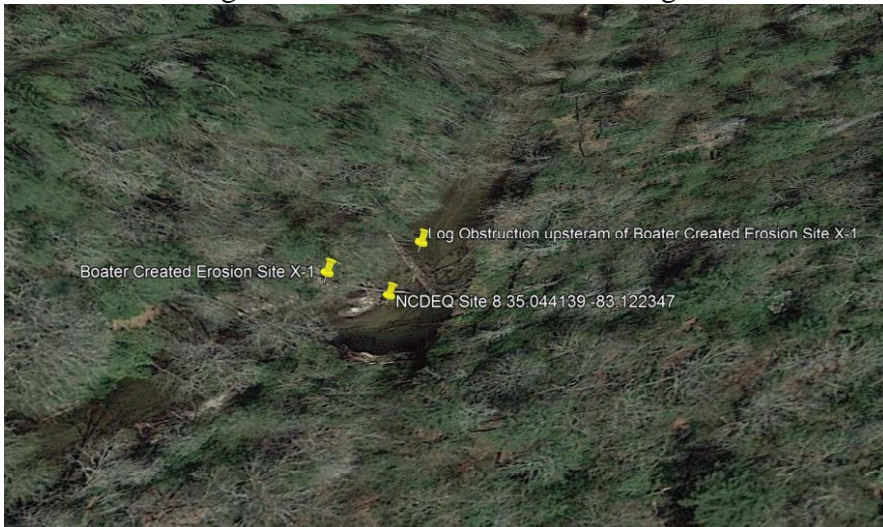
See below a Google Earth Pro aerial view of this log obstruction shown above.

As the photos evidence, sediment is impounding in visibly excessive quantities at this location.

In addition, the presence of this stream-wide log constitutes a potentially life threatening obstruction to whitewater creek boaters. Paddlers must portage around this obstruction. This need to portage around this obstacle resulted in the creation of Boater Created Erosion Site X-1 on the river right bank. Boater Created Erosion Site X-1 now constitutes a chronic point source of sediment discharge into this ORW stream.

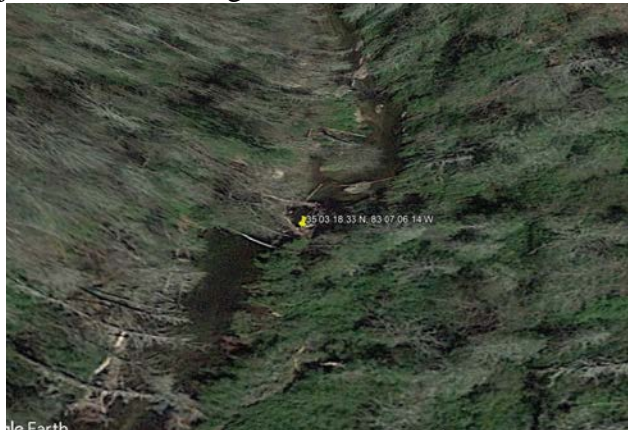
See below the downstream view of minor logjam #2 and a Google Earth Pro aerial.
