EXHIBIT 37

THE EVIDENCE OF EXCESSIVE EMBEDDED SEDIMENT AND SURFACE EXPOSED FINE SEDIMENT

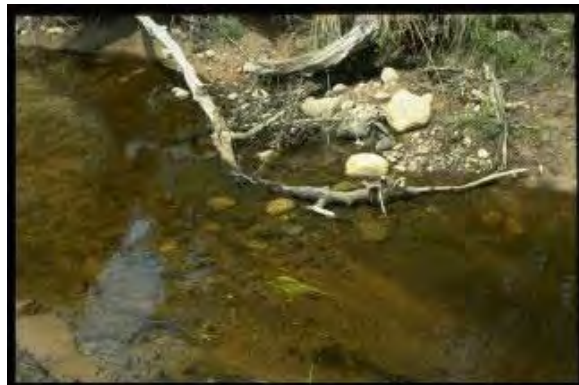
Poor Range (William Taft, MI DNR)

Applying the EPA’s Rapid Bioassessment Protocol, these riffle waters on the Chattooga ought to be assigned a “Poor” habitat condition score. Unfortunately, these two examples of “Poor” condition riffle waters are *typical* of conditions observed up and down this segment of the Chattooga.

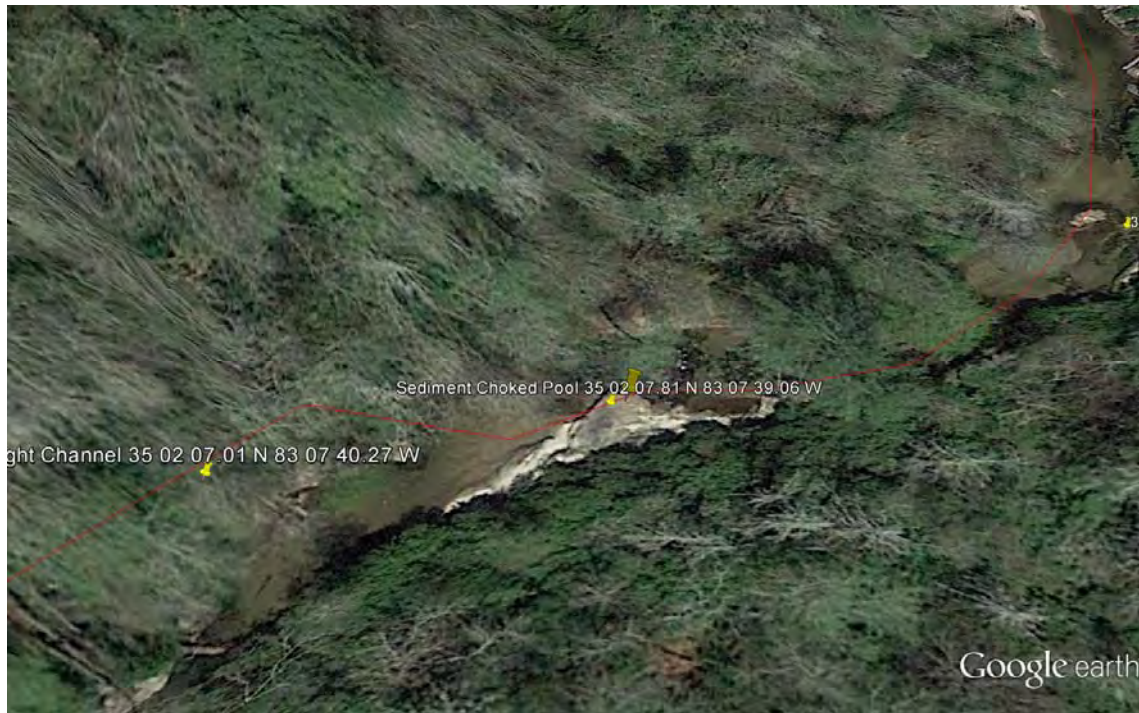
Source: Imagery Date 4/25/2014 (NASA)

Floyd photos @ June 29, 2015. View is upstream. This used to be a *beautiful little* pool where trout were abundantly present @ approximately 35° 02' 07.81" N 83° 07' 39.66" W. This is no longer the case. See the aerial above.

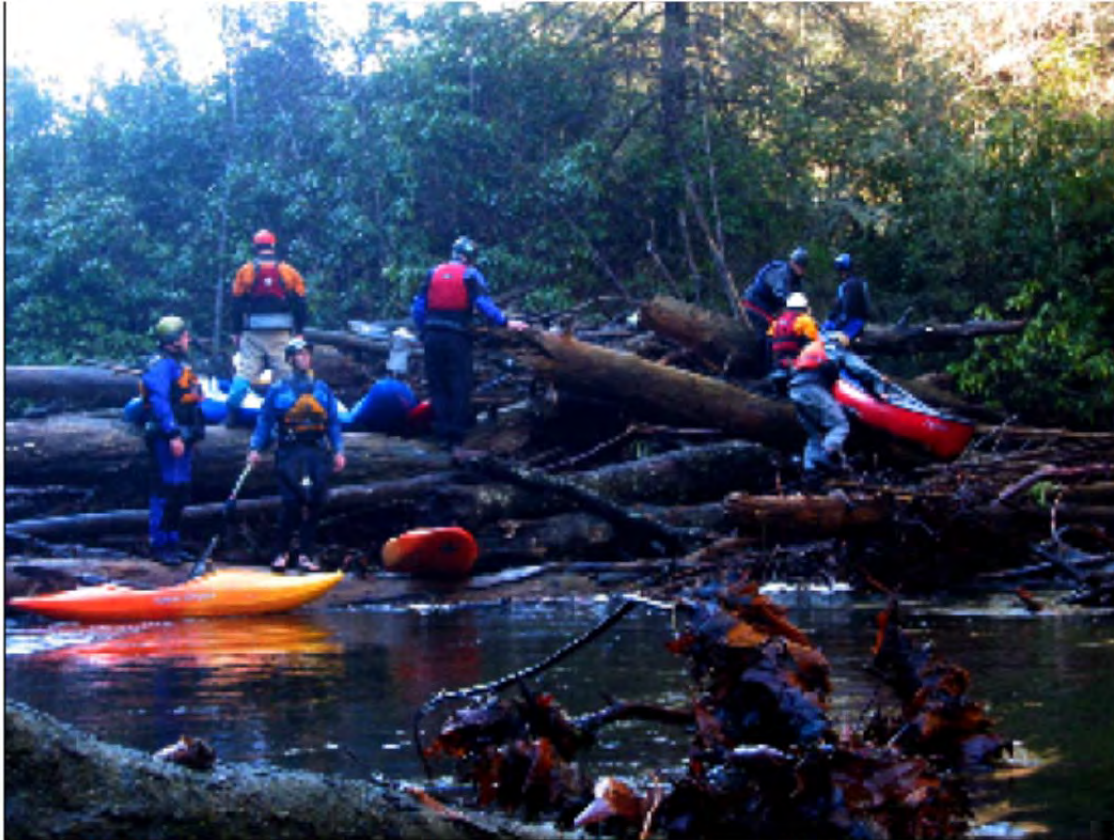
Figure 5. Boaters portaging around log jam within Chattooga Cliffs Reach.
(Photo provided by Todd Corey.)

In spite of the stated intentions to document the field assessment, only a single photograph of this logjam was included in the 2007 Expert Boater Report. This photo is remarkable for what it did not reveal. *The photograph did not disclose any degraded physical condition in front of this logjam.* Here are two photographs that fill that void.
