A REPORT BY WILD VIRGINIA

FEBRUARY 2023

MOUNTAIN VALLEY PIPELINE POLLUTION IN VIRGINIA WATERSHEDS

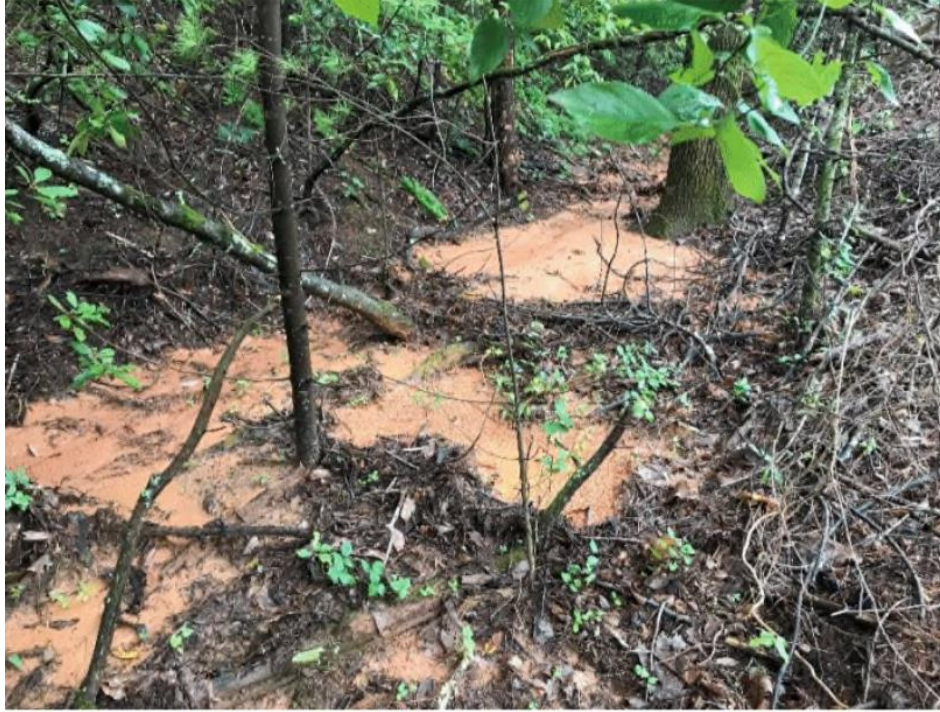
Figure 1 - Sediment deposits in UT to Blackwater River, August 1, 2018, DEQ Inspection, Spread I, Source: DEQ [report says "sediment appears to have been removed from stream" on Aug. 15, 2018]

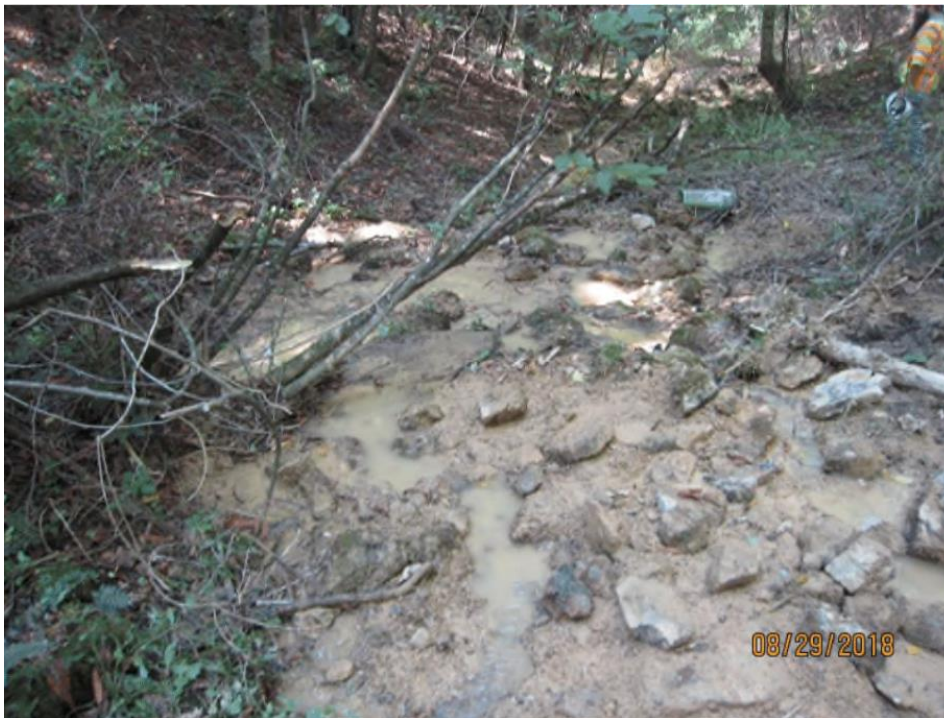
Figure 2 - Sediment deposited in UT to Sinking Creek, August 29, 2018, DEQ VWP inspection, Source: DEQ [notes that sediment shown approx., 300 ft. downstream from ROW]

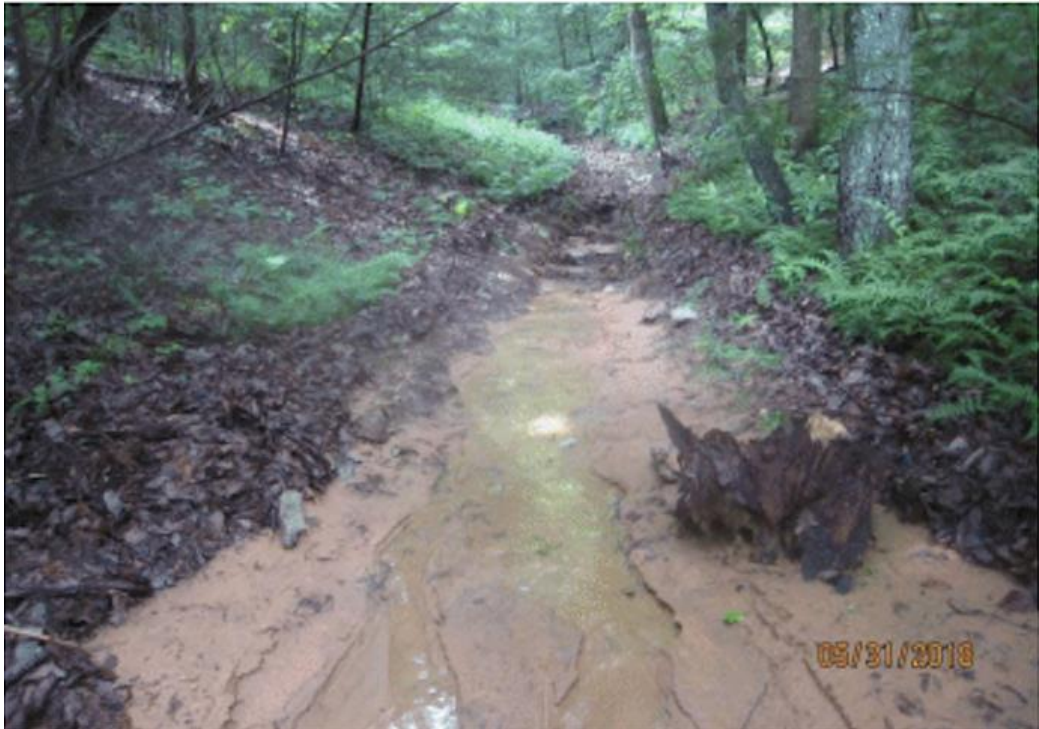
Figure 8 - Sediment deposited in UT to Blackwater River, May 31, 2018, DEQ VWP inspection rpt. [sediment in streambed approx. 1,690 linear feet of stream impacted with deposits up to 5 inches deep; impacted area approx. 685 feet from ROW]

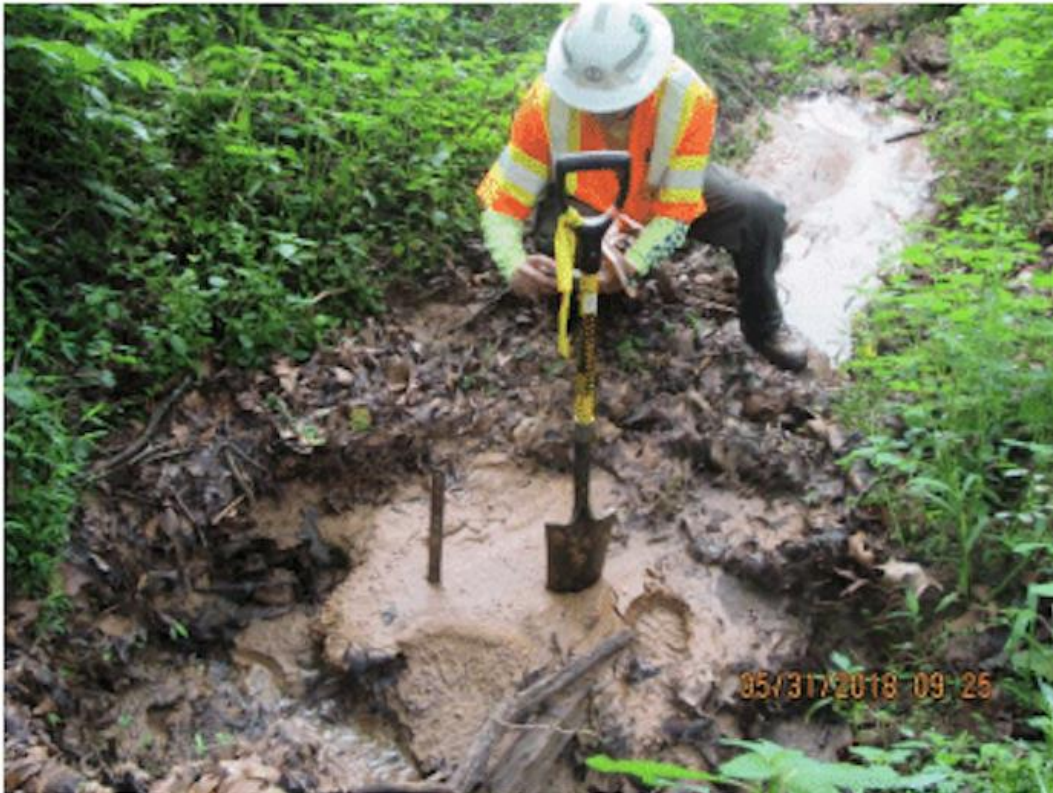
Figure 9 - Sediment deposited in UT to Blackwater River, May 31, 2018, DEQ VWP inspection report, Source: DEQ [sediment covered approx. 1,110 linear feet of streambed, up to 7 inches deep]

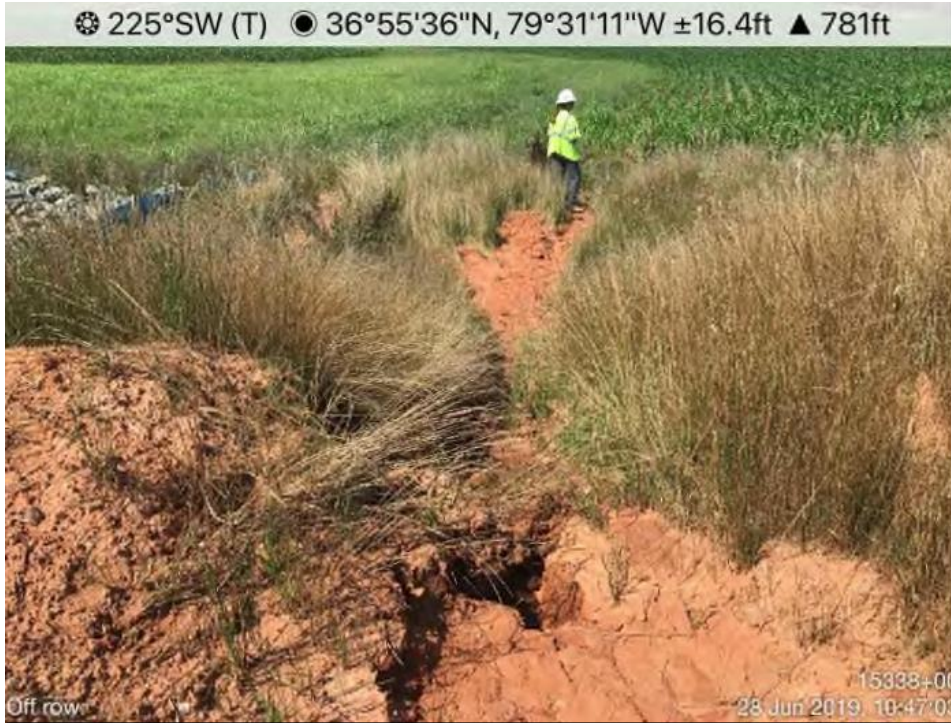
Figure 10 - Sediment deposits off ROW onto a farm field, near UT to Harpen Creek, June 28, 2019, DEQ Inspec. Rpt. Spread I, Source: DEQ

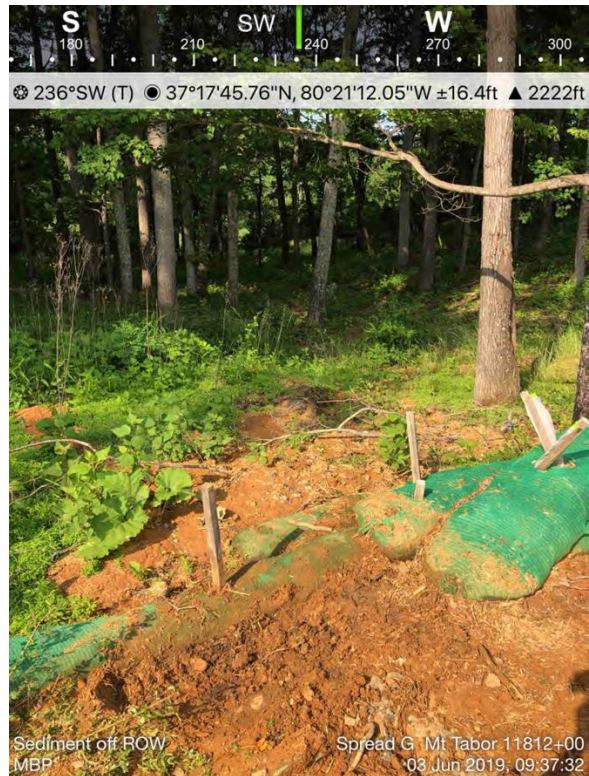
Figure 11 - Sediment deposited off ROW, June 3, 2019, Action Item ID 2844, near Dry Run, Source: MBP

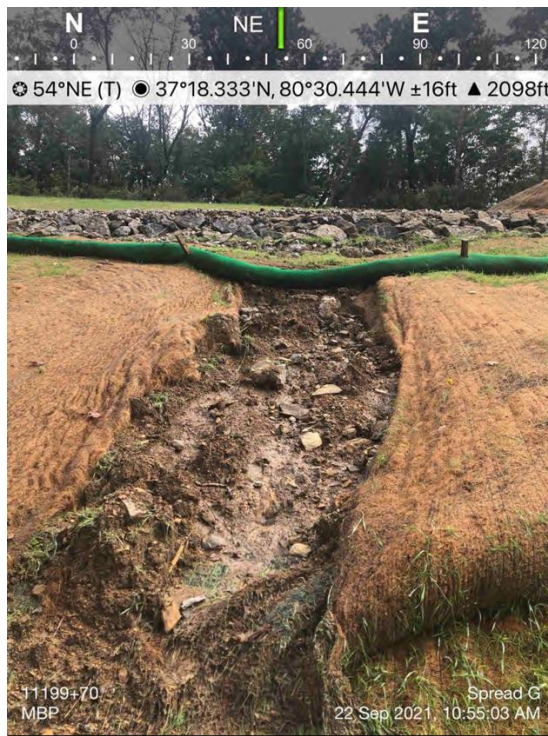
Figure 24 - Compost filter sock undermined near Sinking Creek, September 22, 2021, Action Log ID 5196, Source: MBP

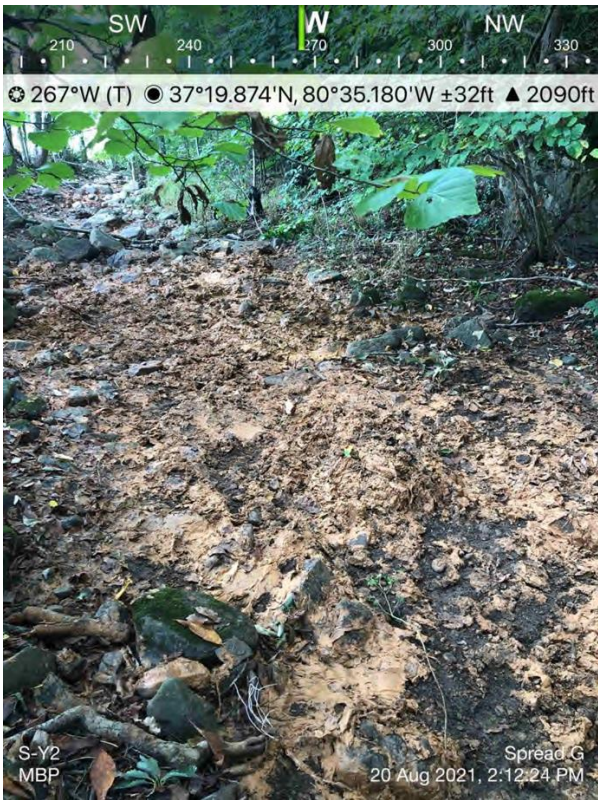
Figure 27 - Sediment deposited off MVP ROW near Doe Creek, August 18, 2021, Action Log ID 5068, Source: MBP

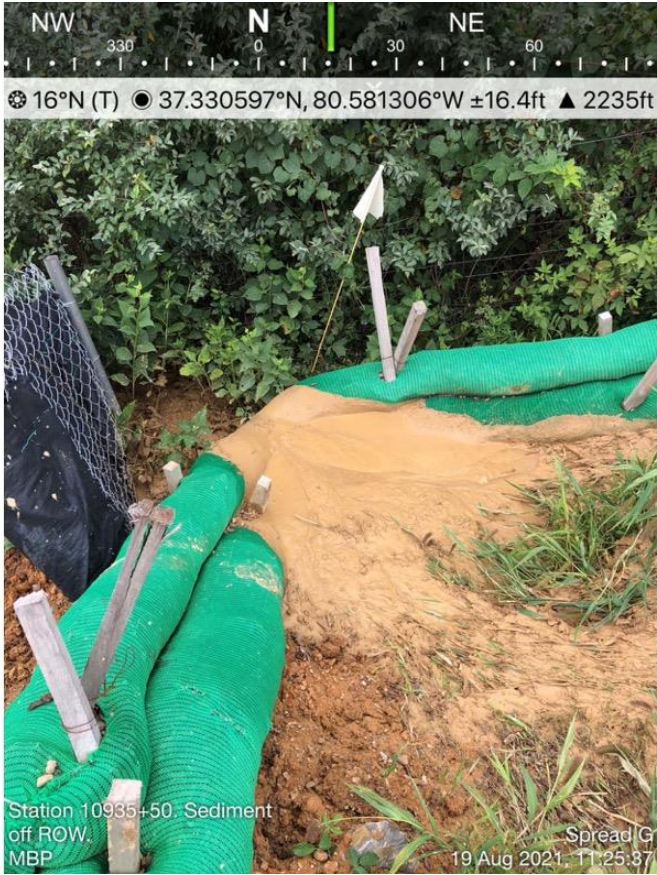
Figure 30 - Sediment overflowing compost filter socks, deposited off MVP ROW near UT to Doe Creek, August 19, 2021, Action Log ID 5081, Source: MBP

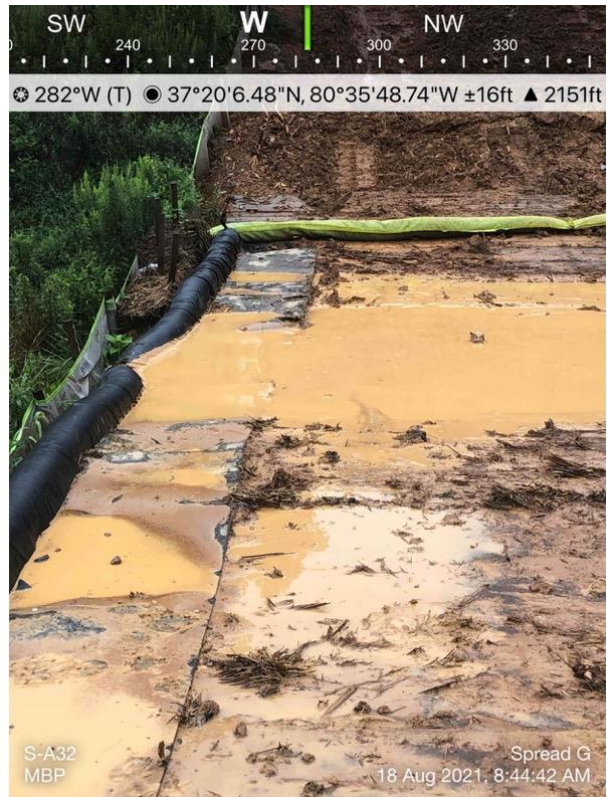
Figure 31 - Sediment deposited in UT to Doe Creek, August 18, 2021, Action Log ID 5065, Source: MBP

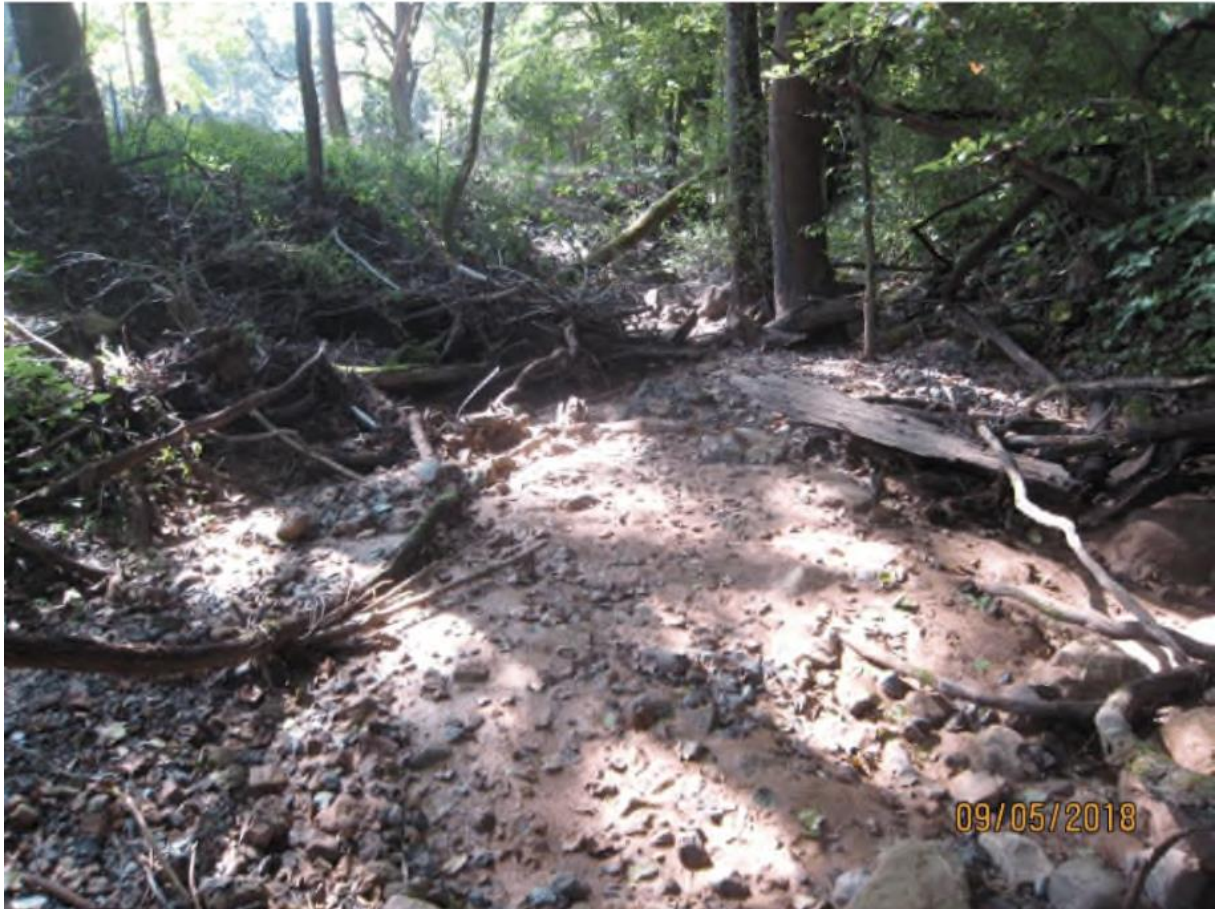
Figure 34 - Sediment deposited in Kimballton Branch, September 5, 2018, VWP inspection report, Spread G, Source: DEQ [Approx. 630 linear feet of Kimballton Branch stream channel impacted by sedimentation. Deposits up to 9 inches depth. Report indicates that aquatic life movement substantially disrupted.]

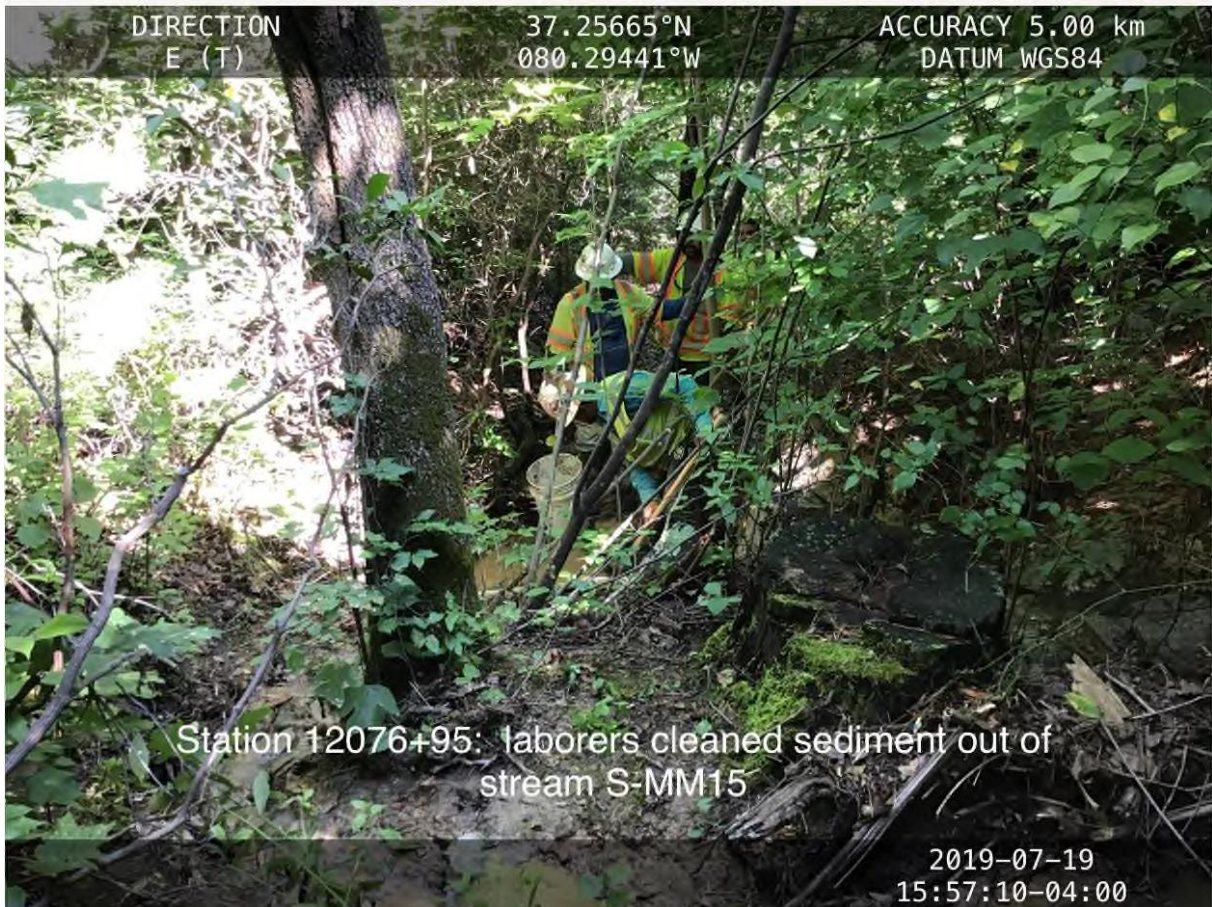
Sediment in UT Flatwoods Branch. Sediment "retrieved" seven days later, after a delay in getting landowner agreement to access the area. (Action Item Log ID 3248). This is the same stream as was impacted in June and August of 2018. See Figure 38.

Figure 38 - Sediment deposited in UT Flatwoods Branch, July 19, 2019, Action Item Log ID 3248, Source: MBP [This is an example of what inspectors often term "remediation" through physical removal of sediments from the stream, using shovels and buckets.]

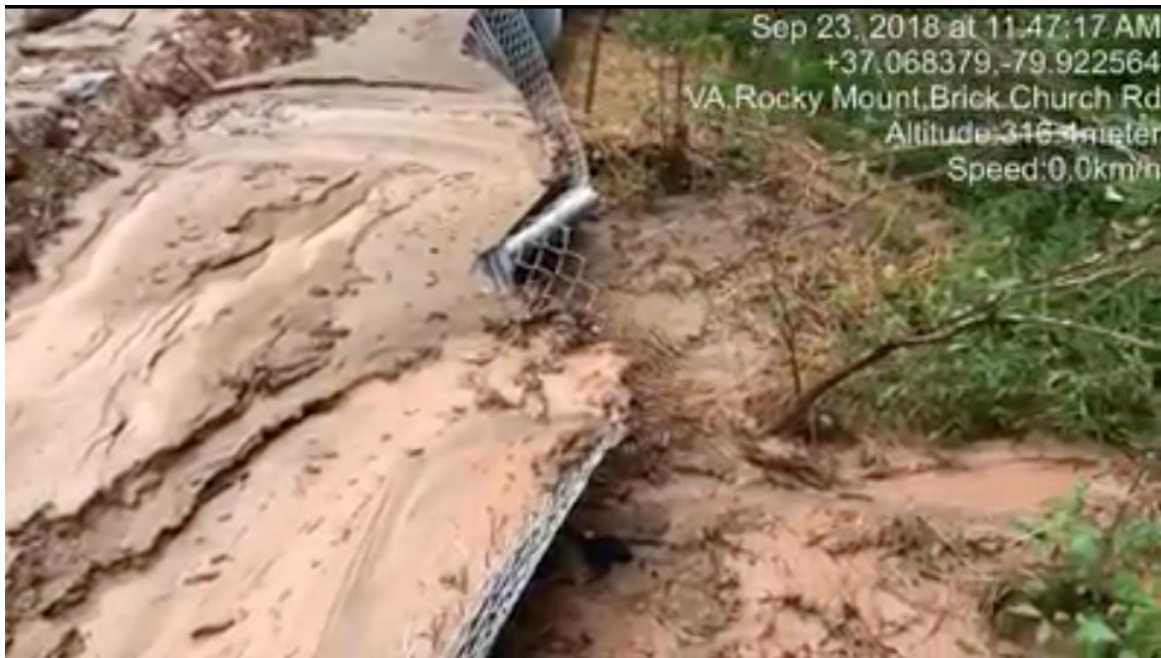
Figure 39 - Sediment deposits off ROW, at UT to Teels Creek, September 23, 2018, Source: citizen monitor

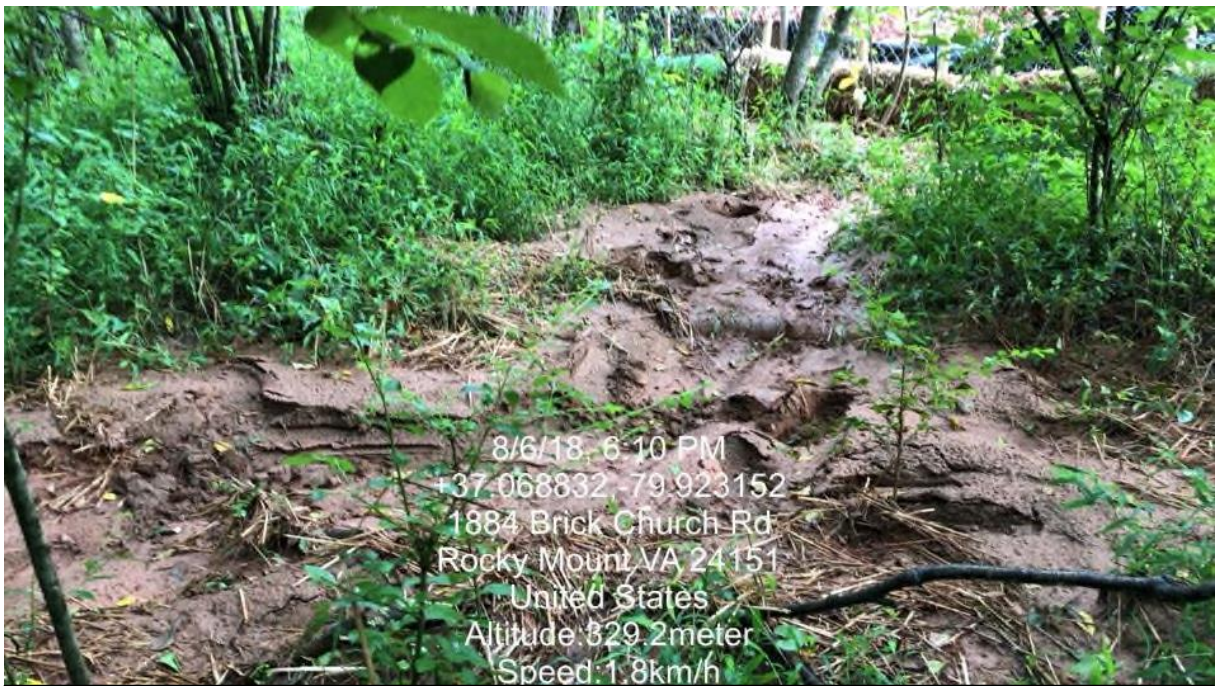
Figure 40 - Sediment deposits off ROW, at UT to Teels Creek, September 23, 2018, Source: citizen monitor

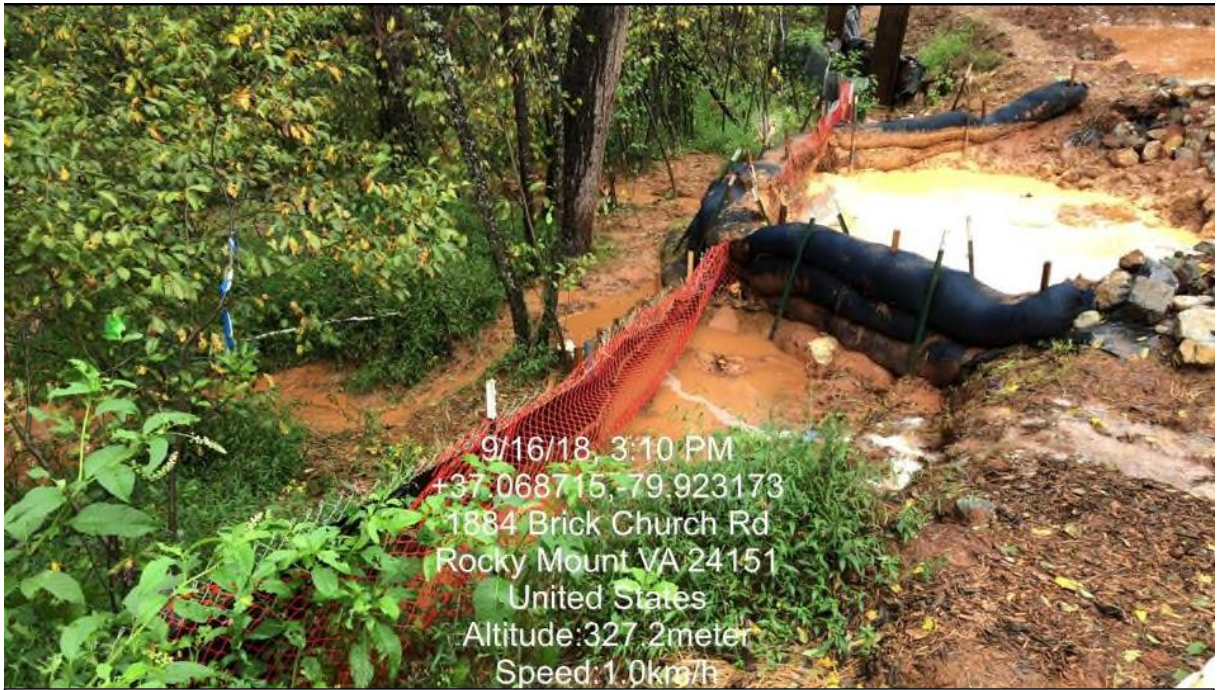
Figure 41 - Sediment deposits off ROW, at UT to Teels Creek, September 23, 2018, Source: citizen monitor.

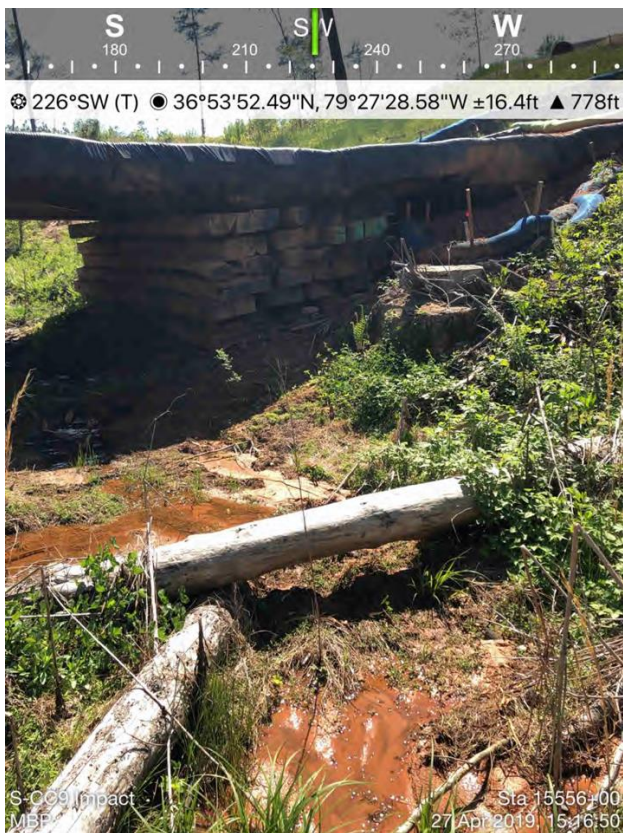
A number of pollution incidents have already been documented in the upper Cherrystone watershed, including those shown in Figures 48 and 49 below, from February and April of 2019. One particularly significant event is labeled Action Item Log ID 1547 and is described in the inspection reports as follows:

Figure 48 - Sediment deposited in UT to Cherrystone Creek, Action Item ID 2646, Source: MBP

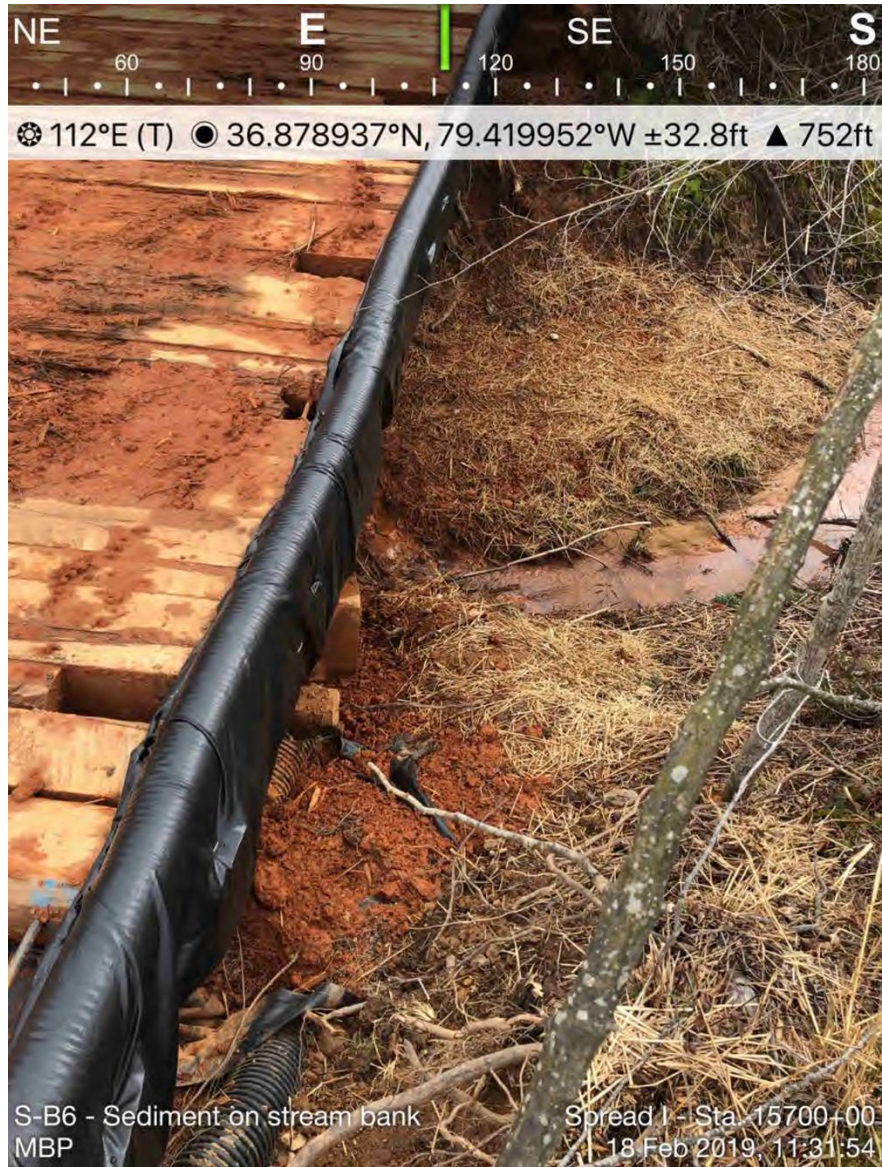
Figure 49 - Sediment deposited off ROW onto streambank at UT to Pole Bridge Branch, February 18, 2019, Action Log ID 1901, Source: MBP [deadline to remove extended "due to wet ROW," not removed until 6 days after deposited]

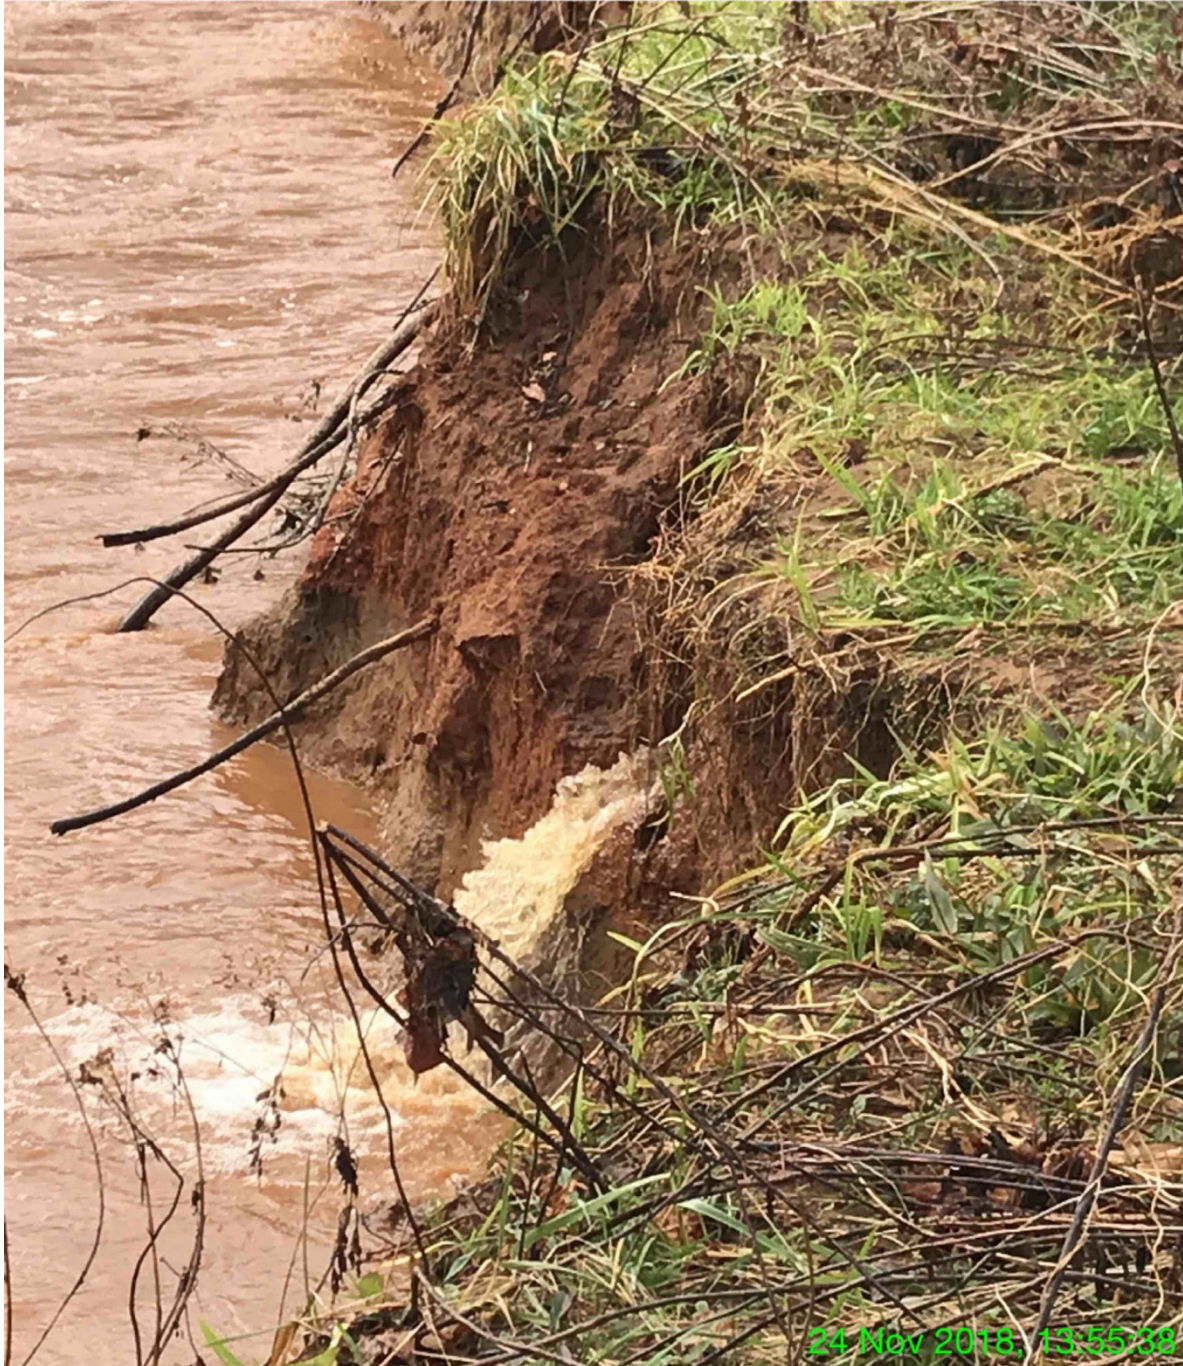
EXHIBIT A – Water gushing out of bank of Little Creek on Four Corners Farm, November 24, 2018. The gusher was discovered on November 15, 2018.

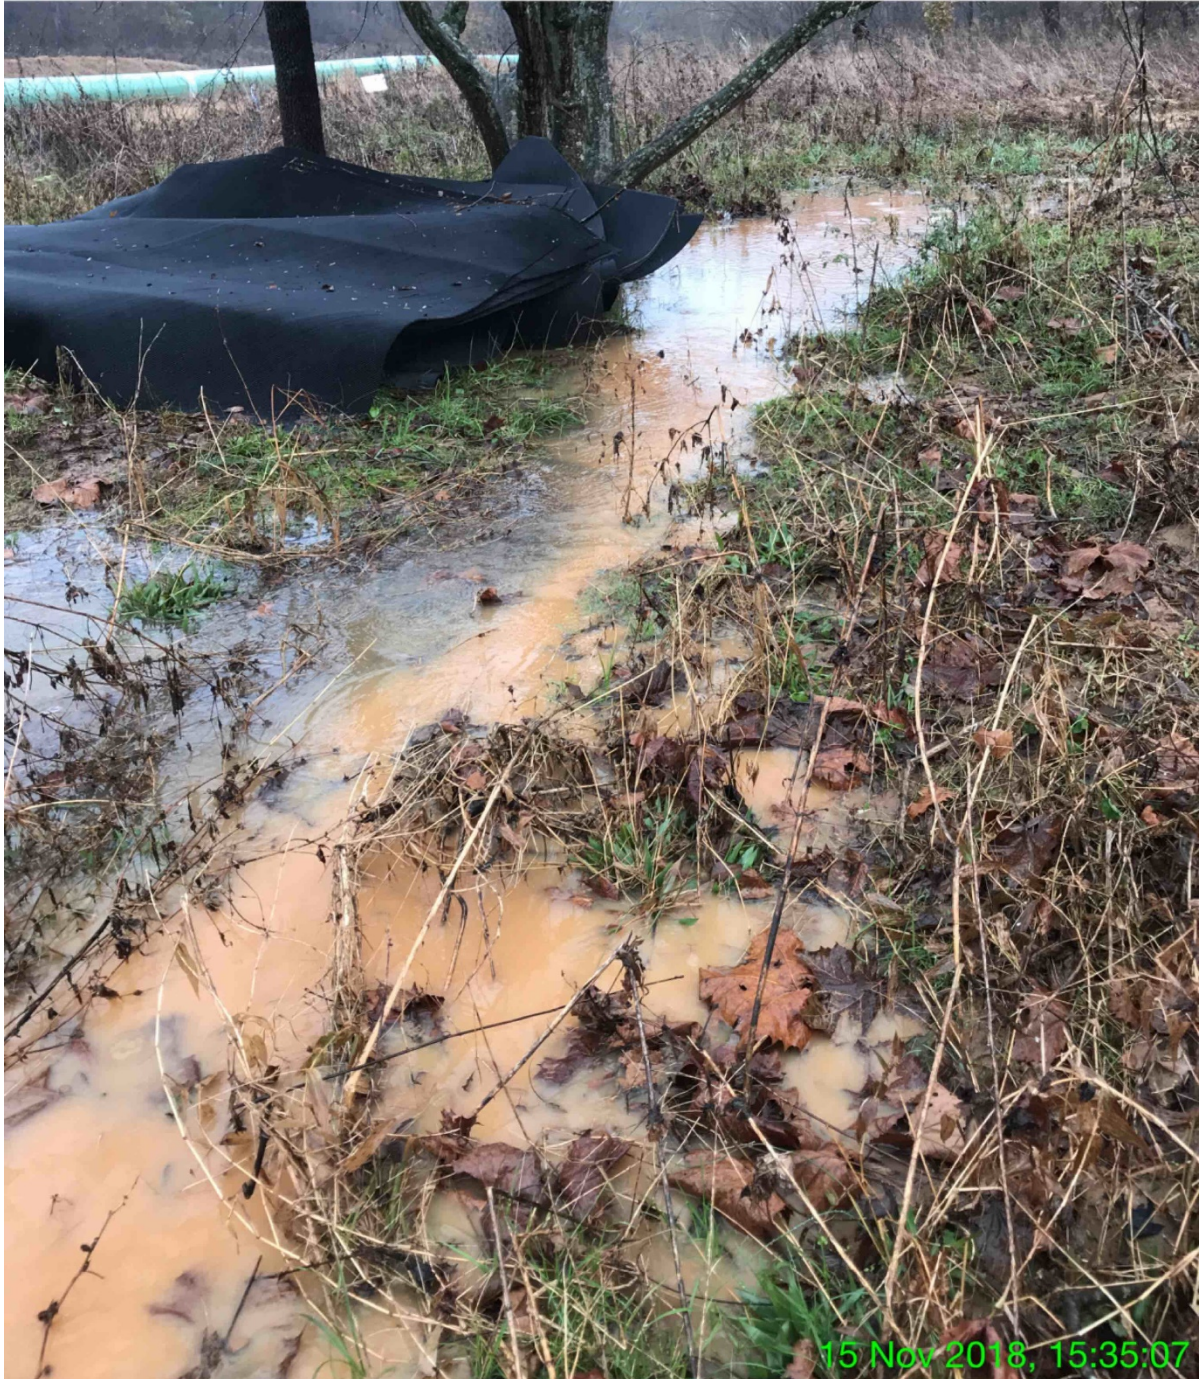
EXHIBIT B – Sediment-laden stormwater that was flowing out the gusher on the creek bank when the gusher was discovered on November 15, 2018. The black matting against the tree washed off the corridor and is a point of reference in these photos.

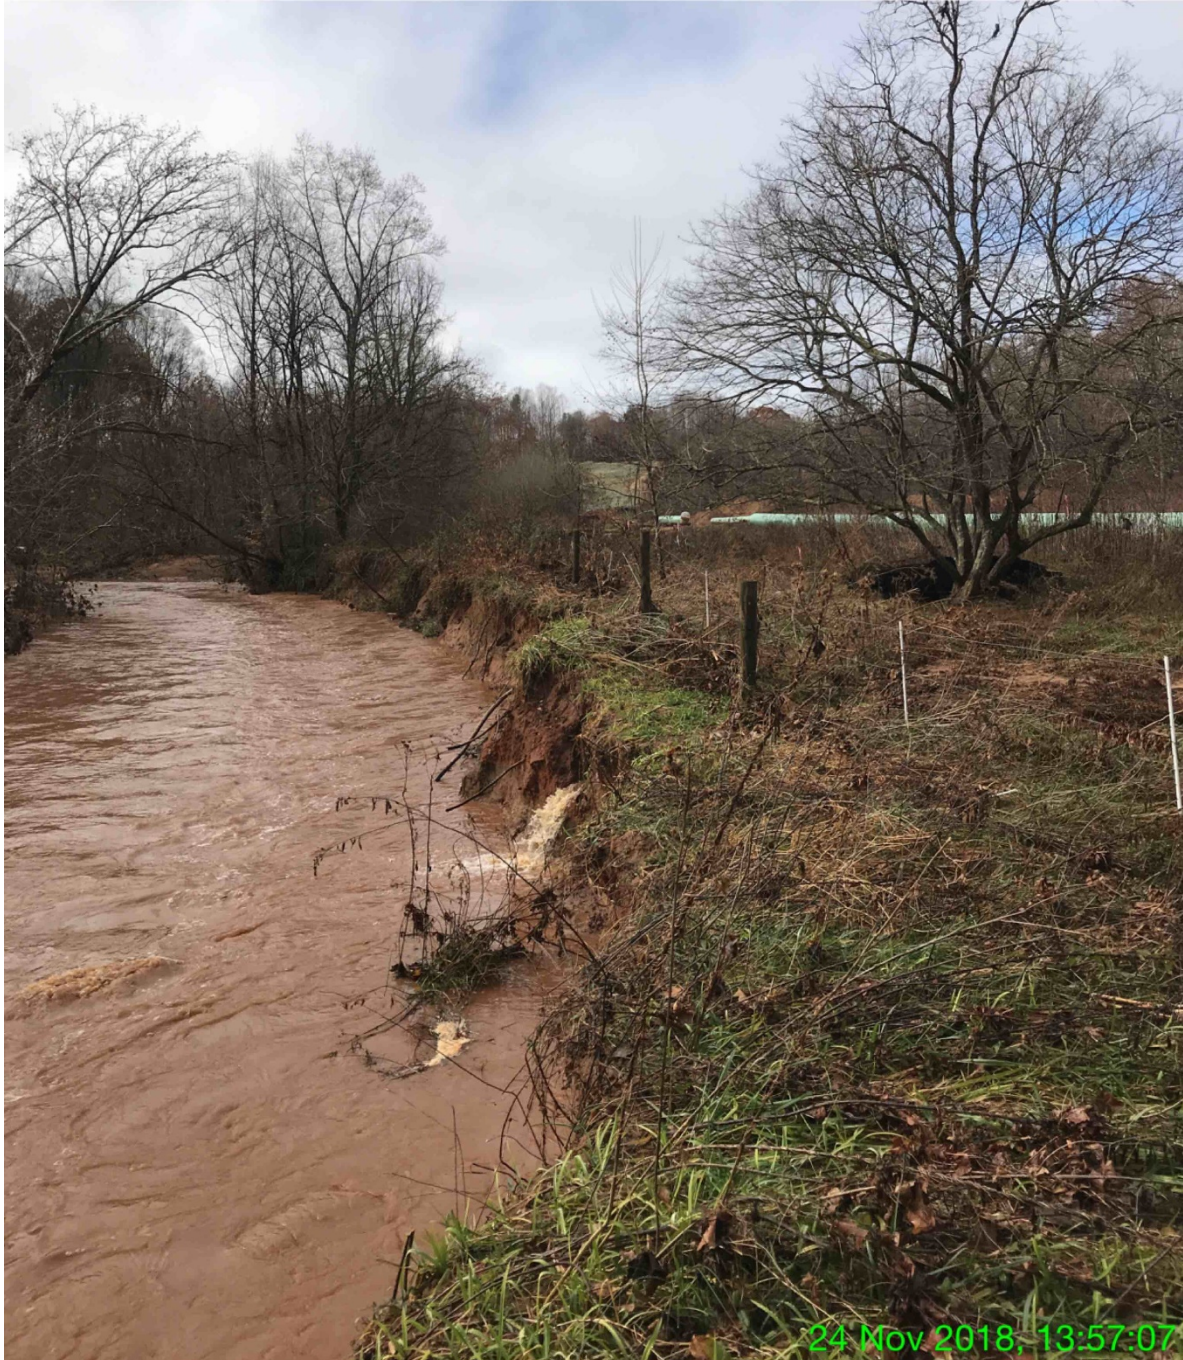
EXHIBIT C – Water gushing out of bank of Little Creek. Note the location of the cattle fence on the creek bank. Black matting against the tree and pipe on ground in background.

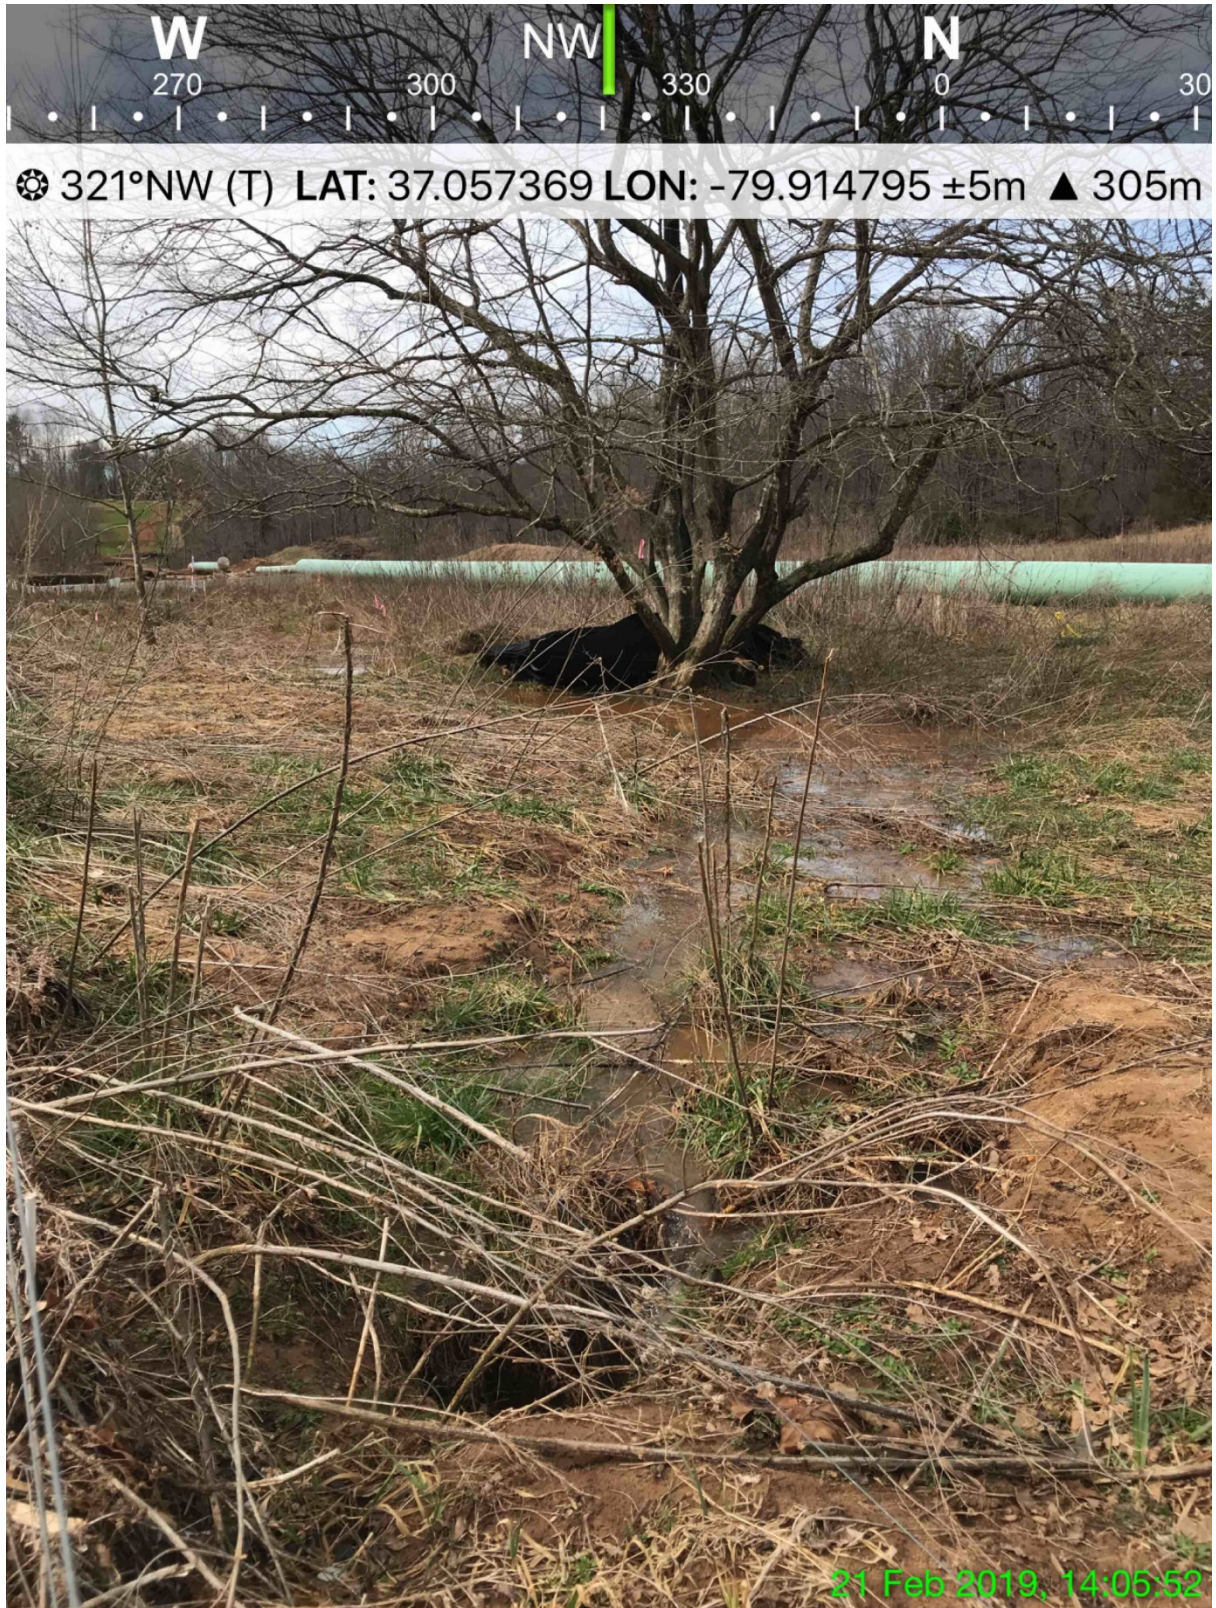
EXHIBIT D – Water flow from corridor toward Little Creek. The water that had been gushing from a hole is now eroding the creek bank.

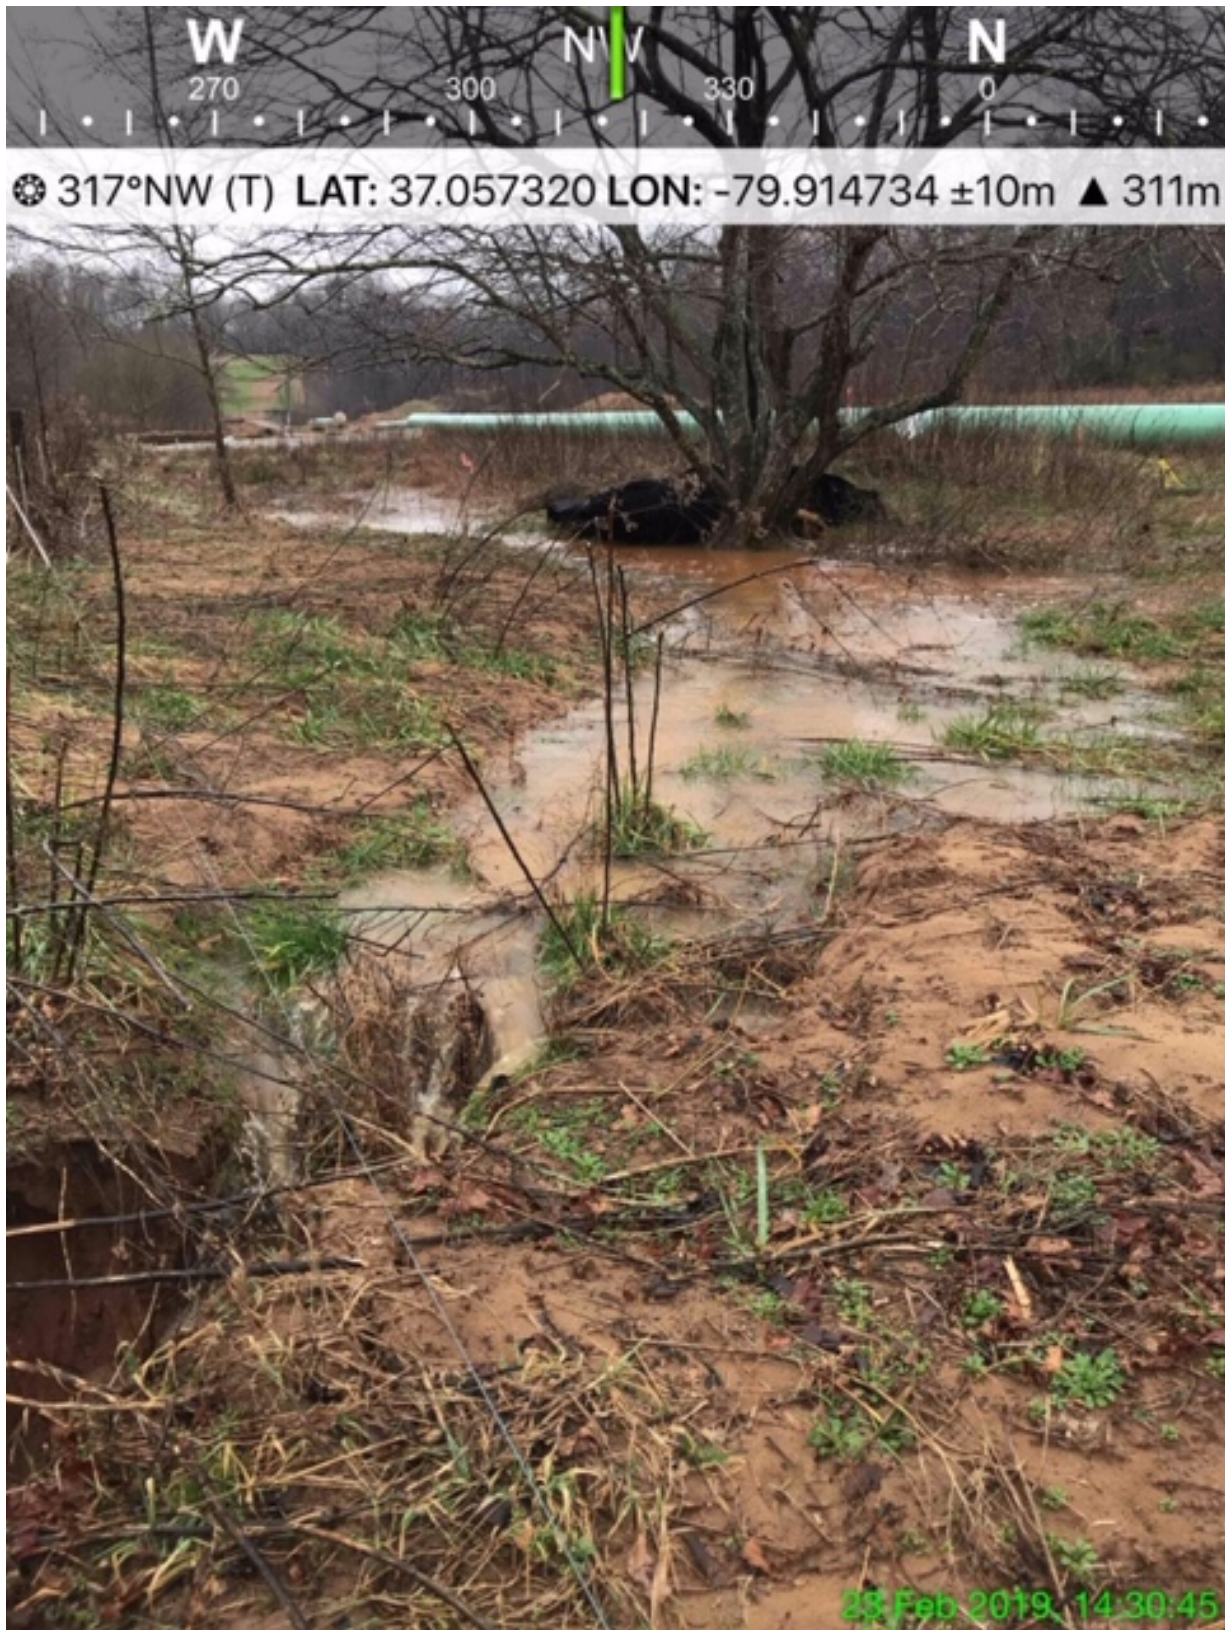
Exhibit E – Same location as in Exhibit D, two days later, after 2.5 inches of rain. The drainage into the creek is collapsing. The fence wire is visible on the left.
