A REPORT BY WILD VIRGINIA

FEBRUARY 2023

MOUNTAIN VALLEY PIPELINE POLLUTION IN VIRGINIA WATERSHEDS

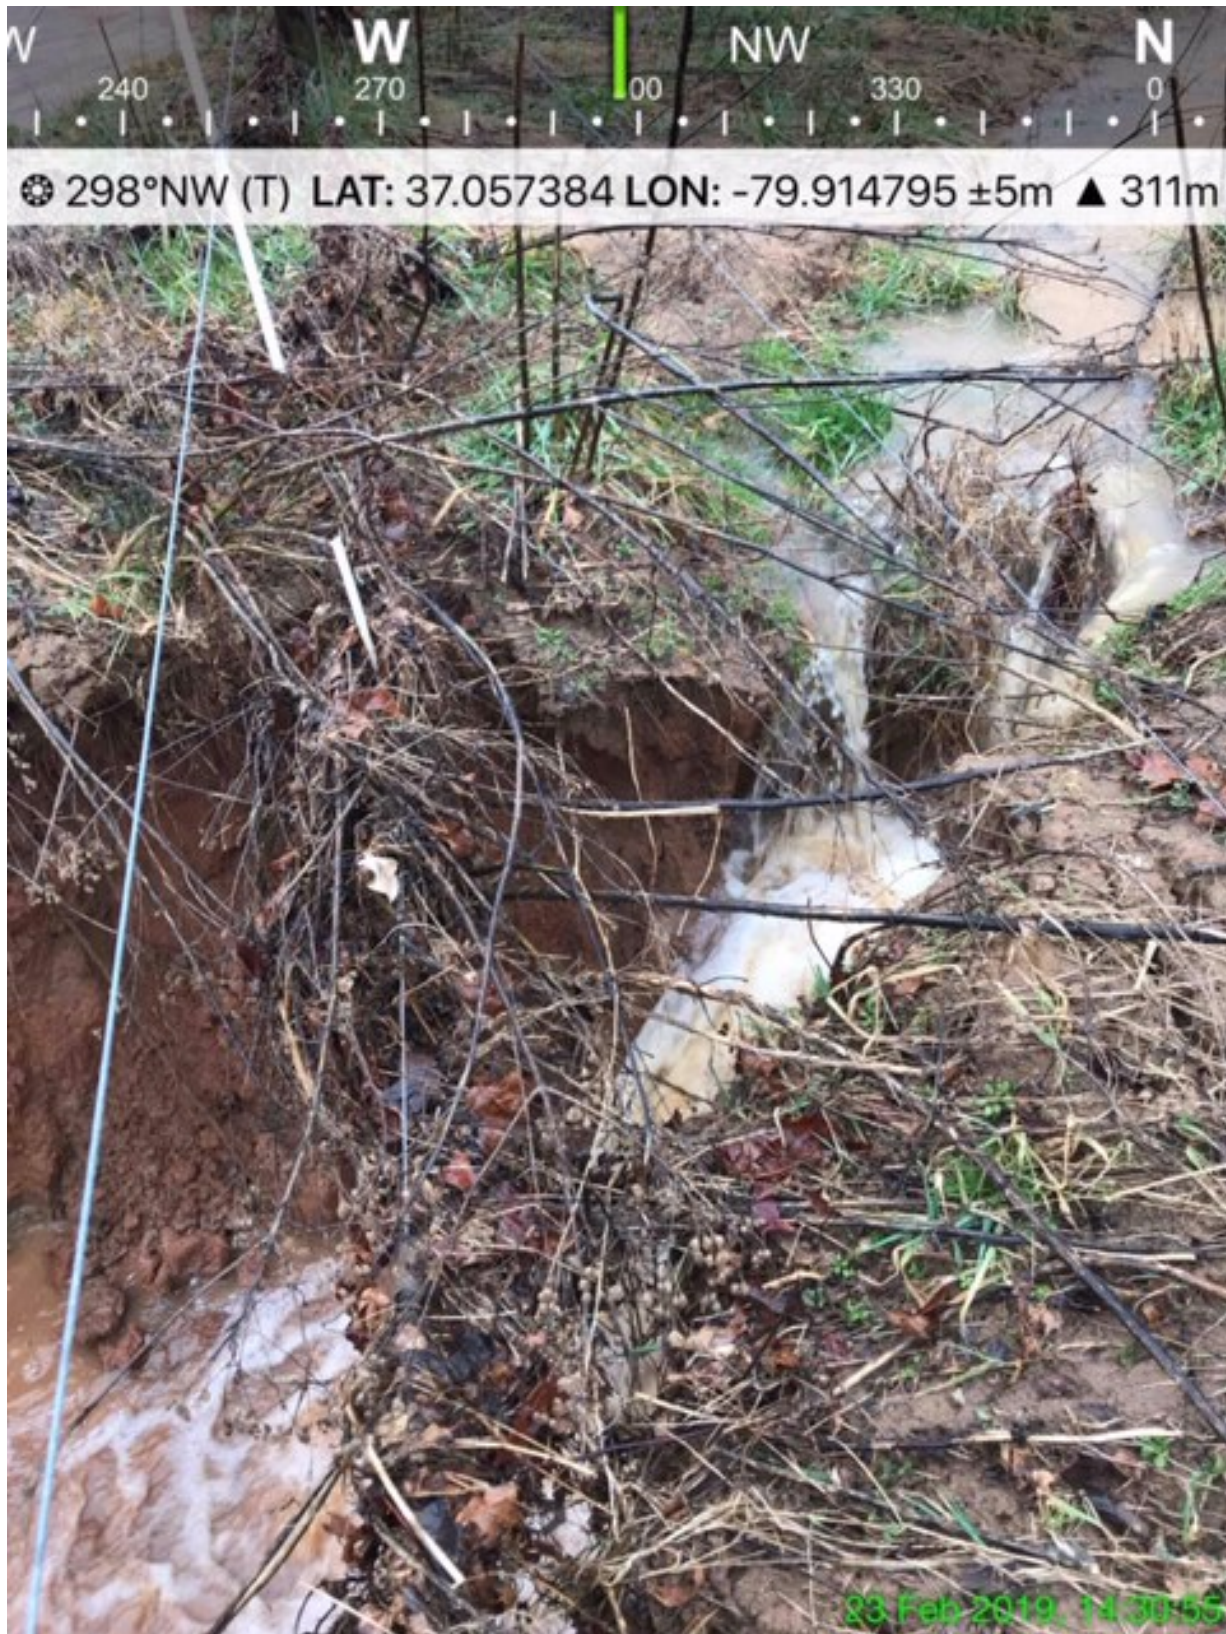
EXHIBIT F – A close-up view of the gusher eroding the creek bank on February 23, 2019. Notice the fence wire.

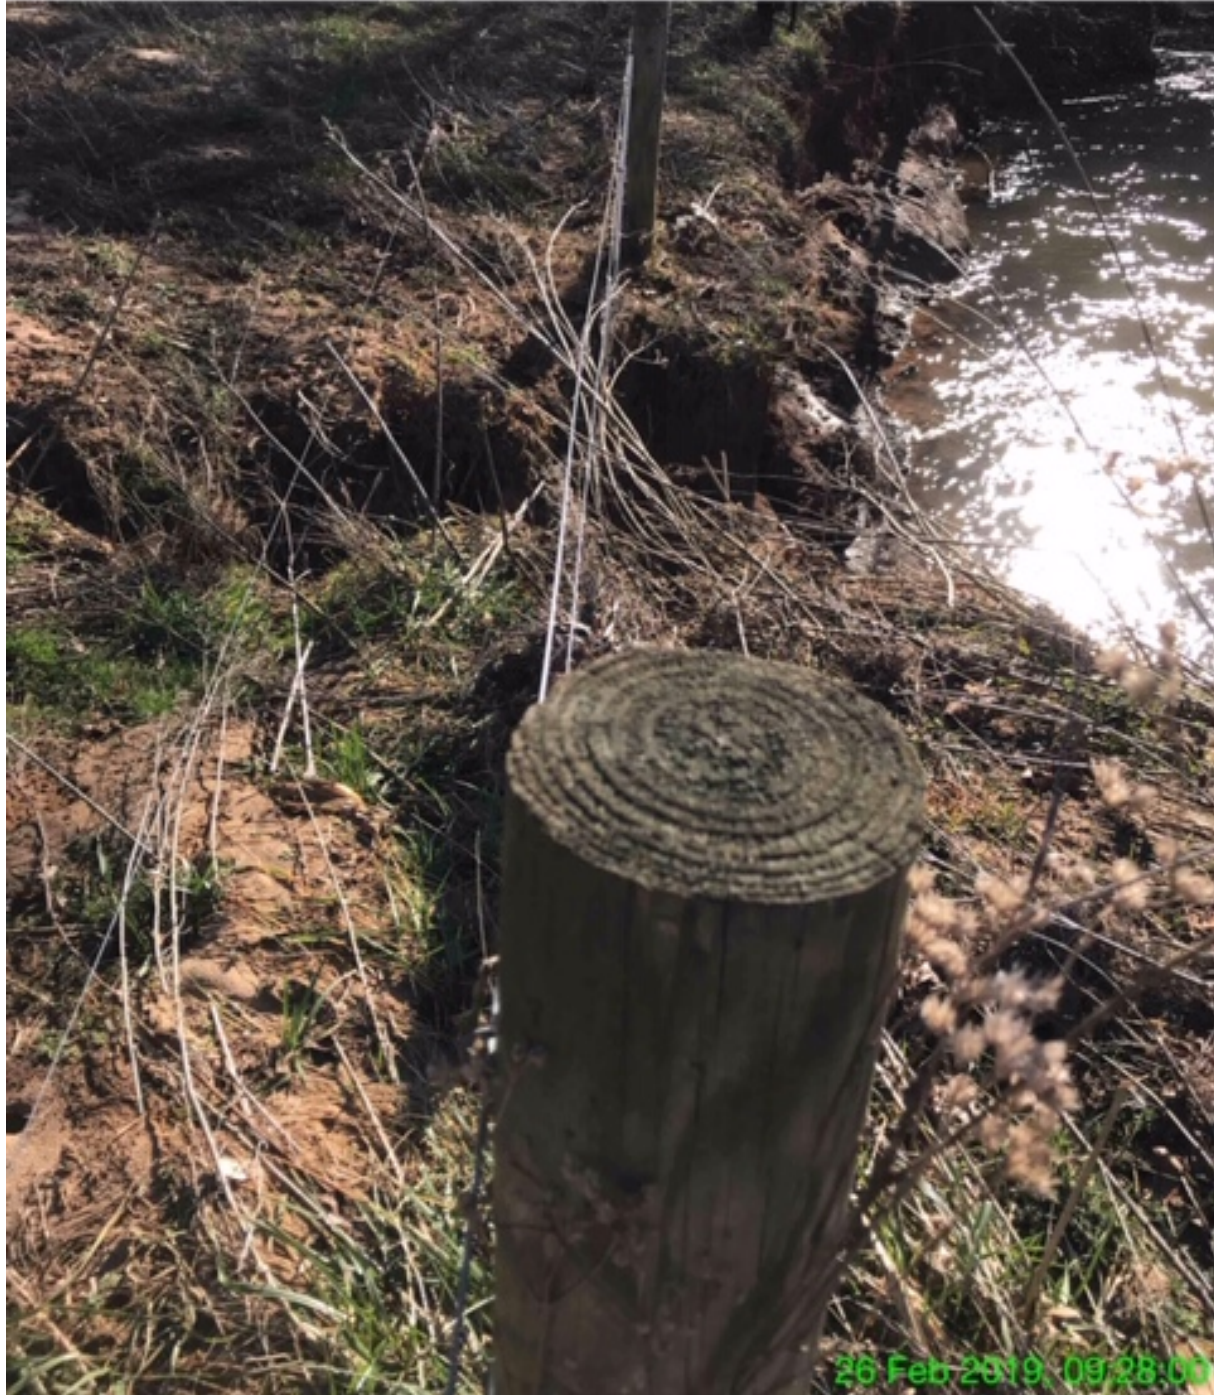
EXHIBIT G – The gusher had eroded to a full ditch that discharges sediment-laden runoff to Little Creek.

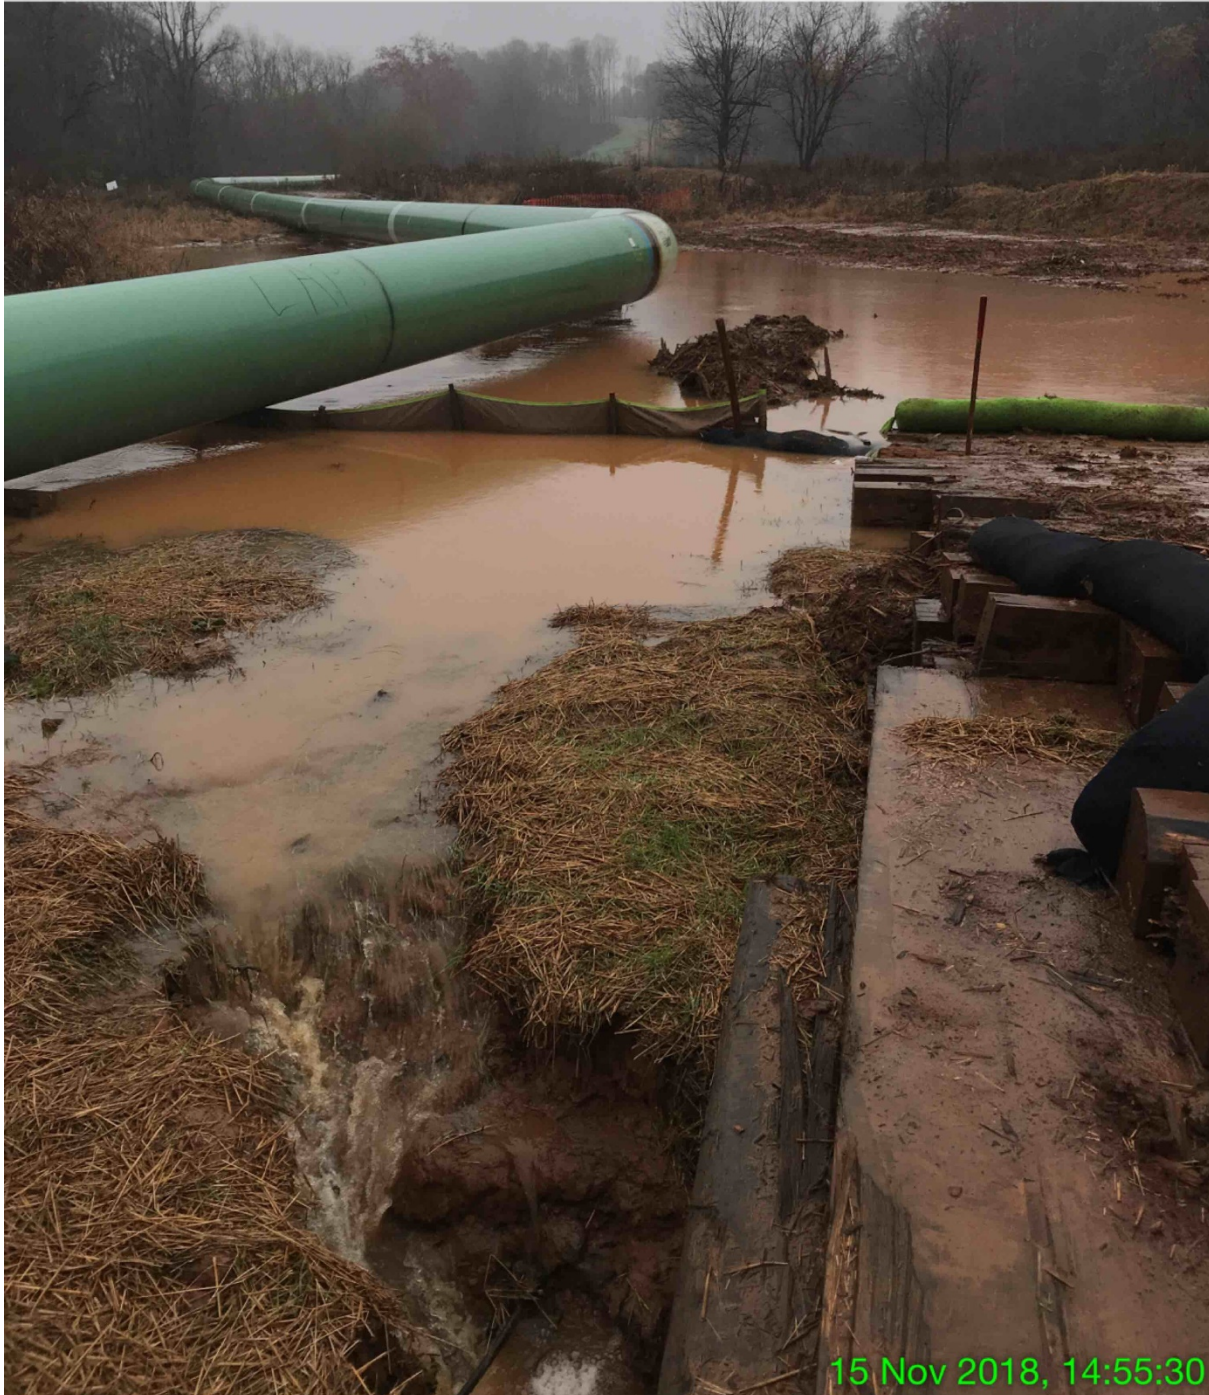
EXHIBIT I – The upstream side of the bridge over Little Creek. Muddy water flows under the bridge and out the downstream side of the bridge before entering the creek, seen in Exhibit J.

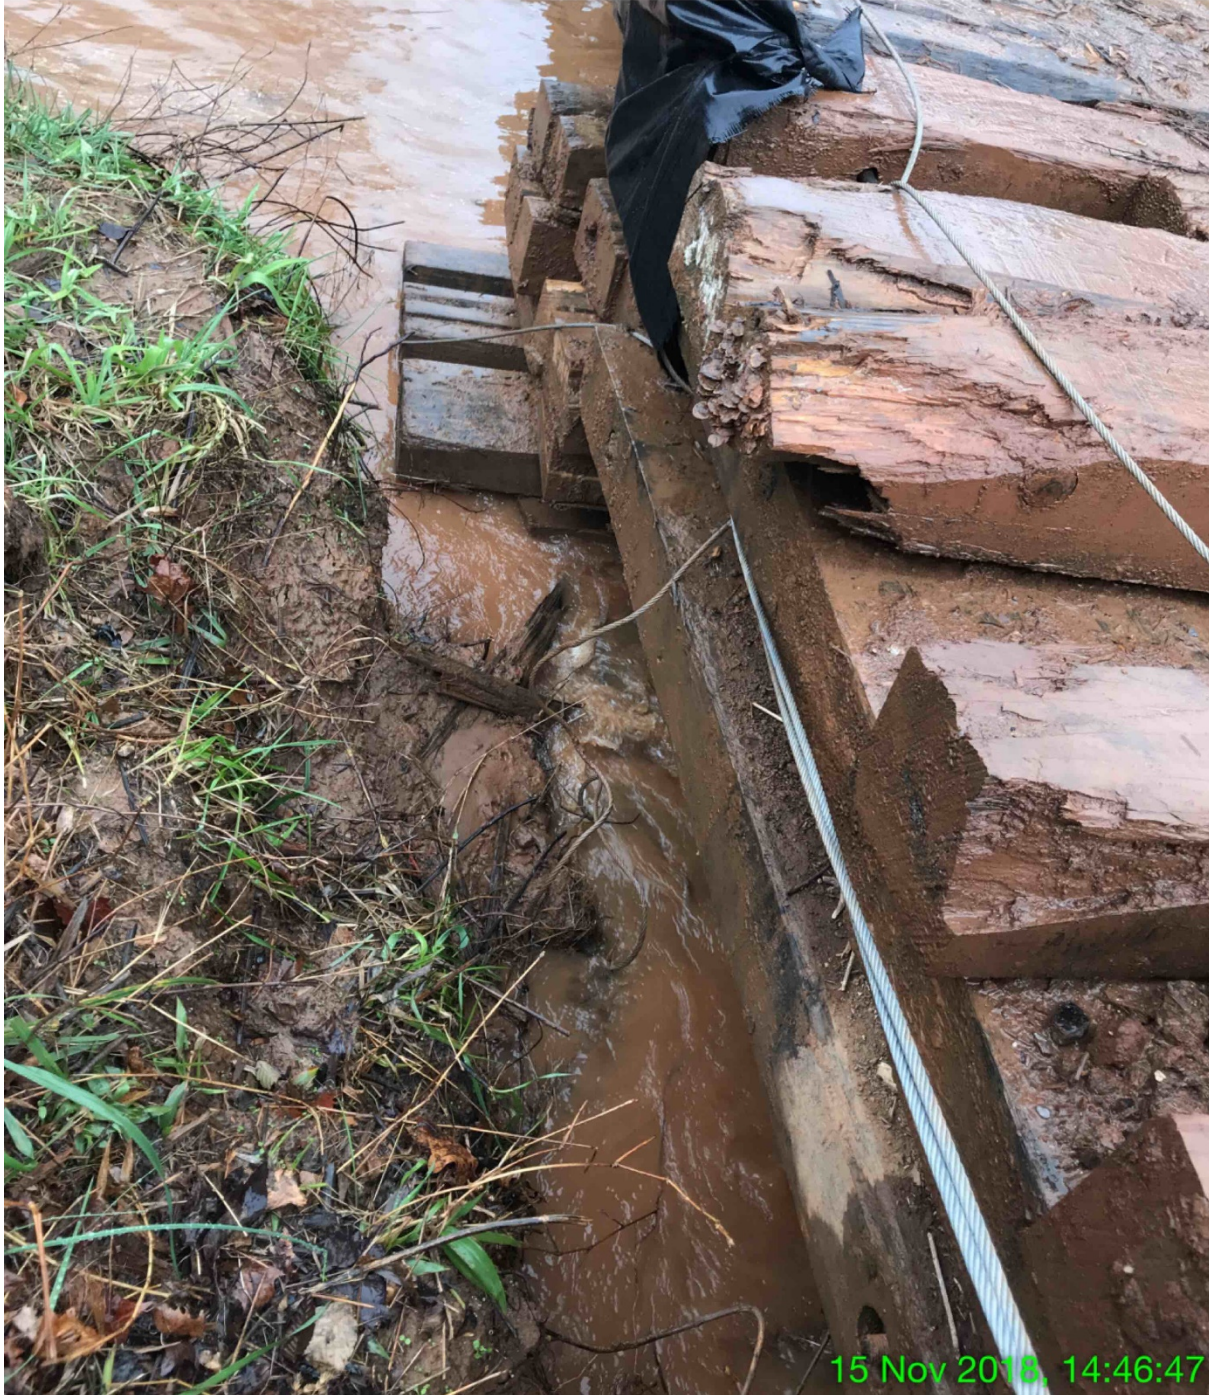
EXHIBIT J – The downstream side of the bridge over Little Creek. Muddy water flowing from the upstream side of the bridge, and under the bridge and into Little Creek with the creek almost full.

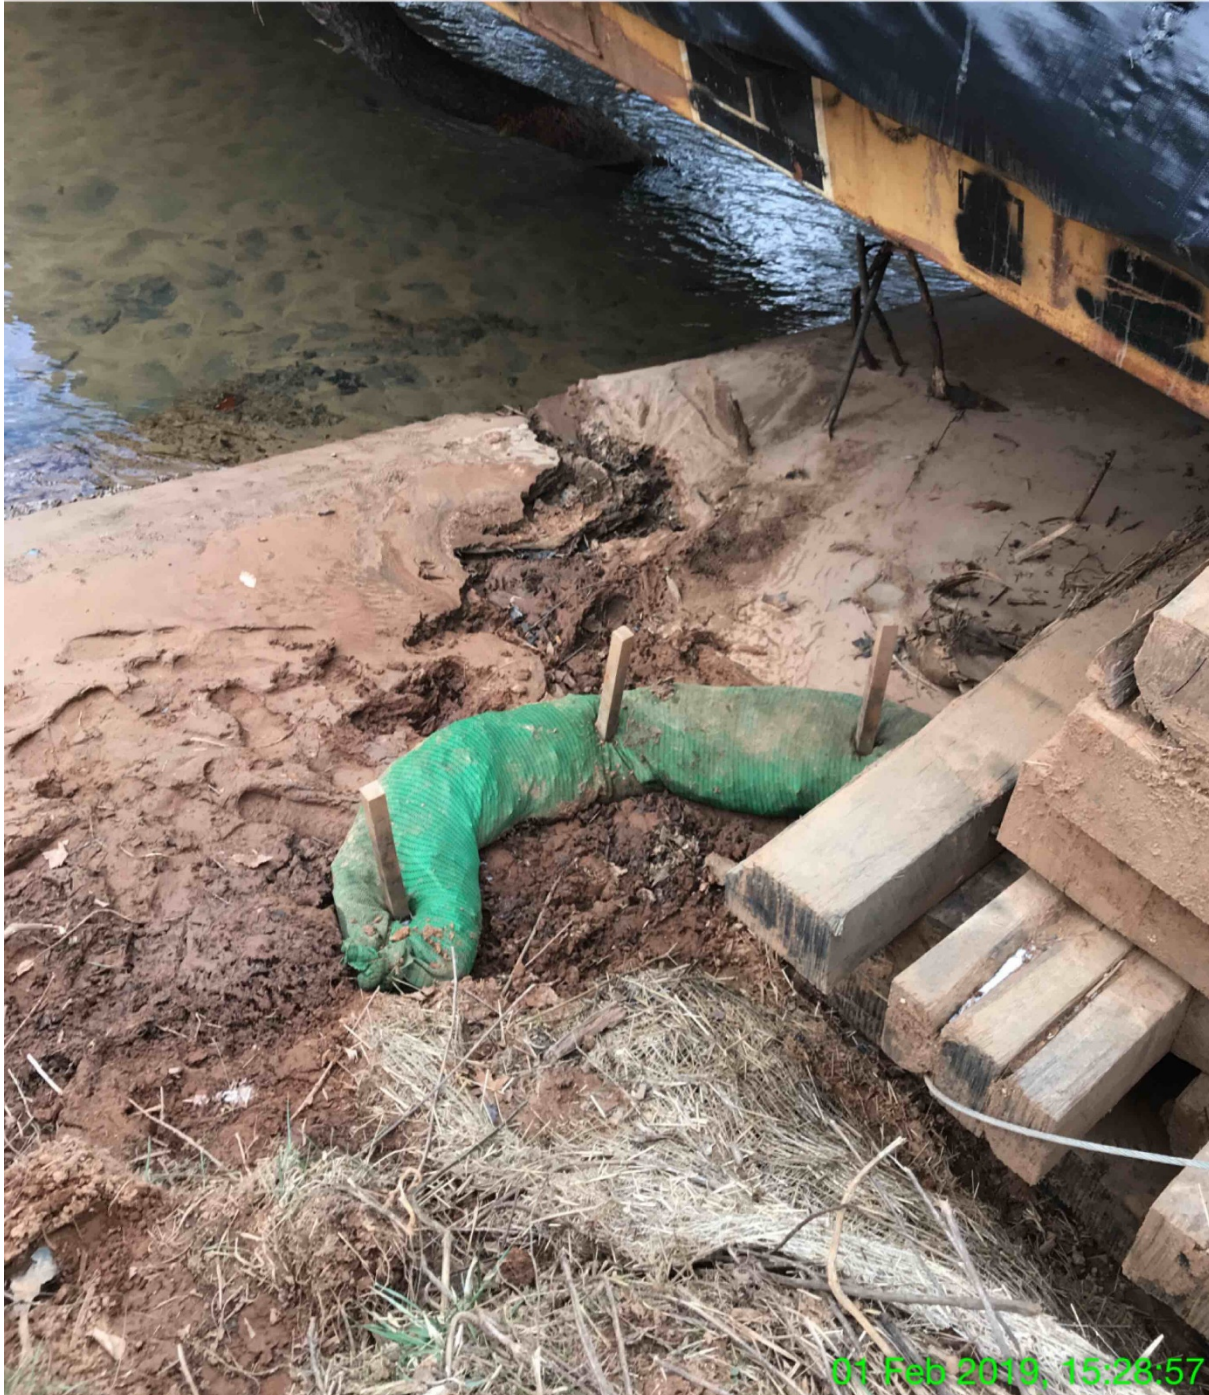
EXHIBIT K – The downstream side of the bridge over Little Creek which is the same location as Exhibit J above. The creek bottom which used to be rocky is covered in sediment. Sediment is piled on the banks. The erosion control sock had been recently installed when this photo was taken on February 1, 2019.

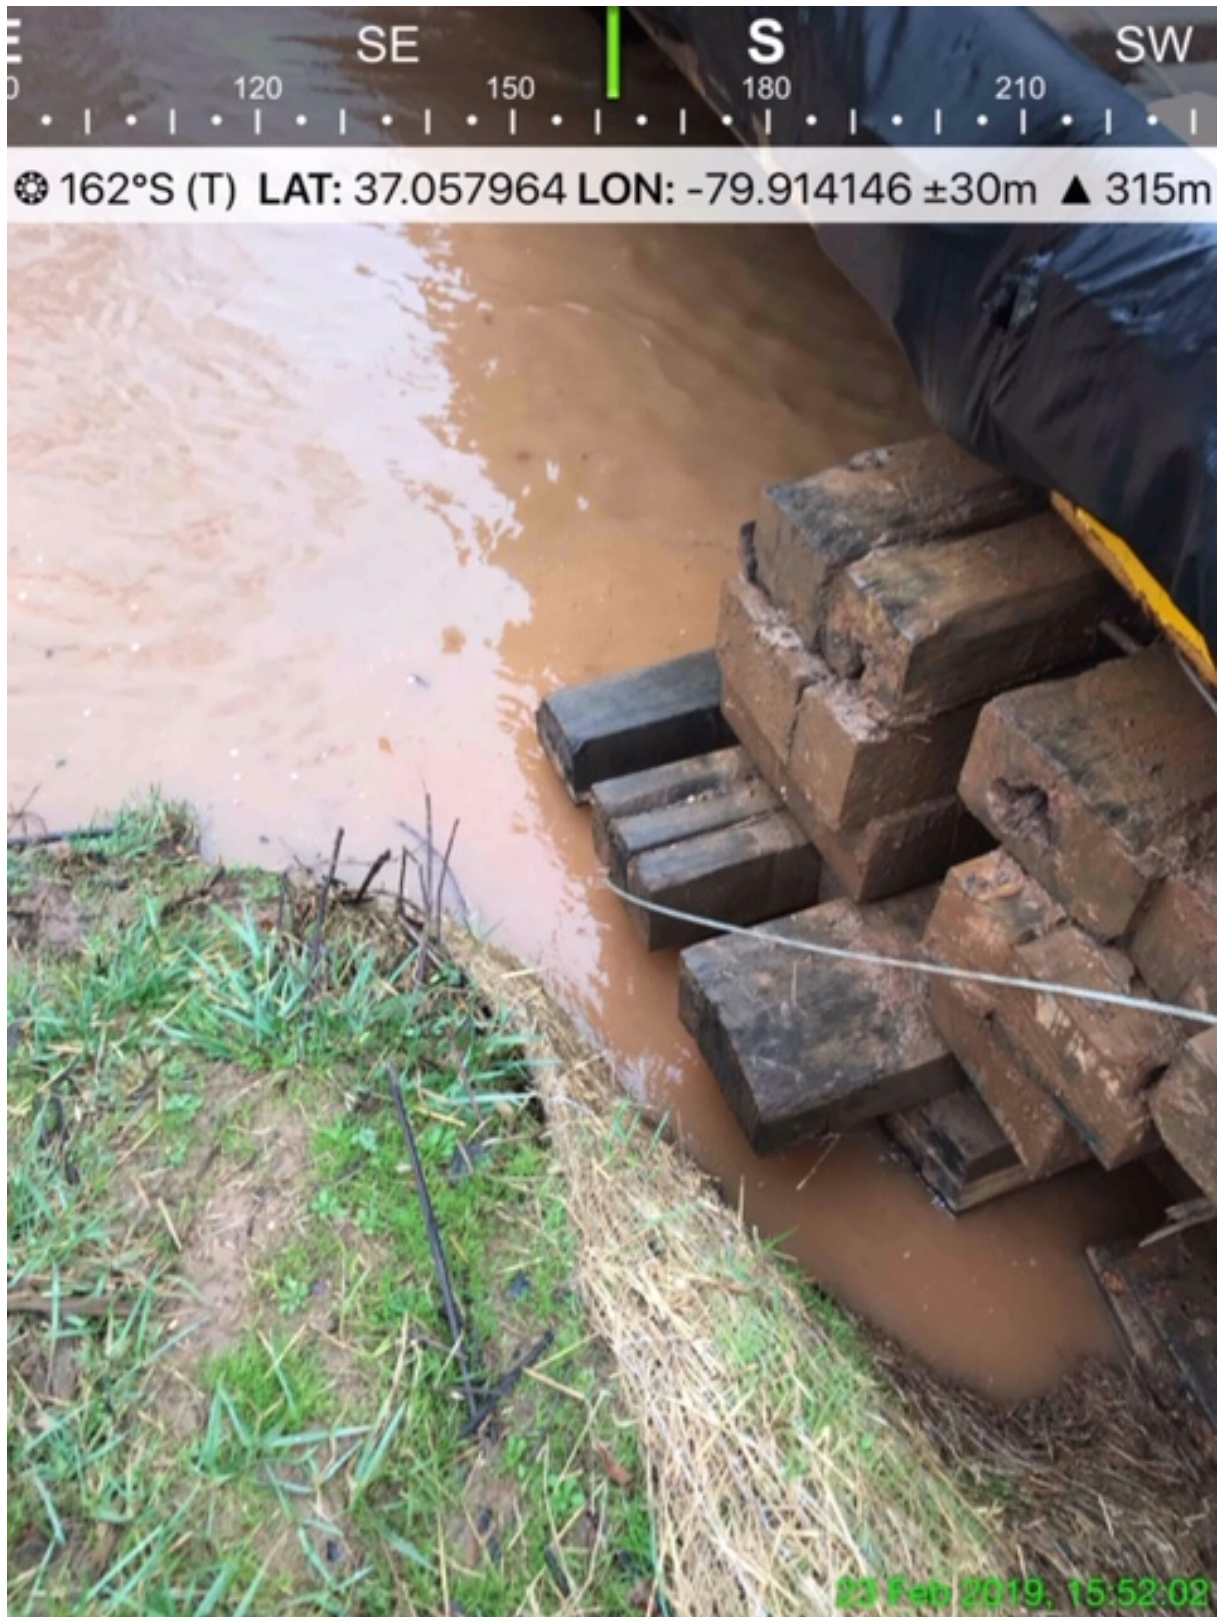
EXHIBIT L – The downstream side of the bridge across Little Creek on February 23, 2019. This is the same location as in Exhibits J and K.

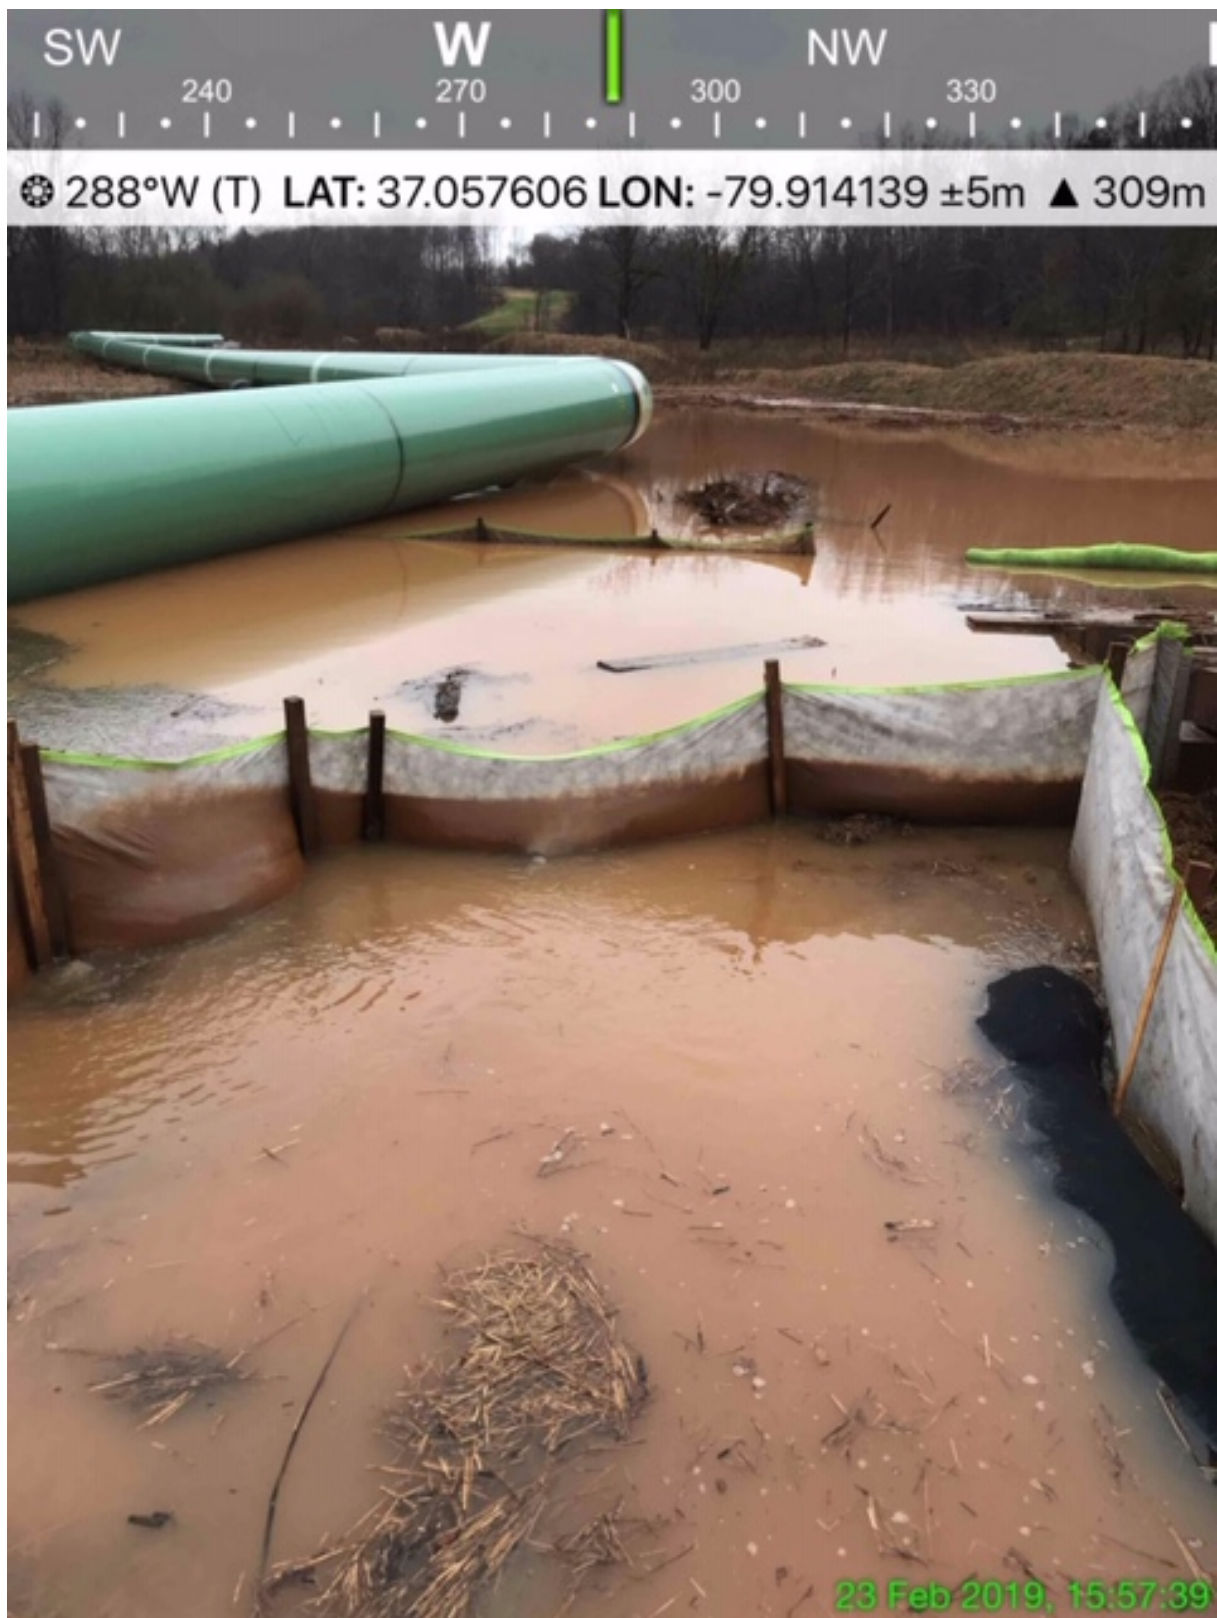
EXHIBIT M – The upstream side of the bridge over Little Creek on February 23, 2019. This is the same location as Exhibit I.

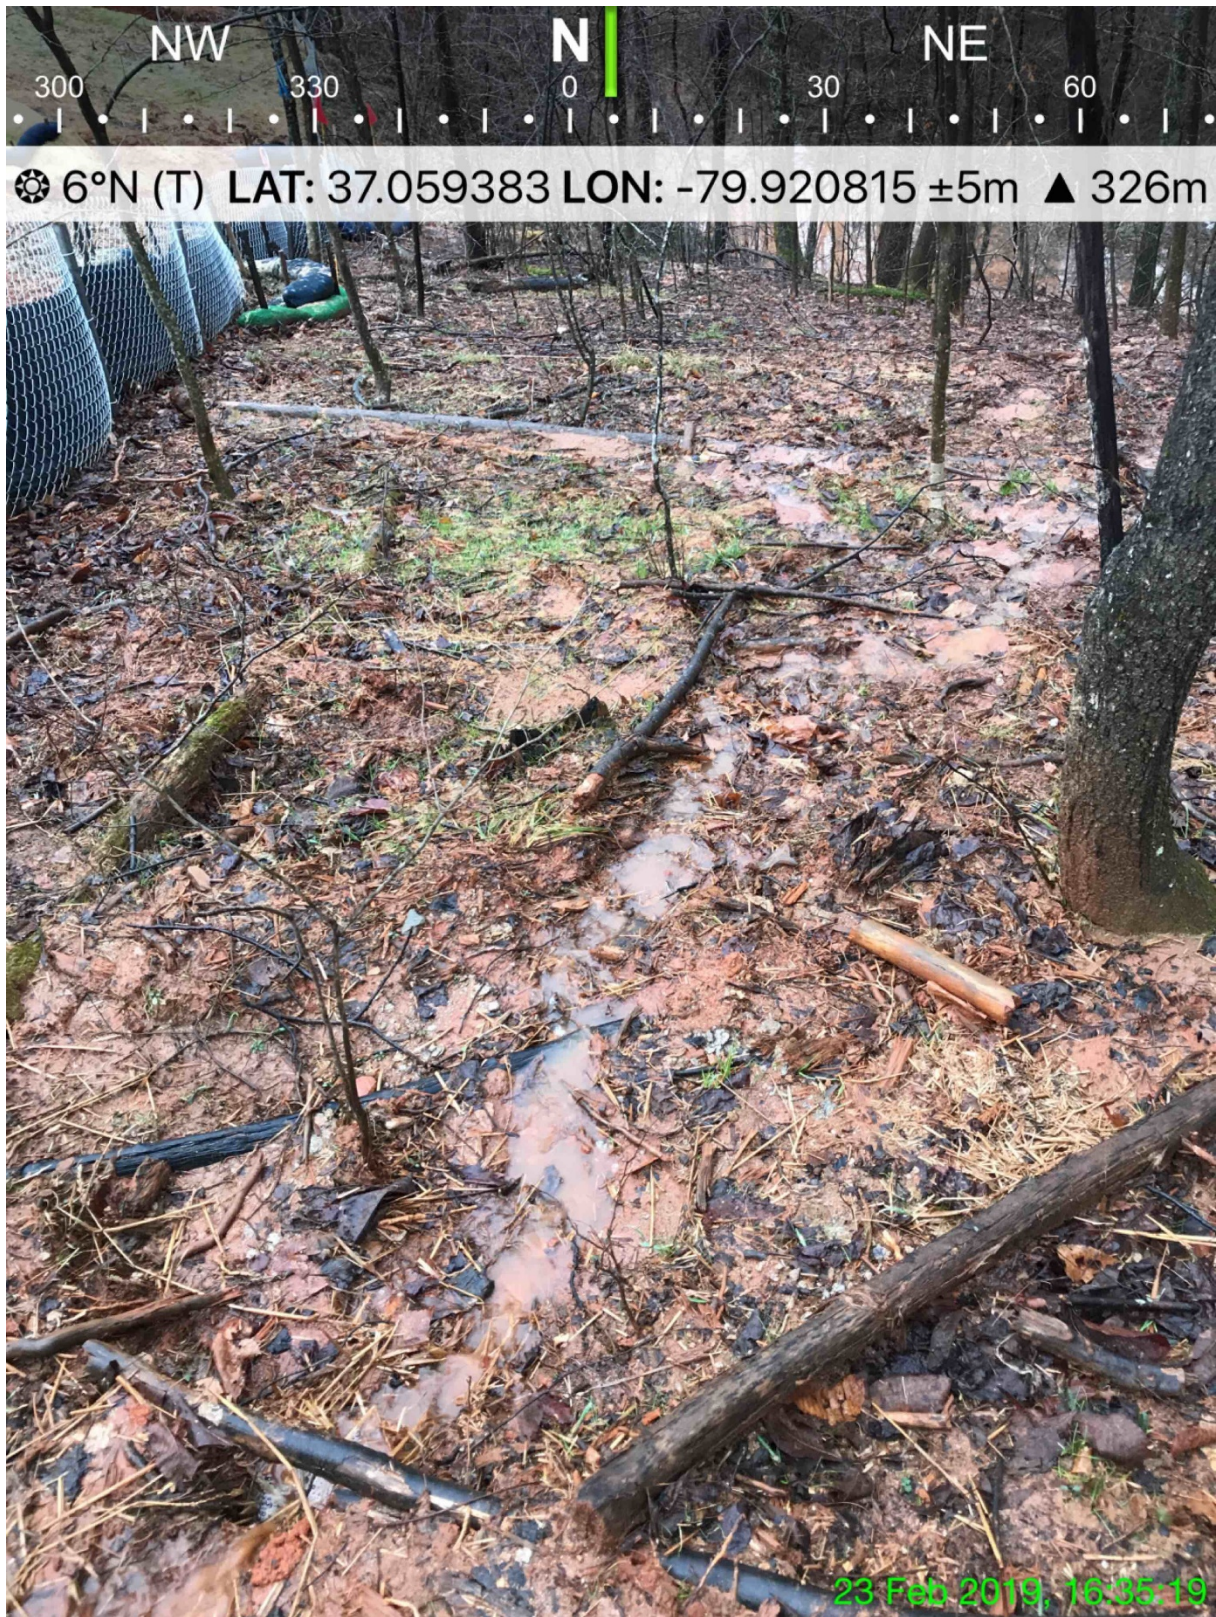
EXHIBIT R – Sediment-laden runoff has flowed from the construction corridor.

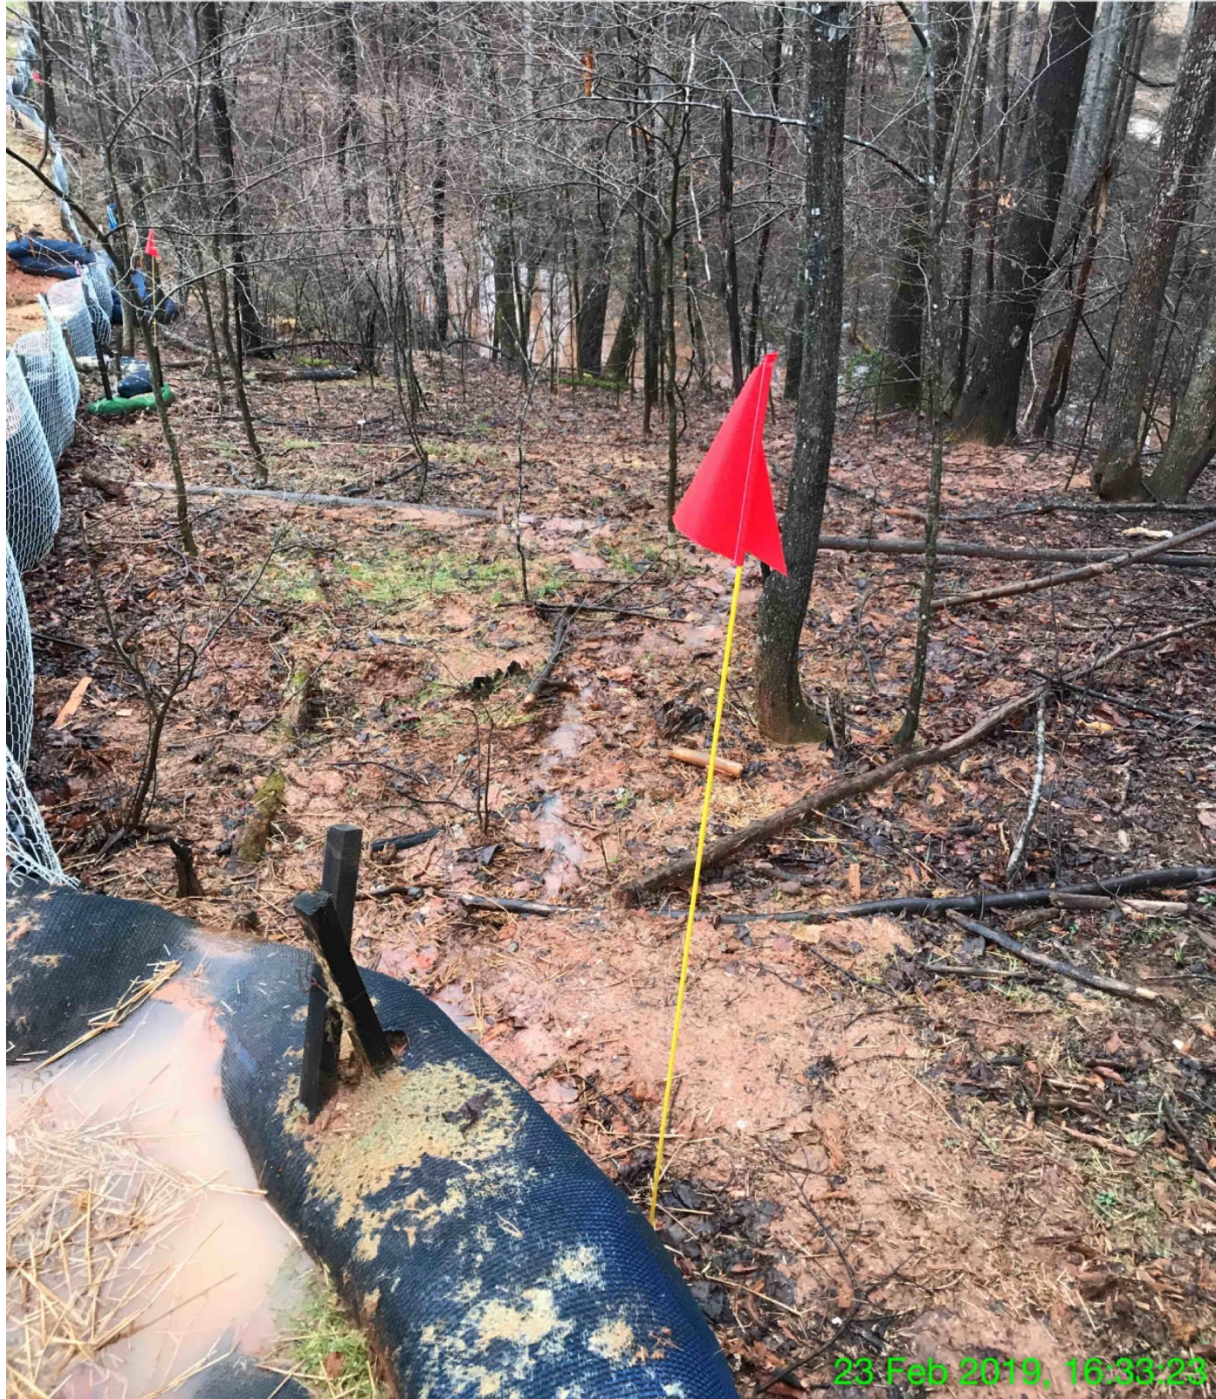
EXHIBIT S – Sediment-laden runoff has flowed from the construction corridor.

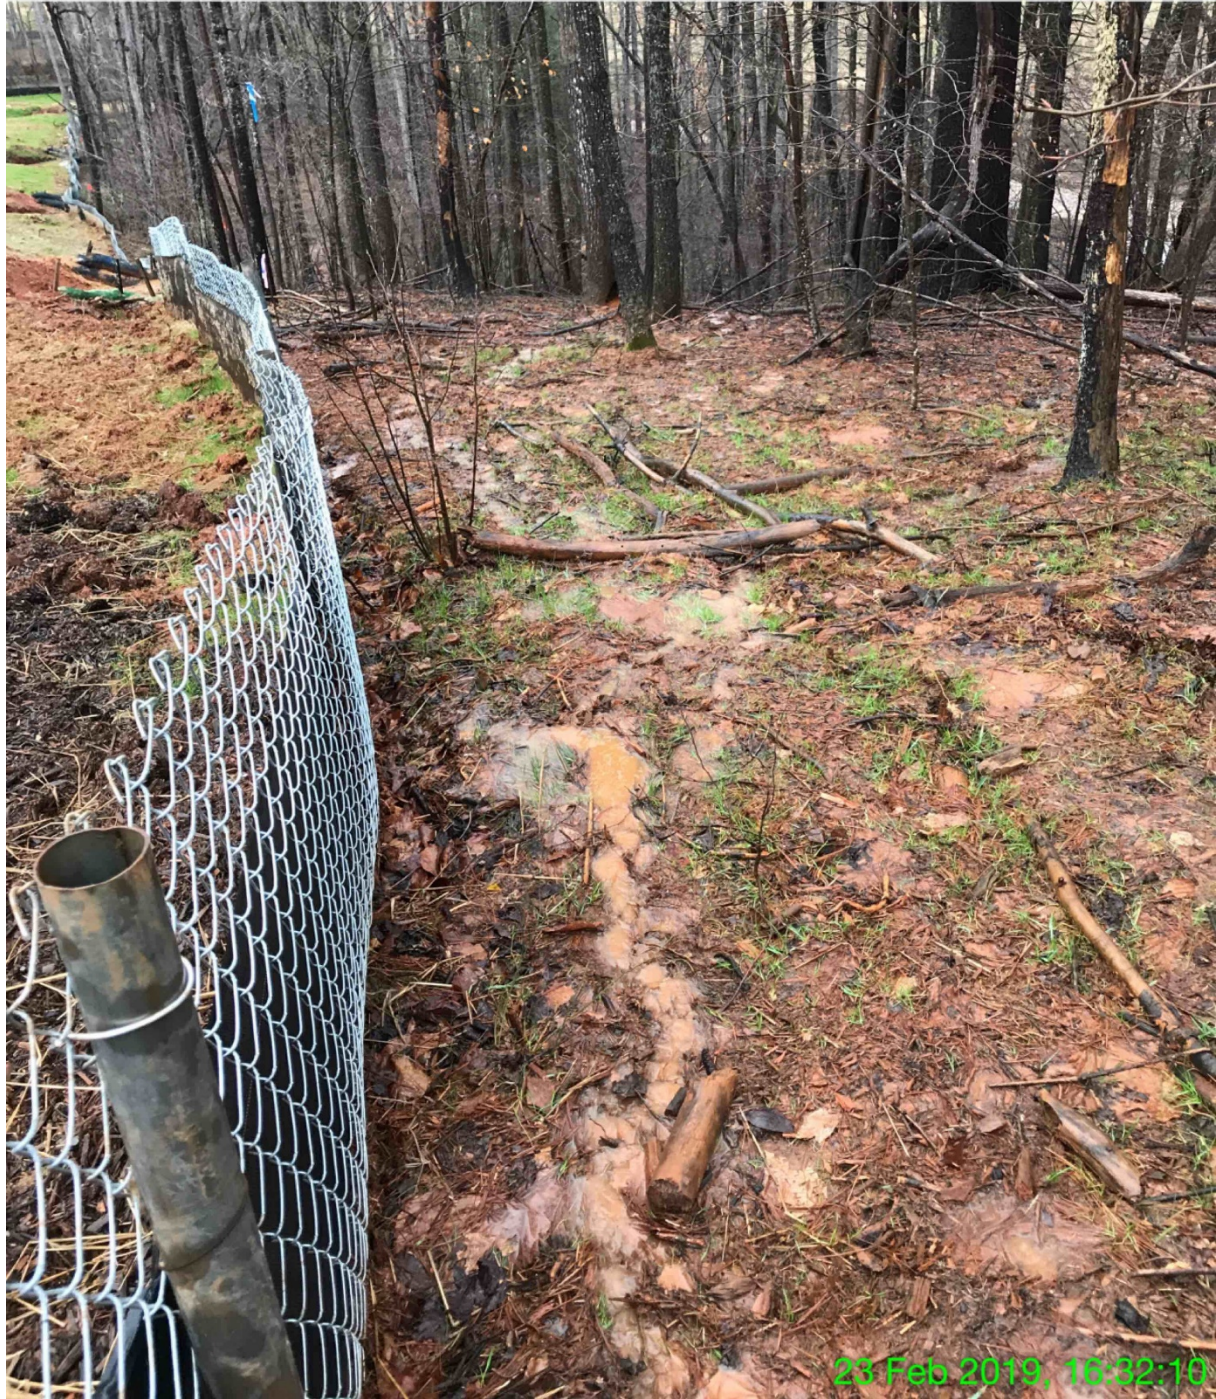
EXHIBIT T – Sediment-laden runoff flowing from the construction corridor.

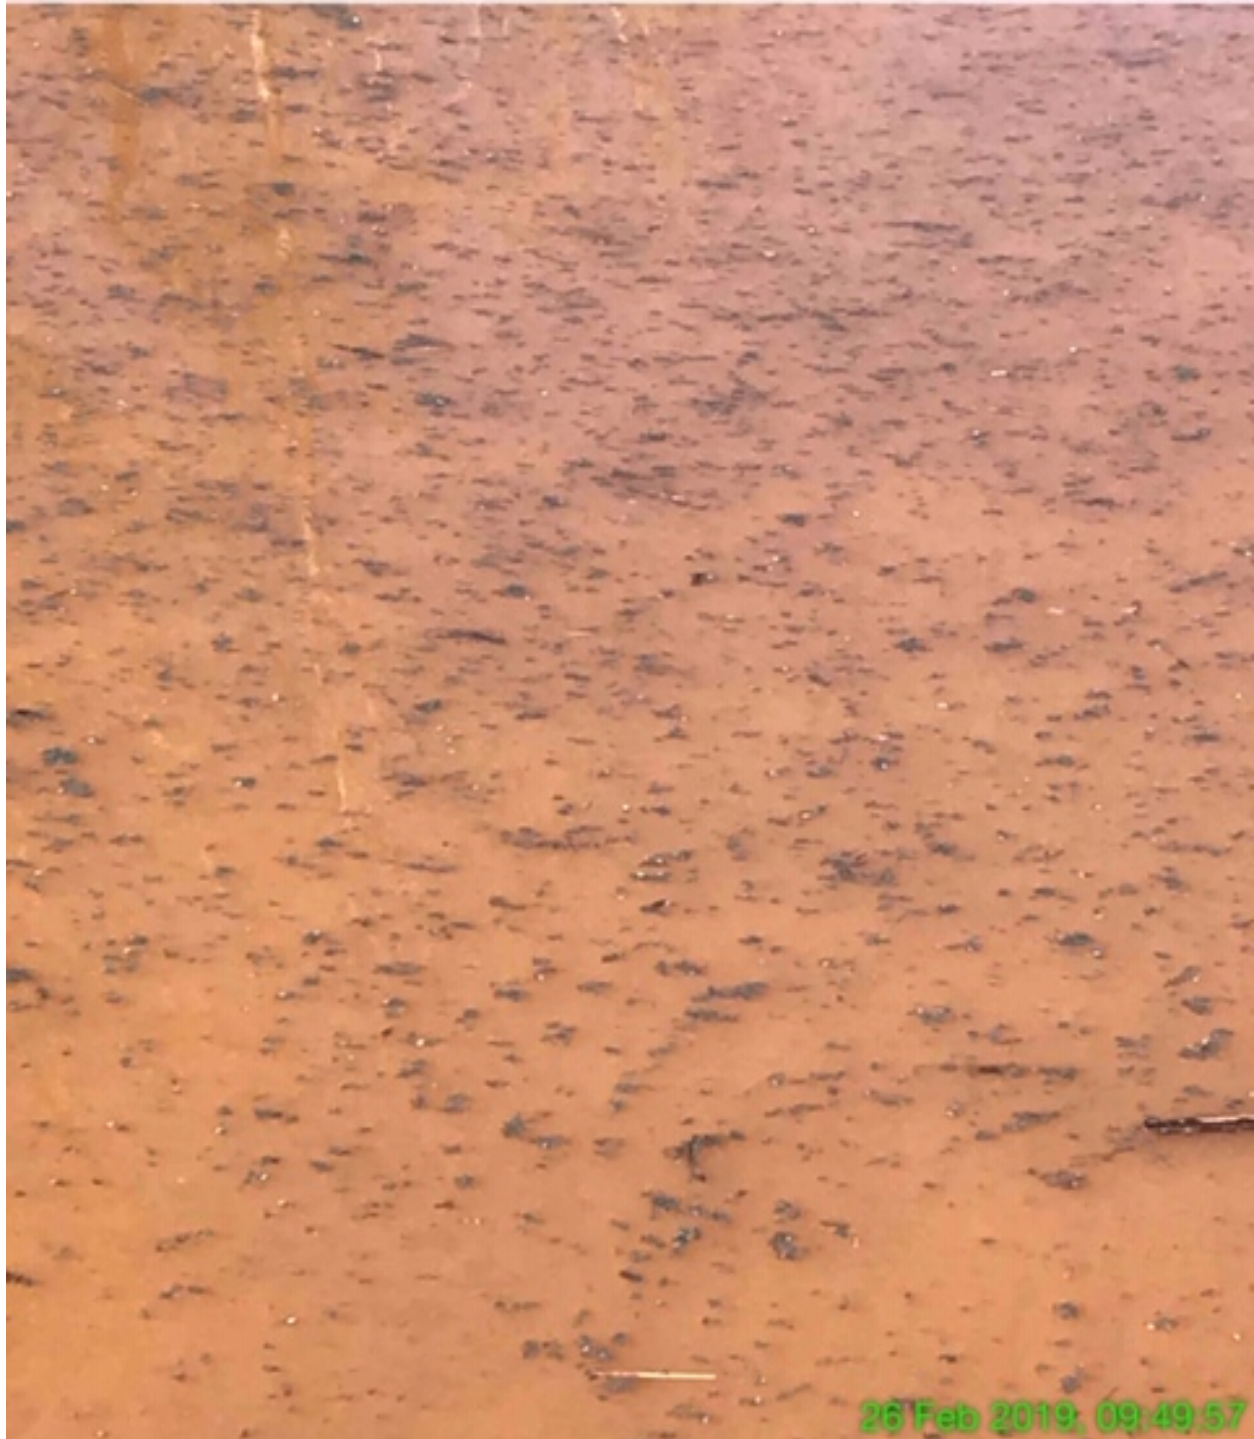
EXHIBIT V- Erosion control pellets dropped on the construction corridor where the stormwater has been ponding.

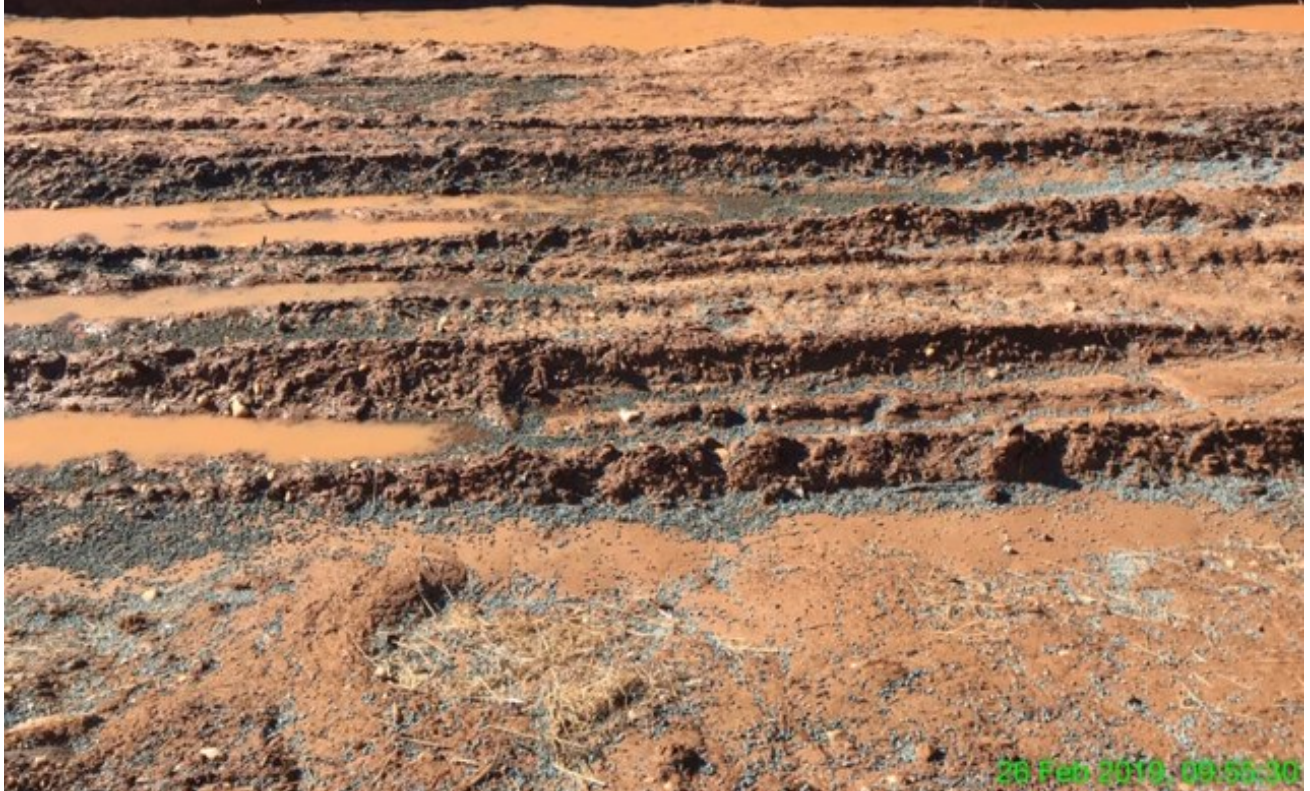
EXHIBIT W – Erosion control pellets.

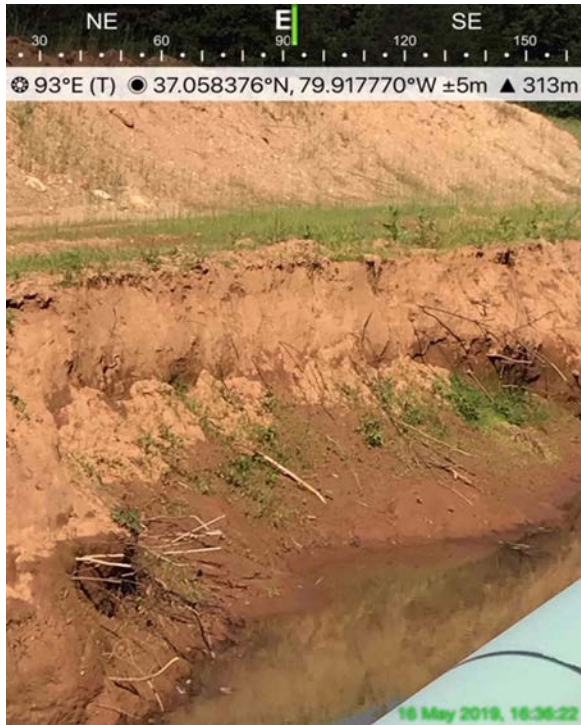
Exhibit HH- Sprouted grass and erosion along ROW

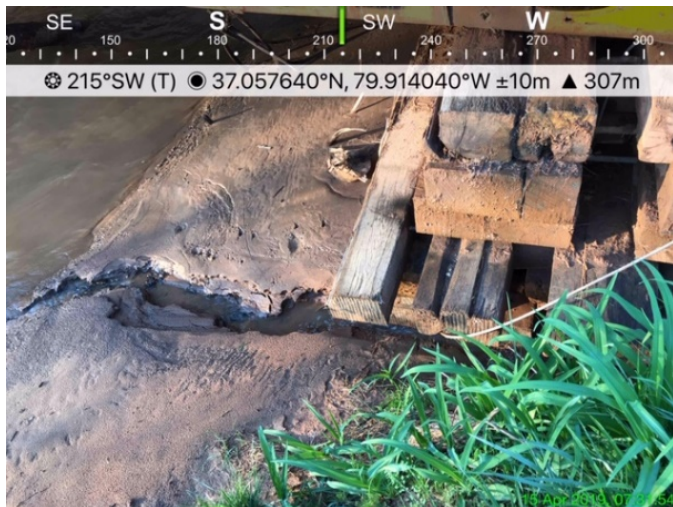
Exhibit LL – Sediment from ROW continuing to flow into Little Creek
