A REPORT BY WILD VIRGINIA

FEBRUARY 2023

MOUNTAIN VALLEY PIPELINE POLLUTION IN VIRGINIA WATERSHEDS

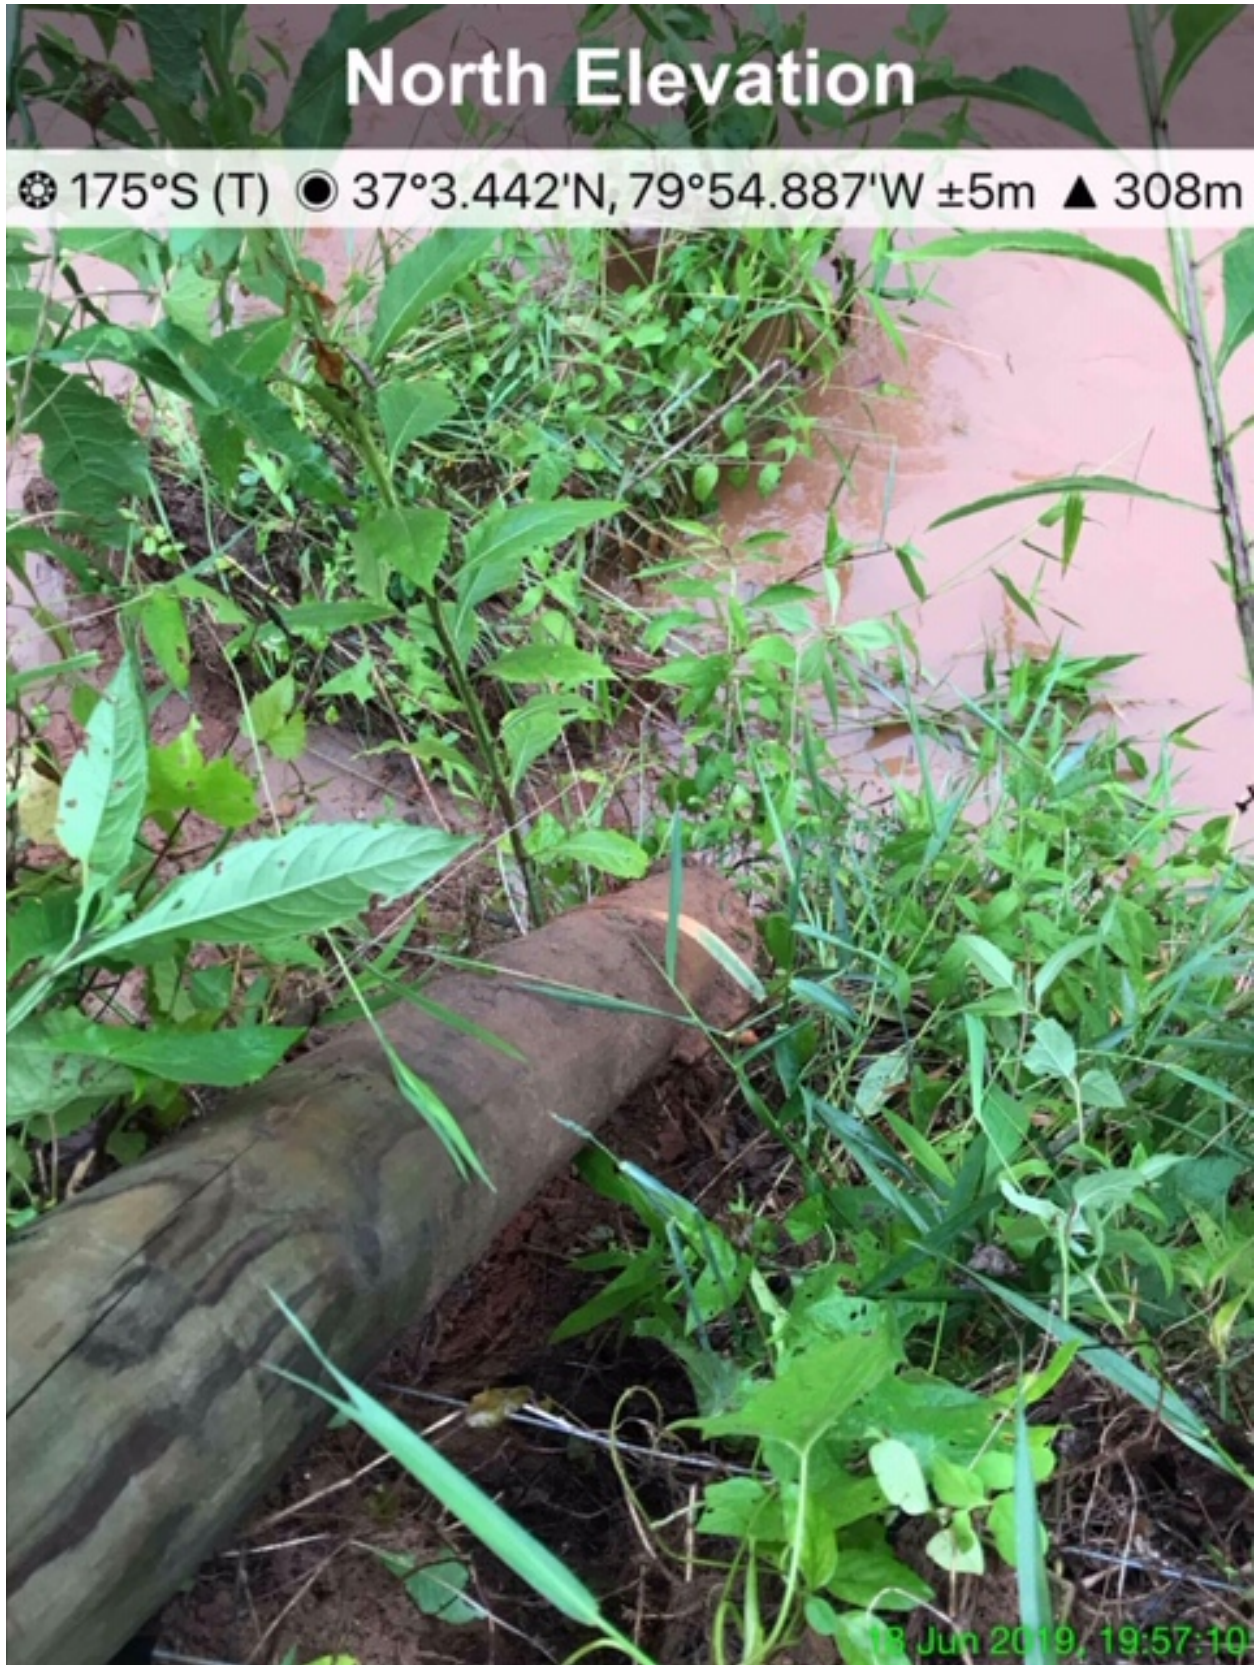
Exhibit OO – By June 18, 2019, the creek bank has eroded away from a fencepost that was at least six feet from the creek bank before construction started.

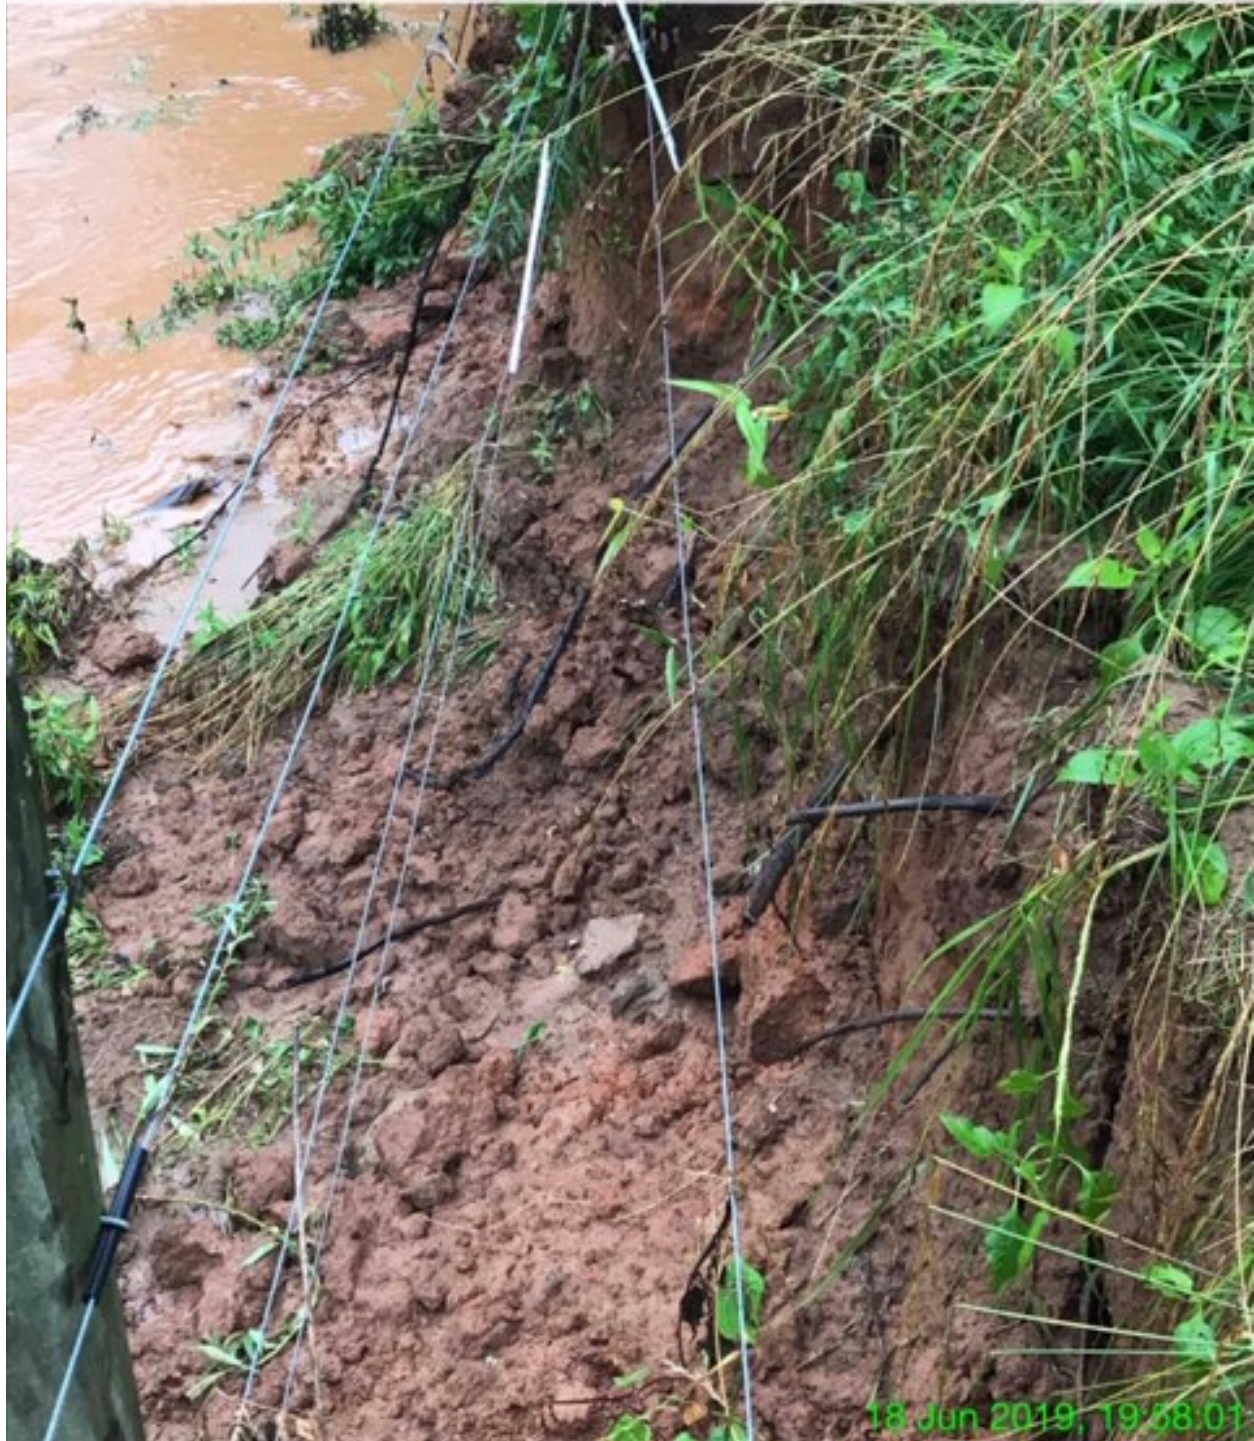
Exhibit PP – By June 18, 2019, the creek bank has eroded several feet beyond a fencepost that was at least six feet from the creek bank before construction started.

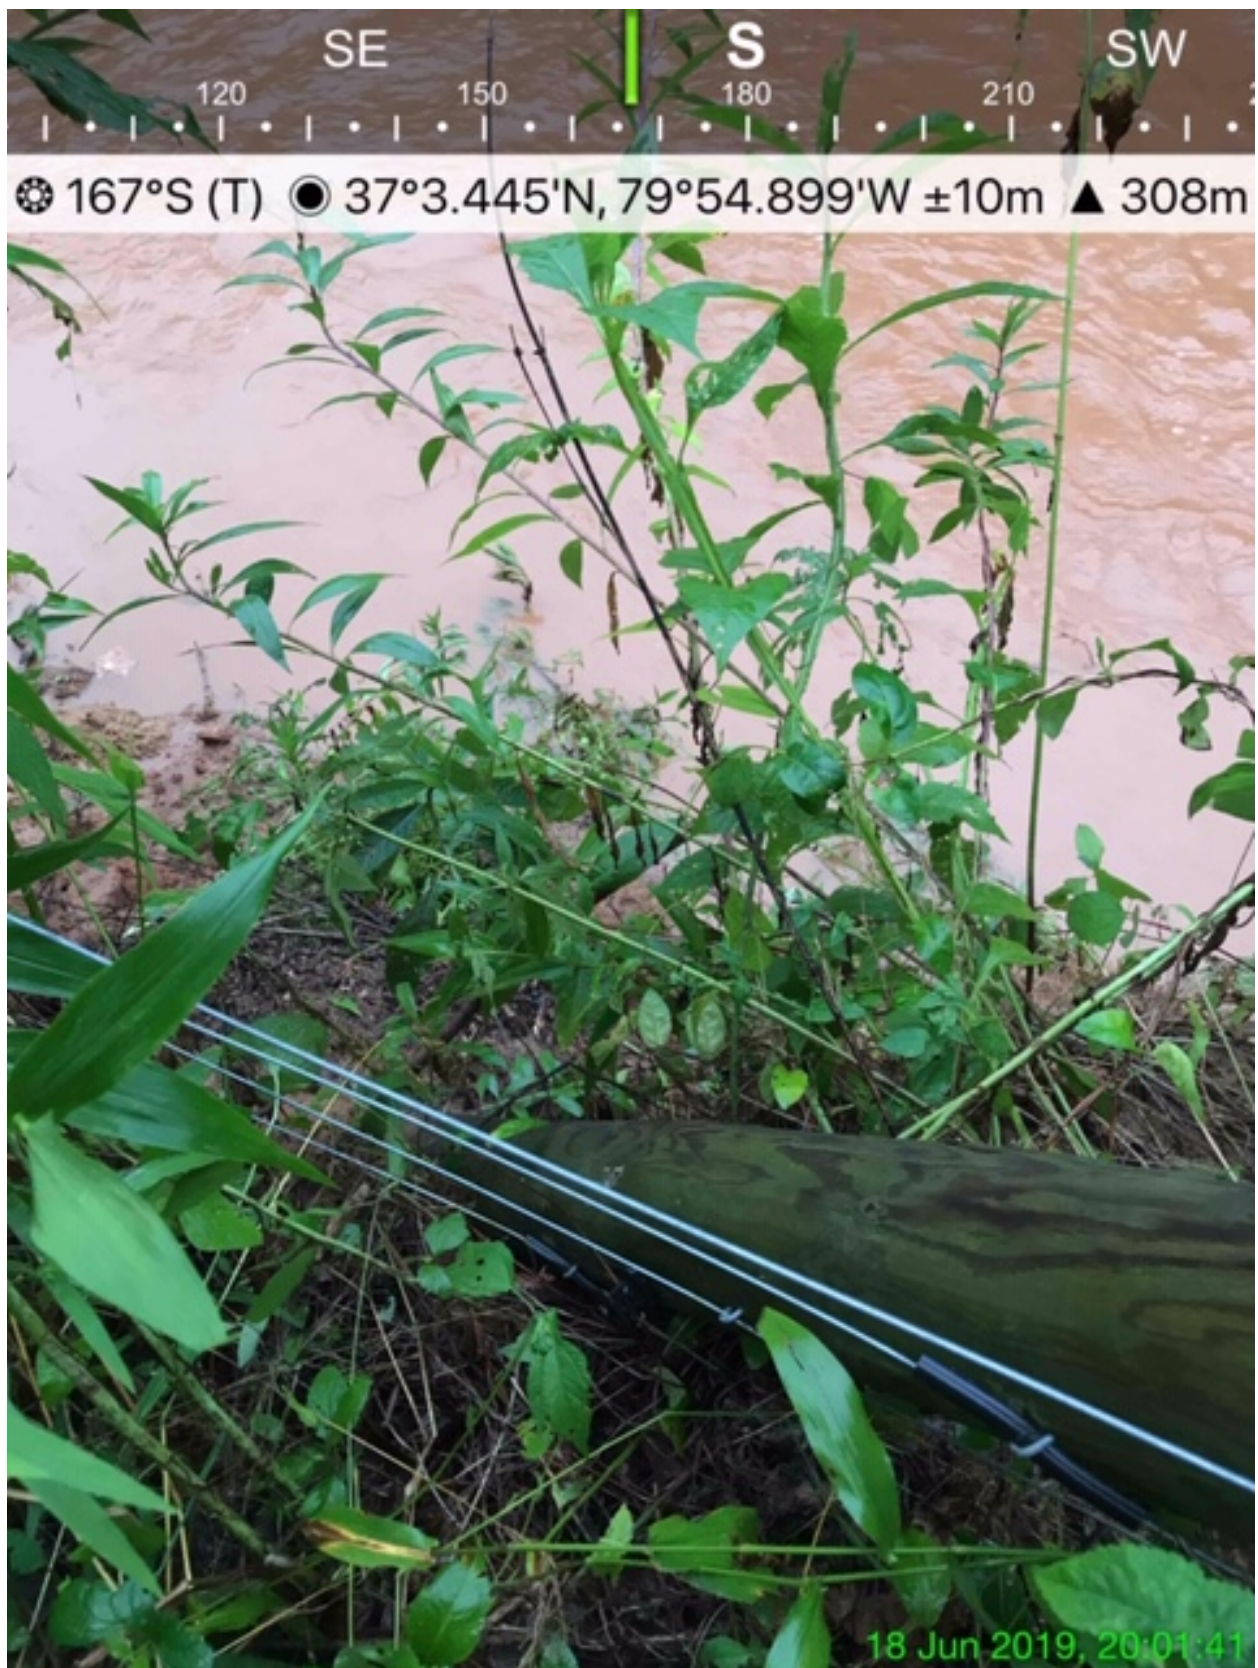
Exhibit RR – By June 18, 2019, the creek bank has eroded away from a fencepost that was at least six feet from the creek bank before construction started.

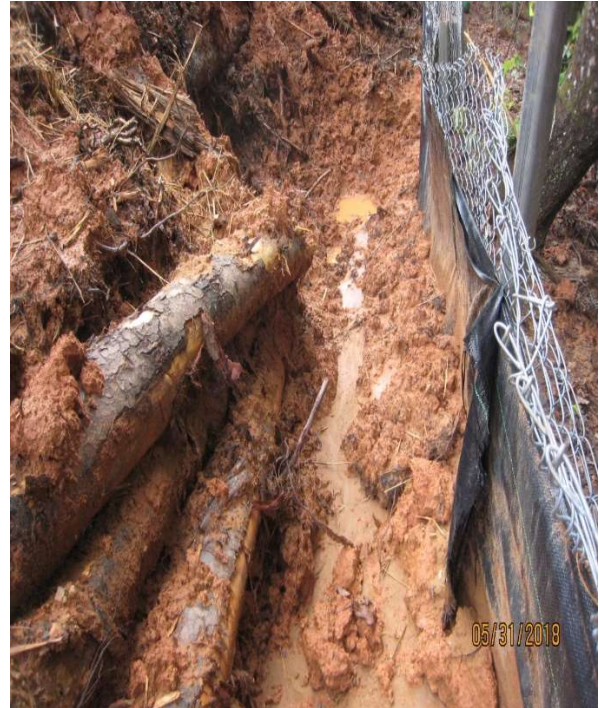
Sediment located on north side of SF

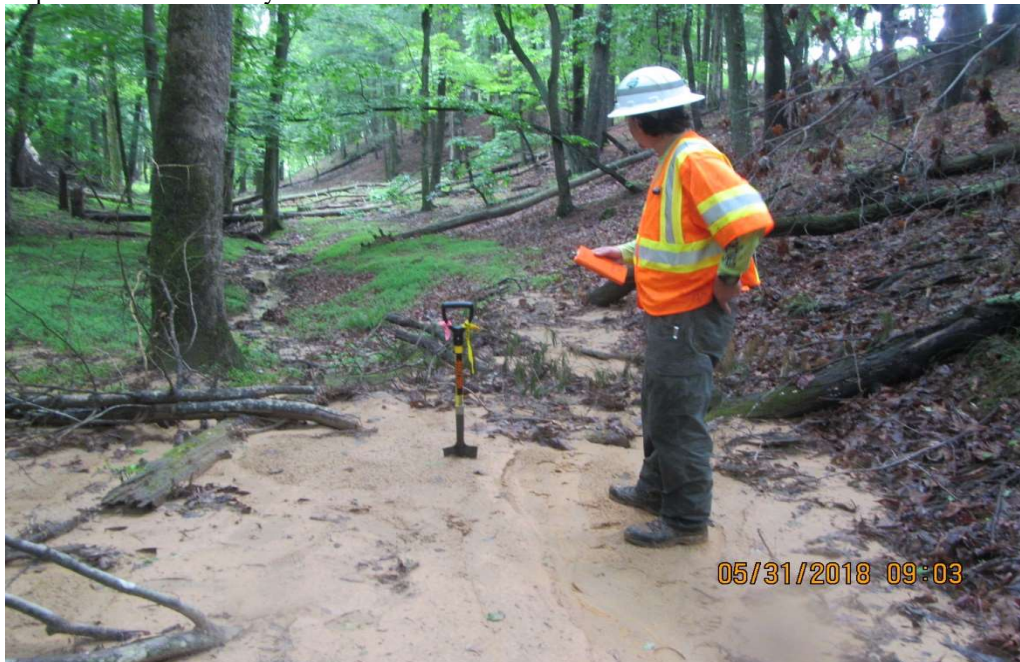
Approximately 1,690 linear feet of stream channel contained sediment ranging from 1-inch to a maximum depth of 10-inches was observed. Sediment within the stream's thalweg was generally 1.5 to 5-inches in depth; sediment bars and pool deposition was generally 3 to 6 inches in depth.

Sediment within channel at debris dam ~420-feet from MVP LOD
Depth 3 to 8-inches (average), Maximum depth of 11-inches; Sediment deposit 12-feet wide

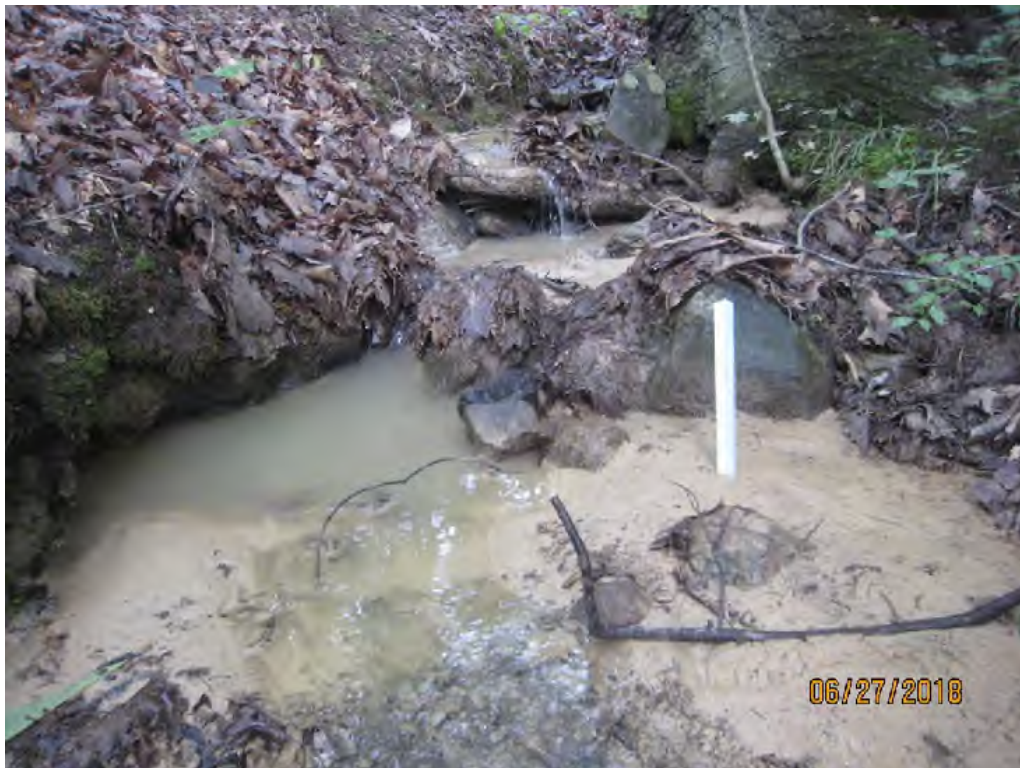
Photo 2: Sediment in stream ~685’ from LOD; Depth = 3”

1. Repair erosion and sediment controls in areas where needed;
2. Stabilize all slopes above and below perimeter controls;
3. Remove sediment from impacted stream channels using hand removal methods (buckets and shovels) and stabilize with appropriate seed mix where applicable.

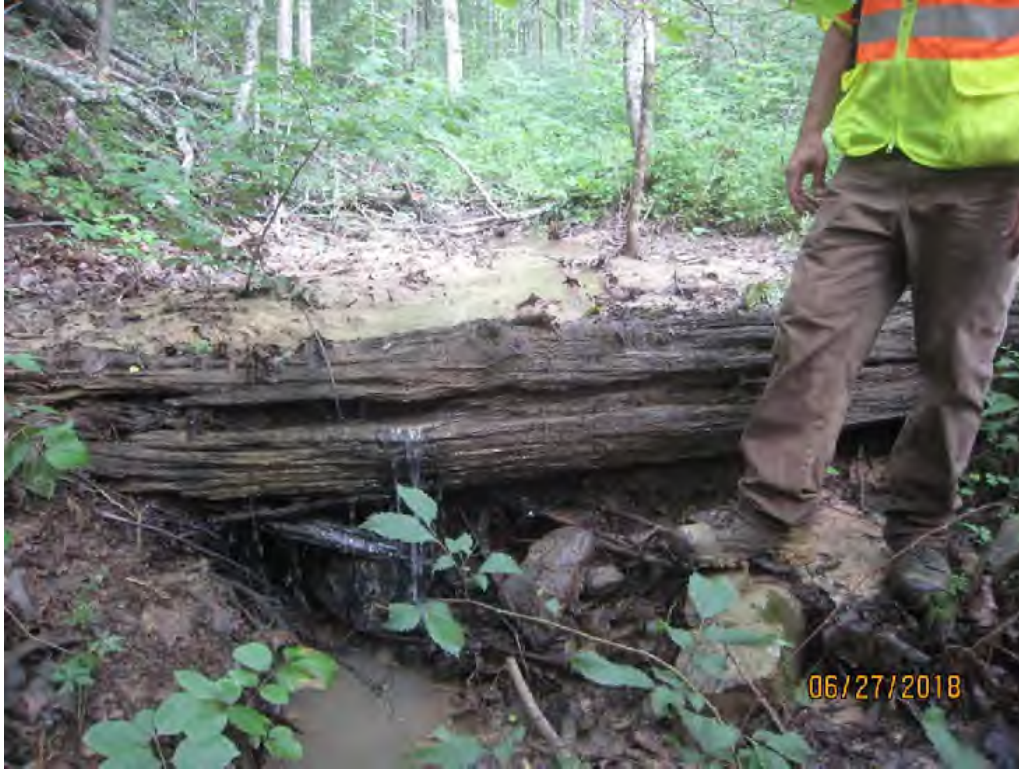
Photo 3: Sediment in stream at debris dam ~1,690' downstream of LOD; Depth = 2-7"
Orientation: Upstream

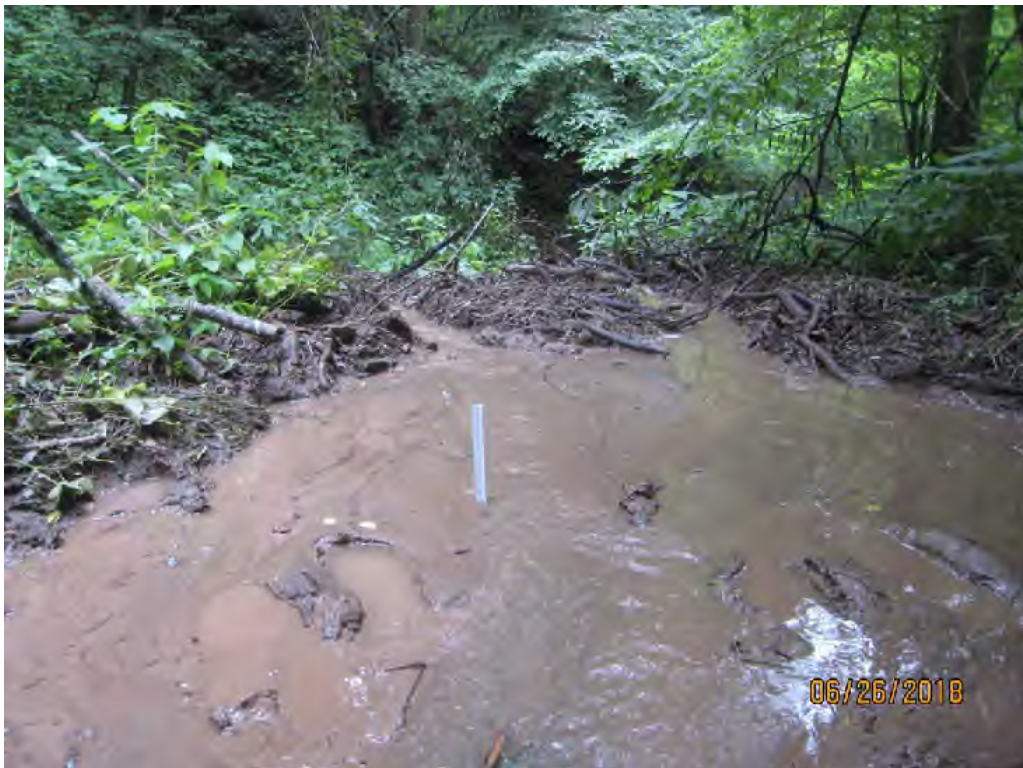
Photo 2: 4.5' of sediment at debris dam ~210' from Photo 1

1. Repair erosion and sediment controls in areas where needed;
2. Stabilize all slopes above and below perimeter controls;
3. Remove sediment from impacted stream channels using hand removal methods (buckets and shovels) and stabilize with appropriate seed mix where applicable.

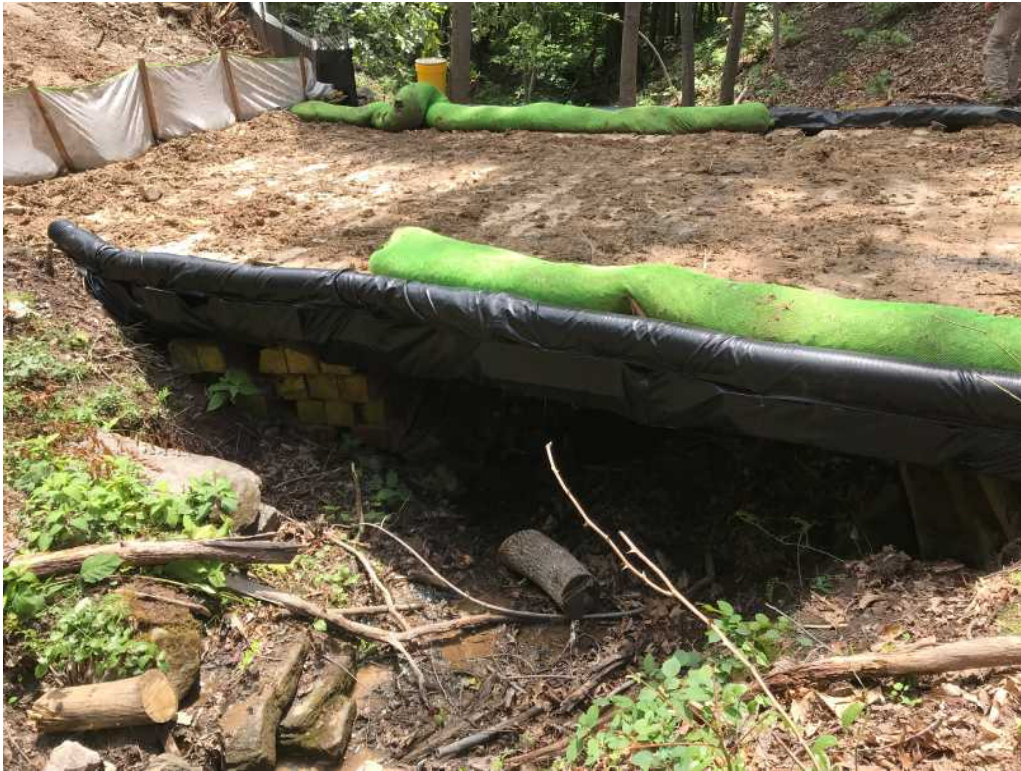
Photo 1: Sedimentation and woody debris within Stream MN-513 at bridge crossing
Orientation: Downstream

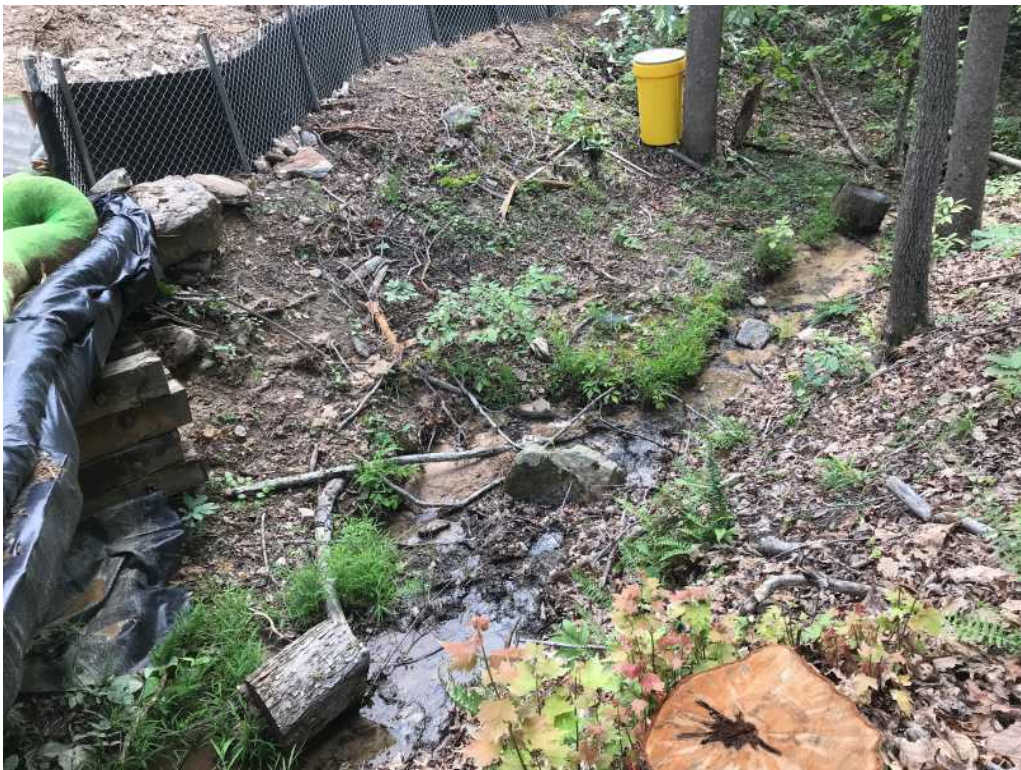
Photo 2: Sedimentation and woody debris downstream of bridge crossing
Orientation: Downstream

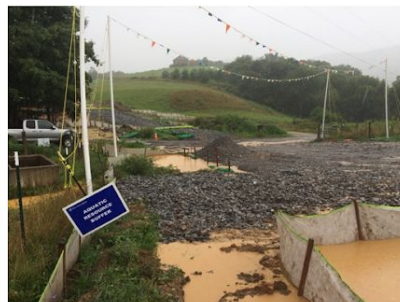
Looking westward toward SGT. Failed mulch socks and silt fencing. Note thick gravel layer placed to fill and hide pooling mud between silt fence and SGT, is not effective in slowing sediment loss. Besides BMP failure, sediments are clearly entering 1) an Aquatic Resource Buffer, 2) a State Road, 3) a

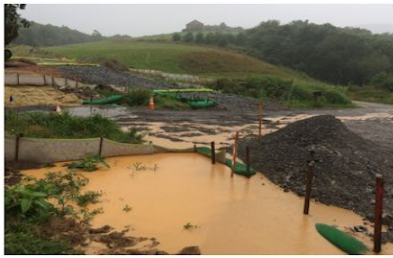
Ineffective silt fence and mulch socks allowing sediment to move into SGT.

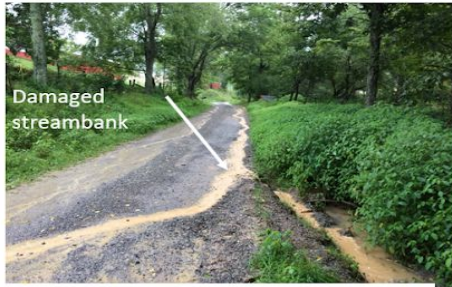
D. The ditch and culvert are still not stopping sediment flow down SGT. This photo at 7:12 am 05 Aug, over 24 hr after last significant rain on Thur, and before MVP Crews begin "cleanup". Why the strange diversion? This is where MVP traffic destroyed the stream bank.

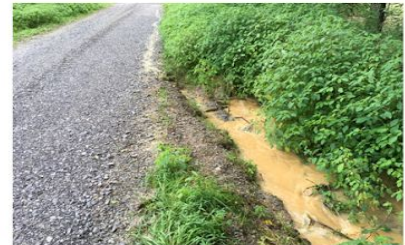
This is 05 Aug at 15:08 hr. Sediment is still still entering stream at damaged bank.

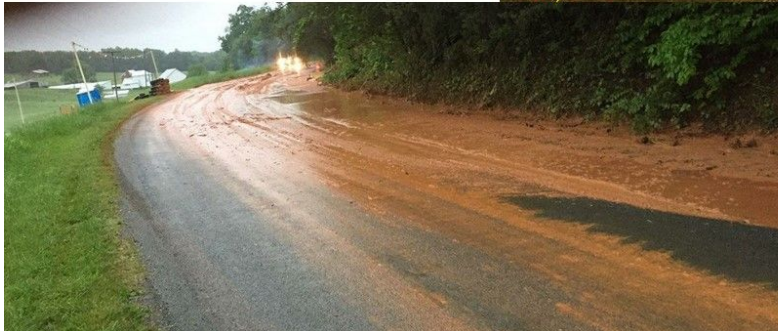
Figure 11: Potential violation reported - May 18, 2018

Erosion gullies, Bare soil - no mulch, Failing slopes, Failed BMPs, Sediment discharge outside construction area

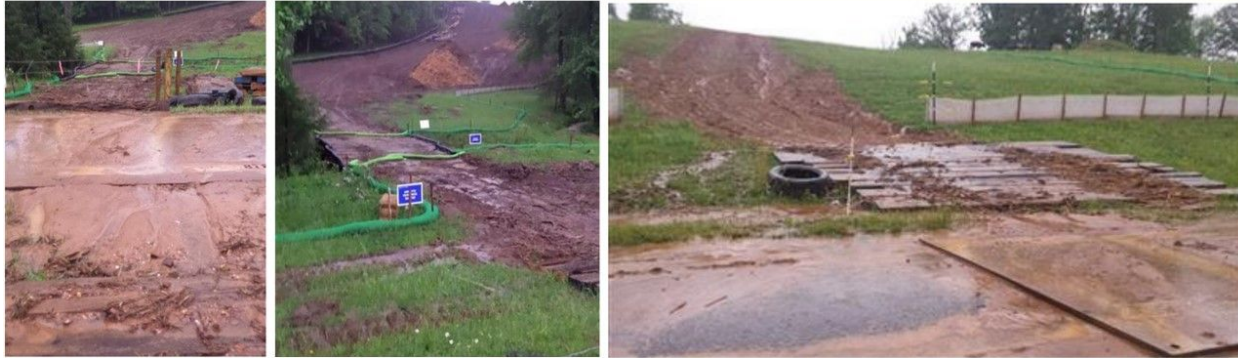
Figure 16: Potential violations reported May 18, 2018

Bare soil - no mulch , Failed BMPs , Sediment discharge outside construction area

Location Notes: 580 Wildwood Rd, Boones Mill, VA

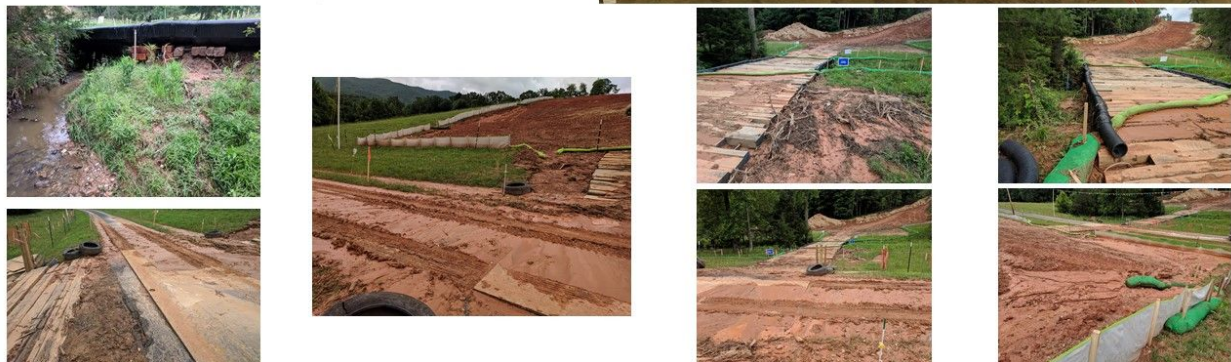
Figure 17: Potential violations reported May 28, 2018

Bare soil - no mulch , Failed BMPs , Sediment discharge outside construction area

Location Notes: 580 Wildwood Rd, Boones Mill, VA

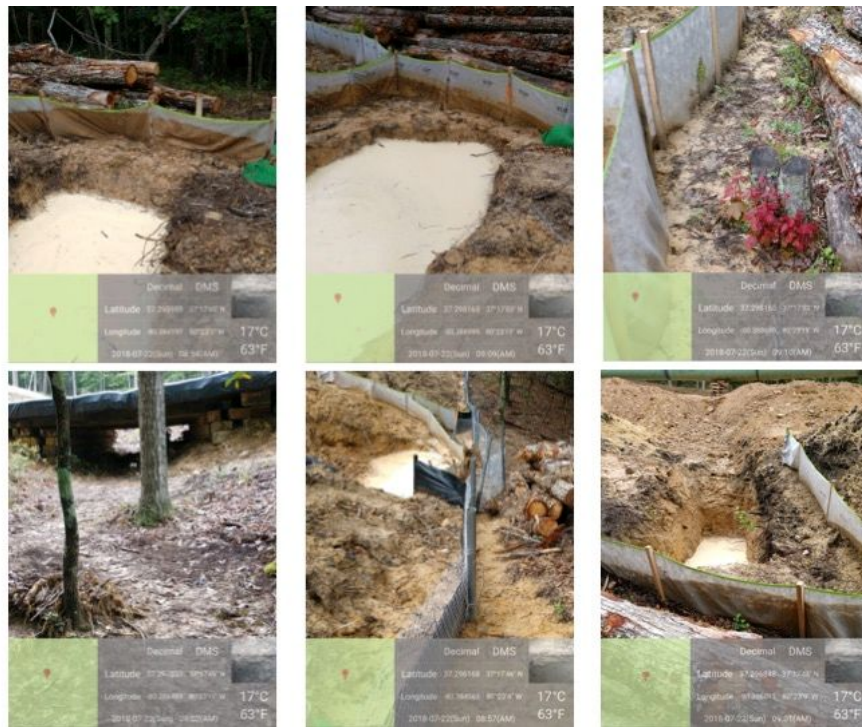
Figure 31: Photos from July 22, 2018 reported incident on Slayton property

Despite DEQ's issuance of a Notice of Violation July 9, 2018 and MVP's subsequent voluntary stop work to repair ESC measures, the Slusser's Chapel Conservation area continued to see erosion and sediment control incidents, with additional ESC failures reported on the Dyer property July 17 and July 22, and on the Slayton property July 22, 2018. The images shown below are from those reports. One image from the reported incident on the Slayton property shows the stream bed clogged with mud as a result of repeated failures.

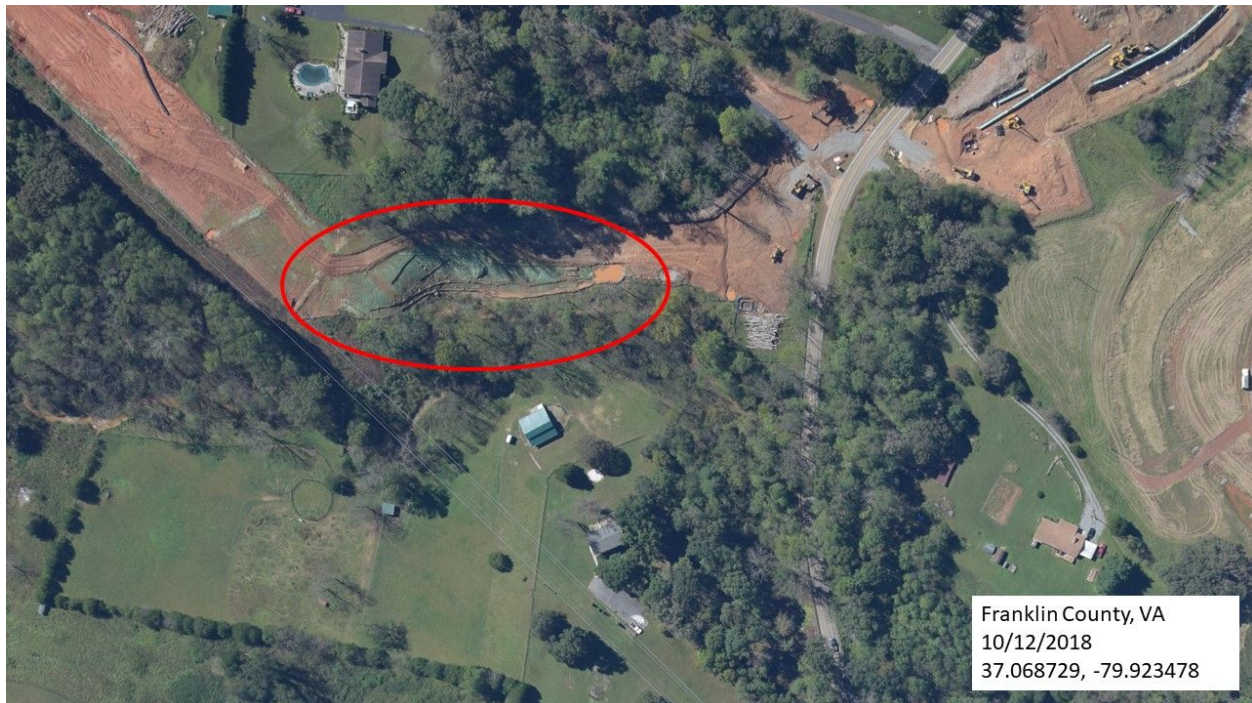
Figure 3: Image from 10/12/2018 shows E&S issues in area identified by red circle.

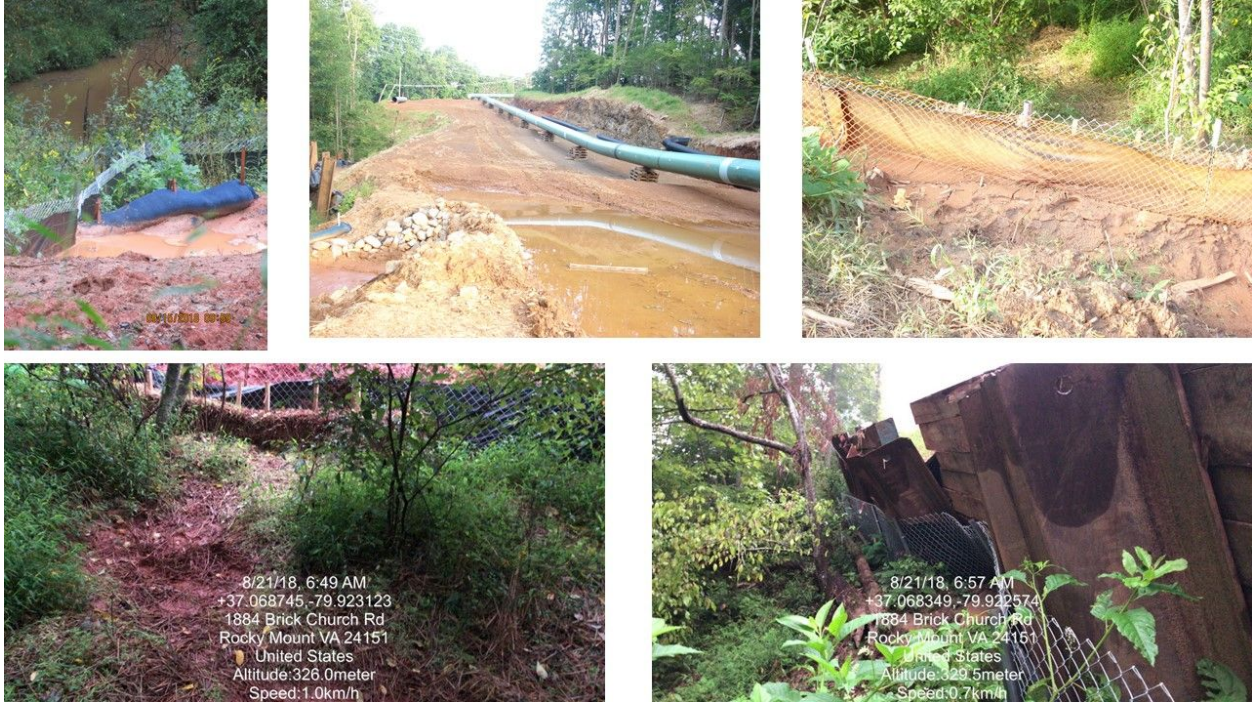
Figure 5: Ground support images. Pallets and plywood sheeting used as sediment barriers.

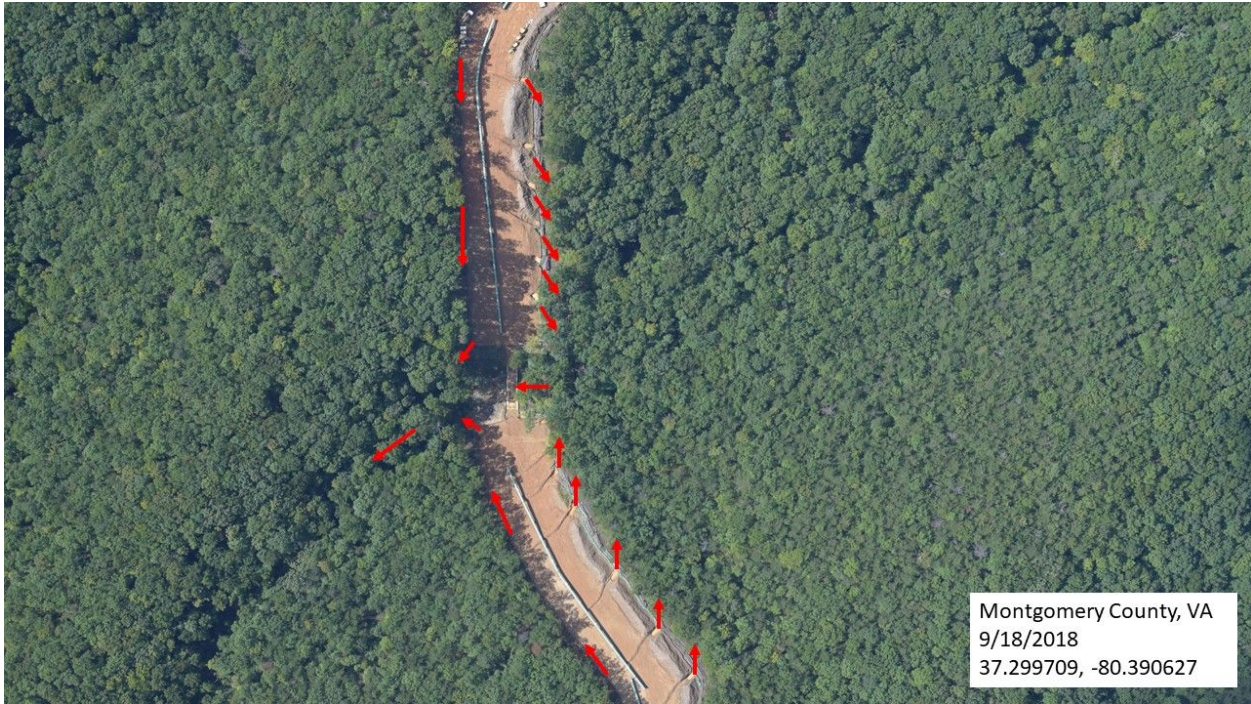
Figure 6: Brush Mountain in Montgomery County, Virginia; Flight date 9/18/2018; Flow lines indicated by red arrows.

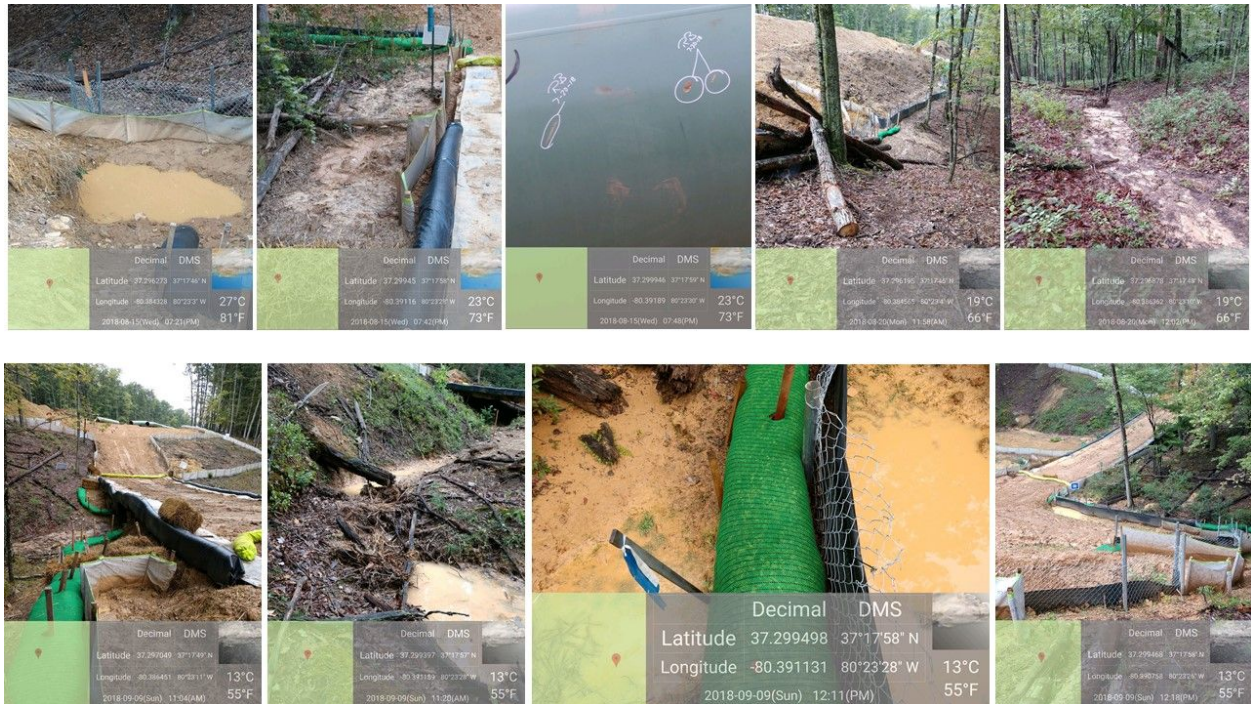
Figure 7: Ground images showing issues along the MVP construction LOD

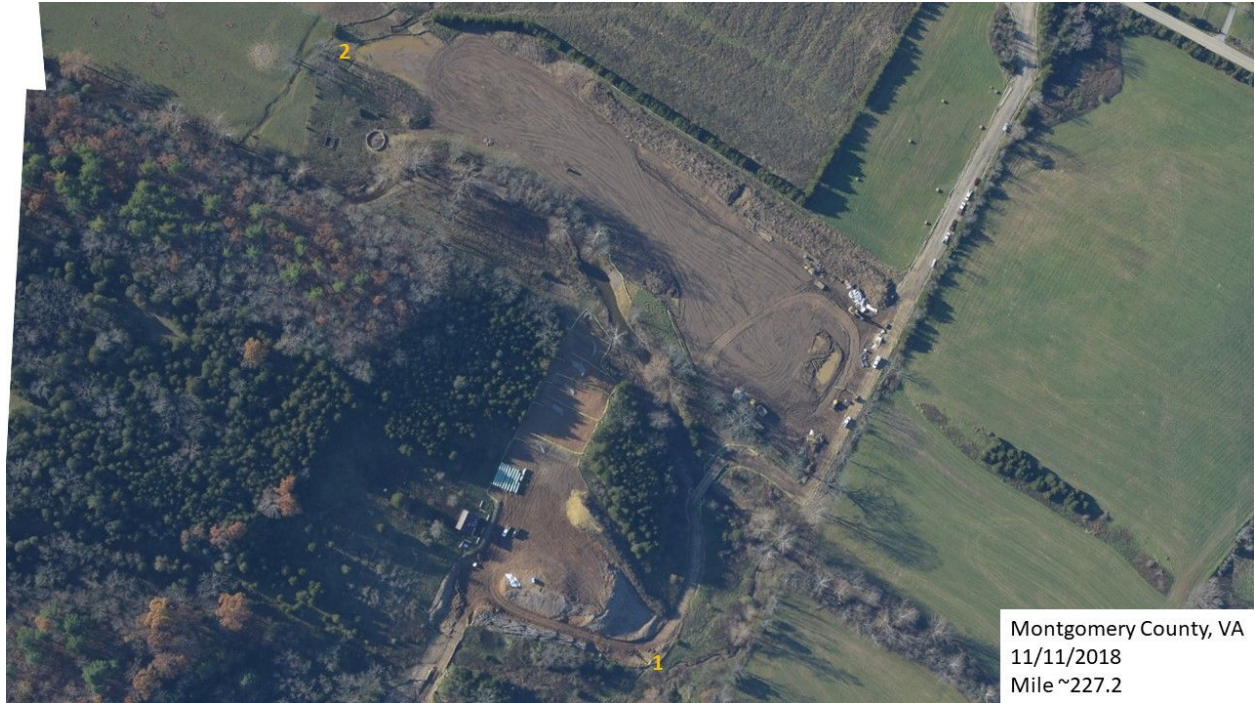
Figure 9: Base of Paris Mountain in Catawba. Numbers 1 & 2 indicate locations of constant overflow. Closer views in figure 10 & 11.

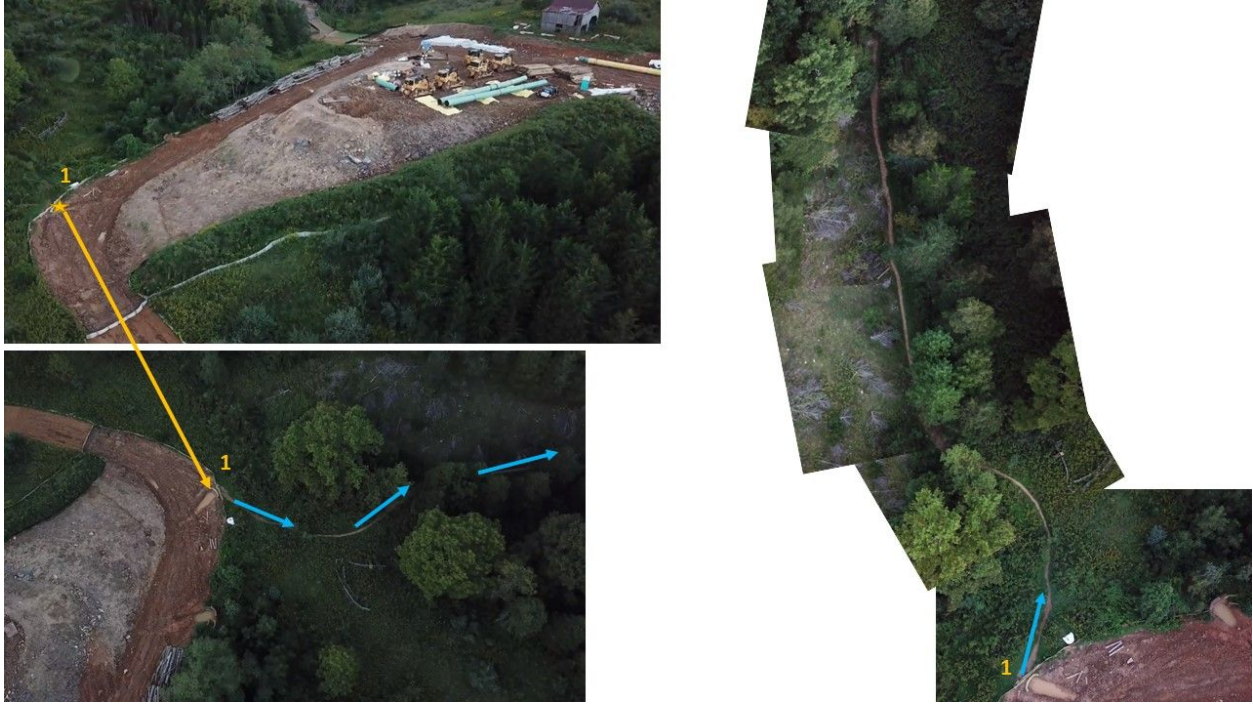
Figure 10: Location 1 shows full catch basins and sediment laden stormwater flowing to the North Fork of the Roanoke River. Flows are constant during every rain event.

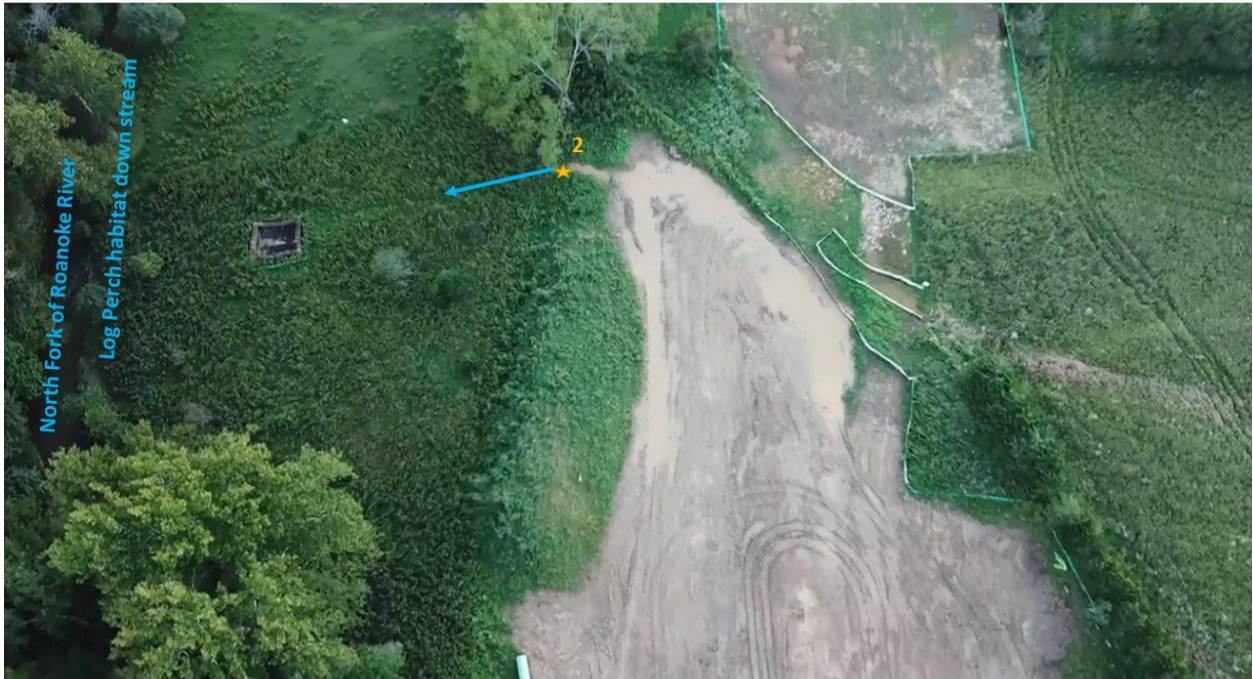
Figure 11: Location 2 is another location at this site where sediment laden stormwater continually flows into the North Fork of the Roanoke River during rain events.

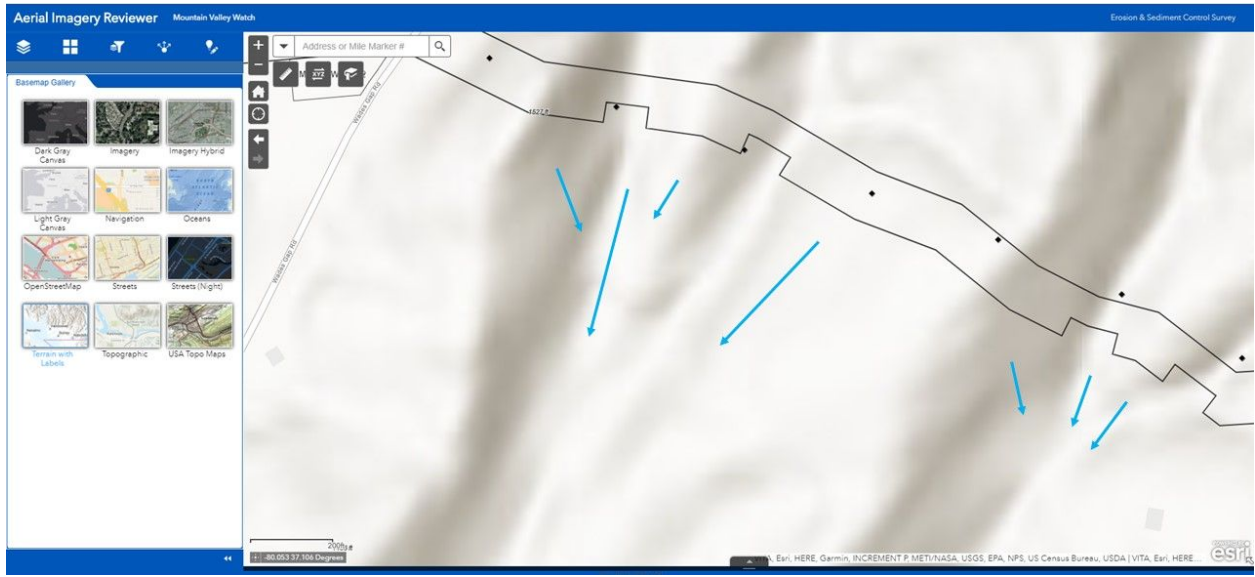
Figure 13: Same location as figure 6, shaded relief map used as basemap showing drainage flow patterns.

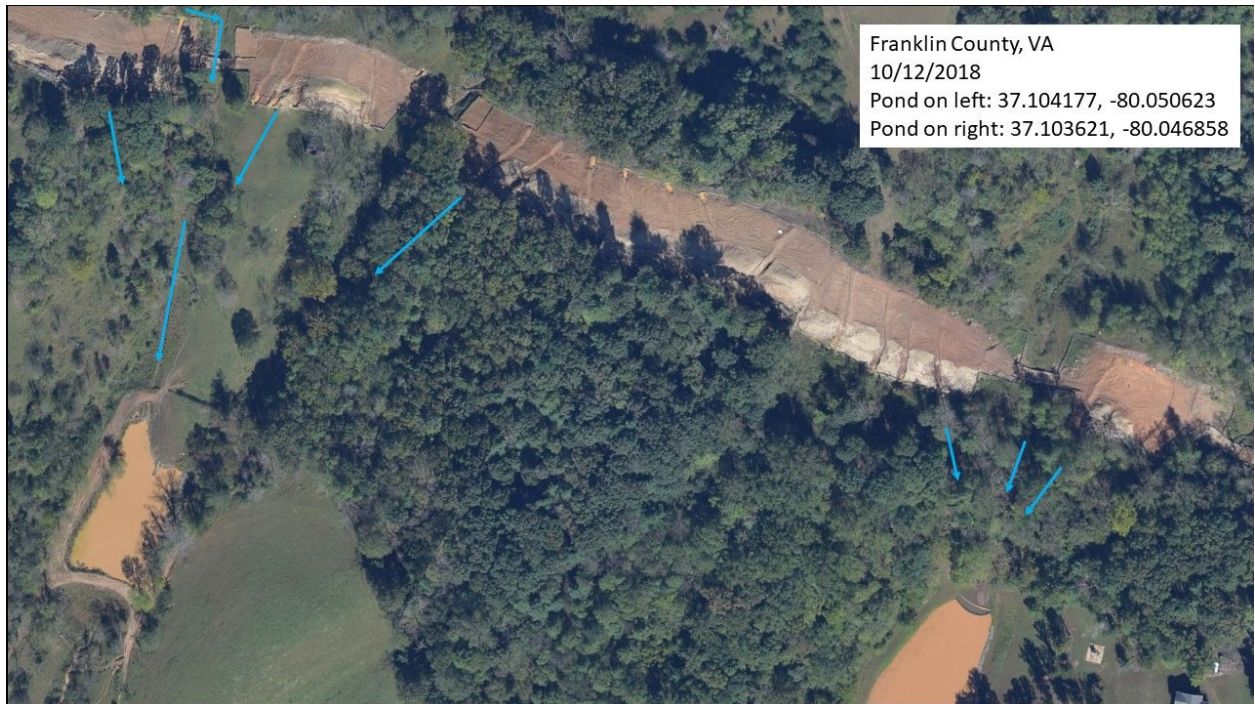
Figure 14: Same location as figures 6 & 7. Sediment laden **ponds** and flow pattern arrows from MVP construction LOD indicate potential source.
