A REPORT BY WILD VIRGINIA

FEBRUARY 2023

MOUNTAIN VALLEY PIPELINE POLLUTION IN VIRGINIA WATERSHEDS

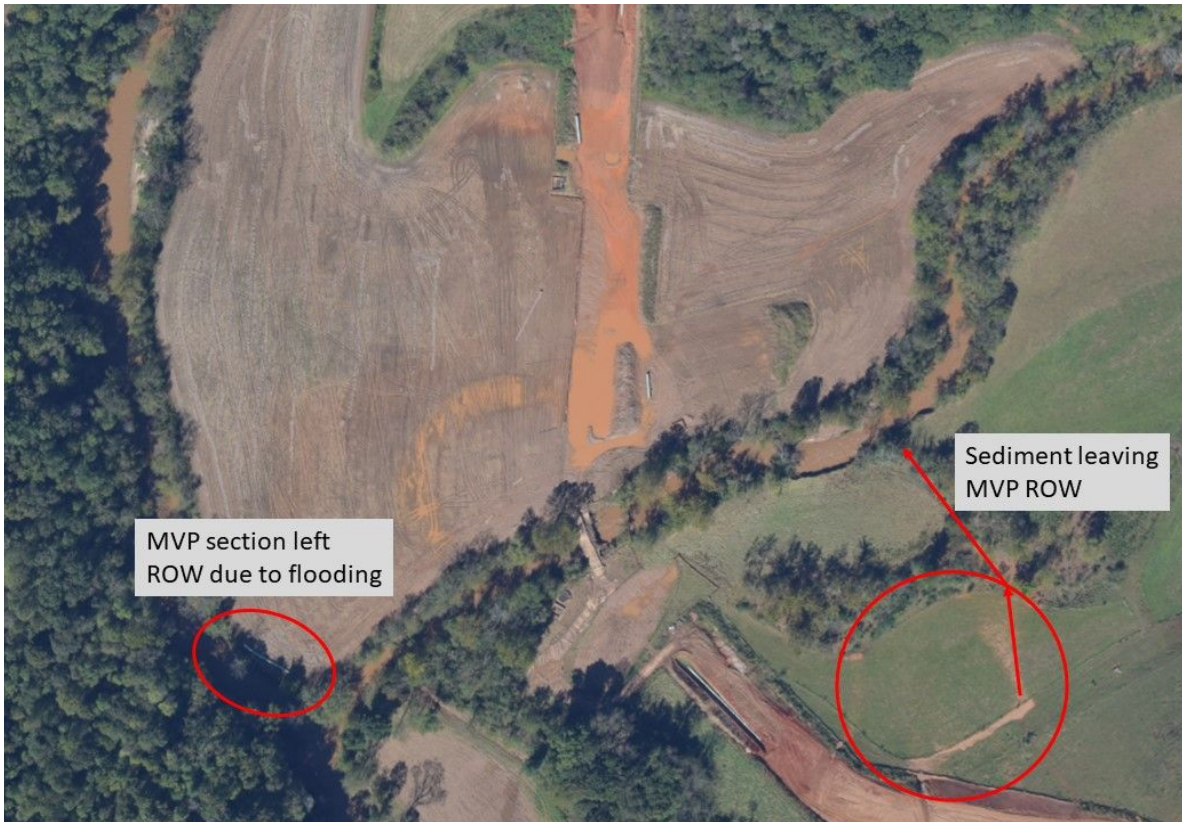
Figure 15: Franklin County, Virginia image (10/12/2018) showing a large section of pipe washed from MVP construction ROW due to flooding.

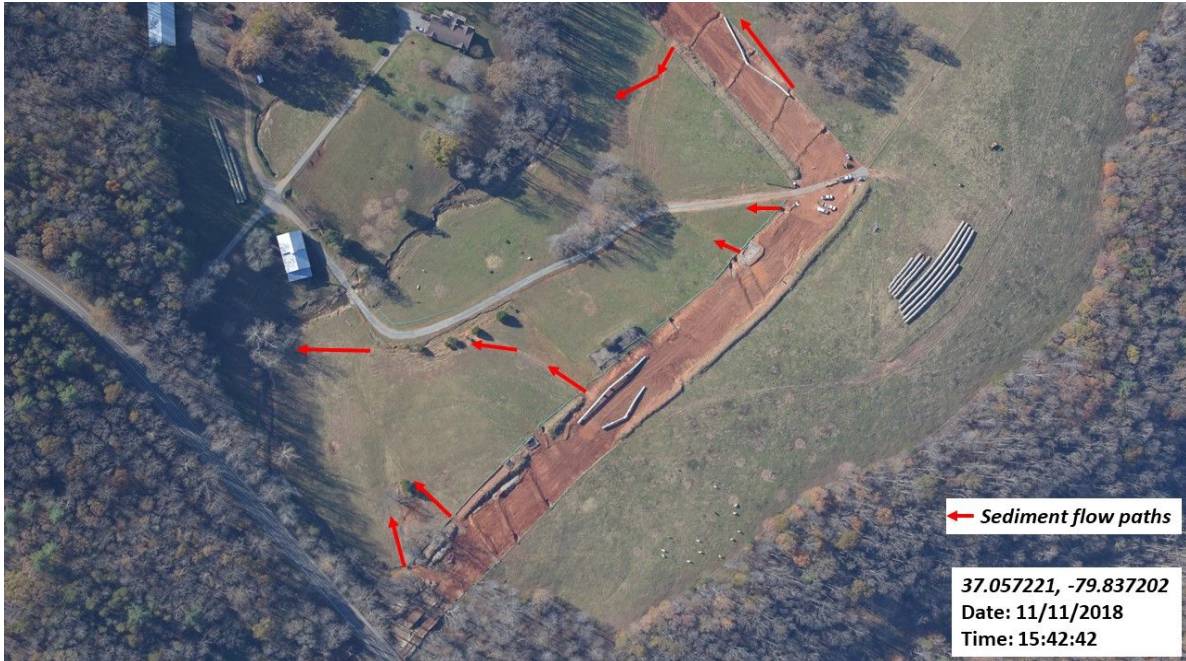
Figure 16: Flow paths where sediment leaves MVP construction ROW during rain events.

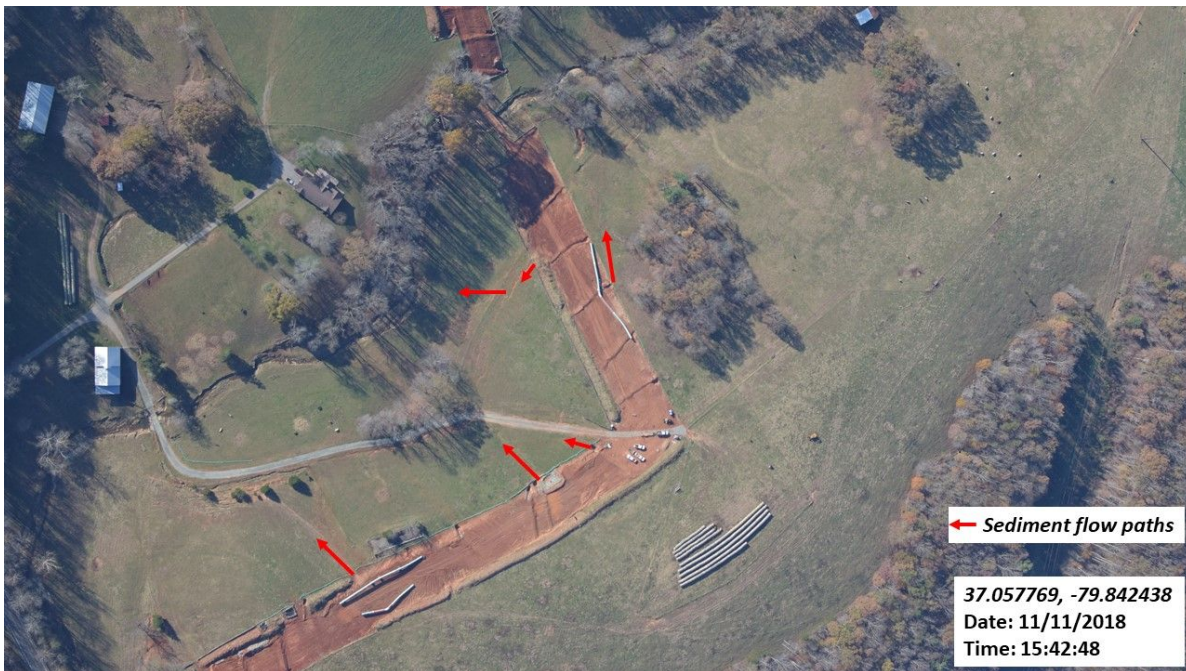
Figure 17: Flow paths where sediment leaves the MVP construction ROW during rain events.

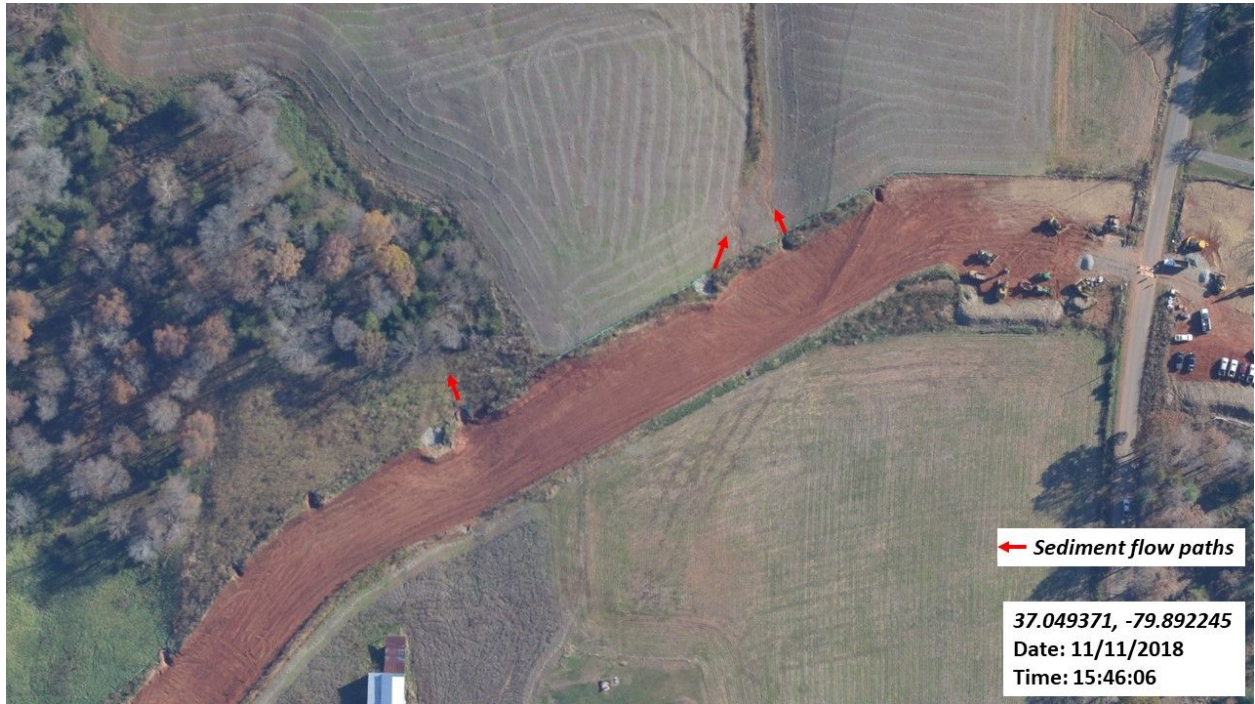
Figure 18: Sediment flowing off pipeline corridor onto adjacent properties.

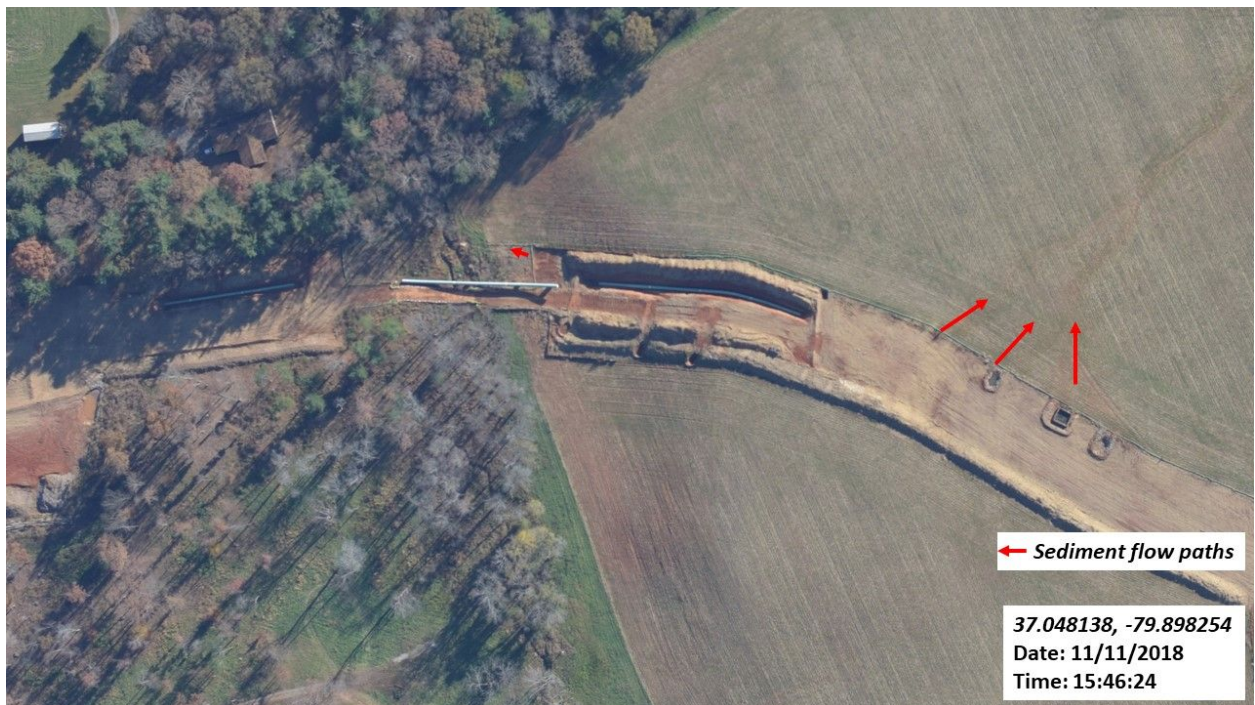
Figure 19: Sediment flowing into adjacent field.

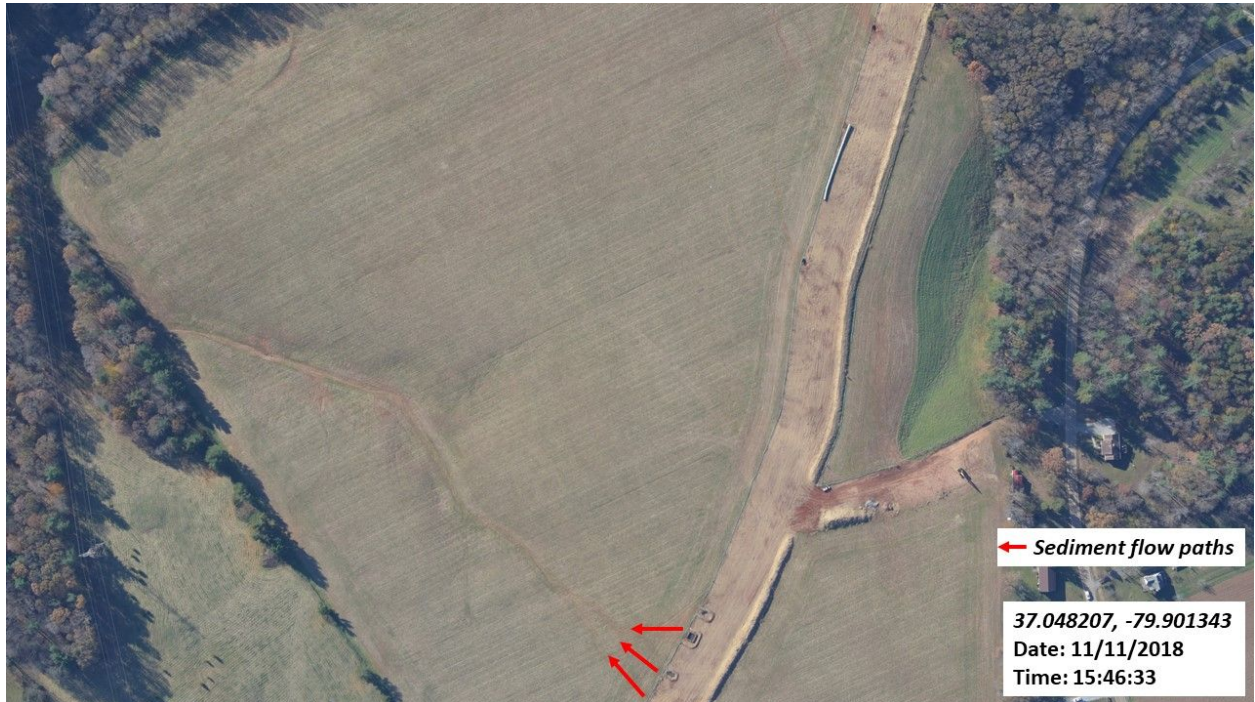
Figure 20: Sediment flowing into adjacent field into drainage channel conveying sediment to stream.

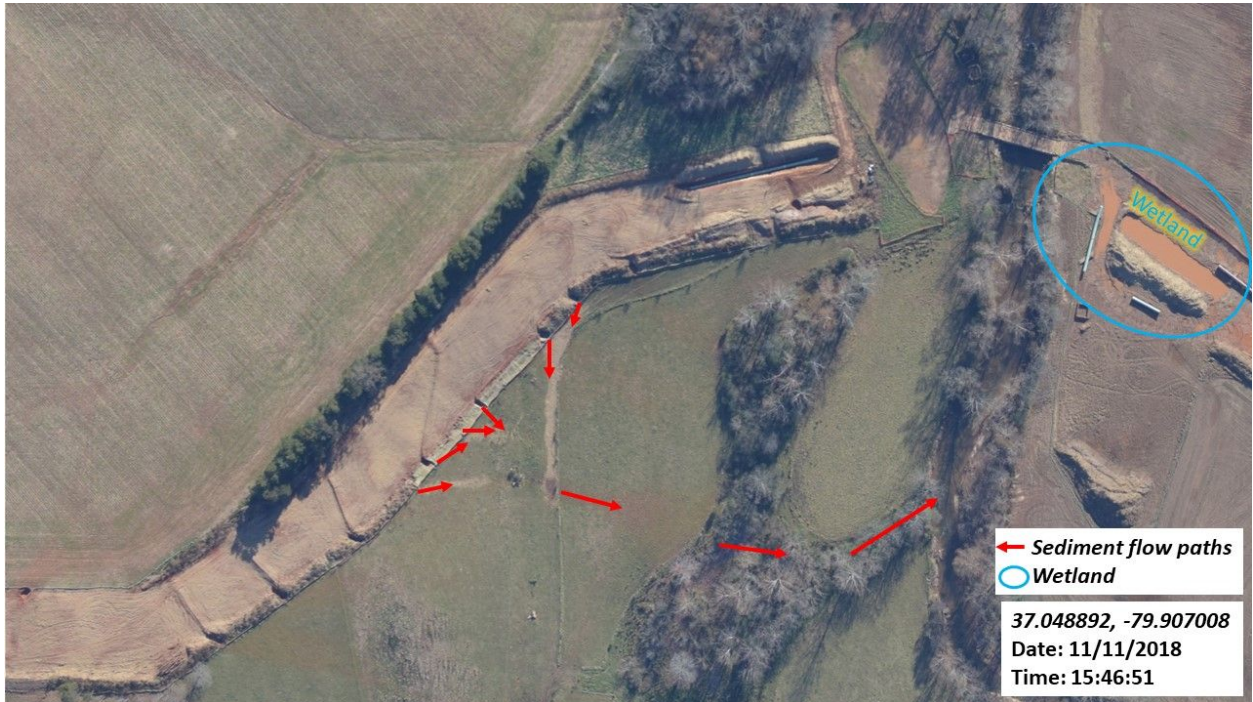
Figure 22: Sediment flowing into adjacent fields and drainage channels flowing to stream. Sediment ponding in delineated wetlands.

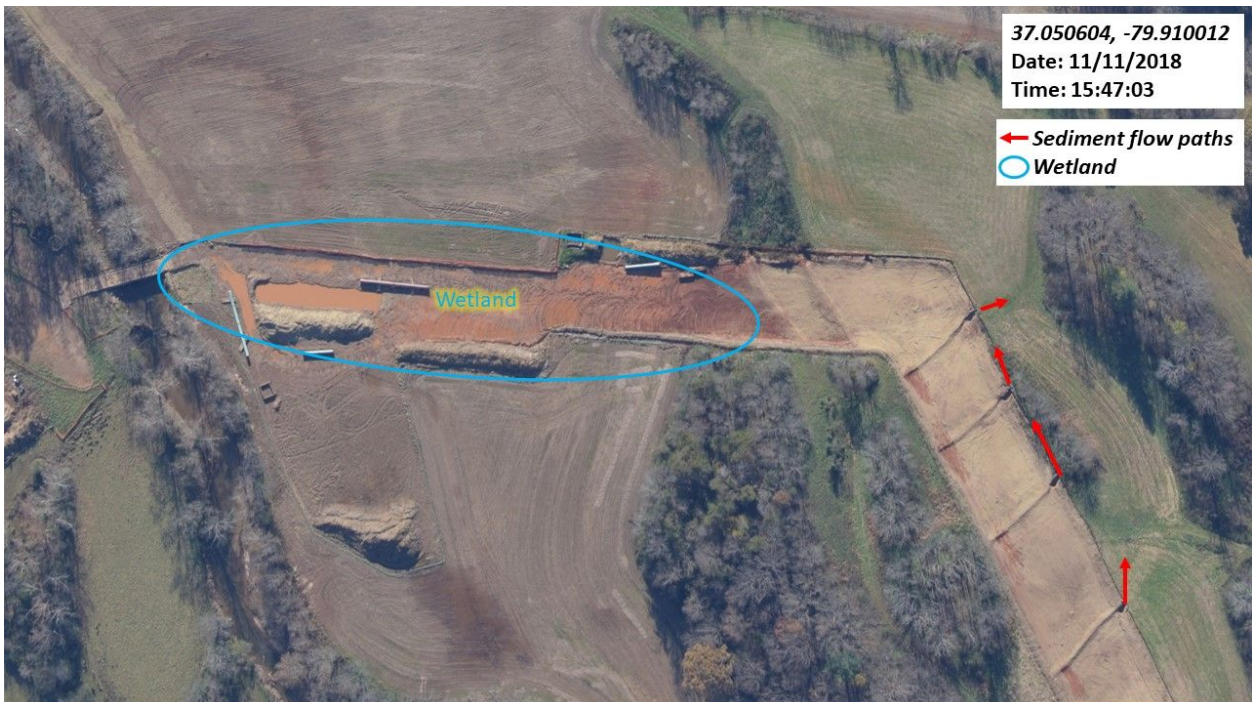
Figure 23: Sediment flowing from waterbars off of pipeline corridor. Sediment ponding in delineated wetlands.

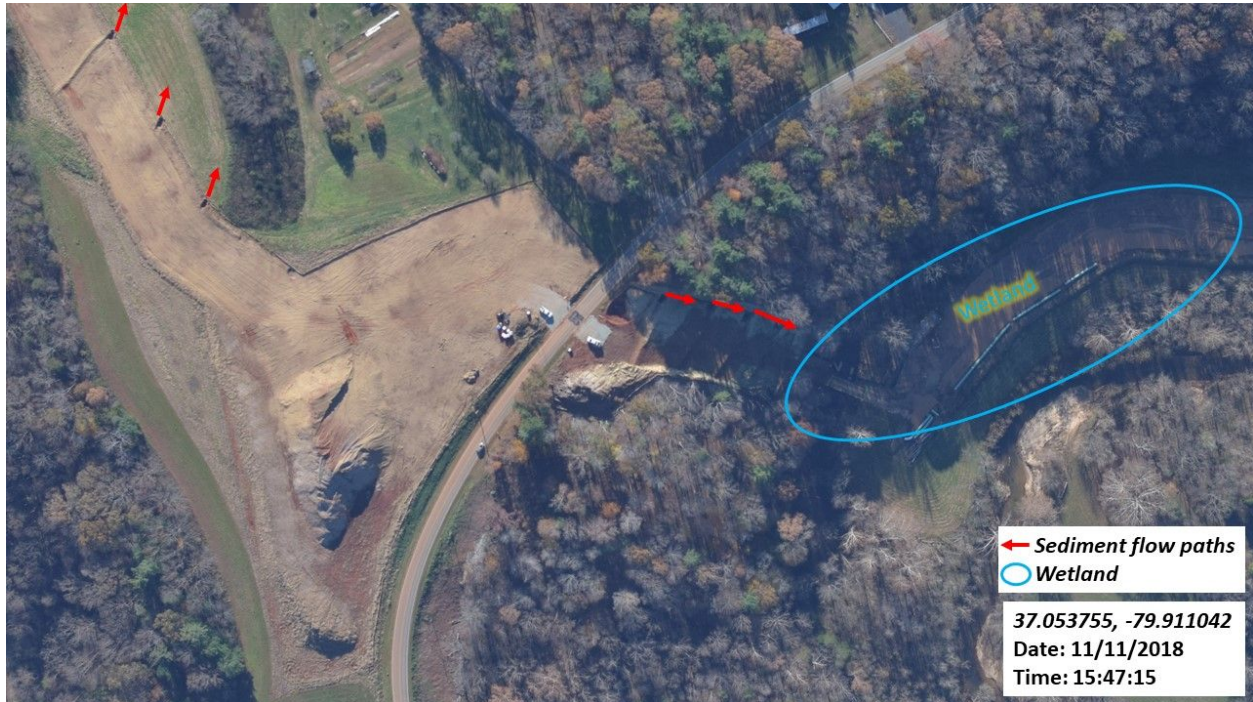
Figure 24: Iron Ridge Road shows discoloration from mud in roadway. Flow paths and wetland identified.

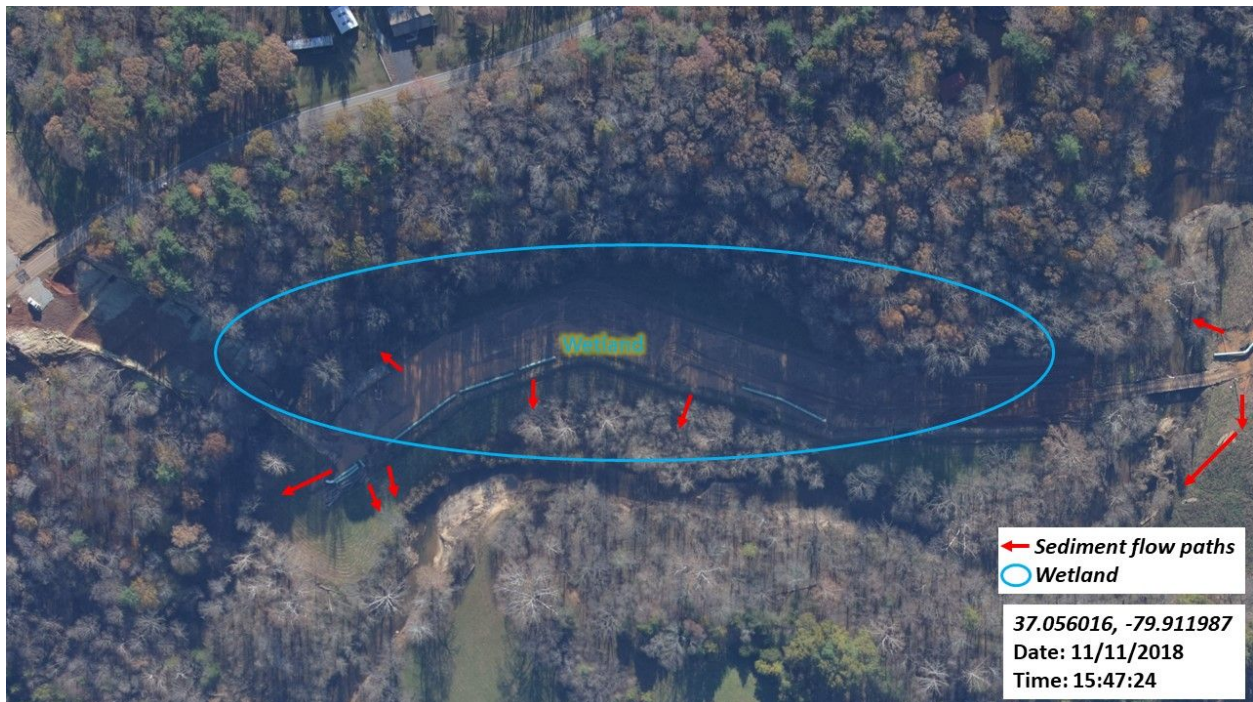
Figure 25: Sediment flowing off right of way into adjacent stream. Sediment deposits may be seen along stream.

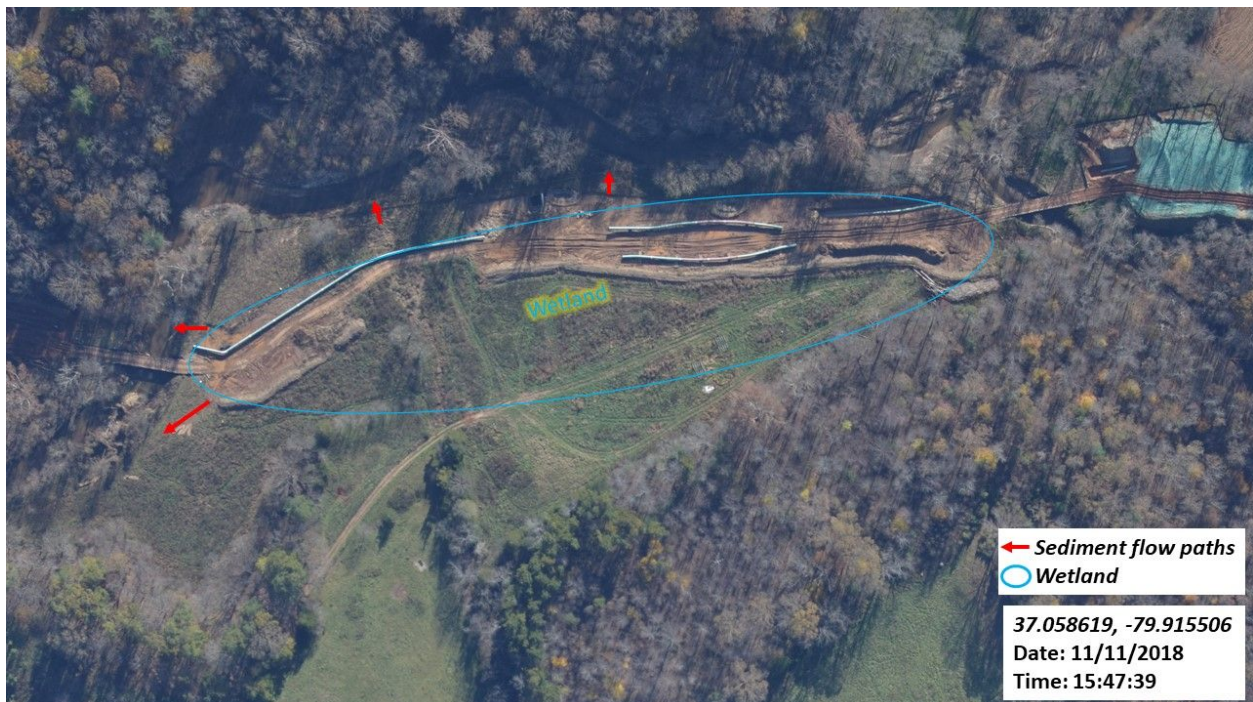
Figure 27: Trenching in a wetland; area is shown in ground photos below from table 1 & 2.

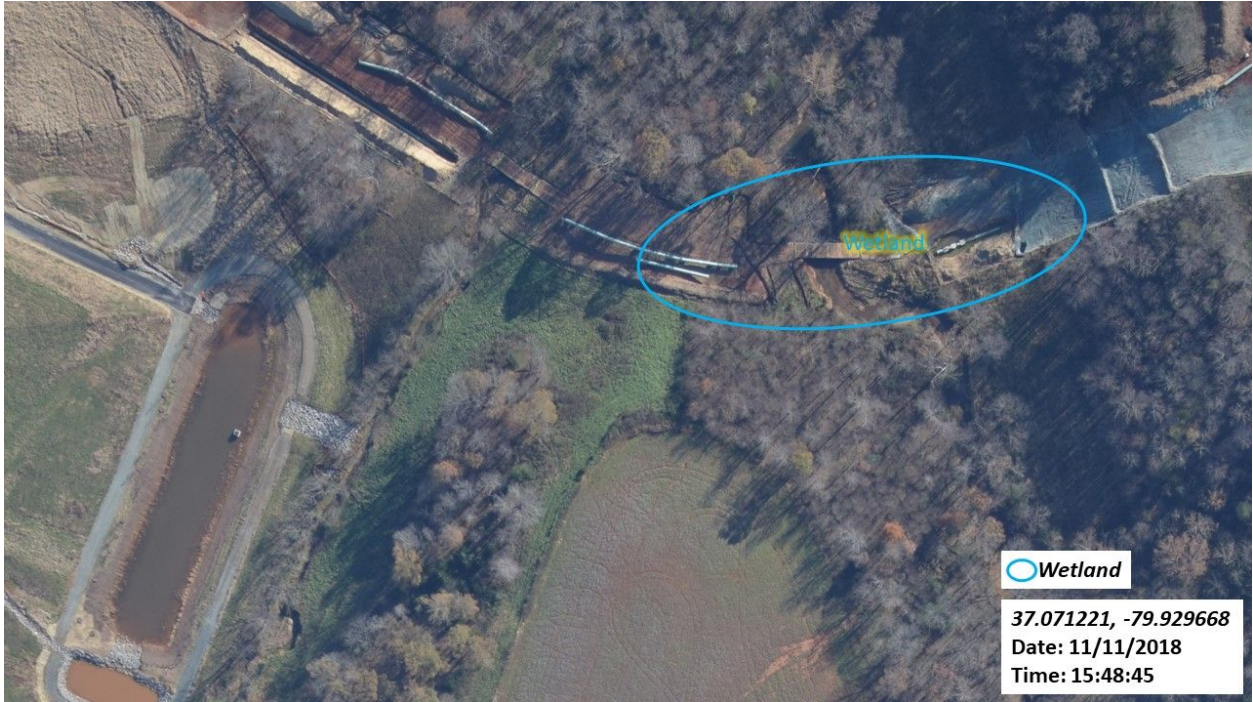
Figure 28: Wetlands and stream show evidence of sediment contamination.

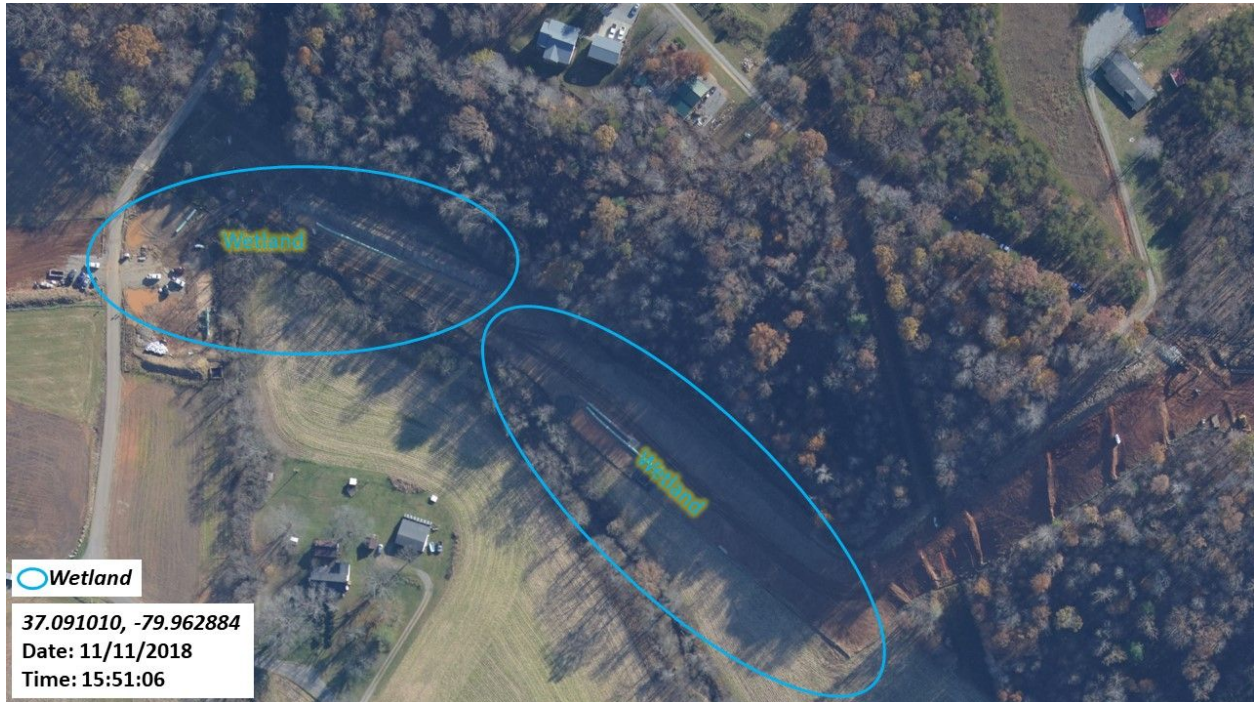
Figure 34: Wetlands area encroachment. Sediment flowing into stream adjacent to right of way.

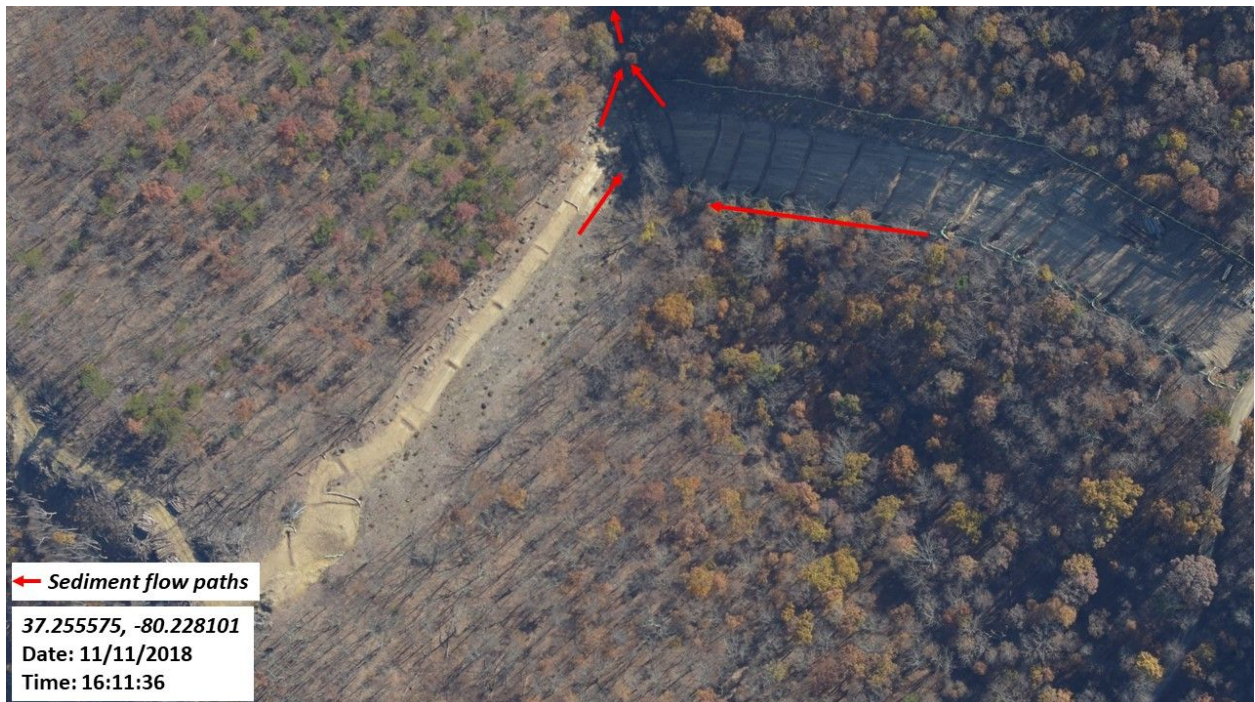
Figure 35: Sediment flowing into stream channel from pipeline right of way. Stream channel is at bottom or slopes.

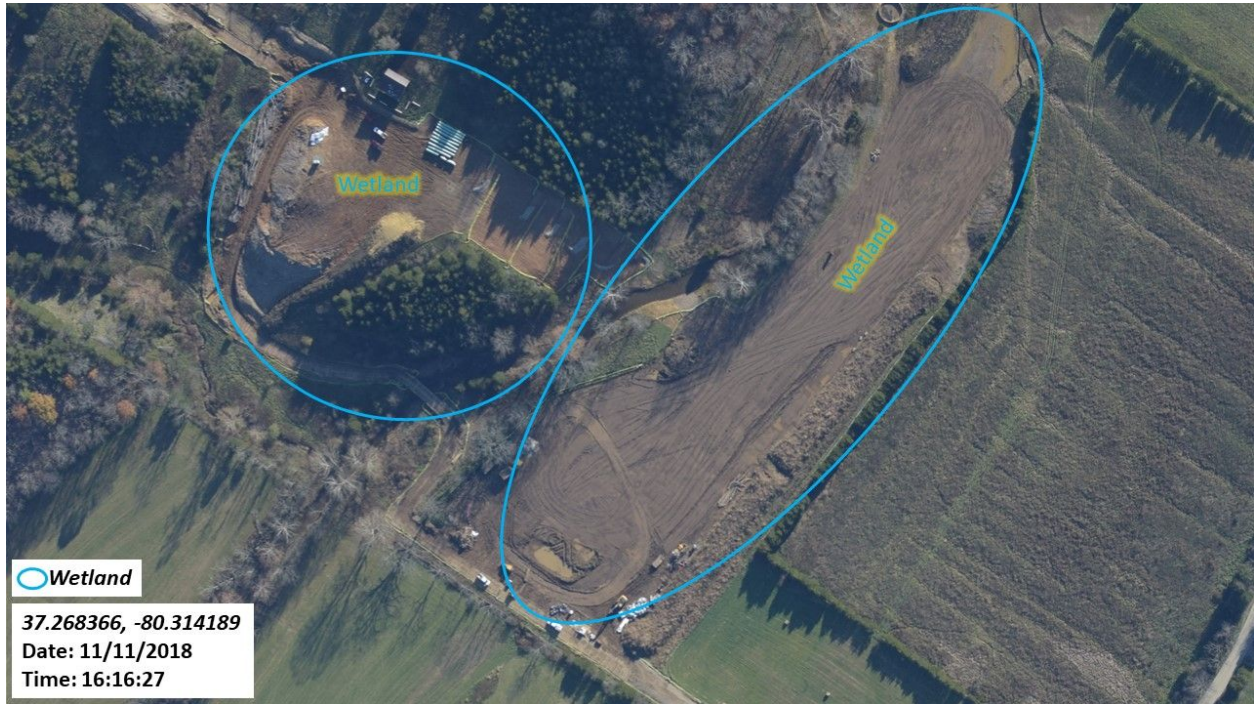
Figure 36: Wetlands area encroachment. Sediment flowing into North Fork Roanoke River.

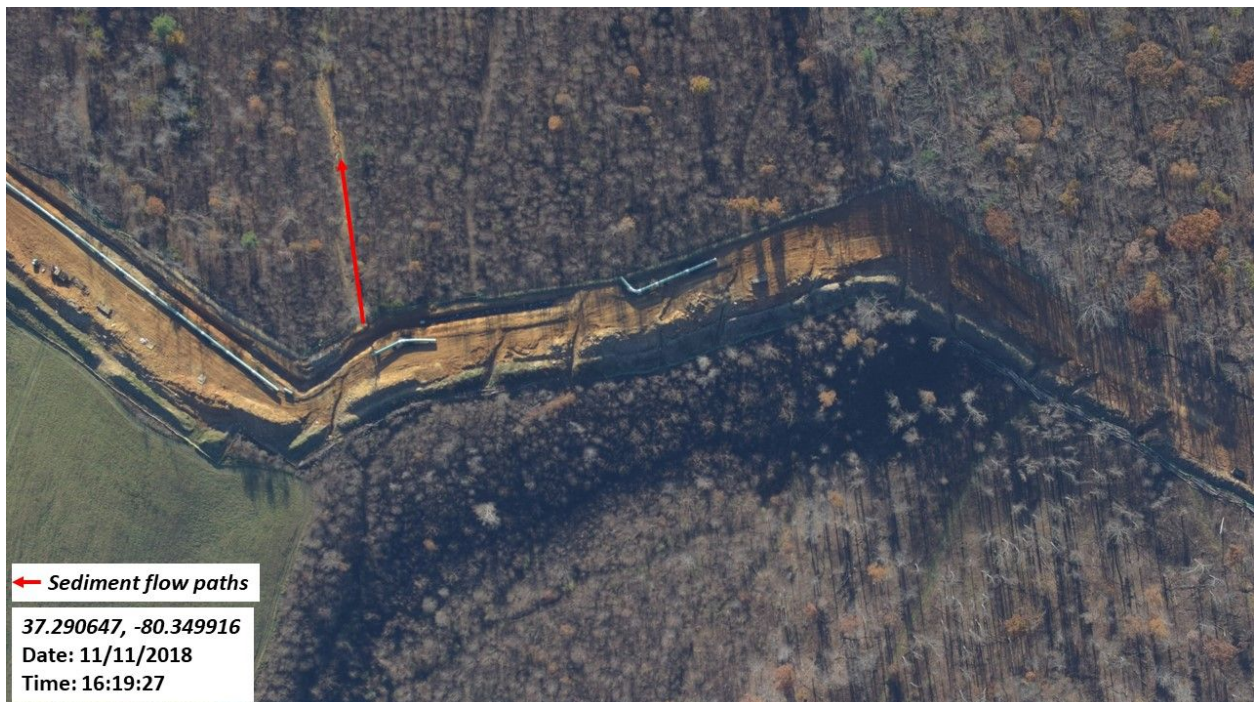
Figure 37: Sediment flowing into stream channel from right of way.
