**The Wilderness Society et al. Comments on the  
U.S. Forest Service Mountain Valley Pipeline and  
Equitrans Expansion Project Draft Supplemental  
Environmental Impact Statement (#50036)**

**EXHIBIT 1**

Assessment of erosion, sedimentation, and water quality impacts of the Mountain Valley Pipeline and Equitrans Expansion Project's proposed crossing of the Jefferson National Forest as it pertains to the U.S. Forest Service's Draft Supplemental Environmental Impact Statement dated December 2022

Prepared by Jonathan A. Czuba, Ph.D., Licensed Professional Engineer

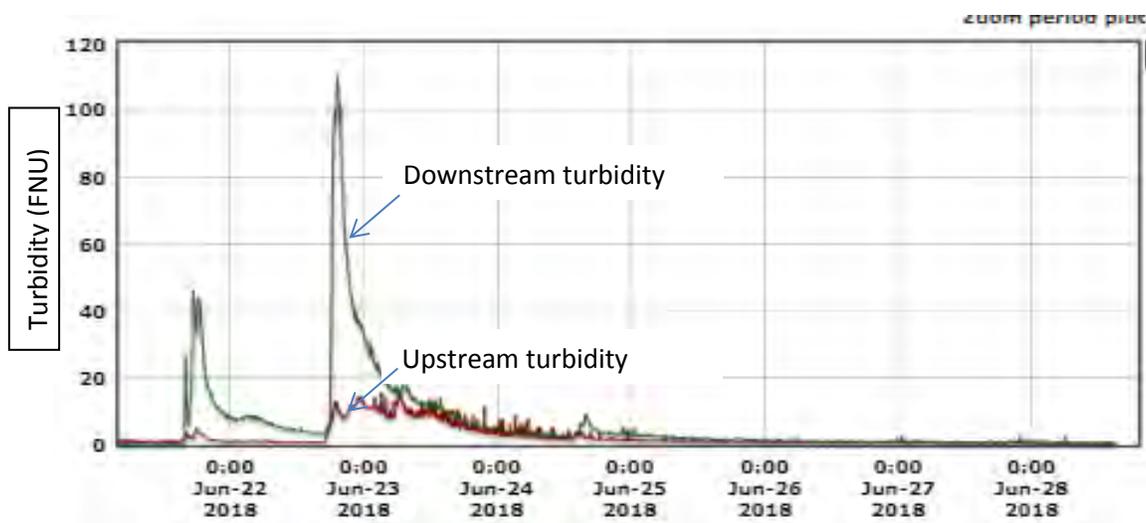
Figure2: Turbidity (FNU) at Ramsey’s Draft, June 21-28.

At Ramsey's Draft, along the proposed ACP pipeline corridor, elevated turbidity was observed in the USGS online data on June 21 and again on June 22. Elevated turbidity was observed at monitoring stations both upstream and downstream of the proposed stream crossing. Turbidity pulses were closely aligned in time to high-flow events (Fig. 1 below). In both instances, observed turbidity was an order of magnitude higher at the site downstream of the proposed crossing than at the site upstream of the proposed crossing (Fig. 2). A USGS technician visited the site on June 24 and found no evidence of probe fouling or equipment failure. Areas where tree felling had occurred some time in the past several months were observed in the watershed, but no active construction, tree felling or ground disturbance was observed (photos may be provided upon request). No further evidence as to the cause of the observed elevated turbidity was observed.

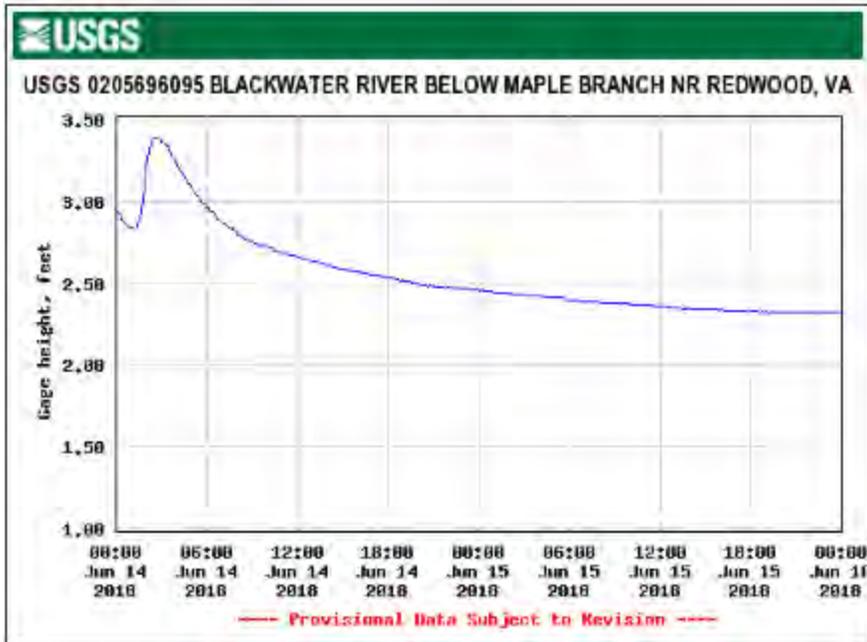
Figure 3: Stream gage height at Blackwater River, June 14-16.

At the Blackwater River along the proposed MVP pipeline corridor, elevated turbidity was observed at monitoring sites located both upstream and downstream of the proposed river crossing on June 14 and again on June 26-27. Both events were closely aligned in time with high flow events on the river (Figs. 3 and 4). During both high-turbidity events, a secondary pulse of high turbidity was observed downstream of the proposed crossing that was not observed upstream of the proposed crossing (compare Fig. 5 to Fig. 6 and Fig. 7 to Fig. 8). A USGS technician visited the site on June 25 and found no evidence of probe fouling or equipment failure. Areas of exposed soil from apparent recent construction activities were observed, as were multiple soil erosion control structures. All erosion control structures appeared intact, and no direct evidence of erosion from the apparent construction areas into the river were observed (photos taken during the site visit are available upon request). This river system is characterized by a high sediment load which has been visually observed by DEQ staff since the study began in summer 2017. Maggodee Creek, located approximately 100m upstream of the upstream monitoring location, also carries a high sediment load, and may have contributed to the turbidity responses discussed above. No further evidence regarding the causes of the observed high-turbidity events was observed.

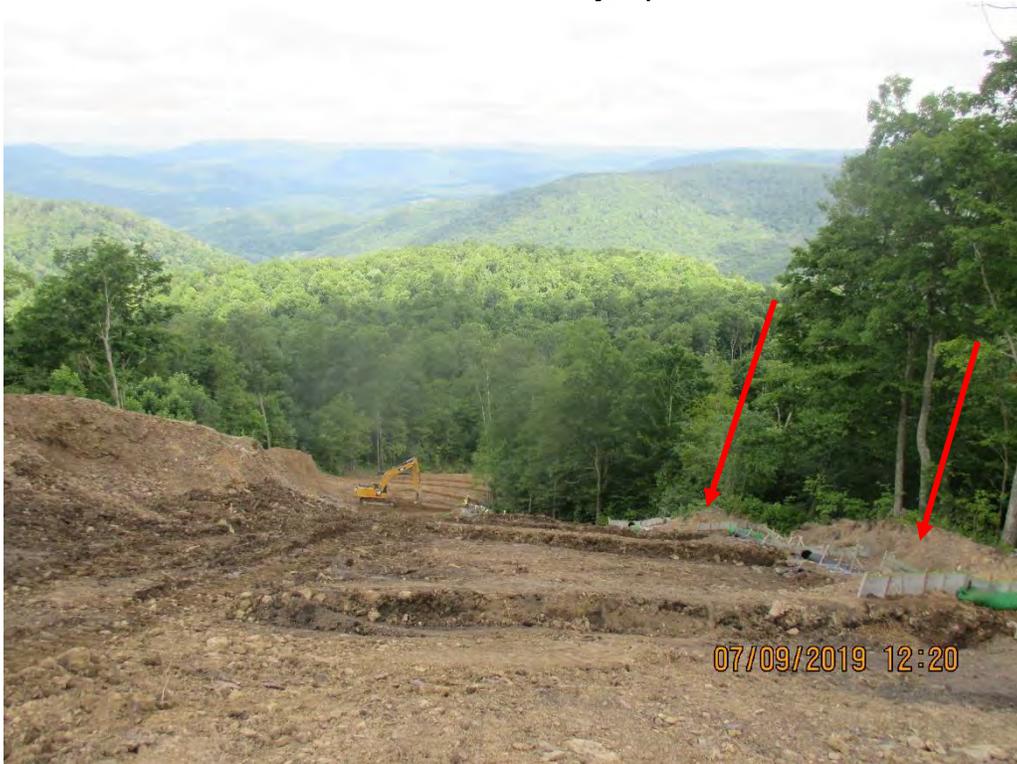
Overview of Lick Creek basin facing North above Station No. 8634+00 on upper section of slope. Arrow depicts cut into natural grade that continues down to lower portion of slope.

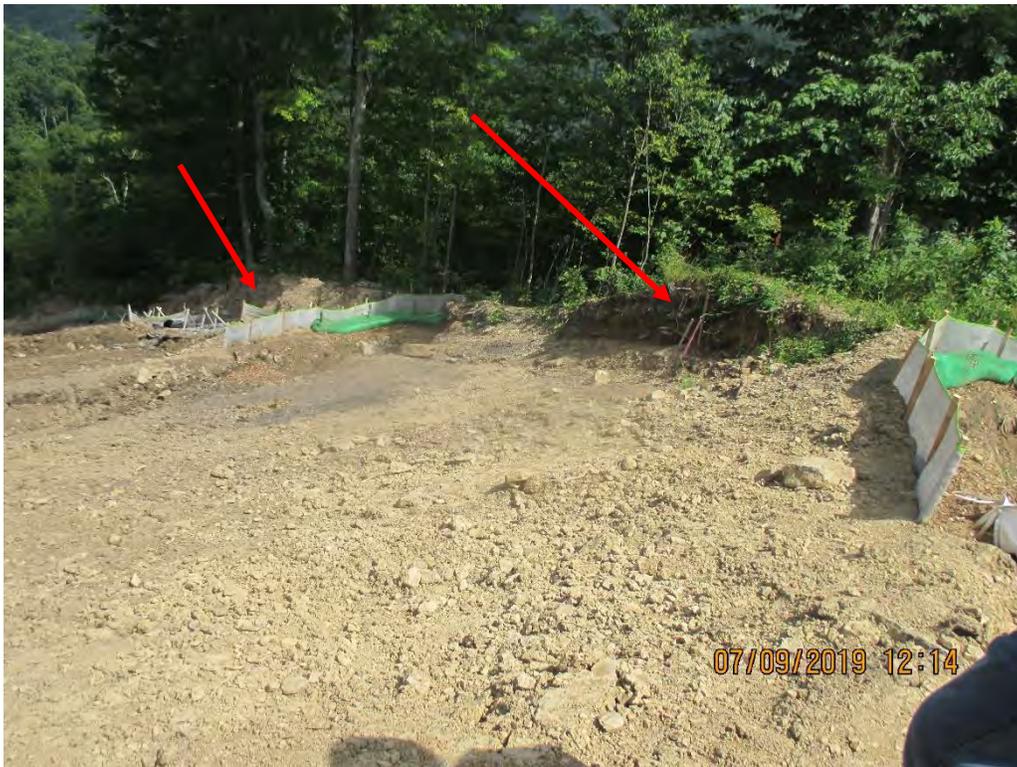
Standing above Stream S-T35A near station No. 8634+00 facing towards the East side of LOD. Arrows depict how the original cut to grade ROW created a wall preventing proper Waterbar outlet installation.

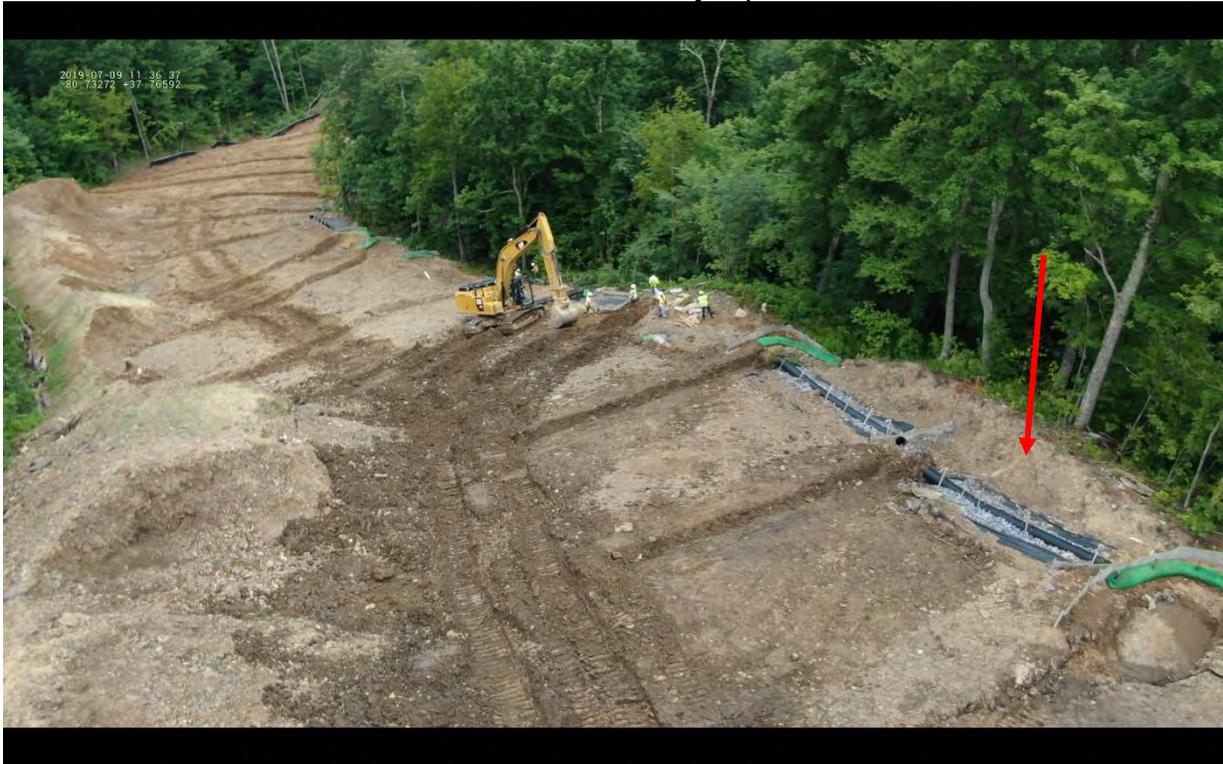
Overview of upper portion of slope near station No. 8634+00. Flume pipe system actively being maintained and enhanced during inspection. Arrow depicts cut original cut that created a “wall” effect not allowing for proper Waterbar outlets to be installed per SWPPP.

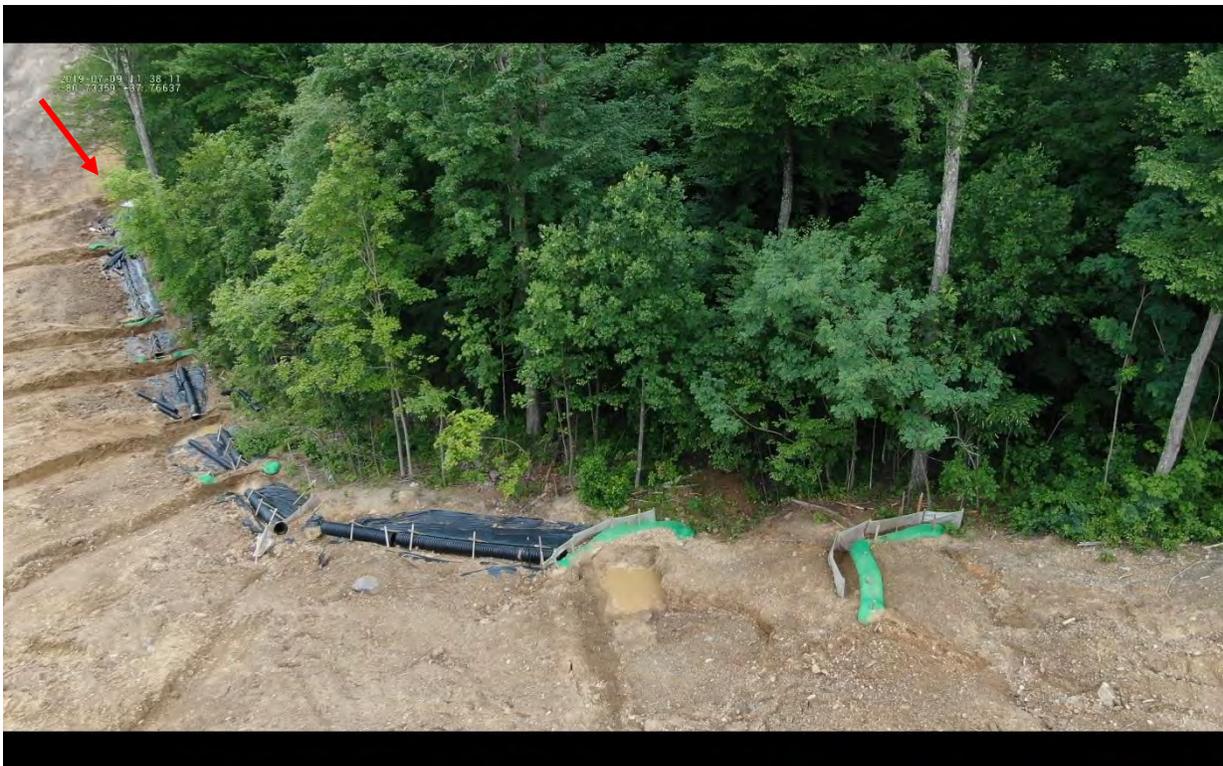
Lower Portion of Slope with flume pipe system. Arrow depicts where single outlet received concentrated flow from Run off and impacts occurred to East side of LOD.

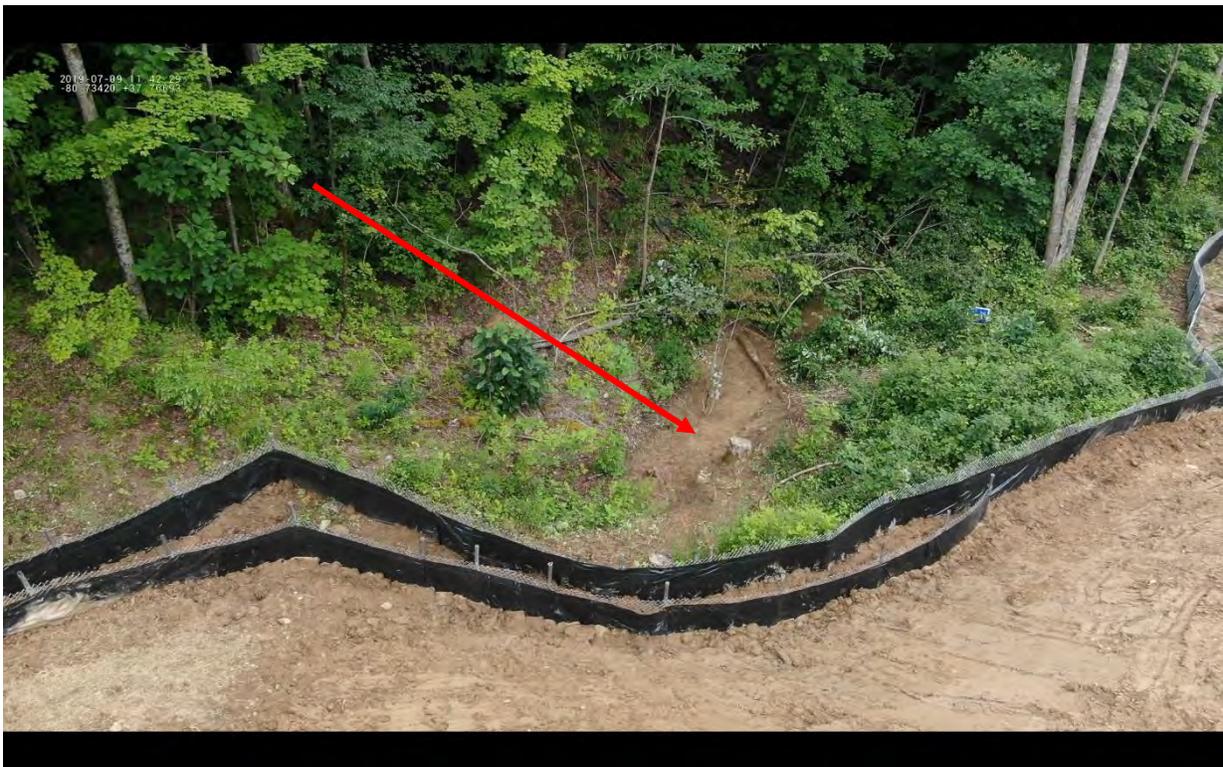
Close up view of additional waterbars added to re-direct run-off to East side of LOD. Arrow depicts photo of sediment deposits in stream S-T35A.

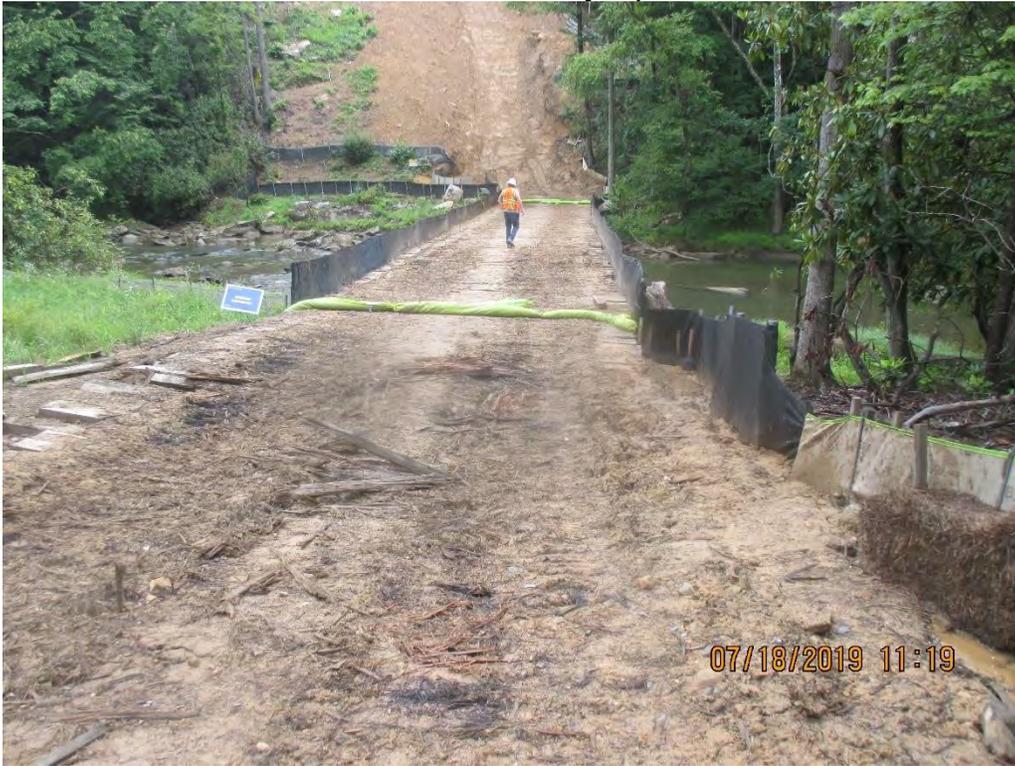
Holly River ROW crossing at station No. 4440+00 facing South.

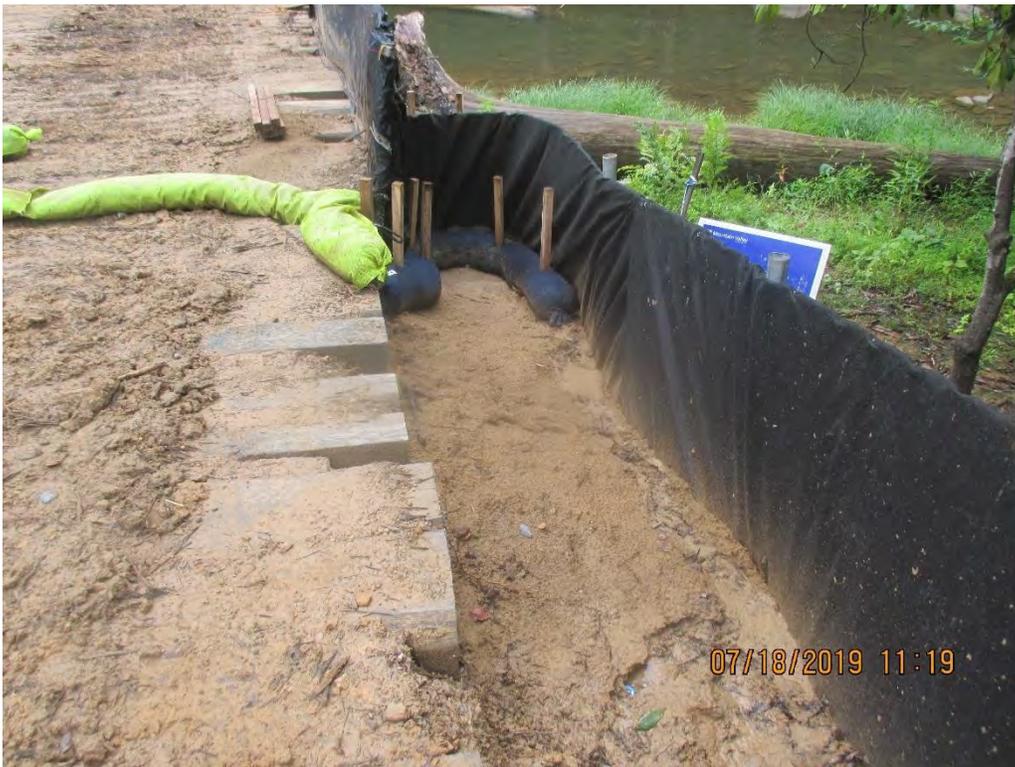
Sediment deposited behind controls on NW side of Bridge.

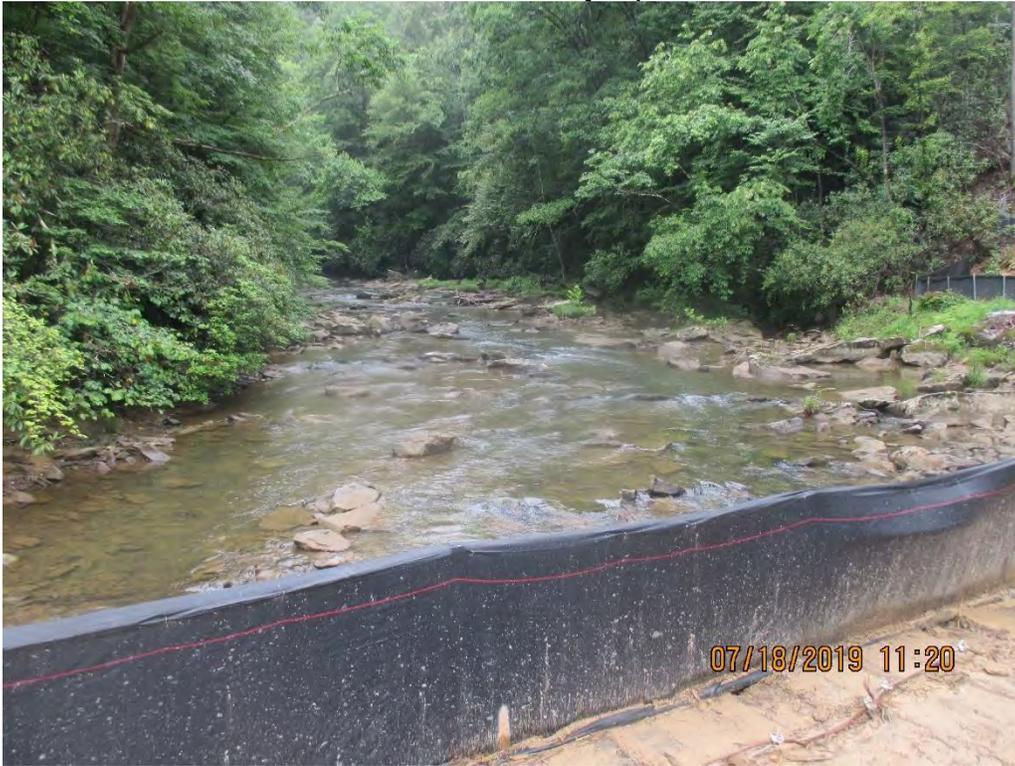
Facing upstream at the Holly River MVP RPW crossing near station No. 4440+00

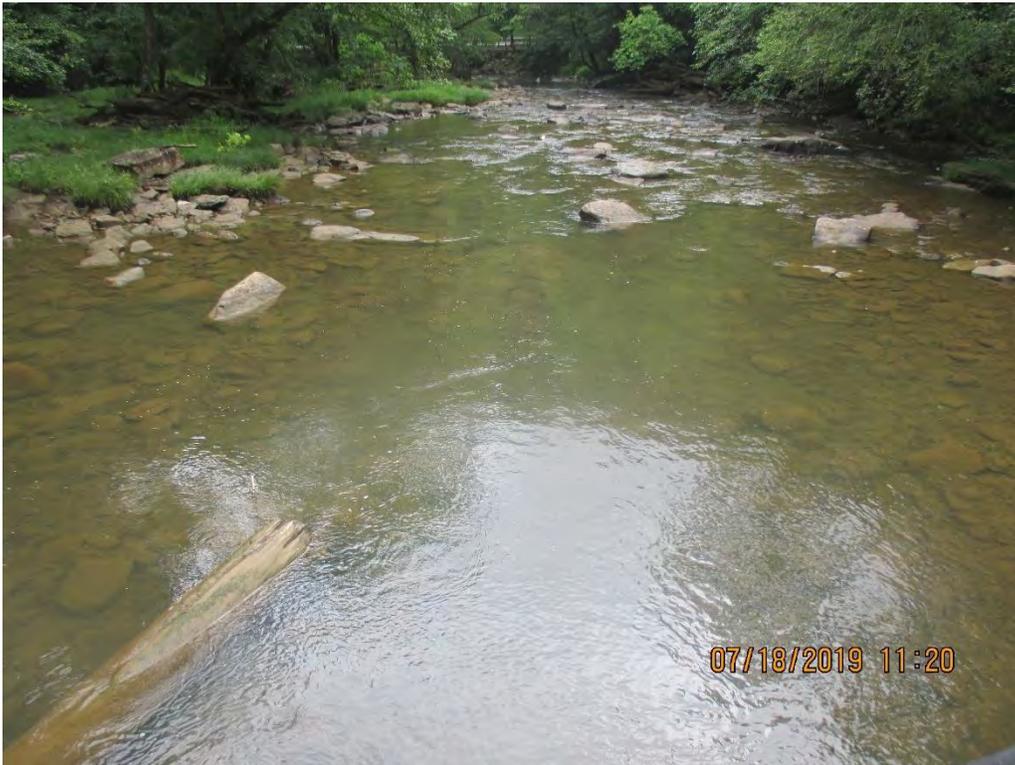
Facing downstream at the Holly River MVP RPW crossing near station No. 4440+00

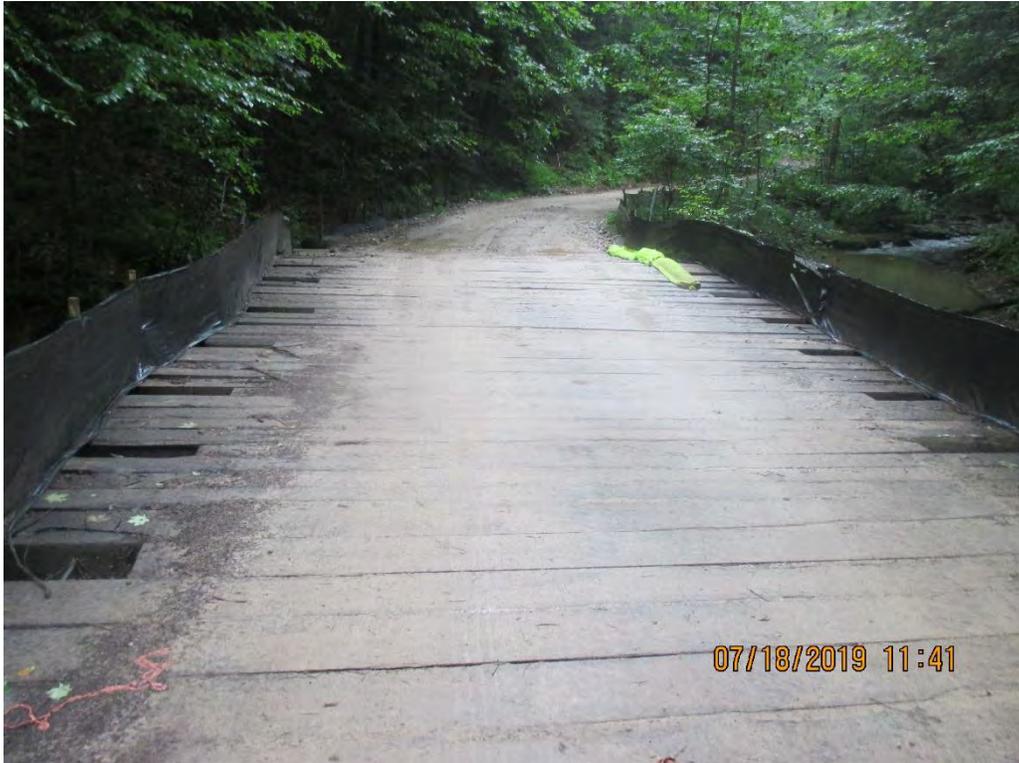
Access Road MVP-WB-119 crossing with Stream SB-02 (Narrows Run) a tributary of Holly River.

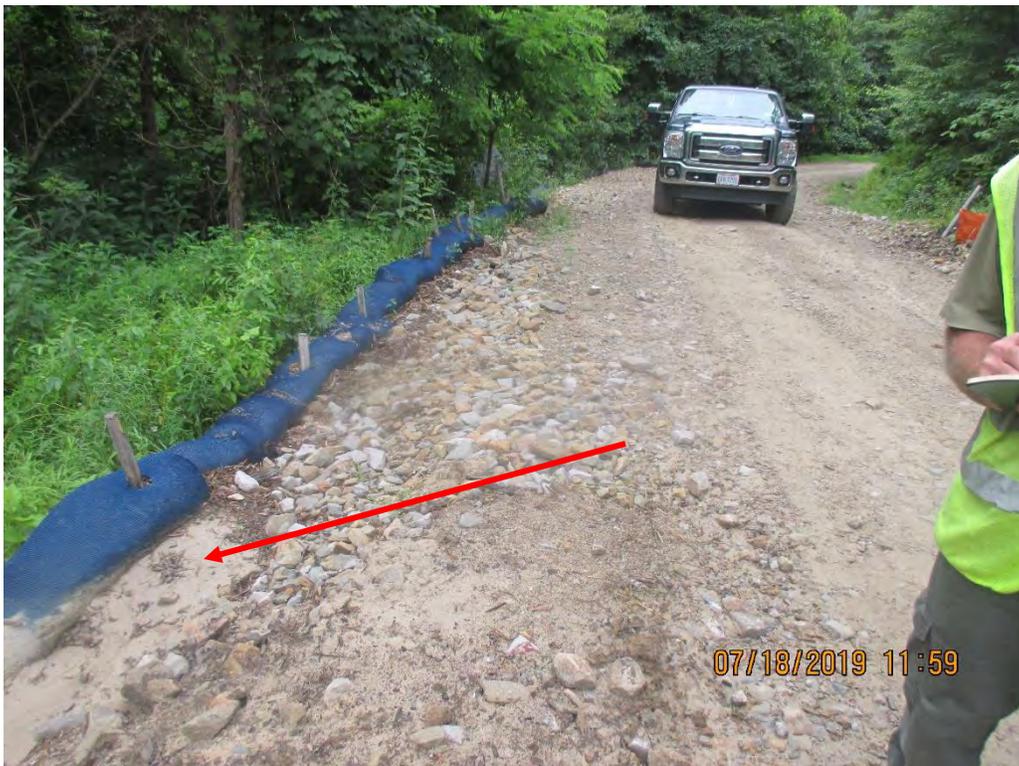
Facing perimeter controls along access road MVP-WB-119. Controls were overwhelmed with sediment.

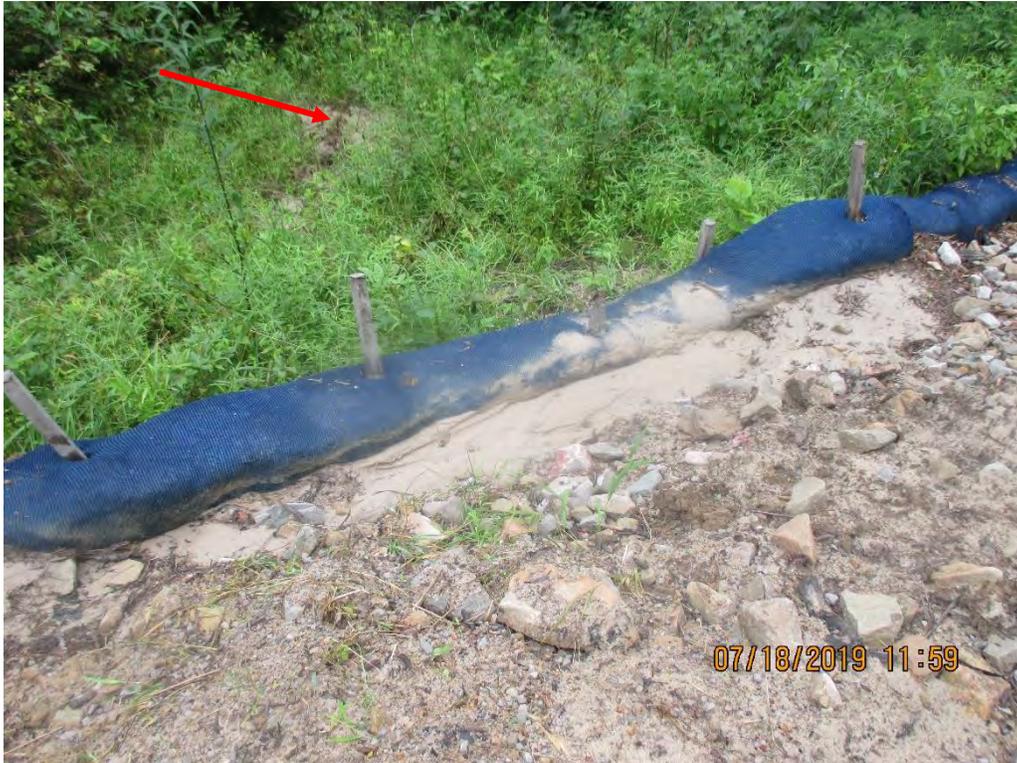
Perimeter controls overwhelmed with sediment with sediment deposits past the LOD. Arrow depicts sediment deposits.

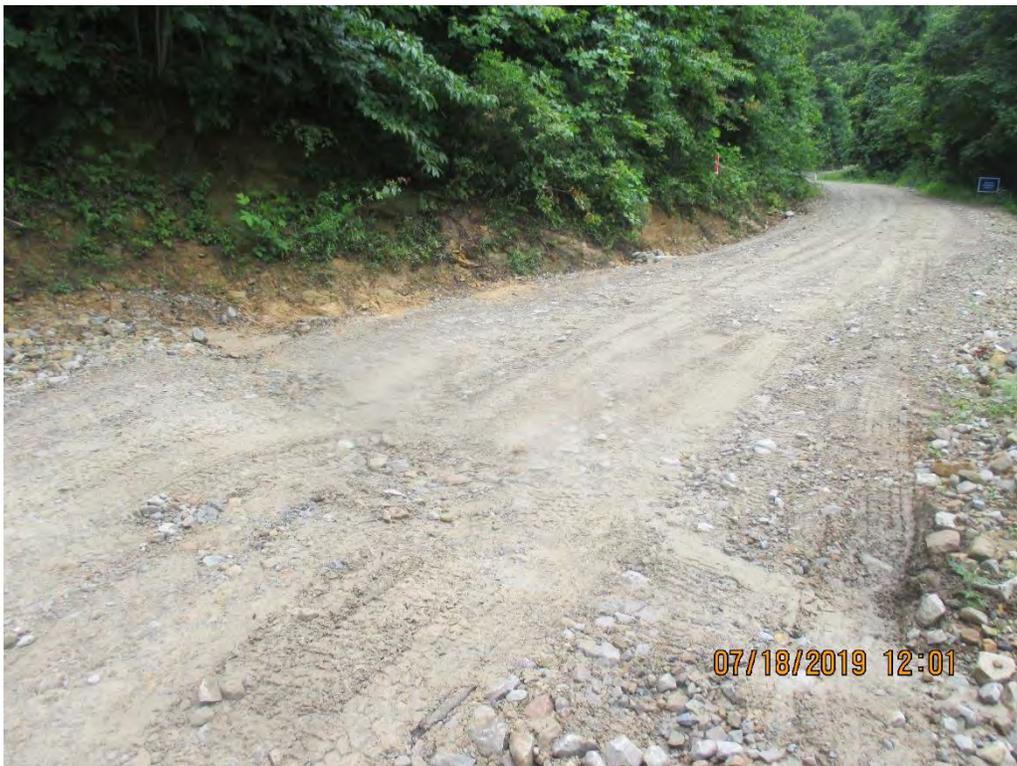
Waterbar installed on Access Road MVP-WB-119. Ditch line had rock checks present. Sediment deposits overwhelmed perimeter controls downslope of Waterbar.

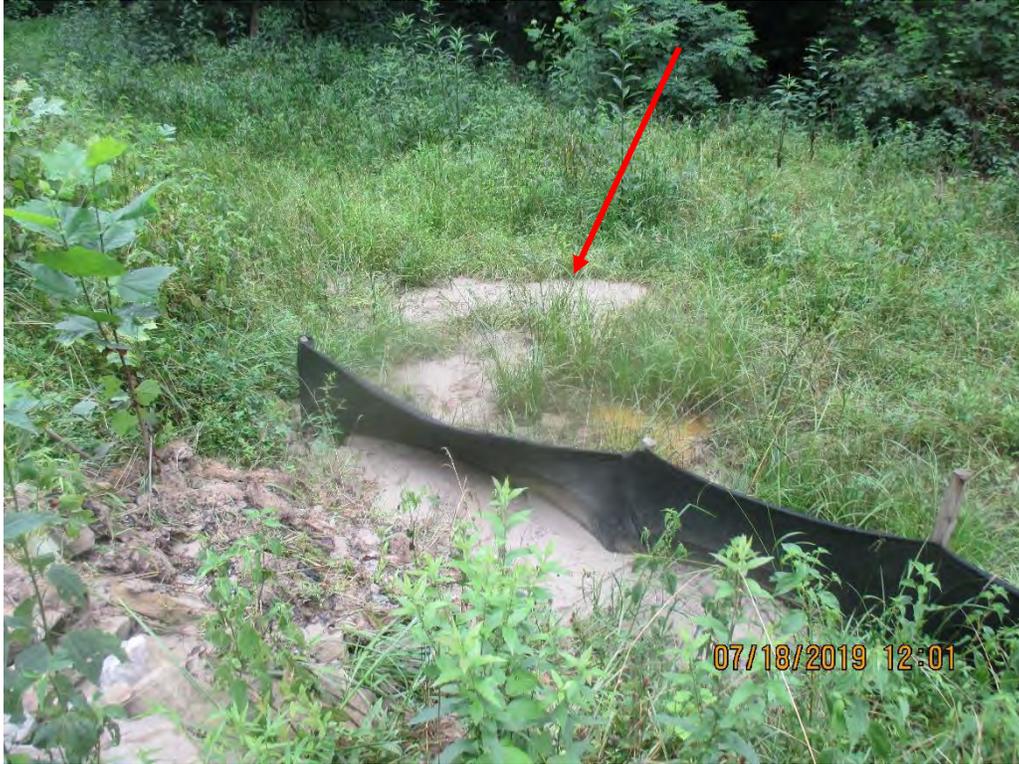
Downslope of Waterbar outlet terminating on slope. Controls overwhelmed with sediment and deposits were present past the LOD and Controls. Arrow depicts sediment deposits.

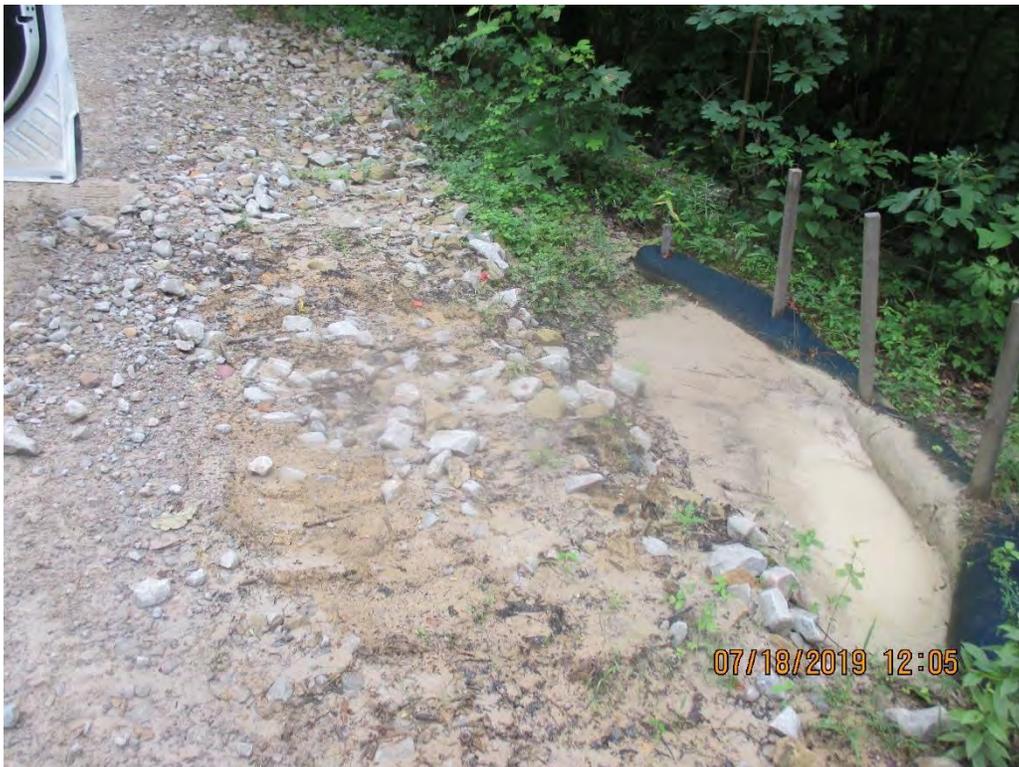
Perimeter controls overwhelmed with sediment along access road MVP-WB-119

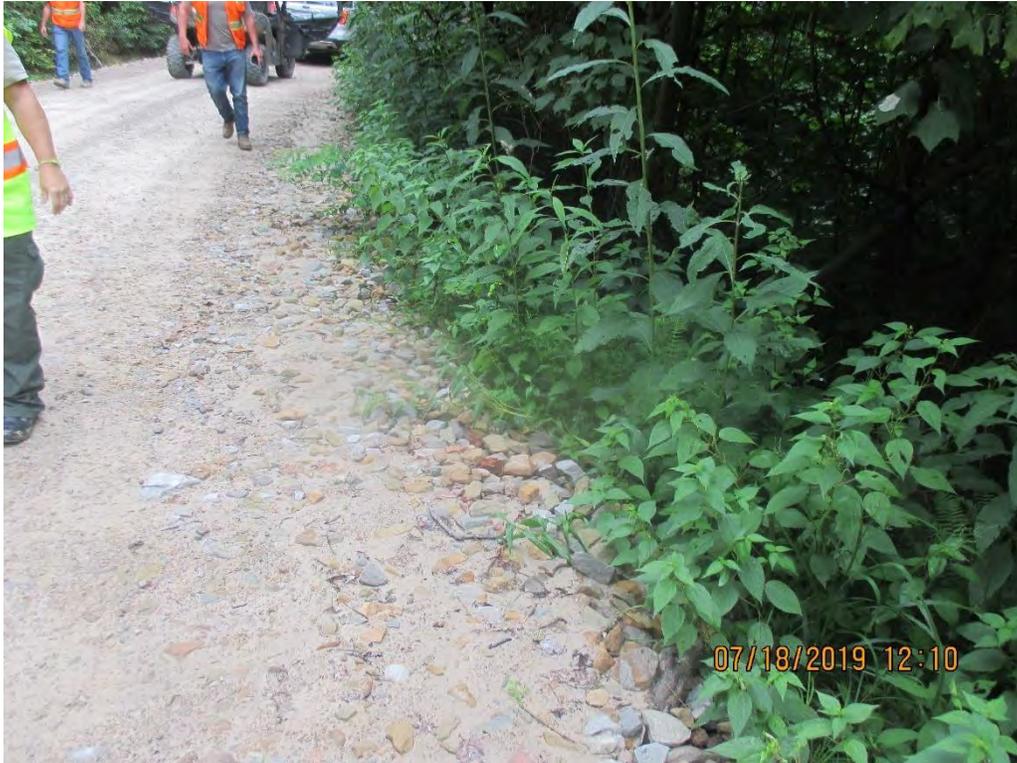
Section of MVP-WB-119 with no perimeter controls installed. Sediment deposits were observed pas the LOD.

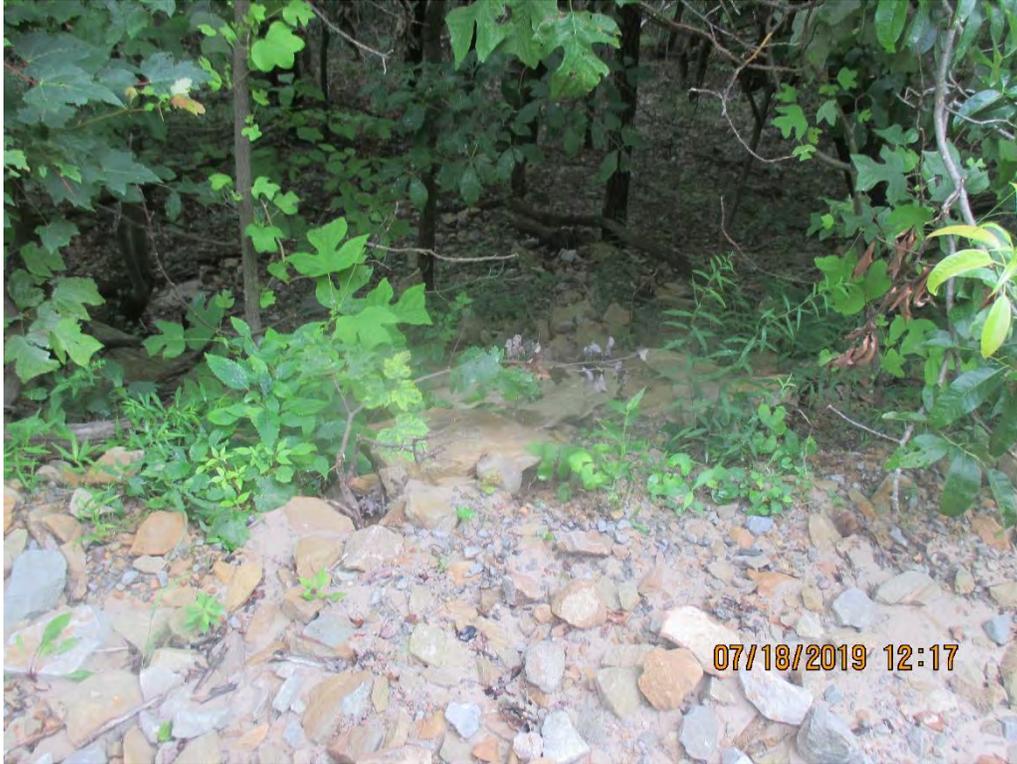
Section along Access road MVP-WB-119 where rock washed out past LOD. No controls present on downslope edge of road. Sediment deposits observed past LOD.

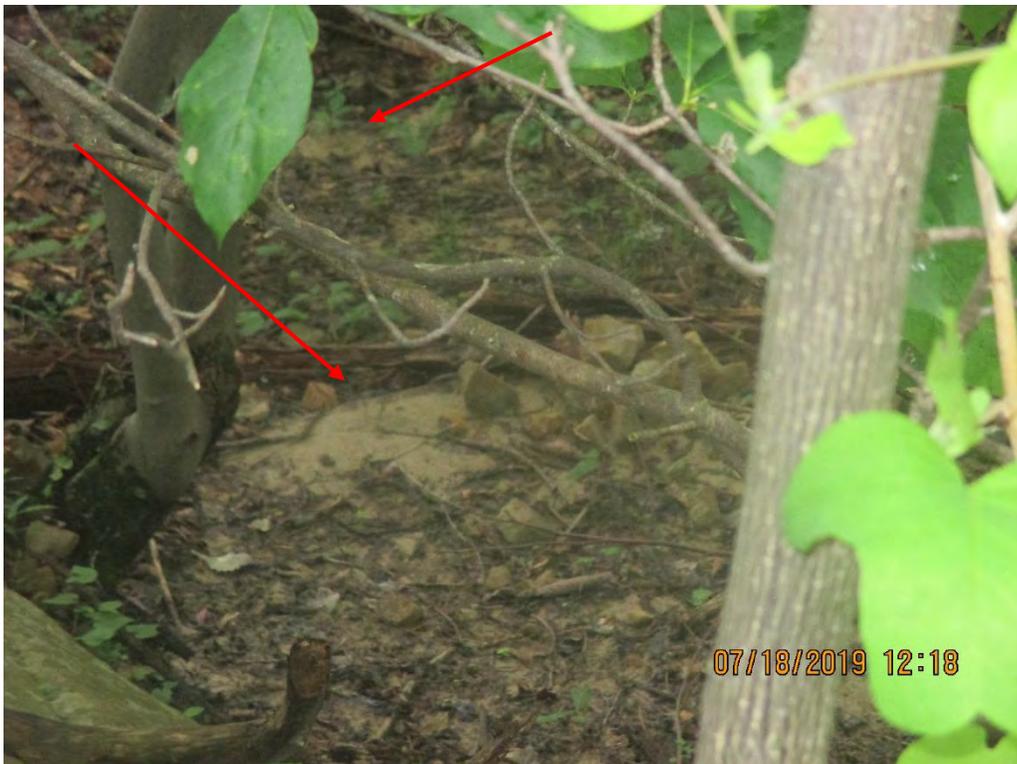
Section along Access road MVP-WB-119 where rock washed out past LOD. No controls present on downslope edge of road. Sediment deposits observed past LOD. Arrow depicts deposits.

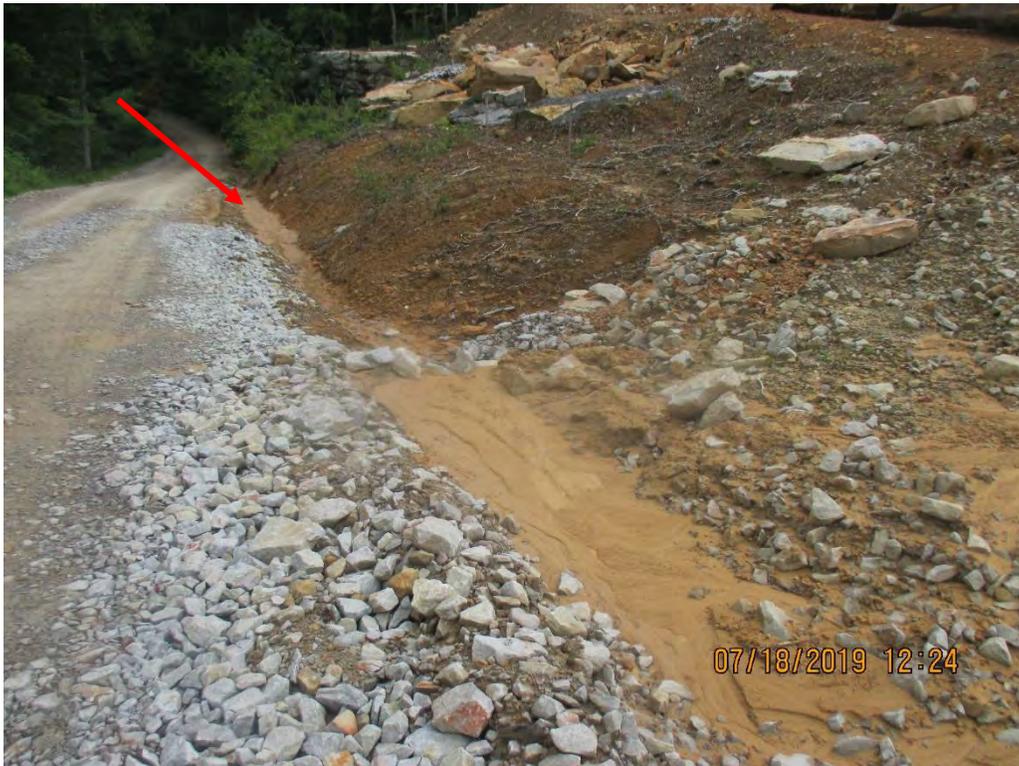
Standing at station No. 4559+96 facing Access Road MVP-WB-119. Sediment deposits present in roadside ditch.

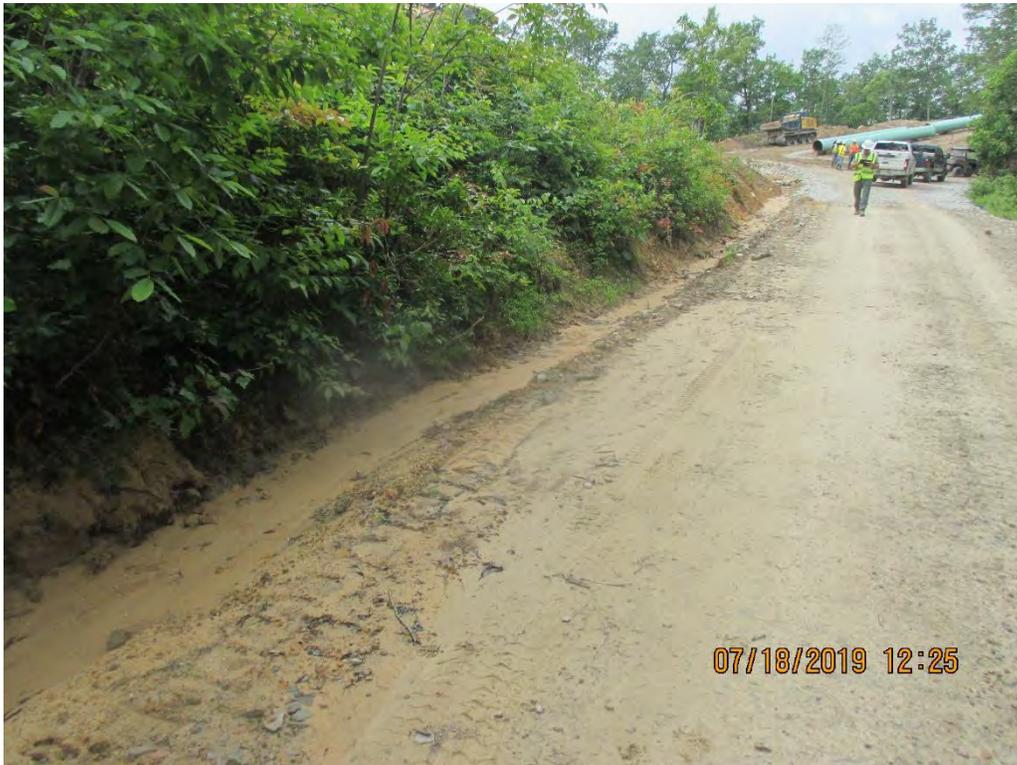
Standing downslope from station No. 4559+96 from Access Road MVP-WB-119 facing towards MVP ROW. Sediment deposits present in roadside ditch.

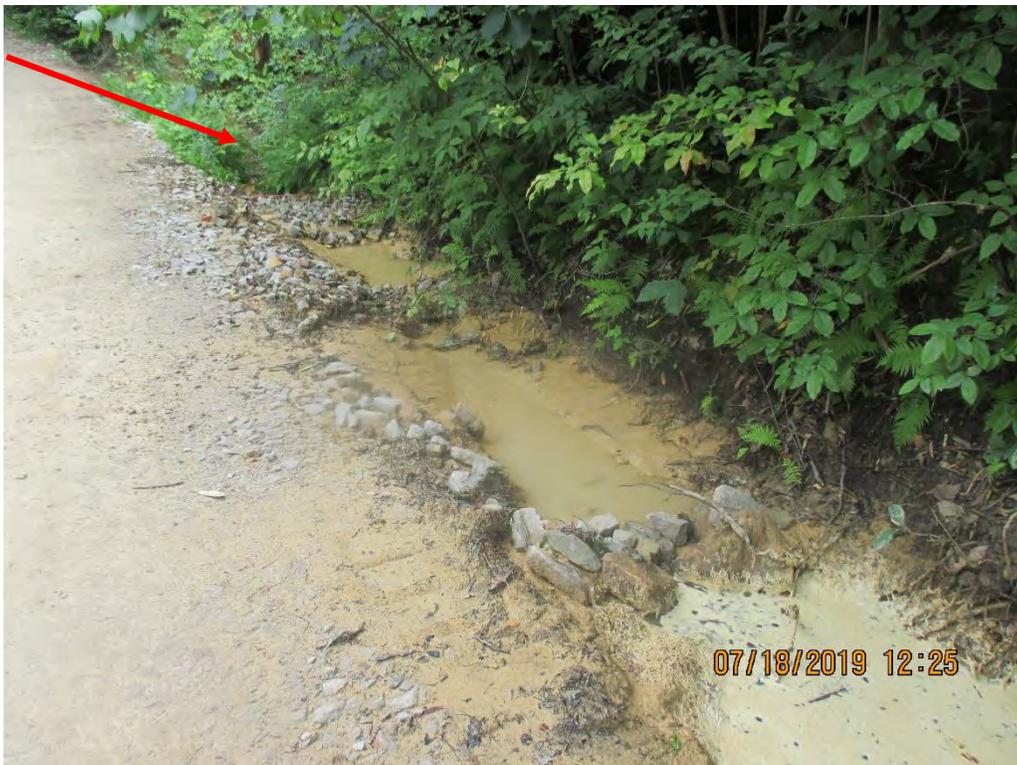
Standing downslope of Station No. 4559+96 on Access Road MVP-WB-119. Sediment deposits present in roadside ditch and conveying to culvert inlet. Arrow depicts approximate location of culvert inlet.

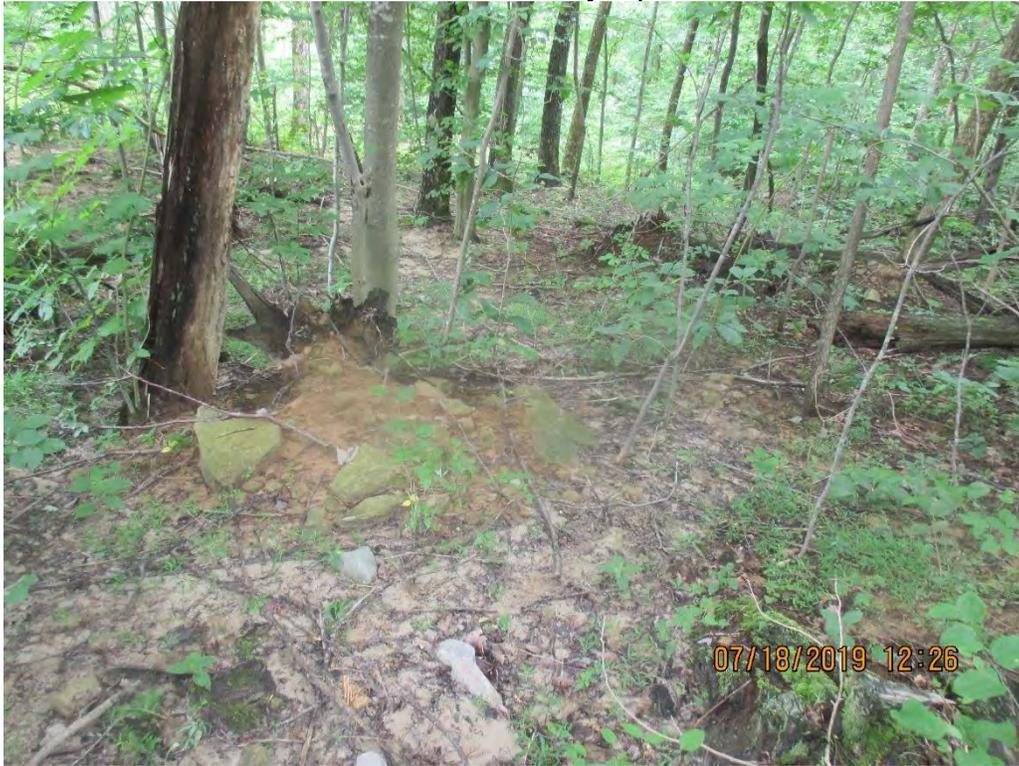
Downslope of culvert outlet. Significant sediment deposits present past controls and LOD.

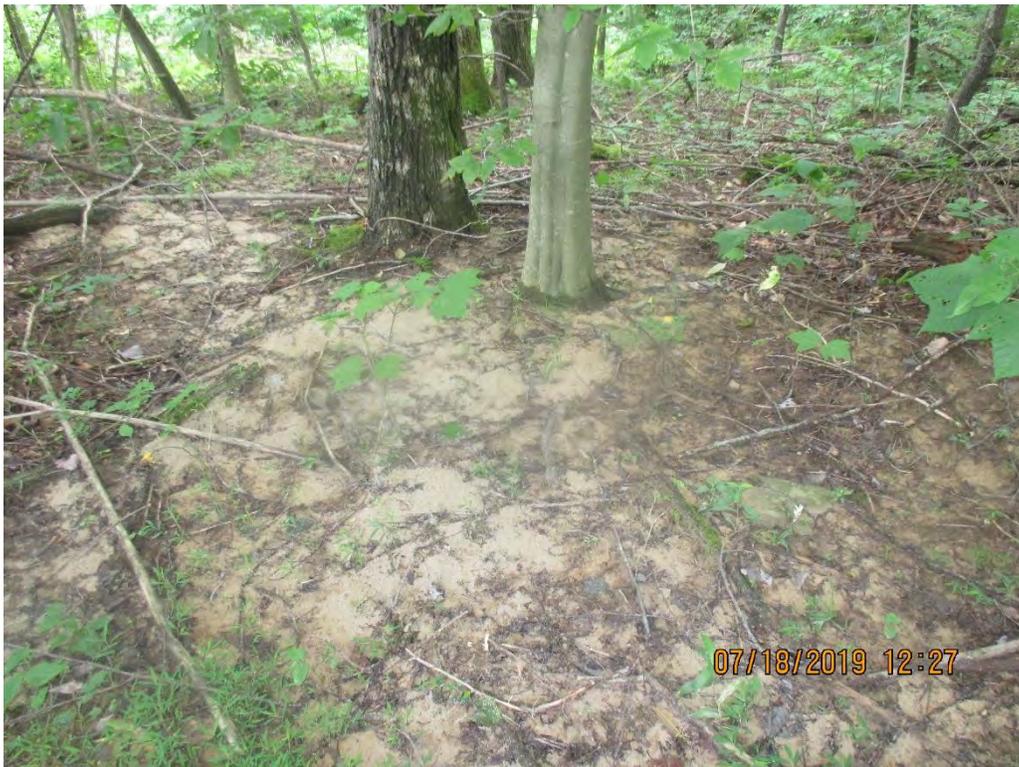
Downslope of culvert outlet. Significant sediment deposits present past controls and LOD.

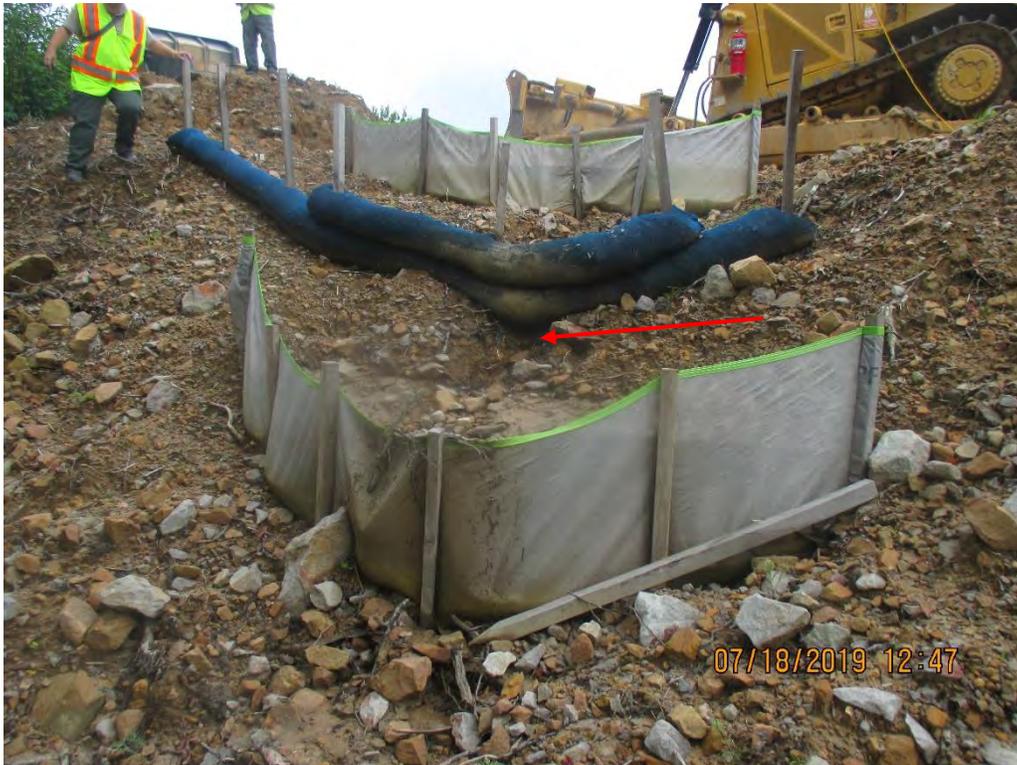
Waterbar outlet on opposite side of ROW at station no. 4559+96. Controls undercut and sediment deposits observed past controls and LOD. Arrow depicts undercut controls.

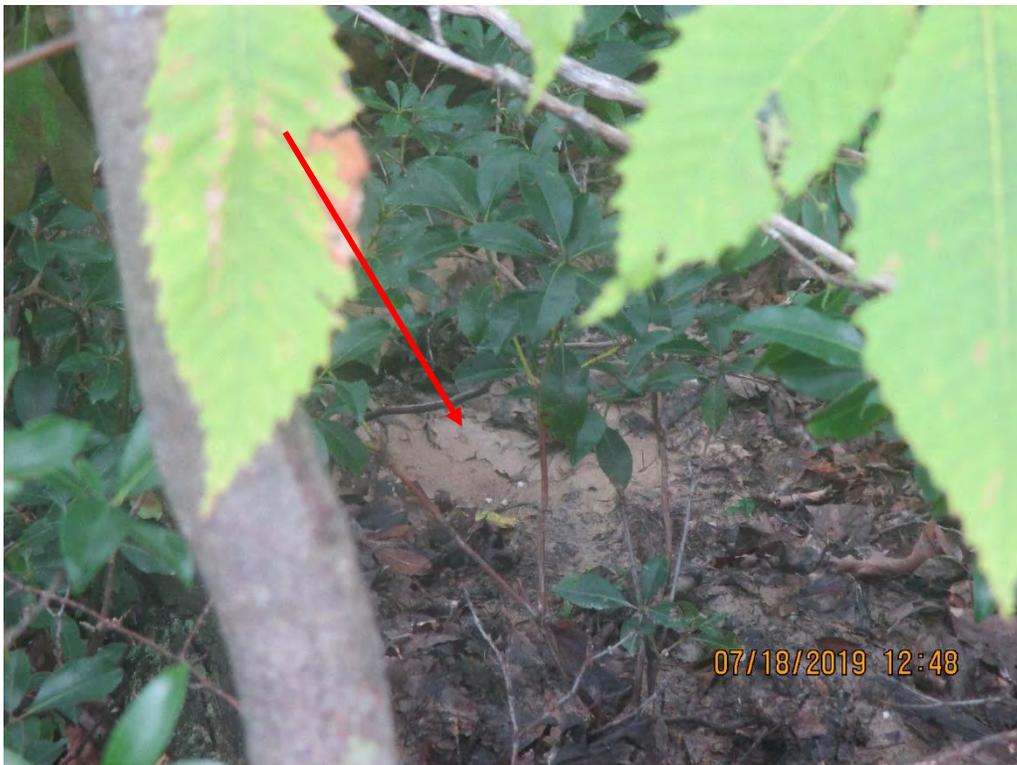
Waterbar outlet on opposite side of ROW at station no. 4559+96. Controls undercut and sediment deposits observed past controls and LOD.
