**The Wilderness Society et al. Comments on the  
U.S. Forest Service Mountain Valley Pipeline and  
Equitrans Expansion Project Draft Supplemental  
Environmental Impact Statement (#50036)**

**EXHIBIT 1**

Assessment of erosion, sedimentation, and water quality impacts of the Mountain Valley Pipeline and Equitrans Expansion Project's proposed crossing of the Jefferson National Forest as it pertains to the U.S. Forest Service's Draft Supplemental Environmental Impact Statement dated December 2022

Prepared by Jonathan A. Czuba, Ph.D., Licensed Professional Engineer

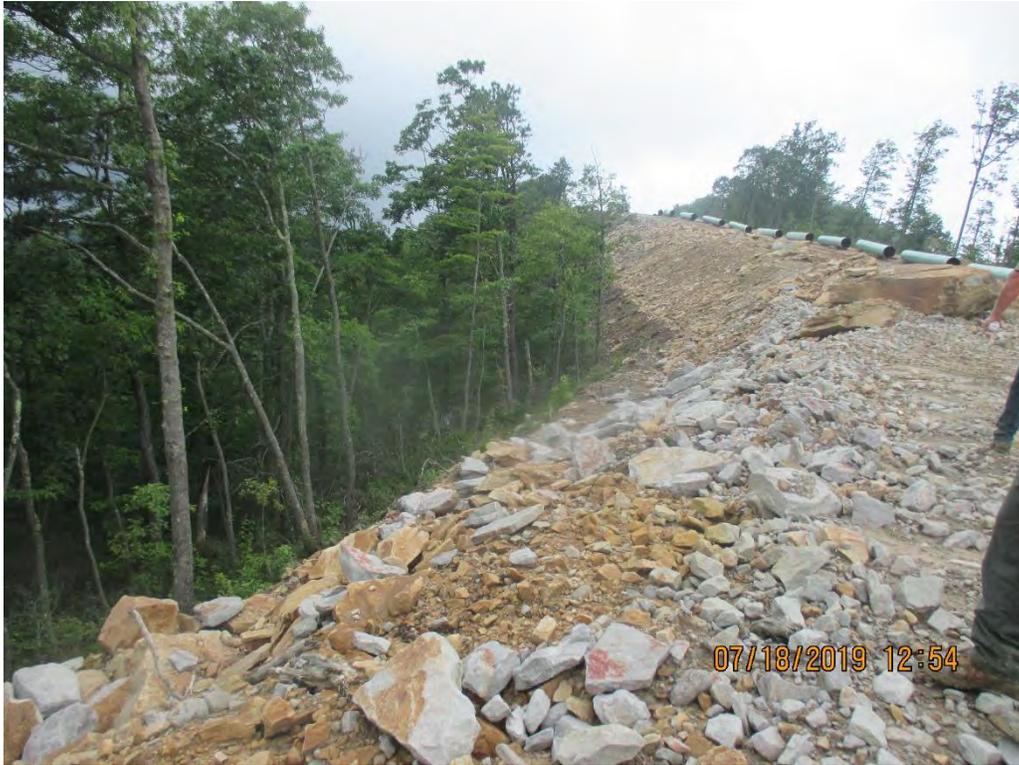
Near station No. 4559+96 facing ROW fill slope.

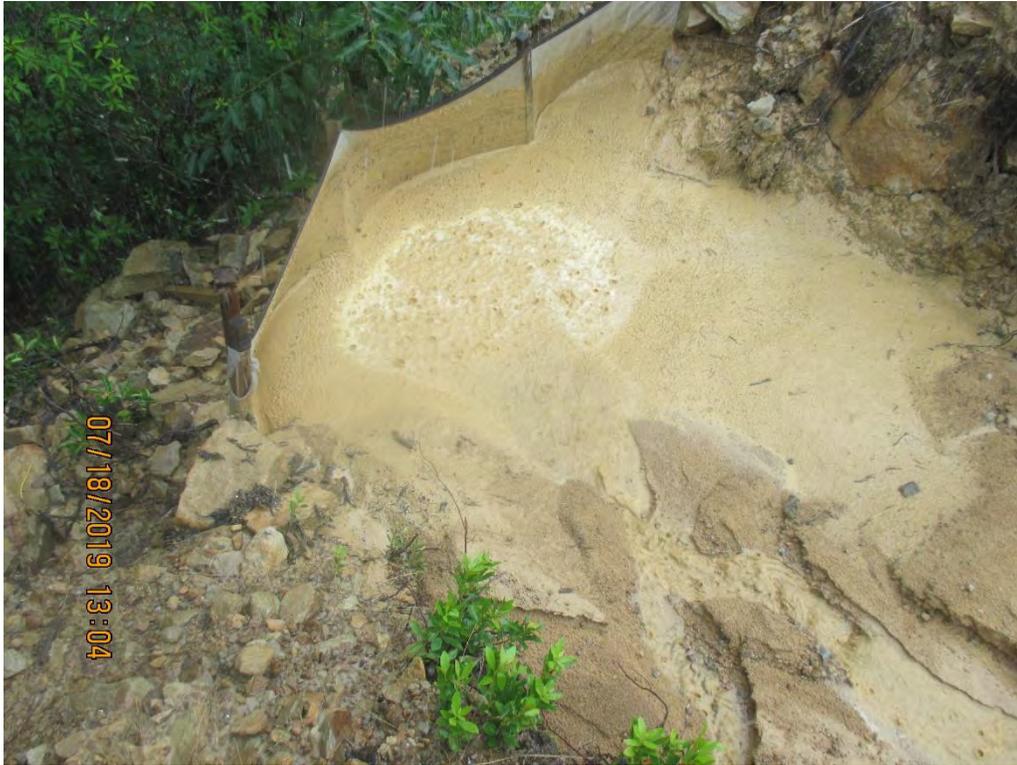
Above station No. 4539+00 during rain event. Sump full of sediment and in need of maintenance. Sediment laden water undercutting silt fence and flowing past LOD.

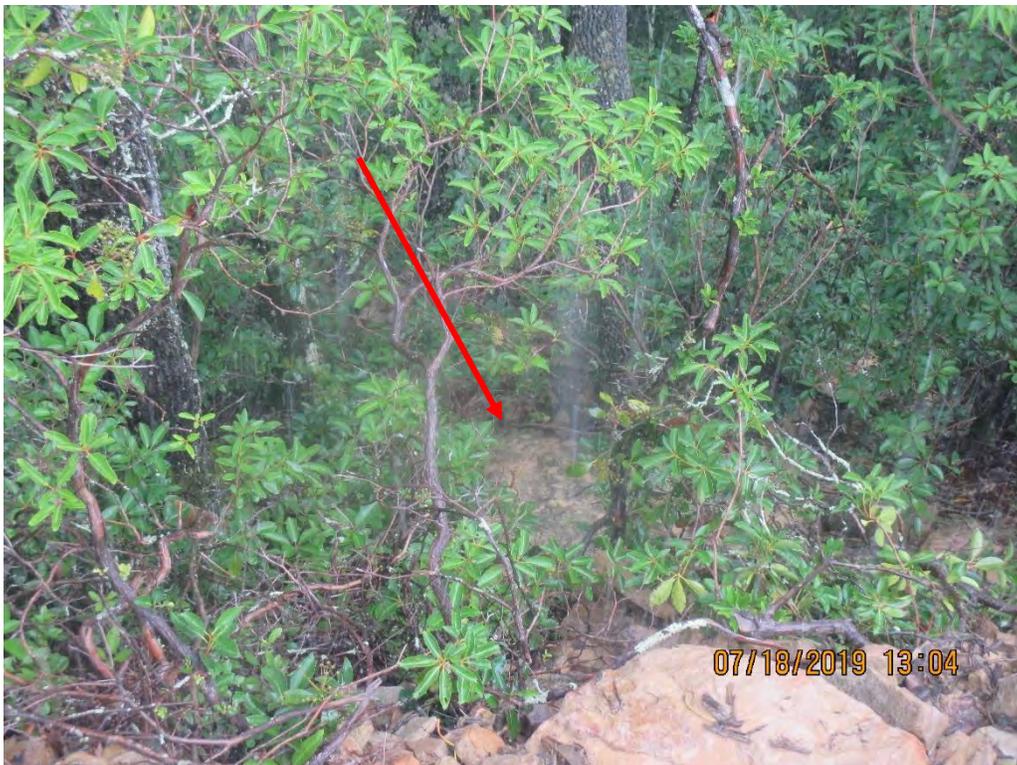
Above station No. 4539+00 during rain event. Sediment laden water undercutting silt fence and flowing past LOD. Arrow depicts SLW leaving site.

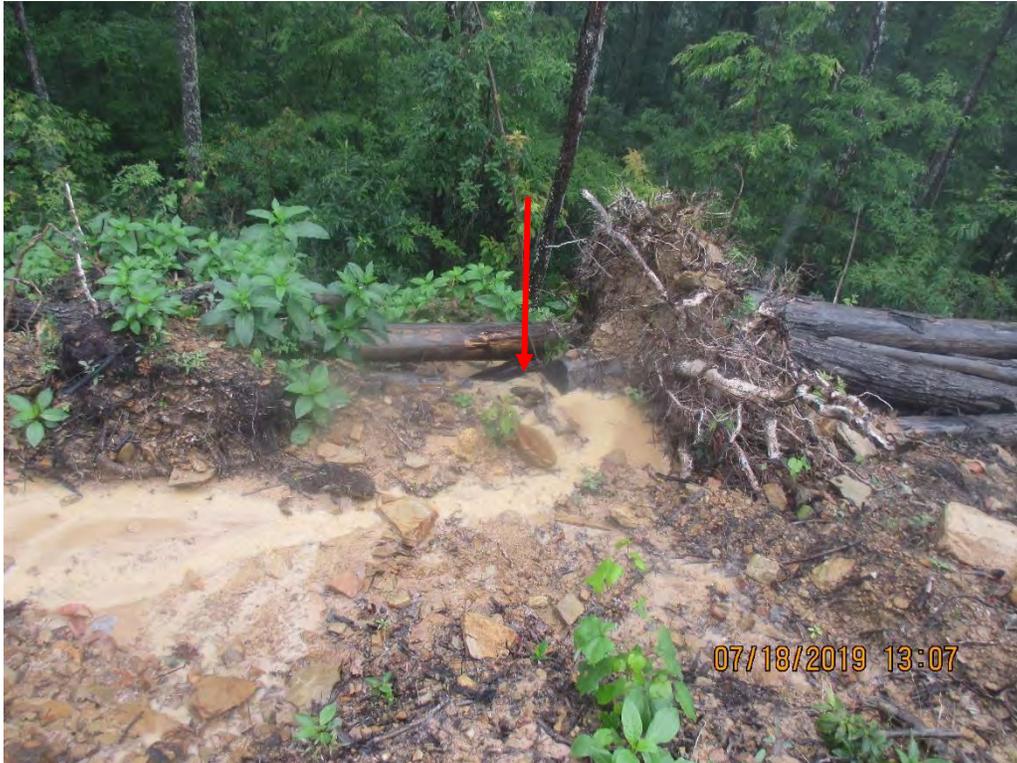
Sediment laden water flowing off ROW and through log pile during rain event. No perimeter controls were present at the base of the slope. Arrow depicts where SLW was flowing through log pile.

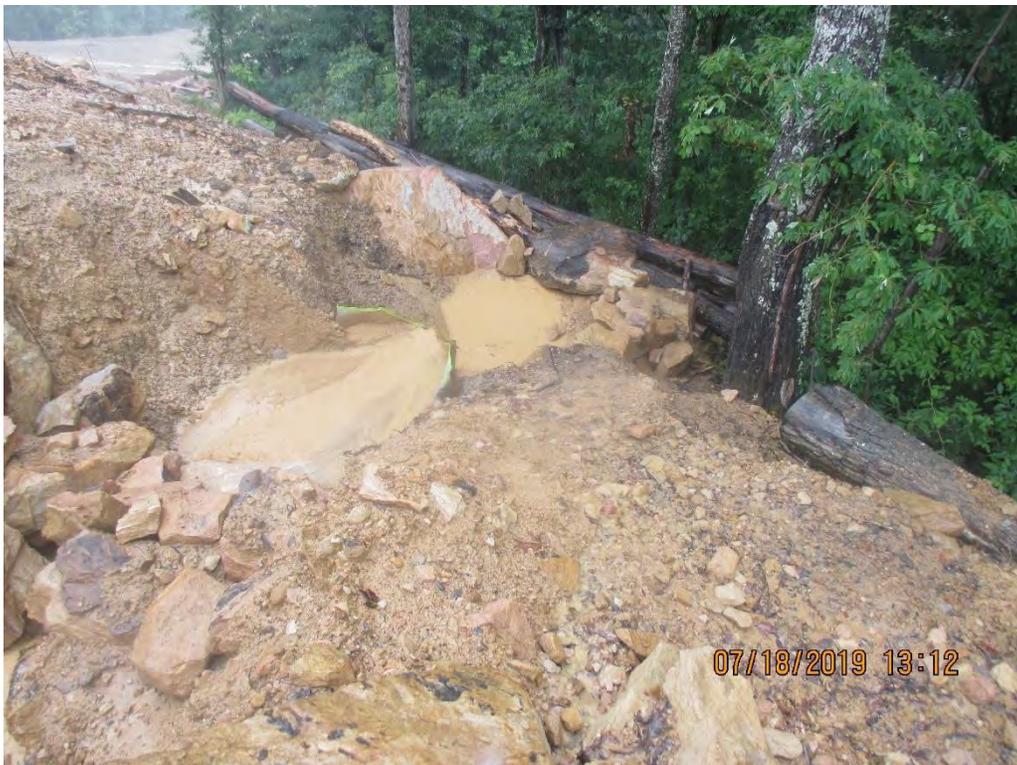
Waterbar terminating onto fill slope at station No. 4539+00. Large rocks installed as checks in eroded channel. SLW was flowing under and through these checks overwhelming controls.

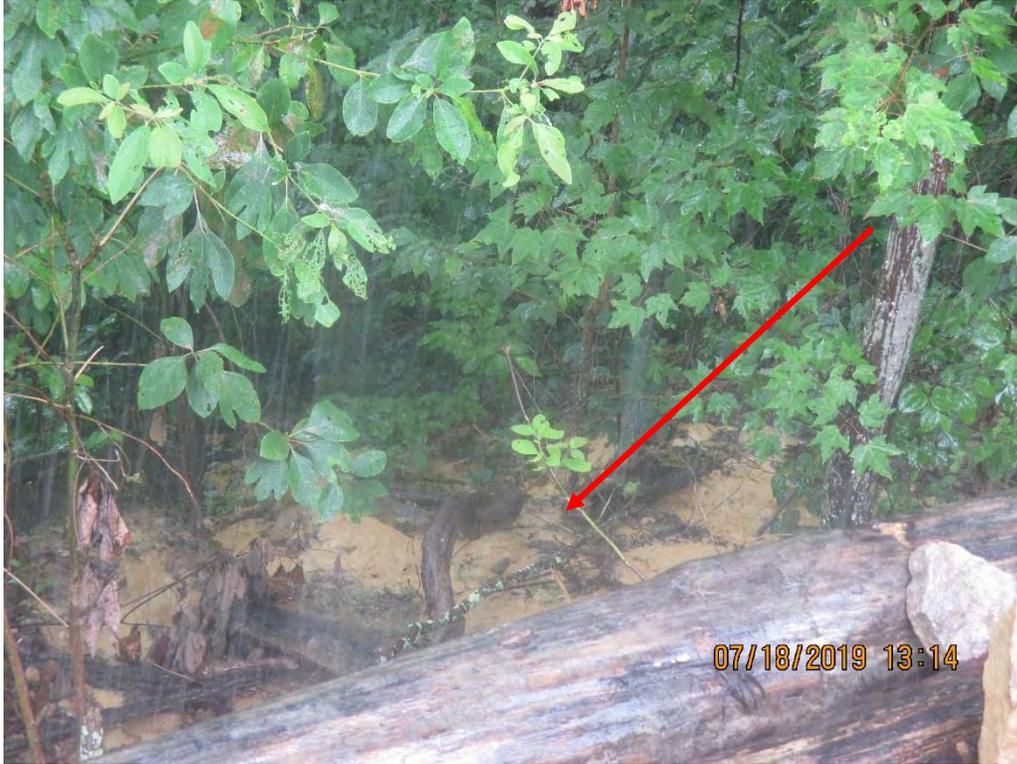
Downslope from Waterbar terminating onto fill slope at station No. 4539+00. SLW observed past controls and LOD conveying downslope.

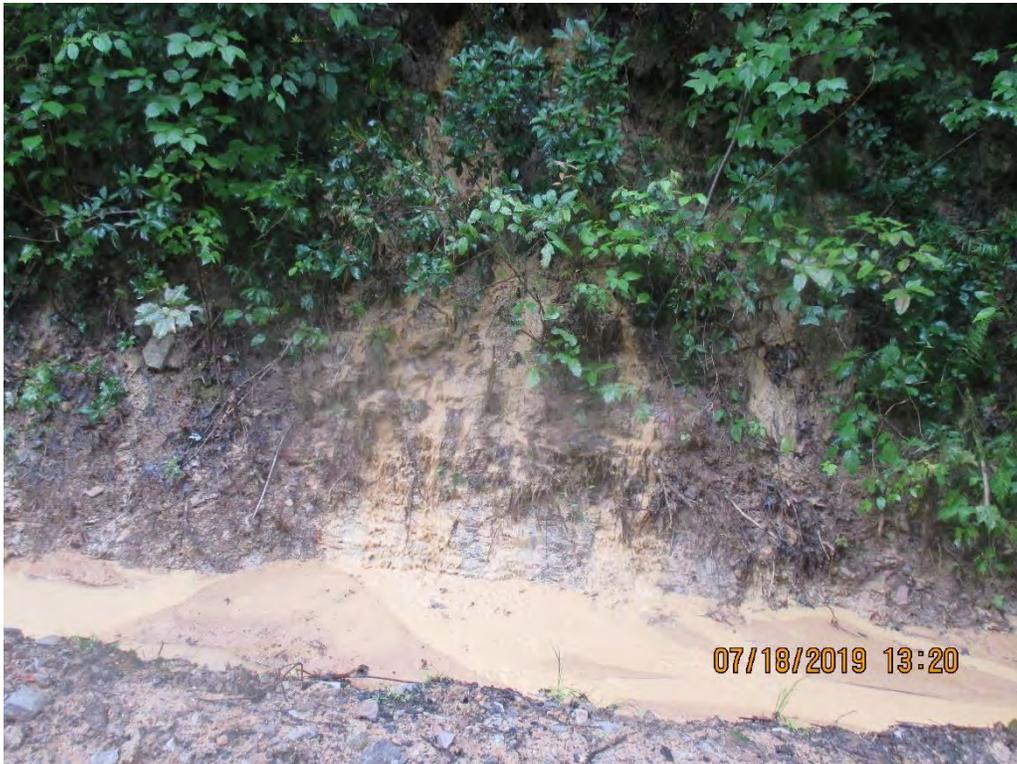
Downslope of failed controls post rain event along Access Road MVP-WB-119. SLW was entering/cascading into the ditch that conveys back downslope towards ROW crossing with access road.

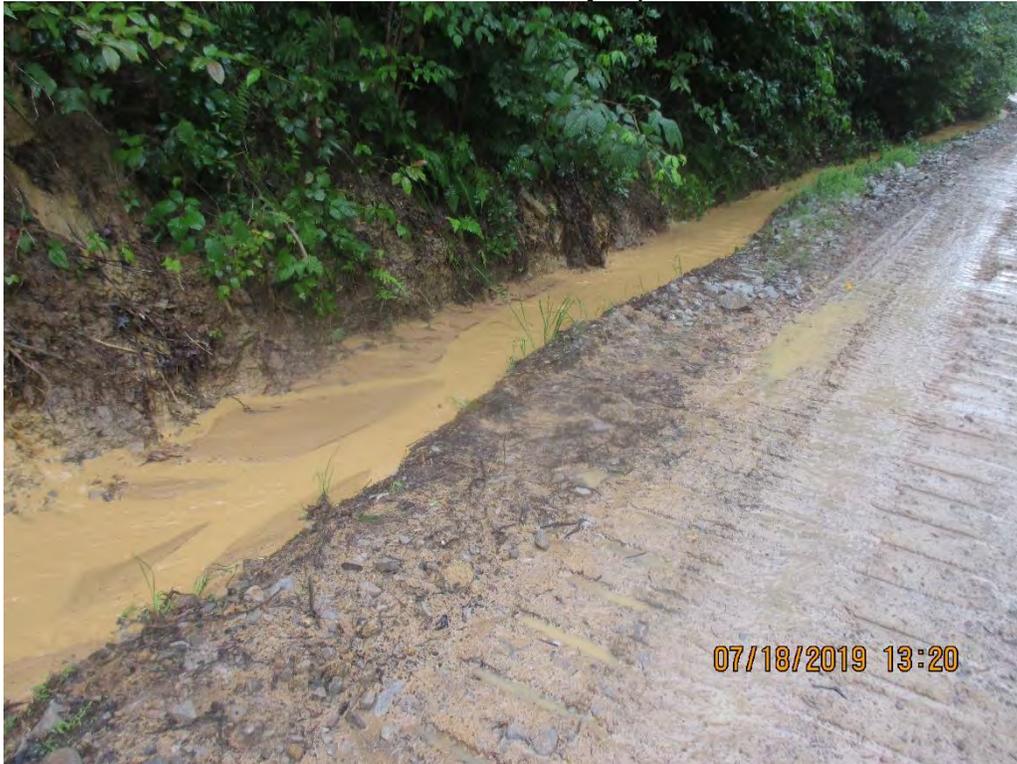
Downslope of failed controls post rain event along Access Road MVP-WB-119. SLW was entering/cascading into the ditch that conveys back downslope towards ROW crossing with access road.

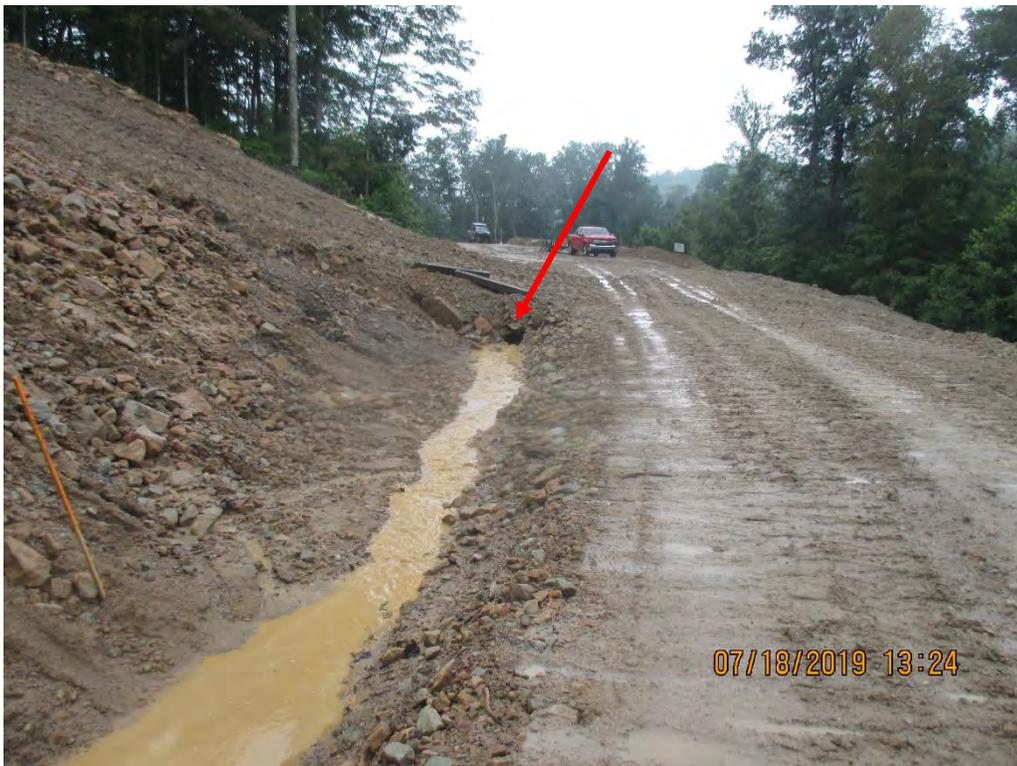
Downslope from where SLW was entering ditch. Arrow depicts culvert that conveys under ROW crossing. No controls present upslope of ditch below station No. 4539+00.

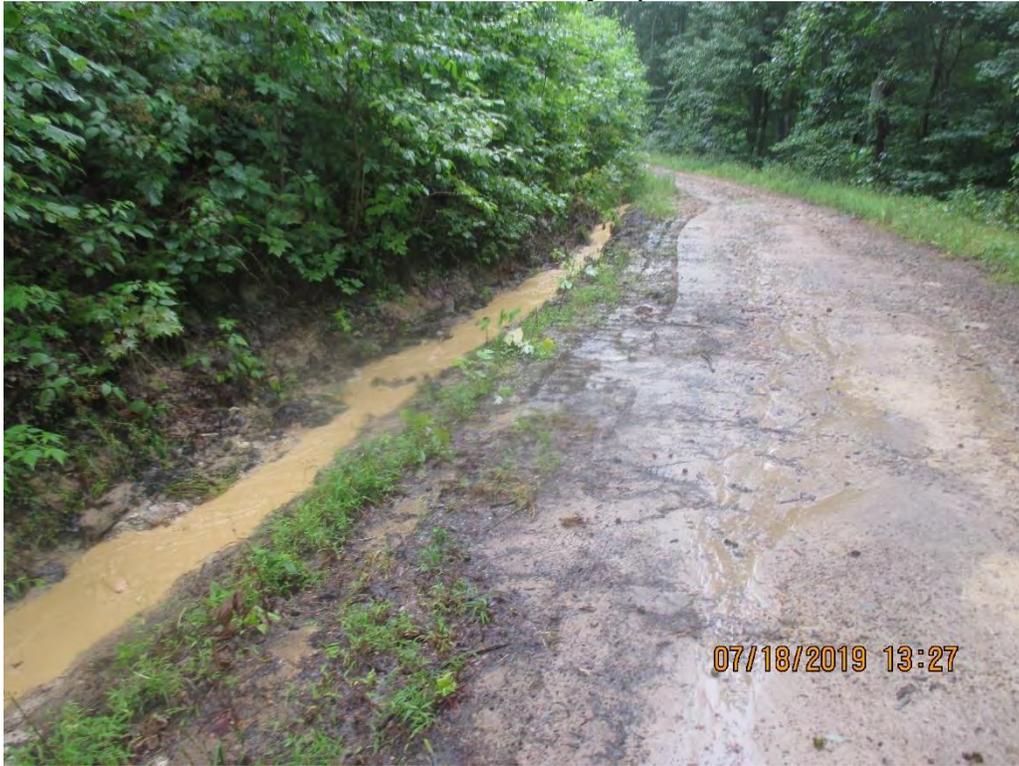
Approximately 200 feet downslope of ROW crossing with MVP-WB-119. SLW being conveyed to culvert.

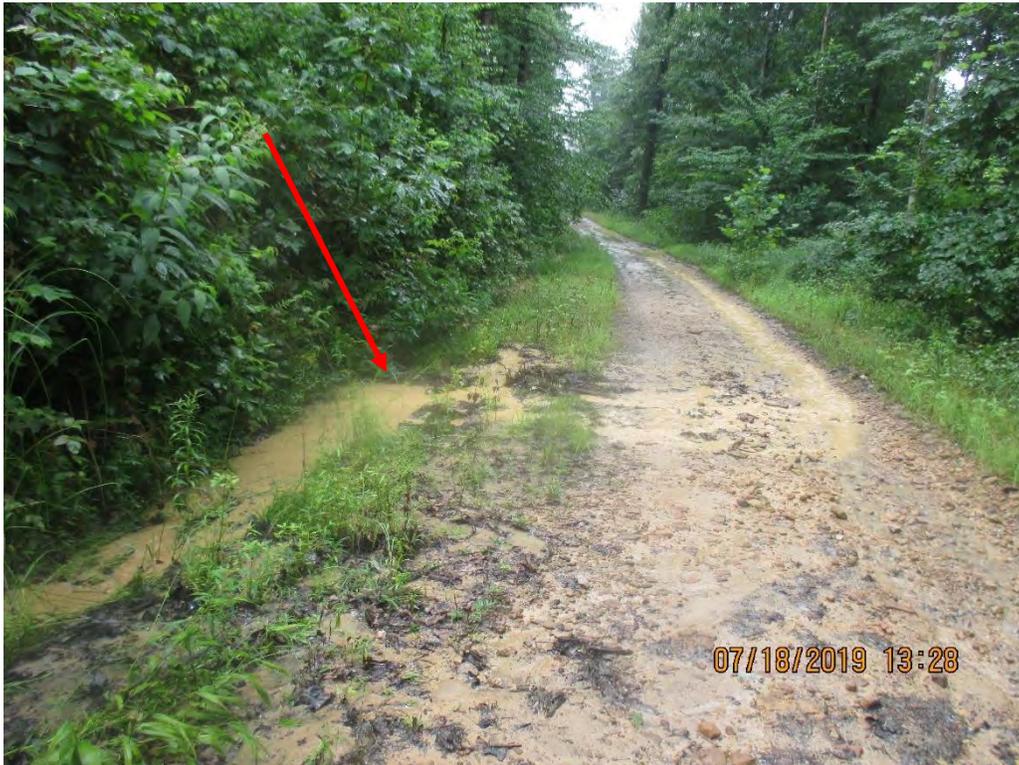
Culvert inlet that conveys under unapproved access road.

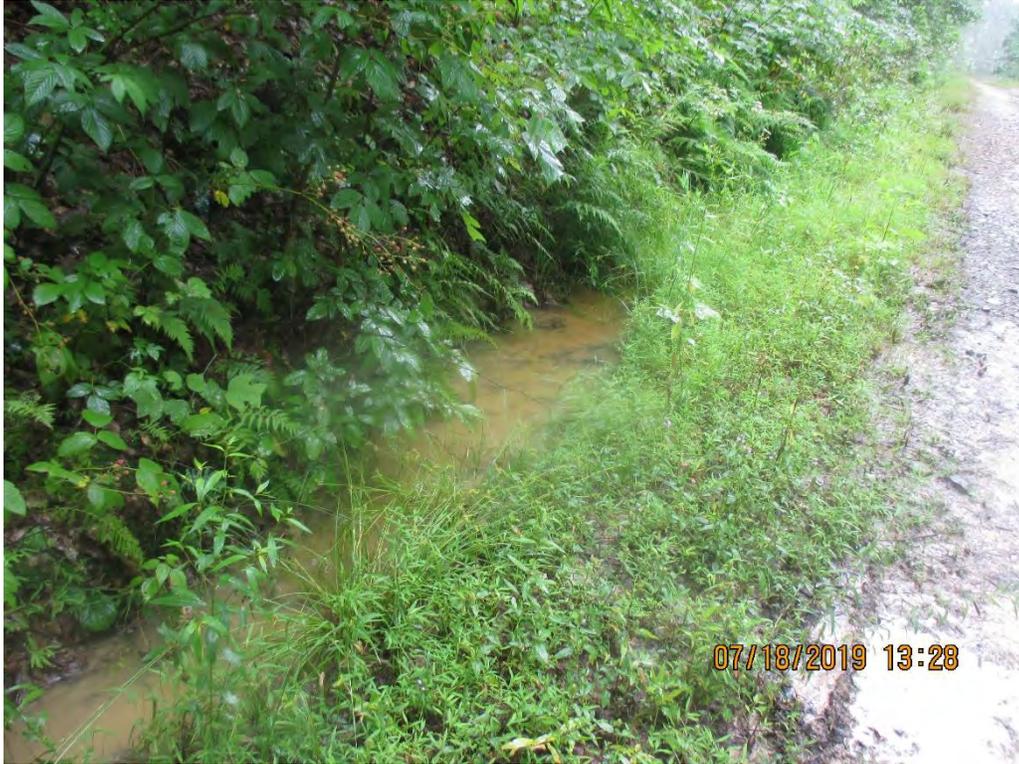
Upslope of culvert inlet receiving sediment laden water. Run-off present in ditch line distinguishably different than what was originating from upslope and entering culvert.

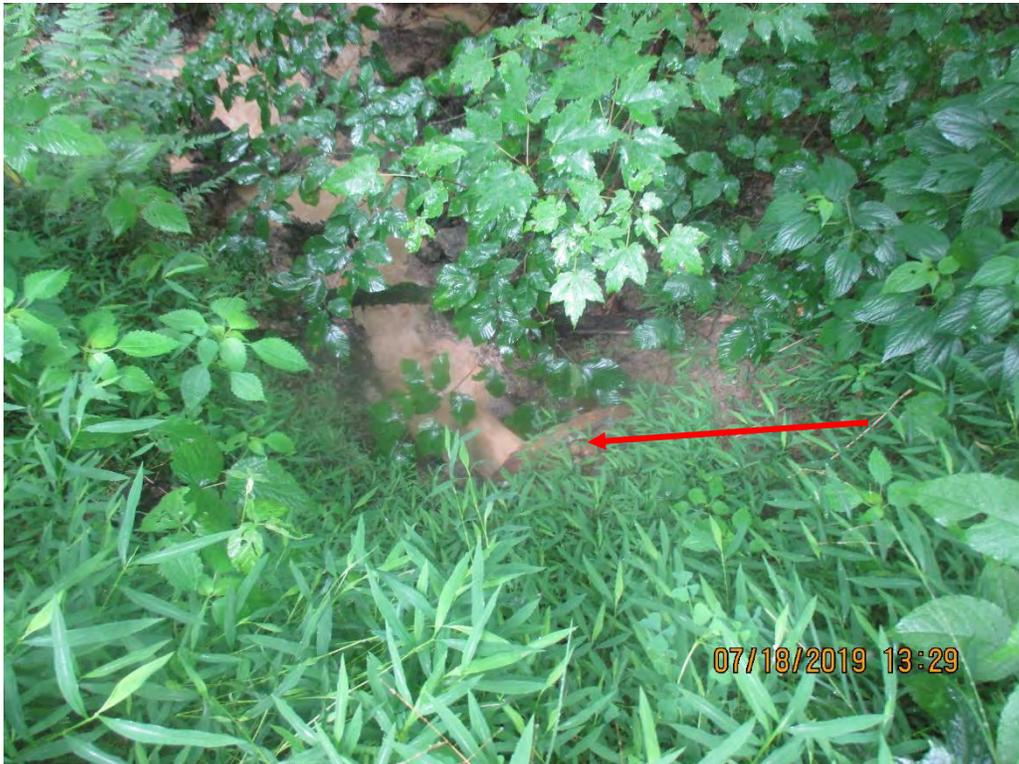
Culvert outlet conveying SLW downslope towards Fall Run a tributary of Holly River. Arrow depicts culvert.

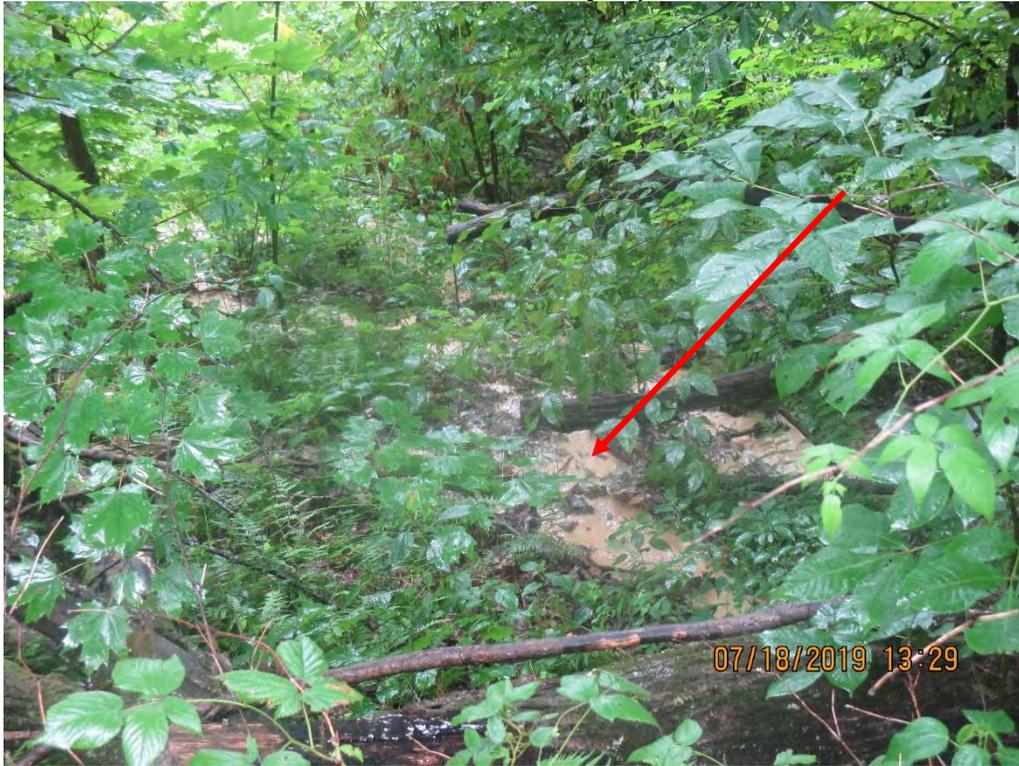
SLW conveying downslope towards Fall Run a tributary of the Holly River.

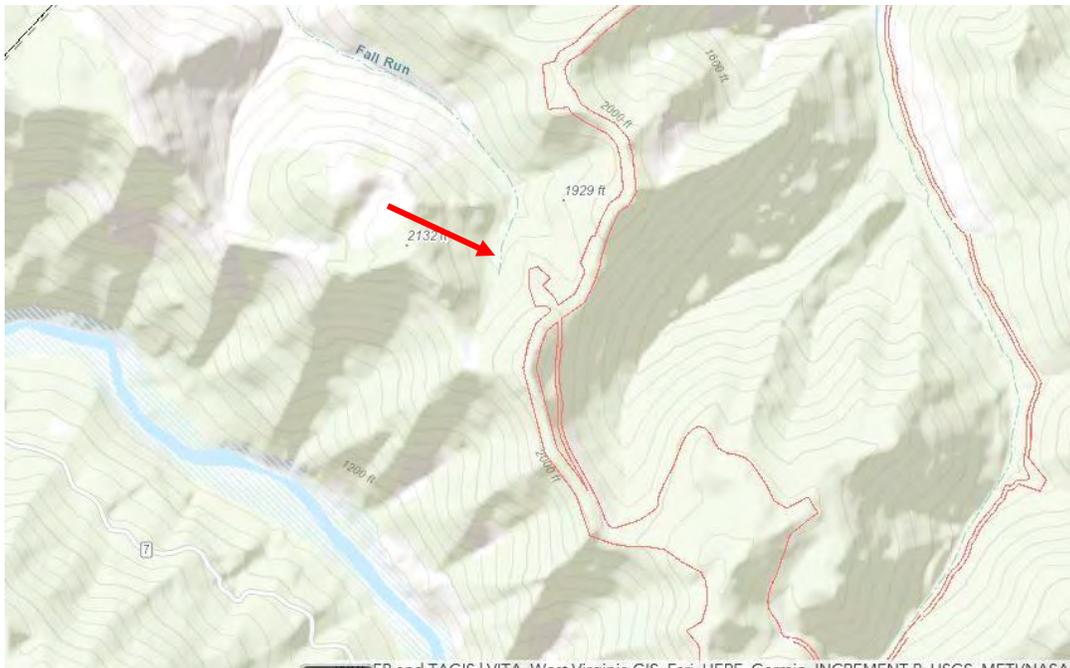
Arrow depicts where unapproved access road is located and SLW conveyed under road and towards Fall Run at 38.629N, 80.501W.

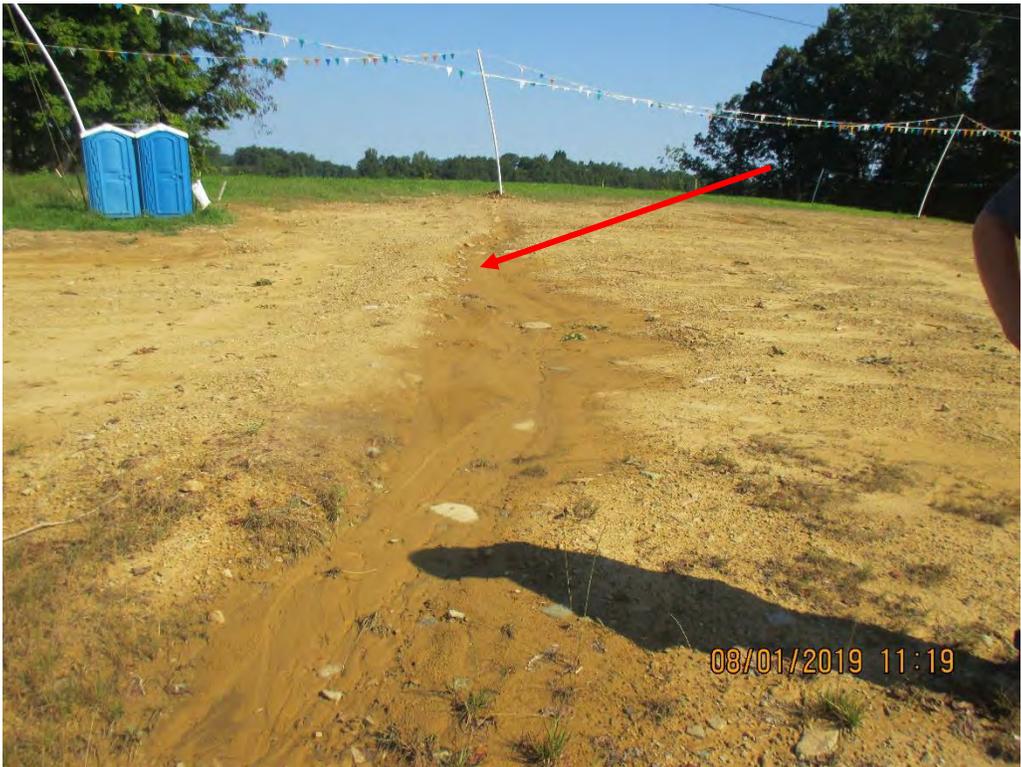
Facing North where Access Road MVP-BR-099 intersects ROW near station No. 3897+75. Arrow depicts diversion berm installed and where Run-off was overtopping the berm and flowing downslope.

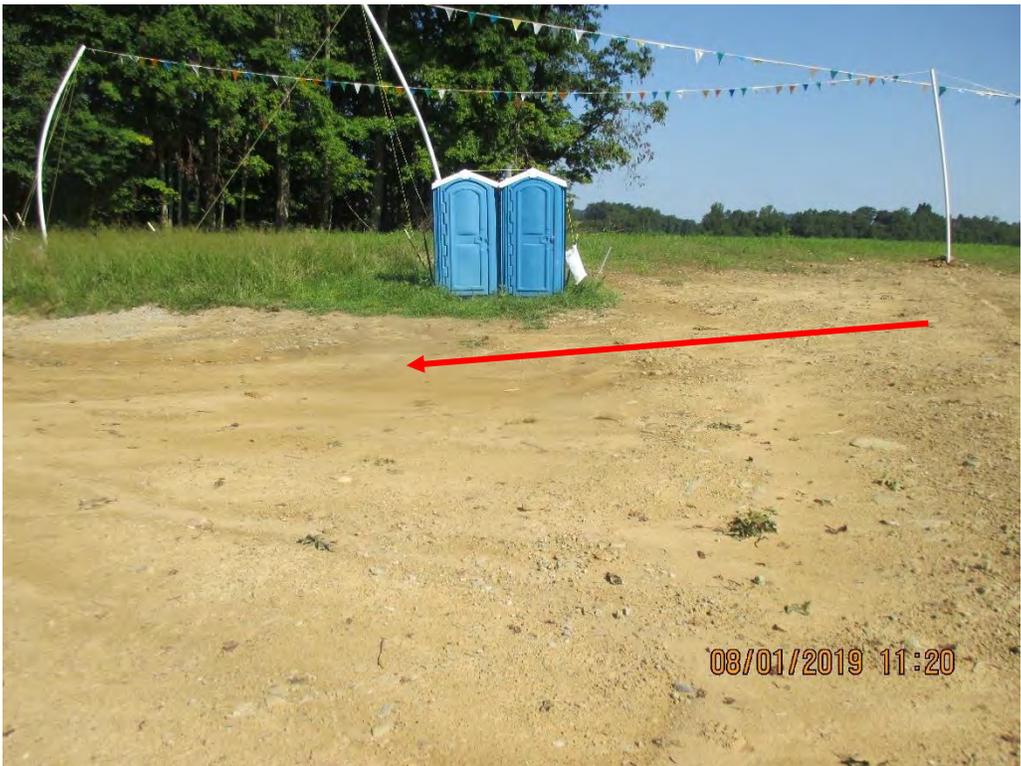
Standing downslope of diversion berm near station no. 3897+75. Arrow depicts where sheet flow due to run-off was occurring.

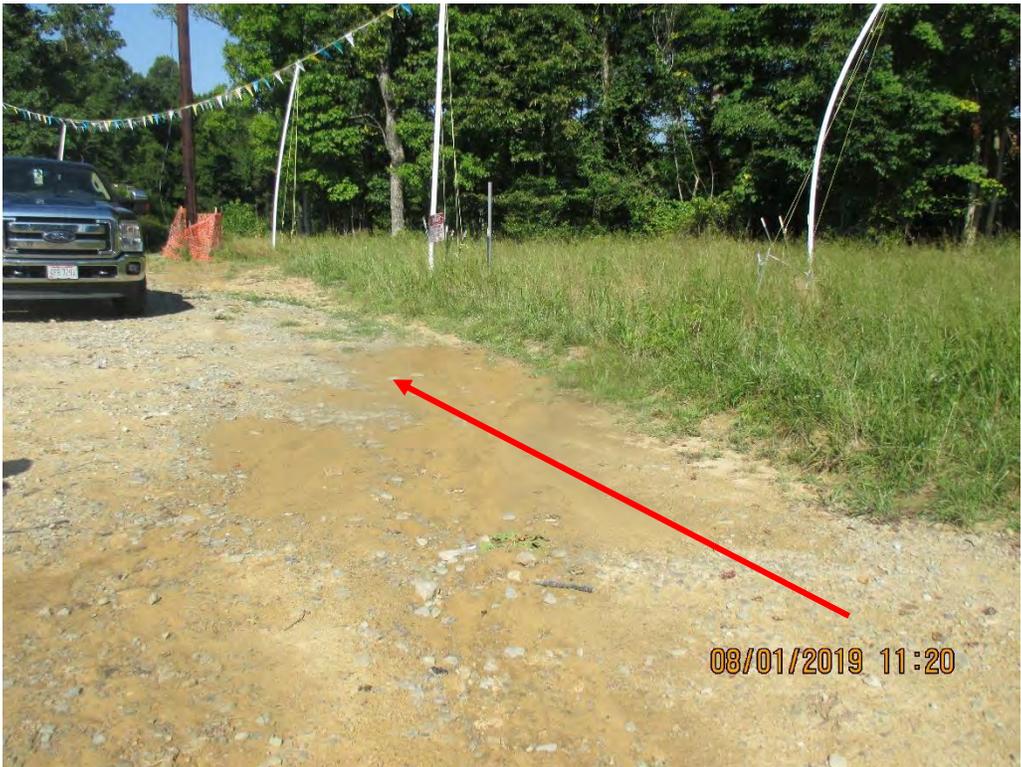
Standing below diversion berm and facing CR 24 and MVP-BR-099. Arrow depicts direction of sheet flow and sediment transportation downslope towards CR24.

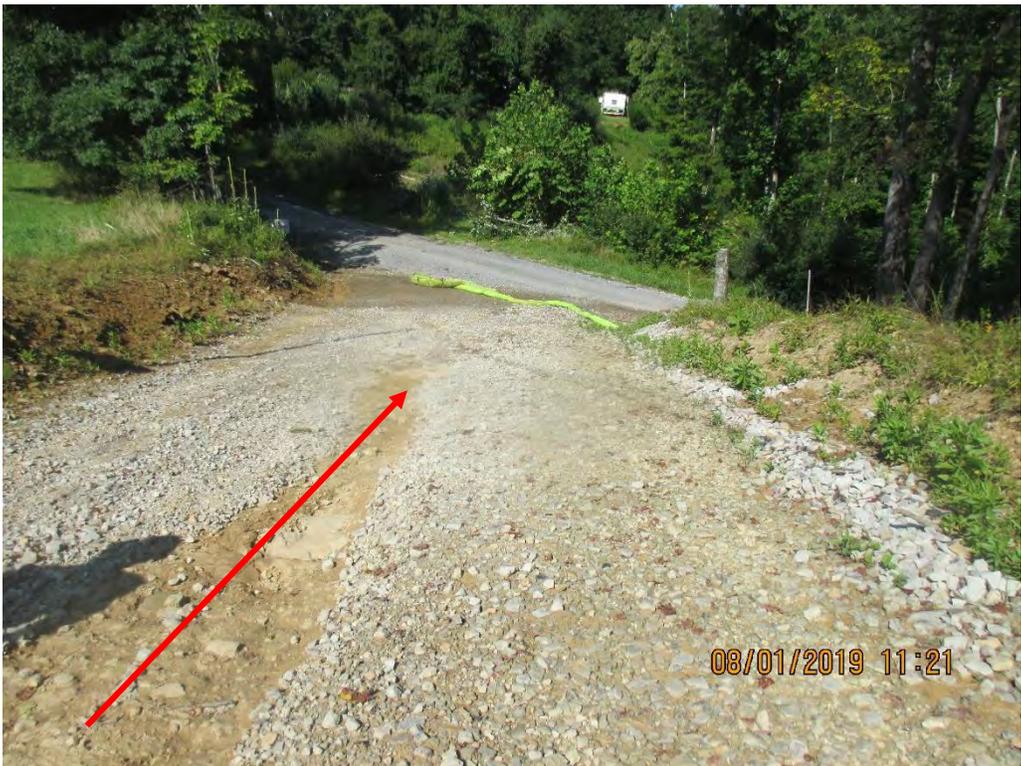
Access Road MVP-BR-099 facing CR 24 (Green Hill Road) ditch line. Arrow depicts where run-off was conveying towards ditch.

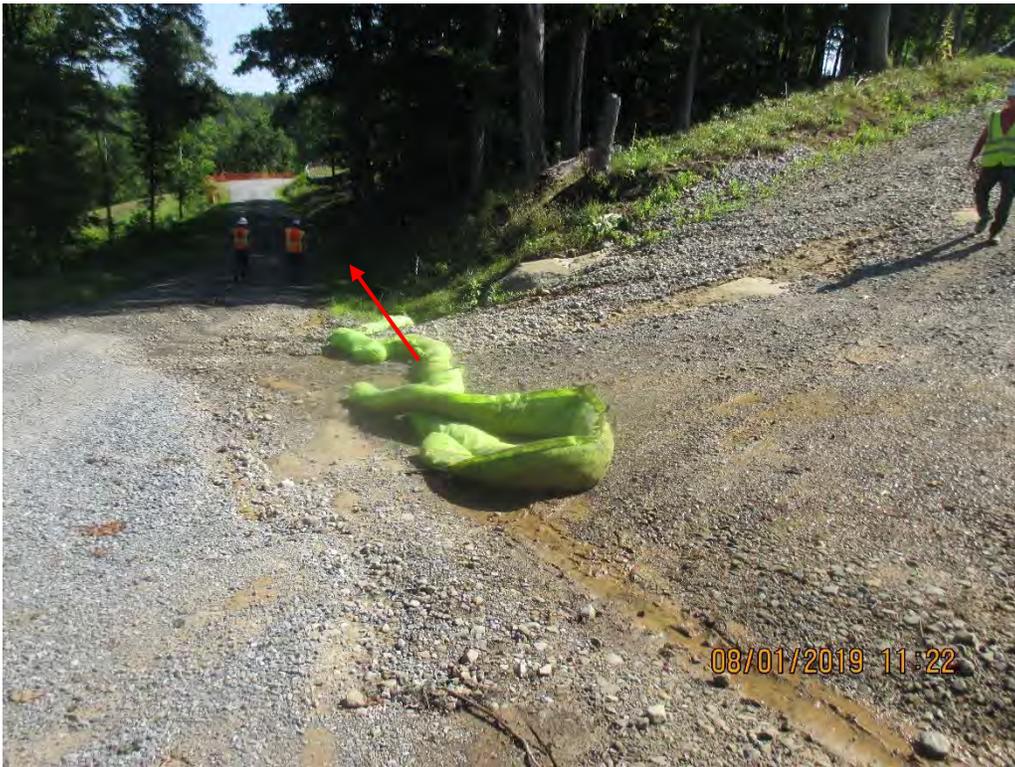
Facing downslope at intersection of BR-099 and CR24. Arrow depicts ditch line and where sediment deposits were observed.

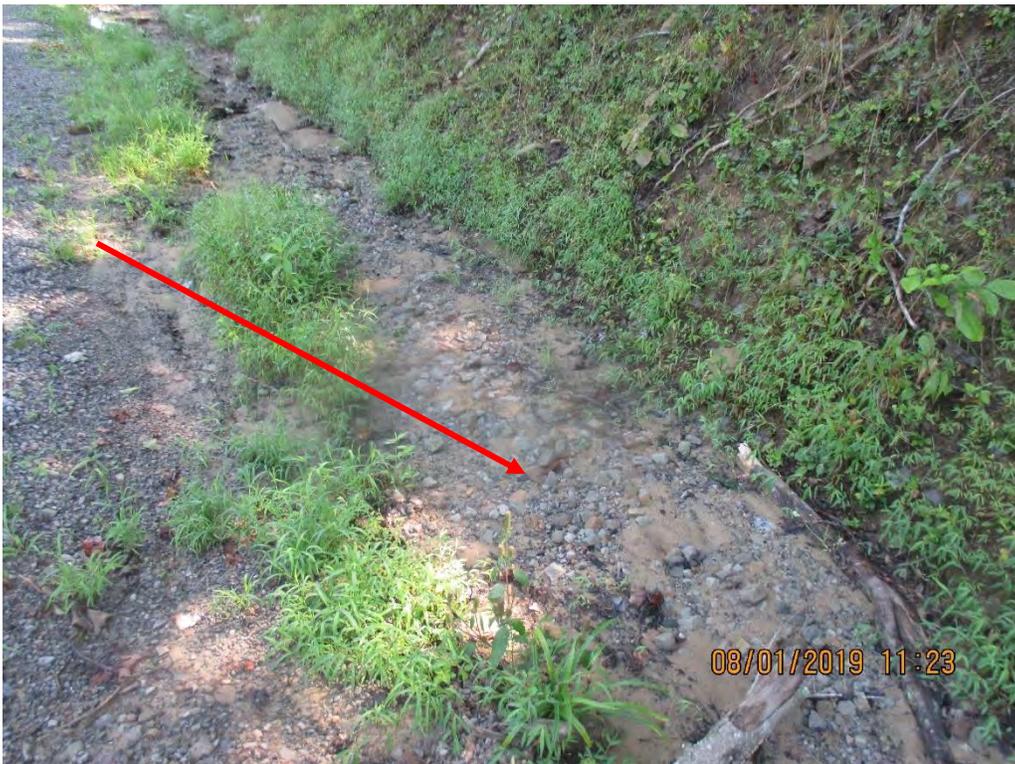
Sediment deposits observed along CR 24 downslope of Access Road MVP-BR-099 near station No. 3897+75.

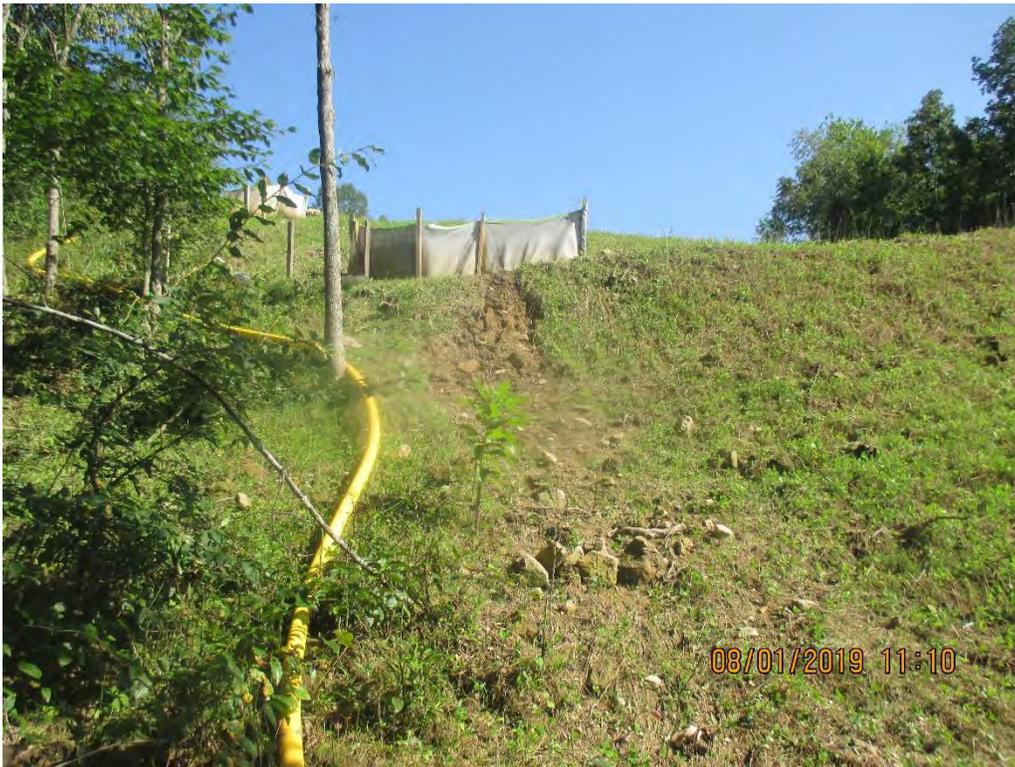
Waterbar that was overwhelmed with run-off causing undermining of controls leading to erosion downslope of controls South of BR-099 near station No. 3897+75.

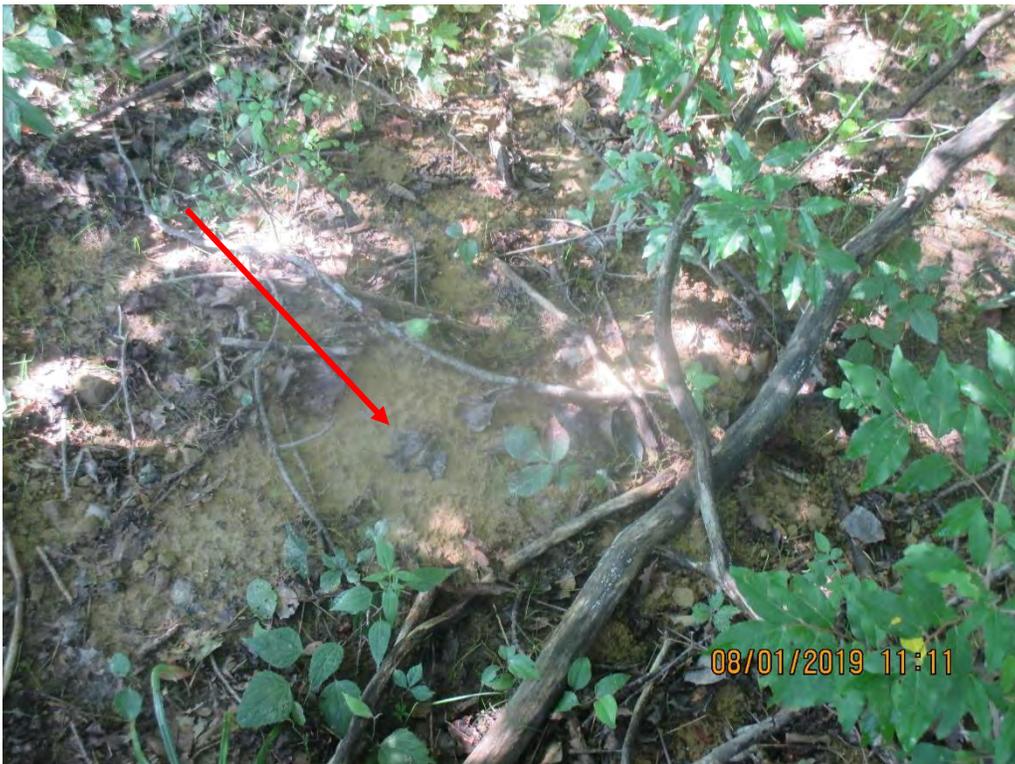
Downslope of Waterbar control failure South of BR-099 near station No. 3897+75. Sediment deposits observed past the LOD.

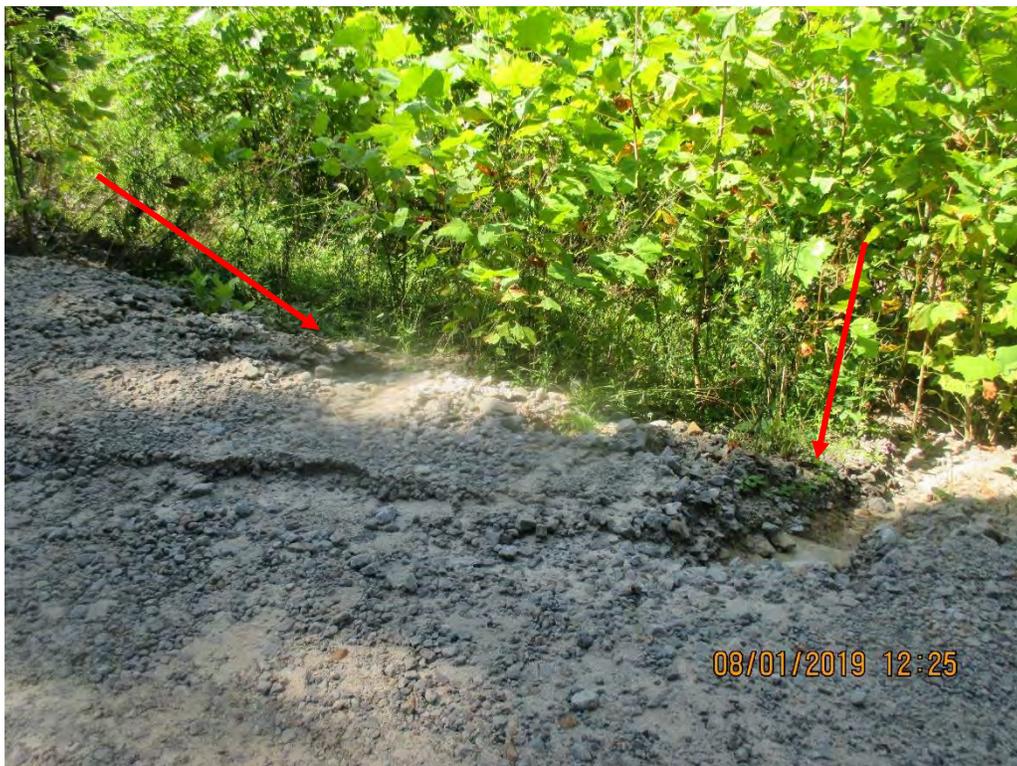
MVP-AR-095 upslope above CR 19. Arrow depicts where road was eroded out overwhelming downslope controls.

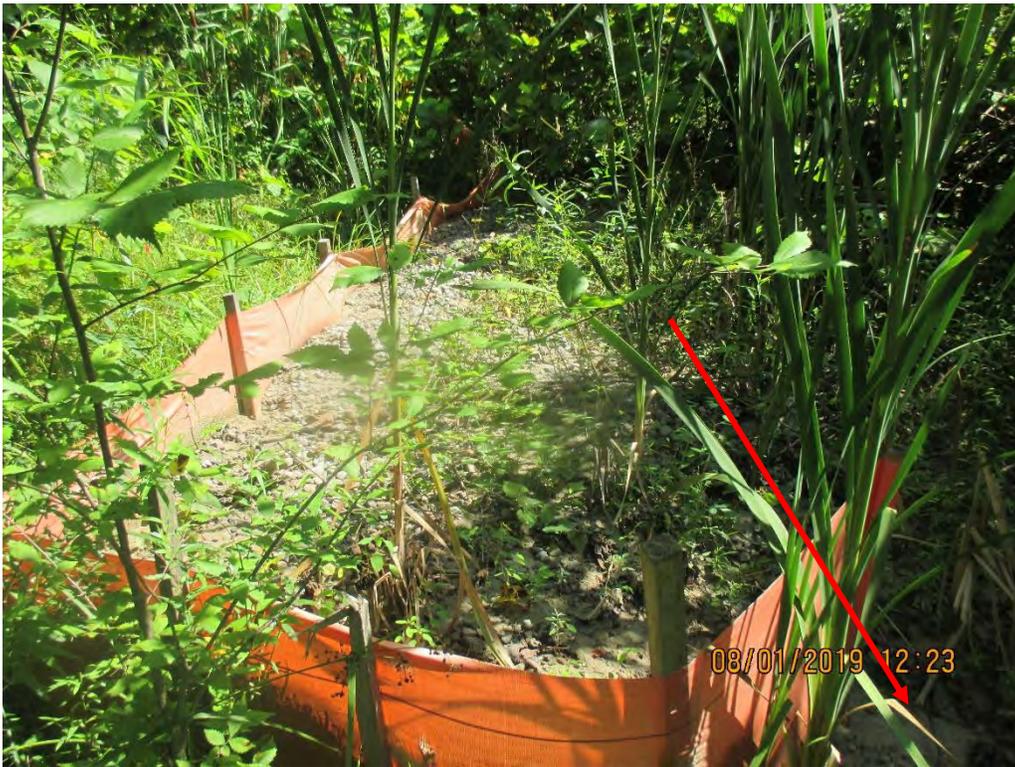
Controls located below washed out section of AR-095 and above stream S-J74 and Wetland W-J42. Arrow depicts where controls were overwhelmed and evidence that sediment laden water had flowed past controls was observed.

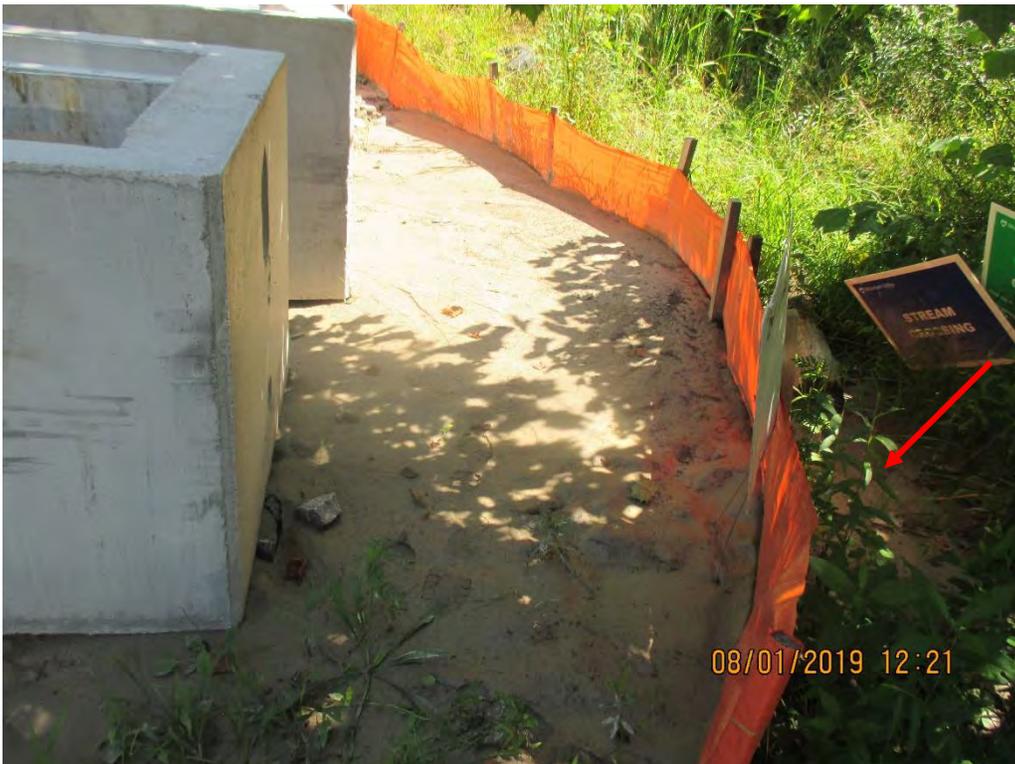
Sediment deposited behind controls at the entrance to BR-095 adjacent to US19/Hwy4. Arrow depicts sediment deposits past LOD above Stream S-J74 and Wetland W-J42.

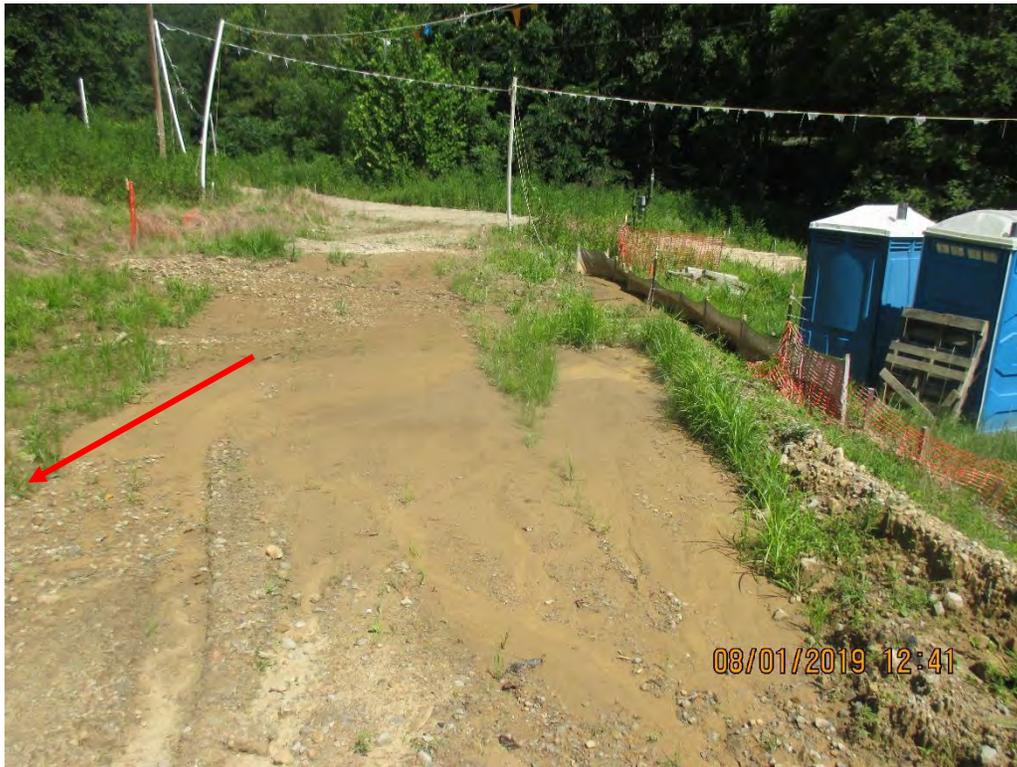
Standing above Access Road MVP-BR-097 and Falls Run (Stream S-J70) facing North. Run-on entering LOD and causing sediment to overwhelm controls. Arrow depicts where Run-On was coming onto Access Road.

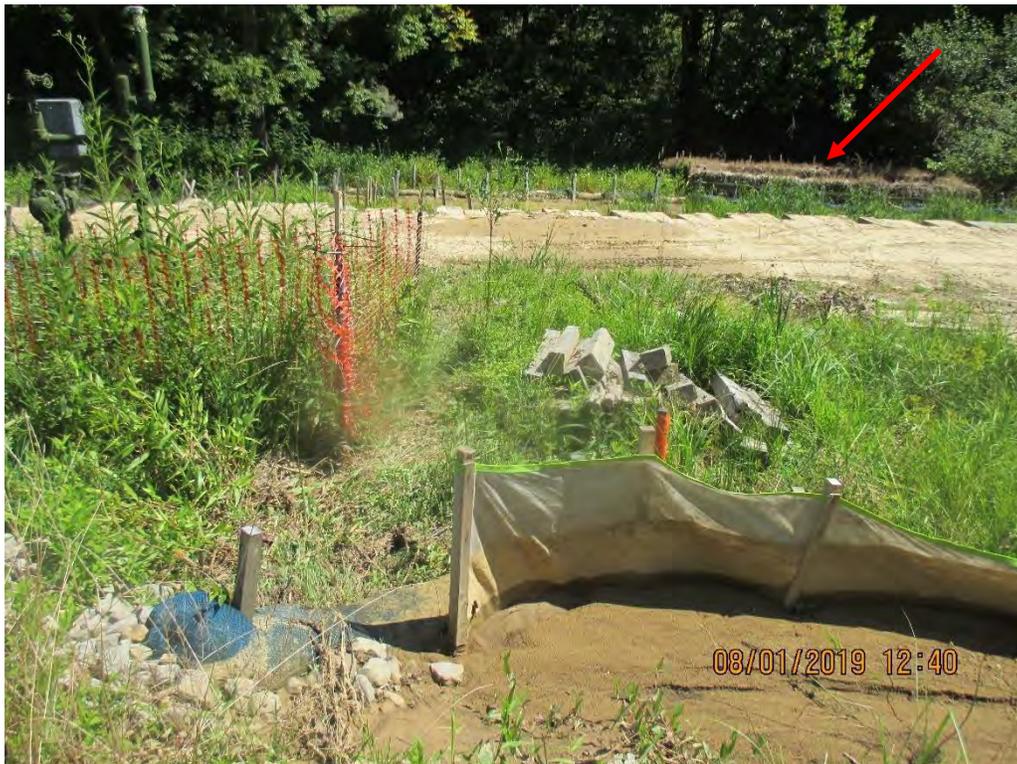
Facing Access Road MVP-BR-097. Controls overwhelmed with sediment due to run-on causing erosion. Controls had not been maintained. Arrow depicts dewatering structure.
