**The Wilderness Society et al. Comments on the  
U.S. Forest Service Mountain Valley Pipeline and  
Equitrans Expansion Project Draft Supplemental  
Environmental Impact Statement (#50036)**

**EXHIBIT 1**

Assessment of erosion, sedimentation, and water quality impacts of the Mountain Valley Pipeline and Equitrans Expansion Project's proposed crossing of the Jefferson National Forest as it pertains to the U.S. Forest Service's Draft Supplemental Environmental Impact Statement dated December 2022

Prepared by Jonathan A. Czuba, Ph.D., Licensed Professional Engineer

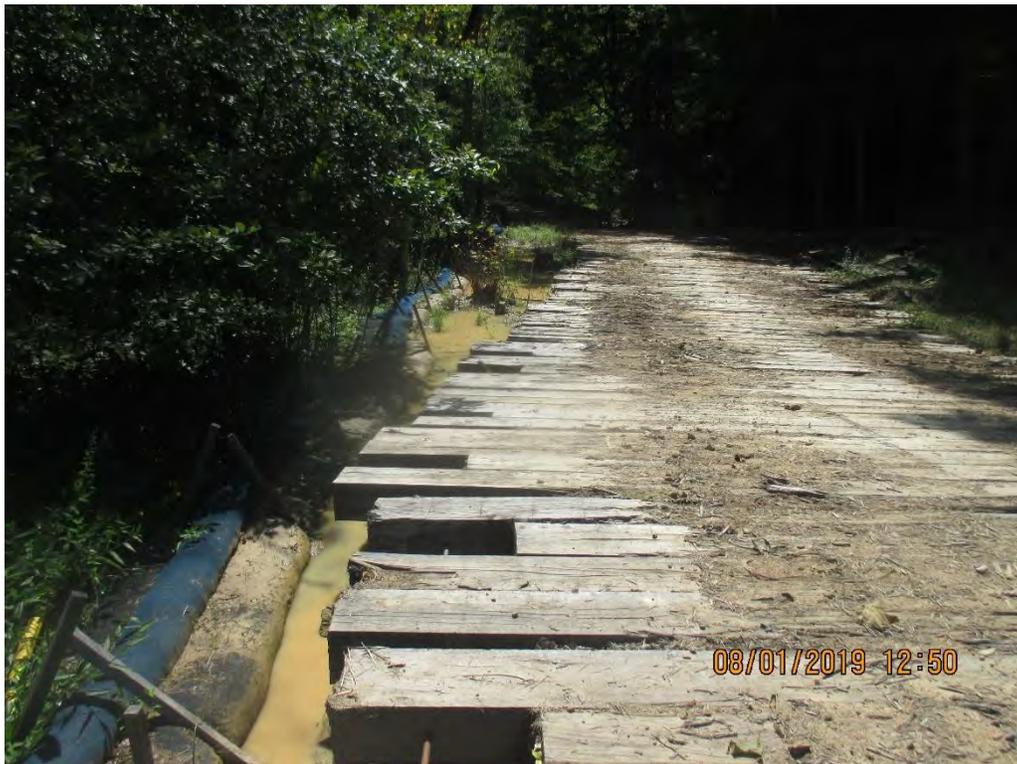
Perimeter controls below MVP-BR-097. Sediment laden water ponded behind controls.

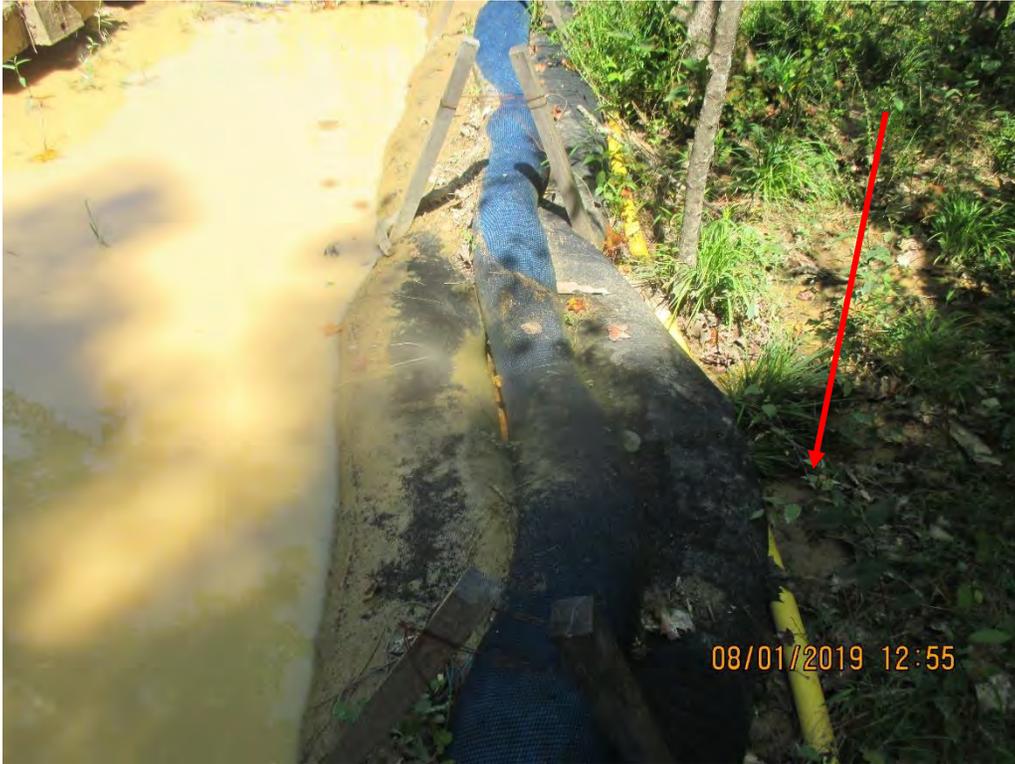
Perimeter controls below timber mat bridge on edge of LOD with sediment deposits past the LOD below MVP-BR-097.

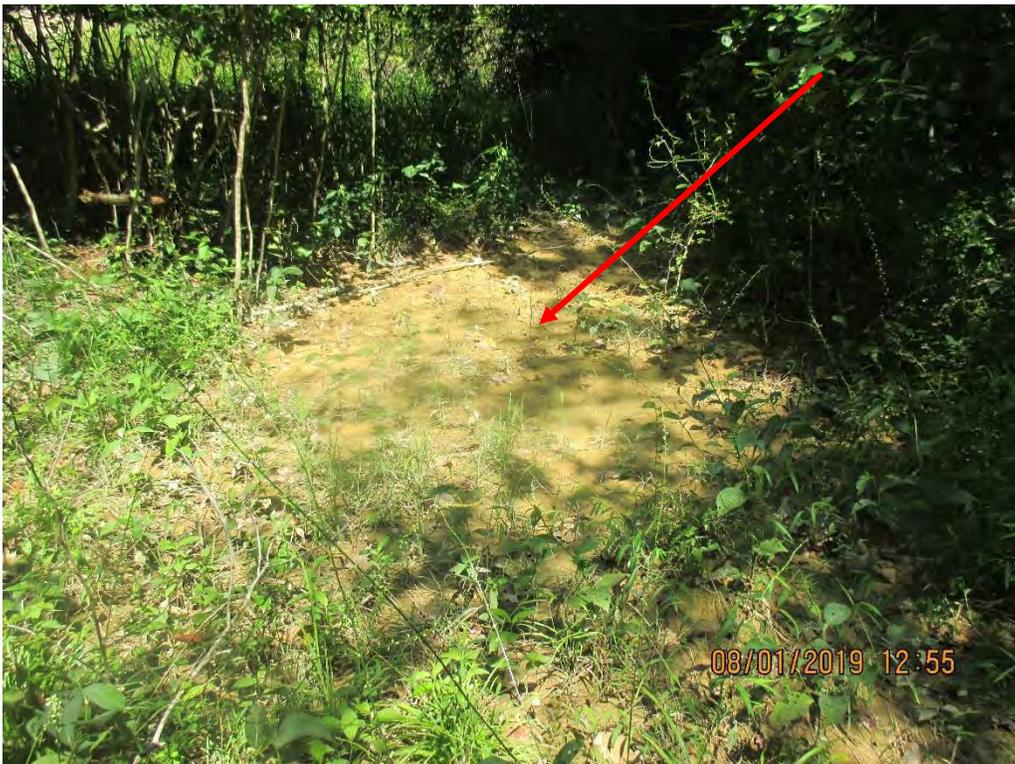
Sediment deposits present below MVP-BR-097 past the LOD and controls

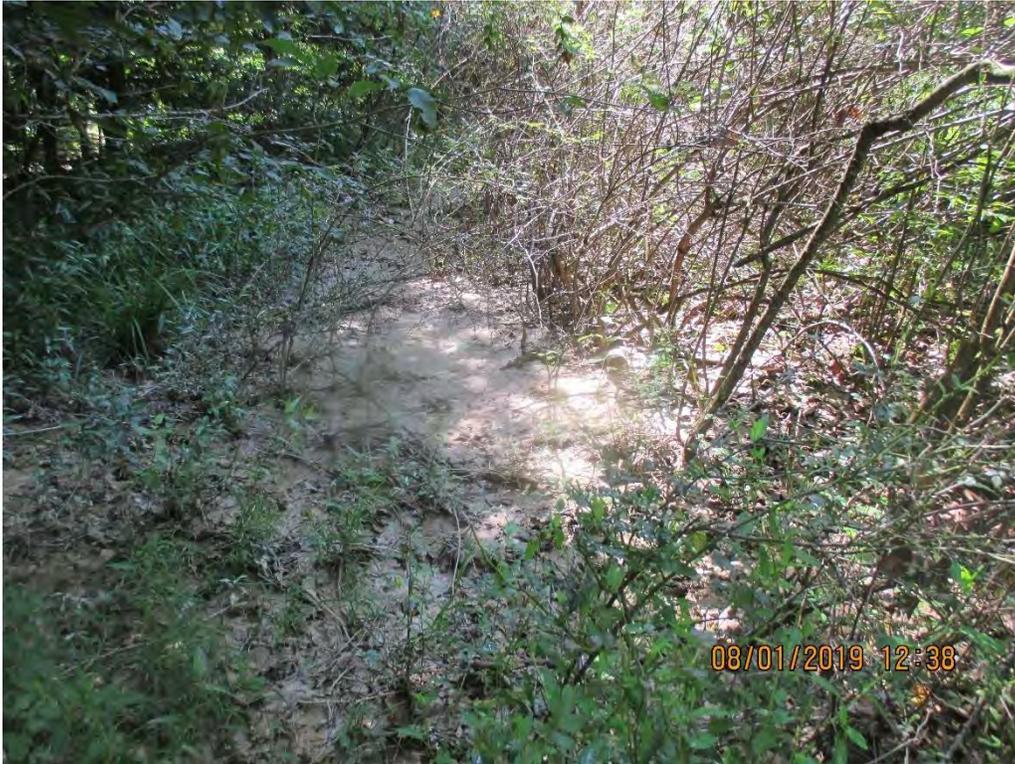
Sediment deposits pas the LOD and controls below MVP-BR-097.

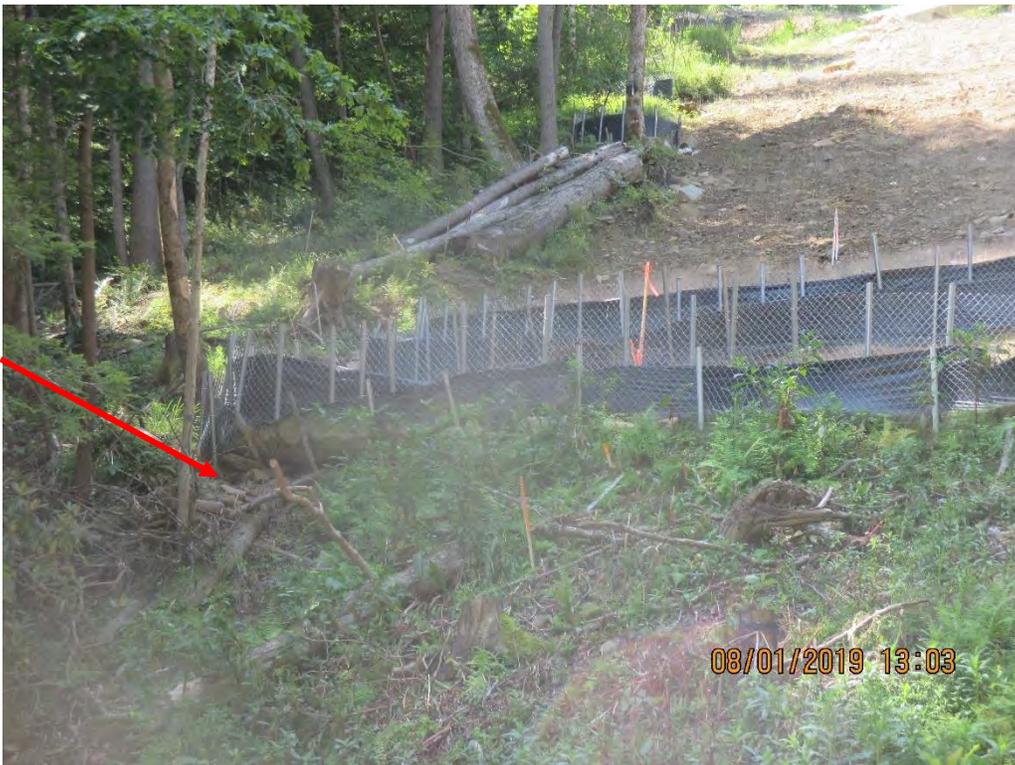
Controls above the South side of the Falls Run (Stream S-J70) and US 19/Hwy4 ROW crossing. Scouring present below controls. No sediment deposits observed below controls or in Falls Run on day of inspection.

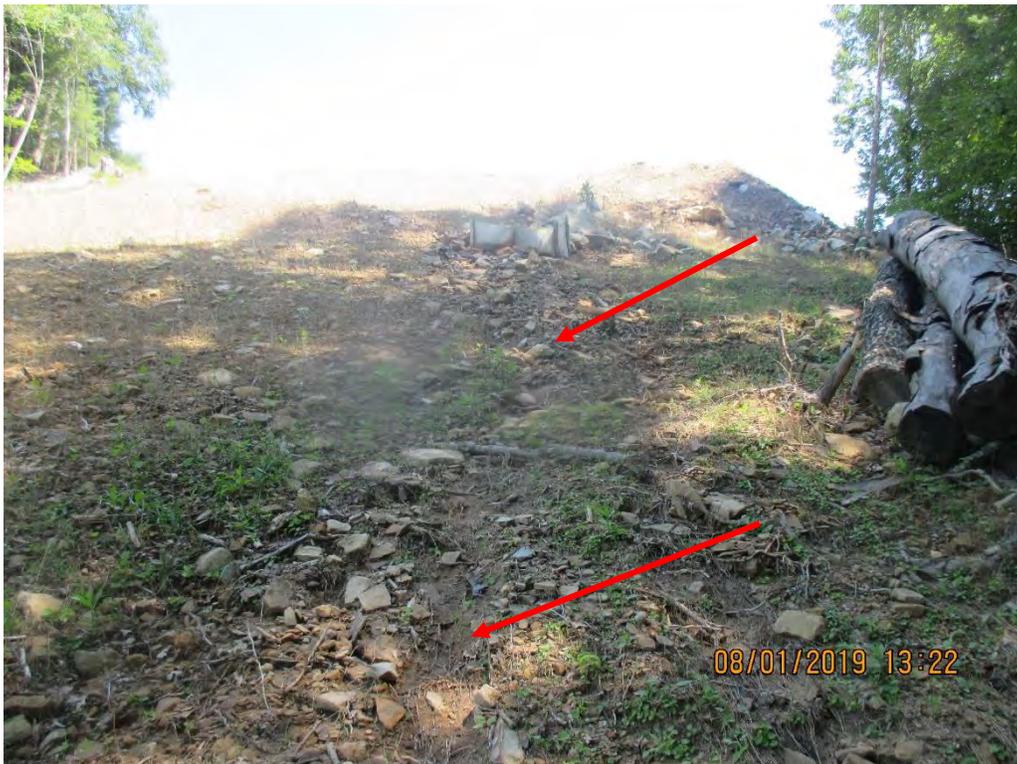
Slope above US19/Hwy4 and station No. 3831+00 not stabilized. Waterbars terminating onto ROW and not at edge of LOD. Arrow depicts erosion occurring below Waterbar on slope.

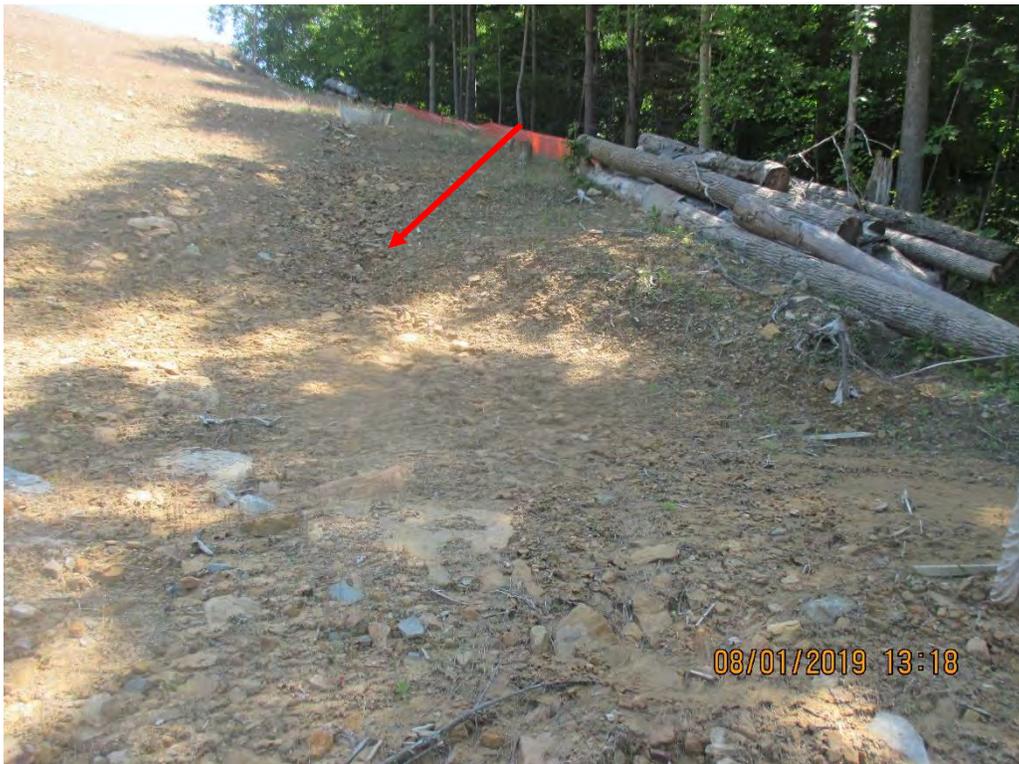
Further downslope from station No. 3831+00. Arrow depicts Erosion present below Waterbar on slope.

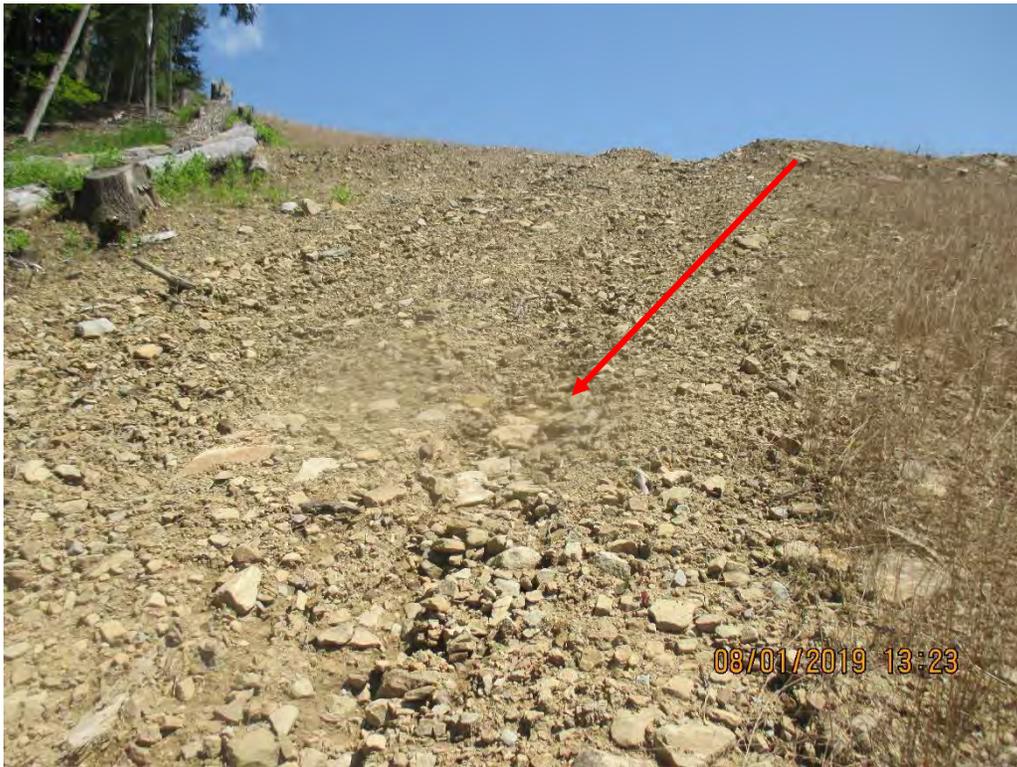
Travel lane on slope near station No. 3831+00. Erosion present in travel lane leading to Waterbar being overwhelmed with sediment and not functioning as designed.

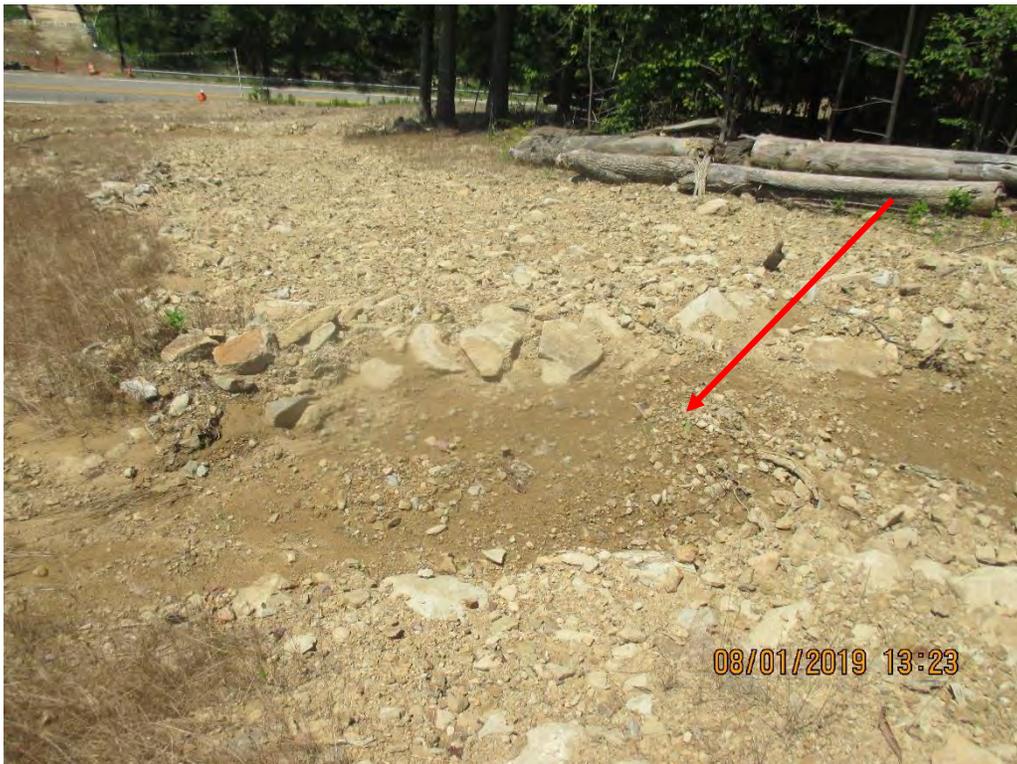
Near station No. 3831+00. Erosion present in travel lane leading to Waterbar being overwhelmed with sediment and not functioning as designed. Arrow depicts sediment deposited behind Waterbar.

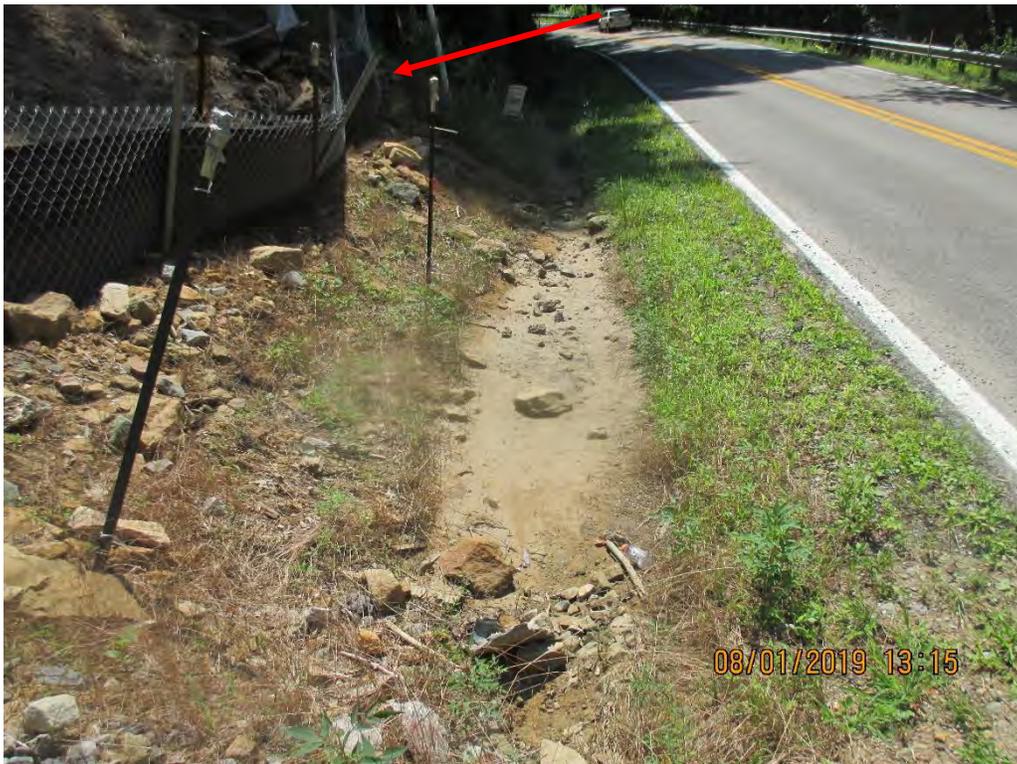
Sediment present in ditch that parallels US19/Hwy4 due to control failure. Arrow depicts control failure at base of slope.

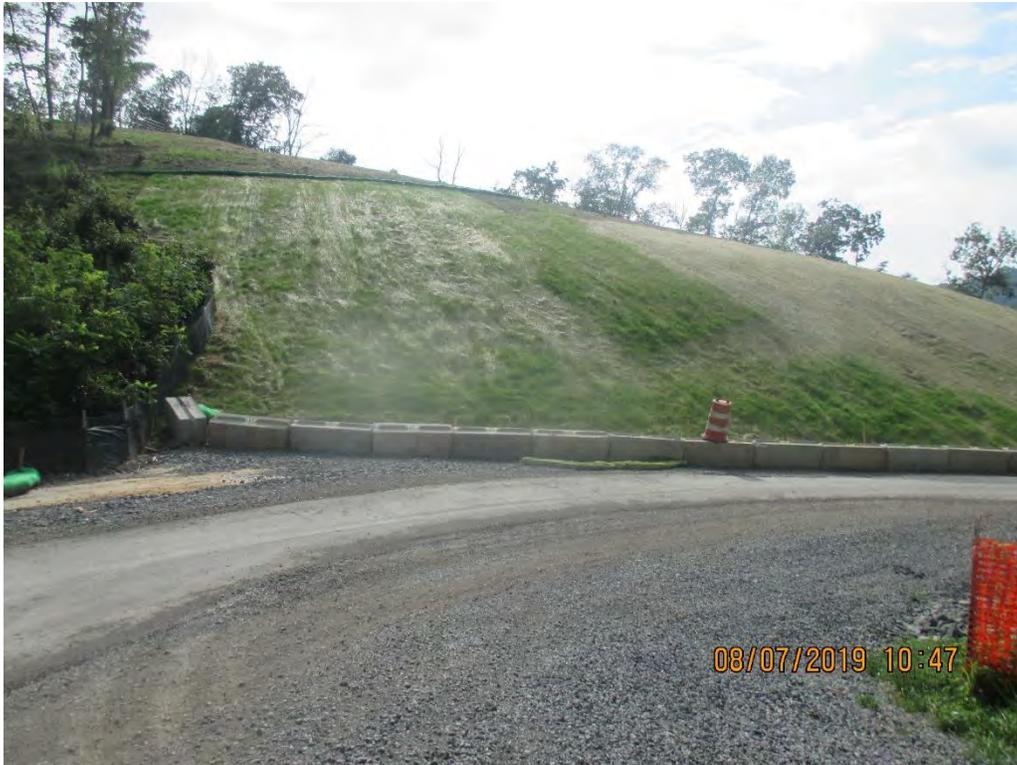
Facing MVP ROW at fisher Hill/ West Clayton Road Crossing. Slope had been stabilized with Curlex and CFS was added behind the road barriers.

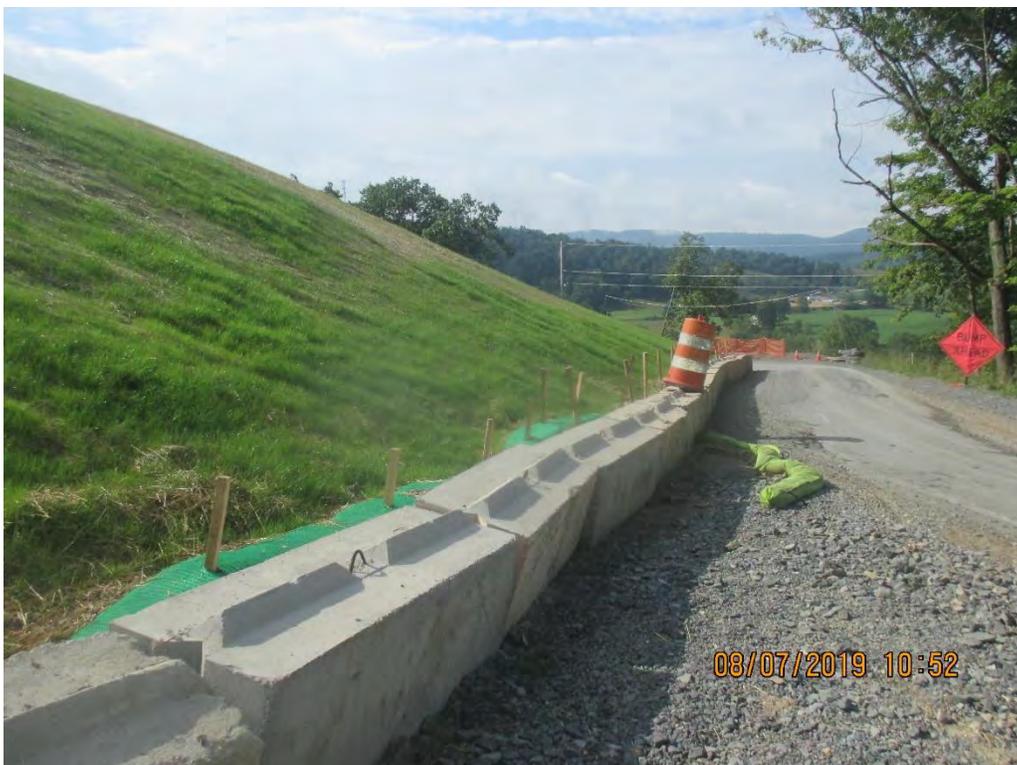
Facing towards Greenbrier River on West Clayton Road/Fisher Hill crossing. Grass germinating on slope.

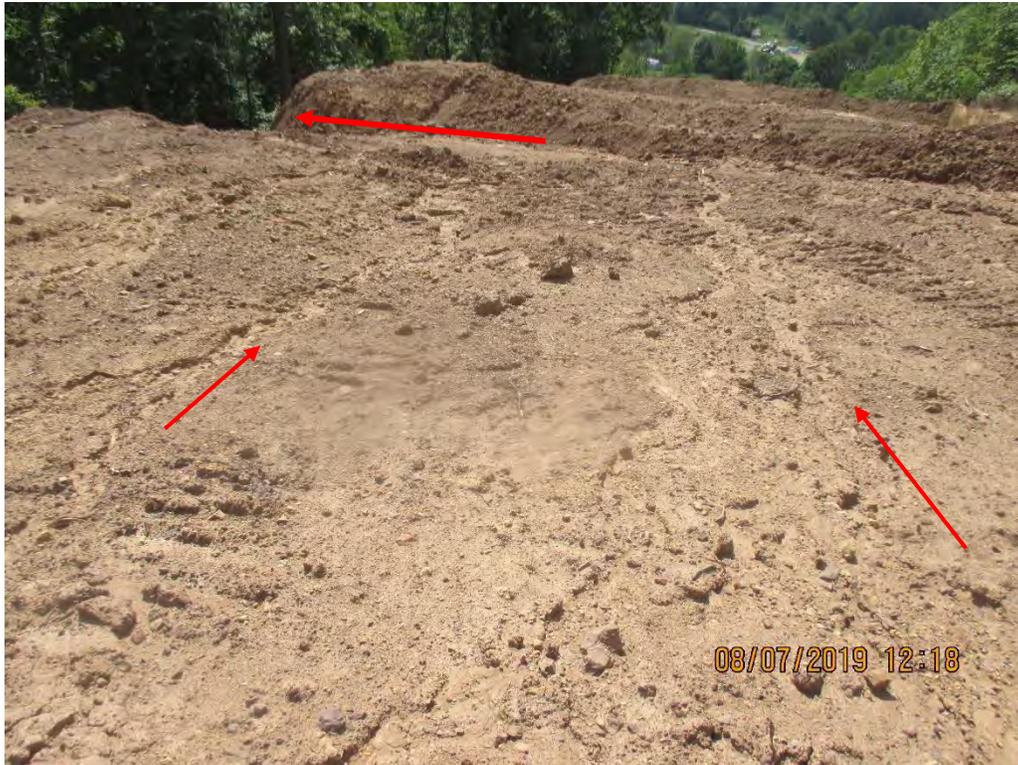
Standing at top of steep slope facing South towards Boom Hollow Road at station No. 8951+00. Arrow depicts erosion on slope and Waterbar with no outlet control.

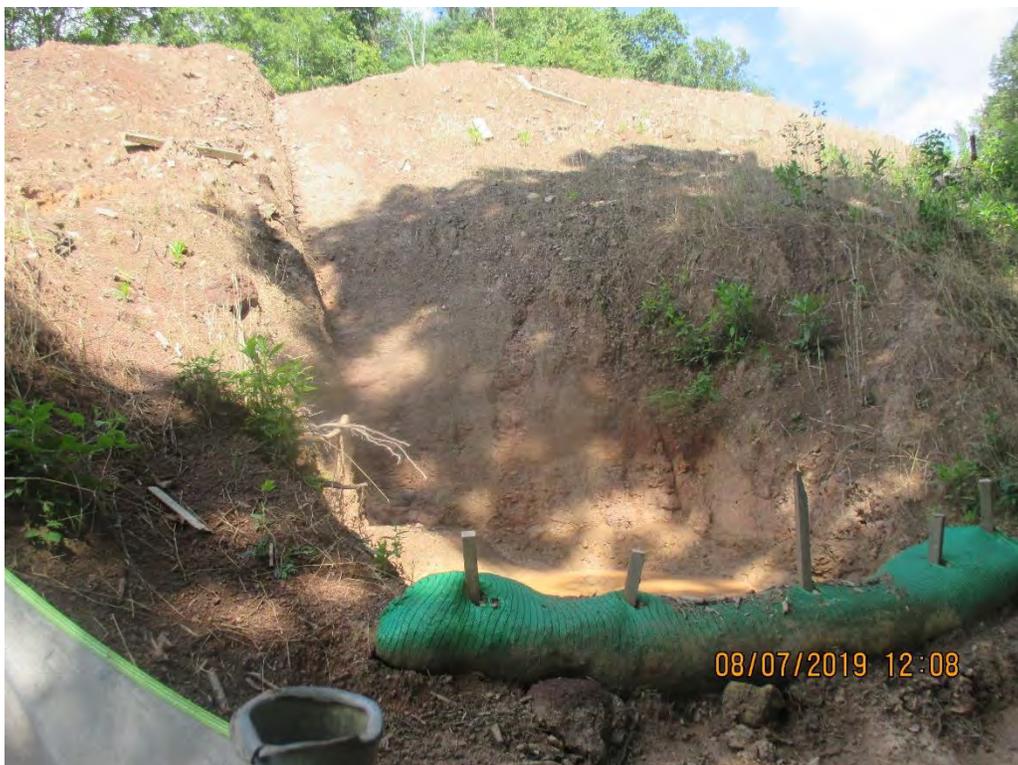
Controls below Waterbar termini with no outlet control terminating onto fill slope and above LOD near station No. 8951+00.

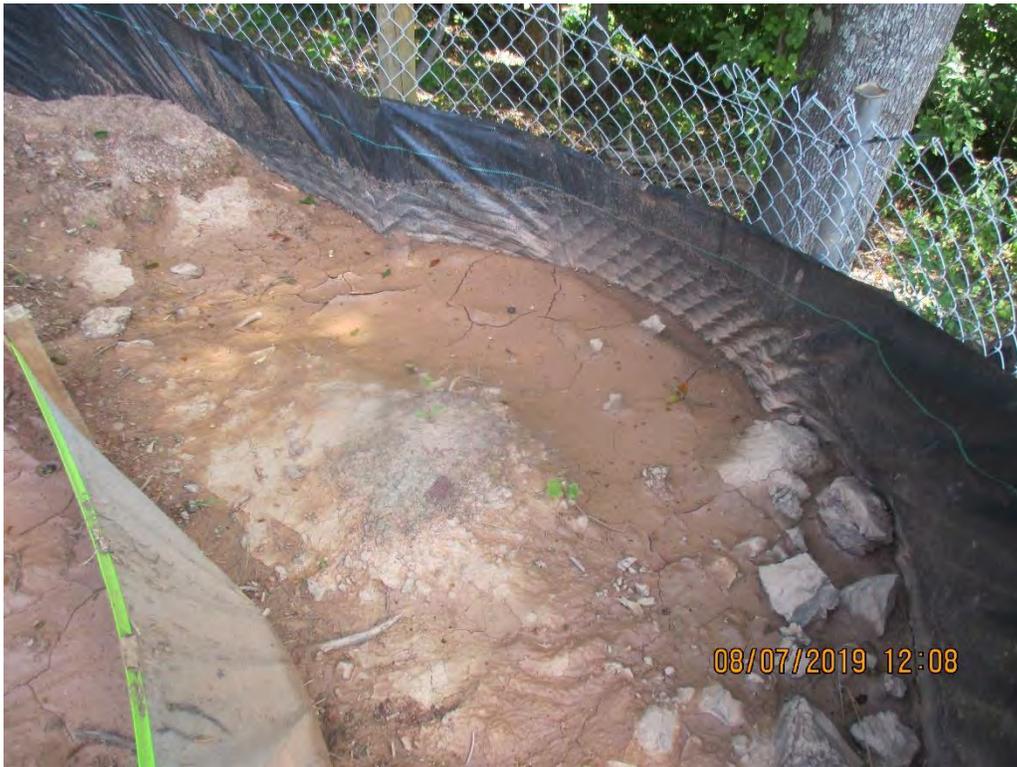
Further downslope near station no. 8951+00. Controls below Waterbar termini with no outlet control terminating onto fill slope and above LOD. Controls needed maintained.

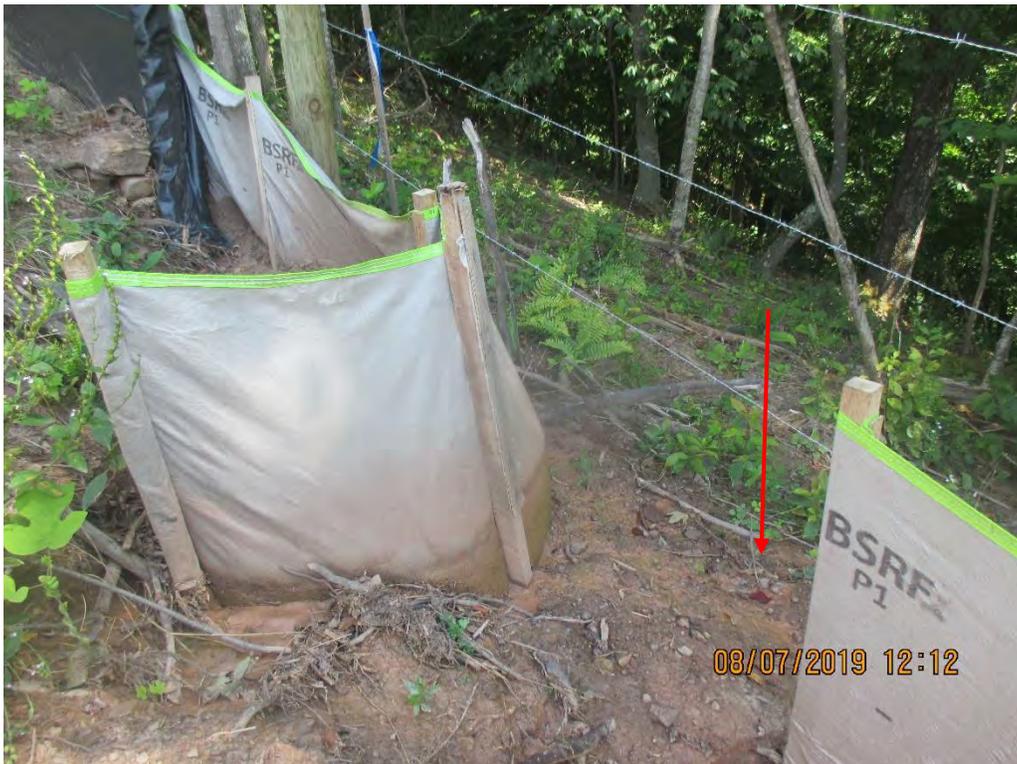
Further downslope near station no. 8951+00. Perimeter Controls below Waterbar termini with no outlet control terminating onto fill slope and above LOD. Sediment deposits observed past the LOD.

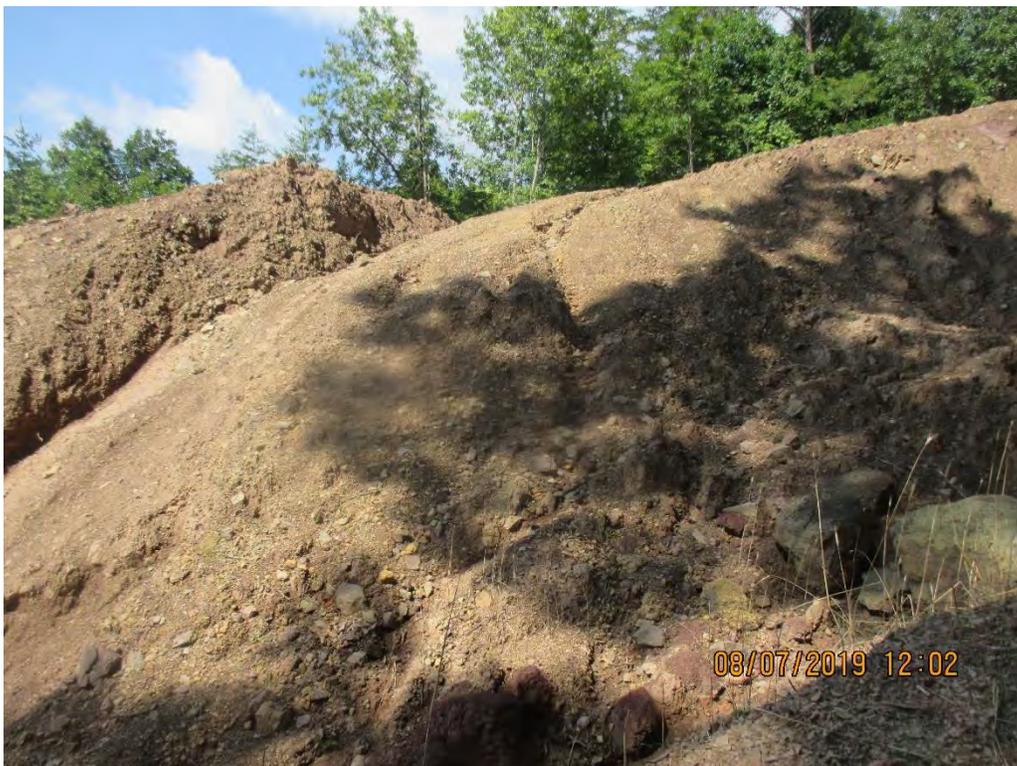
Near station No. 8954+00. Waterbar terminating onto fill slope.

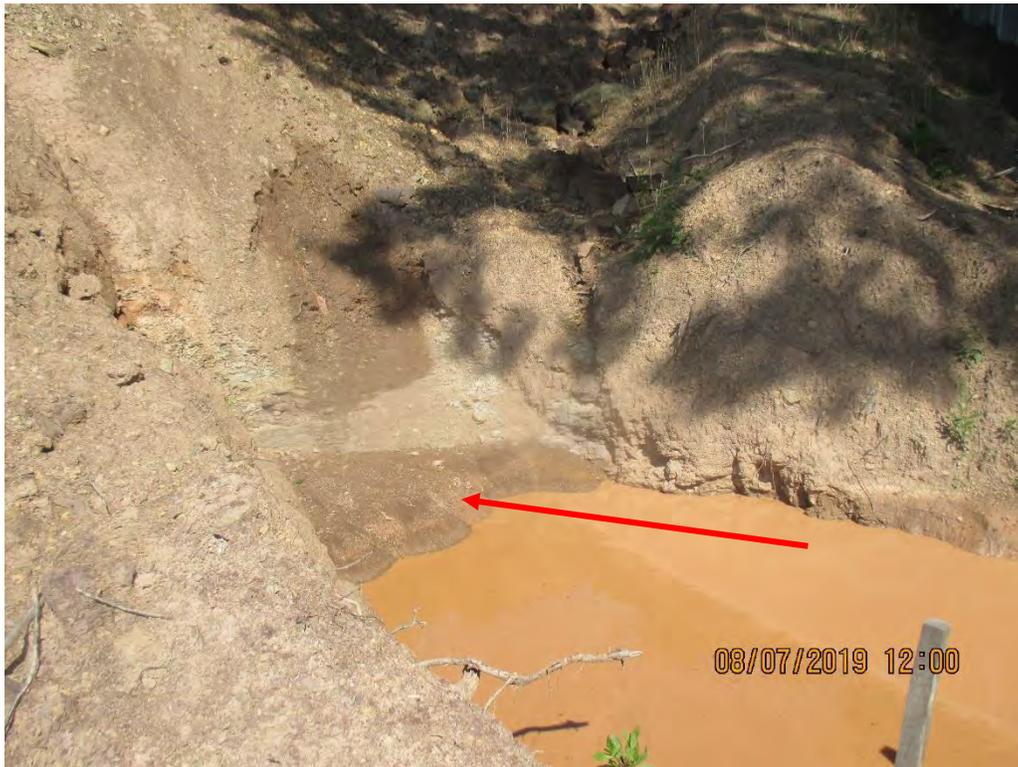
Near station No. 8955+00. Sump below Waterbar terminating onto fill slope. Sump overwhelmed with sediment.

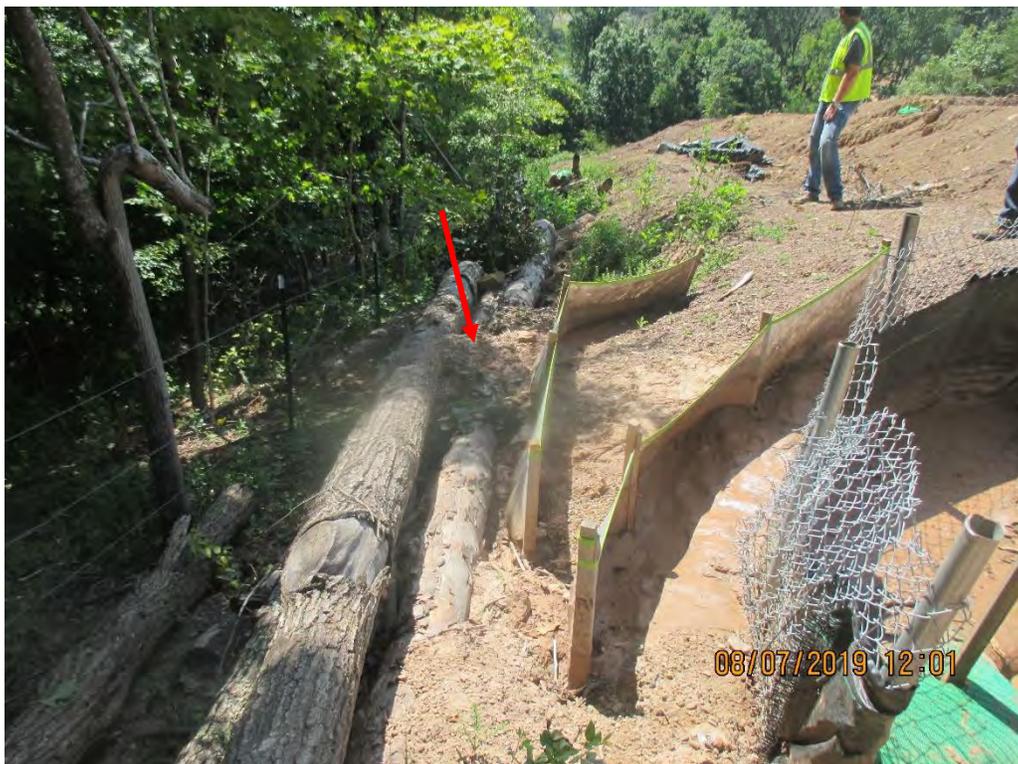
Near station No. 8955+00. Perimeter controls below Waterbar terminating onto fill slope and sump that was full of sediment. Perimeter controls overwhelmed and sediment deposits present past log pile.

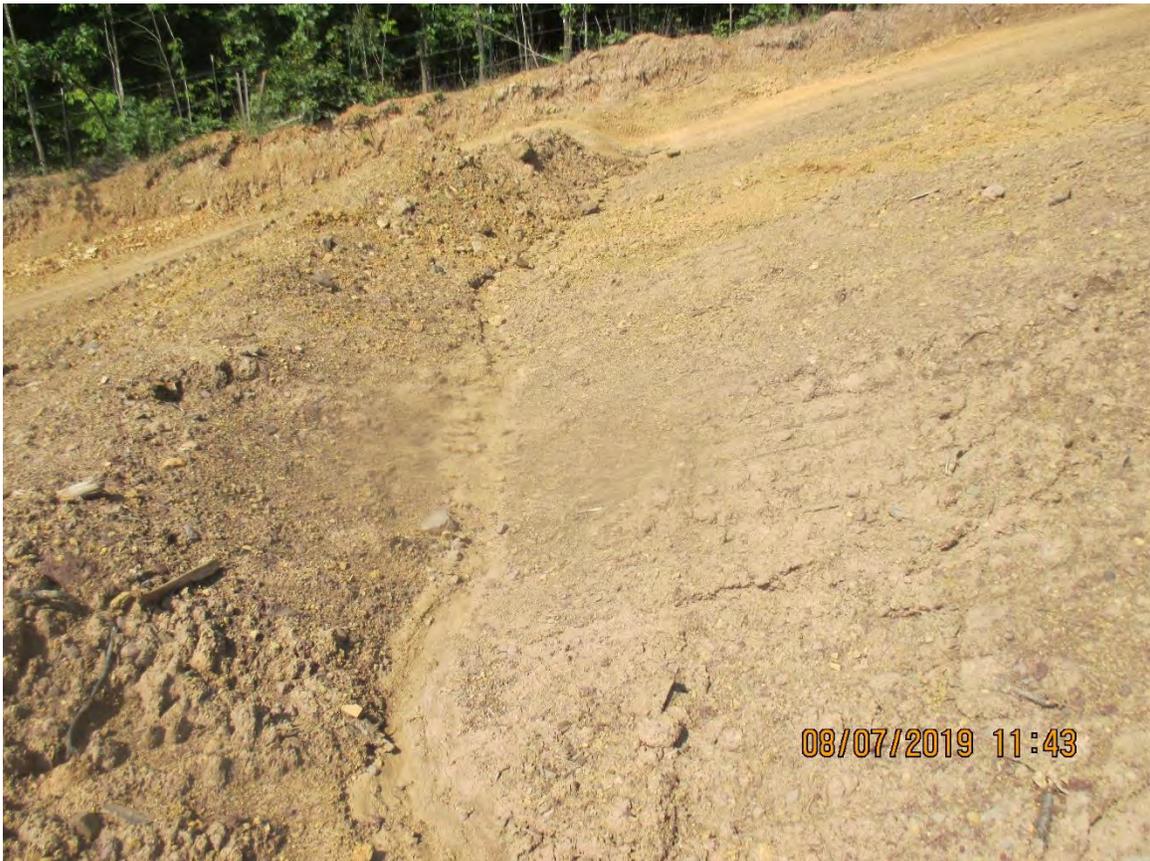
Erosion present in Waterbar near station No. 8955+00 facing upslope.

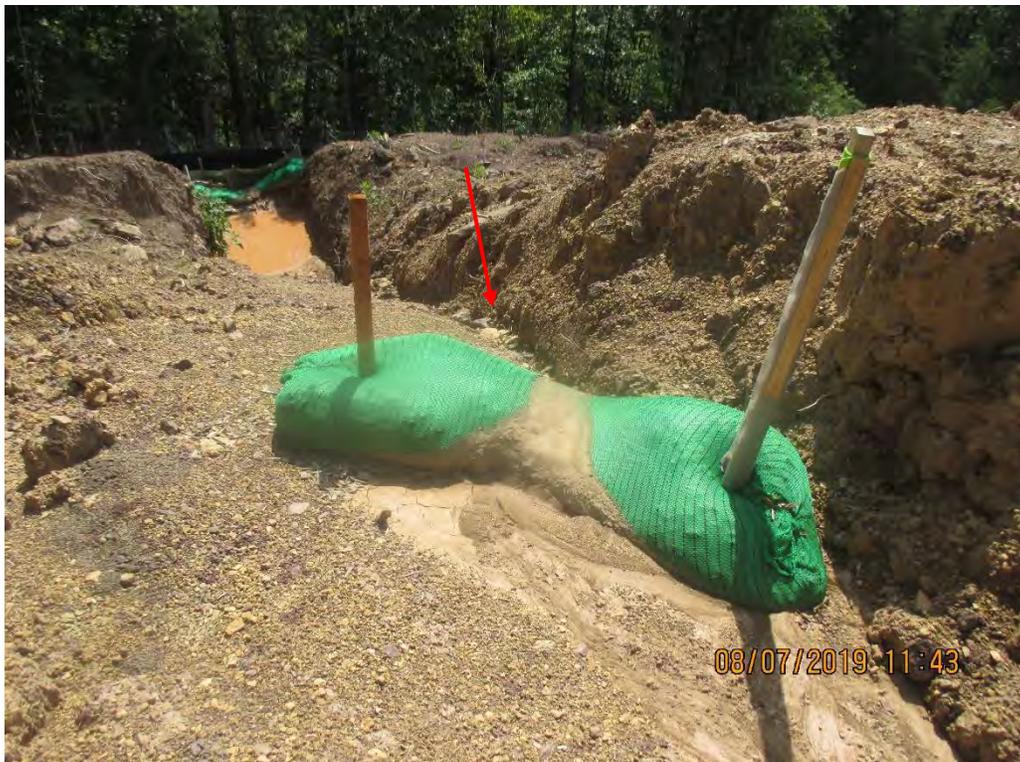
Waterbar terminus near station No. 8955+00. Erosion present on slope below Waterbar terminus.

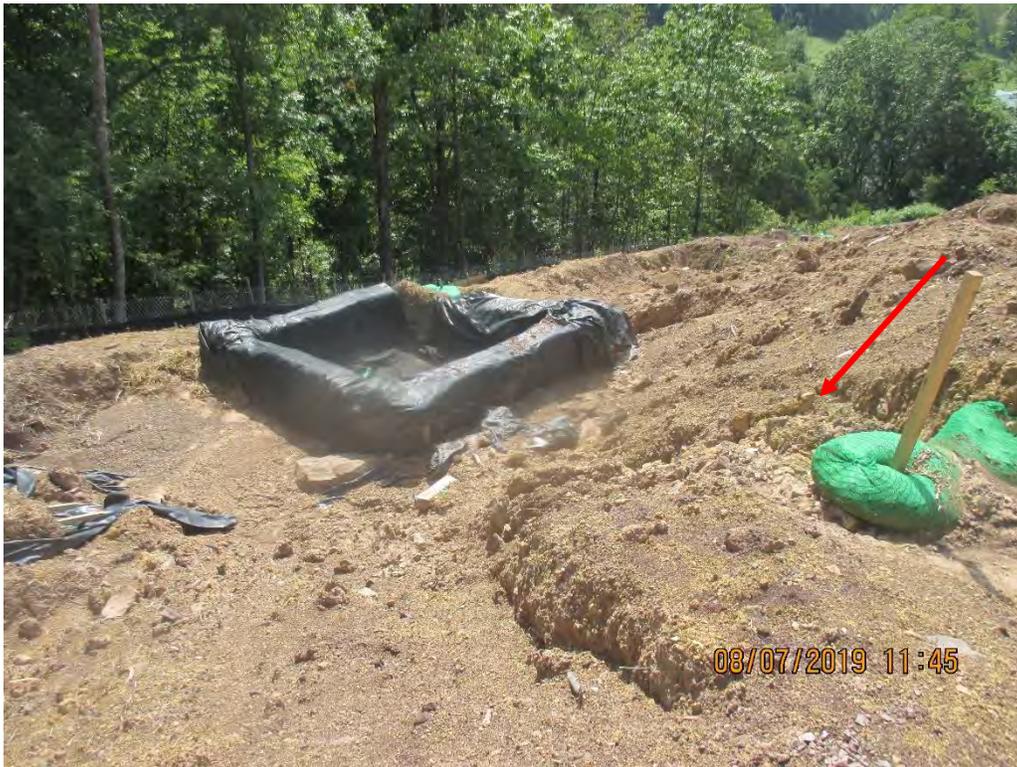
Dewatering Structure present on slope and below Waterbar terminus near station No. 8955+00. Erosion present on slope.

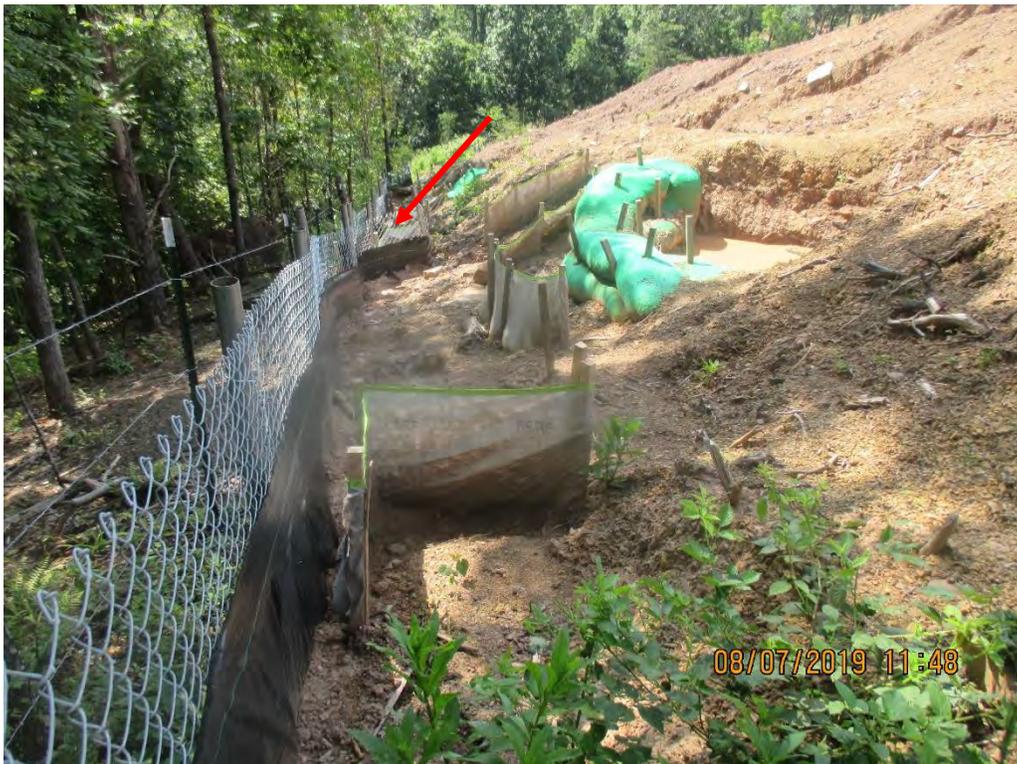
Perimeter controls below dewatering structure at station No. 8955+00. Arrow depicts where controls were overwhelmed with sediment.

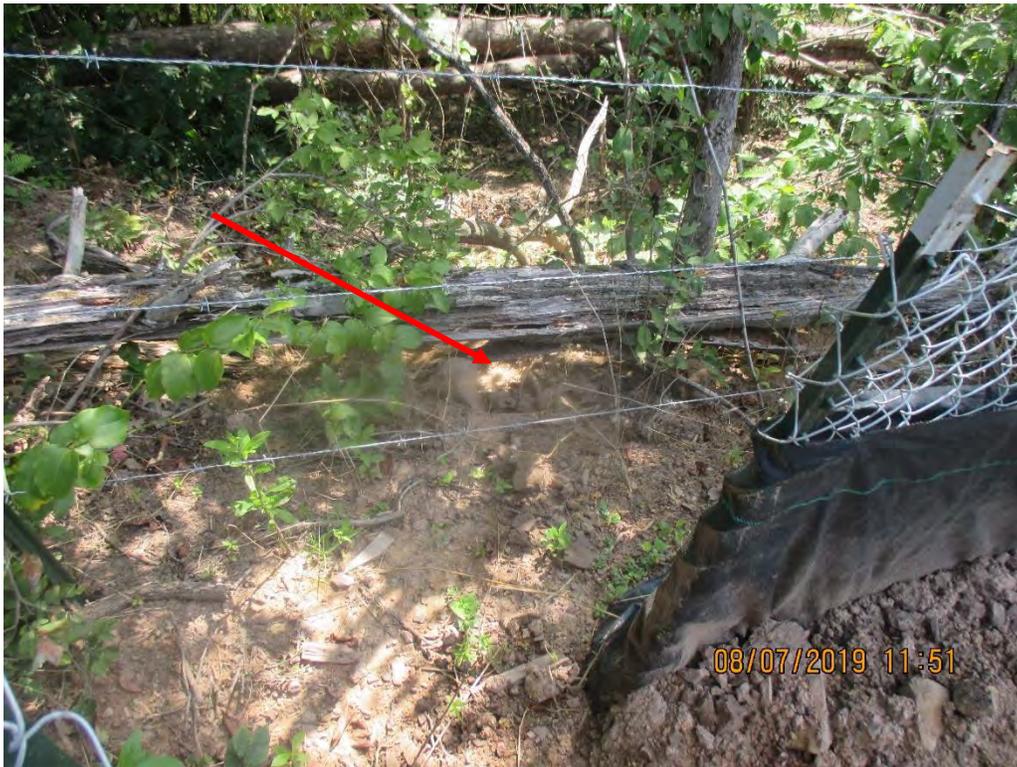
Sediment deposits past the LOD near station No. 8955+00 downslope of Waterbar terminating onto ROW.

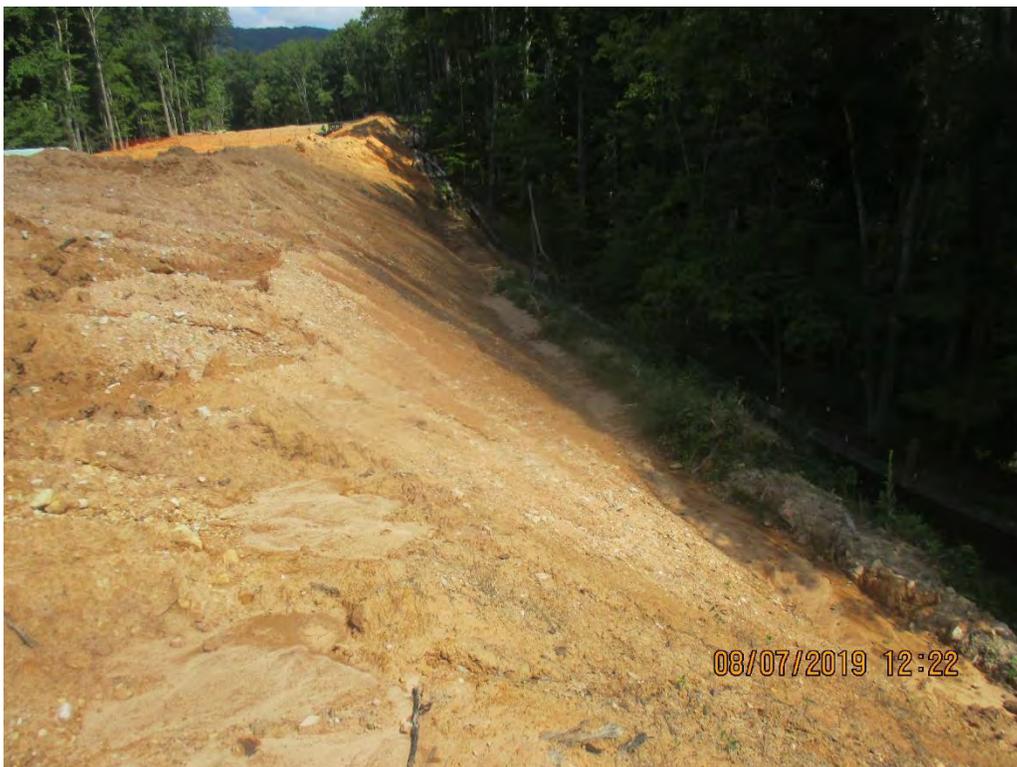
Fill slope near station No. 8946+00. Erosion present on fill slope leading to sediment overwhelming perimeter controls.

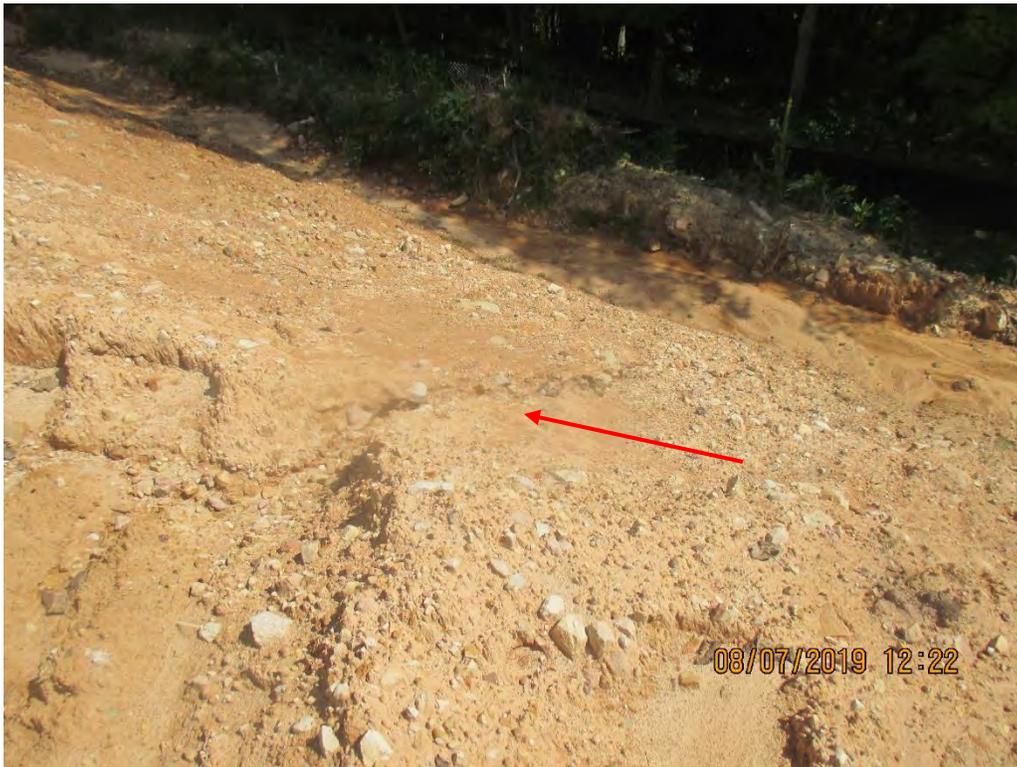
Fill slope near station No. 8946+00. Erosion present on fill slope leading to sediment overwhelming perimeter controls.

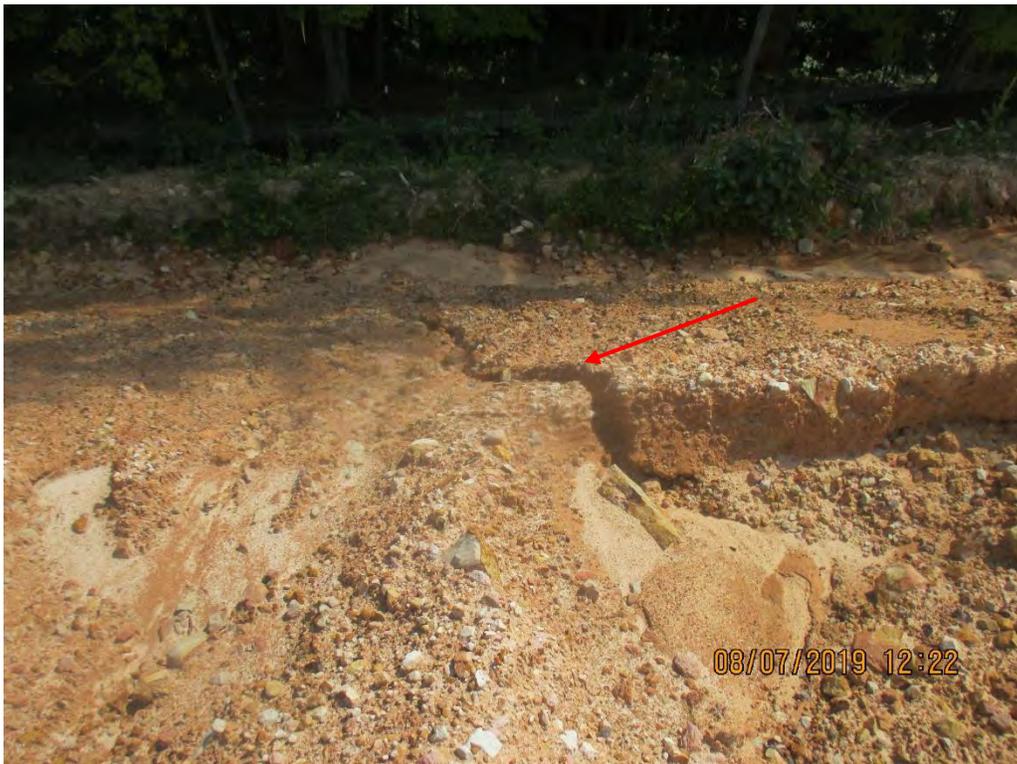
Fill slope near station No. 8946+00. Erosion present on fill slope leading to sediment overwhelming perimeter controls.

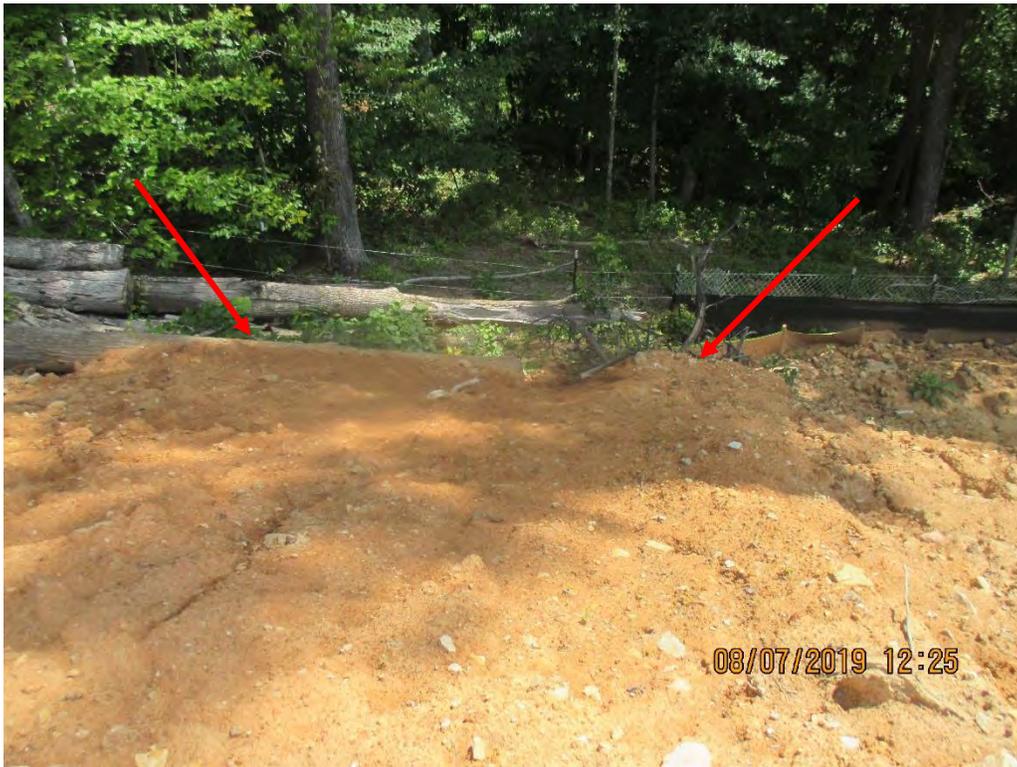
Fill slope near station No. 8946+00. Erosion present on fill slope leading to sediment overwhelming perimeter controls. Arrows depict overwhelmed controls.
