**The Wilderness Society et al. Comments on the  
U.S. Forest Service Mountain Valley Pipeline and  
Equitrans Expansion Project Draft Supplemental  
Environmental Impact Statement (#50036)**

**EXHIBIT 1**

Assessment of erosion, sedimentation, and water quality impacts of the Mountain Valley Pipeline and Equitrans Expansion Project's proposed crossing of the Jefferson National Forest as it pertains to the U.S. Forest Service's Draft Supplemental Environmental Impact Statement dated December 2022

Prepared by Jonathan A. Czuba, Ph.D., Licensed Professional Engineer

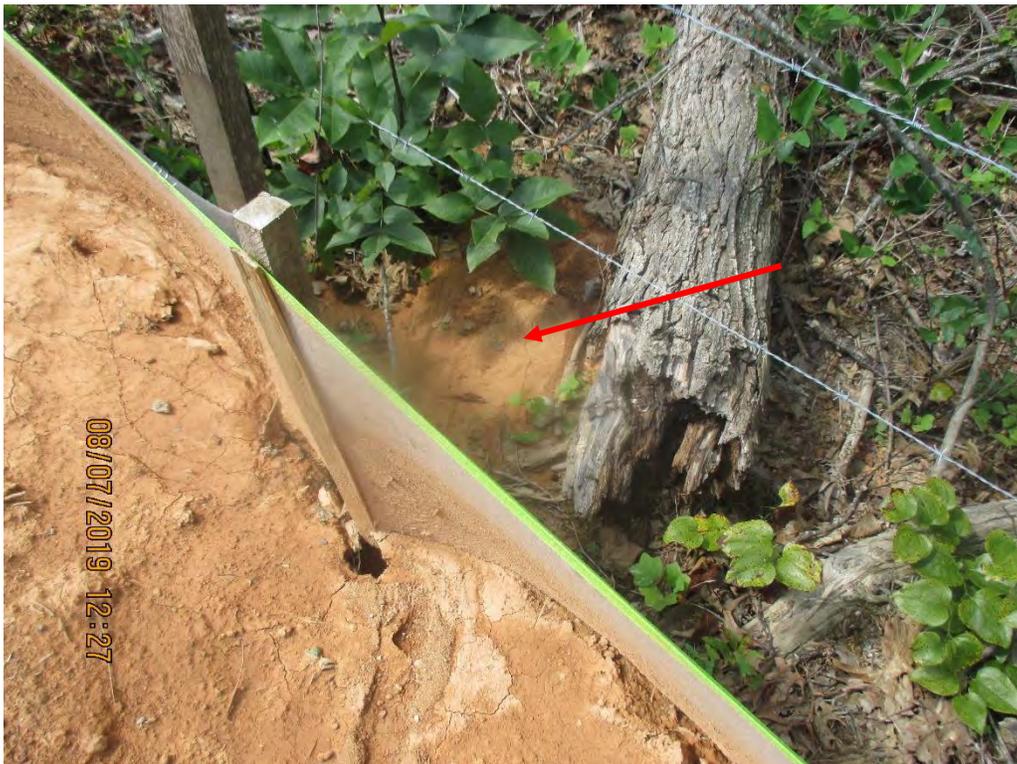
Sediment deposits past controls at station No. 8944+00.

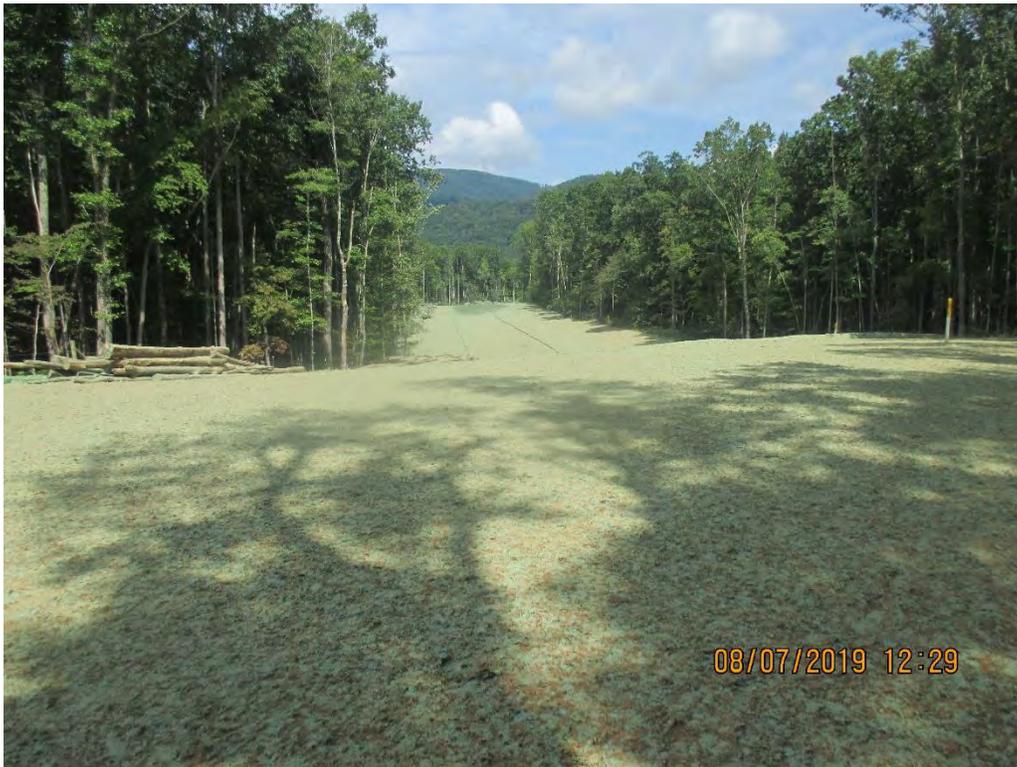
MVP ROW facing North near station No. 8946+00. ROW recently hydroseeded.

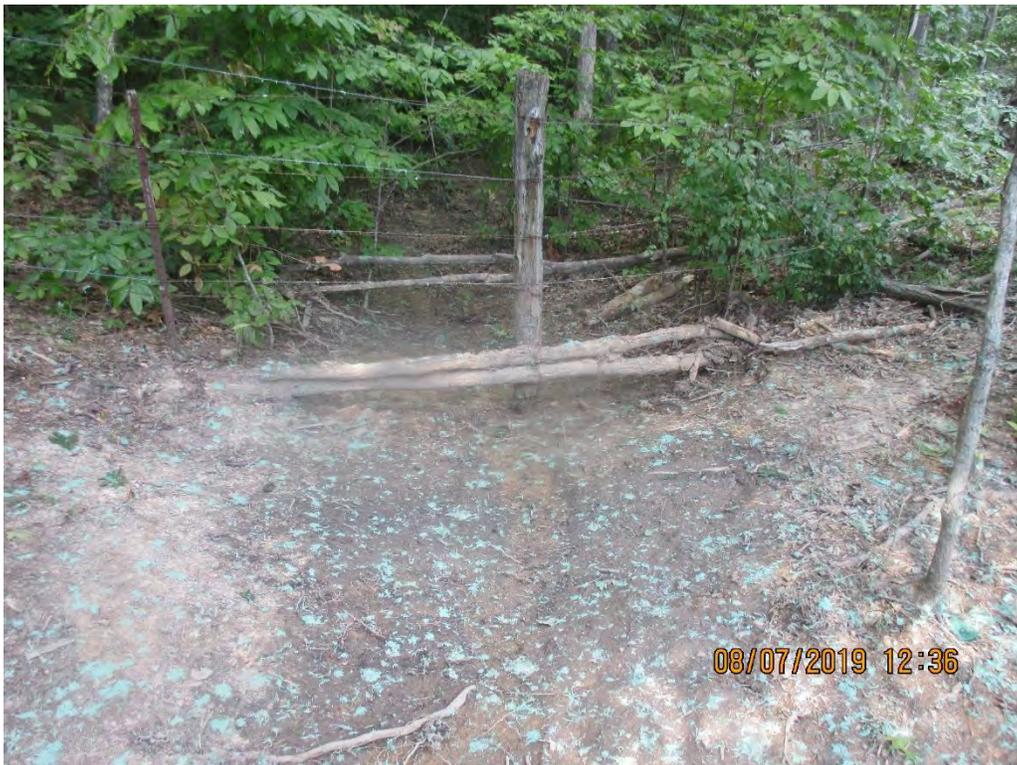
Beginning of Stream S-K16 at edge of LOD near station No. 8929+00. Sediment deposits had been recovered.

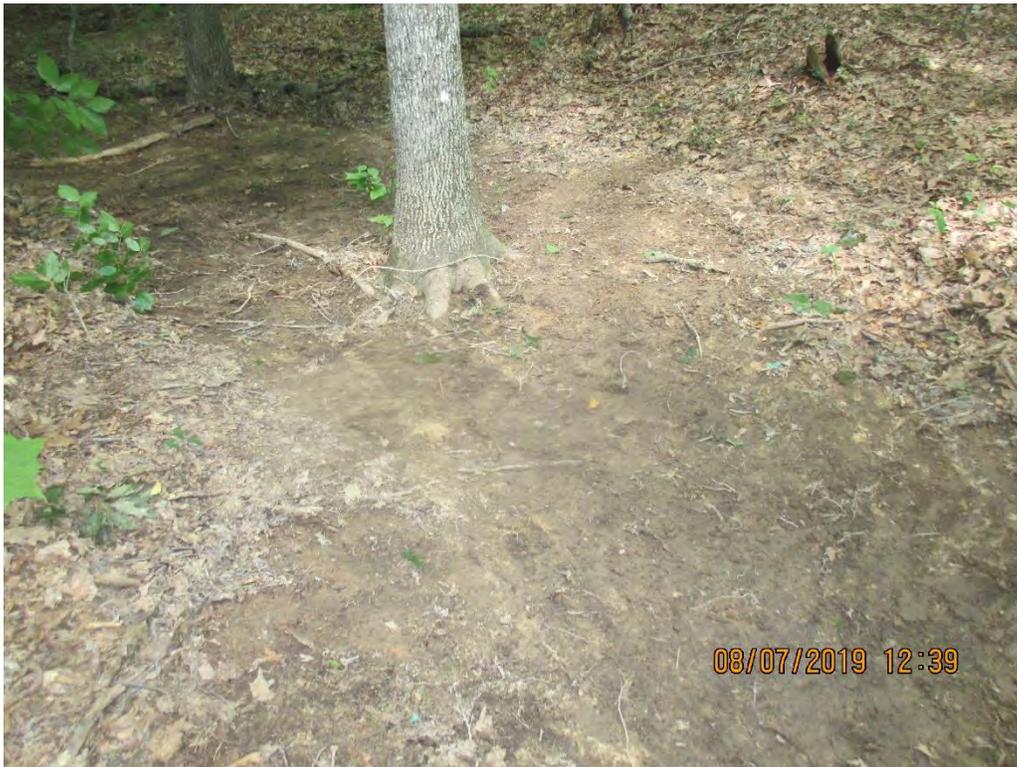
Approximately 50-foot downslope of LOD near Station No. 8929+00. Sediment deposits had been recovered.

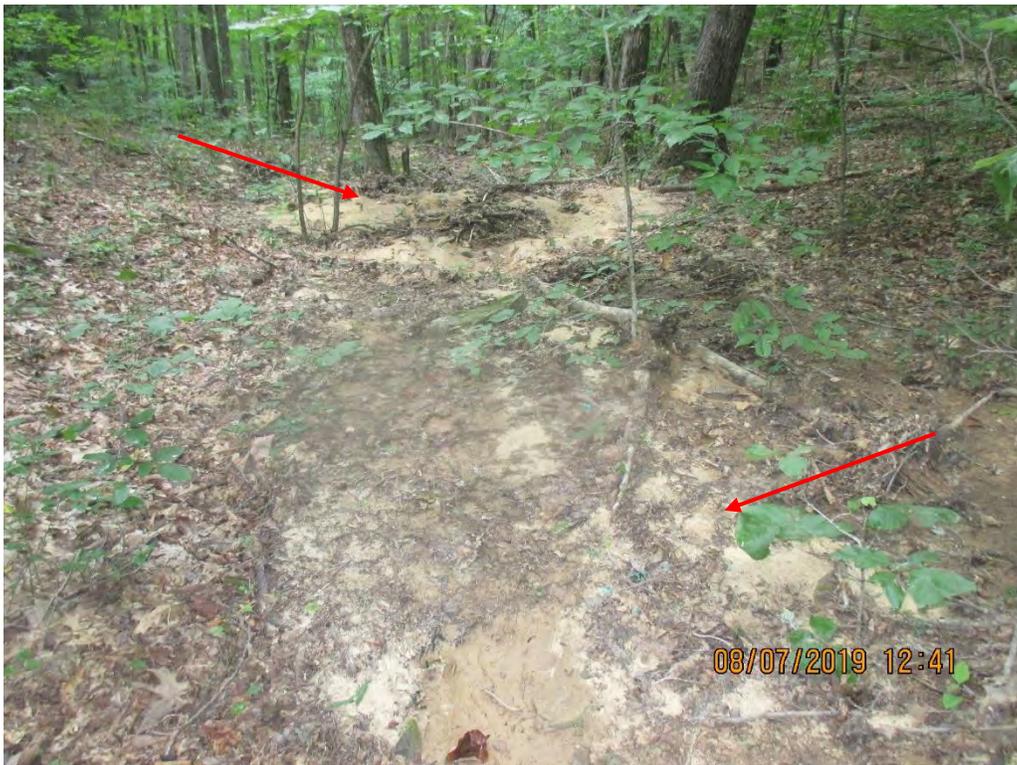
Approximately 150-foot past LOD near Station No. 8929+00. Sediment deposits observed in Stream S-K16.

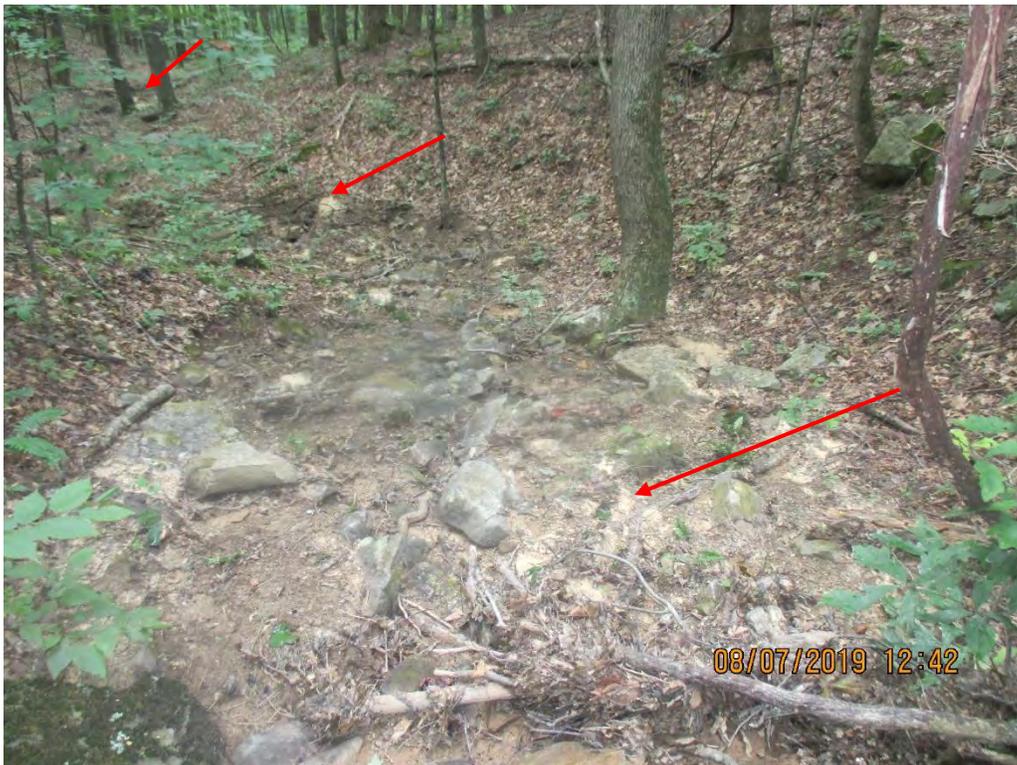
Sediment deposits present approximately 300-foot past LOD in Stream S-K16.

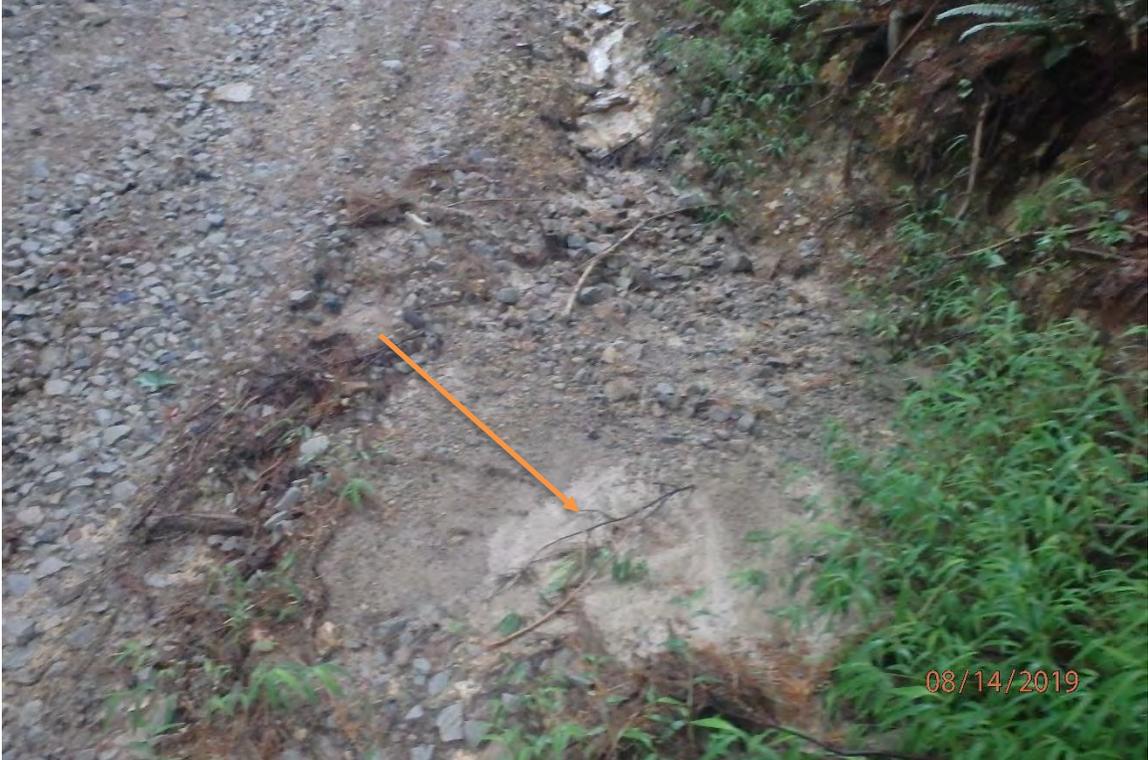
1). (2, 6, 8, 13, 15, 19 & 20) A culvert on access road MVP-BR-092.01 was plugged and in need of maintenance. This allowed concentrated flow stormwater to flow from the top of the slope to the base of the slope. The approved SWPPP indicates the need for ditch checks in the upslope ditch of all access roads as well as rock outlet protection and a sediment control device placed at the outlets of the installed culverts. The access road lacked the proposed ditch checks, rock outlet protection and an installed sediment control device at the outlet of the installed culverts. These deficiencies caused offsite sediment deposits and Conditions Not Allowable (CNA) deposits in Keith Run (38° 47.179' X 80° 31.816') in two locations. The roadside ditch lacked adequate BMPs to prevent sediment laden water from leaving the site.

Culvert inlet on access road MVP-BR-092.01 showing the need for maintenance.

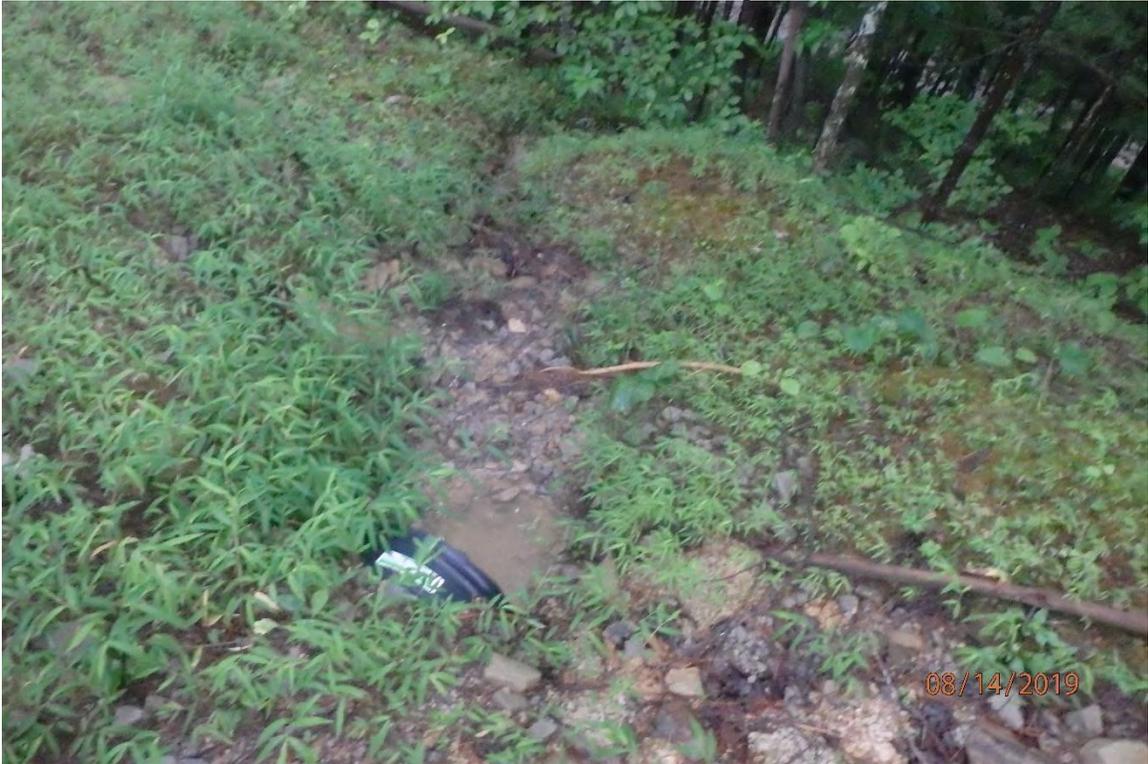
3). (1, 19 & 21) A culvert on access road MVP-BR-092.01 lacked a BMP at the outlet. There were no offsite sediment deposits associated with this deficiency due to the culvert head being plugged.

Outlet of the above pictured culvert showing the lack of installed outlet protection and the lack of a BMP.

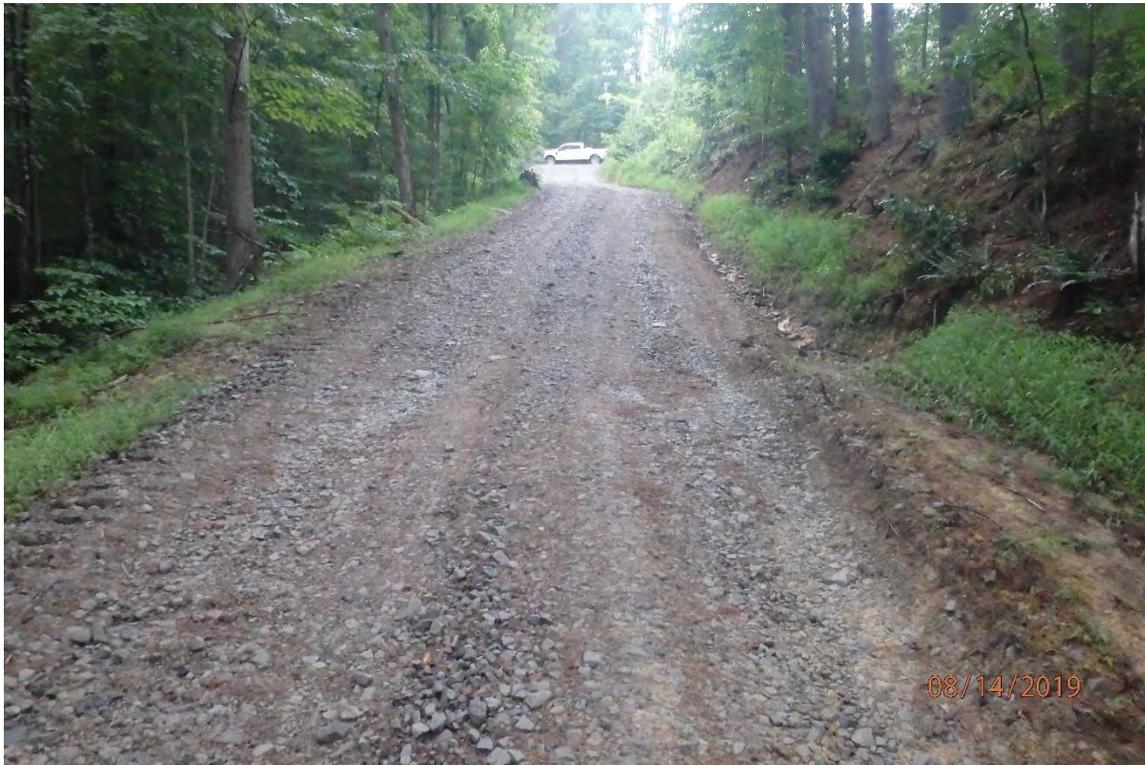
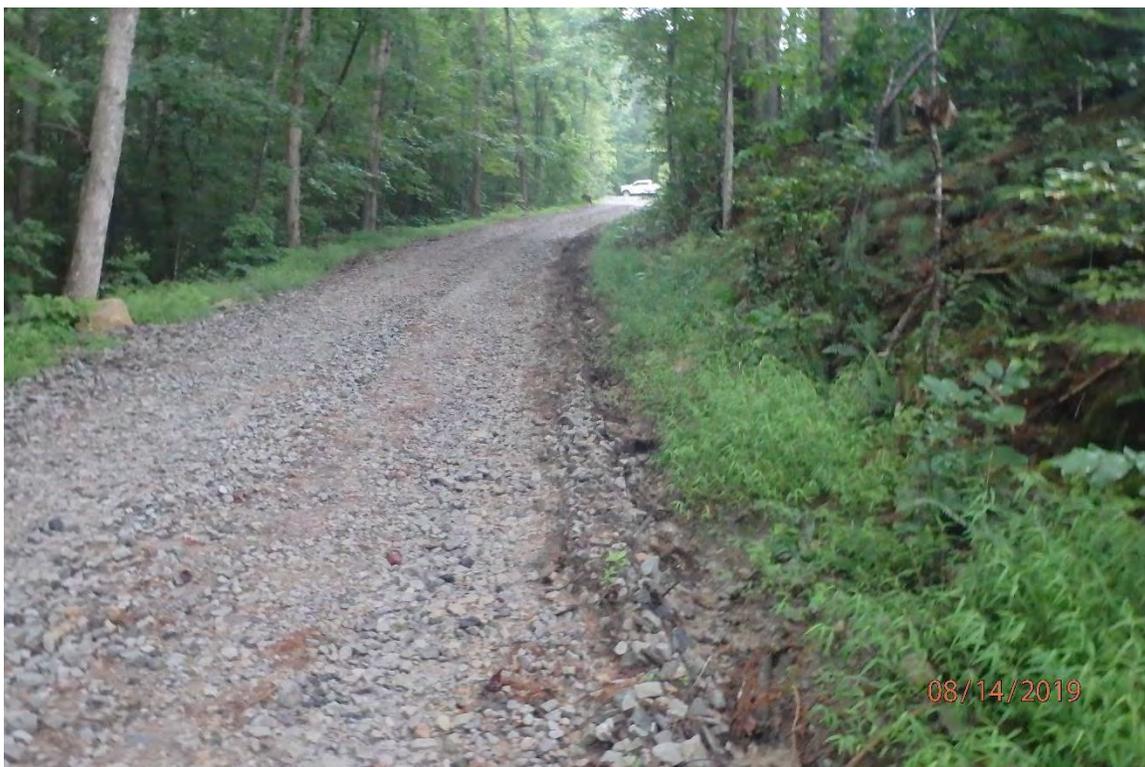
Access road MVP-BR-092.01 showing the area where concentrated flow stormwater is flowing from the top of the slope to the base of the hill due to poor maintenance on the installed culvert. The diversion lacks installed BMPs.

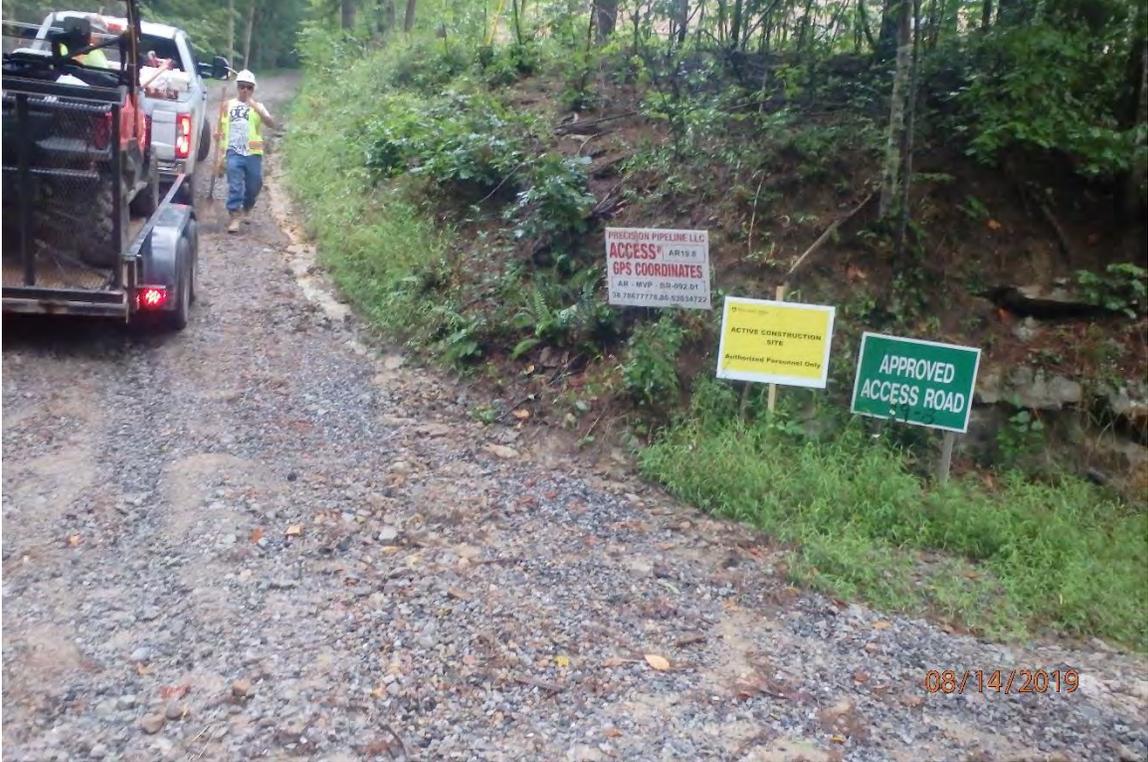
The bottom of the slope on access road MVP-BR-092.01.

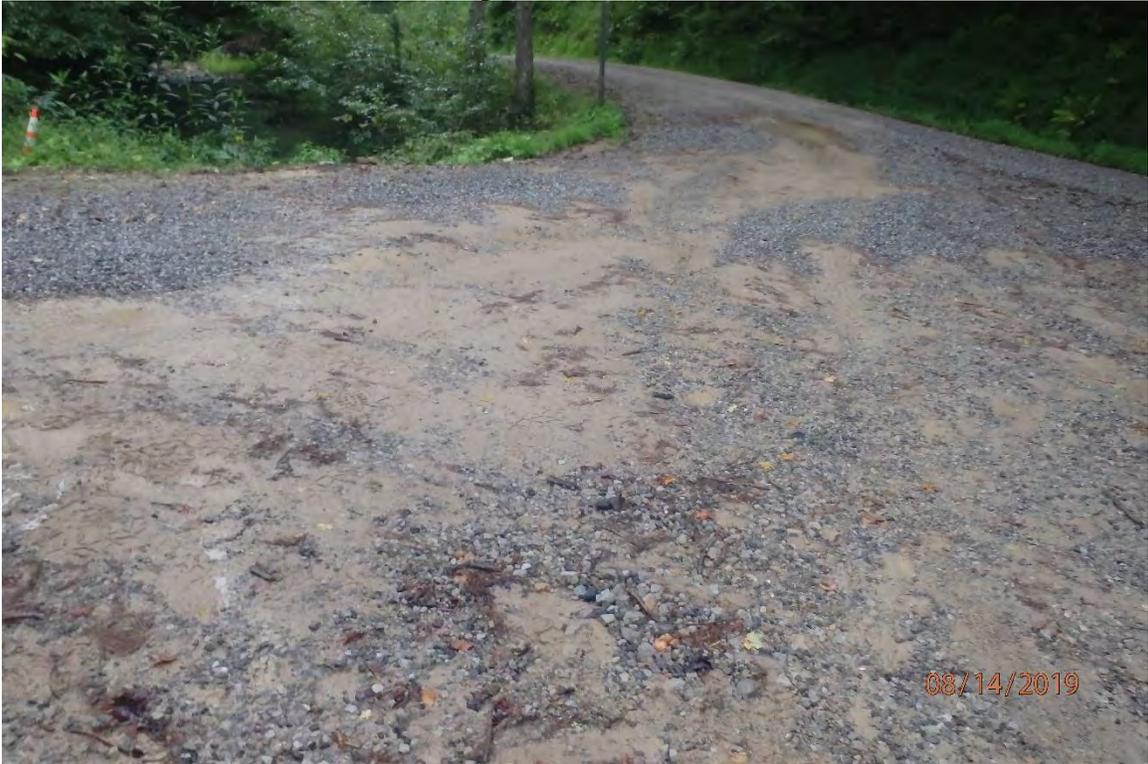
Trail of sediment deposits leading to Keith Run from the above pictured area.

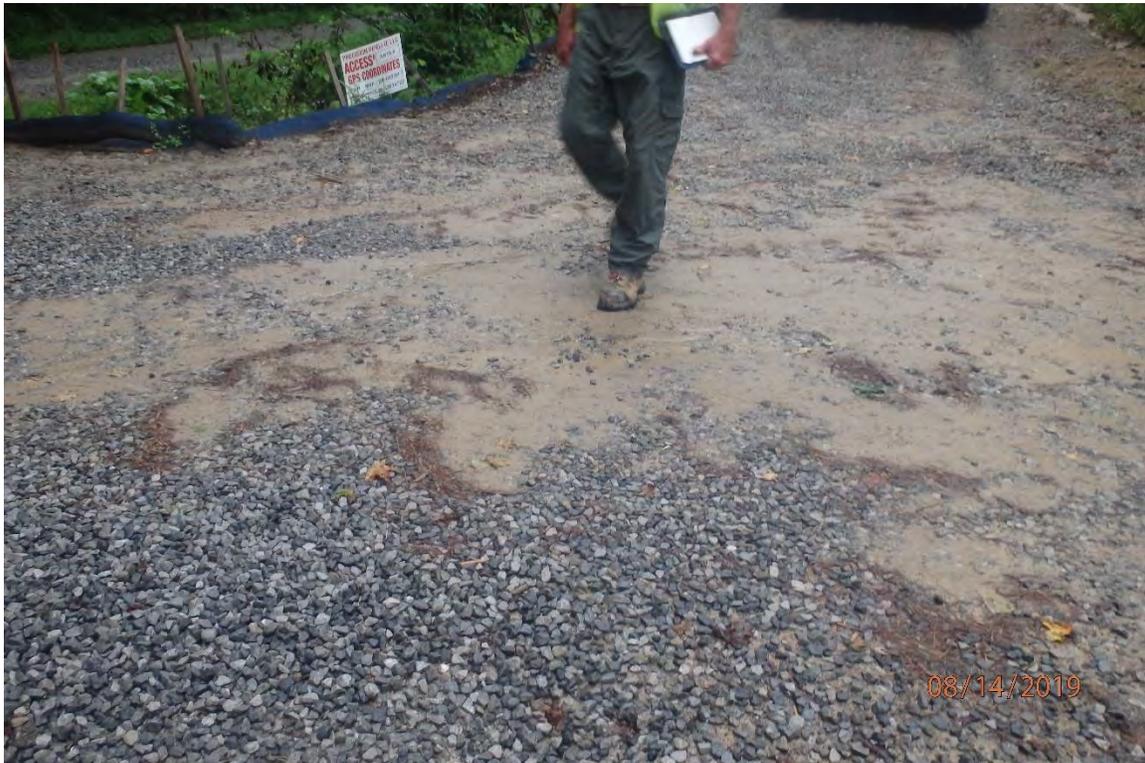
Trail of sediment deposits leading to Keith Run from access road MVP-BR-092.01.

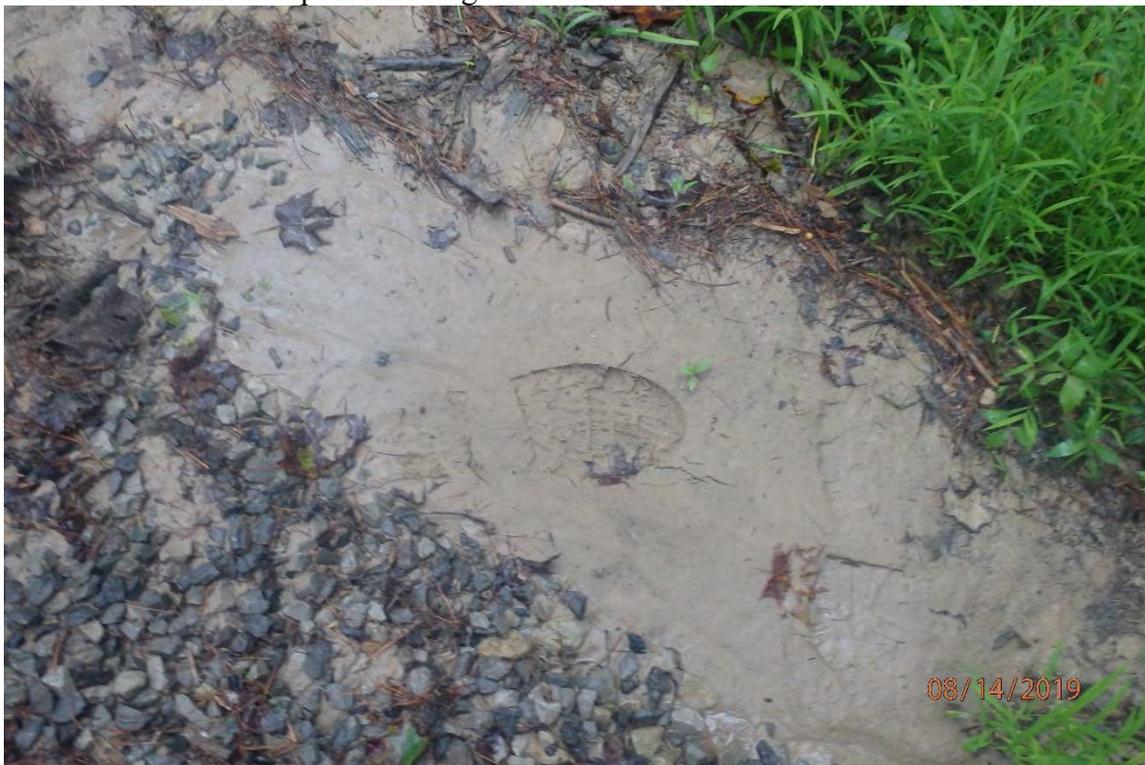
Trail of sediment deposits leading to Keith Run from access road MVP-BR-092.01.

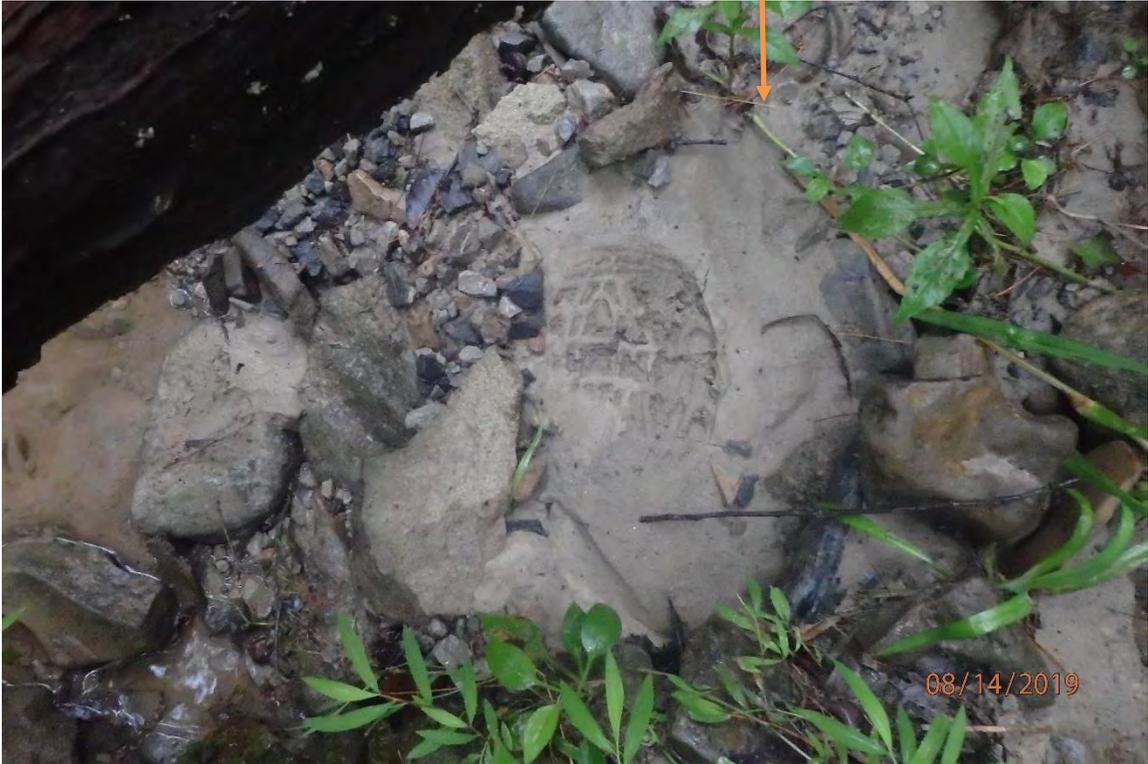
4. Title 47, Series 2, Section 3.2.b.-Caused conditions not allowable in waters of the State by allowing sediment deposits on the bottom of Keith Run (38° 47.179' X 80° 31.816') in two locations.

CNA CNA deposits in Keith Run (38° 47.179' X 80° 31.816') at the second location.

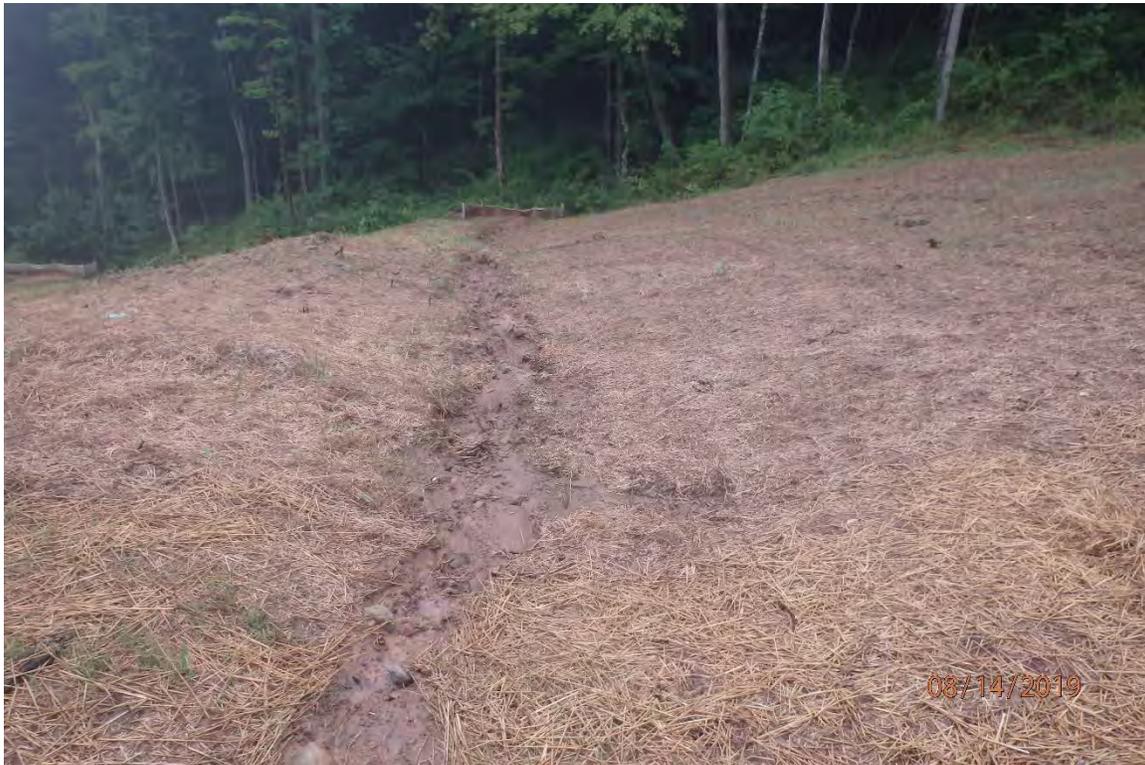
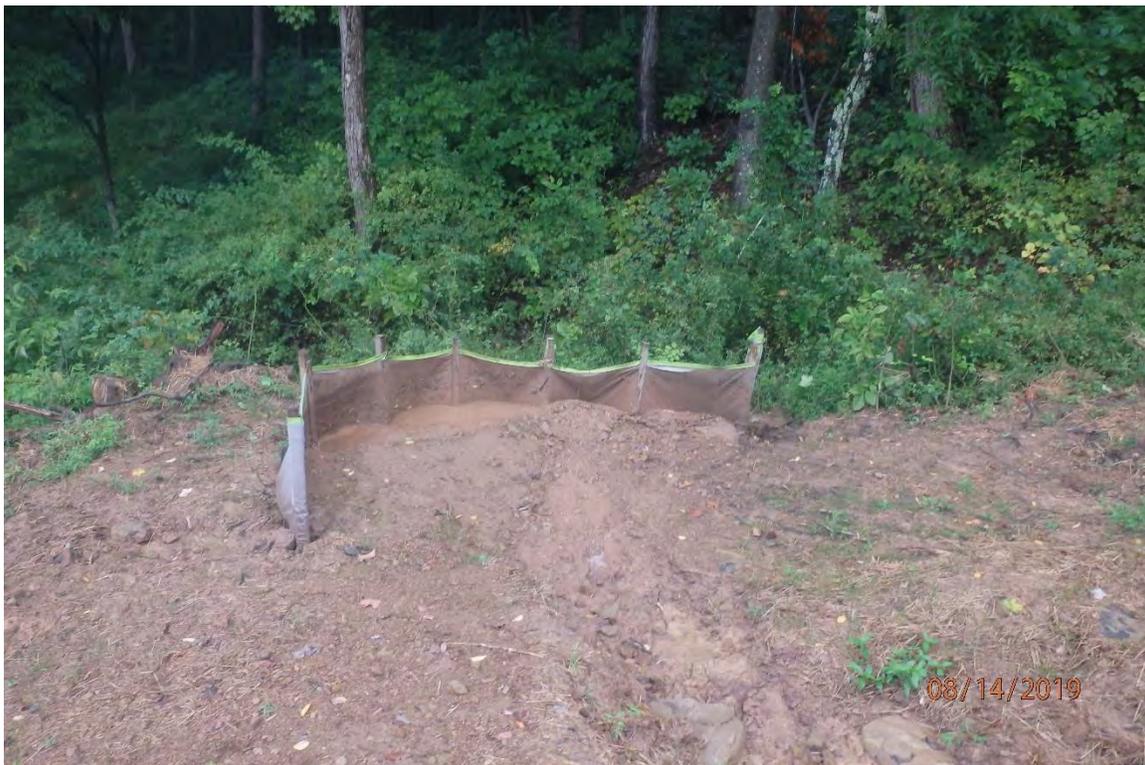
2). (6, 7 & 19) A water bar terminus BMP in inspected area 3 was inundated with sediment and in need of maintenance. This caused offsite sediment deposits.

Water bar terminus BMP adjacent to 3760+00 that is in need of maintenance.

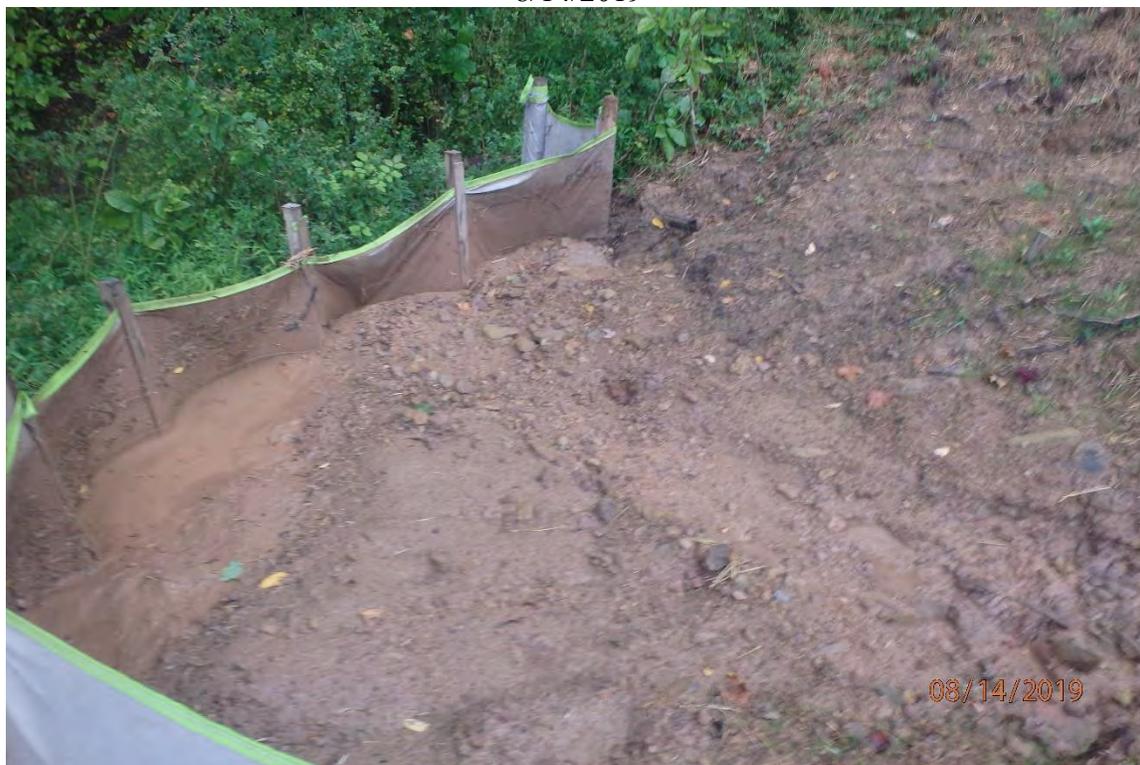
Water bar terminus BMP adjacent to 3760+00 that is in need of maintenance.

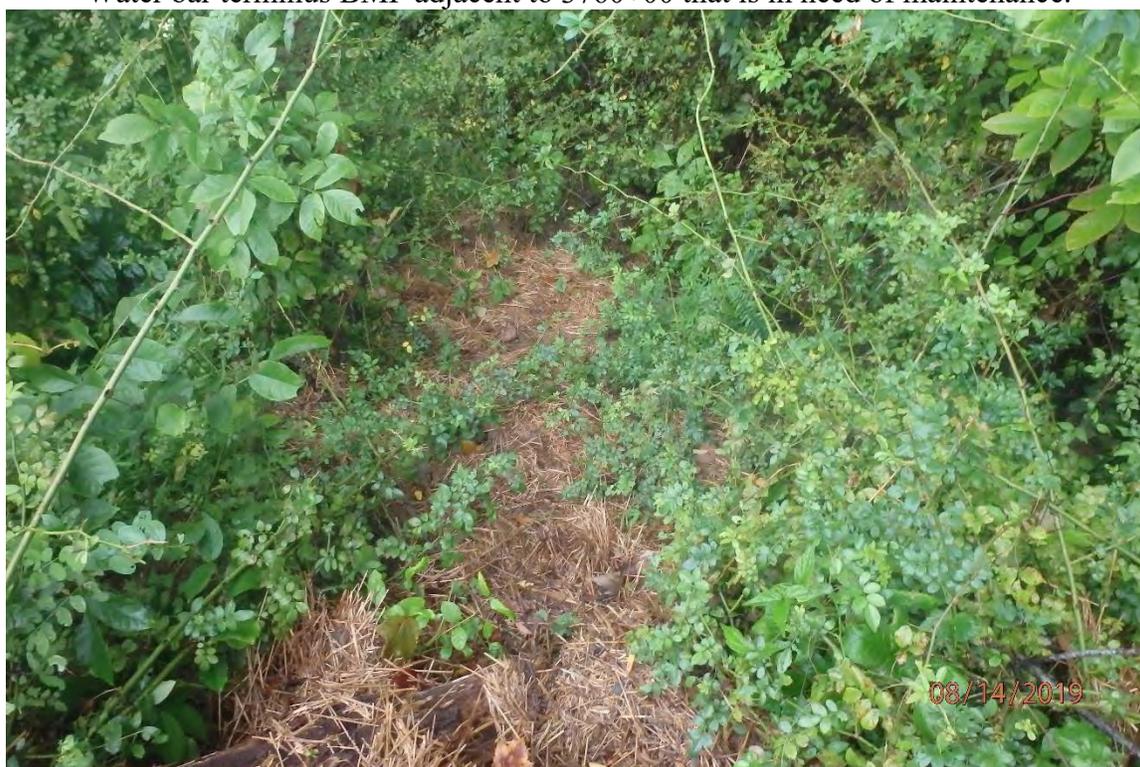
Offsite sediment deposits downslope of the above pictured BMP.

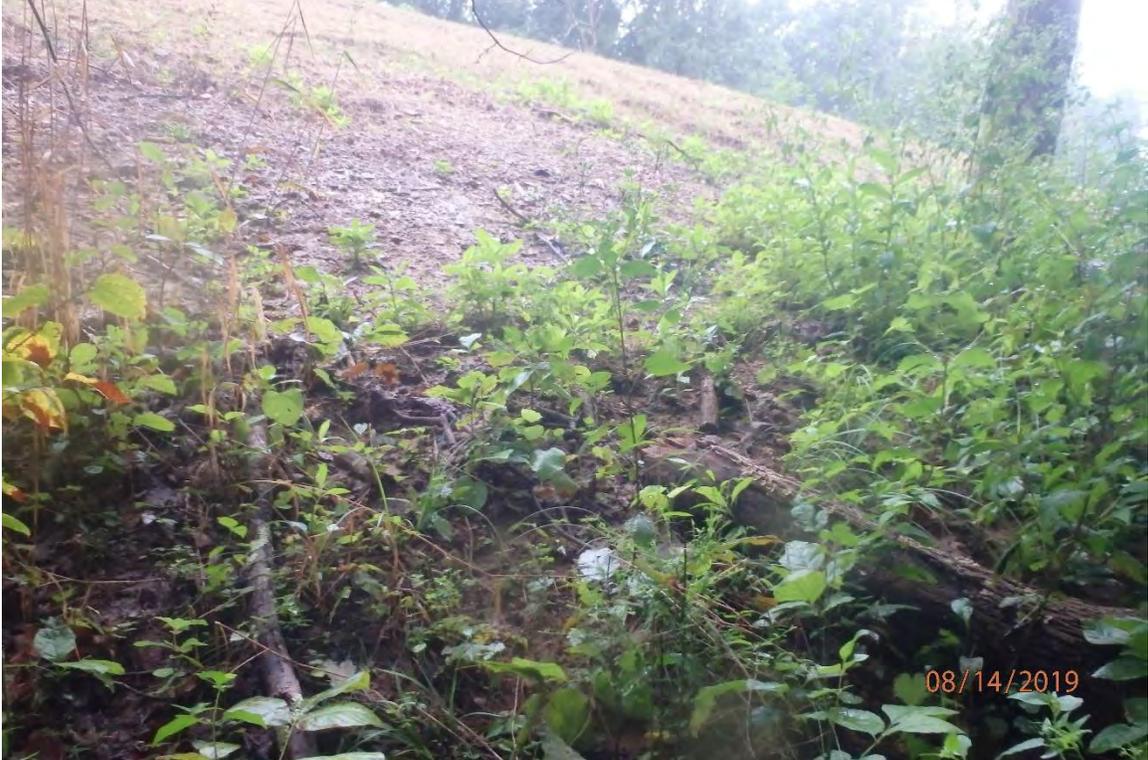
- 1). (1, 13, 15, 19 & 21) An area of disturbance where sediment laden water was leaving the site and the approved SWPPP does not indicate the need for a BMP was noted in inspected area 3. The lack of an installed BMP caused offsite sediment deposits.
- 2). (6, 8, 11 & 12) Access road MVP-BR-89.01 was in need of maintenance to the rock construction entrance adjacent to the public road. A small amount of track out was noted.

Project area in the Keith Run watershed showing where sediment laden water is leaving the site in an area where the approved SWPPP does not indicate the need for an installed BMP.

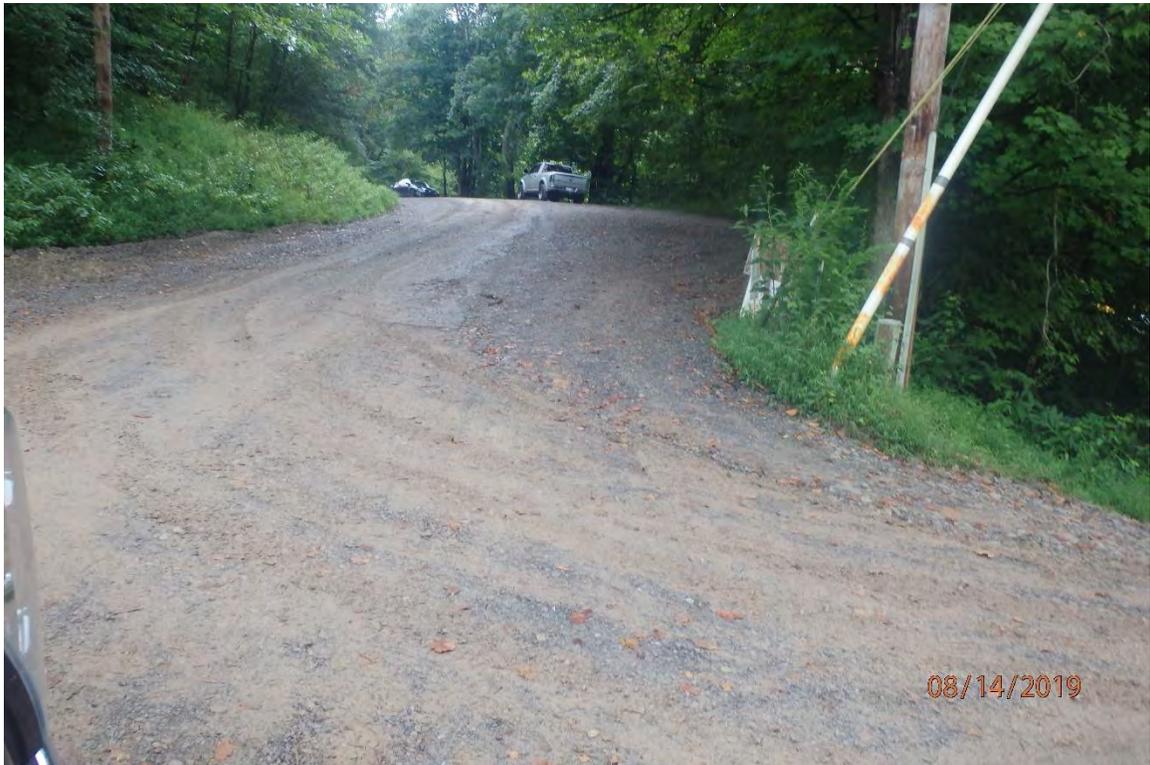
Access road MVP-BR-89.01 showing the small amount of track out onto the public roadway.

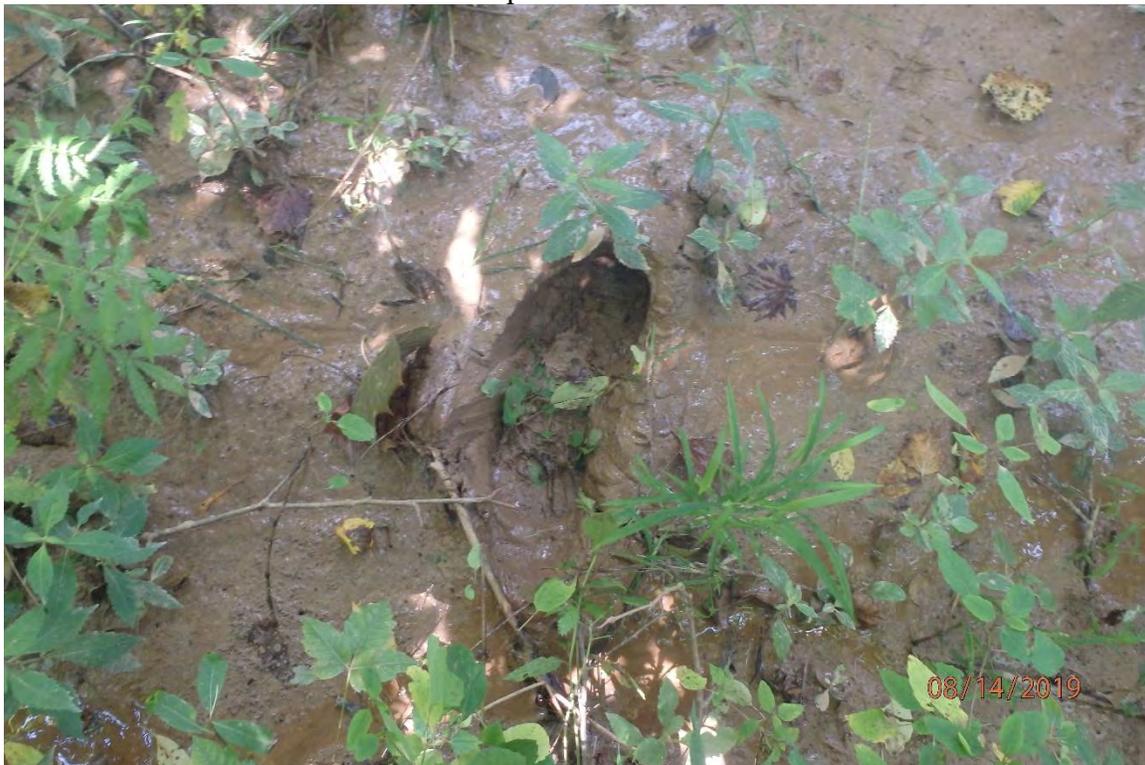
Six improperly installed water bars on the project area adjacent to 2768+00 (inspected area 8) were discharging into a stabilized diversion. The installed diversion carried the stormwater to the base of the hill where it was being treated with two pieces of perimeter silt fence. The amount of stormwater being directed at the installed perimeter controls overwhelmed the BMPs and caused a significant amount of offsite sediment deposits adjacent to Cove Run. The improperly installed water bars in this area could have been installed so that they discharged at a point with positive drainage so that the water bar outlets would discharge offsite in small quantities as designed.

Recent offsite sediment deposits that originate from site downslope of the above pictured BMP.

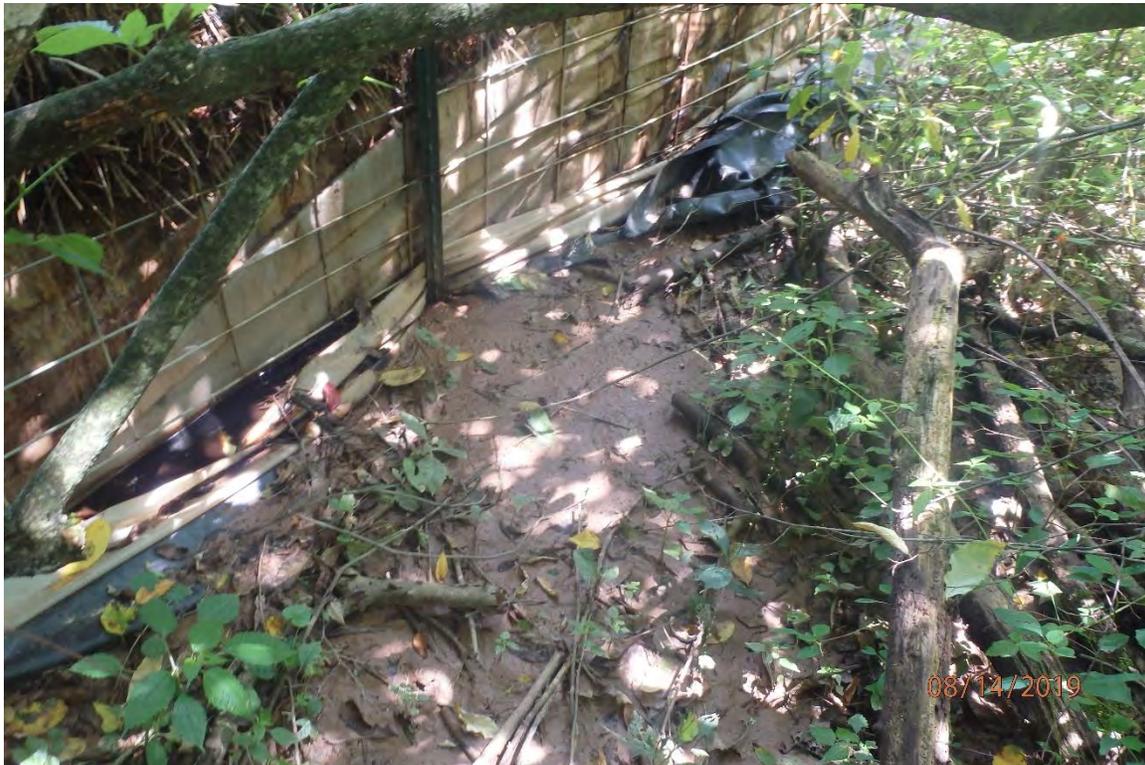
Dewatering structure with impermeable plastic installed causing it to not function as designed in inspected area 8. Offsite sediment deposits pictured.

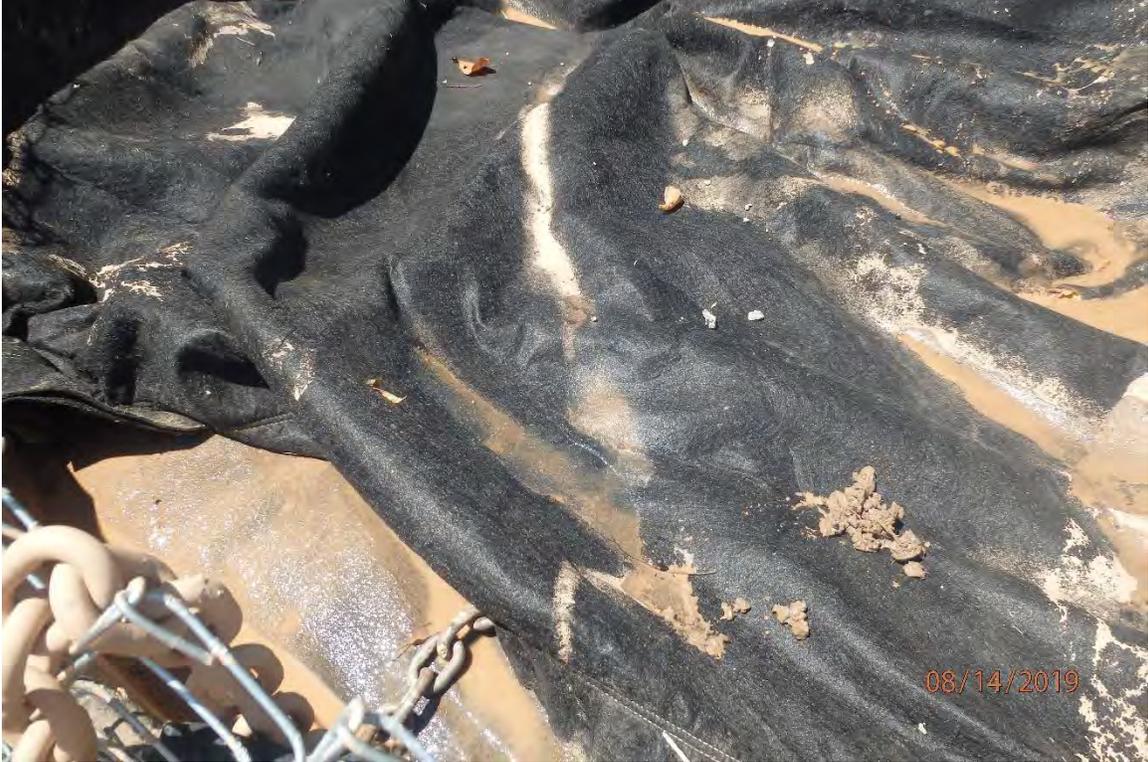
Dewatering bag being utilized in inspected area 6.

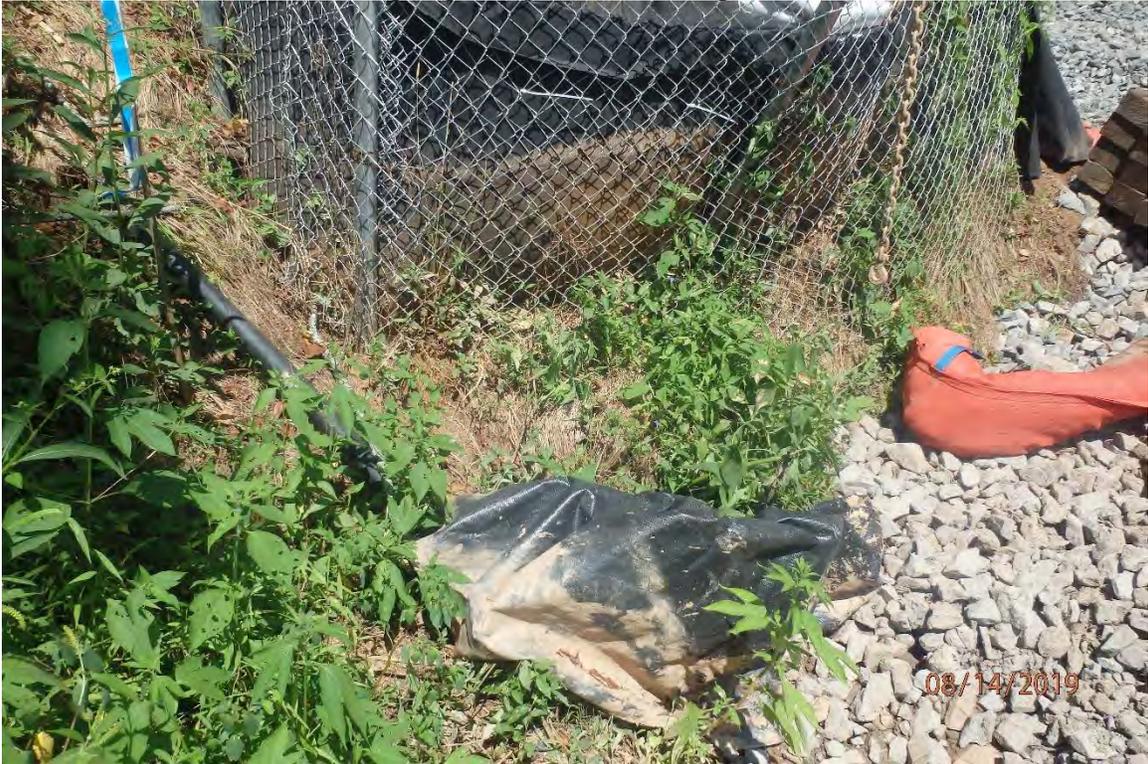
Perimeter control downslope of the above pictured dewatering bag.
