**The Wilderness Society et al. Comments on the  
U.S. Forest Service Mountain Valley Pipeline and  
Equitrans Expansion Project Draft Supplemental  
Environmental Impact Statement (#50036)**

**EXHIBIT 1**

Assessment of erosion, sedimentation, and water quality impacts of the Mountain Valley Pipeline and Equitrans Expansion Project's proposed crossing of the Jefferson National Forest as it pertains to the U.S. Forest Service's Draft Supplemental Environmental Impact Statement dated December 2022

Prepared by Jonathan A. Czuba, Ph.D., Licensed Professional Engineer

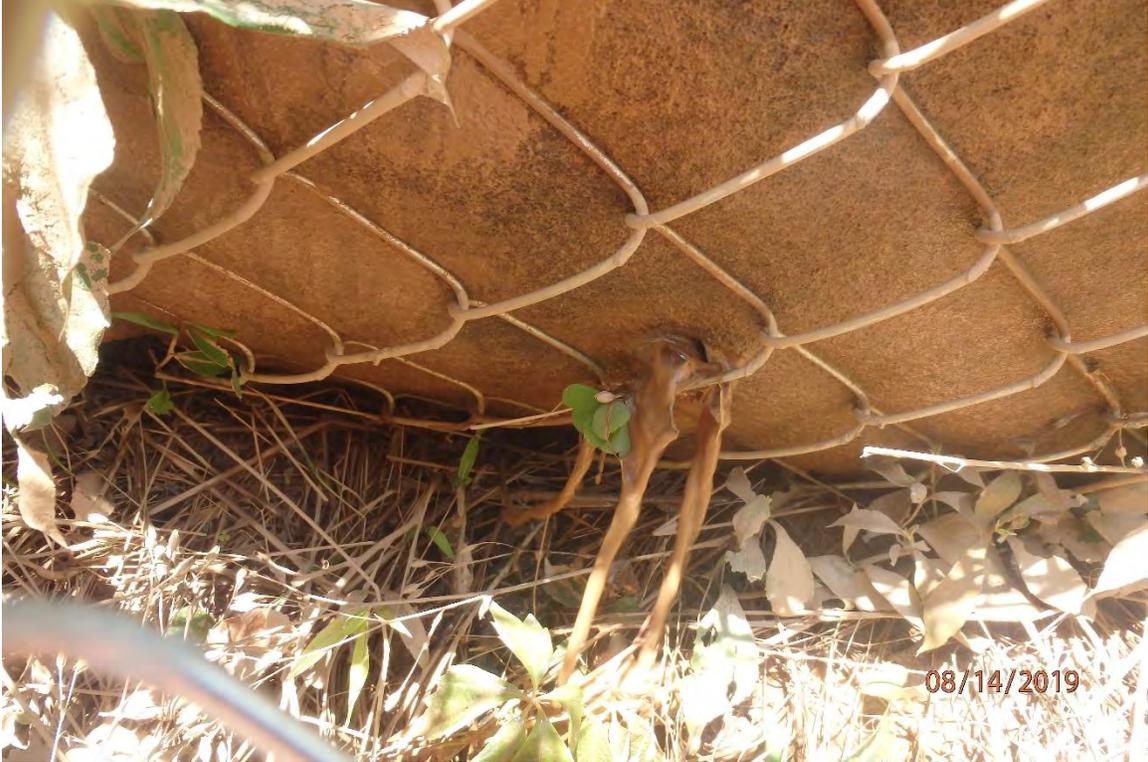
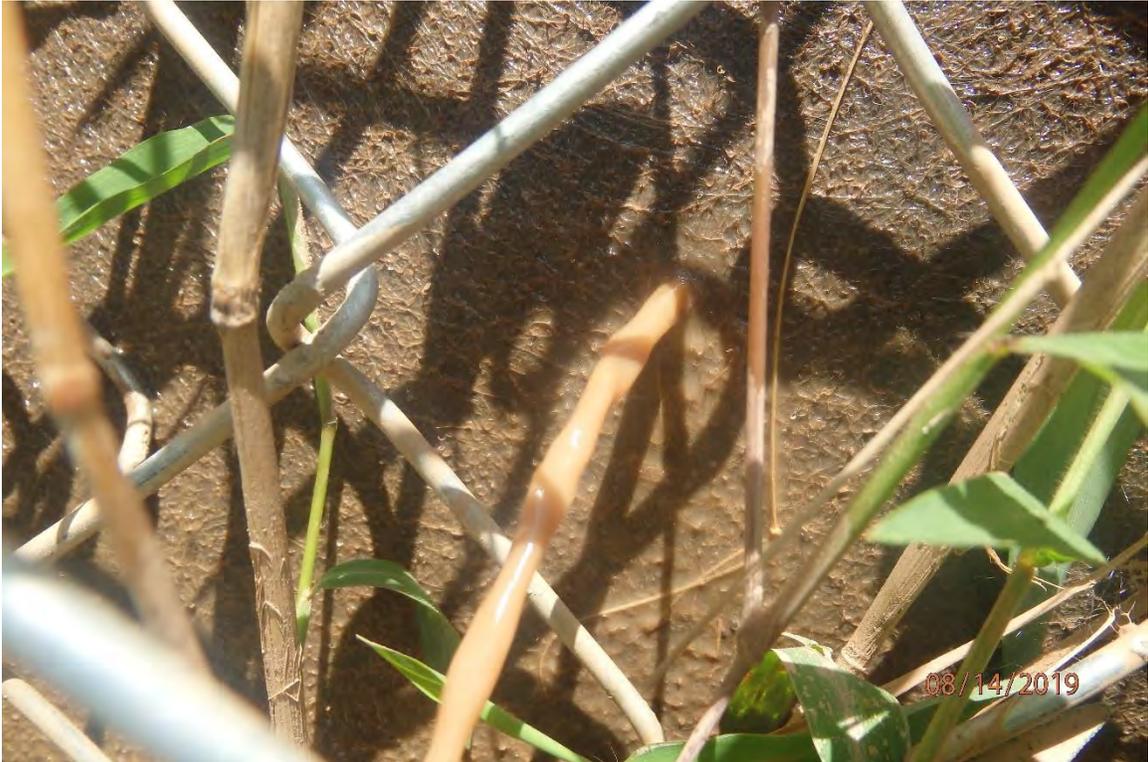
Perimeter control in inspected area 6 downslope of the previously pictured dewatering bag showing the need for maintenance and sediment laden water bypassing treatment.

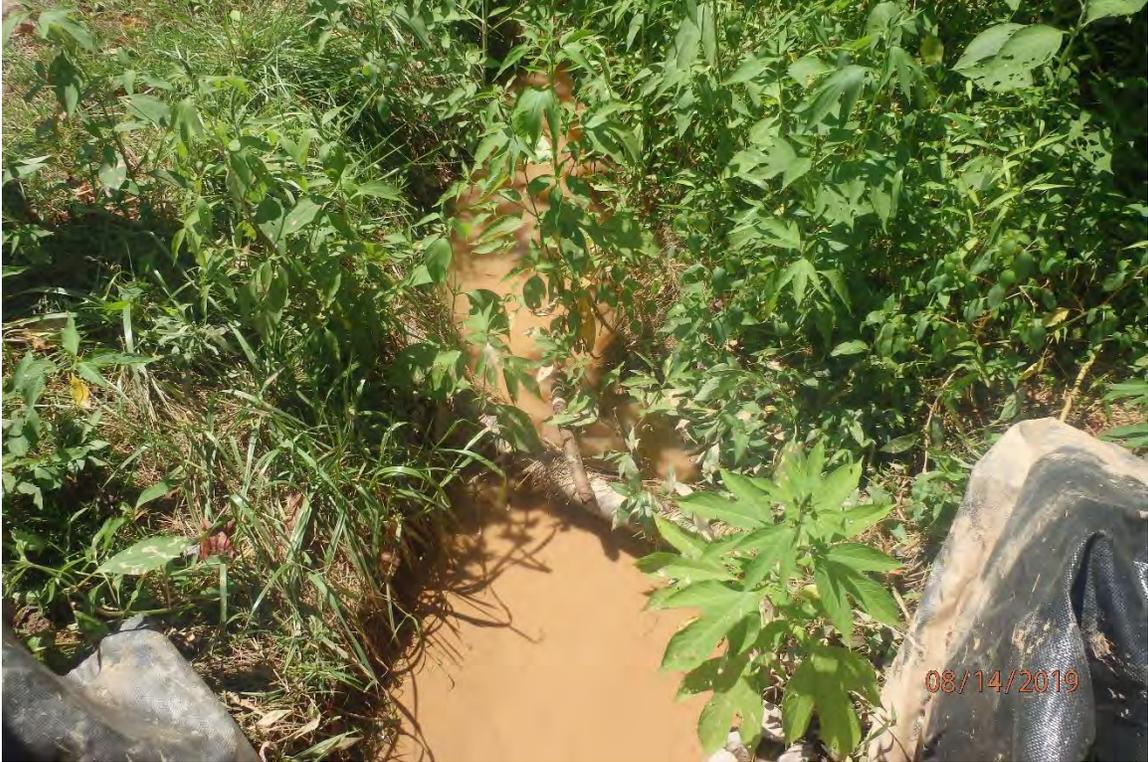
Onsite sediment laden water in DOH conveyance.

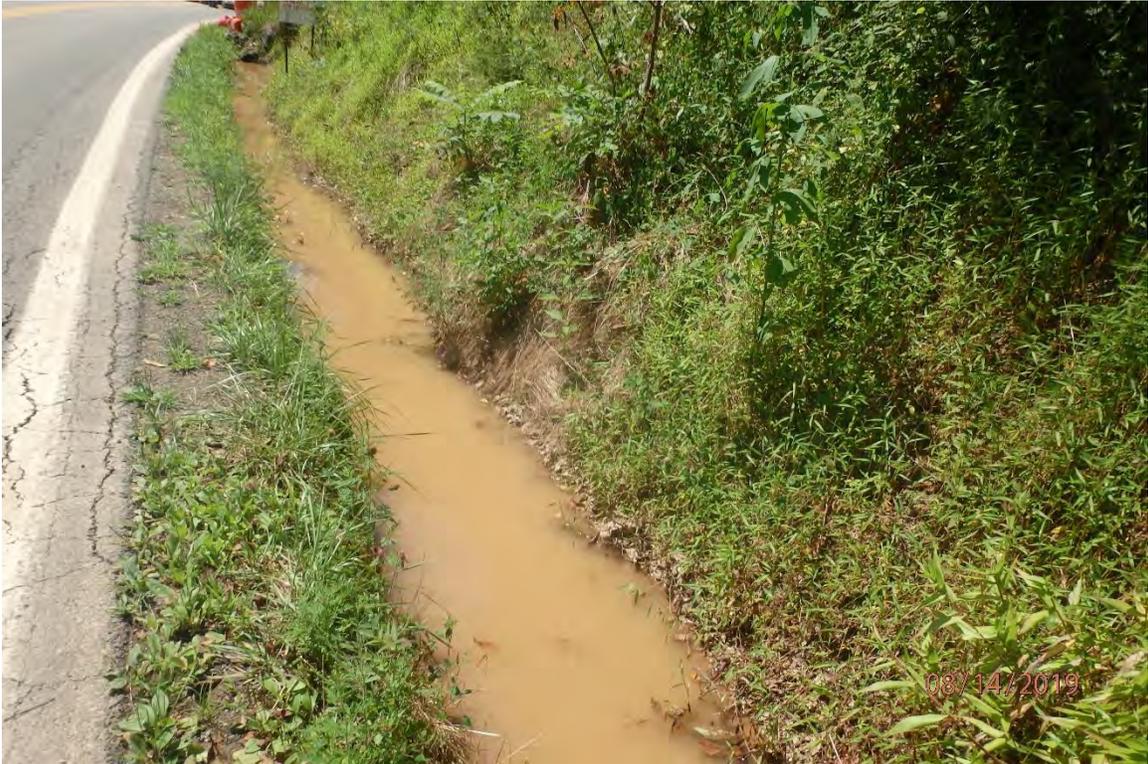
Offsite sediment laden water in DOH conveyance that leads from the previously pictured dewatering operation with the unmaintained perimeter control.

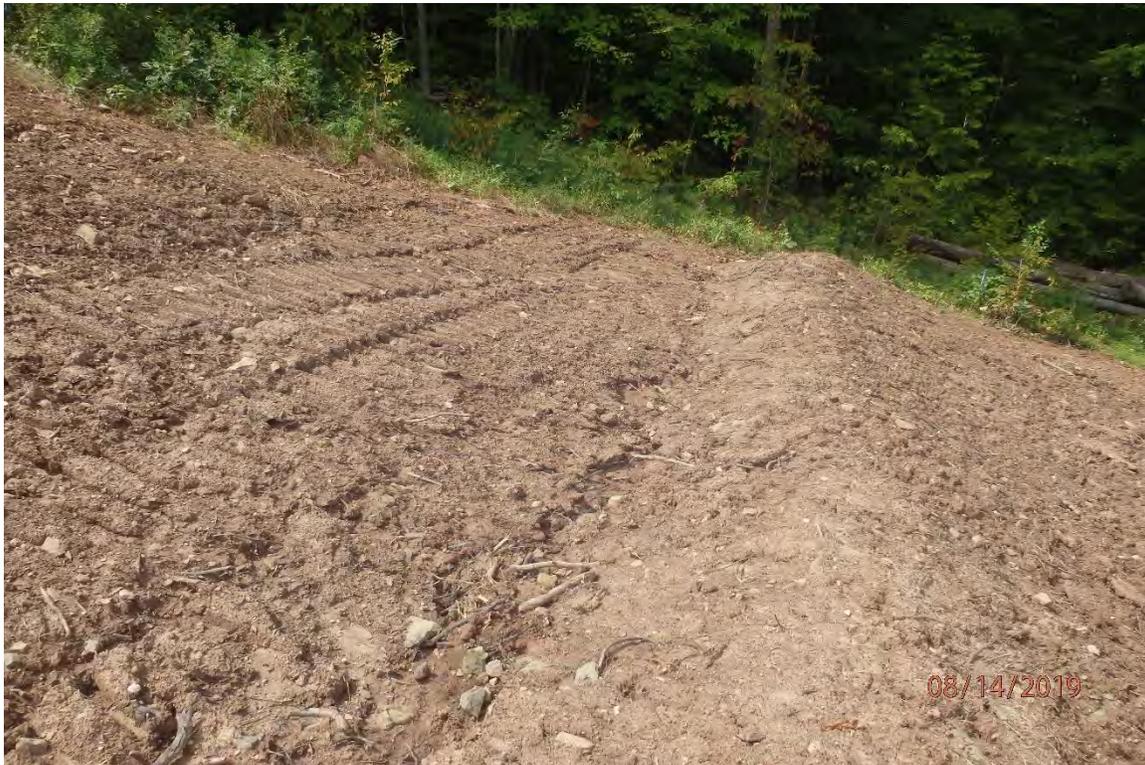
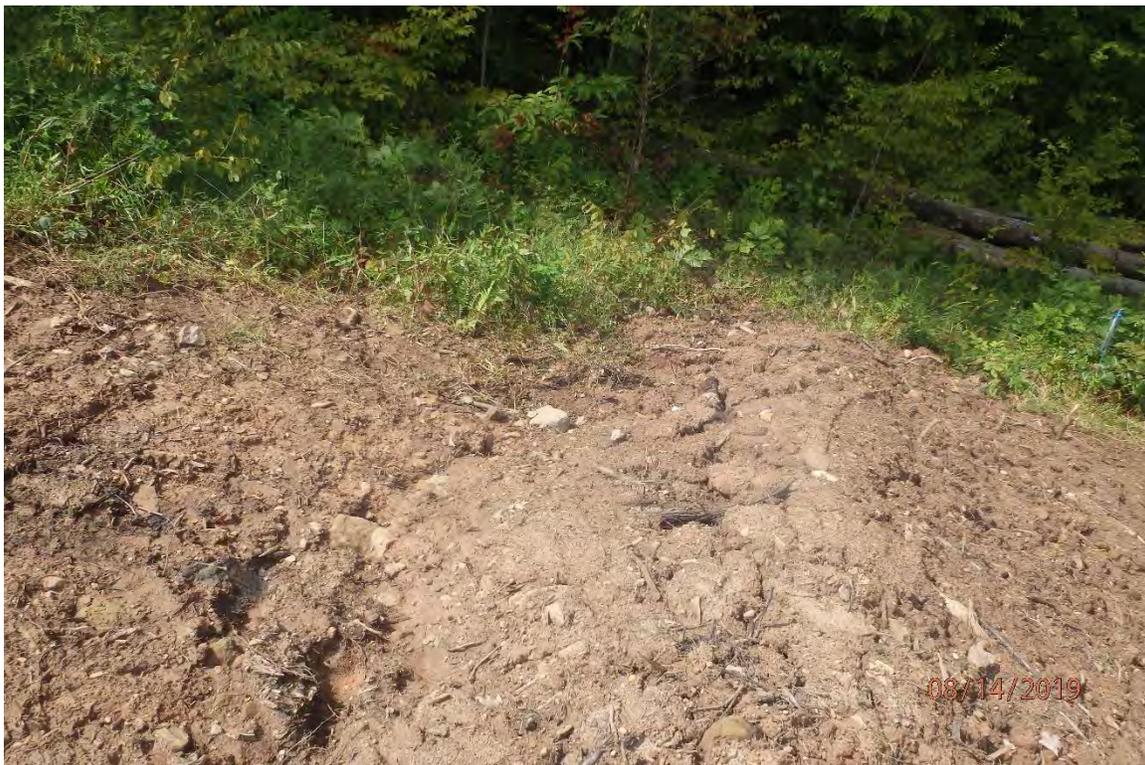
1). (7, 13, 15, 19 & 21) Three water bars in inspected area 5 were noted as lacking the water bar terminus BMPs that are indicated in the approved SWPPP.

Water bar in inspected area 5 showing the lack of a water bar terminus BMP that is indicated in the approved SWPPP.

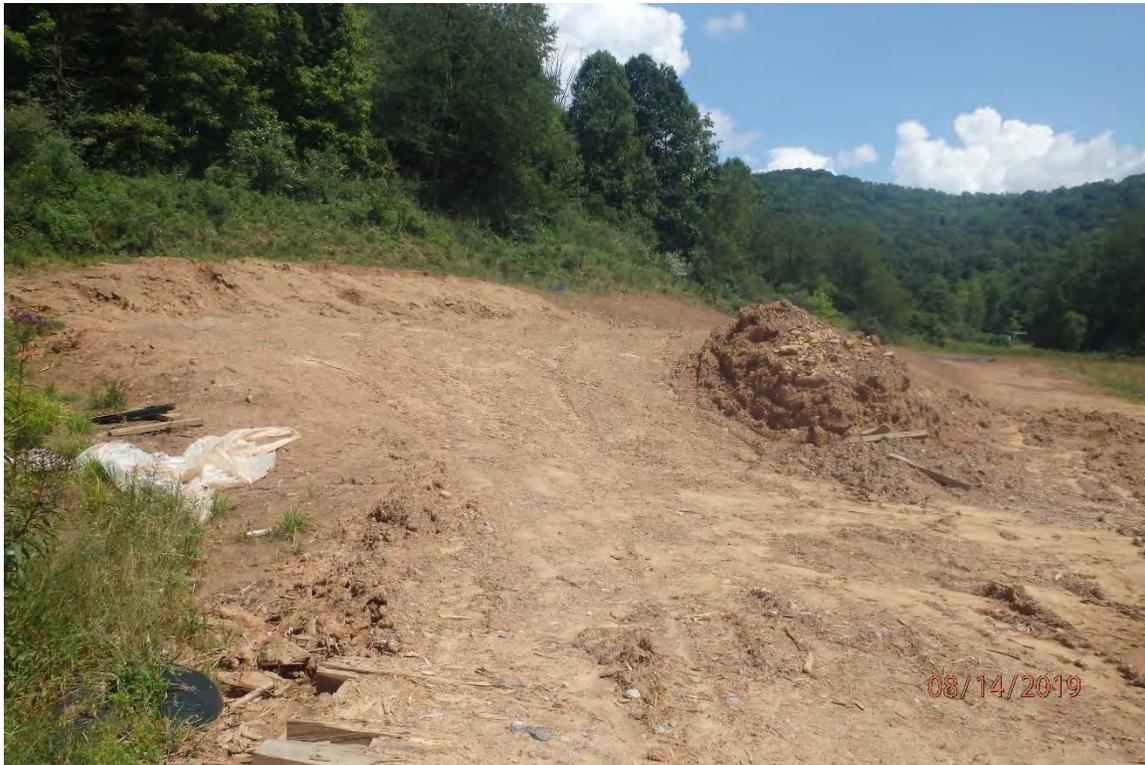
Area of disturbance associated with an extra workspace in inspected area 8 showing the lack of temporary stabilization even though it appears that the site has been idle for a long period of time.

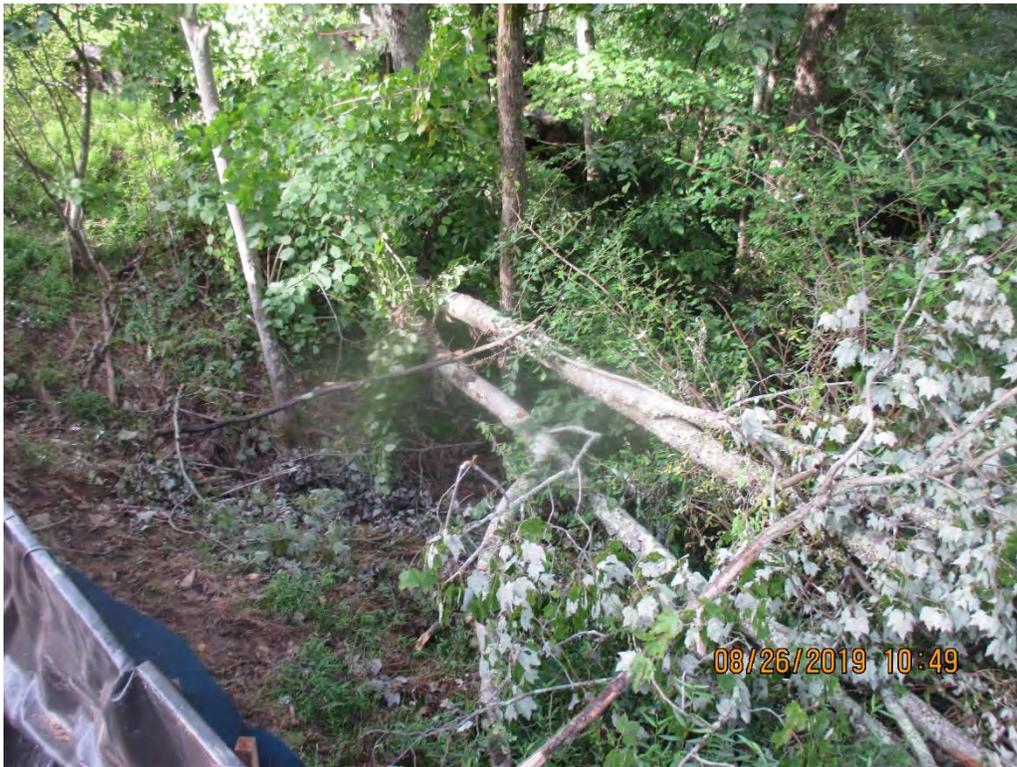
Facing downstream at stream SK-63 near station No. 1816+00. Tree fell and took out section of bridge. Bridge had been rebuilt prior to inspection.

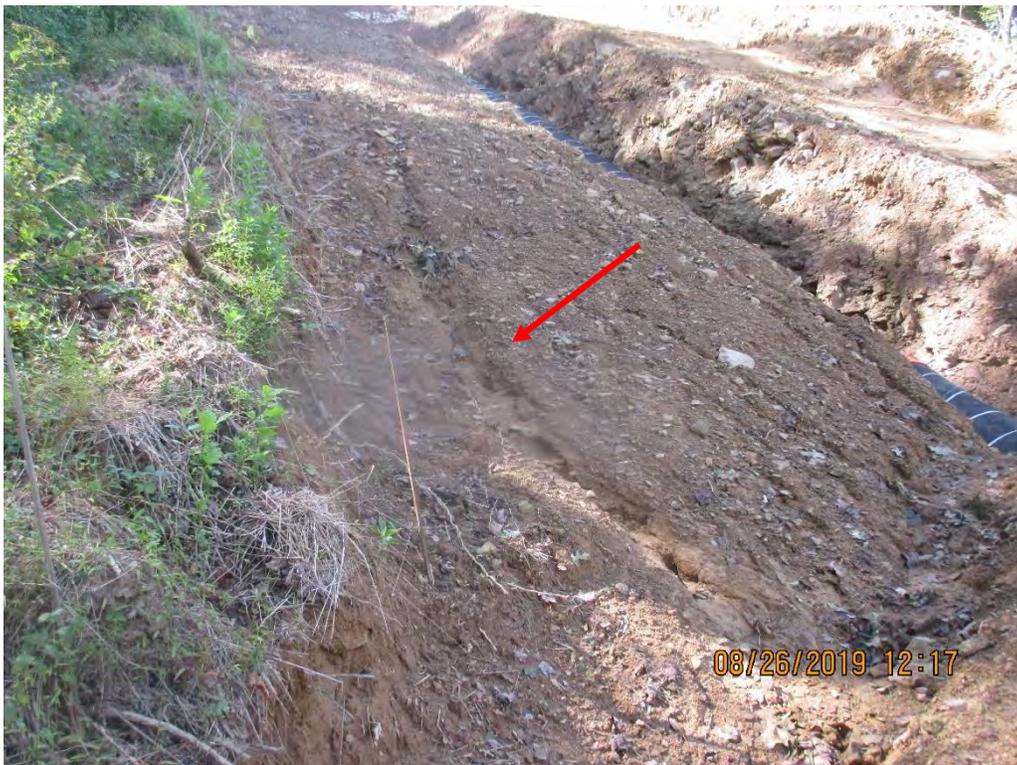
Erosion on slope of Waterbar leading to non-maintained sump at station No. 1822+50. Arrow depicts erosion occurring on slope.

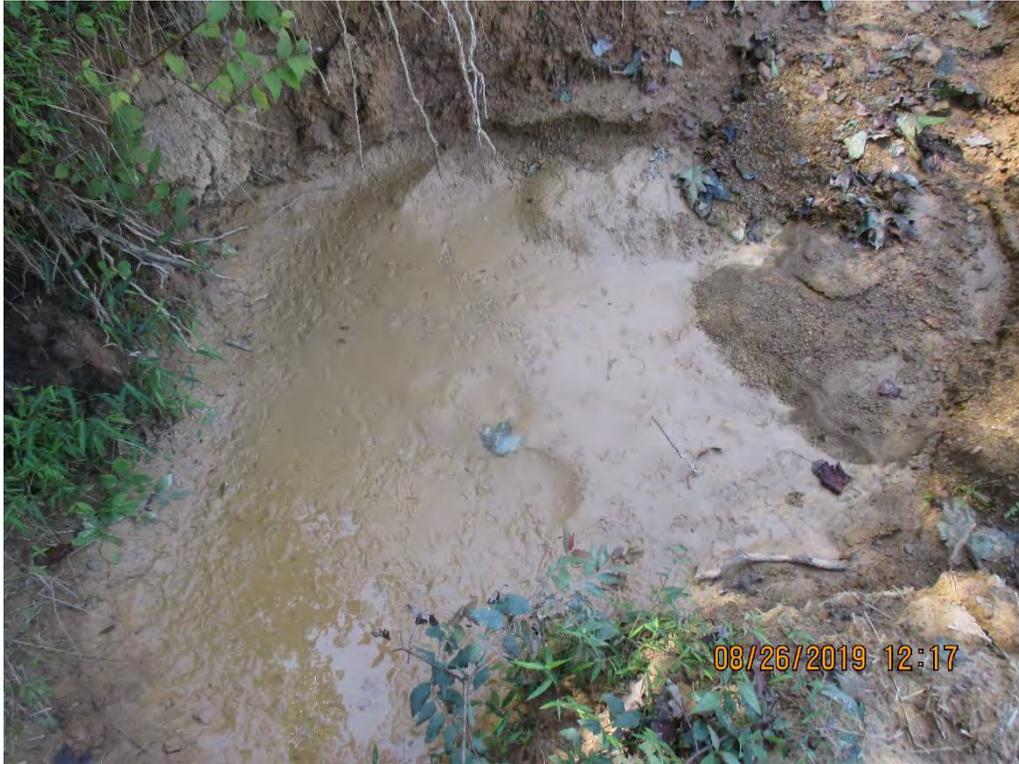
Sump full of sediment below erosion occurring on slope and Waterbar near station No. 1822+50.

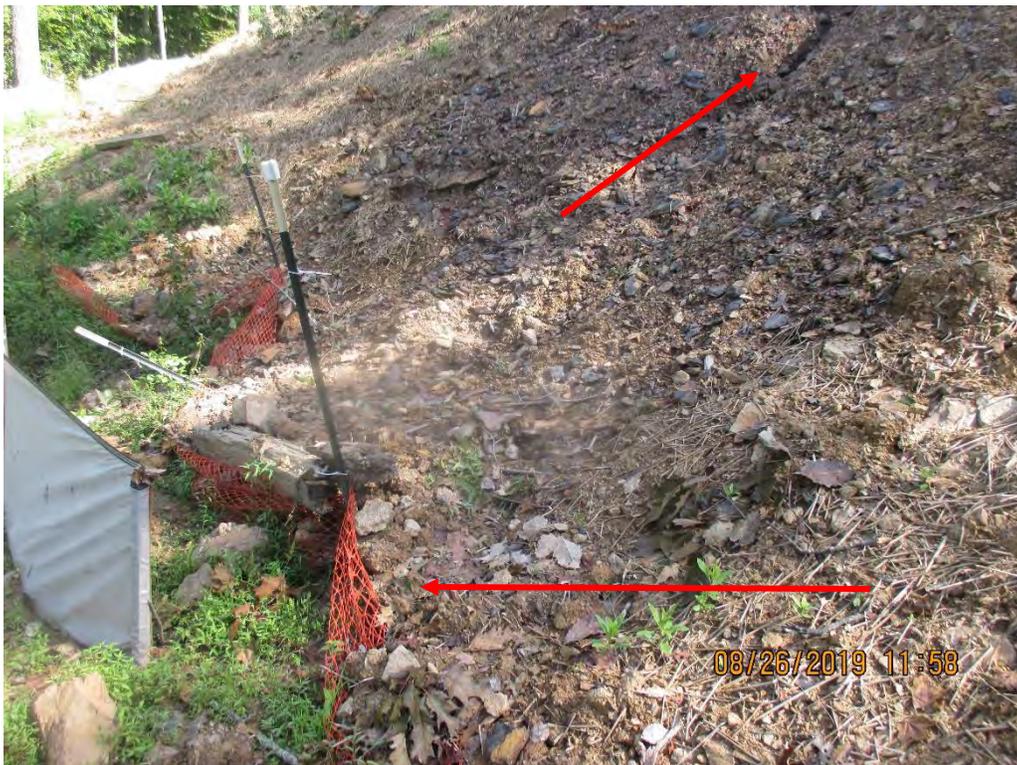
**Section D.1. - Permittee has failed to properly operate and maintain all systems of treatment and controls: At station No.'s 1833+50 and 1730+00 controls were not being maintained leading to perimeter controls being overwhelmed with sediment causing them not to function as designed. Section G.4.e.2.A.ii.j.-Permittee has failed to prevent sediment laden water from leaving the site without going through an appropriate device: Evidence that Sediment Laden water left the site was observed due to sediment deposits being observed past the LOD due to control failures at Station No.'s 1833+00 and 1730+00.**

Near Station No. 1833+00. Erosion occurring on slope leading to sediment deposits being present past the LOD.

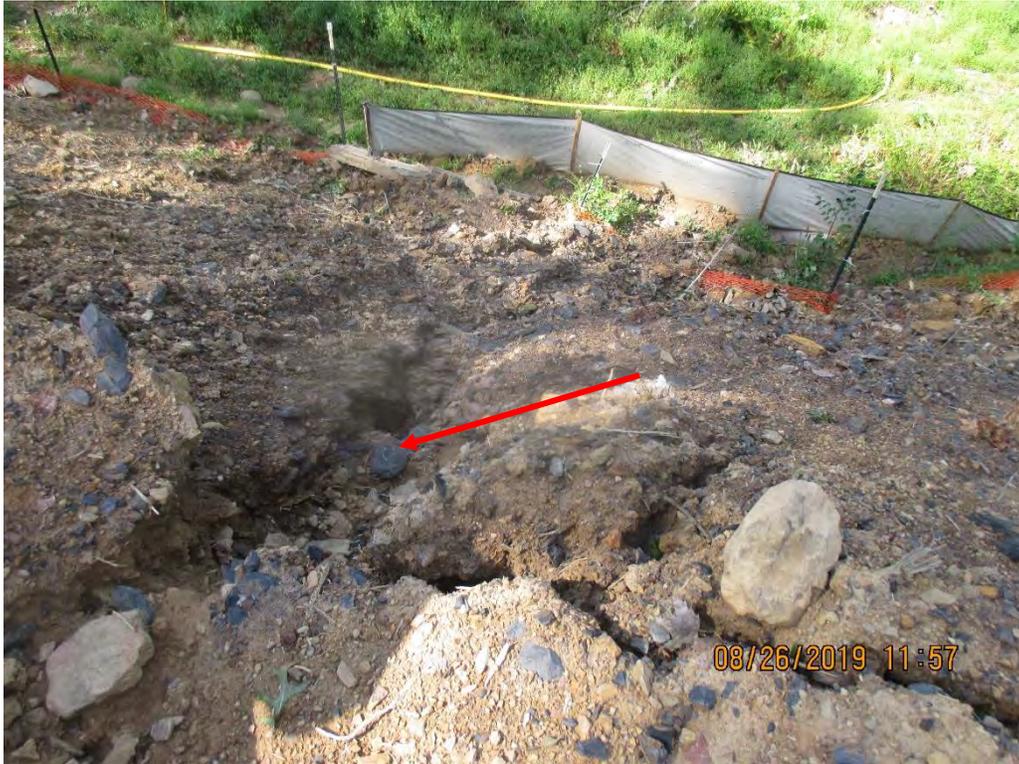
Near Station No. 1833+00. Erosion occurring on slope leading to sediment deposits being present past the LOD.

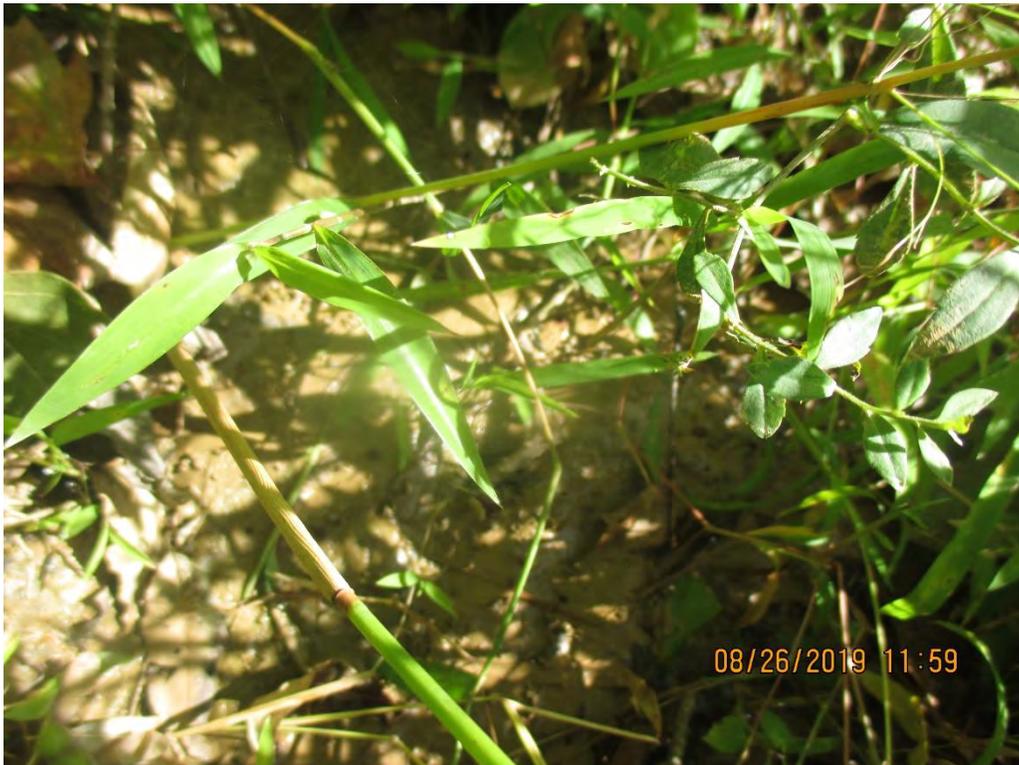
Near Station No. 1833+00. Erosion occurring on slope leading to sediment deposits being present past the LOD.

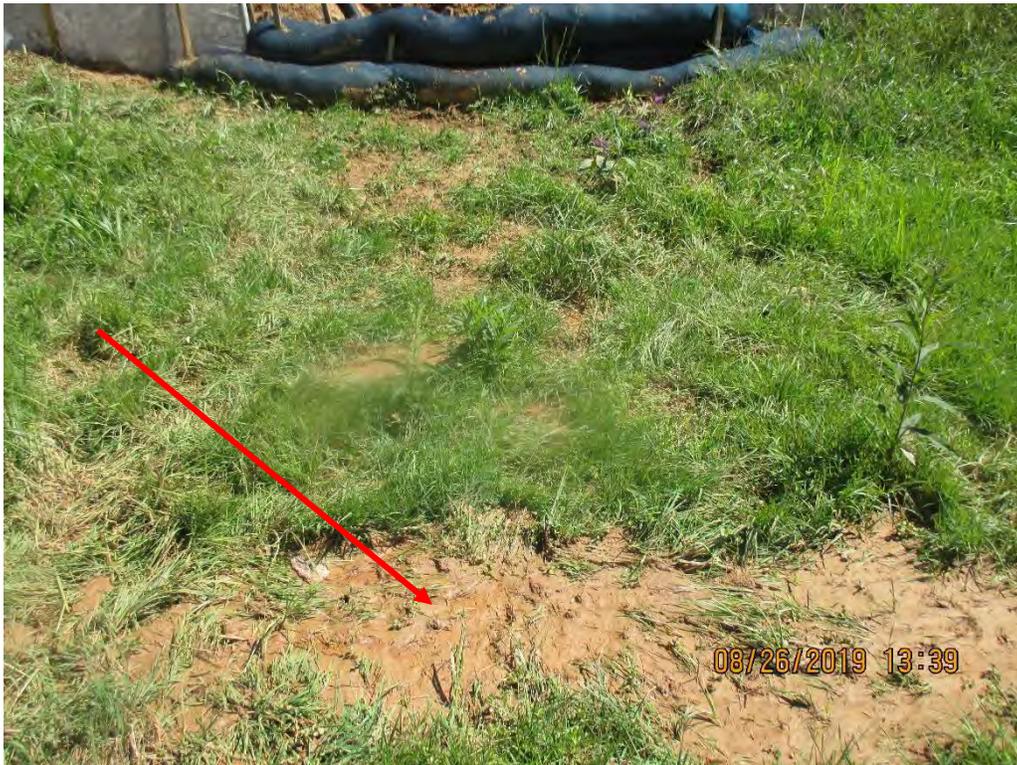
Below perimeter controls at station No. 1730+00. Arrow depicts sediment deposits.

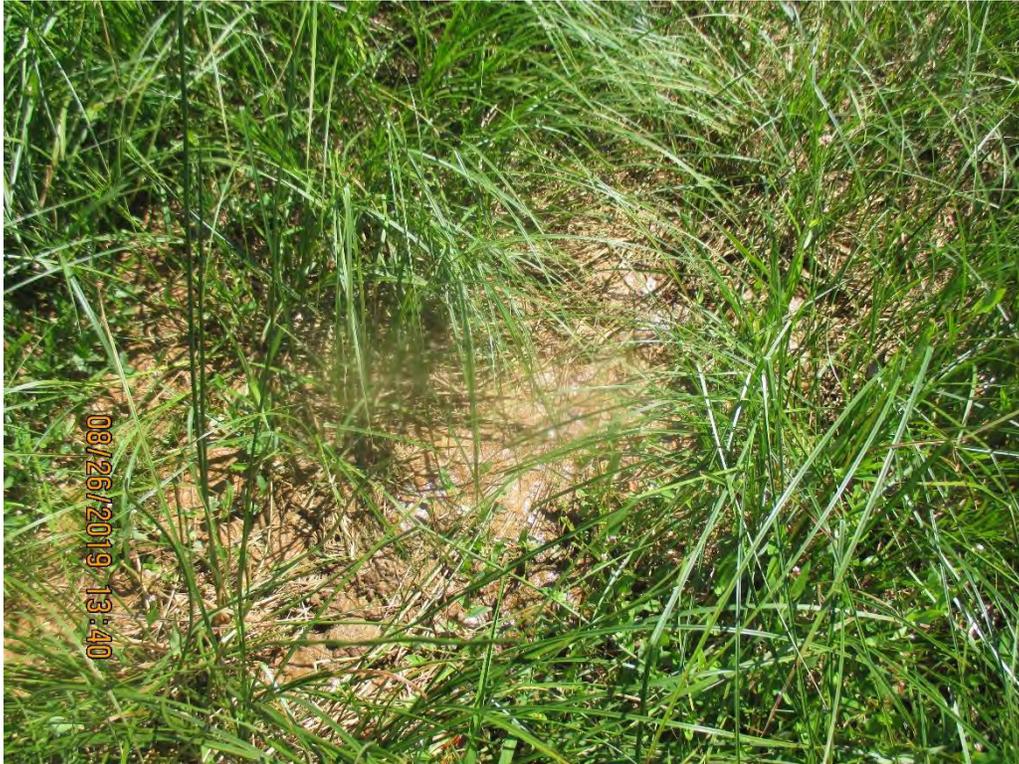
Sediment deposits above wetland W-K48 near station No. 1730+00.

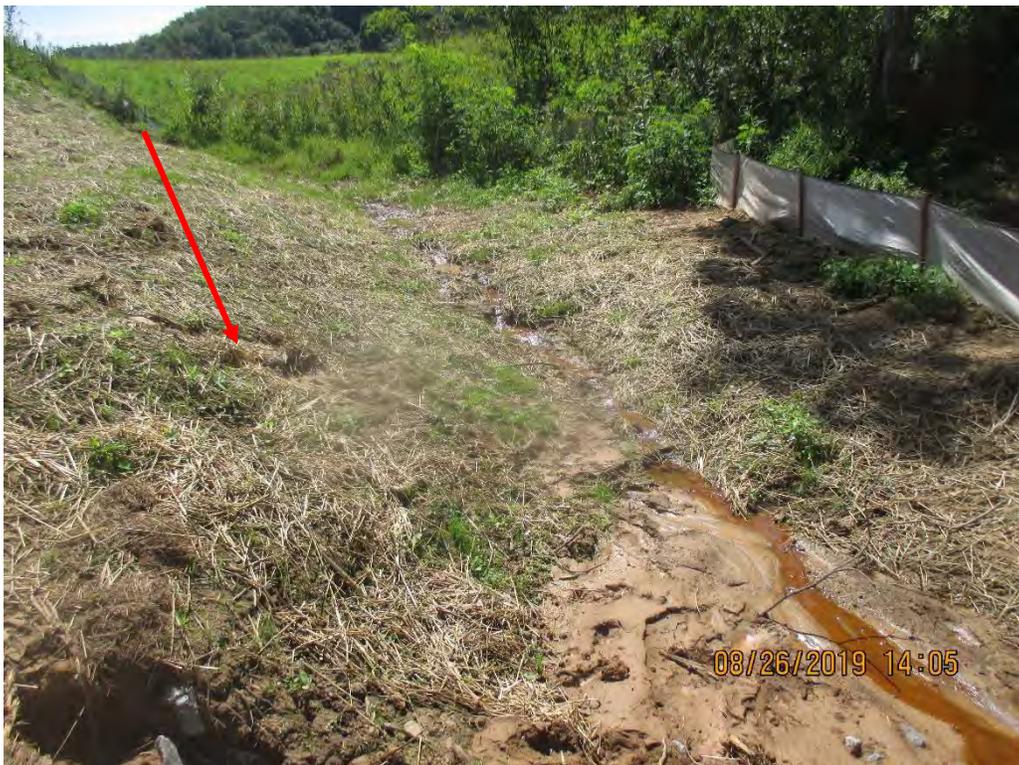
Run on from field and erosion occurring above seep near Station No. 1725+00 and Stream S-K79. Arrow depicts erosion occurring on slope above seep.

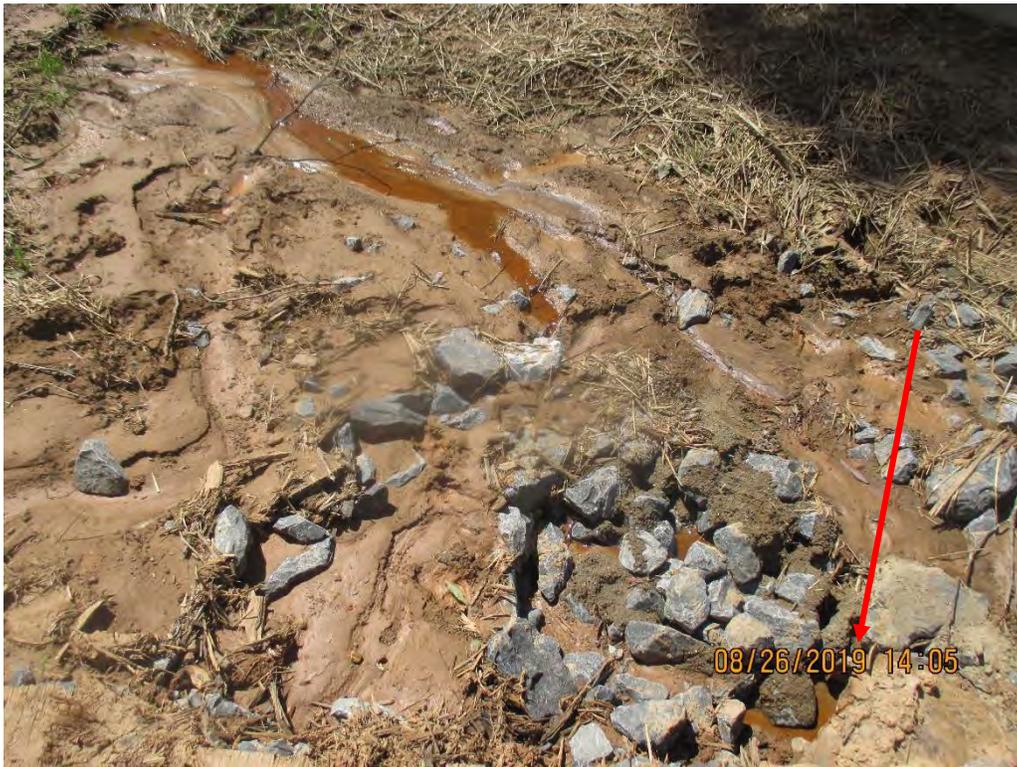
Sediment present in seep and migrating into culvert inlet at station No. 1725+00 above Stream S-K79.  
Arrow depicts culvert inlet.

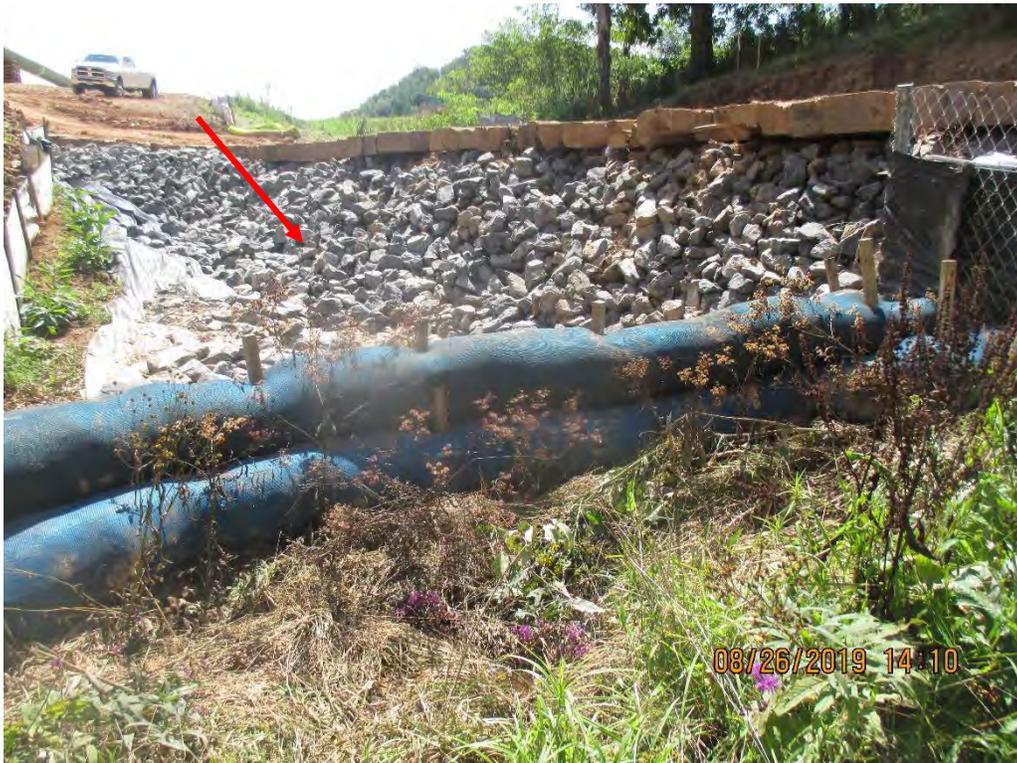
Arrow depicts approximate location according to MVP representatives of the culvert outlet that conveyed under the ROW travel lane above Stream S-K79. Stream started at CFS according to SWPPP.

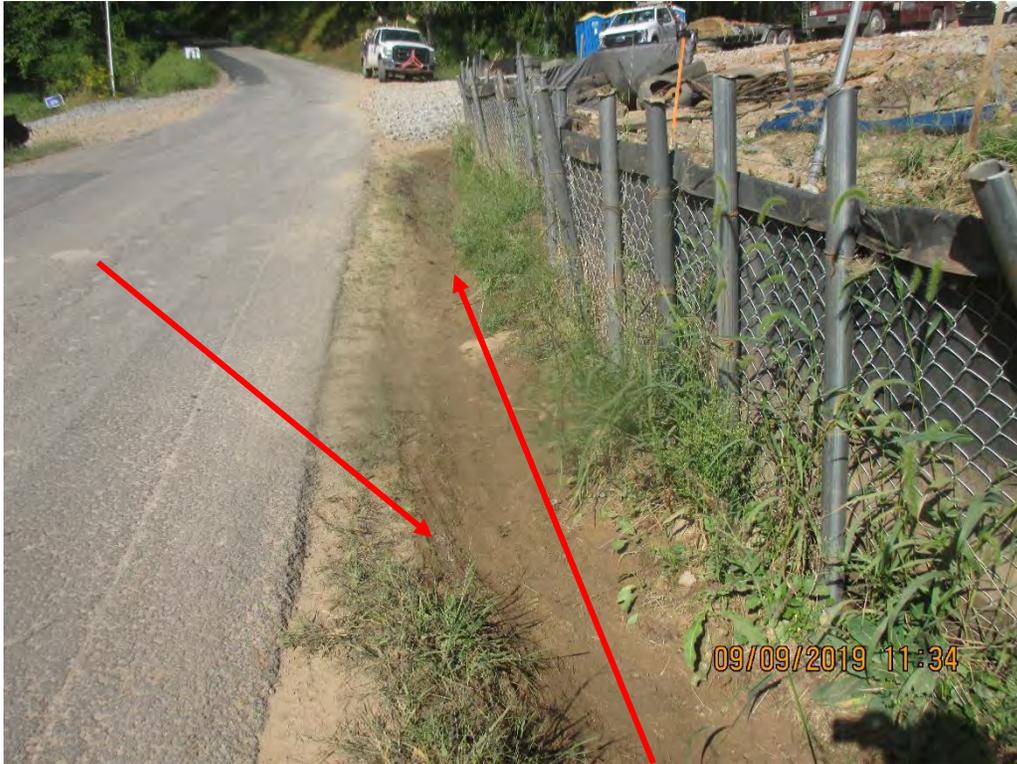
Indian Fork Road (CR21) near station No. 3089+00 facing towards MVP ROW entrance. Arrow depicts where sediment had been removed during inspection. Complainant phot depicted sediment laden water impacting this area.

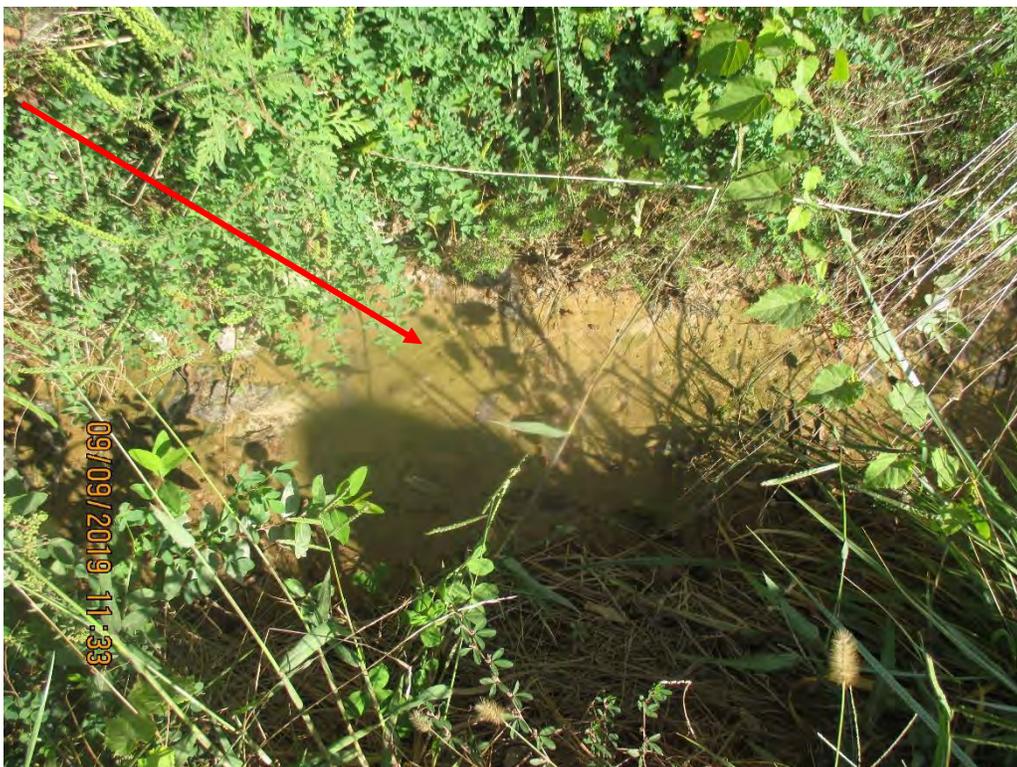
**Section G.4.e.2.A.ii.j.-Permittee has failed to prevent sediment laden water from leaving the site without going through an appropriate device: Evidence that Sediment Laden water left the site was observed due to sediment deposits being observed past the LOD in the roadside ditch that parallels CR21 and conveys to Indian Fork (S-H159)/(Station No. 3089+00).**

Sediment deposits in ditch line downslope of MVP RWP near station No. 3089+00.

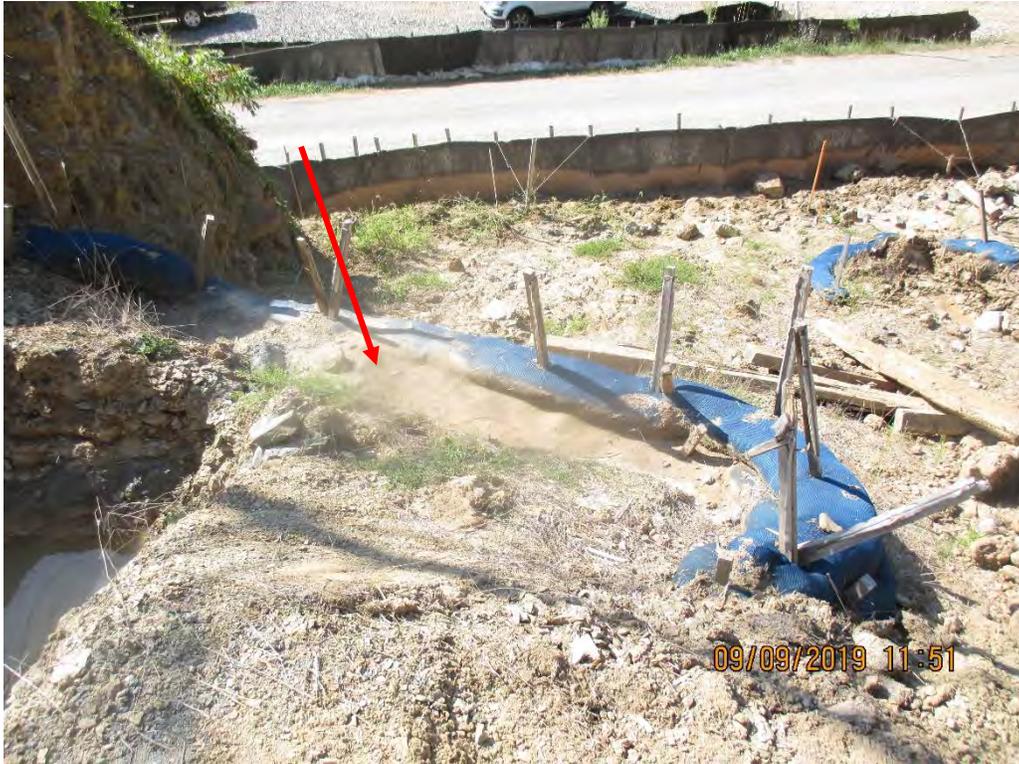
Controls upslope of CR21 and roadside ditch. Arrow depicts where sediment was overwhelming Waterbar outlet controls.

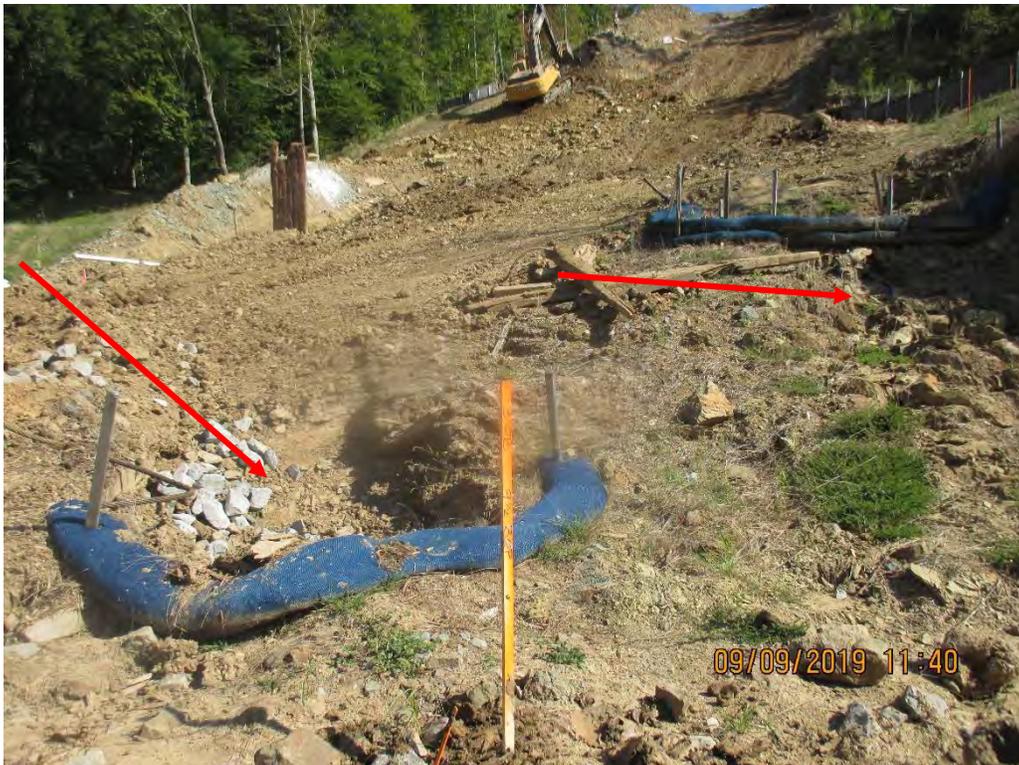
**Section D.1. - Permittee has failed to properly operate and maintain all systems of treatment and controls: At the Route 21/Indian Fork crossing (Station No. 3089+00) controls had not been maintained or enhanced allowing sediment laden water to leave the ROW and enter a roadside ditch that conveys to Indian Fork (S-H159).**

Standing at station No. 3089+00 facing North. Arrow depicts sump not being maintained and erosion on slope below controls.

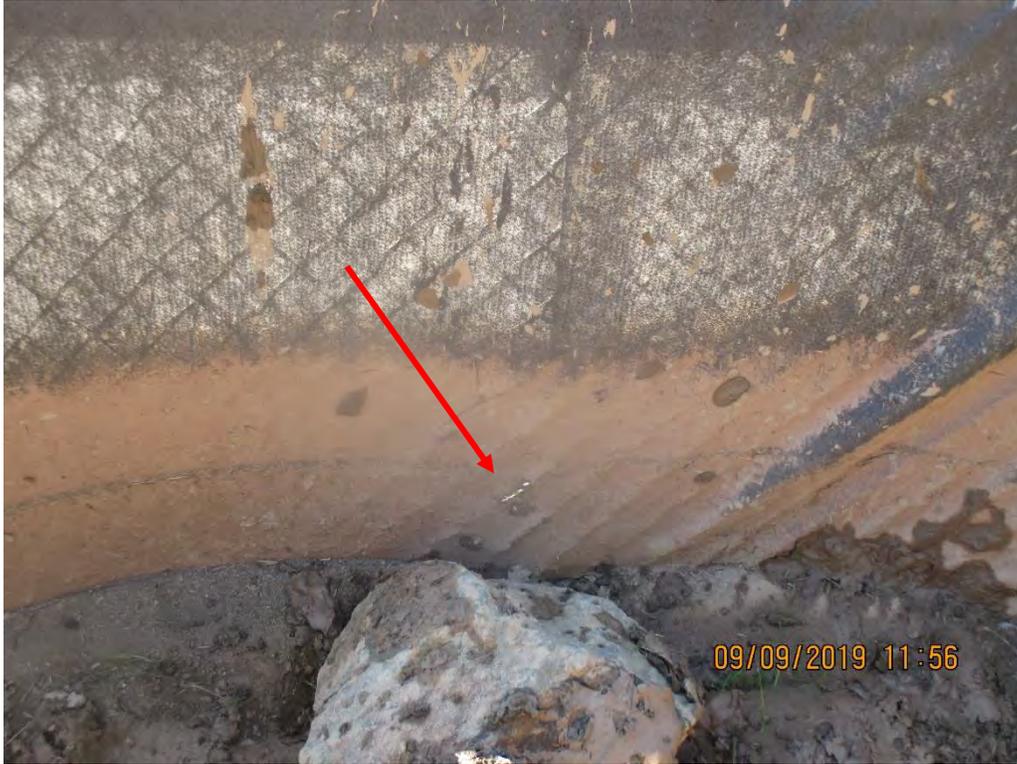
Super Silt fence below unmaintained controls at station No. 3089+00. Hole present in silt fence below where sediment stain line was observed.

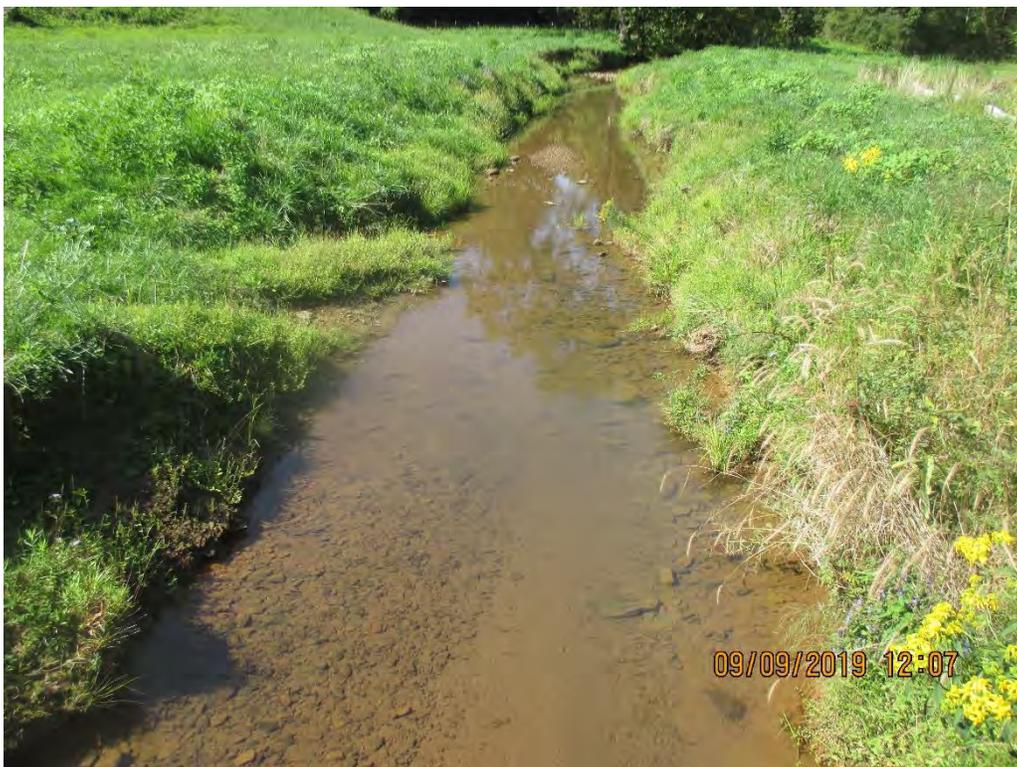
Facing Downstream at Indian Fork Crossing (Stream S-H159) near station No, 3089+00.

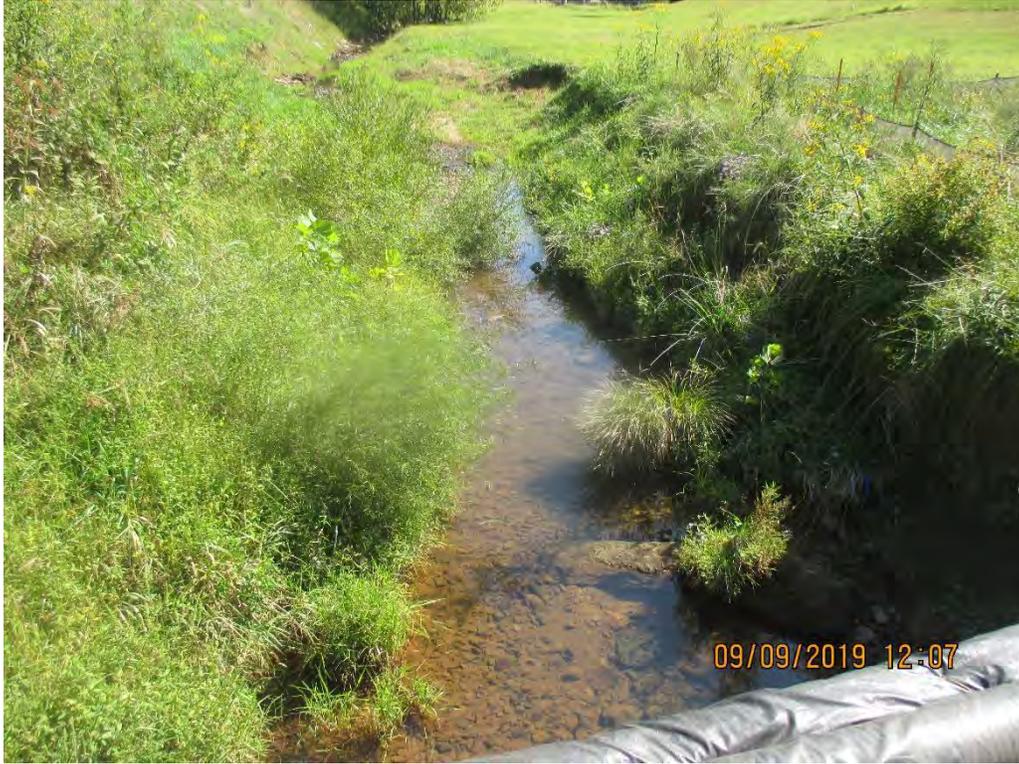
Facing Upstream at Indian Fork Crossing (Stream S-H159) near station No. 3089+00.

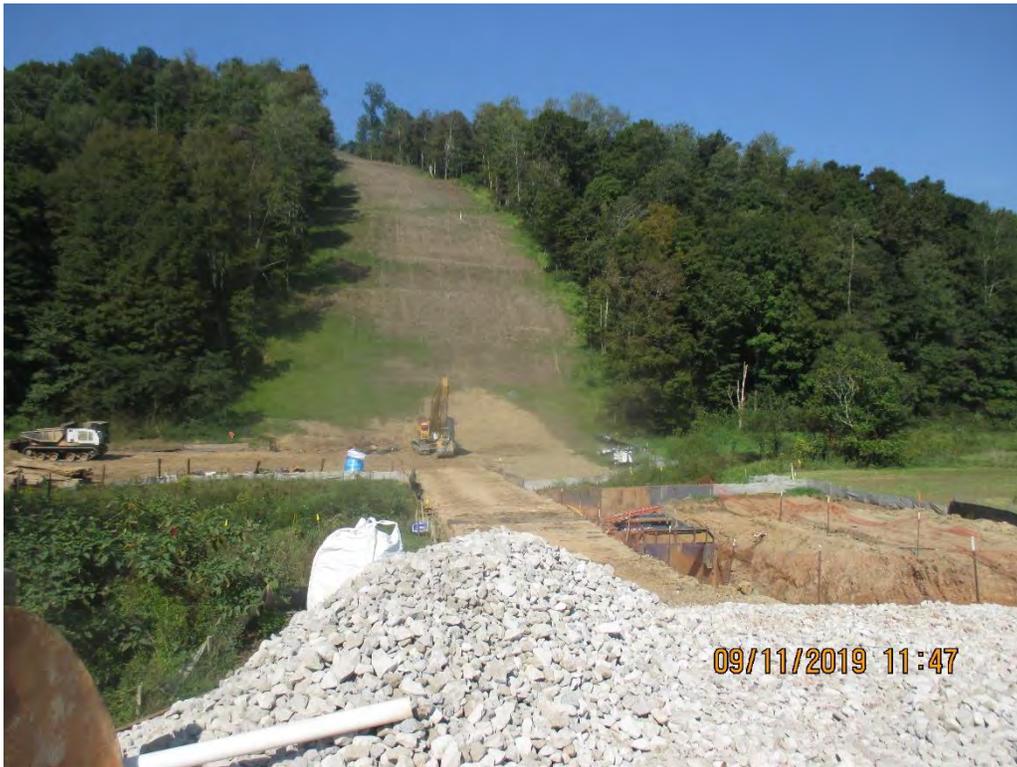
Facing North at the Big Elk Creek crossing at station No. 645+00.

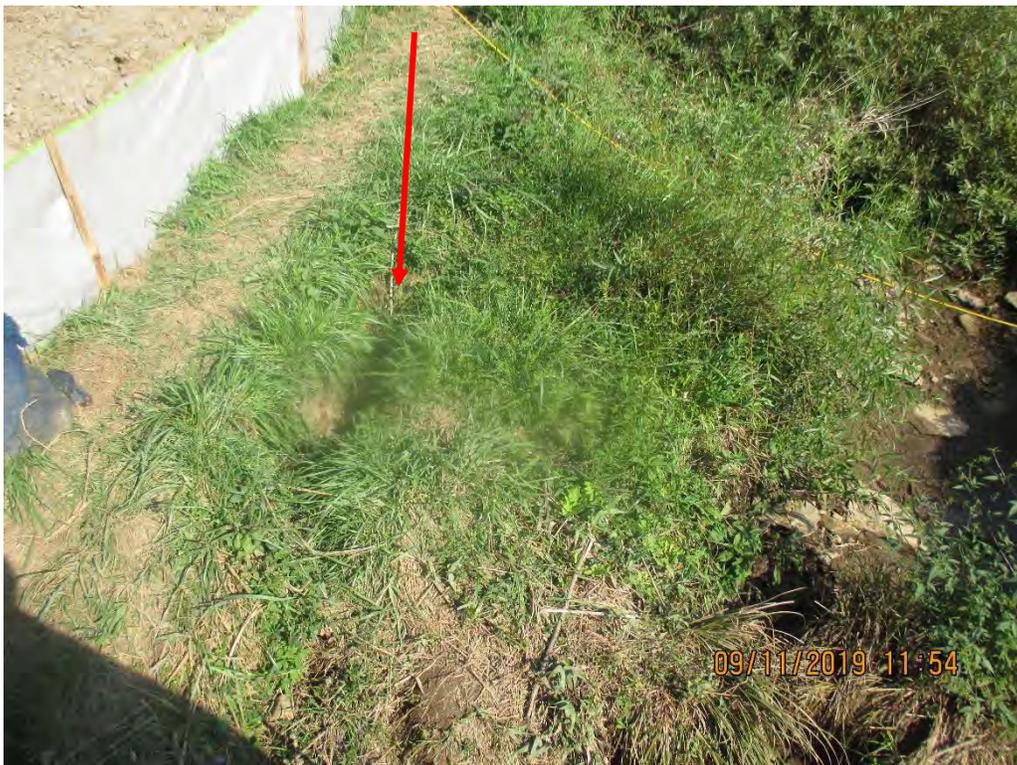
Standing at the Big Elk Creek crossing and where boring activities were occurring. Arrow depicts fisher along stream bank within LOD.
