**The Wilderness Society et al. Comments on the  
U.S. Forest Service Mountain Valley Pipeline and  
Equitrans Expansion Project Draft Supplemental  
Environmental Impact Statement (#50036)**

**EXHIBIT 1**

Assessment of erosion, sedimentation, and water quality impacts of the Mountain Valley Pipeline and Equitrans Expansion Project's proposed crossing of the Jefferson National Forest as it pertains to the U.S. Forest Service's Draft Supplemental Environmental Impact Statement dated December 2022

Prepared by Jonathan A. Czuba, Ph.D., Licensed Professional Engineer

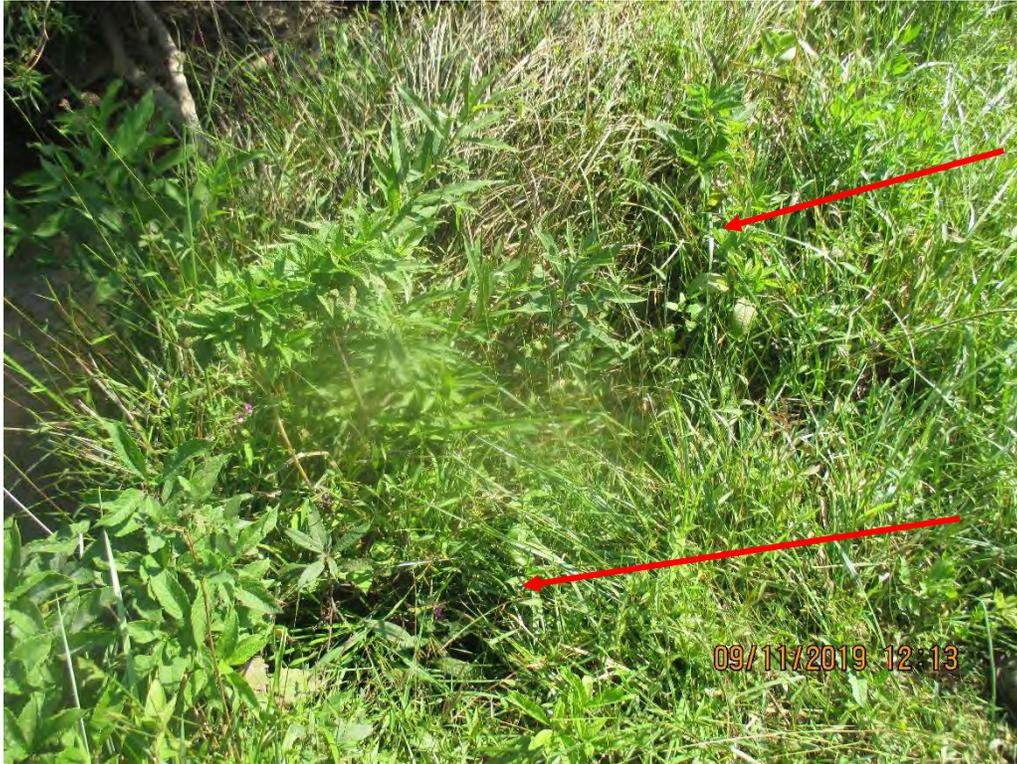
Section of Stream Bank upstream of LOD and Station No. 645+00 where fishers were naturally occurring.

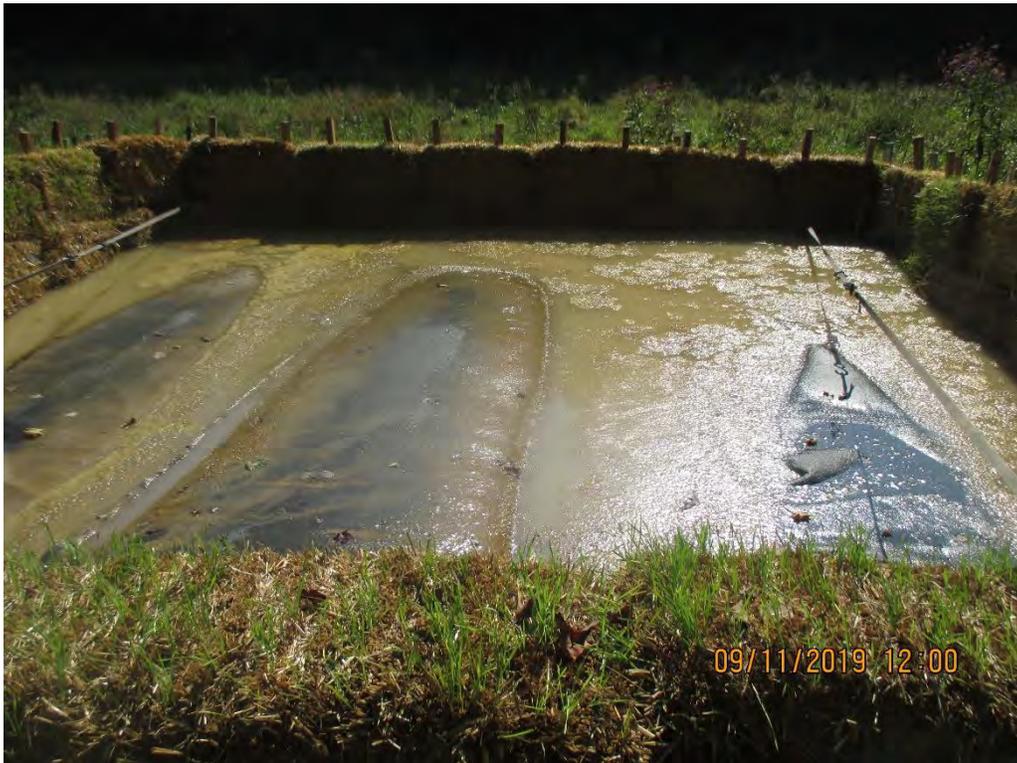
Dewatering Structure located outside LOD near station No. 645+00 upslope of Stream S-J62 (Big Elk creek).

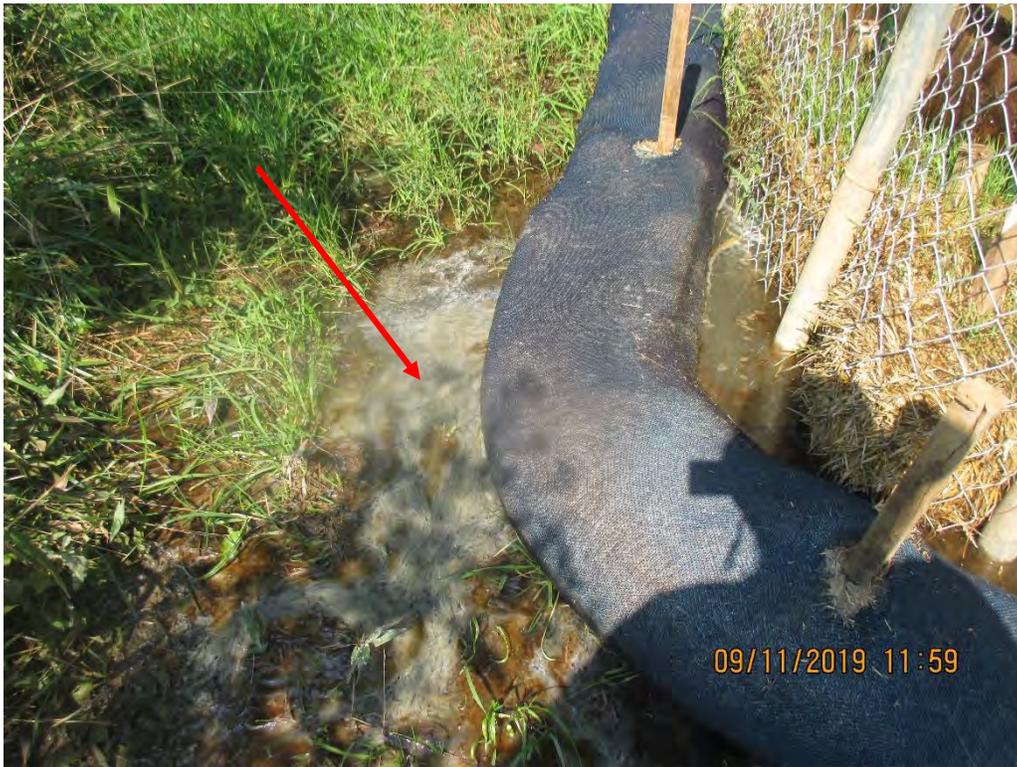
Water discharging from dewatering structure near station No. 645+00. Arrow depicts algae/bacterial growth forming on ground. Water was clear at time of inspection and discharging into a vegetated buffer.

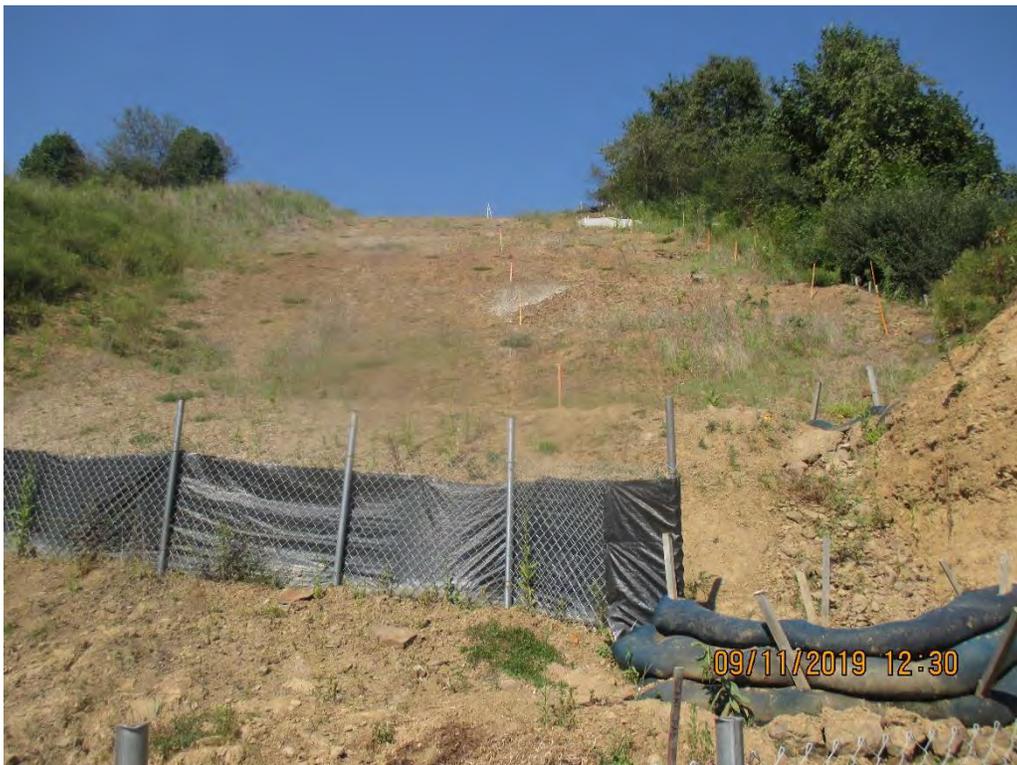
**Section G.4.e.2.A.i.b. - Permittee has failed to provide interim stabilization on areas where construction activities have temporarily ceased for more than 21 days: At station No. 645+00 slopes had not been reseeded or re-stabilized after winter stabilization measures were no longer adequate.**

South slope at station No. 645+00 above the Big Elk Creek crossing. Winter stabilization no longer adequate and reseeding/re-stabilization had not occurred.

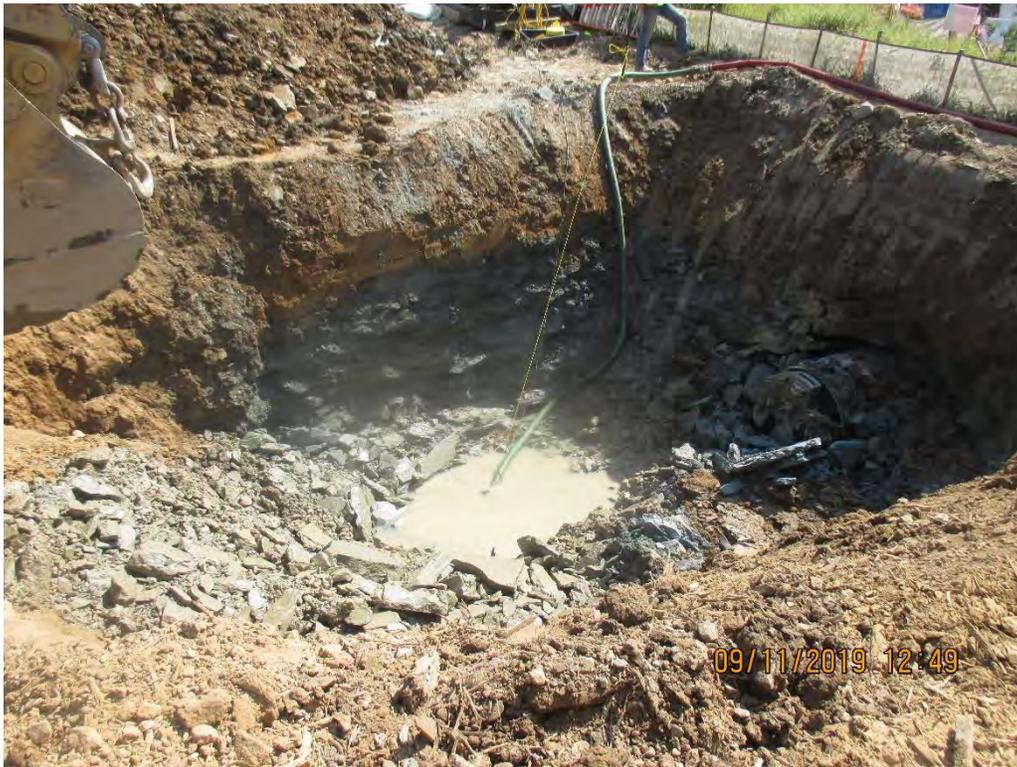
Open bore pit at the Goose Run (Stream S-B75) crossing at station No. 645+35.

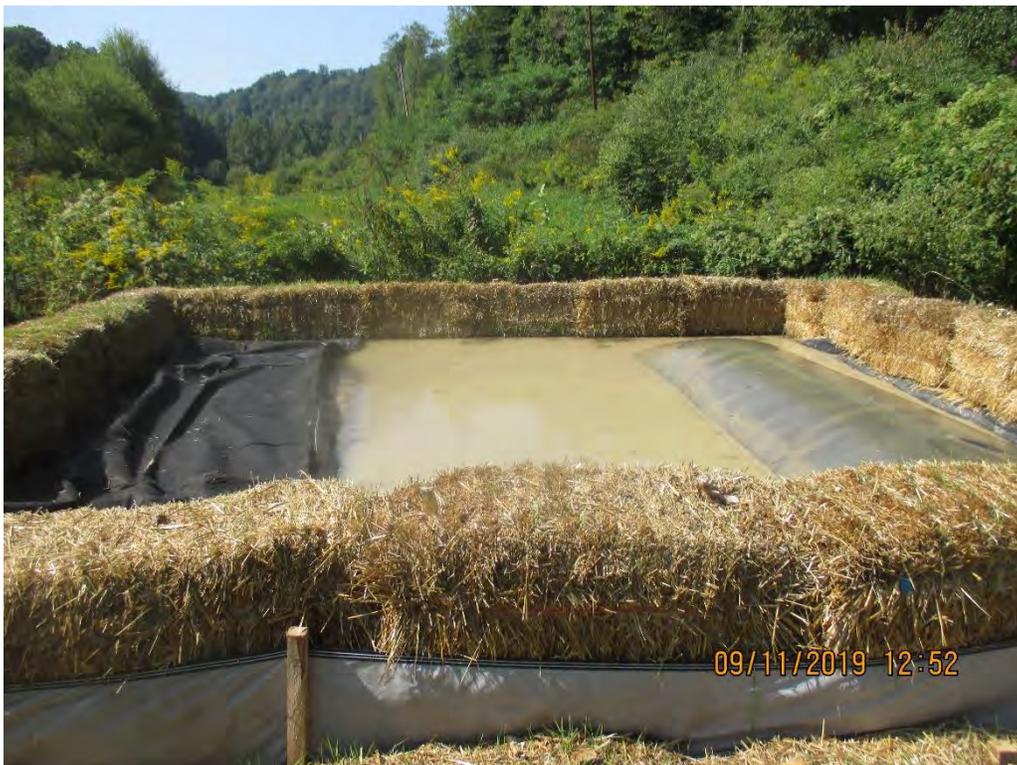
**Section D.1. - Permittee has failed to properly operate and maintain all systems of treatment and controls: At station No. 645+35 the dewatering structure used for the Stream S-B75 bore was not being maintained and operated properly causing the structure to not function as designed causing conditions not allowable in Stream S-B75 (Goose Run).**

Dewatering structure for Goose Run (Stream S-B75) bore near station No. 645+35. Dewatering structure full of Sediment laden water.

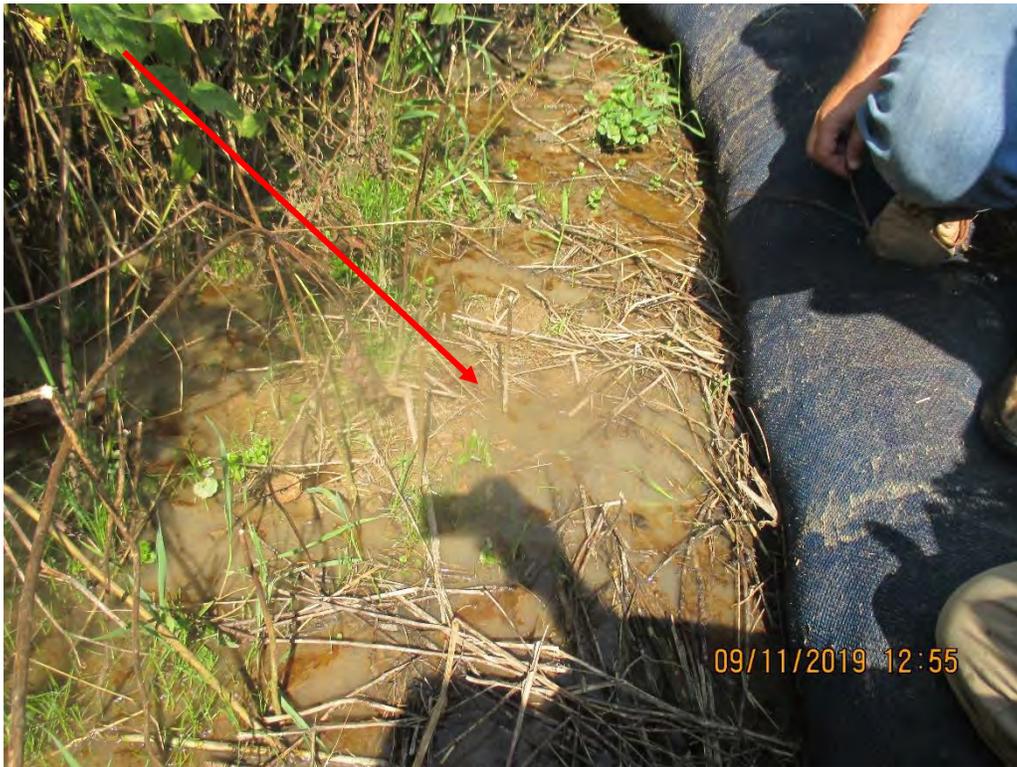
**Section G.4.e.2.A.ii.j.-Permittee has failed to prevent sediment laden water from leaving the site without going through an appropriate device: Sediment Laden water was observed leaving a dewatering structure used for the boring under Stream S-B75 (Goose Run).**

Sediment laden water flowing under controls and into vegetation above Stream S-B75 (Goose Run) near station No. 645+35.

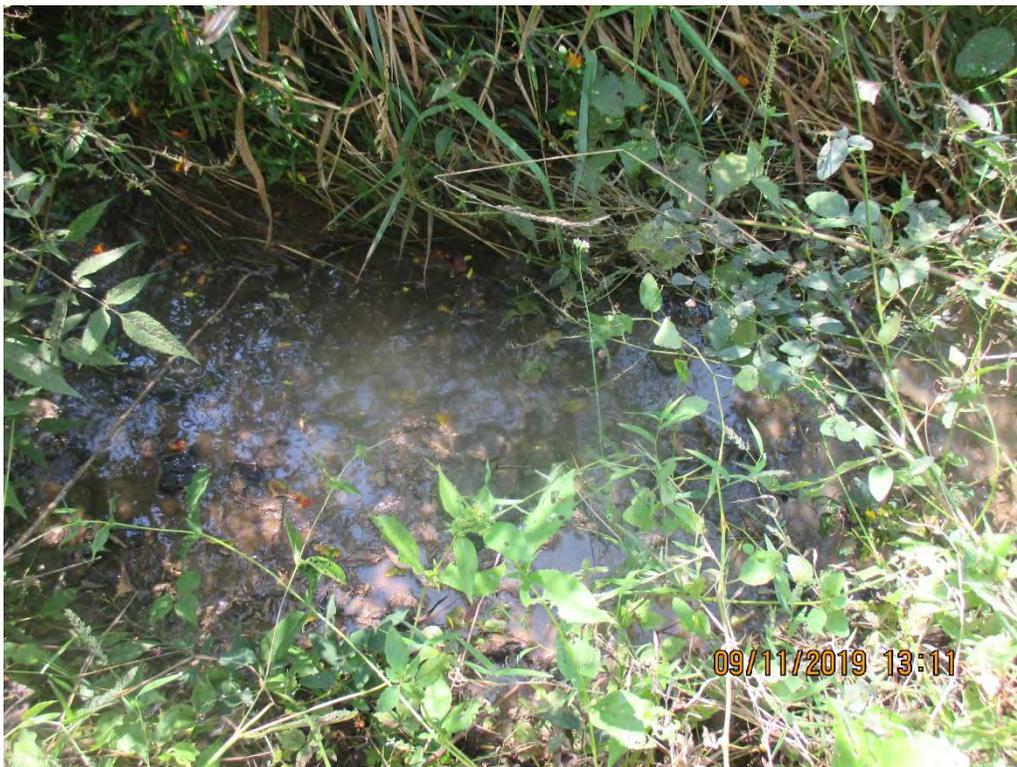
**Section 3.2.a-Responsible party has caused conditions not allowable in waters of the State by allowing distinctly visible settleable solids in Stream S-B75 (Goose Run) a tributary of Big Elk Creek.**

Sediment laden water flowing into Stream S-B75 (Goose Run) near station No. 645+35.

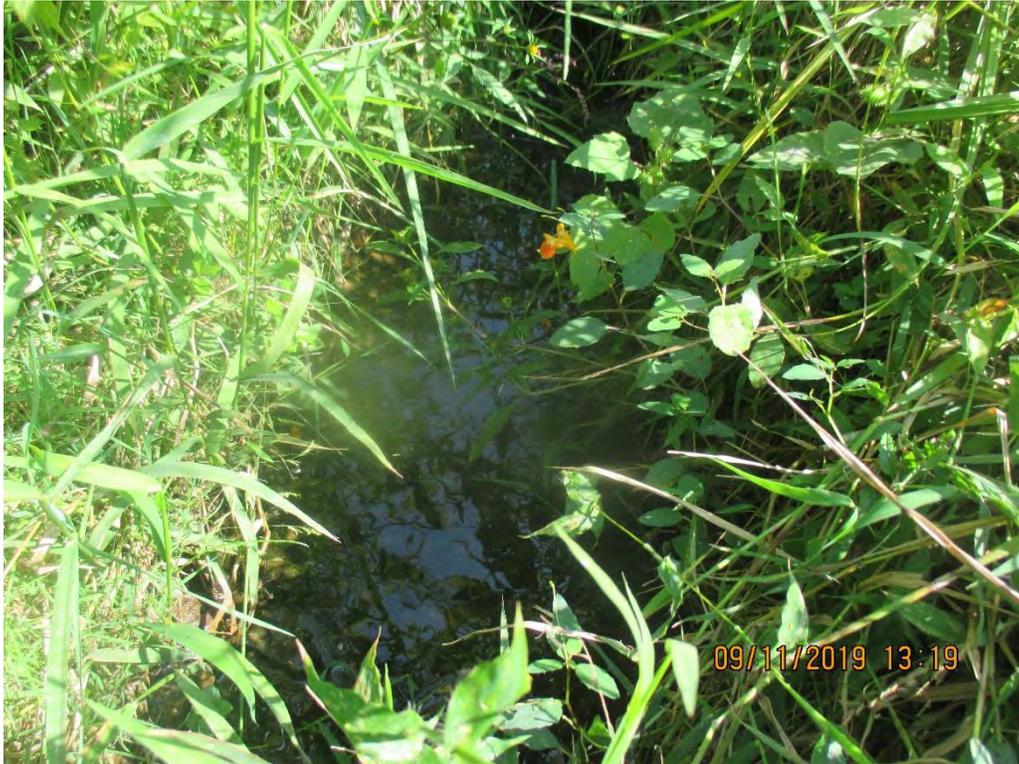
Goose Run (Stream S-B75) above where sediment laden water was entering stream. Stream running clear.

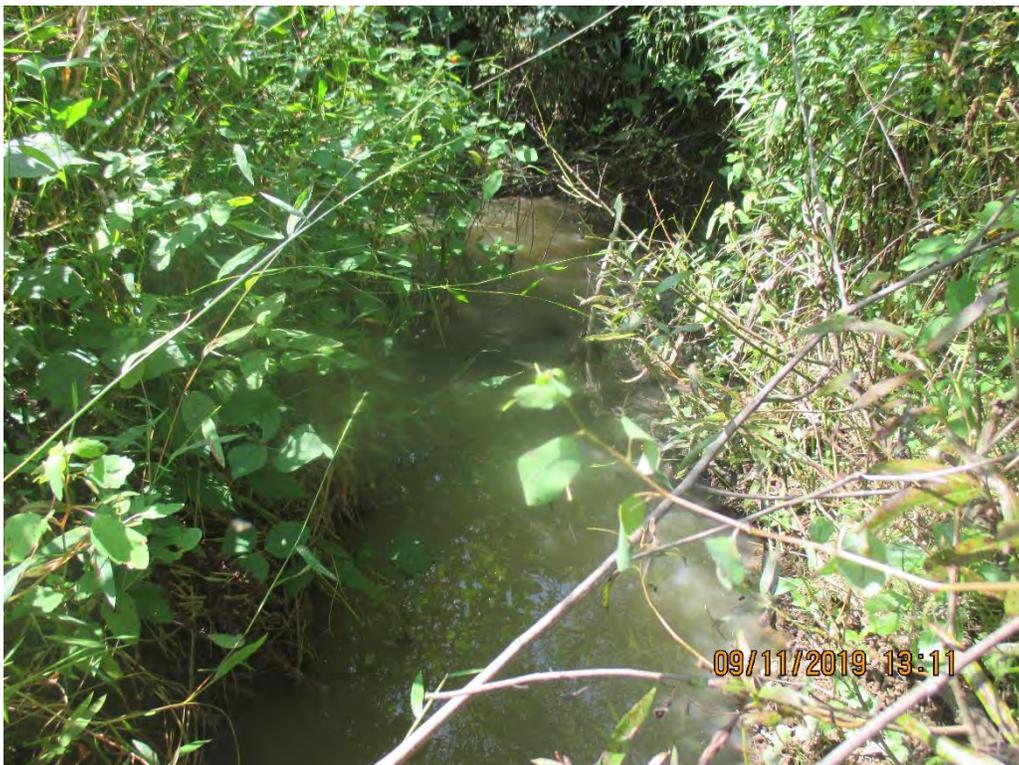
Below where Sediment laden water was entering Goose Run (Stream S-B75) near station No. 645+35.

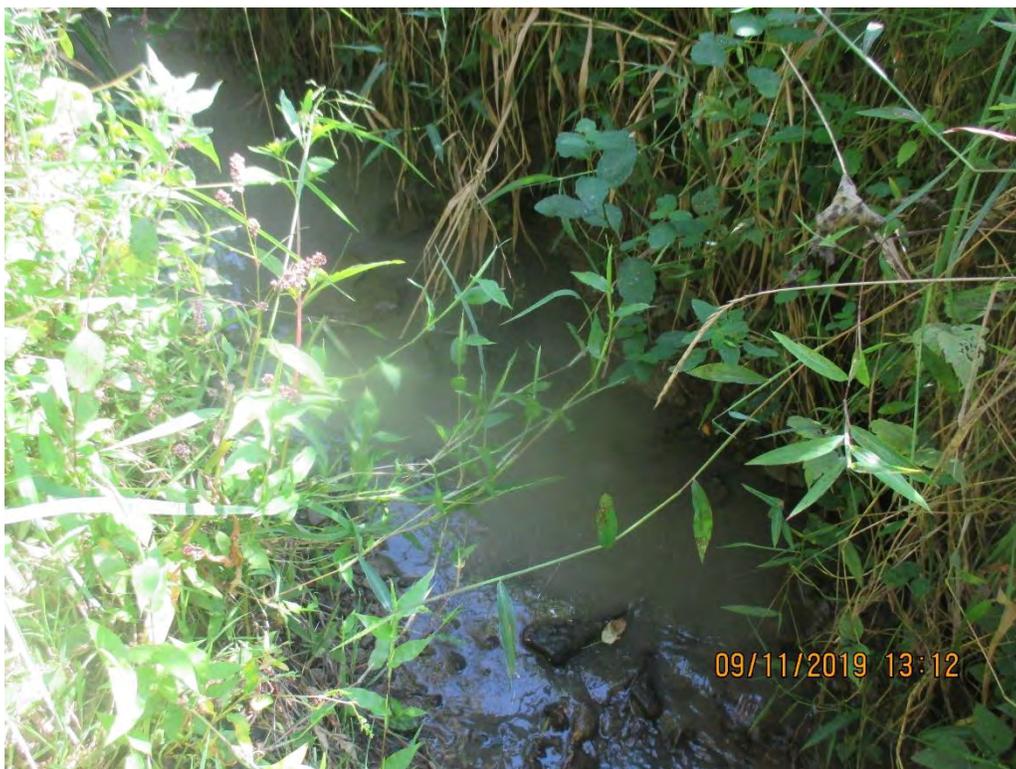
Below where Sediment laden water was entering Goose Run (Stream S-B75) near station No. 645+35.

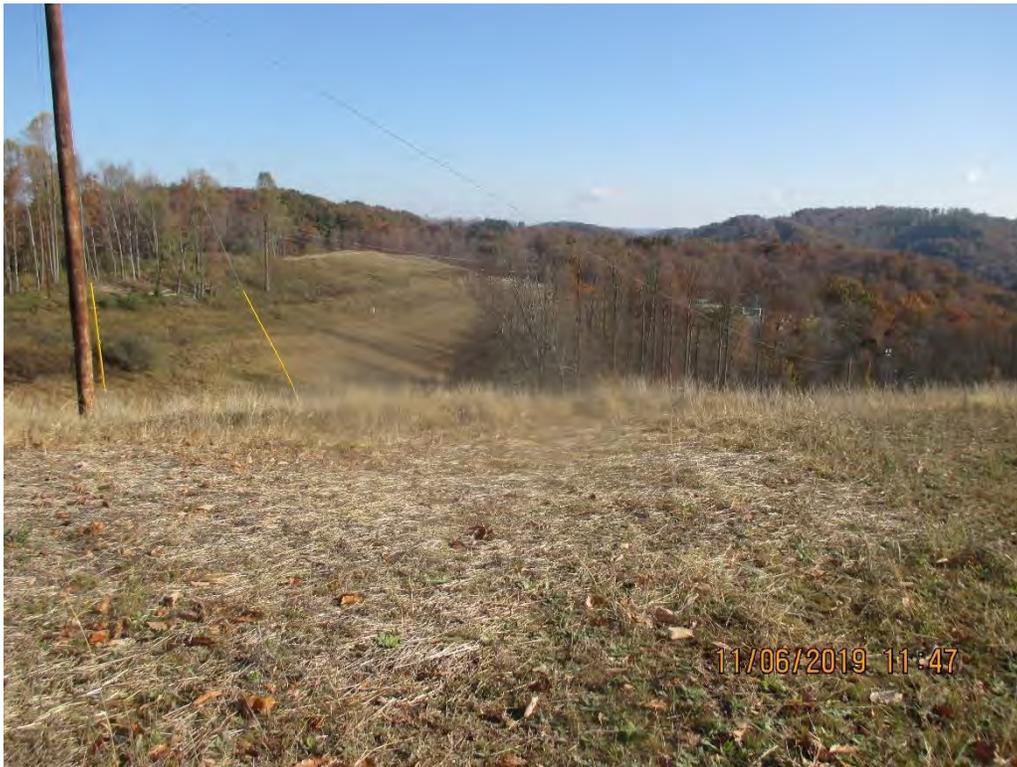
MVP ROW near station No. 4084+00 facing North towards Harris compressor station. ROW had been temporarily stabilized.

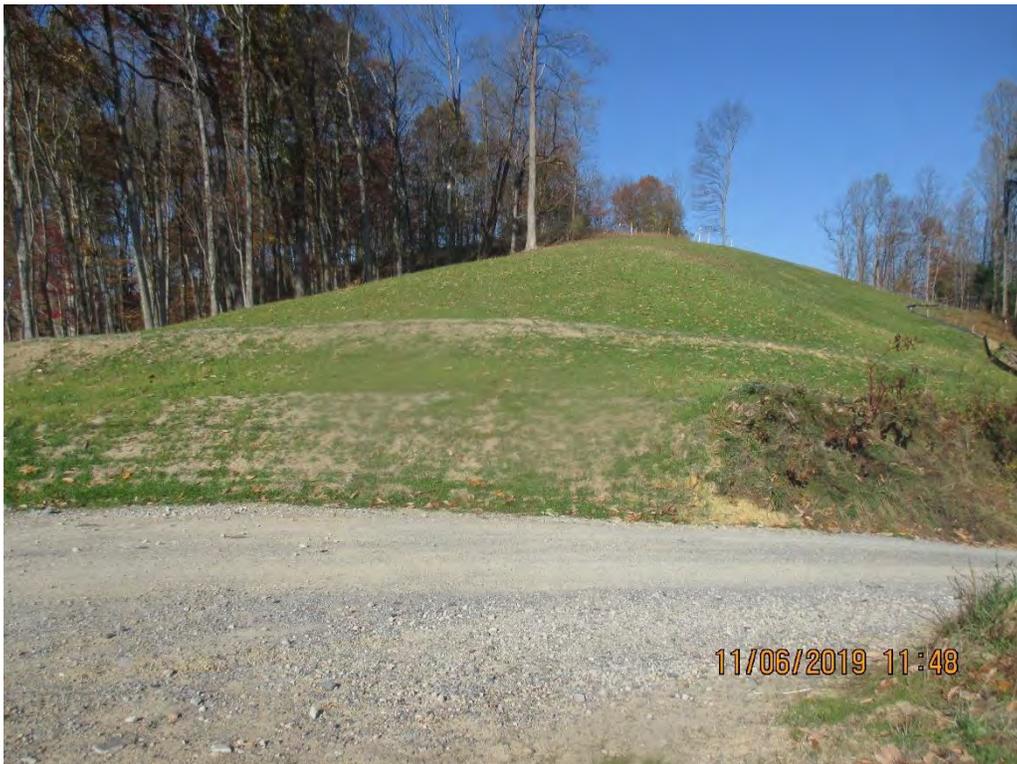
MVP ROW above Harris Compressor station near Station No. 4084+00 facing South. ROW had been temporarily stabilized.

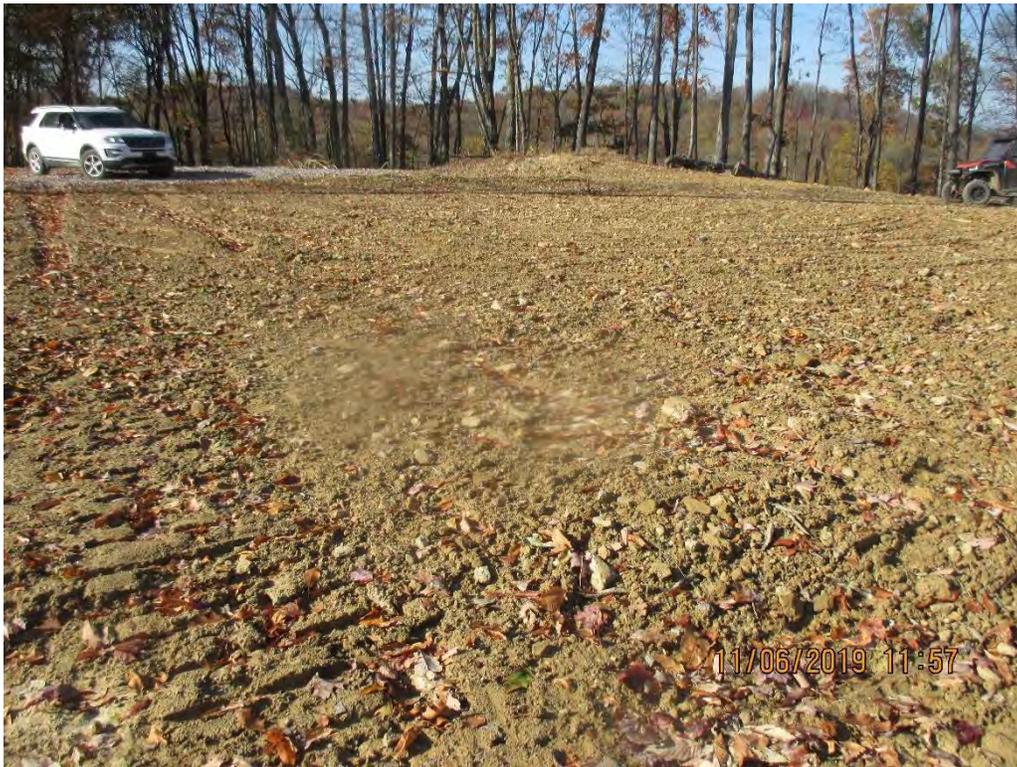
Section of ROW at station No. 4084 where Access Road AR-105 comes onto MVP ROW. ROW had not been temporarily stabilized at the time of inspection.

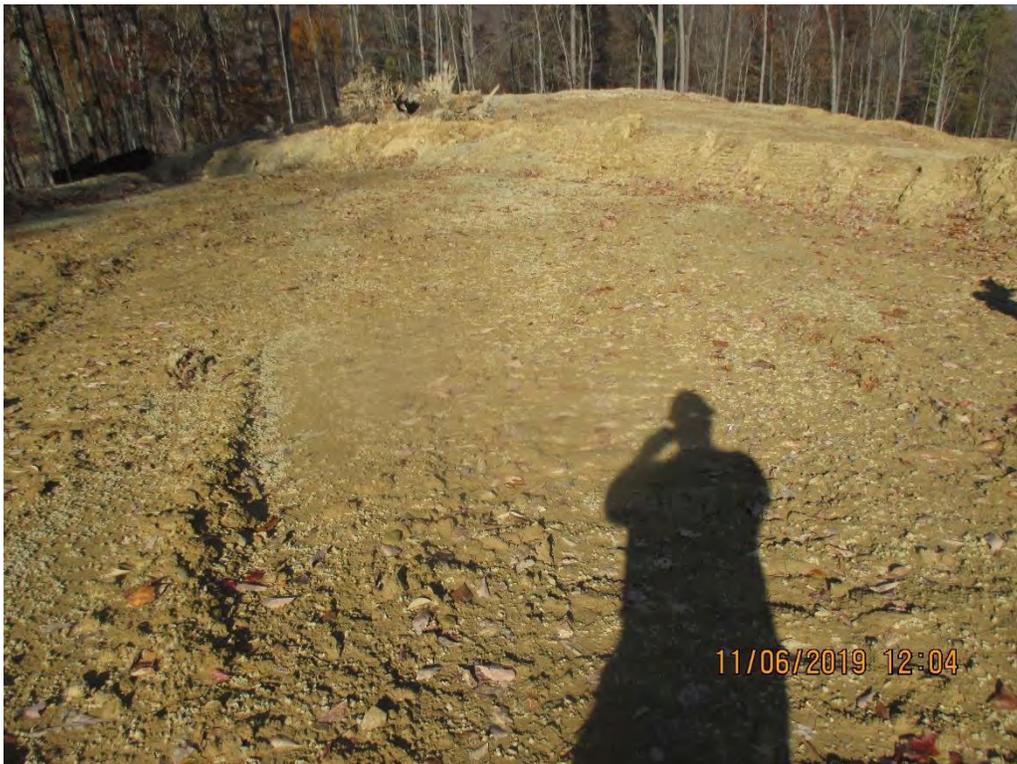
Waterbar at station No. 4082+00 that complaint submitted complaint on outlet control failure. ROW had recently been stabilized with erosion control pellet application by air.

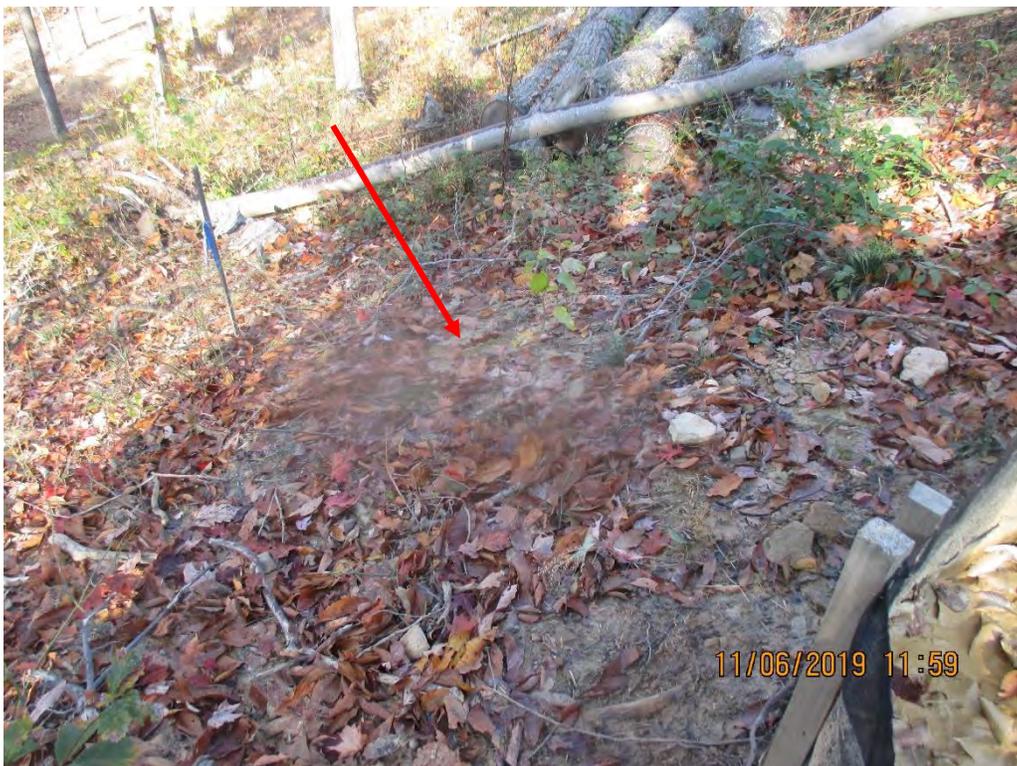
Slope below outlet controls at station No. 4082+00. Sediment deposits observed past controls.

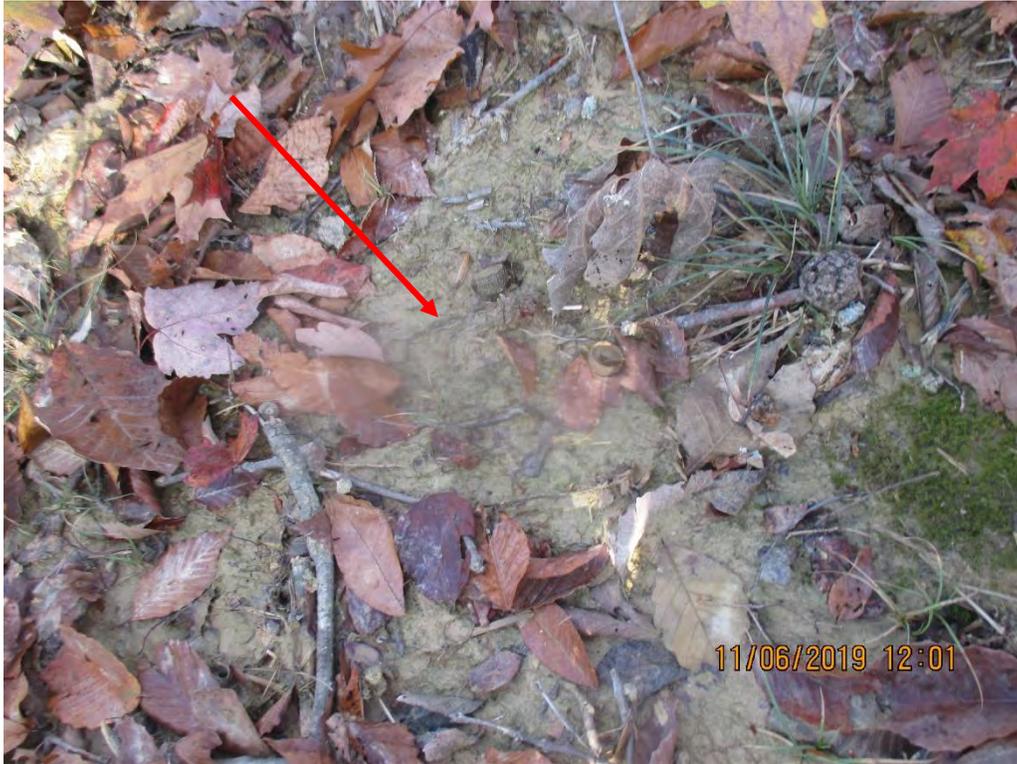
Sediment deposits observed pas the LOD at station No. 4082+00. Deposits were observed approximately 10-15 foot past the LOD on the day of inspection.

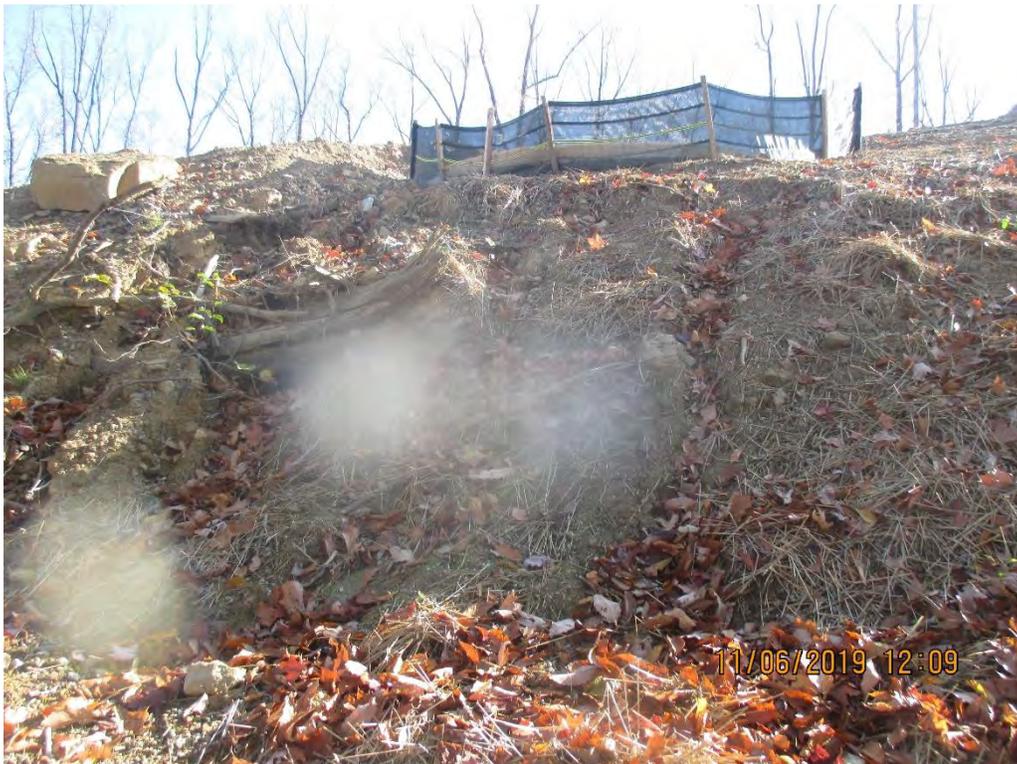
Waterbar outlet terminating onto fill slope causing erosion below controls near station No. 4082+00. Perimeter controls present below outlet on the edge of the LOD.

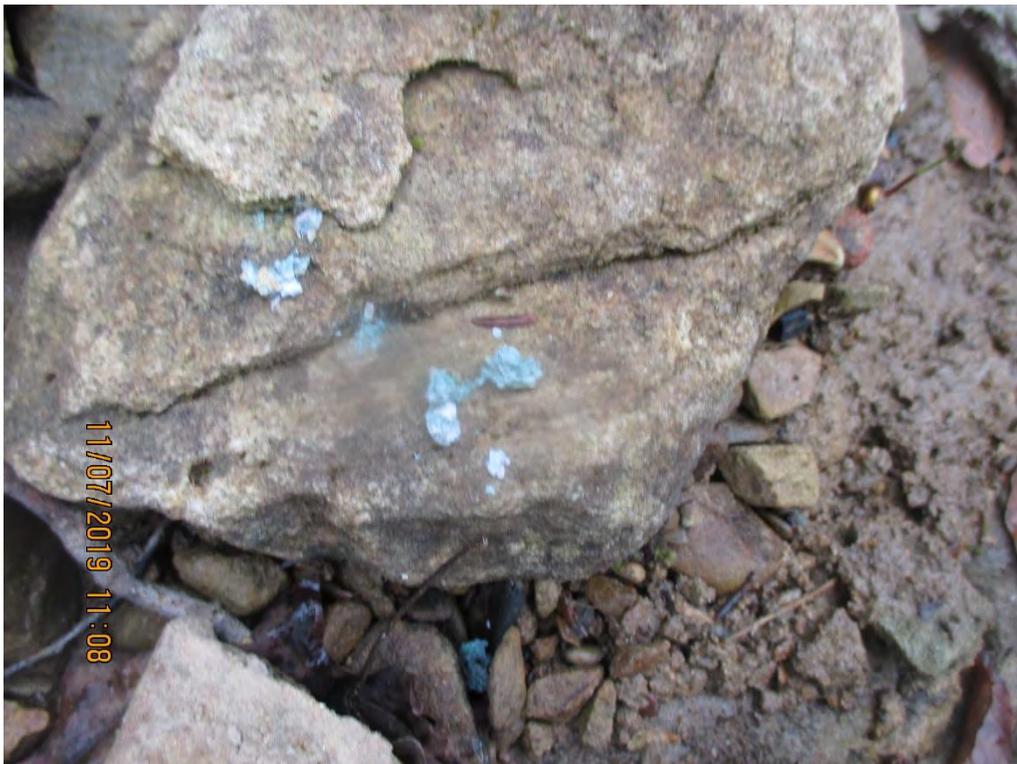
Rock present in Stream S-H117. Pellet remnants present on rocks.

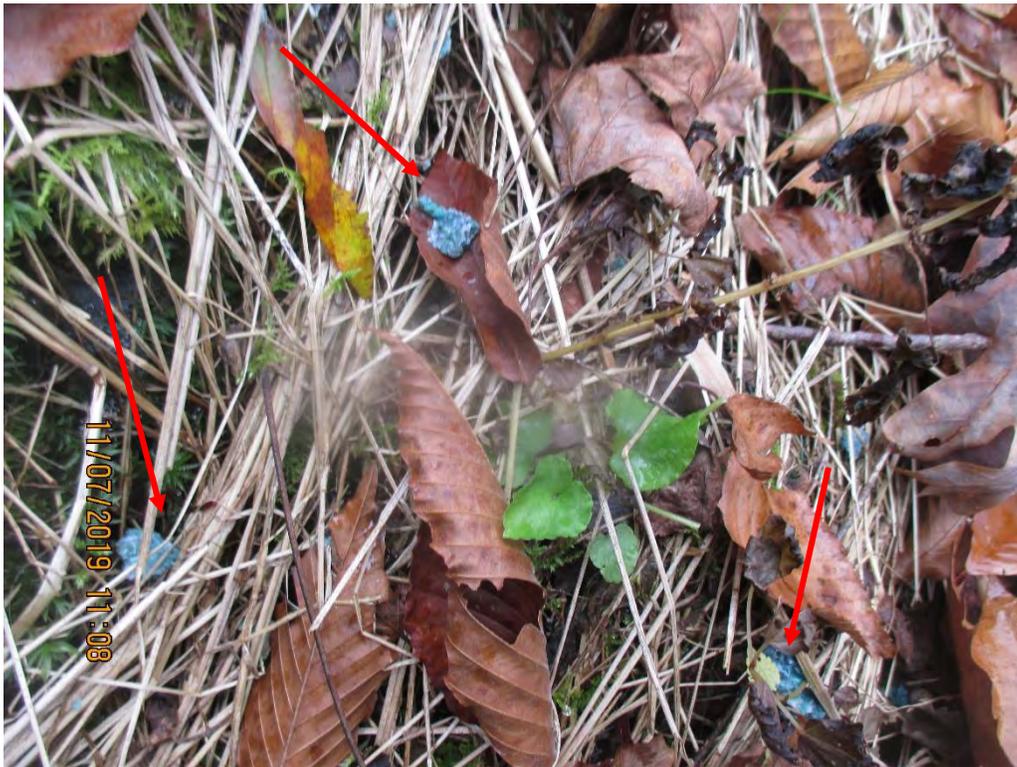
Pellet remnants present along stream bank of Stream S-H117. Significant leaf fall had occurred around the time of inspection.

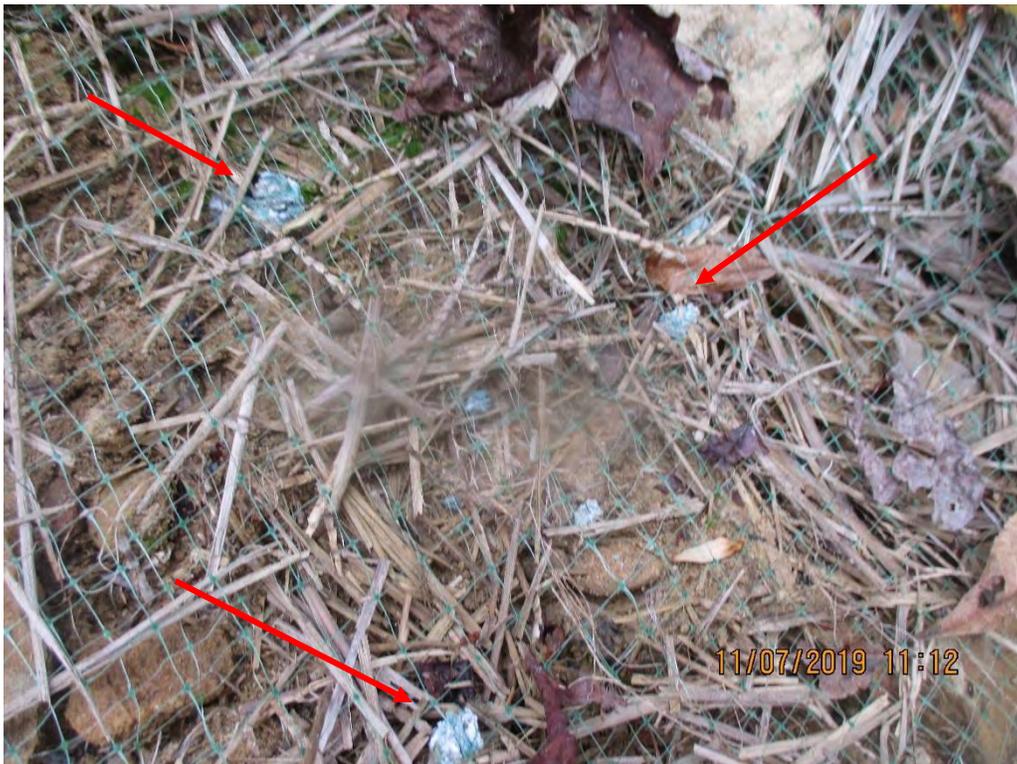
Pellet remnants present along stream bank of Stream S-H117. Significant leaf fall had occurred around the time of inspection.

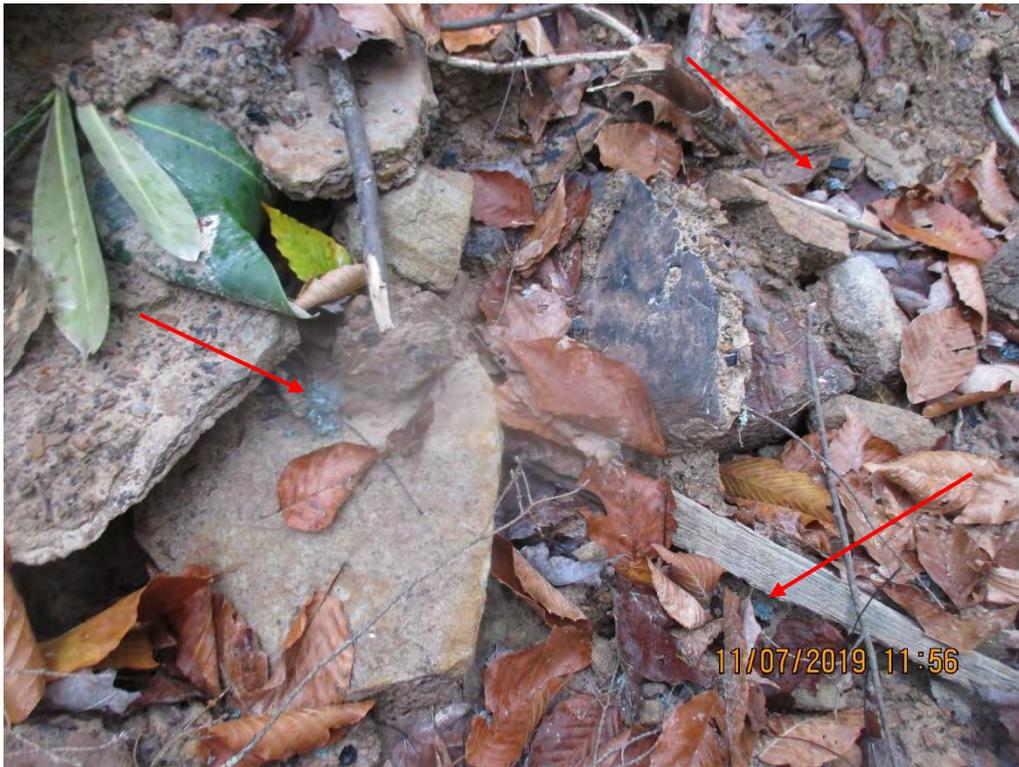
Pellet remnants present in Elliott Run a tributary of the Little Kanawha River.

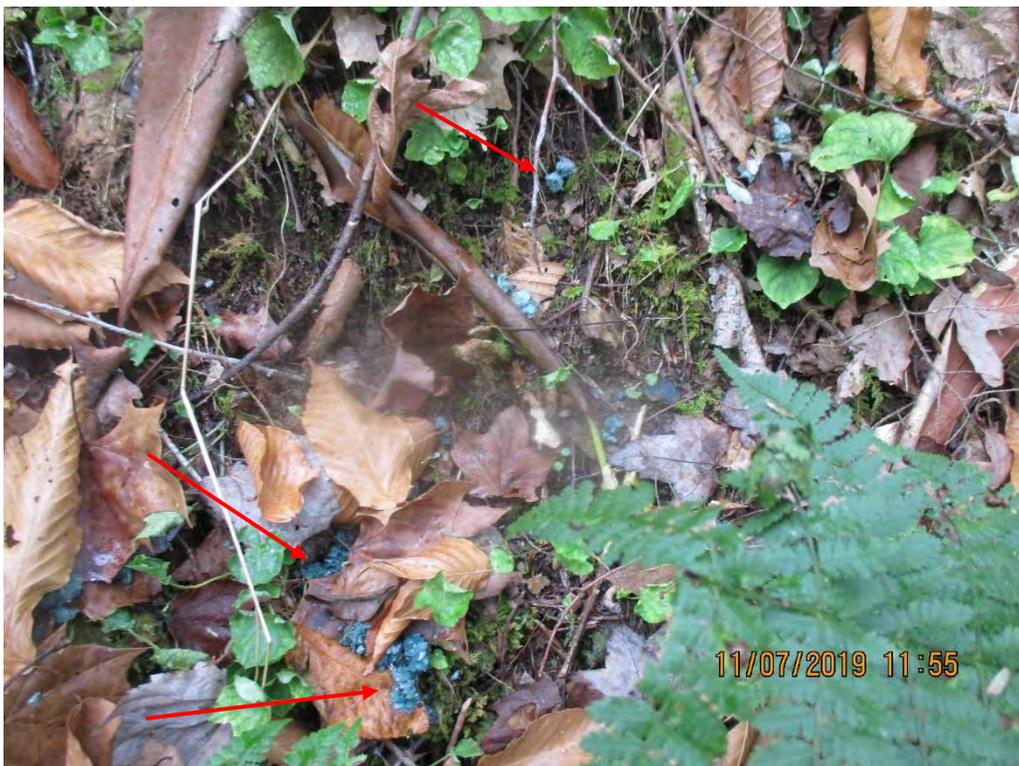
Pellet remnants present on the stream bank on the East bank of Elliott Run past MVP LOD.

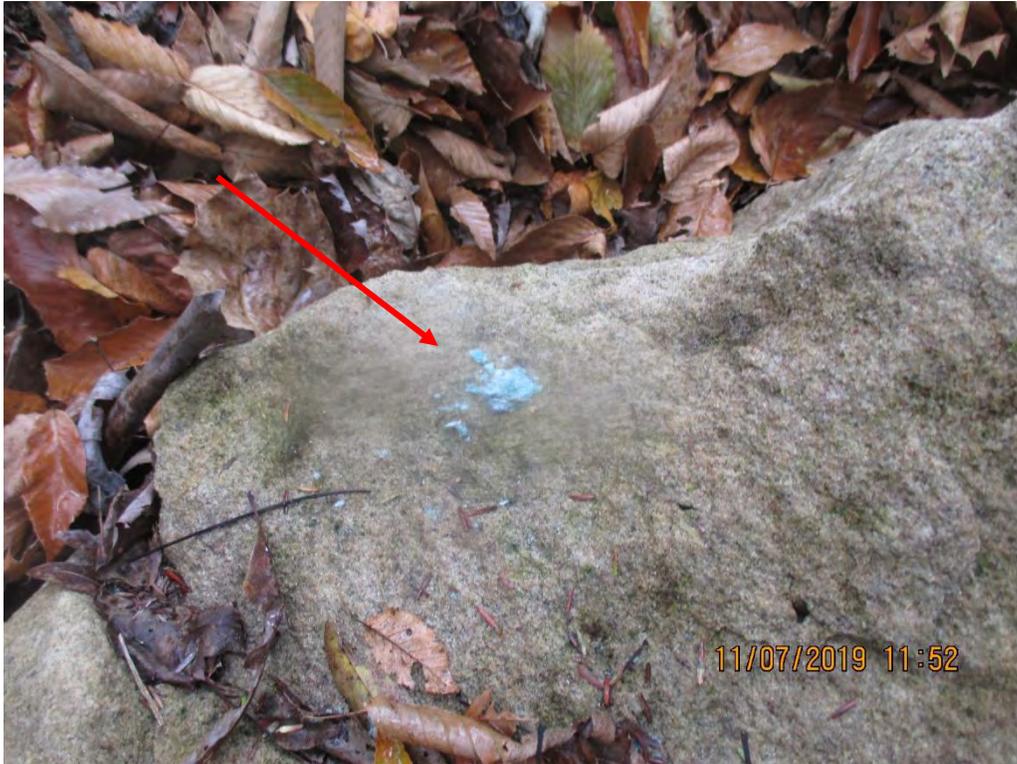
Pellet remnants located on top of rocks in Elliott run on day of inspection.

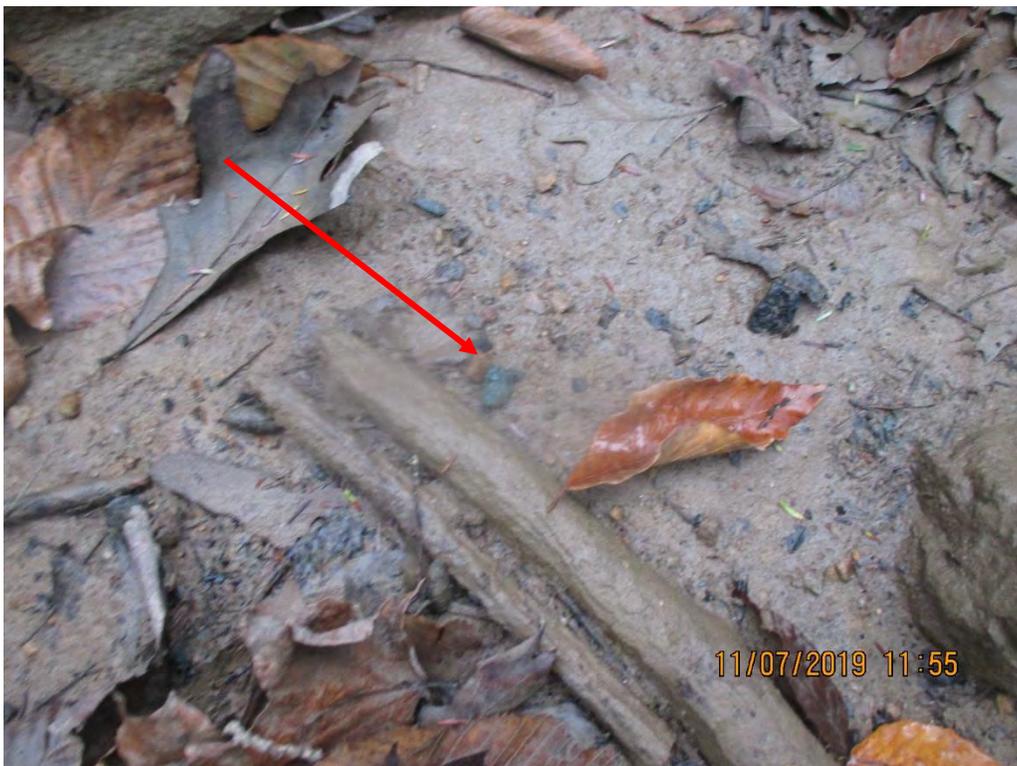
Pellet remnants observed in Stream bed of Elliott Run during inspection approximately 50-75 from confluence with Little Kanawha River.

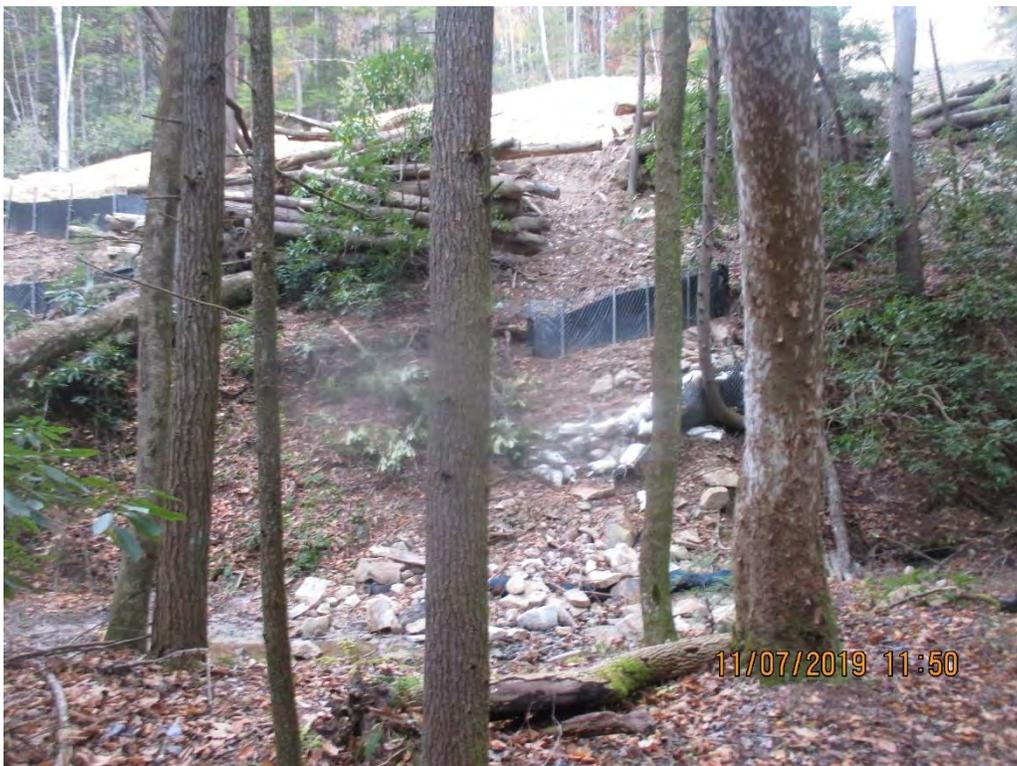
Slip that impacted Elliott Run near Station No. 3946+00 and was not reported to WVDEP spill reporting hotline.

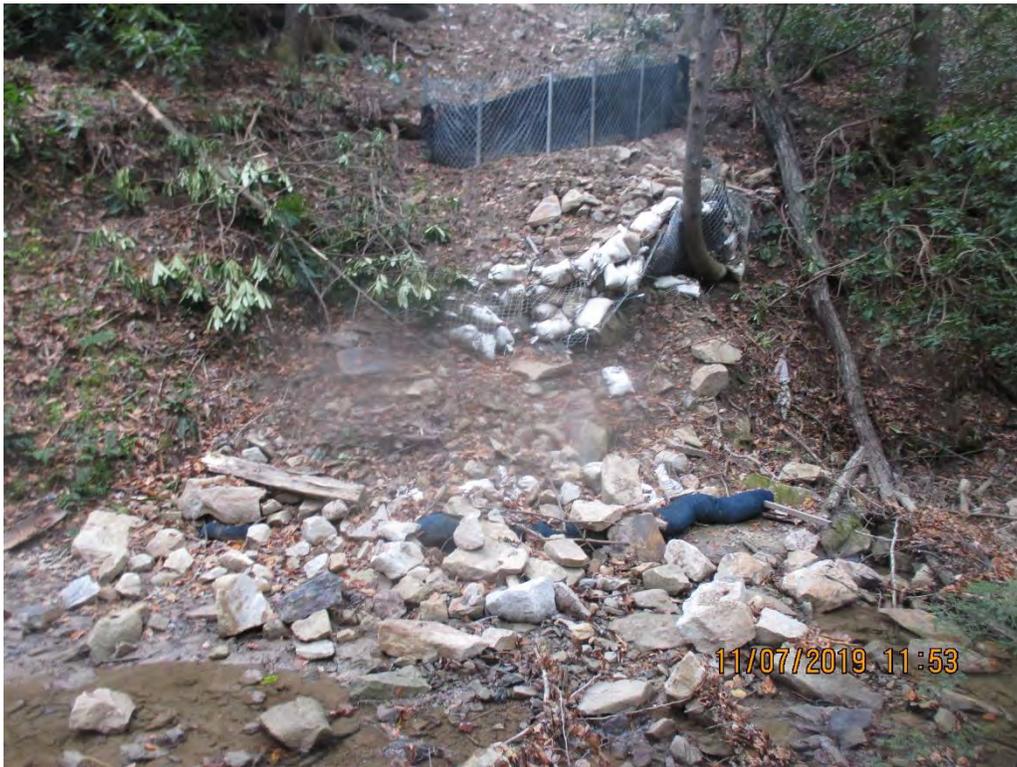
Slip that impacted Elliott Run near Station No. 3946+00 and was not reported to WVDEP spill reporting hotline.

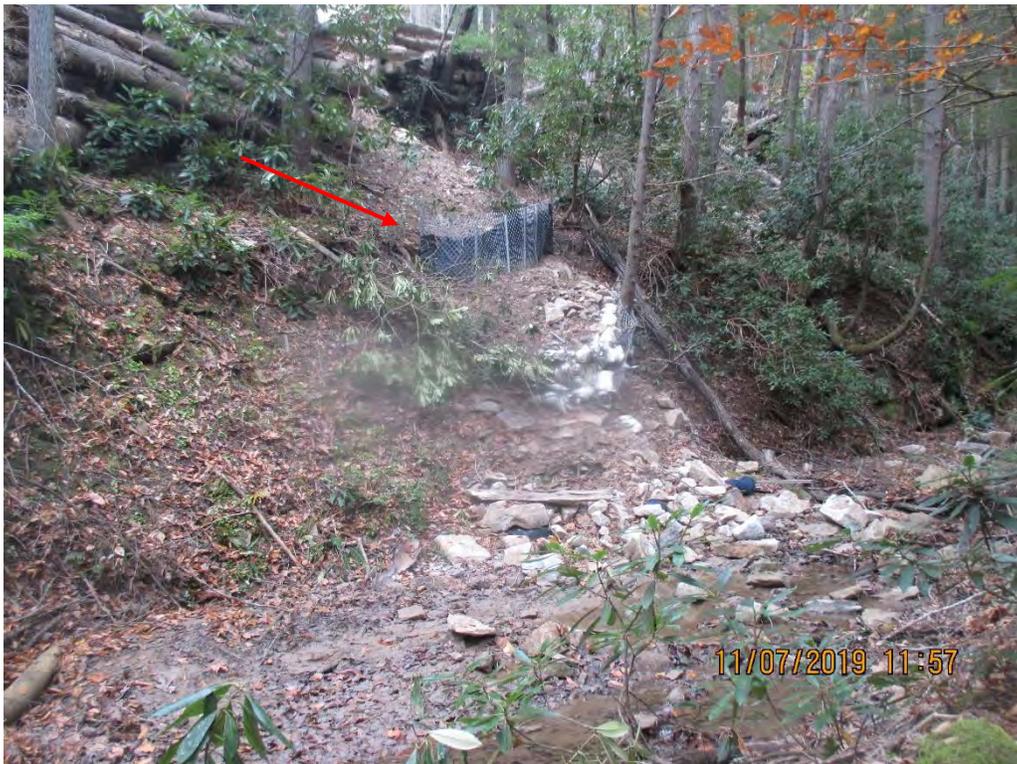
Slip that impacted Elliott Run near Station No. 3946+00 and was not reported to WVDEP spill reporting hotline. Super Silt fence installed at near the edge of LOD.
