**The Wilderness Society et al. Comments on the  
U.S. Forest Service Mountain Valley Pipeline and  
Equitrans Expansion Project Draft Supplemental  
Environmental Impact Statement (#50036)**

**EXHIBIT 1**

Assessment of erosion, sedimentation, and water quality impacts of the Mountain Valley Pipeline and Equitrans Expansion Project's proposed crossing of the Jefferson National Forest as it pertains to the U.S. Forest Service's Draft Supplemental Environmental Impact Statement dated December 2022

Prepared by Jonathan A. Czuba, Ph.D., Licensed Professional Engineer

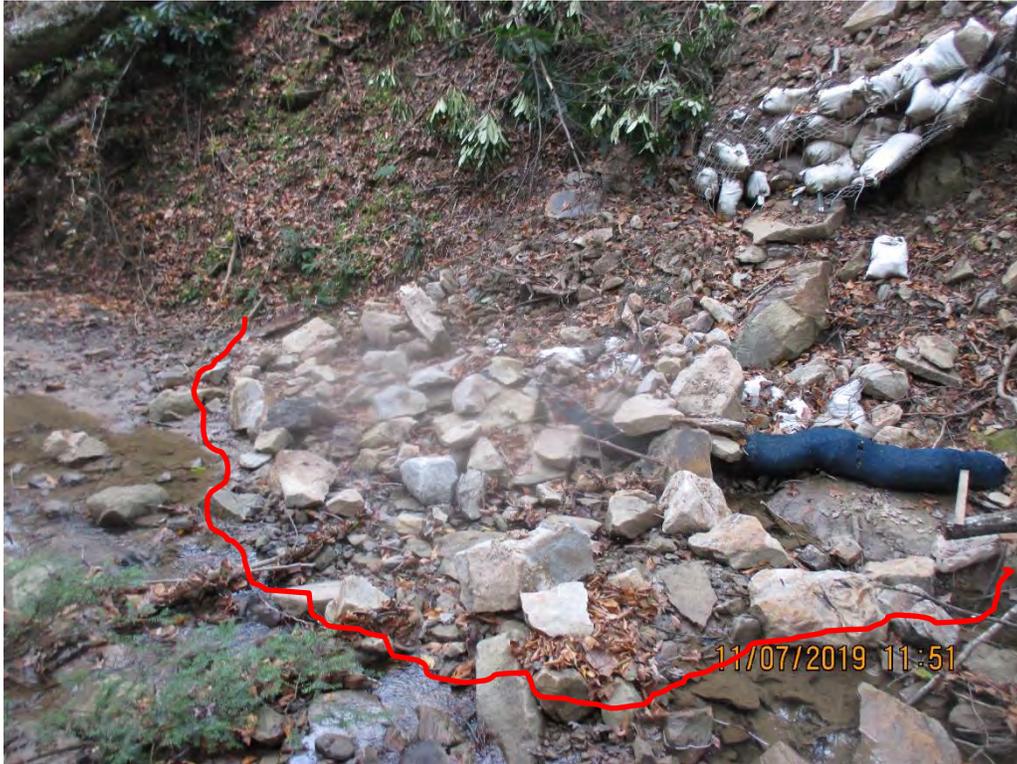
Slip that impacted Elliott Run near Station No. 3946+00 and was not reported to WVDEP spill reporting hotline. Red line indicates extent of impact not including random larger rocks upstream that slipped into stream.

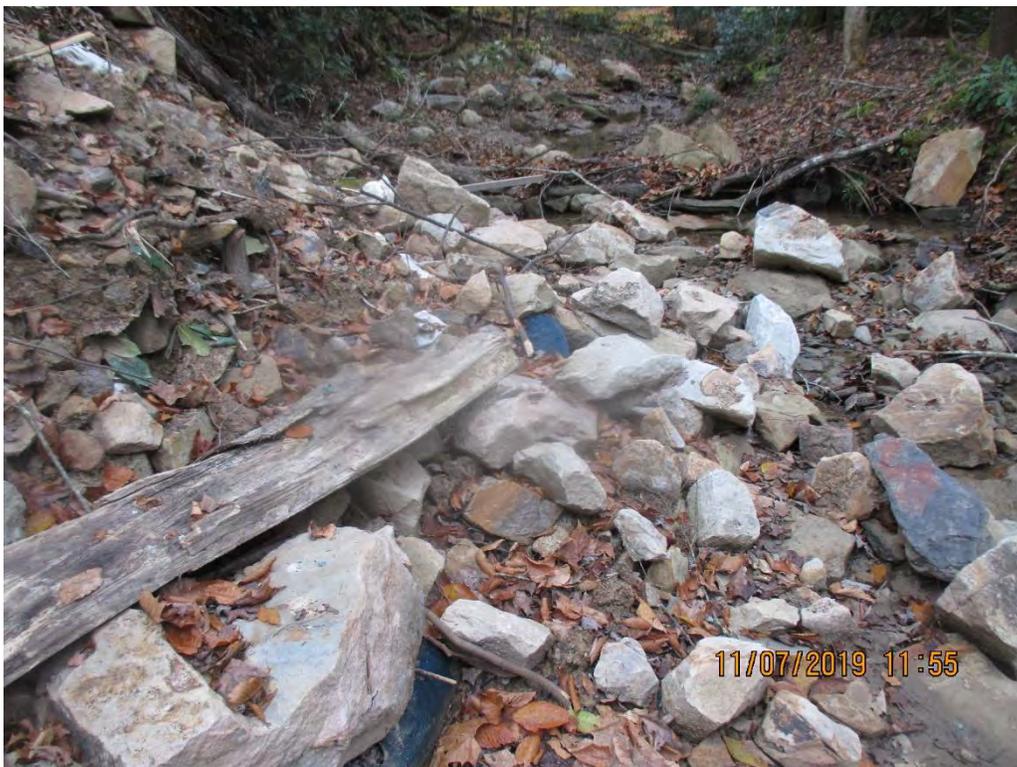
Facing upstream at Elliott Run slip impacts near station No. 3946+00.

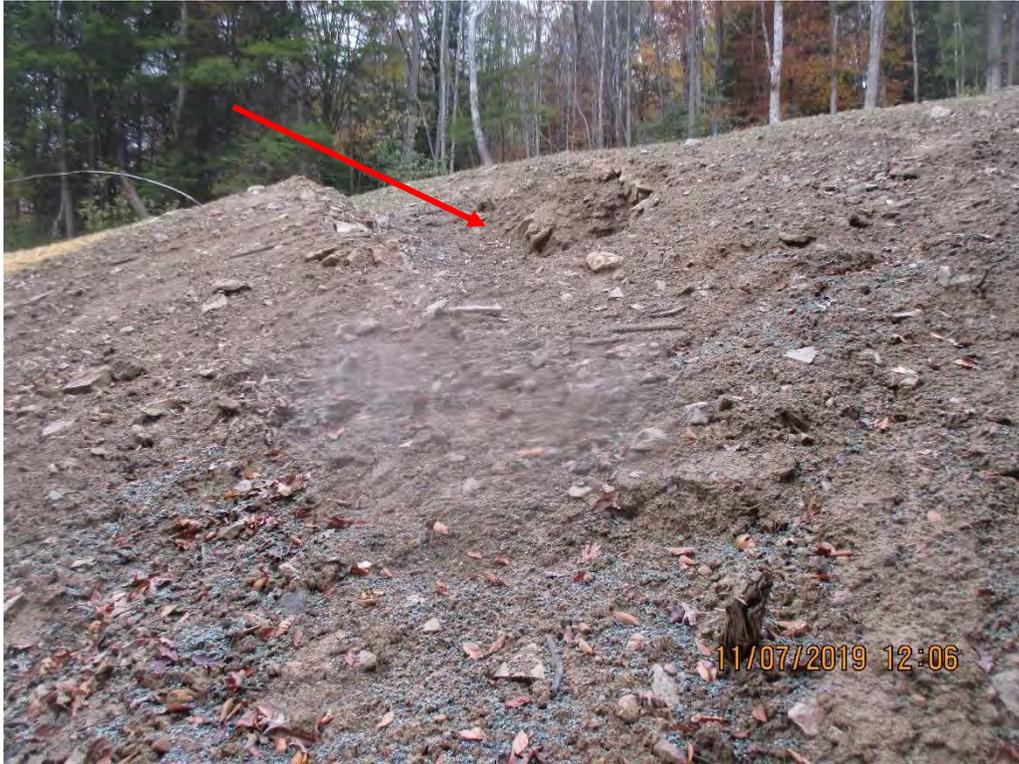
Waterbar terminating onto ROW above slipped section of ROW near Station NO. 3946+00 with no outlet control present. Arrow indicates sump at Waterbar terminus.

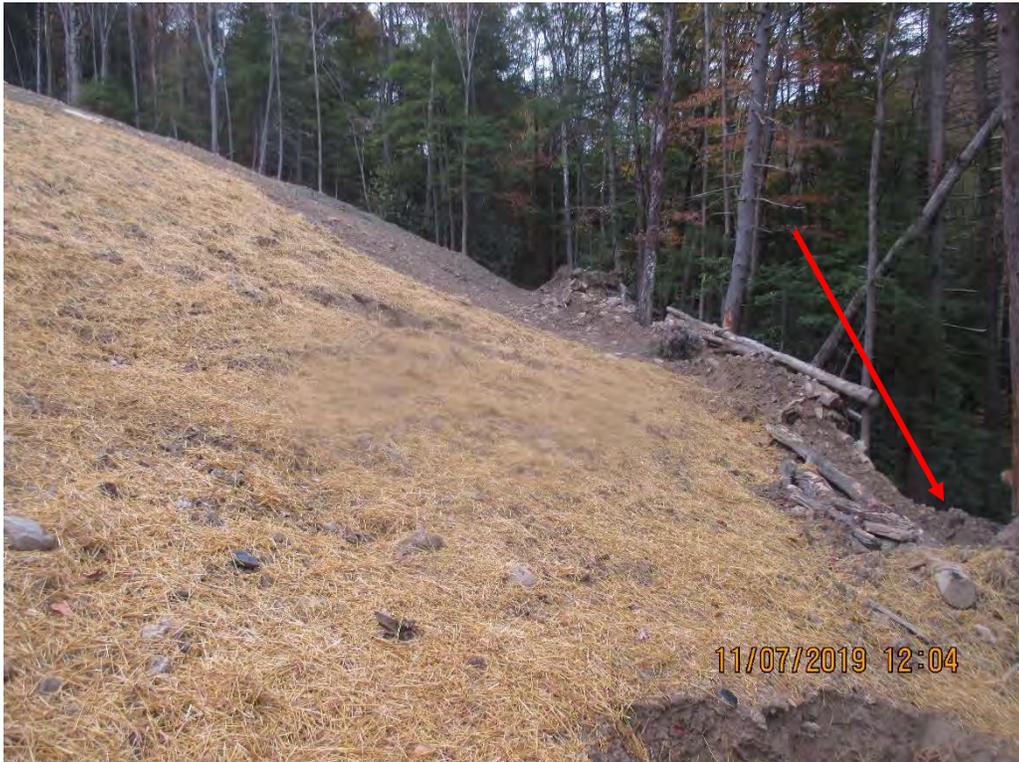
Section of ROW above Elliott Run where slip occurred near station No. 3946+00.

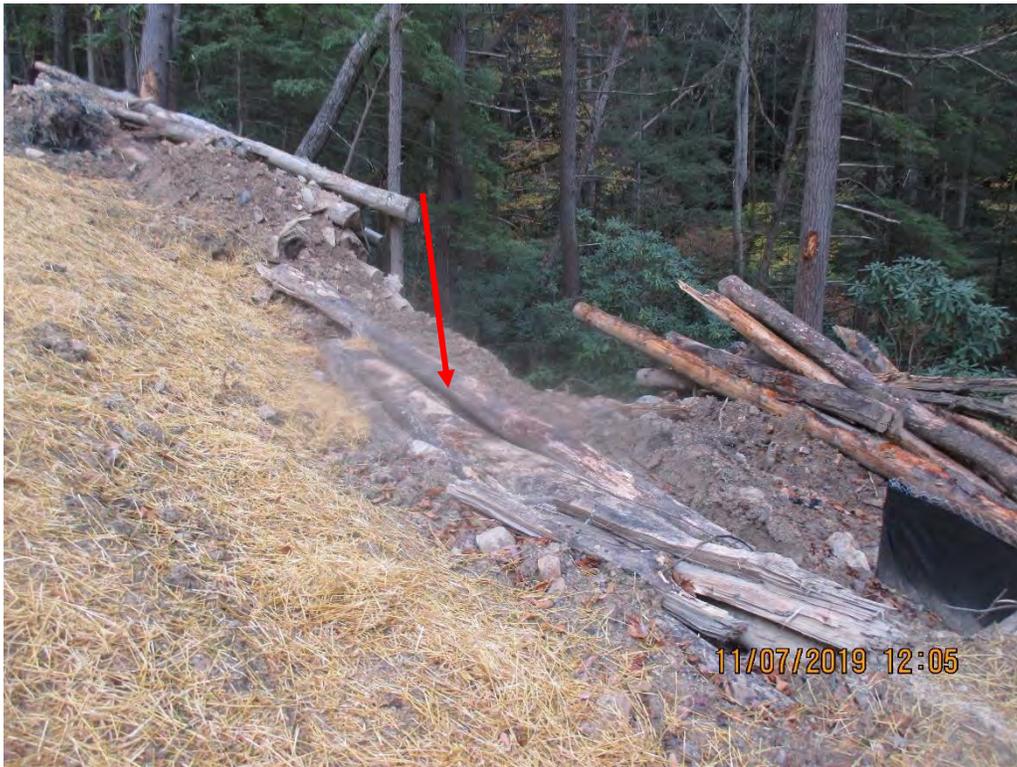
Section of ROW above Elliott Run where slip occurred near station No. 3946+00. Logs being used as controls (red arrow).

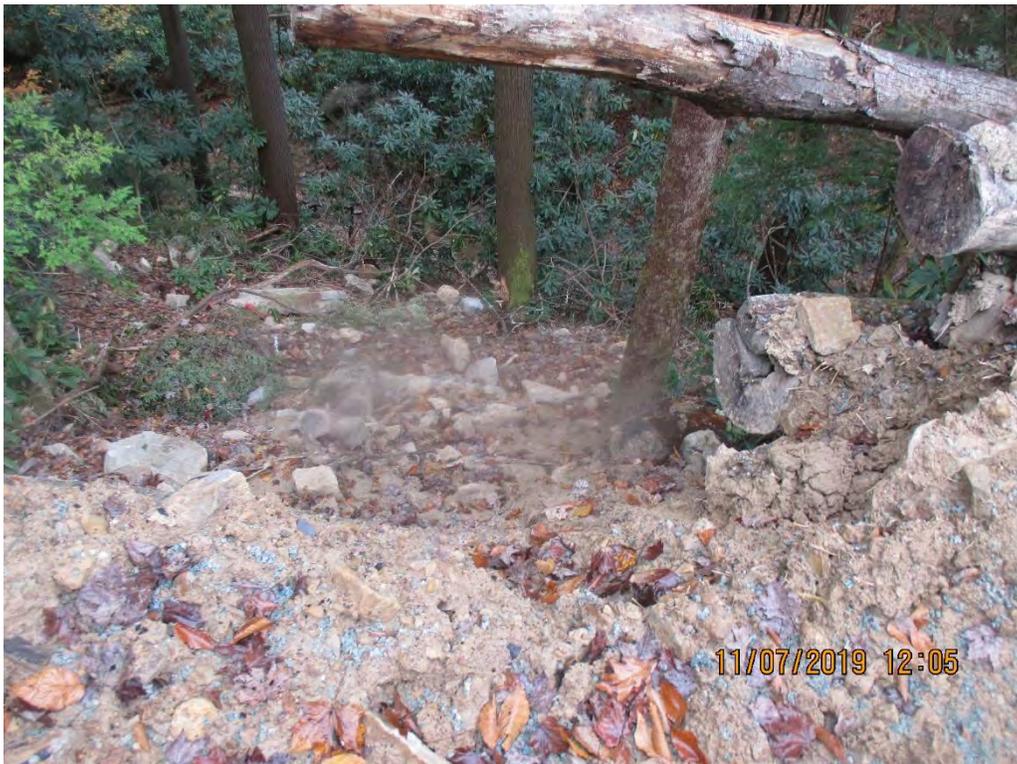
Section of ROW above Elliott Run where material/debris was slipping upstream of larger slip impacting Elliott Run near station No. 3946+00. No perimeter controls were in place at the time of inspection. Large rocks observed in stream above larger slip.

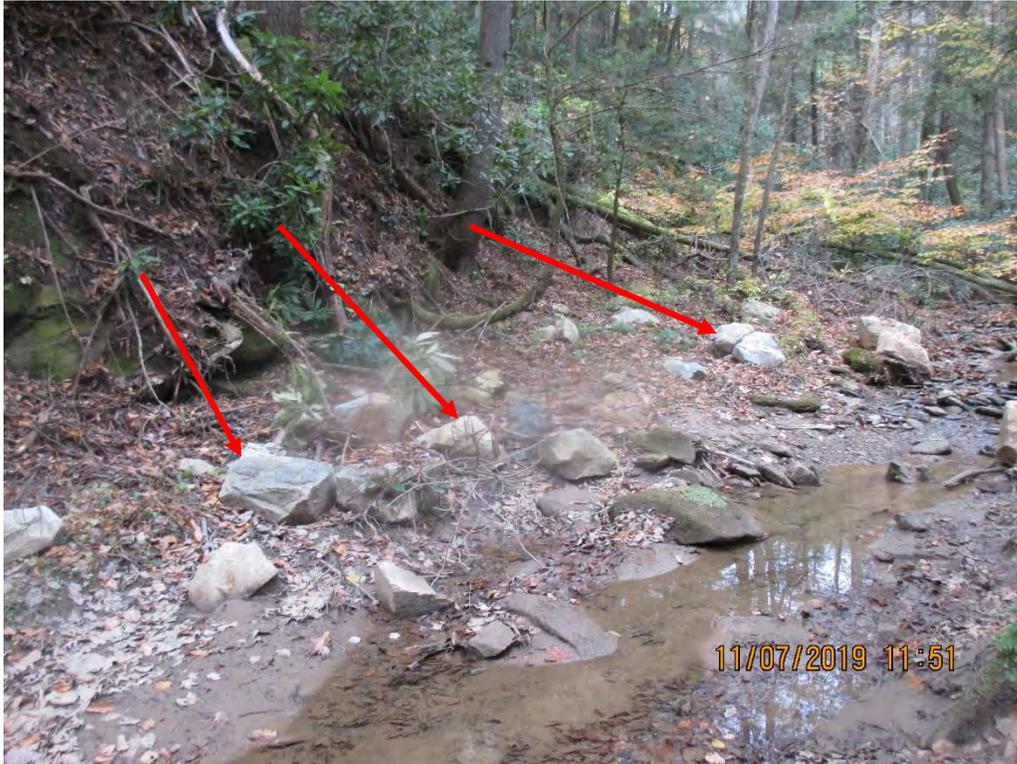
Rocks from ROW present past LOD and in Elliott Run where perimeter controls were not in place upstream from larger impacted section of stream.

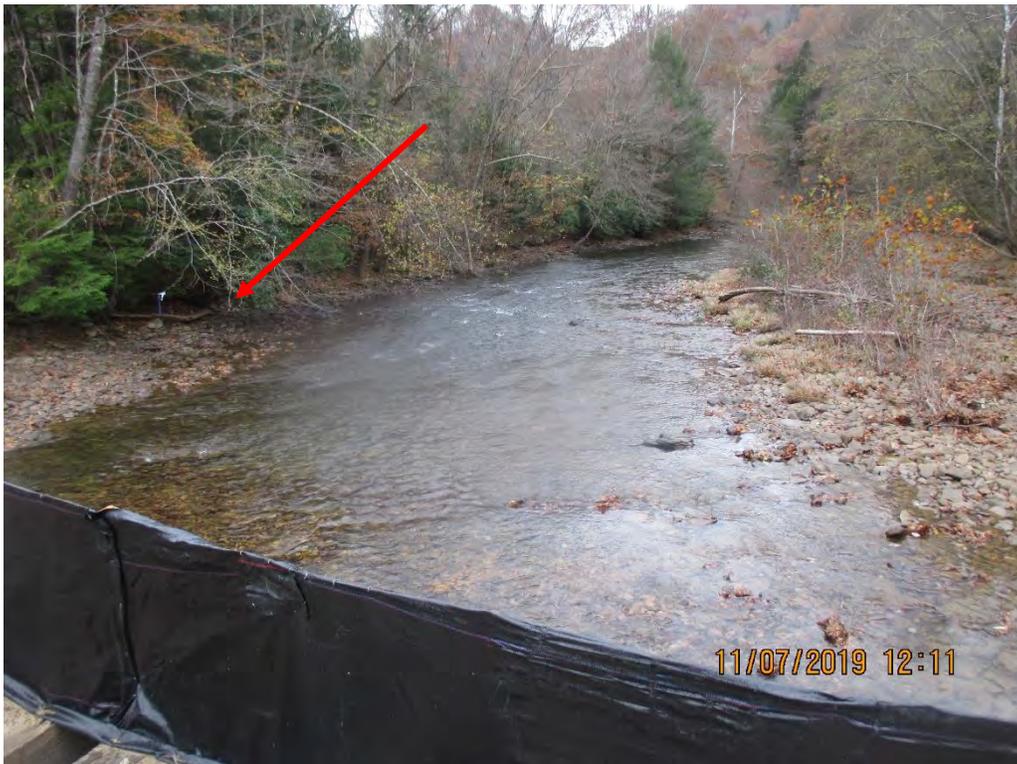
Facing upstream at Little Kanawha River Crossing. Arrow depicts Elliott Run confluence.

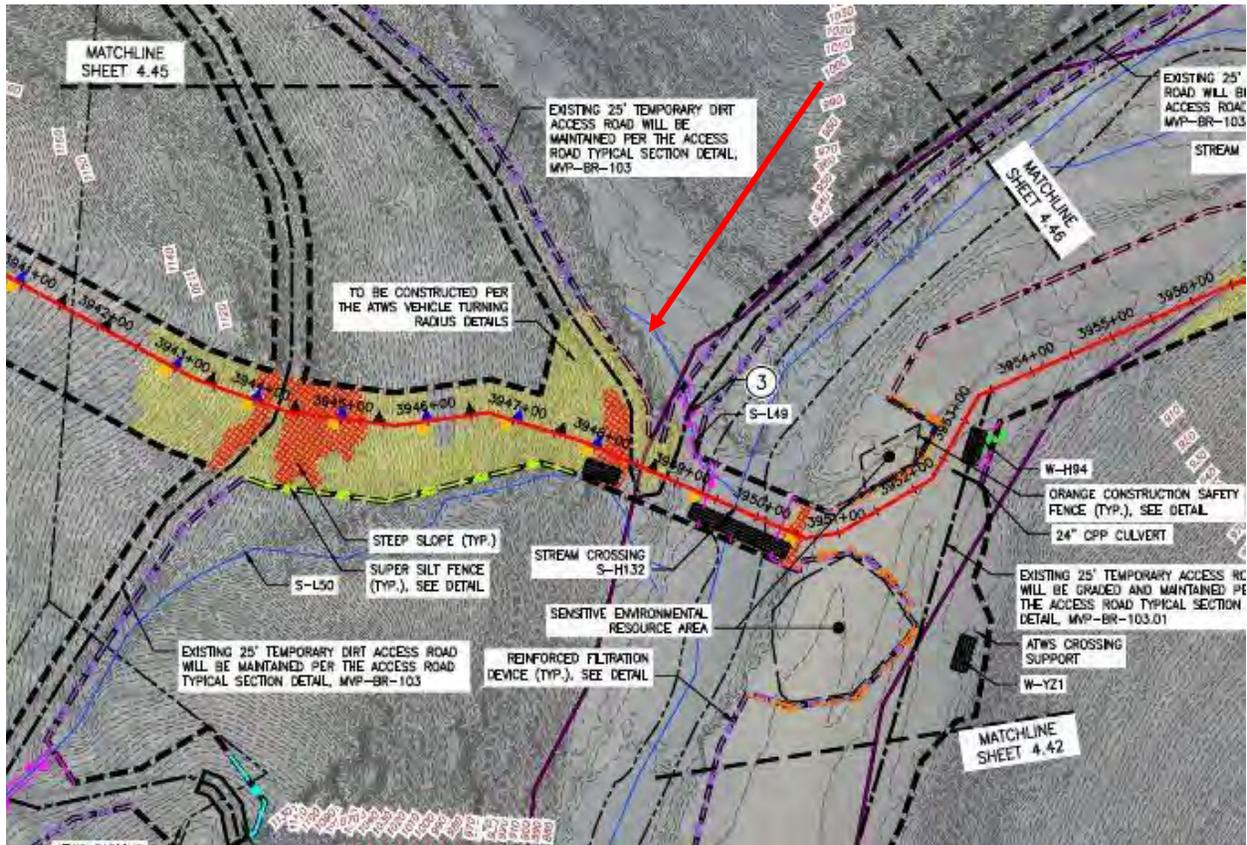
Approximate location of slip that impacted Elliott Run upstream of where AR-MVP-BR-103 crossing with Elliott Run occurs and downstream where AR-MVP-BR-103 leaves MVP ROW upslope of Little Kanawha river crossing.

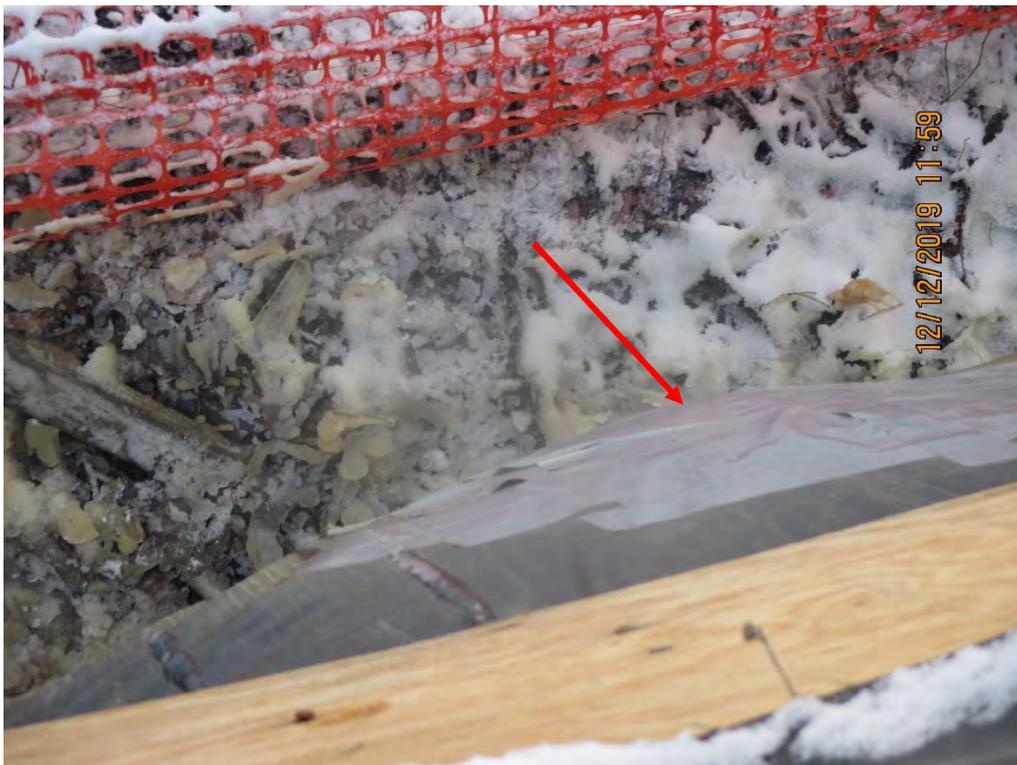
Arrow depicts where duct tape had been used to repair hole in controls.

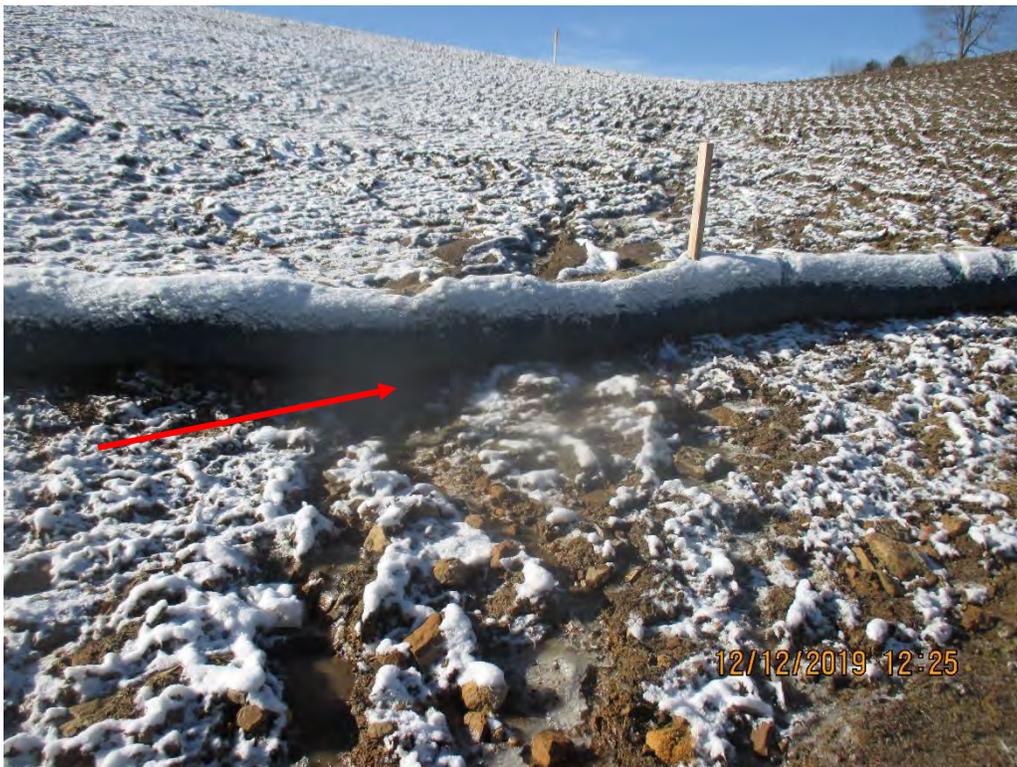
**Section D.1. - Permittee has failed to properly operate and maintain all systems of treatment and controls: At station No. 8433+50 run on from a seep and improper tracking of the slope caused downslope controls to be overwhelmed with SLW/Sediment deposits leading to SLW to be observed past the LOD and controls.**

Section of ROW at Station No. 8433+50 that was not tracked in properly causing enhanced erosion upslope of controls. Arrow depicts where CFS was undermined due to concentrated flows.

**Take measures to correct the aforementioned violations.**

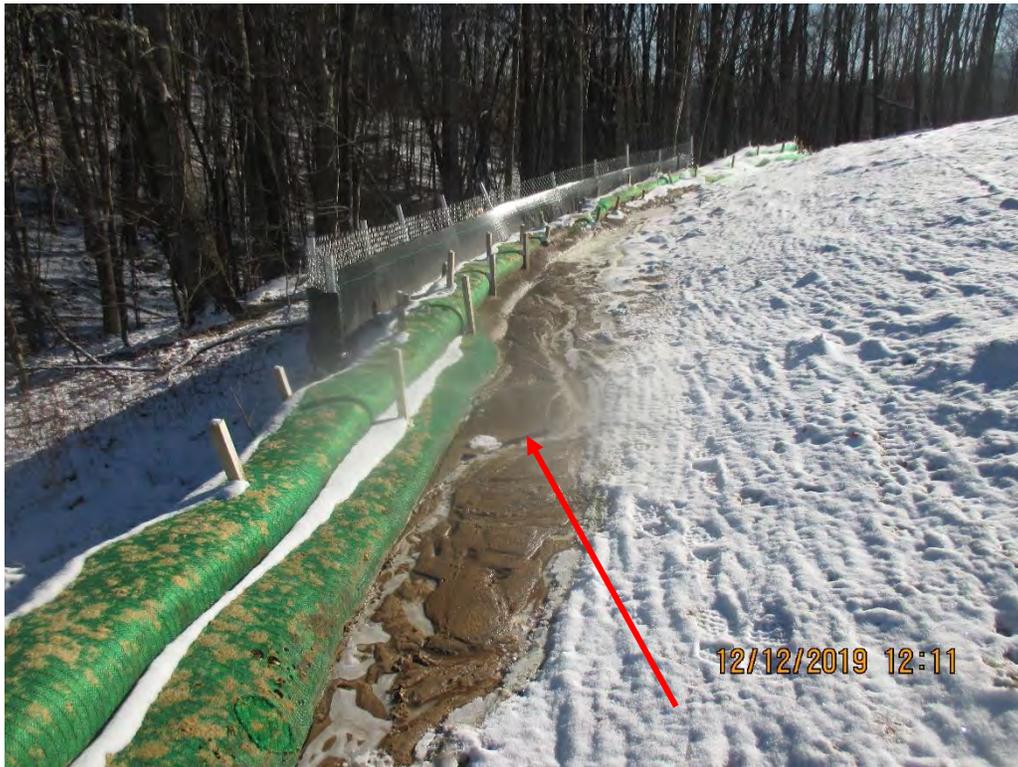
Sediment deposits present behind controls due to upslope erosion at station No. 8433+50.

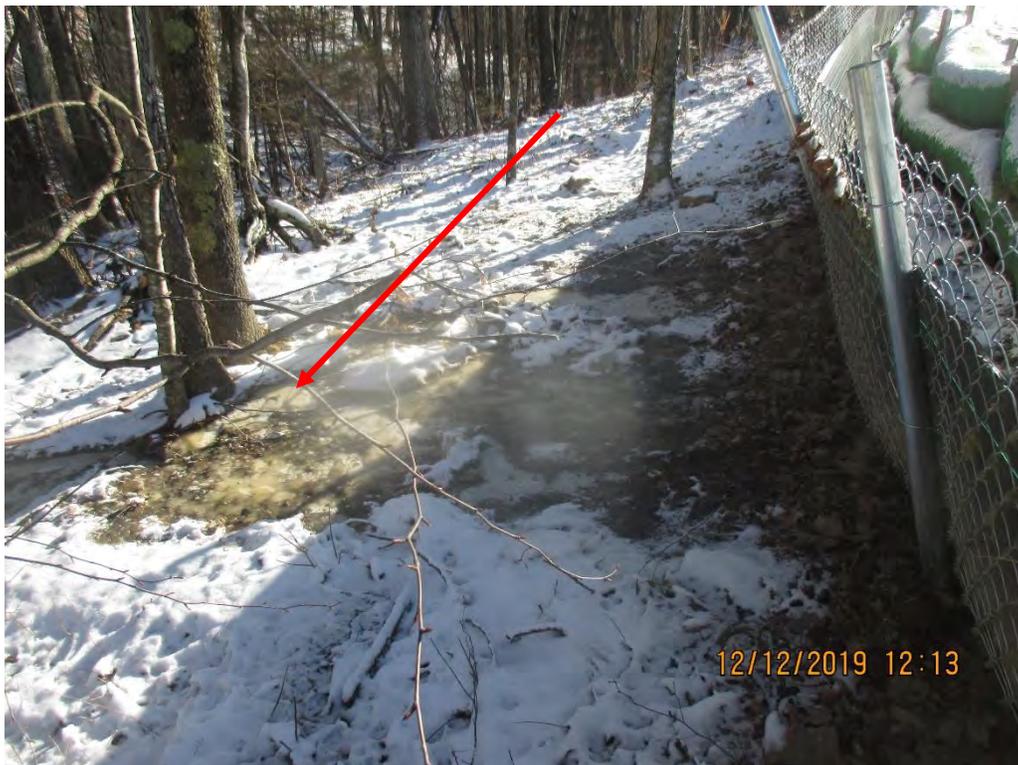
SLW present past controls at the time of inspection at station No. 8433+00

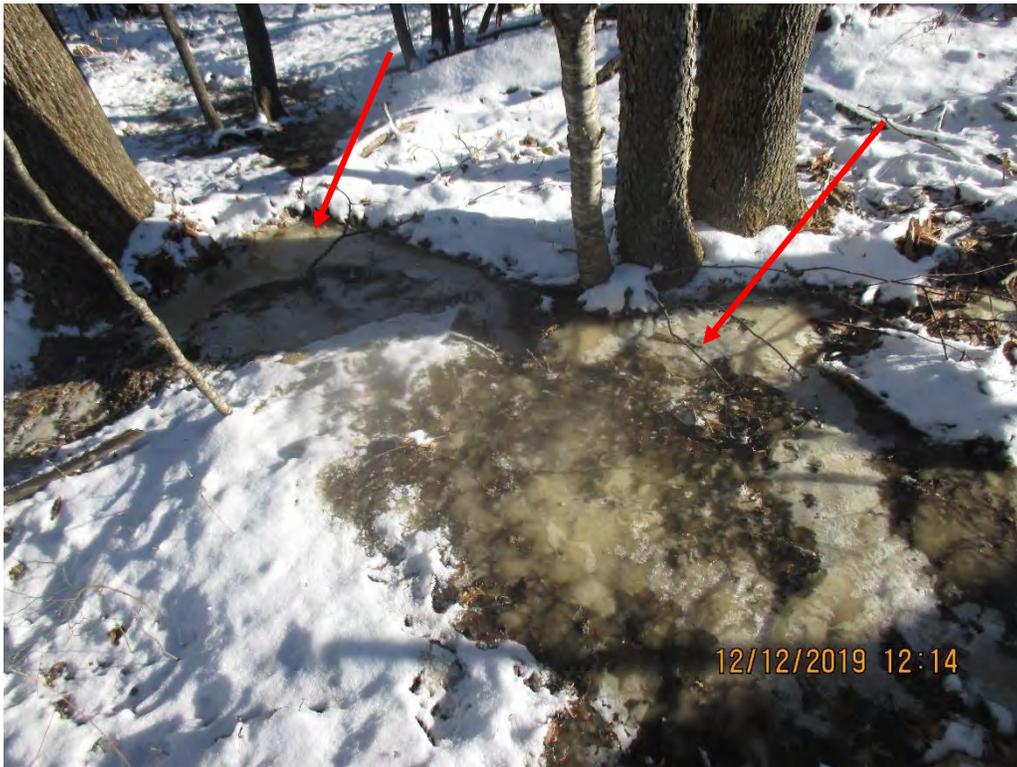
SLW present past controls at station No. 8433+50.

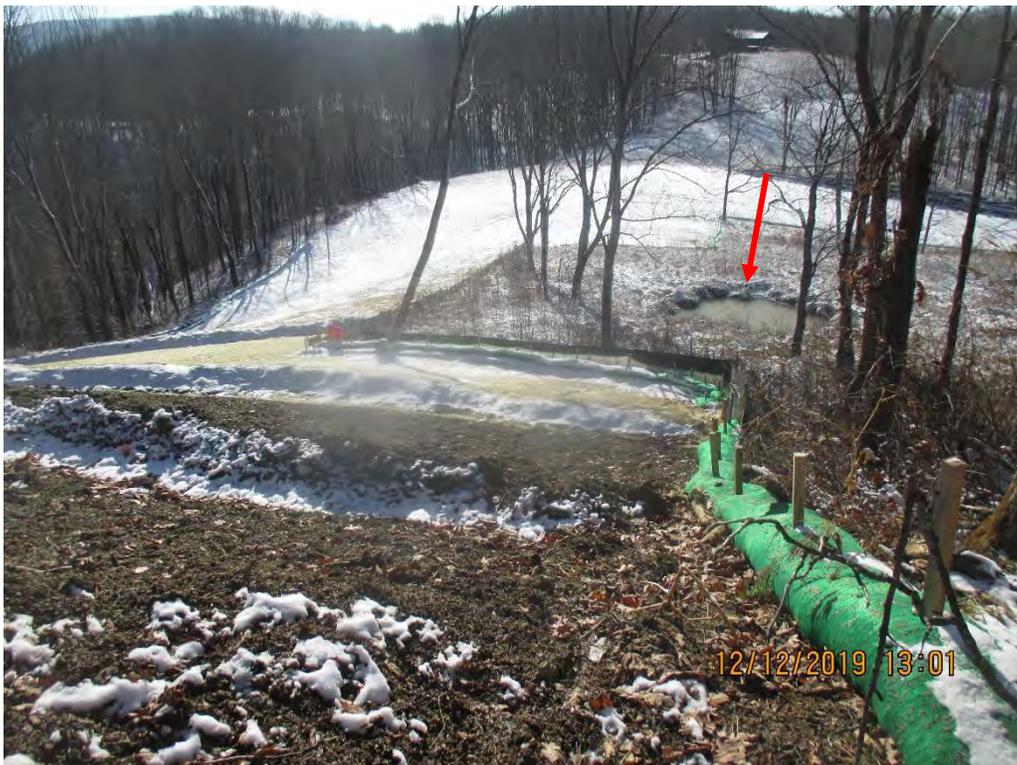
Facing downslope at station No. 8390+00 towards pond. No impacts to pond were observed on the day of inspection.

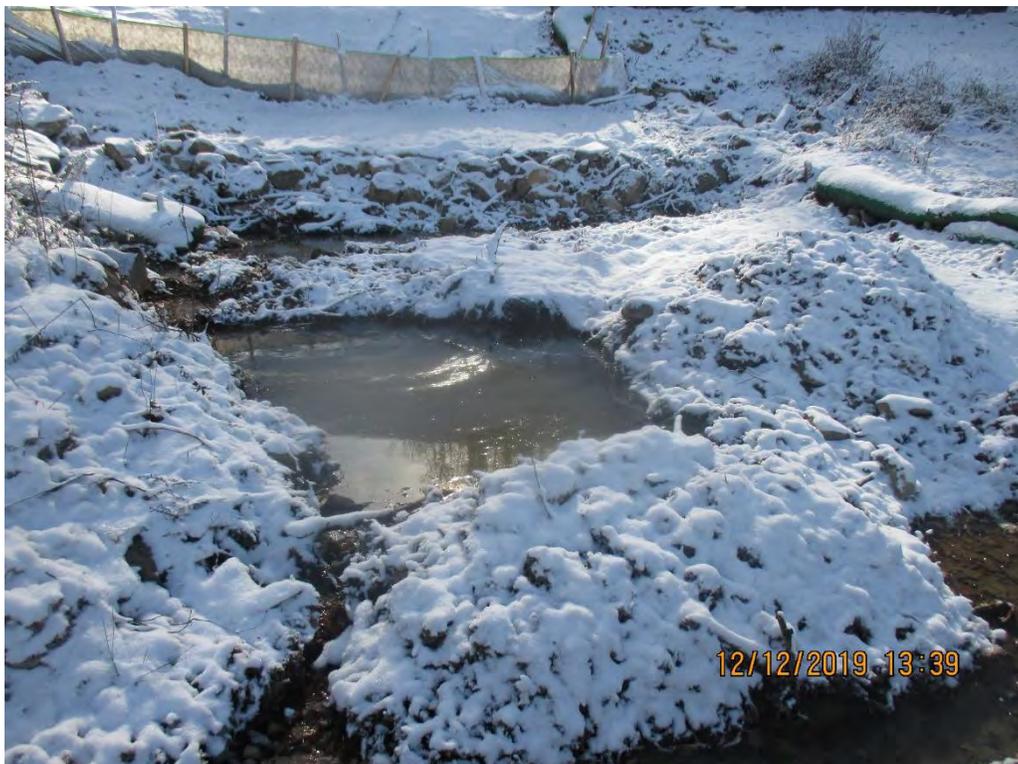
Photo of excavated section of ROW at station No. 8489+65. Impacts were not observed to Stream S-J13 downslope excavation.

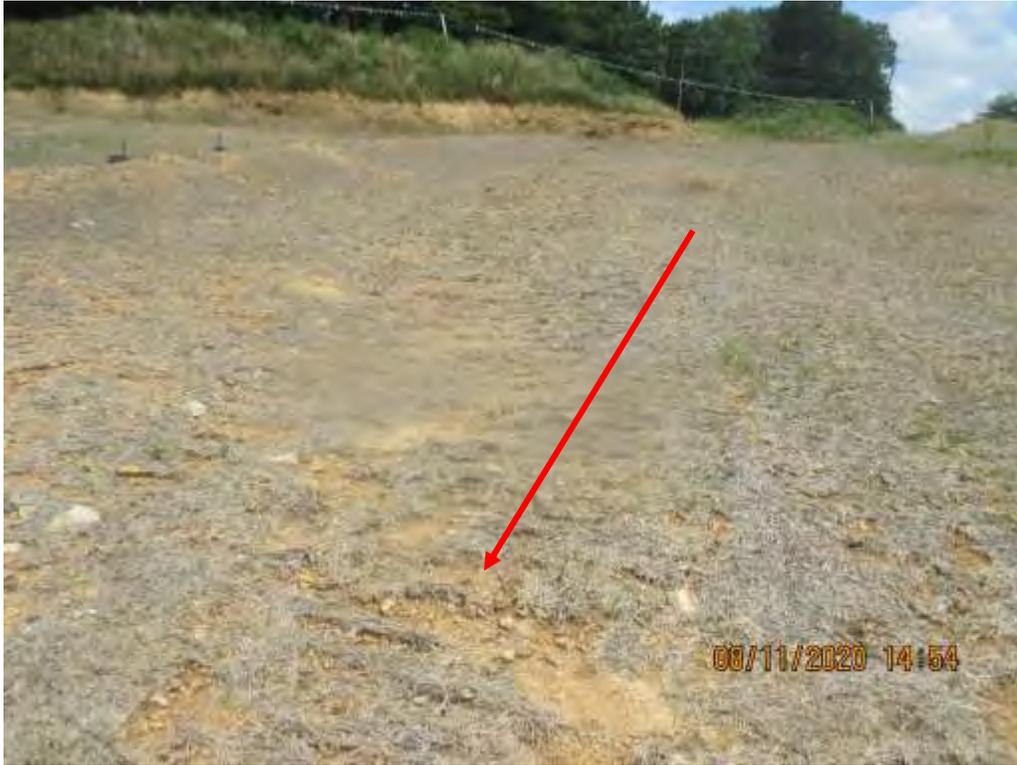
Facing East at the Route 39 crossing. Red Arrow depicts where sheet flow was starting to form erosion rills in an area that had less than 70 percent vegetative coverage.

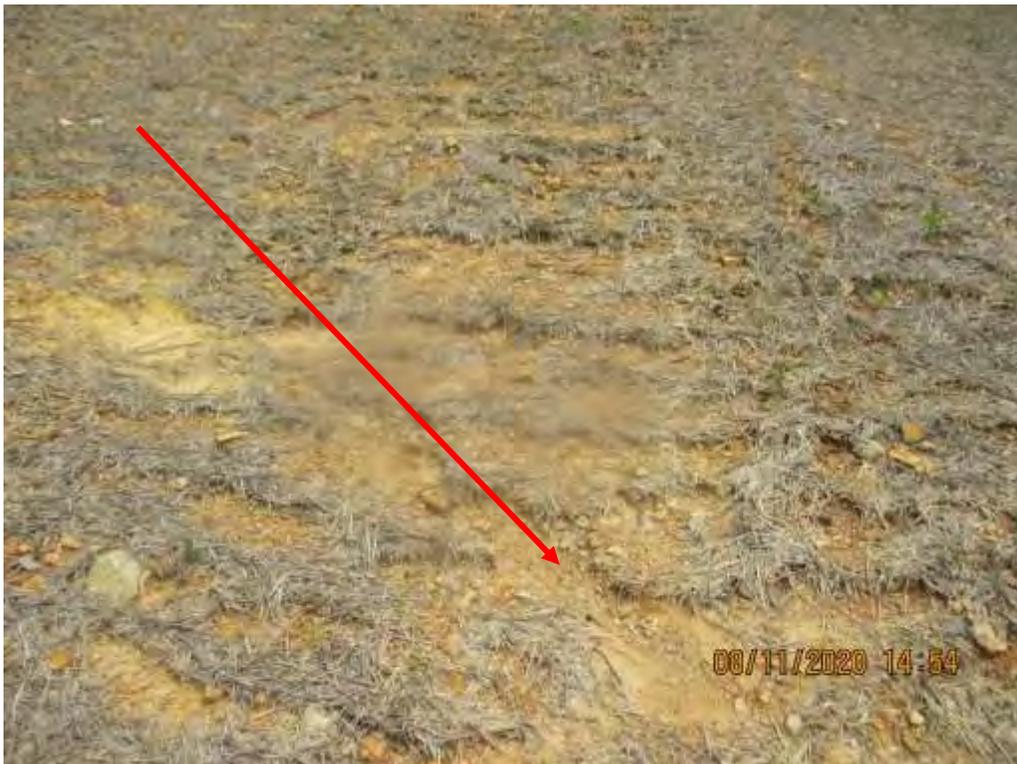
Facing East at the Route 39 crossing. Red Arrow depicts where sheet flow was starting to form erosion rills in an area that had less than 70 percent vegetative coverage.

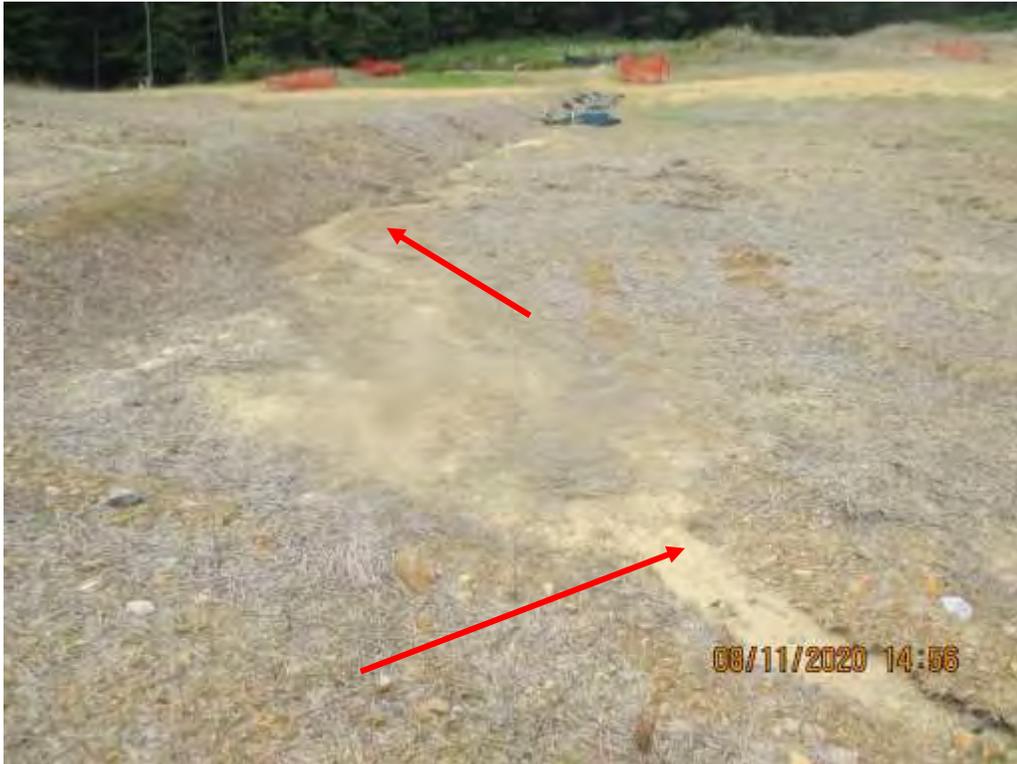
Facing Southwest at the Route 39 crossing. Red Arrow depicts where concentrated flow of runoff was forming erosion rills on slope and in water bar. Less than 70 percent vegetative cover present.

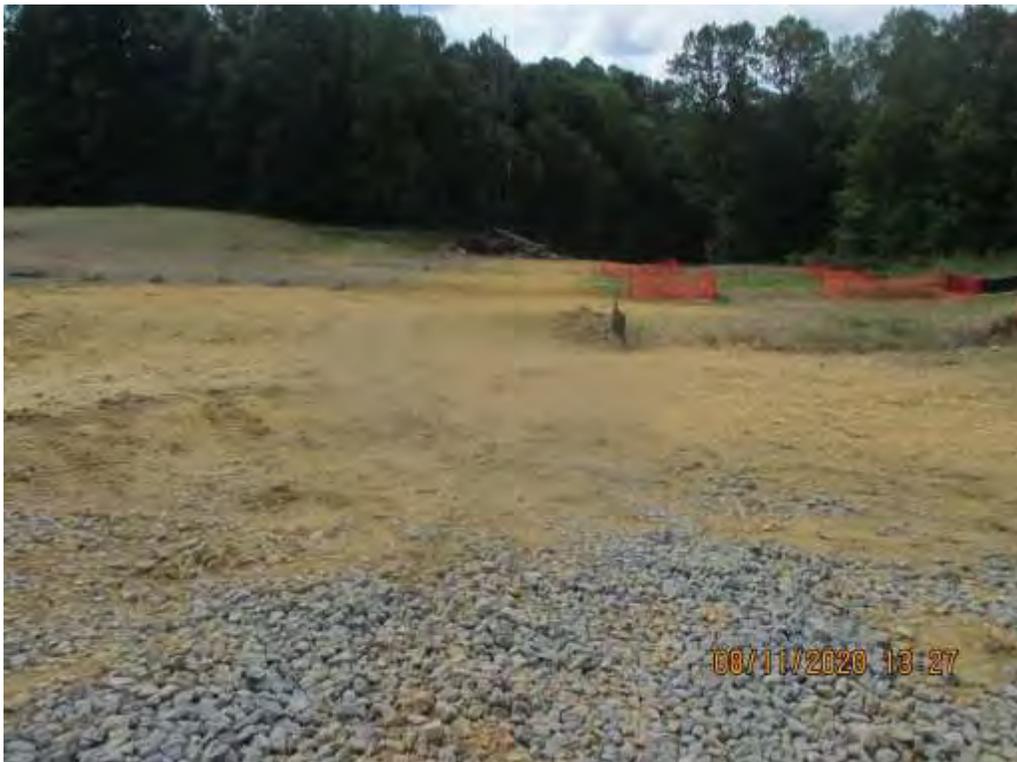
Facing South from Route 39 construction entrance. Recent red line modification work recently took place and travel lane was reseeded.

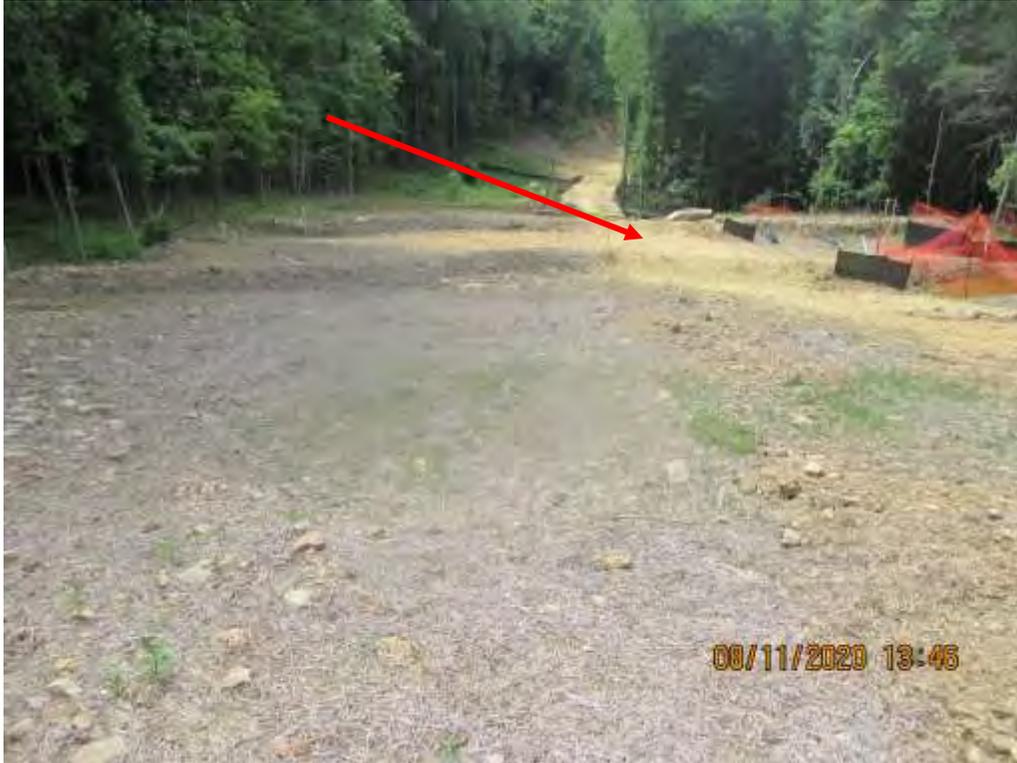
Facing South above Stream S-N10. Red arrow depicts where travel lane was reseeded. To the right and left of the travel lane vegetative cover was less than 70 percent.

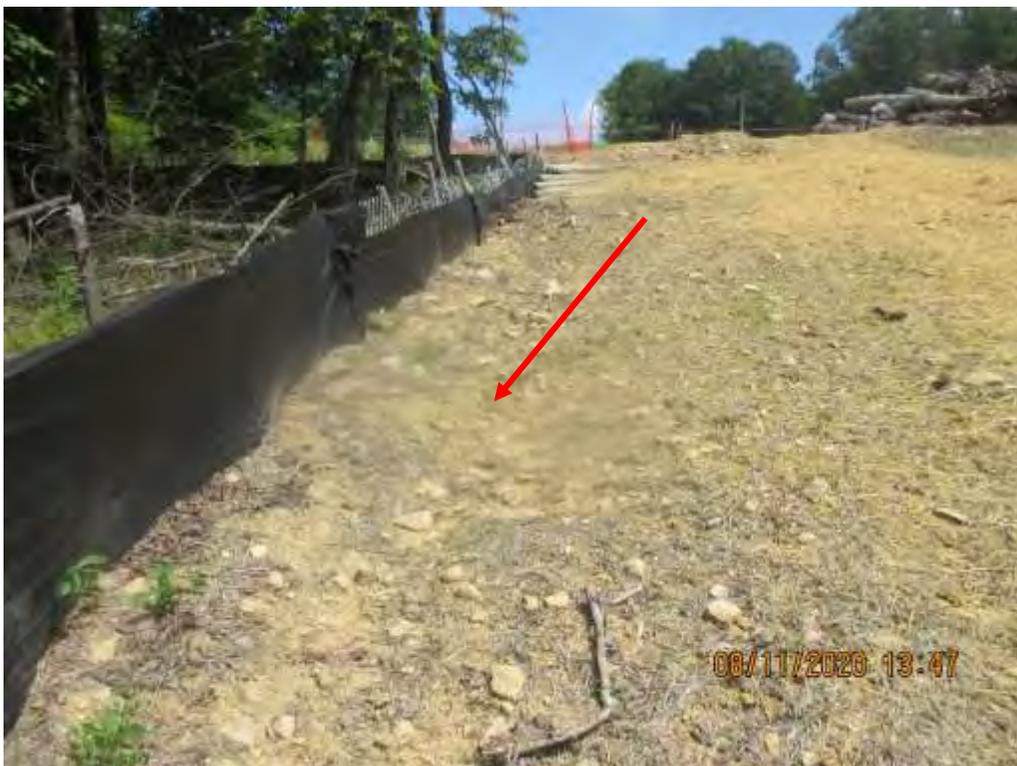
Facing North above Stream S-N10. Perimeter controls recently replaced. However, erosion present along controls lacking j-hooks.

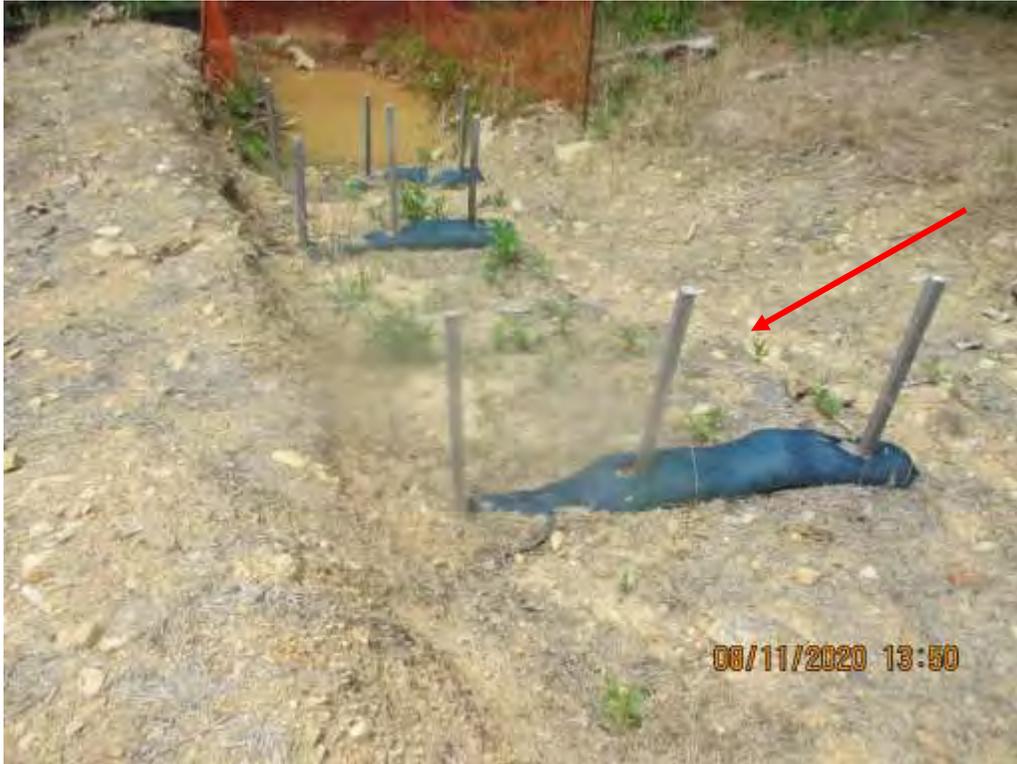
Controls in waterbar on fill slope needing maintenance. Run off causing erosion within waterbar and flowing around controls (red arrow).

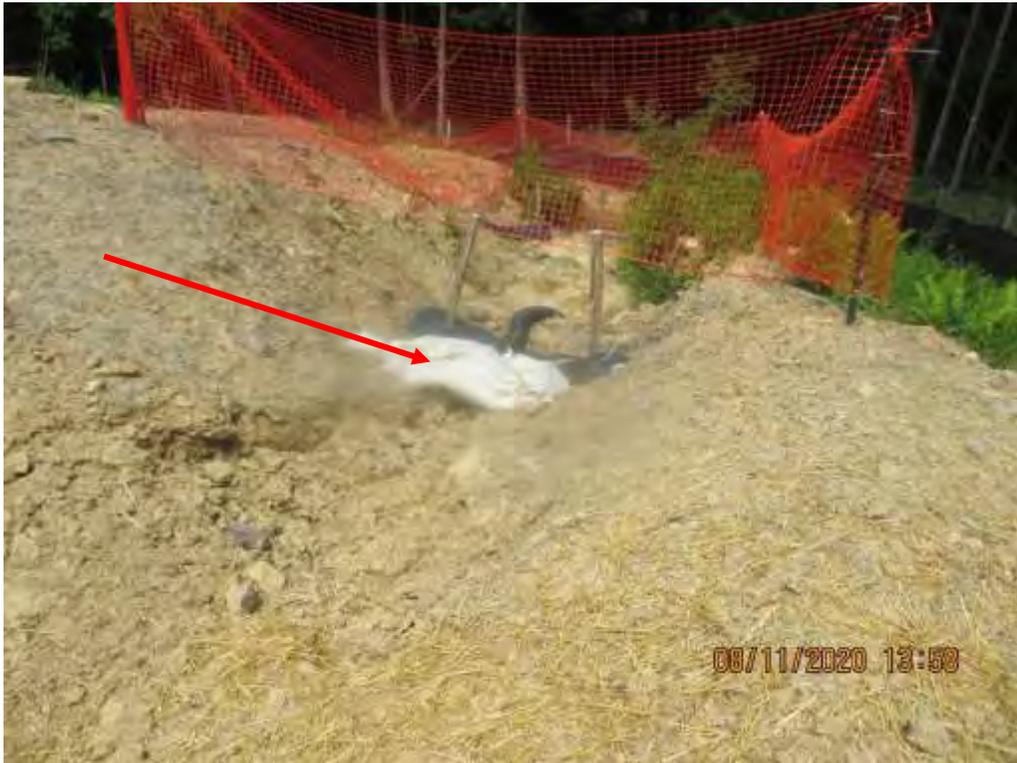
Waterbar outlet terminating onto fill slope. Red arrow depicts recently installed slope drain at top of slope. No sump present at top of slope.

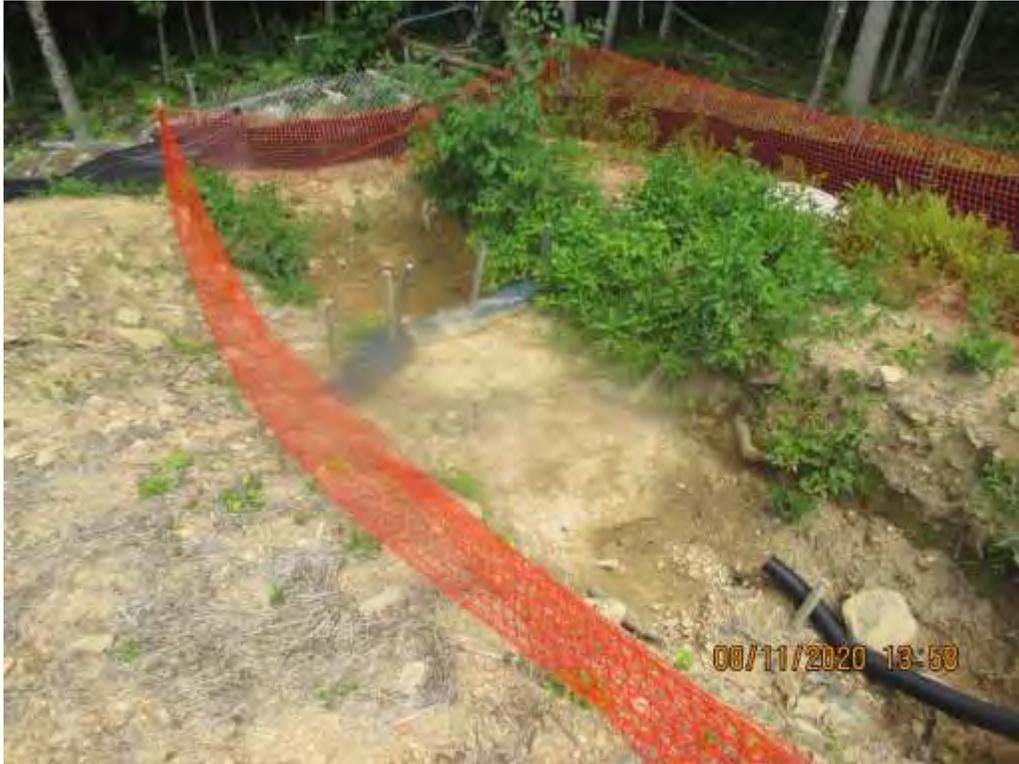
Fill slope below slope drain outlet near station no. 6485+50.

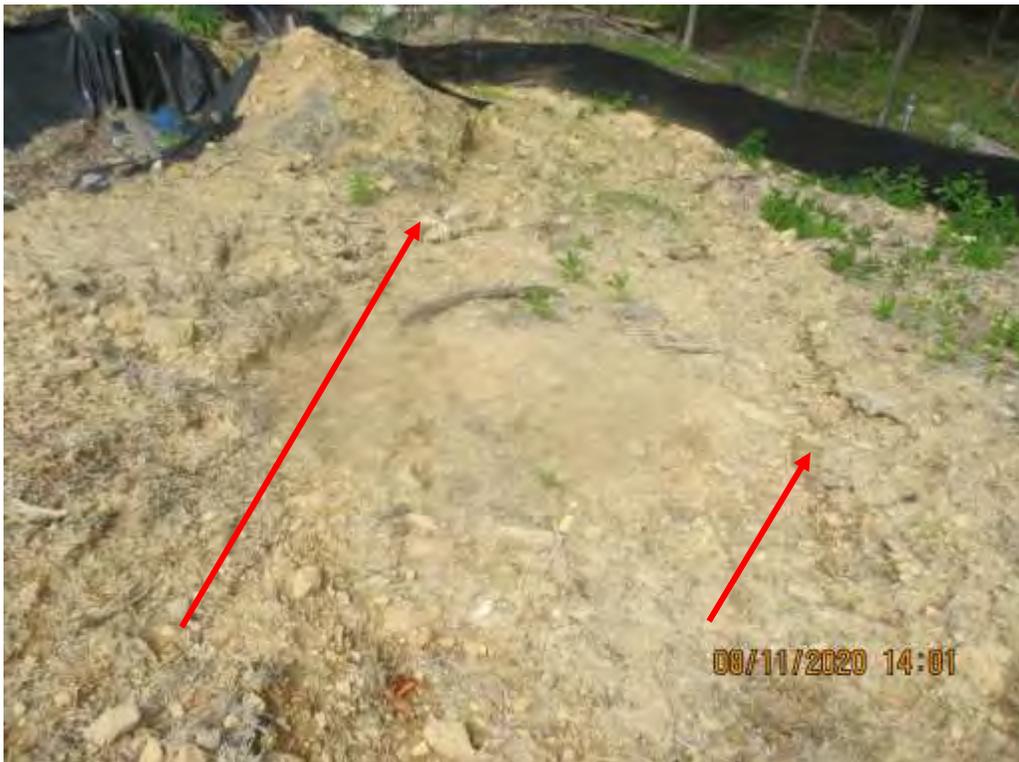
Erosion on fill slope near station No. 6485+50. Lack of 70 percent vegetative cover present and slope not reseeded.

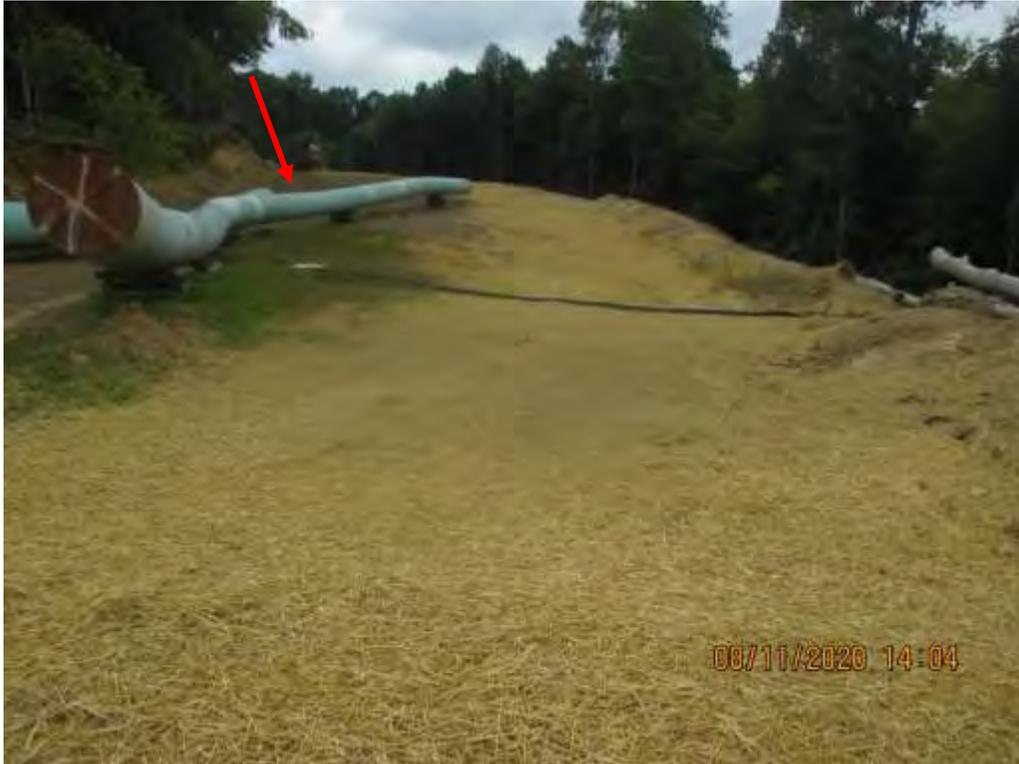
Section of ROW where slope drains were recently installed, and travel lane reseeded. Red arrow shows where ROW was reseeded.
