**The Wilderness Society et al. Comments on the  
U.S. Forest Service Mountain Valley Pipeline and  
Equitrans Expansion Project Draft Supplemental  
Environmental Impact Statement (#50036)**

**EXHIBIT 1**

Assessment of erosion, sedimentation, and water quality impacts of the Mountain Valley Pipeline and Equitrans Expansion Project's proposed crossing of the Jefferson National Forest as it pertains to the U.S. Forest Service's Draft Supplemental Environmental Impact Statement dated December 2022

Prepared by Jonathan A. Czuba, Ph.D., Licensed Professional Engineer

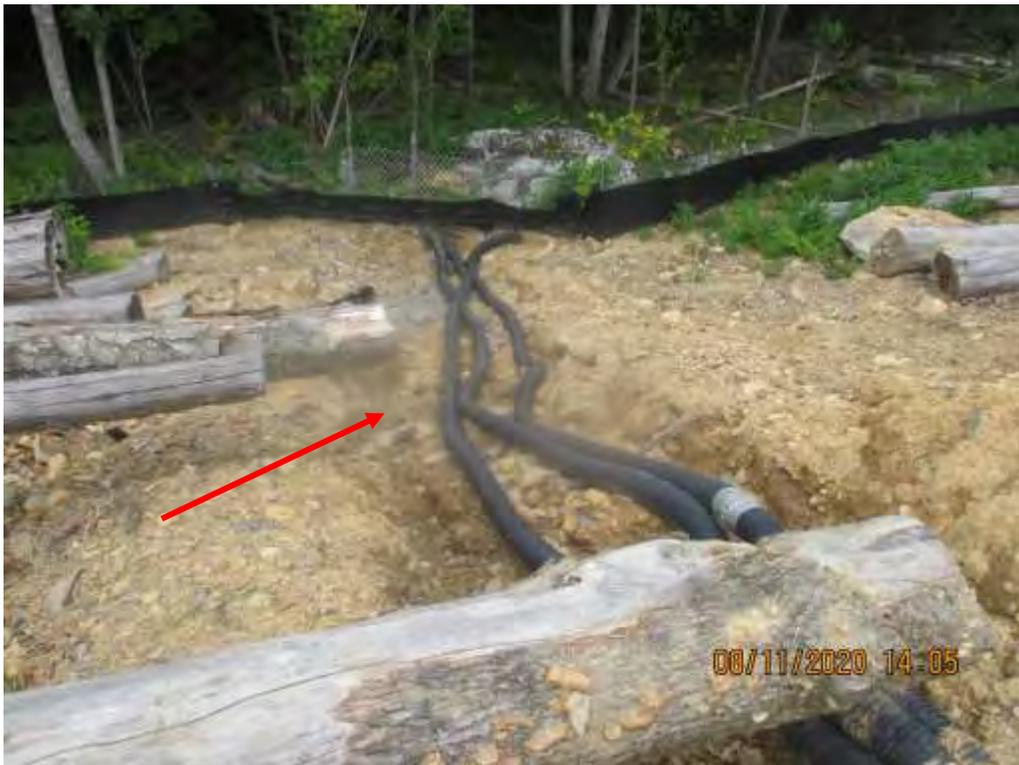
Slope below slope drain install. Erosion present (red arrow) where slope drains were installed and next to log pile.

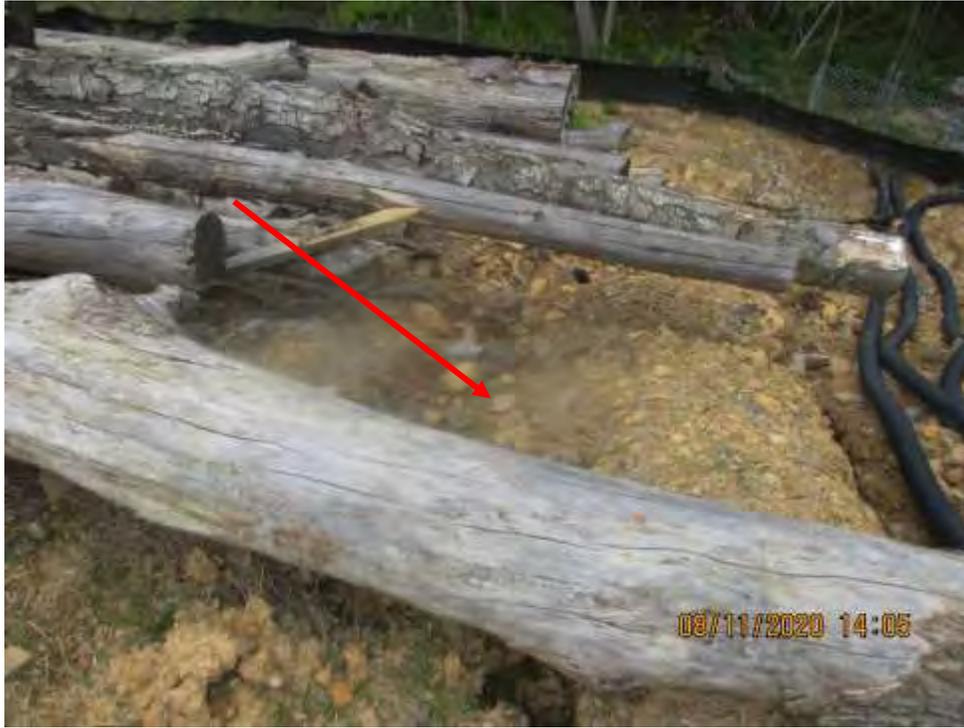
Erosion present (red arrow) next to log pile and slope drains that were recently installed near station no. 6485+50.

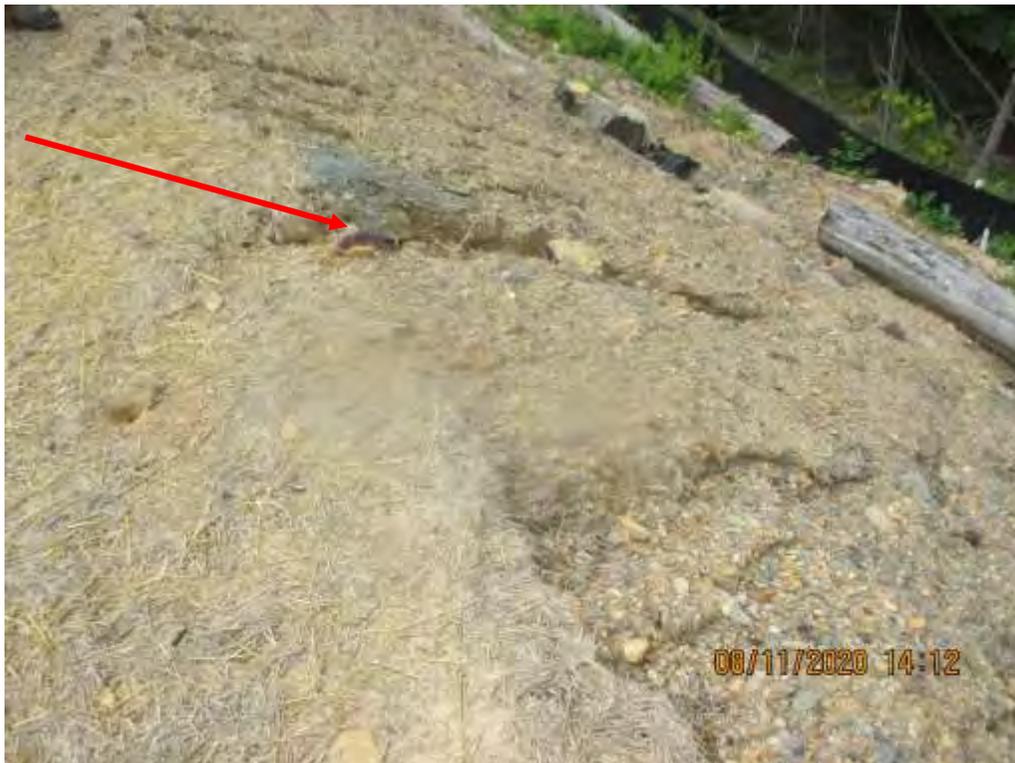
Fill Slope erosion present on slope above log piles near station No. 6485+50.

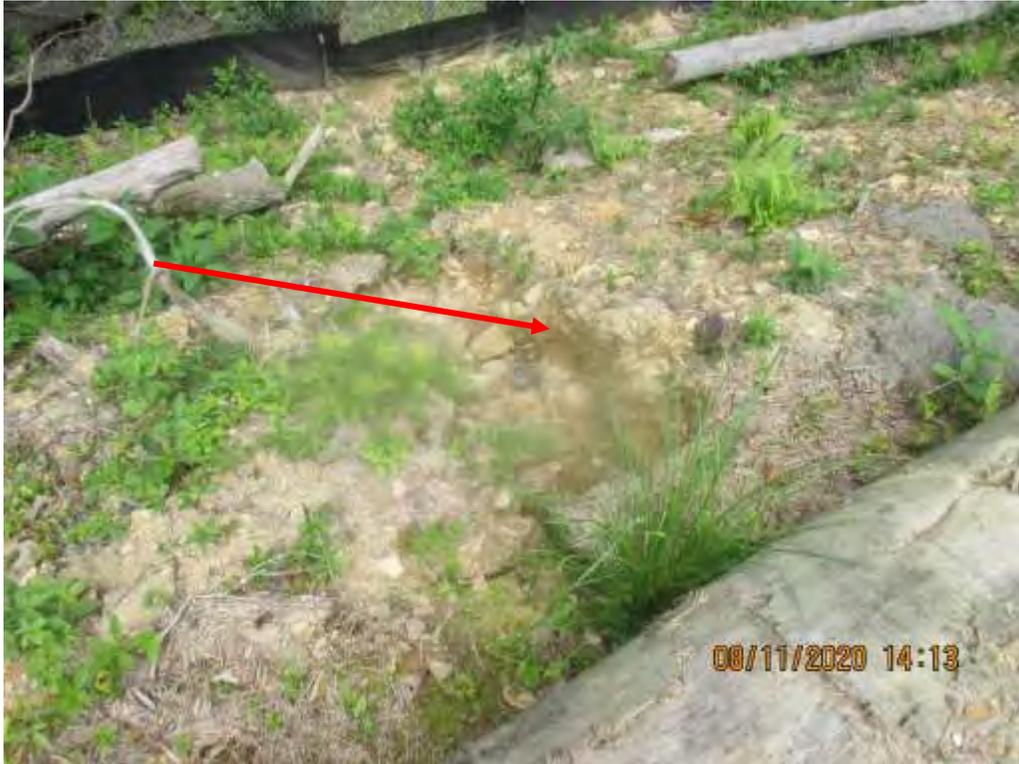
Erosion on fill slope below log pile (red arrow) near station no. 6485+50.

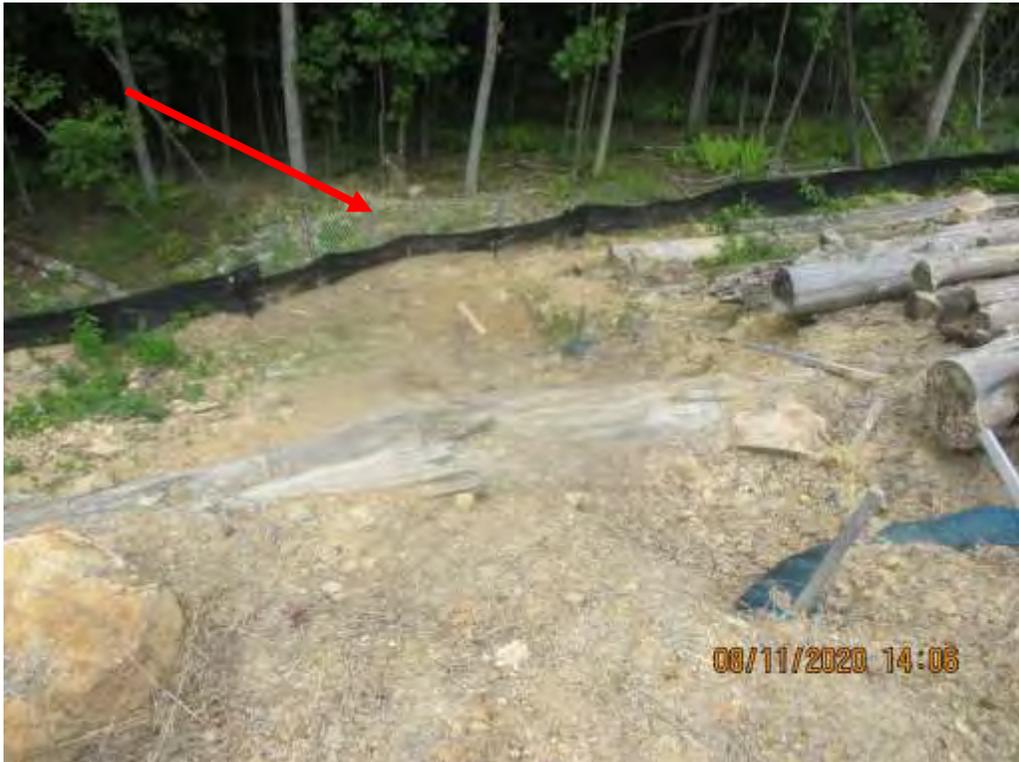
Erosion on fill slope adjacent to log pile near station no. 6485+50. Sediment deposits past LOD (red arrow).

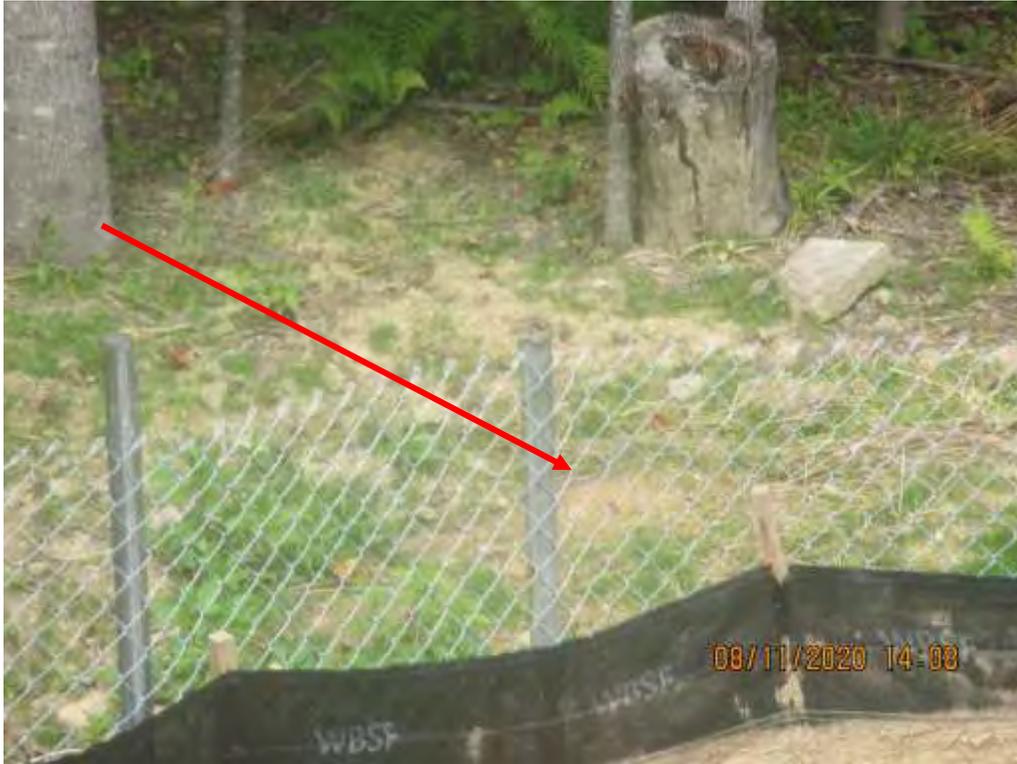
Near station no. 6485+50. Sediment deposits past LOD (red arrow).

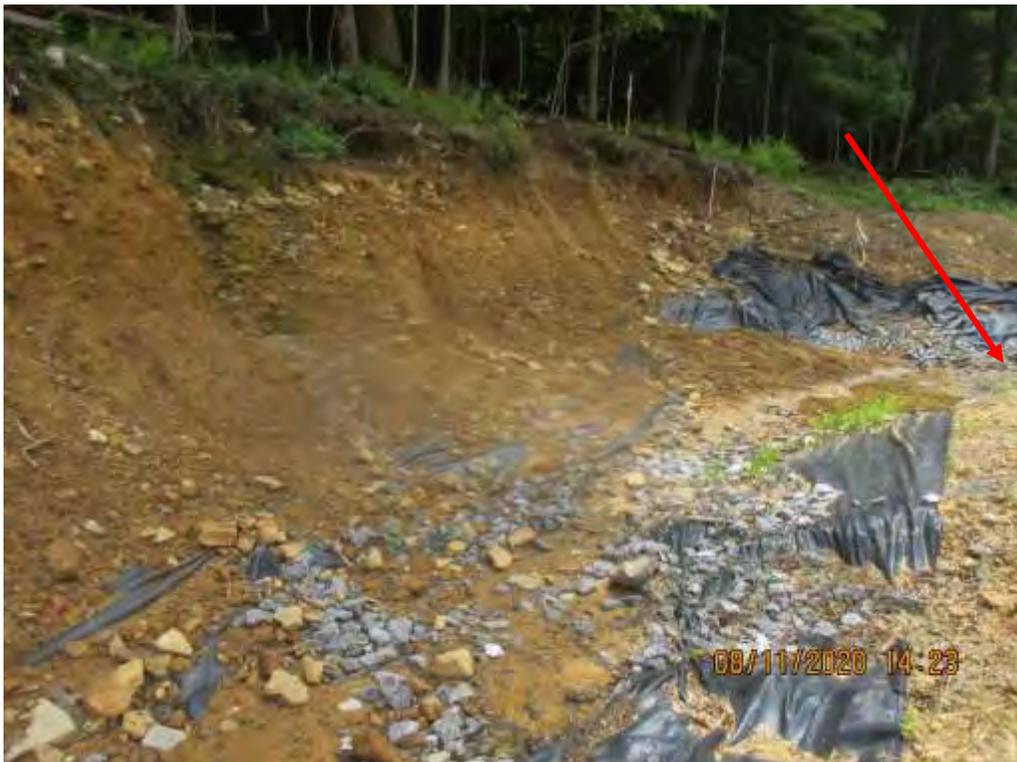
Facing cut slope at station No. 6490+00 where controls were installed to capture run-on and covey under travel lane towards perimeter controls. Red arrow depicts where slope drain was installed.

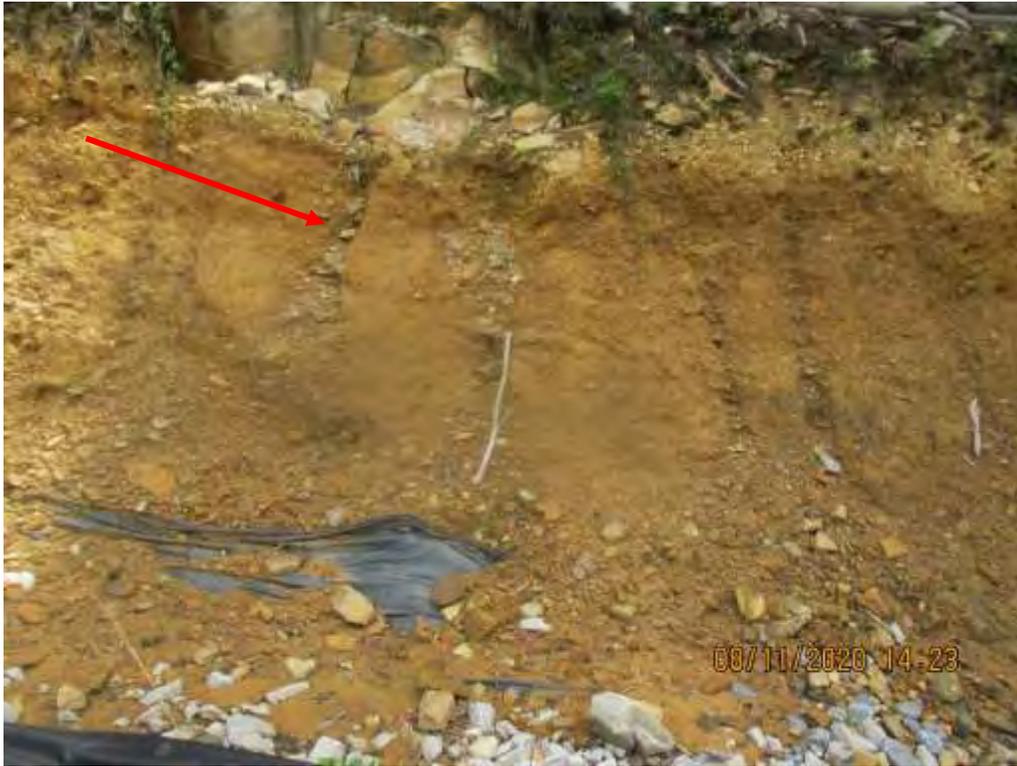
Erosion present on cut slope above slope drain inlet at station no. 6490+00.

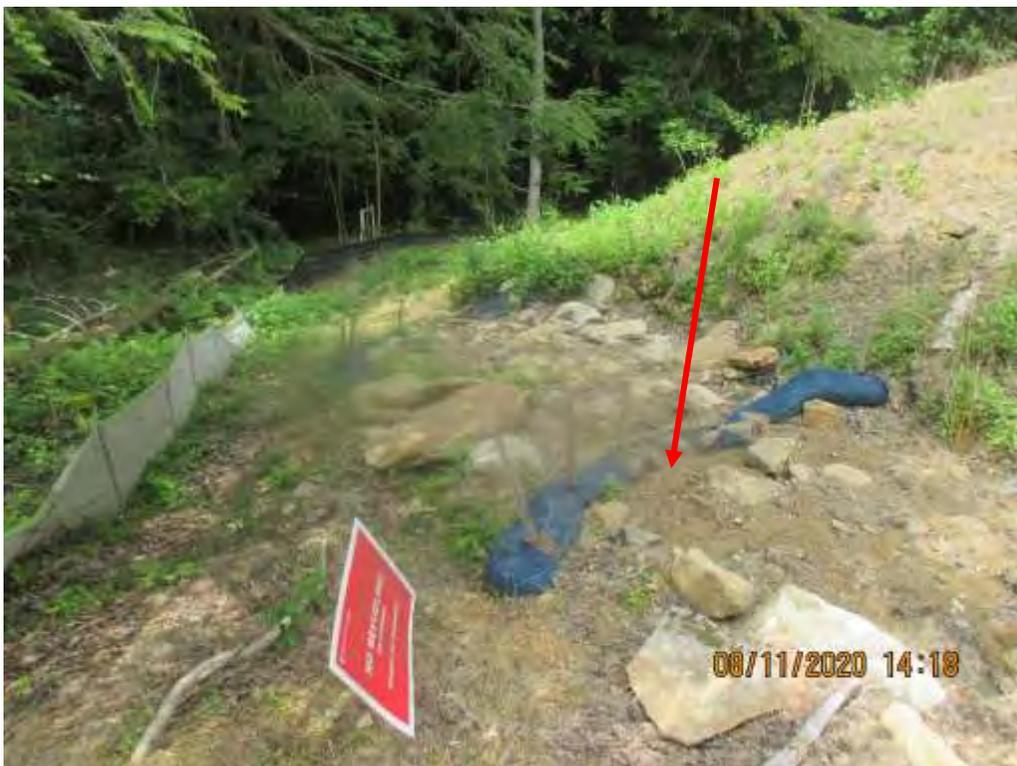
Downslope of slope drain outlet at station no. 6490+00. Sediment deposits observed behind controls.

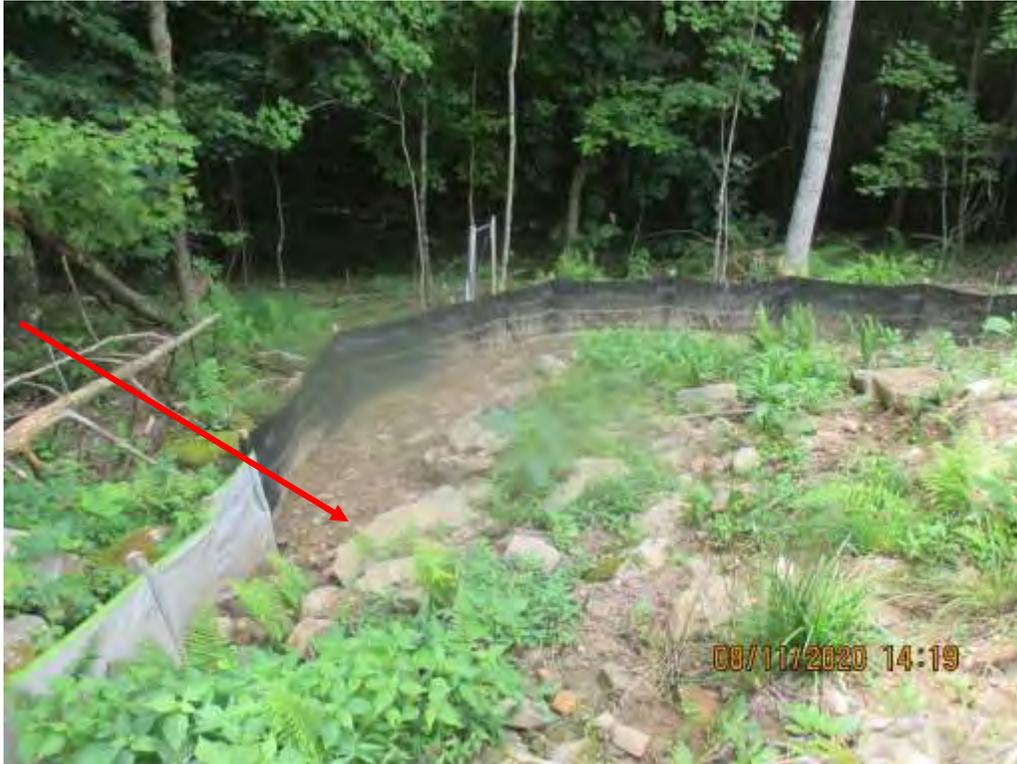
Further downslope of slope drain outlet at station no. 6490+00. Sediment deposits behind controls from erosion occurring upslope.

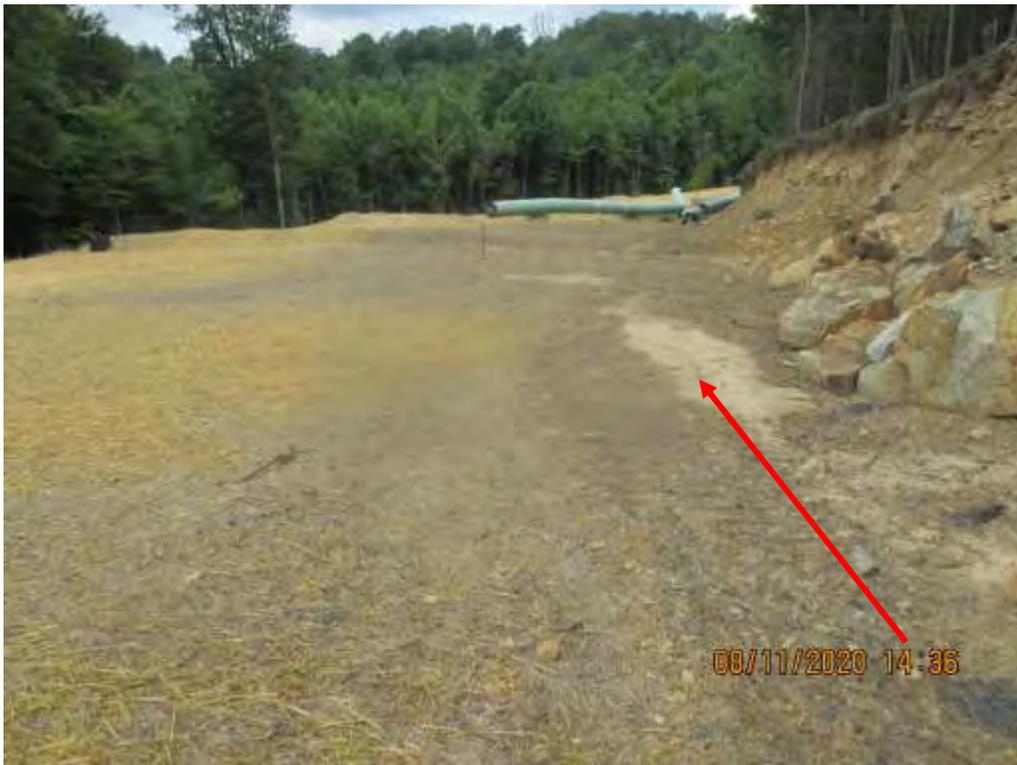
Near Station No. 6485+50 facing North. Sheet flow transporting sediment towards waterbar present. Slight erosion beginning to form (red arrow).

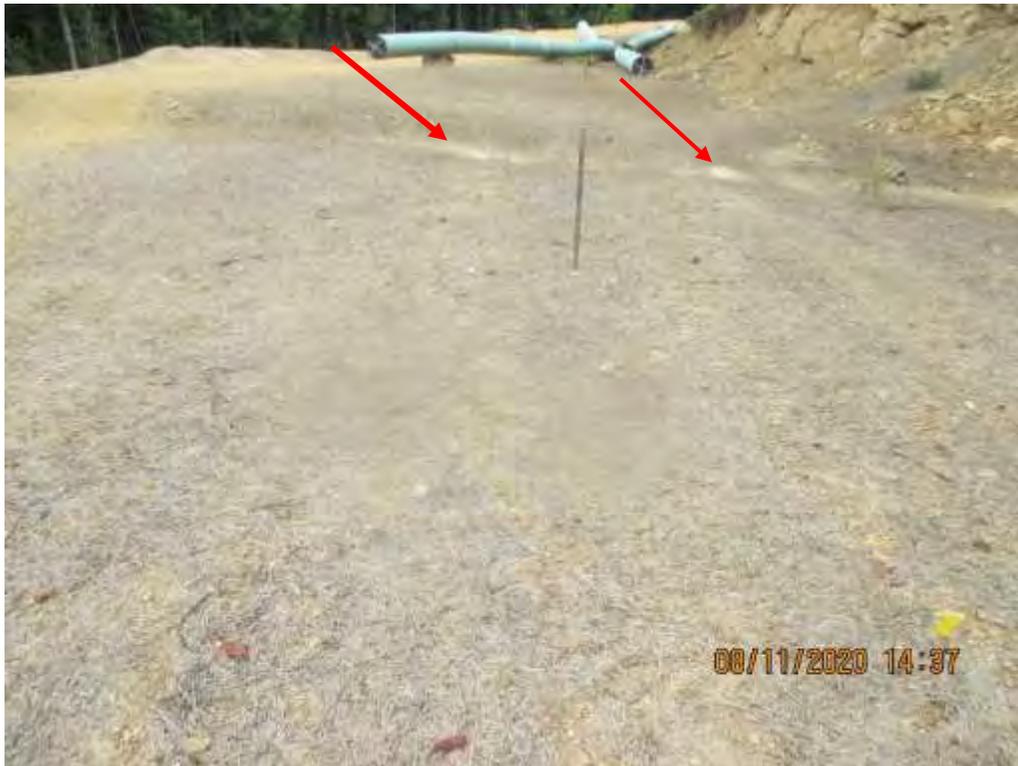
Near Station No. 6485+50 facing North. Sheet flow transporting sediment towards waterbar with sediment deposits (red arrow) in waterbar. Lack of 70 percent vegetative coverage present.

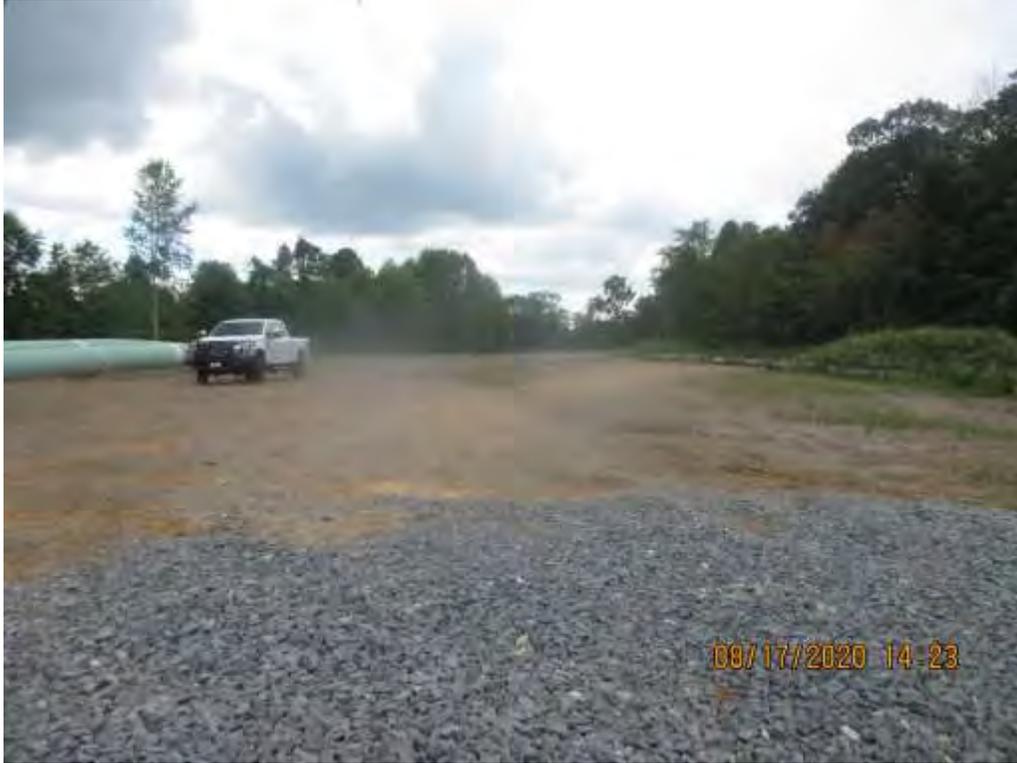
- Failure to reseed within 30 days after seed failing to germinate at the Odell town road at Station No. 6613+00.

Facing South at Station No, 6613+00. Less than 70 percent vegetative coverage present.

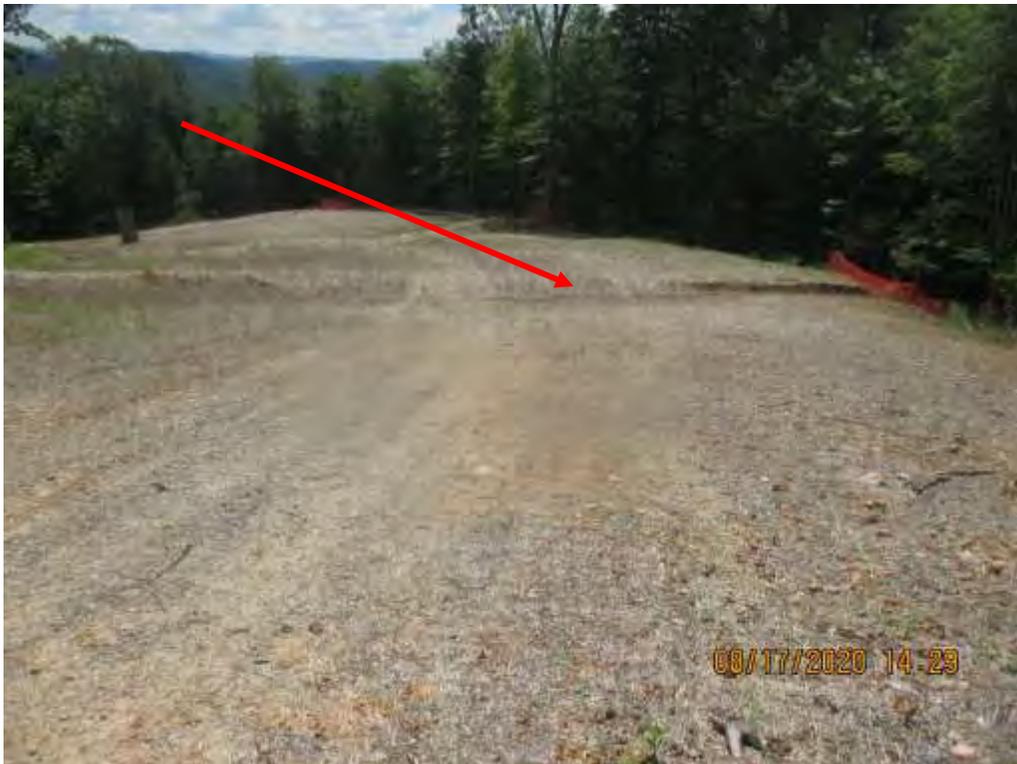
Facing downslope (South) near Station No. 6617+00. No erosion on slope with less than 70 percent vegetative coverage. Erosion present in Waterbar.

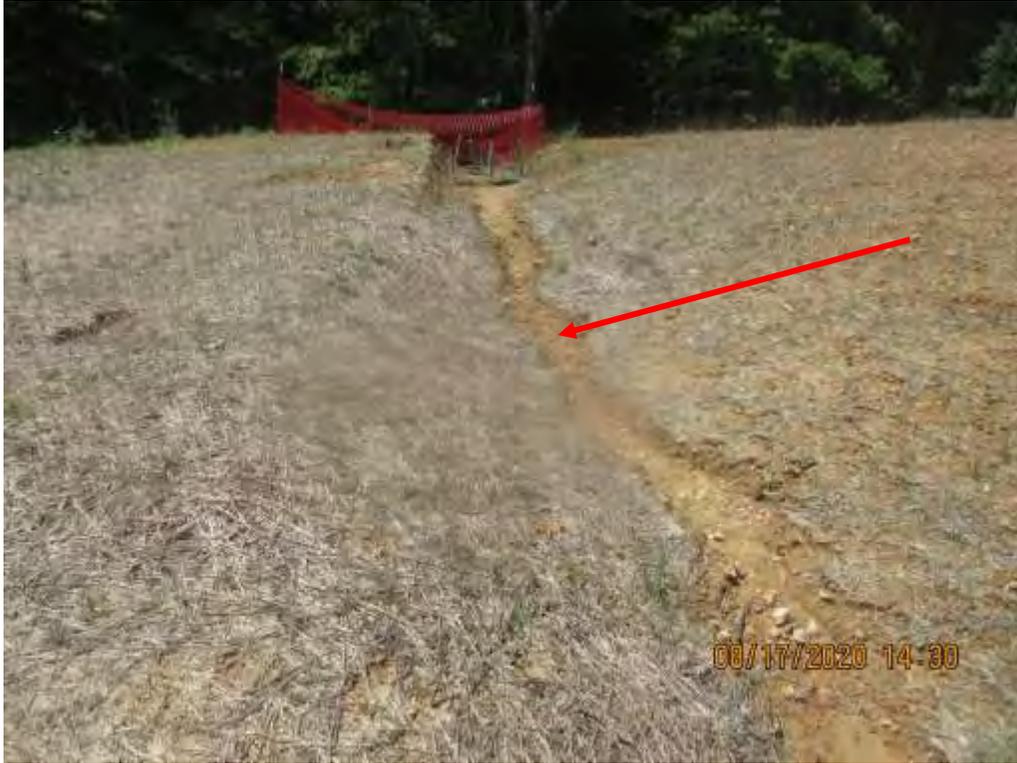
Facing downslope (South) near Station No. 6617+00. No erosion on slope with less than 70 percent vegetative coverage. Erosion present in Waterbar.

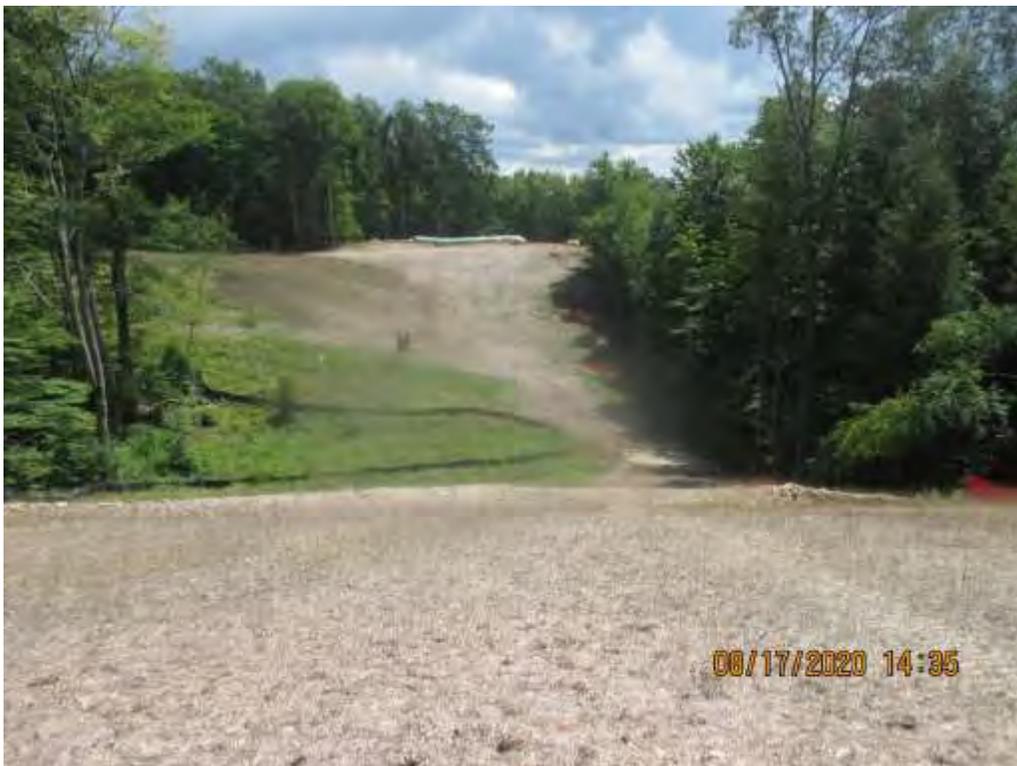
Facing South towards Station No. 6617+00 and Stream S-L37. Less than 70 percent vegetative coverage present with no erosion on slope.

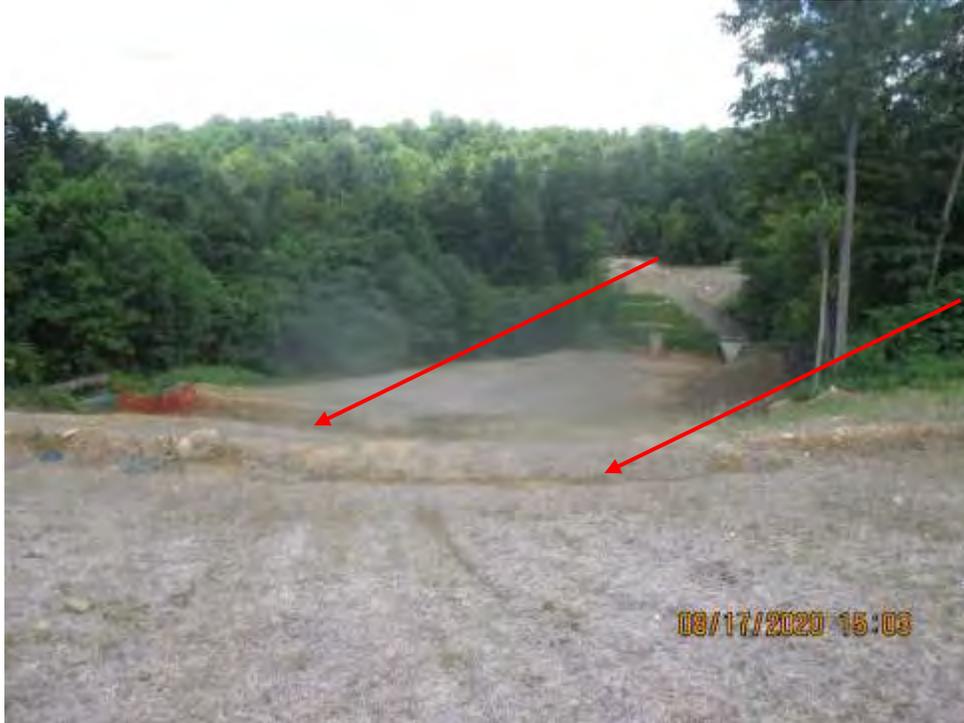
Standing at the Odell town road crossing at Station No. 6613+00 facing North. 70 percent vegetative coverage not present. Erosion present in Waterbars (red arrows).

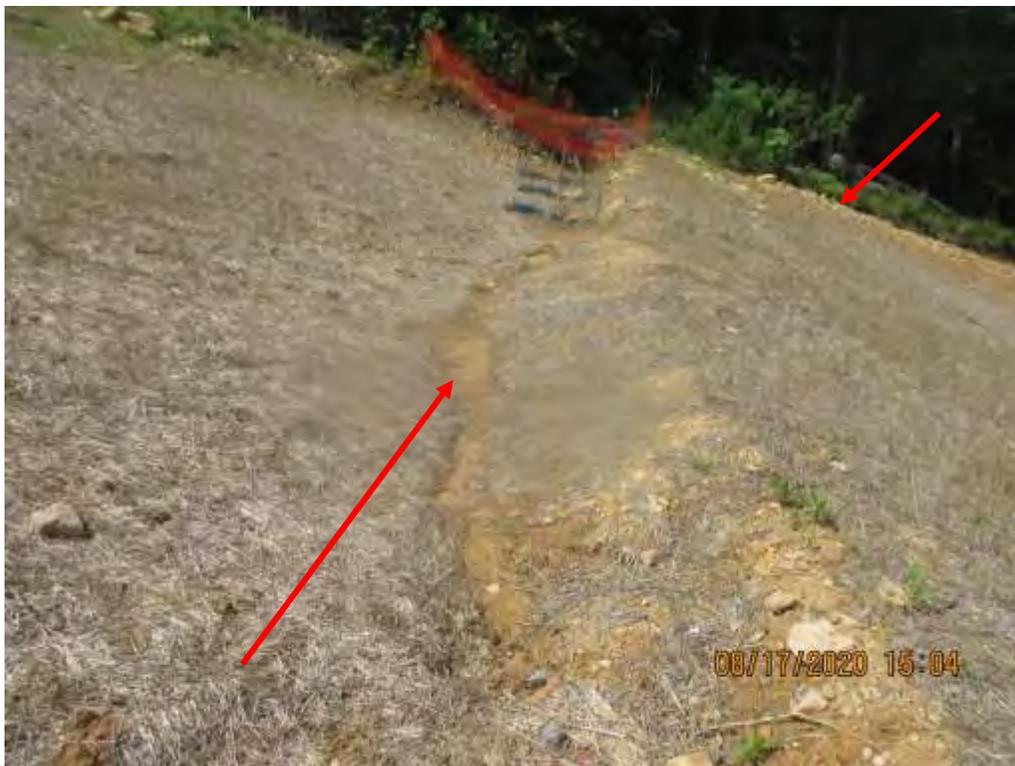
Station No. 6613+00 downslope towards Waterbar that failed. 70 percent vegetative coverage not present. Erosion present in Waterbar and at outlet (red arrows).

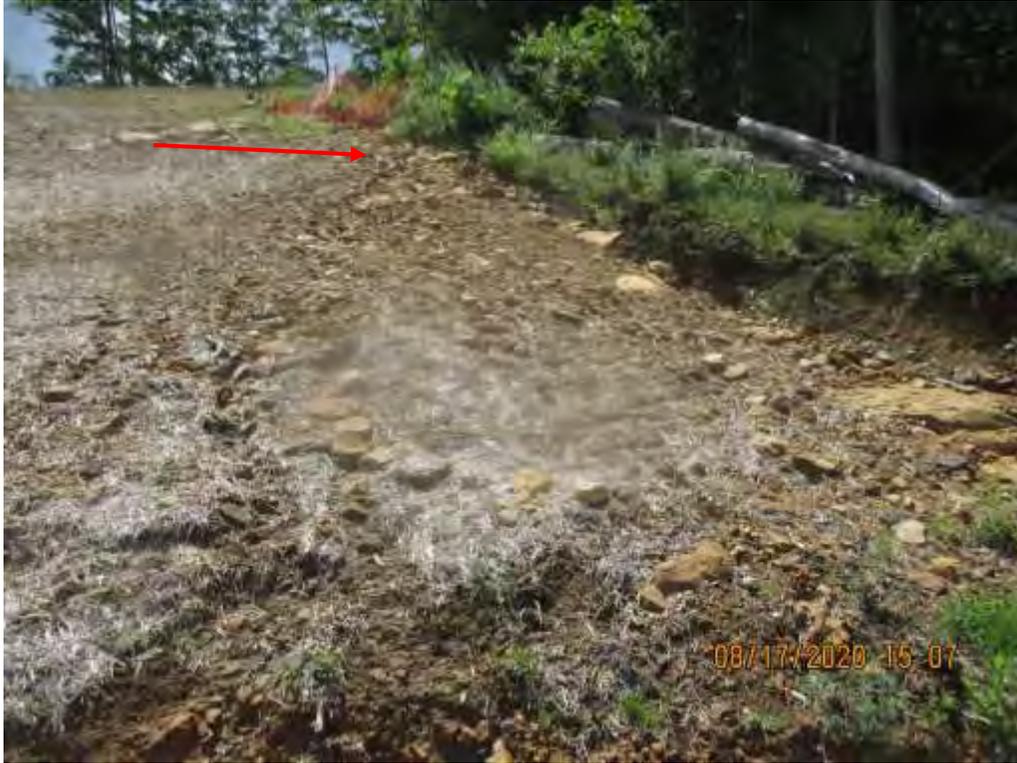
- Failure to follow SWPPP and or modify the SWPPP when it proved ineffective. A Waterbar at station No. 6613+00 was terminating onto the slope causing significant erosion on the fill slope. Run-on was also leading to erosion at the side cut casing sediment to be deposited into the downslope Waterbar leading to concentrated flow above the Waterbar that failed.

**Section D.1. - Permittee failed to properly operate and maintain all systems of treatment and controls: At Station No. 6613+00 a Waterbar was terminating onto the fill slope causing significant erosion downslope of the outlet leading to controls needing maintained and or enhanced.**

Facing upslope at Waterbar that failed and was terminating onto the fill slope and causing erosion at Station No. 6613+00.

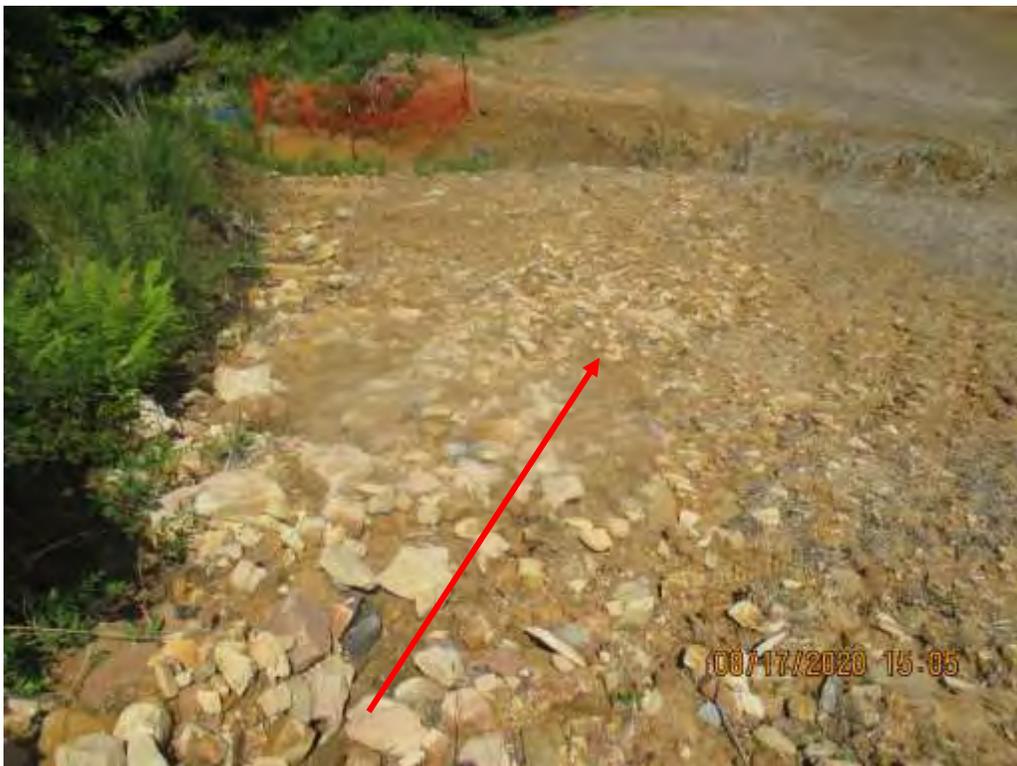
- Failure to protect Fill Slopes. A Waterbar at station No. 6613+00 was terminating onto the fill slope leading to erosion between waterbars above Stream S-L35. This led to a cascading effect downslope between waterbars causing significant erosion on the slope. Also due to the cut into the slope at station No. 6613+00 erosion was occurring due to run-on from upslope leading to sediment being deposited into waterbars leading to controls being overwhelmed with sediment deposits reducing the functionality of the device.

Facing downslope at fill slope where Waterbar failed and was causing erosion at Station No. 6613+00.

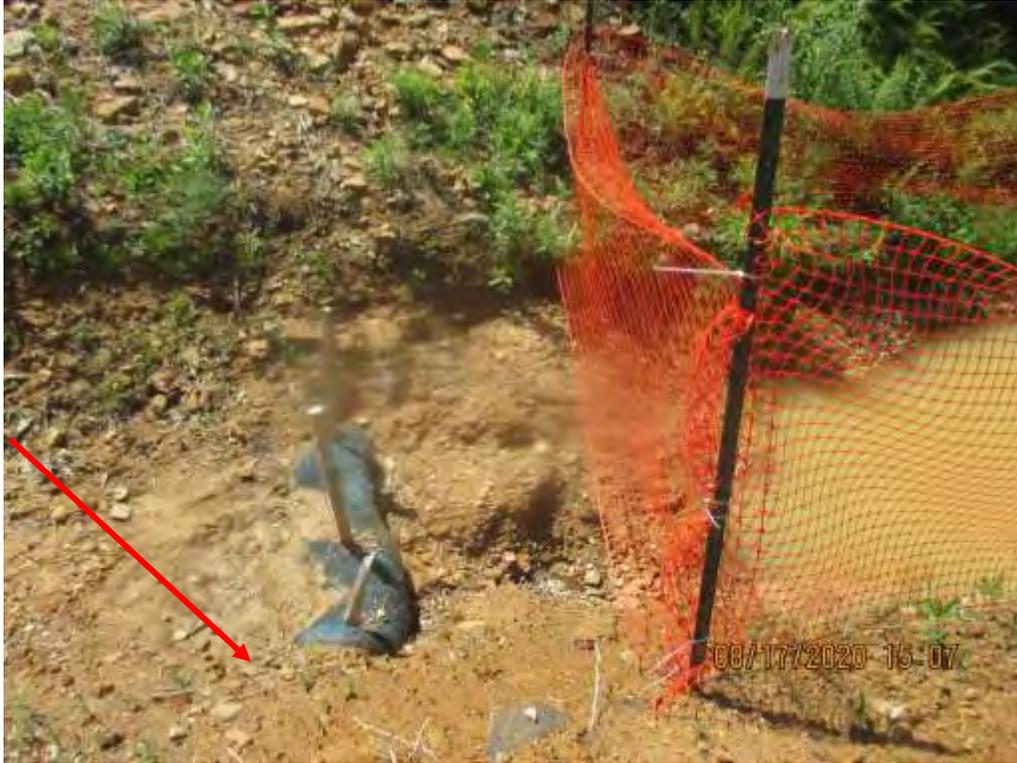
Sediment deposited into Waterbar overwhelming controls below Waterbar failure and erosion occurring on fill slope at station No. 6613+00.

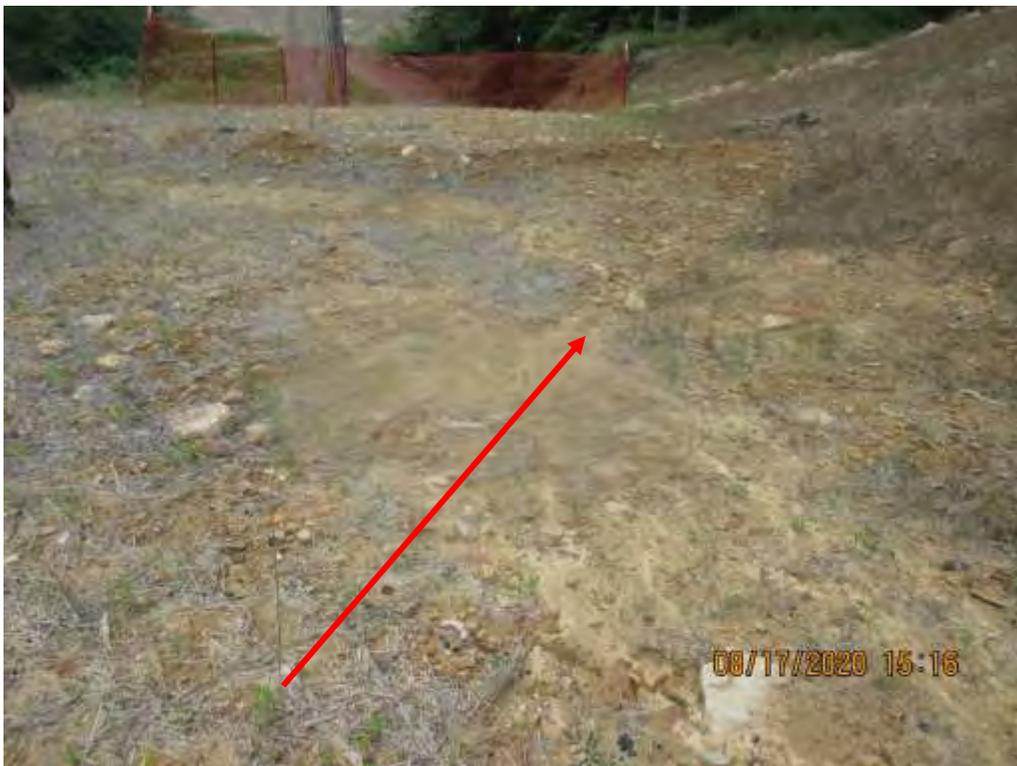
Erosion occurring on fill slope downslope where run-on was conveying onto ROW at Station No. 6613+00.

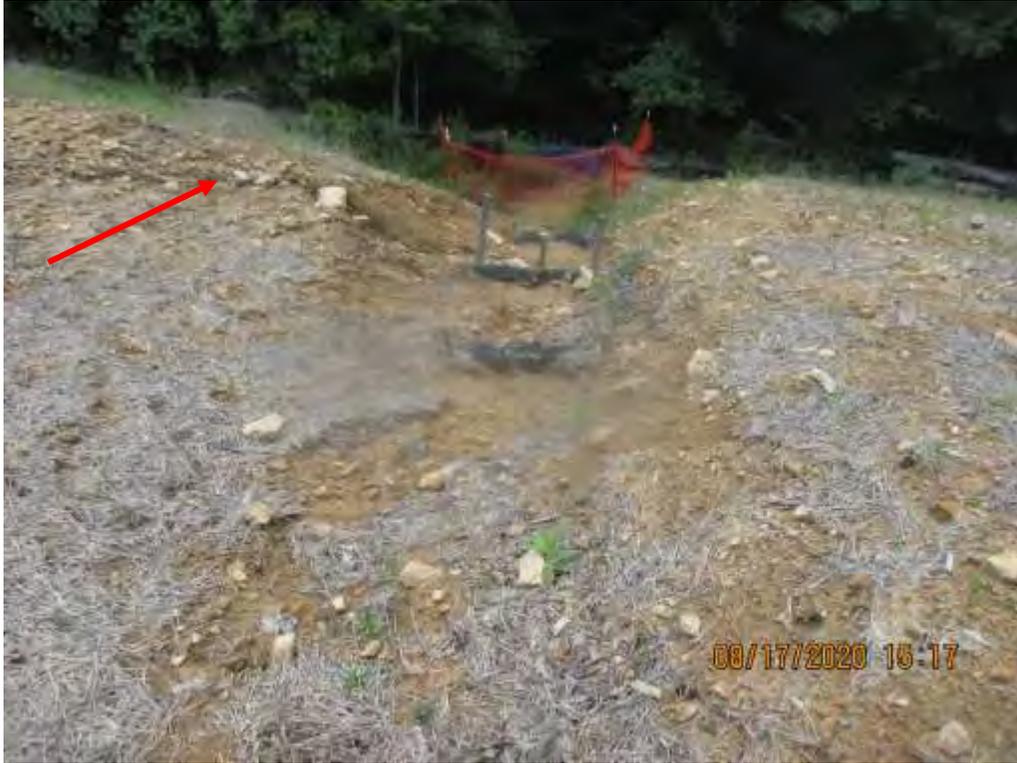
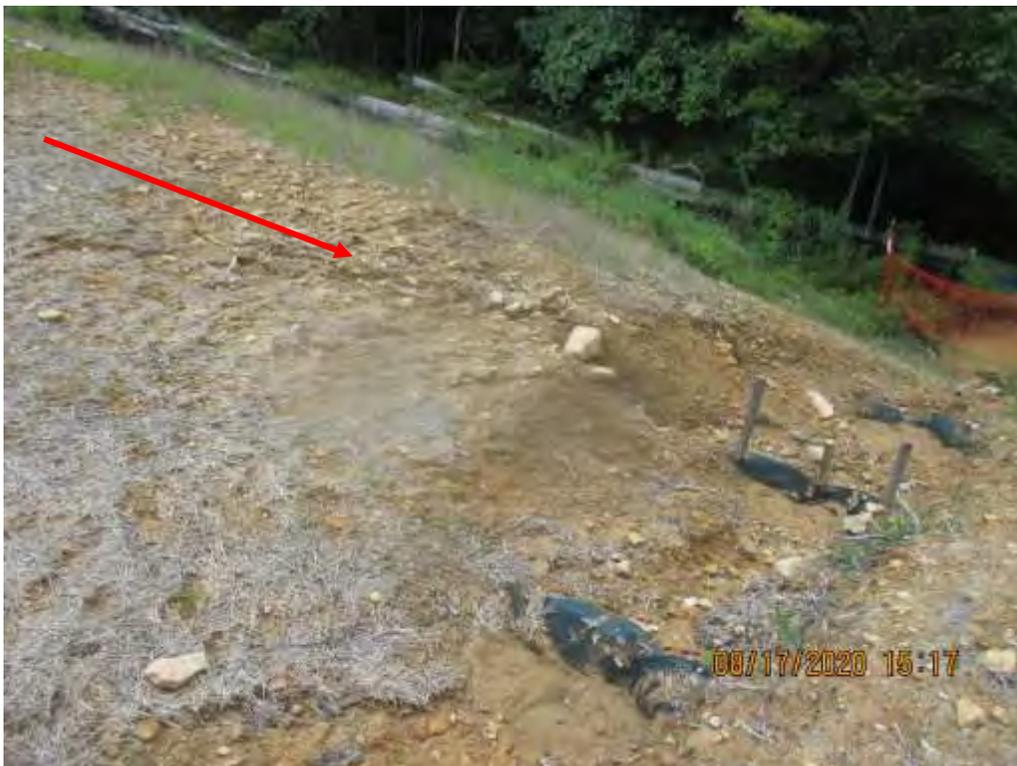
Waterbar downslope of Station No. 6613+00 with erosion present due to concentrated flows. Controls lacking maintenance and or enhancement. Red arrow depicts erosion om fill slope above Waterbar.

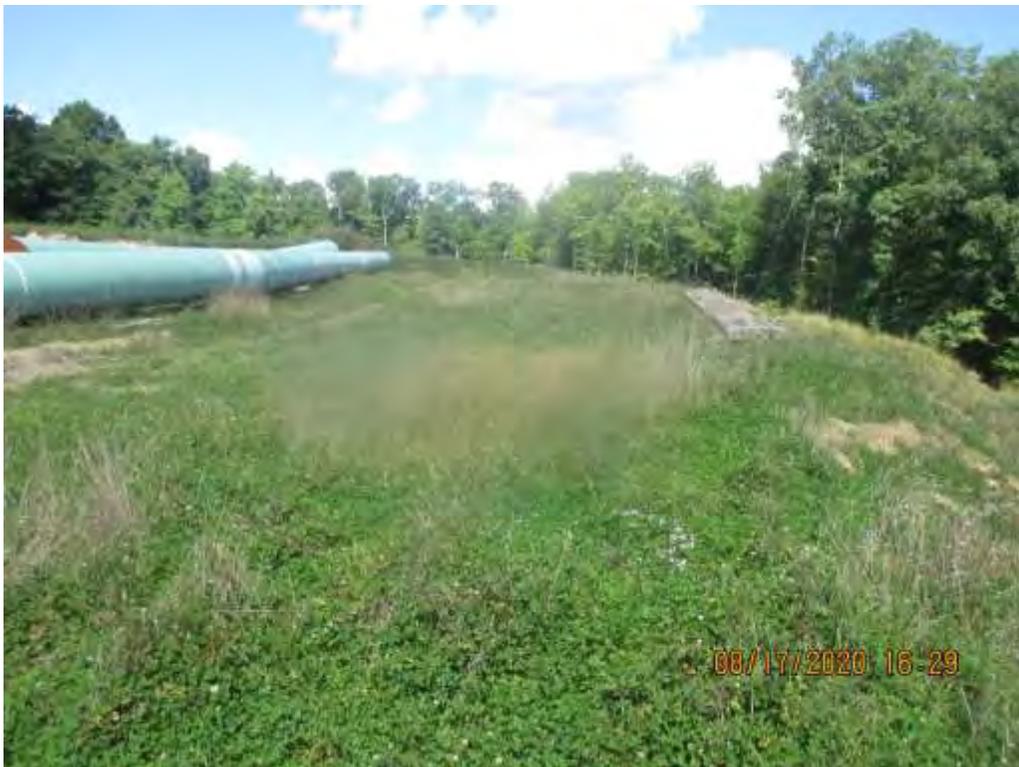
North of Route 82 crossing at Station no. 5548+64. Greater than 70 percent perennial (permanent) vegetative coverage present.

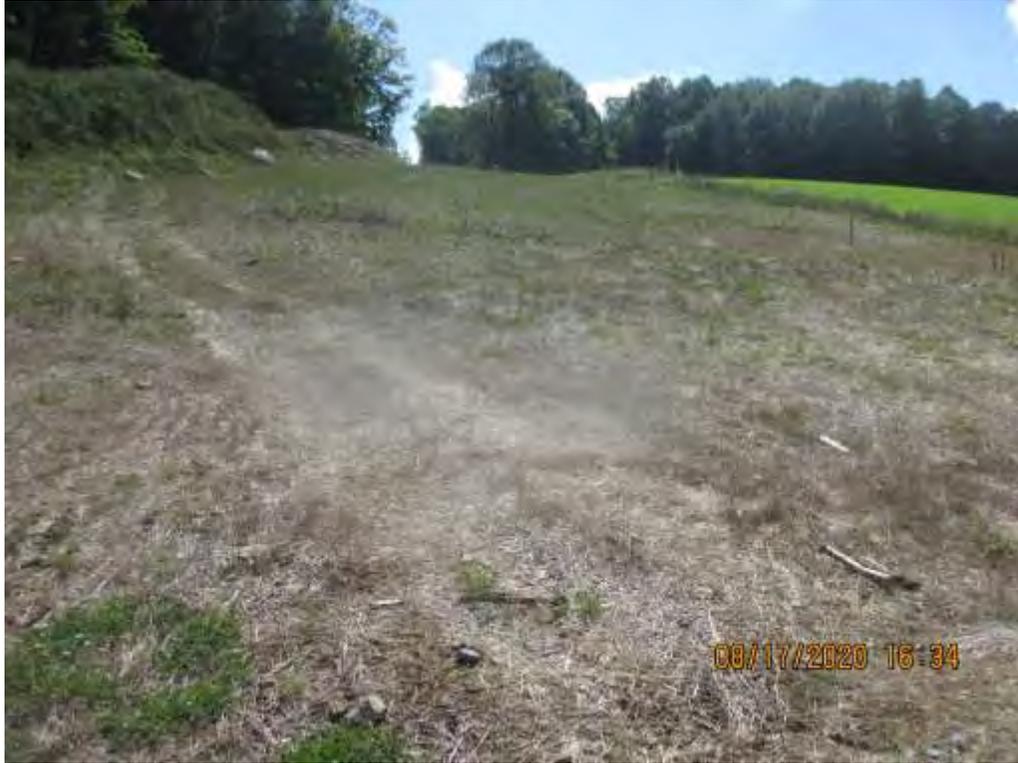
South of Route 82 crossing at near Station No. 5548+64. Approximately 50-70 percent vegetative coverage present. No erosion observed. Area to be reseeded according to MVP representatives.

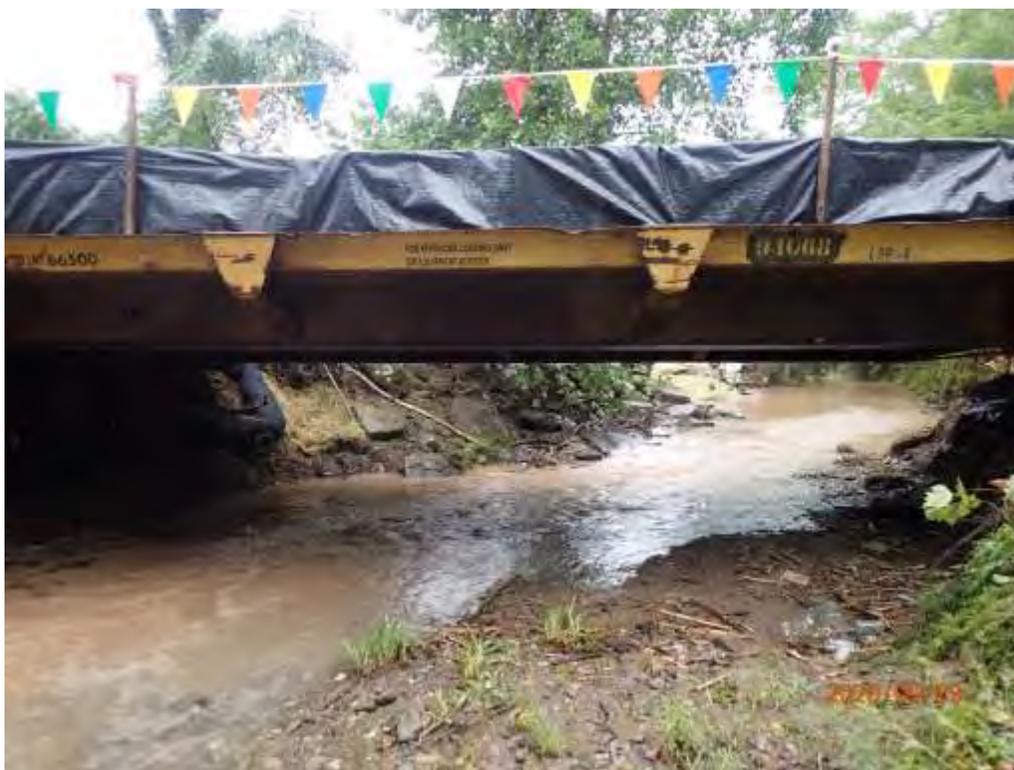
“A timber mat bridge was dislodged and floated downstream due to heavy rains and high waters. 8/29/20”  
The stream span near Mannington road was compromised and required repairs. The repairs included replacing the matting and installing additional compost filter sock. Deficiencies have been corrected

Reinstalled timber mat bridge installed on S Fork Fishing Creek

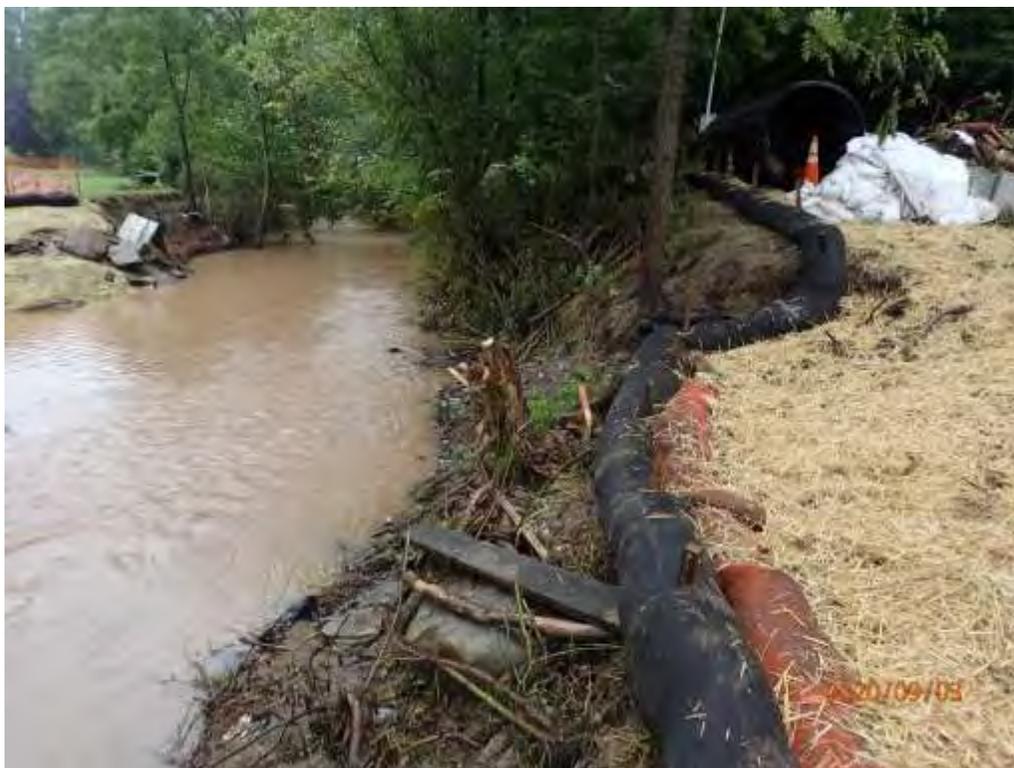
Area has new silt sock and has straw placed near S Fork Fishing Creek
