**The Wilderness Society et al. Comments on the  
U.S. Forest Service Mountain Valley Pipeline and  
Equitrans Expansion Project Draft Supplemental  
Environmental Impact Statement (#50036)**

**EXHIBIT 1**

Assessment of erosion, sedimentation, and water quality impacts of the Mountain Valley Pipeline and Equitrans Expansion Project's proposed crossing of the Jefferson National Forest as it pertains to the U.S. Forest Service's Draft Supplemental Environmental Impact Statement dated December 2022

Prepared by Jonathan A. Czuba, Ph.D., Licensed Professional Engineer

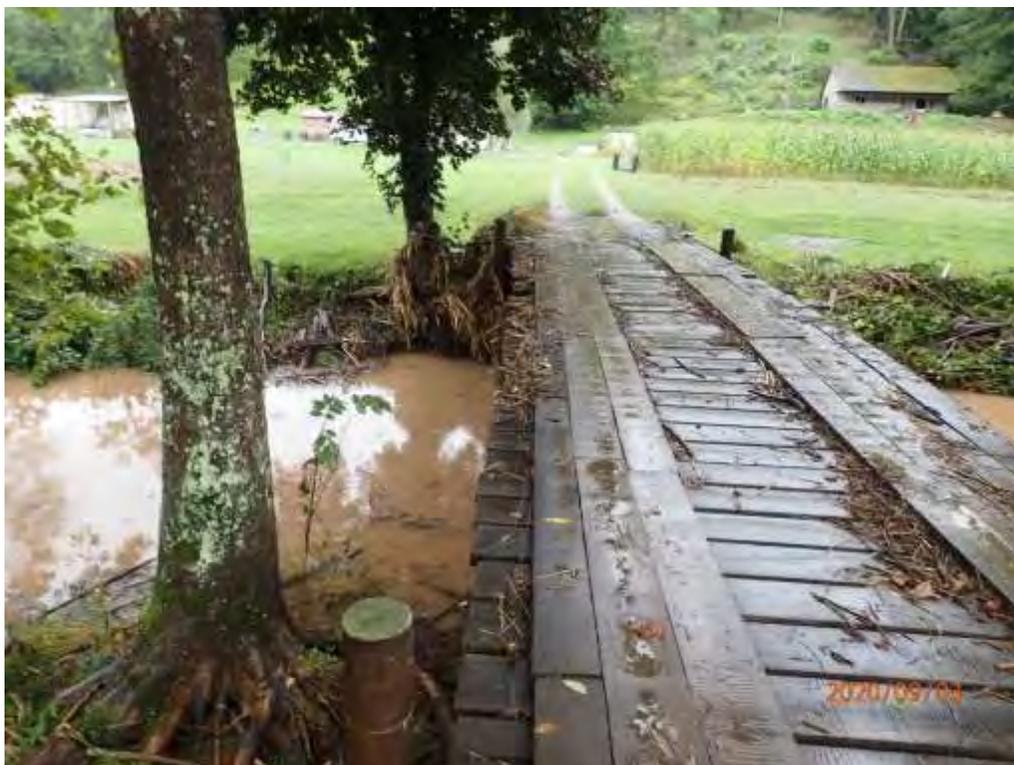
Timber mat bridge been removed from S Fork Fishing Creek near landowner bridge downstream

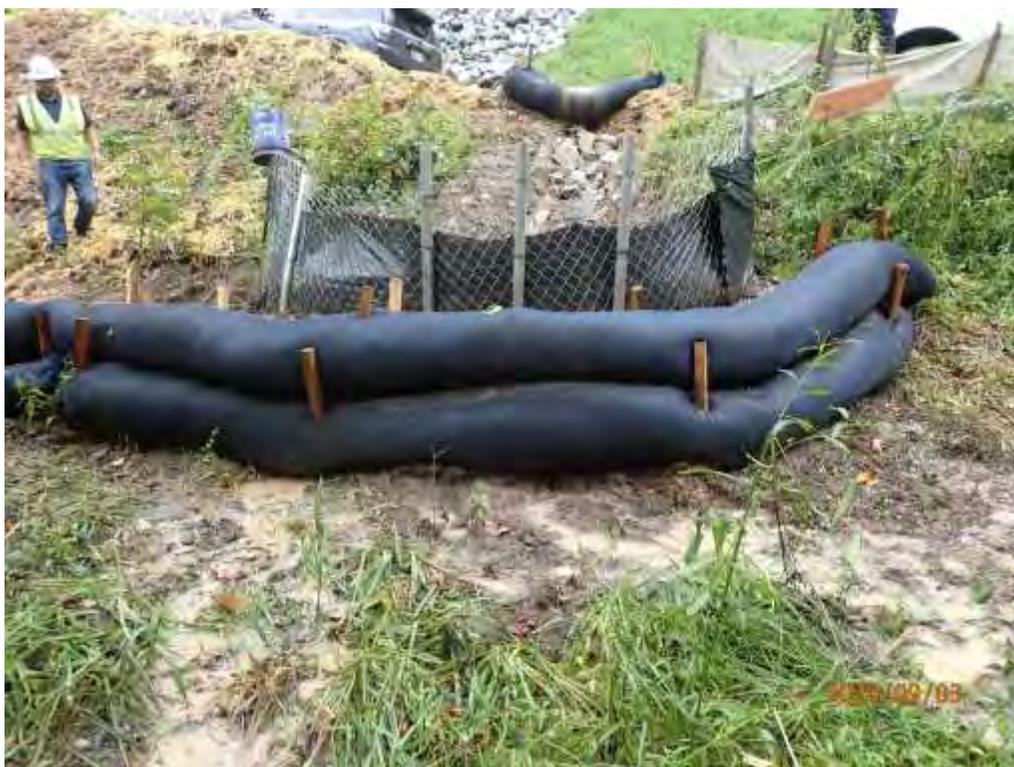
- Section G.4.e.2.A.ii.j - MOUNTAIN VALLEY PIPELINE, LLC has failed to prevent sediment-laden water from leaving the site without going through an appropriate device. Sediment laden water was leaving the site near Stout Run Road through silt sock.
- Section D.1. - MOUNTAIN VALLEY PIPELINE, LLC has failed to properly operate and maintain all systems of treatment and controls- Sediment laden water was leaving the site near Stout Run Road through silt sock.

Controls have been installed below runoff near Stout Run. Sediment-laden water was still leaving the site

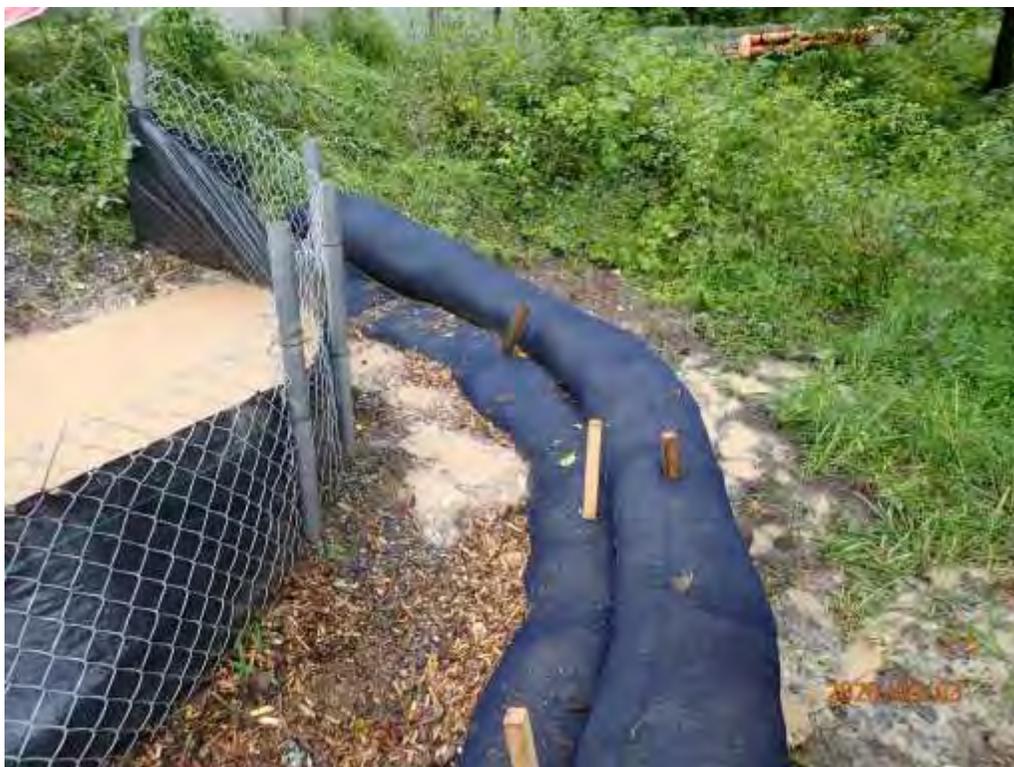
Controls below Stout Run Road were not effective at controlling sediment runoff

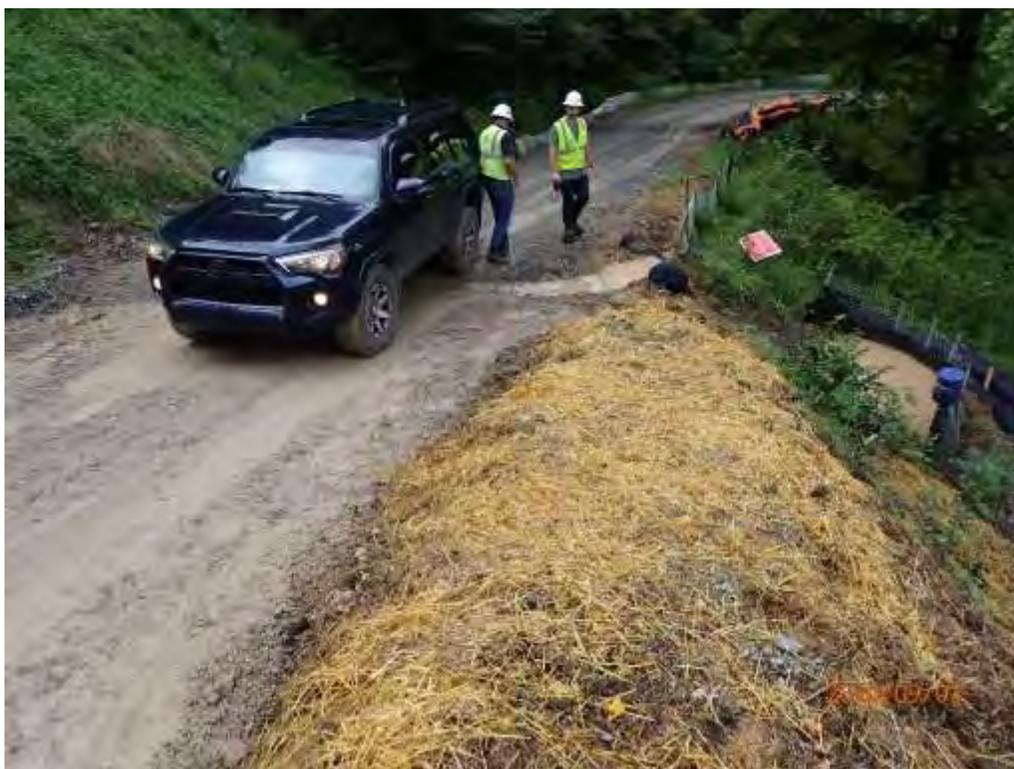
Controls have been installed below runoff near Stout Run

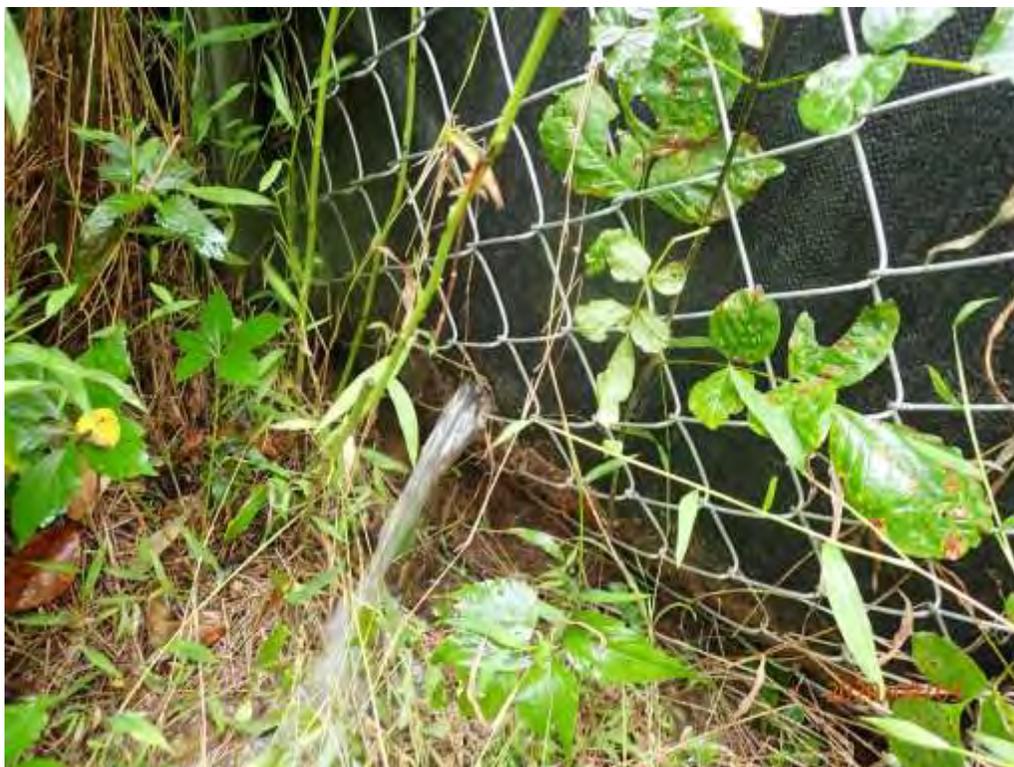
Silt fence is damaged near Stout Run bridge

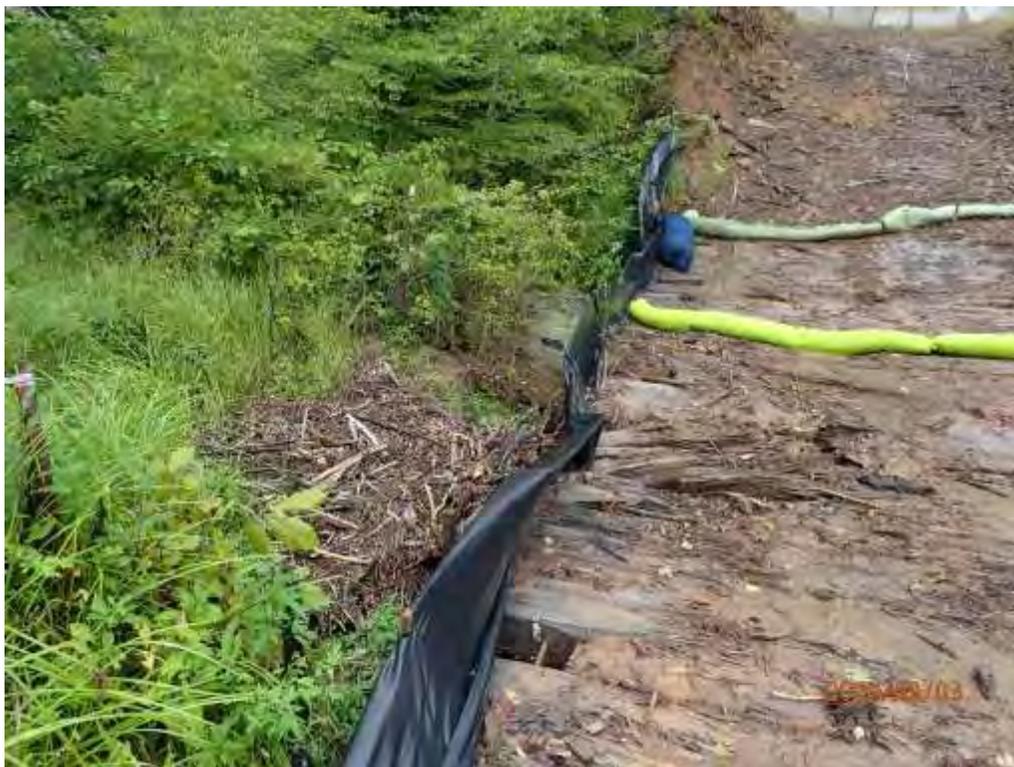
Stout Run crossing was flooded

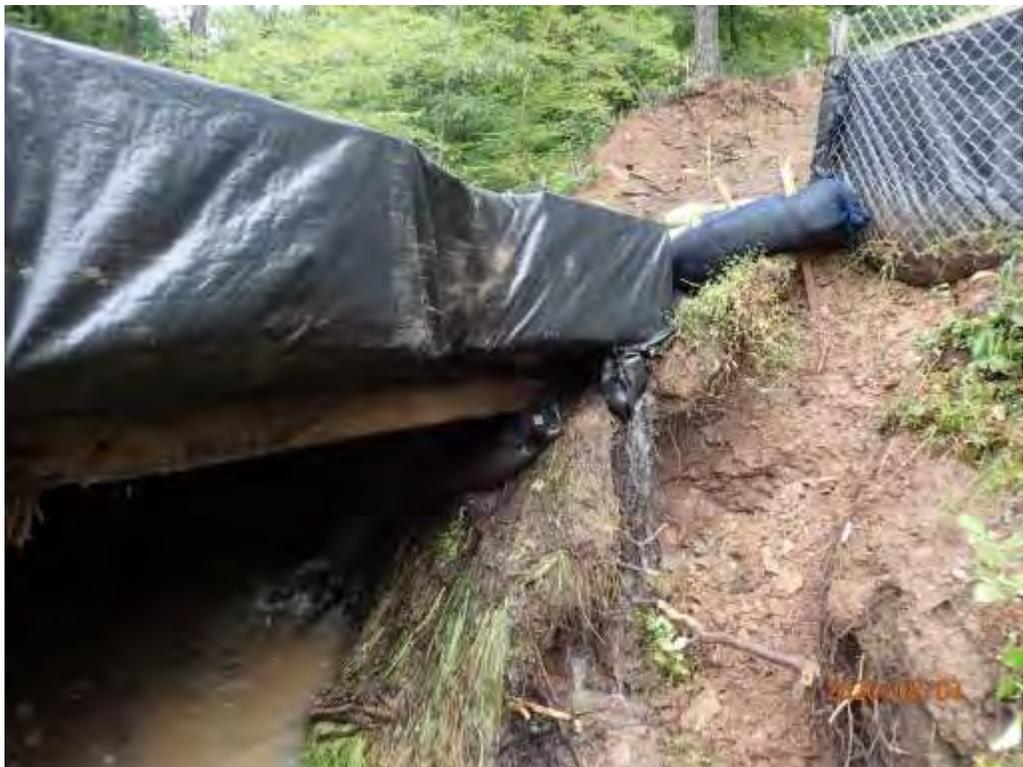
The stream span over Stout Run was compromised and will require repairs. Once the water recedes and the area is safe to work, the appropriate repairs will be completed, and Mountain Valley will coordinate as required with the appropriate agencies.

Stout Run crossing was flooded scouring the embankment

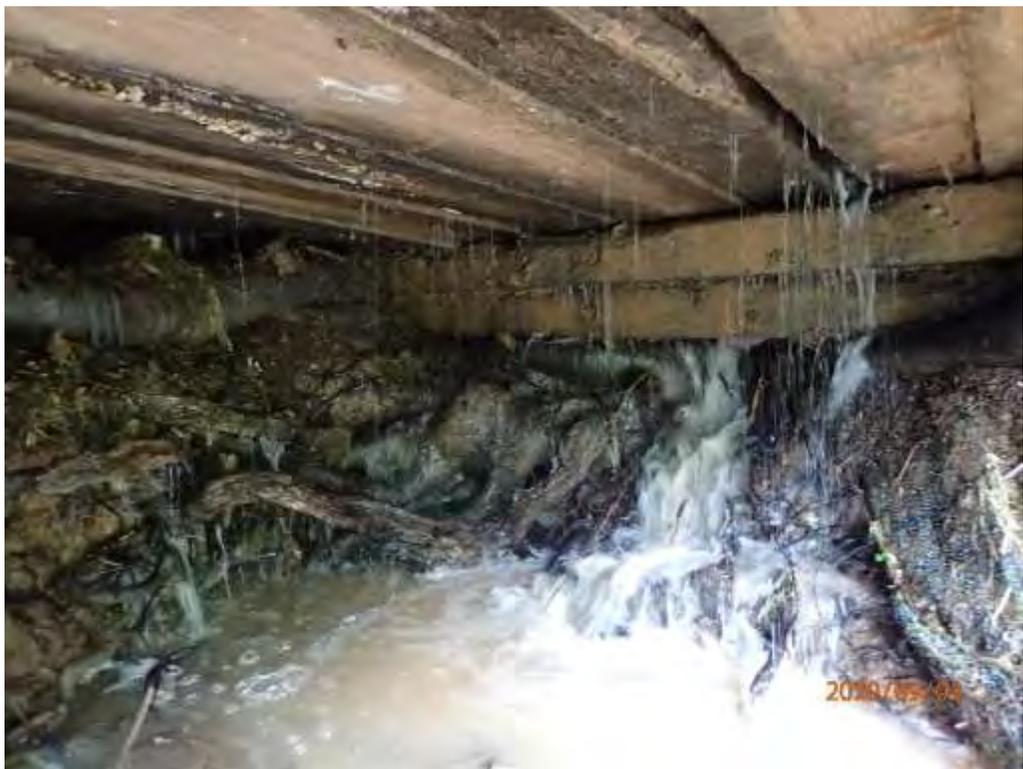
Water has been diverted after timber mat bridge has collapsed

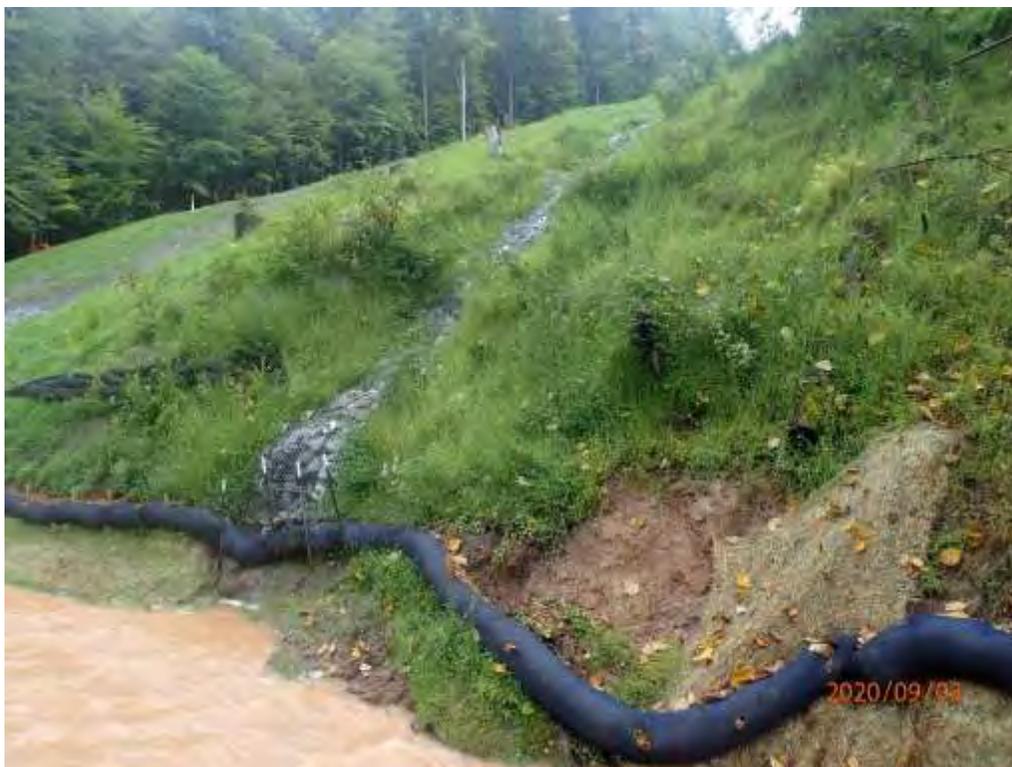
A small slip occurred near Sams Run. Mountain Valley has installed erosion control blanketing and compost filter sock. Permanent repairs are being designed to restore stream bank.

Sams Run slip- controls have been installed and responsible party is developing a plan of corrective action

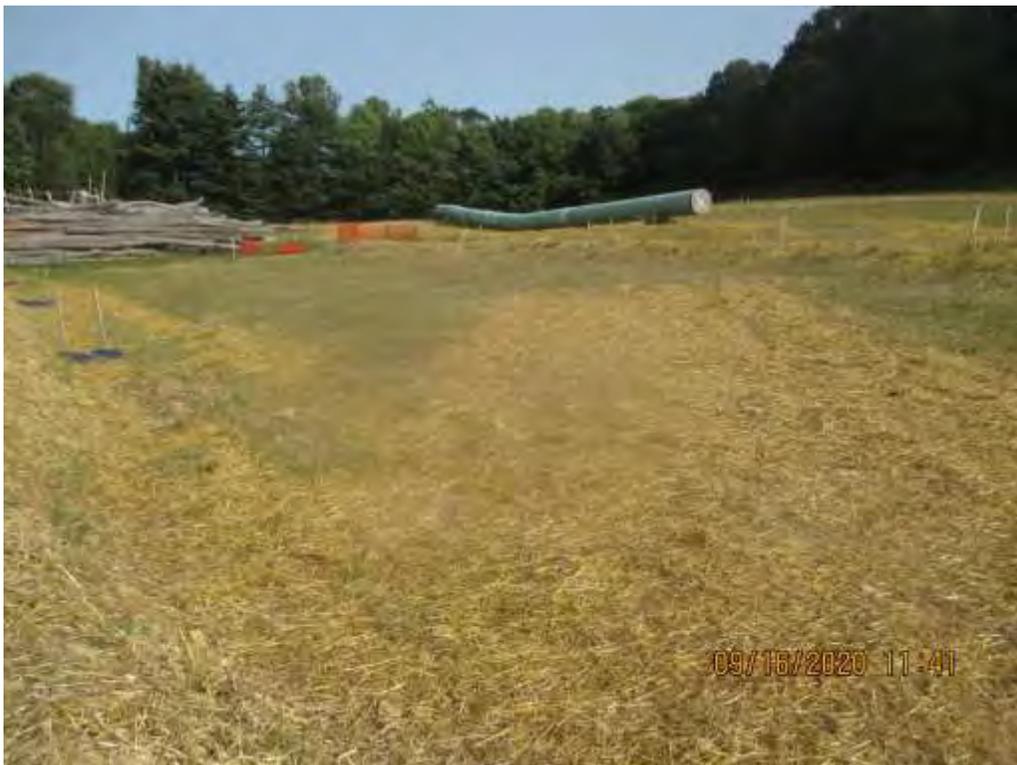
Facing Northwest at station No. 6781+00 at the CR 5 Wahoo Road crossing. Area recently reseeded.

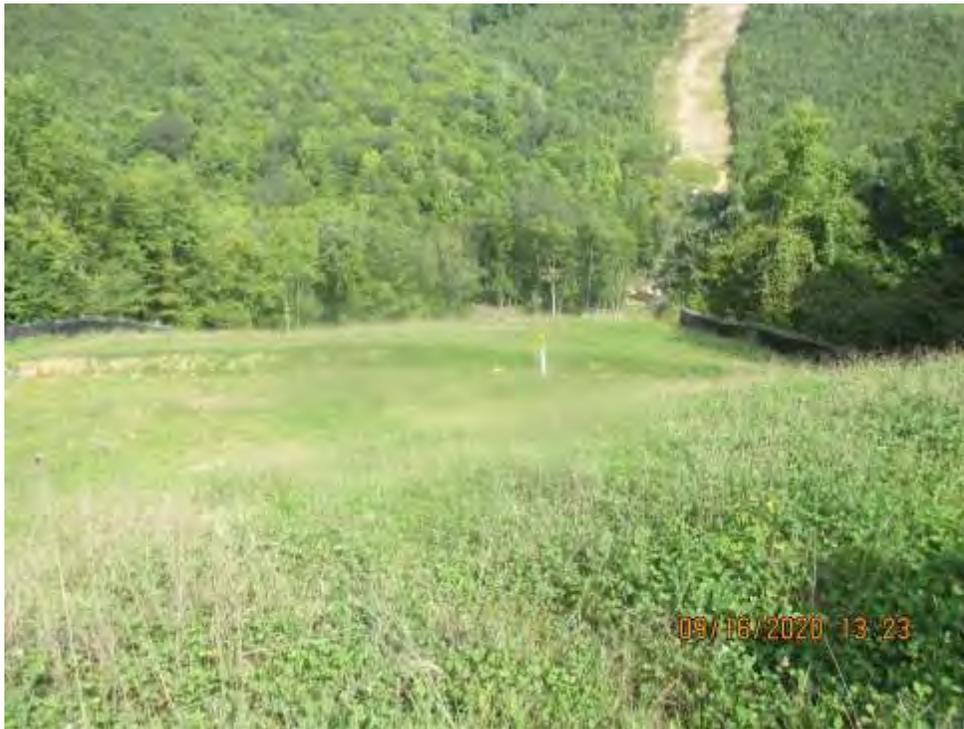
Standing at Access Road 161 facing downslope at Station No. 6715 through 6707 at bottom of slope.  
Area had greater than 70 percent vegetative coverage.

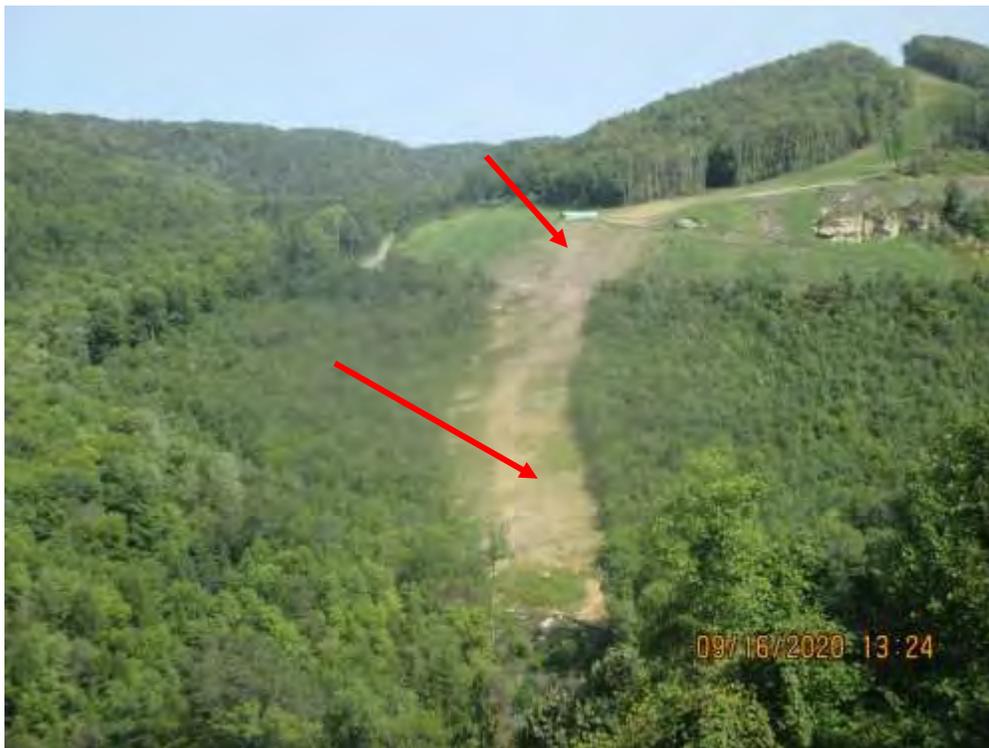
Standing at Station No. 6715+00 towards opposite slope at AR-160.01 (Station No. 6698+00 through 6707+00) Erosion observed on slope (red arrows).

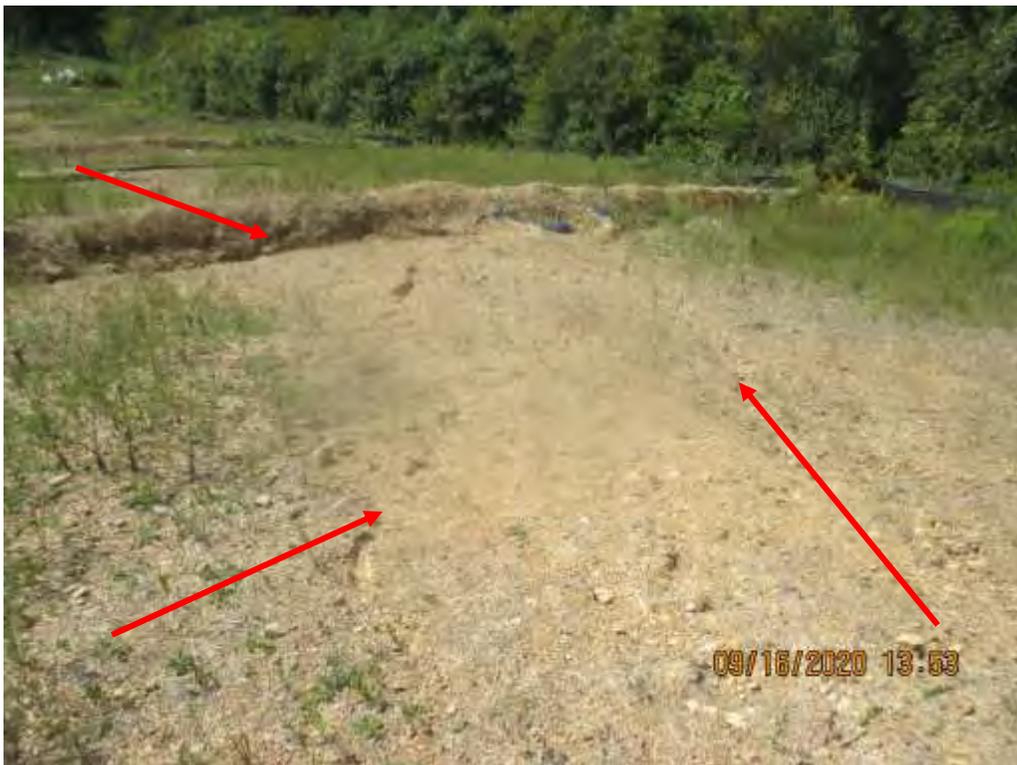
Facing downslope near station No. 6698+00. Erosion occurring between waterbars on slope (red arrow) and in waterbars.

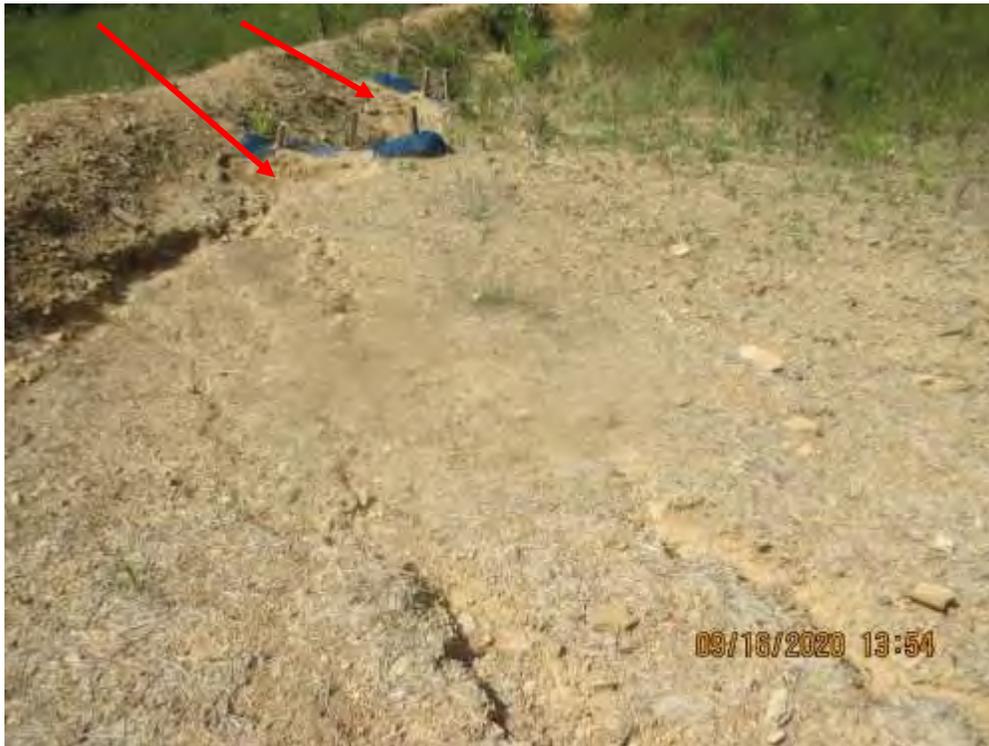
Facing downslope near station No. 6698+00. Erosion occurring between waterbars on slope and in waterbars. Controls lacking maintenance within Waterbar (red arrow).

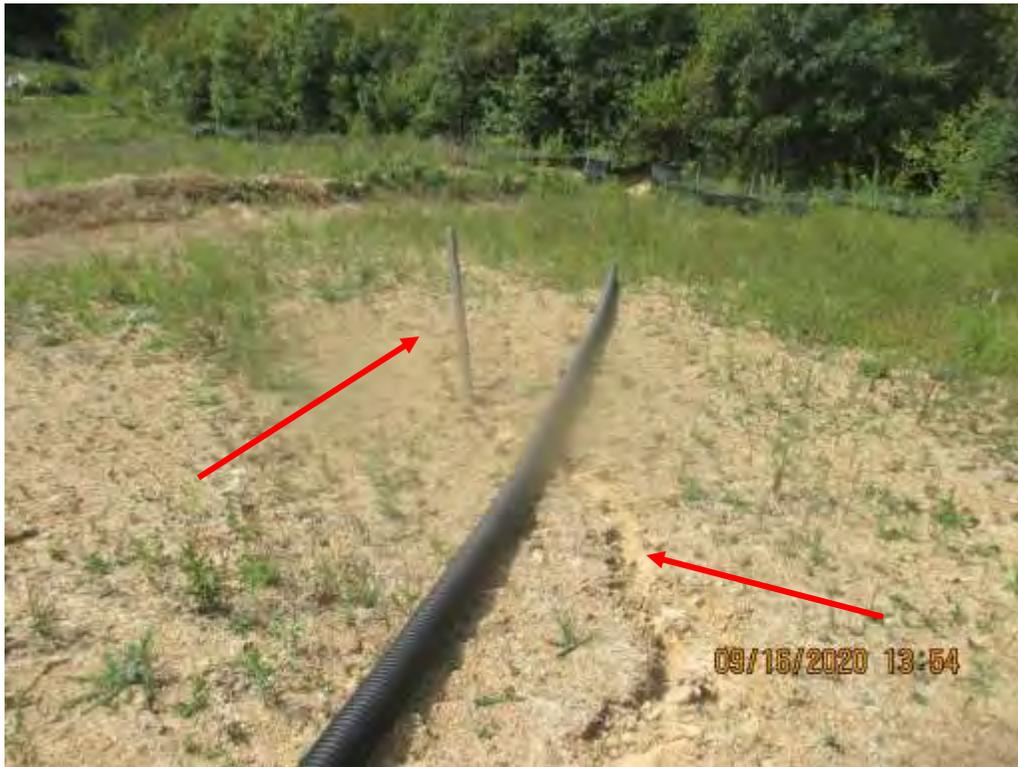
Further downslope from Station No. 6698+00 where trench drain was out letting onto fill slope and causing erosion. (red arrow).

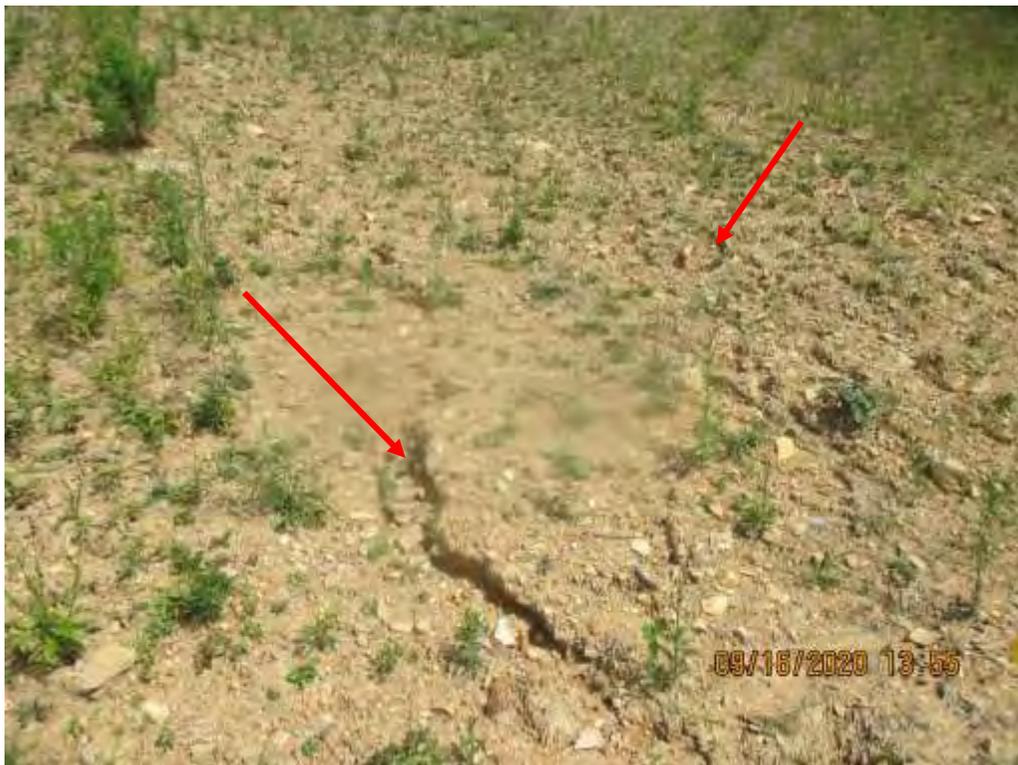
Erosion present on slope below pipe trench drain outlet and slope drain.

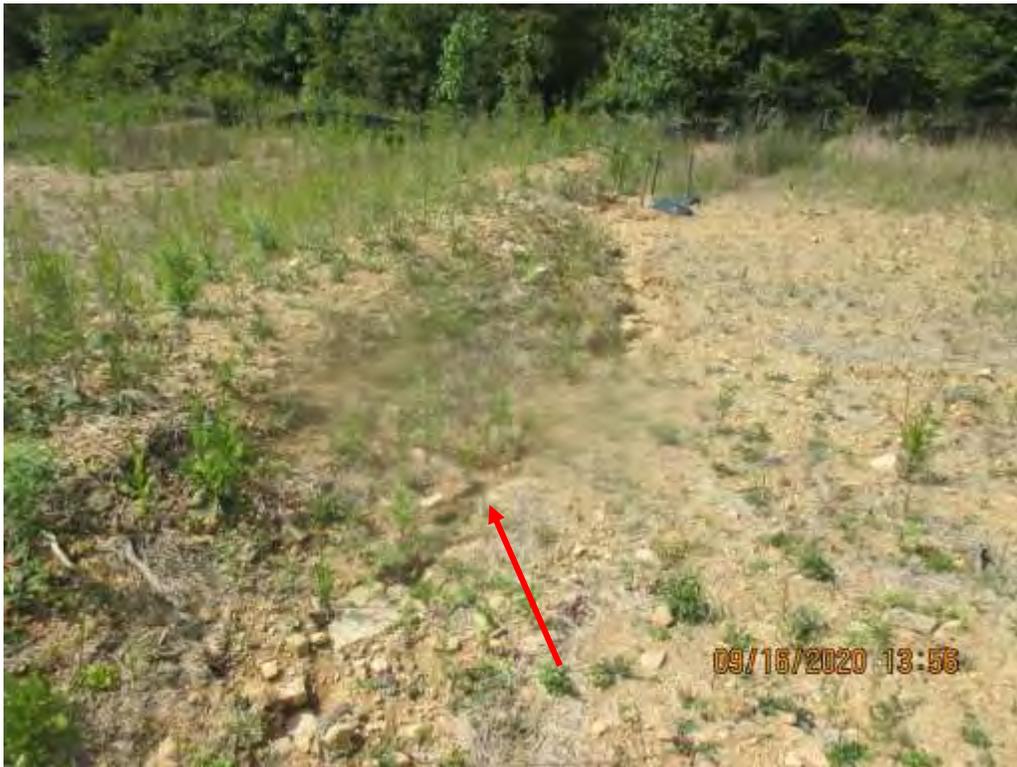
Rill erosion occurring in between waterbars downslope near Station No. 6703+00.

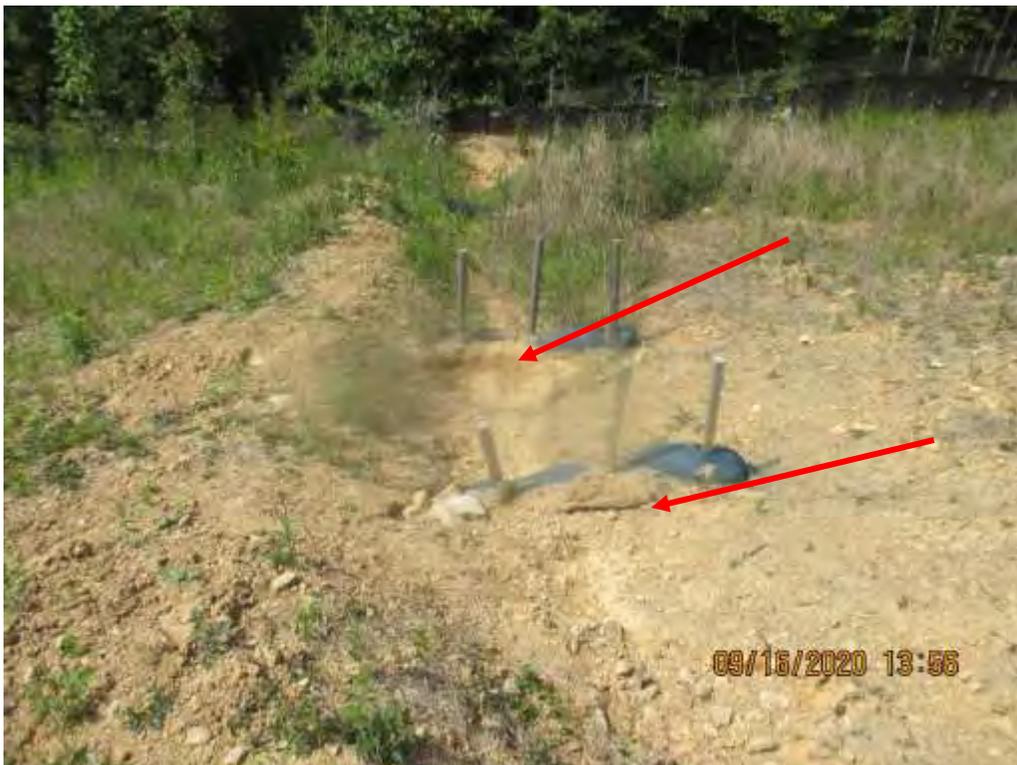
Waterbar with erosion present near Station No. 6703+00, Controls in Waterbar lacking maintenance.

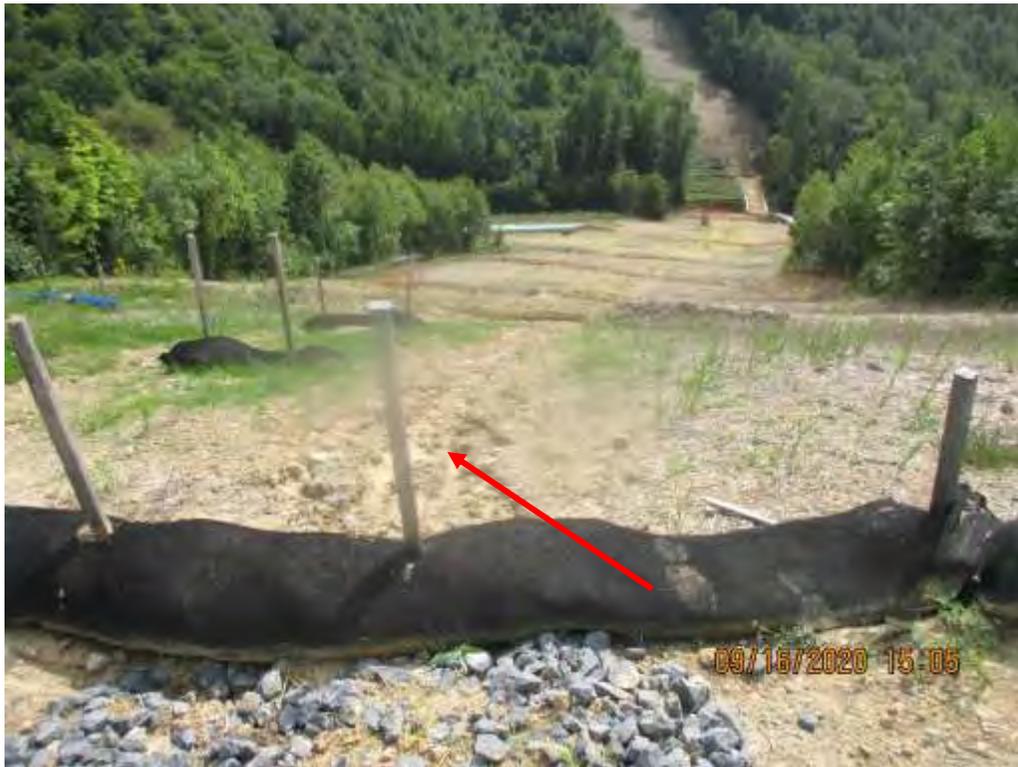
Waterbar with erosion present near Station No. 6703+00, Controls in Waterbar lacking maintenance (Red Arrow).

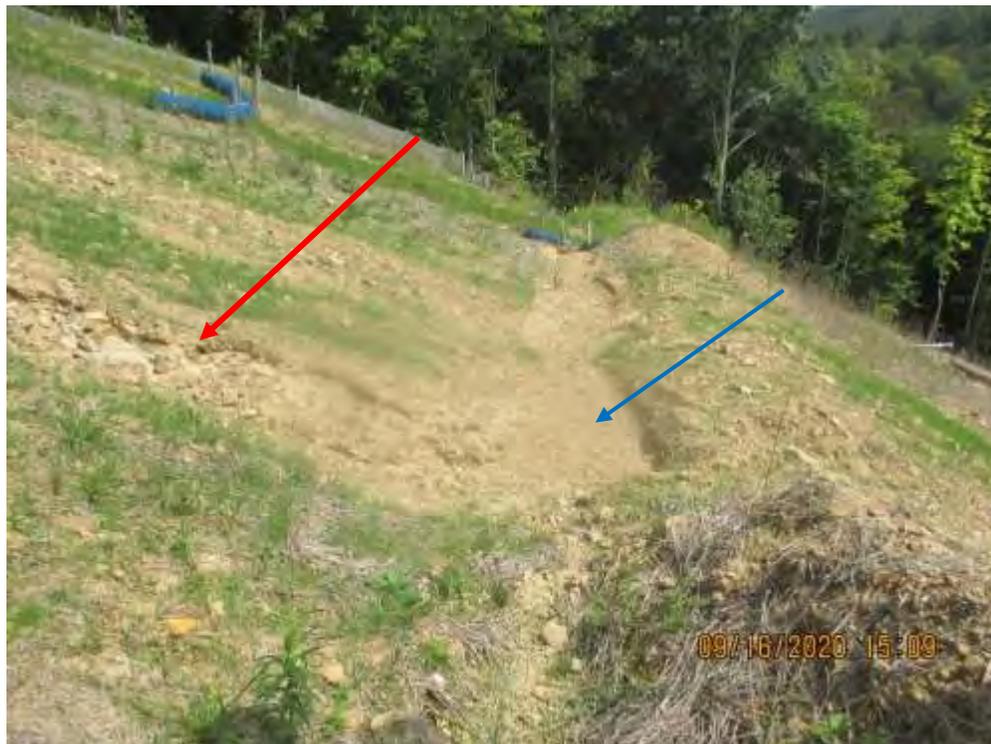
Standing at Access Road 159.01 facing downslope from station No. 6657+00. Erosion present on slope (red arrow) with deposits in the Waterbar channel (blue arrow)

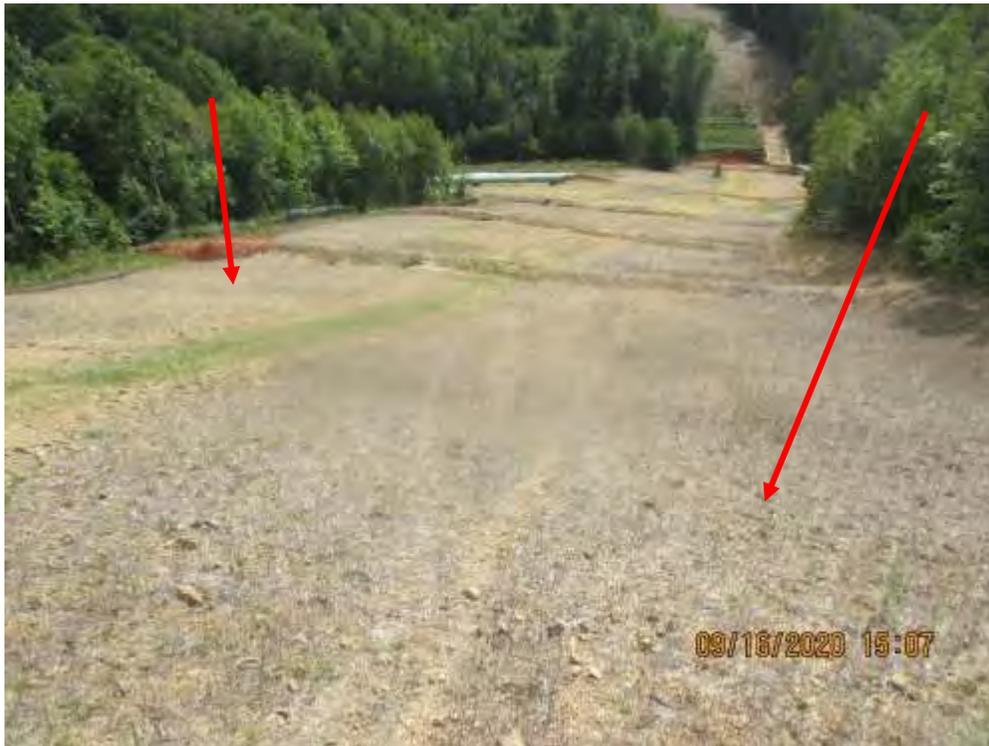
Standing downslope from Access Road 159.01 facing east near station No. 6657+00. Erosion present on slope depositing sediment into Waterbar and controls (red arrow).

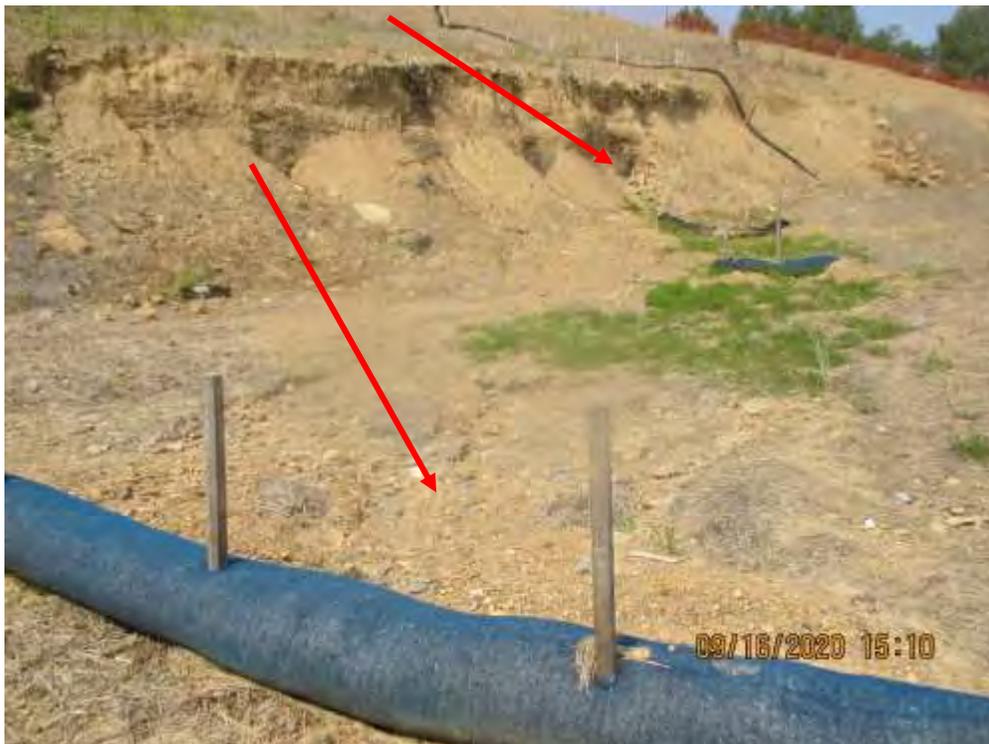
Further downslope of station No. 6657+00. Travel lane was reseeded, however, ROW adjacent to travel lane was not (red arrows).

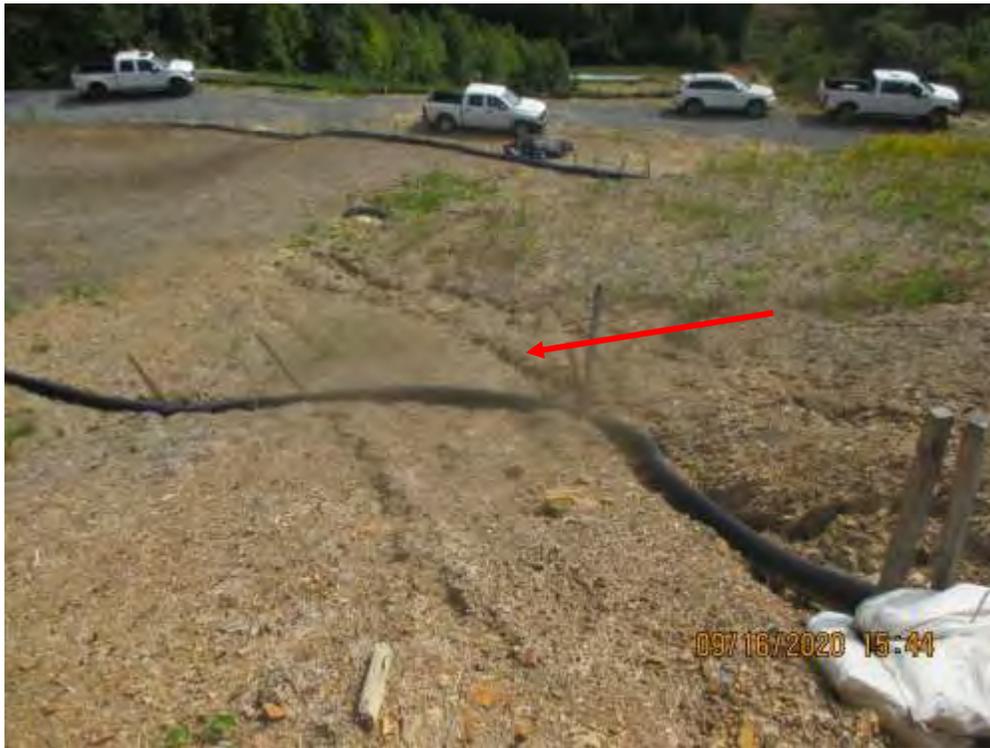
Standing at Access Road 159.01 facing upslope at station No. 6450+76. Erosion present on cut slope and above controls. (red arrow).

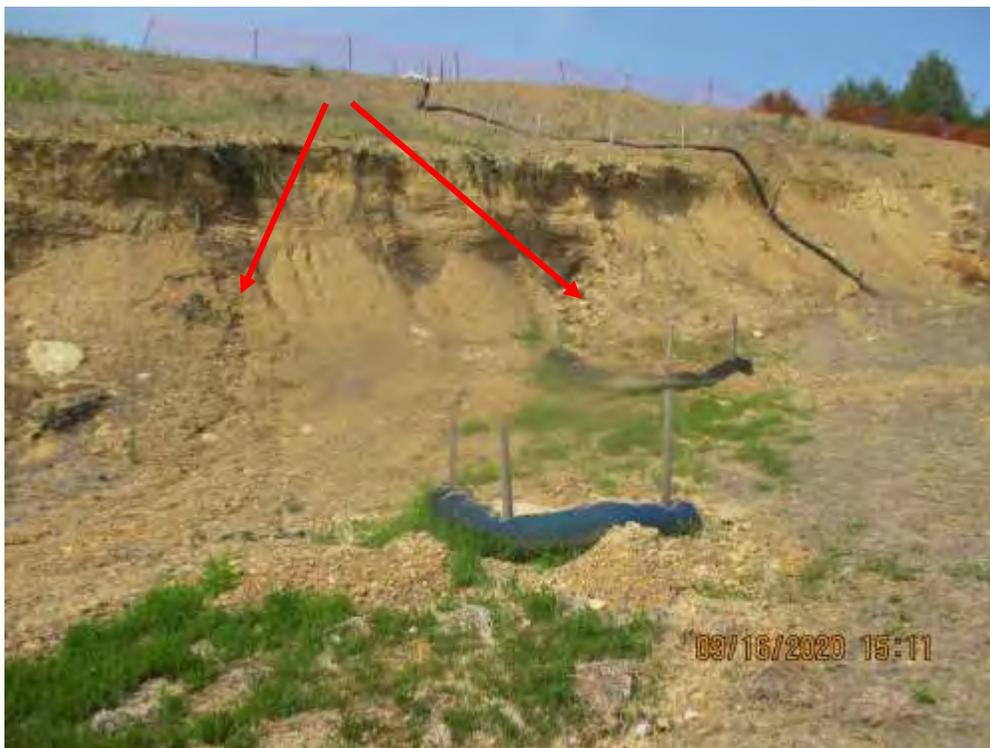
Standing at station No. 6450+76 at slope drain. Run off causing erosion on cut slope. (red arrow)

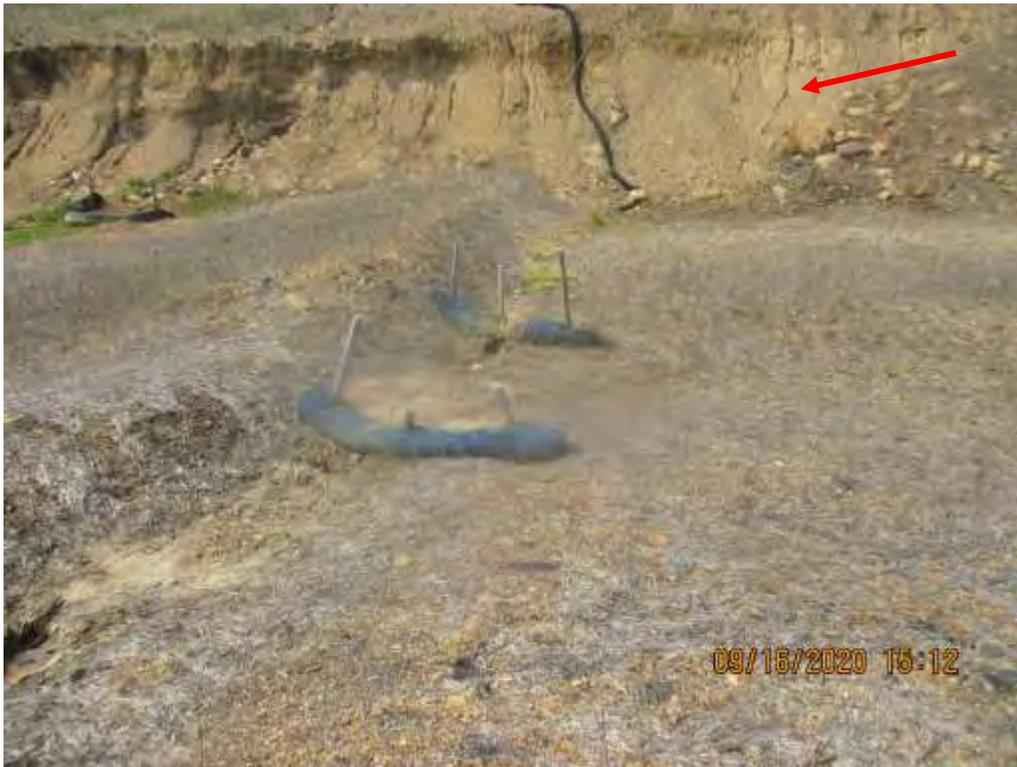
Erosion occurring on cut slope (red arrow) below slope drain outlet at Station No. 6450+76.

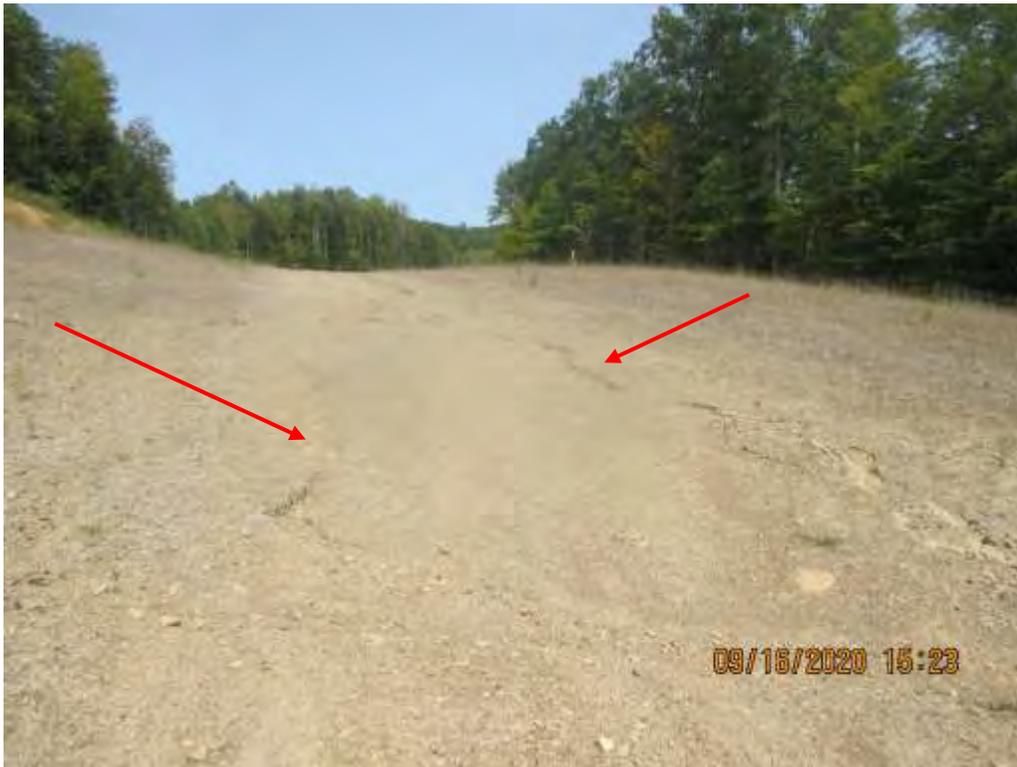
Near Station NO. 6450+76 facing North. Area had not ben reseeded since last Fall.

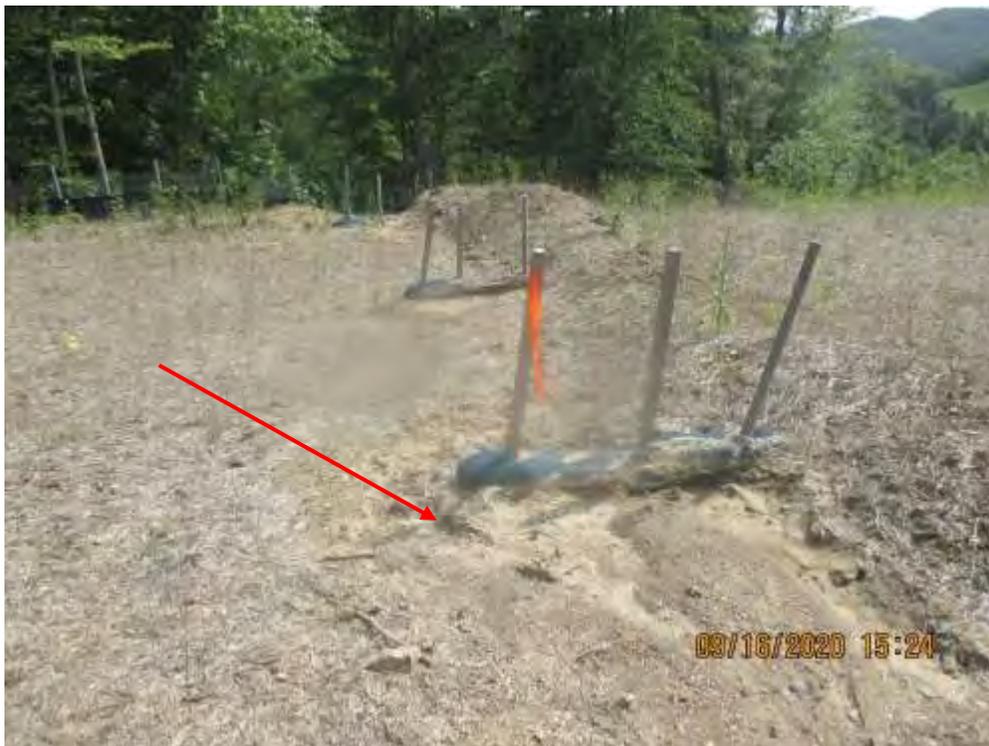
Near Station 6450+76 facing upslope at erosion on slope (red arrow).

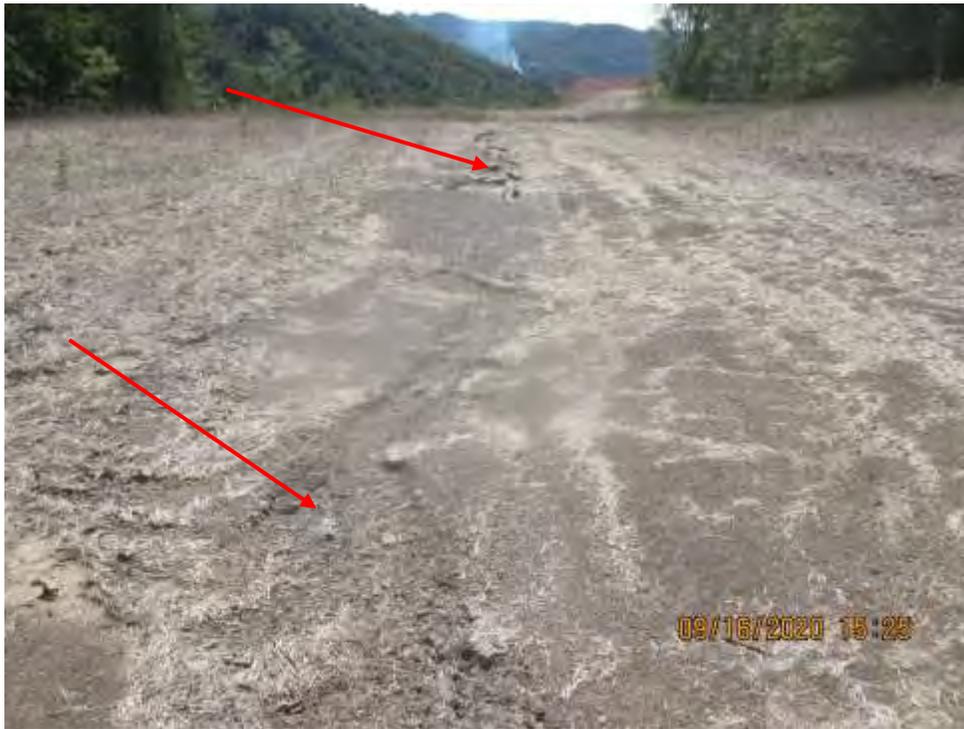
Near Station 6450+76 facing downslope at erosion in Waterbar (red arrow). Sediment was being deposited in Waterbar and run off was flowing around unmaintained controls.

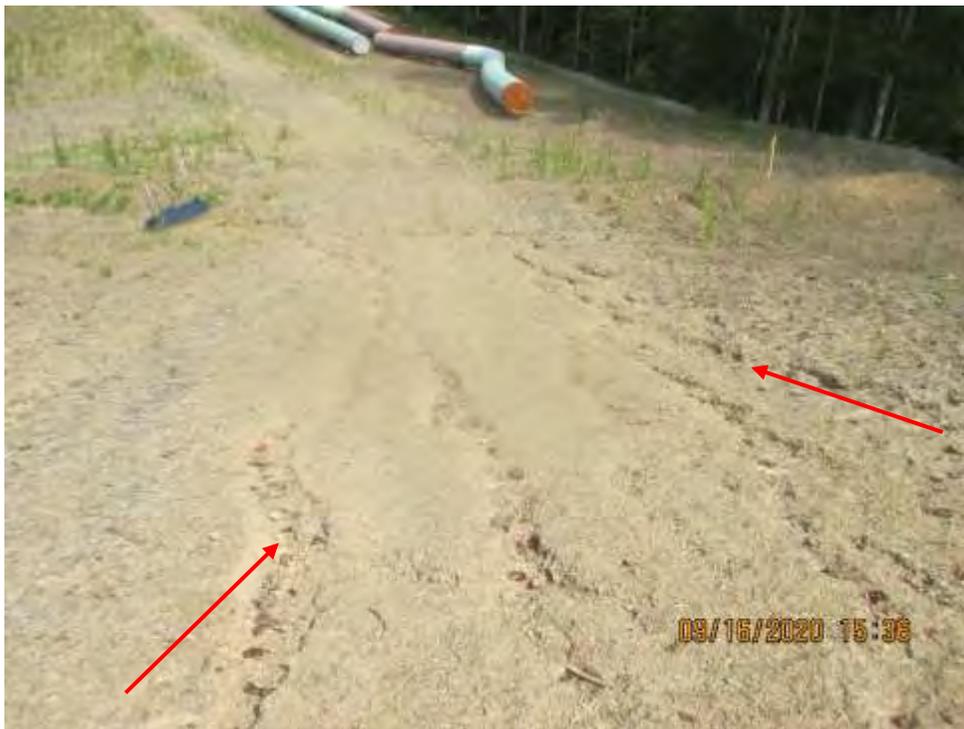
Section of ROW upslope from 6450+76 that was not reseeded since Fall of 2019. Red arrow shows erosion occurring due to increased sheet flow.
