**The Wilderness Society et al. Comments on the  
U.S. Forest Service Mountain Valley Pipeline and  
Equitrans Expansion Project Draft Supplemental  
Environmental Impact Statement (#50036)**

**EXHIBIT 1**

Assessment of erosion, sedimentation, and water quality impacts of the Mountain Valley Pipeline and Equitrans Expansion Project's proposed crossing of the Jefferson National Forest as it pertains to the U.S. Forest Service's Draft Supplemental Environmental Impact Statement dated December 2022

Prepared by Jonathan A. Czuba, Ph.D., Licensed Professional Engineer

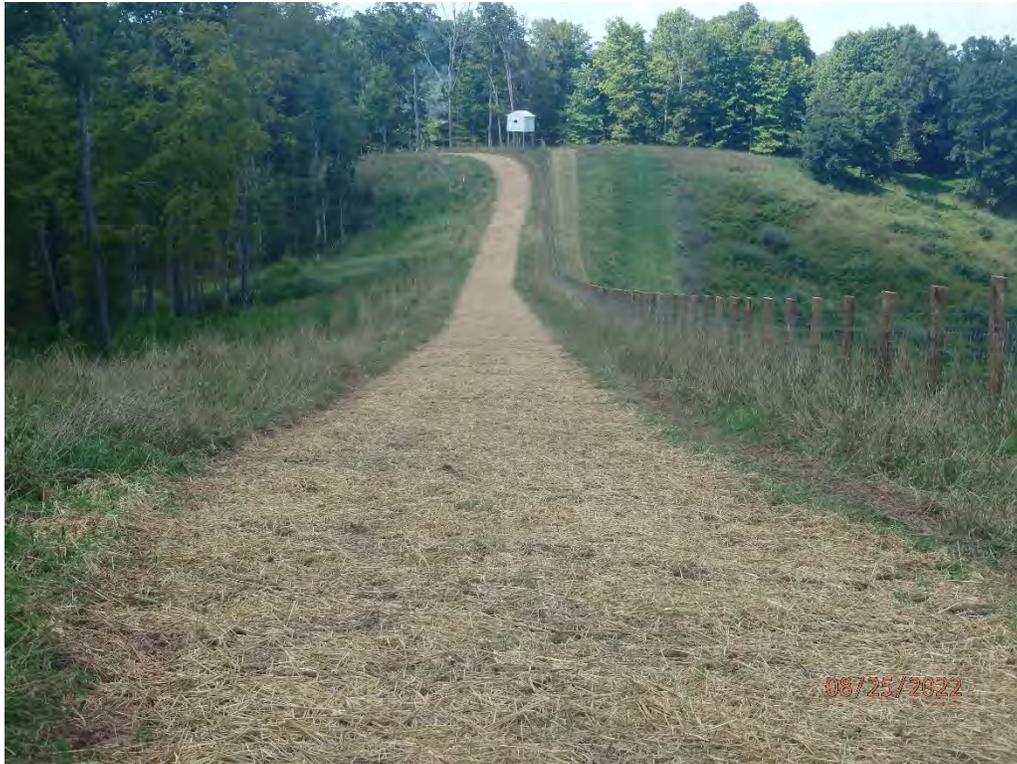
Project area adjacent to 3125+00 showing the lack of an installed water bar and the lack of an installed temporary ROW diversion, or equivalent, as indicated in the approved SWPPP.

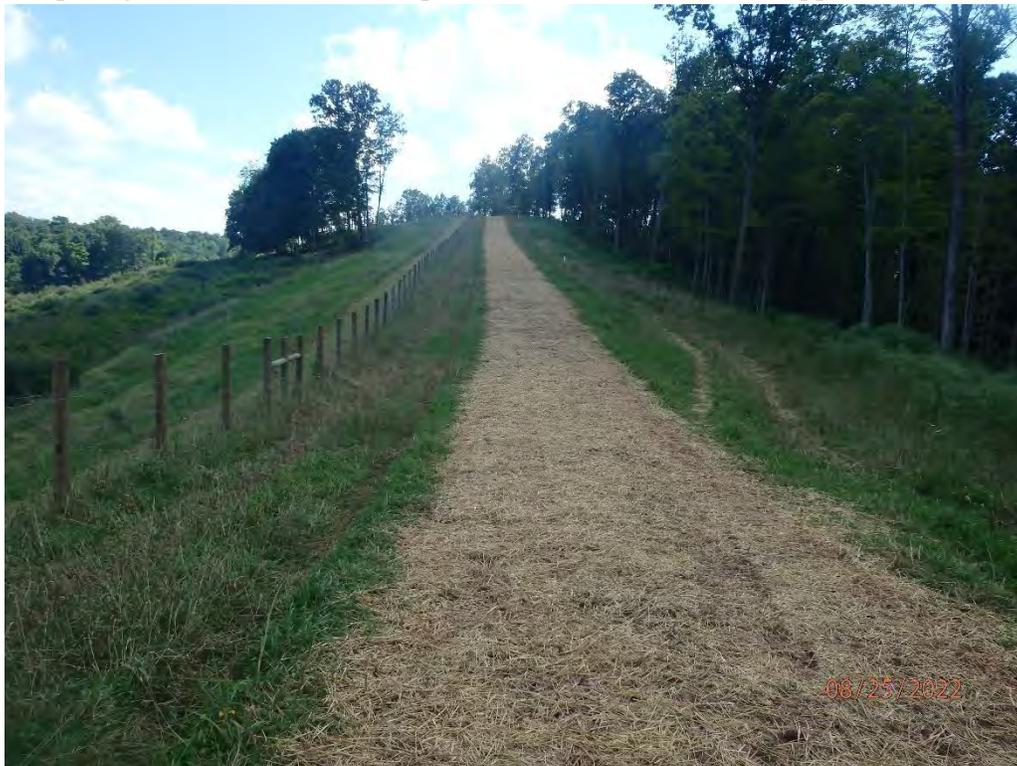
Project area adjacent to 3125+00 showing the lack of an installed water bar and the lack of an installed temporary ROW diversion, or equivalent, as indicated in the approved SWPPP.

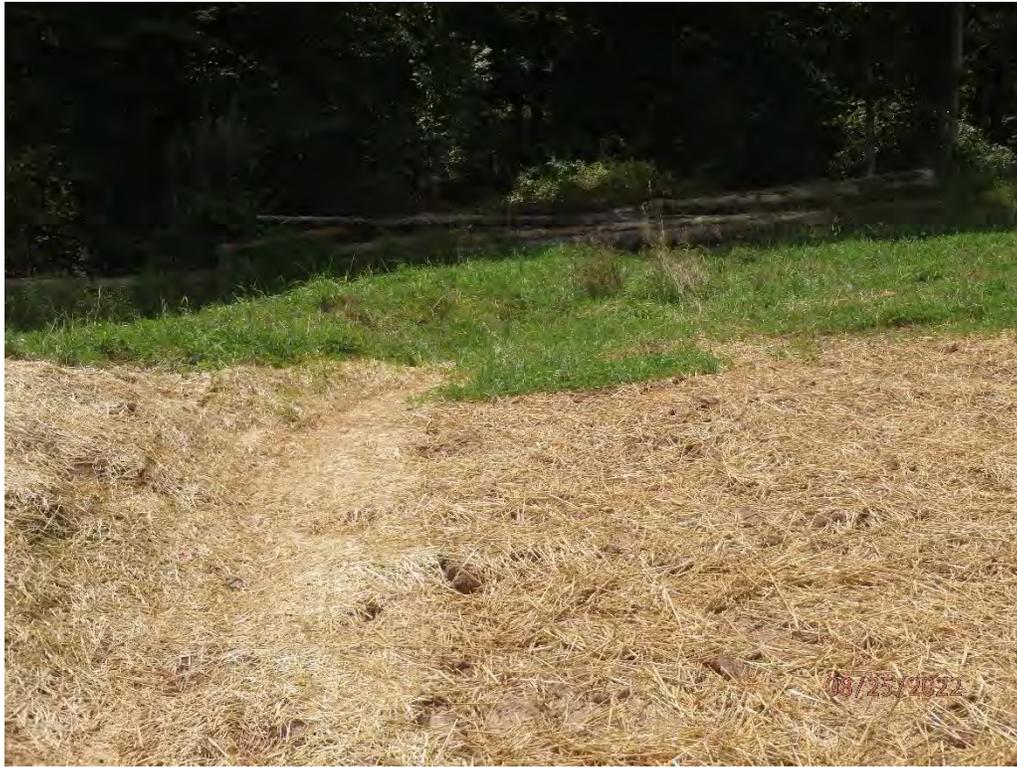
Installed water bar adjacent to 3310+00 showing the lack of installed outlet treatment that is indicated in the approved SWPPP.

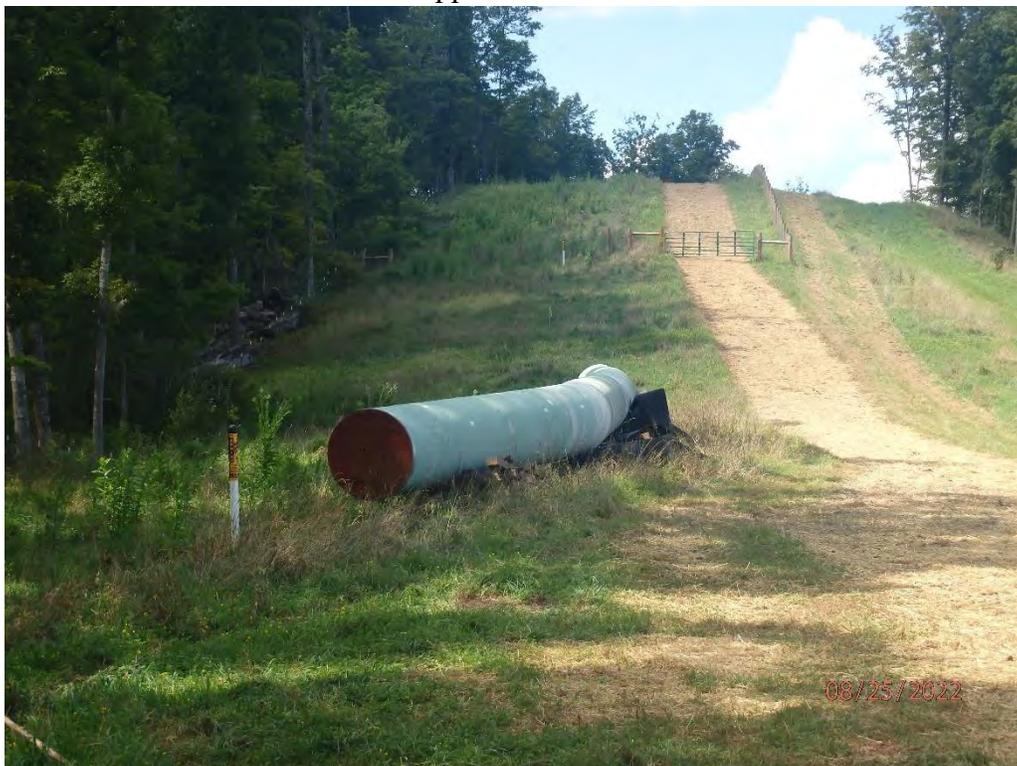
Project area upslope of 3132+00 showing the lack of installed water bars indicated in the approved SWPPP.

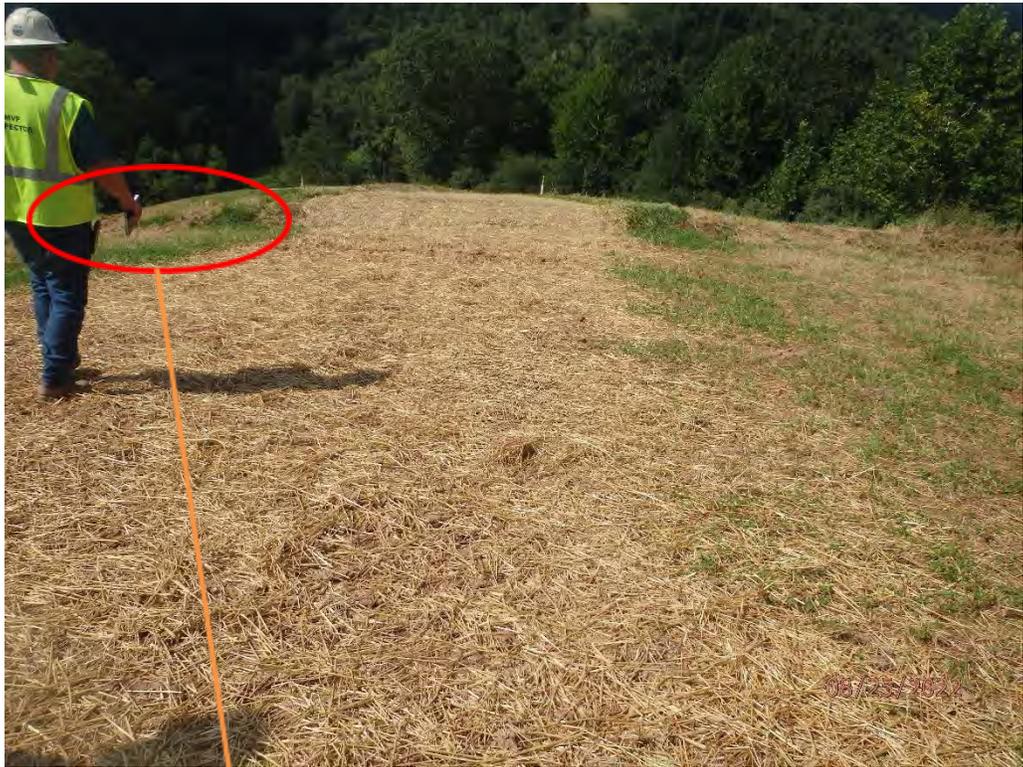
Installed water bar adjacent to 3112+25 showing the lack of installed outlet treatment that is indicated in the approved SWPPP.

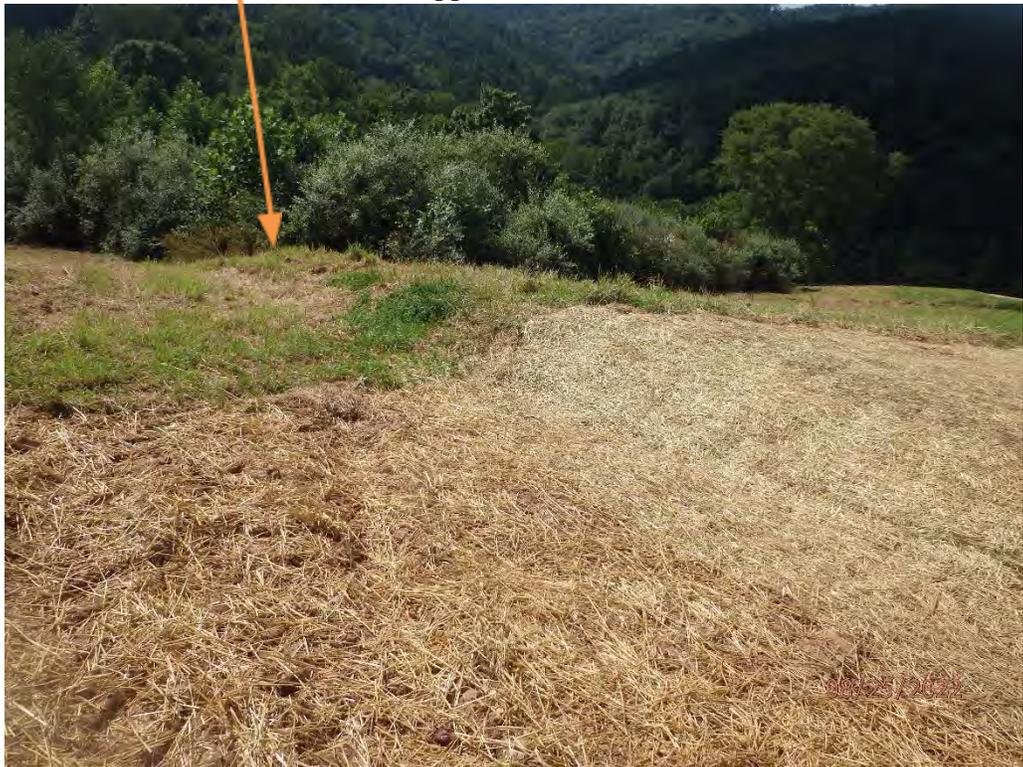
Installed water bar adjacent to 3112+25 showing the lack of installed outlet treatment that is indicated in the approved SWPPP.

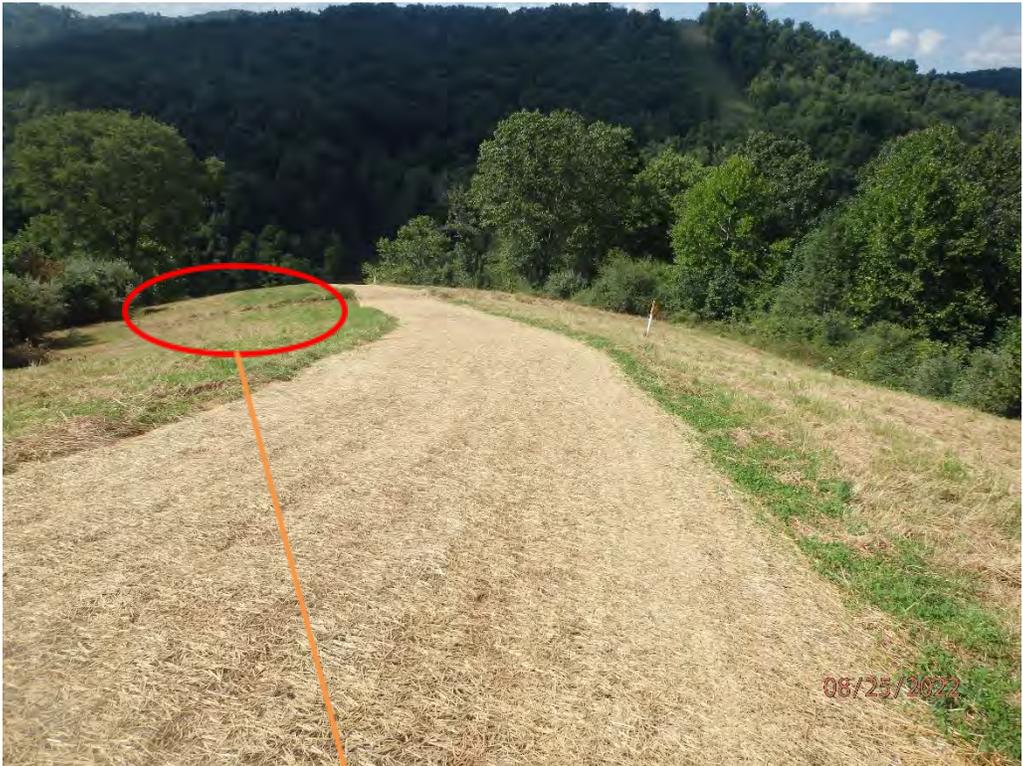
Installed water bar adjacent to 3109+25 showing the lack of installed outlet treatment that is indicated in the approved SWPPP.

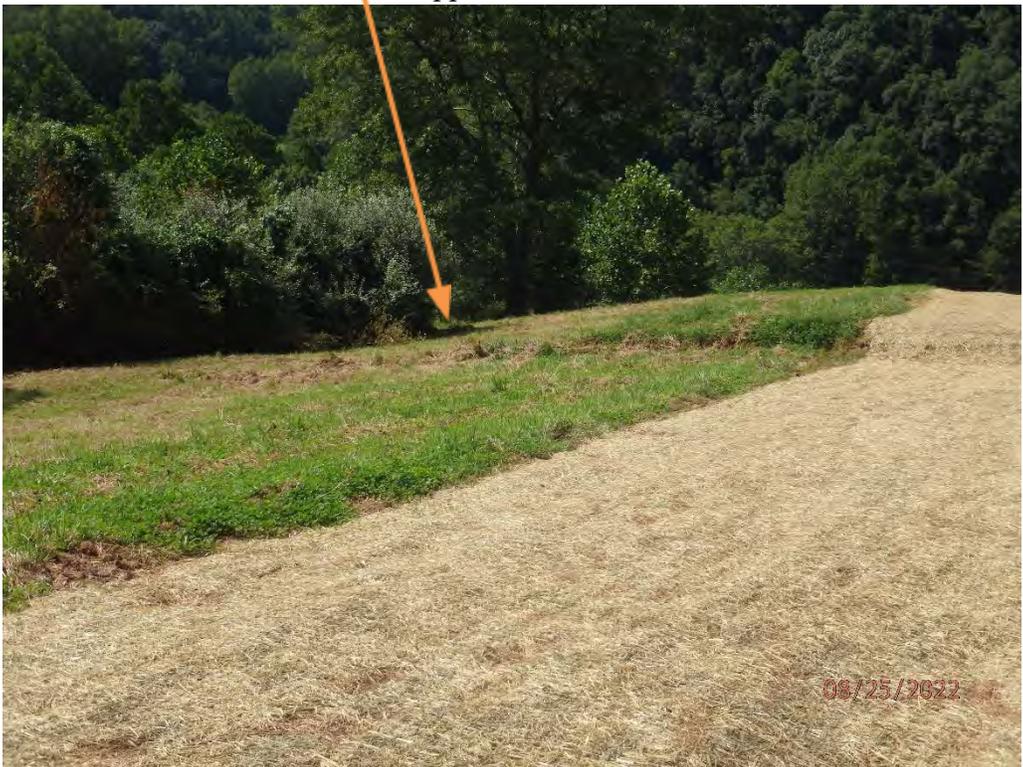
Installed water bar adjacent to 3109+25 showing the lack of installed outlet treatment that is indicated in the approved SWPPP.

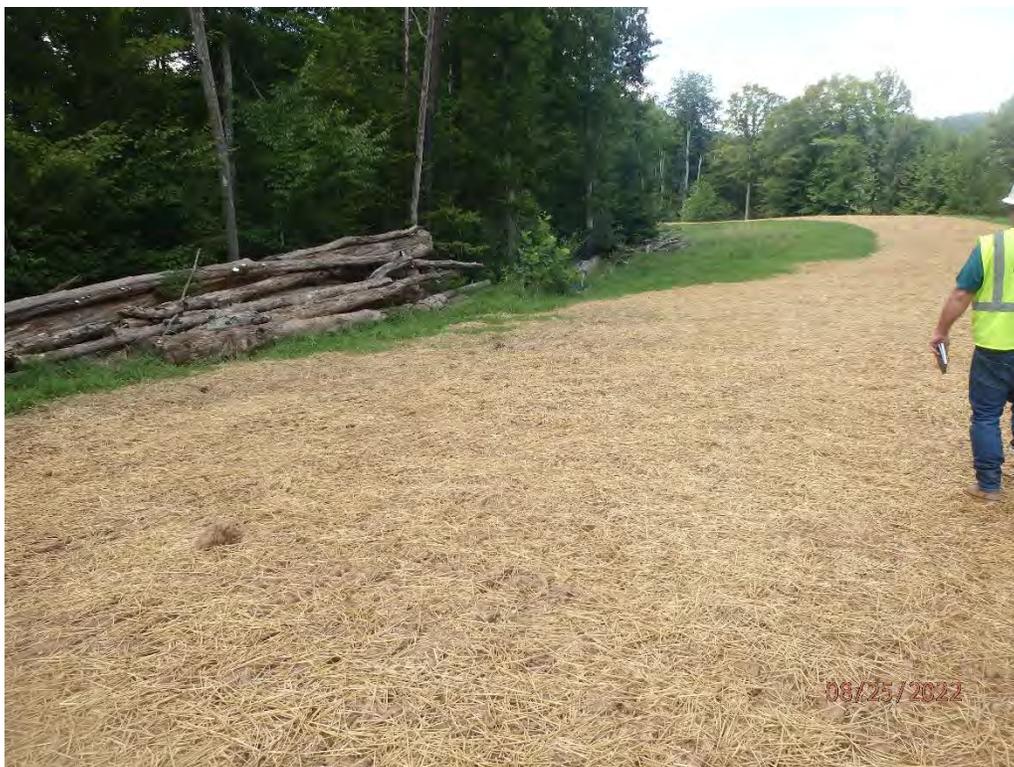
Area of disturbance adjacent to 3316+00 showing the lack of an installed temporary ROW diversion, or equivalent, as indicated in the approved SWPPP.

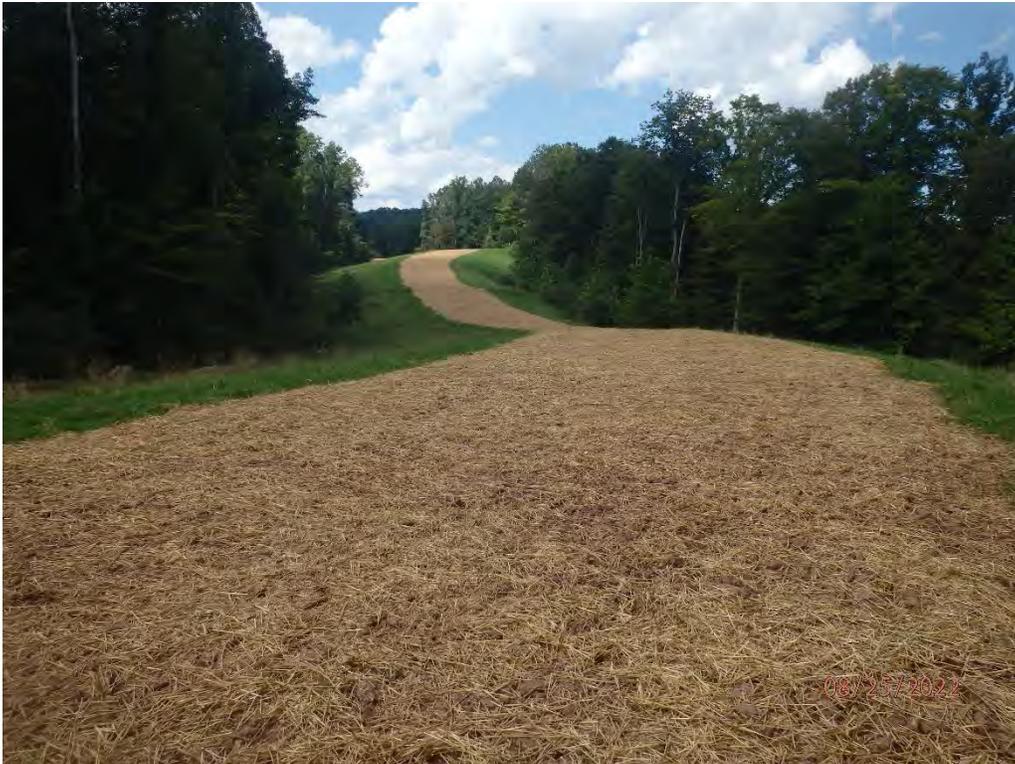
Area of disturbance adjacent to 3312+00 showing the lack of an installed temporary ROW diversion, or equivalent, as indicated in the approved SWPPP.

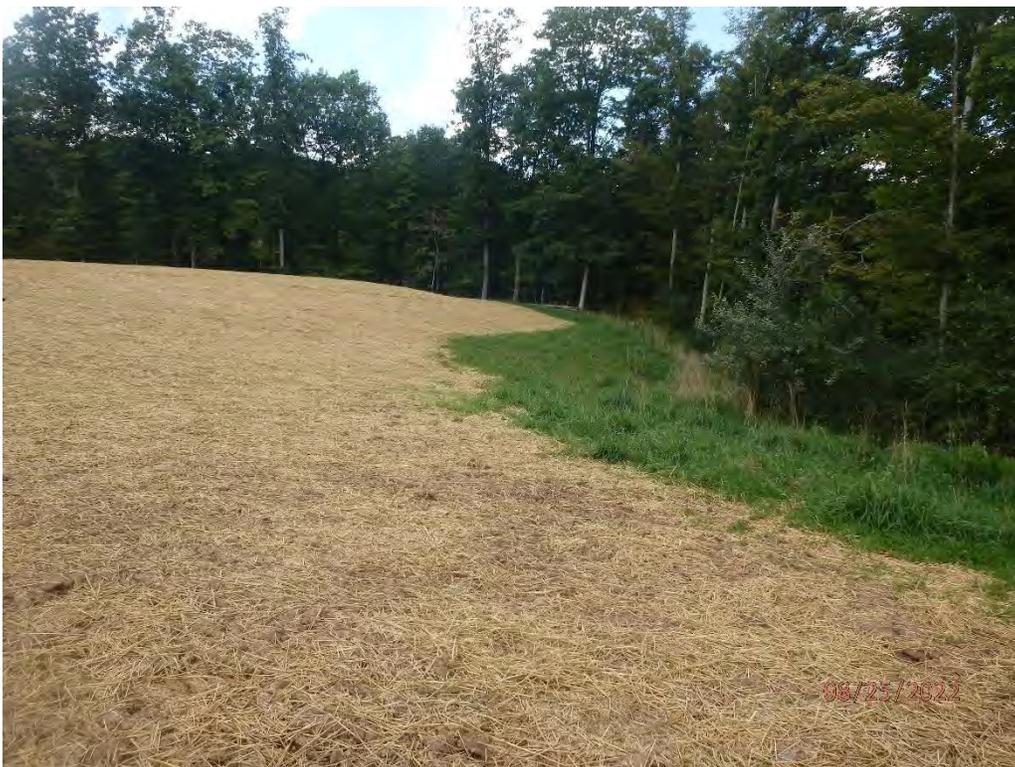
Area of disturbance associated with the ATWS materials and parking adjacent to 3304+00 showing the lack of an installed temporary ROW diversion, or equivalent, as indicated in the approved SWPPP.

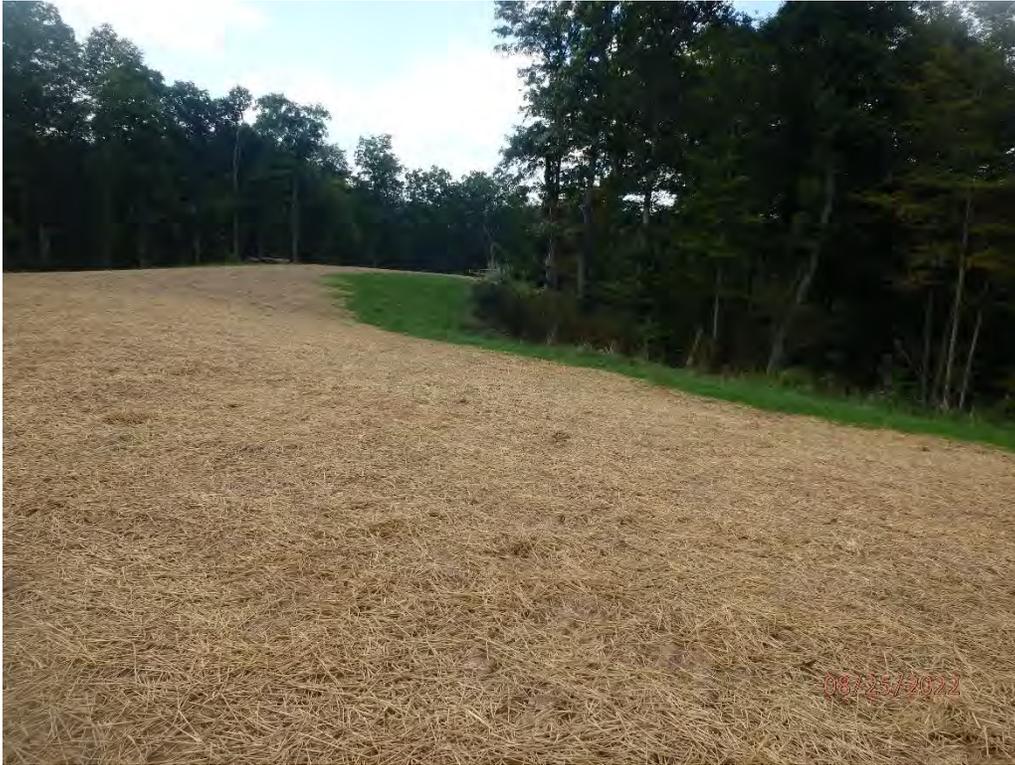
Area of disturbance associated with the ATWS materials and parking adjacent to 3304+00 showing the lack of an installed temporary ROW diversion, or equivalent, as indicated in the approved SWPPP.

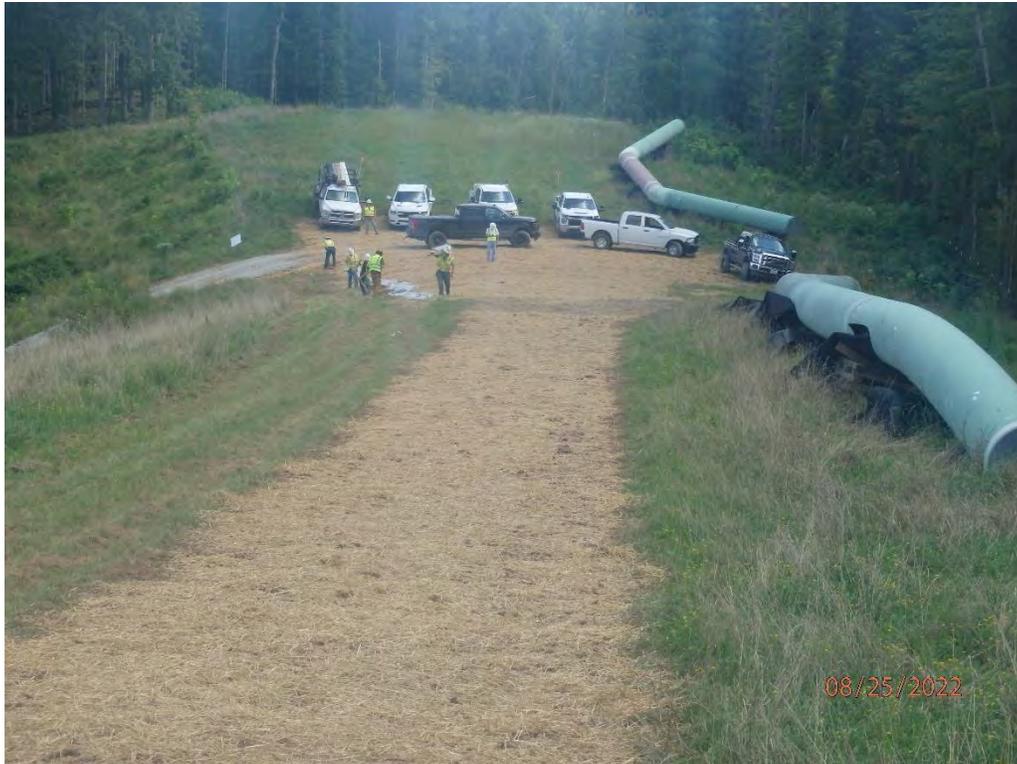
Area of disturbance associated with the ATWS materials and turning adjacent to 3134+00 showing the lack of installed super silt fence and compost filter sock as indicated in the approved SWPPP. Crews working in installing BSRF priority 1 pictured.

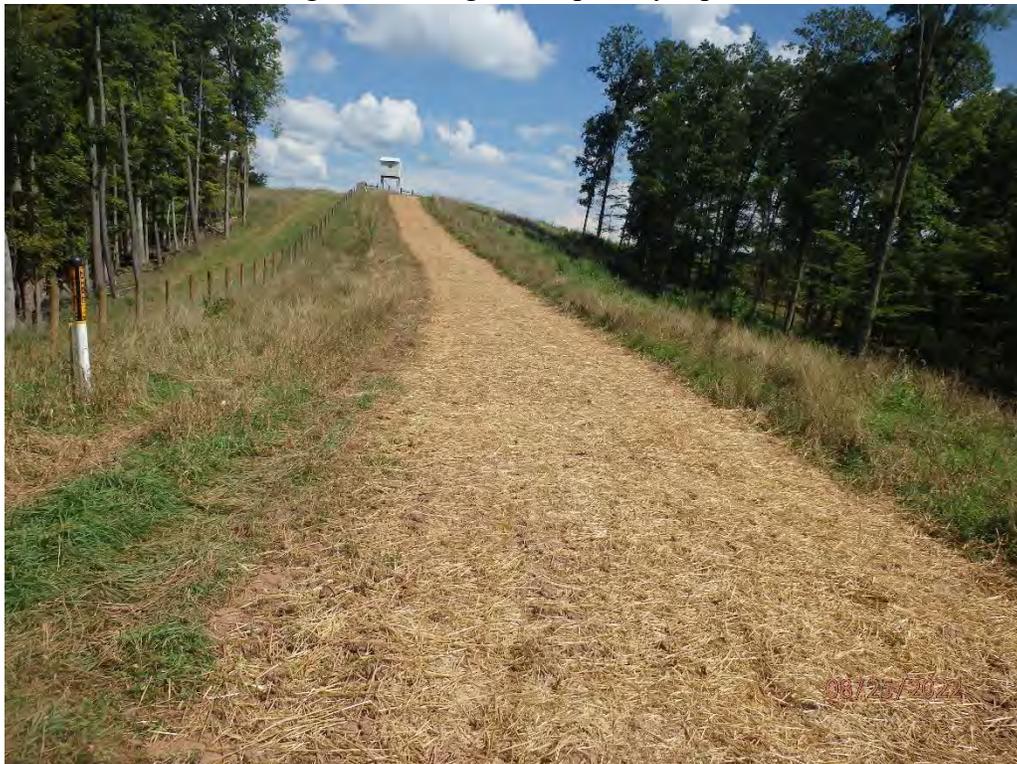
Area of disturbance upslope of 3114+50 showing the lack of an installed temporary ROW diversion, or equivalent, as indicated in the approved SWPPP.

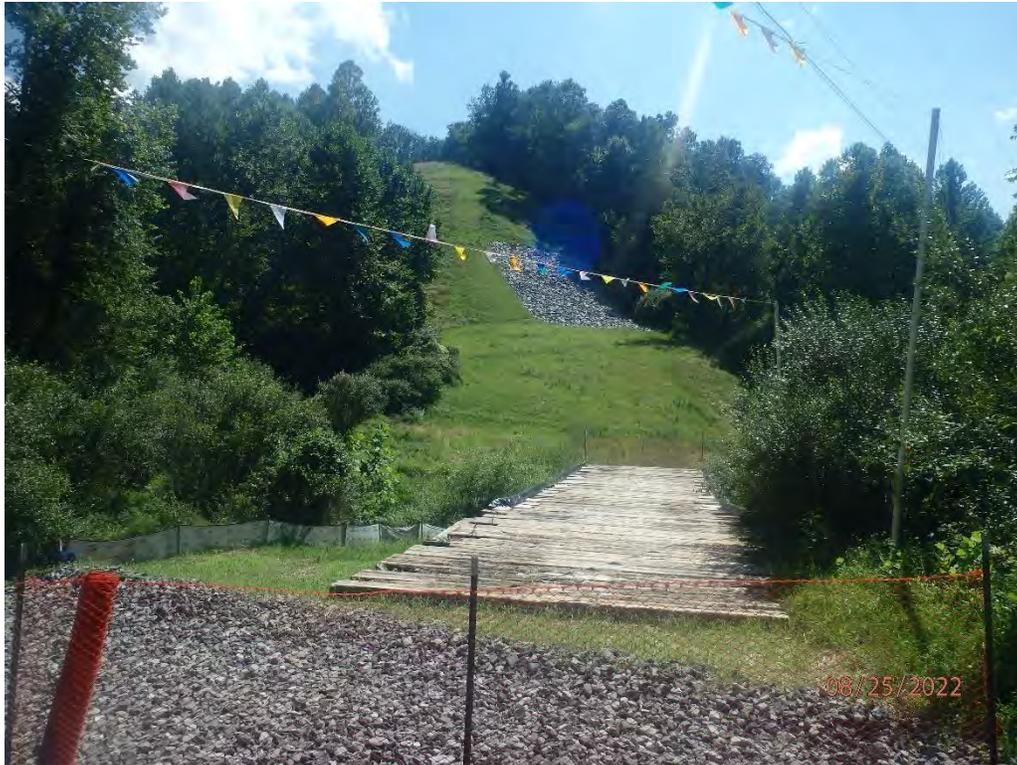
Threelick Run complaint area showing the site as in compliance in the pictured area.

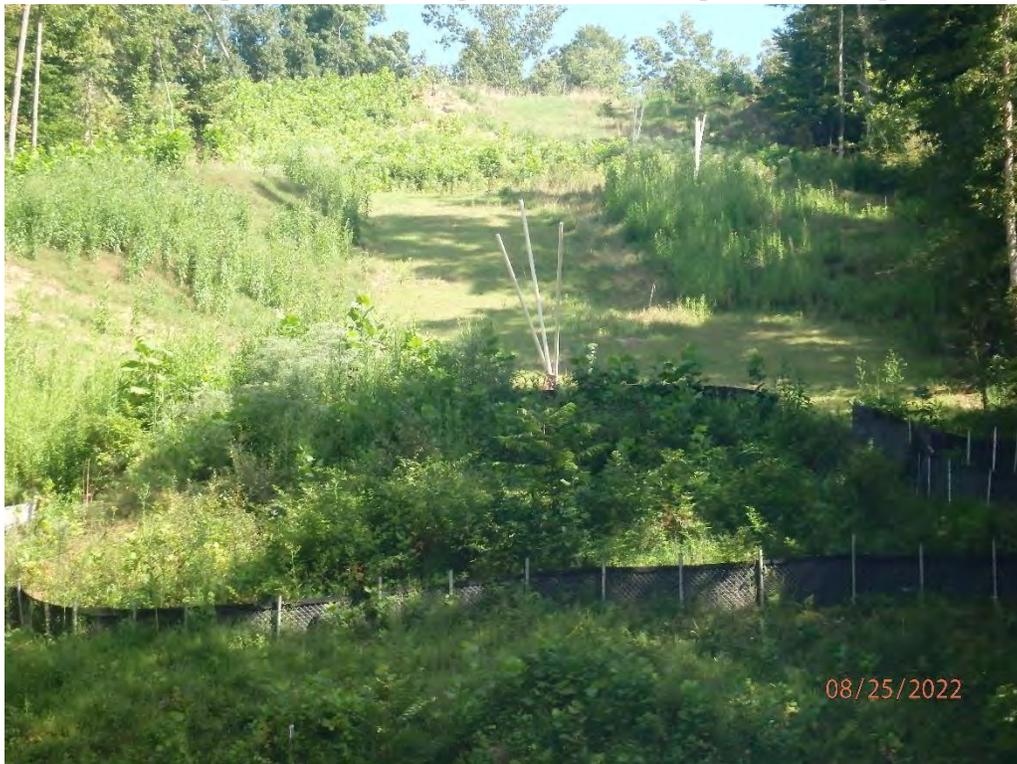
Copley Road / Sand Fork complaint area showing the site as in compliance in the pictured area.

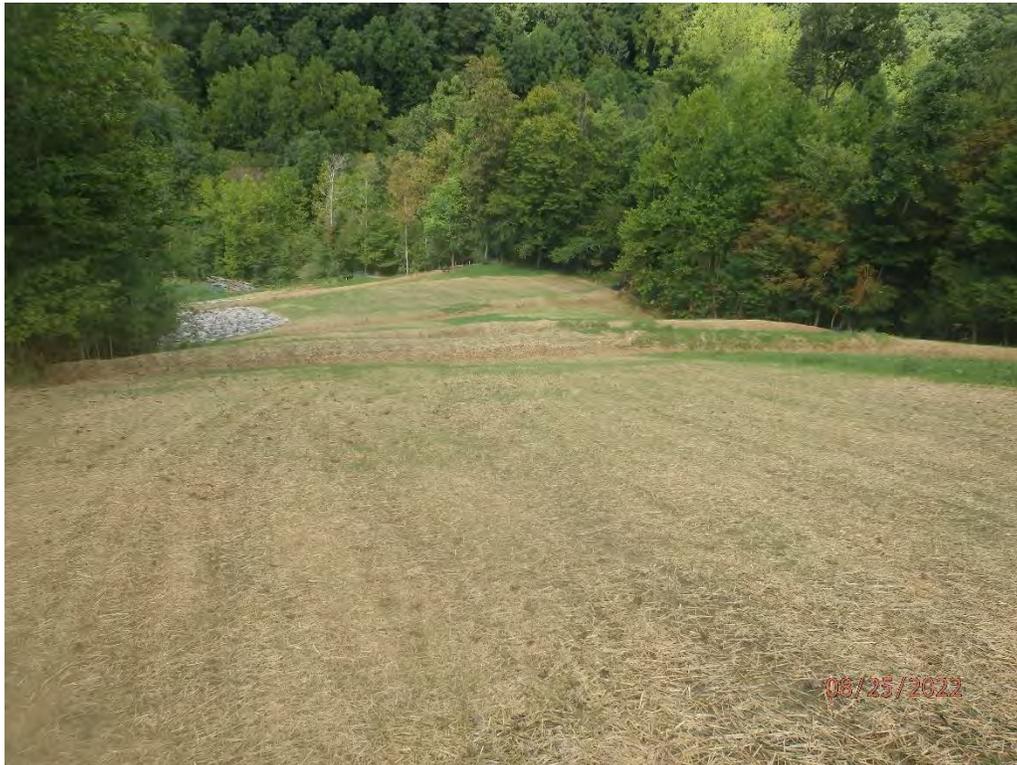
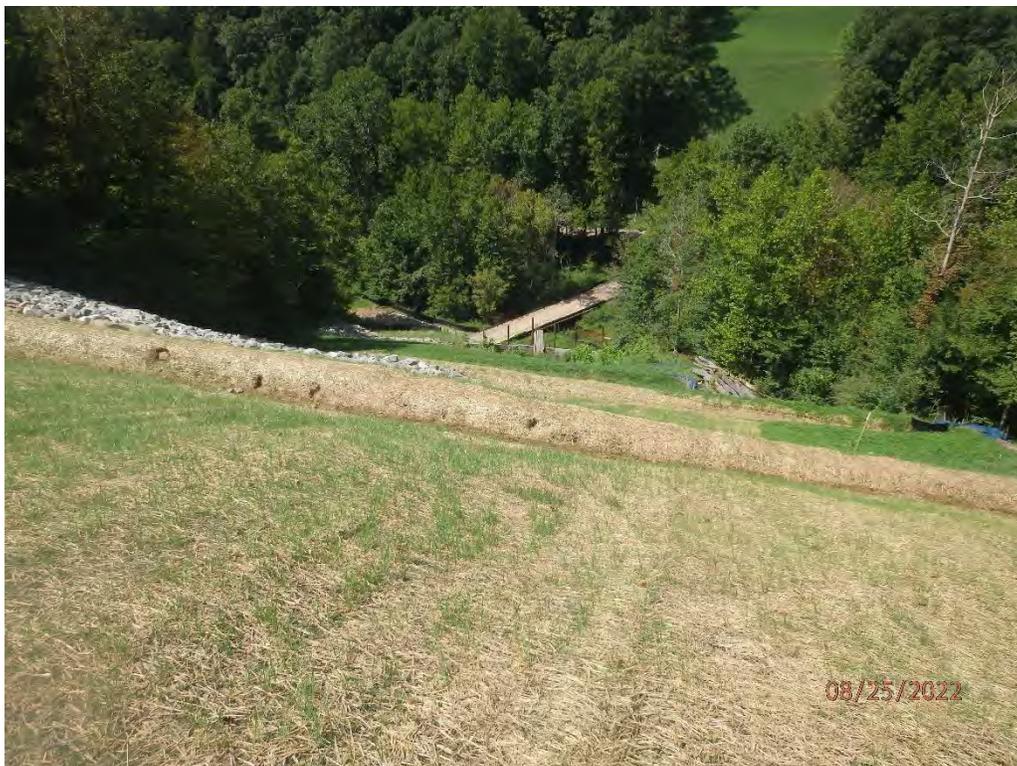
Oil Creek complaint area showing the site as in compliance in the pictured area.

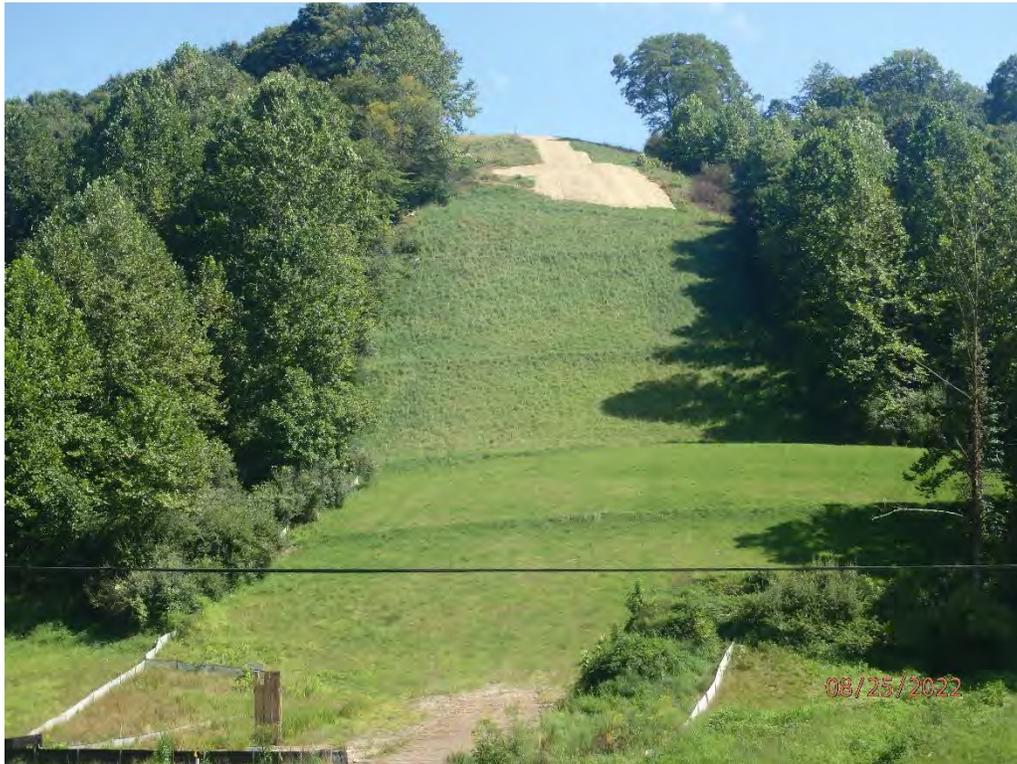
Indian Fork complaint area showing the site as in compliance in the pictured area.

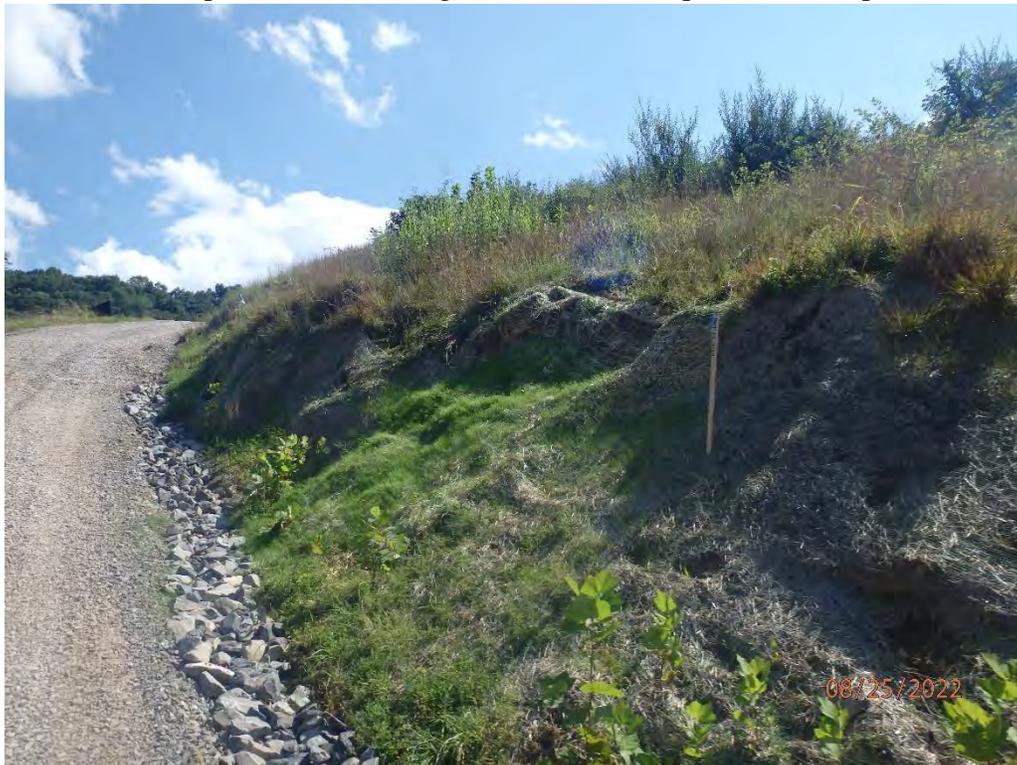
Indian Fork access road complaint area showing the site as in compliance in the pictured area.

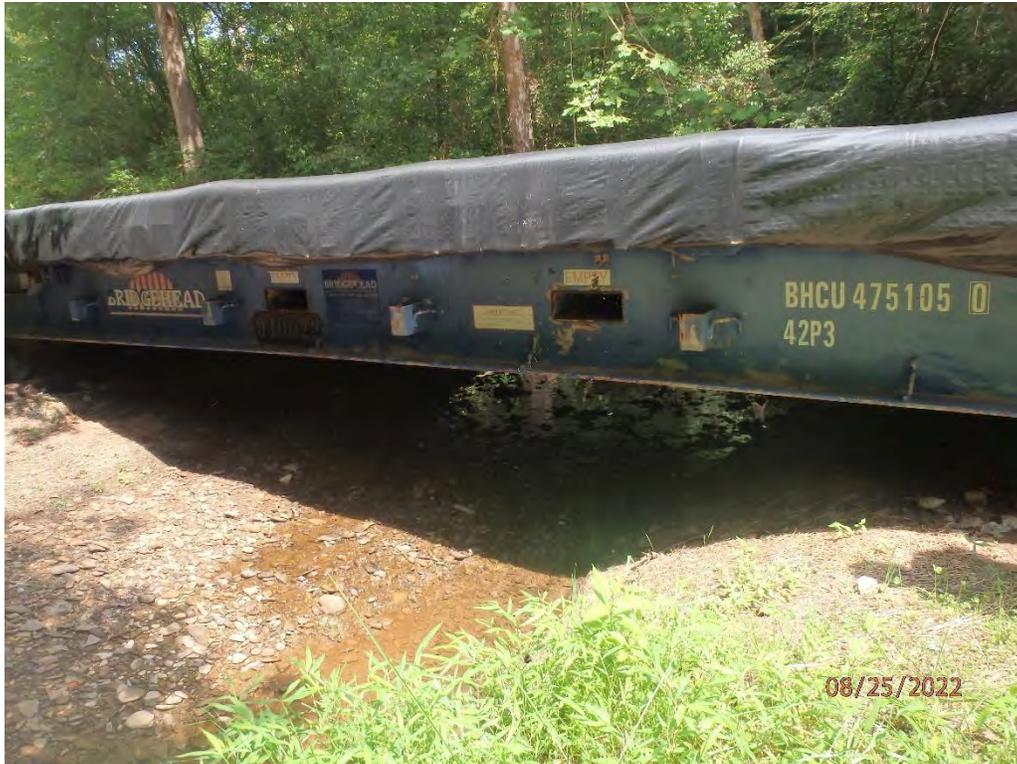
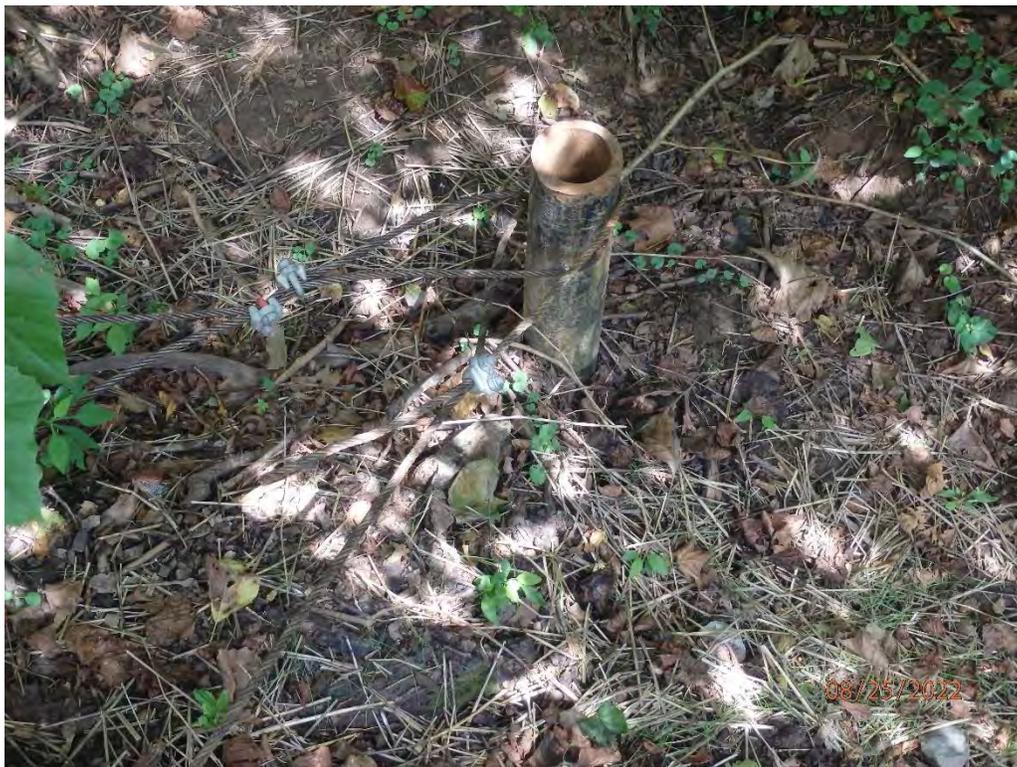
Overview of corrective measures taken on access road MVP-LE-077.01. at the S-W-13d crossing. The lower picture shows that the installed bridge has been appropriately tethered.
