**The Wilderness Society et al. Comments on the
U.S. Forest Service Mountain Valley Pipeline and
Equitrans Expansion Project Draft Supplemental
Environmental Impact Statement (#50036)**

EXHIBIT 12

**WEST VIRGINIA DEPARTMENT OF ENVIRONMENTAL PROTECTION
WV OIL AND GAS CONSTRUCTION STORMWATER PERMIT**

FACILITY NAME:	Mountain Valley Pipeline Project		REG. #	EXPIRE DATE:
PERMITTEE	MOUNTAIN VALLEY PIPELINE, LLC		WVR310667	5/13/2018 Extended: 12/31/2018
ADDRESS/PHONE:	Attn: MATTHEW HOOVER 625 LIBERTY AVE, ST 1700 PITTSBURG, PA 15222 7248733645			
LOCATION:	Harris Compressor Station		Entry Date/Time:	9/25/2018 1000
COUNTY:	Braxton		Exit Date/Time:	9/25/2018 1100
Site Representative /Phone	Brittany Dewitt (Lead EI)/330-987-1682, Matt Hoover MVP/ 412-258-5627 & Jason Hiles, Spread C Lead EI/740-334-7812		PHOTOS <input checked="" type="checkbox"/>	
CO-PERMITTEE:			ADDRESS:	
SITE OPERATOR:	MEC Construction LLC		ADDRESS:	19 RR Meadowbrook, WV 26404
PERMITTED ACREAGE	4311	WEATHER:	Cloudy	LAST INSPECTION: 8/21/2018
RECEIVING STREAM(S)	Trib of Elk/Kanawha R/ Ohio Rv			NOV: 1
Regular Mail <input type="checkbox"/> Certified Mail <input checked="" type="checkbox"/>	Tracking #			
OVERALL FACILITY R

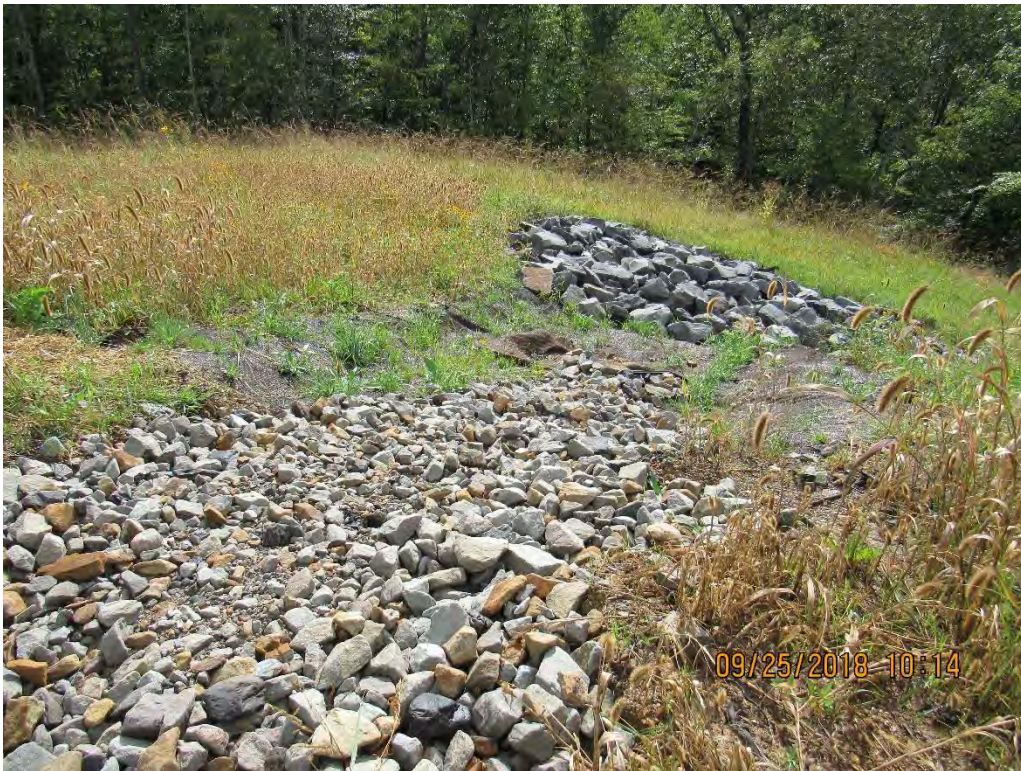
Photo 7: 1 of 2 covered underdrain outlets abating NOV# W18-52-007-CP.

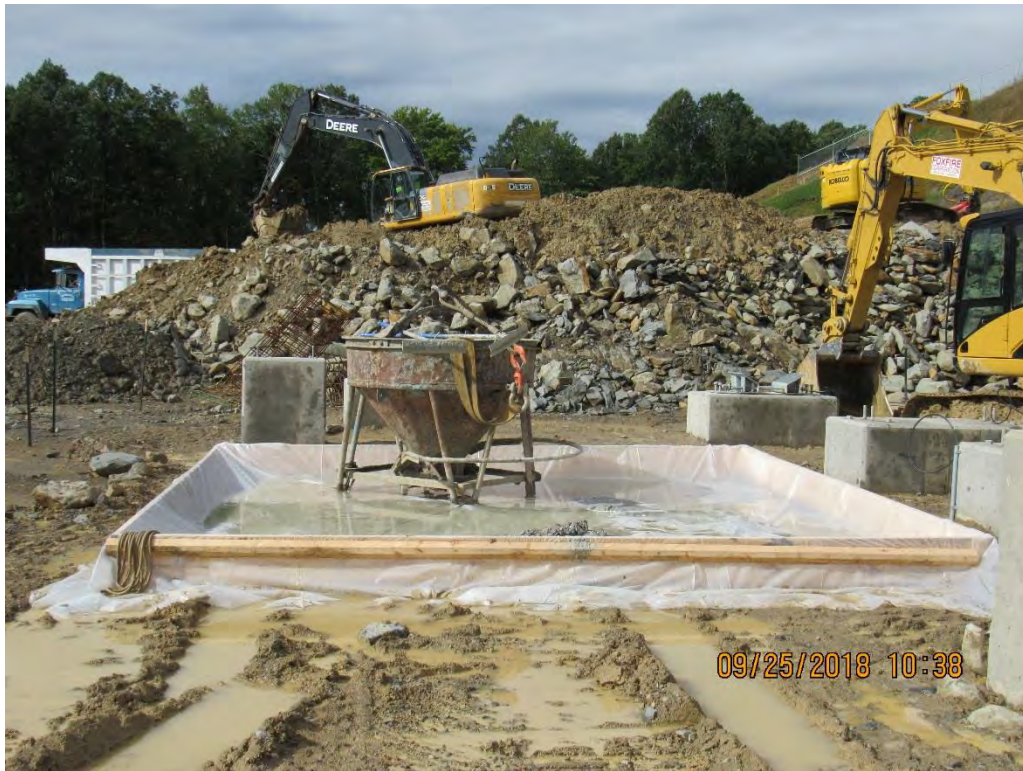
Photo 9: Properly installed concrete washout device abating NOV# W18-52-007-CP.

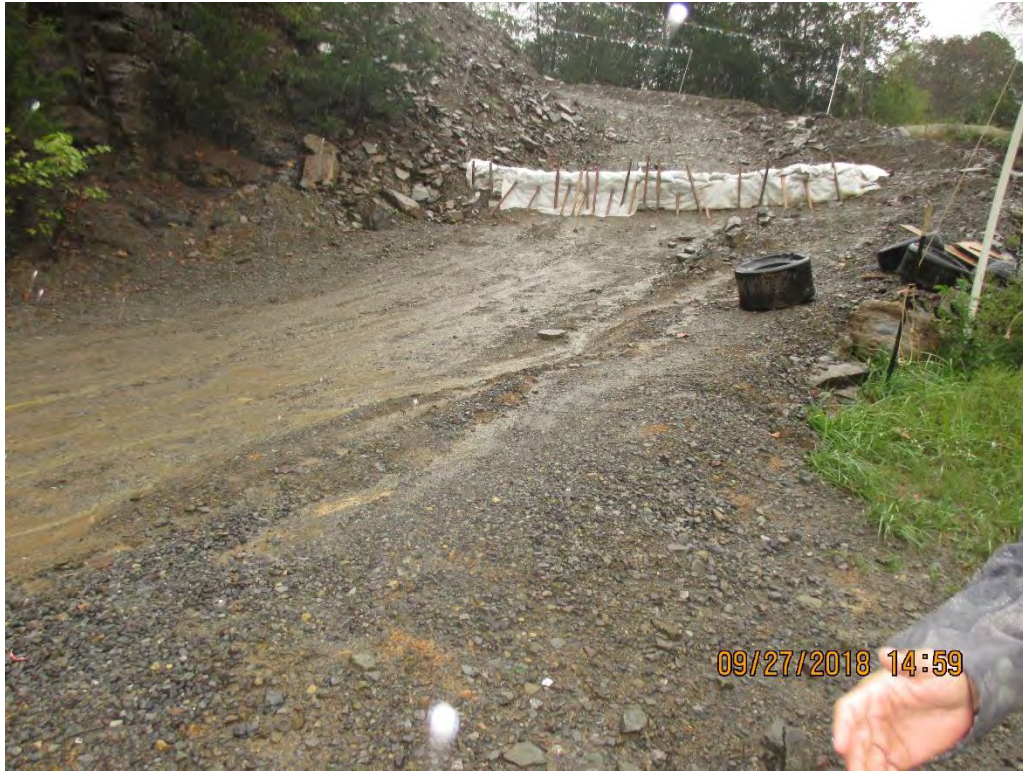
On 9/27/18 SLW was running off the MVP ROW at the CR122 intersection of the MVP ROW creating Conditions not Allowable in Indian Creek. Multiple BMP's were being overwhelmed and SLW was flowing off the ROW and past the LOD and flowing into the drainage that becomes S-A60 (Slate Run). A

Area where SLW was leaving site and being intercepted by road side ditch along Route 122.

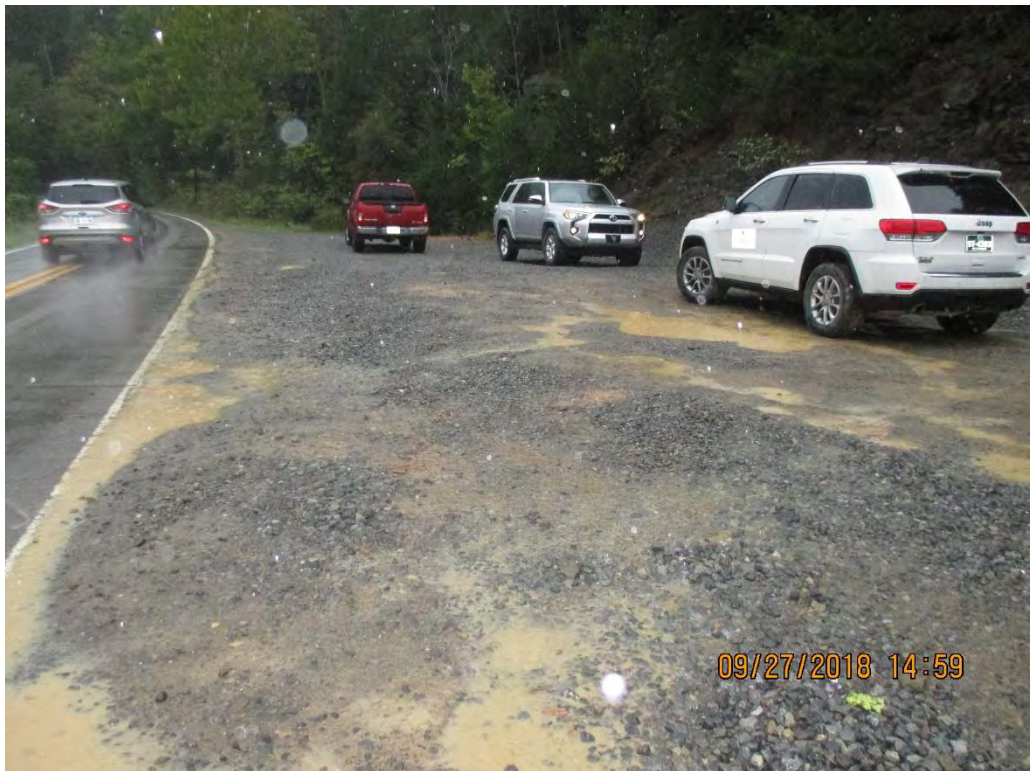
SLW accumulating and draining towards roadside ditch that intersects with S-A60 along Route122.

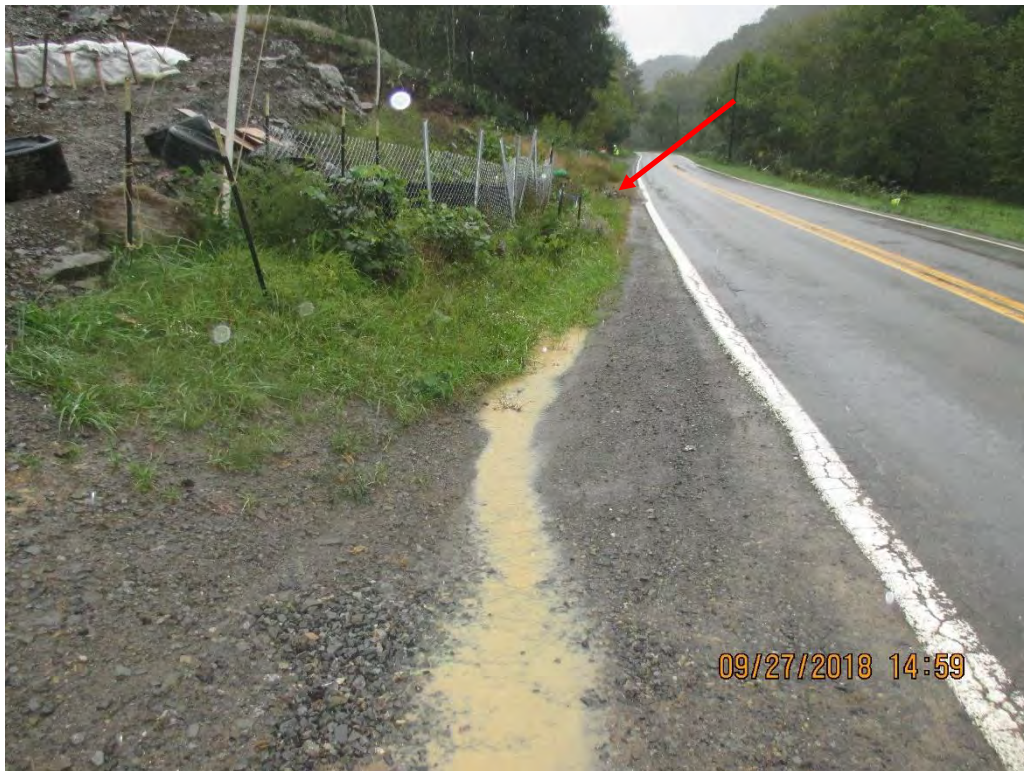
Sediment Laden water leaving ROW intercepted by ditch flowing towards Stream (S-A60). Arrow depicts where ditch connects to stream S-A60 and flows under road via culvert.

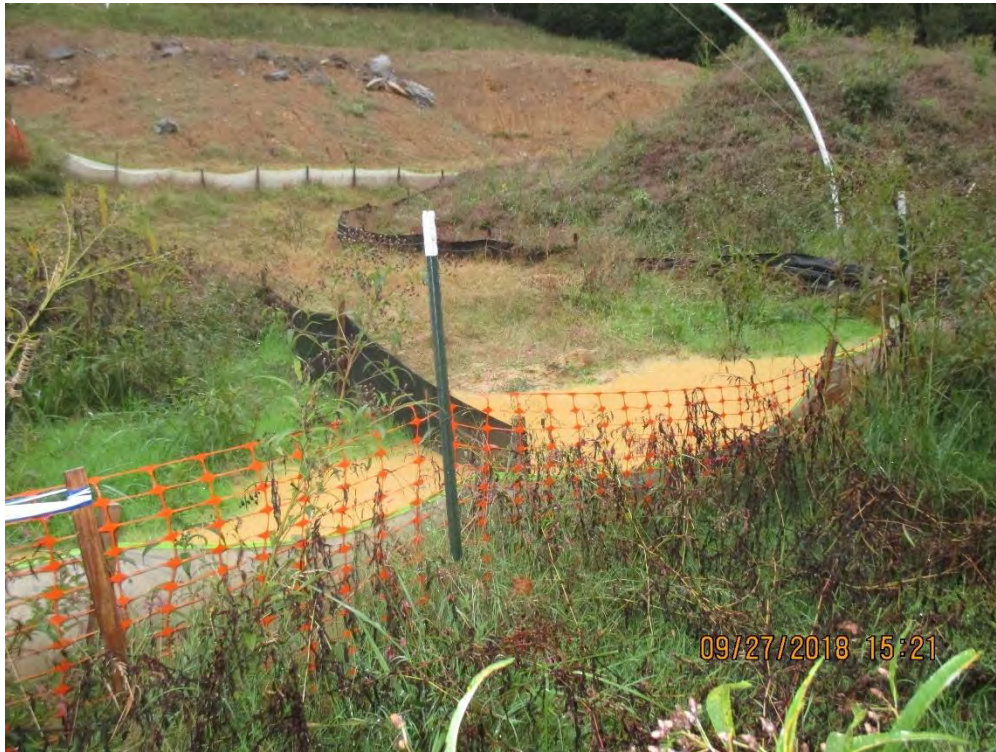
Lack of fill slope protection causing erosion and sediment laden water to accumulate and overwhelm BMP.

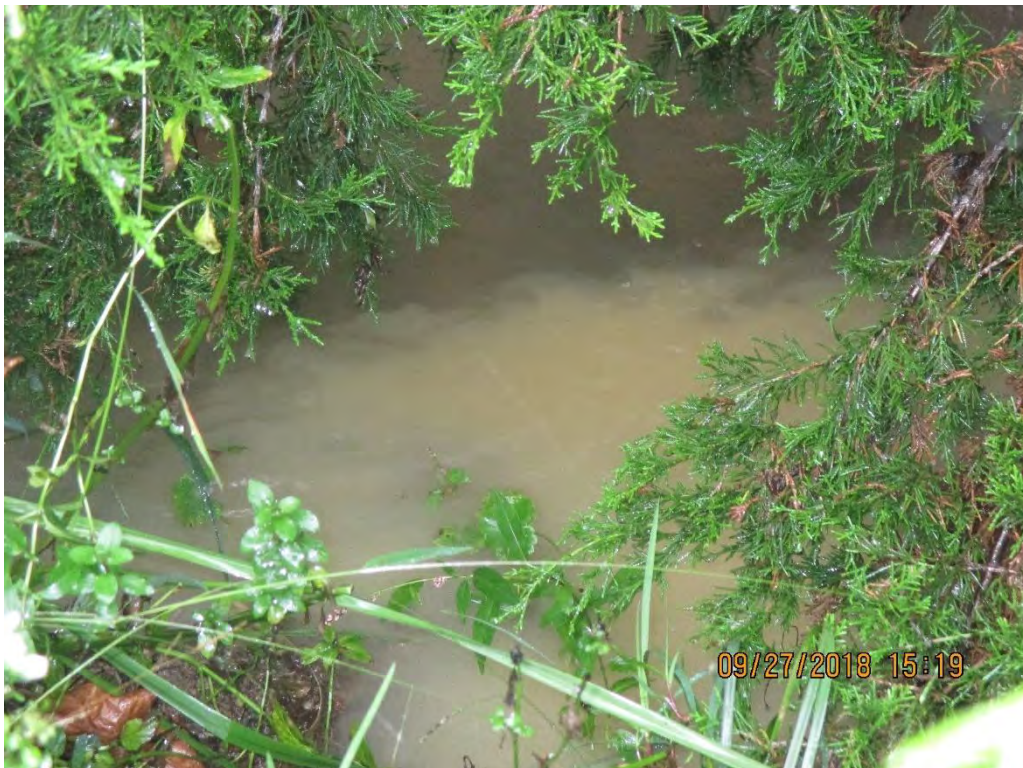
Sediment Laden water leaving project and entering stream (S-A60).

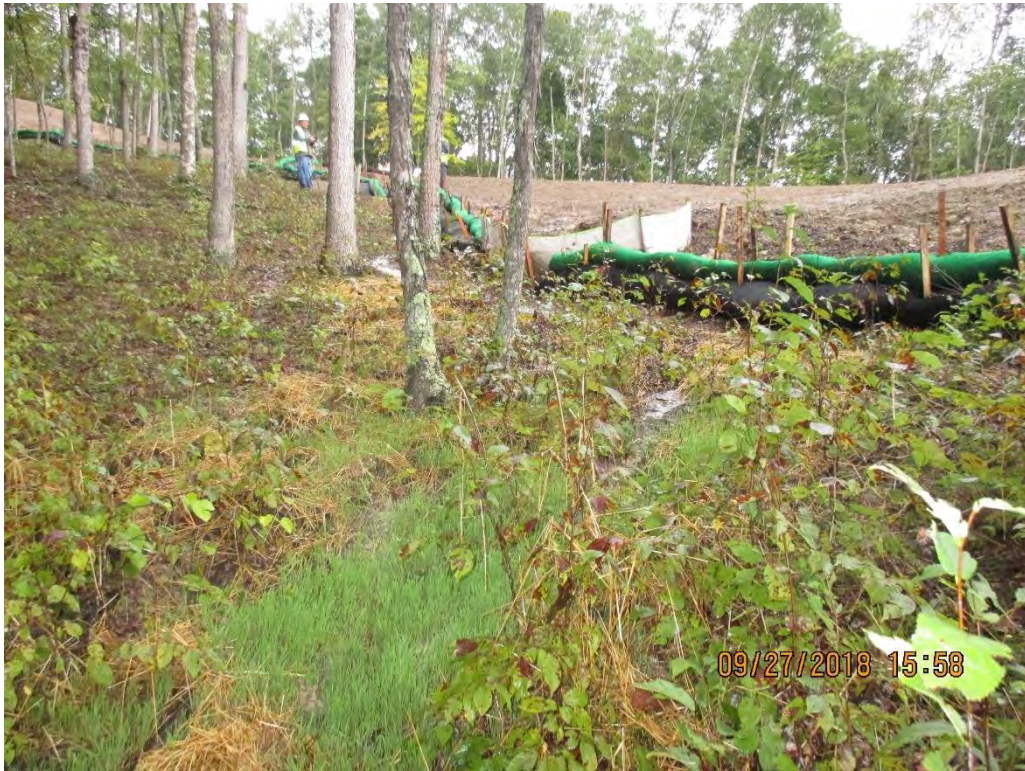
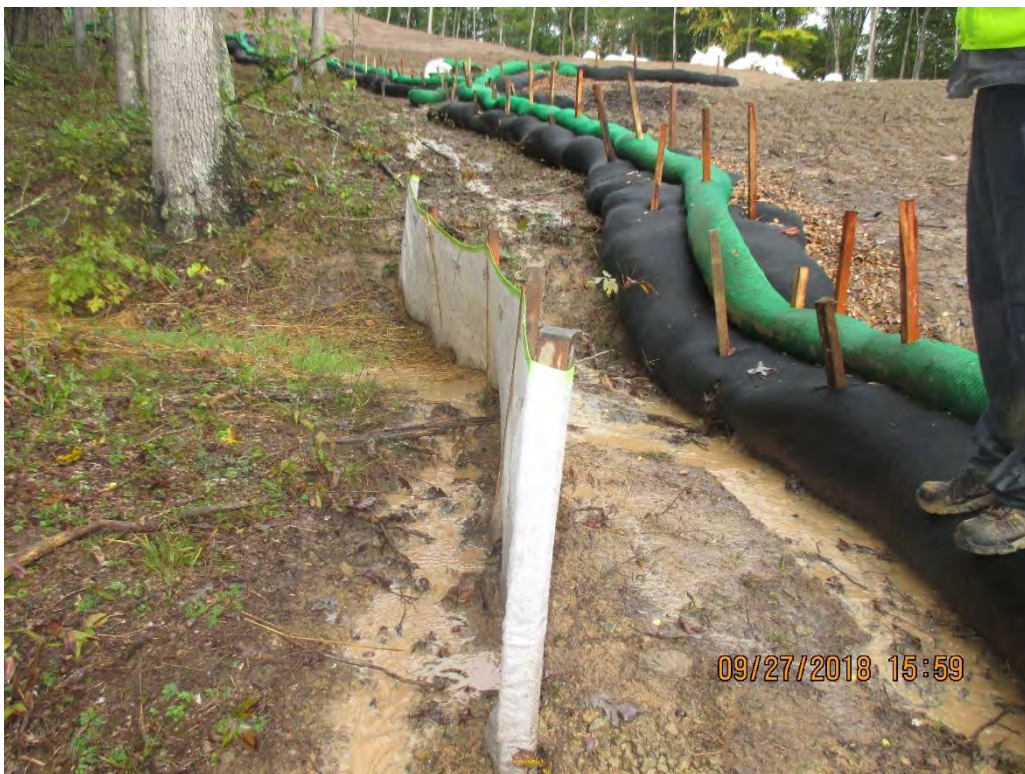
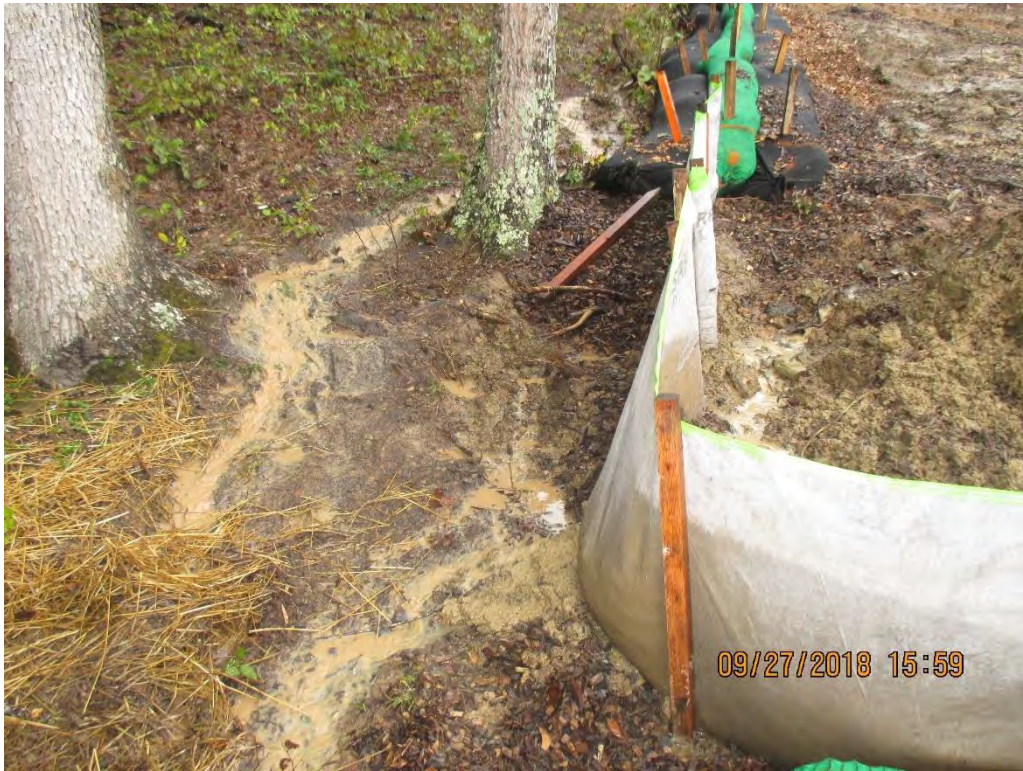
- 2.) (1, 6, 13, 19, 20) On 9/27/18 SLW was observed leaving portions of MVP ROW near Station #9417+75. SLW was overwhelming BMP's at several waterbar outlets and being transported off the ROW and past the LOD and impacting several ephemeral streams that drain into Stream S-A60. Adjacent to station numbers 9779+00 and 9778+00 water bar outlets were being overwhelmed and SLW was passing through BMP's and being transported past LOD.

Areas near station number 9417+75 where water bar terminus being overwhelmed with SLW.

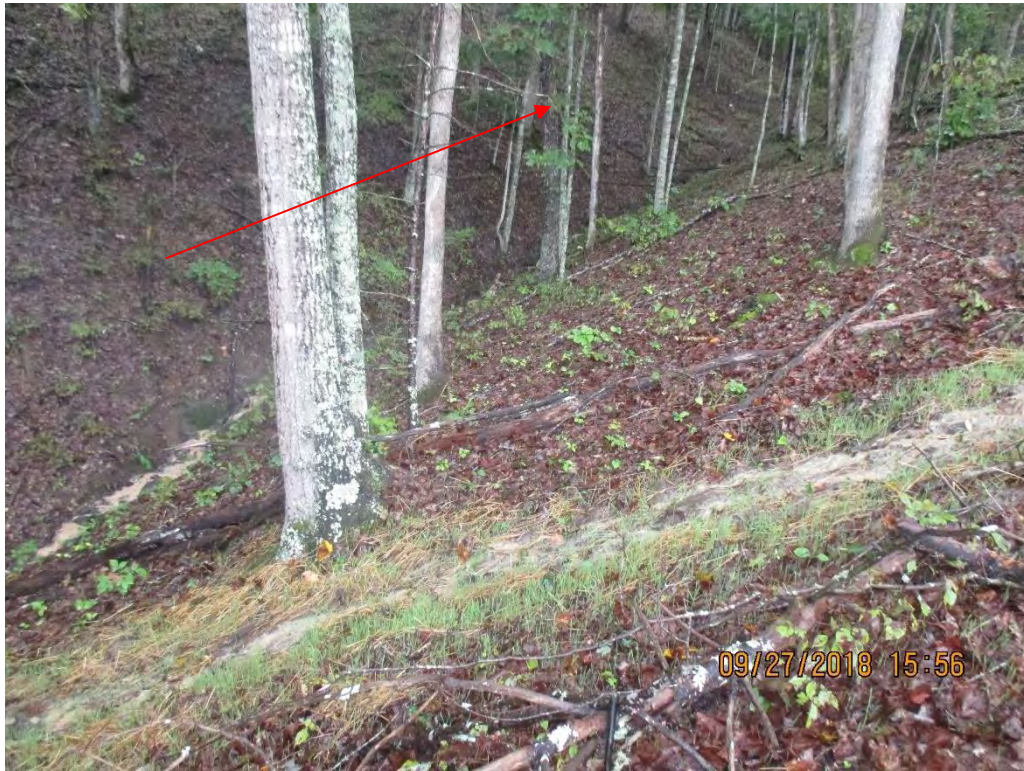
SLW being transported off ROW and past LOD into ephemeral streams near Station #9417+75. Red arrow depicts where ephemeral splits and goes upslope towards spring.

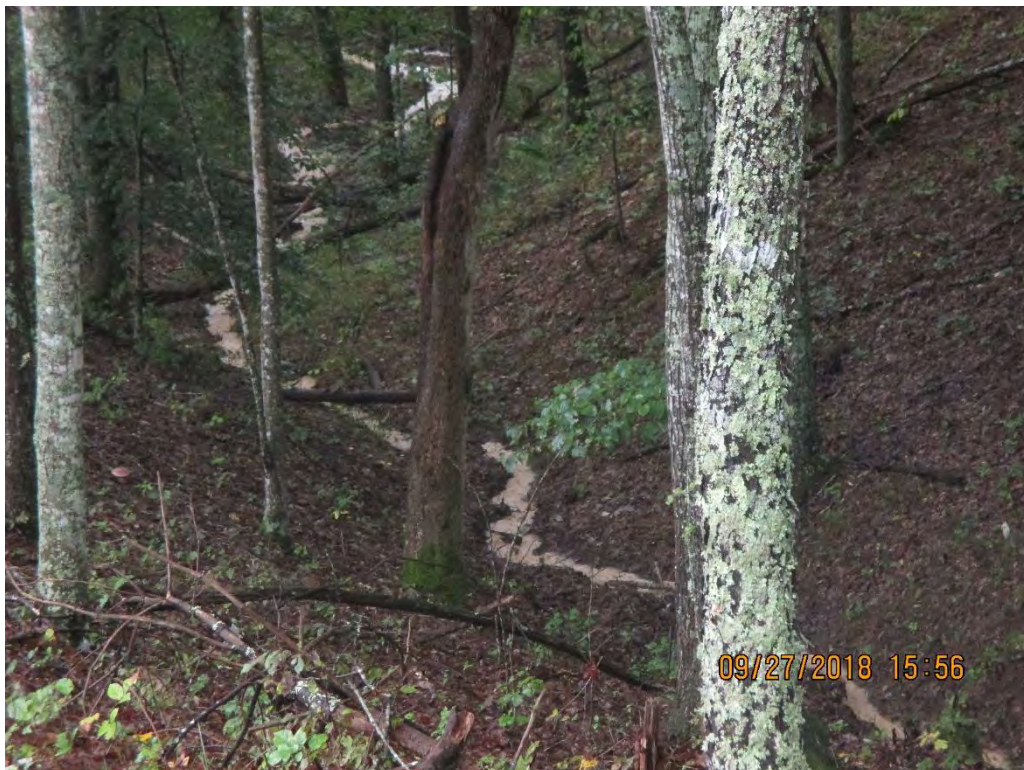
Main stem of ephemeral stream heading towards Stream S-A60 transporting SLW towards and into Indian Creek.

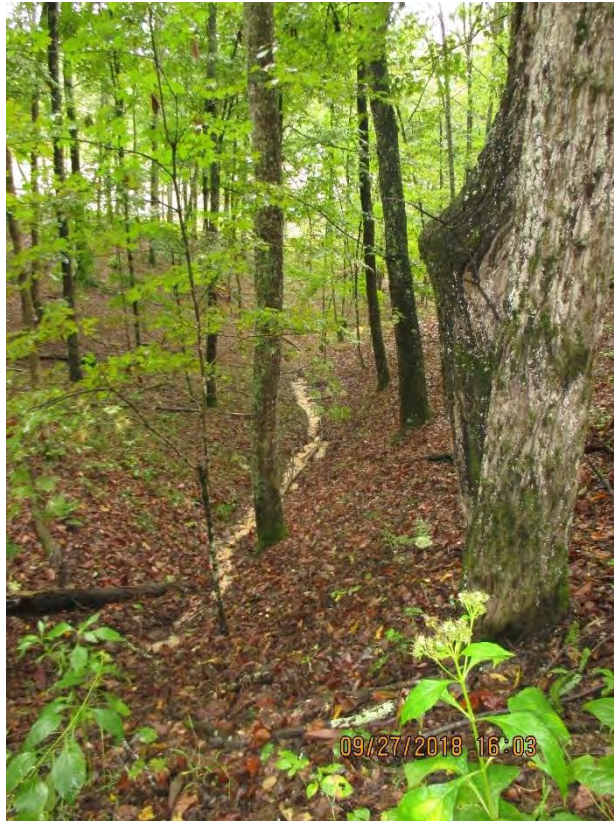
spring that flowed into Slate Run was also observed to be transporting SLW. The origination of what was causing the SLW to enter the spring could not be determined at the time of this inspection.

Standing on top of ridge looking down at spring seeping out of hillside transporting SLW. The source of what was impacting this spring/Seep could not be determined.

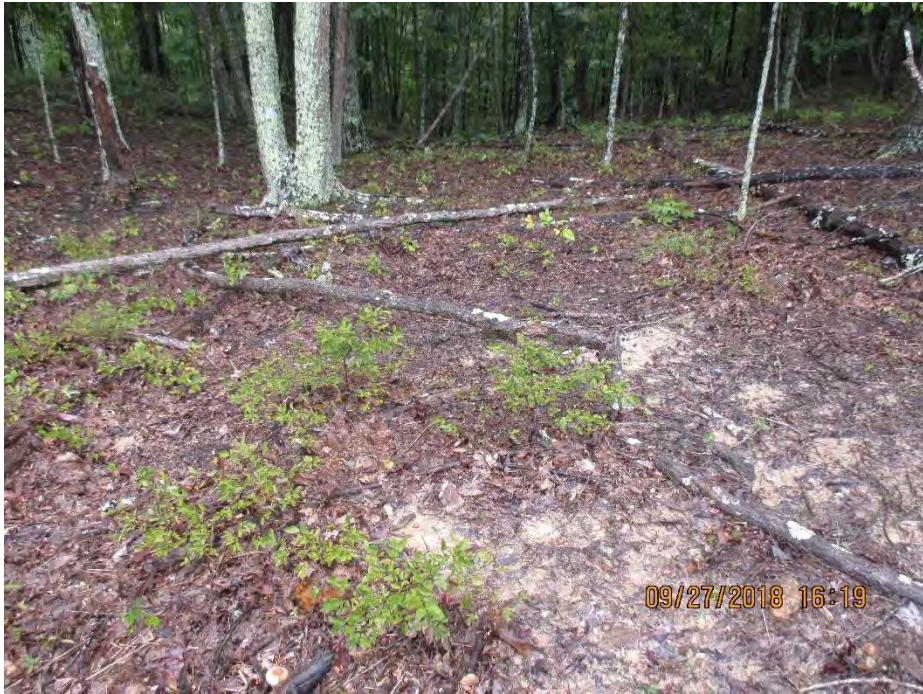
Area above spring/seep where off site sediment deposits were observed past LOD.

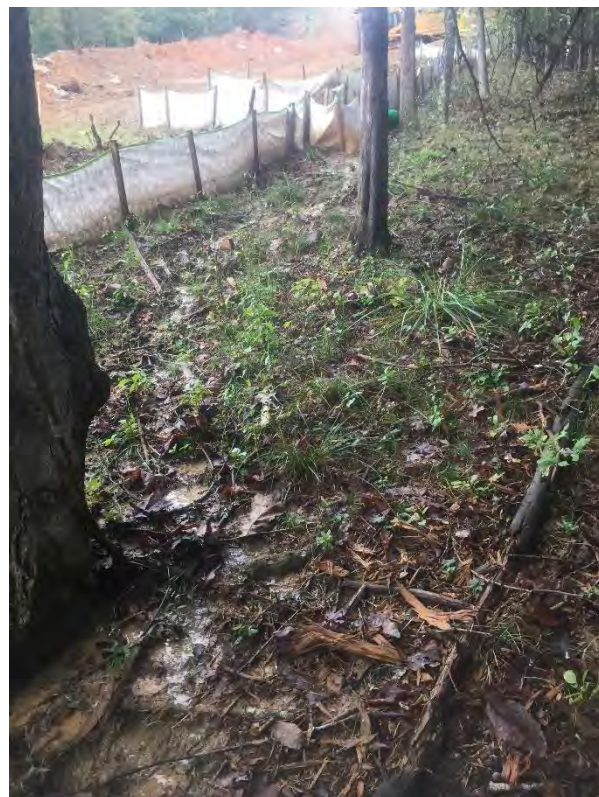
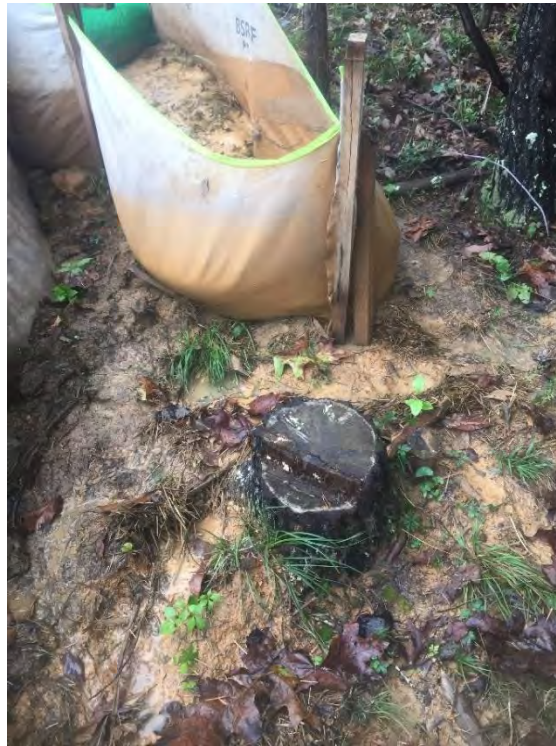
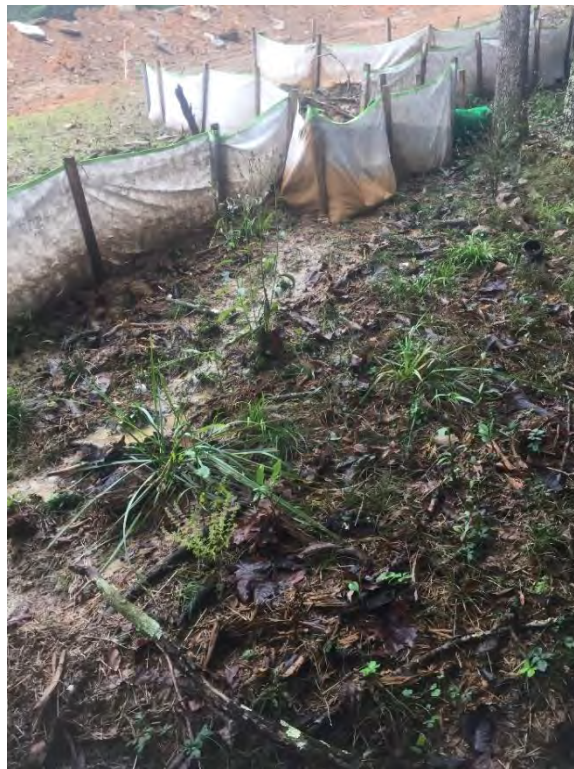
- 3.) (1, 6, 13, 19, 20) On 9/27/18 SLW was observed coming off hillsides on both sides off ROW at the Ellison Ridge road (CR 23/9) near station number 9783+00 and entering drainage ditches that flowed downhill through culverted stream crossings (S-Z5 and S-Z4). SLW was observed flowing downstream and was impacting a pond in line with stream S-Z4 approximately one-half mile down Ellison ridge road.

ROW near station numbers 9779+00 and 9778+00 where water bar outlets were being overwhelmed and SLW was passing through and under and being transported past LOD.

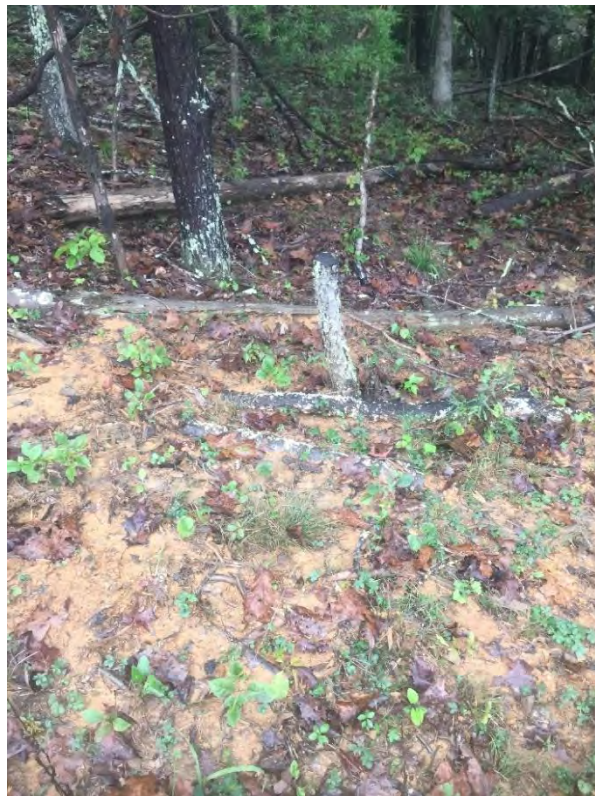
Off-site sediment deposits near station number 9779+00.

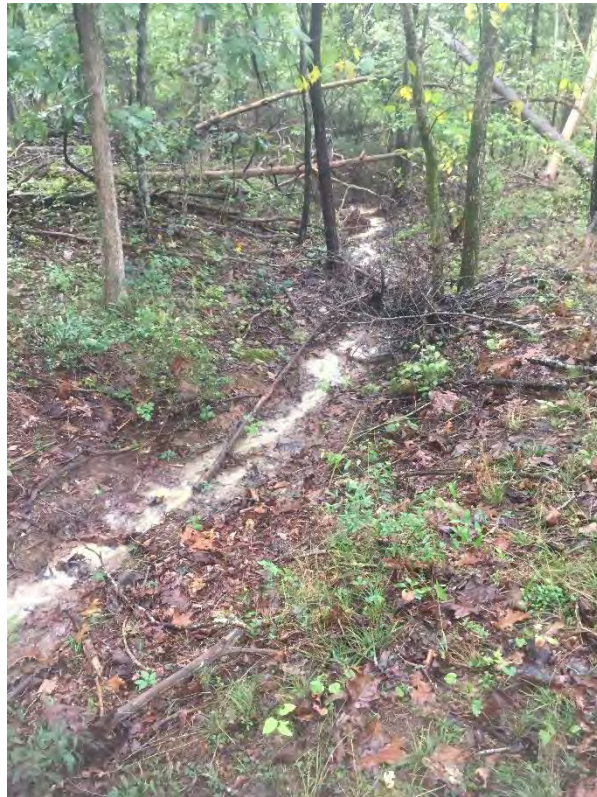
Ephemeral Stream near Station #9778+00 being impacted by SLW and flowing downhill and entering roadside ditch at Ellison ridge road.

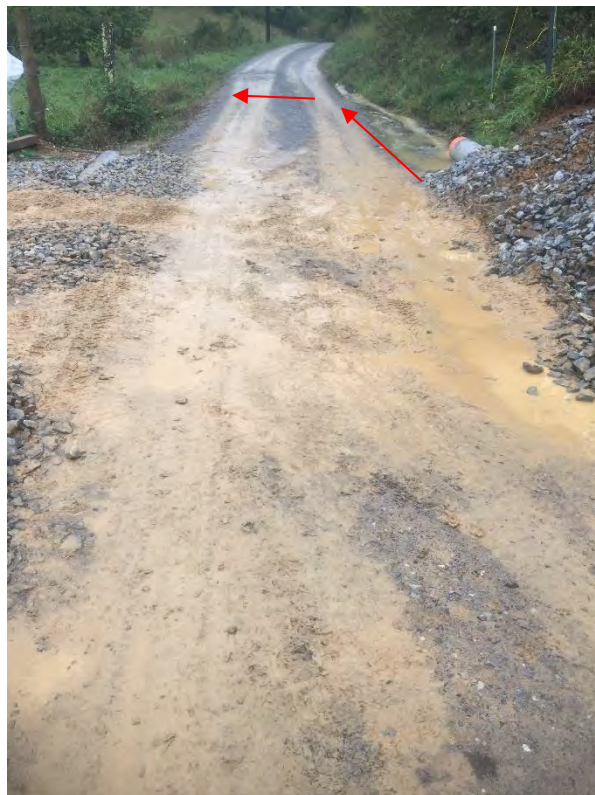
Photo depicting SLW flowing through culverted stream crossing and under road through culvert and into stream on other side of Ellison ridge road. Mud also present on road.

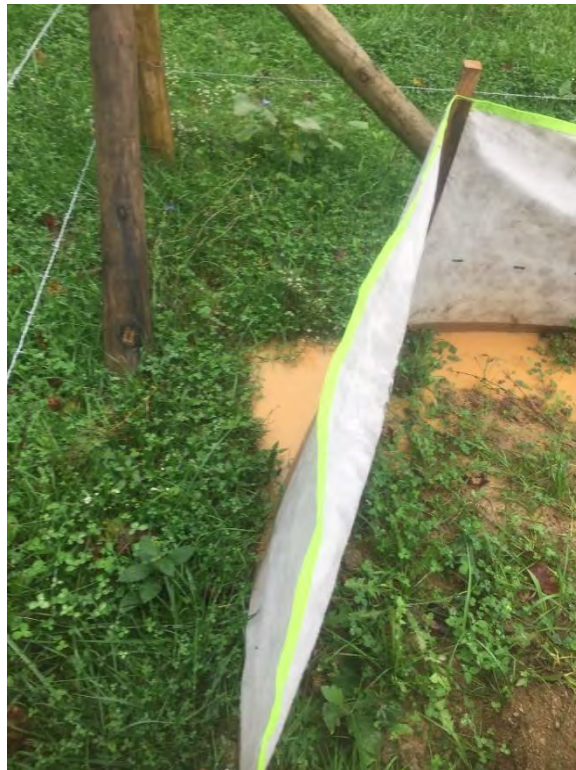
SLW flowing under and through BMP near station number 9784+00.

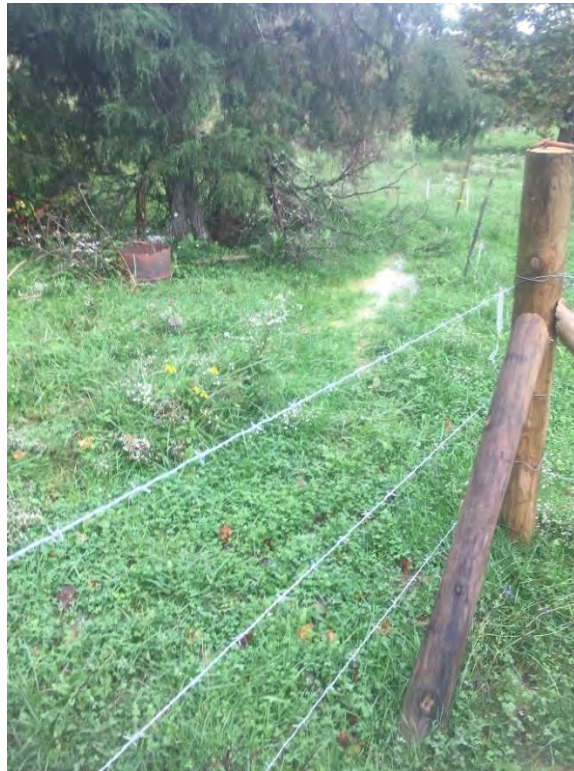
SLW infiltrating past LOD and seeping into wetland (W-22) and entering stream (S-Z3) near station number 9784+00.

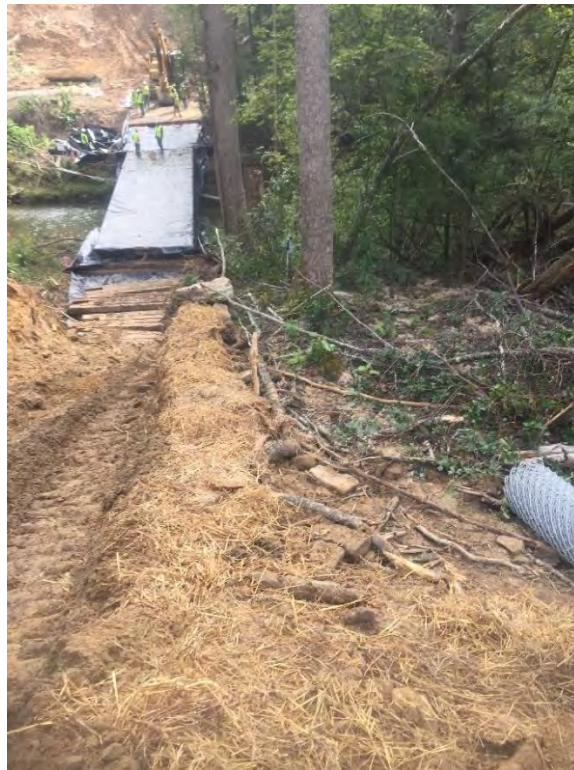
- 4.) (1, 6, 13, 19) On 9/26/18 Off site sediment deposits in multiple locations were observed from station numbers 9915+00 through 9897+00. Near station number 9911+00 off site sediment deposits had been transported through, under, and around BMP's, and past the LOD at the outlets of several waterbars. Stream S-H58 and TTWV-S-E58 that flows into Hans Creek had been impacted with off-site sediment deposits that flowed past several BMP's above and near station #9891+00 through 9897+00

Facing Hans Creek near Station #9907+00. Super Silt fence located next to chain link had failed and sediment deposits were observed migrating towards Hans Creek.

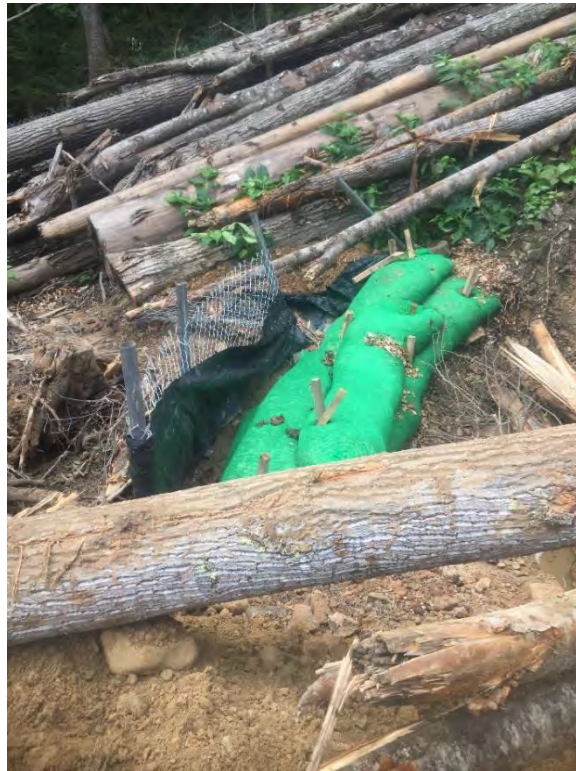
Area near station number 9907+00. Super silt fence had been undermined and damaged by logs.

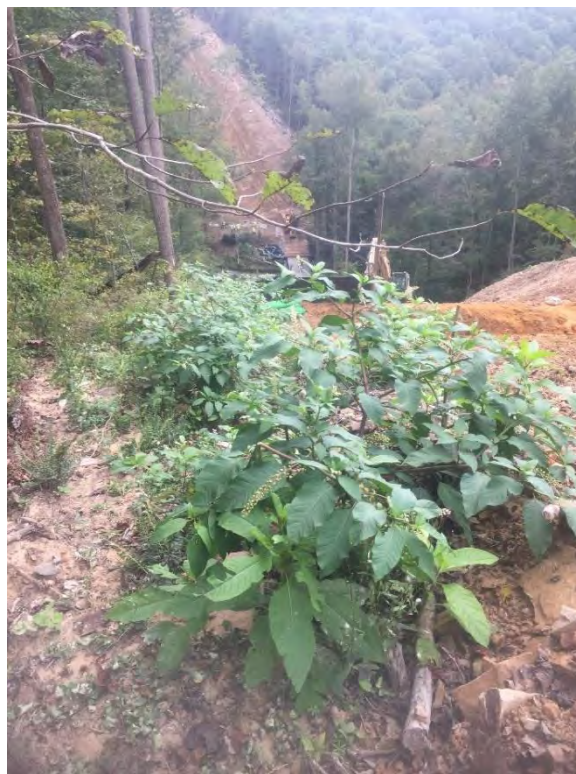
Near Station # 9911+00 where BMP was being overwhelmed and off-site sediment deposits were observed.

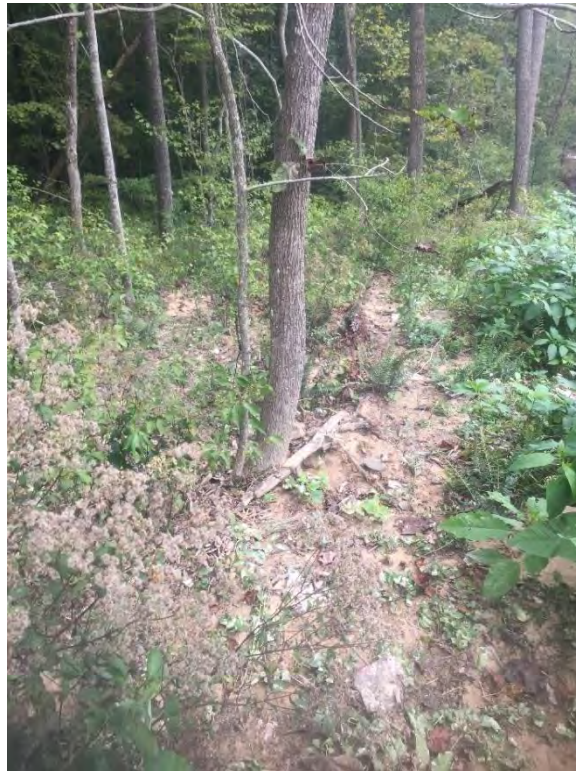
Off-site sediment deposits near station #9911+00.

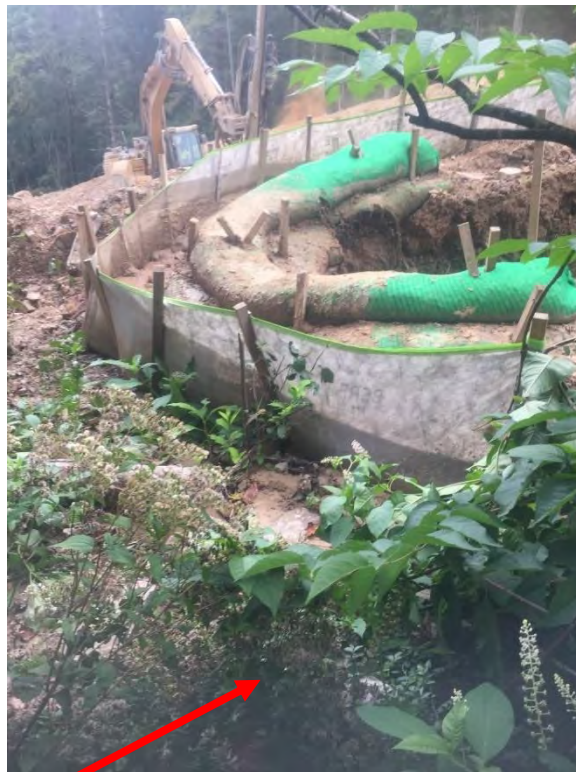
Section G.4.e.2.A.ii.j - Permittee has failed to prevent sediment-laden water from leaving the site without going through an appropriate device. Off-site sediment deposits in multiple locations were observed from station numbers 9915+00 through 9897+00.

BMP near Station #9911+00 being overwhelmed and sediment flowing under and through control. Arrow depicts where SLW was leaving BMP.

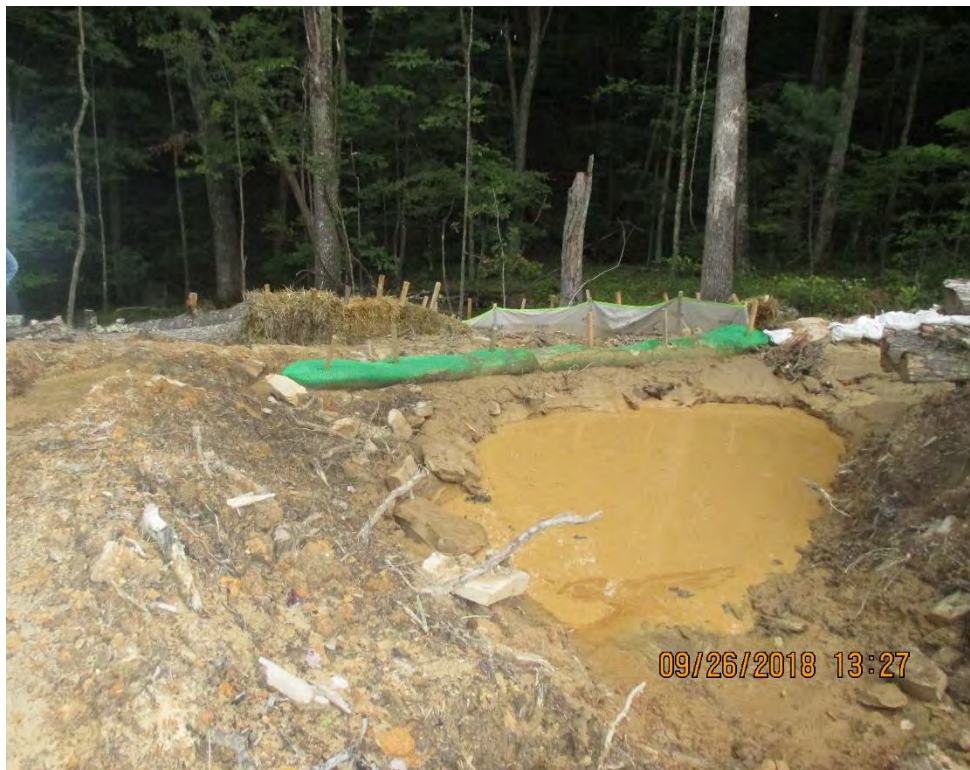
Waterbar terminus near being overwhelmed near Station #9899+00.

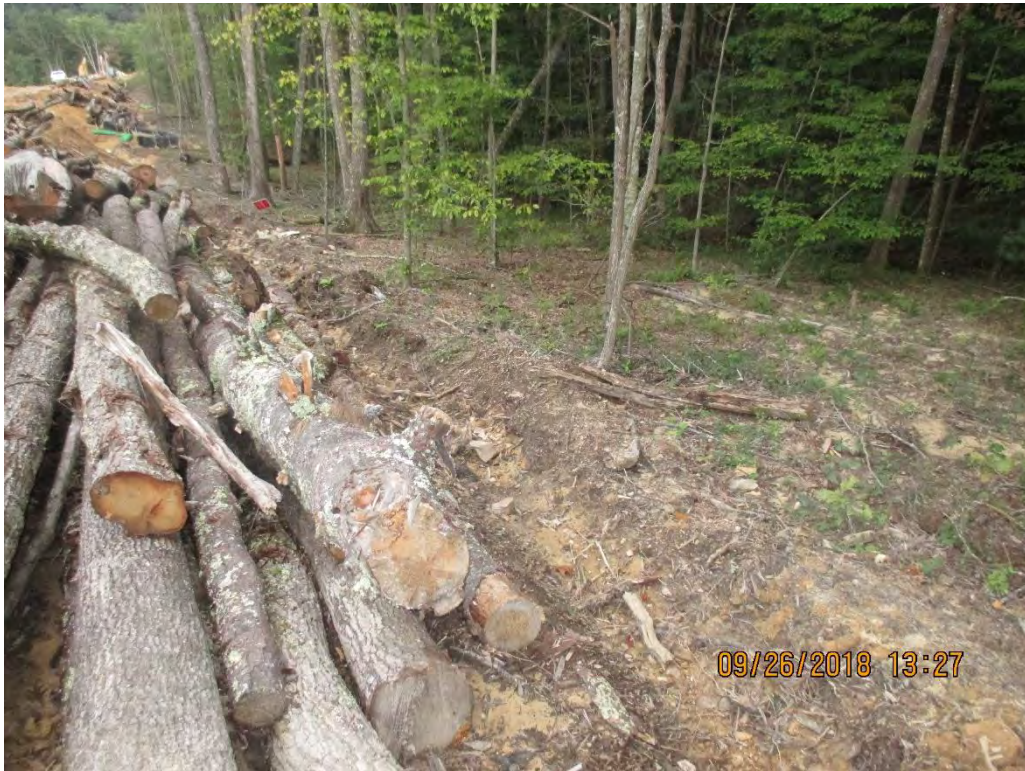
Off-site sediment deposits near Station number 9899+00.

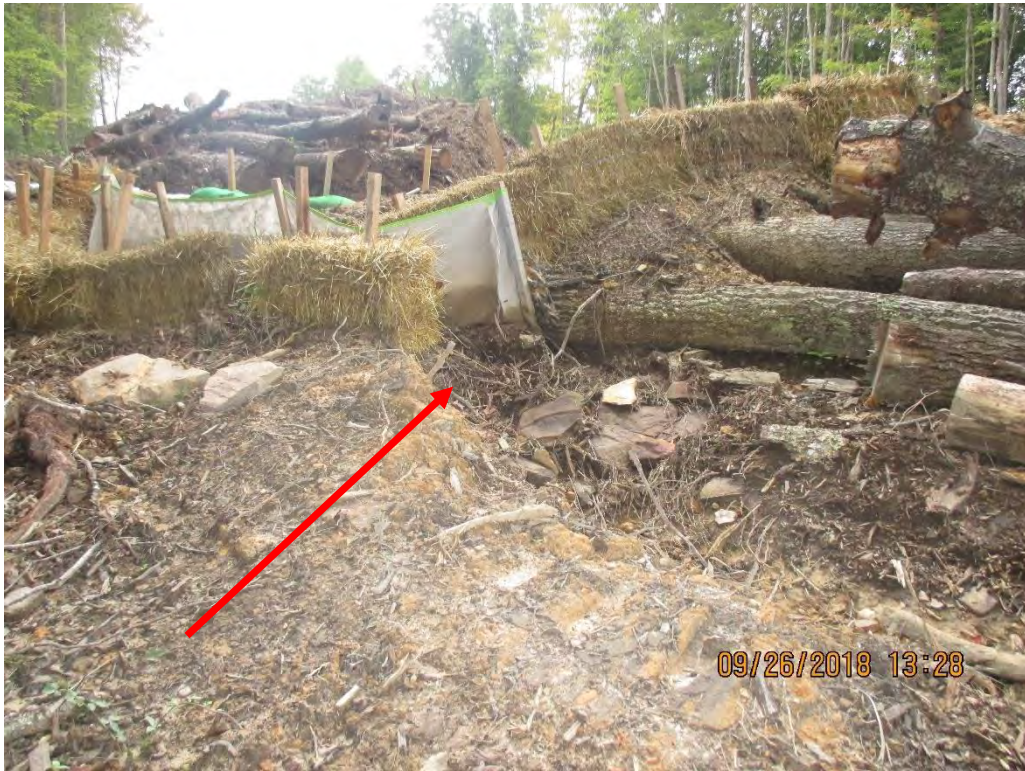
Arrow depicts where BMP was being undermined near Station number 9899+00.

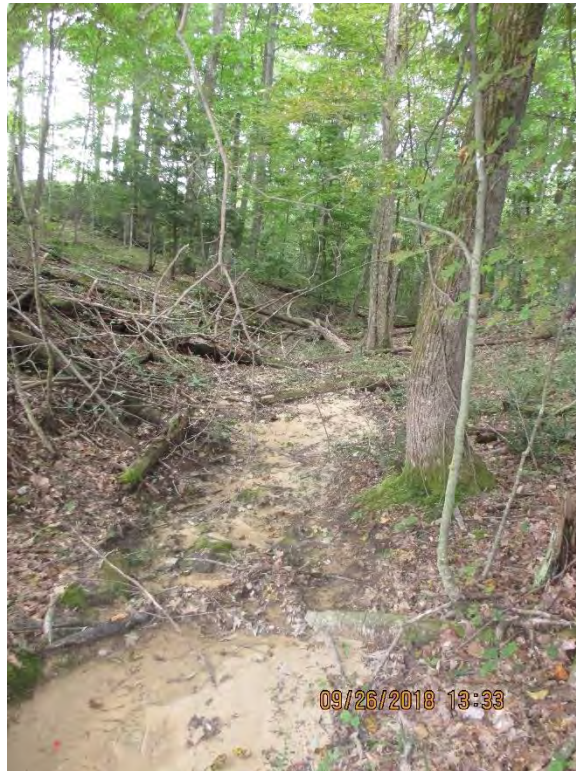
Stream S-H58/TTWV-S-E58 further downhill walking towards Hans Creek near Station number 9897+00.

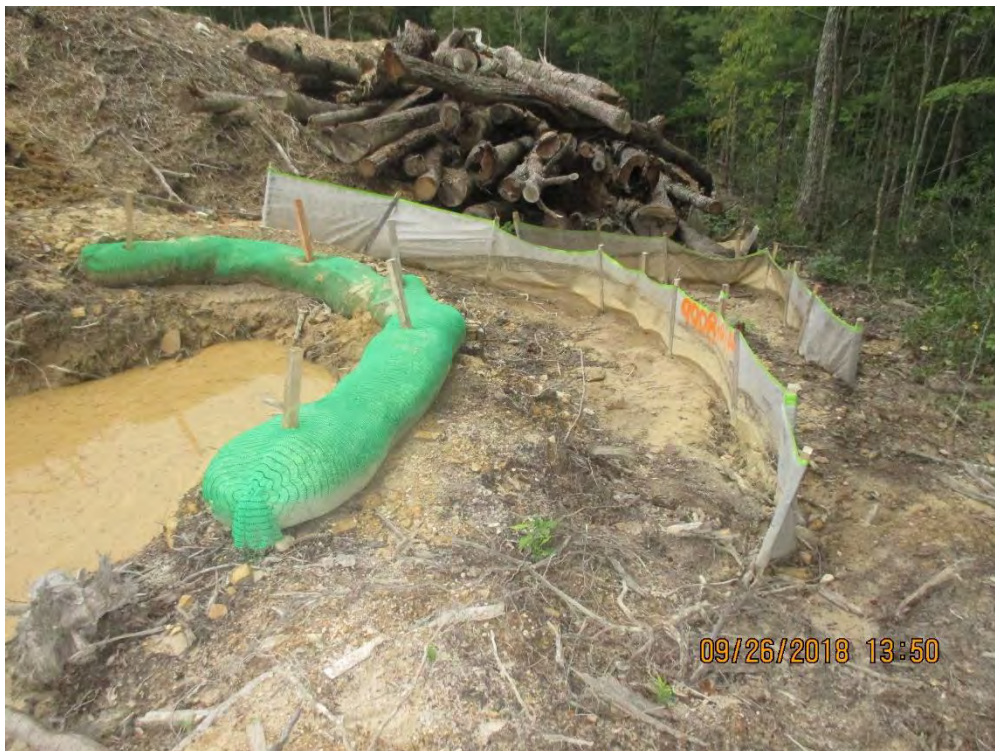
BMP at Station number 9908+00 being overwhelmed where off-site sediment deposits were present past the LOD.

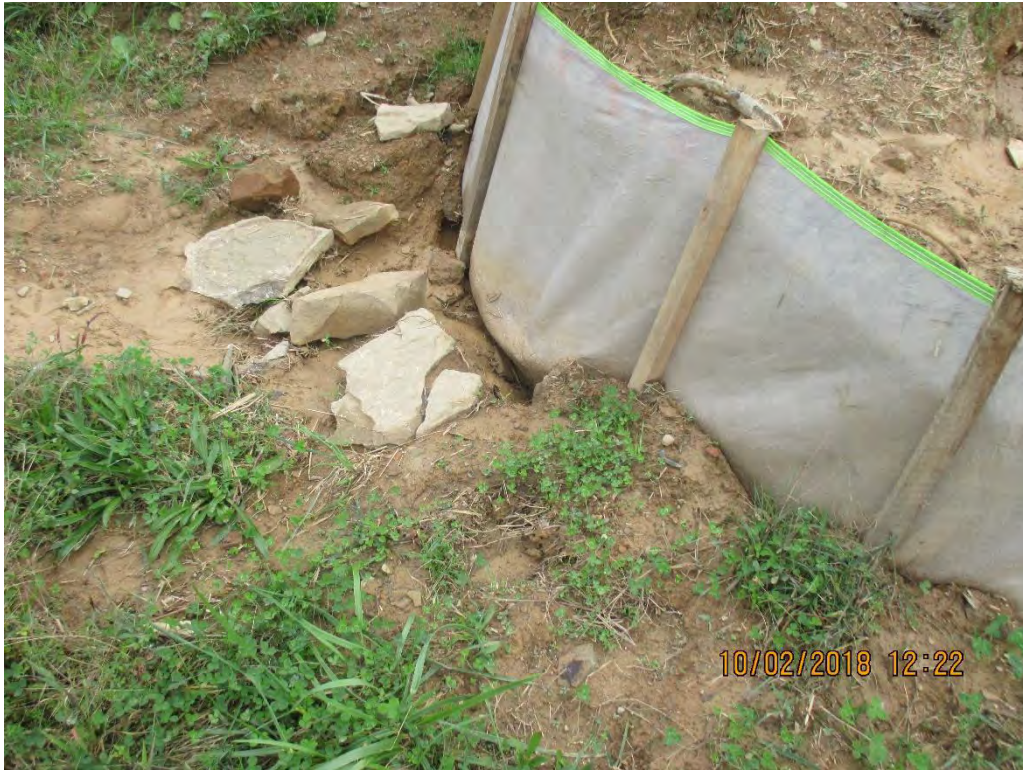
Above mentioned BMP being undercut from run-off.
