**The Wilderness Society et al. Comments on the
U.S. Forest Service Mountain Valley Pipeline and
Equitrans Expansion Project Draft Supplemental
Environmental Impact Statement (#50036)**

EXHIBIT 12

**WEST VIRGINIA DEPARTMENT OF ENVIRONMENTAL PROTECTION
WV OIL AND GAS CONSTRUCTION STORMWATER PERMIT**

FACILITY NAME:	Mountain Valley Pipeline Project		REG. #	EXPIRE DATE:
PERMITTEE	MOUNTAIN VALLEY PIPELINE, LLC		WVR310667	5/13/2018 Extended: 12/31/2018
ADDRESS/PHONE:	Attn: MATTHEW HOOVER 625 LIBERTY AVE, ST 1700 PITTSBURG, PA 15222 7248733645			
LOCATION:	Harris Compressor Station		Entry Date/Time:	9/25/2018 1000
COUNTY:	Braxton		Exit Date/Time:	9/25/2018 1100
Site Representative /Phone	Brittany Dewitt (Lead EI)/330-987-1682, Matt Hoover MVP/ 412-258-5627 & Jason Hiles, Spread C Lead EI/740-334-7812		PHOTOS <input checked="" type="checkbox"/>	
CO-PERMITTEE:			ADDRESS:	
SITE OPERATOR:	MEC Construction LLC		ADDRESS:	19 RR Meadowbrook, WV 26404
PERMITTED ACREAGE	4311	WEATHER:	Cloudy	LAST INSPECTION: 8/21/2018
RECEIVING STREAM(S)	Trib of Elk/Kanawha R/ Ohio Rv			NOV: 1
Regular Mail <input type="checkbox"/> Certified Mail <input checked="" type="checkbox"/>	Tracking #			
OVERALL FACILITY R

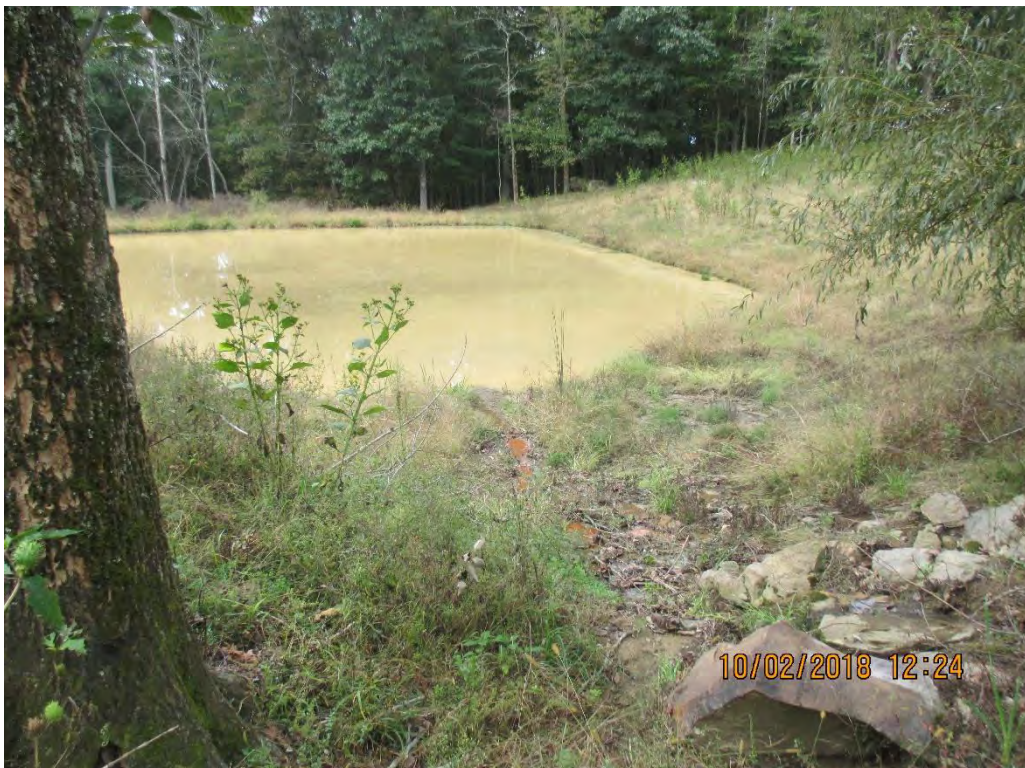
Stream S-D29 leading to Pond P-D1 facing down slope.

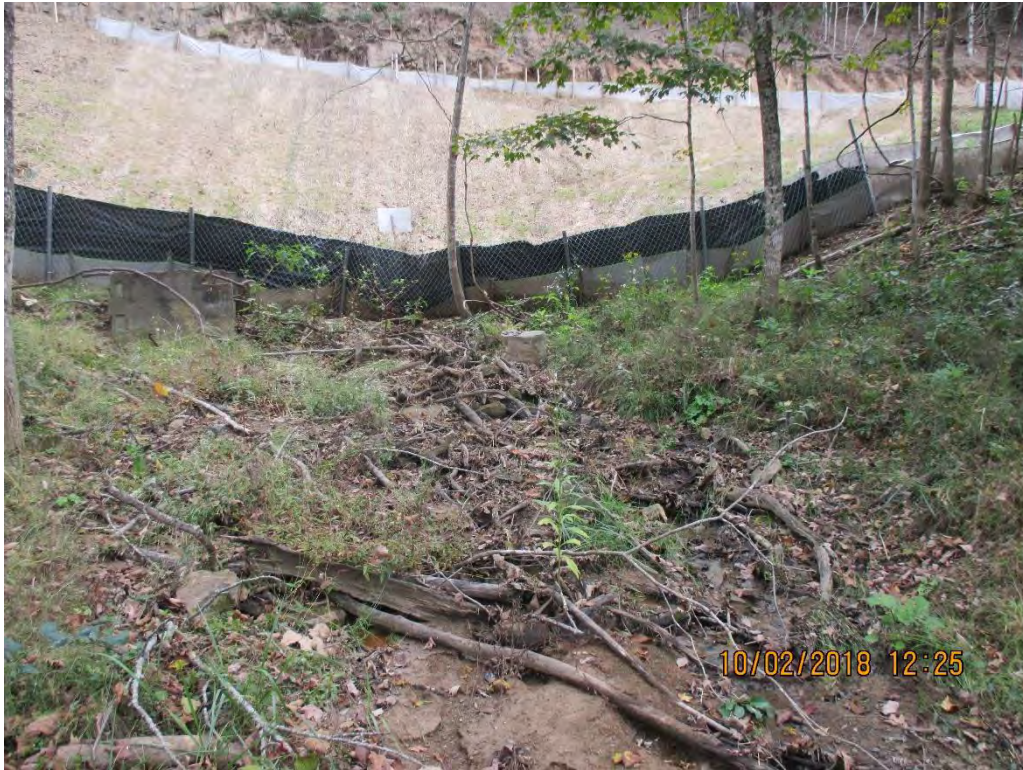
Looking upslope at Stream S-D29 and spring box.

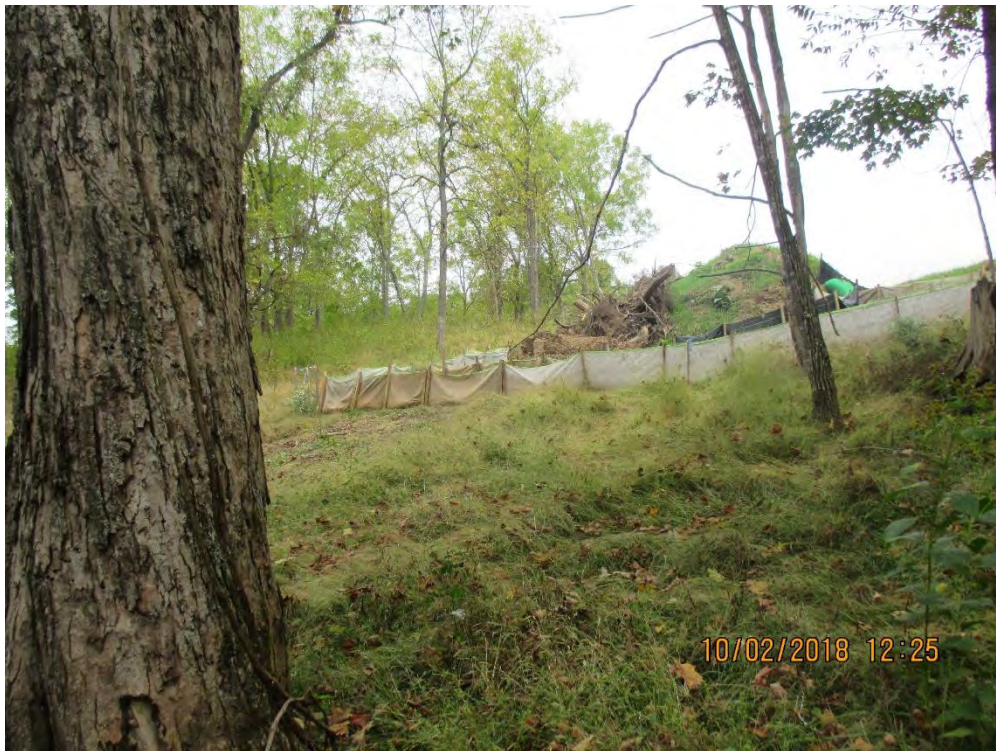
Opposite side of slope where BMP is being overwhelmed.

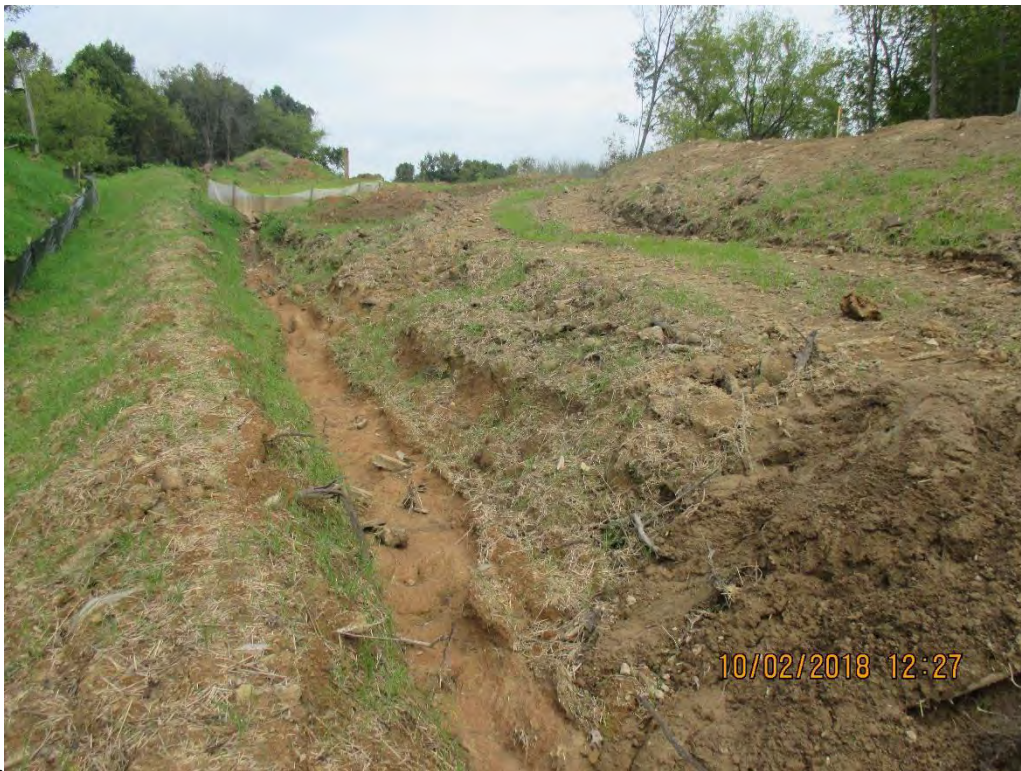
Un-stabilized channel flowing towards above mentioned BMP at station #9687.

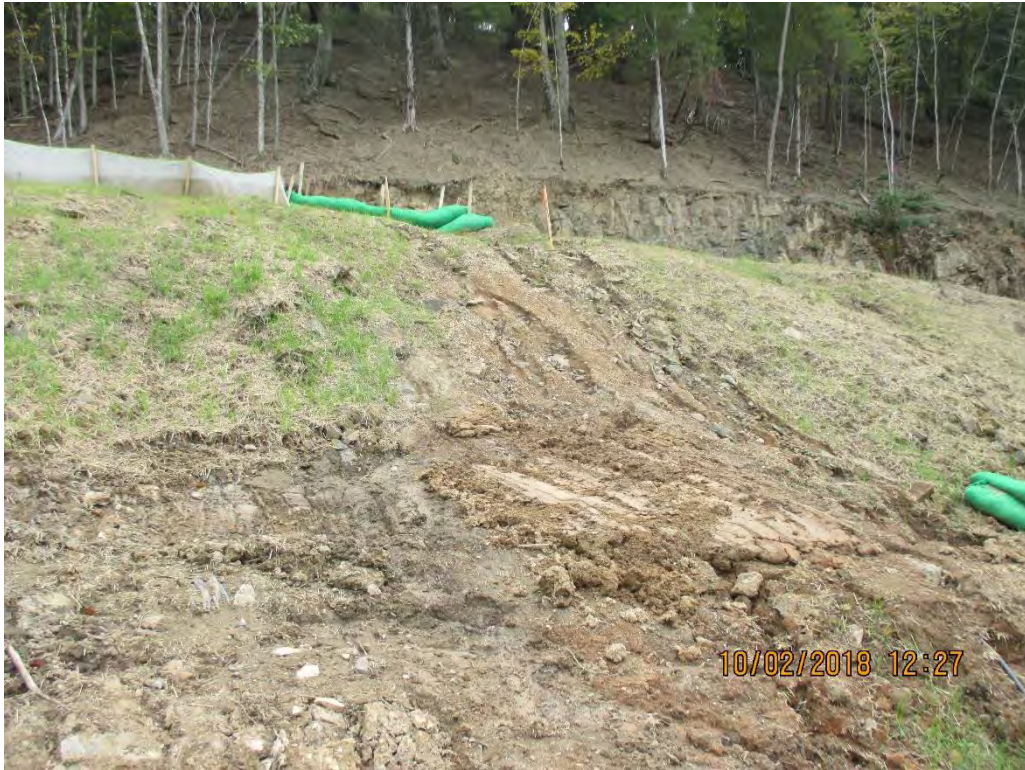
Lack of fill slope protection on opposite side of pond facing upslope near Station #9687.

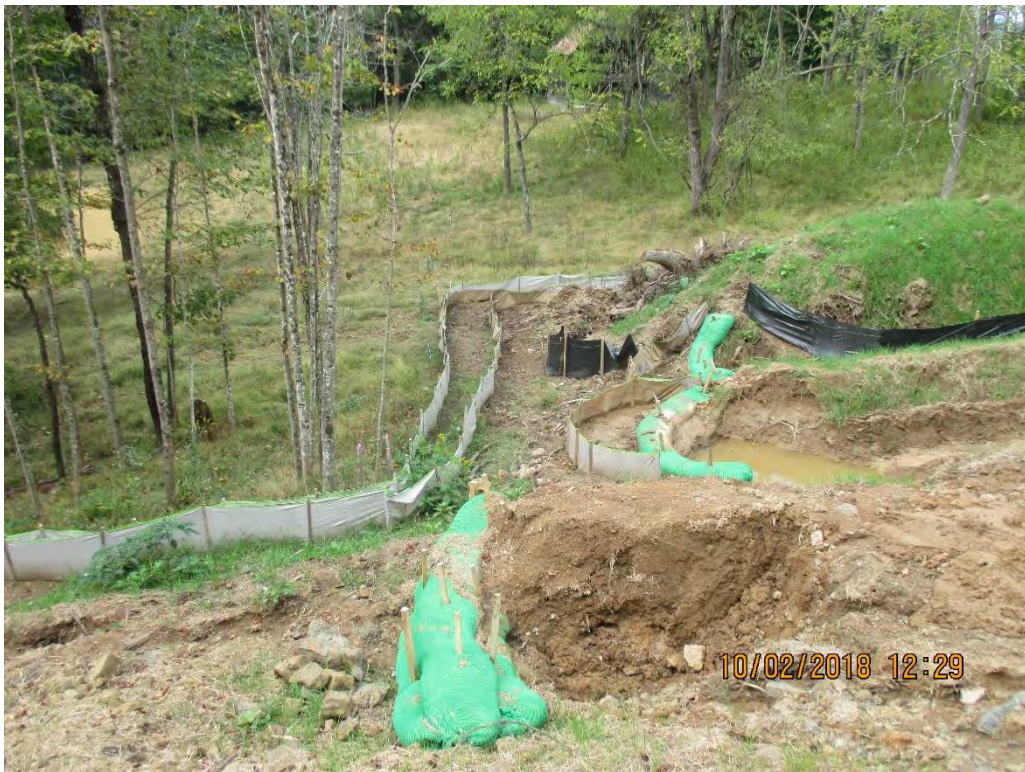
Overview of BMP's north of pond and near station # 9687.

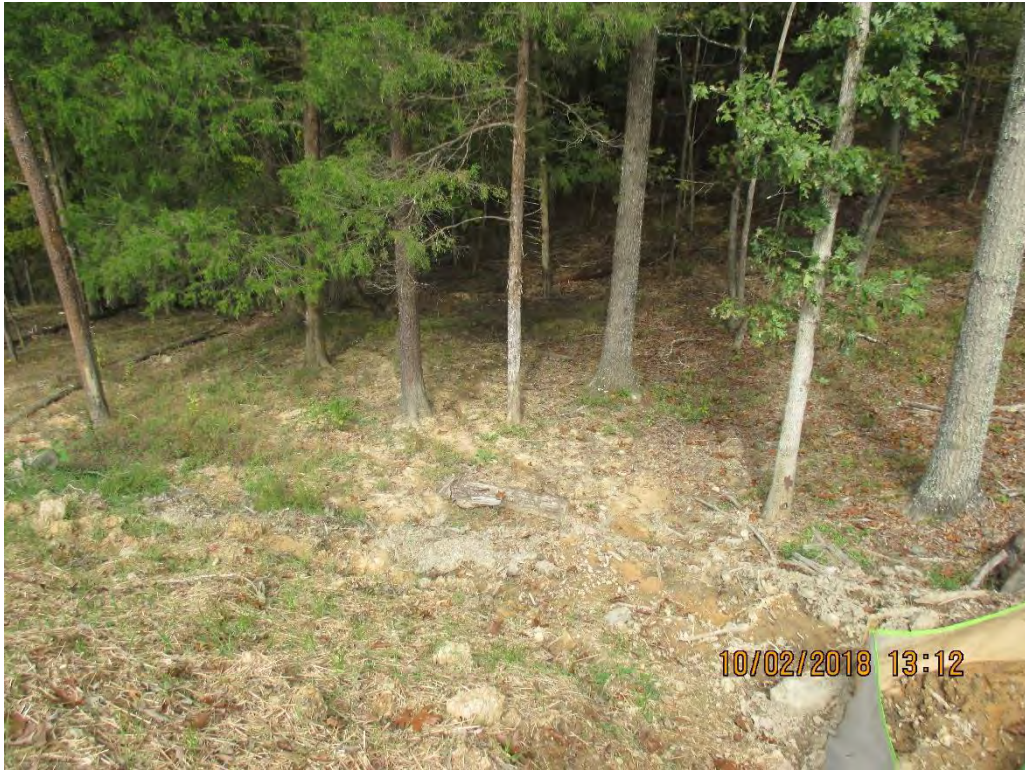
Off-site sediment deposits at Station #9717+52.

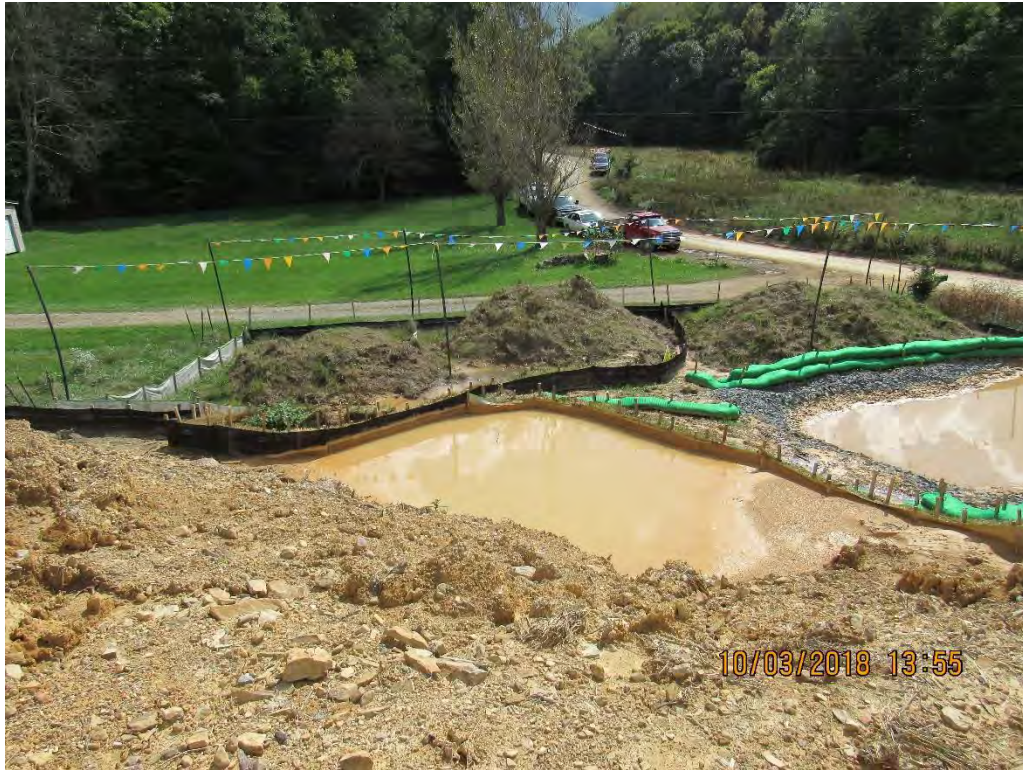
Photo 1: Sump after maintenance performed at Painter's Run Station 10270.

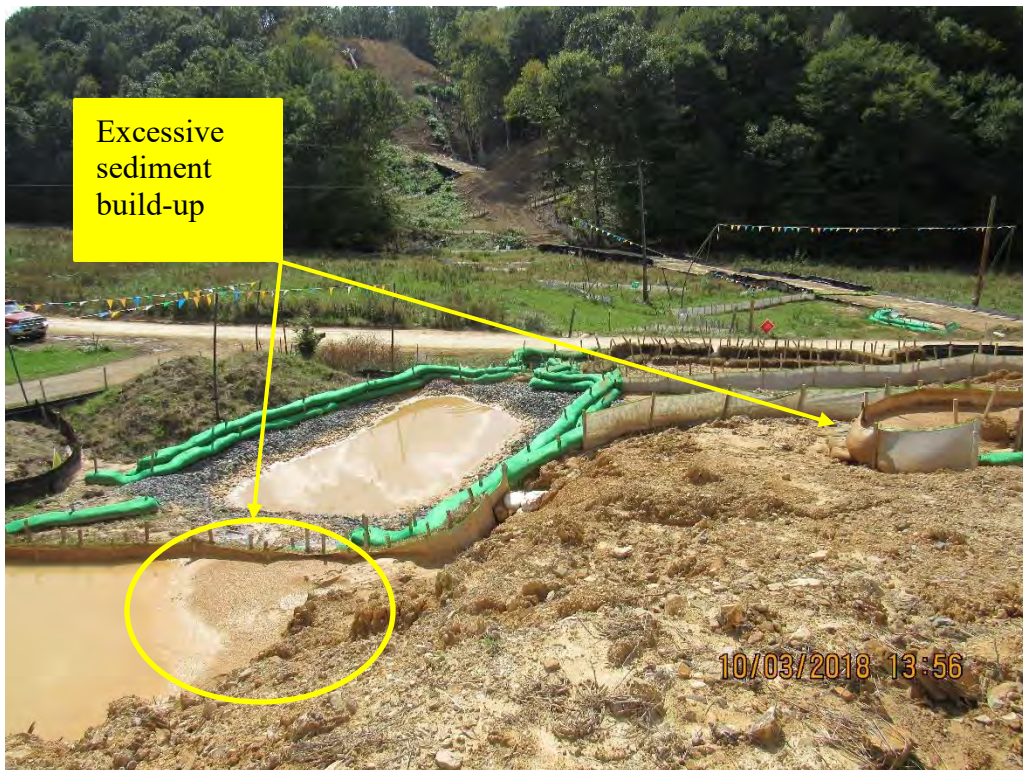
Photo 2: Unacceptable amount of sediment in sumps after maintenance performed at Painter's Run station 10270.

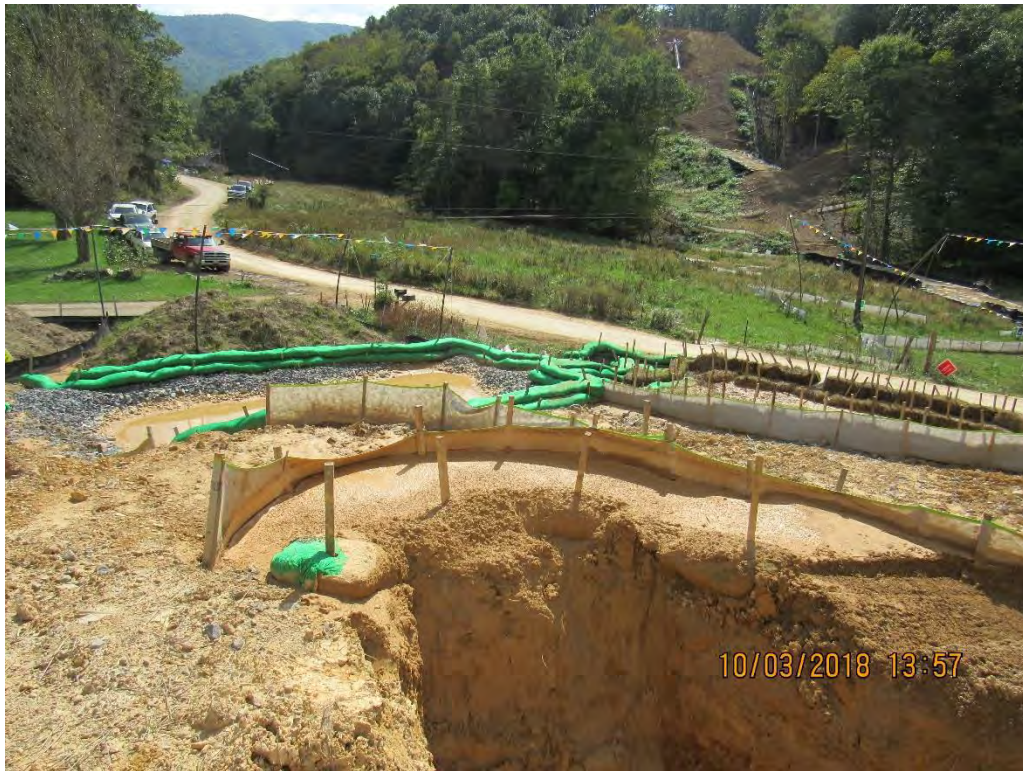
Photo 3: Front of control on right in Photo 2 after maintenance performed at Painter's Run station 10270.

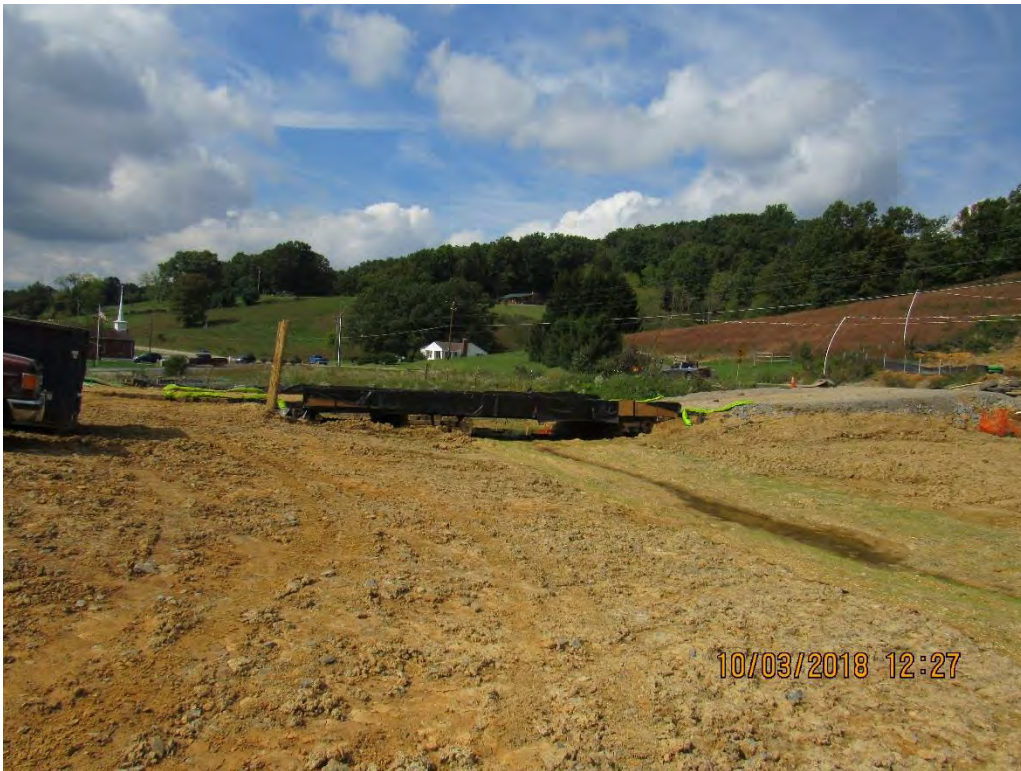
- 13. – Lindside Methodist Church (station 10116+49) continues to be an area of concern. Progress has been made with removal of matting and creation of bridge, as well as establishing a channel for run on water (photos 4 & 5). However, run on water lacks an established channel through site (photos 6 & 7). Per Megan Neylon, this area is waiting on approval for application of herbicide on topsoil vegetation prior to spreading and establishing permanent stabilization.

Photo 5: Bridge installed in established area of concern at Lindsie Methodist Church station 10116+49.

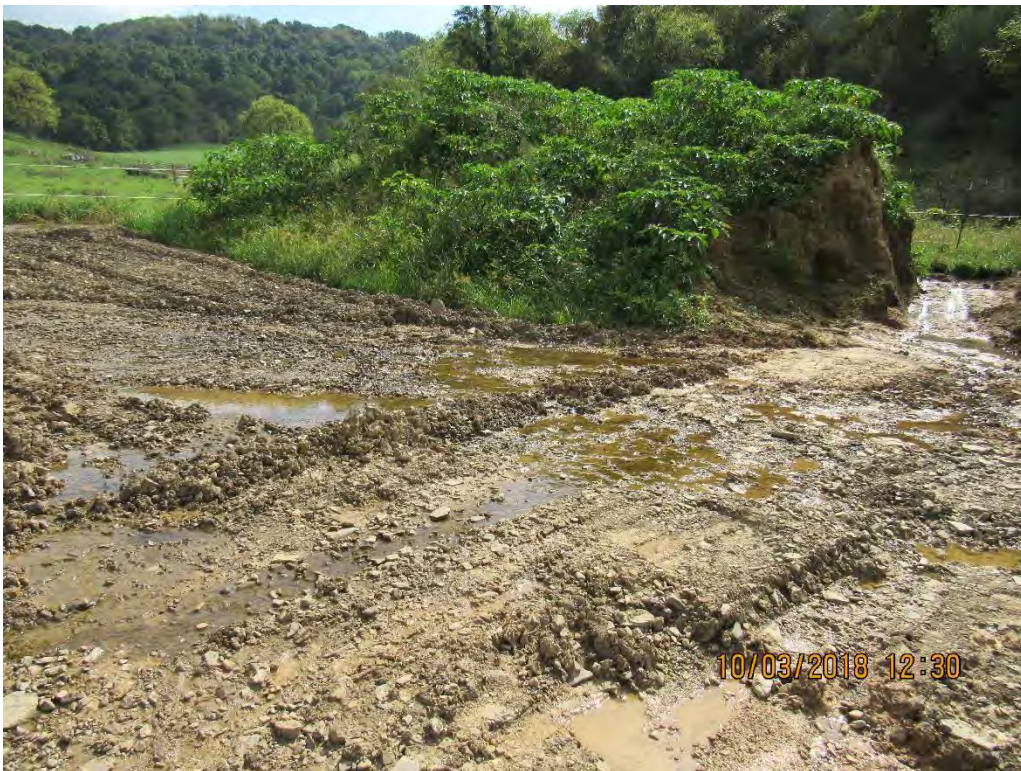
Photo 6: Run on water lacks an established channel through site at Lindsie Methodist Church station 10116+49.

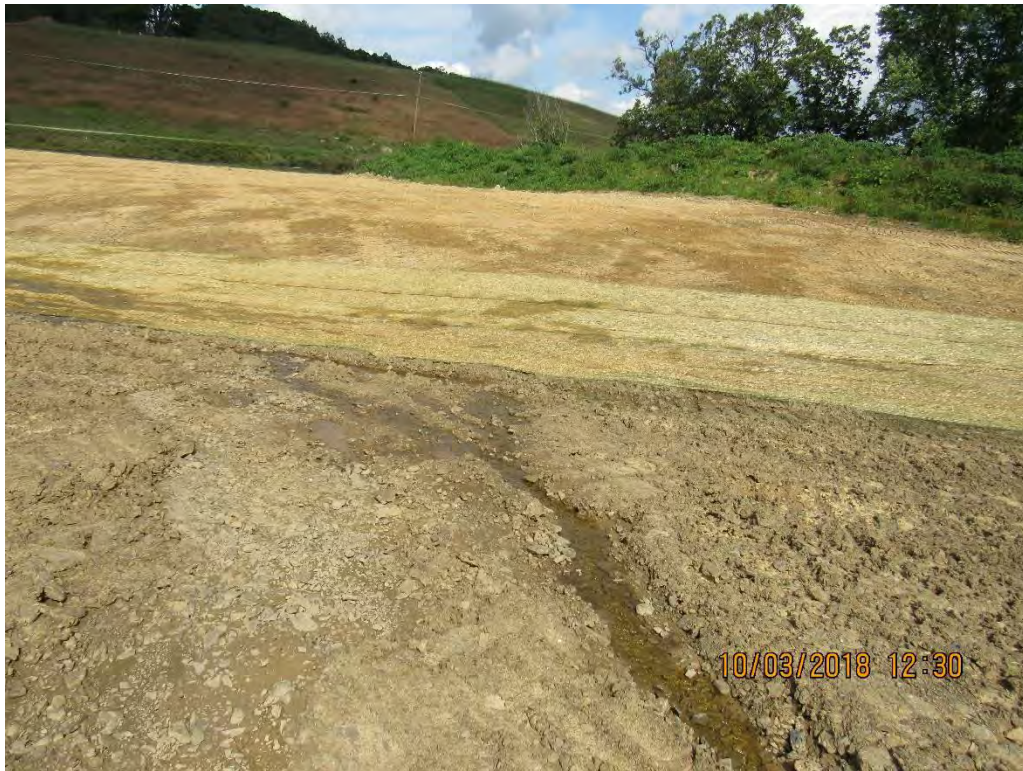
Photo 7: Run on water lacks established channel through site at Lindsie Methodist Church station 10116+49.

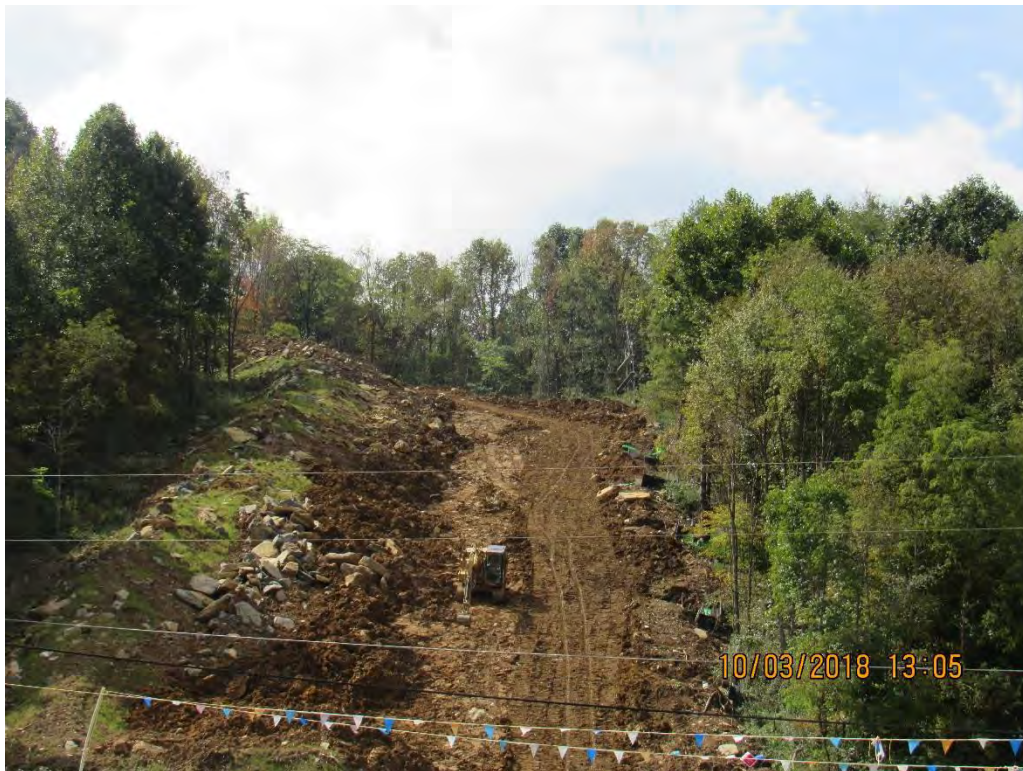
- Back Valley Road (station 10146+32)- Trenching/ditching has not begun in this area (photo 10)
 - Access Road 231.01- location of NOV# W18-52-009-CP. Controls have been fixed and affected stream is clear. NOV has been abated and returned to compliance (photos 11 & 12)

Photo 10: Back Valley Road station 10146+32- trenching/ditching has not started.

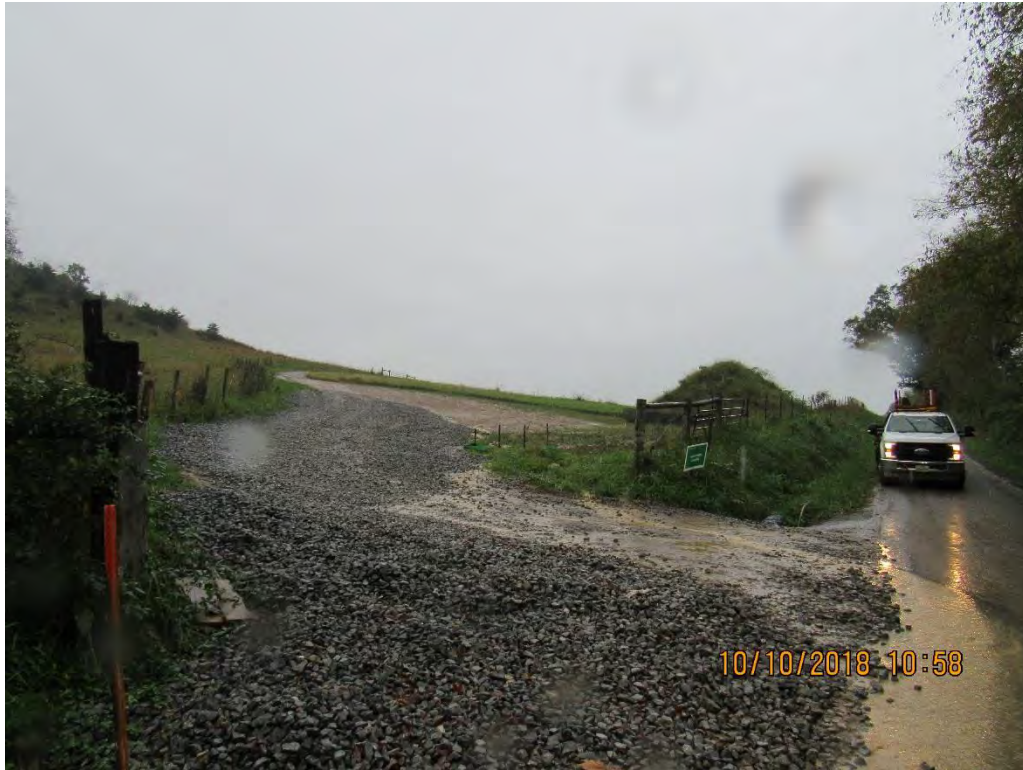
- 12. & 19. – AR 210 (photos 1-3) and Painters Run Road station 10270 (photos 4-6) had mud on roadway which was causing sediment laden water to leave site.
- Lowell Road station 9087 continues to serve as laydown/construction yard. Pipe laying and tie in is progressing south (going away) of this location. Minimal preparation for crossing Greenbrier River has occurred (just north of this location) (photos 7-8)
- Kellers Creek station 9127- location of equipment roll over several weeks ago. Area has been roughly graded and is awaiting finish grading and restoration (photo 9)
- Wayside/Talcott station 9466- rough grade completed. Awaiting final grade and restoration. Awaiting final decision on how much will be restored vs winter stabilized due to tie in required in wetland area and wetland/stream stay of USACE permits (photos 10-11).

Photo 1: AR 210- sediment laden water leaving site.

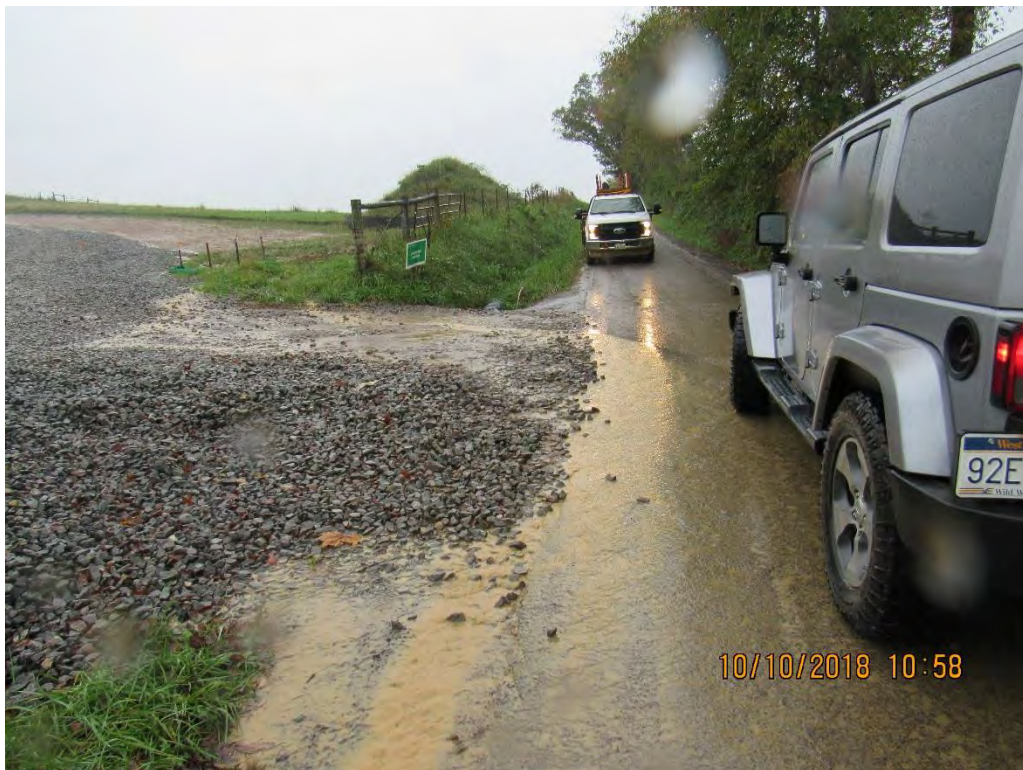
Photo 2: AR 210-sediment laden water leaving site entering county road- up gradient view.

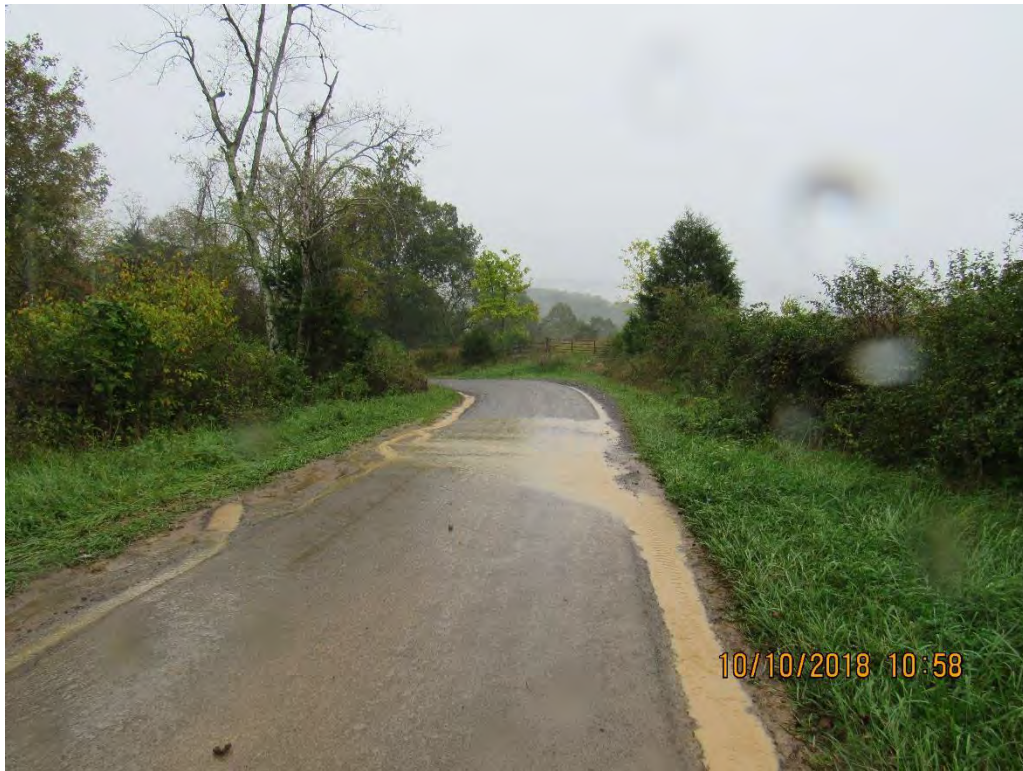
Photo 3: AR 210 sediment laden water crossing county road- down gradient view.

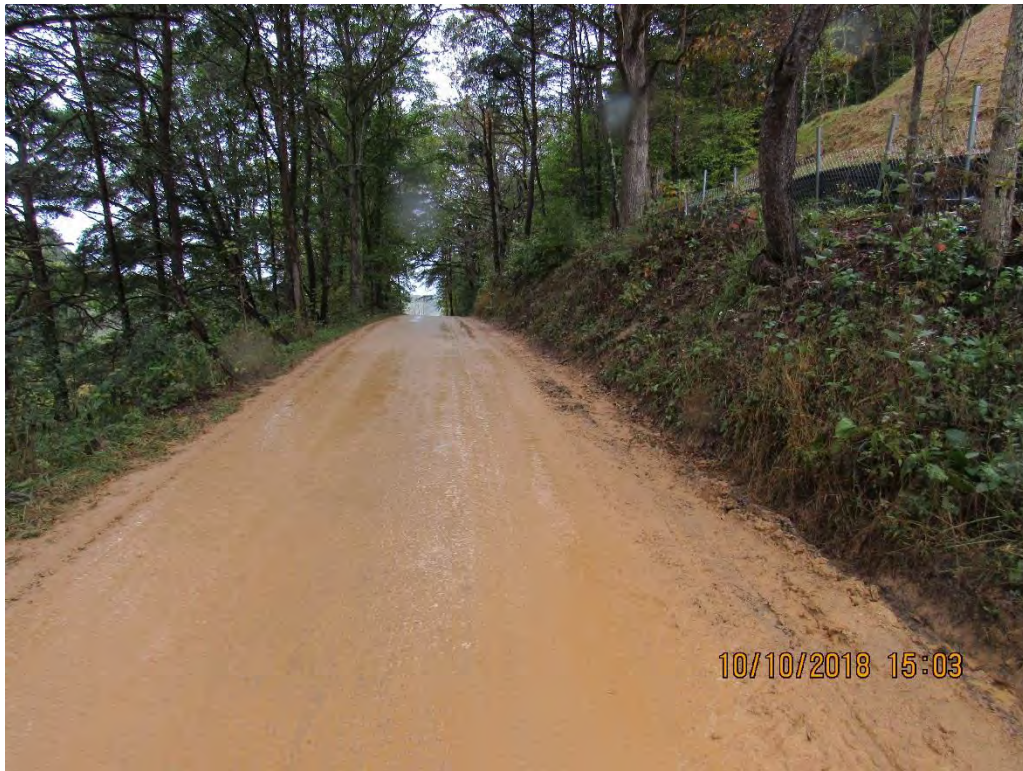
Photo 5: Painter's Run Road station 10270 upgradient of access road crossing.

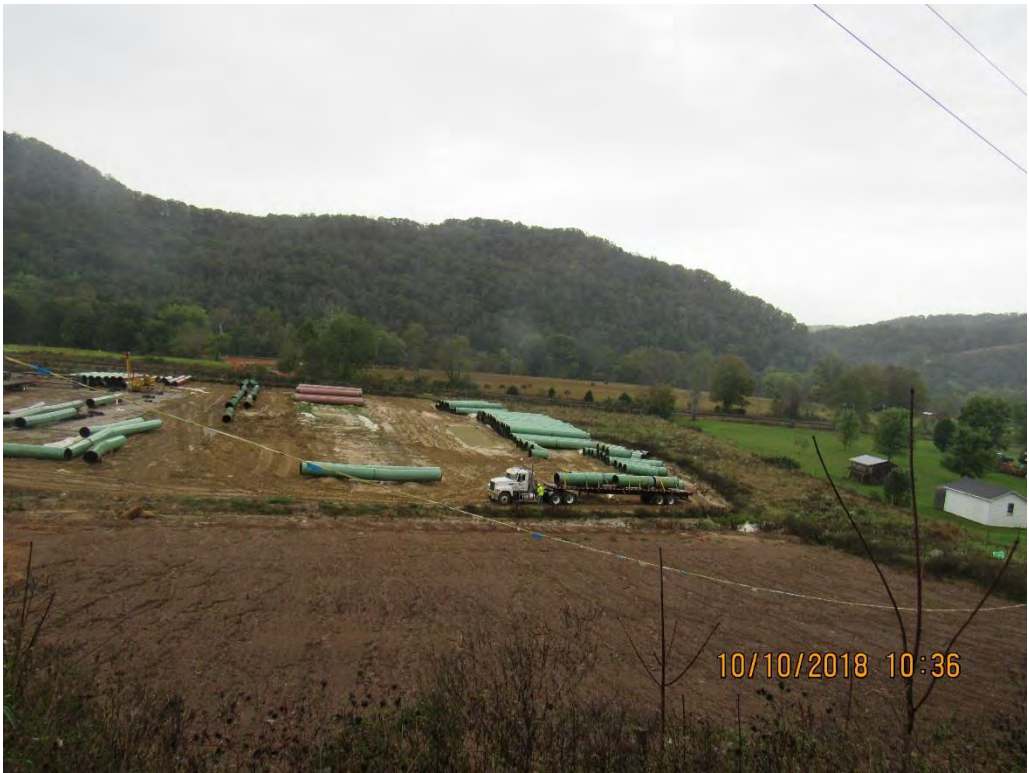
Photo 7: Lowell Road station 9087 laydown yard.

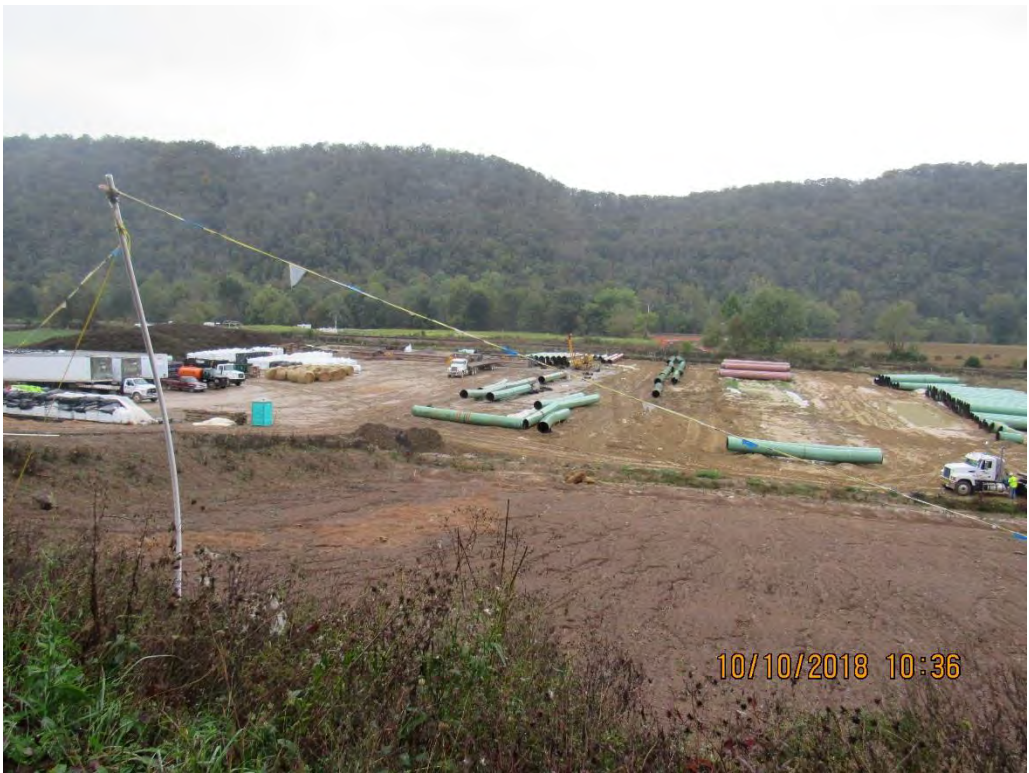
Photo 8: Lowell Road station 9087 laydown yard.

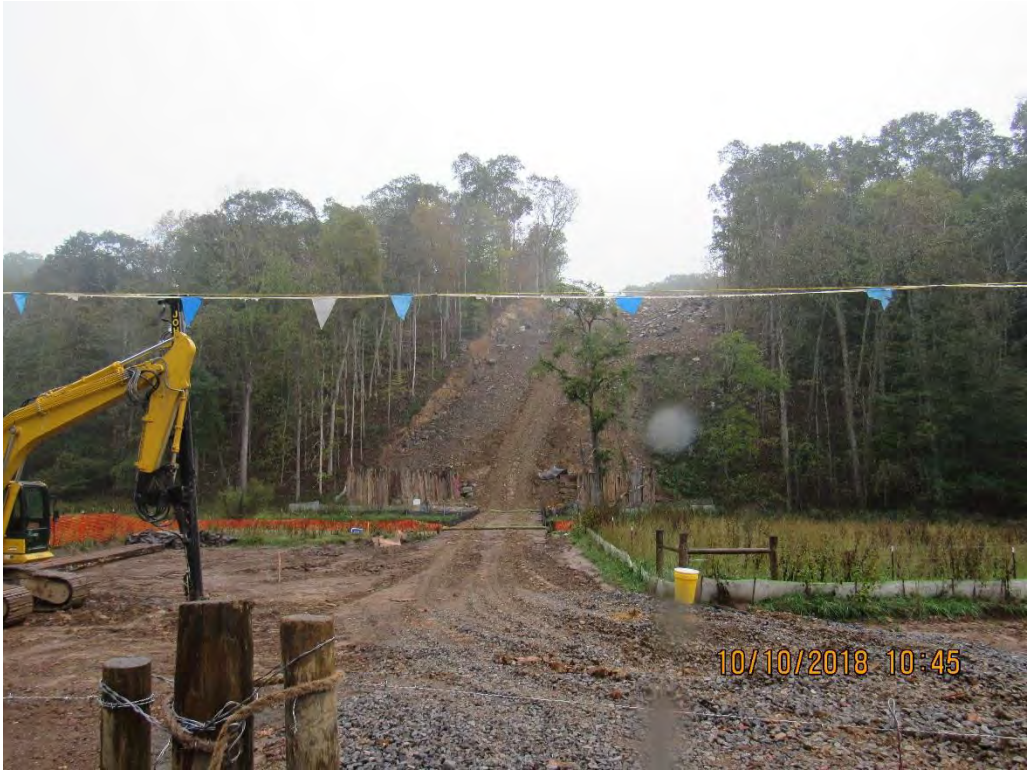
Photo 9: Keller's Creek road station 9127 with rough grade completed awaiting final grade and restoration.

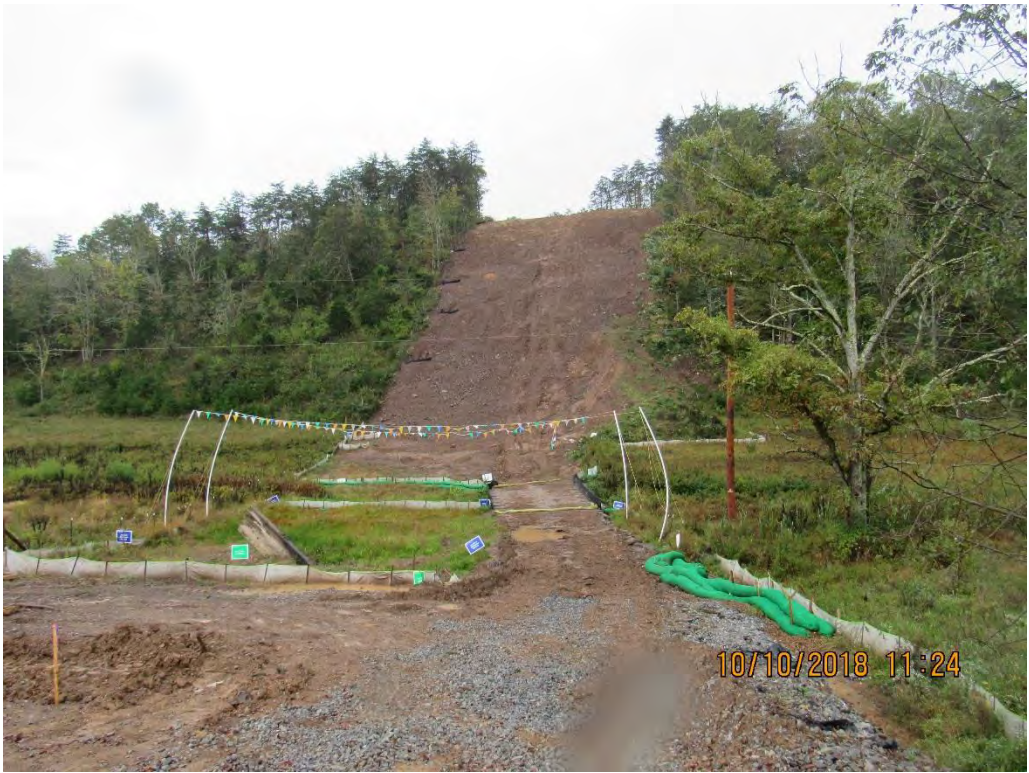
Photo 10: Wayside/Talcott station 9466 with rough grading completed awaiting final grade and restoration.

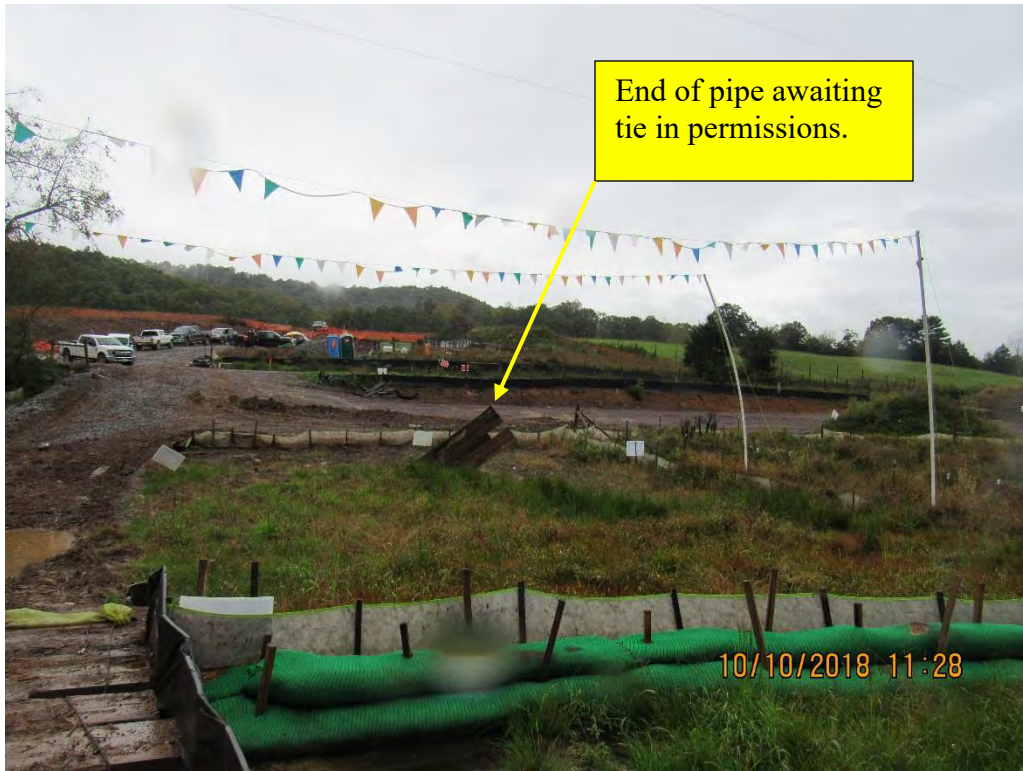
Photo 11: Wayside/Talcott station 9466 with matting indication end of pipe awaiting USACE permission for tie in.

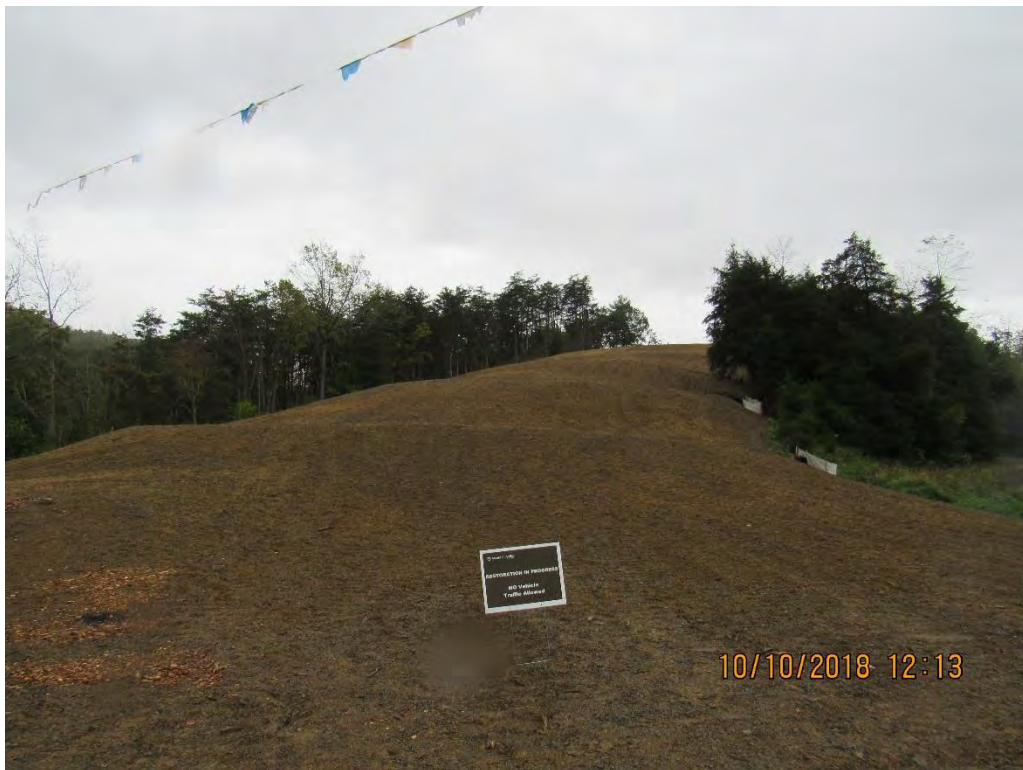
Photo 12: Slate Run station 9624 hill was green several weeks prior to attack of army worm.

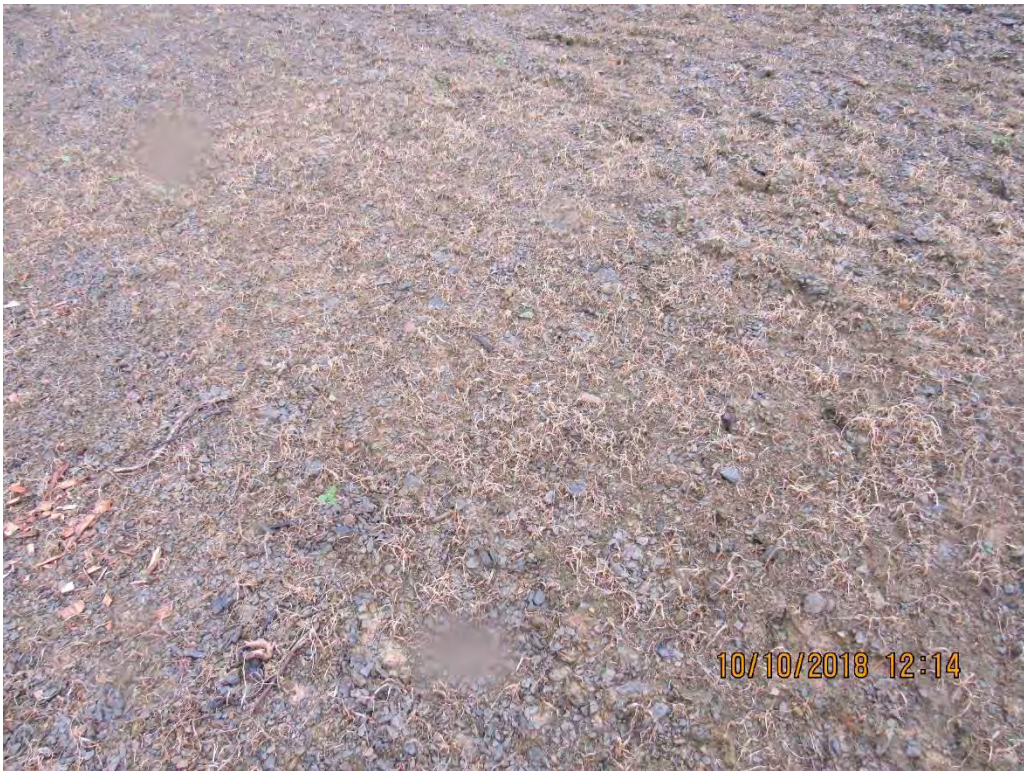
Photo 13: Slate Run station 9624 close-up of root system and remains of vegetation.

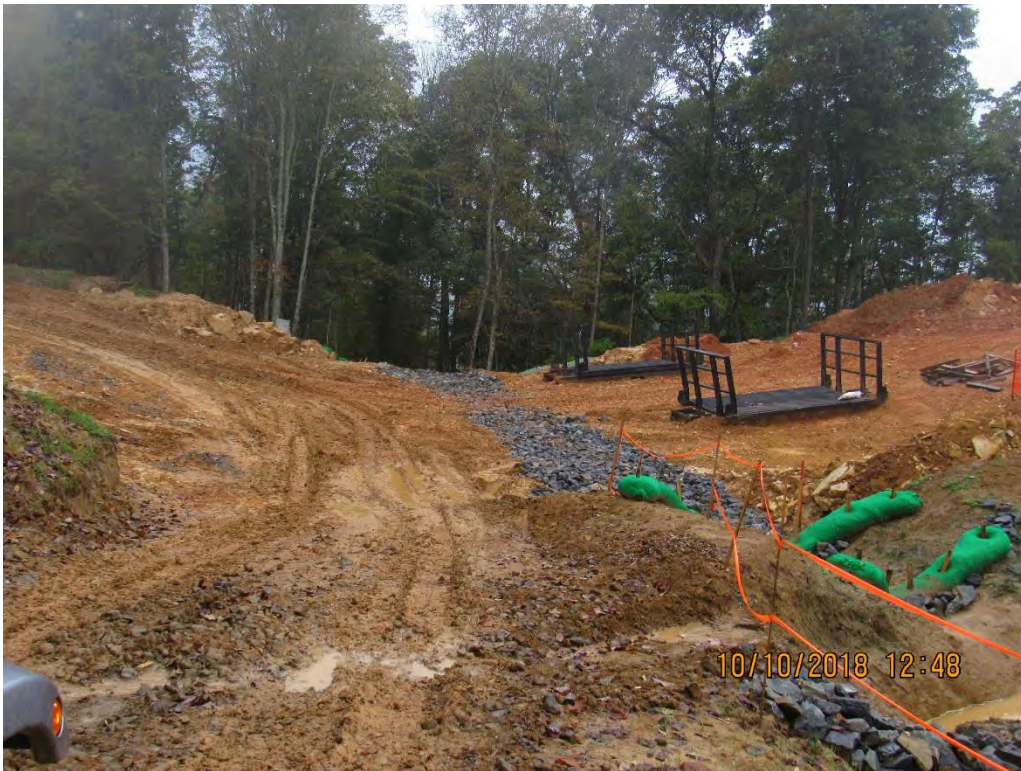
Photo 15: AR 224 at ROW station 9850+50 with diversion ditch across ROW.

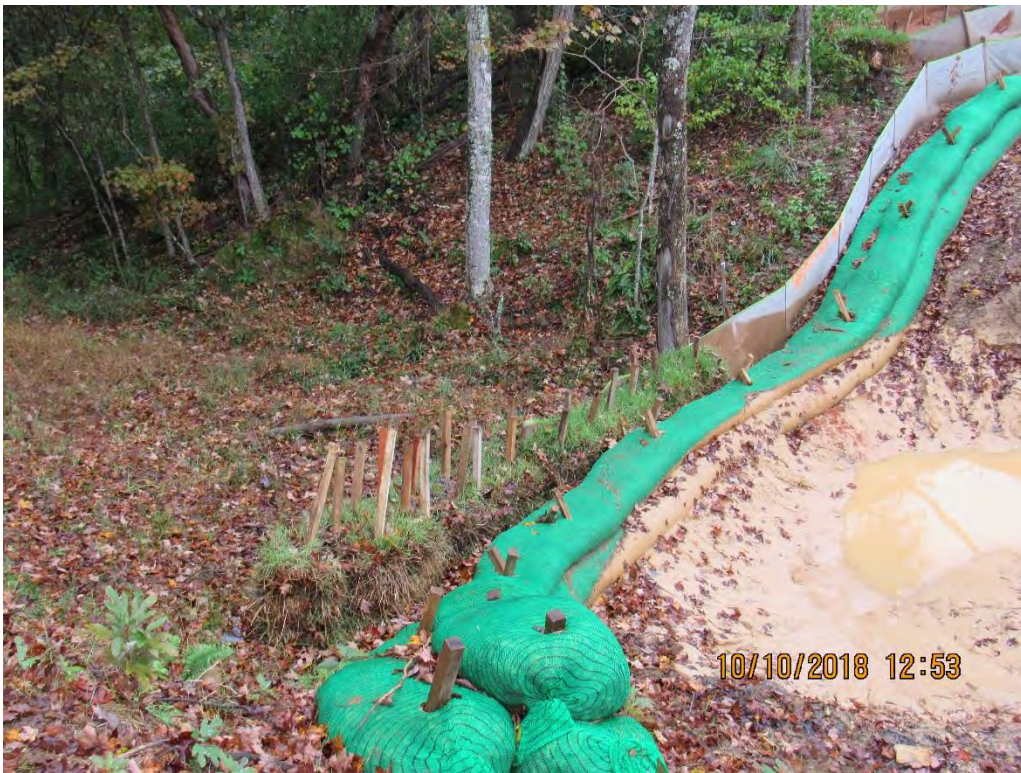
Photo 16: AR 224- sump at end of diversion ditch across ROW station 9850+50 and down slope/outlet of sump.
