**The Wilderness Society et al. Comments on the
U.S. Forest Service Mountain Valley Pipeline and
Equitrans Expansion Project Draft Supplemental
Environmental Impact Statement (#50036)**

EXHIBIT 12

**WEST VIRGINIA DEPARTMENT OF ENVIRONMENTAL PROTECTION
WV OIL AND GAS CONSTRUCTION STORMWATER PERMIT**

FACILITY NAME:	Mountain Valley Pipeline Project		REG. #	EXPIRE DATE:
PERMITTEE	MOUNTAIN VALLEY PIPELINE, LLC		WVR310667	5/13/2018 Extended: 12/31/2018
ADDRESS/PHONE:	Attn: MATTHEW HOOVER 625 LIBERTY AVE, ST 1700 PITTSBURG, PA 15222 7248733645			
LOCATION:	Harris Compressor Station		Entry Date/Time:	9/25/2018 1000
COUNTY:	Braxton		Exit Date/Time:	9/25/2018 1100
Site Representative /Phone	Brittany Dewitt (Lead EI)/330-987-1682, Matt Hoover MVP/ 412-258-5627 & Jason Hiles, Spread C Lead EI/740-334-7812		PHOTOS <input checked="" type="checkbox"/>	
CO-PERMITTEE:			ADDRESS:	
SITE OPERATOR:	MEC Construction LLC		ADDRESS:	19 RR Meadowbrook, WV 26404
PERMITTED ACREAGE	4311	WEATHER:	Cloudy	LAST INSPECTION: 8/21/2018
RECEIVING STREAM(S)	Trib of Elk/Kanawha R/ Ohio Rv			NOV: 1
Regular Mail <input type="checkbox"/> Certified Mail <input checked="" type="checkbox"/>	Tracking #			
OVERALL FACILITY R

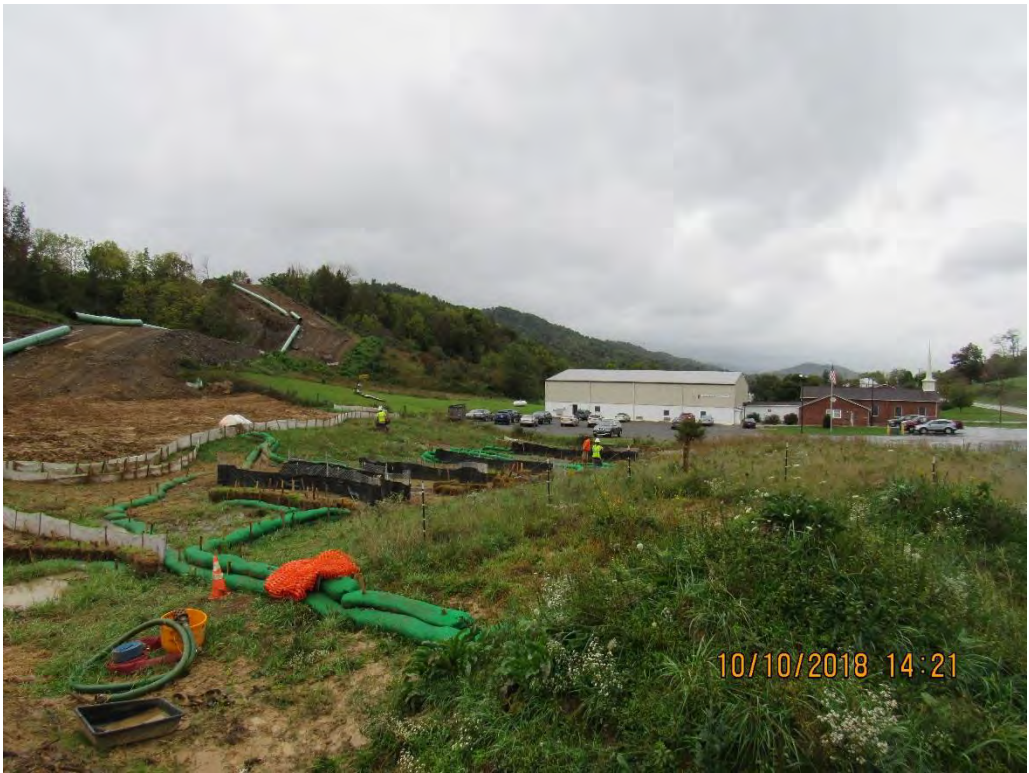
Photo 17: Lindside Methodist Church station 10116 with workers performing maintenance on controls below bridge.

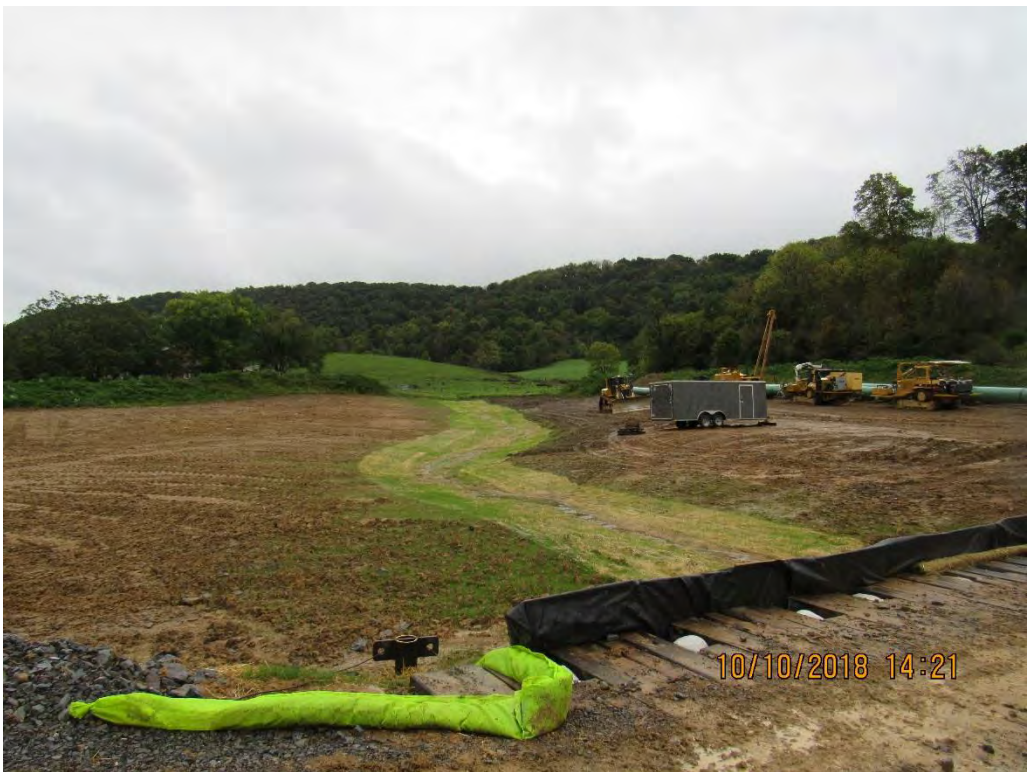
Photo 18: Established diversion for run-on from farmer's pond at Lindside Methodist Church station 10116.

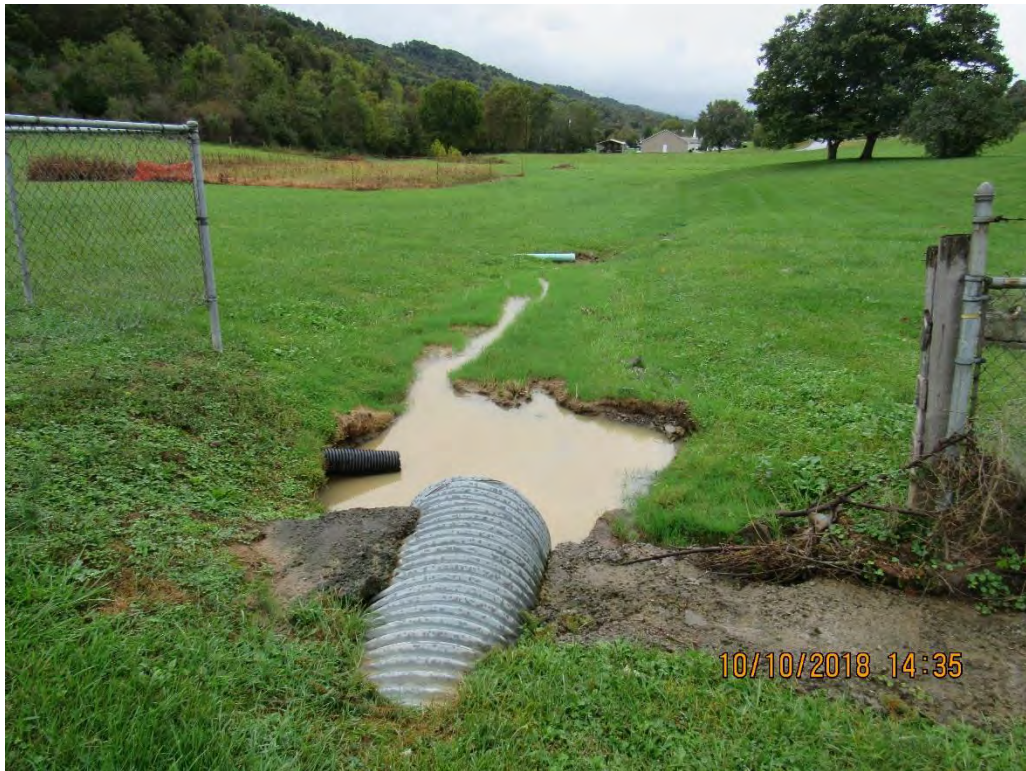
Photo 19: Culvert on west side of Lindside Methodist Church station 10116- unable to determine location of sediment.

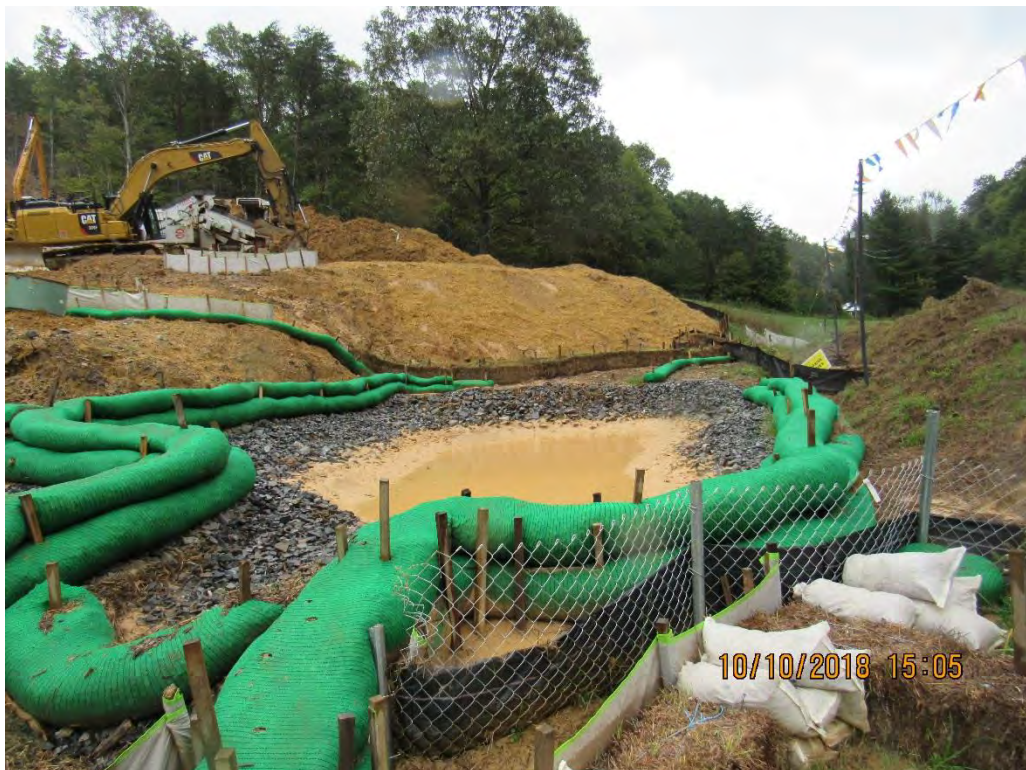
- Painter's Run Road station 10270- location of NOV# W18-52-012-CP issued 10/3/2018 for lack of maintenance on sumps (photos 20). Sumps had been cleaned out and appeared to be working well. Receiving stream, both sections of Painters Run, was clear (photo 21-22) NOV# 18-52-012-CP has been abated and returned to compliance.

Photo 20: Painter's Run Road station 10270- maintenance performed abating NOV# W18-52-012-CP.

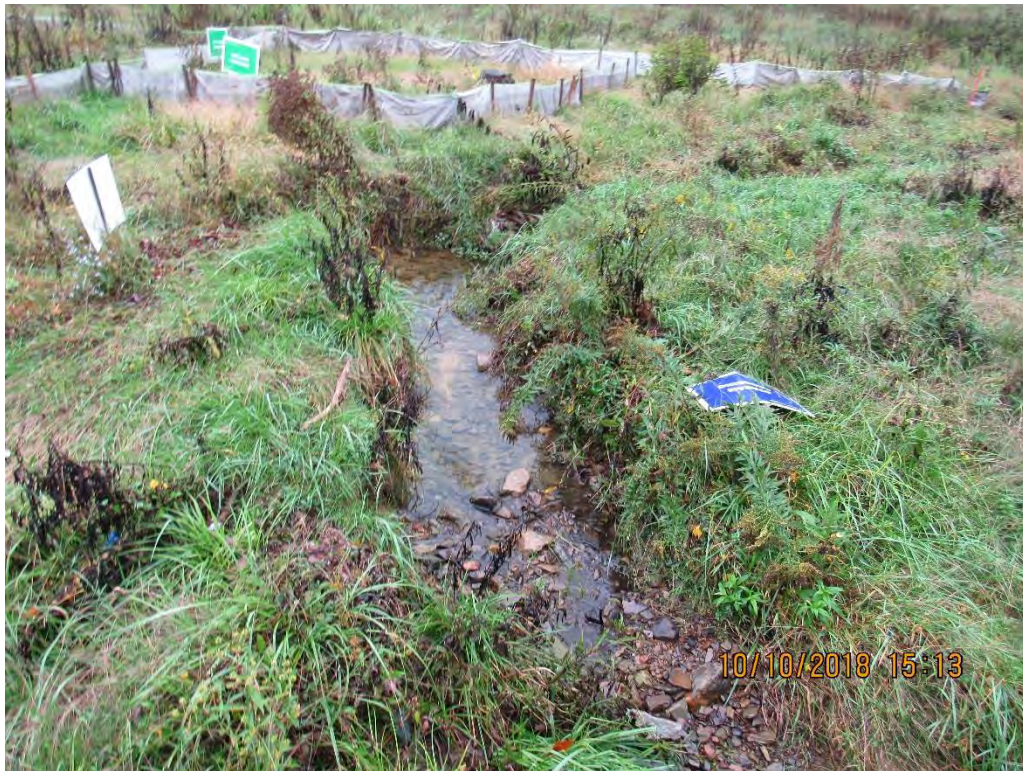
Photo 21: Painters Run after outlet of controls at Painters Run station 10270.

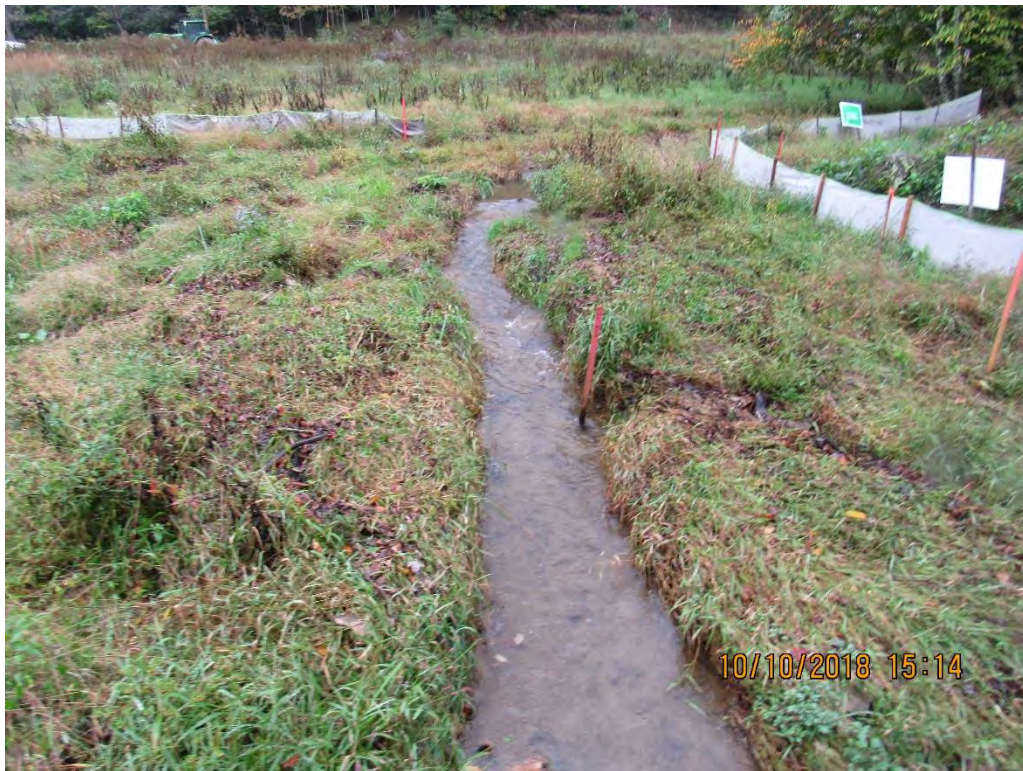
Photo 23: Painters Run after outlet of controls at Painters Run station 10270.

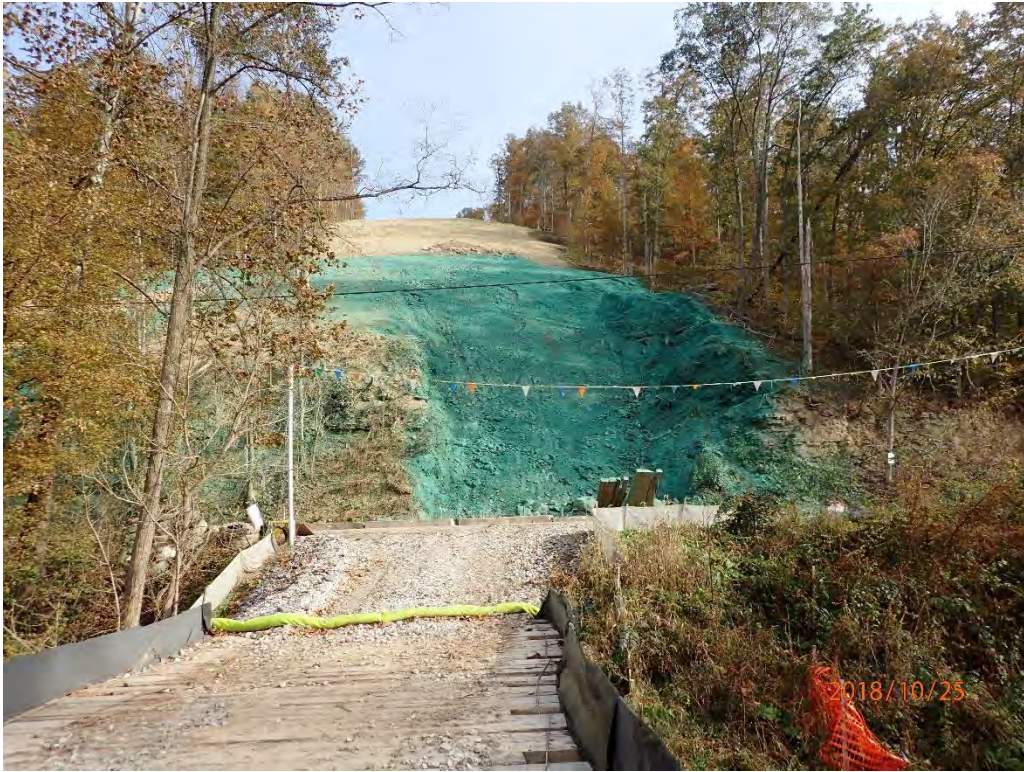
North Fork Road Crossing. Slope has been hydroseeded.

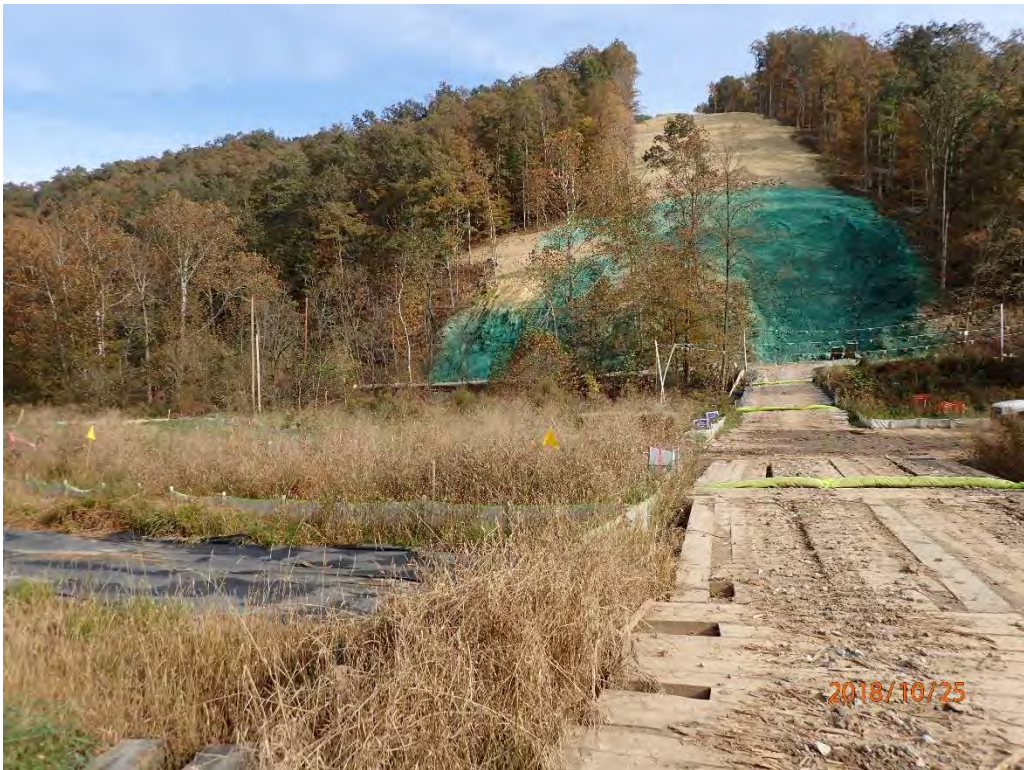
Wetland near 39.55401, -80.54555 has controls in place.

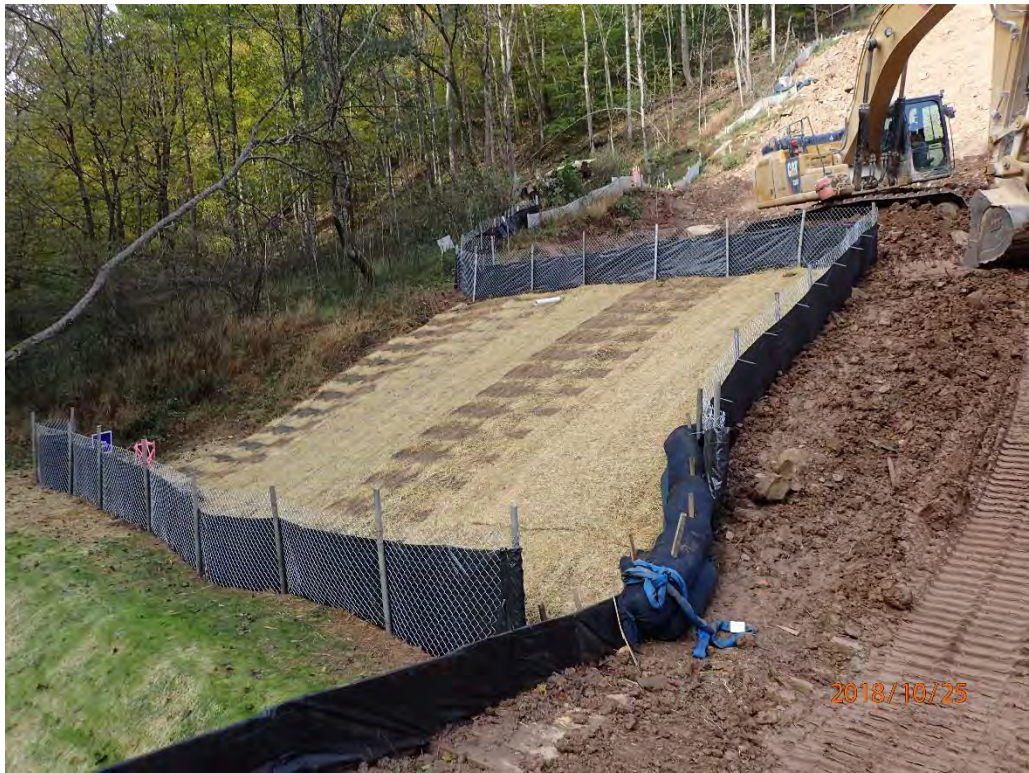
(1)Slope had been restored since previous inspection where sediment had left the site and entered nearby stream. There was sediment build up near the silt sock close to the stream. There was no evidence that sediment had left the site through the control. Contractors replaced the silt sock during the inspection.

UNT to Mobley Run Slope had been restored since previous inspection where sediment had left the site and entered nearby stream.

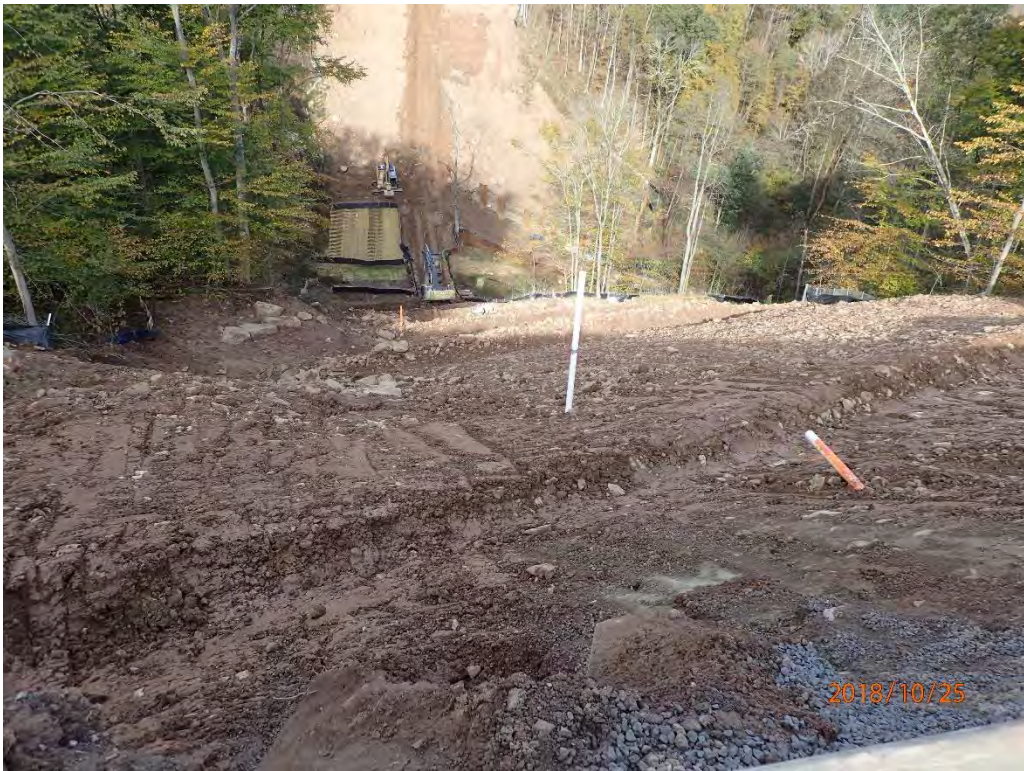
UNT to Mobley Run Waterbars had been reworked since last inspection.

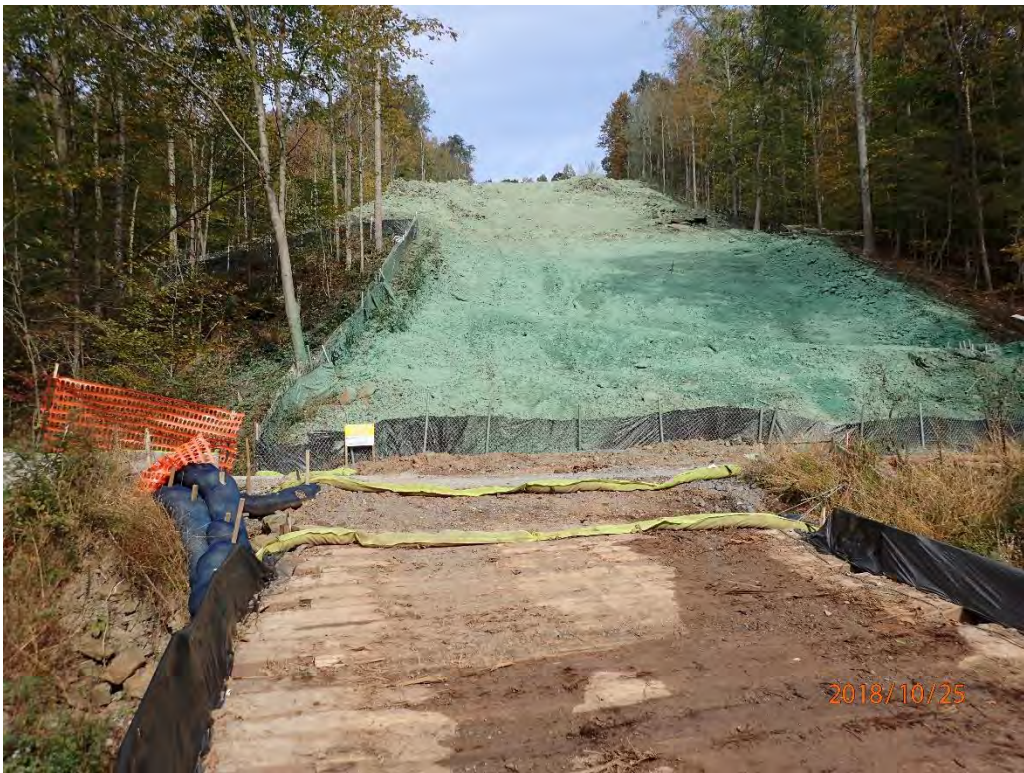
Fallen Timber crossing has been hydroseeded.

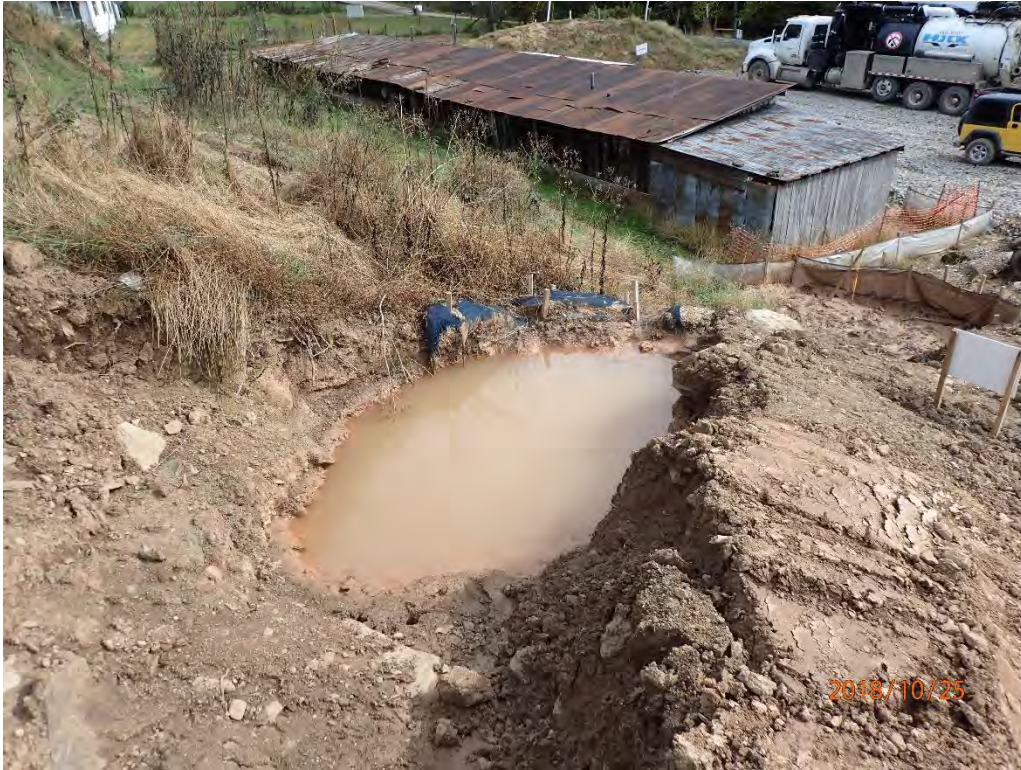
Overwhelmed sump near Sams Run.

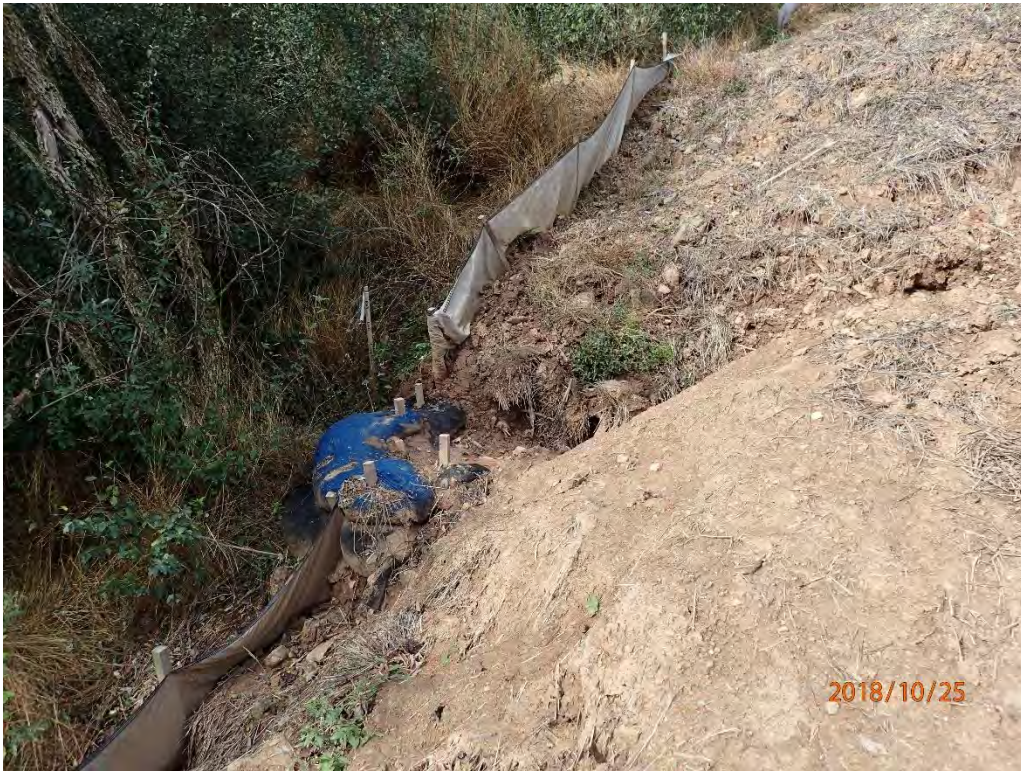
Overwhelmed sump near Sams Run.

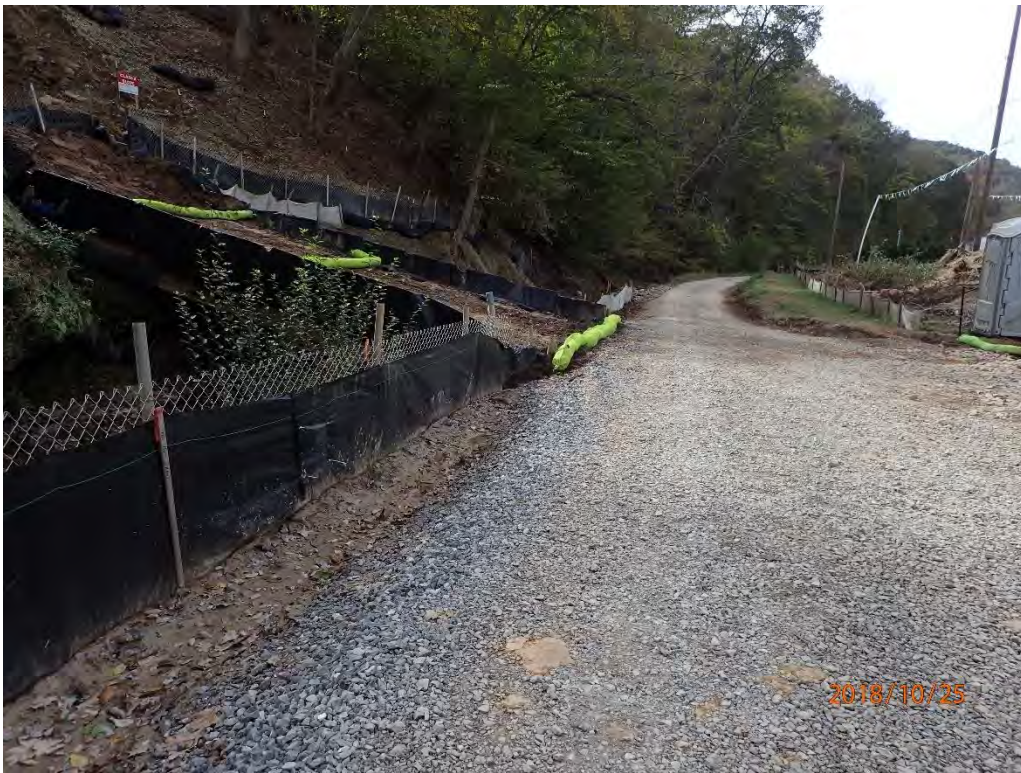
Sams Run Road re-graveled since last inspection.

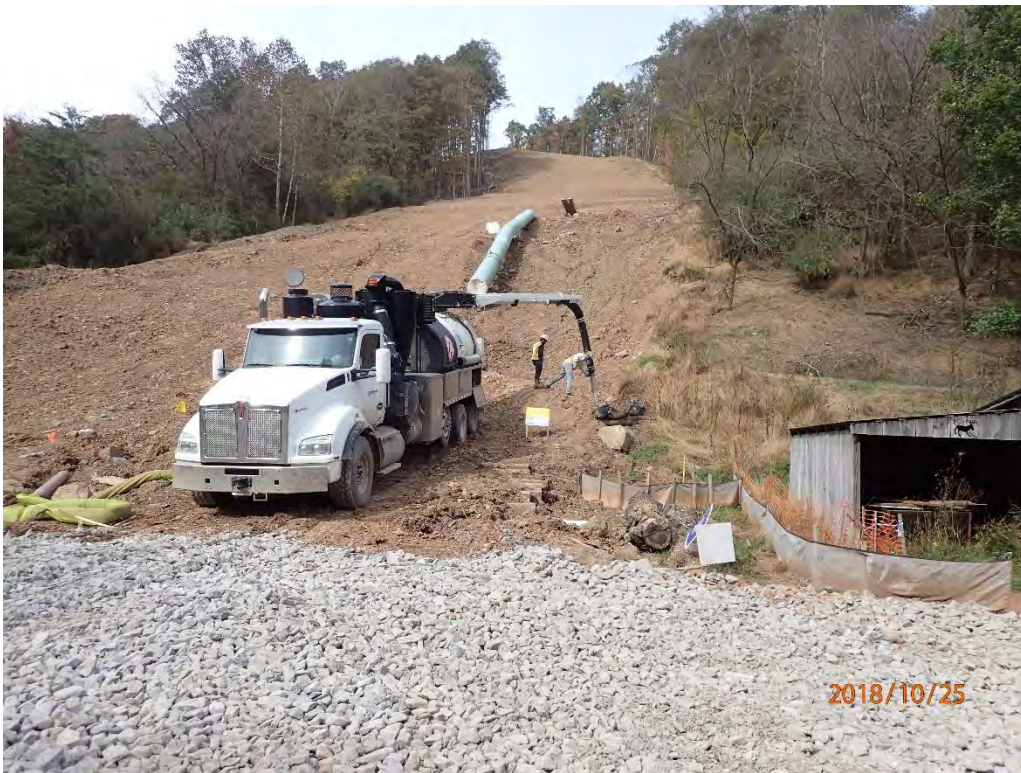
Contractors cleaning out sump near staging area off Sams Run Road.

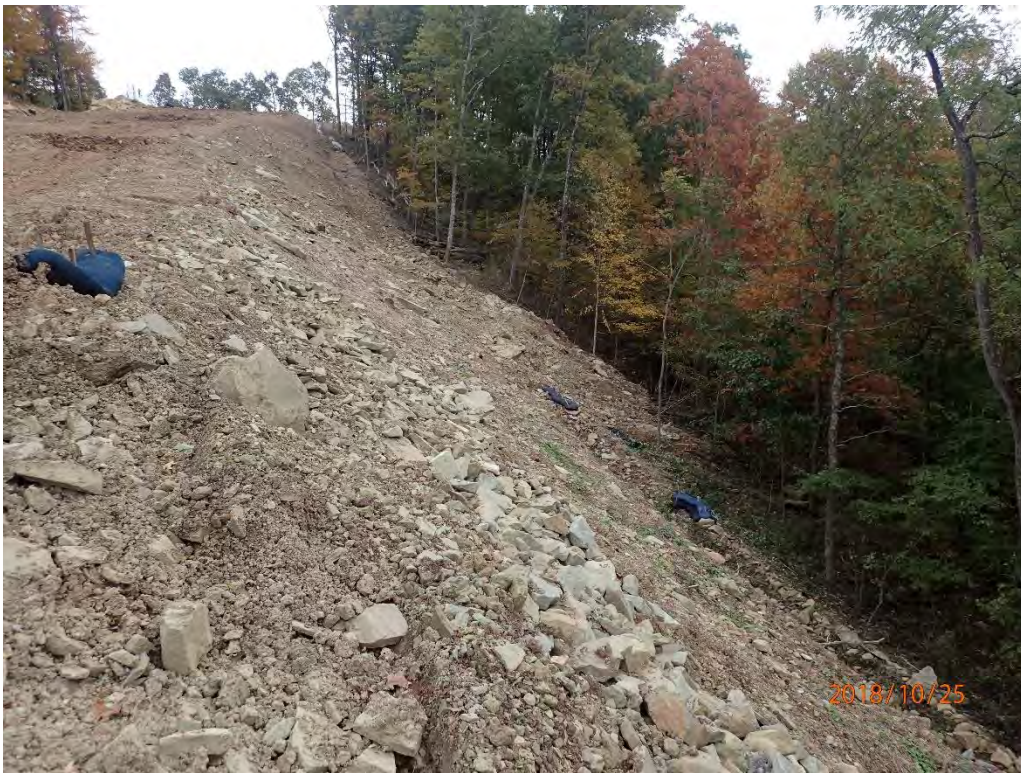
Slip at Station 489 entered the ditchline from a sideslope allowing sediment to leave the project ROW.

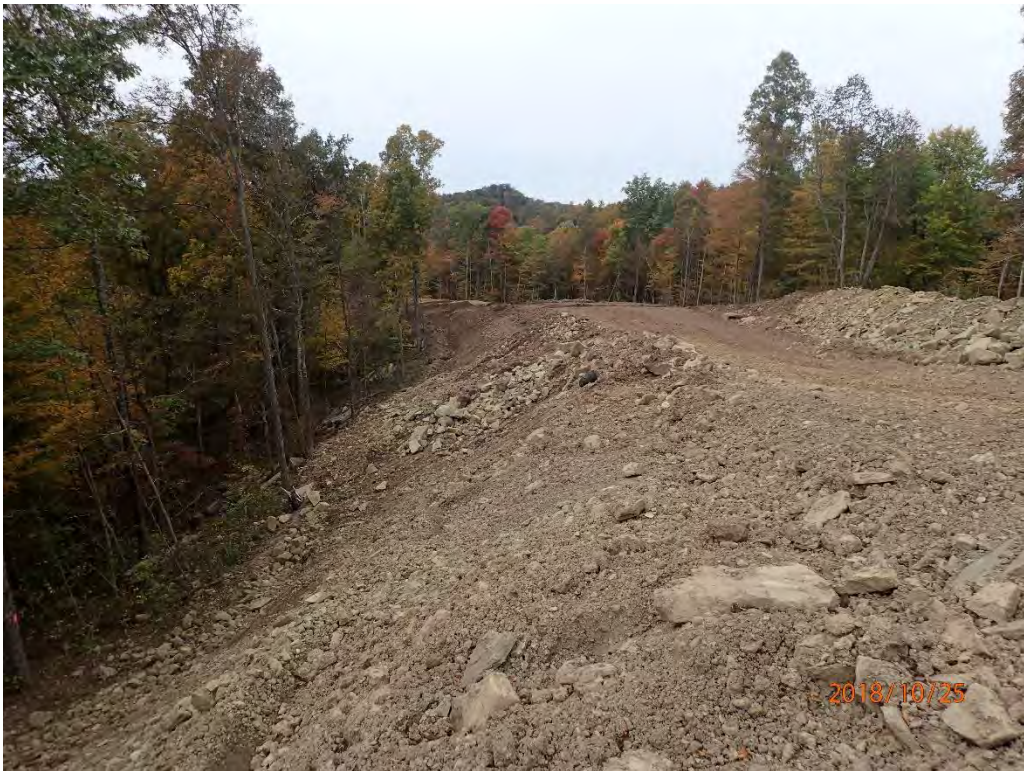
Slip at station 493 had entered the ditchline from a sideslope allowing sediment to leave the project ROW.

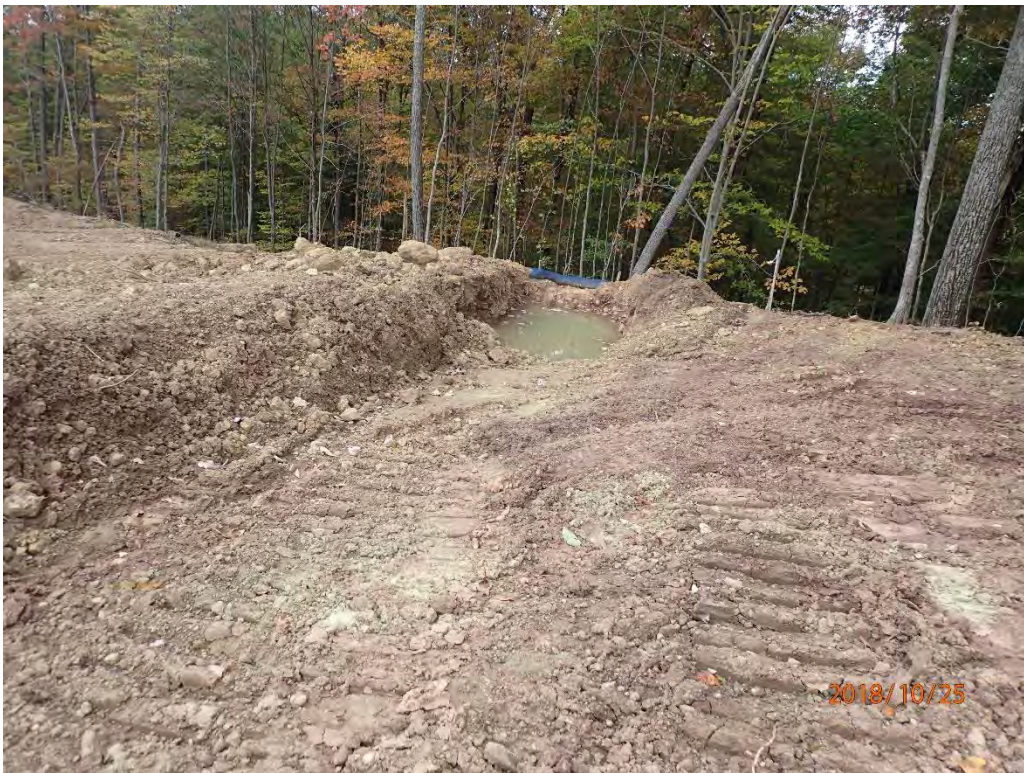
Sump at Station 286 in need of maintenance.

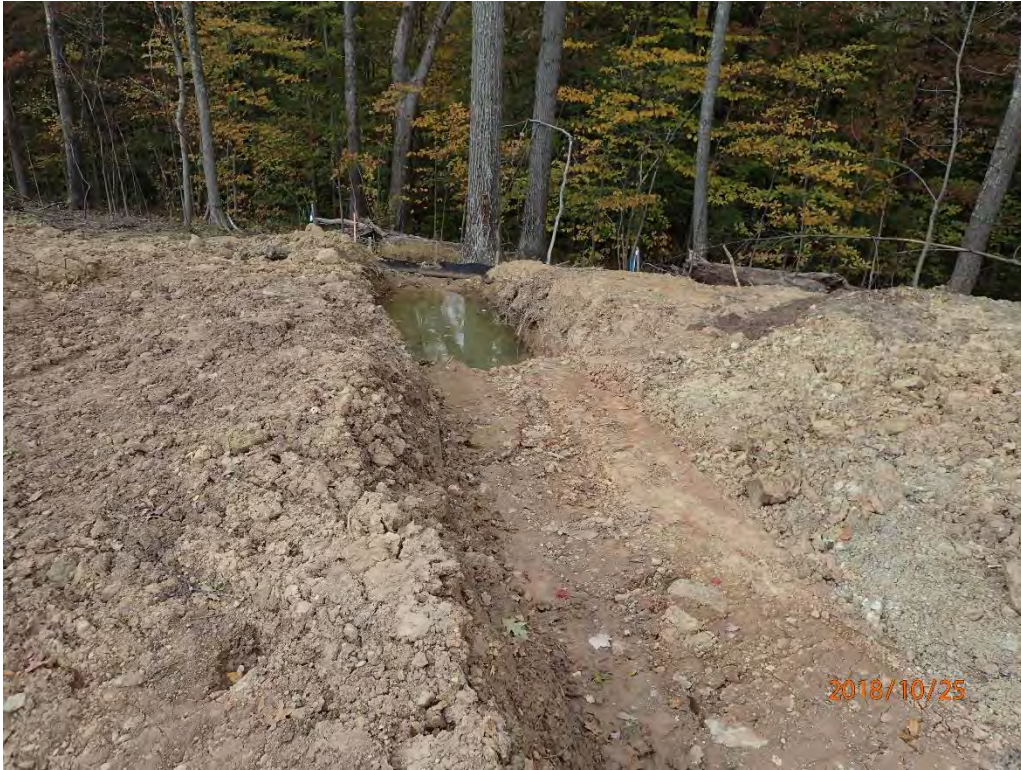
Sump at Station 290 in need of maintenance.

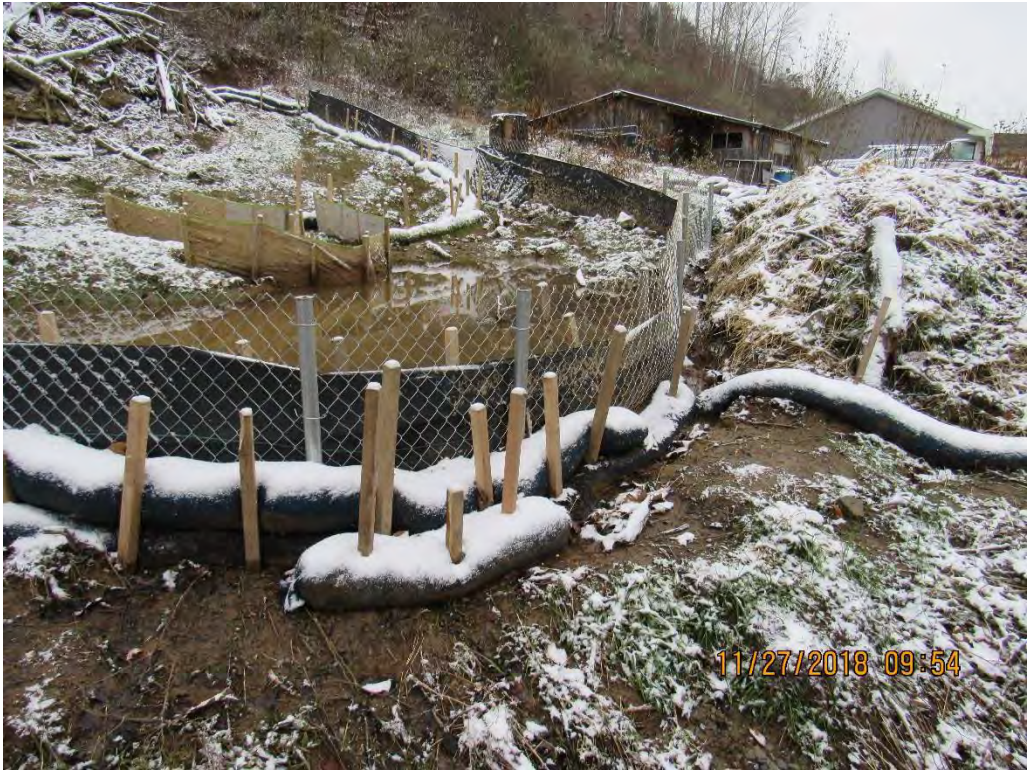
Photo 1: Near station 3634 location of NOV# W18-52-010-CP- additional controls added.

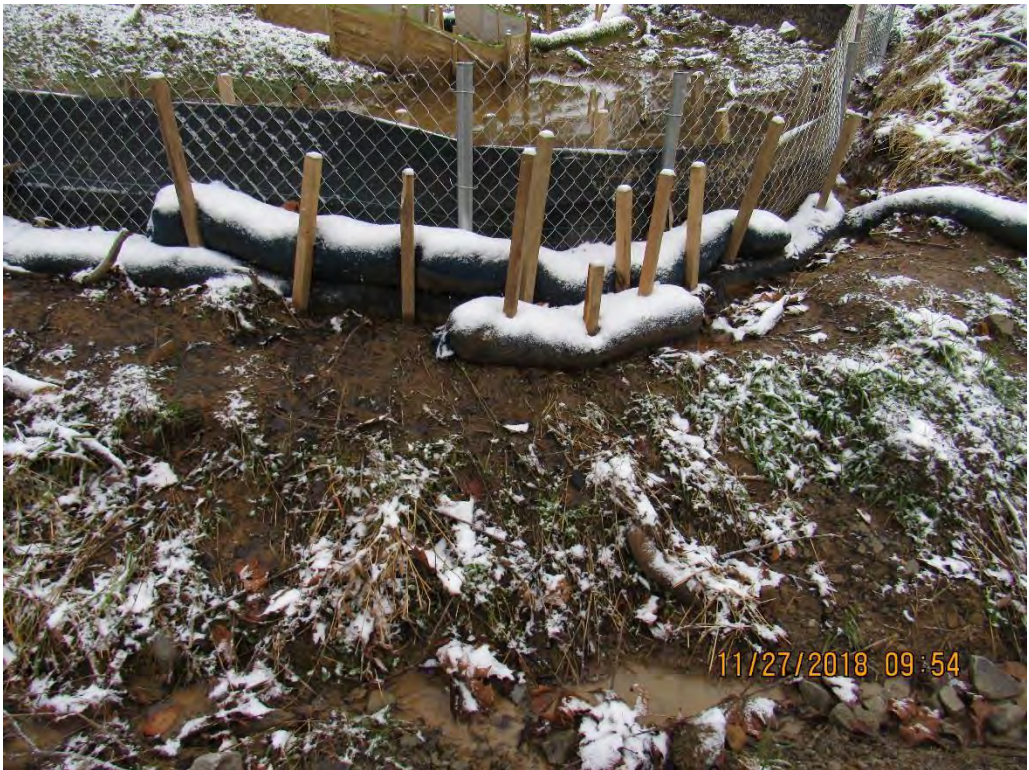
Photo 2: Clear water release from additional controls near station 3634 abating NOV# W18-52-010-CP.

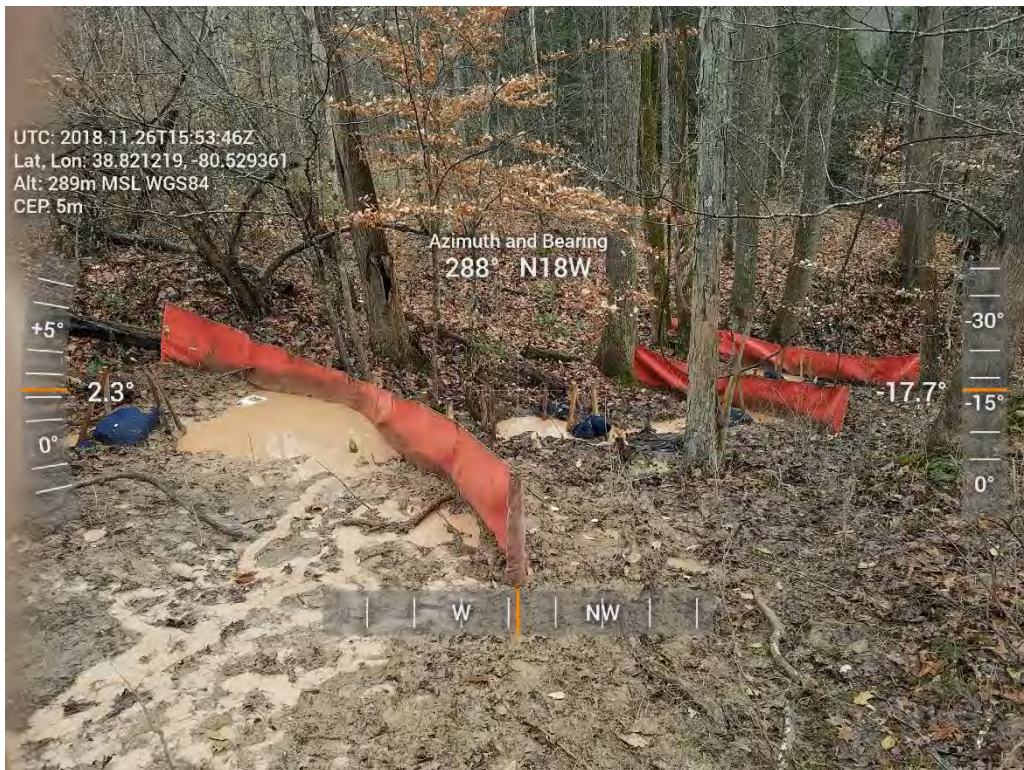
Photo 6: Receiving stream (UNT of Knawl's Creek) below release of slip with additional controls. Photo supplied by EI Andy Pauley.

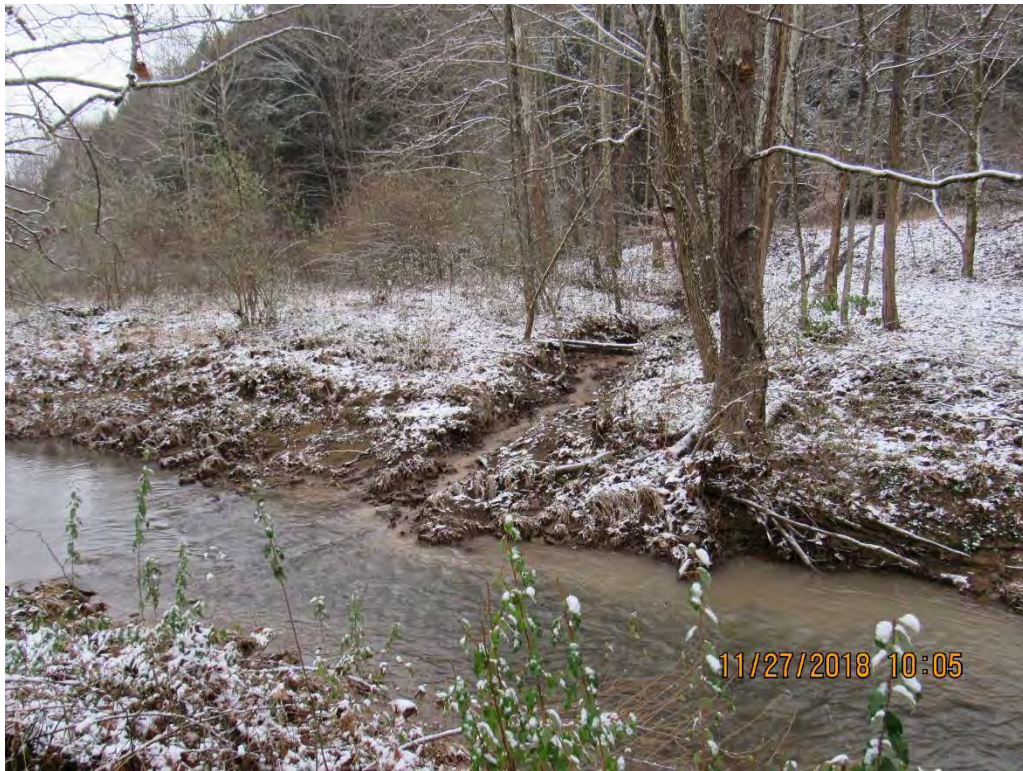
Photo 7: Convergence of UNT of Knawl's Creek into Knawl's Creek below release point (in photo 6)

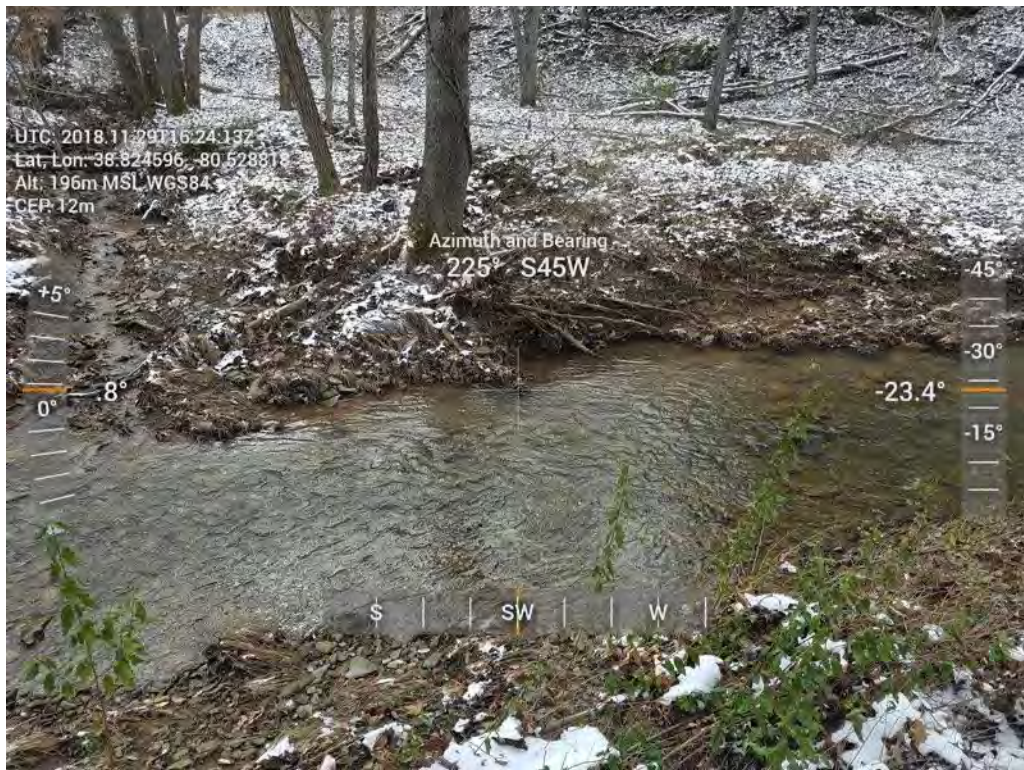
Photo 10: Slightly downstream of convergence point into Knawl's Creek after additional controls added. Photo provided by Jason Hiles, Lead EI taken 11/29/2018.

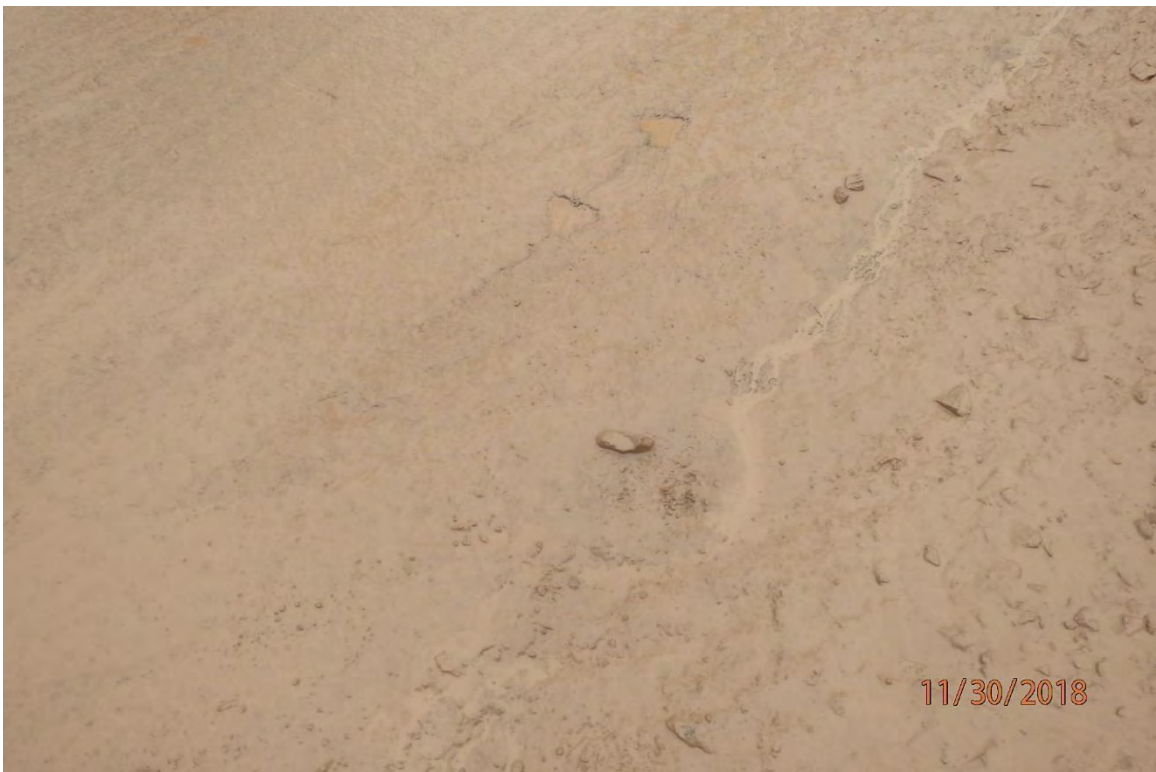
Access Road WV-HA – 31.1 off CR 50/4 showing the lack of an adequately stable construction entrance and the associated track out onto the public road.

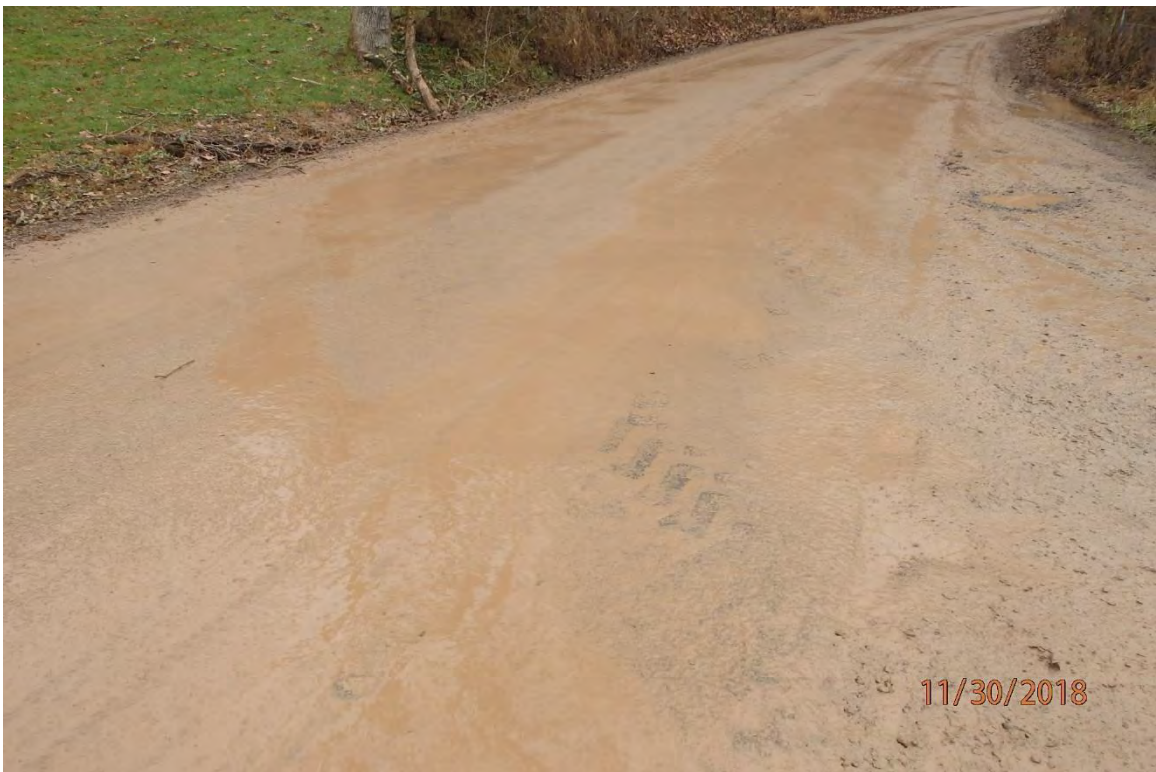
Access Road WV-HA - 29.04 off CR 50/5 showing the lack of an adequately stable construction entrance and the associated track out onto the public road.

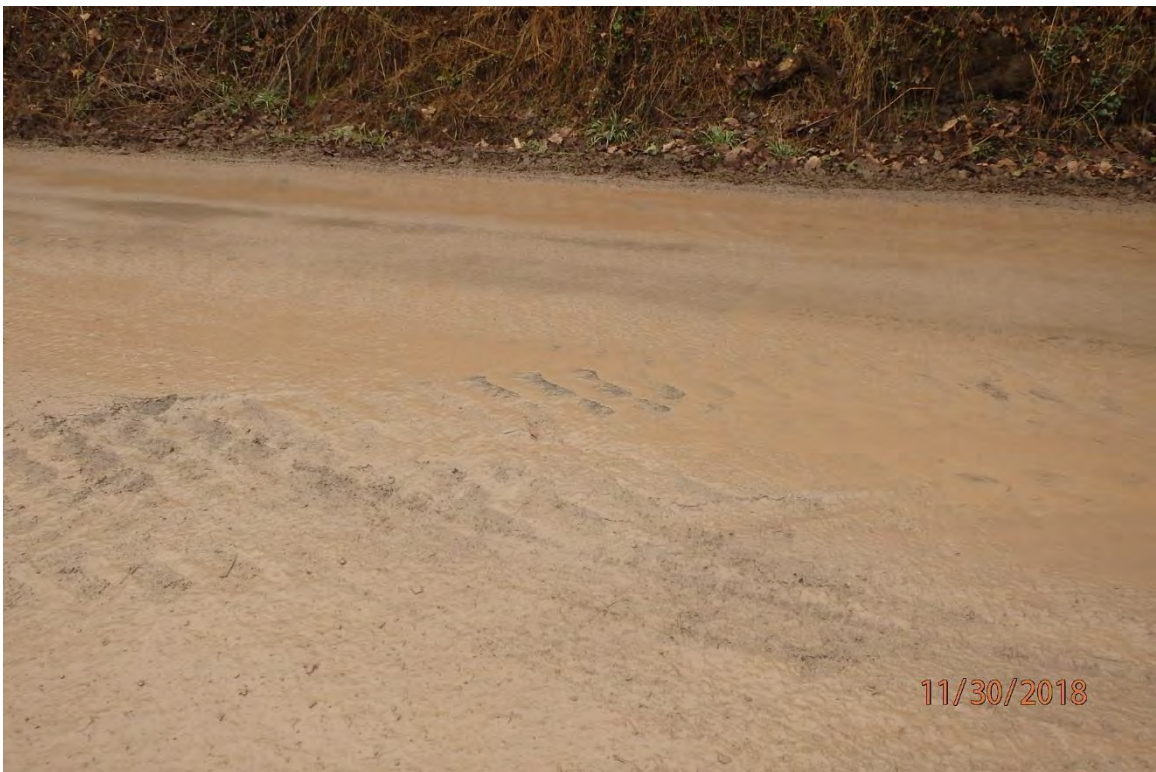
Access Road WV-HA - 29.5 off CR 50/5 showing the lack of an adequately stable construction entrance and the associated track out onto the public road.
