**The Wilderness Society et al. Comments on the
U.S. Forest Service Mountain Valley Pipeline and
Equitrans Expansion Project Draft Supplemental
Environmental Impact Statement (#50036)**

EXHIBIT 12

**WEST VIRGINIA DEPARTMENT OF ENVIRONMENTAL PROTECTION
WV OIL AND GAS CONSTRUCTION STORMWATER PERMIT**

FACILITY NAME:	Mountain Valley Pipeline Project		REG. #	EXPIRE DATE:
PERMITTEE	MOUNTAIN VALLEY PIPELINE, LLC		WVR310667	5/13/2018 Extended: 12/31/2018
ADDRESS/PHONE:	Attn: MATTHEW HOOVER 625 LIBERTY AVE, ST 1700 PITTSBURG, PA 15222 7248733645			
LOCATION:	Harris Compressor Station		Entry Date/Time:	9/25/2018 1000
COUNTY:	Braxton		Exit Date/Time:	9/25/2018 1100
Site Representative /Phone	Brittany Dewitt (Lead EI)/330-987-1682, Matt Hoover MVP/ 412-258-5627 & Jason Hiles, Spread C Lead EI/740-334-7812		PHOTOS <input checked="" type="checkbox"/>	
CO-PERMITTEE:			ADDRESS:	
SITE OPERATOR:	MEC Construction LLC		ADDRESS:	19 RR Meadowbrook, WV 26404
PERMITTED ACREAGE	4311	WEATHER:	Cloudy	LAST INSPECTION: 8/21/2018
RECEIVING STREAM(S)	Trib of Elk/Kanawha R/ Ohio Rv			NOV: 1
Regular Mail <input type="checkbox"/> Certified Mail <input checked="" type="checkbox"/>	Tracking #			
OVERALL FACILITY R

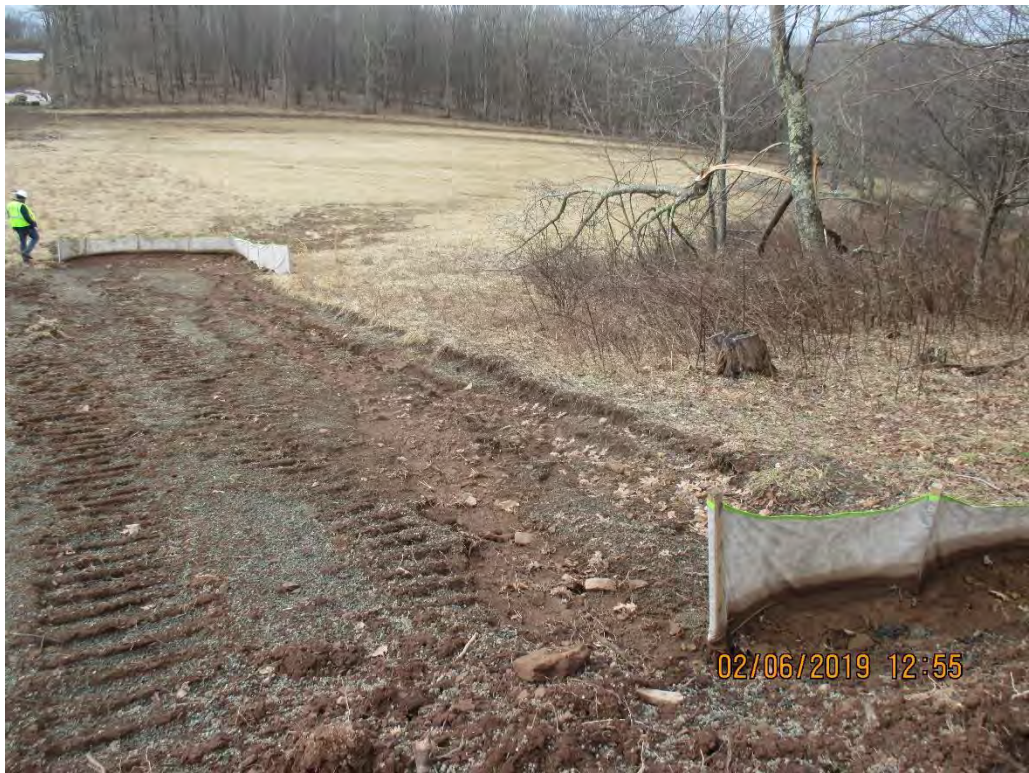
Waterbar termini at station #8780+00 facing South. Rill erosion occurring between controls.

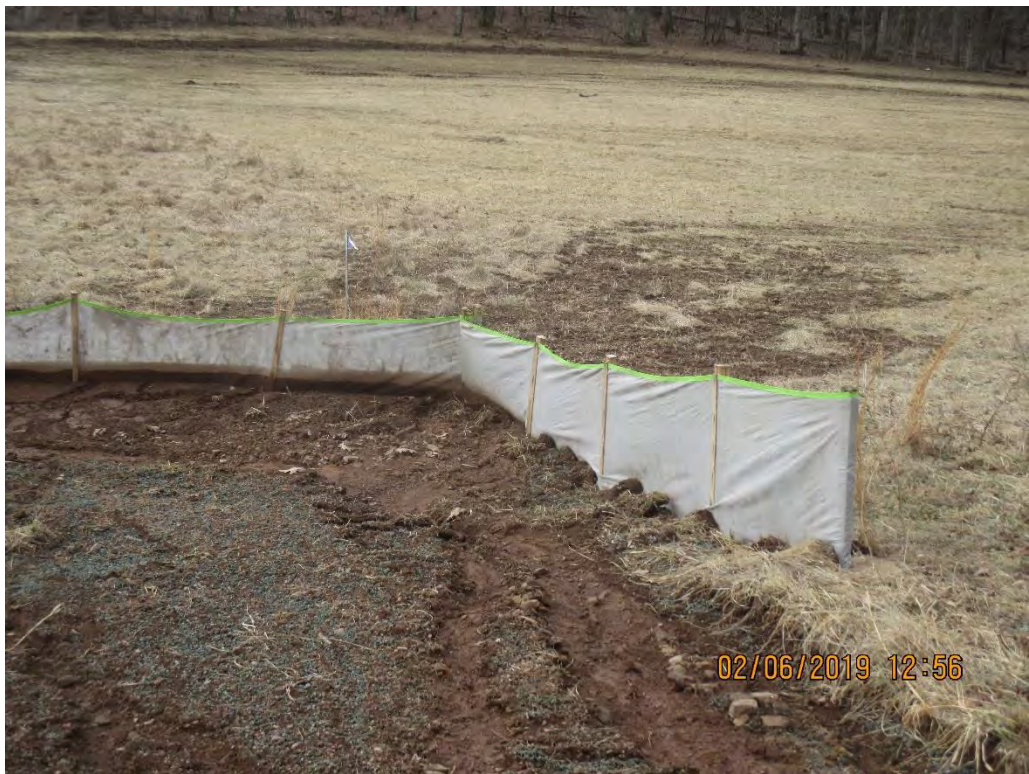
Waterbar termini at station #8780+00 facing South. Evidence of concentrated flow due to absence of vegetation past LOD.

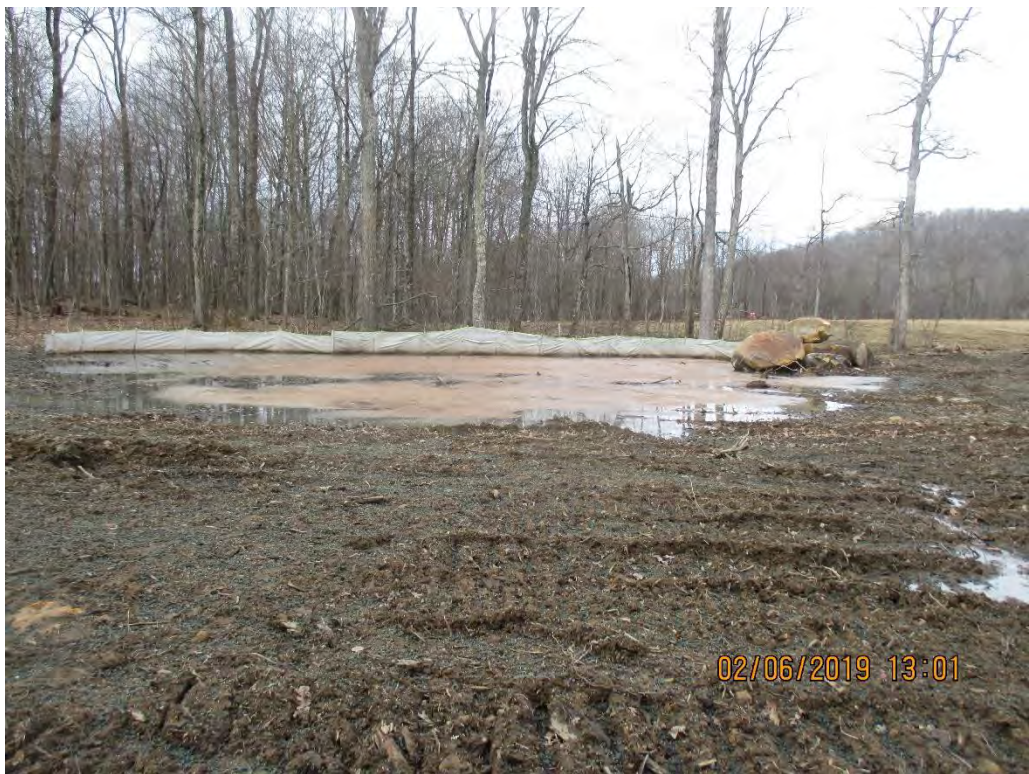
Low lying saturated area in ROW at station #8784+00.

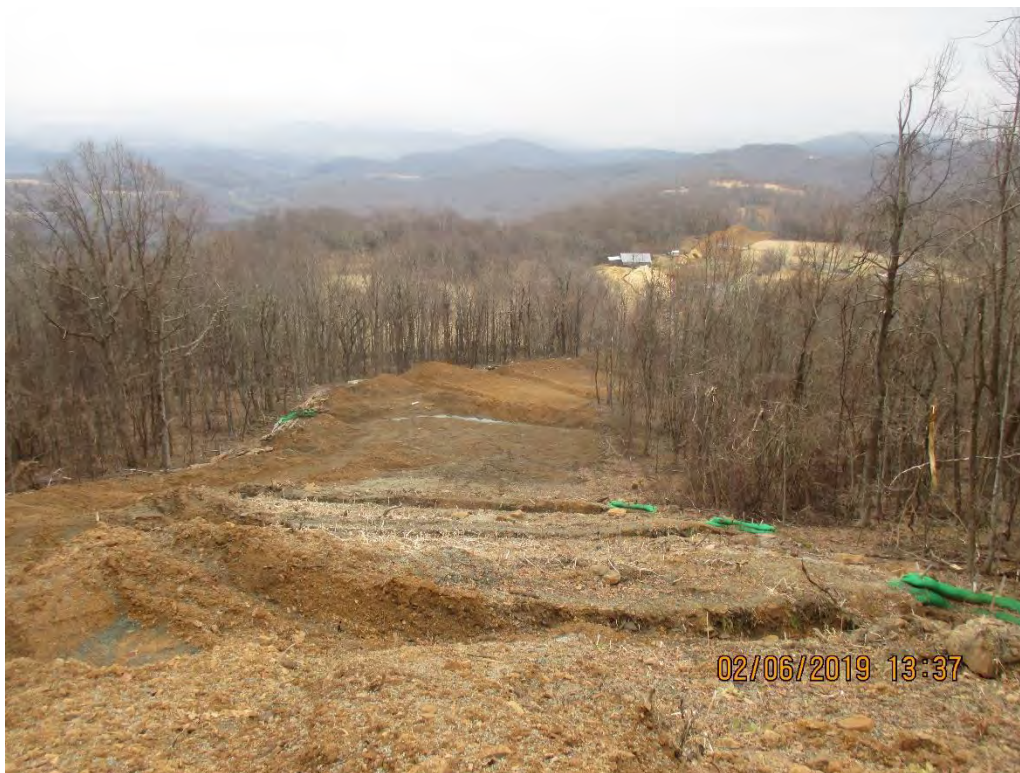
Section G.4. - Permittee has failed to comply with the General Permit and approved Storm Water Pollution Prevention Plan (SWPPP). Erosion control devices near station number 8816+00 are not in place as detailed by the SWPPP.

Standing at station 8809+20. Per SWPPP waterbar to be installed and not present.

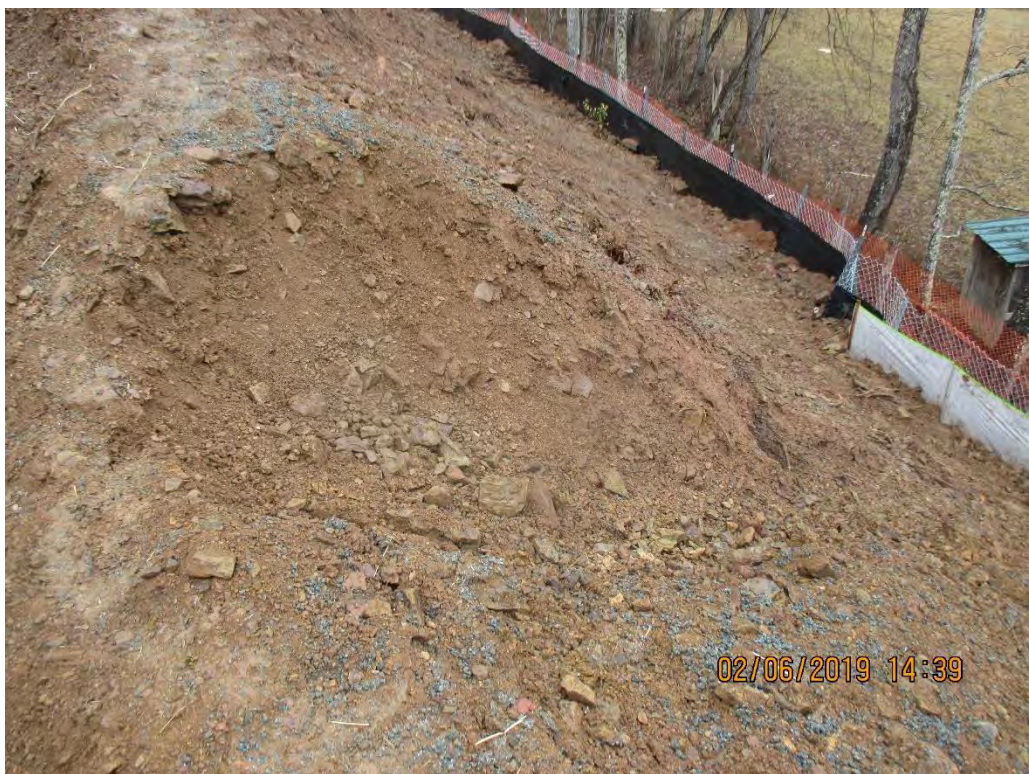
Small slip on side slope near station number 8966+00.

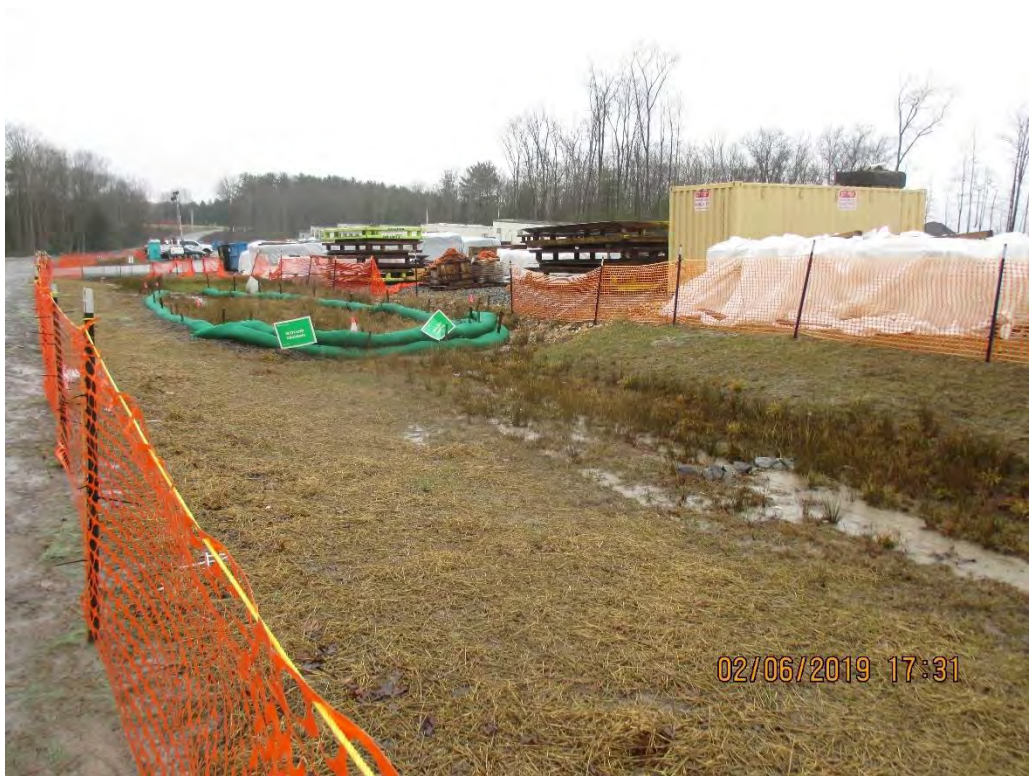
Section G.4.e.2.A.ii.j - Permittee has failed to prevent sediment-laden water from leaving the site without going through an appropriate device at the MVP contractor yard in Beaver, WV. Sediment laden water was entering an UNT of Brammer Branch.

View facing towards wetland in drainage ditch. Sediment laden water (SLW) present in ditch and wetland.

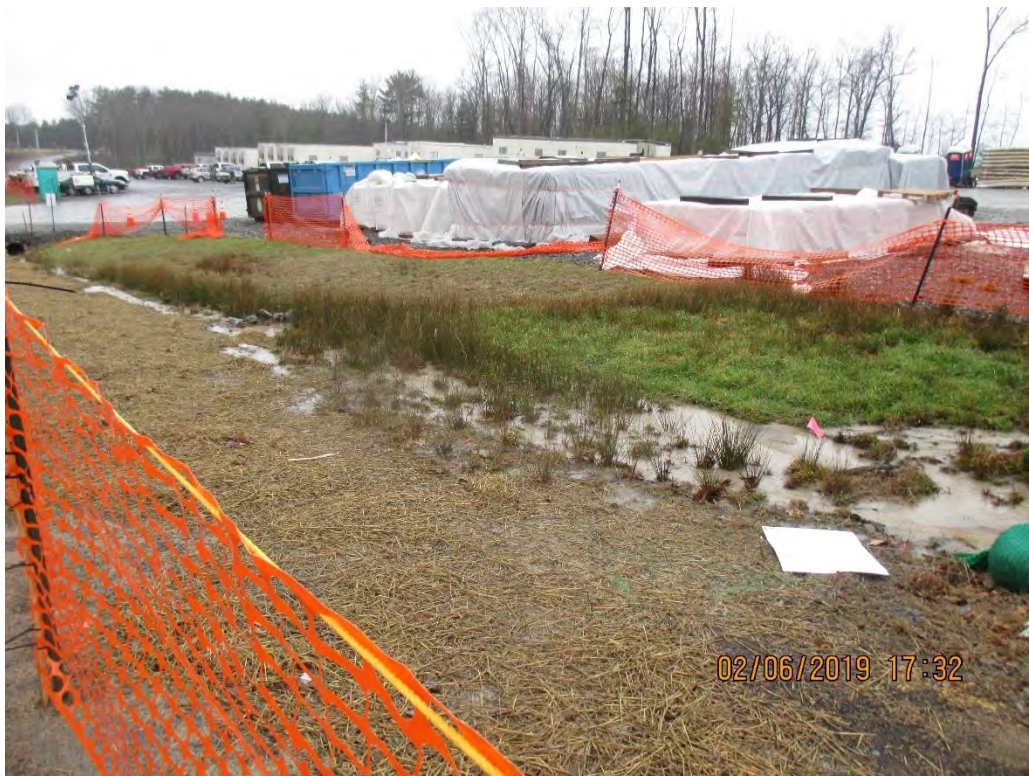
End of wetland. SLW conveying towards culvert.

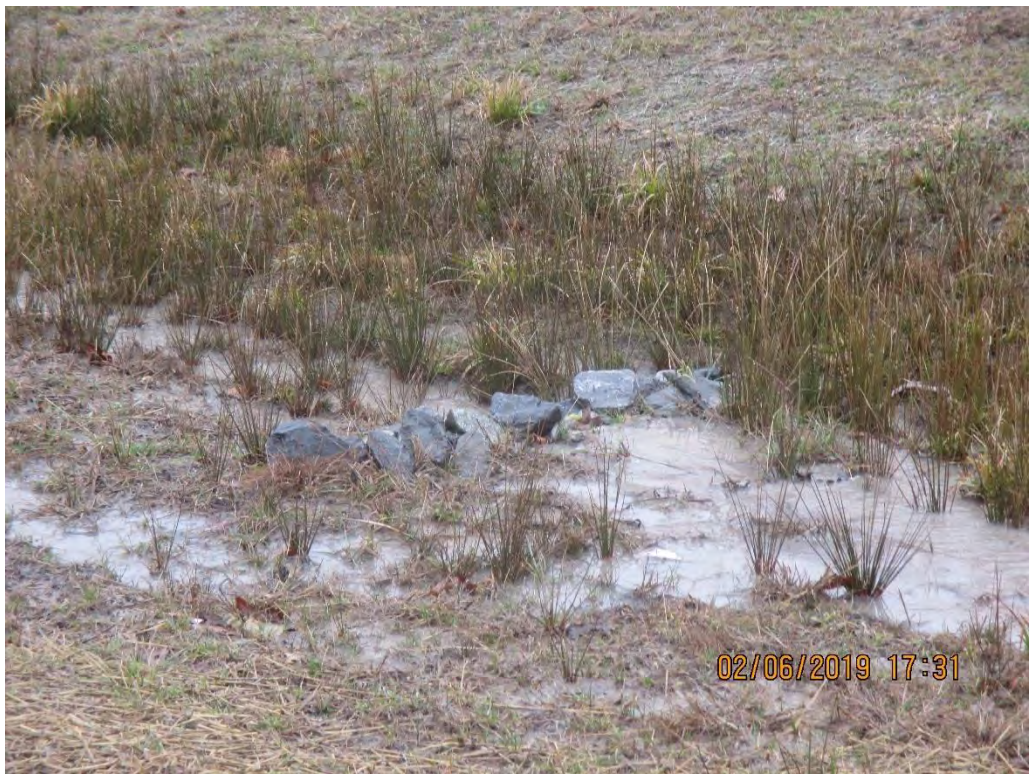
Section D.1-Permittee has failed to properly operate and maintain all facilities and systems: Evidence was observed that BMP's were not being maintained in and along a drainage ditch that flowed through the yard and terminated upslope of the UNT of Brammer Branch causing Conditions Not Allowable.

Rock check in ditch with SLW present draining towards culvert.

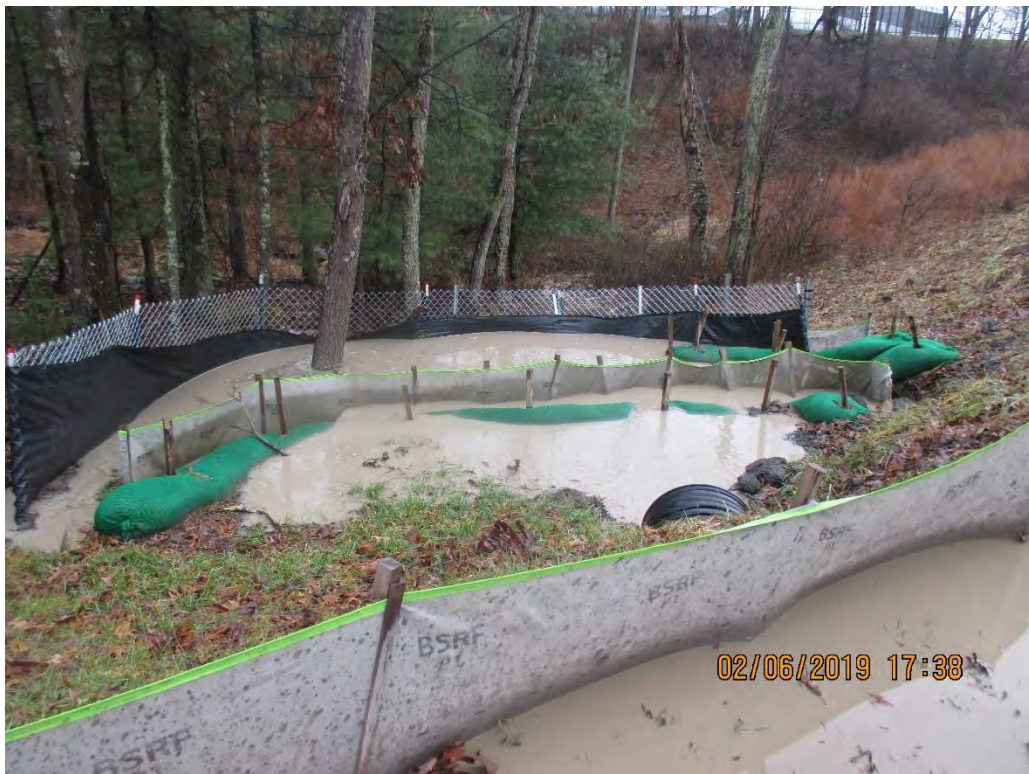
Culvert outflow into multiple controls with SLW present.

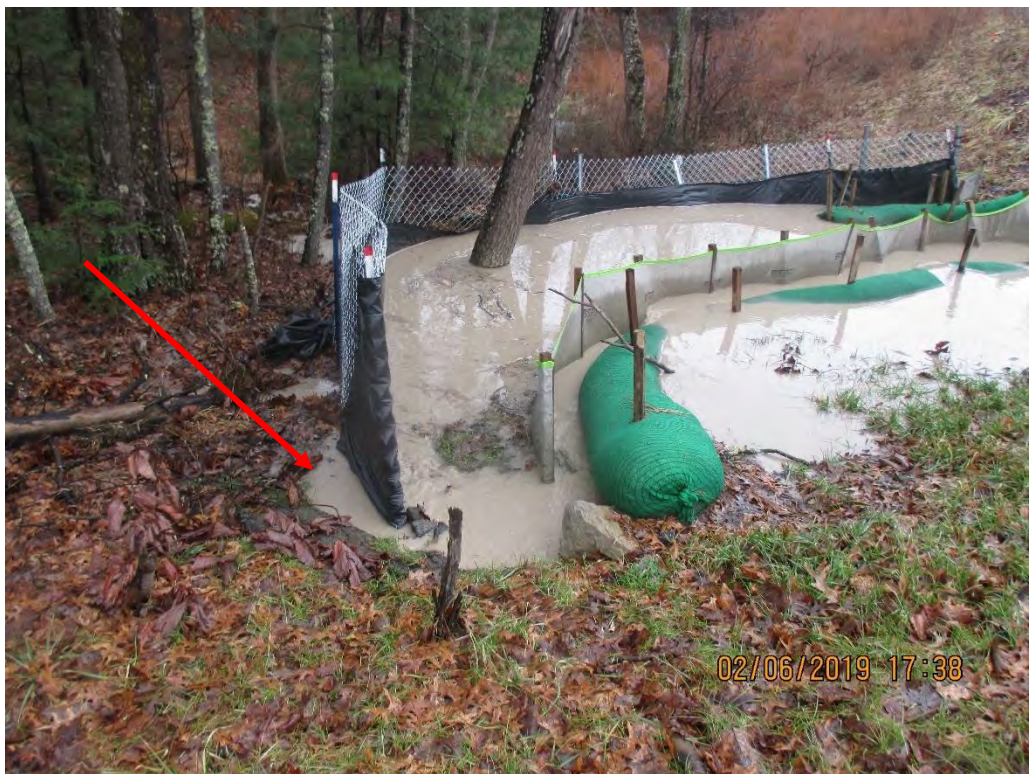
Controls downstream of culvert. SLW present going around controls.

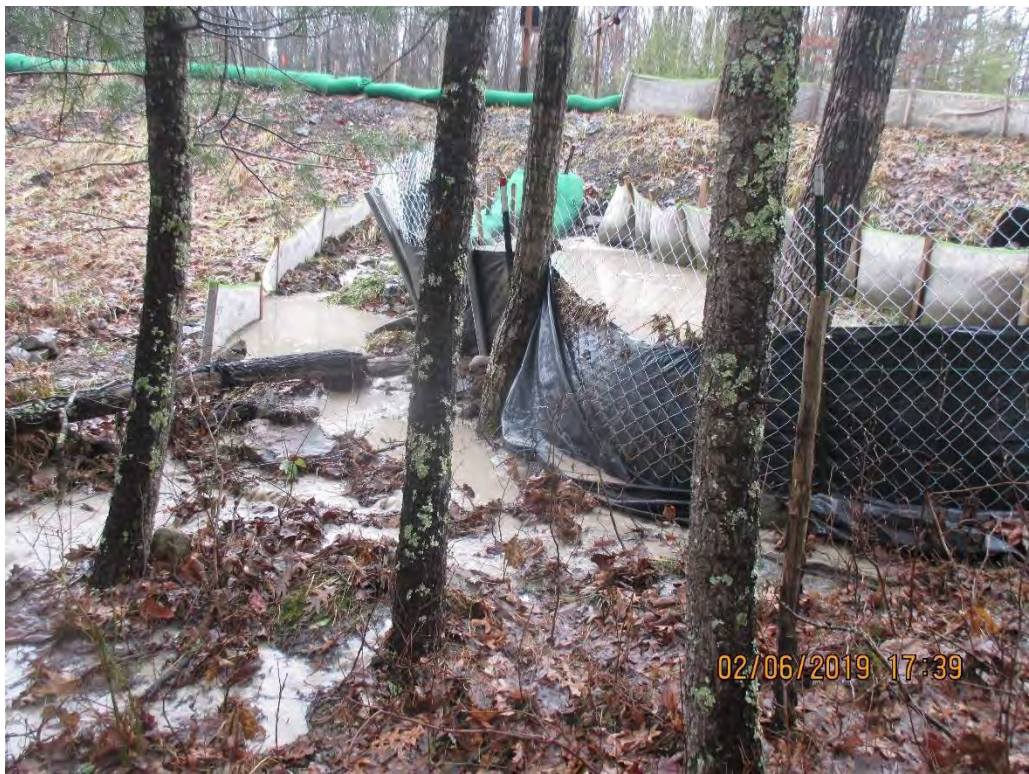
SLW flowing past controls and downslope to UNT of Brammer Branch. Backside of silt fence fallen over.

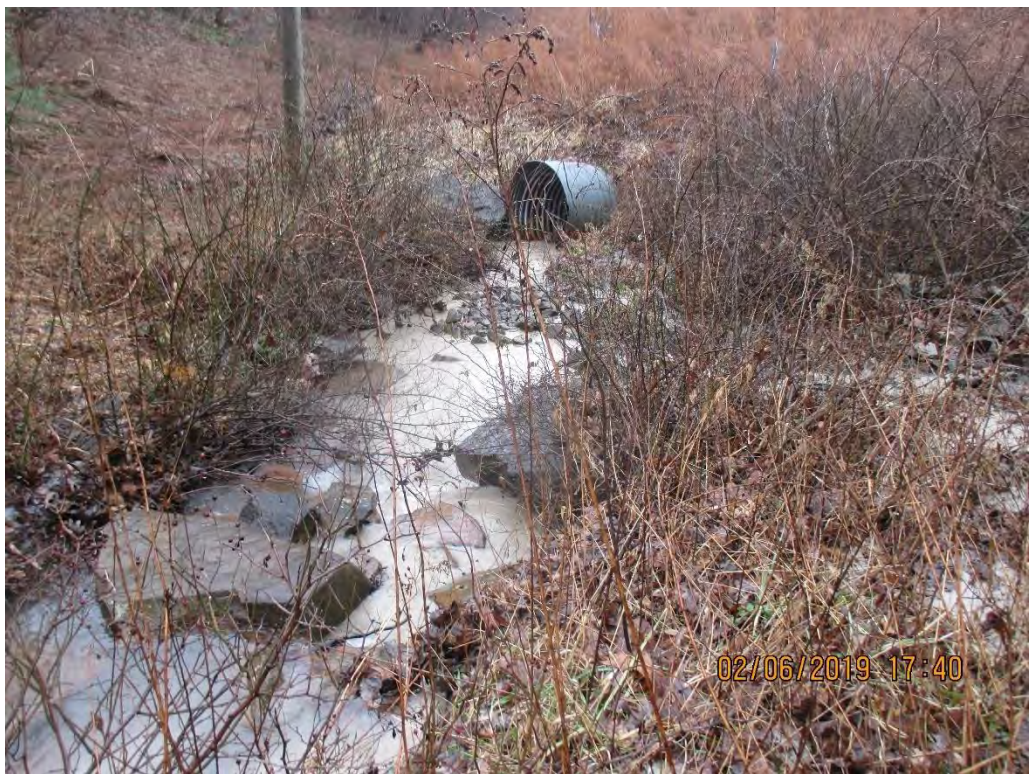
View facing Southeast towards UNT of Brammer Br. SLW present flowing from controls and into creek.

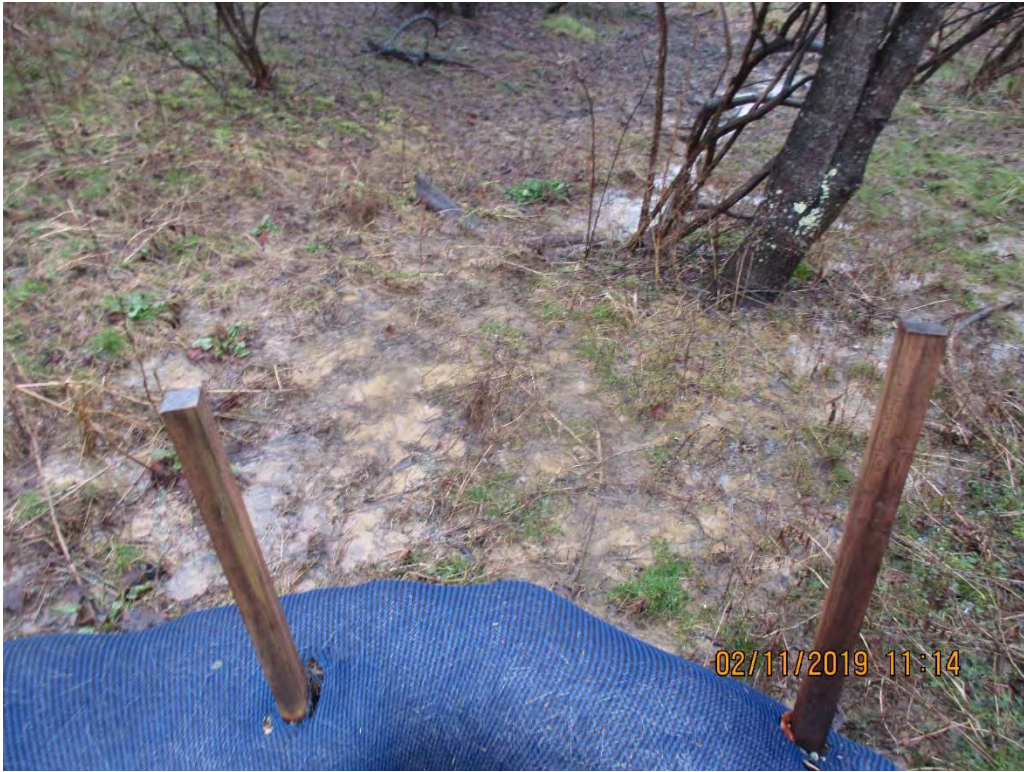
Section G.4.e.2-Permittee failed to implement controls appropriate for the project. Evidence that enhanced erosion was occurring in the waterbar and slopes near station 6017+50 and at station 5960+50 erosion occurring on the slope and SLW being concentrated in wetland W-IJ-55 with the potential to migrate off site.

Evidence of sediment being deposited past LOD near station #6017+50

Take measures to correct the aforementioned violations.

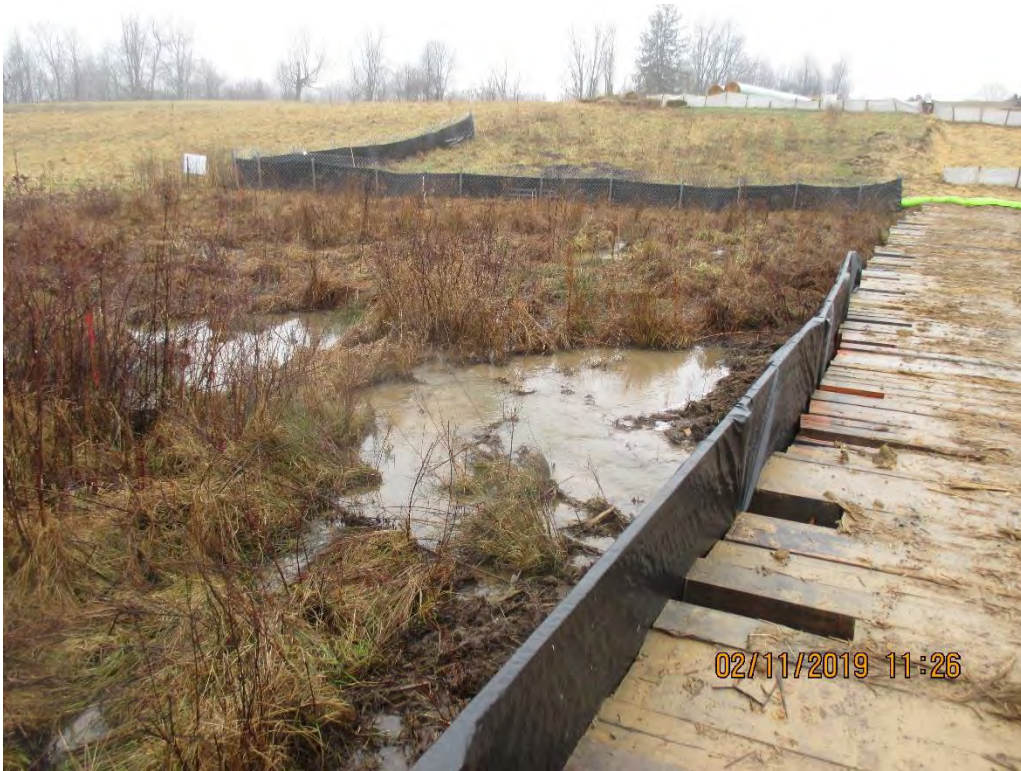
SLW present in Wetland W-B-26 at crossing facing West.

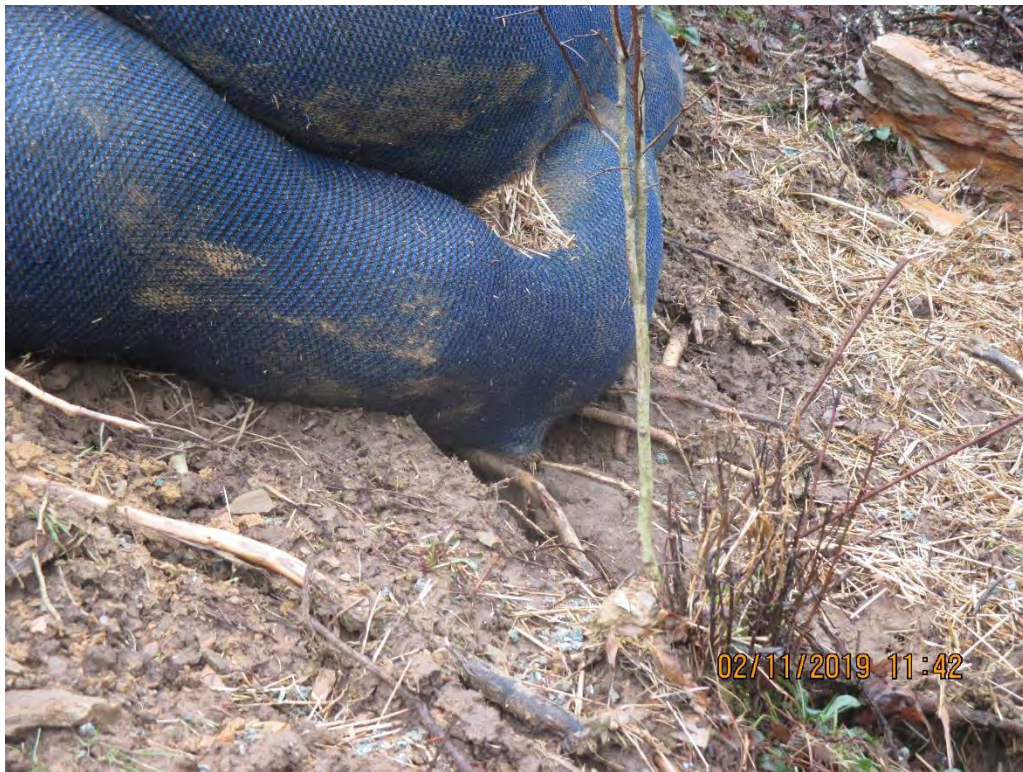
CFS at waterbar terminus near station 5999+50 showing signs of being undermined due to concentrated flow

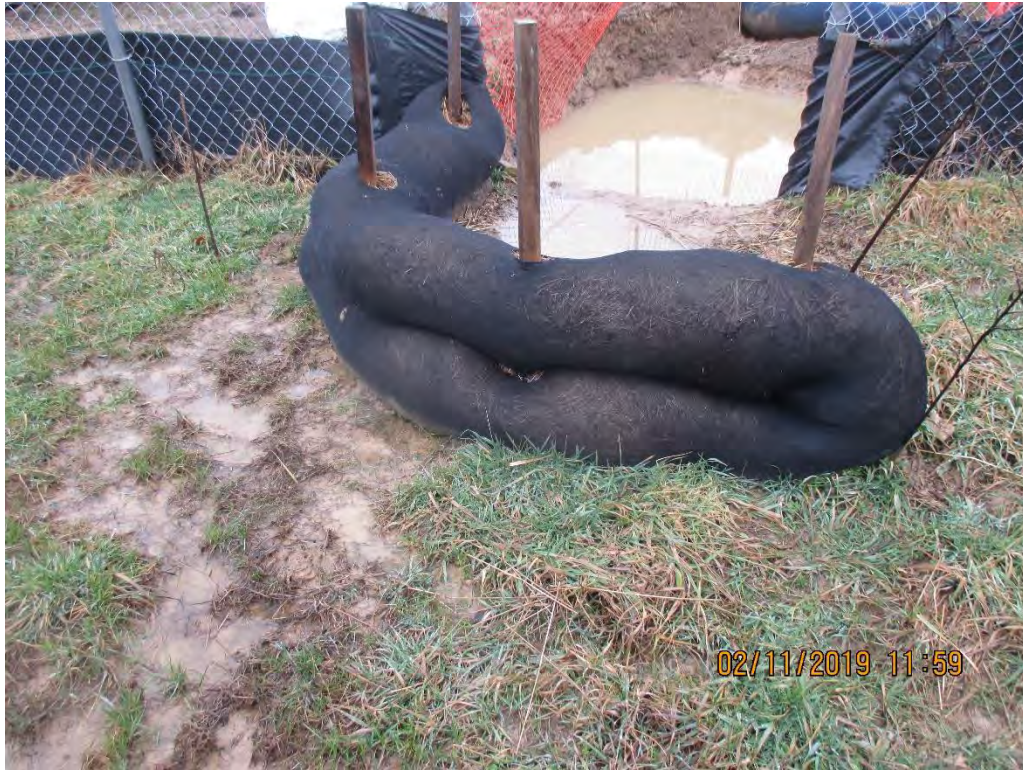
Waterbar terminus near station 5985+50, Sediment deposits and SLW present.

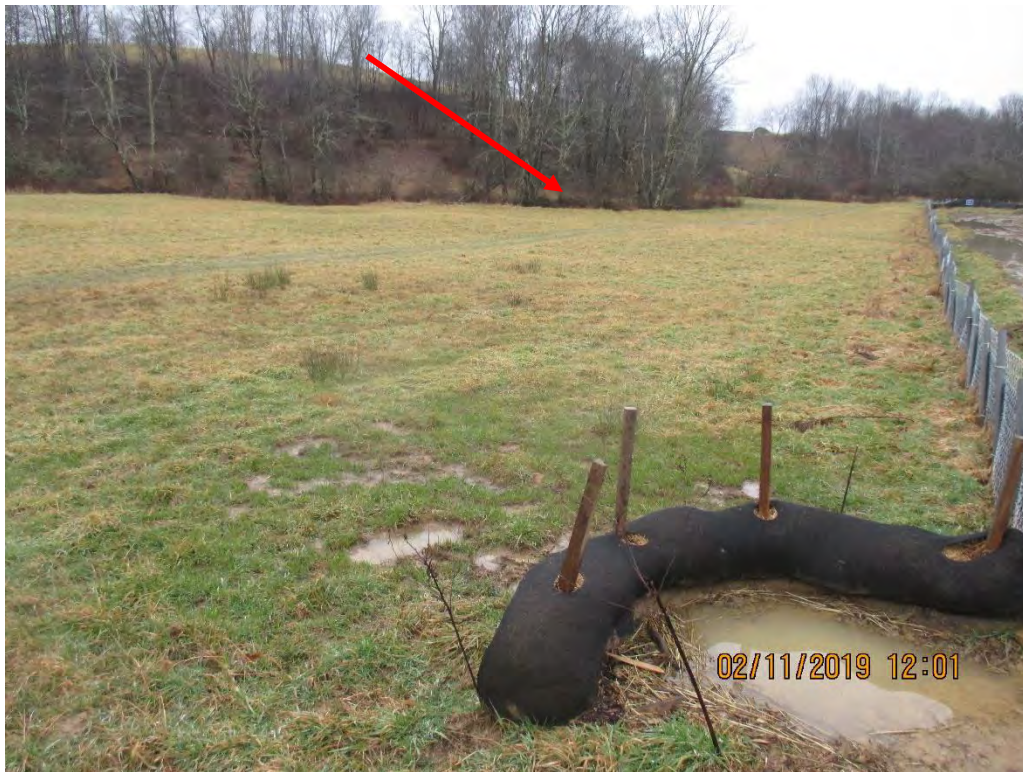
Waterbar terminus near station 5985+50, Sediment deposits and SLW present. Arrow depicts Stream S-B28

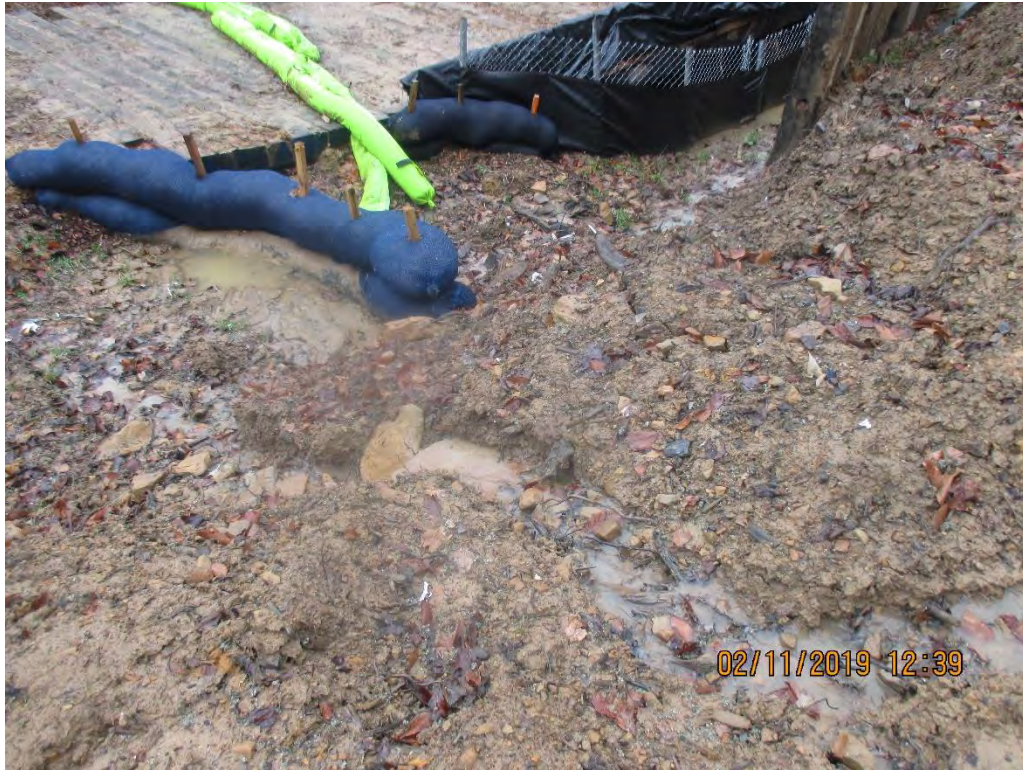
1. (6, 14) At station number 5960+50 erosion was occurring on a slope causing SLW to overwhelm several controls that flowed into wetland W-IJ-55. At the time of inspection SLW had not migrated past the LOD.
2. (6, 13) Evidence of sediment being deposited past LOD near station #6017+50 was observed. The slope above this outlet had rill erosion occurring and the waterbar on the opposite slope showed signs of concentrated flow in the form of CFS in the waterbar being undermined and gully erosion beginning to occur between the layers of CFS.

Section D.1-Permittee has failed to properly operate and maintain all facilities and systems: Evidence was observed at station 5960+50 that BMP's were not being maintained causing Sediment Laden Water to be present in Wetland W-IJ-55.

Section G.4.e.2.A.ii.e.-Permittee has failed to protect fill slopes by diverting runoff away from the slope to a stable channel. At Station 5960+50 above Wetland W-IJ-55 erosion was occurring on the slope and no diversion was in place to convey runoff to a stable channel.

Erosion occurring due to runoff from ROW and being diverted to Wetland W-IJ-55

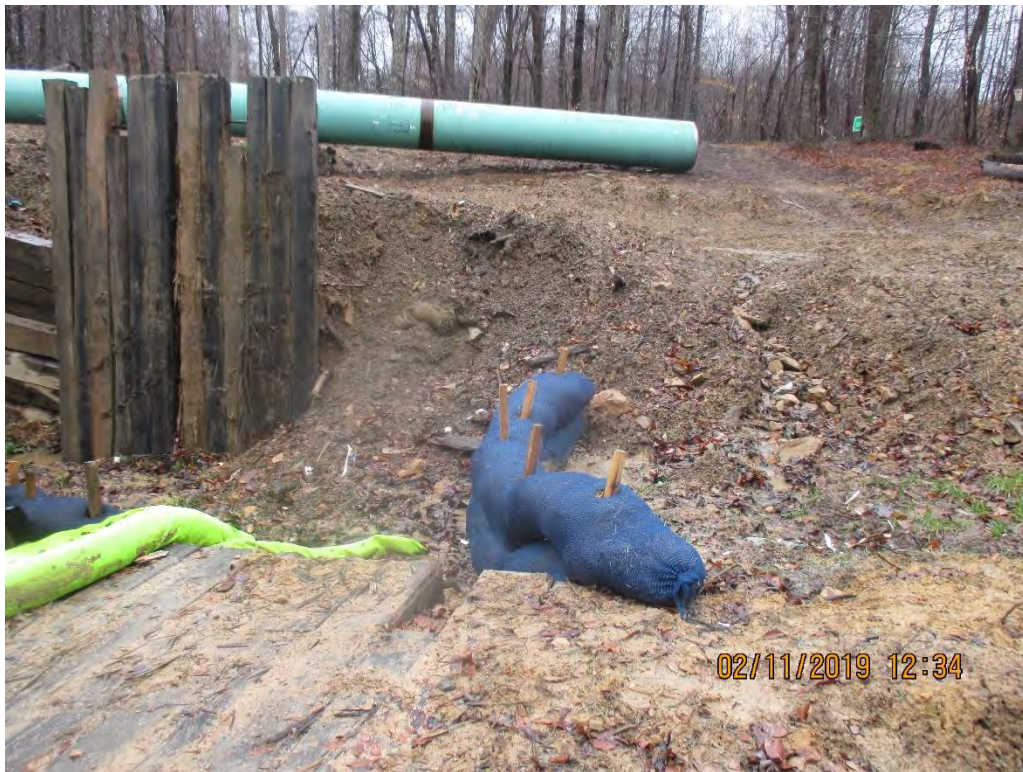
Facing upslope above wetland W-IJ-55

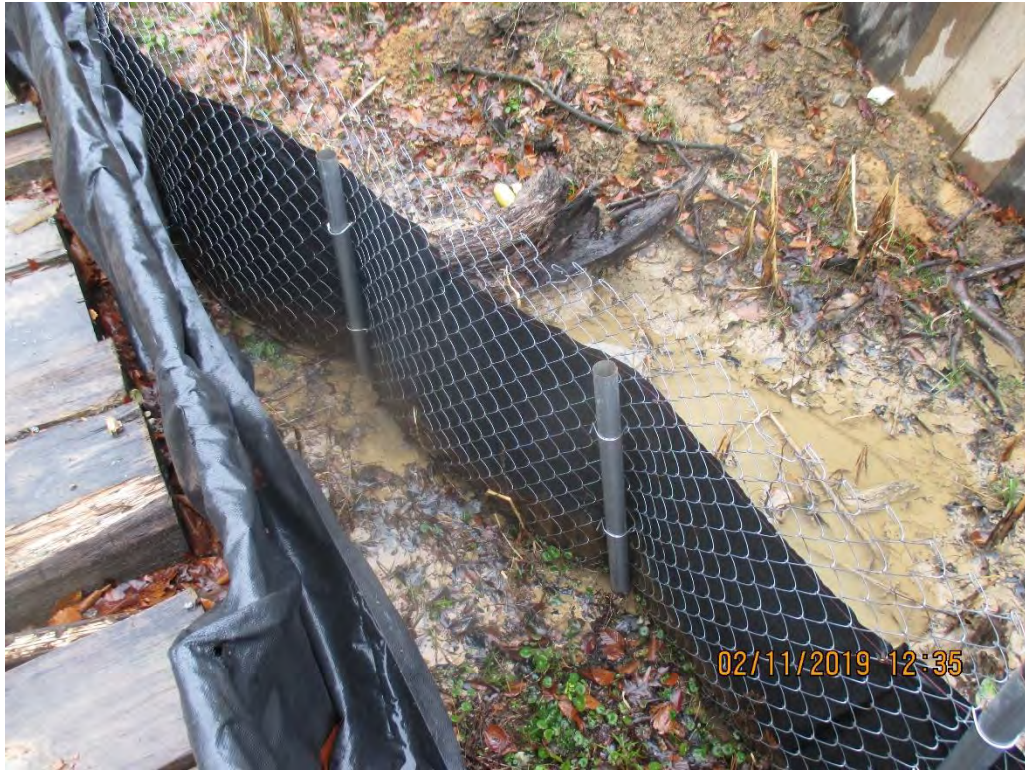
Super Silt fence present in Wetland W-IJ-55

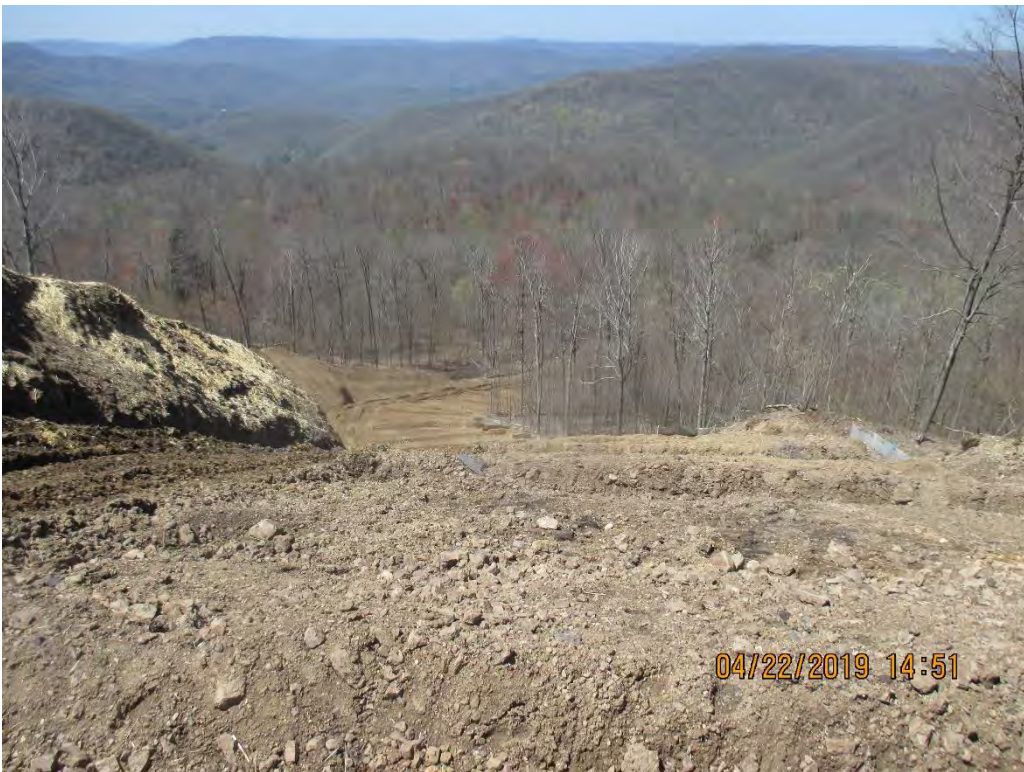
Steep slope above Lick creek crossing facing North above station #8633+71 and Stream S-T35(A).

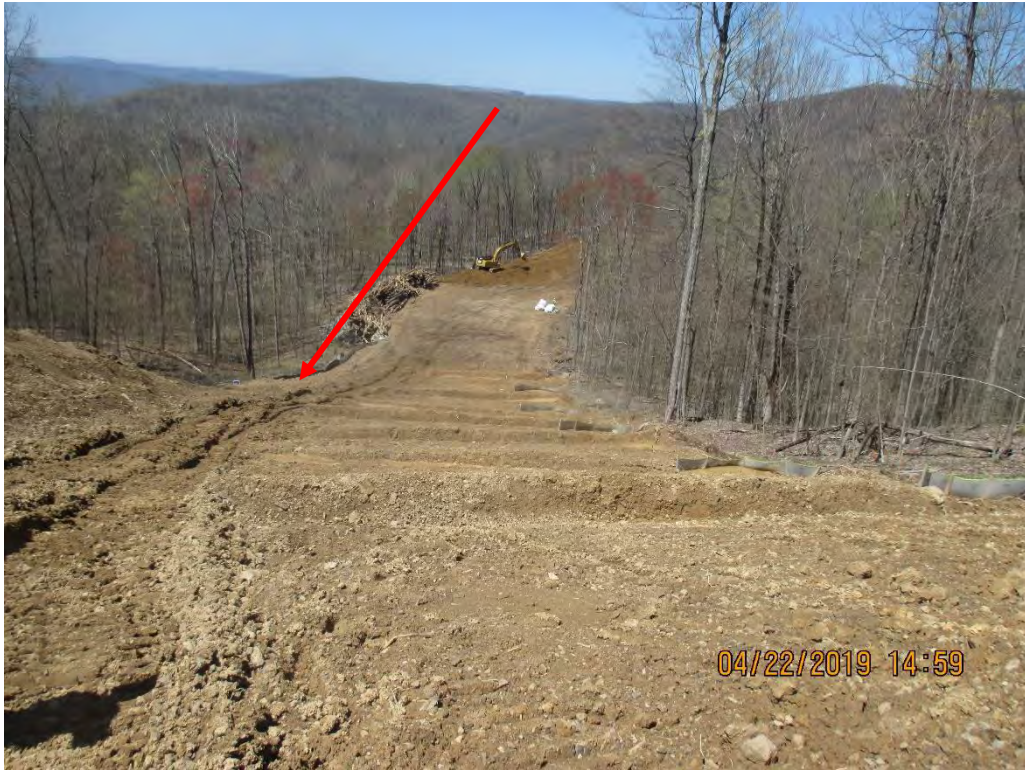
Section G.4.e.2.A.ii.j - Permittee failed to prevent sediment-laden water from leaving the site without going through an appropriate device at station #8633+71. Evidence of Sediment laden water and sediment deposits were observed to have impacted Stream S-T35(A) a tributary of Lick Creek.

Standing above station #8633+71. Arrow depicts where Waterbar conveyed sediment into Stream S-T35(A).

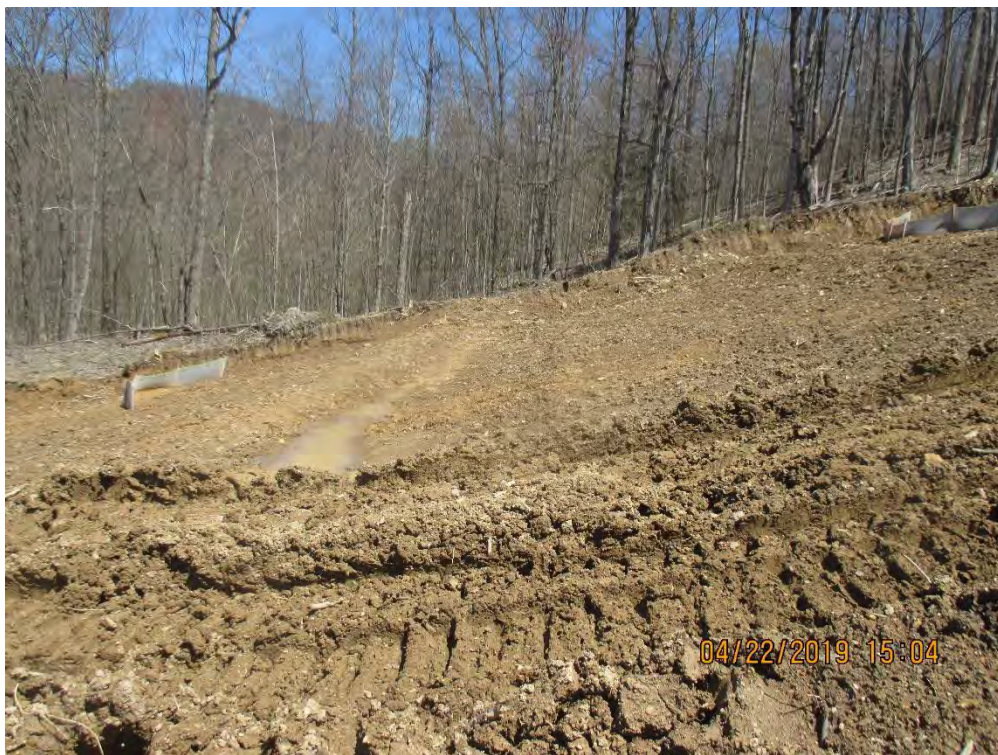
Section G.4.e.2. - Permittee failed to properly implement controls appropriate for the project: Waterbars were installed to terminate on the ROW at station #8633+71 causing erosion to occur on the ROW and sediment to impact Stream S-T35(A).

Facing towards cut slope and where waterbars terminated onto ROW.

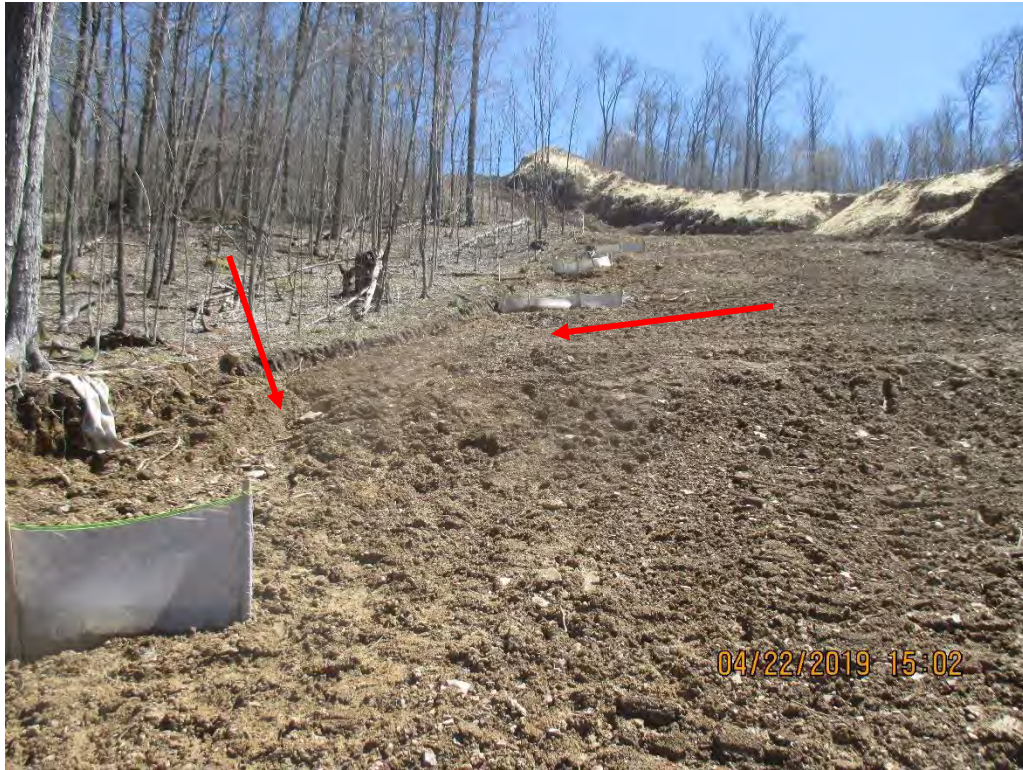
Section G.4.e.2.A.ii.f. - Permittee failed to protect fill slopes between station #8638+00 and #8628+00: Erosion on slope due to improper Waterbar implementation.

Facing upslope at station #8633+71. Arrow depicts where erosion is occurring between waterbars.

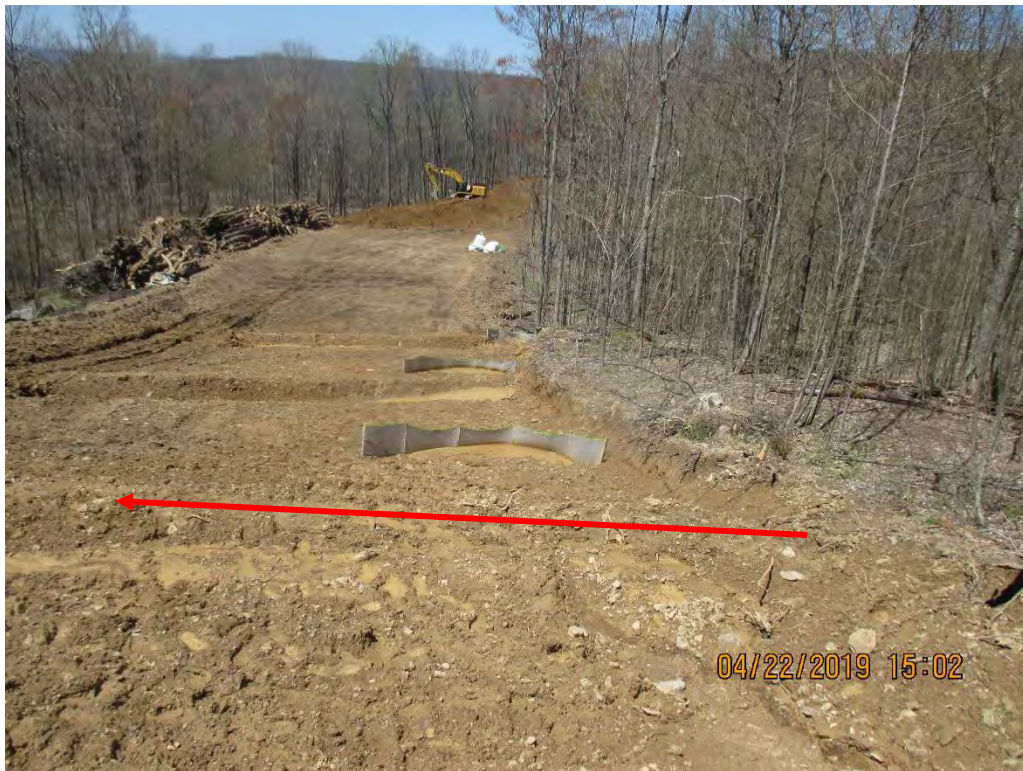
Section D.1.-Permittee failed to properly operate and maintain all systems of treatment: Controls implemented on slope above stream S-T35(A) had sediment build up in waterbars due to erosion occurring on slope.

Waterbars terminating onto ROW at station #8633+71 facing North/Downslope. Arrow depicts Waterbar that was overwhelmed with sediment that impacted stream S-T35(A).

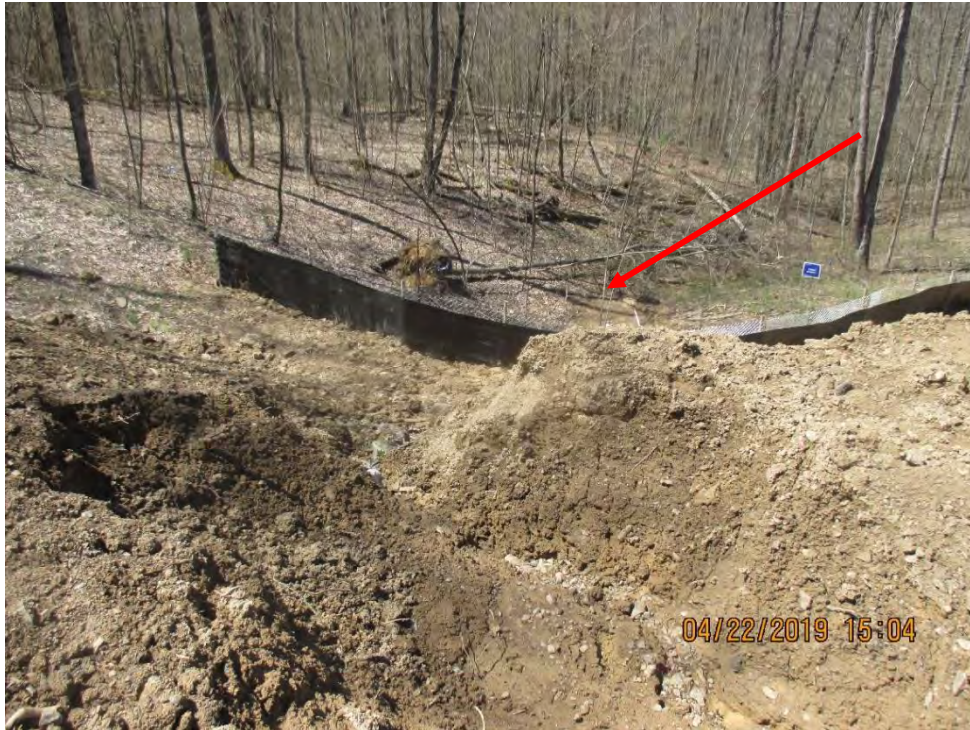
Title 47, Series 2, Section 3.2.b.- Permittee has caused conditions not allowable in waters of the State by allowing sediment deposits on the bottom of stream S-T35(A) a tributary of Lick Creek.

Stream S-T35(A) facing downslope Waterbar terminus at Station #8633+71. Waterbar appeared to be directed towards stream. Controls were buried in sediment where erosion was present. Super Silt was added after clean-up occurred. Arrow depicts Sediment deposits that were present in stream.

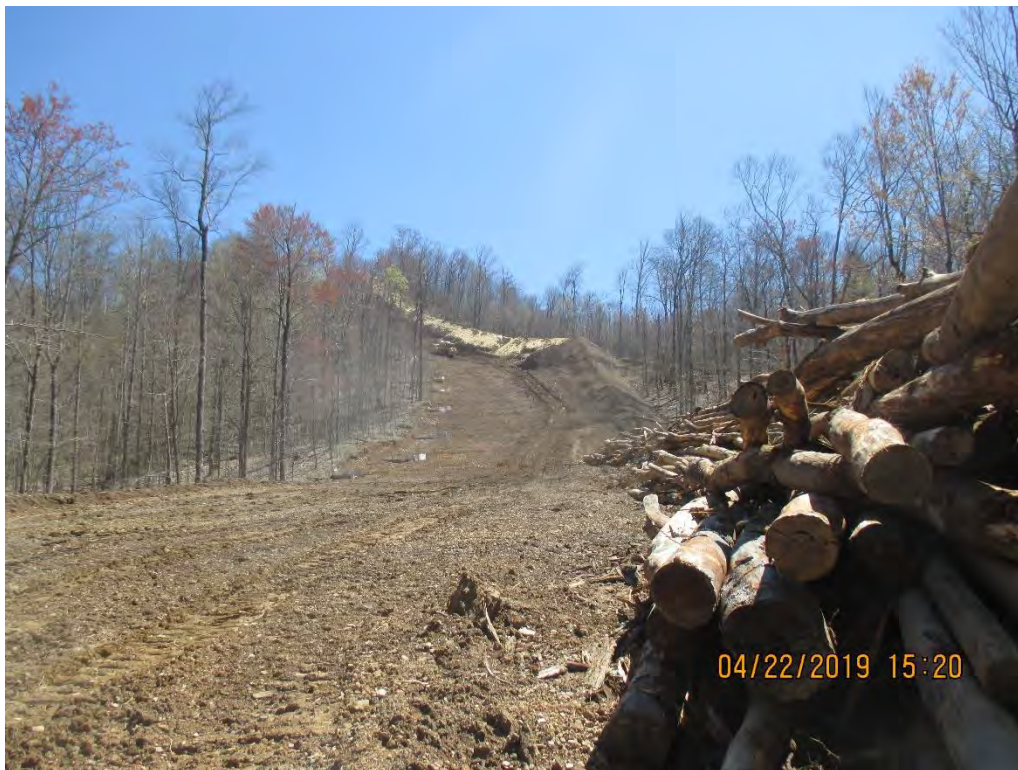
Section G.4.c-Permittee failed to modify the SWPPP by taking measures to ensure compliance with the permit: Waterbars were implemented incorrectly between stations 8438+00 through 8628+00.

Facing South towards slope that had Waterbar failure near station #8628+00.
