**The Wilderness Society et al. Comments on the
U.S. Forest Service Mountain Valley Pipeline and
Equitrans Expansion Project Draft Supplemental
Environmental Impact Statement (#50036)**

EXHIBIT 12

**WEST VIRGINIA DEPARTMENT OF ENVIRONMENTAL PROTECTION
WV OIL AND GAS CONSTRUCTION STORMWATER PERMIT**

FACILITY NAME:	Mountain Valley Pipeline Project		REG. #	EXPIRE DATE:
PERMITTEE	MOUNTAIN VALLEY PIPELINE, LLC		WVR310667	5/13/2018 Extended: 12/31/2018
ADDRESS/PHONE:	Attn: MATTHEW HOOVER 625 LIBERTY AVE, ST 1700 PITTSBURG, PA 15222 7248733645			
LOCATION:	Harris Compressor Station		Entry Date/Time:	9/25/2018 1000
COUNTY:	Braxton		Exit Date/Time:	9/25/2018 1100
Site Representative /Phone	Brittany Dewitt (Lead EI)/330-987-1682, Matt Hoover MVP/ 412-258-5627 & Jason Hiles, Spread C Lead EI/740-334-7812		PHOTOS <input checked="" type="checkbox"/>	
CO-PERMITTEE:			ADDRESS:	
SITE OPERATOR:	MEC Construction LLC		ADDRESS:	19 RR Meadowbrook, WV 26404
PERMITTED ACREAGE	4311	WEATHER:	Cloudy	LAST INSPECTION: 8/21/2018
RECEIVING STREAM(S)	Trib of Elk/Kanawha R/ Ohio Rv			NOV: 1
Regular Mail <input type="checkbox"/> Certified Mail <input checked="" type="checkbox"/>	Tracking #			
OVERALL FACILITY R

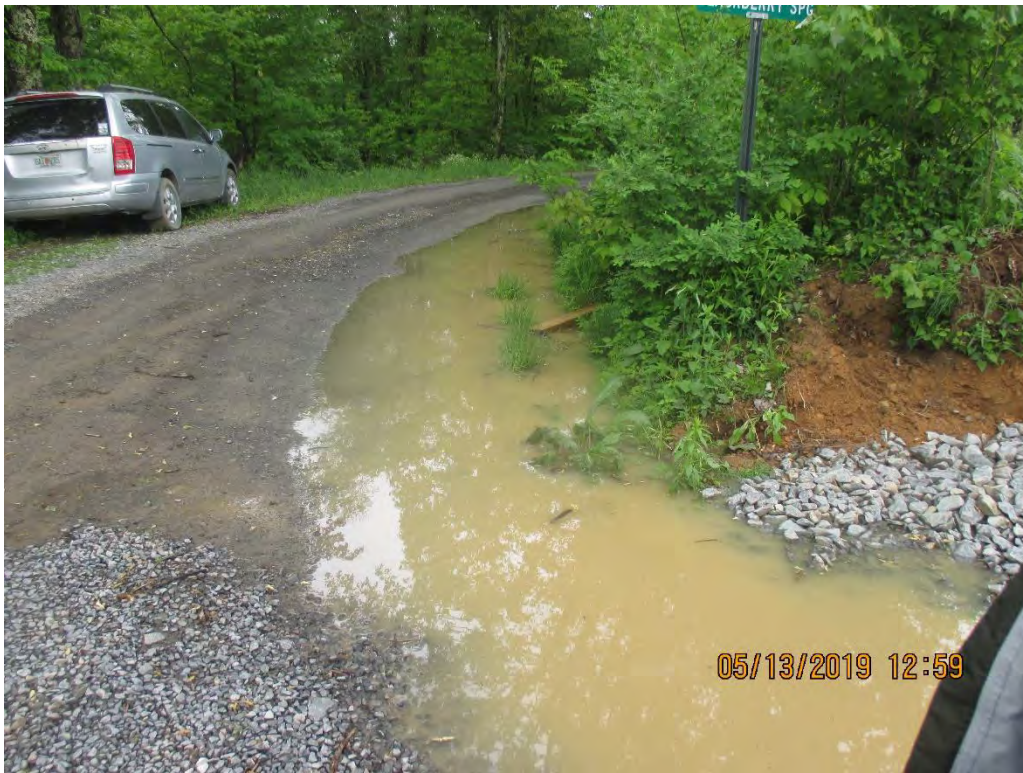
SLW ponding in ditch downslope of MVP ROW construction entrance.

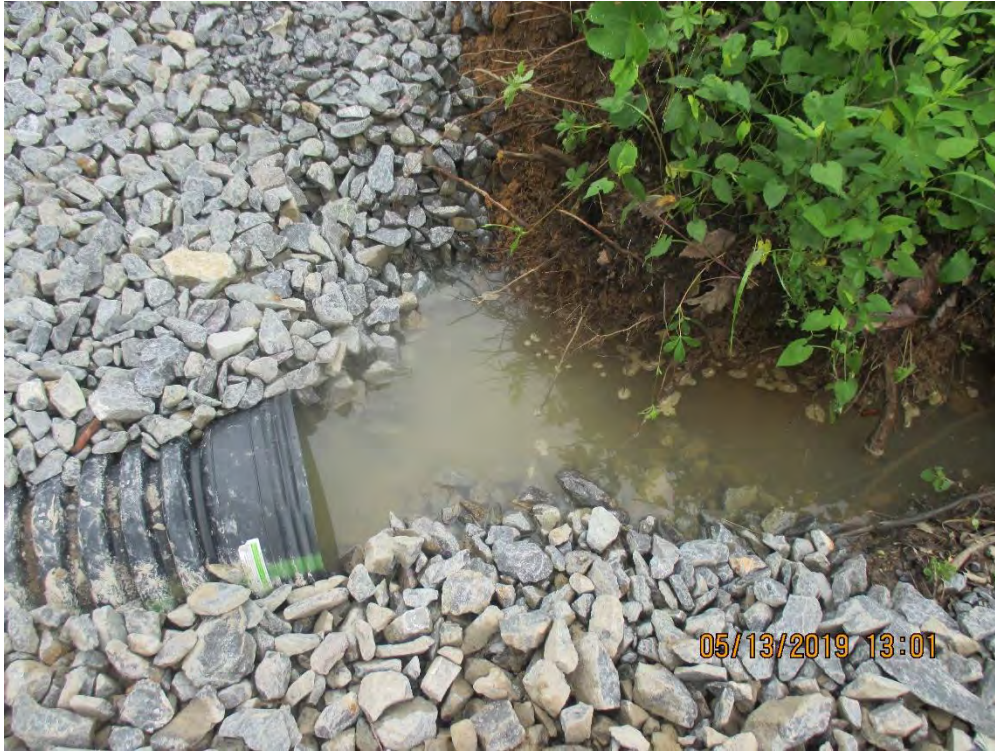
SLW present upslope of MVP ROW entrance entering installed culvert and conveying to ponded area in ditch line.

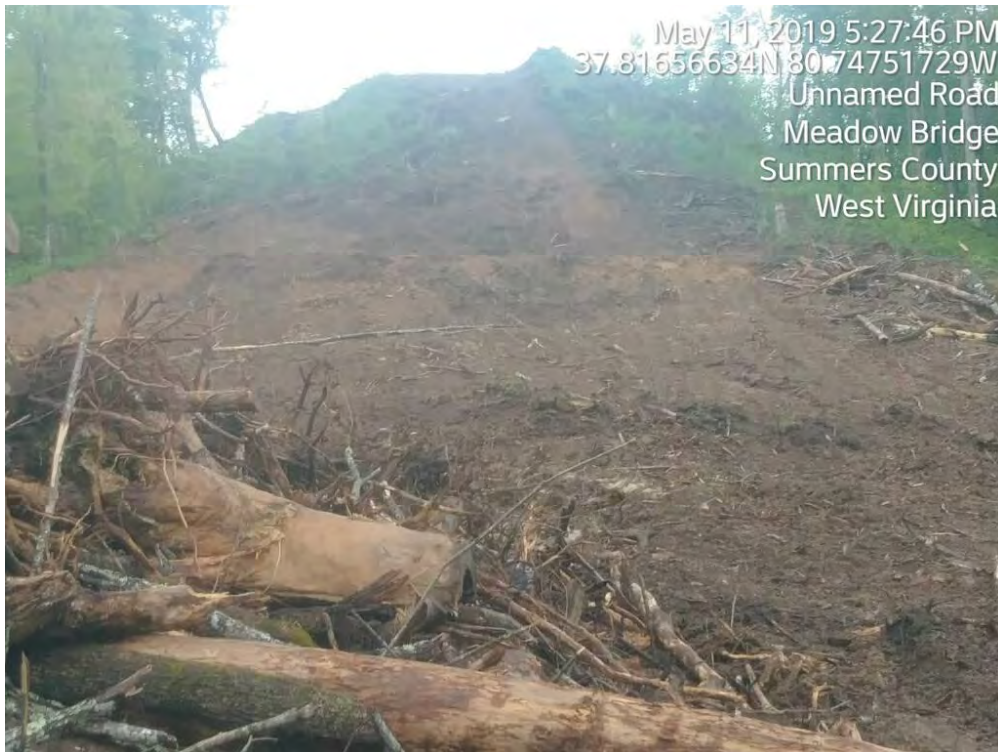
Section G.4. - Permittee has failed to comply with the General Permit and approved Storm Water Pollution Prevention Plan (SWPPP). Waterbar outlet controls near station #8399+10 were not in place at the time of installation as detailed by the SWPPP.

Photo of steep slope near station #8399+10 depicting no controls in place on 5/11/19 at 5:27pm

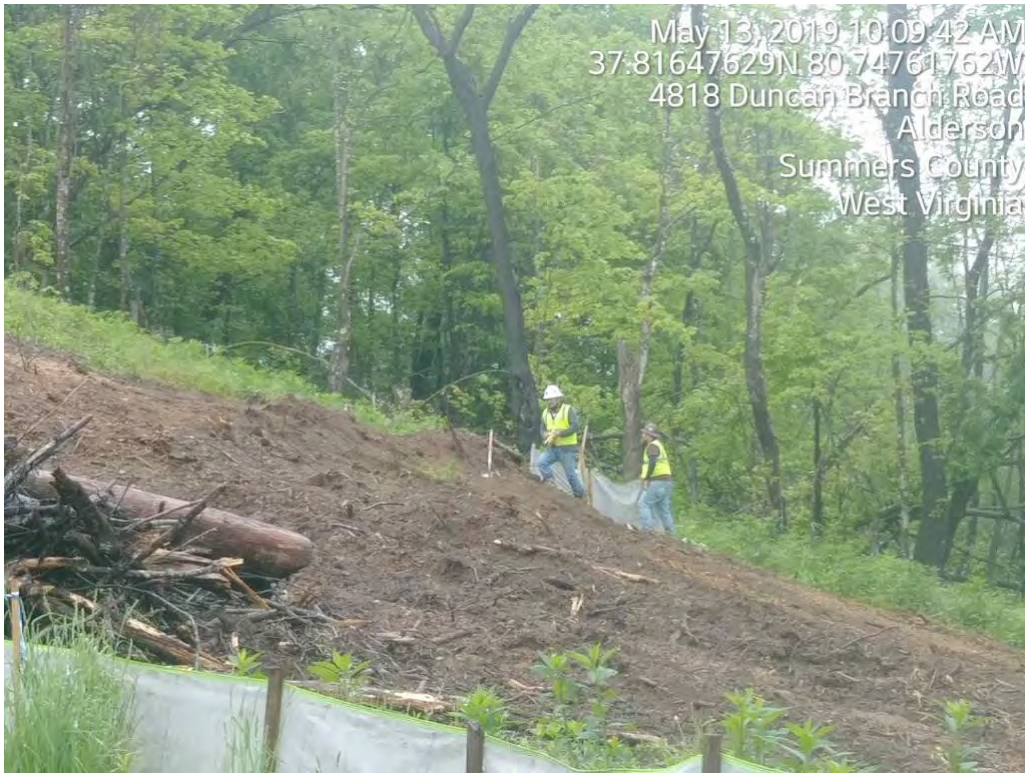
Complainant photo depicting MVP field staff installing outlet controls on Monday 5/13/19 at 10:09am.

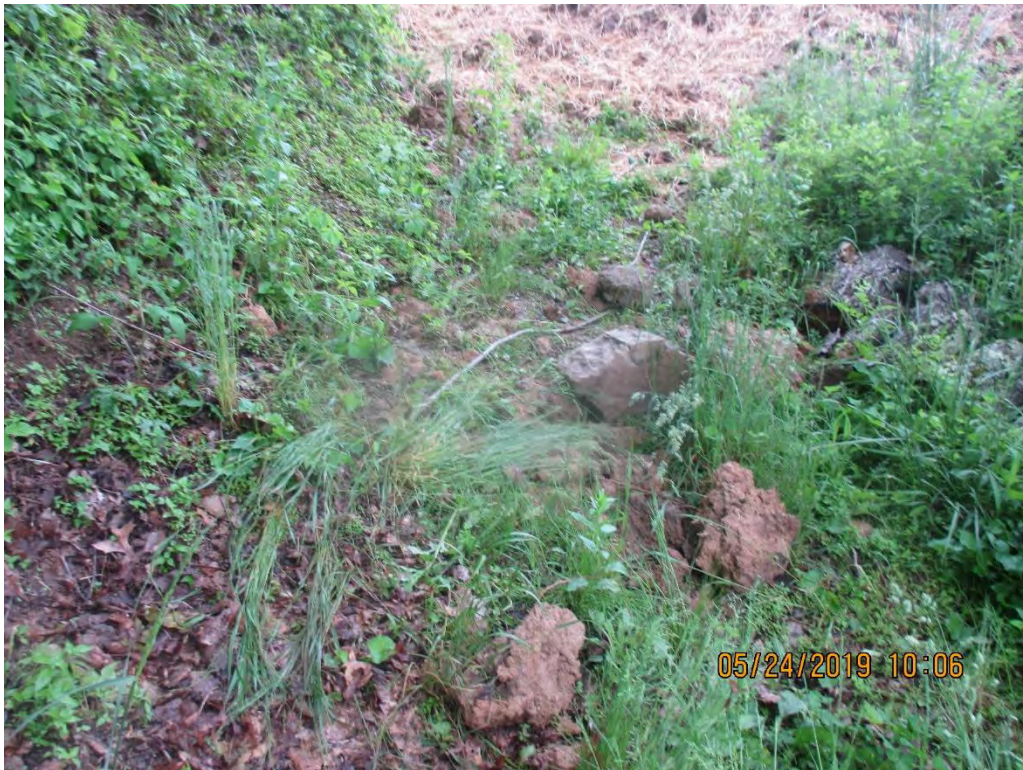
Inspector inspected steep slope near station #8387+96 where spoil pile from grading had been pushed to the edge of the LOD. Material had slipped off the soil pile and past the MVP permitted LOD. No controls were in place along this section of ROW. Detail sheets state that all spoil and topsoil piles require either CFS or silt fence as needed. Near station 8410+00 topsoil pile was slipping into controls. P1 silt fence had hole present (marginal deficiency). Some deposits were present past the LOD along this section of ROW.

Facing towards MVP LOD near station No. 8387+96. Material had slipped from pile off ROW past LOD. No perimeter controls in place.

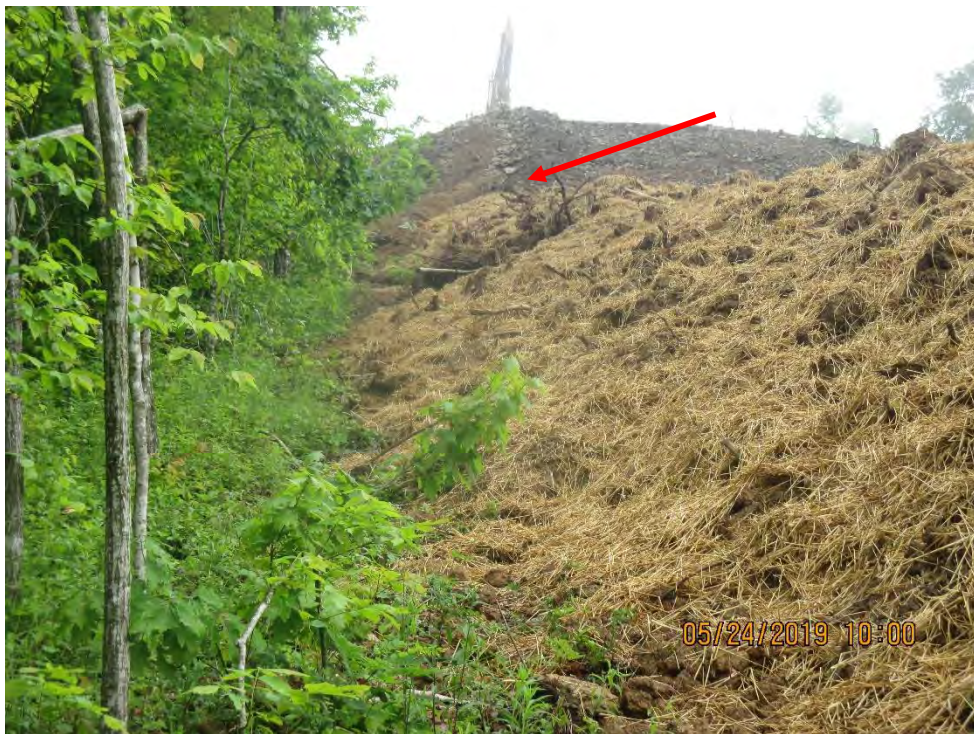
Facing upslope near station No. 8387+96. No perimeter controls in place approximately 150 feet upslope. Berm installed as perimeter controls half way upslope (see red arrow).

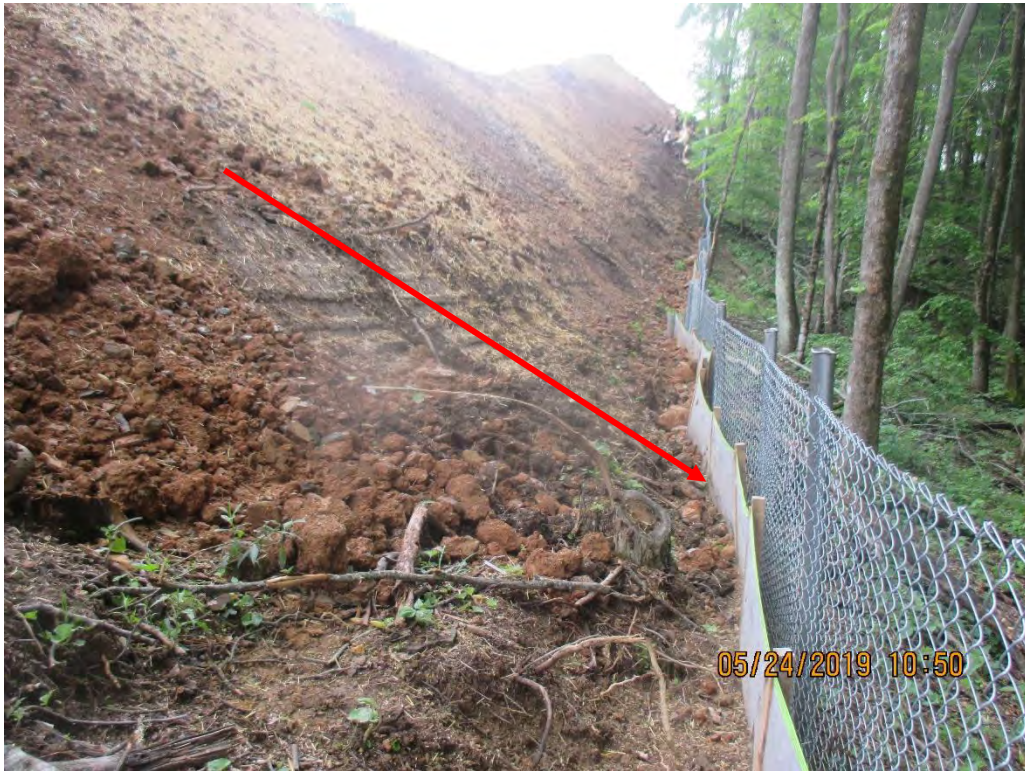
Near station No. 8419+00 facing South. Perimeter controls in place per SWPPP. Arrow depicts where material has slipped into P1 silt fence.

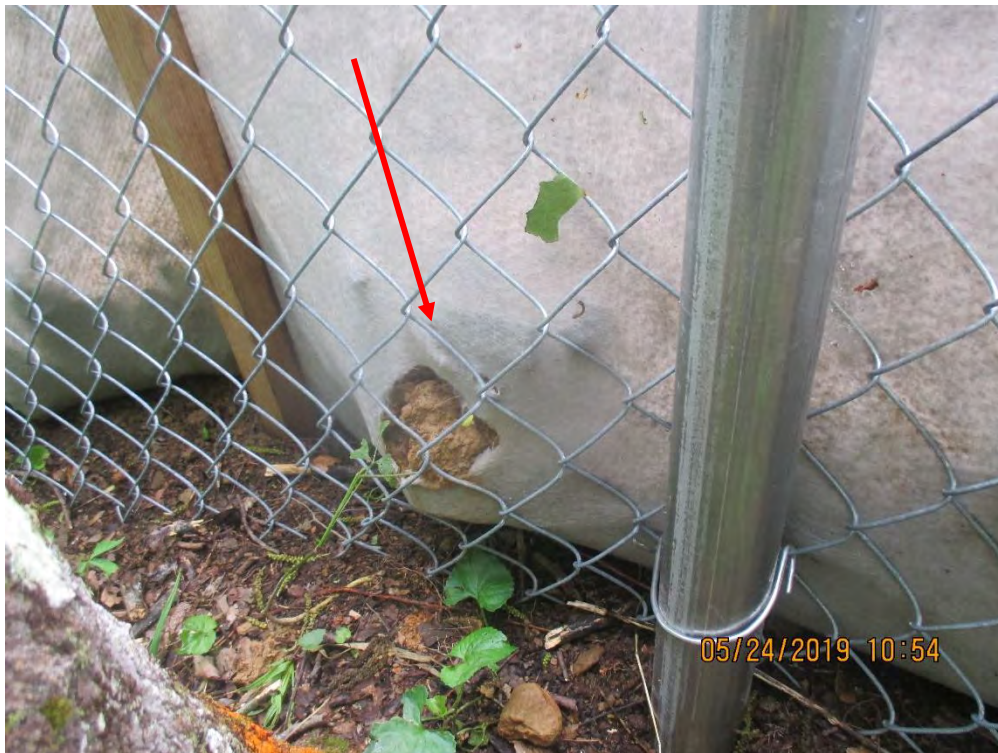
Near station No. 8410+00. Hole present in P1 silt fence due to material slipping into controls.

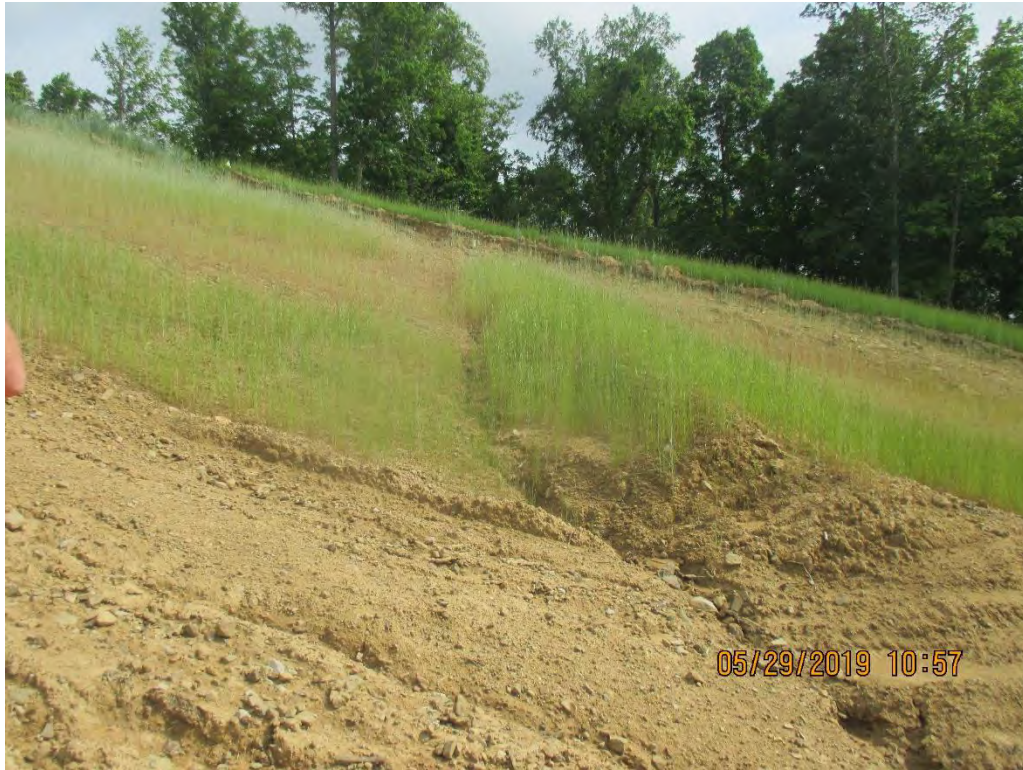
Facing towards cut in slope/ROW at station No. 4031+00. Waterbar had erosion present.

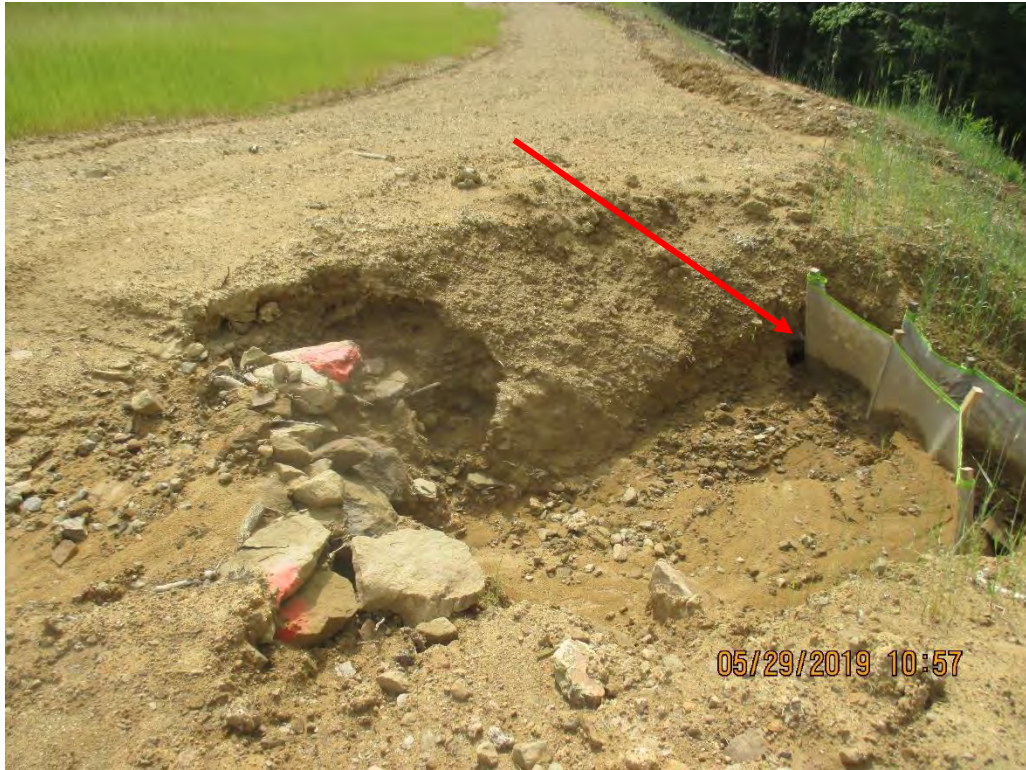
Waterbar outlet at station No. 4031+00. Arrow depicts where runoff was flowing around control and causing increased erosion.

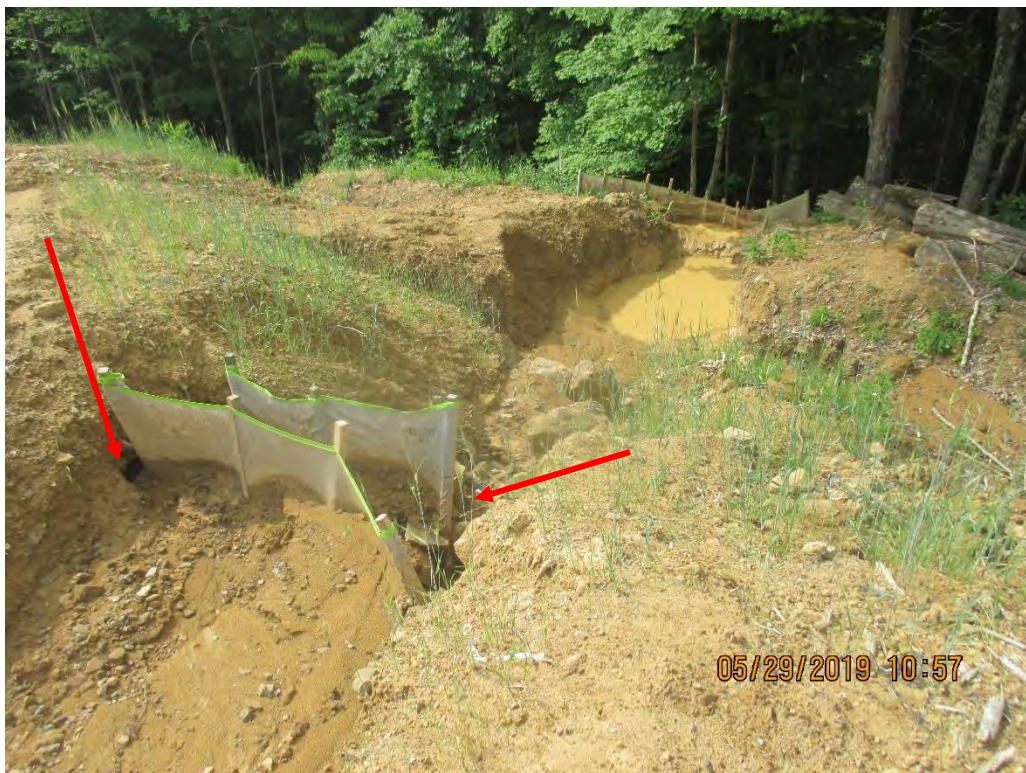
Waterbar outlet and diversion berm outlet at station No. 4031+00. Sediment was being deposited behind controls. Arrow depicts where runoff was flowing around controls.

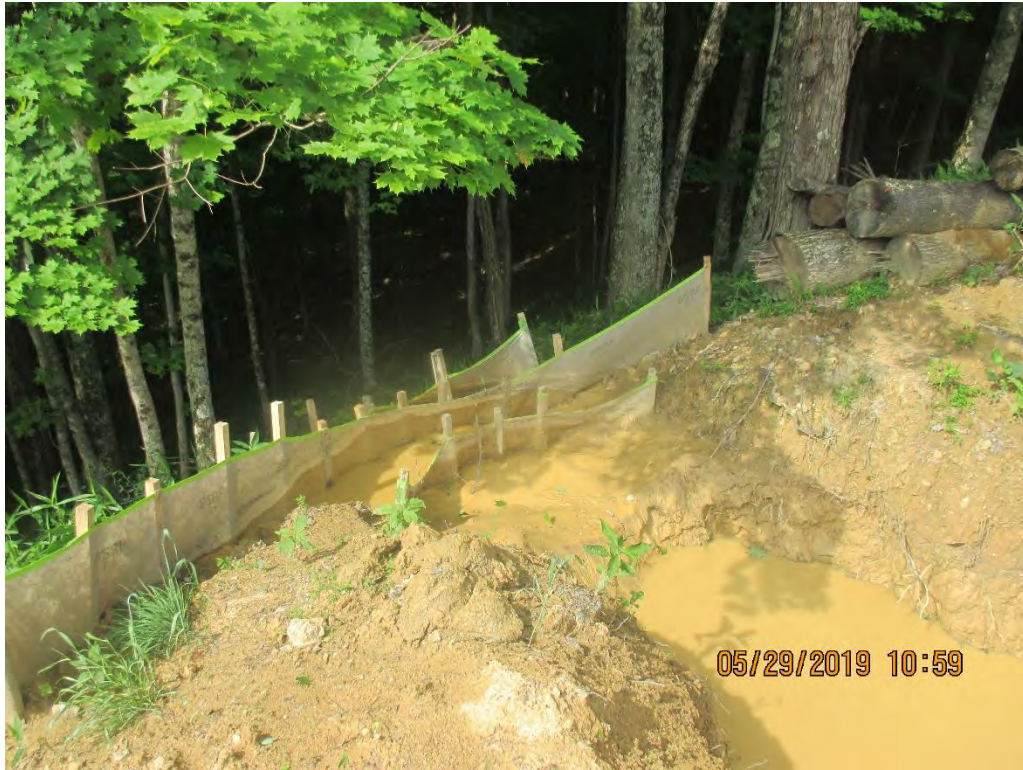
Diversion berm outlet No. 1 at station No. 4031+00. Controls in need of maintenance.

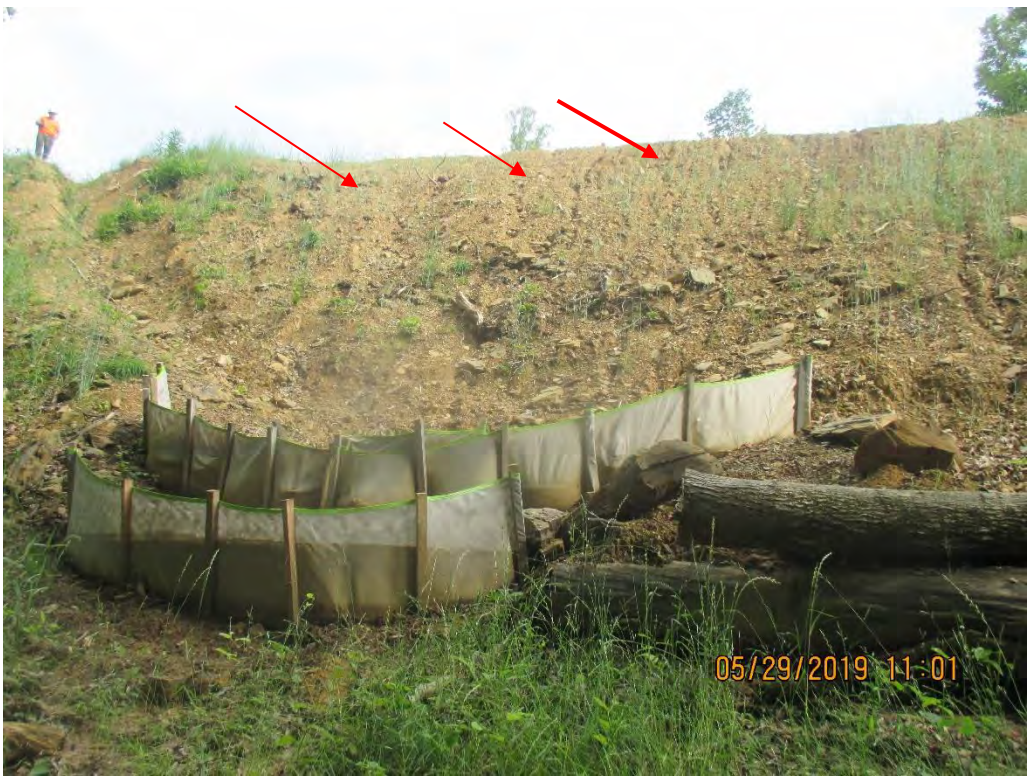
Facing upslope near station #4031+00 at diversion berm outlet No. 2. Waterbar was also terminating onto slope with no controls. Arrow depicts erosion on slope.

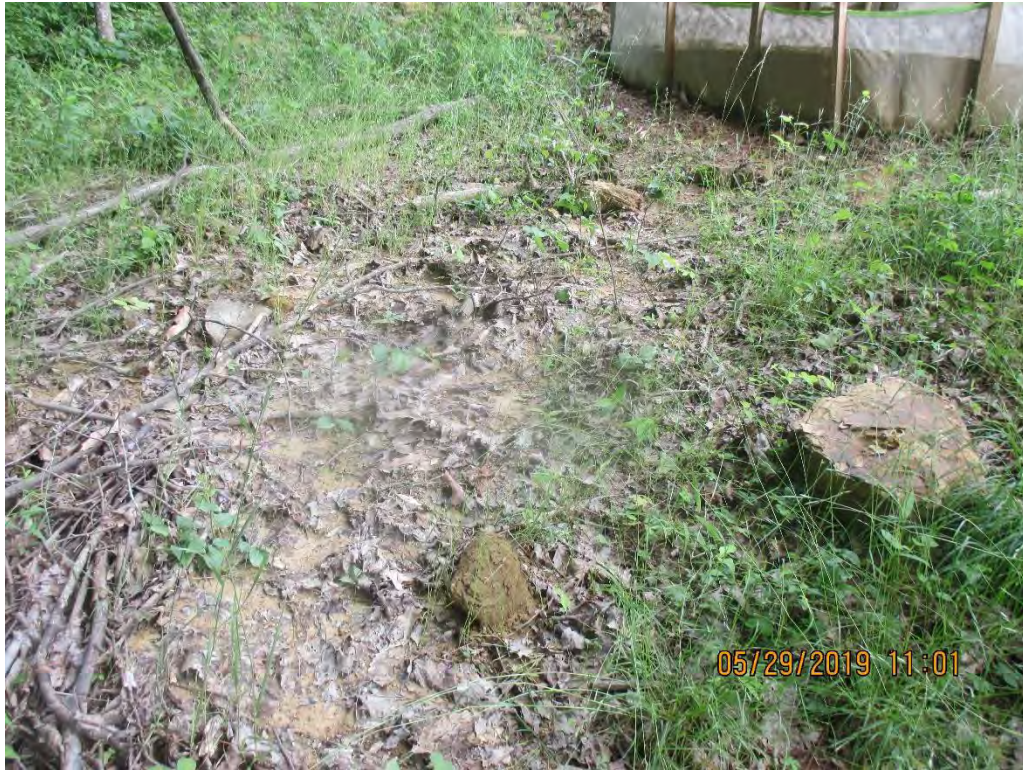
Standing below diversion berm outlet No. 2 near 4031+00. Scouring of vegetation present below control.

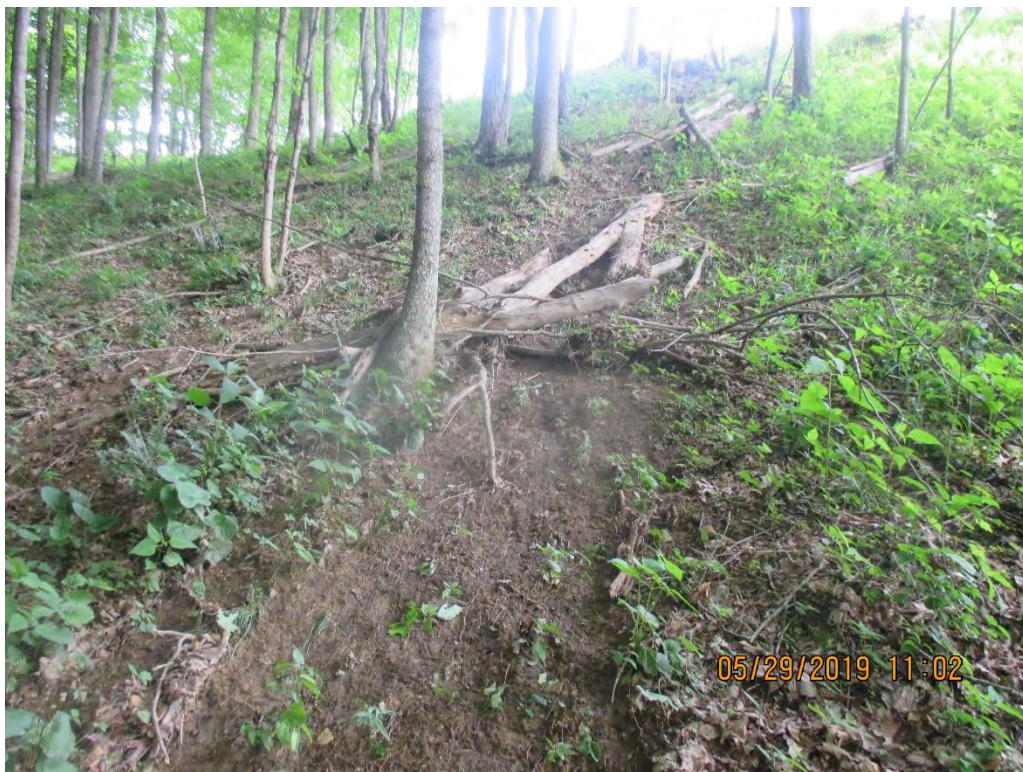
Standing further downslope below diversion berm outlet No. 2 near 4031+00. Scouring of vegetation present below control.

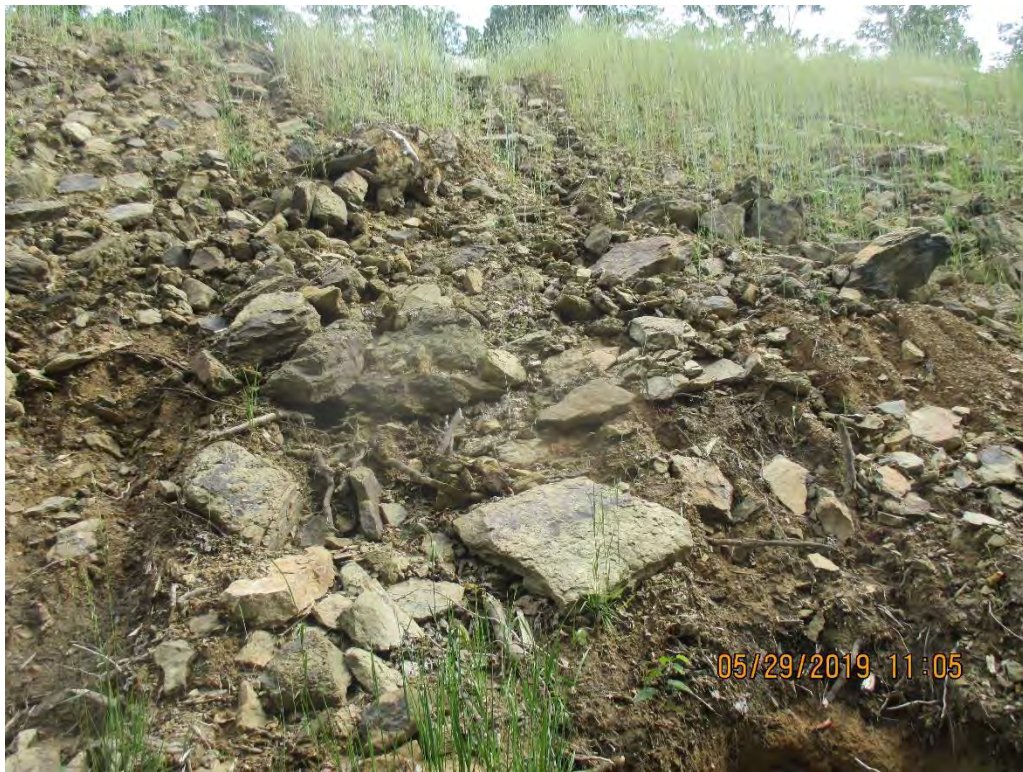
Fill slope with erosion present above diversion berm outlet No.3 near station No. 4031+00.

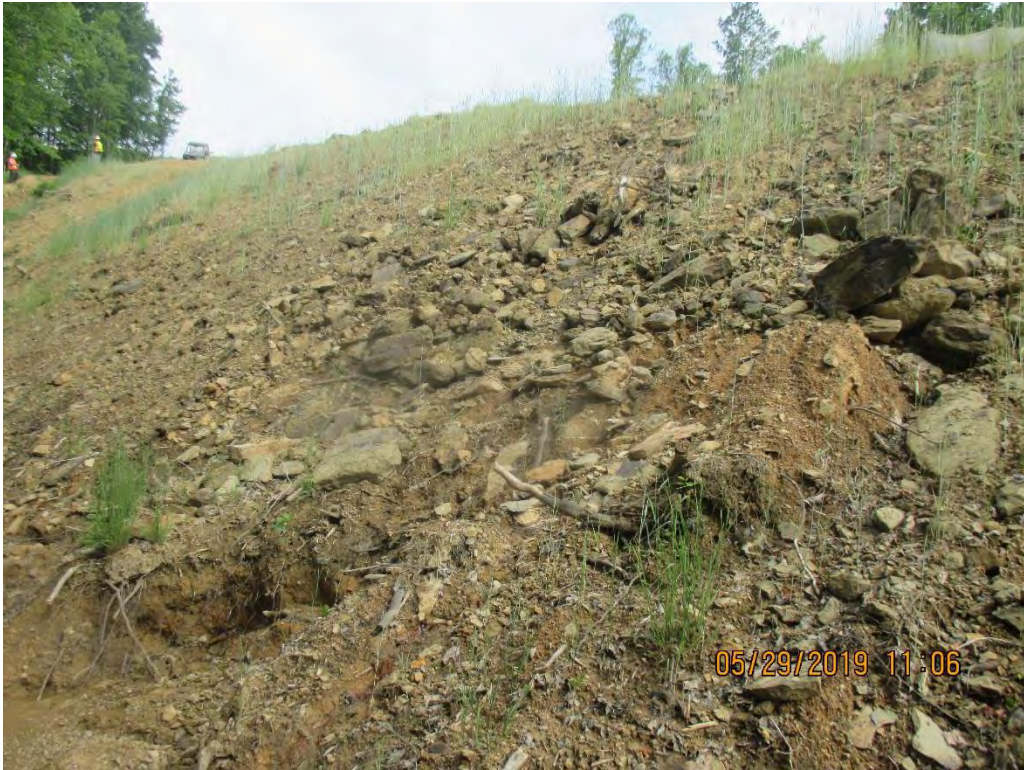
Fill slope with erosion present above diversion berm outlet No. 3.

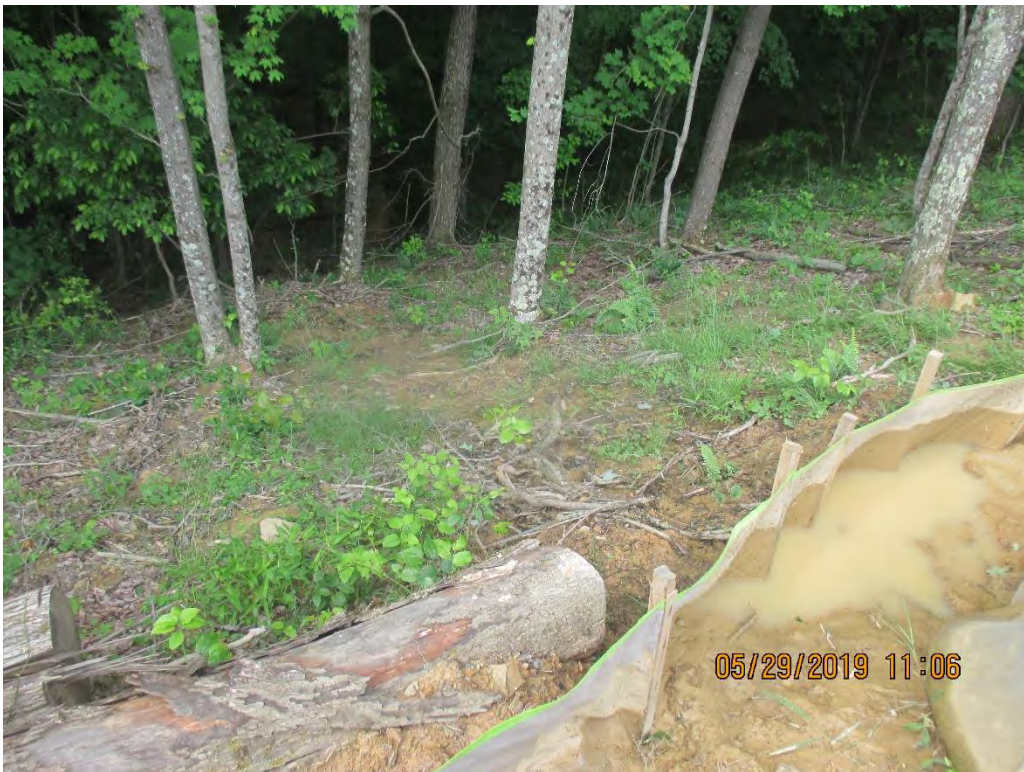
Downslope of diversion berm outlet No. 3 controls. Scouring of vegetation present with sediment deposits present past LOD.

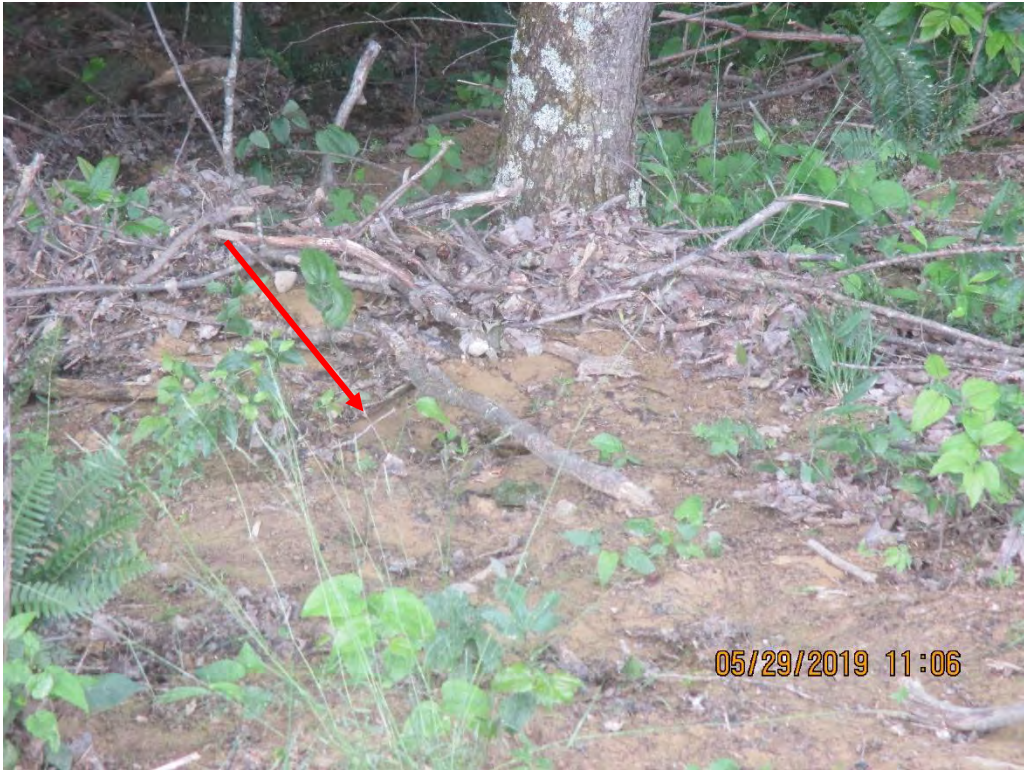
Downslope of diversion berm outlet No. 3. Sediment deposits present.

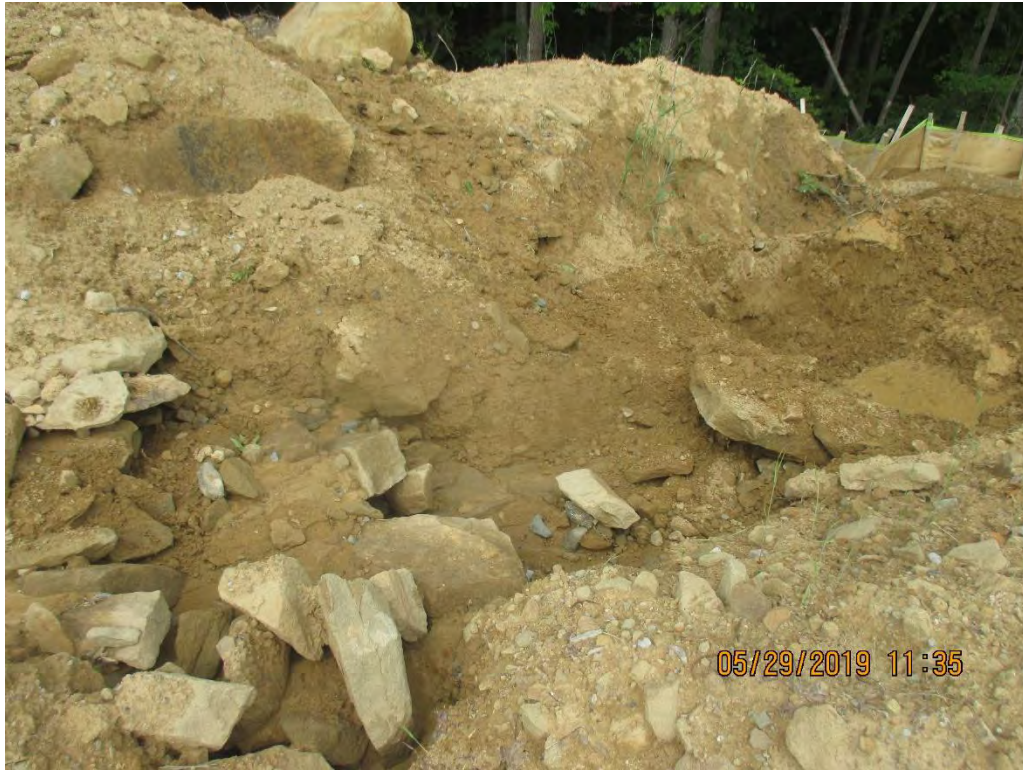
Waterbar outlet terminating onto slope at station No. 4027+00

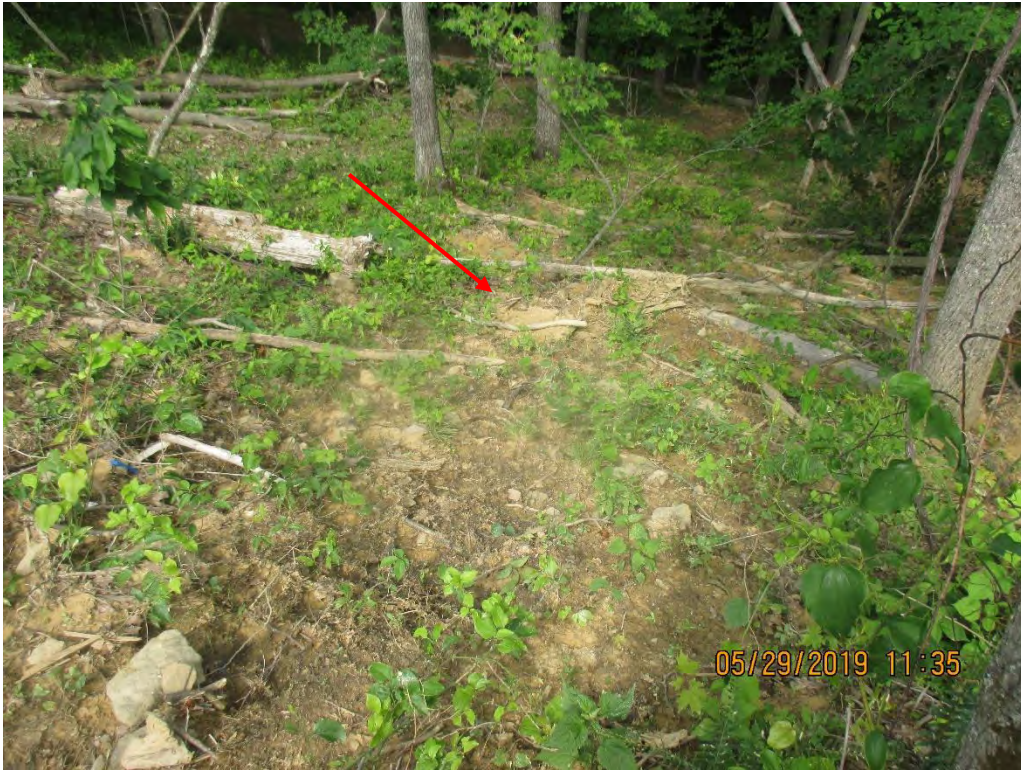
Sediment deposits present past LOD at station No. 4027+00 facing downslope of perimeter outlet.

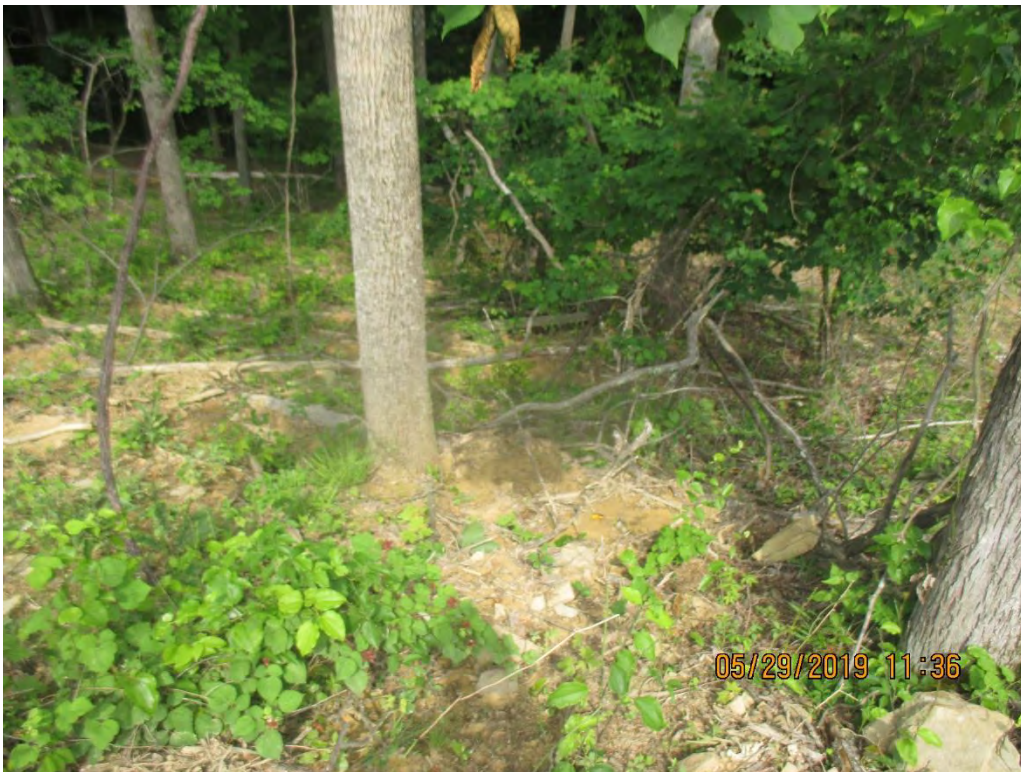
Sediment deposits present past LOD at station No. 4027+00 facing downslope of perimeter outlet.

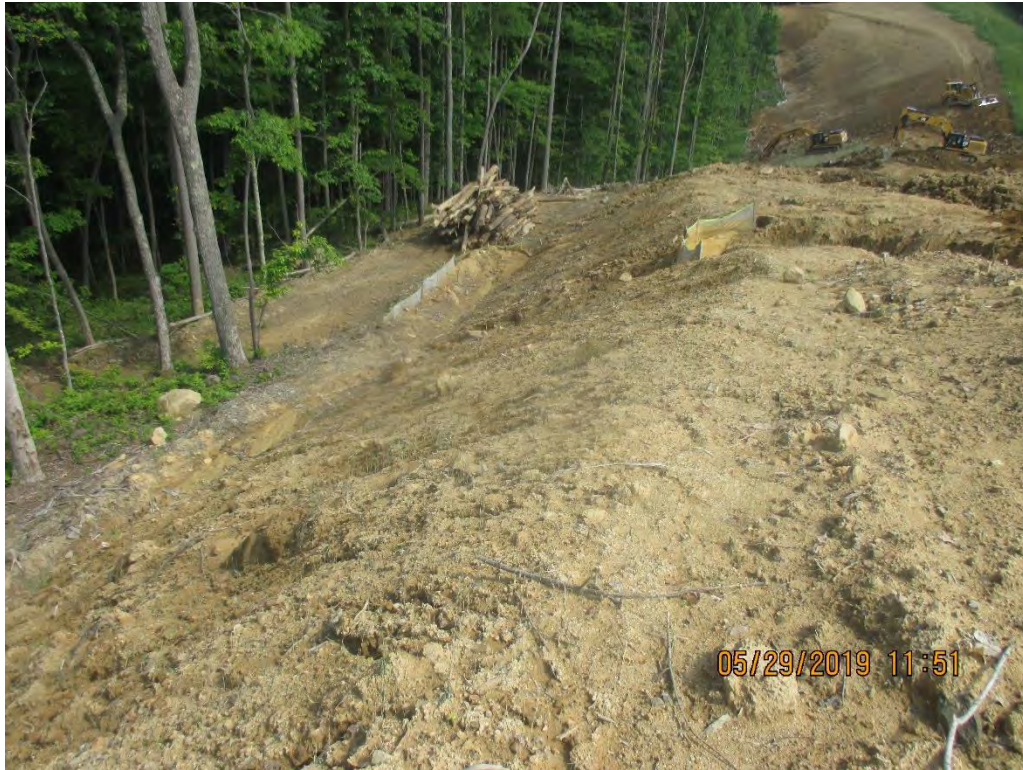
Near station No. 4017+00. Waterbar terminating onto slope.

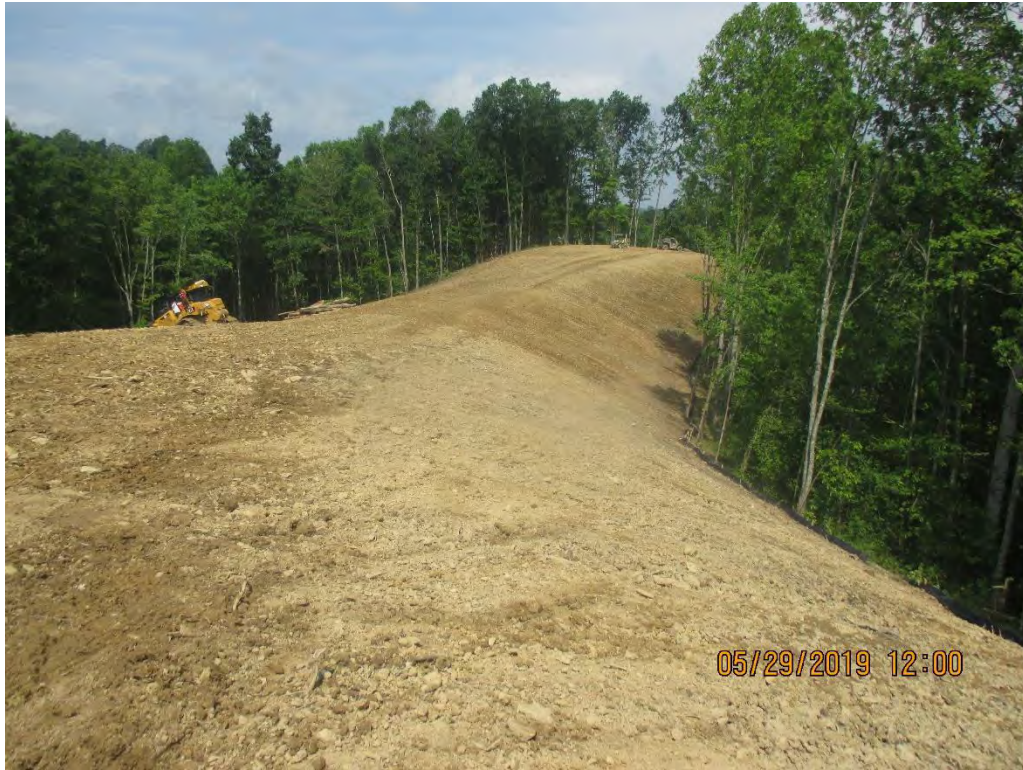
Facing South at station No. 4017+00. ROW was actively being restored to final grade.

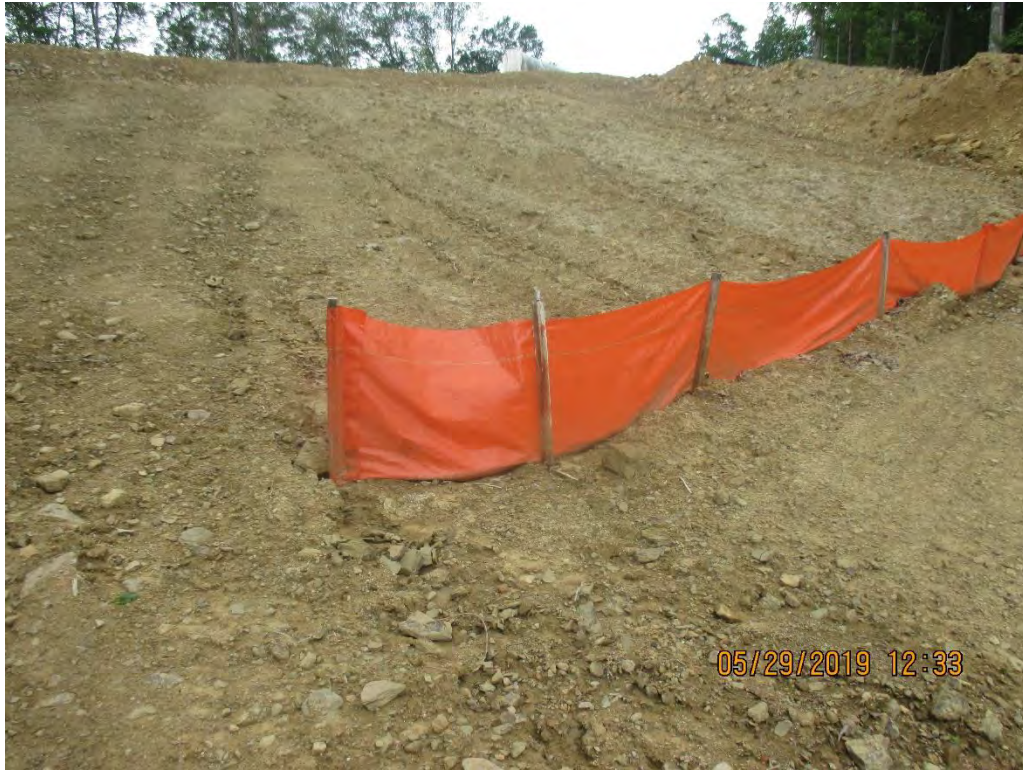
Sit fence installed above Waterbar at station No. 3977+00 facing upslope. Erosion present on slope.

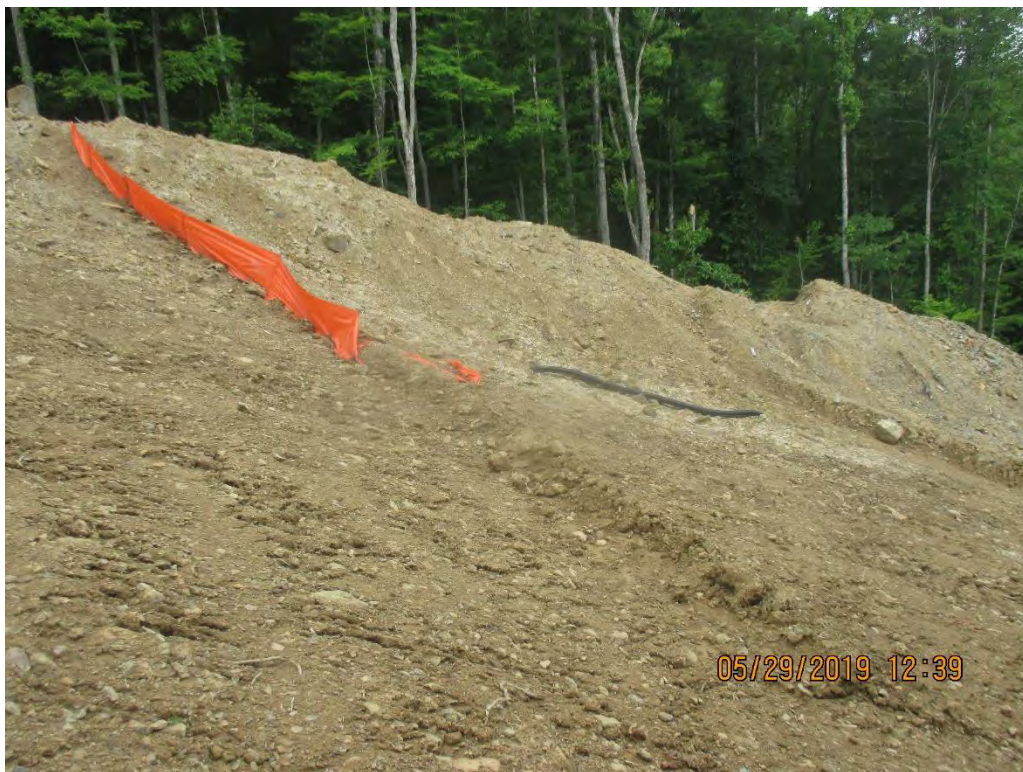
Trench drain outlet terminating onto ROW above Waterbar near station No. 3973+00.

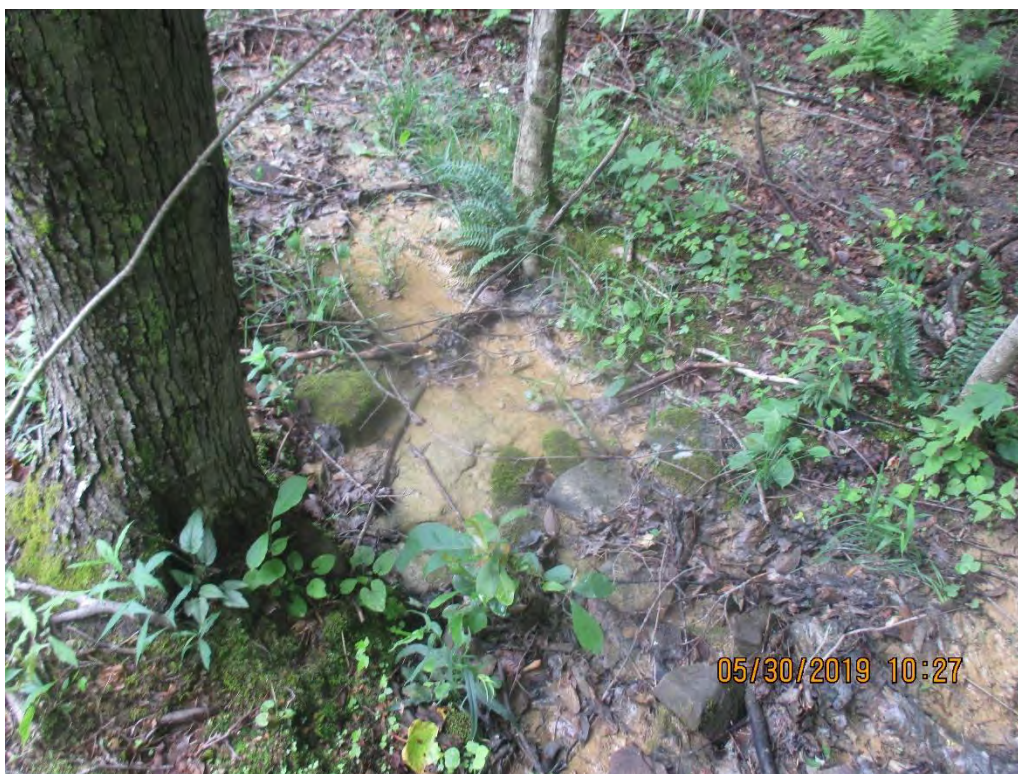
Sediment deposits past the LOD and controls at station No. 6474+16.

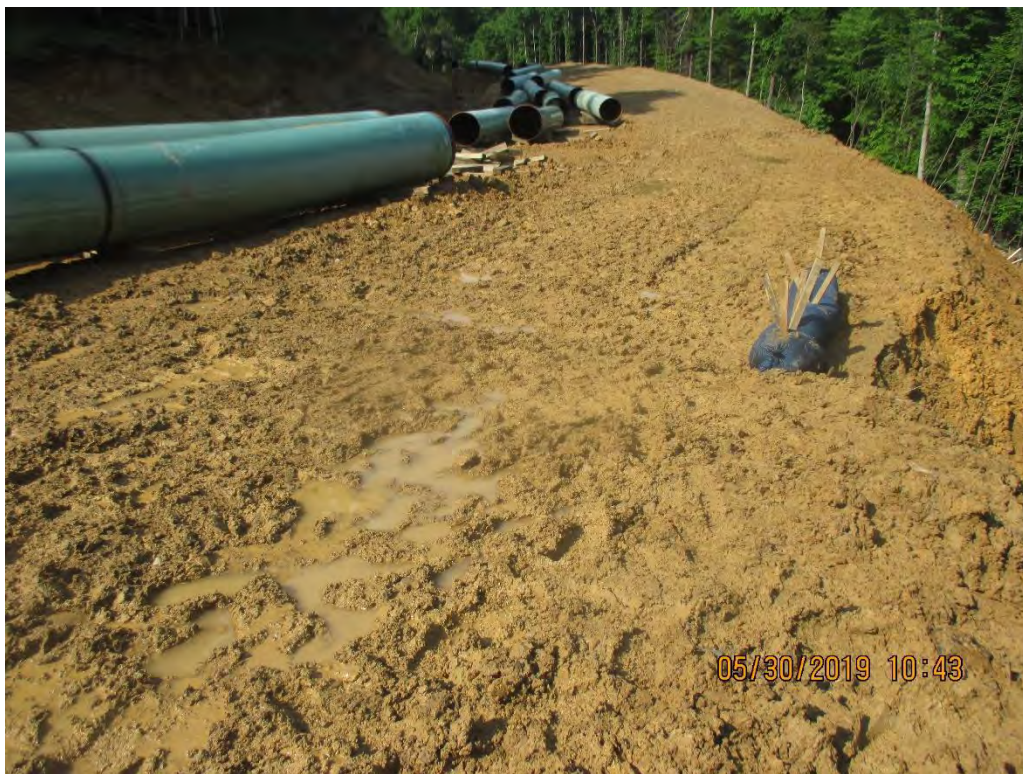
Waterbar outlet terminating onto slope near station No. 6485+10.
