**The Wilderness Society et al. Comments on the
U.S. Forest Service Mountain Valley Pipeline and
Equitrans Expansion Project Draft Supplemental
Environmental Impact Statement (#50036)**

EXHIBIT 12

**WEST VIRGINIA DEPARTMENT OF ENVIRONMENTAL PROTECTION
WV OIL AND GAS CONSTRUCTION STORMWATER PERMIT**

FACILITY NAME:	Mountain Valley Pipeline Project		REG. #	EXPIRE DATE:
PERMITTEE	MOUNTAIN VALLEY PIPELINE, LLC		WVR310667	5/13/2018 Extended: 12/31/2018
ADDRESS/PHONE:	Attn: MATTHEW HOOVER 625 LIBERTY AVE, ST 1700 PITTSBURG, PA 15222 7248733645			
LOCATION:	Harris Compressor Station		Entry Date/Time:	9/25/2018 1000
COUNTY:	Braxton		Exit Date/Time:	9/25/2018 1100
Site Representative /Phone	Brittany Dewitt (Lead EI)/330-987-1682, Matt Hoover MVP/ 412-258-5627 & Jason Hiles, Spread C Lead EI/740-334-7812		PHOTOS <input checked="" type="checkbox"/>	
CO-PERMITTEE:			ADDRESS:	
SITE OPERATOR:	MEC Construction LLC		ADDRESS:	19 RR Meadowbrook, WV 26404
PERMITTED ACREAGE	4311	WEATHER:	Cloudy	LAST INSPECTION: 8/21/2018
RECEIVING STREAM(S)	Trib of Elk/Kanawha R/ Ohio Rv			NOV: 1
Regular Mail <input type="checkbox"/> Certified Mail <input checked="" type="checkbox"/>	Tracking #			
OVERALL FACILITY R

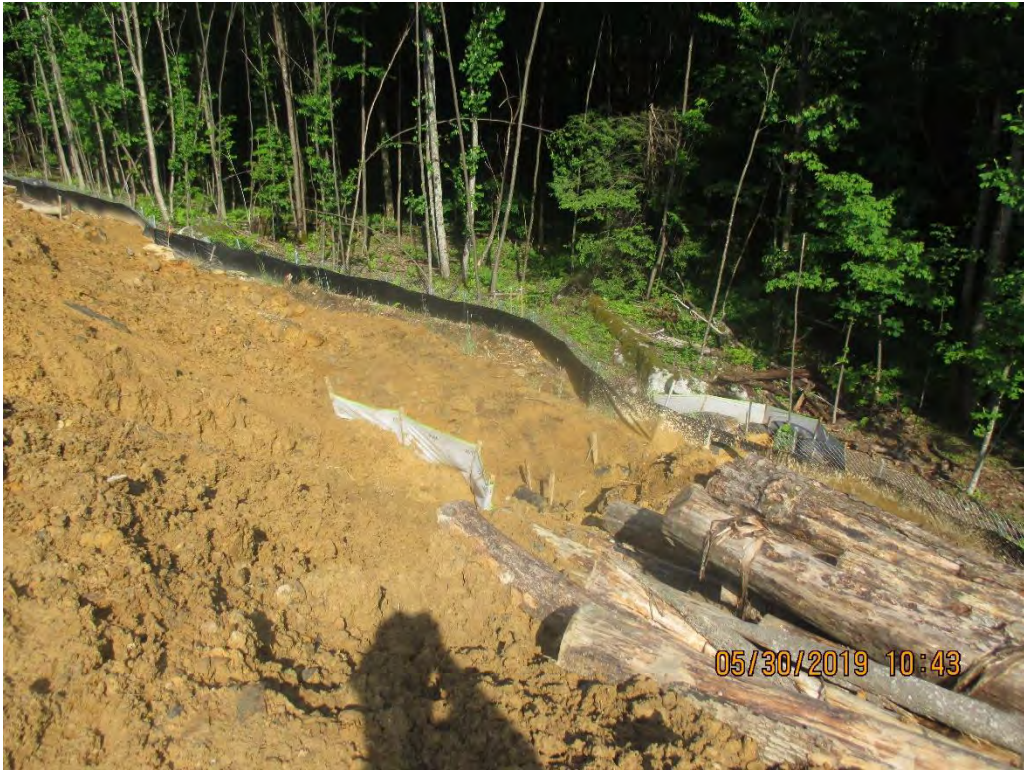
Slope below Waterbar terminus. Perimeter controls becoming overwhelmed with sediment.

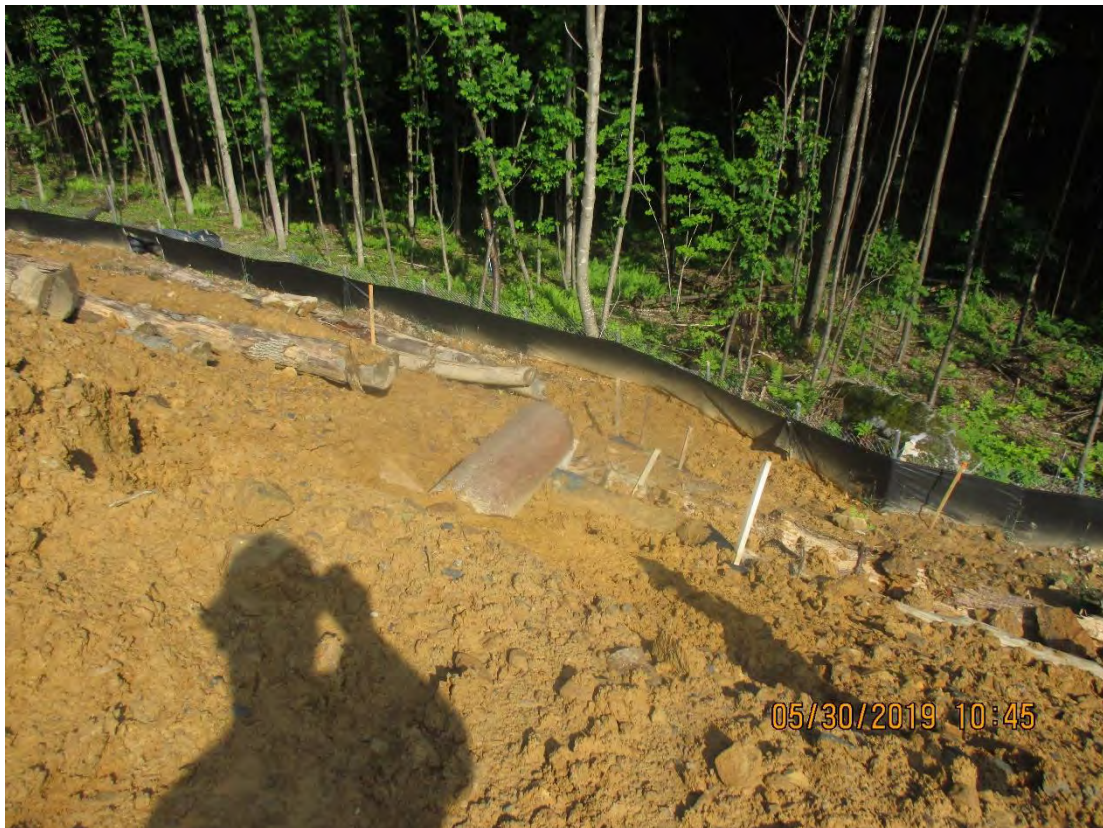
Section G.4.e.2.A.i.d. - Permittee has failed to stabilize clean water diversions prior to becoming functional: Above stream S-EE1 and at station 6485+10 clean water diversions had not been stabilized prior to becoming functional.

Pipe outlet below seep. Diversion not stabilized and No rip rap apron installed as required per SWPPP near station No. 6485+10. The inlet had been cut due to trench being dug.

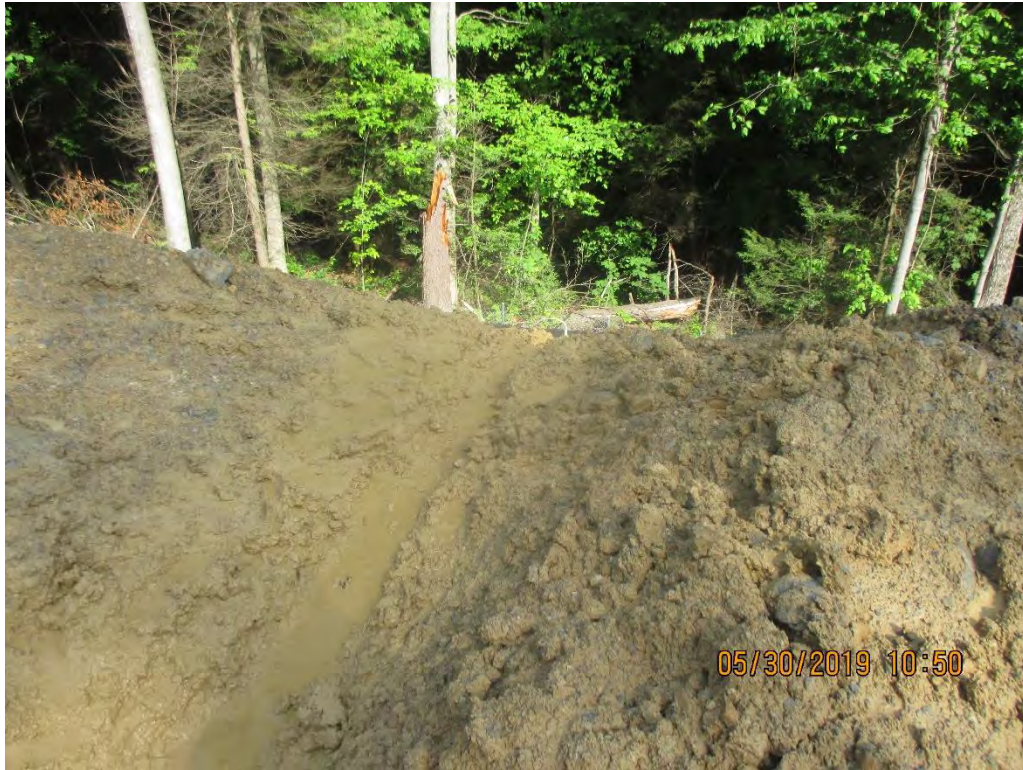
Waterbar outlet terminating onto slope at station No. 6485+10.

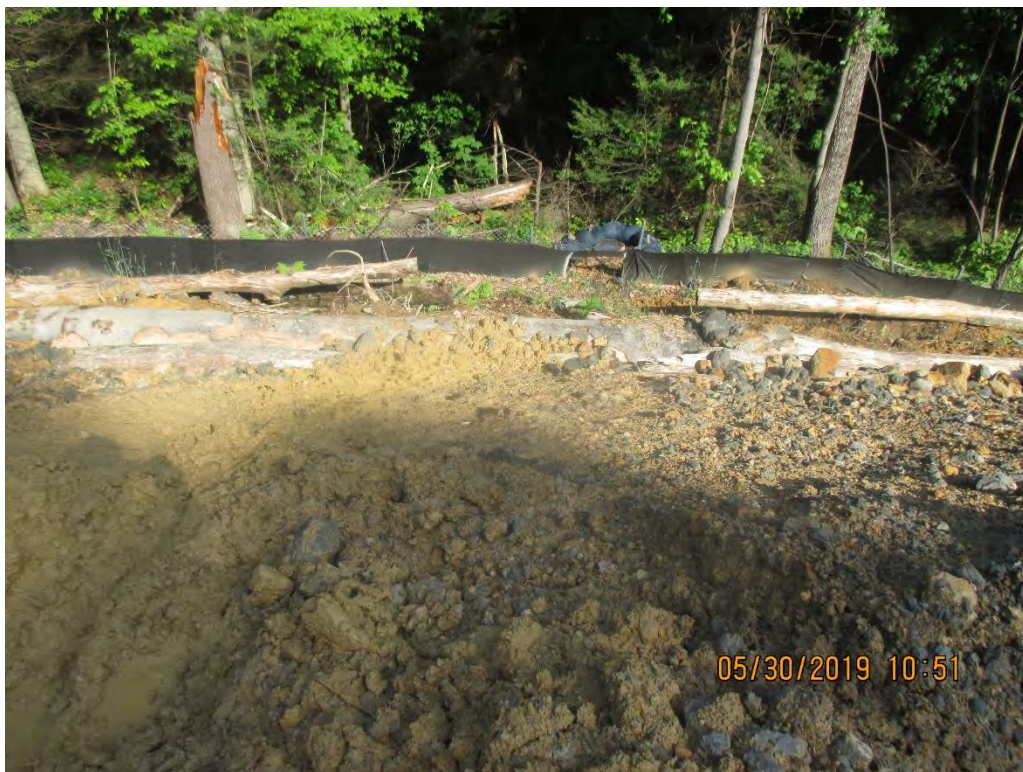
Waterbar outlet terminating onto slope at station No. 6485+10. Erosion present on slope above perimeter controls.

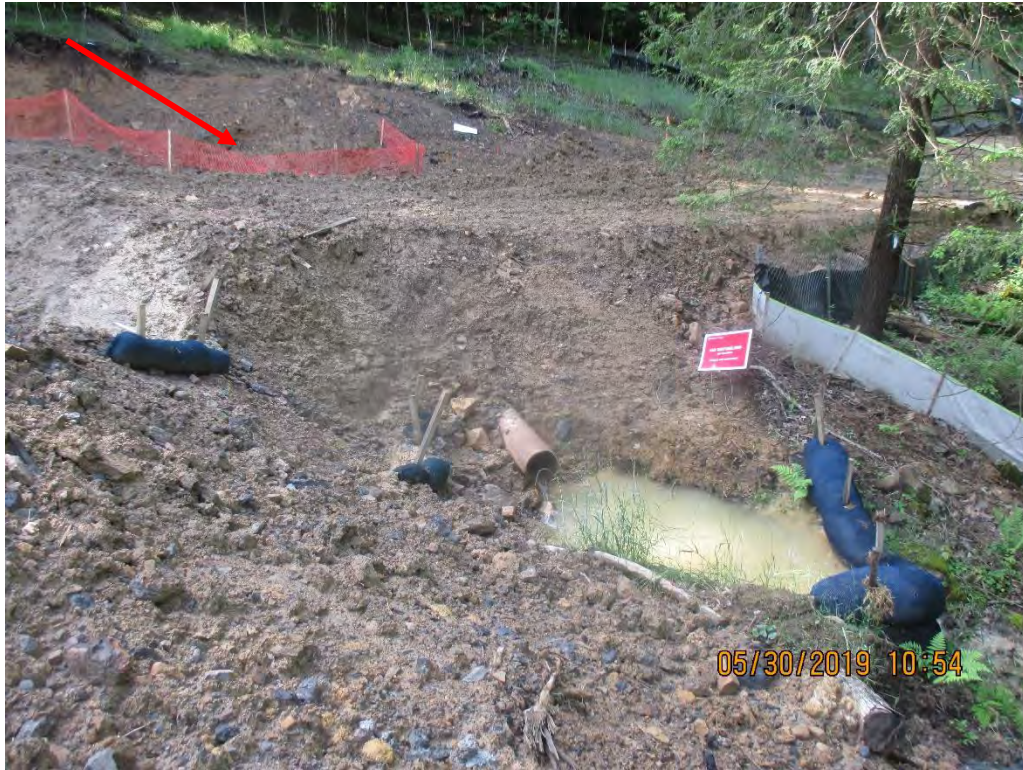
Sep drain outlet above Stream S-EE1. Clean water diversion not stabilized above or below inlet/outlet. Clean water was being conveyed approximately 15 foot across disturbed soil to a sump where the inlet was located. The topsoil pile around the inlet was eroding into the sump. Arrow depicts where inlet was located.

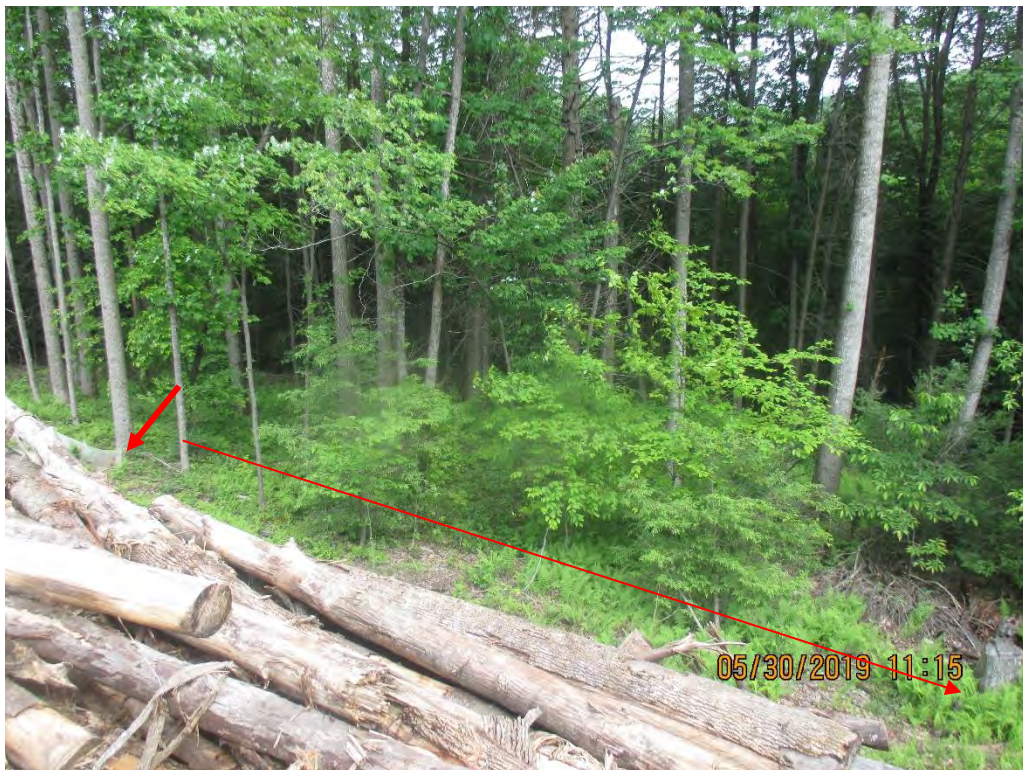
3. **(1, 6, 13, 15, 21)** It was observed that perimeter controls were lacking at station 6495+00. Priority 1 silt fence had not been extended to tie into perimeter outlet controls in this area. Log piles were present with no perimeter controls in place.
4. **(1, 2, 6, 13, 15, 21)** Clean water diversions installed at seeps were not stabilized prior to becoming functional. No rip rap aprons installed at culvert outlets located below seeps as required per SWPPP.
5. **(1, 6, 13, 19, 21)** At Access Road MVP-NI-155 controls were in place per SWPPP. However, the Additional work space had erosion occurring on the NW corner of the LOD. Super silt fence was present and starting to lean over due to the amount of Sediment and SLW being deposited behind it. Sediment deposits were observed past the LOD in this area.

No perimeter control installed per SWPPP on downslope side of fill slope at station No. 6495+00.

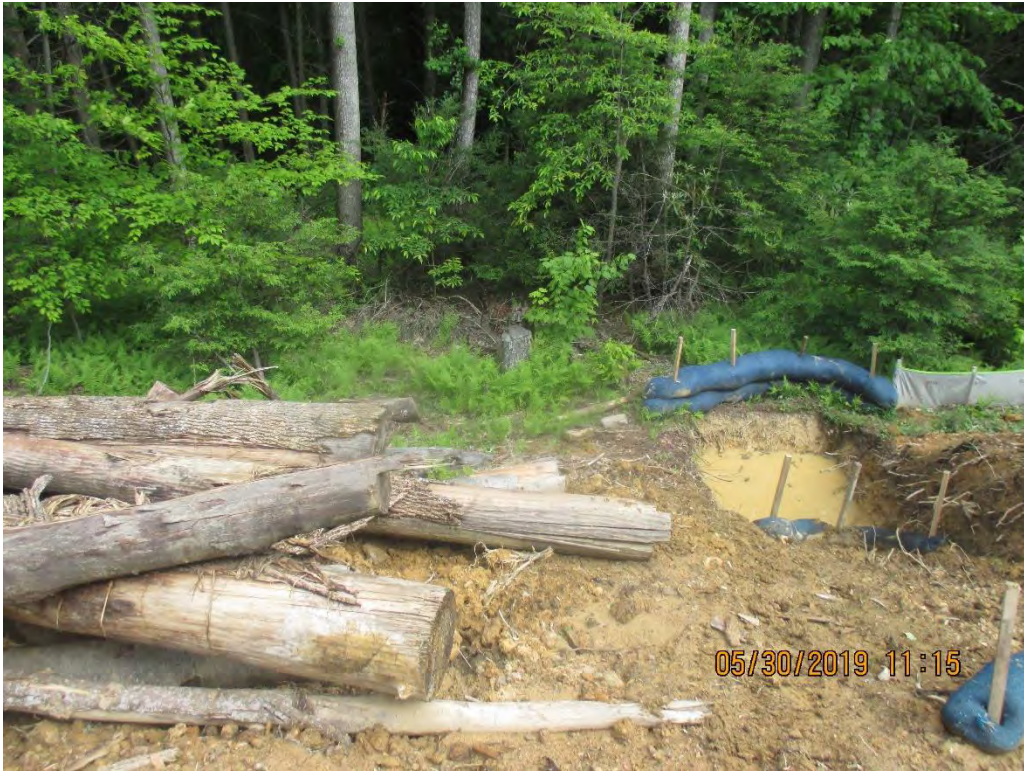
Same area near station No. 6495+00. Perimeter controls not extended per SWPPP into outlet controls.

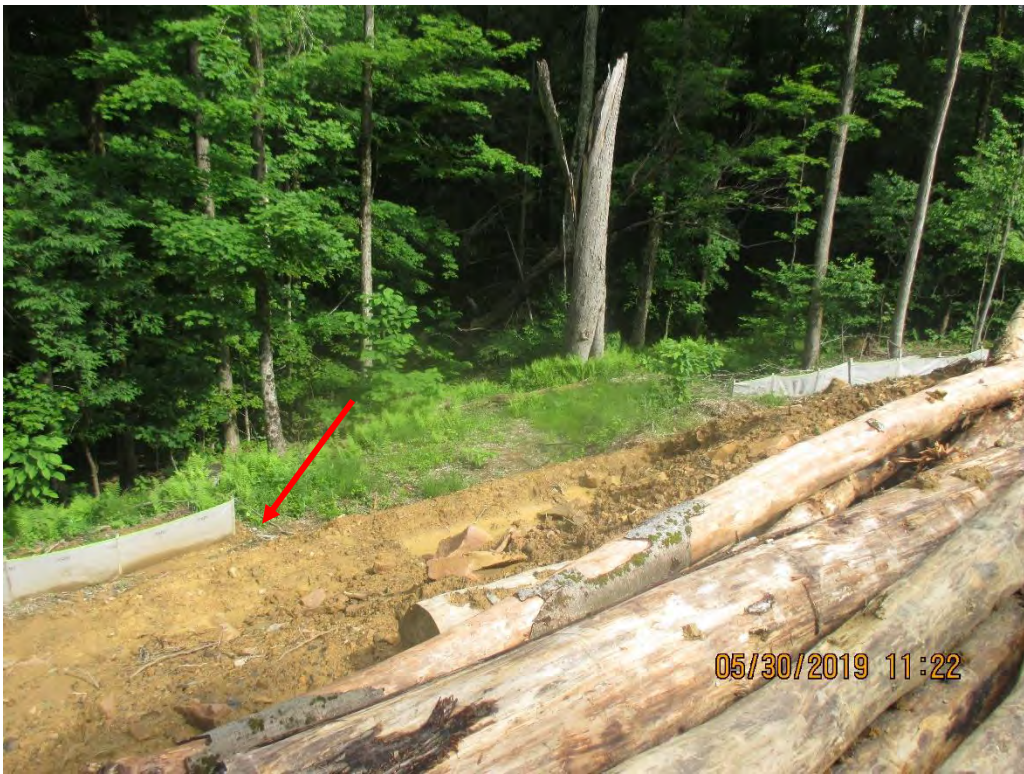
Section G.4-Permittee has failed to follow approved SWPPP: At station 6945+00 ROW diversion had not been installed per SWPPP. Station No. 6497+50 Perimeter controls not installed per SWPPP.

Station No. 6497+50. Perimeter controls not installed per SWPPP. Diversion berm installed however, arrow depicts section where sediment was being deposited against controls and not tied into berm.

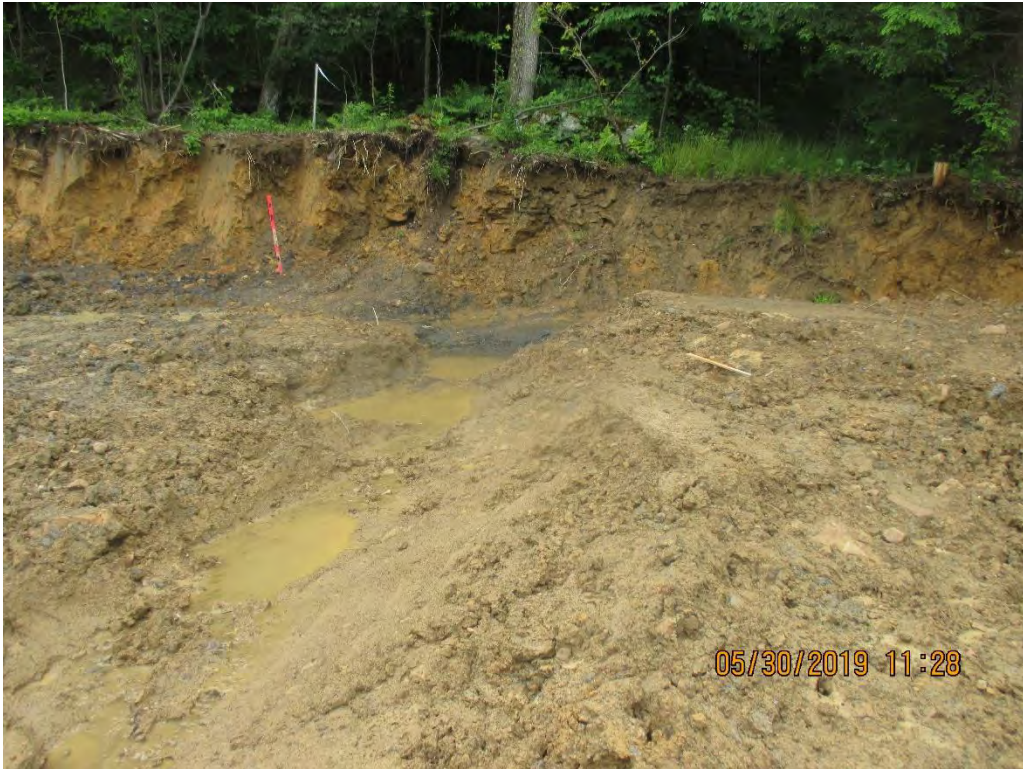
Seep running onto ROW above Stream S-N13. Diversion not stabilized near station No. 6940+00.

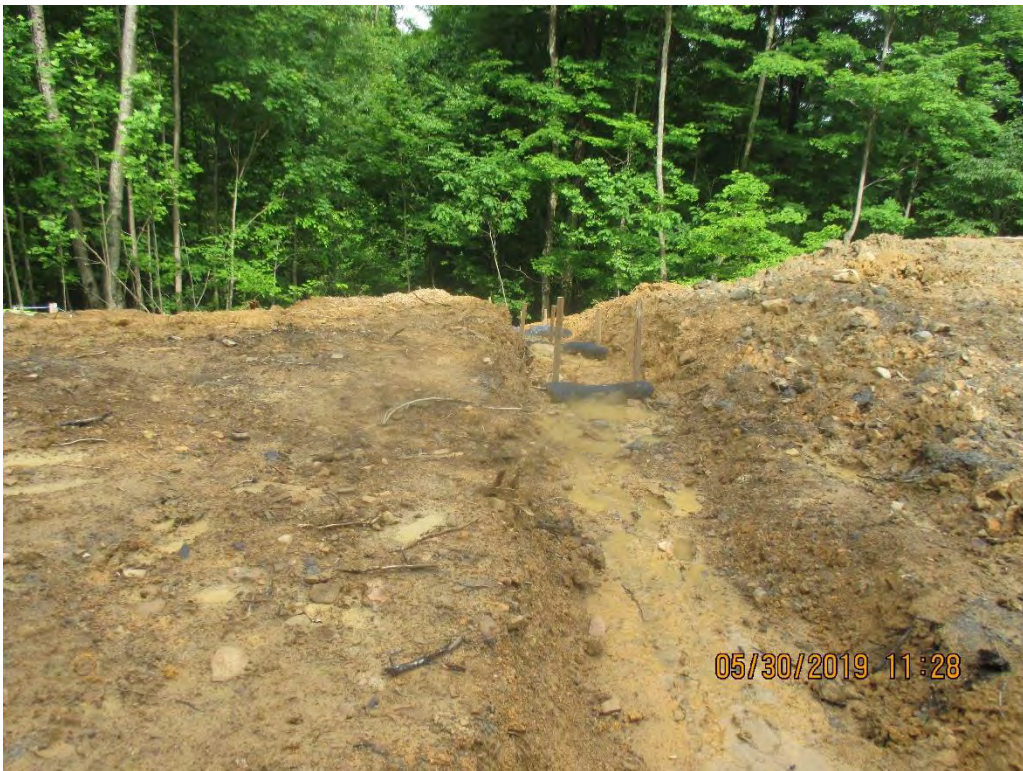
Seep running onto ROW via Waterbar above Stream S-N13. Diversion not stabilized near station No. 6940+00.

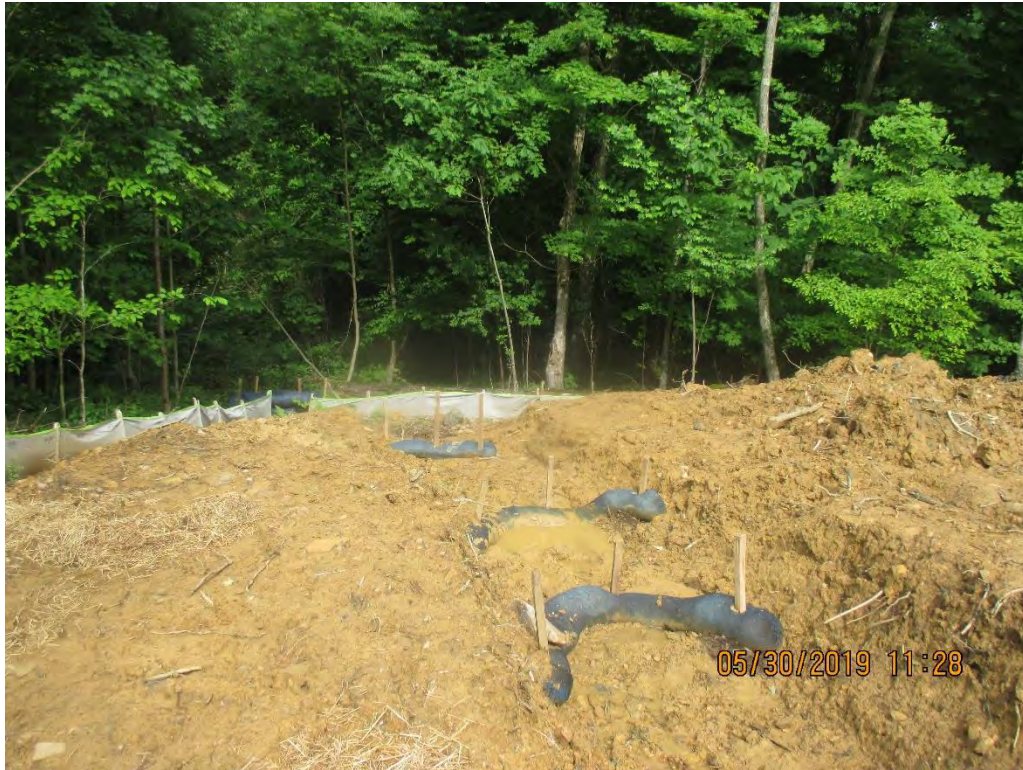
Seep running onto ROW via Waterbar above Stream S-N13. Diversion not stabilized near station No. 6940+00.

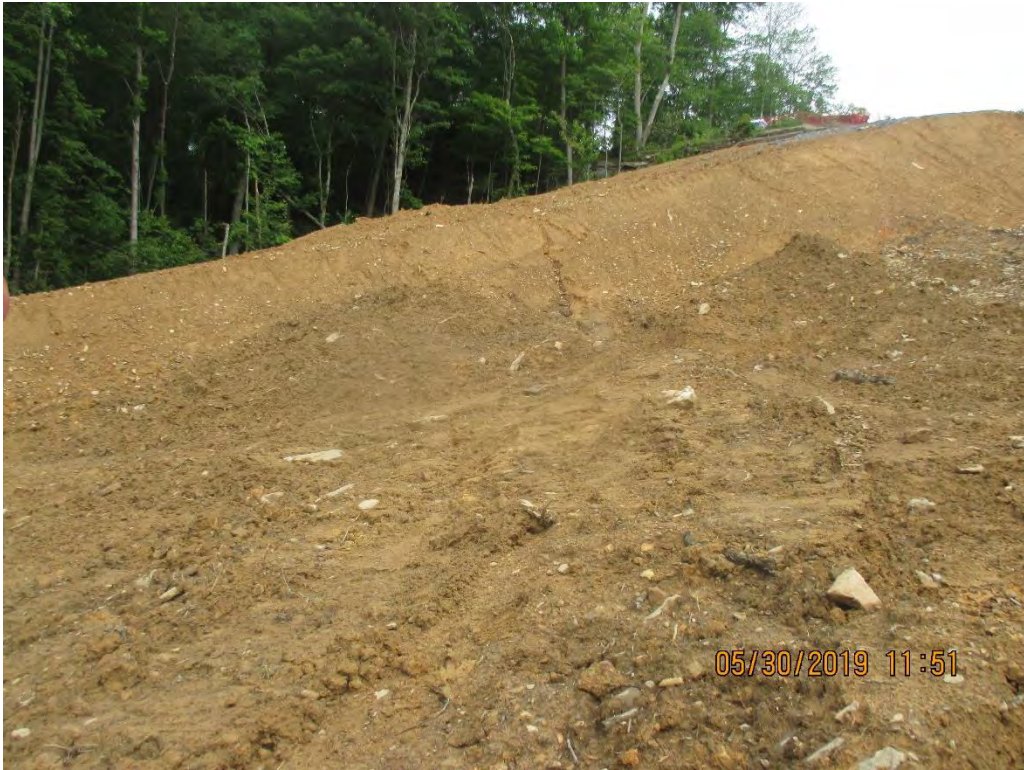
Facing upslope at Deepwell road construction entrance near station No. 6504+20. Erosion present on fill slope and ROW leading to Waterbar.

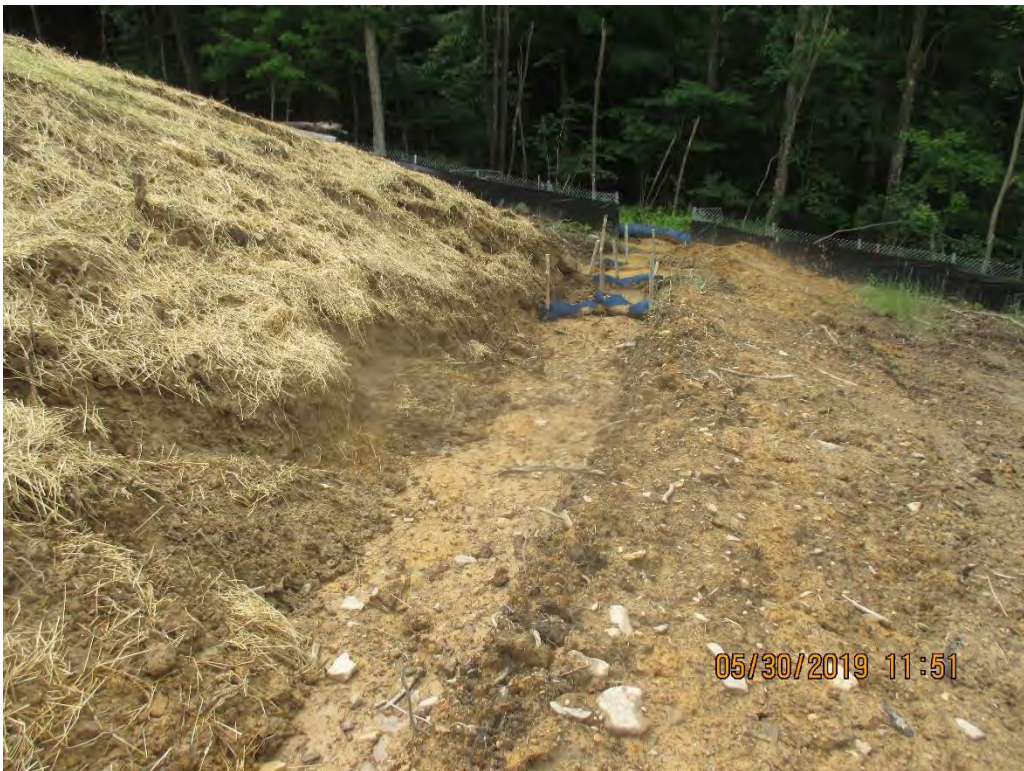
Waterbar with CFS checks installed and scouring topsoil pile below Deepwell road crossing at Station No. 6508+30.

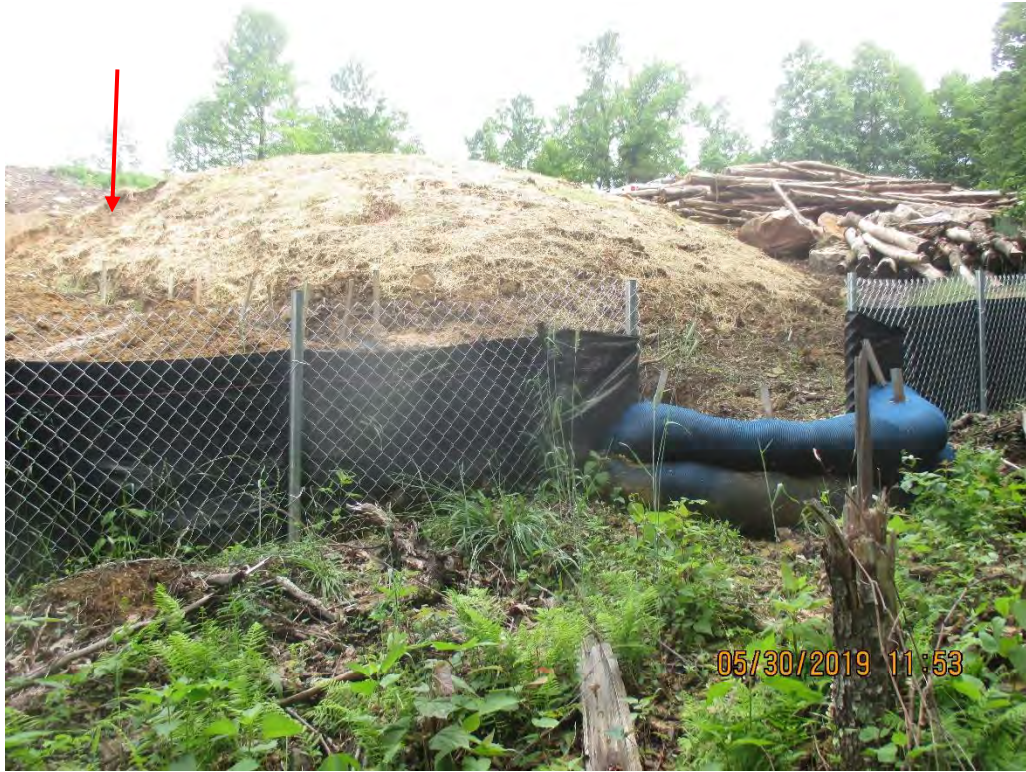
Facing upslope at Waterbar and topsoil pile at station No. 6508+30. Arrow depicts topsoil pile that is slipping into Waterbar.

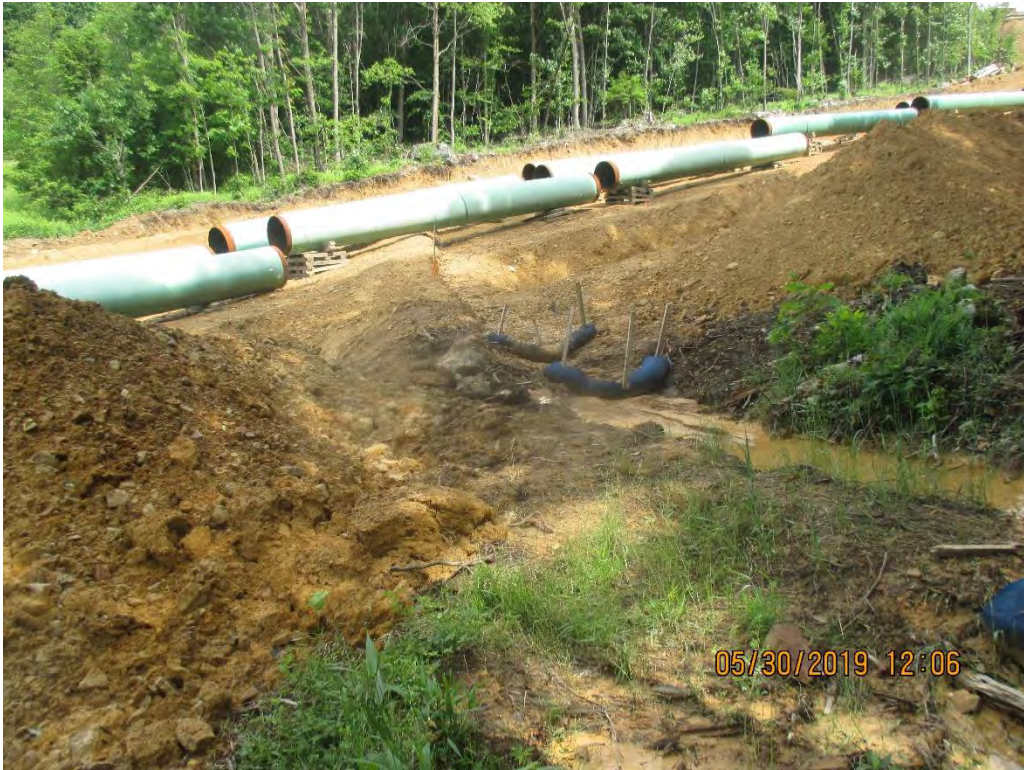
Waterbar at station No. 6510+40 facing upslope.

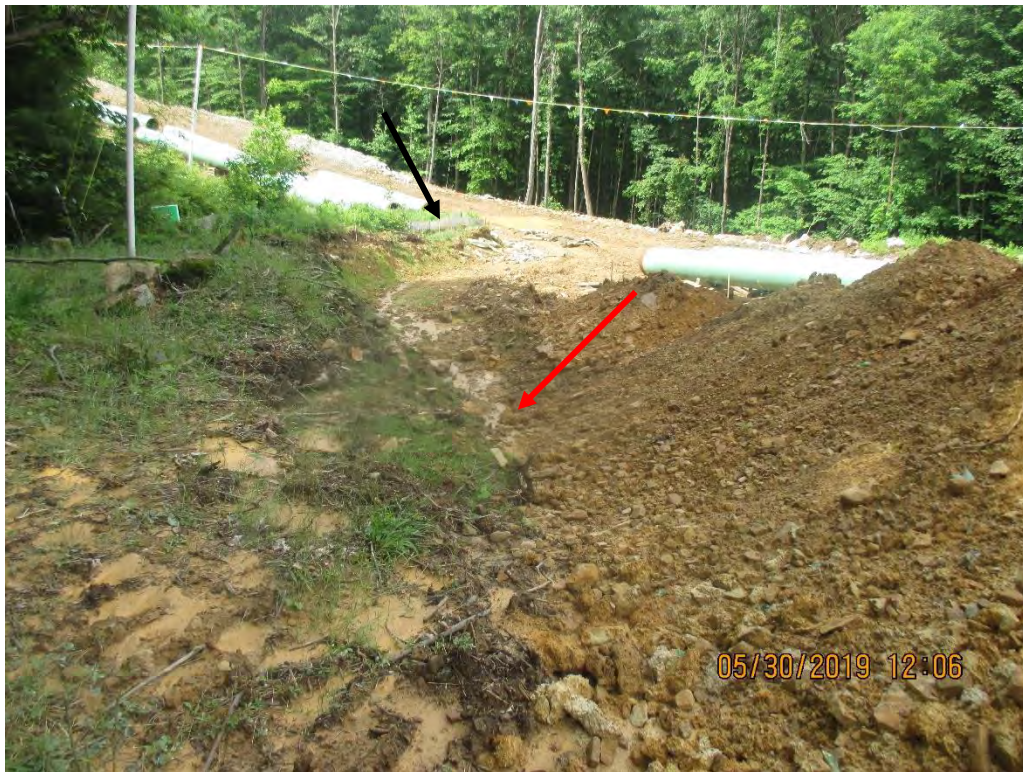
Sediment deposits and SLW traveling downslope at station No. 6510+40. Seep was present in cut next to topsoil pile. Channel wasn't stabilized and conveys to a sump with a slope drain that crosses ROW. Arrow depicts seep. Black arrow shows sump with slope drain inlet.

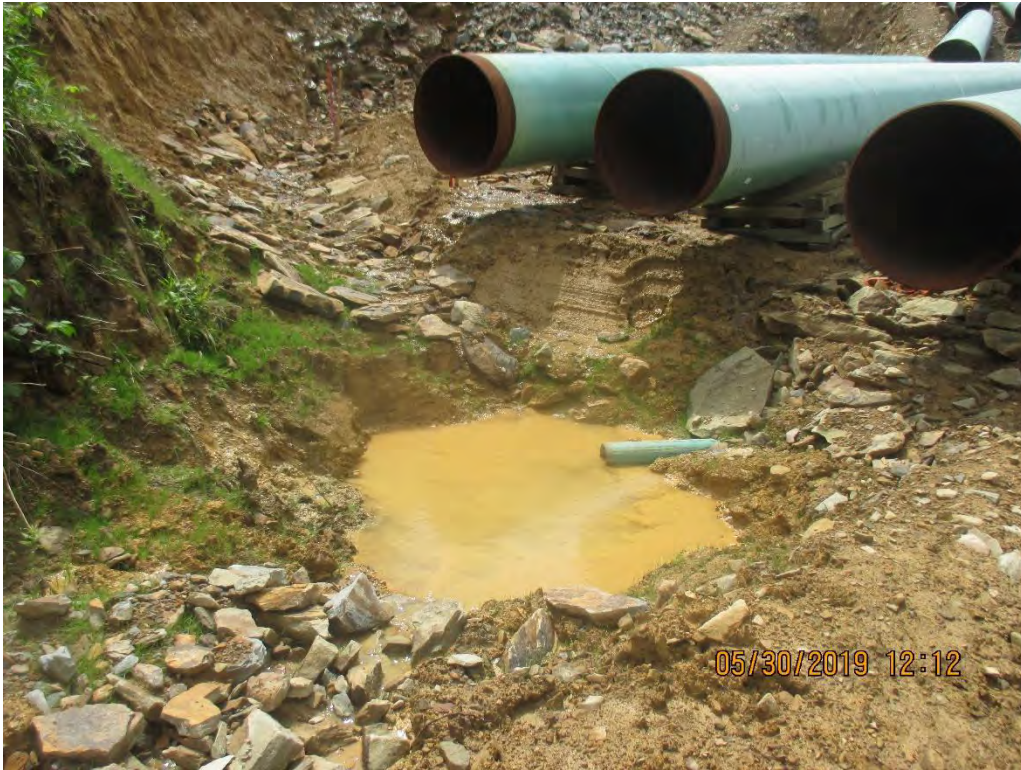
Sump with slope drain inlet for seep at station No. 6510+40.

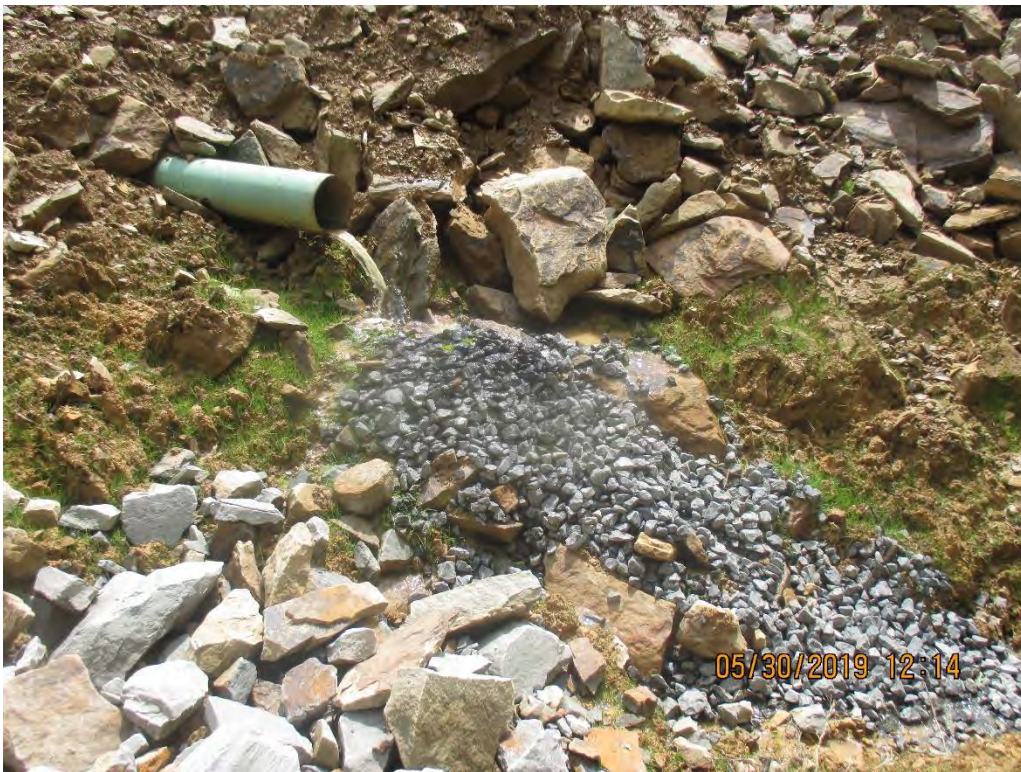
Seep slope drain outlet. Rock apron present.

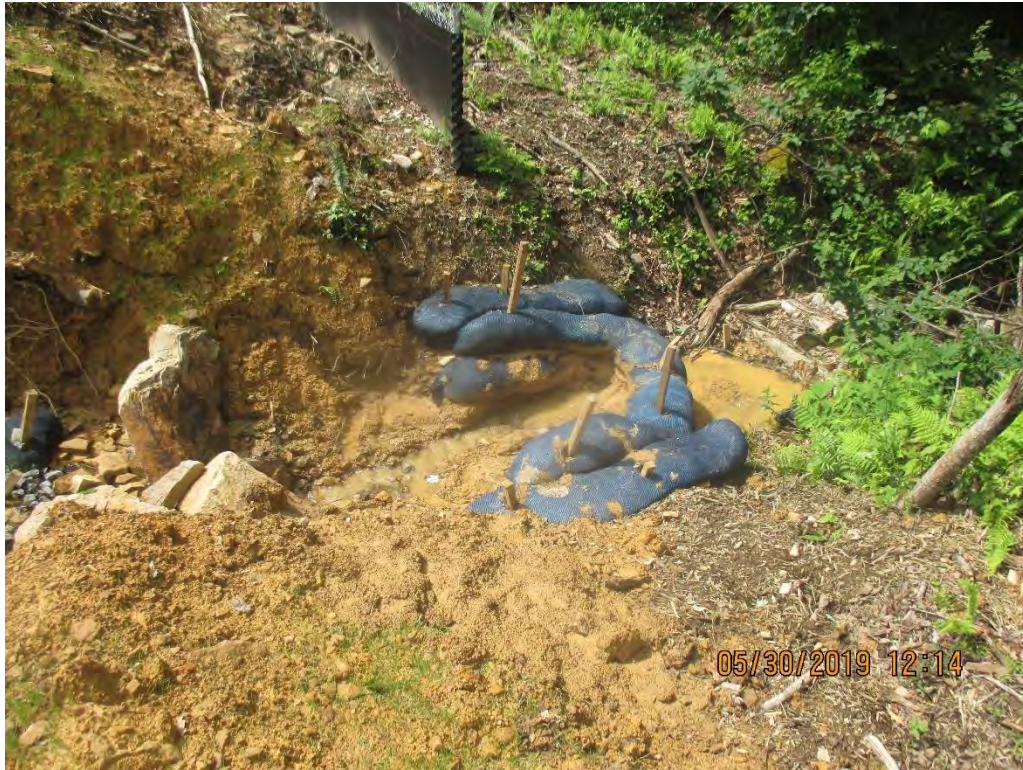
Below seep slope drain outlet. SLW and sediment overwhelming controls.

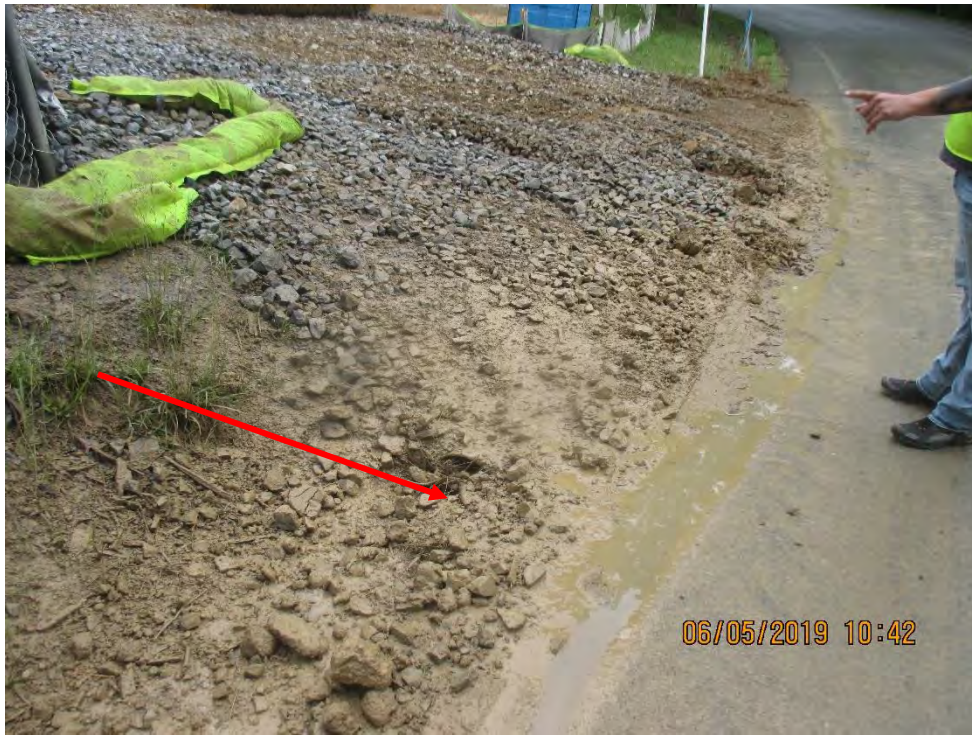
Section D.1-Permittee has failed to at all times properly operate and maintain all systems of treatment and control: Construction entrance at Rt 82 crossing was not maintained to prevent sediment laden water and sediment to be deposited past the permitted LOD.

Construction entrance at the Route 82 crossing at station No. 5539+00. Arrow depicts culvert inlet.

Take measures to correct the aforementioned violations.

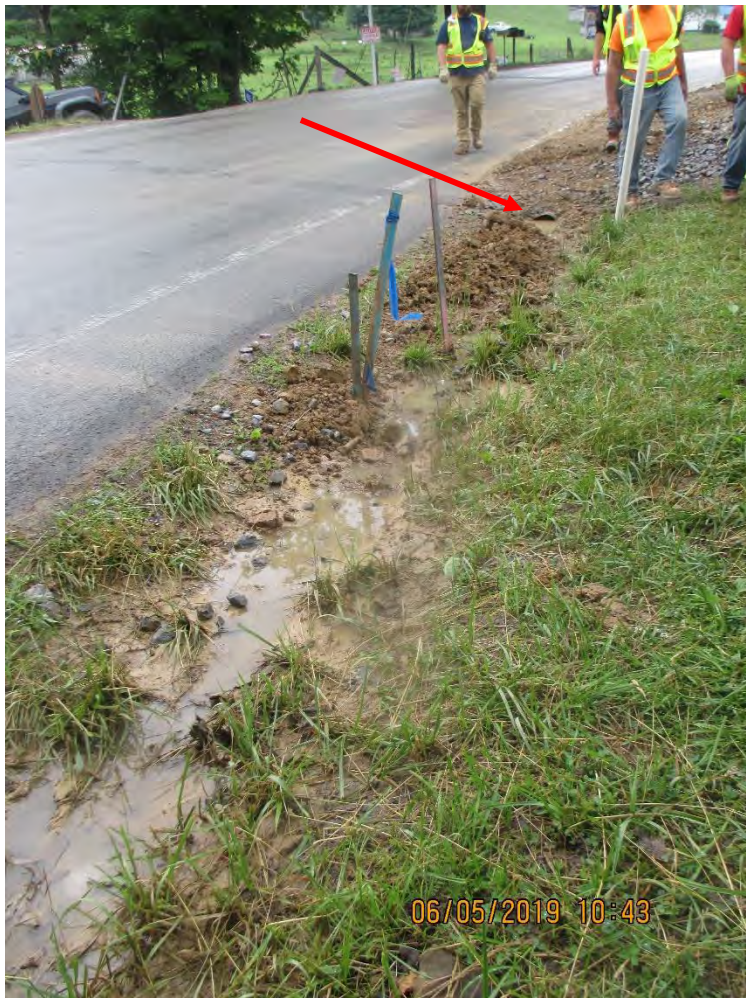
Roadside ditch and culvert outlet. Sediment laden water being conveyed downslope.

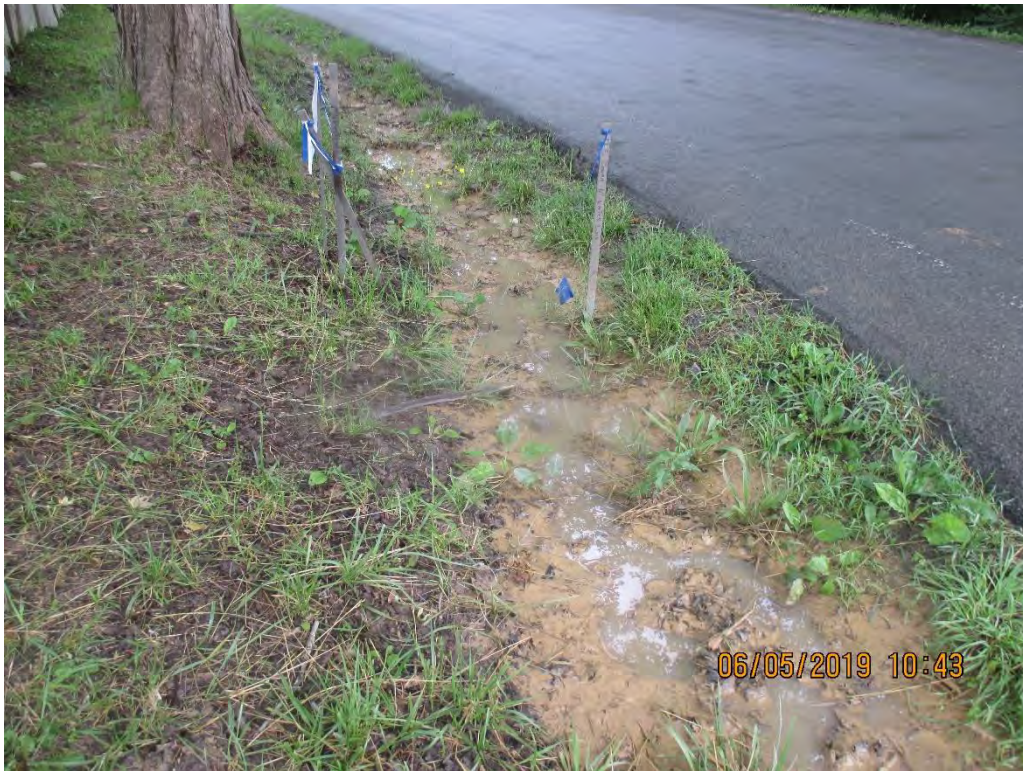
Section G.4.e.2.A.ii.j Permittee has failed to prevent sediment laden water from leaving the site without going through an appropriate device: At the Route 82 crossing sediment deposits and sediment laden water were observed past the LOD. Sediment deposits were observed in the roadside ditch that paralleled Route 28 as well as downslope past a culvert outlet approximately 500 feet past the LOD.

Sediment deposits and sediment laden water being conveyed past the LOD along Route 82.

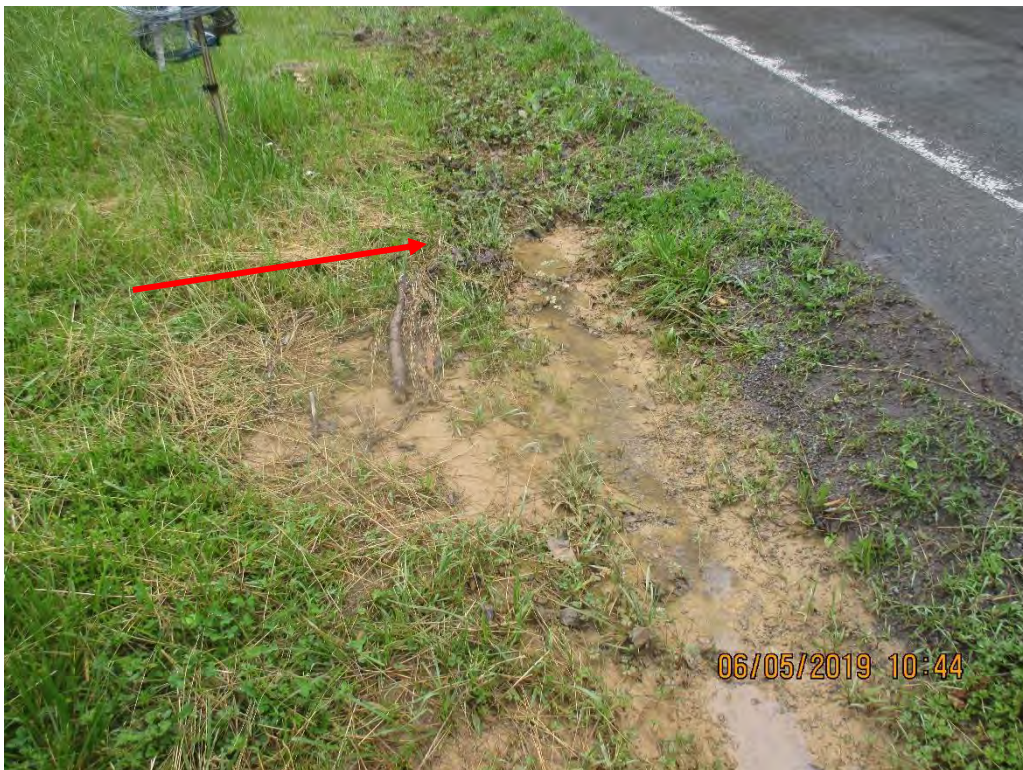
Sediment deposits in roadside ditch that parallels route 82. Arrow depicts culvert intake that conveys under route 82.

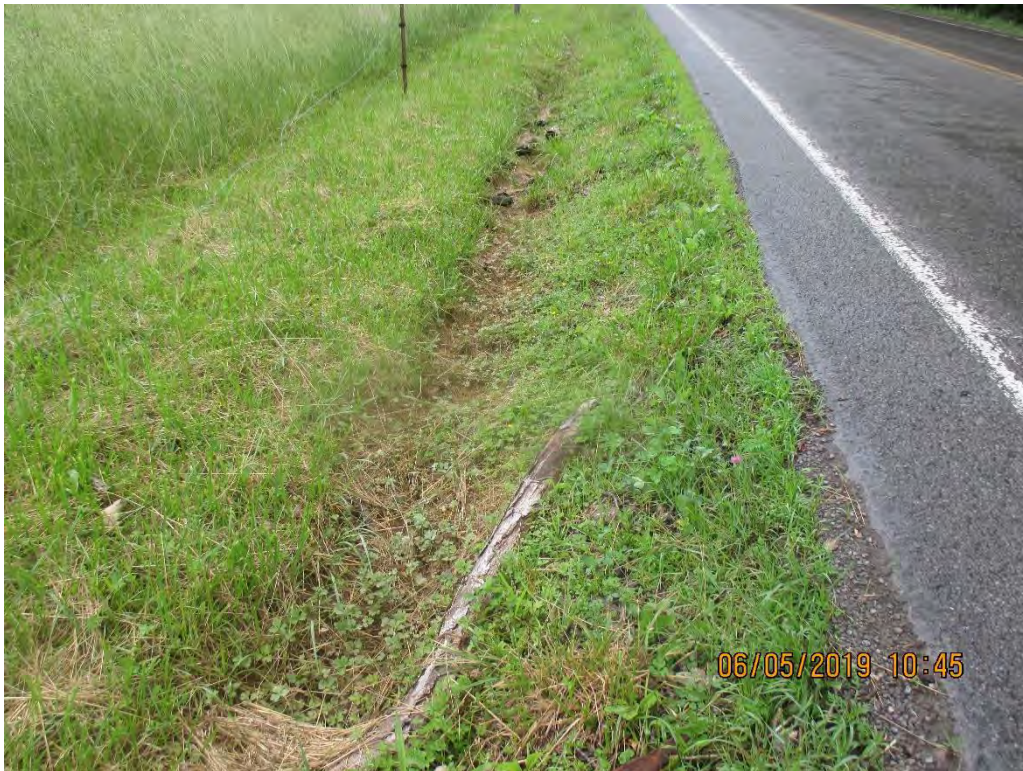
Upslope of culvert intake that conveys under route 82. No sediment deposits present at time of inspection.

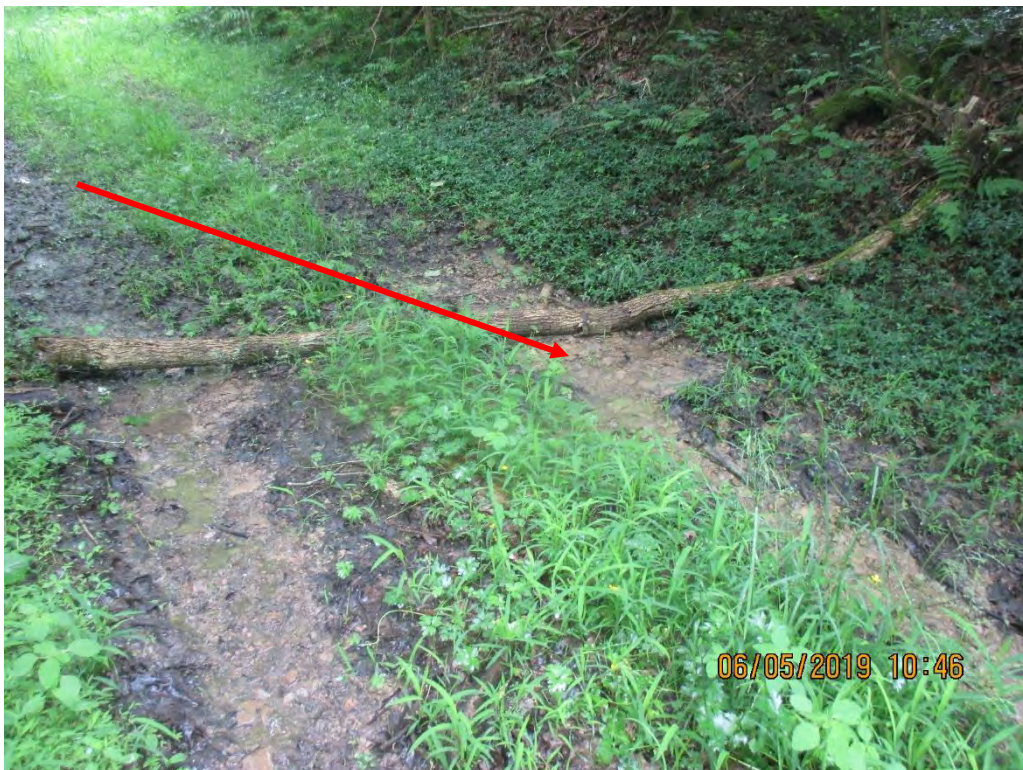
Sediment deposits approximately 500 feet past the LOD downslope of construction entrance.

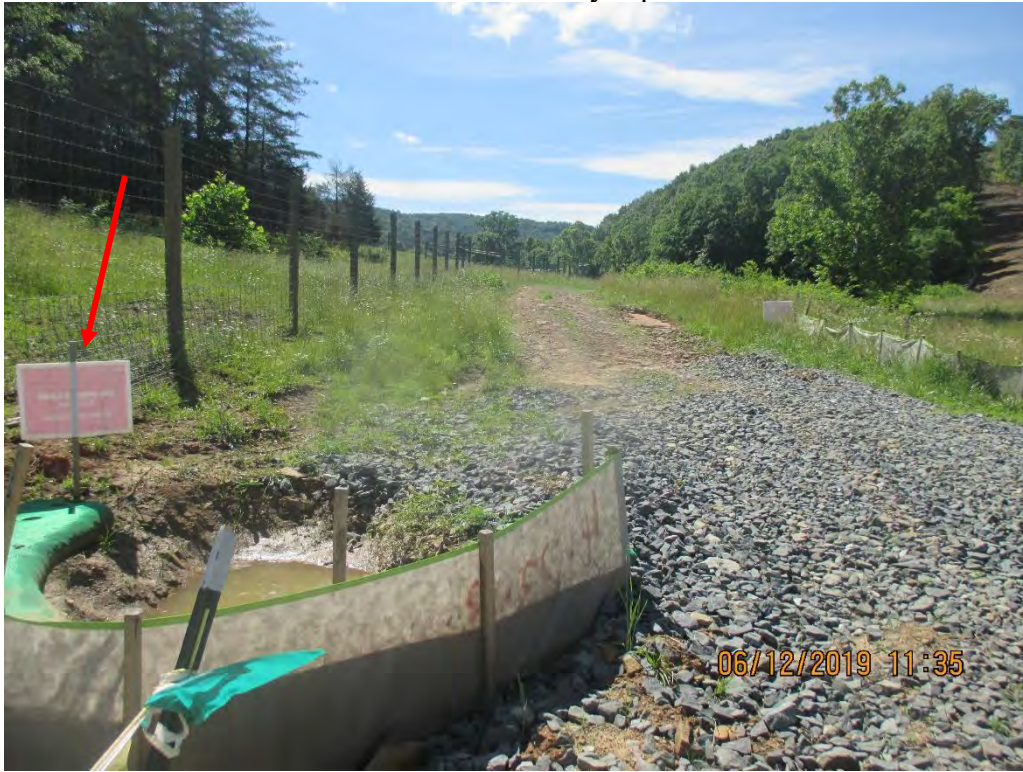
Above Anne's Branch crossing near station 9744+00. Facing upslope of MVP ROW. Erosion ongoing on road as well as slope above road. Arrow depicts LOD.

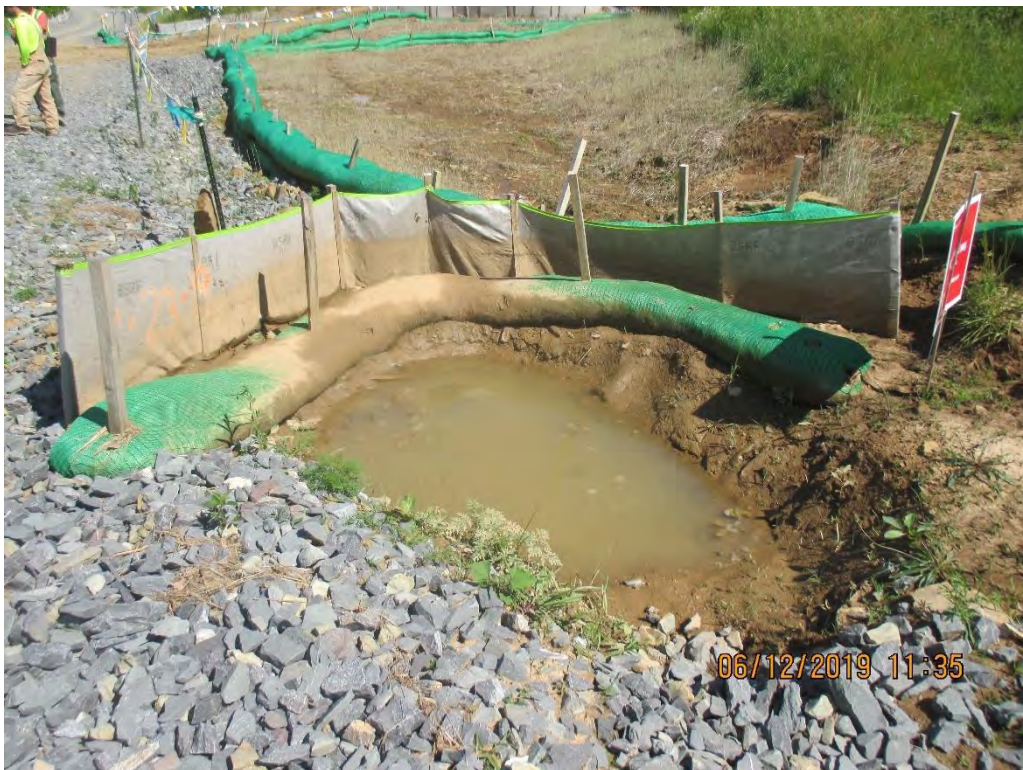
Controls added on edge of LOD to control run-on from adjacent property disturbance.
