**The Wilderness Society et al. Comments on the
U.S. Forest Service Mountain Valley Pipeline and
Equitrans Expansion Project Draft Supplemental
Environmental Impact Statement (#50036)**

EXHIBIT 12

**WEST VIRGINIA DEPARTMENT OF ENVIRONMENTAL PROTECTION
WV OIL AND GAS CONSTRUCTION STORMWATER PERMIT**

FACILITY NAME:	Mountain Valley Pipeline Project		REG. #	EXPIRE DATE:
PERMITTEE	MOUNTAIN VALLEY PIPELINE, LLC		WVR310667	5/13/2018 Extended: 12/31/2018
ADDRESS/PHONE:	Attn: MATTHEW HOOVER 625 LIBERTY AVE, ST 1700 PITTSBURG, PA 15222 7248733645			
LOCATION:	Harris Compressor Station		Entry Date/Time:	9/25/2018 1000
COUNTY:	Braxton		Exit Date/Time:	9/25/2018 1100
Site Representative /Phone	Brittany Dewitt (Lead EI)/330-987-1682, Matt Hoover MVP/ 412-258-5627 & Jason Hiles, Spread C Lead EI/740-334-7812		PHOTOS <input checked="" type="checkbox"/>	
CO-PERMITTEE:			ADDRESS:	
SITE OPERATOR:	MEC Construction LLC		ADDRESS:	19 RR Meadowbrook, WV 26404
PERMITTED ACREAGE	4311	WEATHER:	Cloudy	LAST INSPECTION: 8/21/2018
RECEIVING STREAM(S)	Trib of Elk/Kanawha R/ Ohio Rv			NOV: 1
Regular Mail <input type="checkbox"/> Certified Mail <input checked="" type="checkbox"/>	Tracking #			
OVERALL FACILITY R

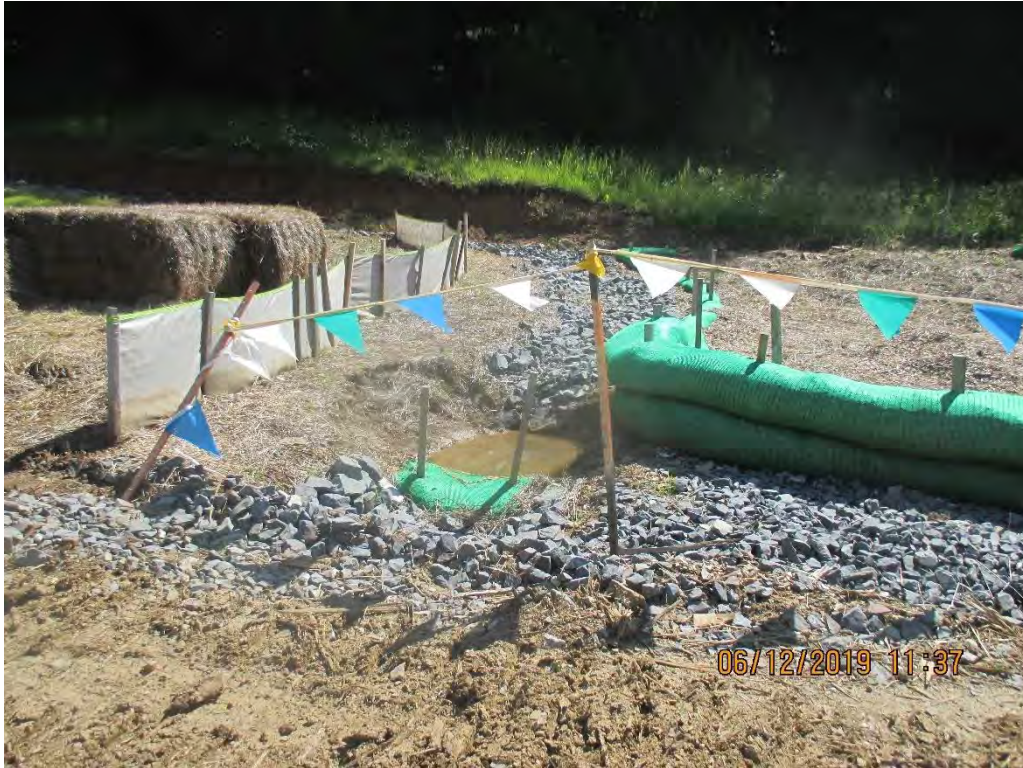
French drain installed at base of cut slope. Drain terminated into sump with controls and conveys under ROW to outlet that has sump present with controls.

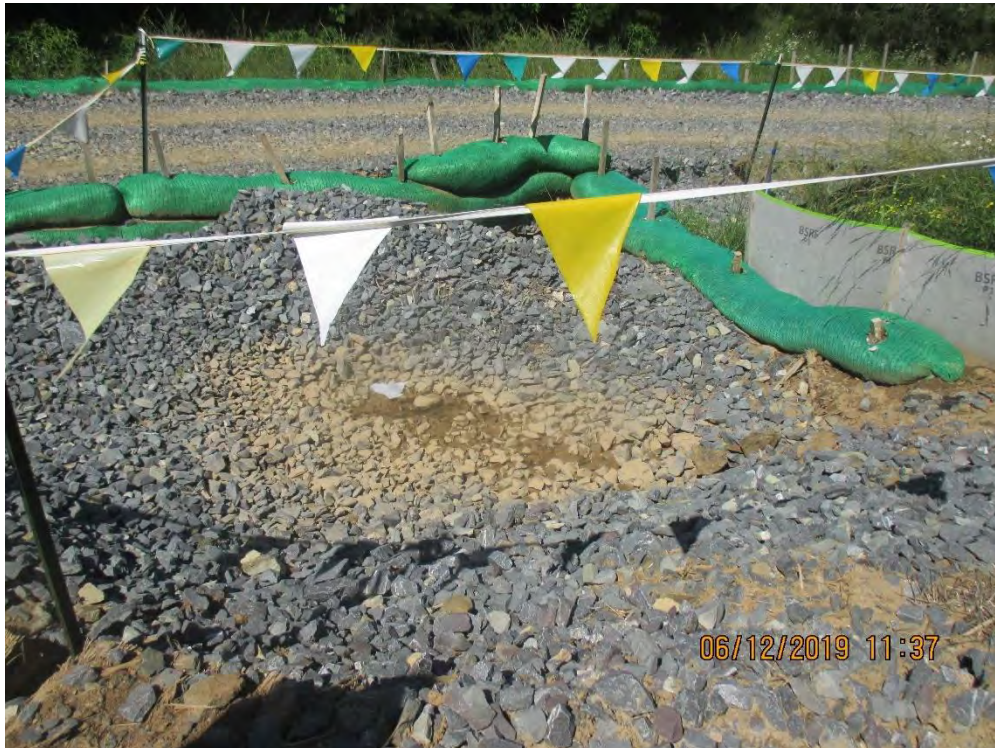
Culvert outlet terminating in sump along AR 227.

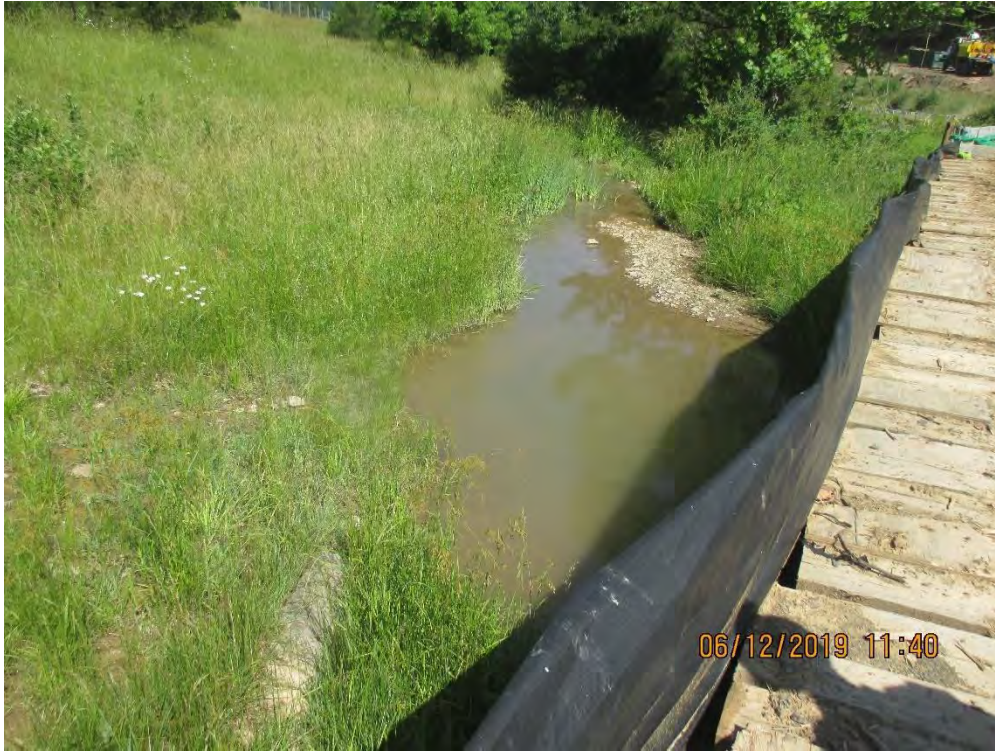
Anne's Branch crossing near station No. 9744+00 facing downstream. Past disturbance observed from land owner traffic across stream.

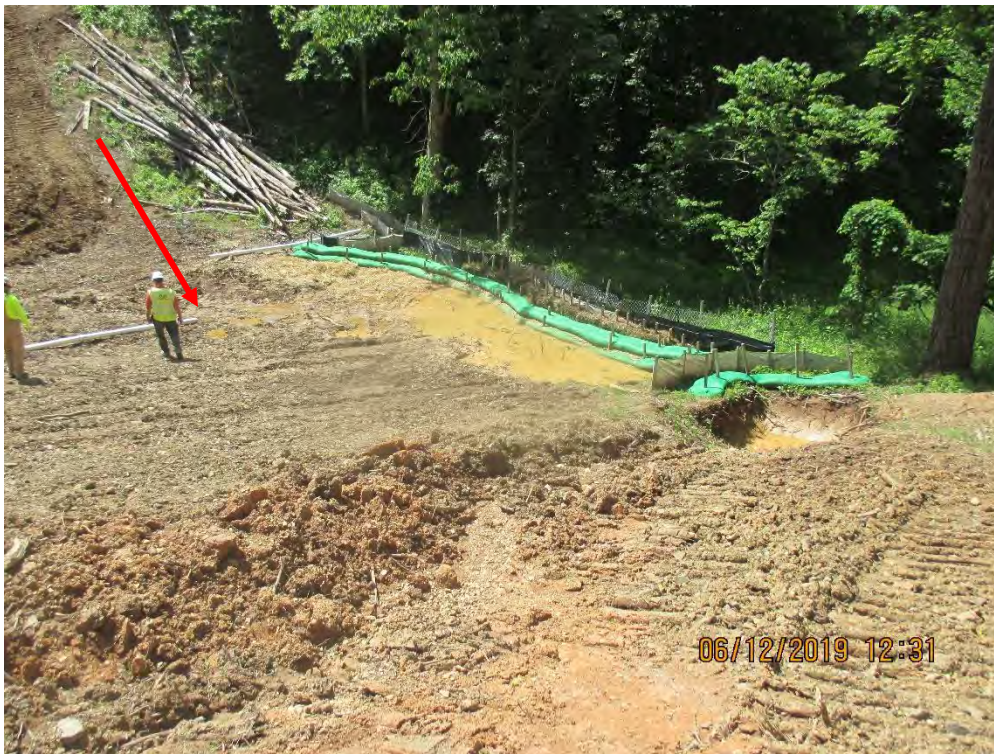
Dargo silt fence. Pipe slope drain terminating on ROW and not extended to edge of LOD. Arrow depicts slope drain outlet.

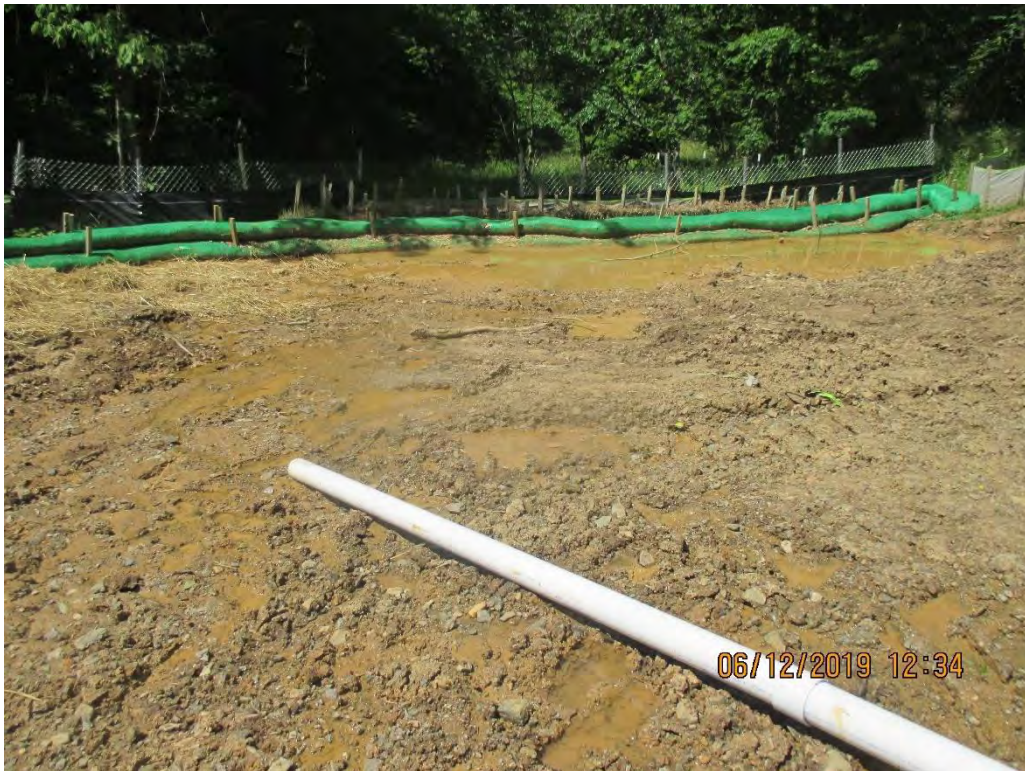
Pipe slope drain terminating onto ROW above controls (Dargo silt fence).

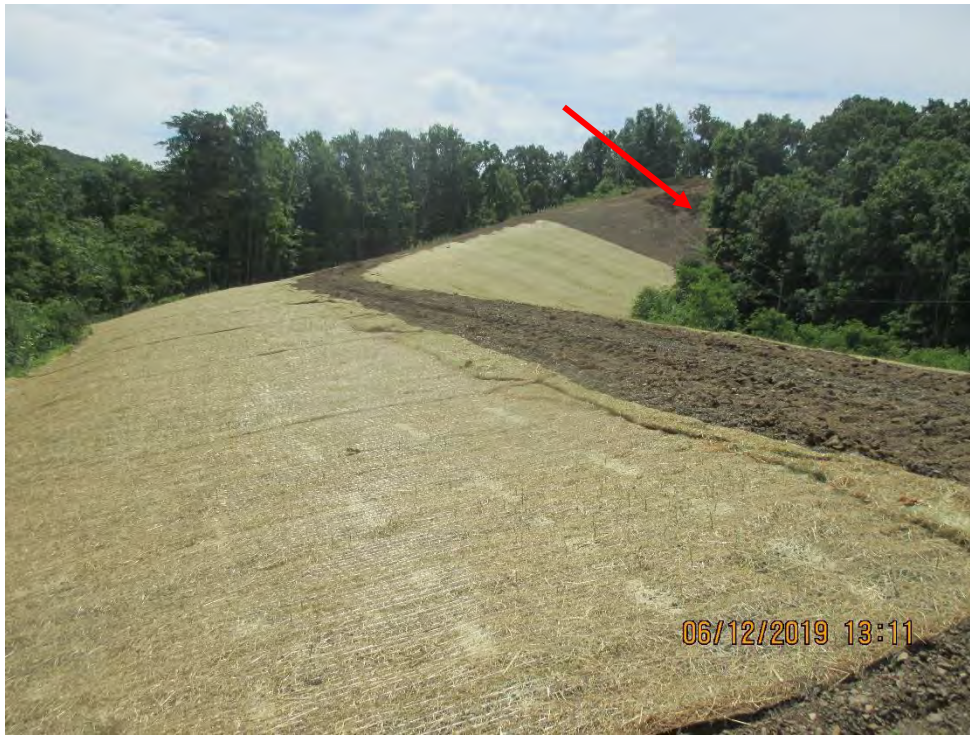
Upslope of Dargo silt fence. Facing South towards AR-221. Arrow depicts where dozer work was ongoing during inspection and controls needed maintenance.

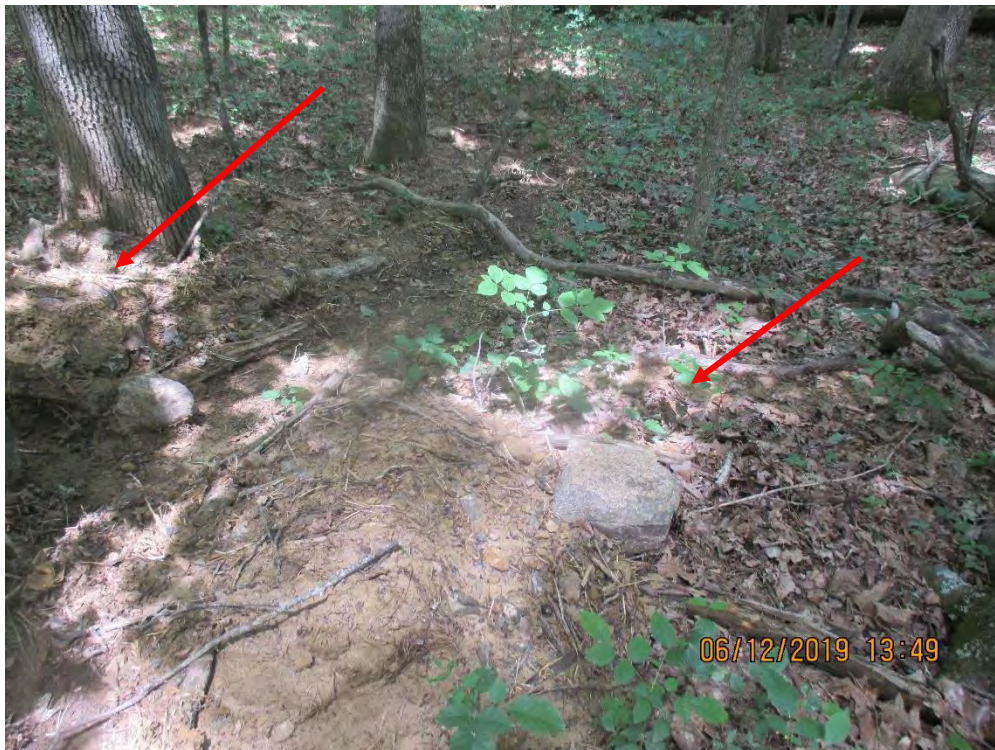
Section G.4.e.2.A.ii.j-Perimtte has allowed sediment laden to leave the site without going through and appropriate device: At station No. 9780+00 evidence that SLW had left the site was observed due to a significant amount of sediment deposits and scouring being present past controls and LOD. At the Dargo silt fence downslope of station No. 9780+00 sediment deposits was observed past controls and the LOD.

Sediment Deposits below and past controls/LOD at station No. 9780+00. Arrow depicts deposits.

Take measures to correct the aforementioned violations.

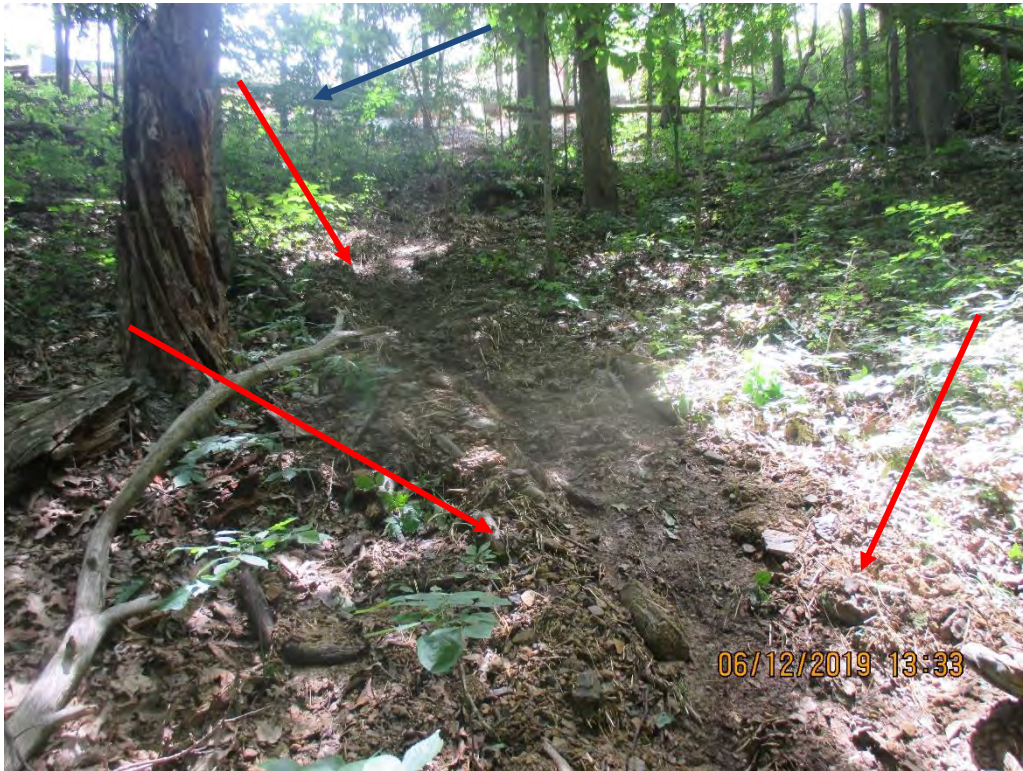
Scoring and sediment deposits below controls at station No. 9780+00. Red Arrow depicts deposits. Blue arrow depicts controls at edge of LOD.

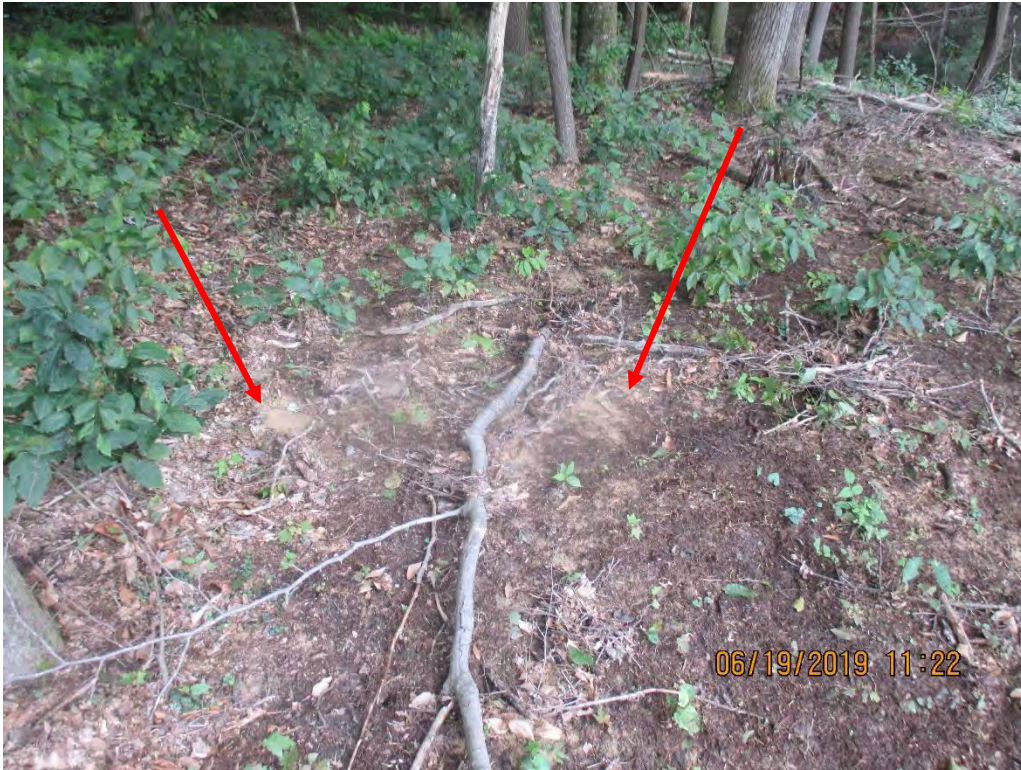
Section G.4.e.2.A.ii.j-Permittee has allowed sediment laden to leave the site without going through and appropriate device: At station No. 6587+00 evidence was observed that sediment laden water had left the site due to sediment deposits being present past controls and the LOD above Stream S-L38.

Downslope of Waterbar outlet controls at Station No. 6587+00. Arrow depicts Sediment Deposits.

The following corrective measures were discussed with you at the time of this inspection:
Take measures to correct the aforementioned violations.

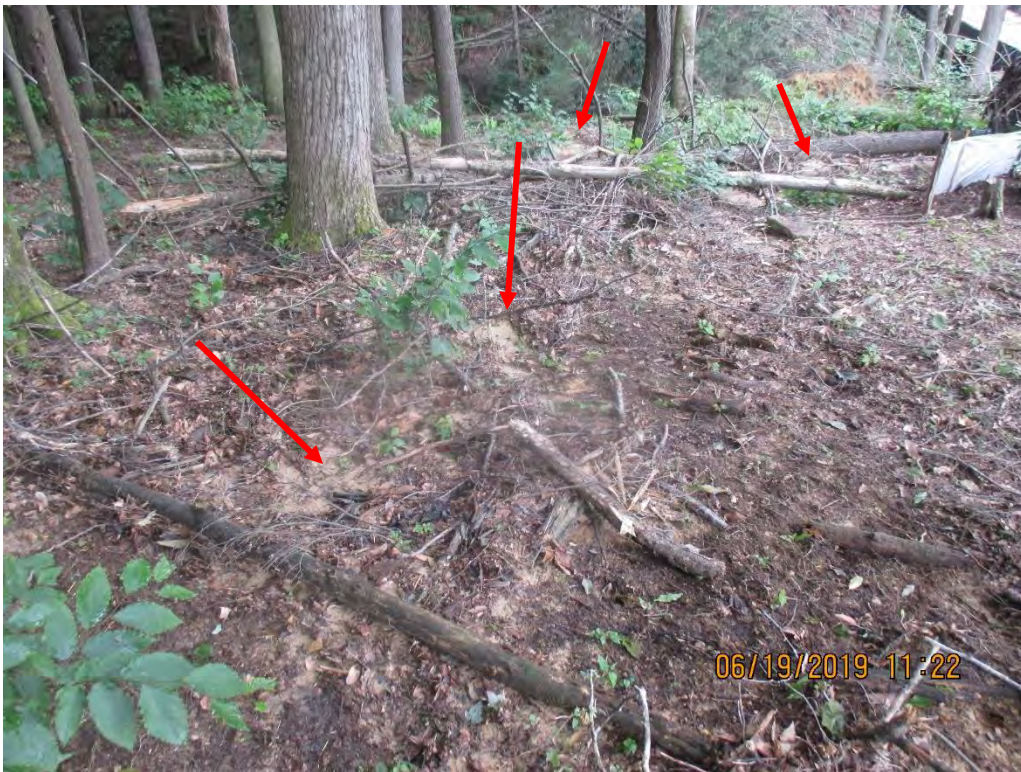
Downslope of Waterbar outlet controls at Station No. 6587+00. Arrow depicts Sediment Deposits.
