**The Wilderness Society et al. Comments on the
U.S. Forest Service Mountain Valley Pipeline and
Equitrans Expansion Project Draft Supplemental
Environmental Impact Statement (#50036)**

**WEST VIRGINIA DEPARTMENT OF ENVIRONMENTAL PROTECTION
WV OIL AND GAS CONSTRUCTION STORMWATER PERMIT**

FACILITY NAME:	Mountain Valley Pipeline Project			REG. #	EXPIRE DATE:
PERMITTEE	MOUNTAIN VALLEY PIPELINE, LLC			WVR310667	5/13/2018
ADDRESS/PHONE:	Attn: Matt Hoover 625 LIBERTY AVE, ST 1700 PITTSBURGH, PA 15222				
LOCATION:	Wileyville, WV			Entry Date/Time:	4/3/18 8:30am
COUNTY:	Wetzel			Exit Date/Time:	4/3/18 1:37pm
Site Representative /Phone	Matt Hoover Sr. Environmental Coordinator (412) 258-5627			PHOTOS <input checked="" type="checkbox"/>	
CO-PERMITTEE:				ADDRESS:	
SITE OPERATOR:	Precision Pipeline			ADDRESS:	
PERMITTED ACREAGE	4214	WEATHER:	Rain	LAST INSPECTION:	N/A
RECEIVING STREAM(S)	Mobley Run > Ohio River				NOV: 1
Regular Mail <input type="checkbox"/> Certified Mail <input checked="" type="checkbox"/>	Tracking #				
OVERALL FACILITY RATING:	Unsatisfactory		COMPLIANCE OUTCOME	Not Immediately Corrected

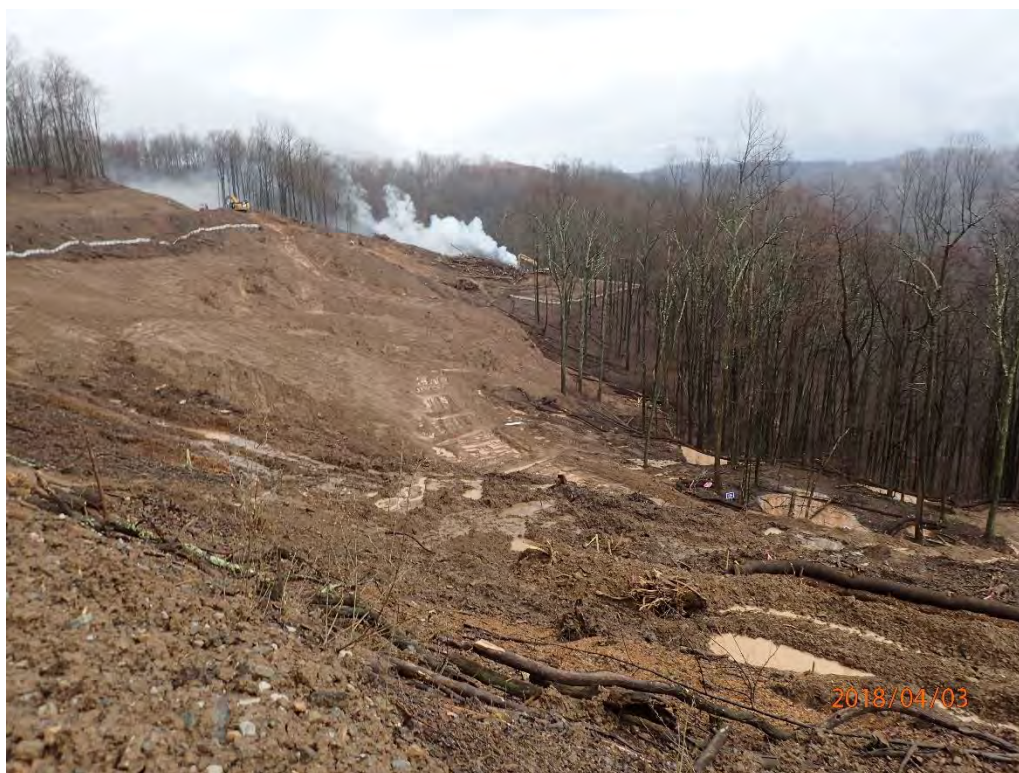
Disturbed area near the reported slip area.

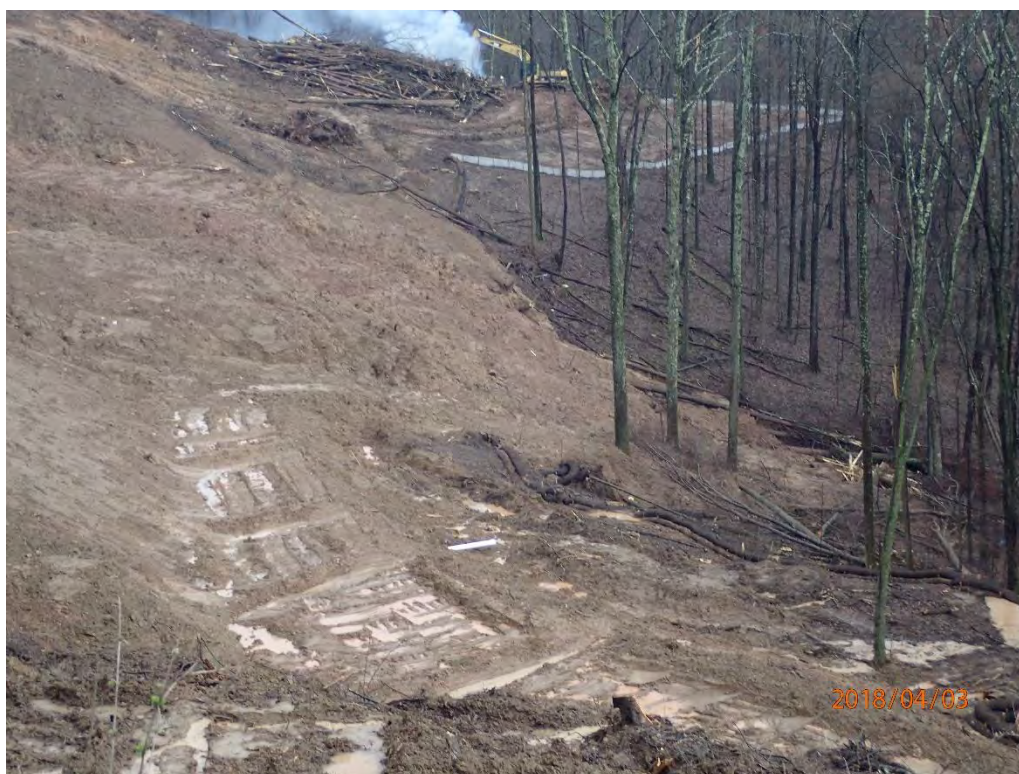
Reported slip area near Bradshaw Compressor Station.

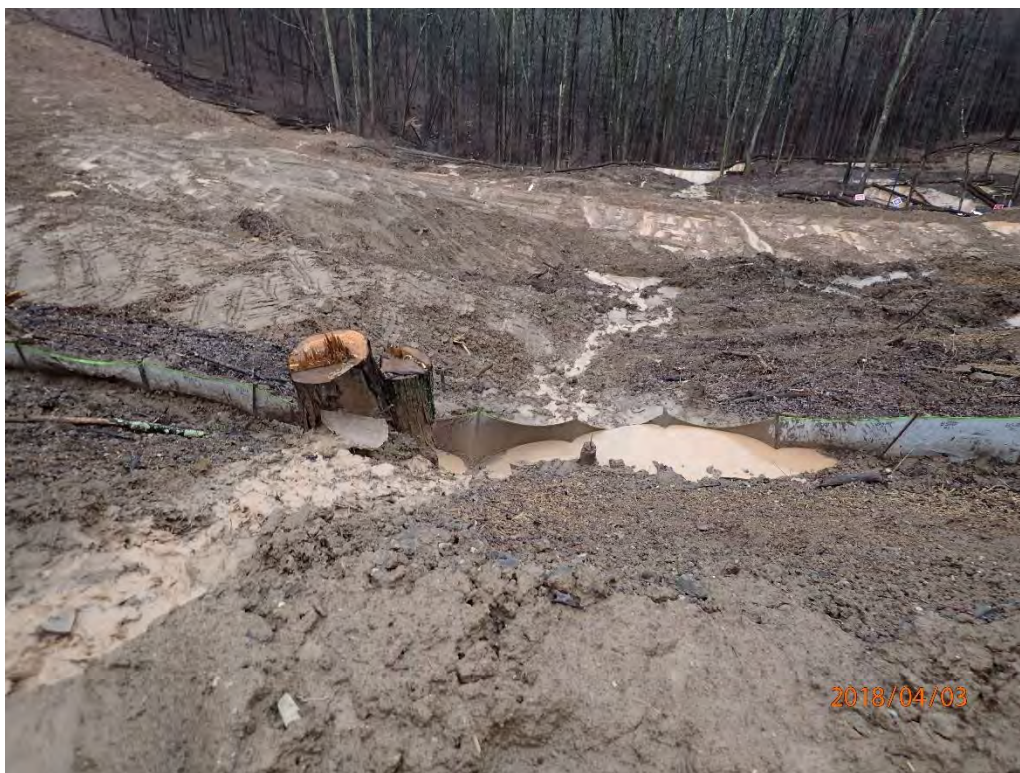
Concentrated flow eroding slope near slip.

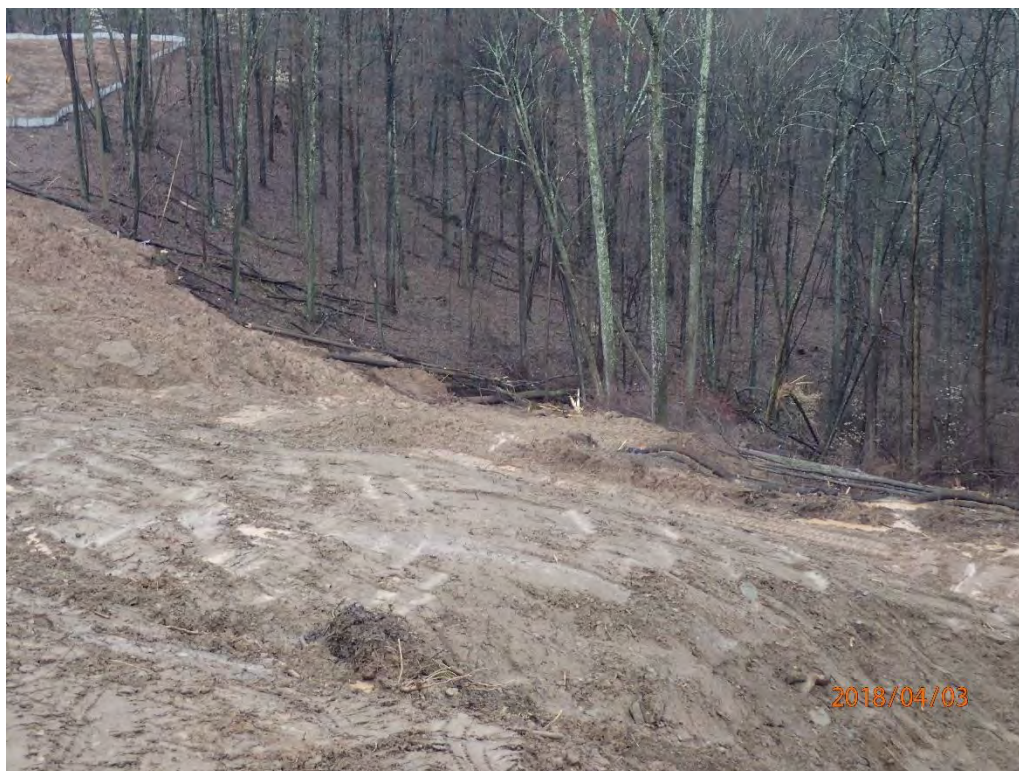
Slope above slip area.

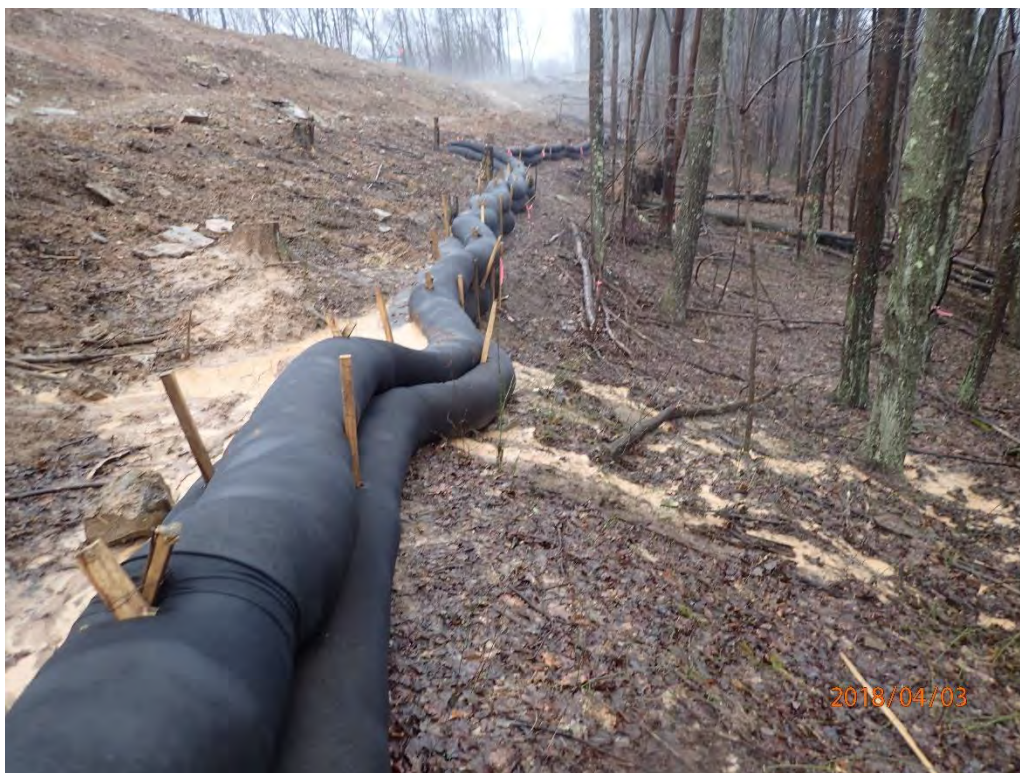
Second site of sediment laden water leaving site at Bradshaw Compressor Station.

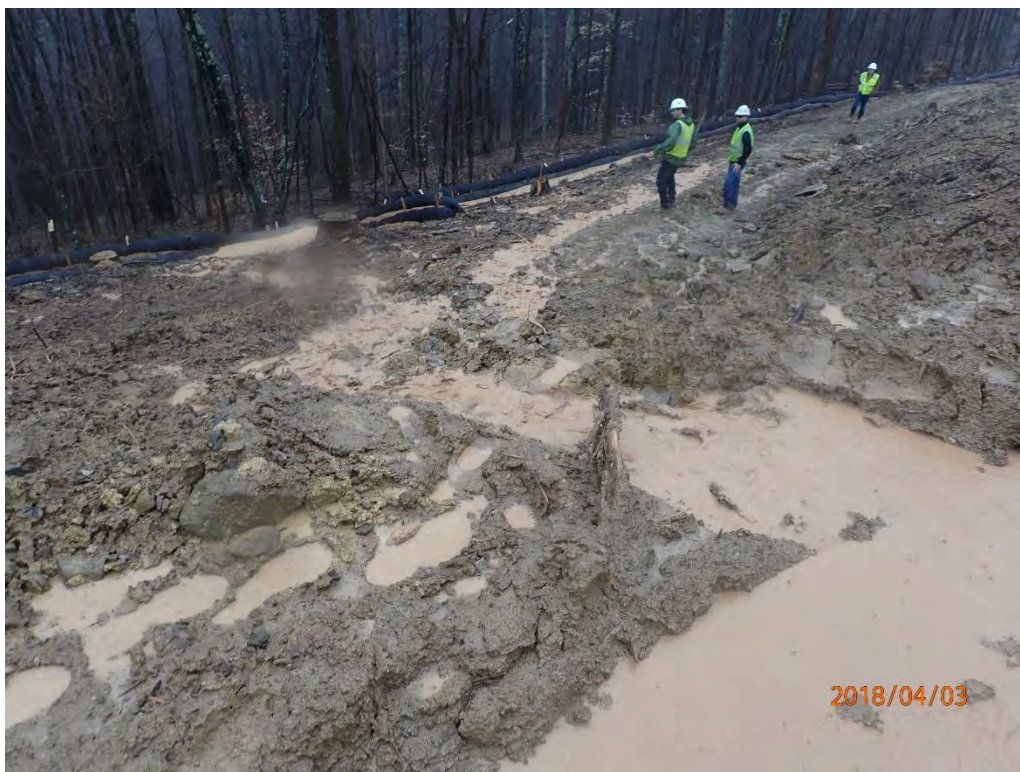
Third site of sediment laden water leaving site at Bradshaw Compressor Station.

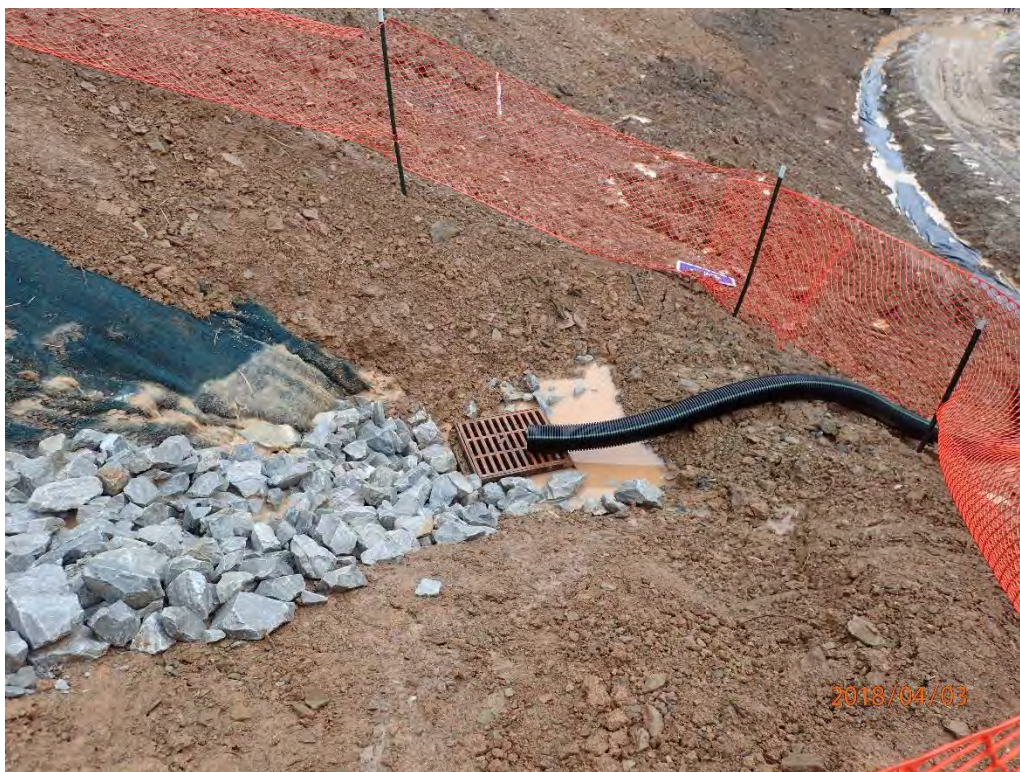
Unprotected drop inlet at Mobley Compressor Station.

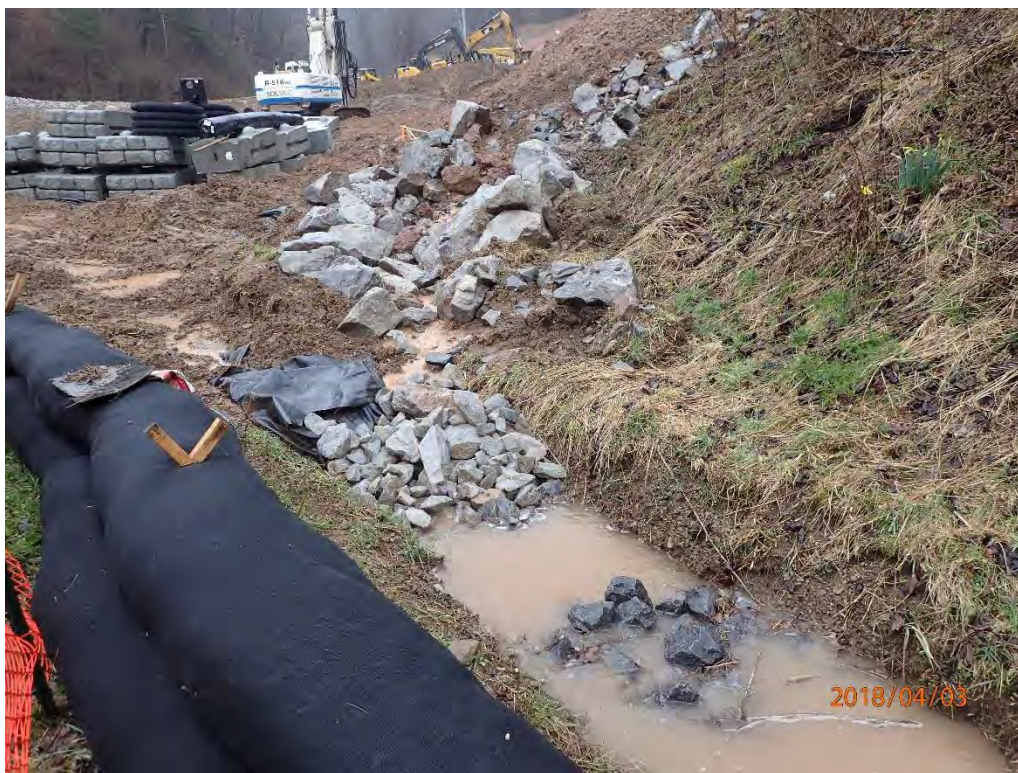
Sediment laden water leaving site through drop inlet.

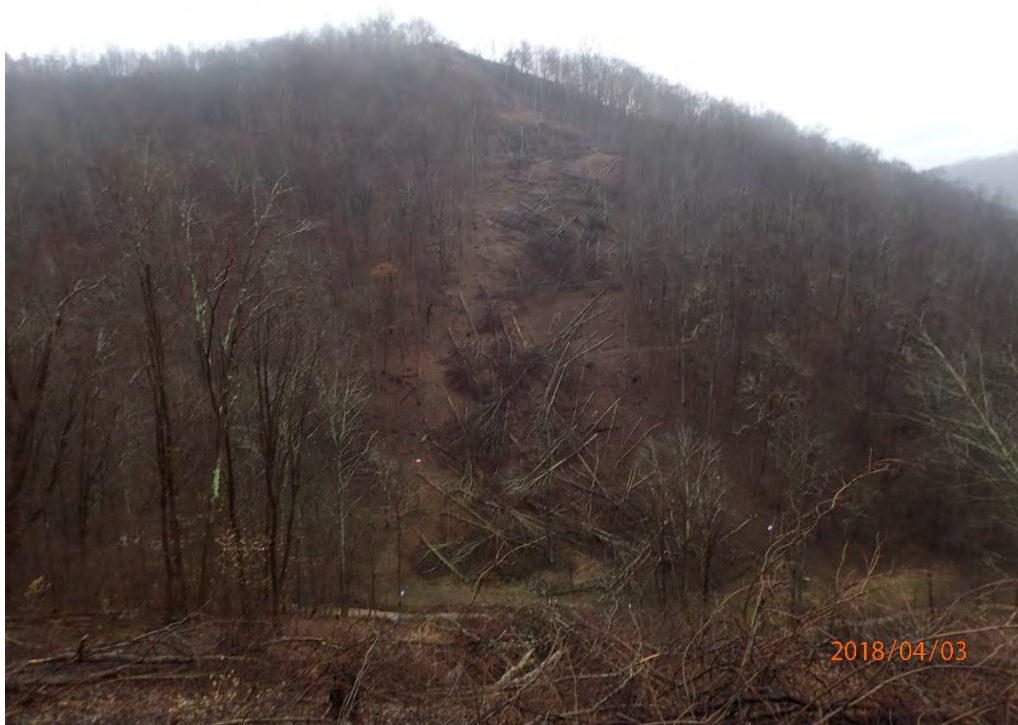
Line clearing off North Fork Road.

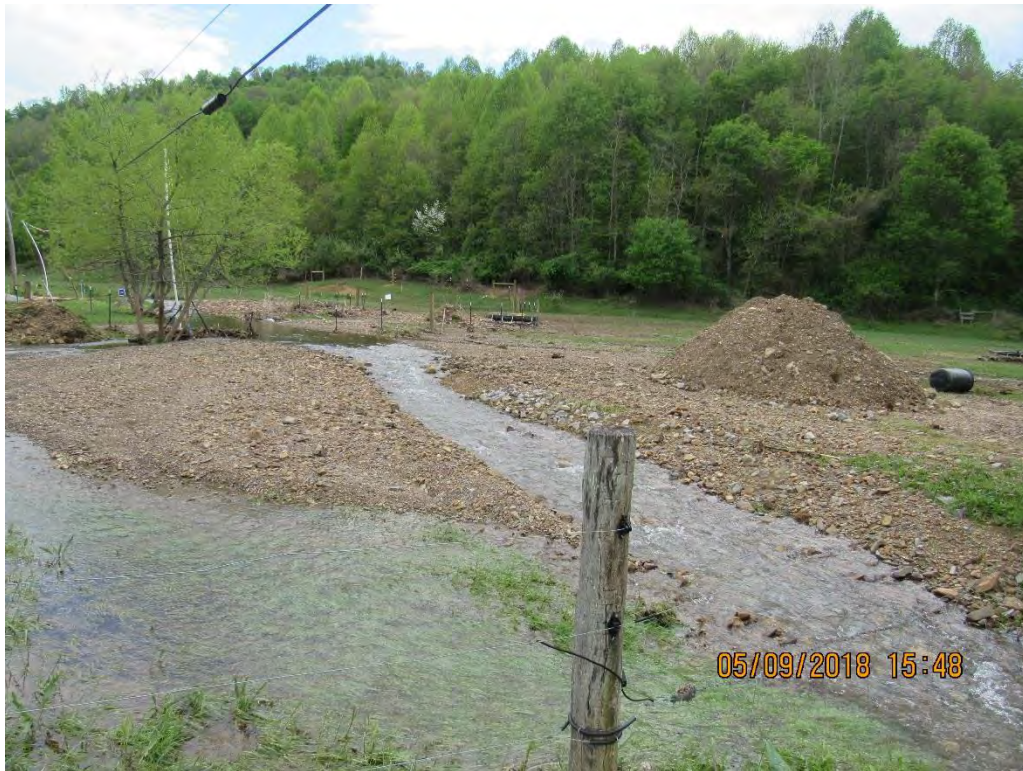
Photo 3: Mr. Laws field (station 10146+32, sheet 9.35)- stream has been partially returned to channel. Rock/soil pile from landowner removing debris to restore to channel.

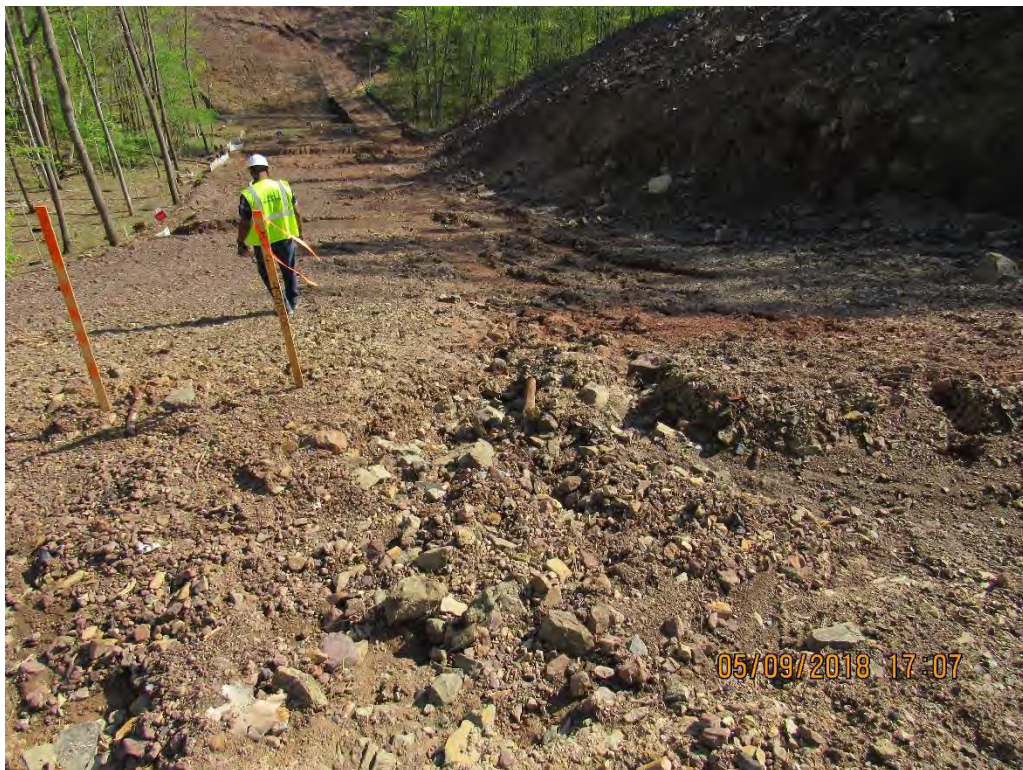
built, scheduled for next day. Sediment deposits were observed in stream causing conditions not allowable. (Photos 4-8)

Photo 4: Downslope view of site of sediment laden water left site- erosion gullies observed on slope. (view south)

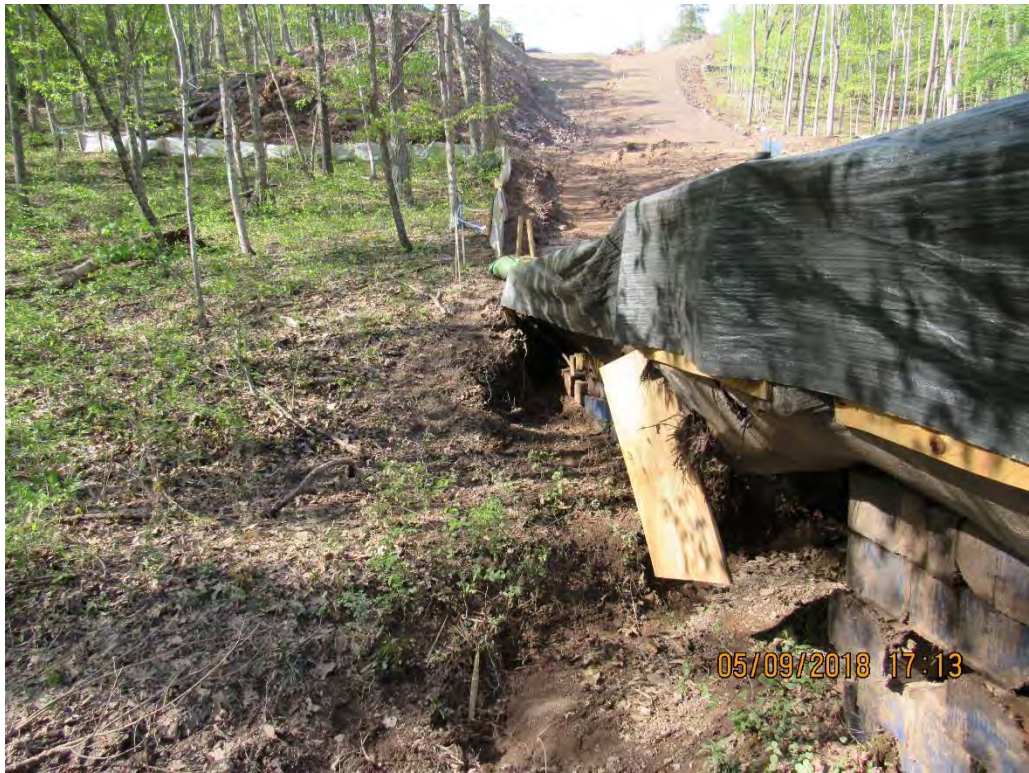
Photo 5: Stream crossing where sediment laden water left site after controls failed at stream S-IJ65 (view north). Additional controls added prior to re-building of bridge.

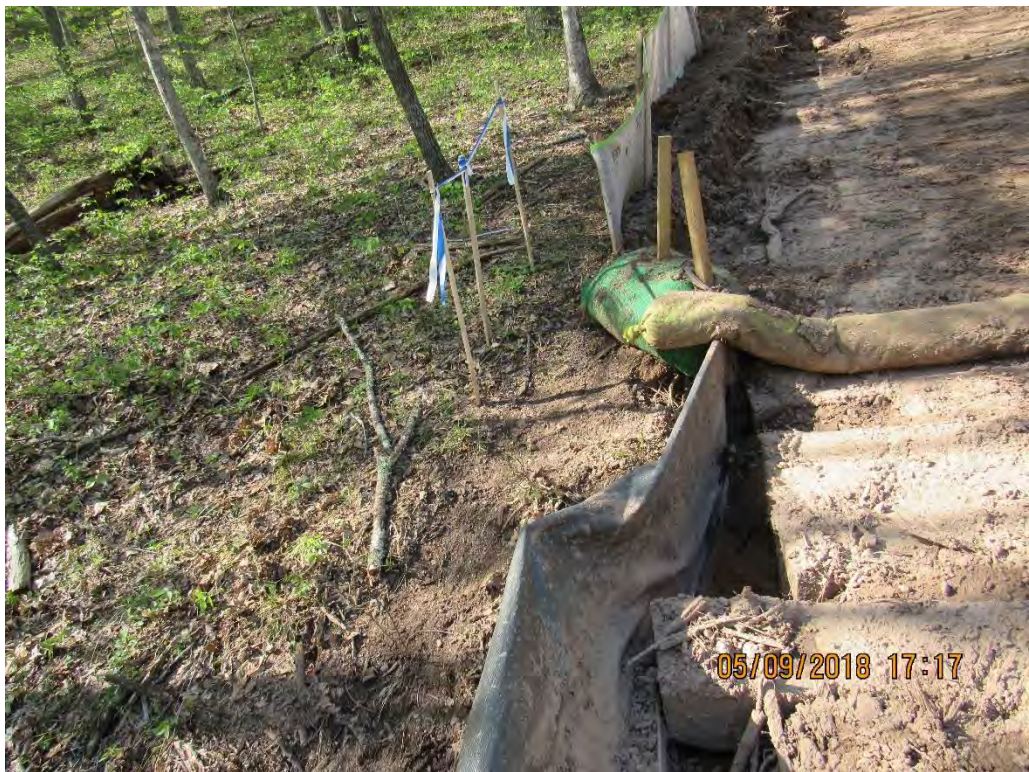
Photo 6: Location of control failure and breach allowing sediment laden water to leave site. Additional control (larger silt sock) added prior to bridge re-build.

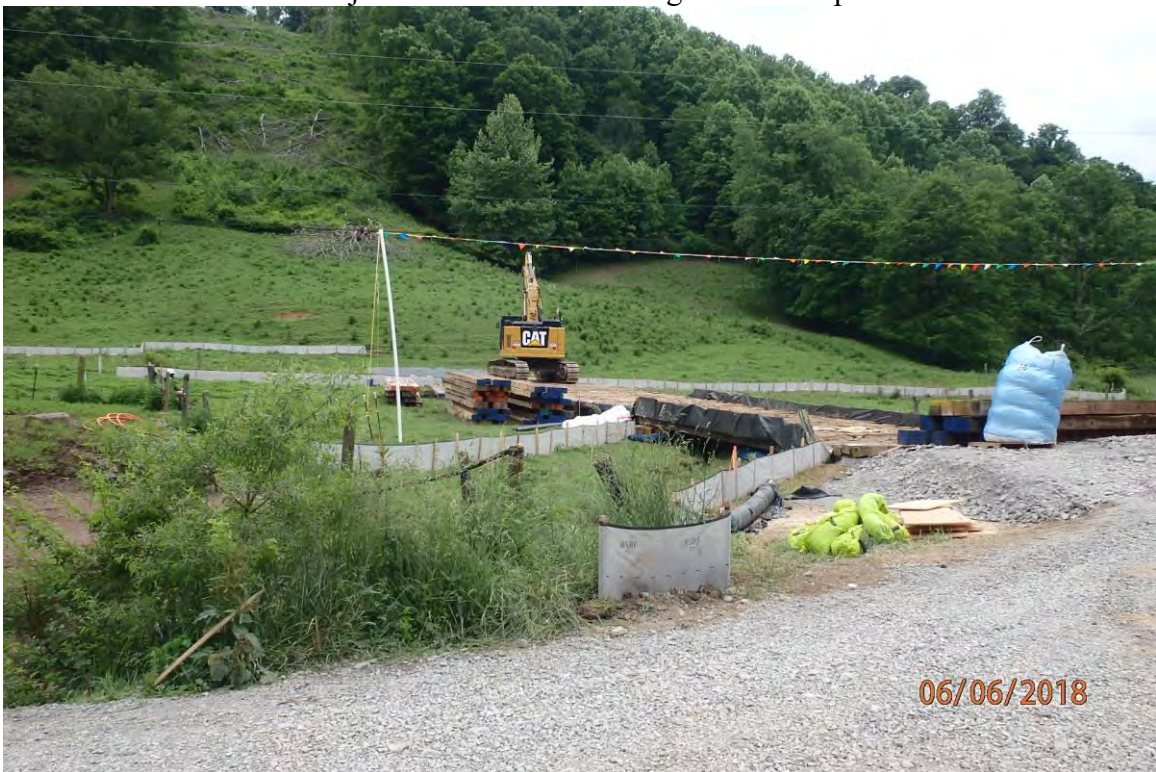
Area adjacent to AR 19 showing BMP installation.

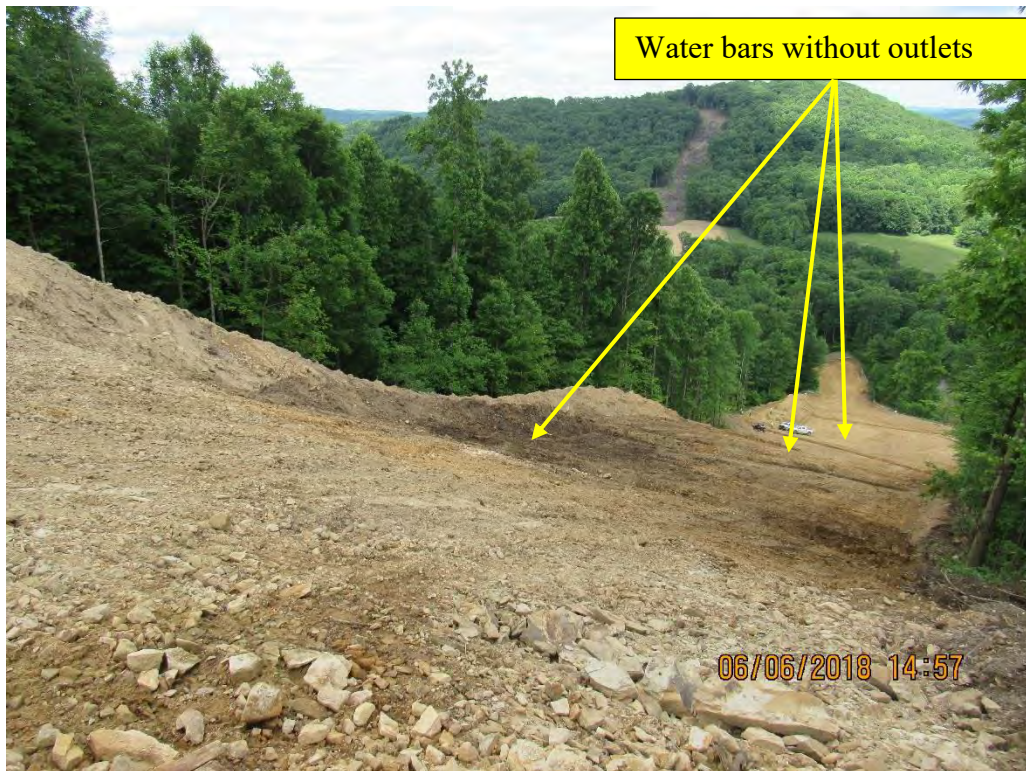
Photo 3: Water bars installed without adequate outlets near station # 6801+38 with $<24^{\circ}$ to $>30^{\circ}$ slope.

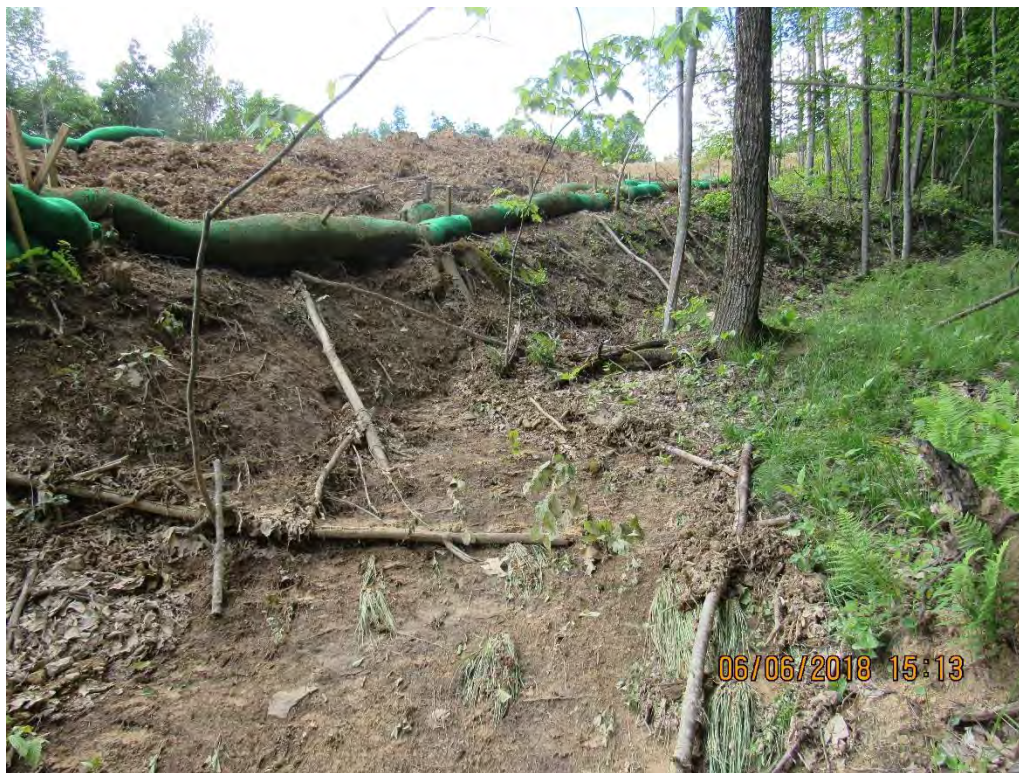
Photo 4: Control failure at station 6812+58 allowing sediment laden water to leave site.

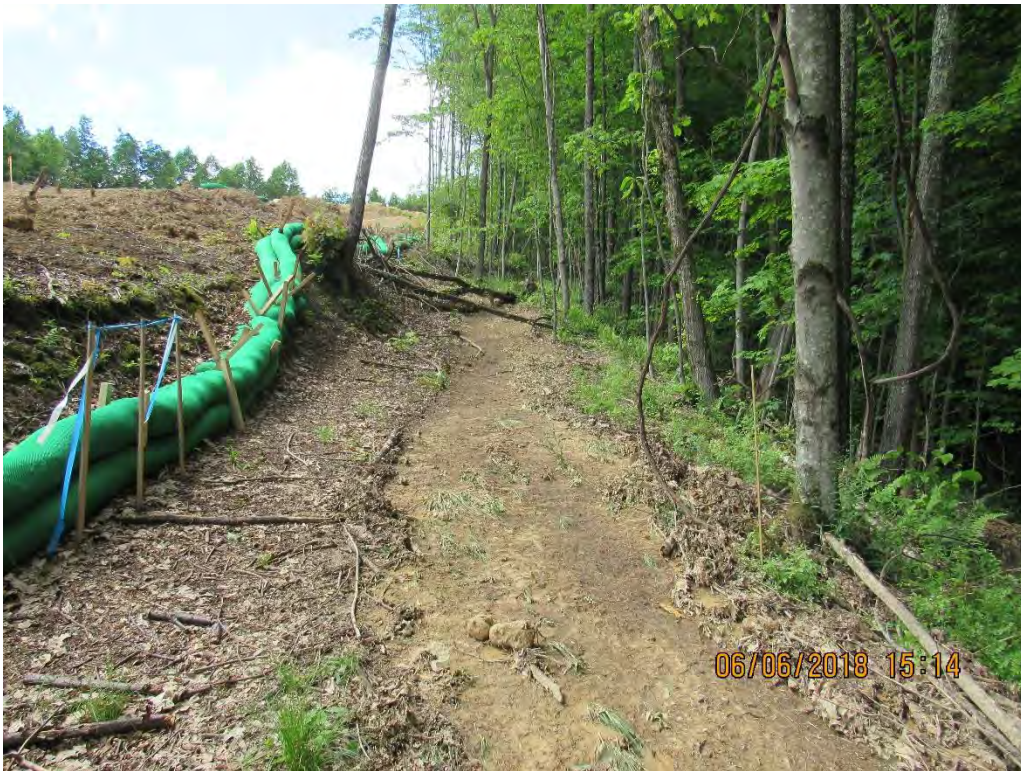
Photo 5: Scoured path from control failure at station 6812+58.

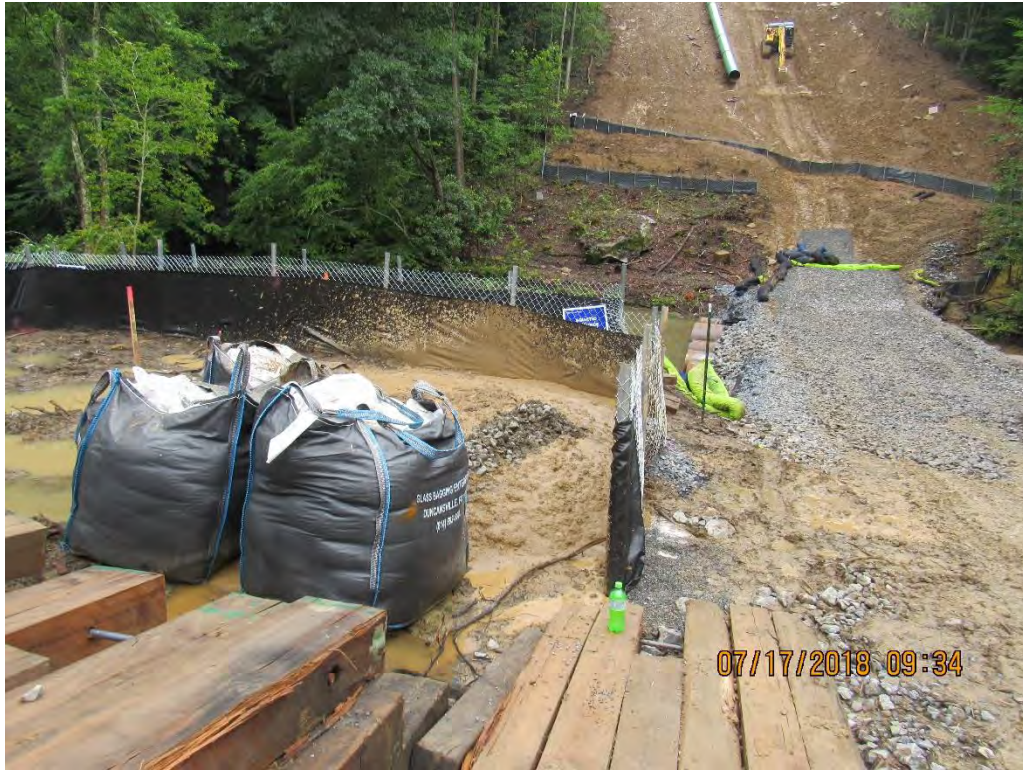
Photo 1: Sump at access road 129 needs maintenance.

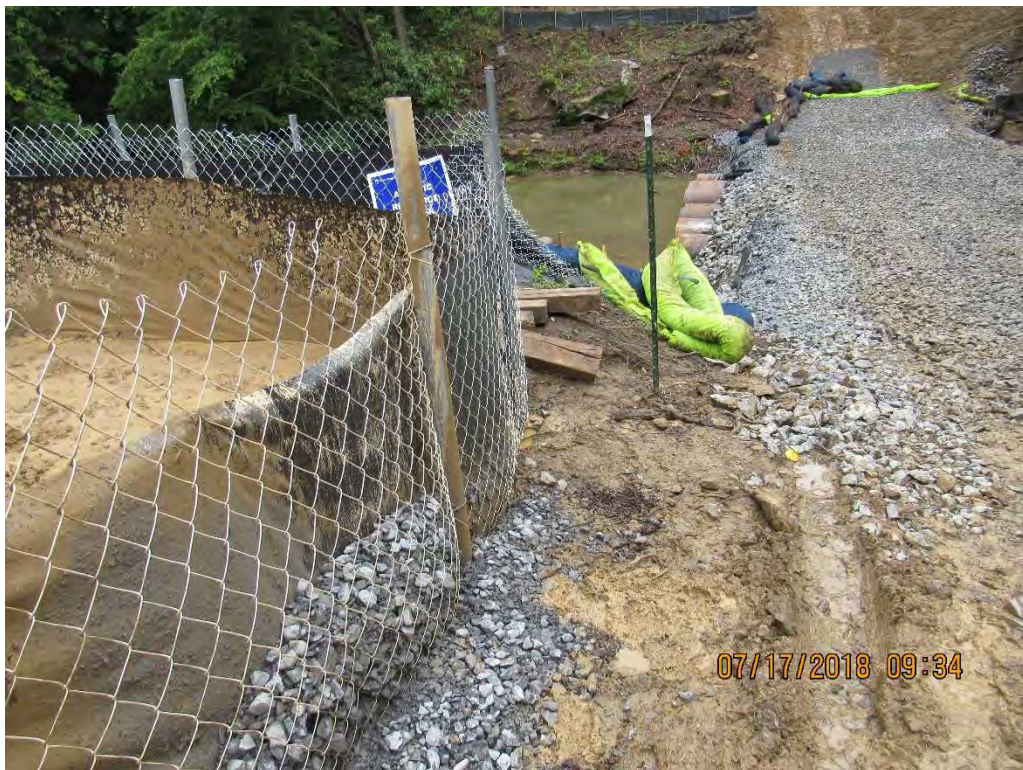
Photo 2: Proximity of outlet of sump and amount of accumulated sediment creates an area of concern.

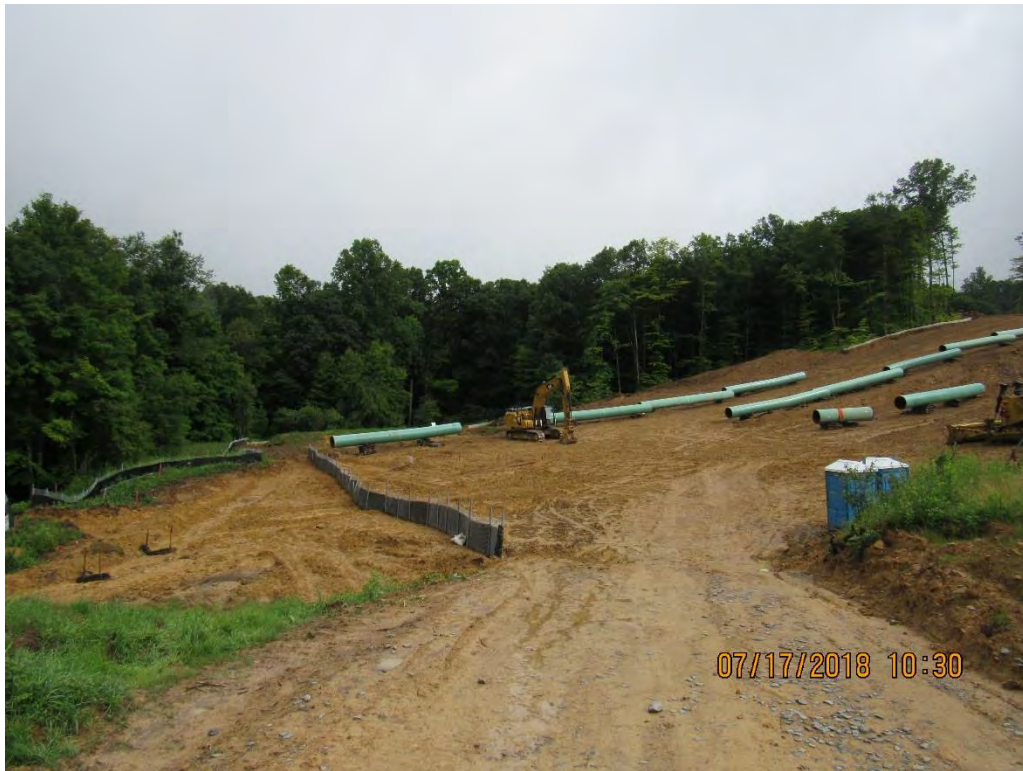
Photo 3: Drainage area where sediment laden water left site.

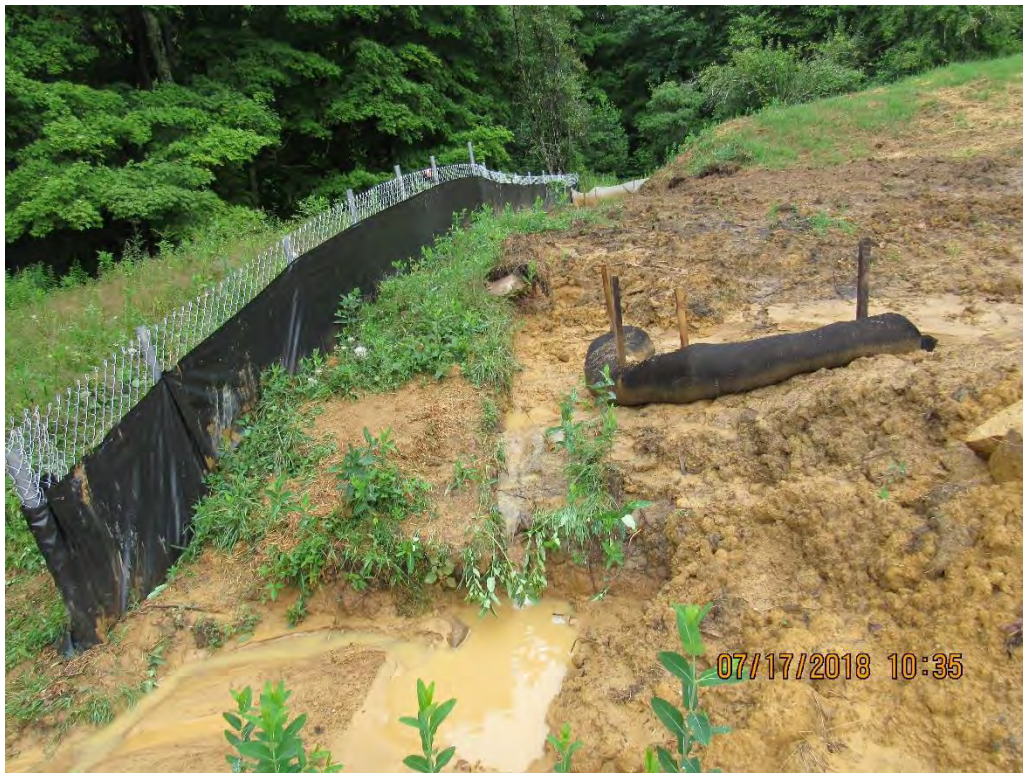
- 7., 19., & 20. – Water bar near station 5518+00 had failed- water had undercut and went around compost filter sock releasing sediment laden water off site and into UNT of Birch River (S-F34). (Photos 4-11) Sediment deposits were observed in stream (Photo 9) as well as stream was muddy downstream (Photo 11). GPS coordinates of control failure location: 38° 25.4570'N, 80° 34.2329'W

Photo 4: Station 5518+00 where water went around and undercut compost filter sock allowing sediment laden water to leave the site.

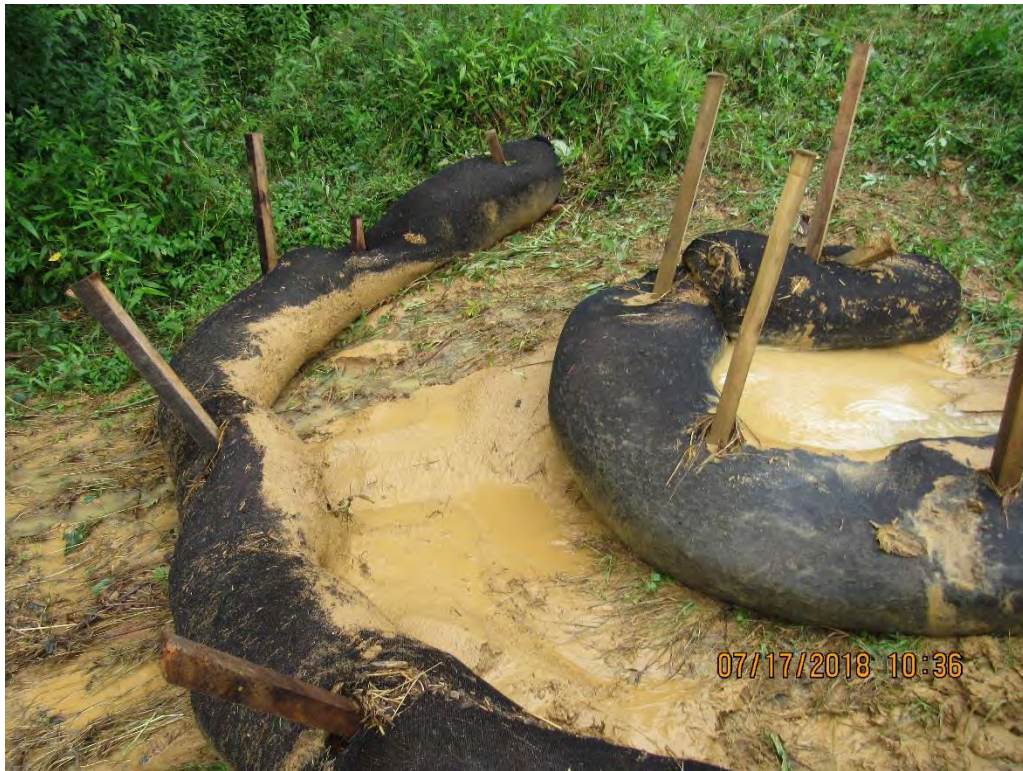
Photo 5: Next set of compost filter sock in sequence which was overtopped allowing sediment laden water to leave site.

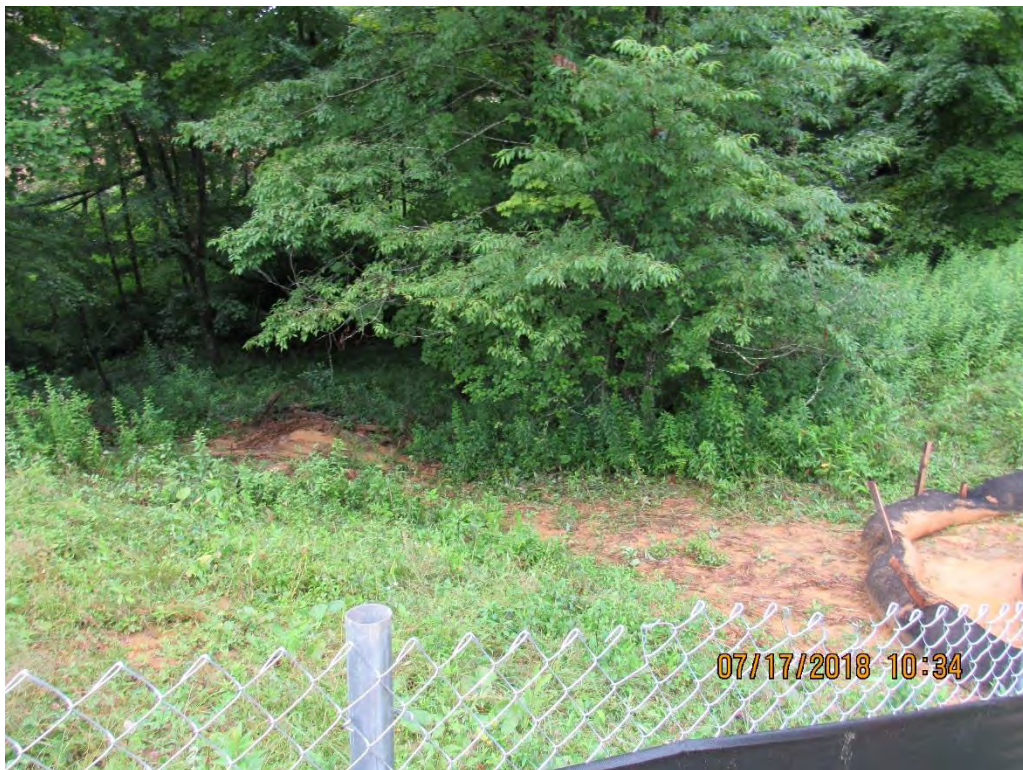
Photo 6: Last compost filter sock in sequence and path sediment laden water created leading to stream.

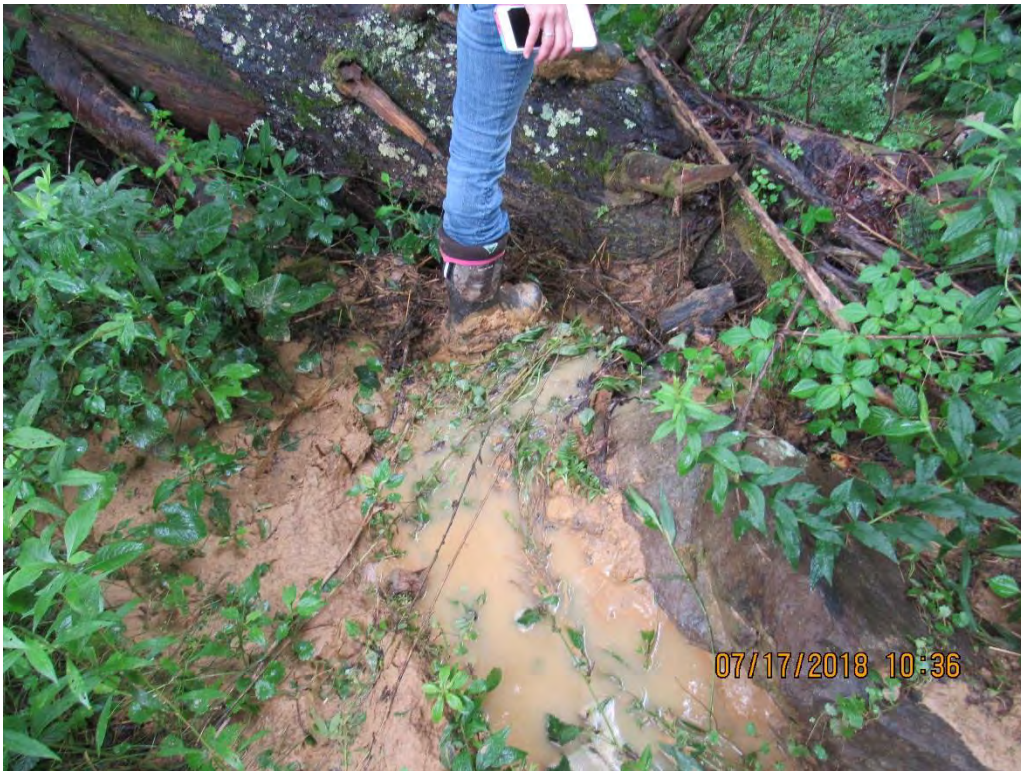
Photo 7: Sediment build up and muddy water temporarily stopped against downed tree.

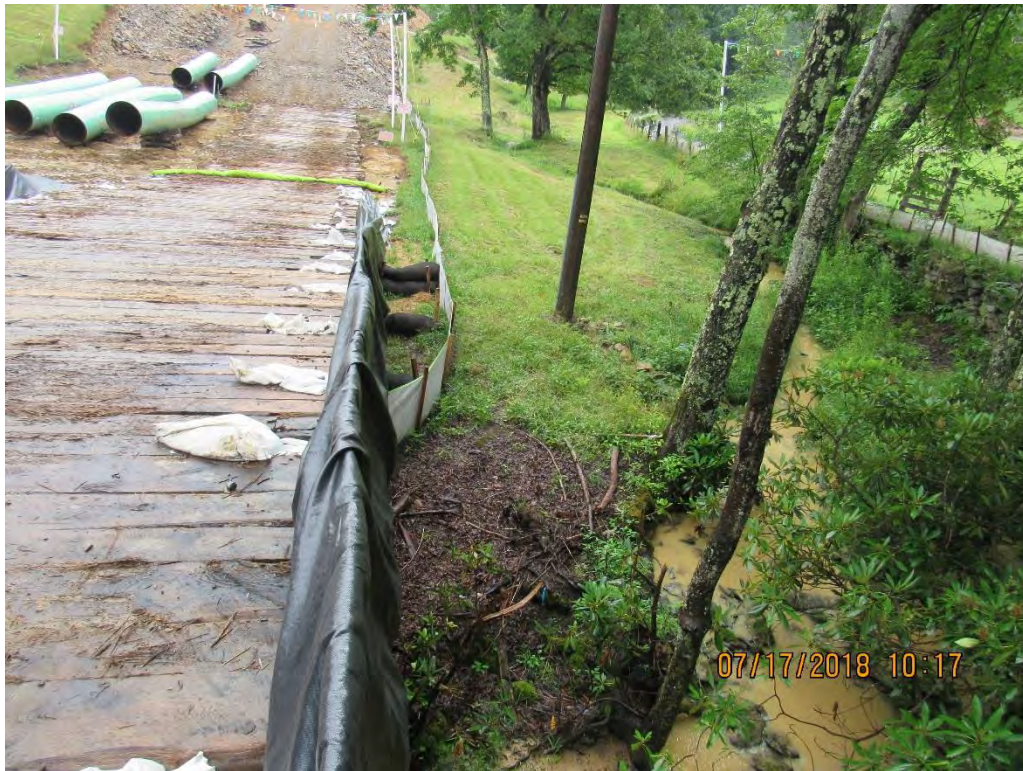
Photo 11: UNT #2 of Birch River (S-F365) at station 5548+00 where breached control upstream allowed sediment laden water in UNT #1 of Birch River (S-F34)

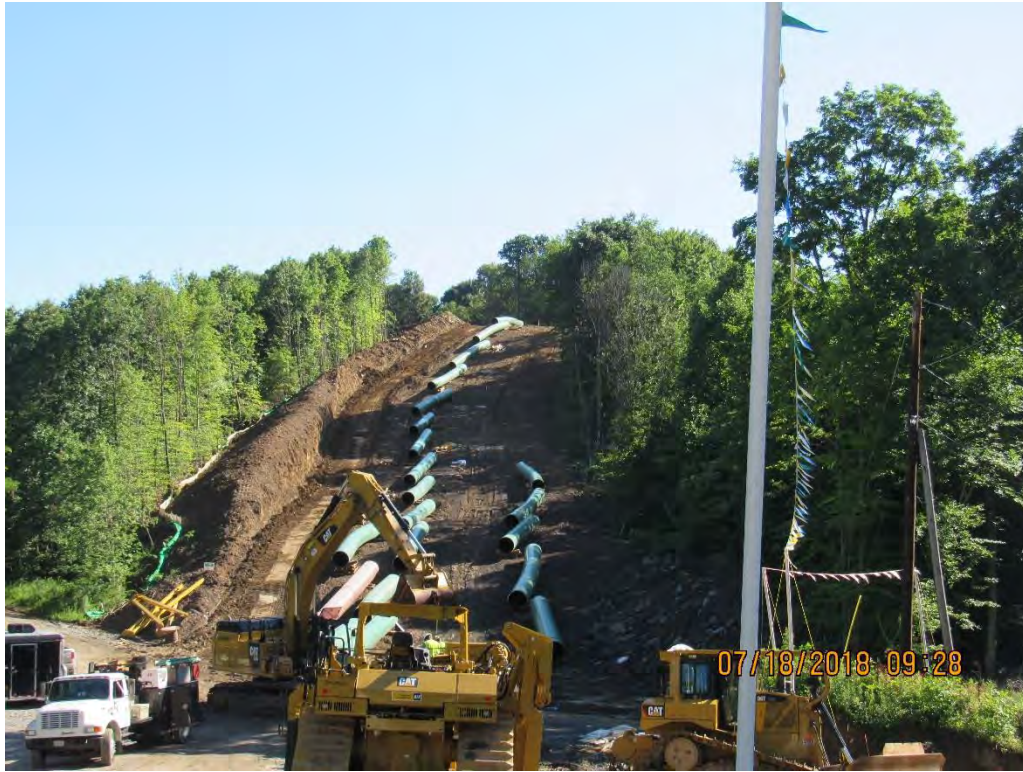
Photo 1: Station 6857+28 at access road 164 without temporary stabilization on large spoil pile. Photo is representative of project.

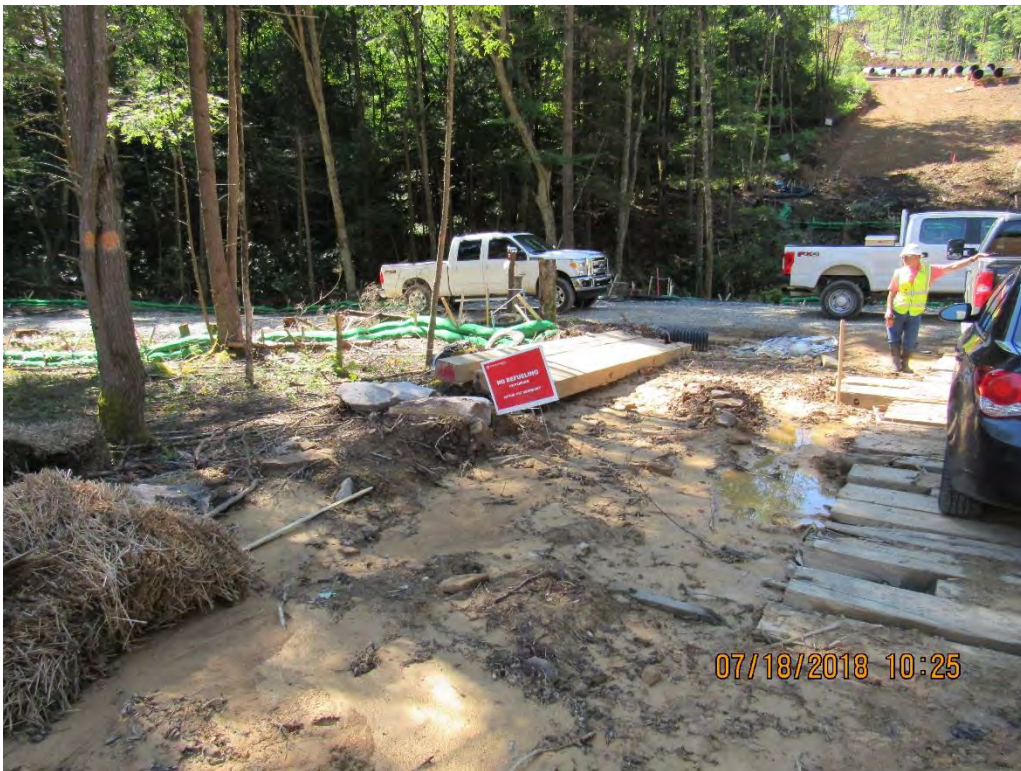
Photo 4: Sediment down gradient of straw bale pile (on right in above photo).
