**The Wilderness Society et al. Comments on the
U.S. Forest Service Mountain Valley Pipeline and
Equitrans Expansion Project Draft Supplemental
Environmental Impact Statement (#50036)**

**WEST VIRGINIA DEPARTMENT OF ENVIRONMENTAL PROTECTION
WV OIL AND GAS CONSTRUCTION STORMWATER PERMIT**

FACILITY NAME:	Mountain Valley Pipeline Project			REG. #	EXPIRE DATE:
PERMITTEE	MOUNTAIN VALLEY PIPELINE, LLC			WVR310667	5/13/2018
ADDRESS/PHONE:	Attn: Matt Hoover 625 LIBERTY AVE, ST 1700 PITTSBURGH, PA 15222				
LOCATION:	Wileyville, WV			Entry Date/Time:	4/3/18 8:30am
COUNTY:	Wetzel			Exit Date/Time:	4/3/18 1:37pm
Site Representative /Phone	Matt Hoover Sr. Environmental Coordinator (412) 258-5627			PHOTOS <input checked="" type="checkbox"/>	
CO-PERMITTEE:				ADDRESS:	
SITE OPERATOR:	Precision Pipeline			ADDRESS:	
PERMITTED ACREAGE	4214	WEATHER:	Rain	LAST INSPECTION:	N/A
RECEIVING STREAM(S)	Mobley Run > Ohio River				NOV: 1
Regular Mail <input type="checkbox"/> Certified Mail <input checked="" type="checkbox"/>	Tracking #				
OVERALL FACILITY RATING:	Unsatisfactory		COMPLIANCE OUTCOME	Not Immediately Corrected

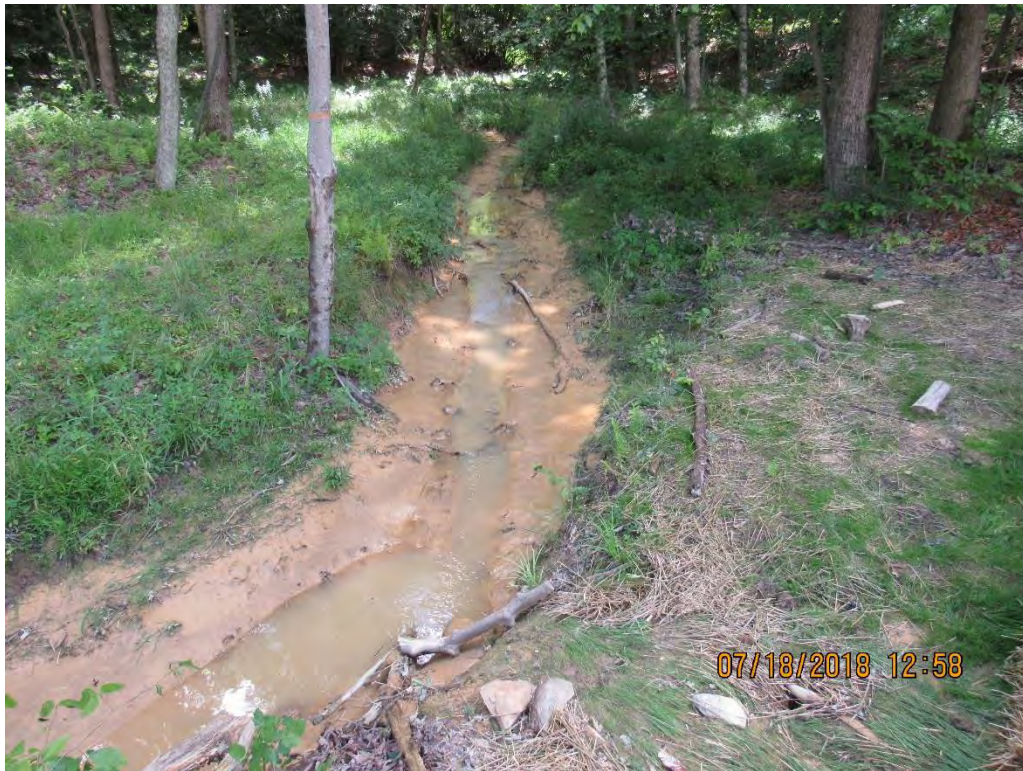
- 19., & 20. – Several water bars & controls adjacent to UNT of Hominy Creek between MP 128.3 and 128.5 have failed allowing sediment laden water to enter stream and depositing sediment on bottom and on banks of stream. (Photos 6-8)

Photo 7: Sediment deposits in UNT of Harmony Creek- upstream of Photo 6. Terminus of control failure in Photos 9 & 10 (vegetation indication under date/time stamp)

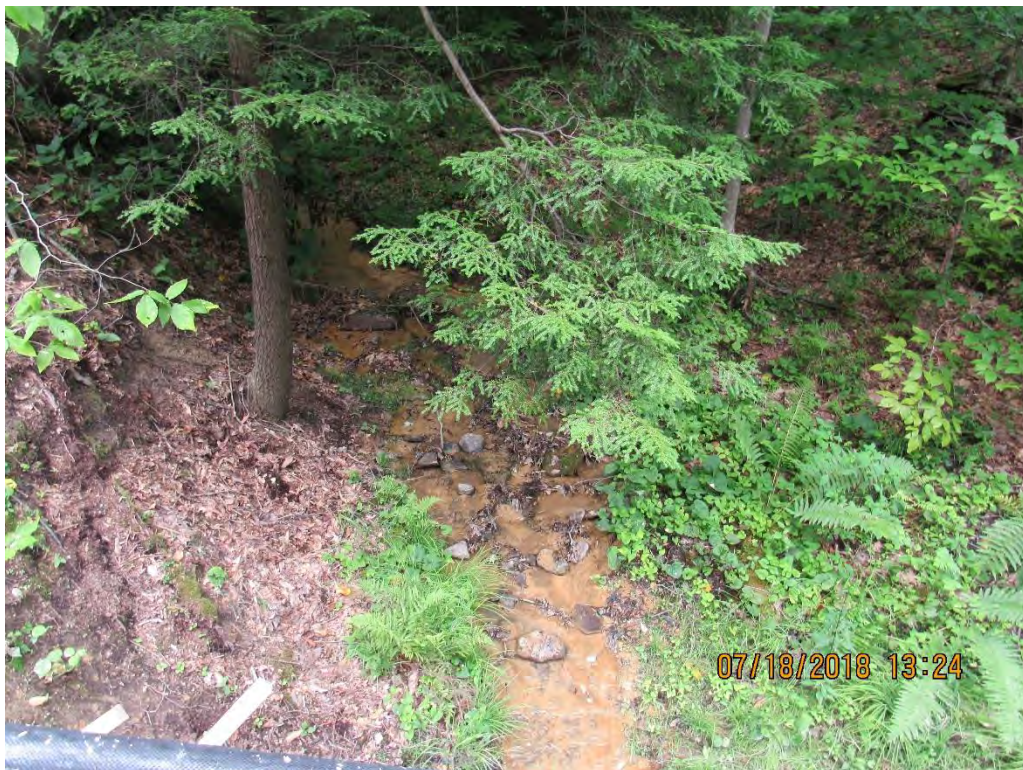
Photo 8: Sediment deposits in UNT of Harmony Creek below 1st water bar failure

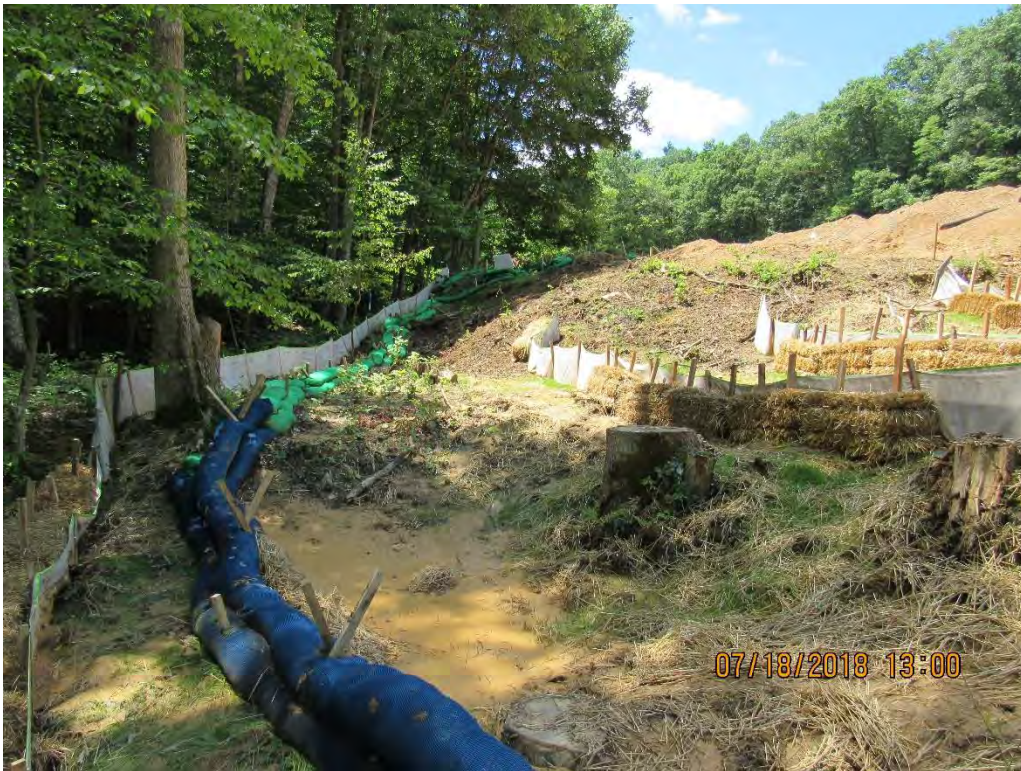
Photo 9: Control sequence near station 6781+87 with multiple control failure.

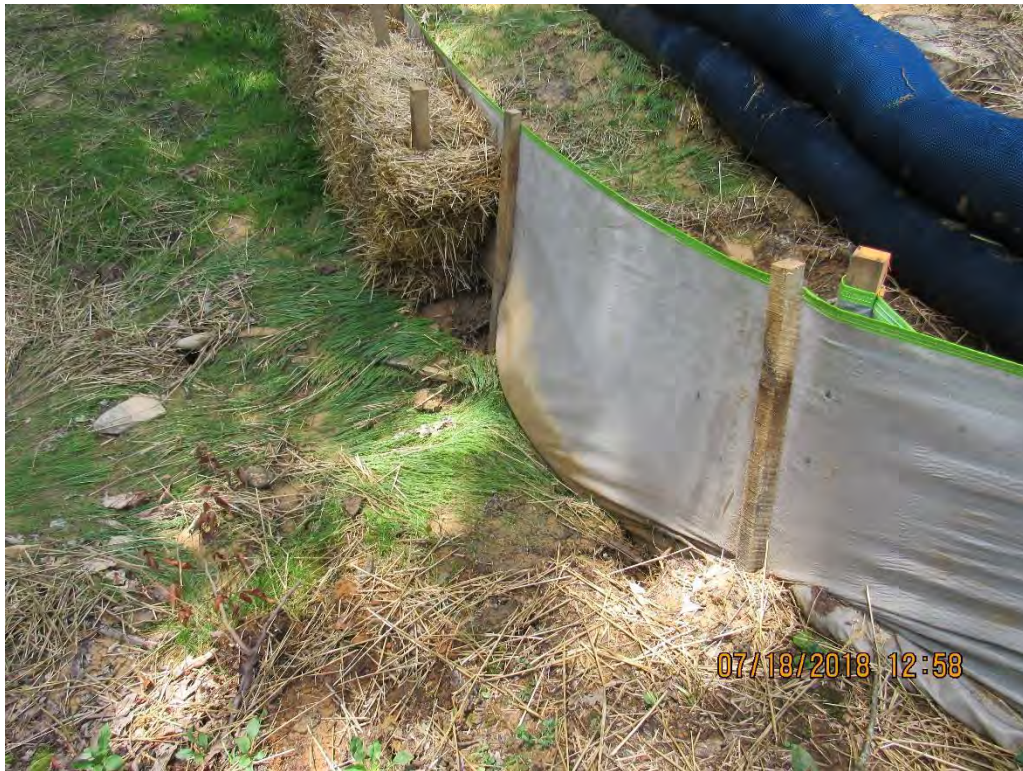
Photo 11: Down gradient of control failure from Photo 10. Photo #7 shows terminus of this control failure.

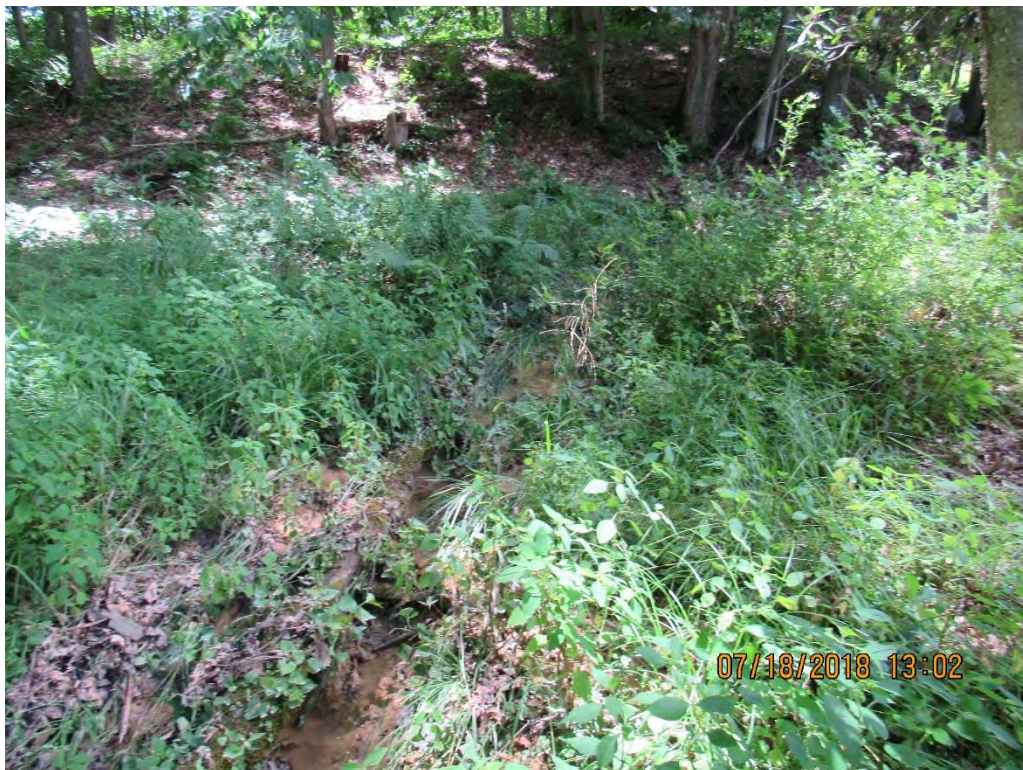
Photo 12: Terminus of sediment laden water leaving site from control failure near station 6785+50 (between MP 128.3 & 128.5)

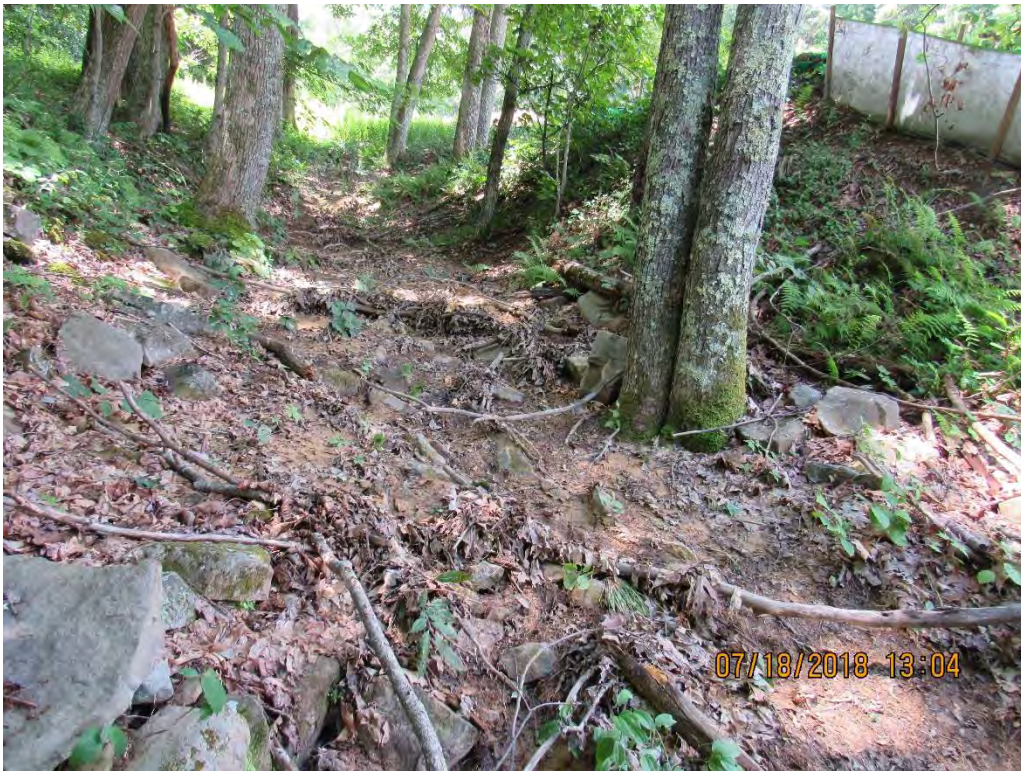
Photo 15: Scour through woods off limits of disturbance upgradient of sediment deposits in Photo 14.

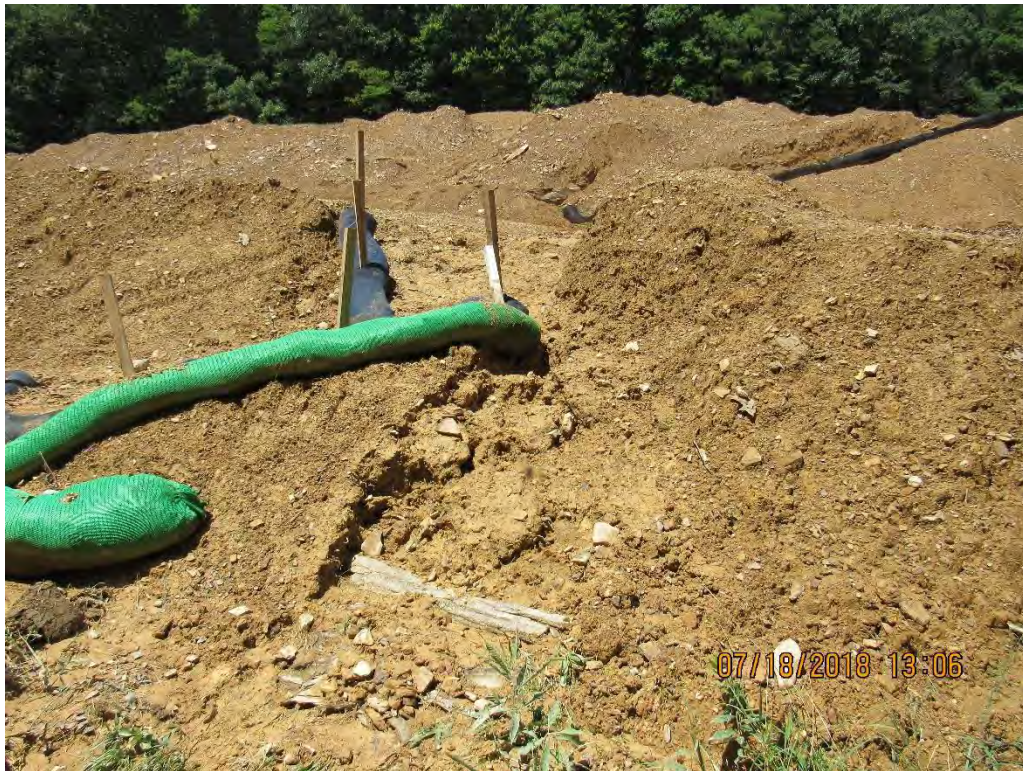
Photo 17: Erosion gullies from failed control at end of water bar near station 6785+50, which allowed sediment laden water to leave site.

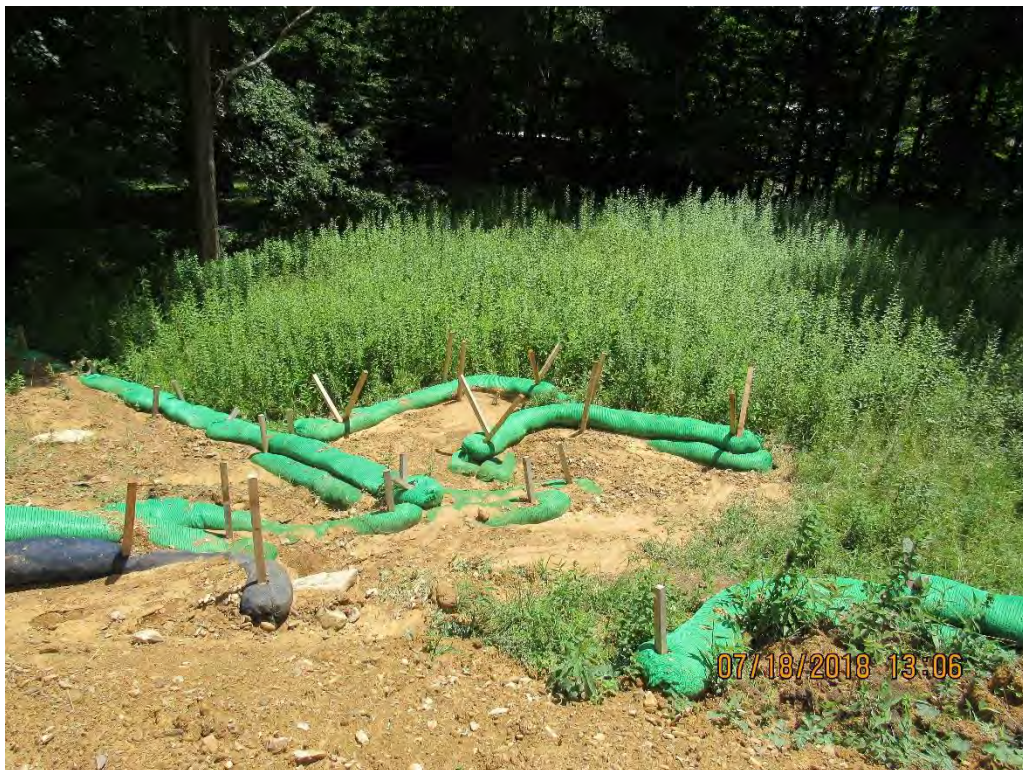
- 7., 13., & 15.: Water bars lack adequate controls at terminus. Sumps are not installed, along with additional controls. Failures have occurred several places throughout the spread.

Photo 18: Installed controls at end of water bar proved inadequate and failed allowing sediment laden water to leave site.

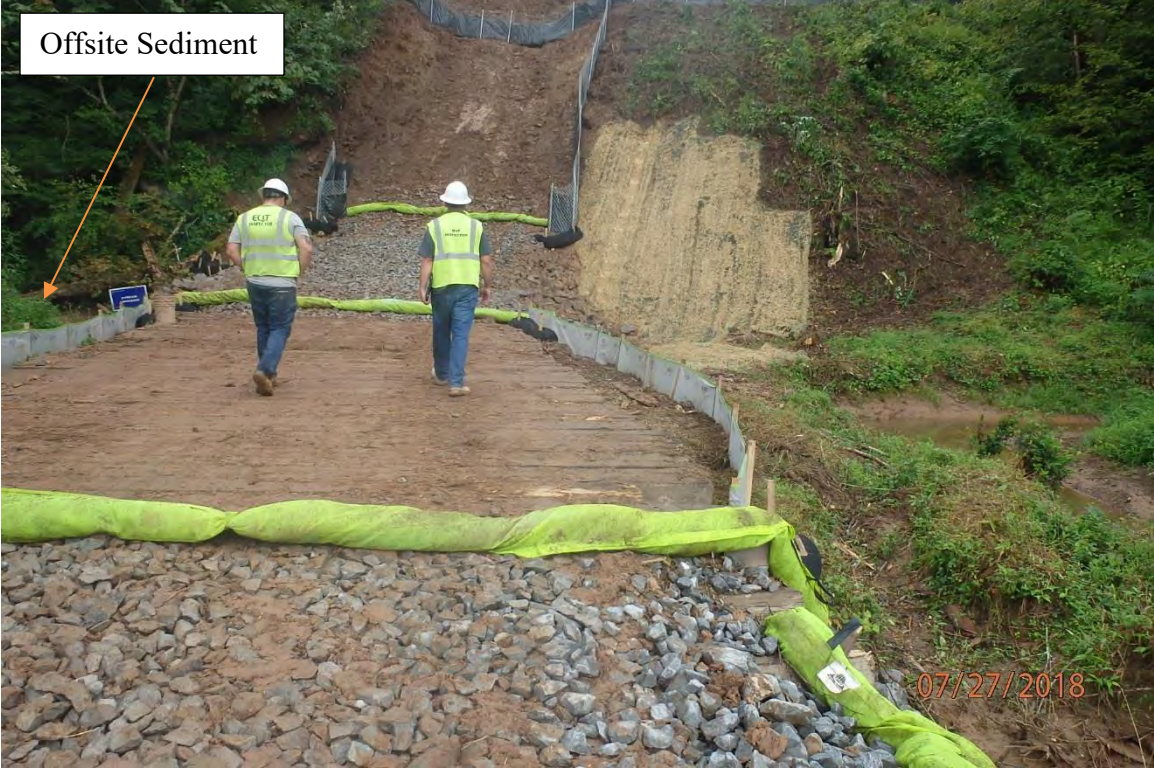
Overview of Grass Run crossing.

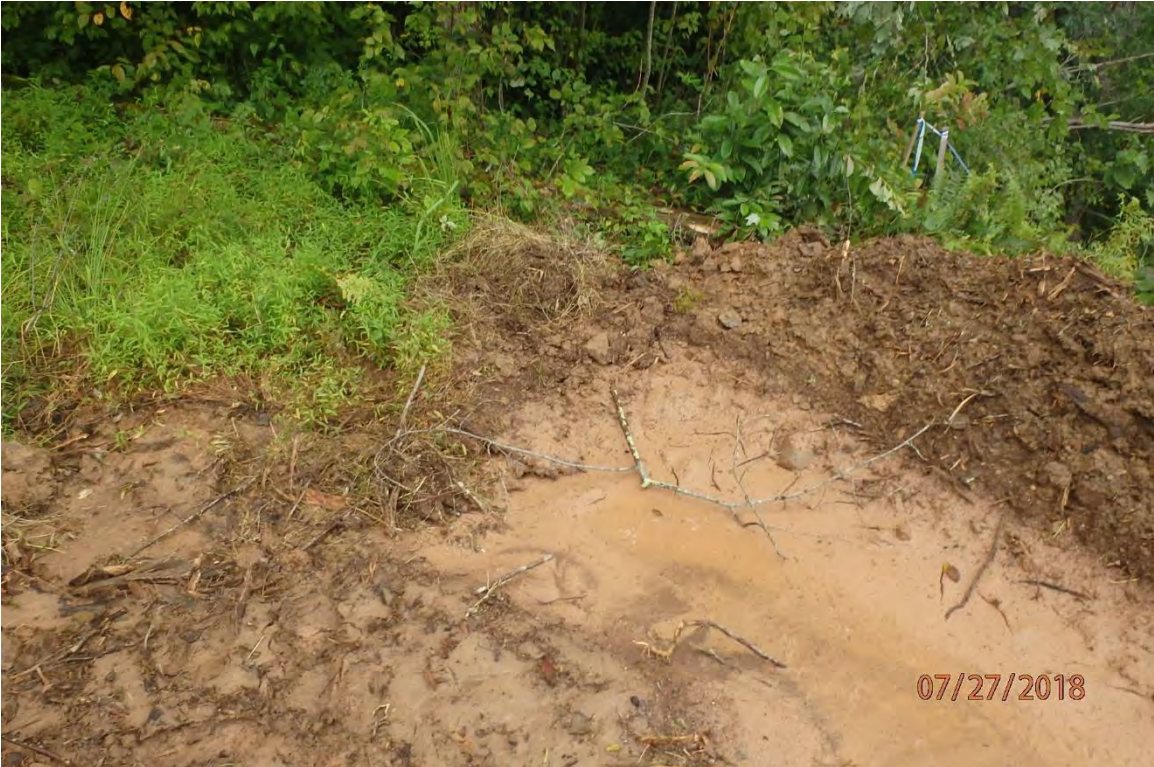
Water bar that lacked outlet protection was noted upslope of grass run adjacent to 1142+00. Marginal deficiencies in site evaluation item numbers 7, 15, 19 & 21 pictured.

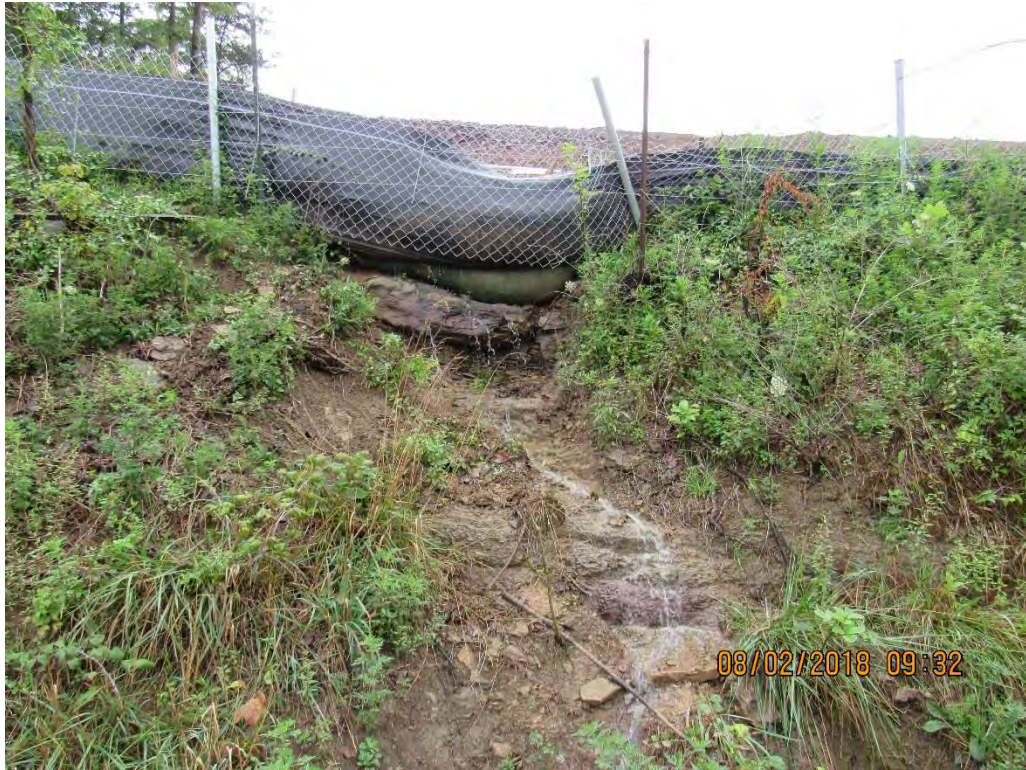
- Lowell Road (station 9087+12)- Location of previous mud slide. Still in process of stabilizing slope. Environmental crew removing sediment from road side ditch from previous night's rain (photo 3). Water bar discharging clear water (photo 1) and mixing with sediment in road side ditch (photo 2). Road side ditch discharging into field upslope of laydown yard, receiving additional treatment prior to release (photo 4 & 5).

Photo 1: Clear discharge from water bar near station 9087+17.

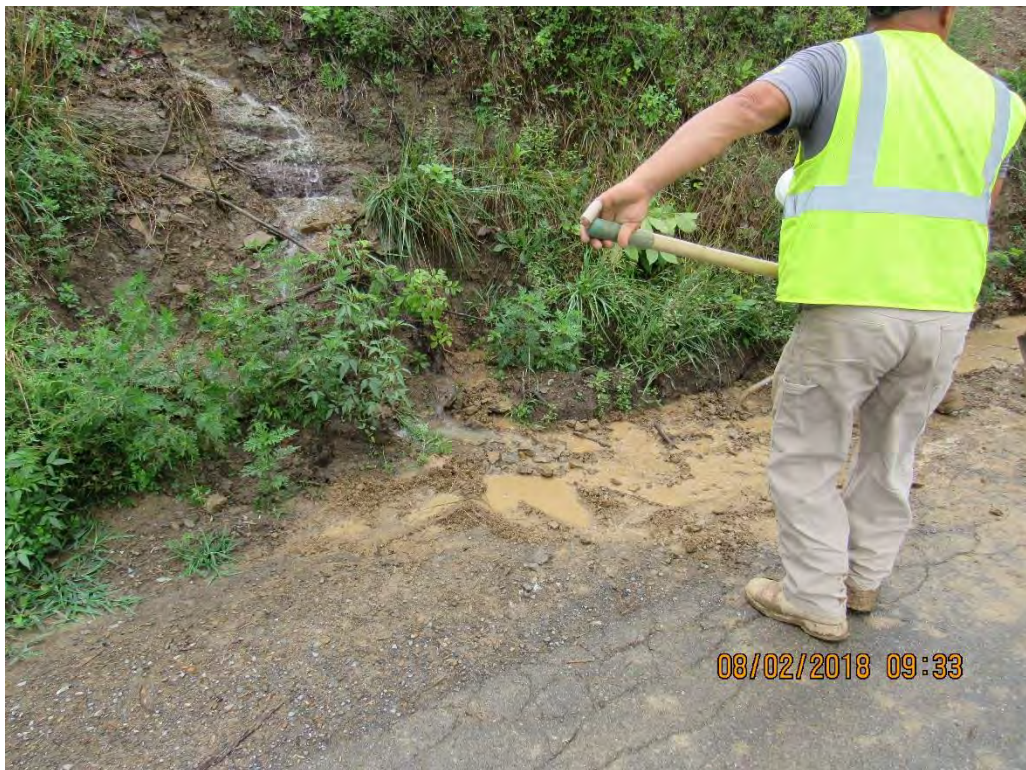
Photo 2: Water bar discharge mixing with sediment in road side ditch with crew performing maintenance.

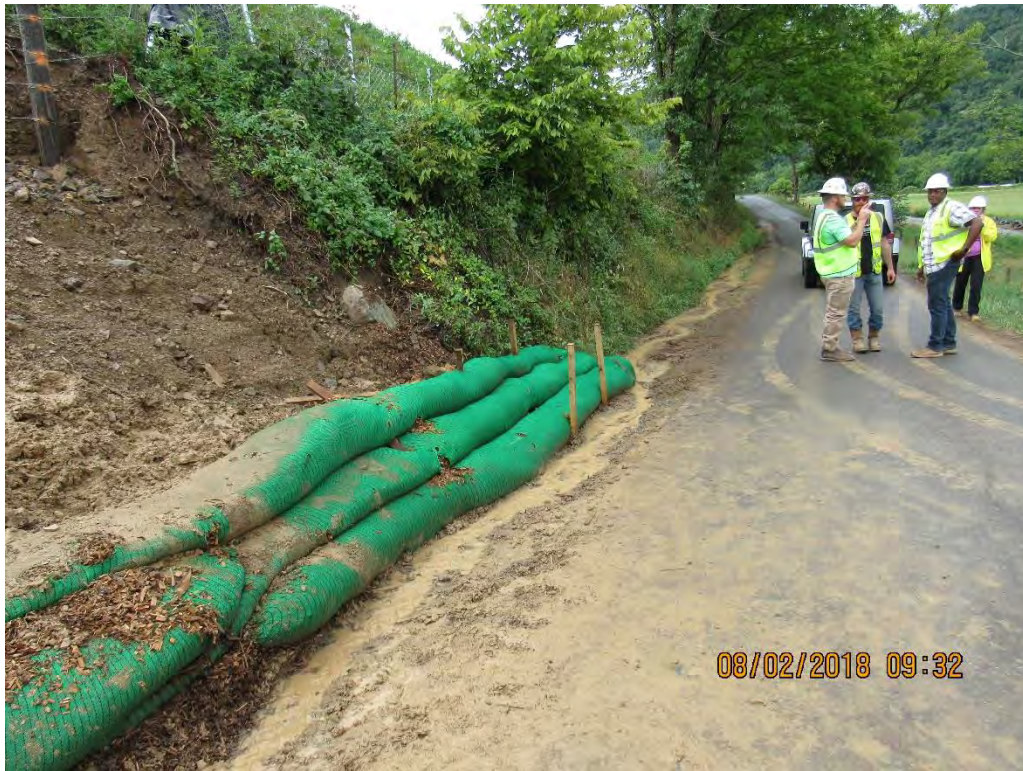
Photo 3: In process of stabilizing slope. Mud on road from crews performing maintenance.

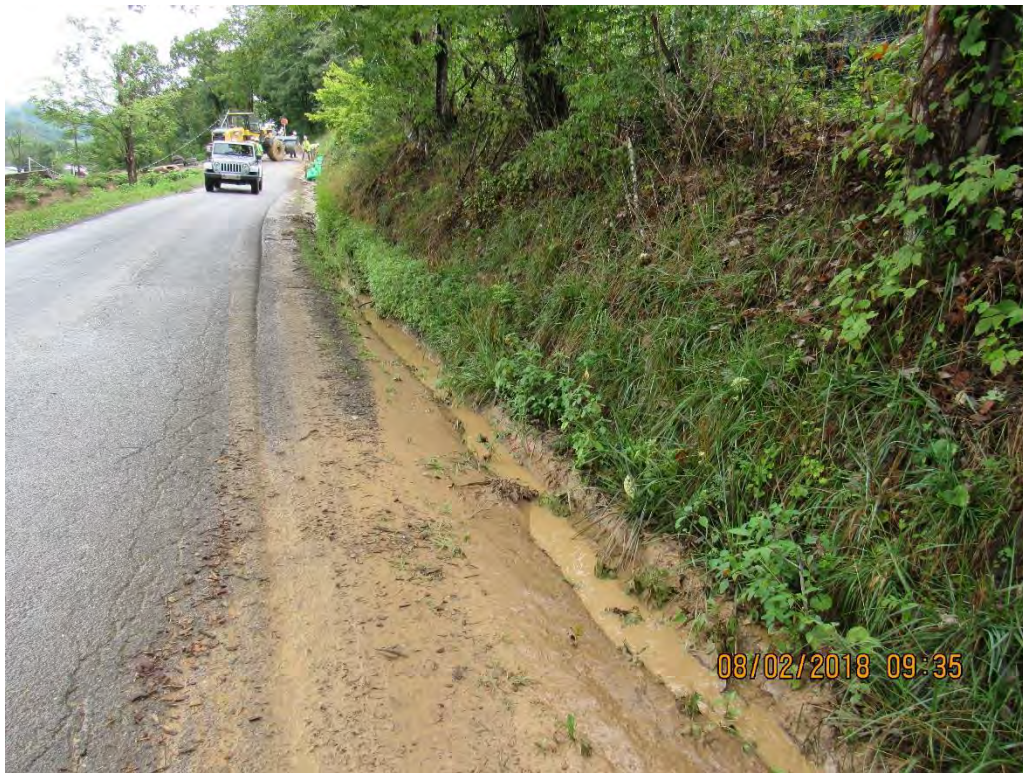
Photo 4: End of road side ditch prior to culvert diverting to laydown yard.

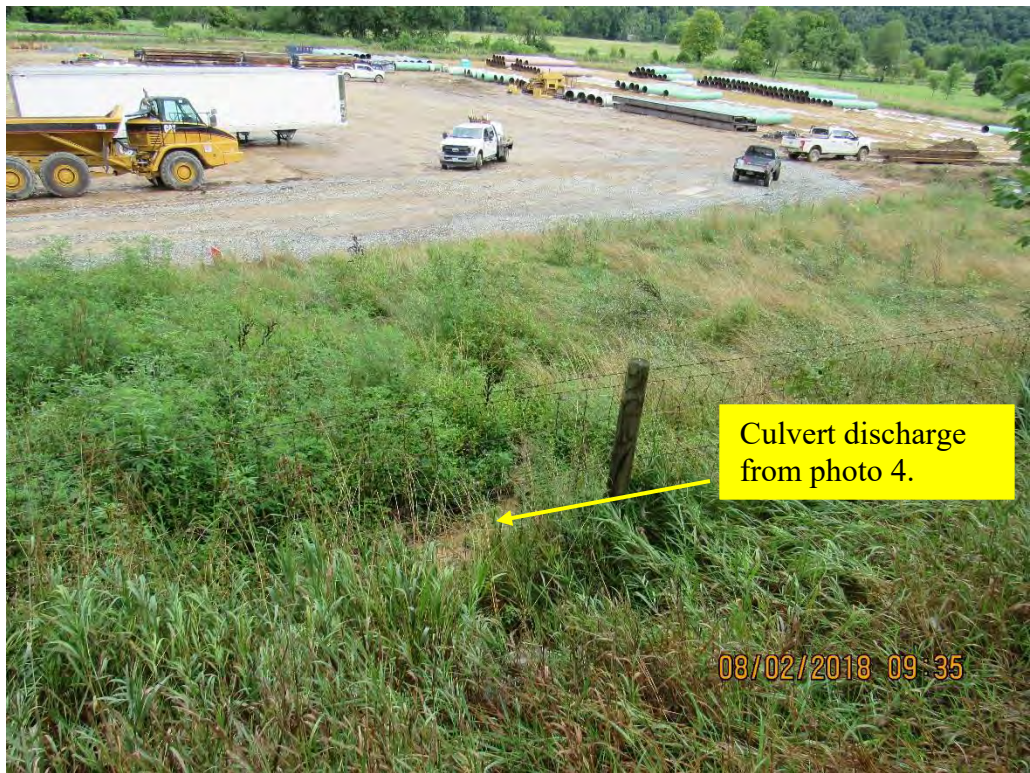
Photo 5: Road side ditch discharging into field upslope of laydown yard, receiving additional treatment prior to release

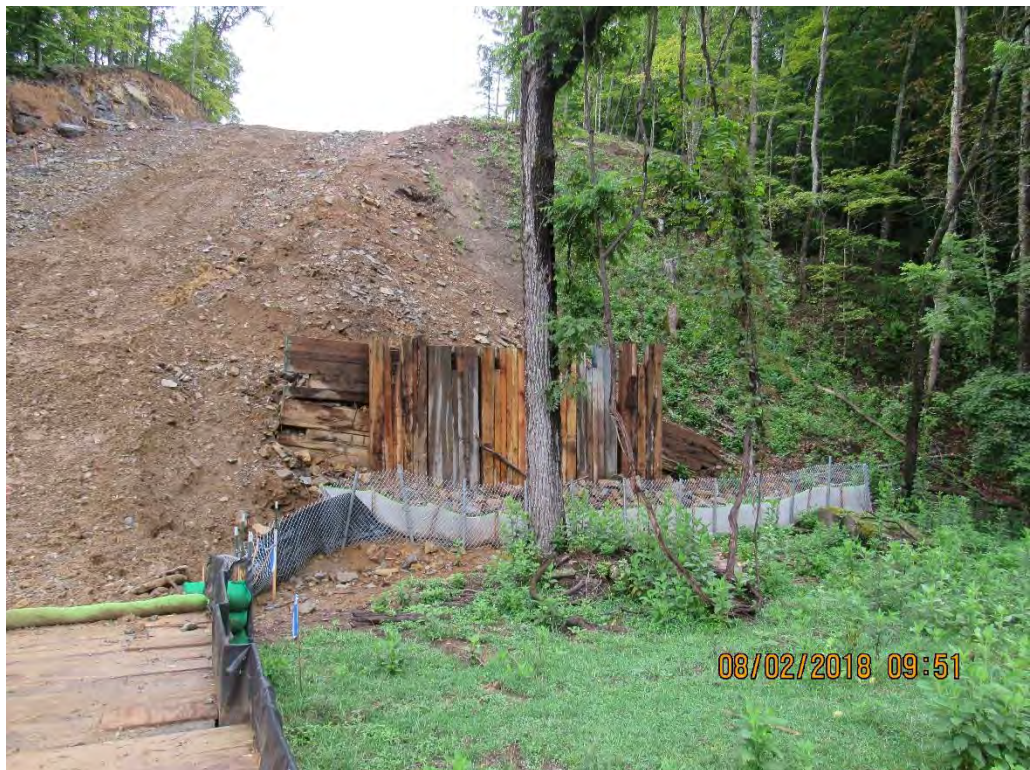
Photo 6: Large sump at end of water bar behind vertical mats.

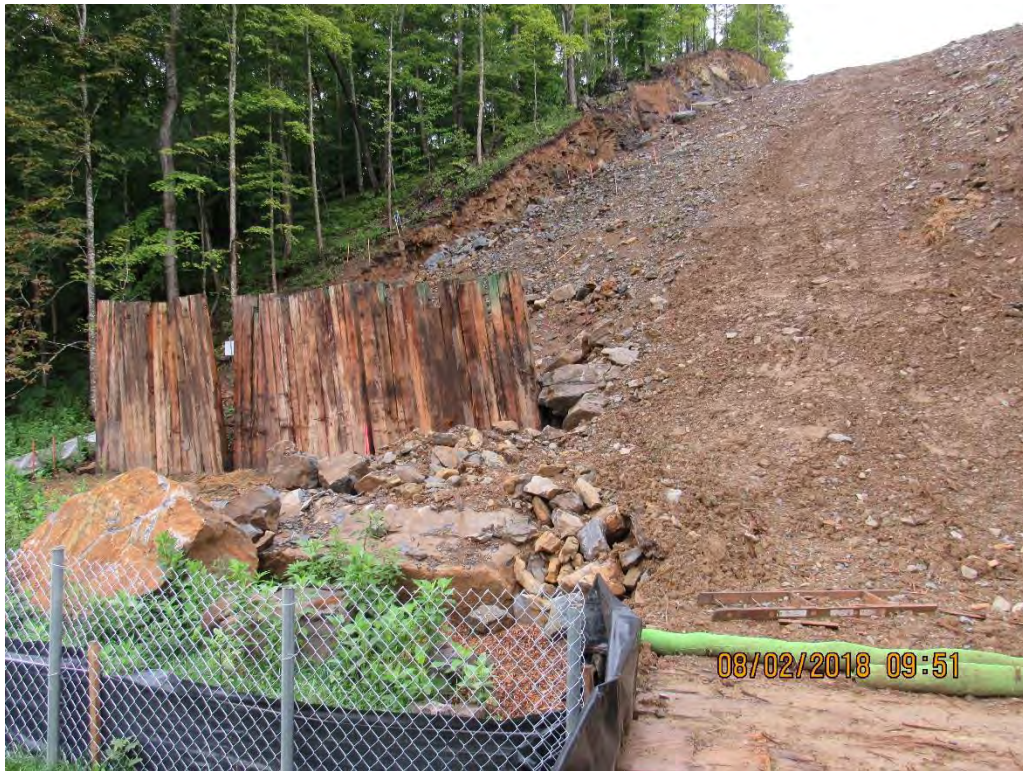
Photo 7: Vertical mats installed to divert rocks from stream.

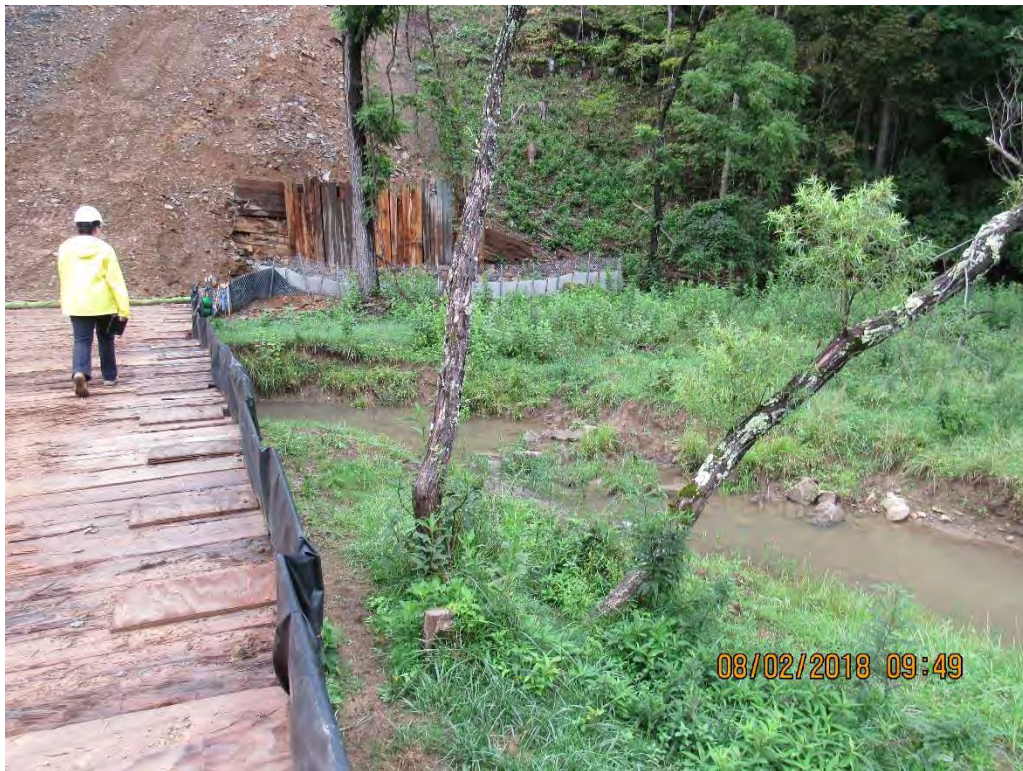
Photo 8: Downstream of installed bridge with sump behind vertical mats in back ground.

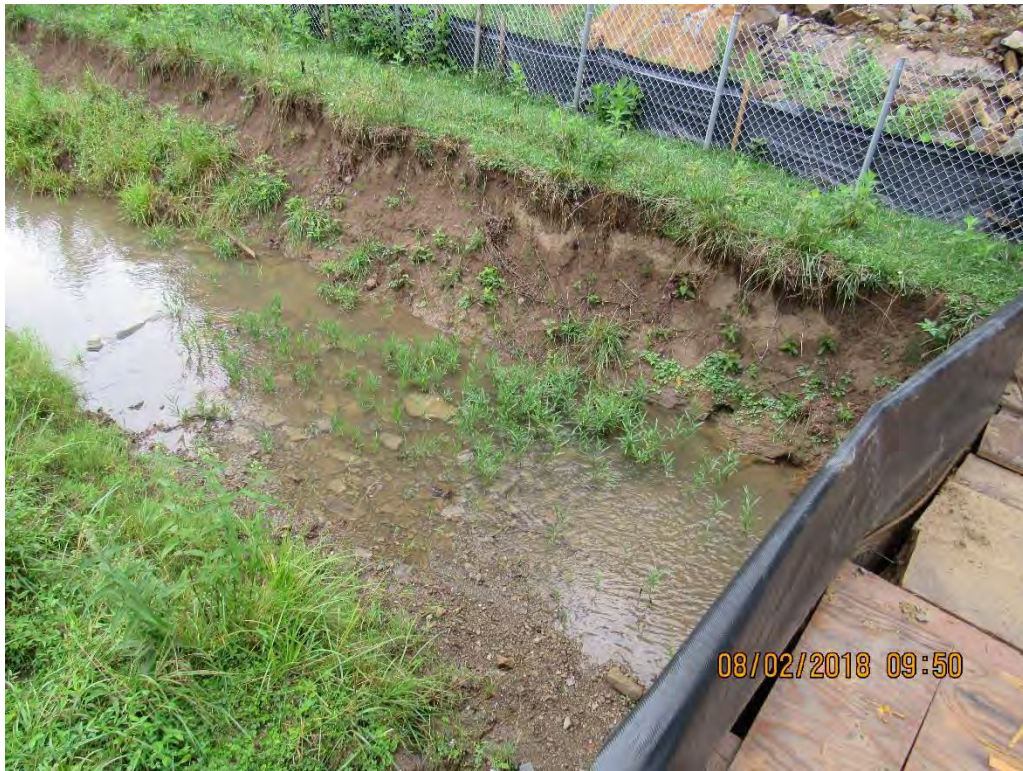
Photo 9: Upstream of bridge on east side of site below vertical mat rock barrier.

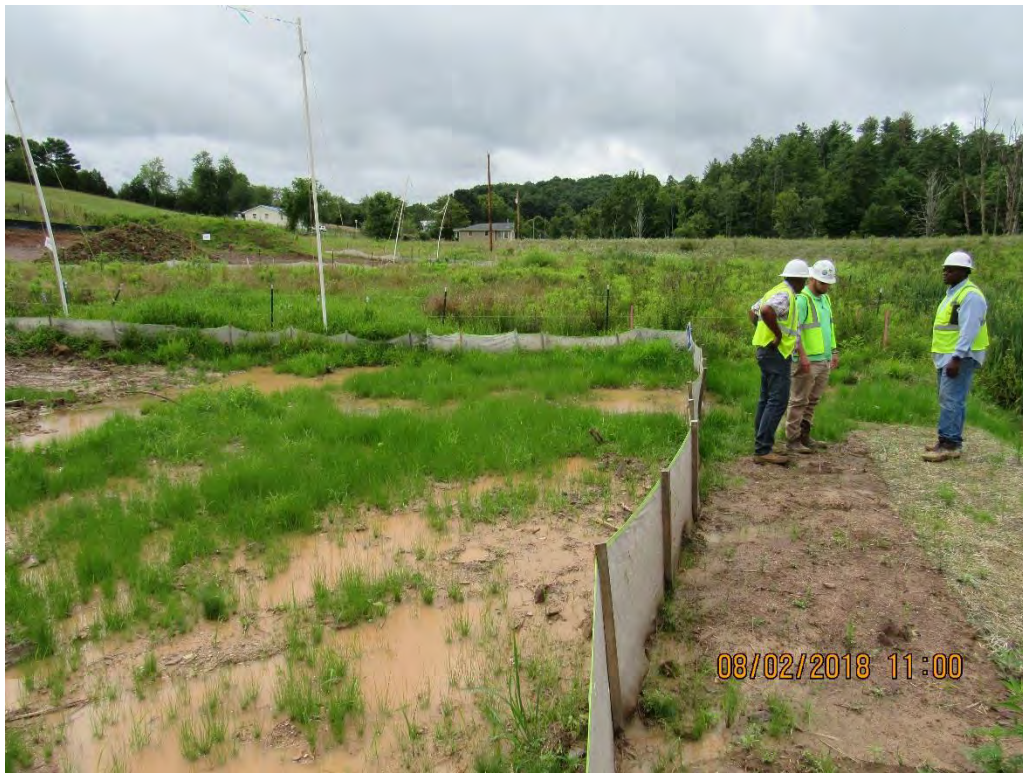
Photo 10: Installed silt fence is retaining sediment laden water

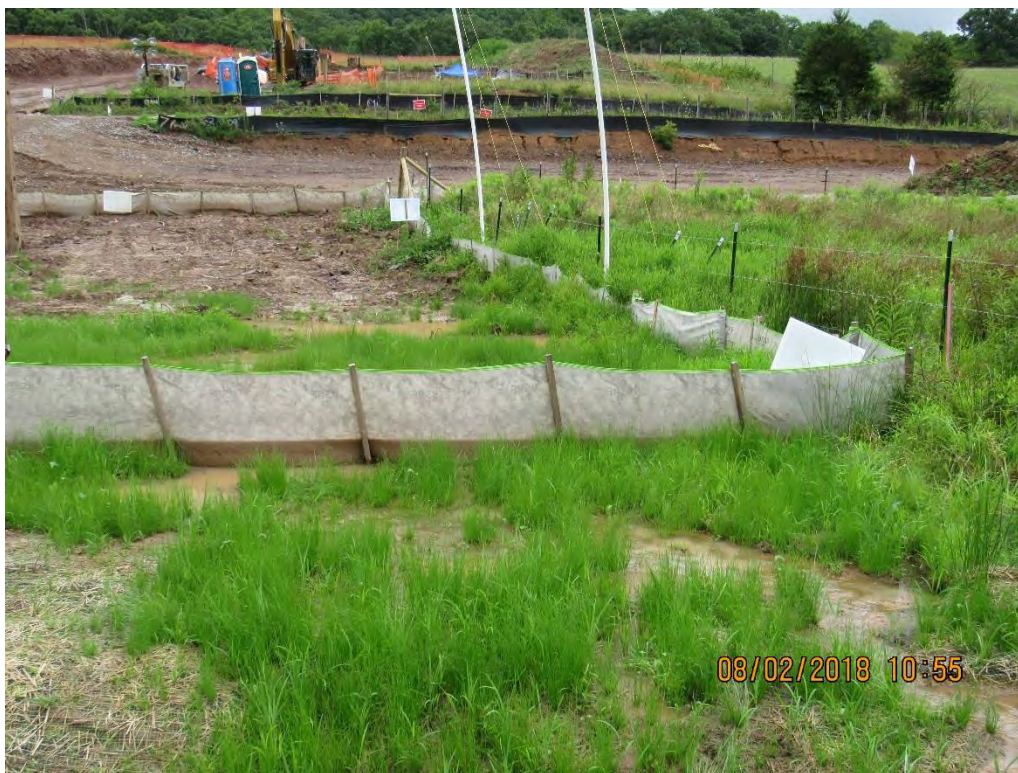
Photo 11: Installed silt fence is releasing filtered water.

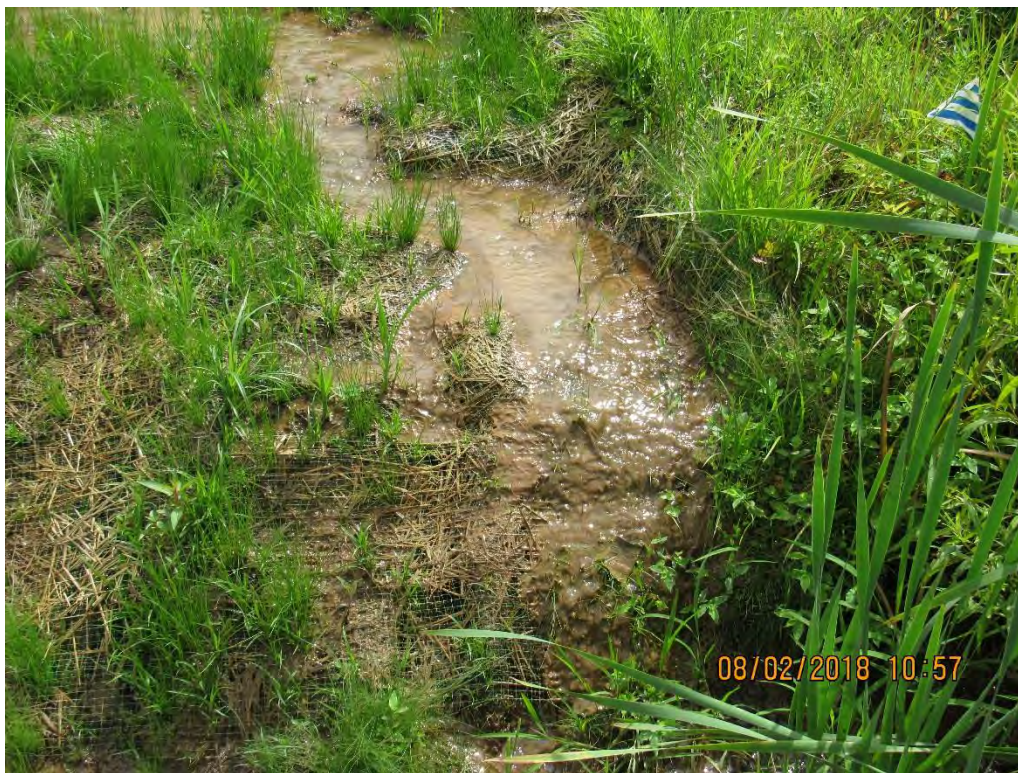
Photo 12: Clear water prior to overtopping bank.

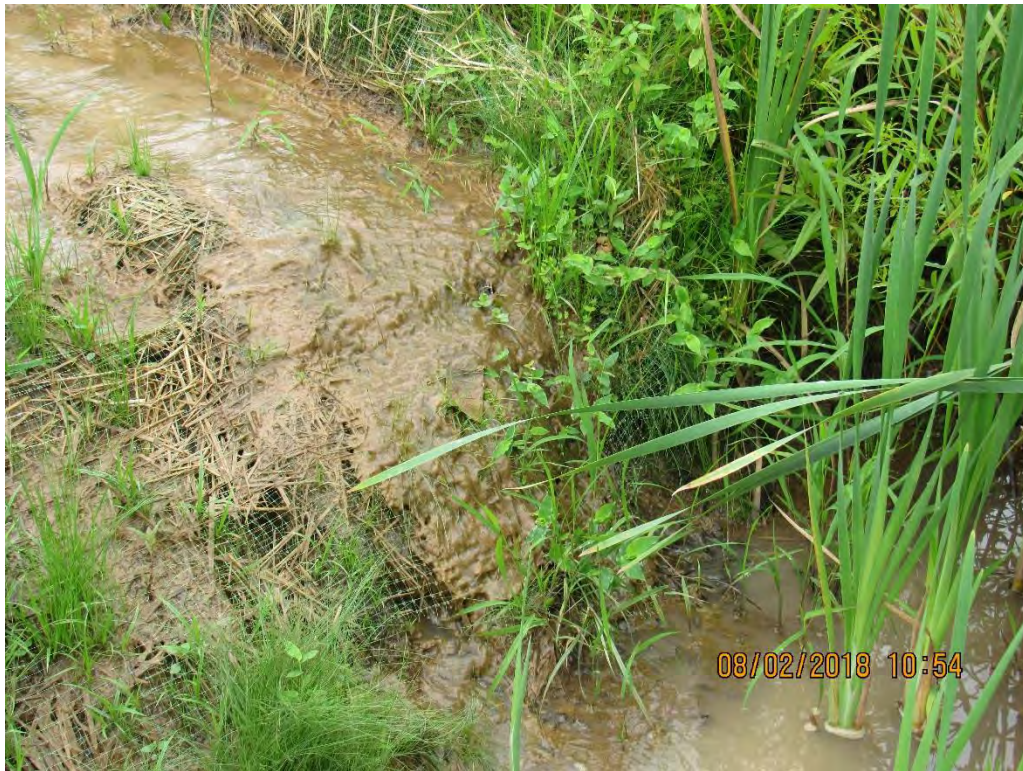
Photo 13: Sediment has been deposited on bank protection product, which is being picked back up prior to entering stream

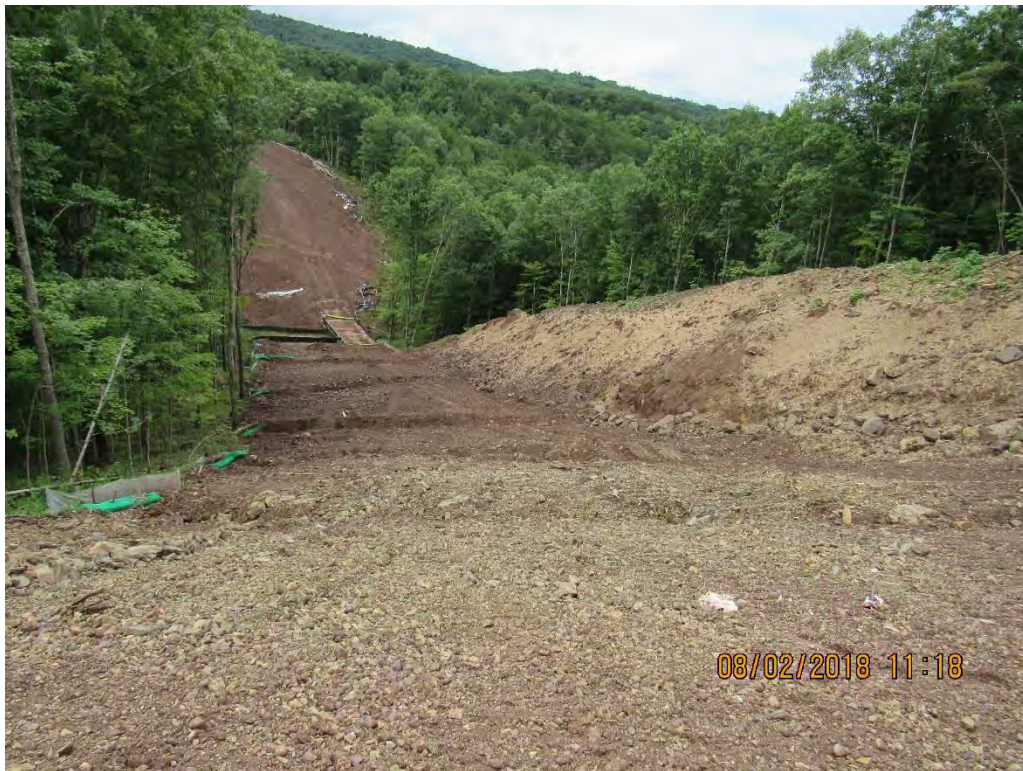
- War Ridge (station 9498+53)- Pipe installed across UNT of Little Stony Creek with restoration expected within a week. Crossing has good start on vegetation growth and controls are in good condition. (photo 16).

Photo 16: War Ridge Pipe installed across UNT of Little Stony Creek with restoration expected within a week. Crossing has good start on vegetation growth and controls are in good condition.

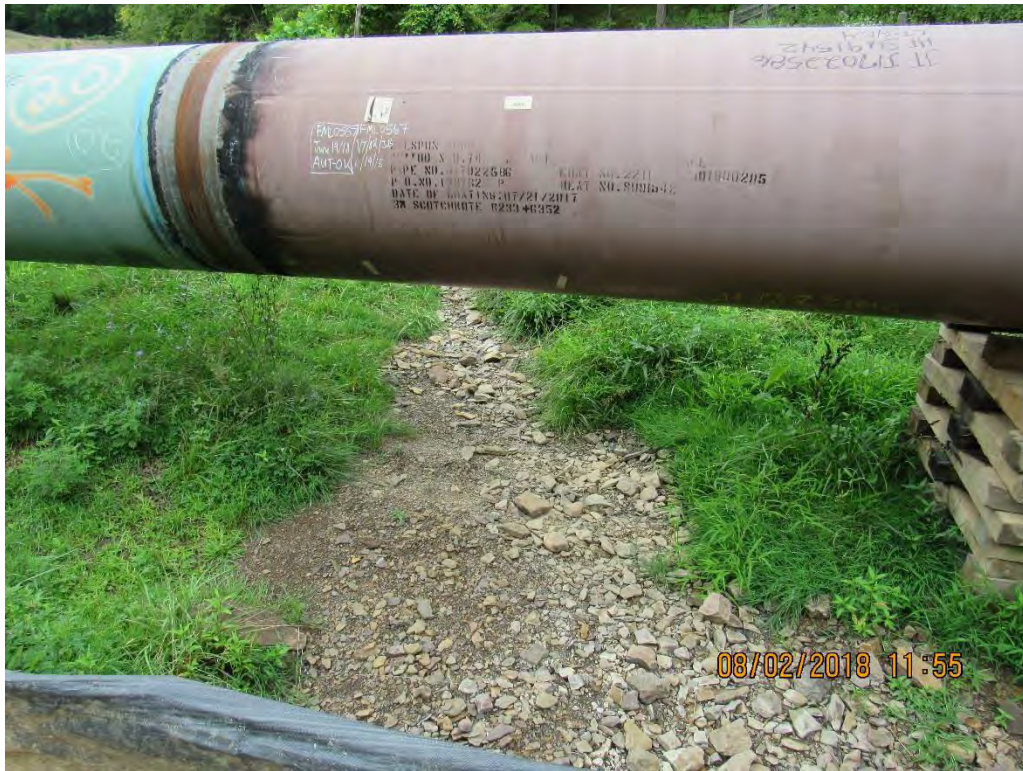
- Slate Run (station 9624+00)- Location of sediment laden water leaving site at last bridge over Slate Run. Upstream of bridge, Slate Run is dry (photo 17). Sediment deposits observed below base of bridge (photo 18) with sediment laden water traced under bridge matting (photo 19) to sump upgradient of stream (photo 20). Muddy conditions observed in Slate Run below sediment deposits at bridge mat.

Photo 17: Upstream of last bridge over Slate Run.

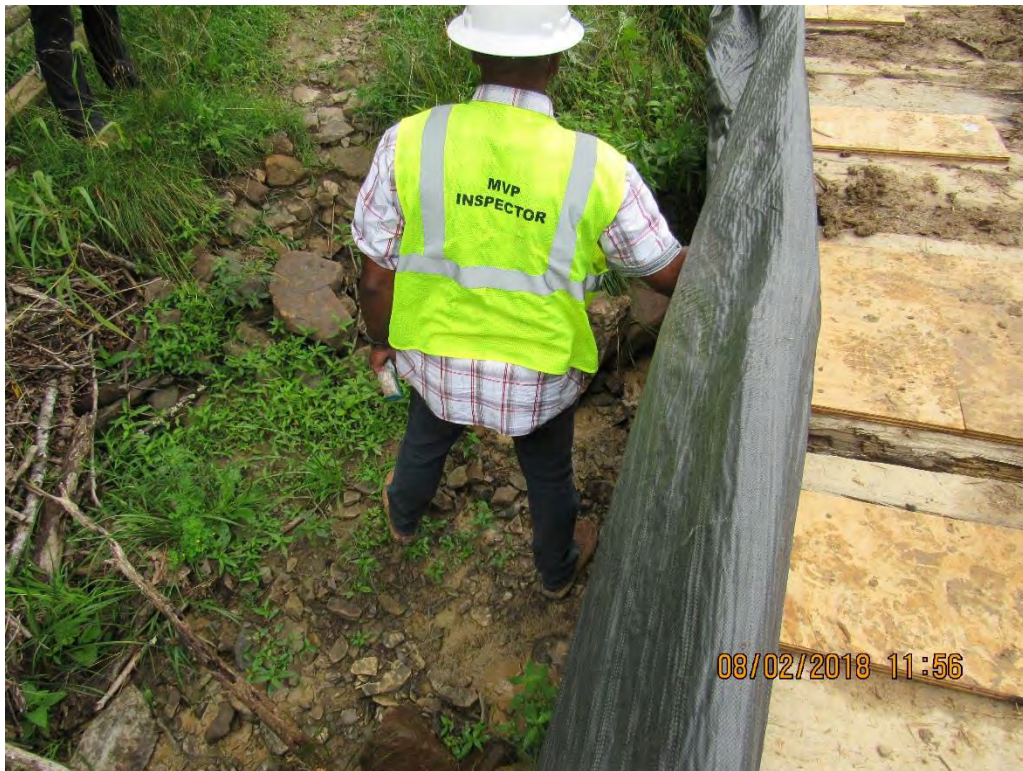
Photo 18: Sediment deposits observed below base of bridge between feet and in front of inspector.

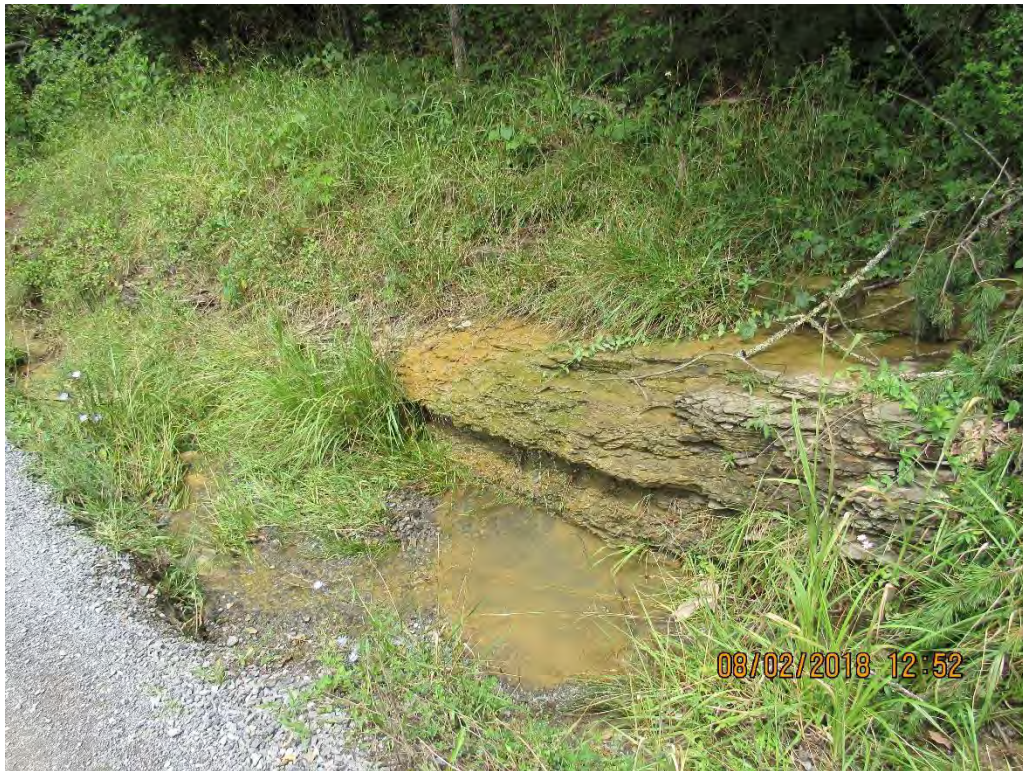
- Ellison Ridge Road & Access Road 221)- approximately station 9778+00 location of reported backhoe ‘stuck’ in mud along with failure of controls. Controls did fail; additional controls installed (sump was enlarged, additional filter fabric and compost filter socks added). (photo 21) Backhoe waiting for drier conditions to complete work. Seeders scheduled for midweek of following week to seed along access road (photo 22). Control failure lead to sediment laden water entering neighboring pond downstream of failure. Location entering stream from right of way (ROW) to pond was clear (photos 23-29).

Photo 23: Entrance to UNT of Hans Creek several days after control failure on ROW-view downstream.
