**The Wilderness Society et al. Comments on the
U.S. Forest Service Mountain Valley Pipeline and
Equitrans Expansion Project Draft Supplemental
Environmental Impact Statement (#50036)**

**WEST VIRGINIA DEPARTMENT OF ENVIRONMENTAL PROTECTION
WV OIL AND GAS CONSTRUCTION STORMWATER PERMIT**

FACILITY NAME:	Mountain Valley Pipeline Project			REG. #	EXPIRE DATE:
PERMITTEE	MOUNTAIN VALLEY PIPELINE, LLC			WVR310667	5/13/2018
ADDRESS/PHONE:	Attn: Matt Hoover 625 LIBERTY AVE, ST 1700 PITTSBURGH, PA 15222				
LOCATION:	Wileyville, WV			Entry Date/Time:	4/3/18 8:30am
COUNTY:	Wetzel			Exit Date/Time:	4/3/18 1:37pm
Site Representative /Phone	Matt Hoover Sr. Environmental Coordinator (412) 258-5627			PHOTOS <input checked="" type="checkbox"/>	
CO-PERMITTEE:				ADDRESS:	
SITE OPERATOR:	Precision Pipeline			ADDRESS:	
PERMITTED ACREAGE	4214	WEATHER:	Rain	LAST INSPECTION:	N/A
RECEIVING STREAM(S)	Mobley Run > Ohio River				NOV: 1
Regular Mail <input type="checkbox"/> Certified Mail <input checked="" type="checkbox"/>	Tracking #				
OVERALL FACILITY RATING:	Unsatisfactory		COMPLIANCE OUTCOME	Not Immediately Corrected

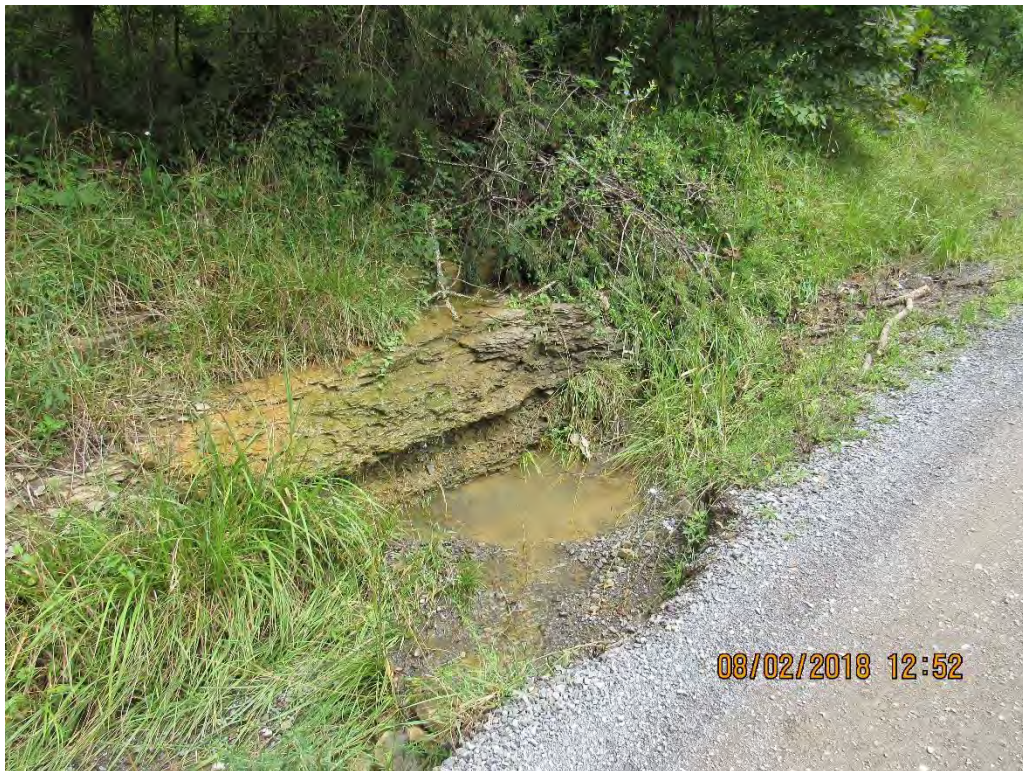
- Ellison Ridge Road & Access Road 221)- approximately station 9778+00 location of reported backhoe ‘stuck’ in mud along with failure of controls. Controls did fail; additional controls installed (sump was enlarged, additional filter fabric and compost filter socks added). (photo 21) Backhoe waiting for drier conditions to complete work. Seeders scheduled for midweek of following week to seed along access road (photo 22). Control failure lead to sediment laden water entering neighboring pond downstream of failure. Location entering stream from right of way (ROW) to pond was clear (photos 23-29).

Photo 24: Entrance to UNT of Hans Creek several days after control failure on ROW- view upstream.

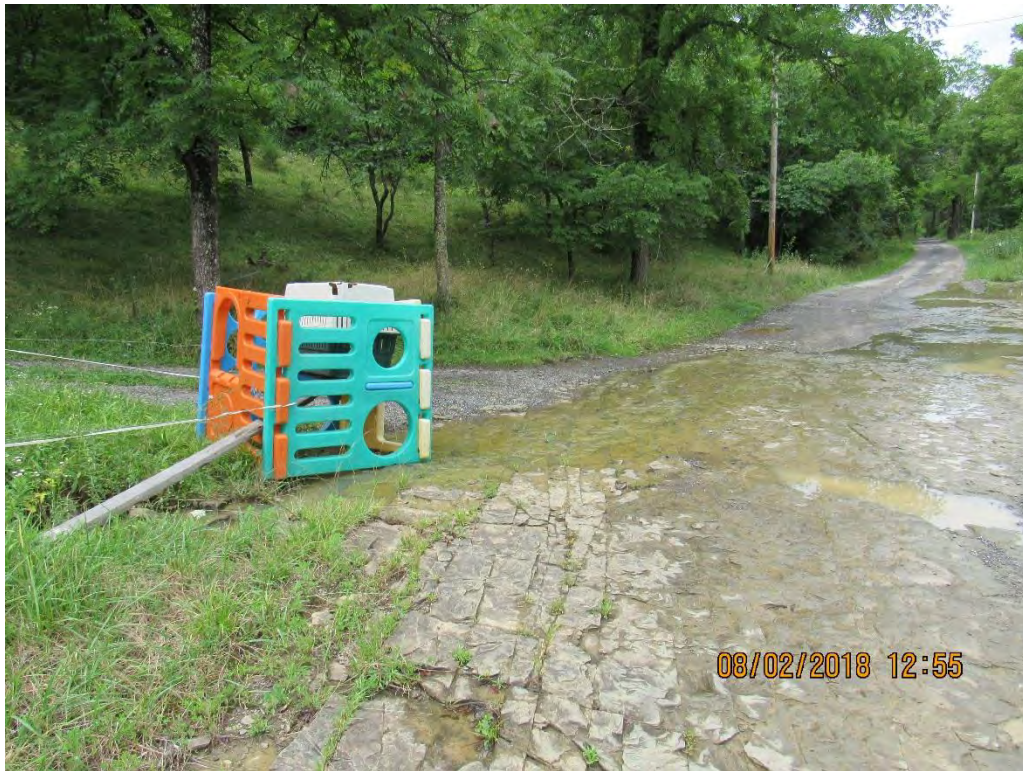
Photo 25: UNT of Hans Creek crossing- entrance of stream onto Ellison Ridge Road.

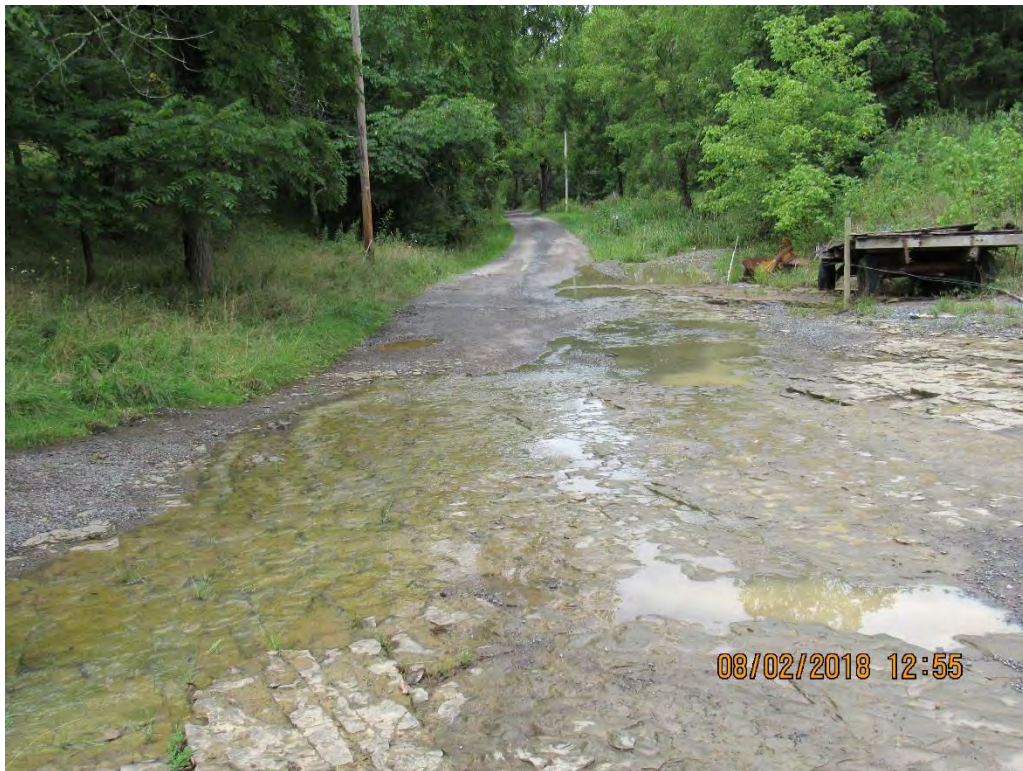
Photo 26: UNT of Hans Creek crossing- exit of stream over Ellison Ridge Road.

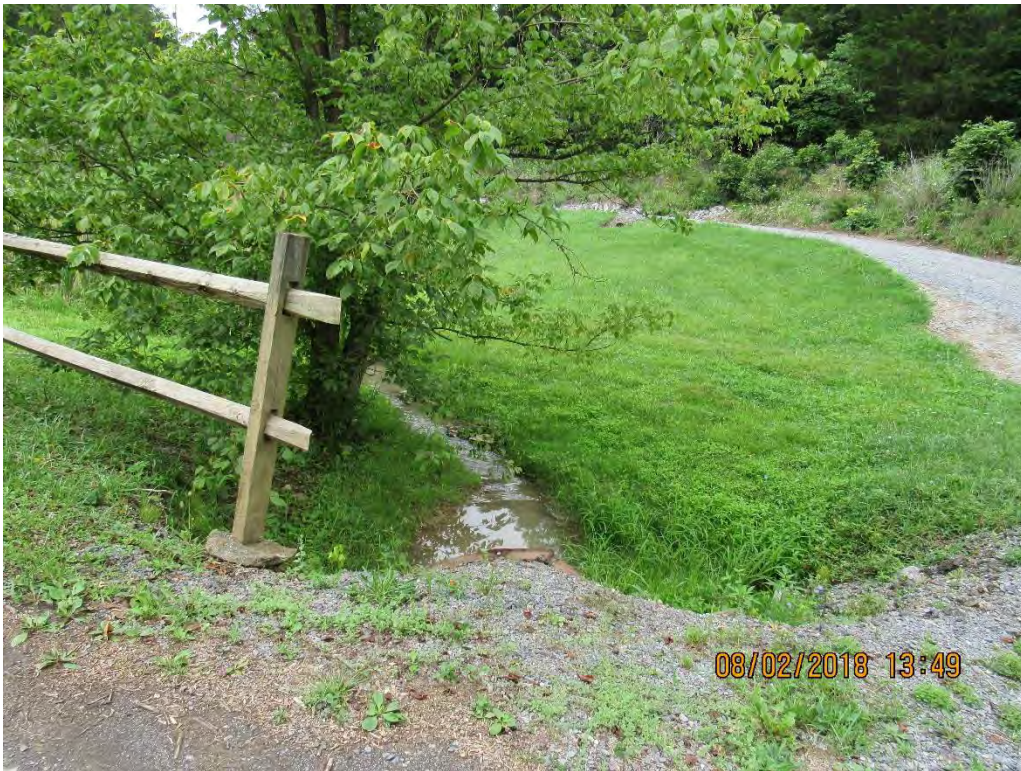
Photo 27: Road access of UNT of Hans Creek feeding pond.

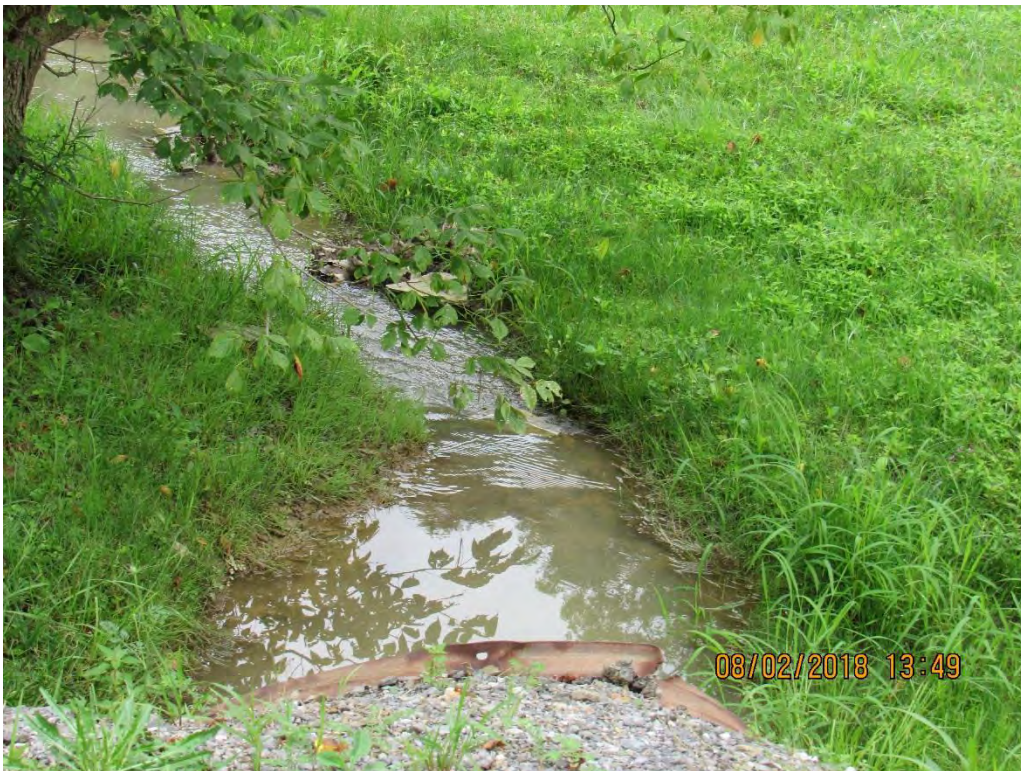
Photo 28: Close-up of water several days after control failure on ROW upstream of pond

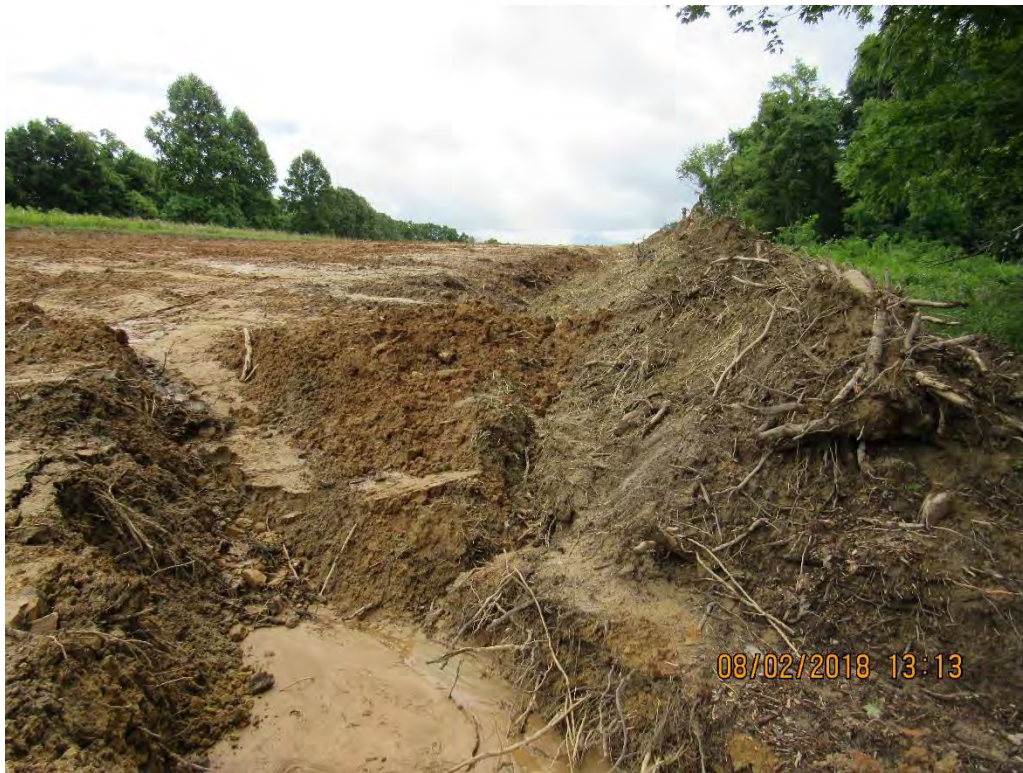
Photo 30: Additional sump installed above control failure near station 9961+00 (off access road 227)

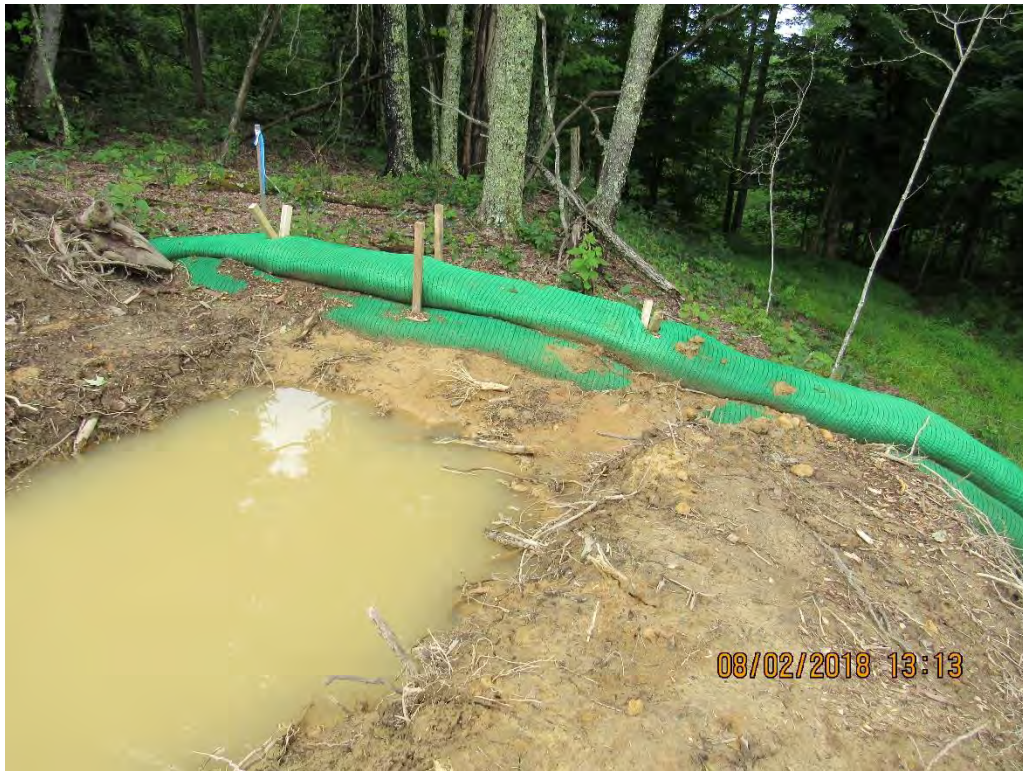
Photo 31: Water bar end altered to alleviate future failure of controls down gradient.

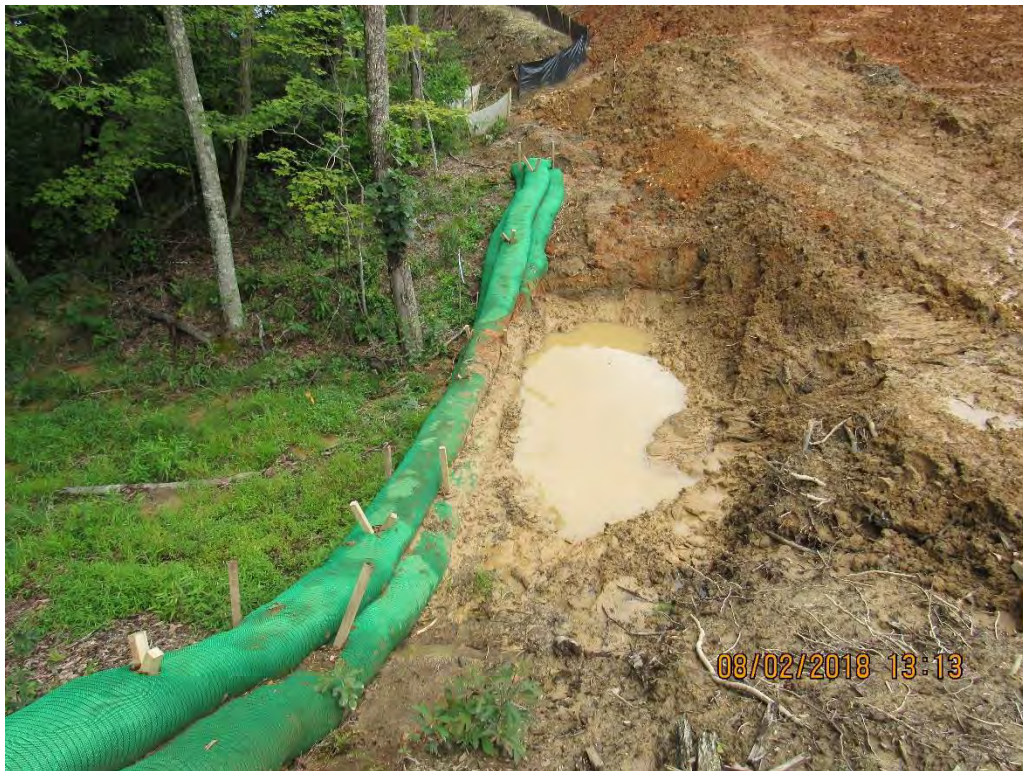
Photo 32: Location of previous failure near station 9961+00.

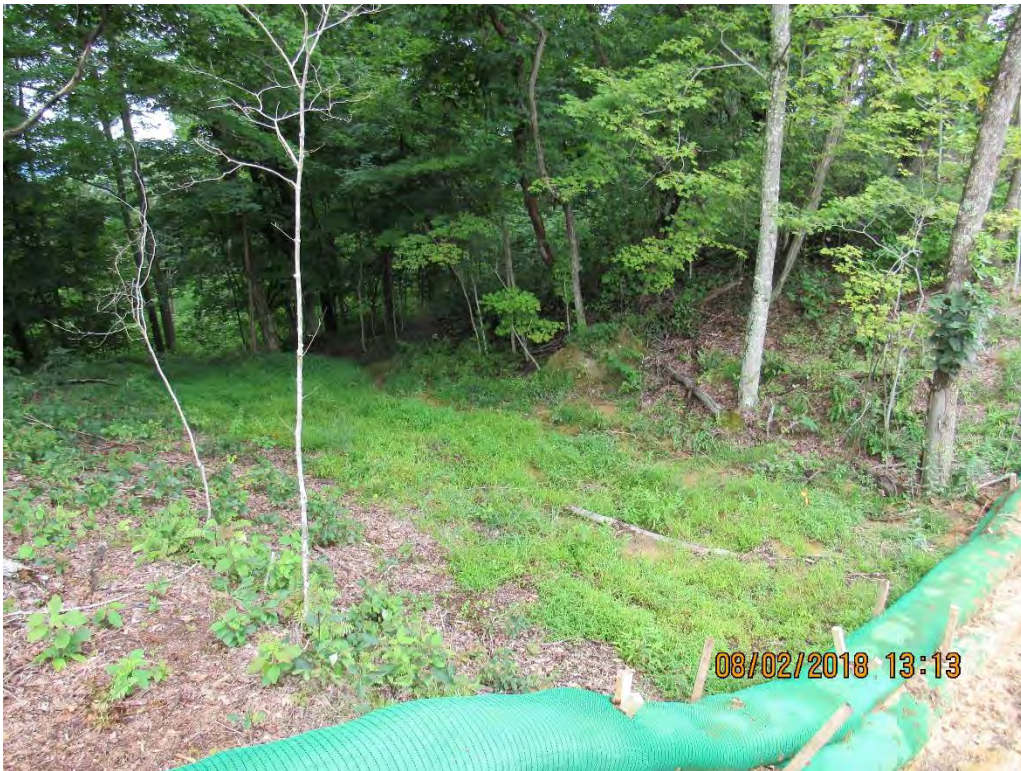
Photo 33: Down gradient of previous control failure in Photo 32.

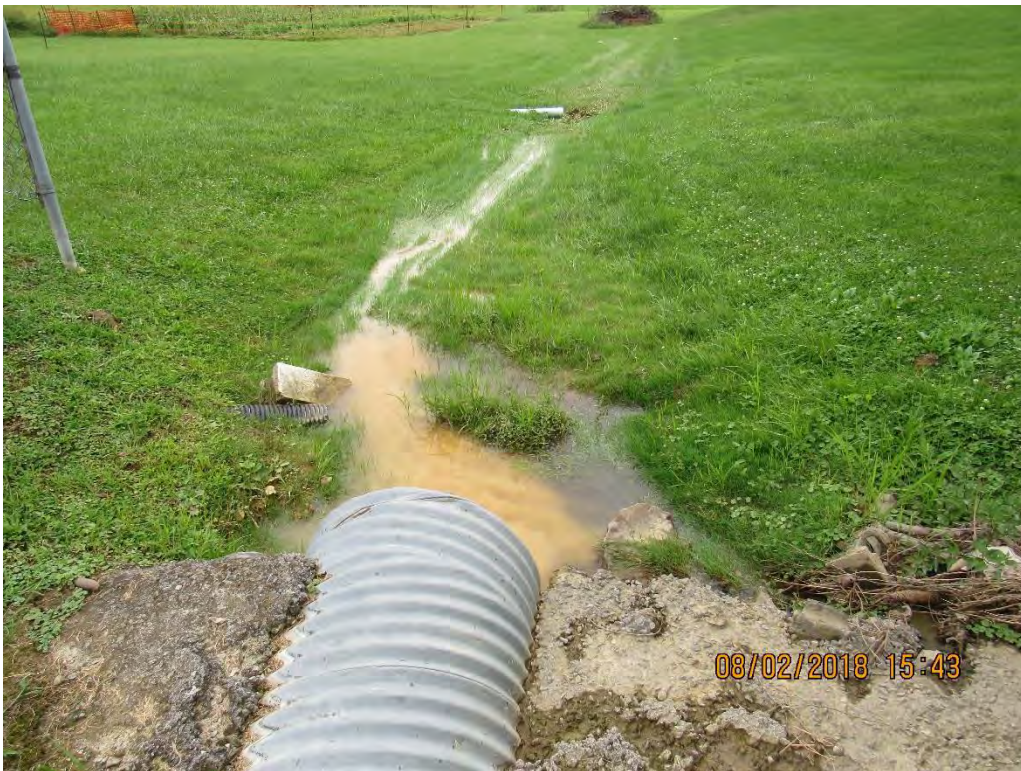
- Near Lindsie Methodist Church – GPS coordinates 37° 27.3818;’N, 80° 39.9588’W sediment laden water leaving culvert from under Lindsie Methodist Church (photo 34). Upstream drop inlet had clear water (photo 35). Unable to determine source of sediment laden water. ROW is located behind church. Requested that MVP find source of sediment laden water.

Photo 34: Sediment laden water from unknown source near Lindsie Methodist Church.

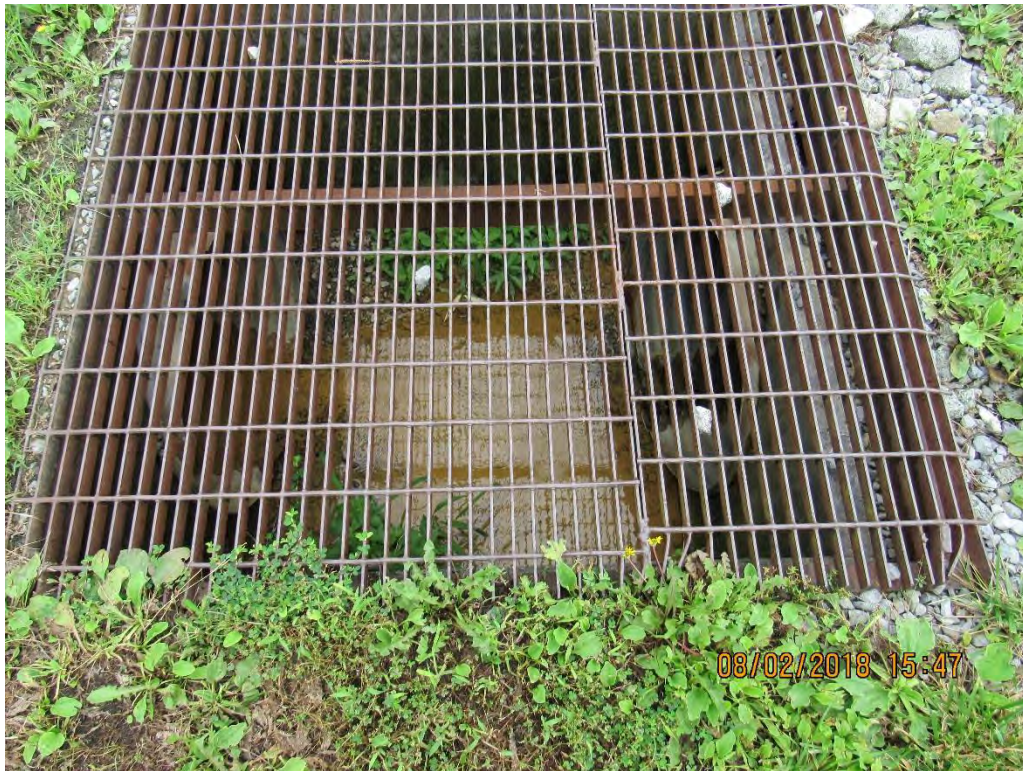
Photo 35: Clear water in drop inlet upstream of culvert (photo 34).

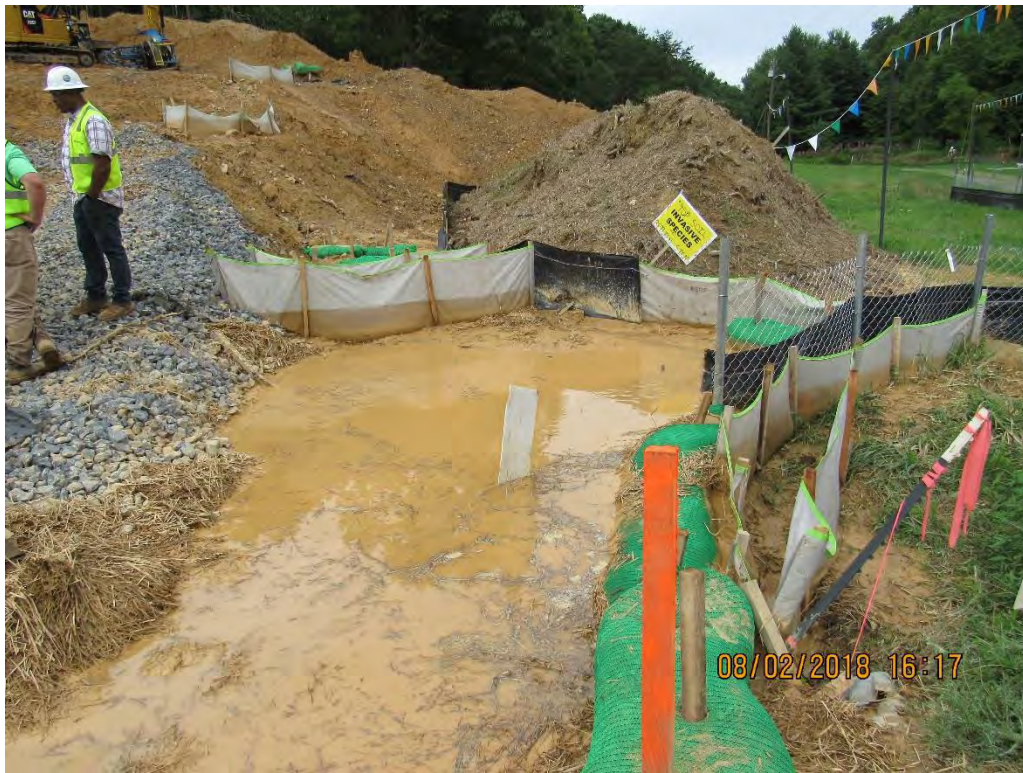
- Painter’s Run Road/Spruce Run Road – Sump near station 10270+00 needs maintenance. Sump is full (photo 36) and allowing sediment laden water to enter culvert (photo 37) into wetland area across road (photo 38). Sediment laden water is still within limits of disturbance (LOD) (photo 39). Wetland feeder streams and adjacent stream, Painter Run are clear (photos 40-42). Prior to inspection completion, maintenance crew arrived to address situation. Area did not have cell service, so arrival was unprompted.

Photo 36: Station 10270+00, sump is full.

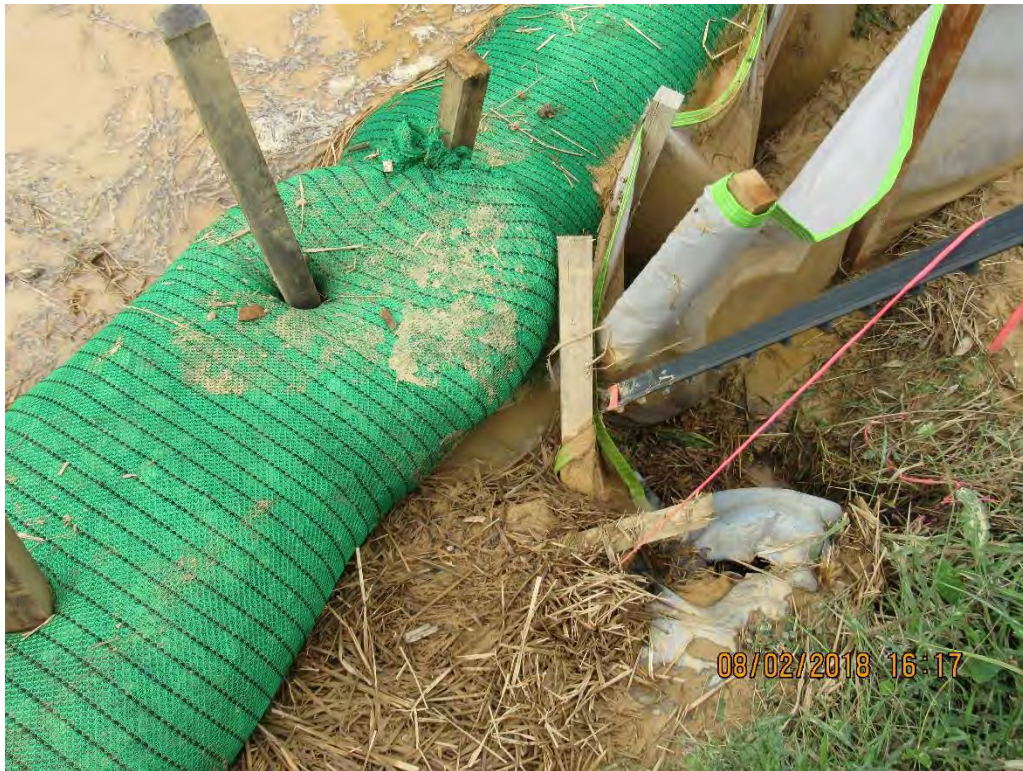
Photo 37: Sediment laden water entering culvert.

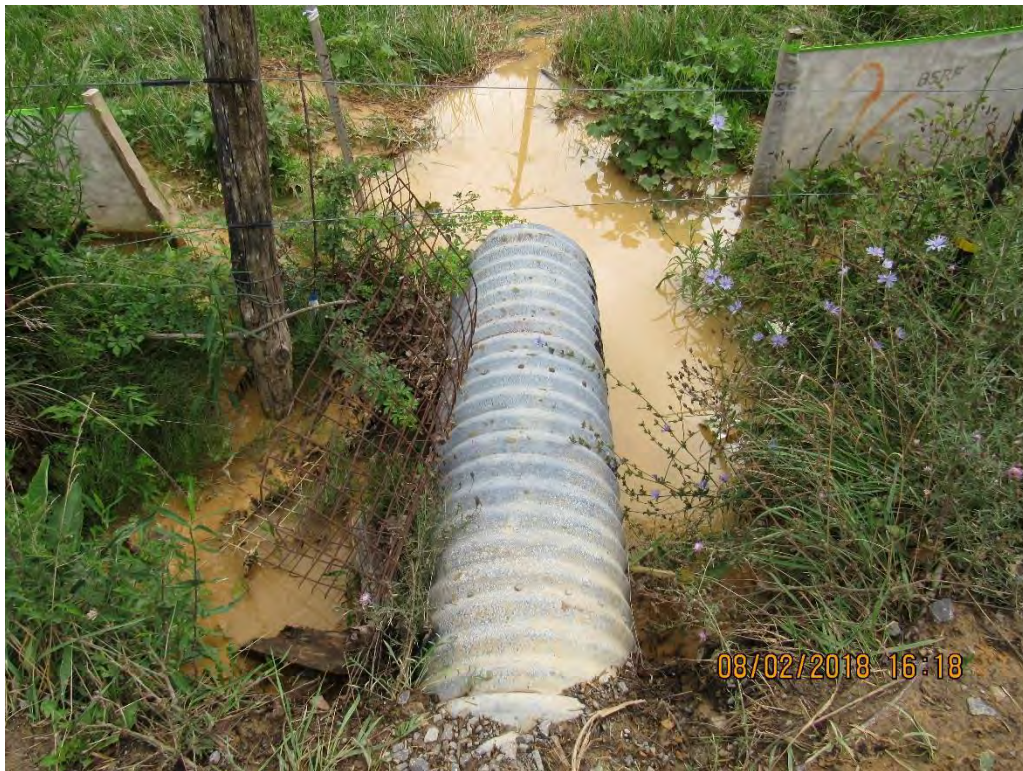
Photo 38: Culvert outlet into wetland area across road from full sump.

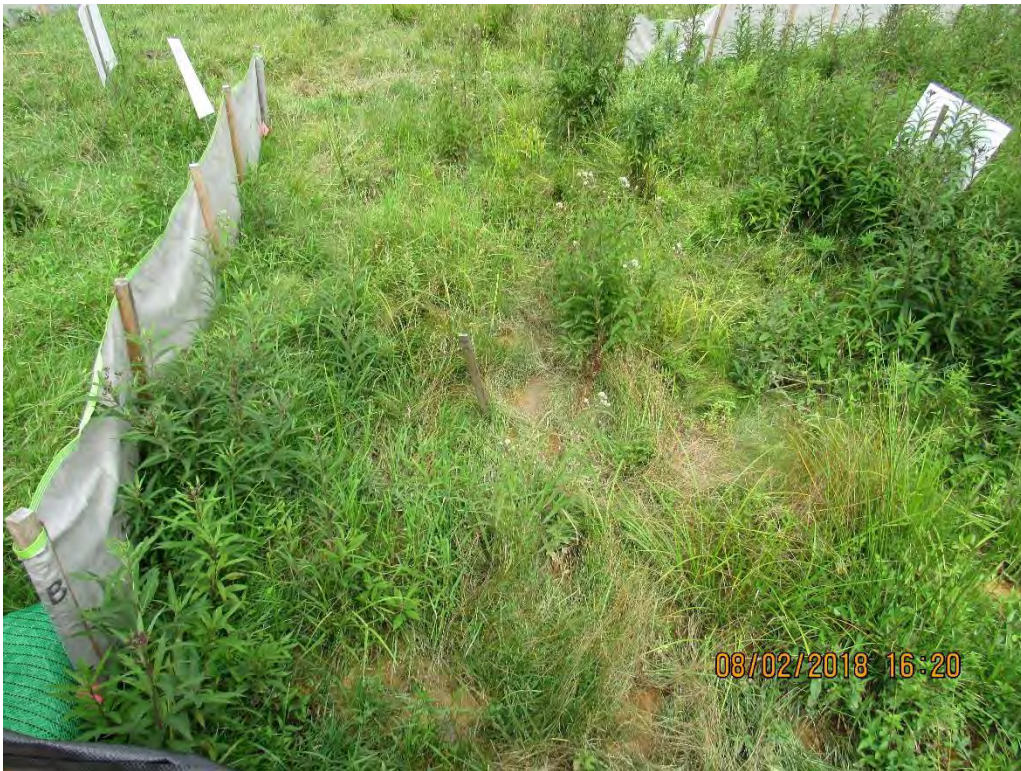
Photo 39: Sediment laden water is still within (LOD).

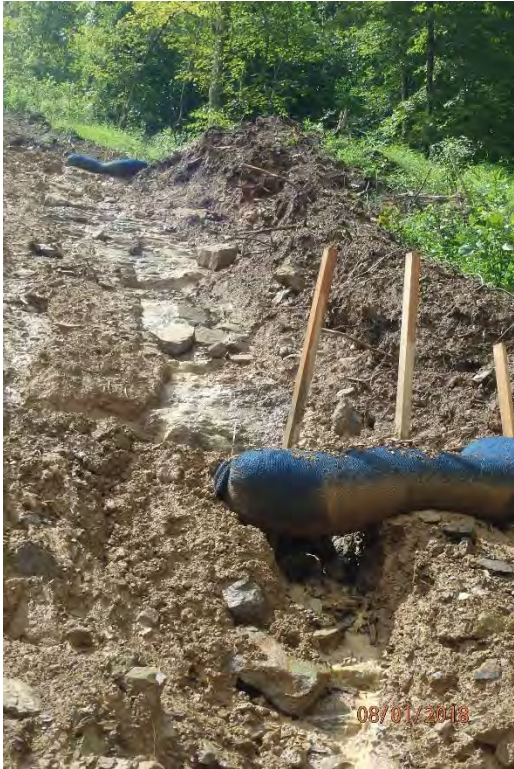
- 1). (2, 6, 7, 8, 13, 14, 19, 20 & 21) Improperly constructed water bars were found throughout the inspected area. Water bars did not shed stormwater off of the LOD in small quantities as designed. In many cases the water bars terminated prior to the edge of the Limits of Disturbance (LOD) and the installed perimeter controls which placed concentrated flow over the fill slope. Concentrated flow stormwater was then treated at the base of the hill with perimeter controls. In a few cases water bars terminated into unstable diversions that carried stormwater downslope to the base of the hill. Water bars that were in need of maintenance were also noted in areas scattered throughout the inspected area. Improperly constructed and poorly maintained water bars led to fill slope erosion, offsite sediment deposits and Conditions Not Allowable (CNA) in several instances. Offsite CNA deposits were noted in UNT Goose Run (39° 26.100' X 80° 28.4922'), Seal Run (39° 20.4891' X 80° 30.7324') and Grass Run (39° 20.1127' X 80° 31.3233'). CNA distinctly visible settleable solids were noted in Right Fork of Big Elk Creek (39° 26.6589' X 80° 28.9724'), Goose Run (39° 26.17952' X 80° 28.5256') and UNT Goose Run (39° 26.100' X 80° 28.4922').

Improperly installed water bars that have caused fill slope erosion in the Big Elk Creek watershed.
Deficiencies in site evaluation item numbers 6, 7, 8, 14, 19, 20 & 21 pictured.

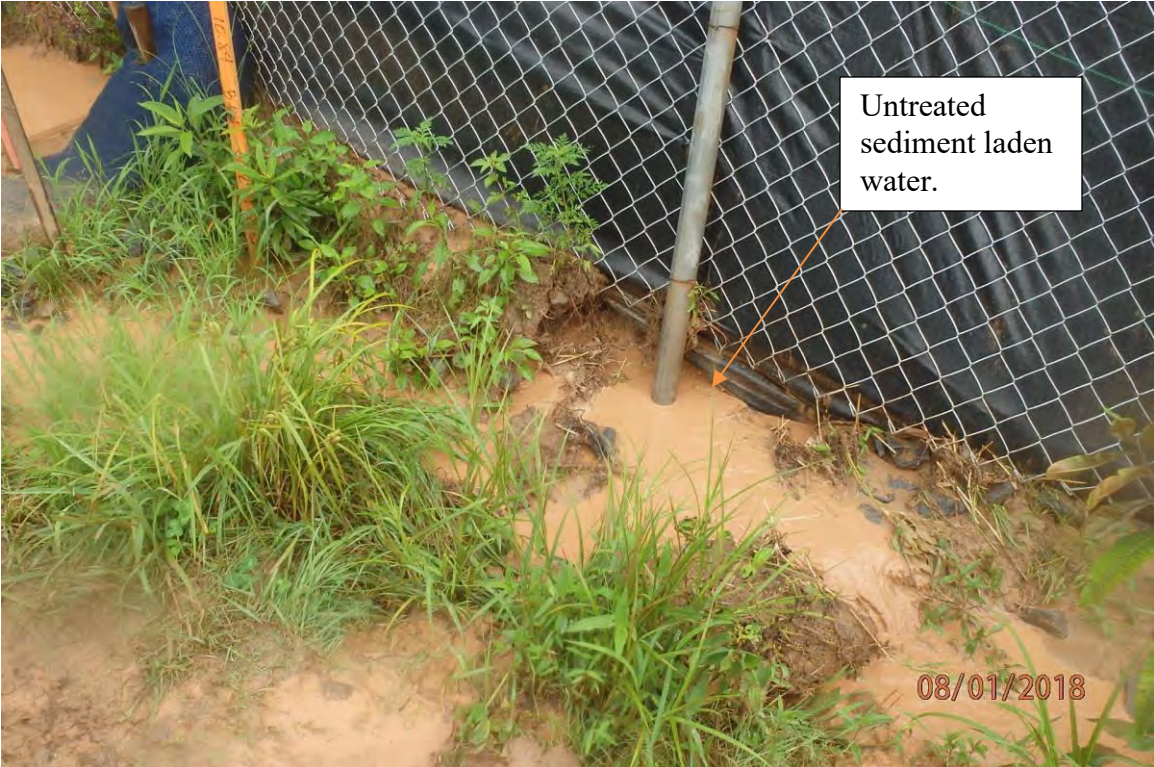
Concentrated flow from water bar outlet that is being treated by sheet flow BMP in the Big Elk Creek watershed. Deficiencies in site evaluation item numbers 1, 6, 7, 8, 13, 14, 19, 20 & 21 pictured.

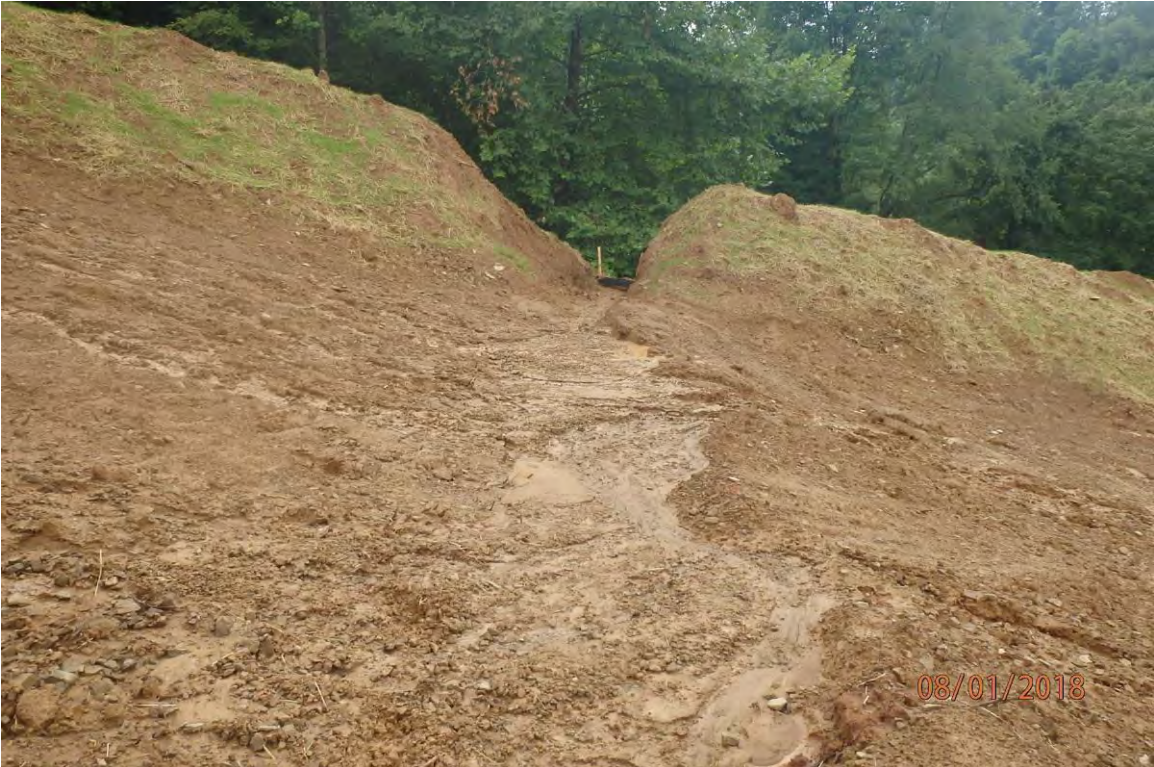
Improperly installed and poorly maintained water bars in the Goose Run watershed. Deficiencies in site evaluation item numbers 6, 7, 14, 19, 20 & 21 pictured.

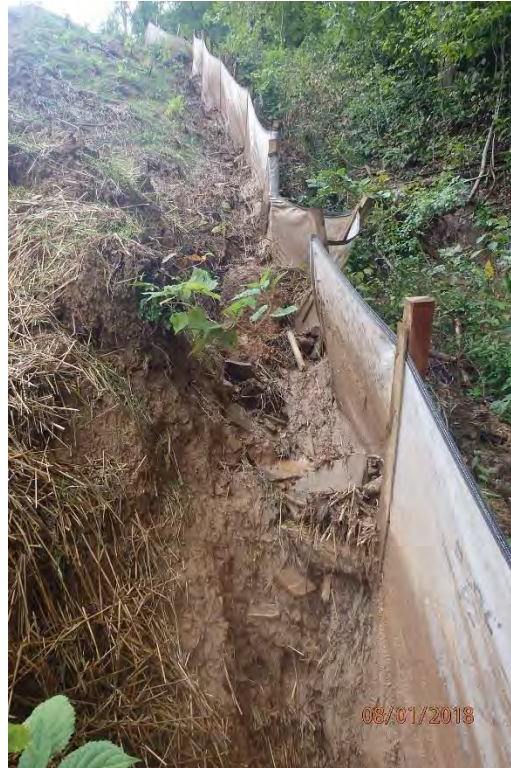
Concentrated flow being channeled along perimeter control trench due to improperly installed water bars in the Goose Run watershed.

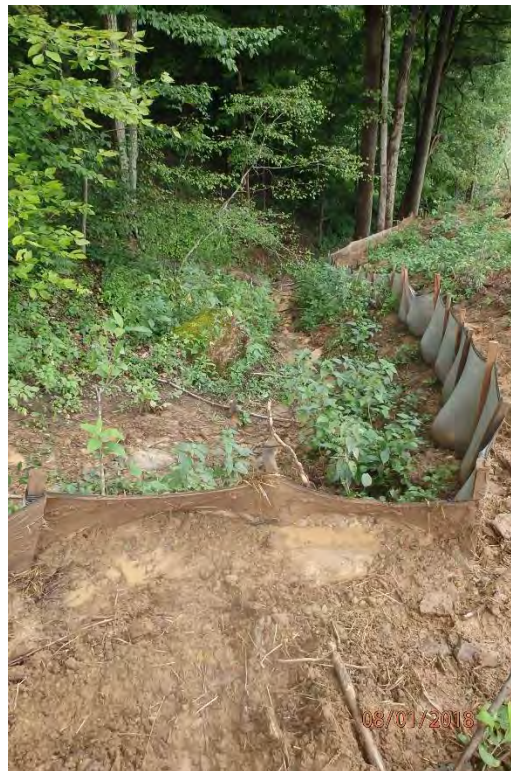
Perimeter control that has been overwhelmed due to concentrated flow from improperly installed water bars in the Goose Run watershed. Deficiencies in site evaluation item numbers 1, 6, 7, 14, 19, 20 & 21 pictured.

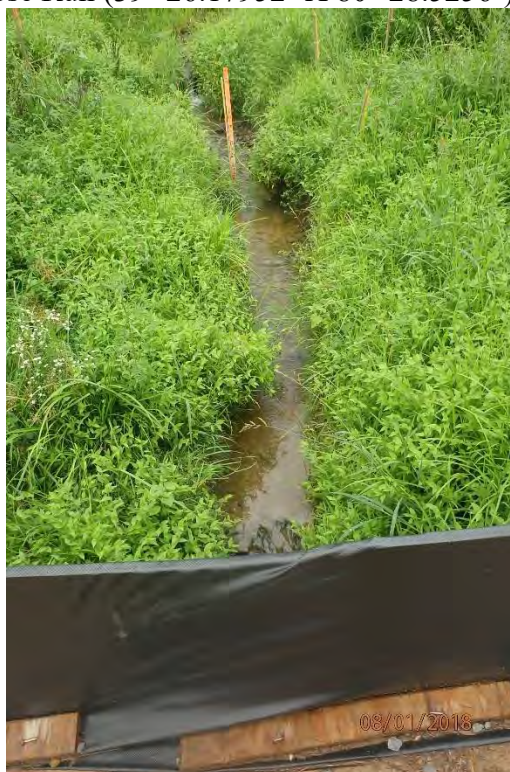
Goose Run water quality upstream of project. Deficiencies in site evaluation item numbers 1, 6, 19, 20 & 21 pictured.

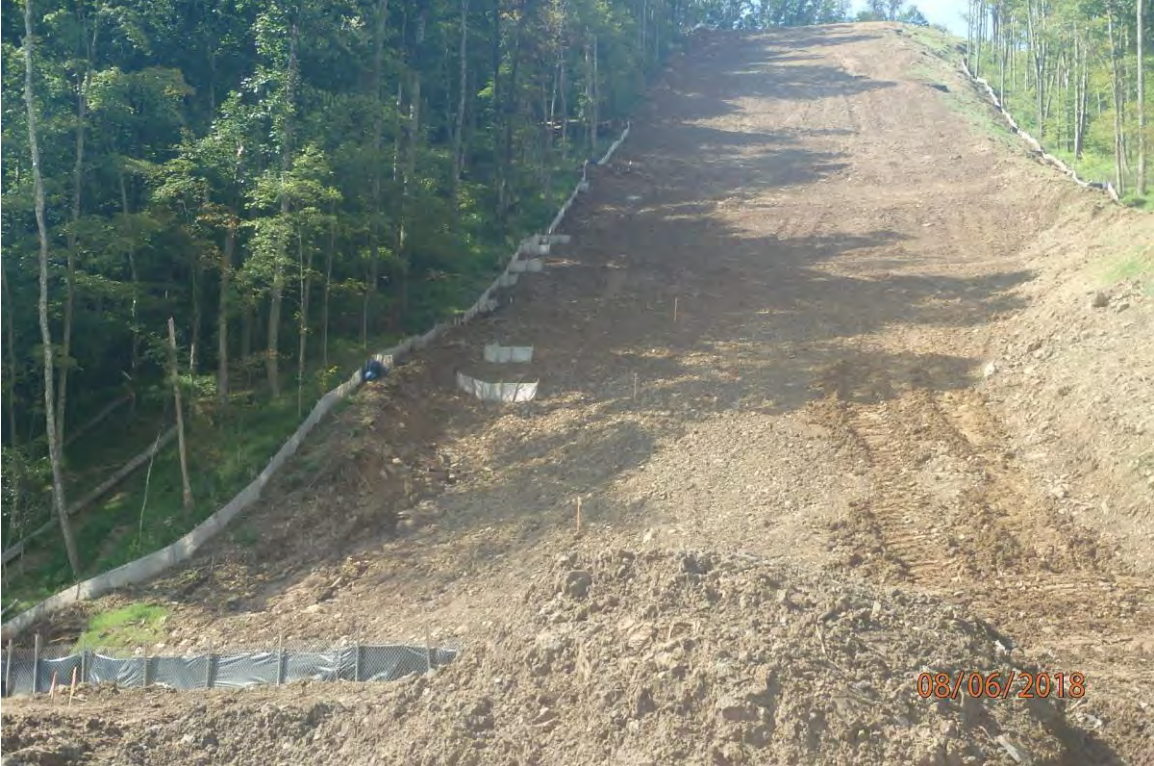
Improperly installed water bars and associated fill slope erosion in the Tenmile Creek watershed.

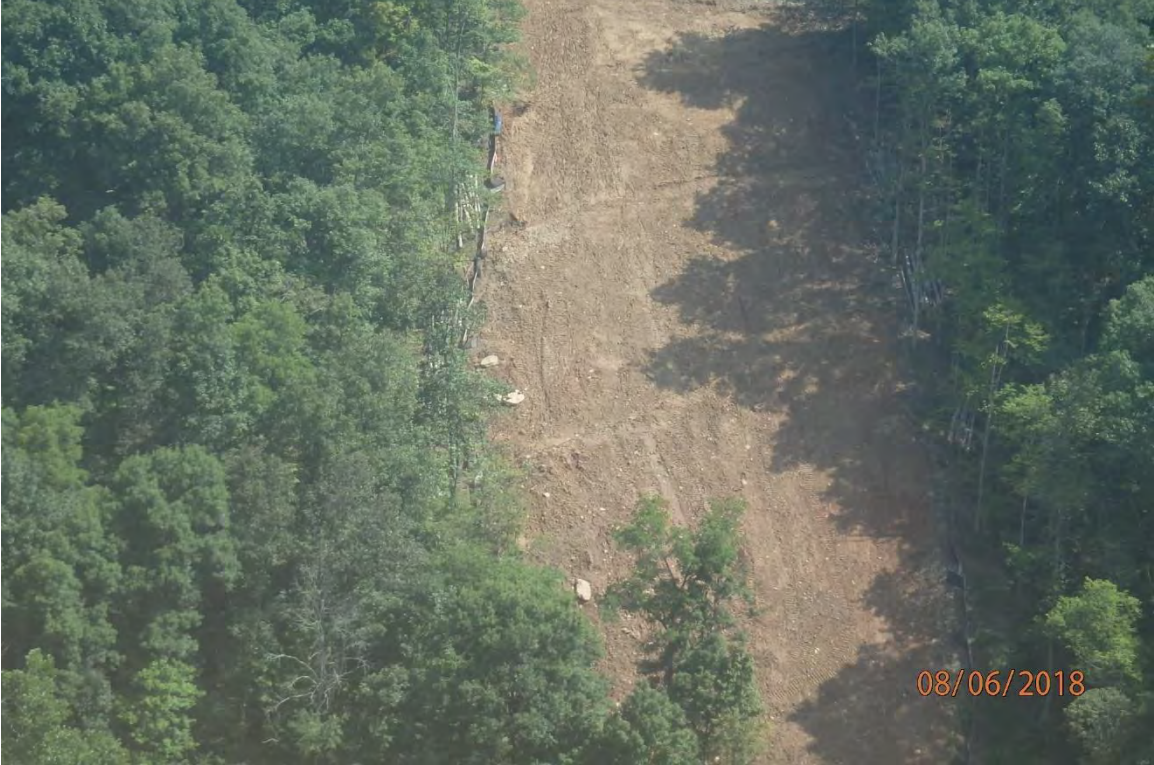
Improperly installed water bars and associated fill slope erosion in the Little Rockcamp Run watershed.
Deficiencies in site evaluation item numbers 1, 6, 7, 13, 14, 19 & 21 pictured.

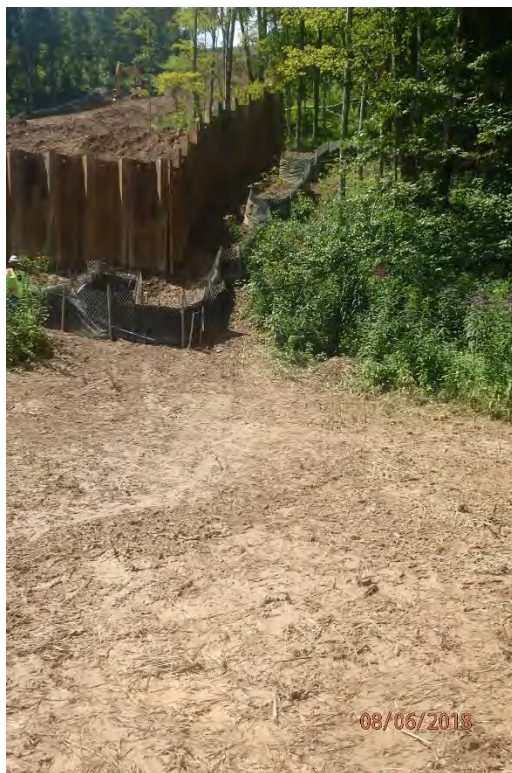
Offsite sediment deposits associated with the overwhelmed BMP at Rockcamp Run. Deficiencies in site evaluation item numbers 1, 2, 6, 7, 8, 13, 14, 19 & 21 pictured.

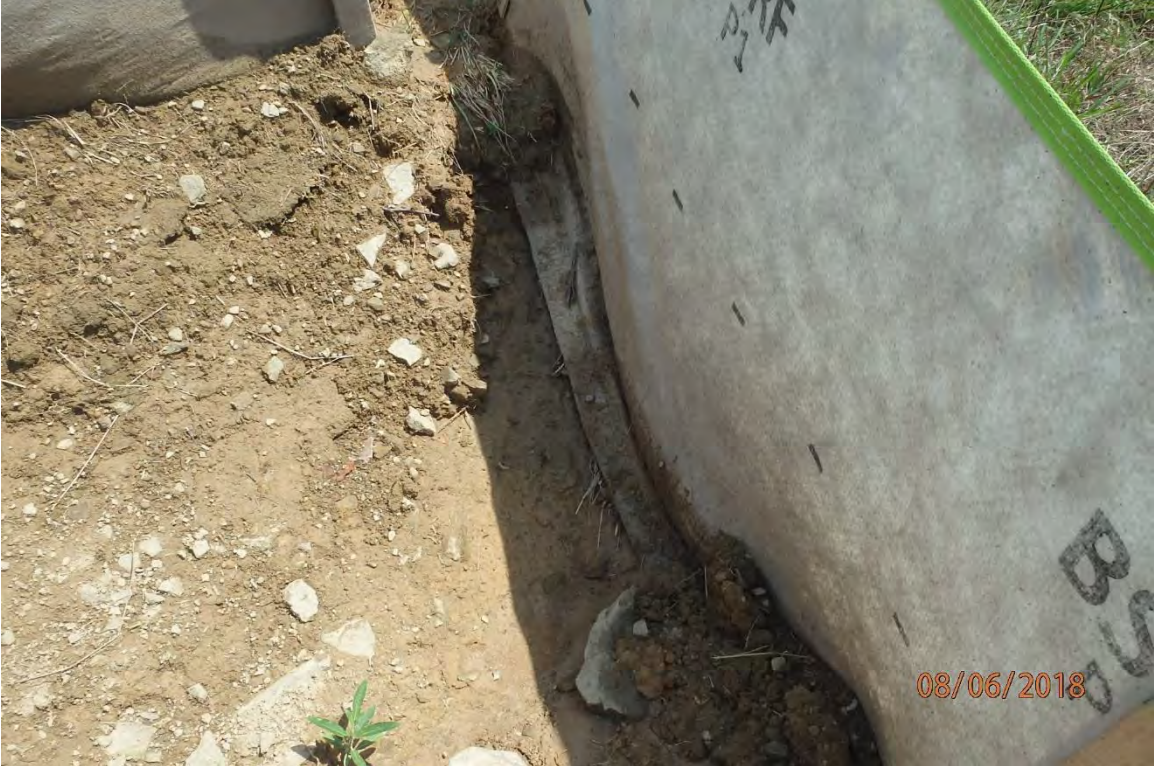
BMP in Seal Run watershed in need of maintenance that led to offsite sediment deposits.

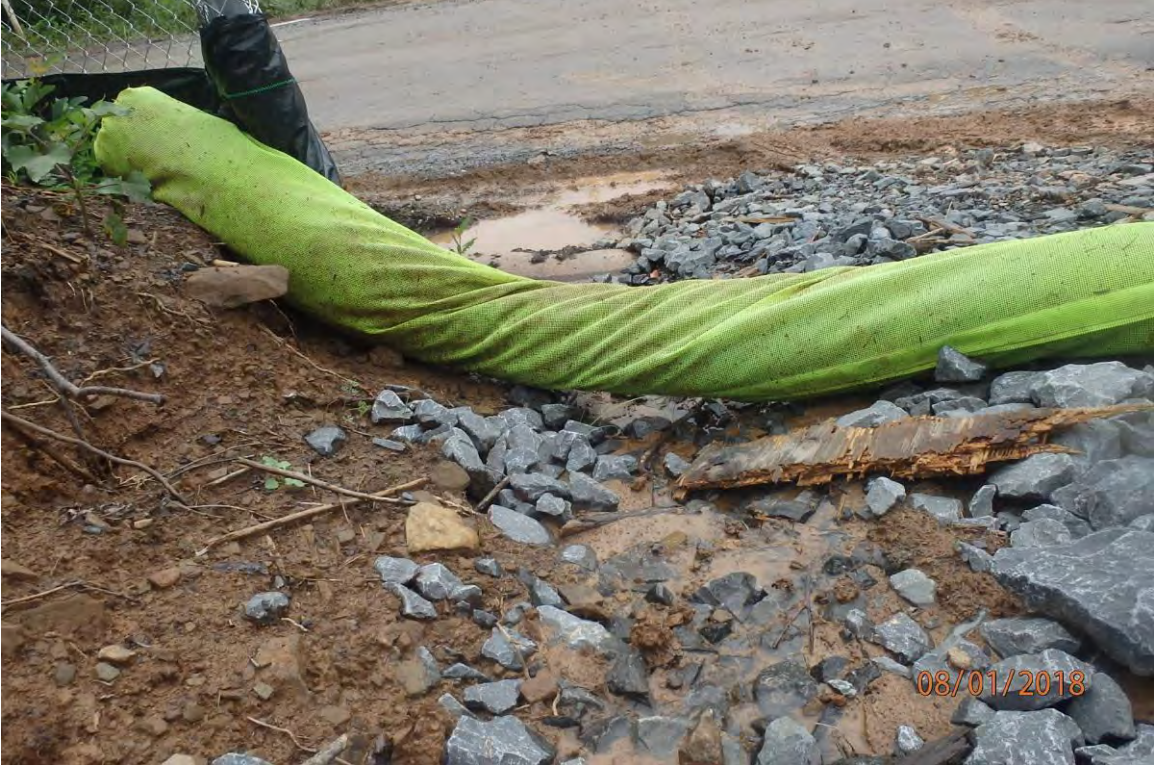
Improperly operated BMP in Right Fork of Big Elk watershed. Deficiencies in site evaluation item numbers 1, 6, 19 & 21 pictured.

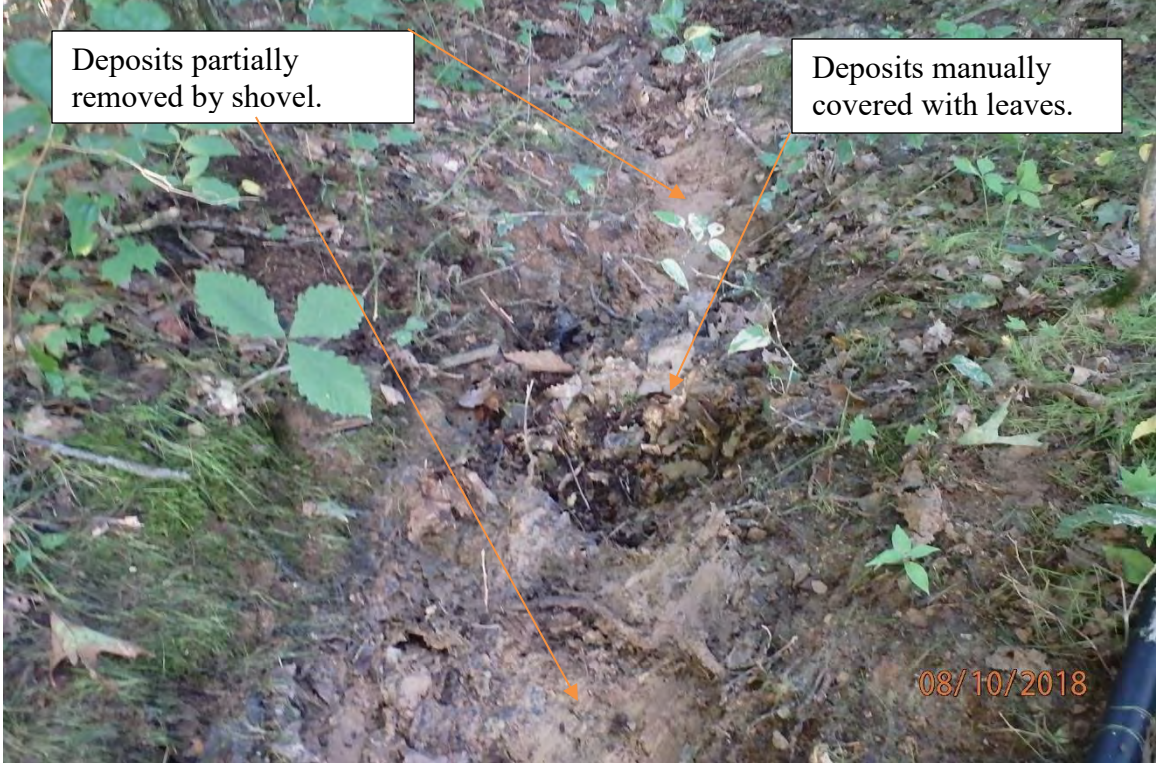
CNA deposits in UNT Dry Fork (39° 11.377' X 80° 33.566') that originate from site. Evidence of a portion of the deposits being removed by shovel and some deposits being manually covered with leaves was noted. Deficiencies in site evaluation item numbers 6, 7, 19, 20 & 21 pictured.

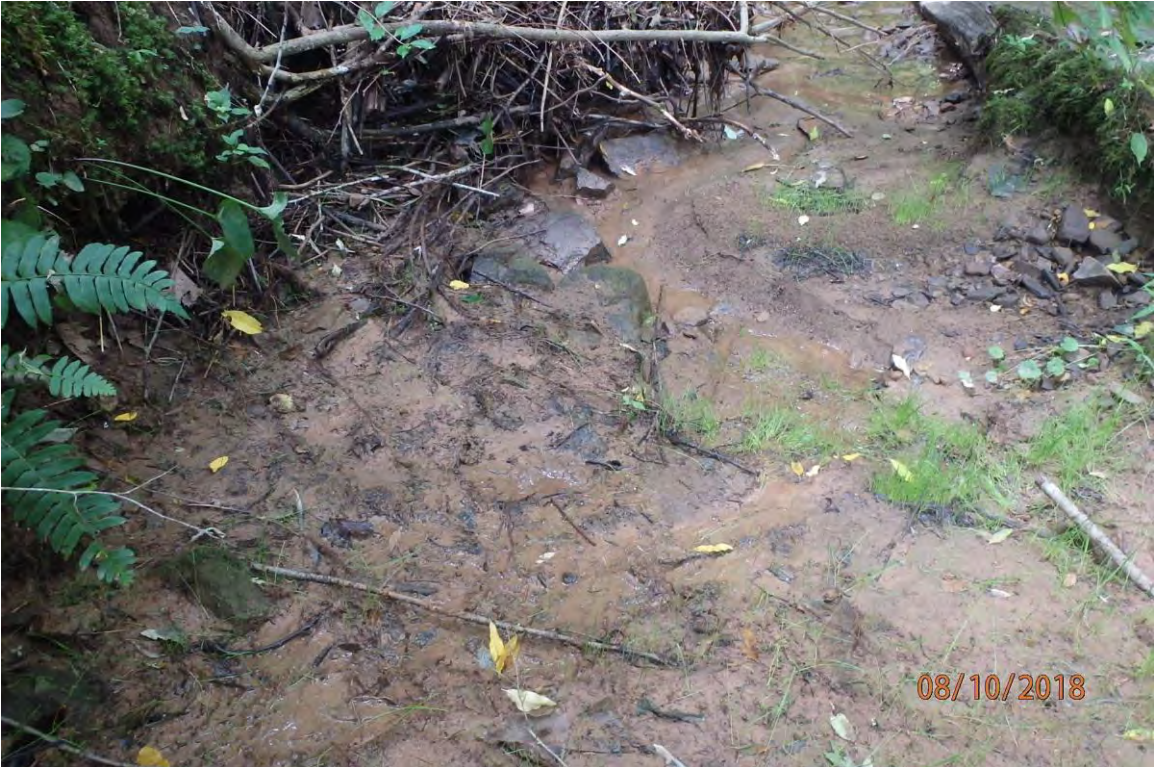
Offsite sediment deposits in Laurel Run (39° 01.043' X 80° 35.867') that originate from site. Deficiencies in site evaluation item numbers 6, 7, 14, 19, 20 & 21 pictured.
