**The Wilderness Society et al. Comments on the
U.S. Forest Service Mountain Valley Pipeline and
Equitrans Expansion Project Draft Supplemental
Environmental Impact Statement (#50036)**

**WEST VIRGINIA DEPARTMENT OF ENVIRONMENTAL PROTECTION
WV OIL AND GAS CONSTRUCTION STORMWATER PERMIT**

FACILITY NAME:	Mountain Valley Pipeline Project			REG. #	EXPIRE DATE:
PERMITTEE	MOUNTAIN VALLEY PIPELINE, LLC			WVR310667	5/13/2018
ADDRESS/PHONE:	Attn: Matt Hoover 625 LIBERTY AVE, ST 1700 PITTSBURGH, PA 15222				
LOCATION:	Wileyville, WV			Entry Date/Time:	4/3/18 8:30am
COUNTY:	Wetzel			Exit Date/Time:	4/3/18 1:37pm
Site Representative /Phone	Matt Hoover Sr. Environmental Coordinator (412) 258-5627			PHOTOS <input checked="" type="checkbox"/>	
CO-PERMITTEE:				ADDRESS:	
SITE OPERATOR:	Precision Pipeline			ADDRESS:	
PERMITTED ACREAGE	4214	WEATHER:	Rain	LAST INSPECTION:	N/A
RECEIVING STREAM(S)	Mobley Run > Ohio River				NOV: 1
Regular Mail <input type="checkbox"/> Certified Mail <input checked="" type="checkbox"/>	Tracking #				
OVERALL FACILITY RATING:	Unsatisfactory		COMPLIANCE OUTCOME	Not Immediately Corrected

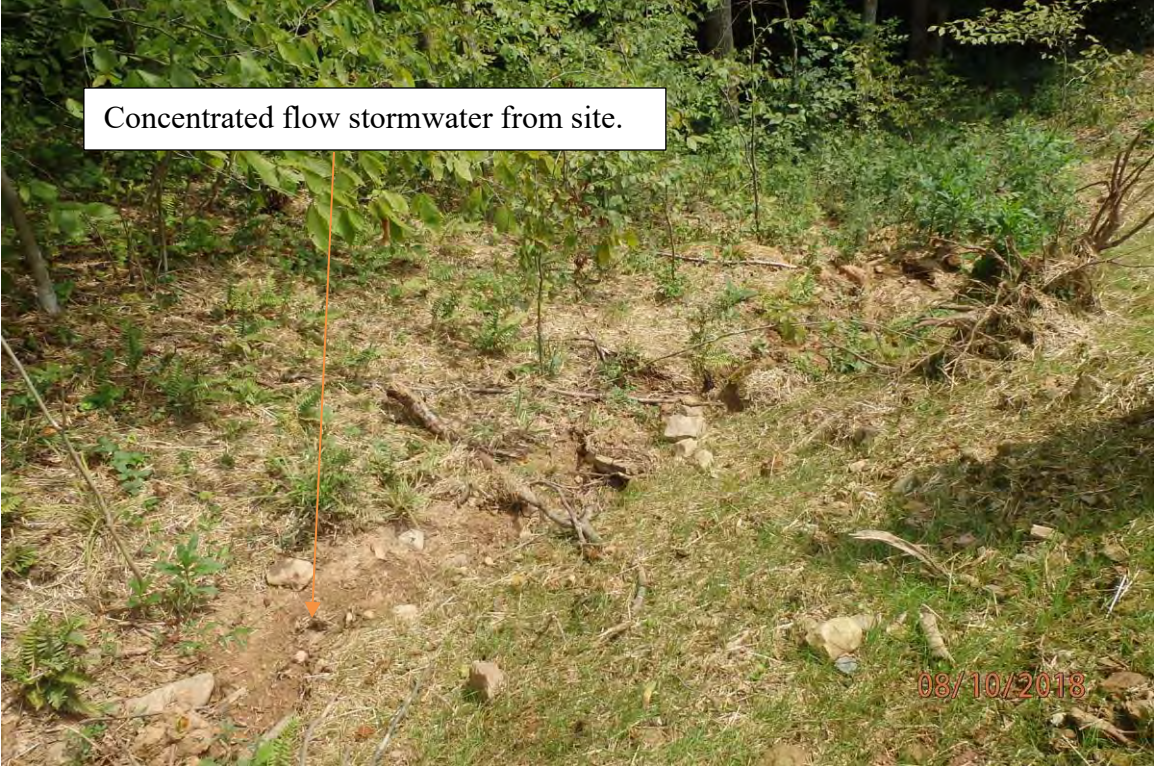
2). (1, 13, 15, 19, 20 & 21) BMPs were not indicated on the approved SWPPP in the area of 2692+00 adjacent to UNT Laurel Run (WKK-4a). Sediment laden water was leaving the site in this area and the responsible party failed to modify their plan and install additional BMPs. The failure to install additional BMPs caused offsite sediment deposits and CNA deposits in UNT Laurel Run (39° 01.133' X 80° 35.813').

Project area adjacent to 2692+00 showing a lack of installed BMPs where sediment laden water leaves the site.

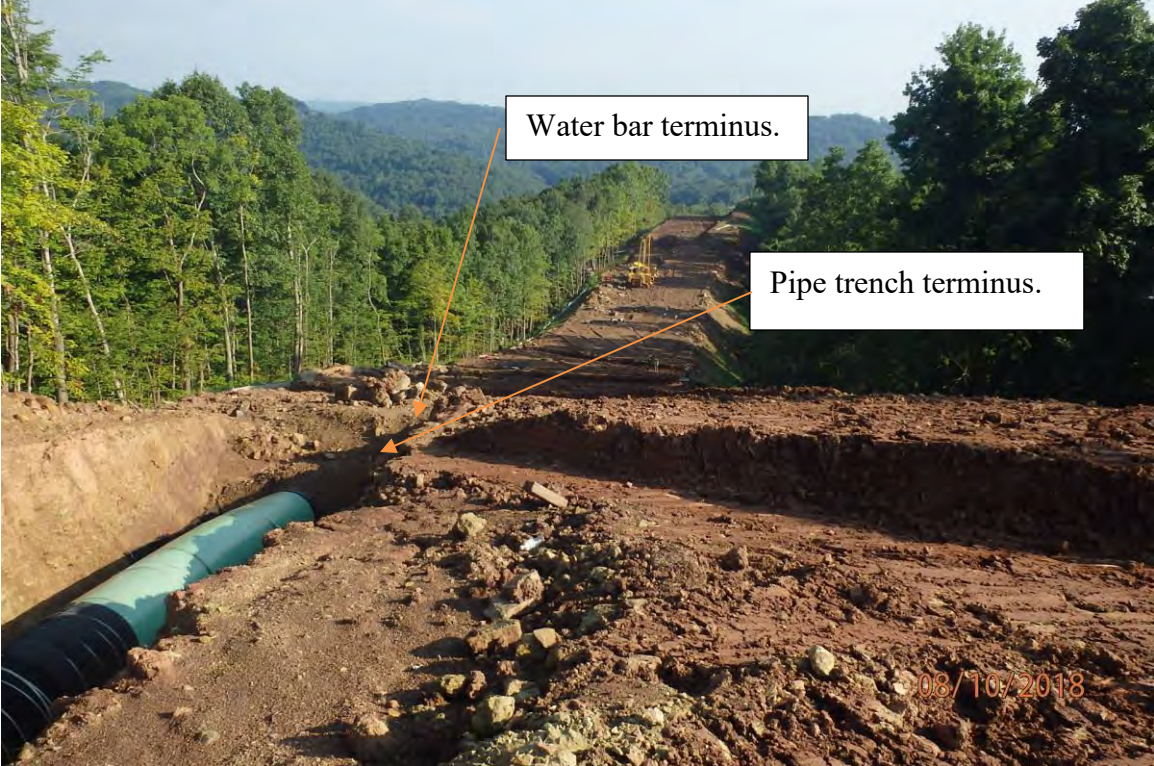
Improperly installed water bar in the Meathouse Fork watershed.

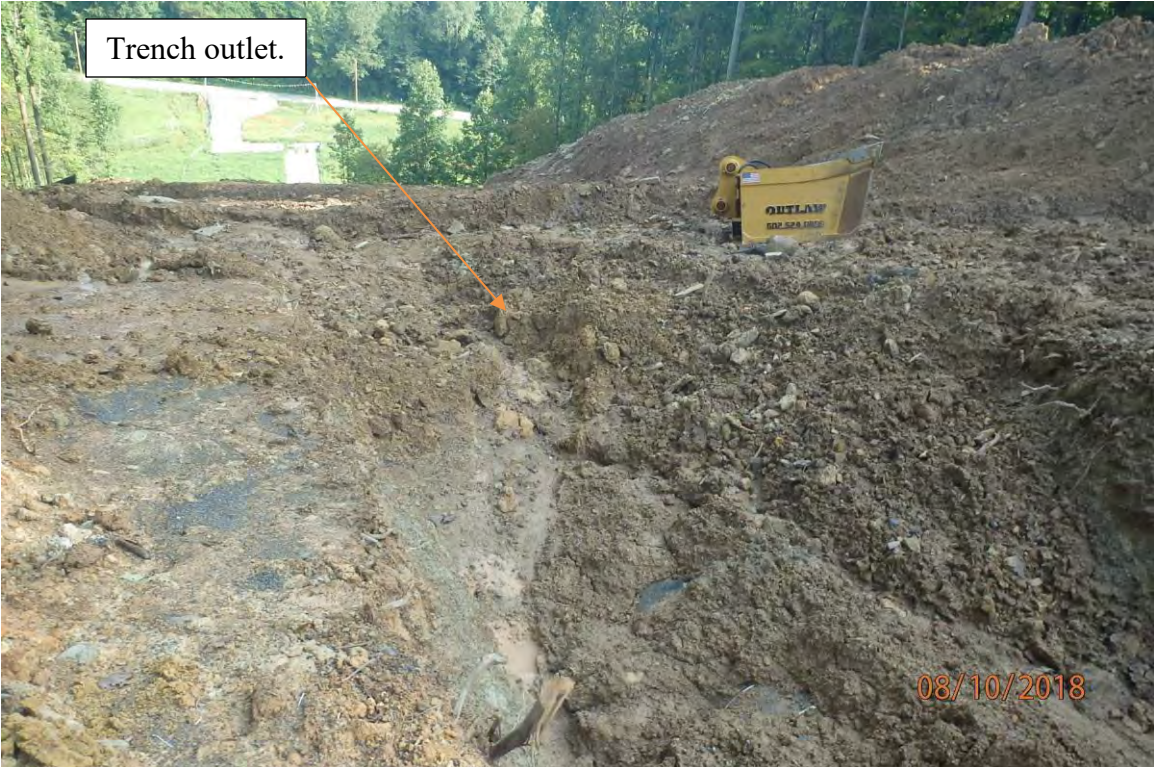
Issues with water bars that discharge into the pipe trench causing fill slope erosion. Deficiencies in site evaluation item numbers 2, 6, 8, 14, & 21 pictured.

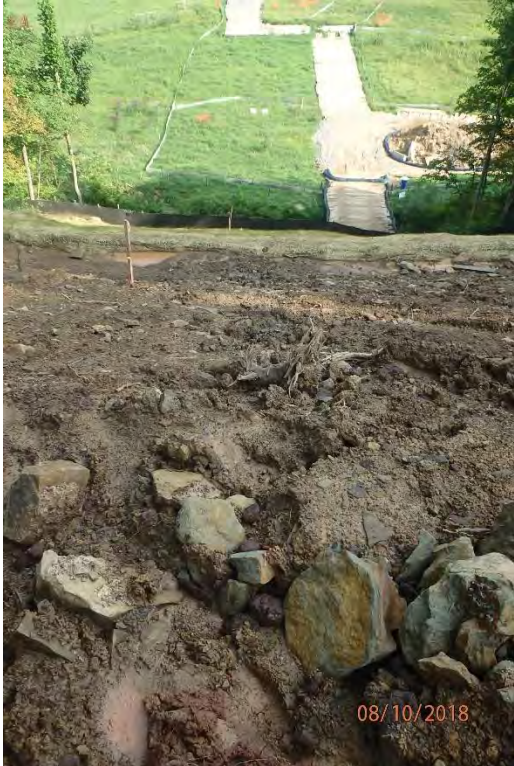
Water bar in Laurel Fork of Meathouse Fork watershed that has failed and is in need of maintenance.

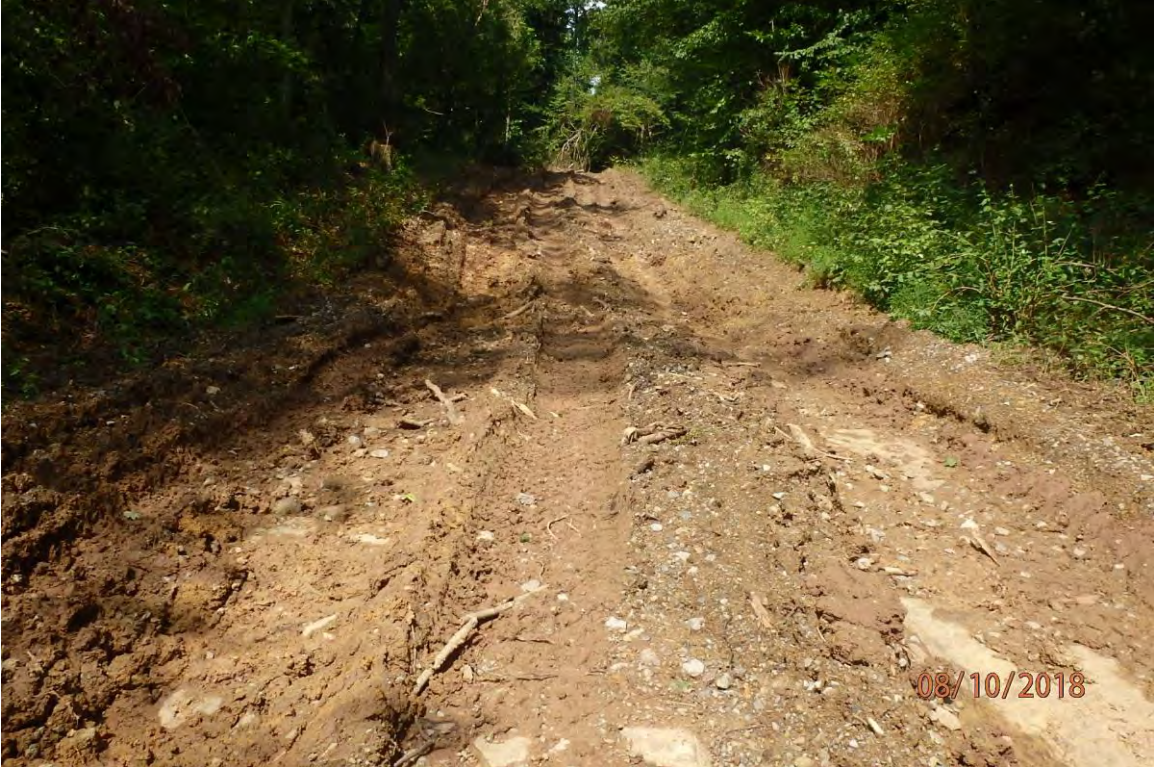
Water bar on access road LE-73.01 in the Sand Fork watershed that has been damaged by the clearing crew (Inactive since FERC permit suspension) and is in need of maintenance. Deficiencies in site evaluation item numbers 6, 7, 8 & 14 pictured.

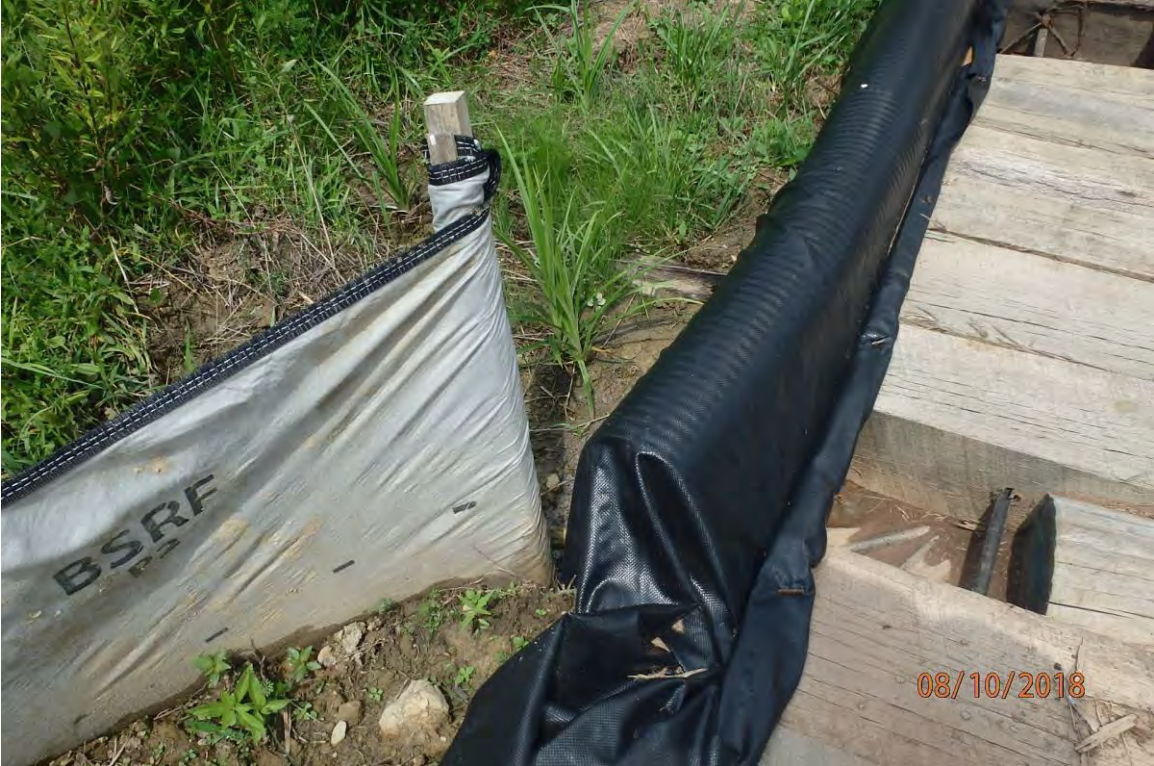
7). (1, 19 & 21) (Marginal) Perimeter controls that were not properly tied in to the timber mat bridge BMP was noted at W-K31 (Left Fork of Freemans Creek UNT wetland), SKK6 (Laurel Run of Cove Lick) & S-163 Sand Fork. No offsite sediment deposits or stream impacts were noted as a result of this deficiency.

Wetland UNT Left Fork Freemans Creek (W-K31) crossing showing perimeter control not properly tied in to timber mat crossing.

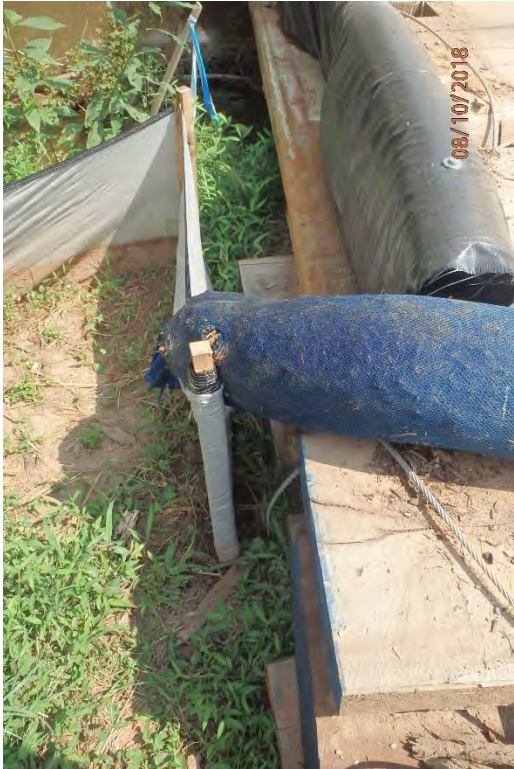
Sand Fork (S-163) crossing showing perimeter control not properly tied in to timber mat crossing. Marginal deficiencies in site evaluation item numbers 1, 19 & 21 pictured.

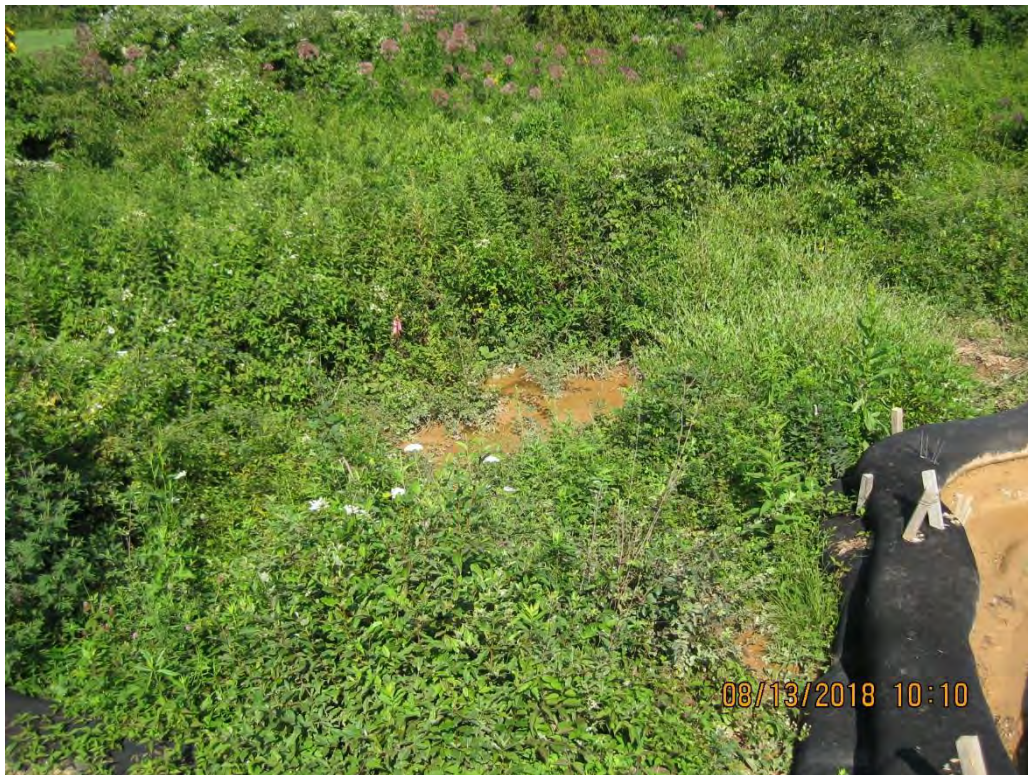
- (6. 13. 19. 20.) At St. 00+50 Sediment laden water had left the site via controls that had not been maintained. This control point is receiving concentrated stormwater from a large area and therefore requires an appropriately sized trapping structure. Perimeter controls were in place at the time of inspection. This area was identified in the 8-11-18 inspection log as requiring maintenance, which had not taken place. Sediment deposits were evident in adjacent wetland WQR-1 creating Conditions Not Allowable in the waters of the State.

At St. 00+50 Sediment laden water had left the site via controls that had not been maintained. This control point is receiving concentrated stormwater from a large area and therefore requires an appropriately sized trapping structure.

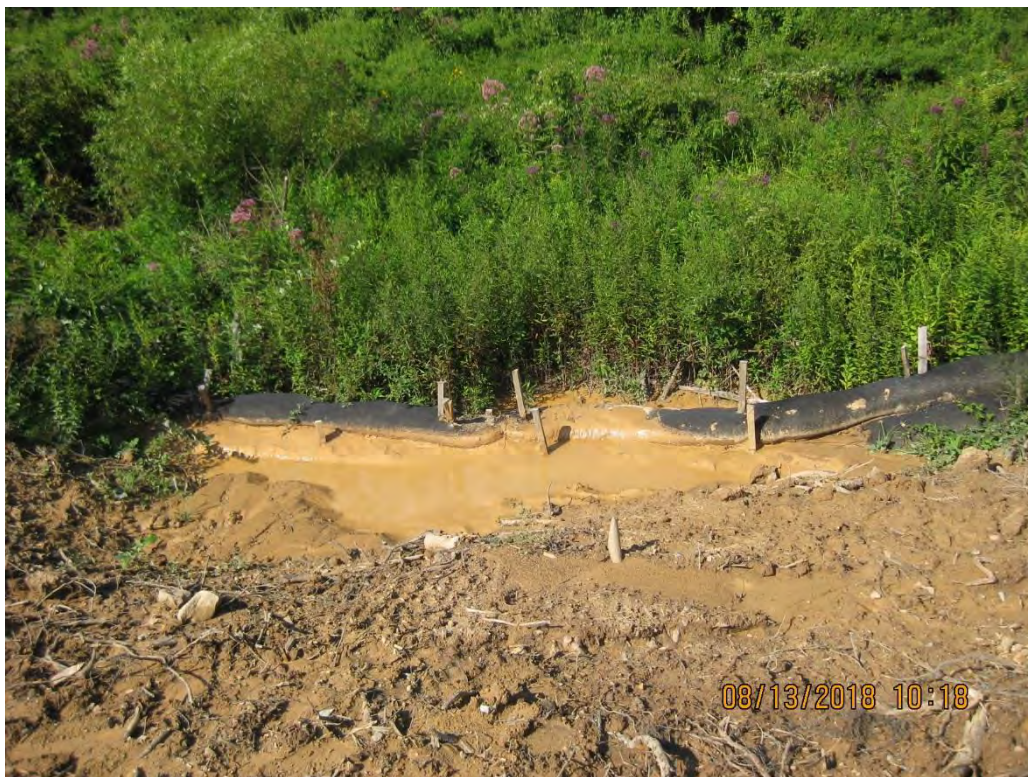
At St. 00+150 Sediment laden water left the site as a result of perimeter controls receiving concentrated flow and a lack of fill slope protection.

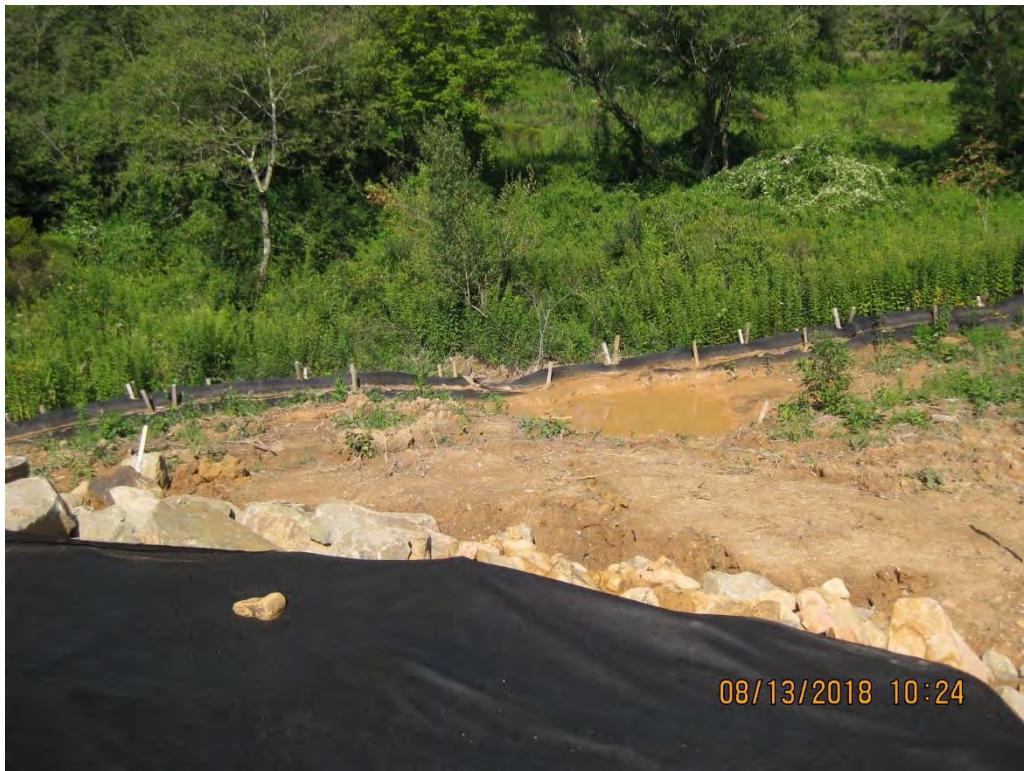
At St. 00+400 Sediment laden water left the site in three locations as a result of the lack of fill slope protection and the use of perimeter controls in an area of concentrated flow for a large drainage area that requires a sized trapping structure.

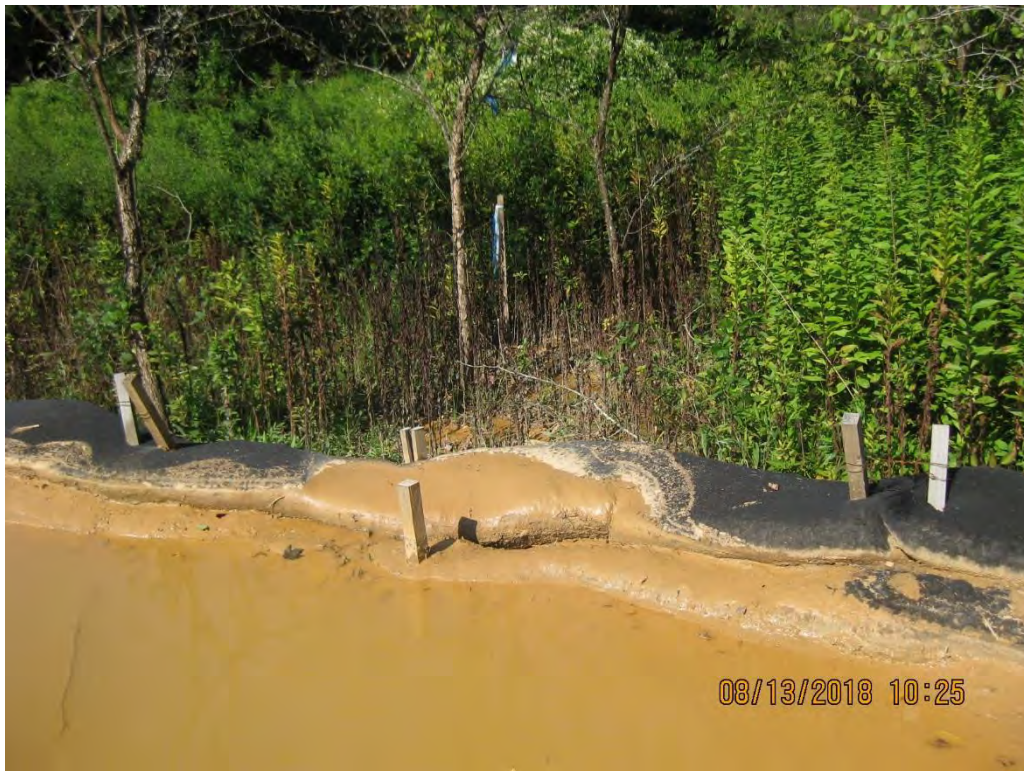
At St. 00+400 Sediment laden water left the site in three locations as a result of the lack of fill slope protection and the use of perimeter controls in an area of concentrated flow for a large drainage area that requires a sized trapping structure.

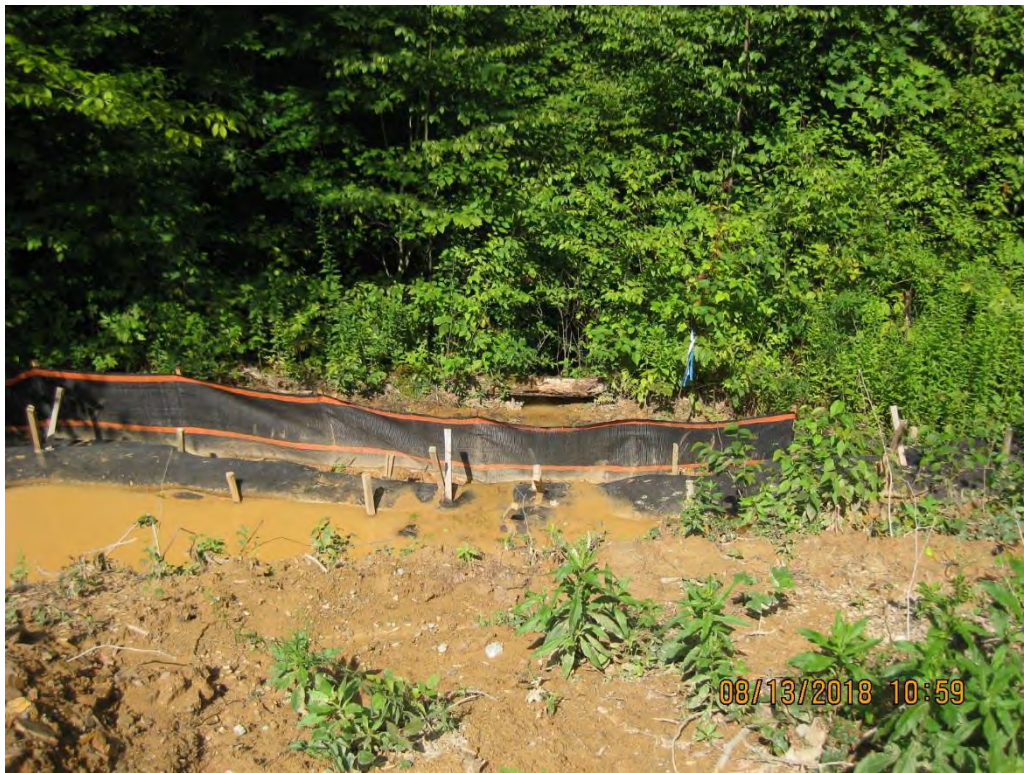
At St. 00+650 Sump/CFS/Priority 1 SF for terminus of upper diversion has not been maintained, sediment laden water left the site as a result.

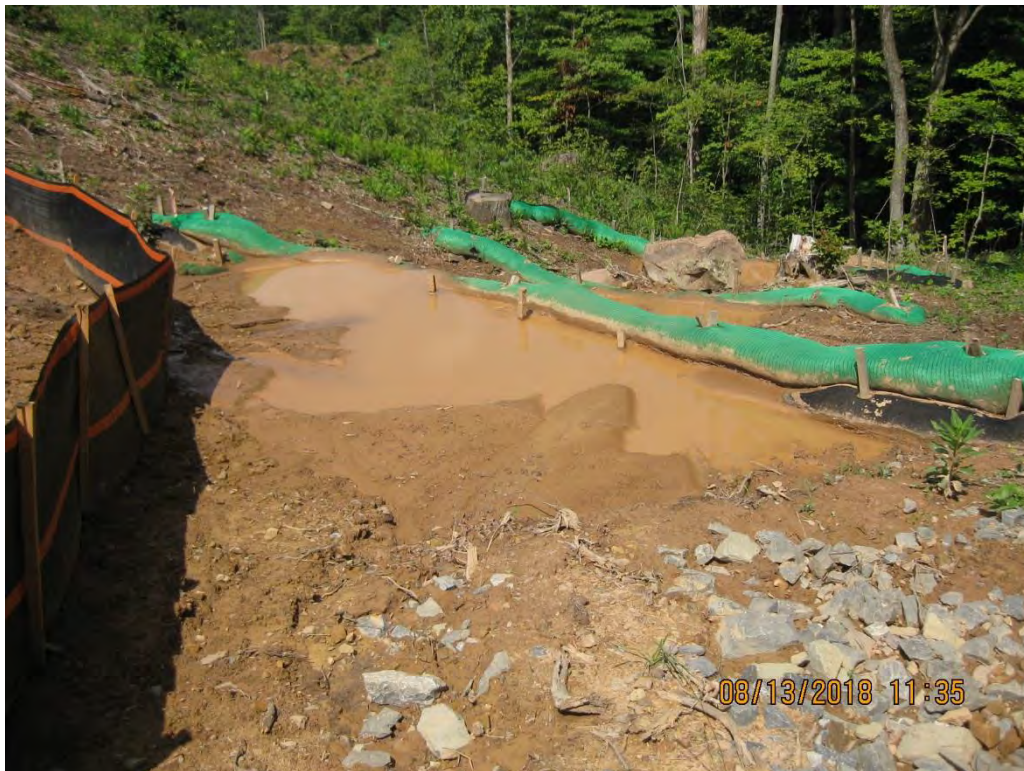
At St. 00+220 a series of perimeter controls used in a concentrated flow area had failed allowing sediment laden water to leave the site.

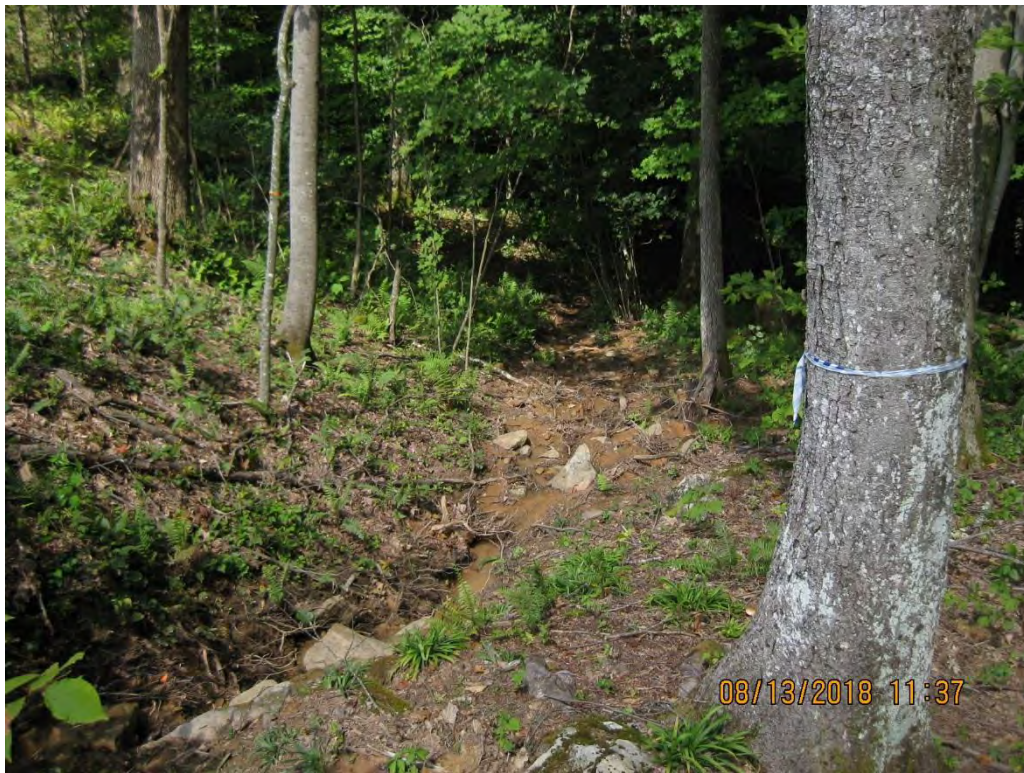
At St. 00+220 a series of perimeter controls used in a concentrated flow area had failed allowing sediment laden water to leave the site. Sediment deposits were noted in receiving stream A-104 creating Conditions Not Allowable in the Waters of the State.

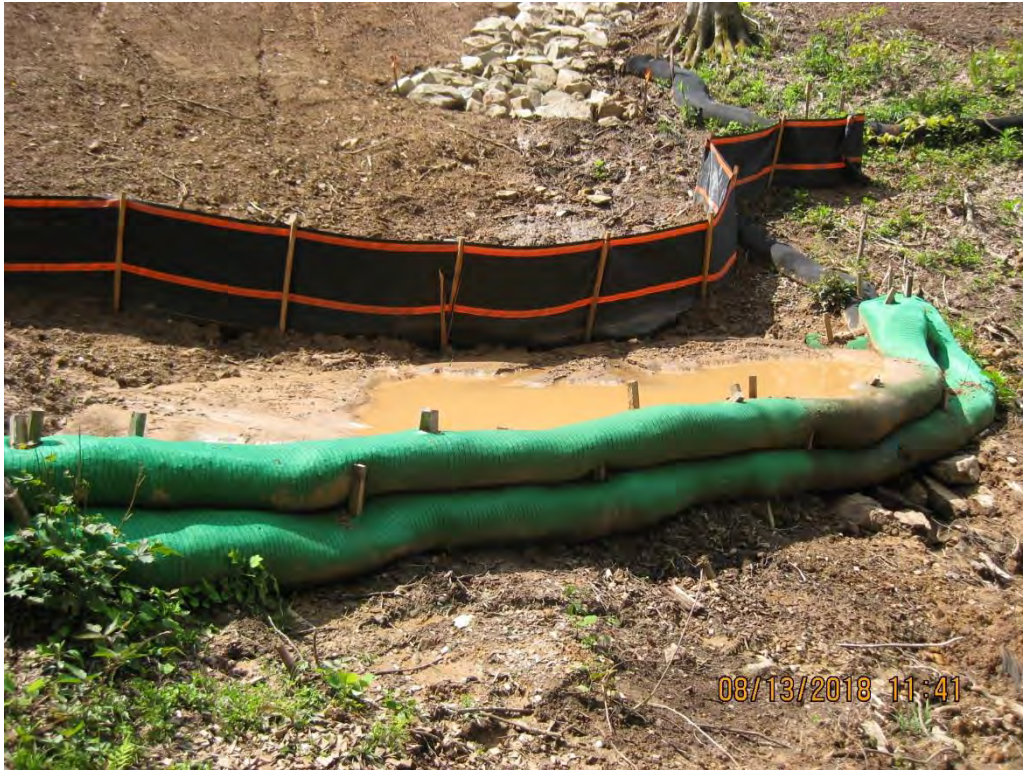
Maintenance needed north of the east wall.

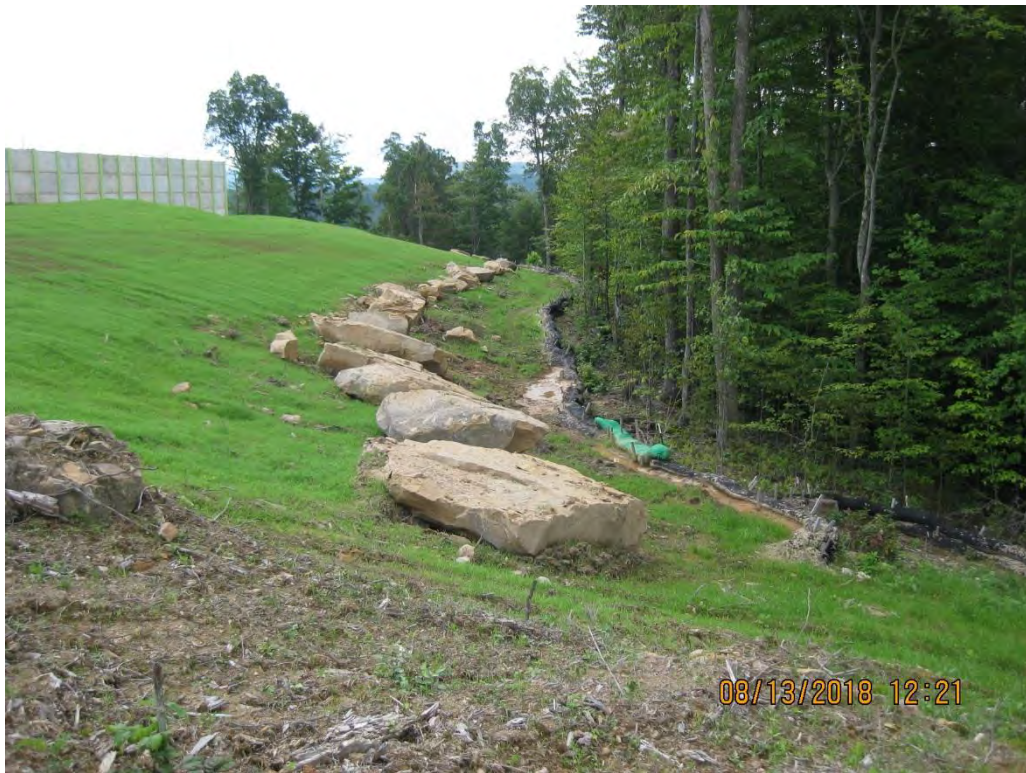
Maintenance needed for CFS at Southwest wall (marginal).

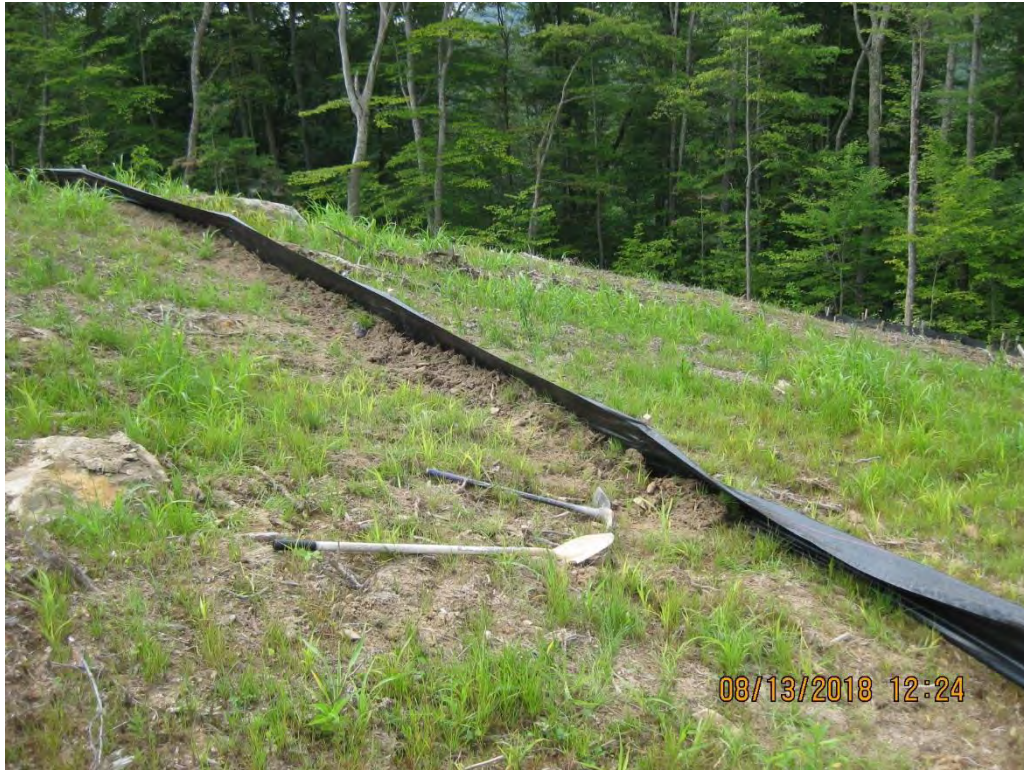
Silt fence being installed on the southern portion of the pad area was not joined or trenched in properly.

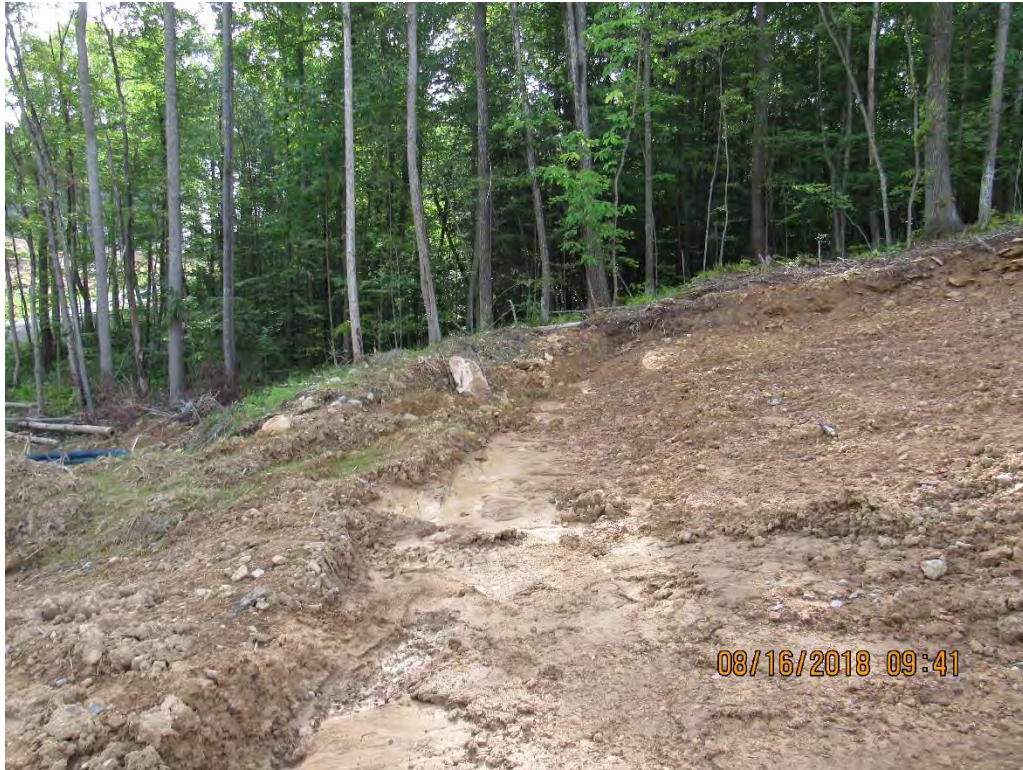
- 6, 7, & 13.- Bingham Road (station 7450+00) water bars were sloped incorrectly (Photos 1-4), water bars terminus need maintenance (Photo 5), water bar did not have proper outlet (Photos 6-8), bridge fabric was broken by timber mat at station 7465+00 (Photos 9 & 10) and entrance off Bingham Road needed controls installed- erosion rills were evident on slope adjacent to stream (Photo 11). Compost filter sock (cfs) needs maintenance near Bingham Road (Photo12) and station 7232+00 (Photos 13 & 14)

- Section G.4.e.2. - Permittee has failed to properly implement controls: inadequate controls were installed near ROW entrance of Bingham Road station 7450+00 (Photo 11), water bars were improperly sloped near Bingham Road station 7450+00 (Photos 1-4), water bars lacked outlet near Bingham Road station 7450+00 (Photos 6-8), inadequate controls installed at base of fill slope at 7158+00 (Photos 17 & 18), inadequate number of water bars were installed between stations 7084+00 to 7093+50 (photos 21 & 22), inadequate controls were installed at water bar terminus at station 7084+00 (photos 23-30) and ditch checks were not installed in road side ditch below failed control at 7084+00.

Photo 1: Eastern view of one of several incorrectly sloped water bars off Bingham Road station 7450+00.

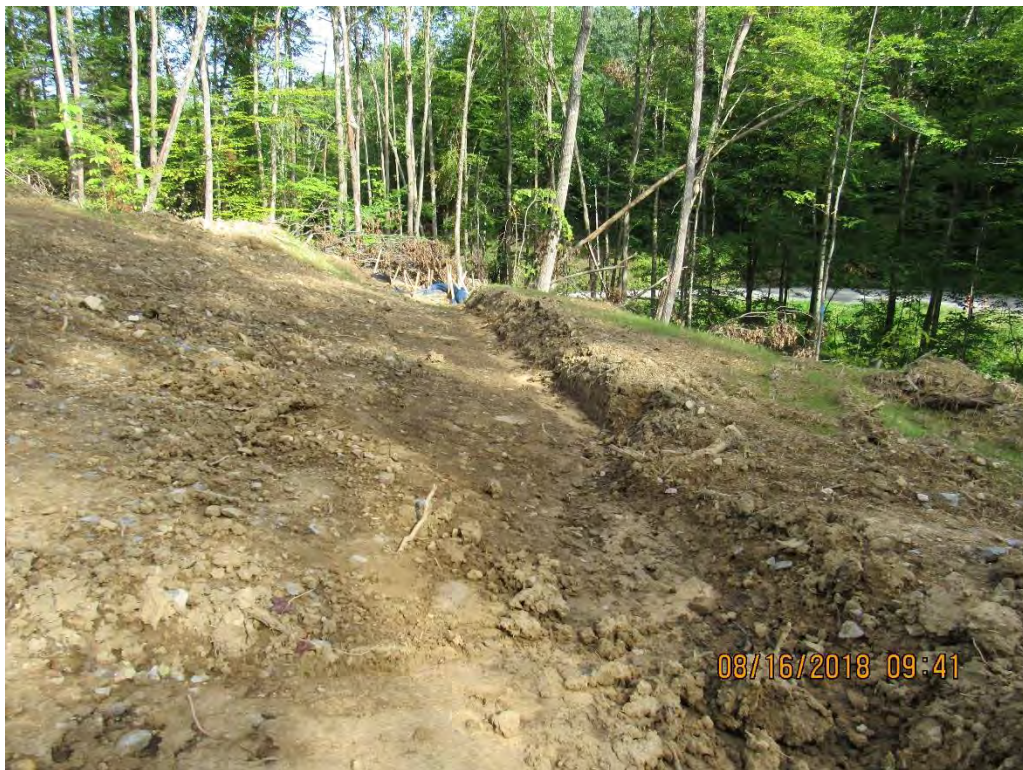
Photo 2: Western view of one of several incorrectly sloped water bars in Photo 1 off Bingham Road station 7450+00.

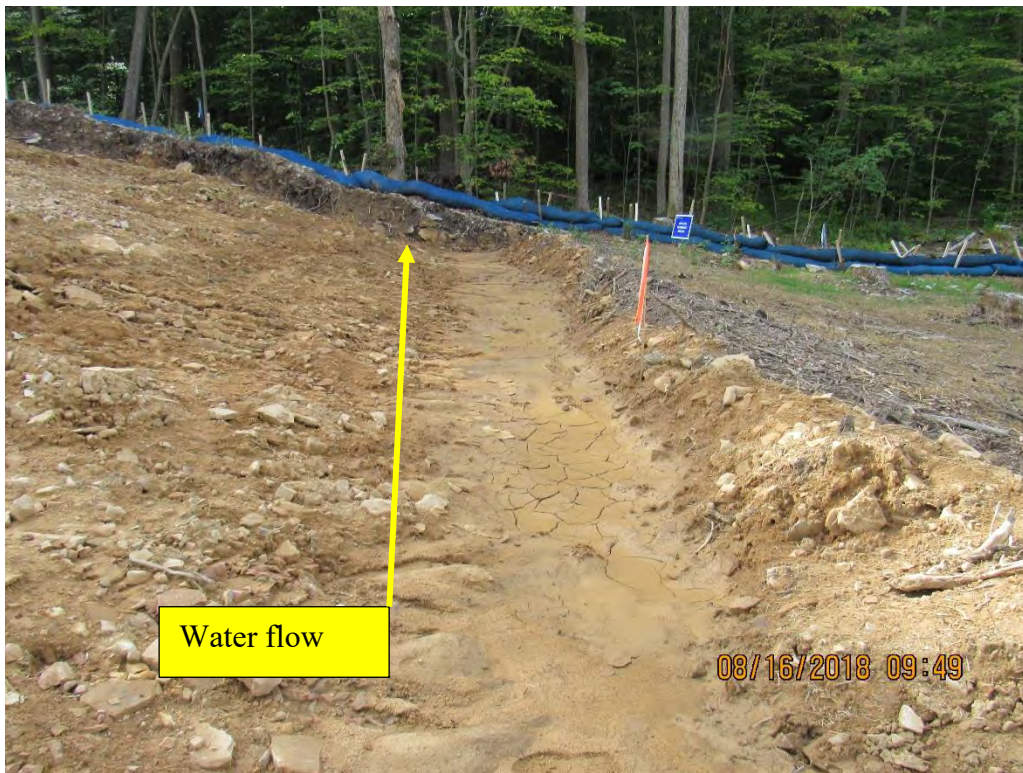
Photo 3: Incorrectly sloped water bar at Bingham Road station 7450+00- water is flowing away from outlet.

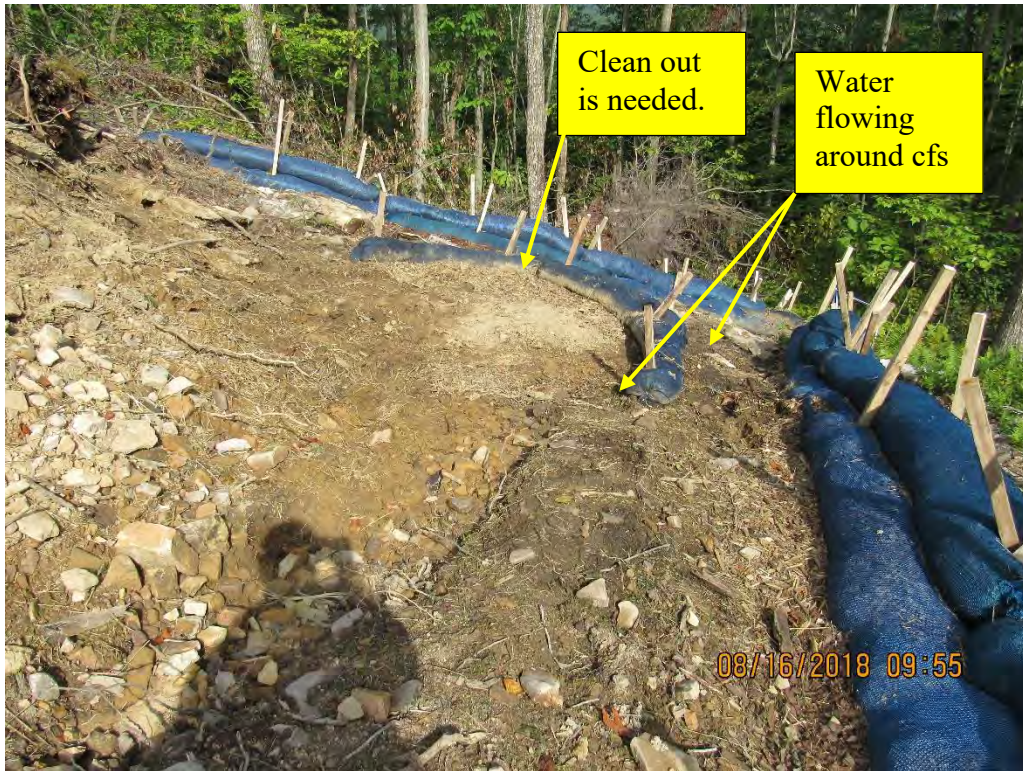
- Section D.1. - Permittee has failed to properly operate and maintain all systems of treatment and controls- Water bar terminus needed maintenance near Bingham Road station 7450+00 (Photo 5), timber mat bridge fabric was torn station 7465+00 (Photos 9& 10), CFS needs maintenance near Bingham Road (Photo 12) and station 7232+00 (Photos 13 & 14)

Photo 5: Water bar terminus needs maintenance at Bingham Road station 7450+00.

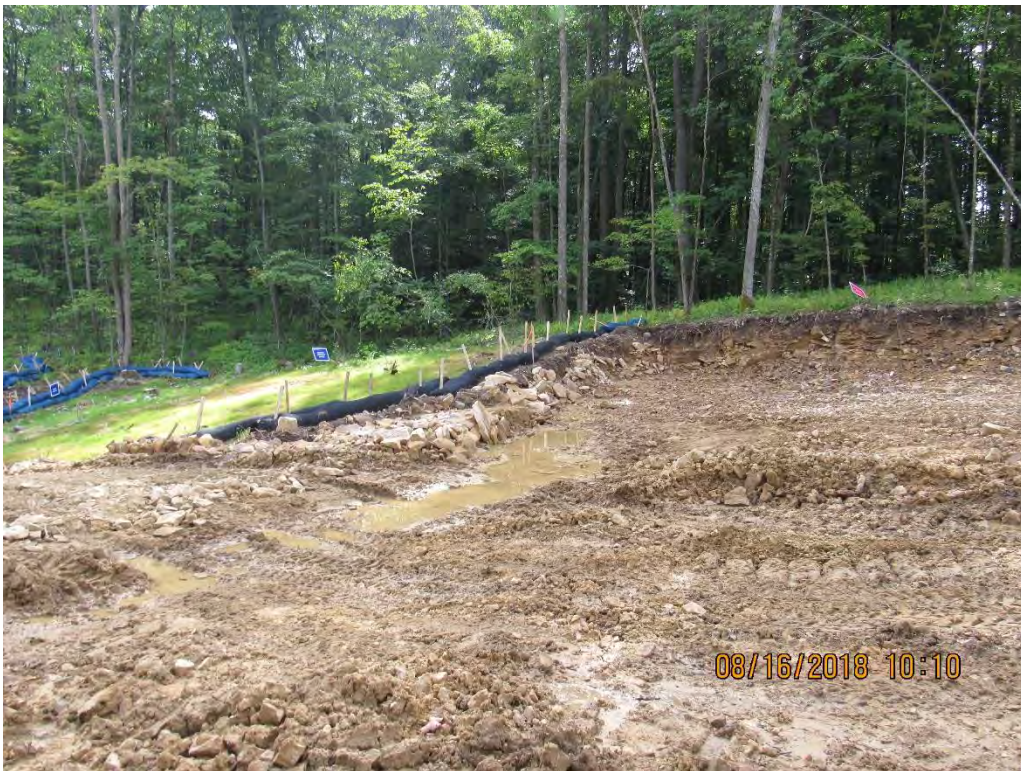
Photo 8: Eastern view of water bar without outlet near Bingham Road.

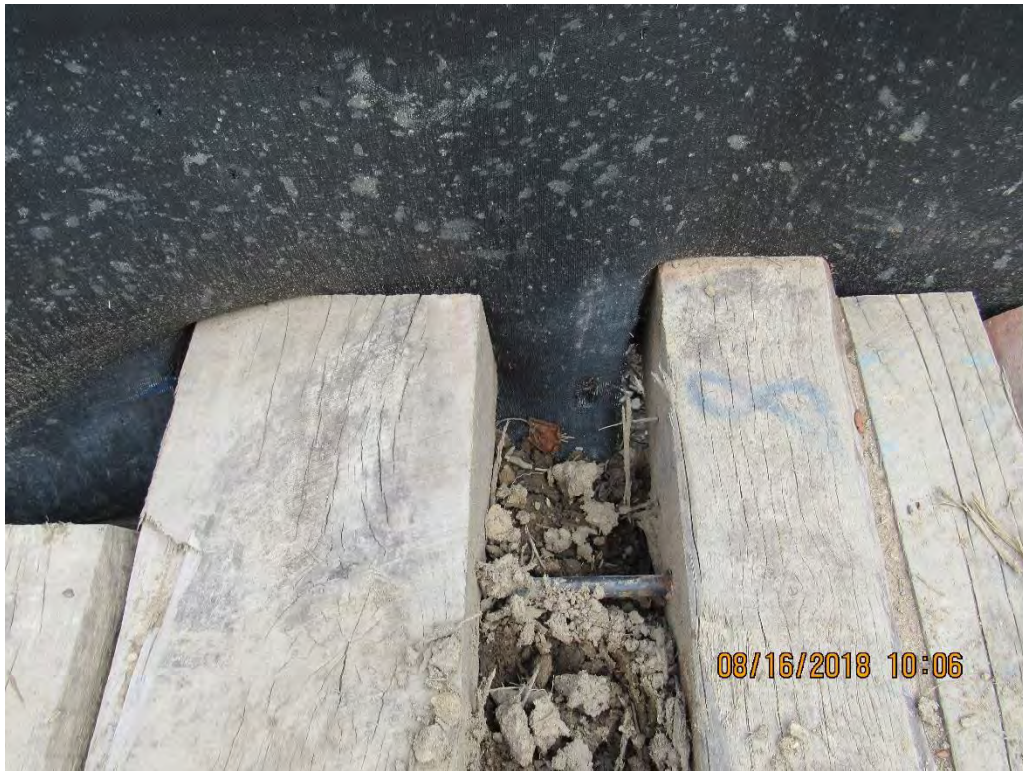
Photo 9: Timber bridge mat punctured filter fabric at station 7465+00.

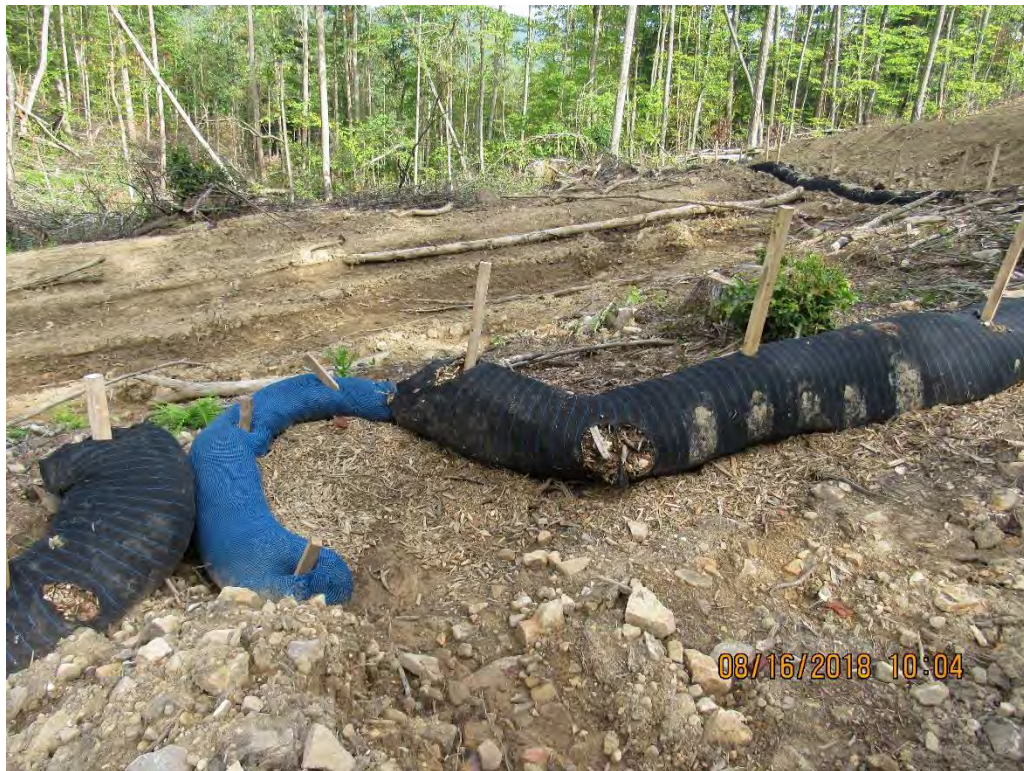
Photo 12: CFS needs maintenance near Bingham Road station 7450+00.

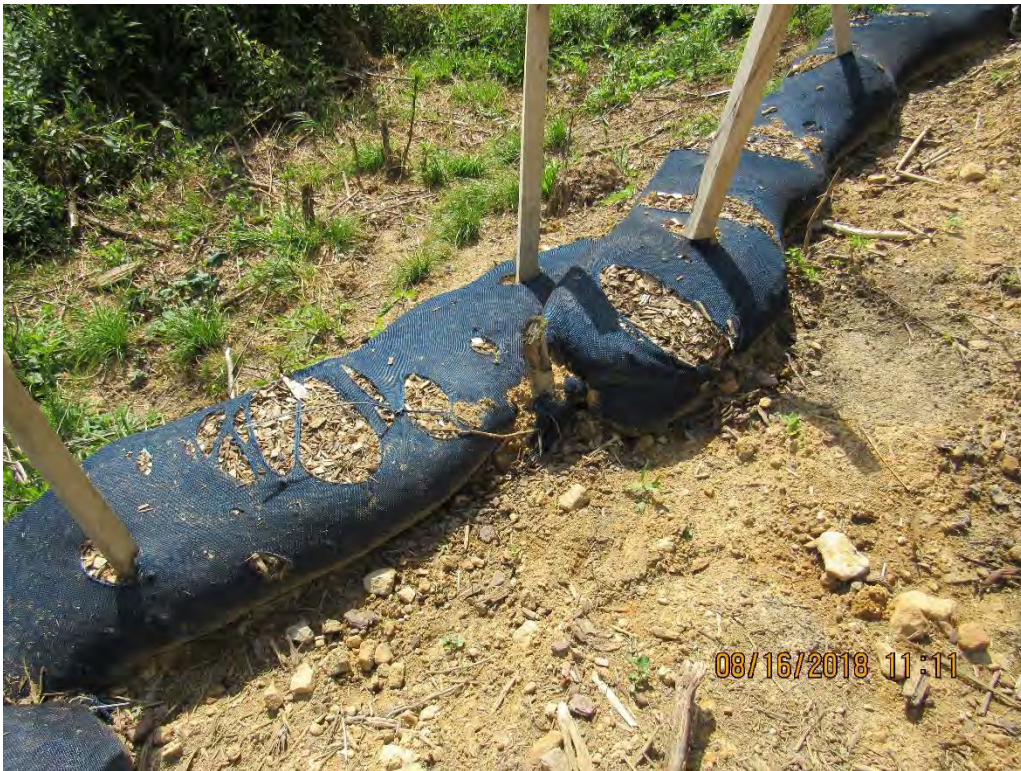
Photo 13: CFS needs maintenance near station 7232+00

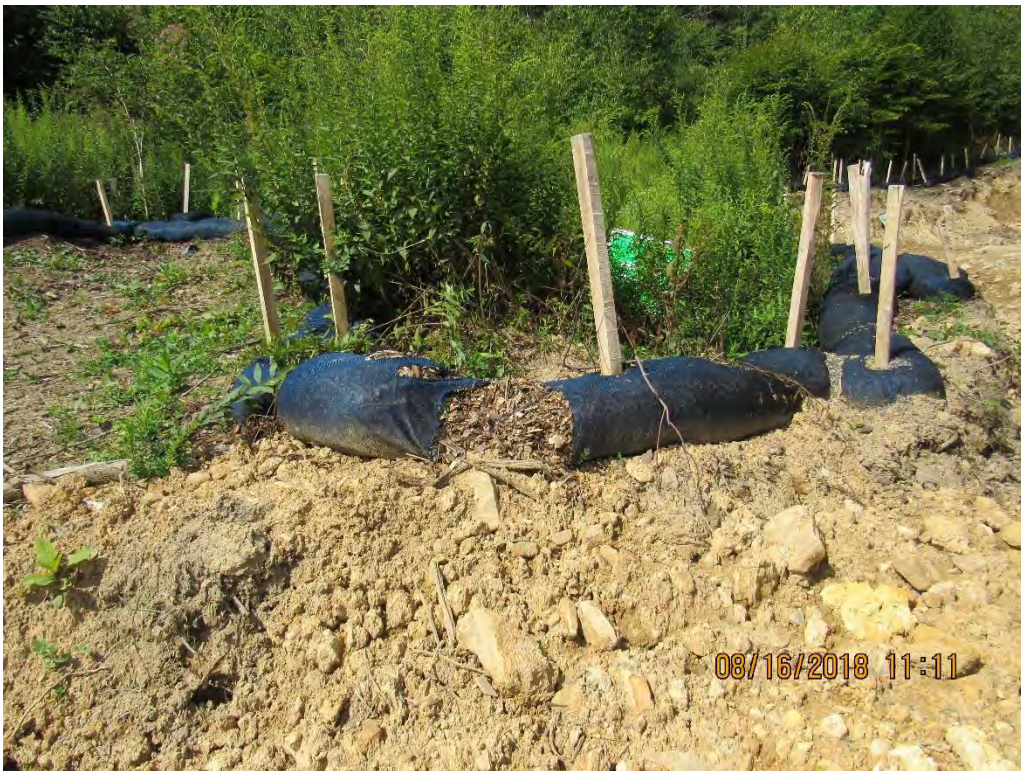
Photo 14: CFS needs maintenance near station 73232+00.
