**The Wilderness Society et al. Comments on the
U.S. Forest Service Mountain Valley Pipeline and
Equitrans Expansion Project Draft Supplemental
Environmental Impact Statement (#50036)**

**WEST VIRGINIA DEPARTMENT OF ENVIRONMENTAL PROTECTION
WV OIL AND GAS CONSTRUCTION STORMWATER PERMIT**

FACILITY NAME:	Mountain Valley Pipeline Project			REG. #	EXPIRE DATE:
PERMITTEE	MOUNTAIN VALLEY PIPELINE, LLC			WVR310667	5/13/2018
ADDRESS/PHONE:	Attn: Matt Hoover 625 LIBERTY AVE, ST 1700 PITTSBURGH, PA 15222				
LOCATION:	Wileyville, WV			Entry Date/Time:	4/3/18 8:30am
COUNTY:	Wetzel			Exit Date/Time:	4/3/18 1:37pm
Site Representative /Phone	Matt Hoover Sr. Environmental Coordinator (412) 258-5627			PHOTOS <input checked="" type="checkbox"/>	
CO-PERMITTEE:				ADDRESS:	
SITE OPERATOR:	Precision Pipeline			ADDRESS:	
PERMITTED ACREAGE	4214	WEATHER:	Rain	LAST INSPECTION:	N/A
RECEIVING STREAM(S)	Mobley Run > Ohio River				NOV: 1
Regular Mail <input type="checkbox"/> Certified Mail <input checked="" type="checkbox"/>	Tracking #				
OVERALL FACILITY RATING:	Unsatisfactory		COMPLIANCE OUTCOME	Not Immediately Corrected

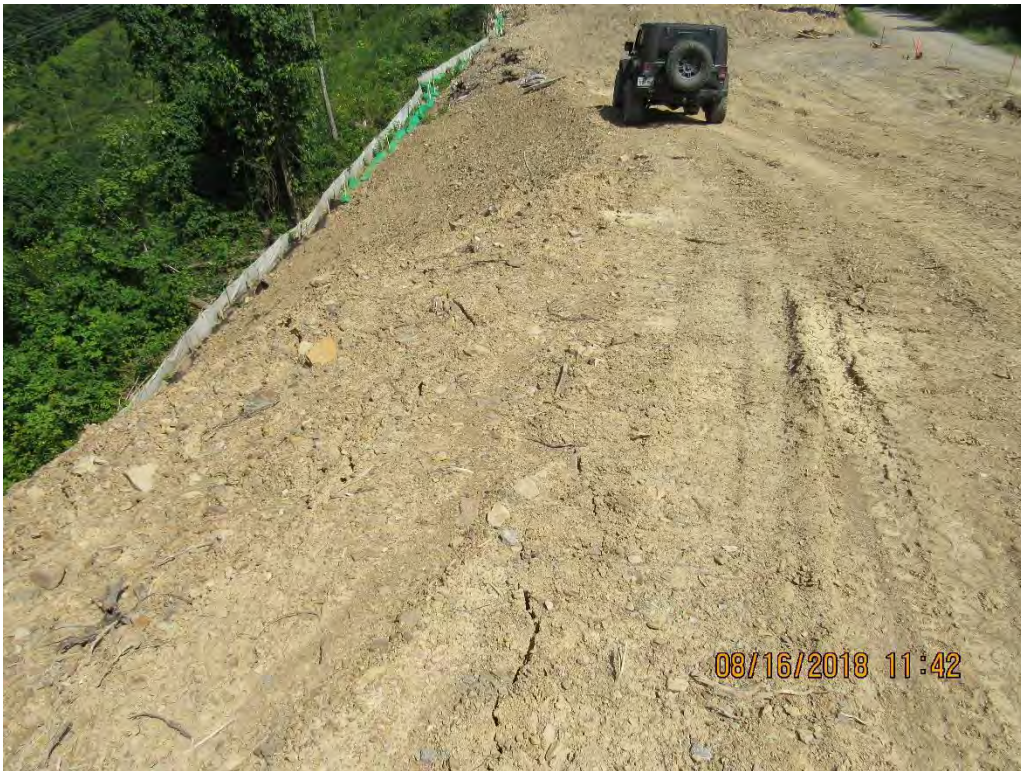
- 8, 13, & 14. – Bamboo Road station 7158+00 - fill slope is not protected, temporary stabilization has not been applied (Photos 15 & 16) and inadequate controls at base of slope (Photos 17 & 18). Waste pile at Bingham Road (approximate station 7465+37) needs additional stabilization applied (Photos 19 & 20) and all other areas where applicable.

- Section G.4.e.2.A.i.b. - Permittee has failed to provide interim stabilization on areas where construction activities have temporarily ceased for more than 21 days, specifically on waste piles near Bingham Road station 7465+37 (Photos 19 & 20), Bamboo Road station 7158+00 (Photos 15 & 16) and all other areas where applicable.

- Section G.4.e.2.A.ii.f. - Permittee has failed to protect fill slopes at station 7158+00 (Photos 15 & 16).
- Section G.4.e.2.A.ii.j - Permittee has failed to prevent sediment-laden water from leaving the site without going through an appropriate device- sediment laden water from failed water bar terminus is conveyed through road side ditch into culverts to leave perimeter at GPS location 38° 5.84131'N, 80° 43.1339'W (photos 28-30).

Photo 15: Northern view of Bamboo Road near Station 7158+00 without fill slope protection and temporary stabilization.

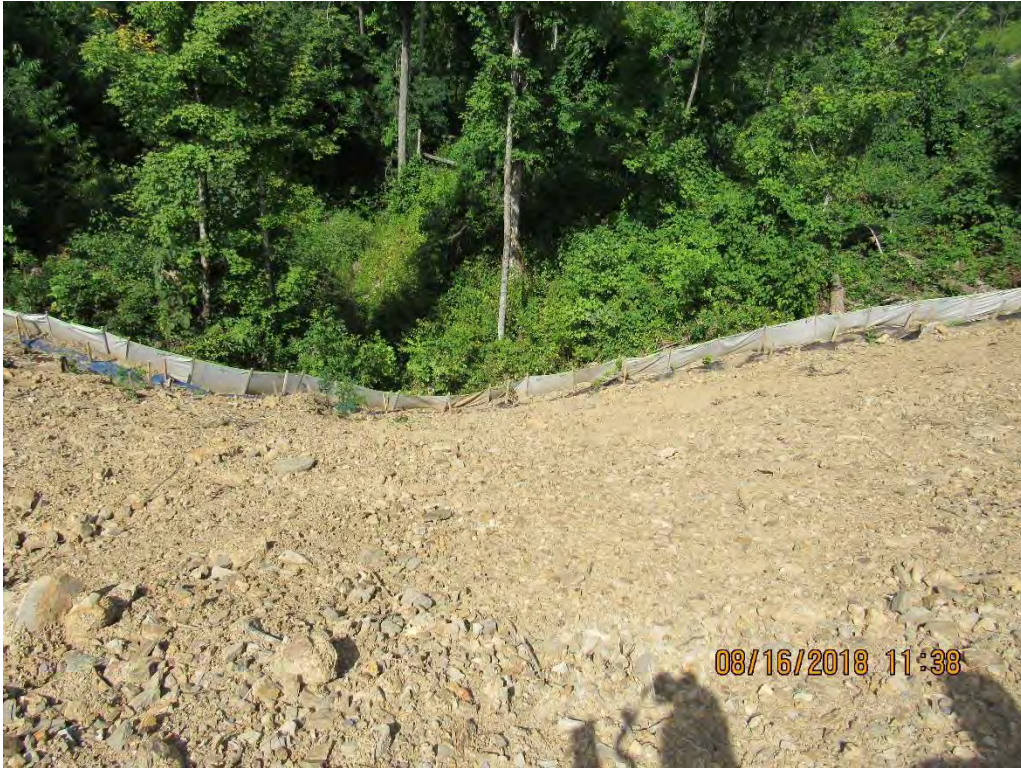
Photo 17: Inadequate controls for concentrated flow at base of fill slope near station 7158+00.

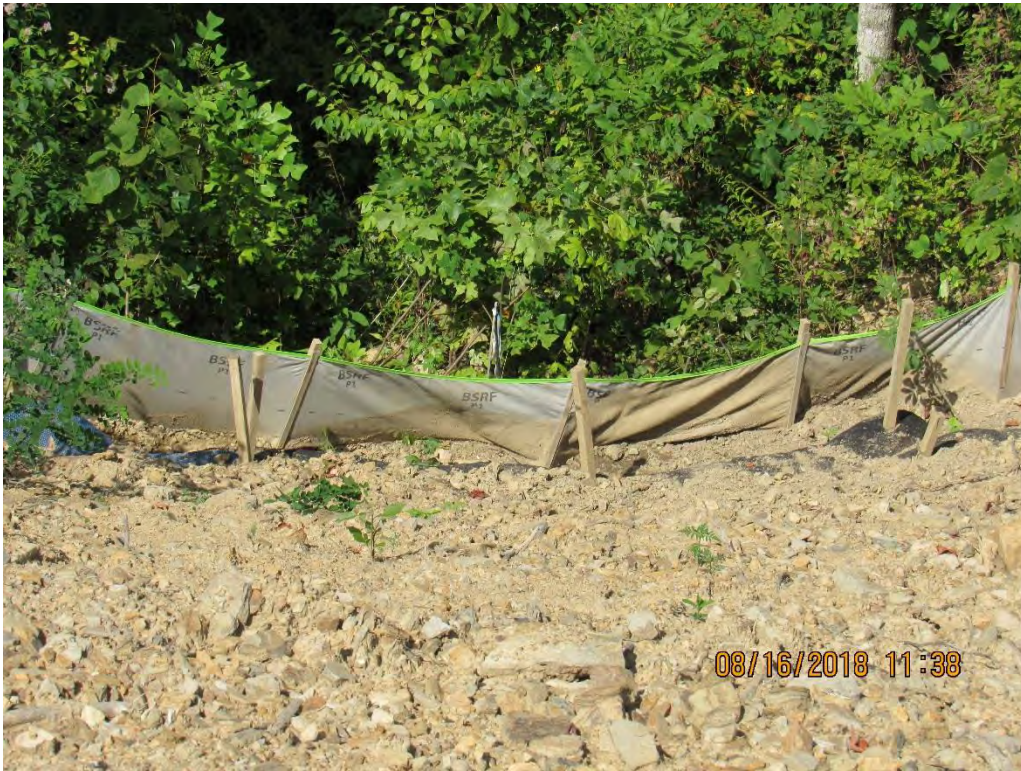
Photo 18: Close-up of inadequate controls for concentrated flow at base of fill slope near station 7158+00.

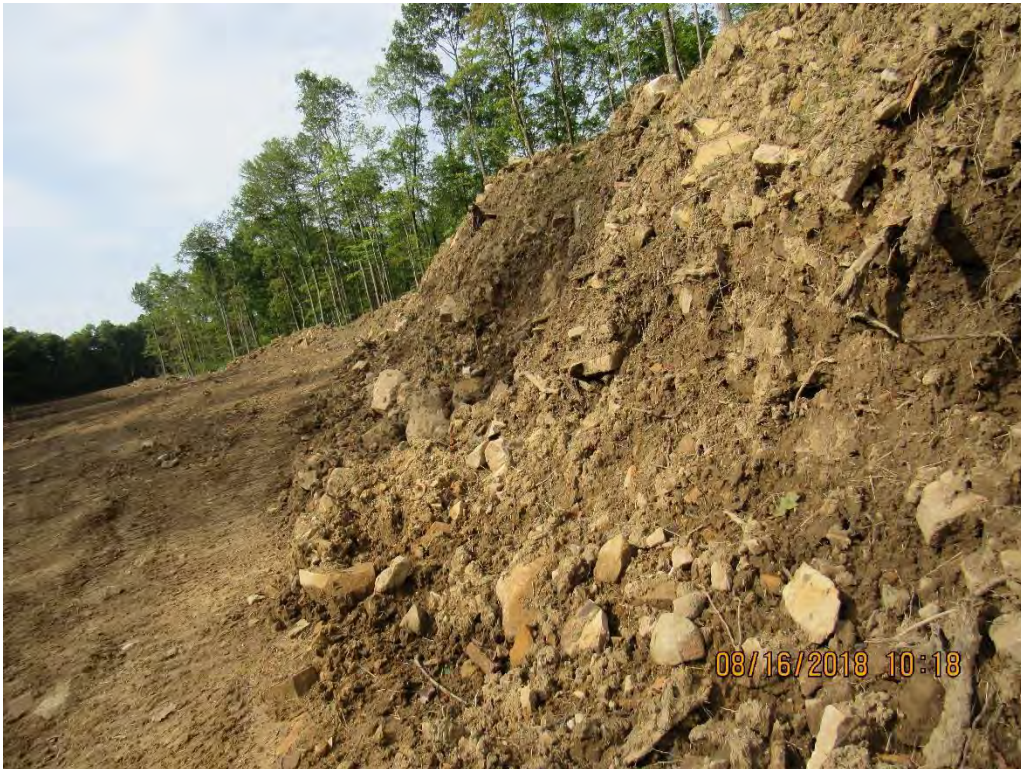
Photo 20: Southern view of waste pile with inadequate stabilization. (Photo taken near Bingham Road station 7450+00)

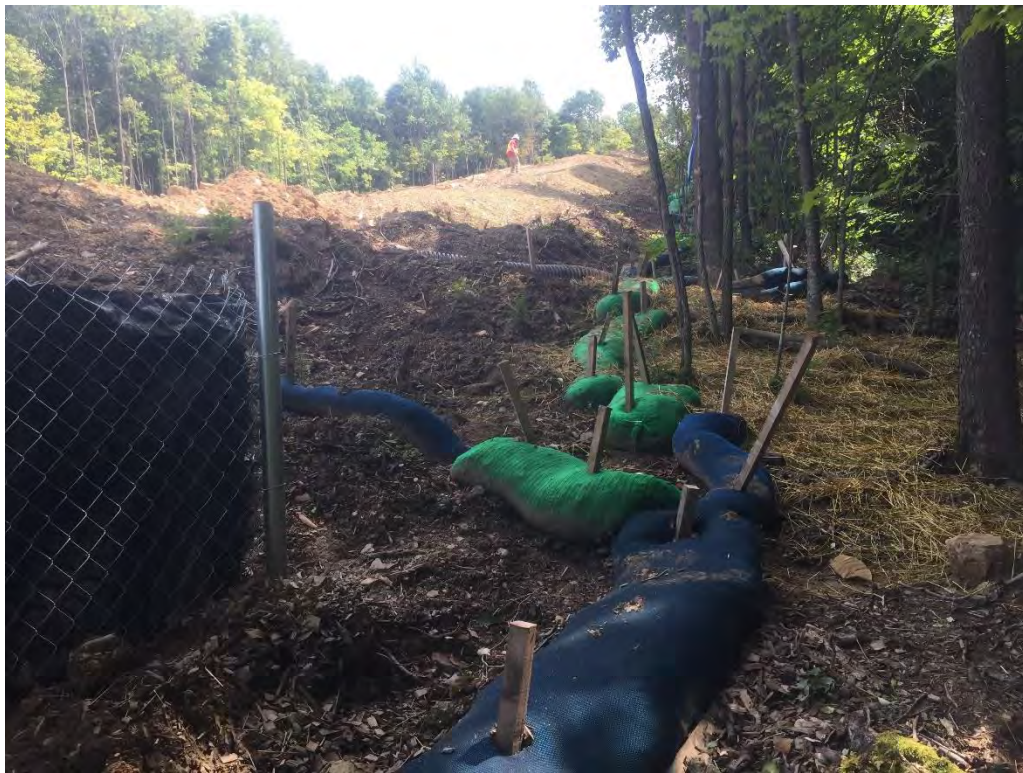
Photo 22: Failure of installed water bars between stations 7084+00 – 7093+50.

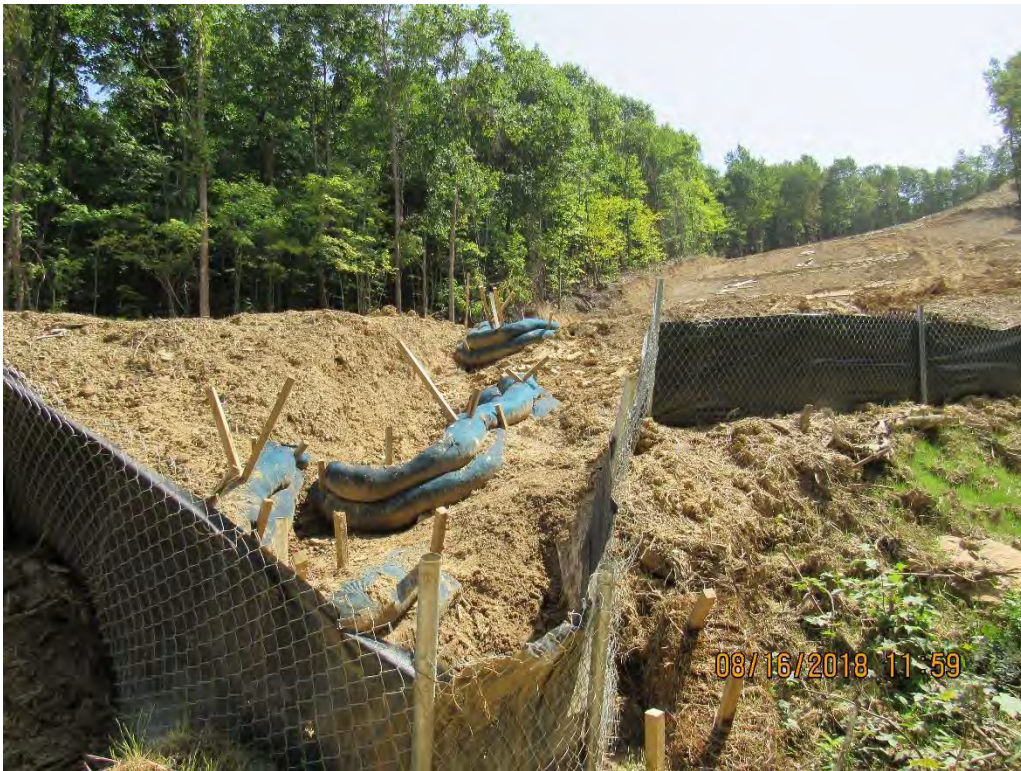
Photo 23: Water bar terminus at station 7084+00 with ROW slope of Photo 21 in background.

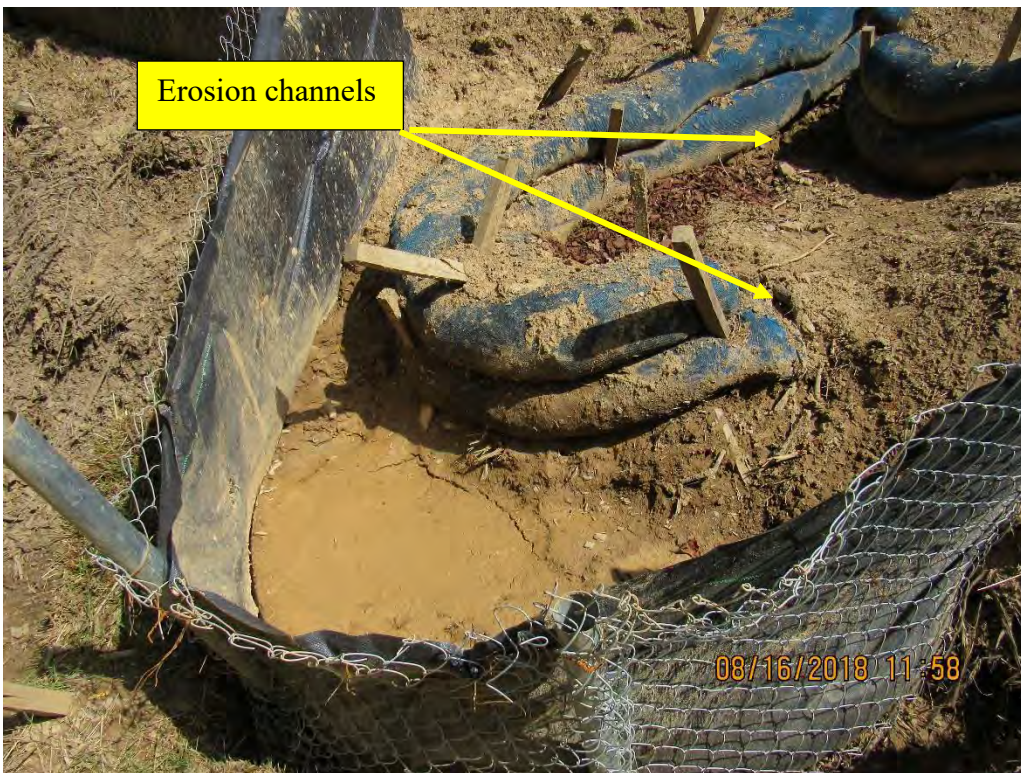
Photo 24: Water bar terminus at station 7084+00. Erosion channels observed at ends of CFS.

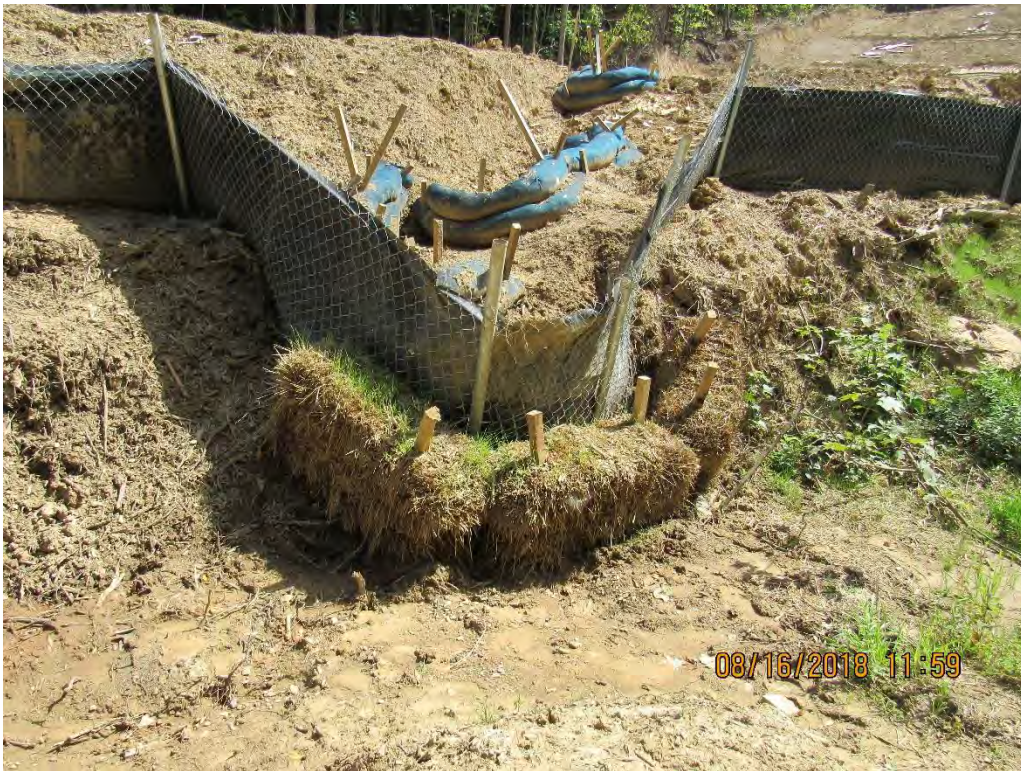
Photo 25: Controls and sediment deposits in road side ditch at water bar terminus at station 7084+00.

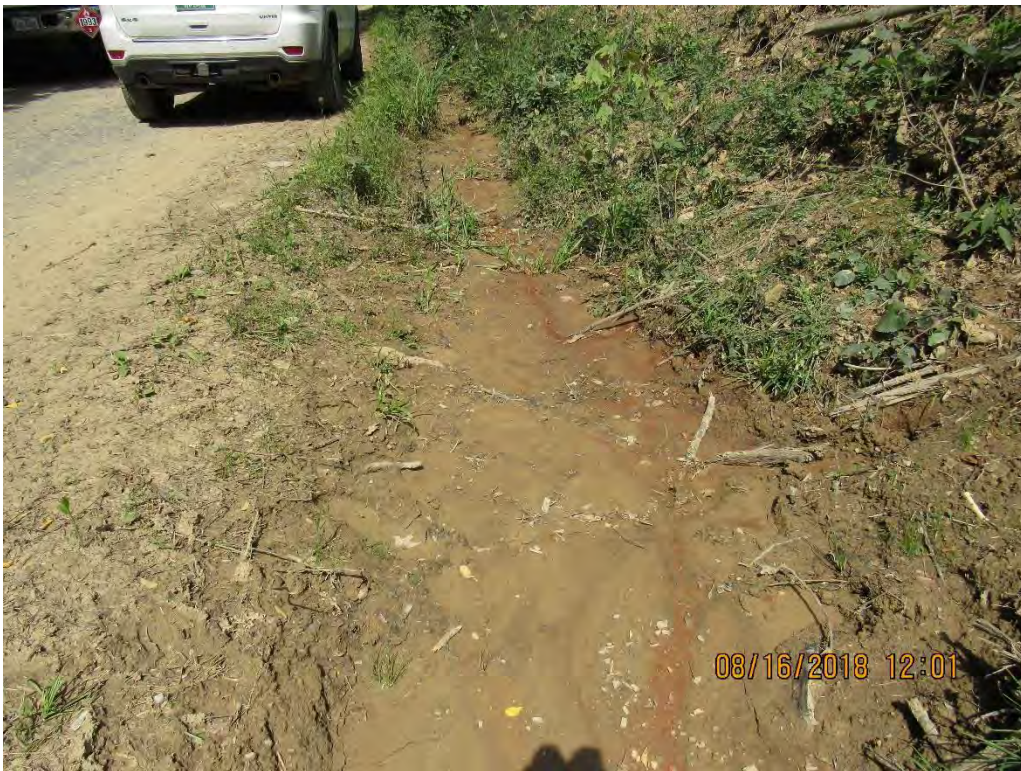
Photo 26: Road side ditch below water bar terminus in photos 23-25 conveying sediment laden water to installed culvert.

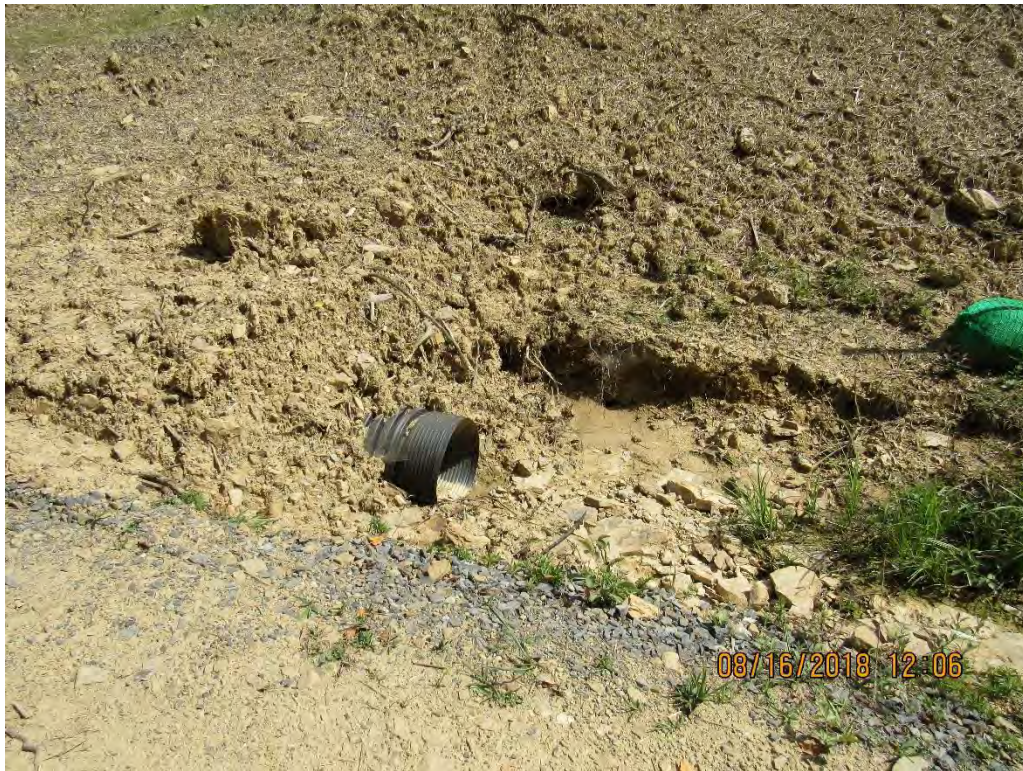
Photo 27: Installed culvert inlet near 7080+00 conveying sediment laden water from water bar terminus in photos 23-25 to SR culvert.

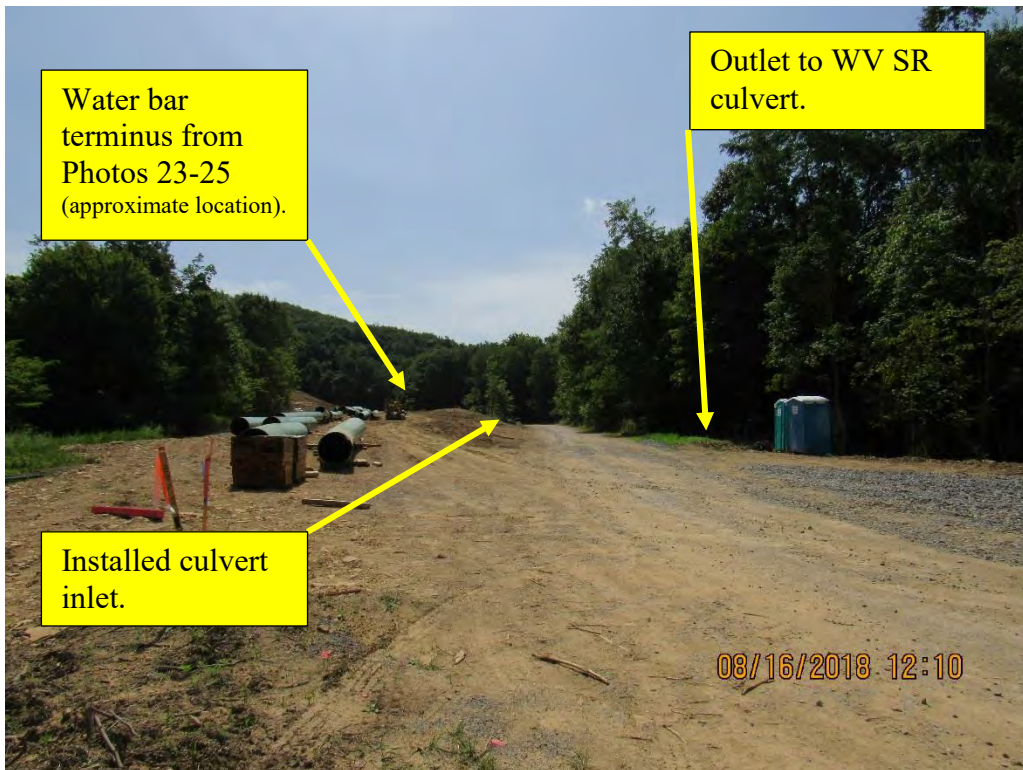
Photo 28: Relative distance of failed water bar terminus, culvert inlet and SR culvert outlet.

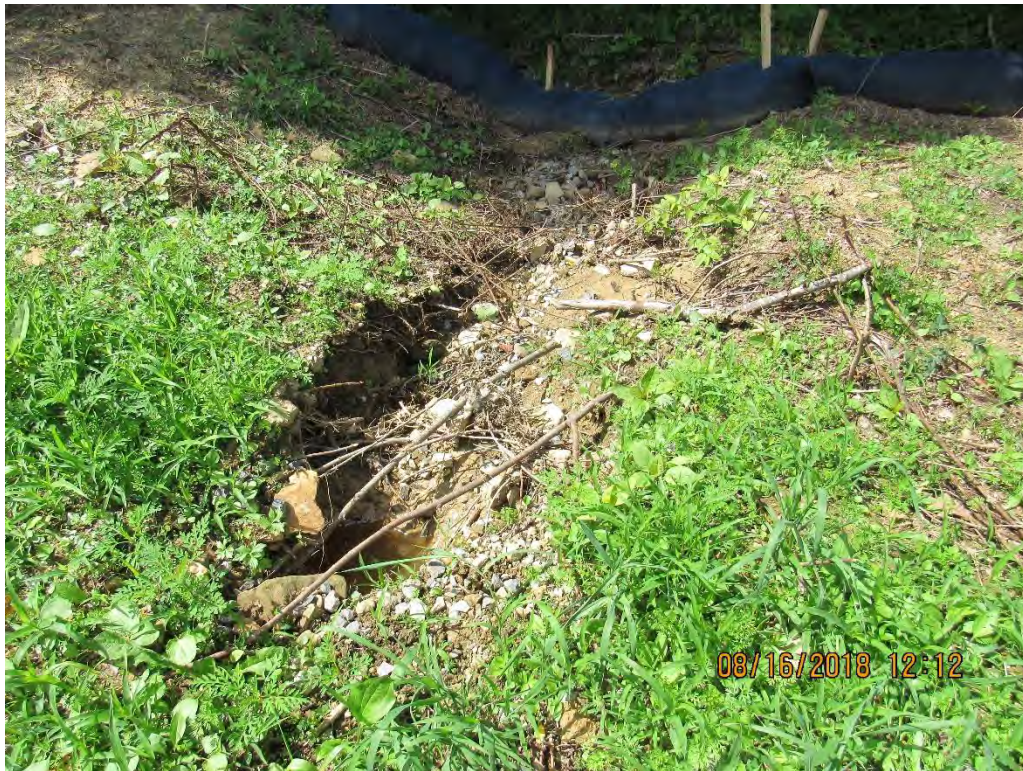
Photo 29: Outlet to SR culvert connected to installed culvert in photo 27.

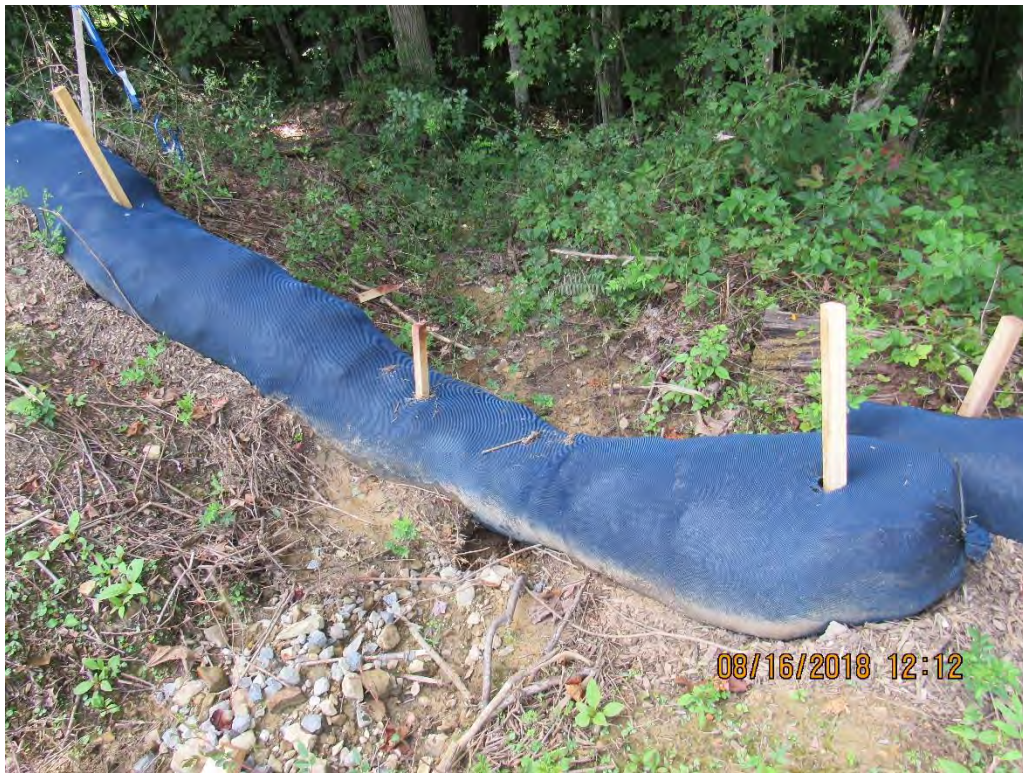
Photo 30: Perimeter controls failure downslope of SR culvert outlet allowing sediment laden water to leave site.

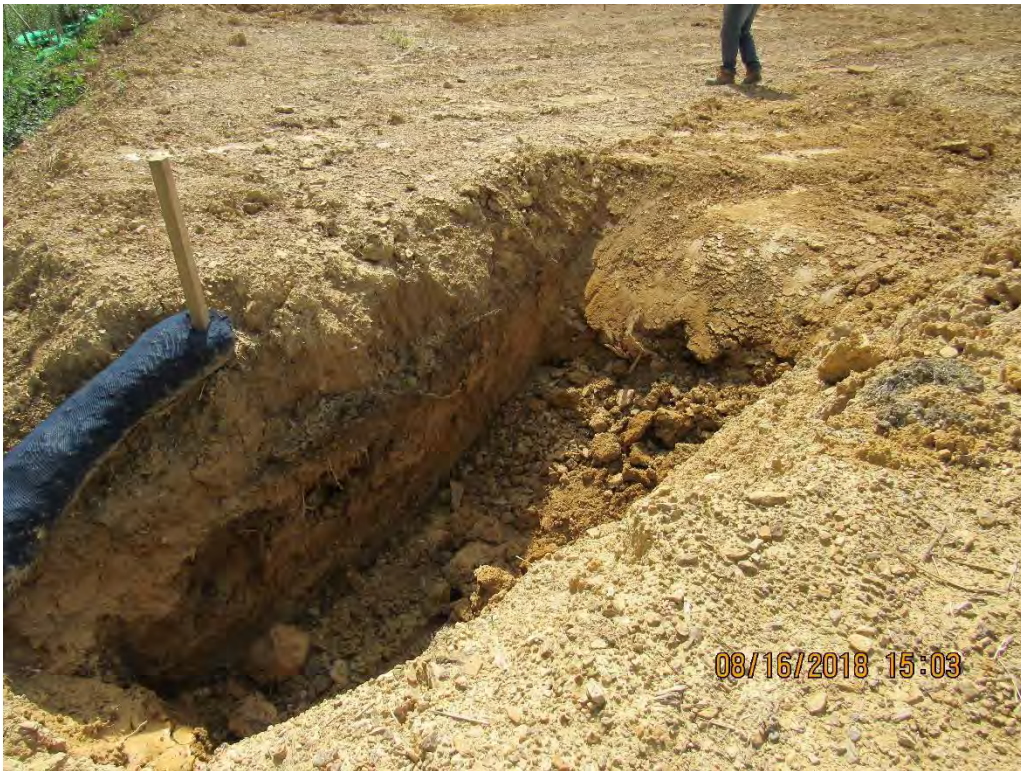
- Wahoo Road (Station 6781+51)- location of control failure leading to NOV# W18-52-004-CP. Sumps added to terminus of water bars. Per EI Cheek, installed sumps have not failed with recent rain events. (Photos 31 & 32)
- Recommendations:
 - Station 6781+51 (Wahoo Road)- add safety fencing to installed sump (Photo 33).
 - Station 6968-6978+70- add additional water bars to slope.
 - Station 6978+70- Lengthen "J" hooks at base of pipe slope drains. (Photo 34)
 - Station 7232+00- add additional control to bridge adjacent to wetland. (Photo 35)

Photo 31: Sumps installed at terminus of water bars near Wahoo Road station 6781+51 which has reduced failure.

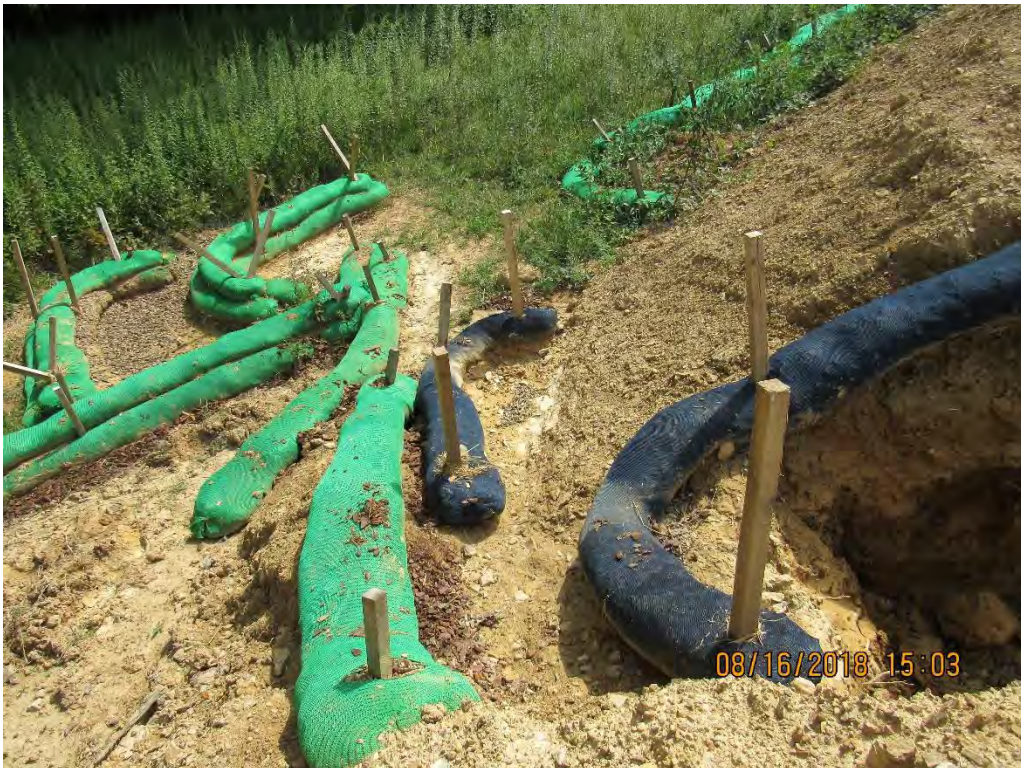
Photo 32: Site of historical water bar terminus control failure- sump installed has reduced failure.

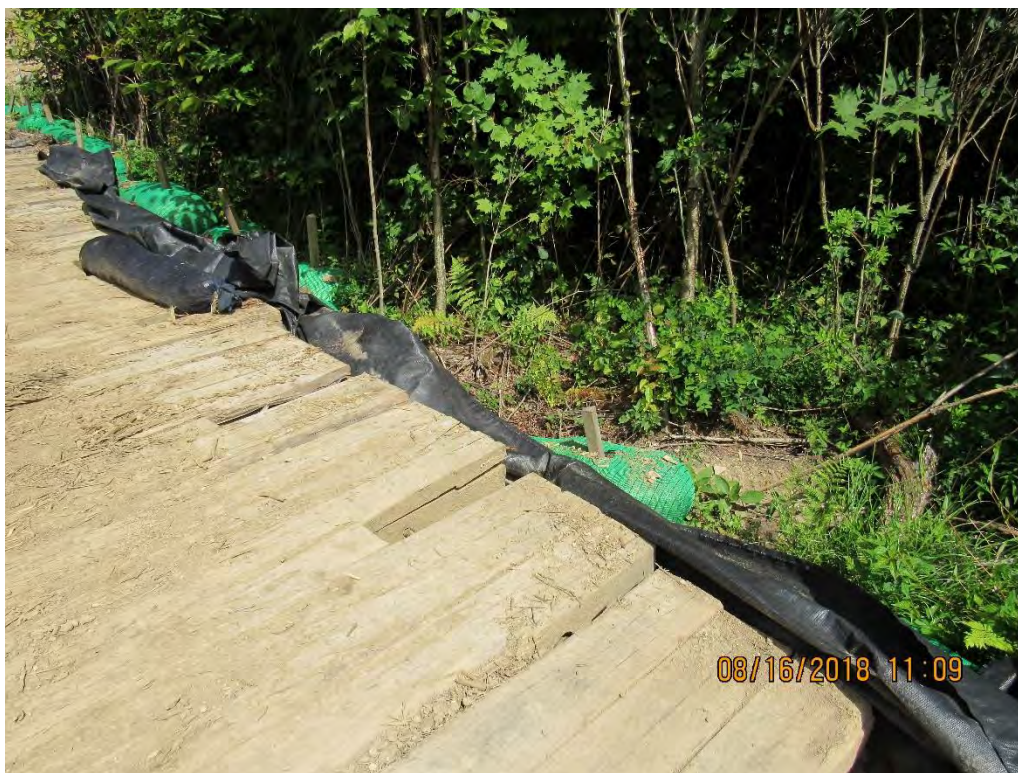
Photo 35: Recommended to add additional controls to timber mat bridge adjacent to wetland at station 7232+00.

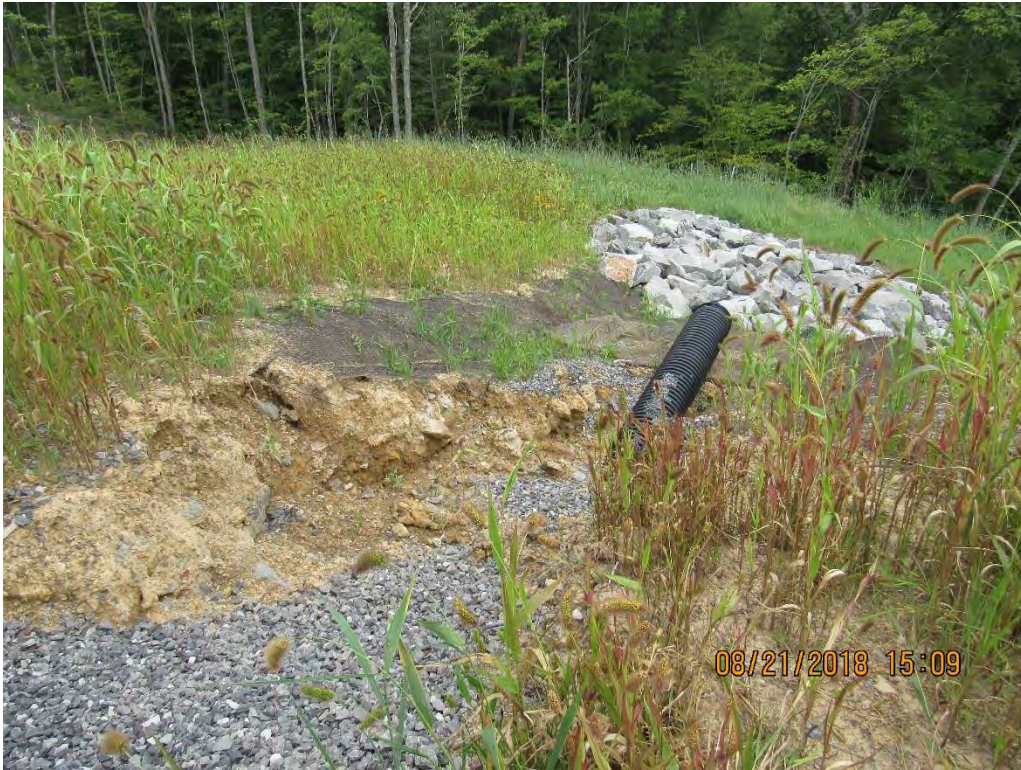
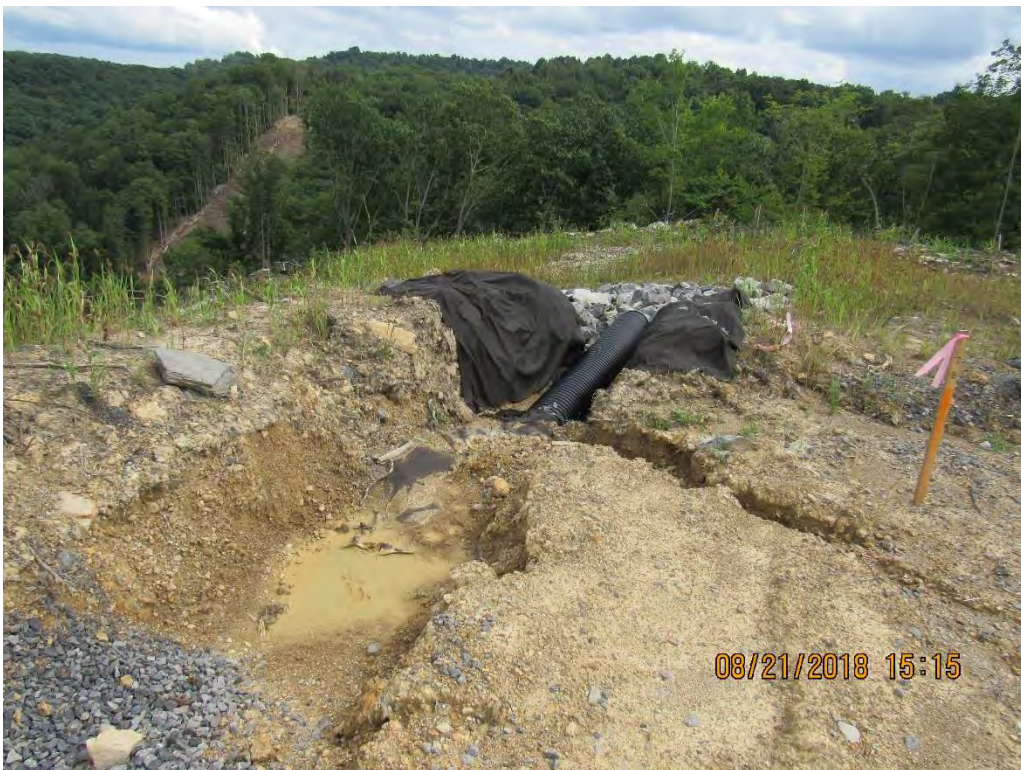
- 6. & 15.- Under drains outlets were not completed during install at last inspection. Notated to finish installation in report. Installation remains unfinished (Photos 1 & 2).
- 8. – Slope on northwestern side of site has not had re-seeding applied to areas without growth. (Photos 3 & 4). Middle of slope has good vegetative growth. Re-seeding was completed by hand at locations on fill slopes with minimal growth noted at last inspection but due to lack of sufficient rain, seed has not begun to grow (Photos 5 & 6).
- 13. & 17. Concrete wash out is filtering water instead of capturing for removal releasing water without treatment for pH adjustment. (Photos 7 & 8)

Photo 1: Unfinished underdrain installation.

Photo 2: Unfinished underdrain installation.

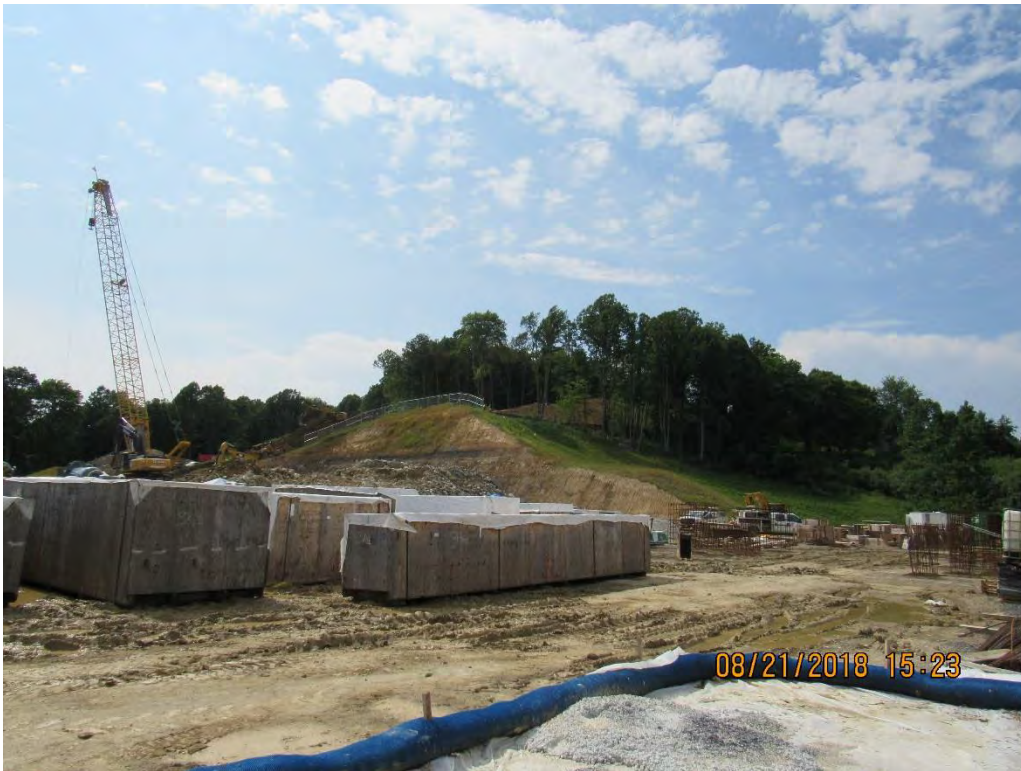
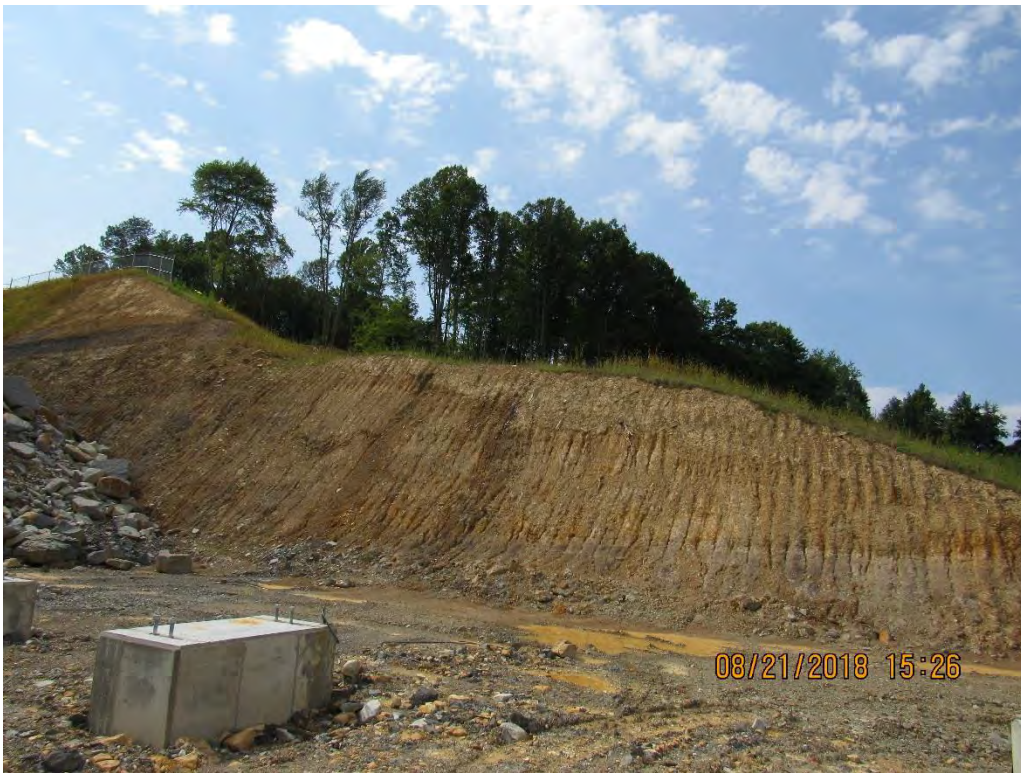
Photo 3: Slope on northwest side of site which has not been reseeded.

Photo 4: Slope on northwest side of site which has not been reseeded.

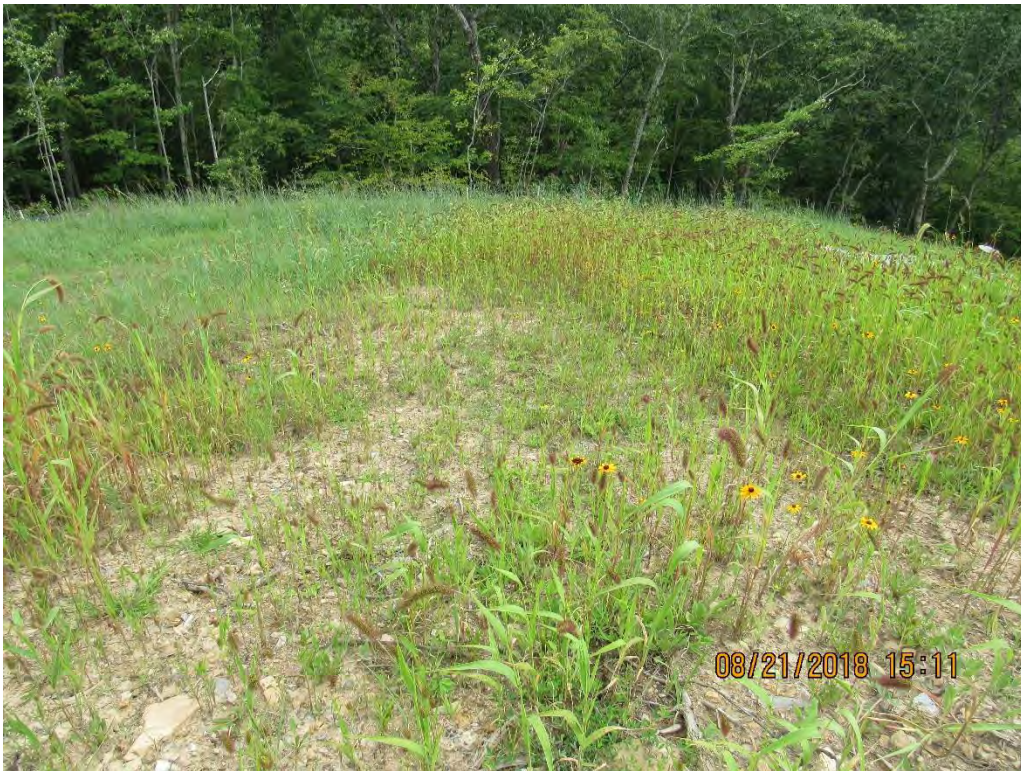
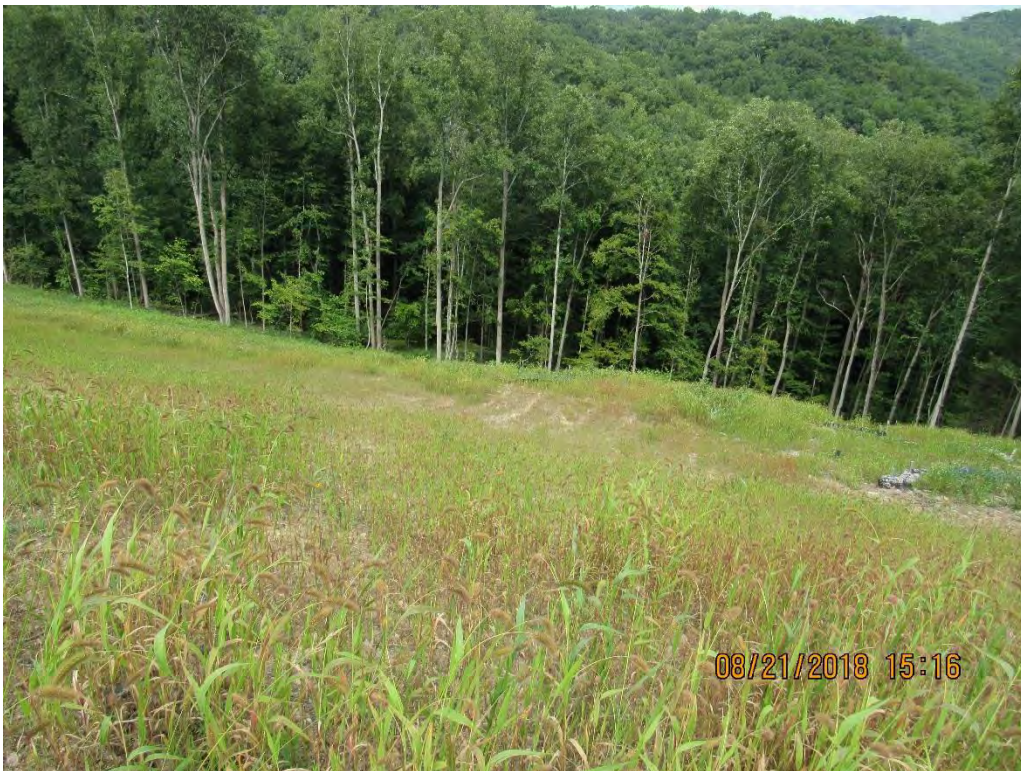
Photo 5: Area reseeded but growth not observed due to lack of sufficient rain.

Photo 6: Area reseeded but growth not observed due to lack of sufficient rain.

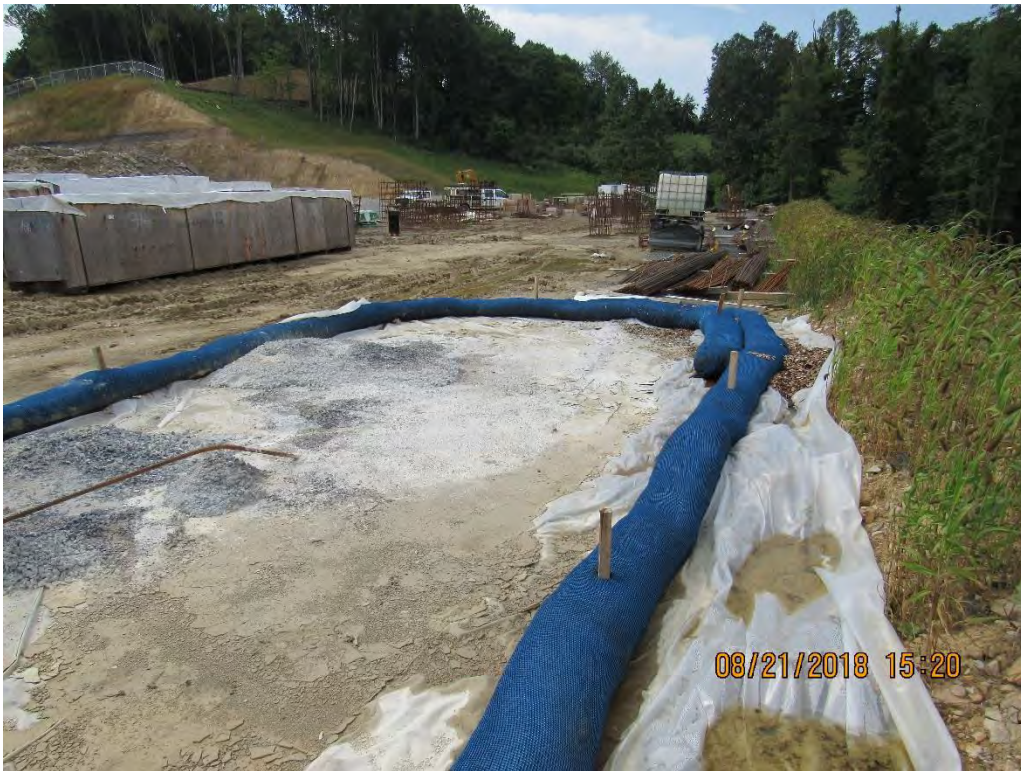
Photo 7: Improperly implemented control for concrete wash out area.

Photo 8: Improperly implemented control for concrete wash out area.

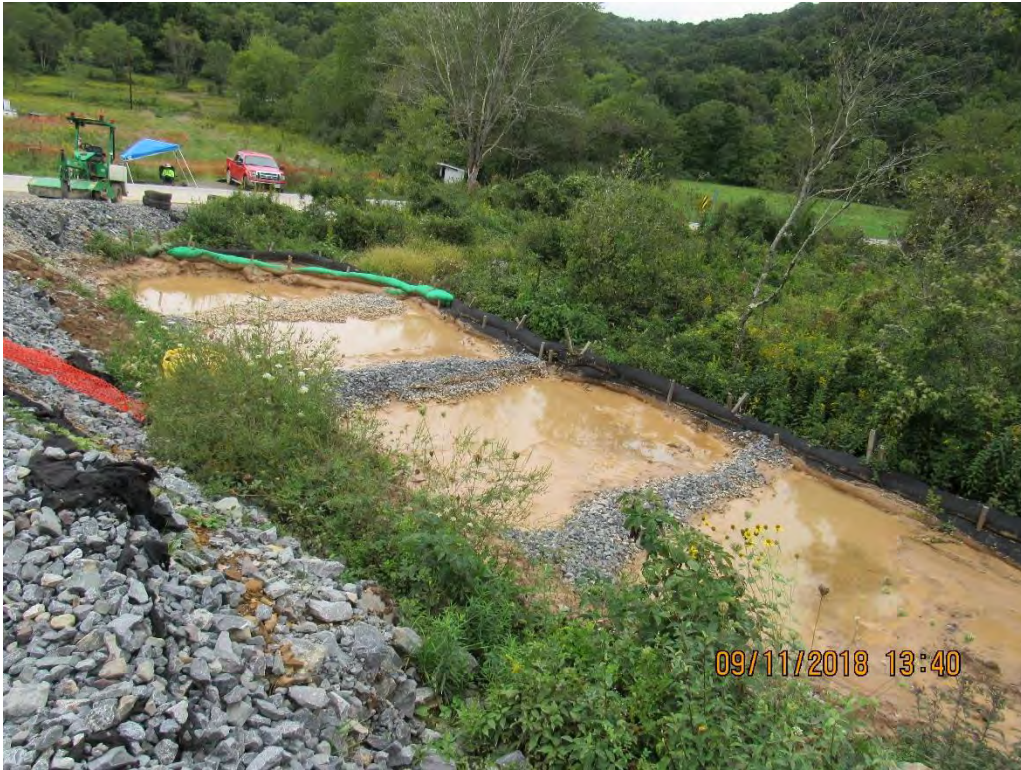
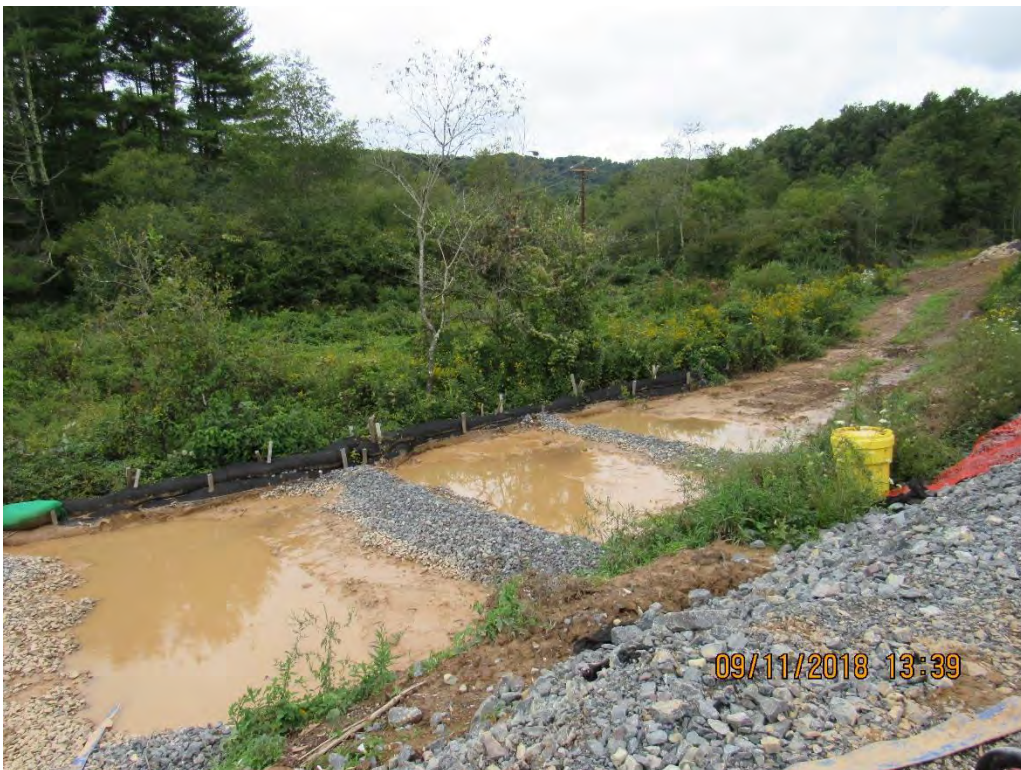
Photo 1: Station 50-New controls installed abating NOV issued 8/13/2018.

Photo 2: Station 50- New controls installed abating NOV issued 8/13/2018.

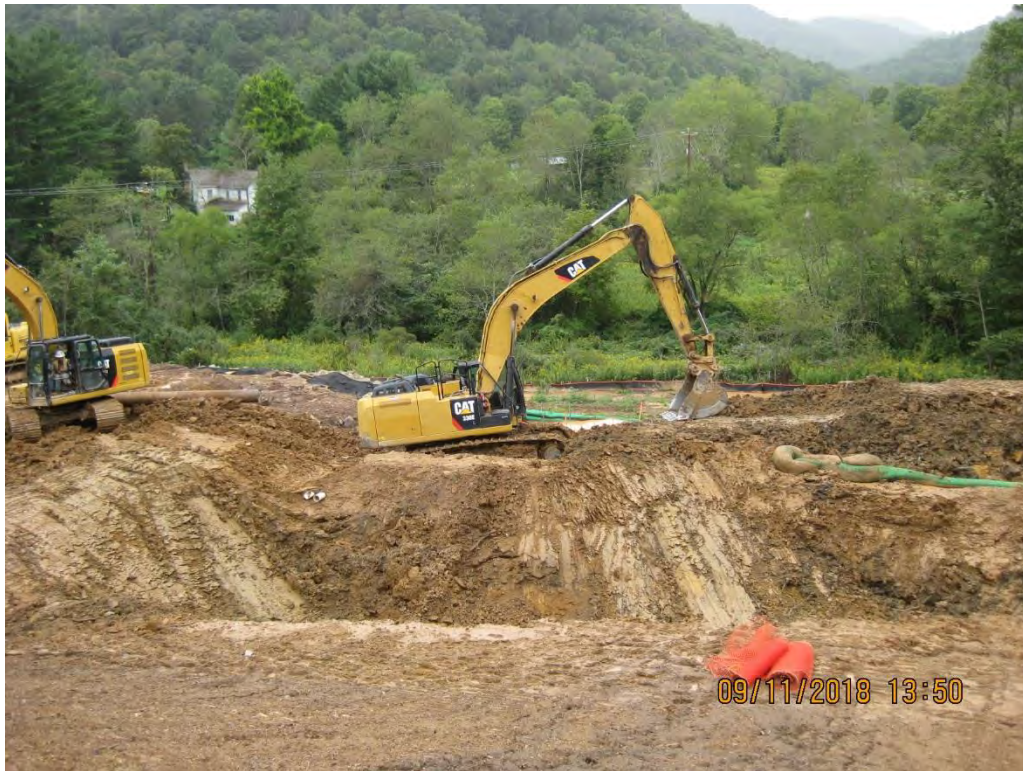
Photo 3: Station 150- Construction of temporary basin in preparation for Hurricane Florence.
