**The Wilderness Society et al. Comments on the
U.S. Forest Service Mountain Valley Pipeline and
Equitrans Expansion Project Draft Supplemental
Environmental Impact Statement (#50036)**

**WEST VIRGINIA DEPARTMENT OF ENVIRONMENTAL PROTECTION
WV OIL AND GAS CONSTRUCTION STORMWATER PERMIT**

FACILITY NAME:	Mountain Valley Pipeline Project			REG. #	EXPIRE DATE:
PERMITTEE	MOUNTAIN VALLEY PIPELINE, LLC			WVR310667	5/13/2018
ADDRESS/PHONE:	Attn: Matt Hoover 625 LIBERTY AVE, ST 1700 PITTSBURGH, PA 15222				
LOCATION:	Wileyville, WV			Entry Date/Time:	4/3/18 8:30am
COUNTY:	Wetzel			Exit Date/Time:	4/3/18 1:37pm
Site Representative /Phone	Matt Hoover Sr. Environmental Coordinator (412) 258-5627			PHOTOS <input checked="" type="checkbox"/>	
CO-PERMITTEE:				ADDRESS:	
SITE OPERATOR:	Precision Pipeline			ADDRESS:	
PERMITTED ACREAGE	4214	WEATHER:	Rain	LAST INSPECTION:	N/A
RECEIVING STREAM(S)	Mobley Run > Ohio River				NOV: 1
Regular Mail <input type="checkbox"/> Certified Mail <input checked="" type="checkbox"/>	Tracking #				
OVERALL FACILITY RATING:	Unsatisfactory		COMPLIANCE OUTCOME	Not Immediately Corrected

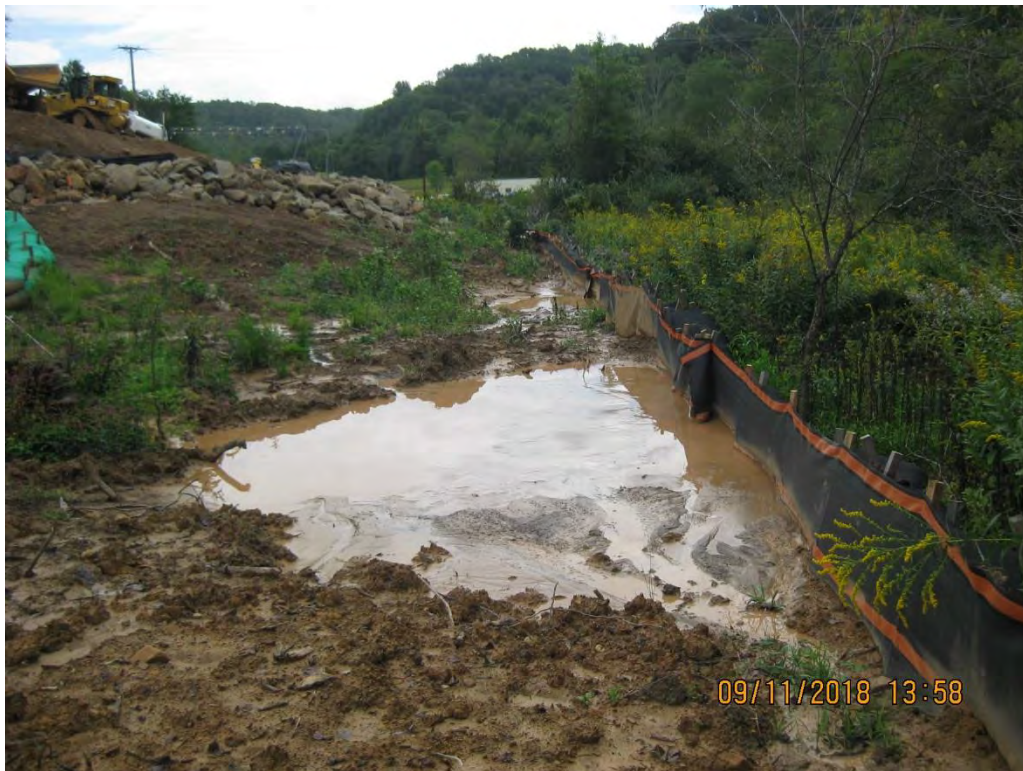
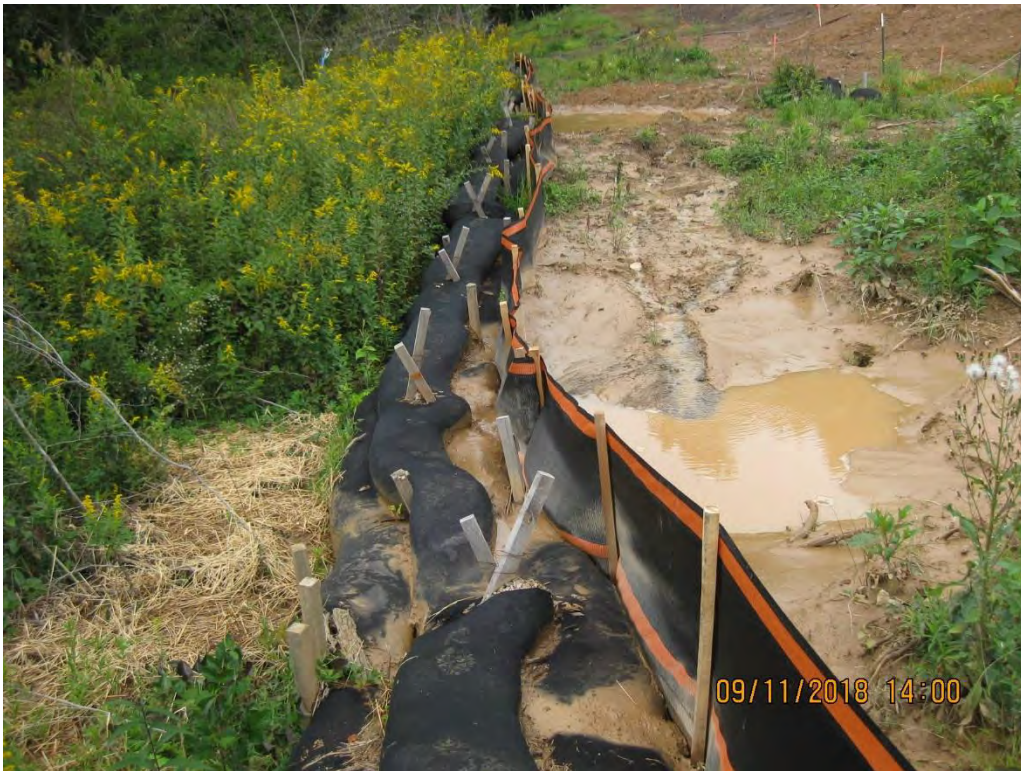
Photo 4: Station 150 (approximately)- controls maintained abating NOV issued 8/13/2018.

Photo 5: Station 150 (approximately)- controls maintained abating NOV issued 8/13/2018.

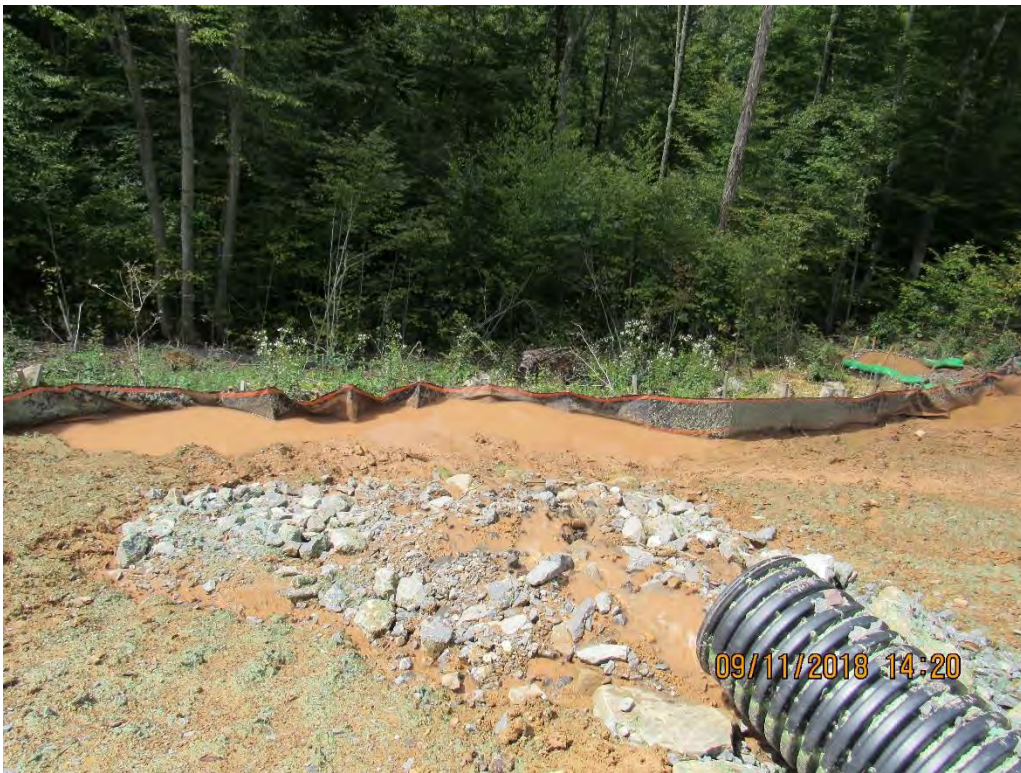
Photo 6: Station 900- Culvert outlet concentrating flow from diversion ditch.

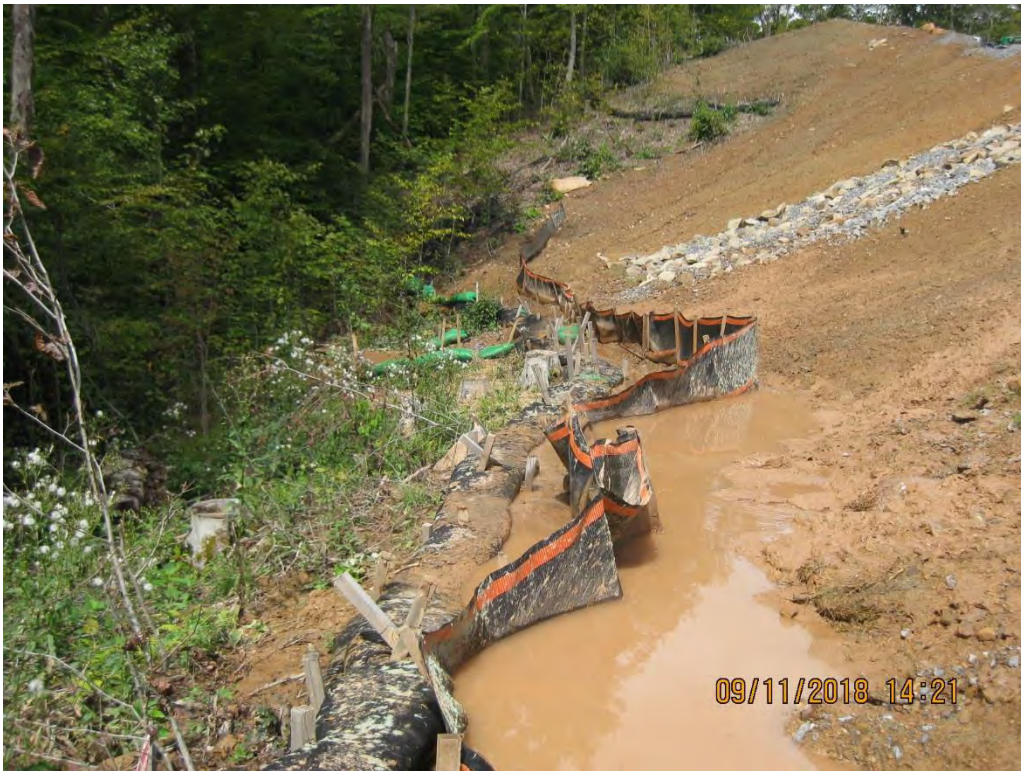
Photo 7: Station 900 (approximately) -Flow along silt fence from culvert outlet downslope to sump.

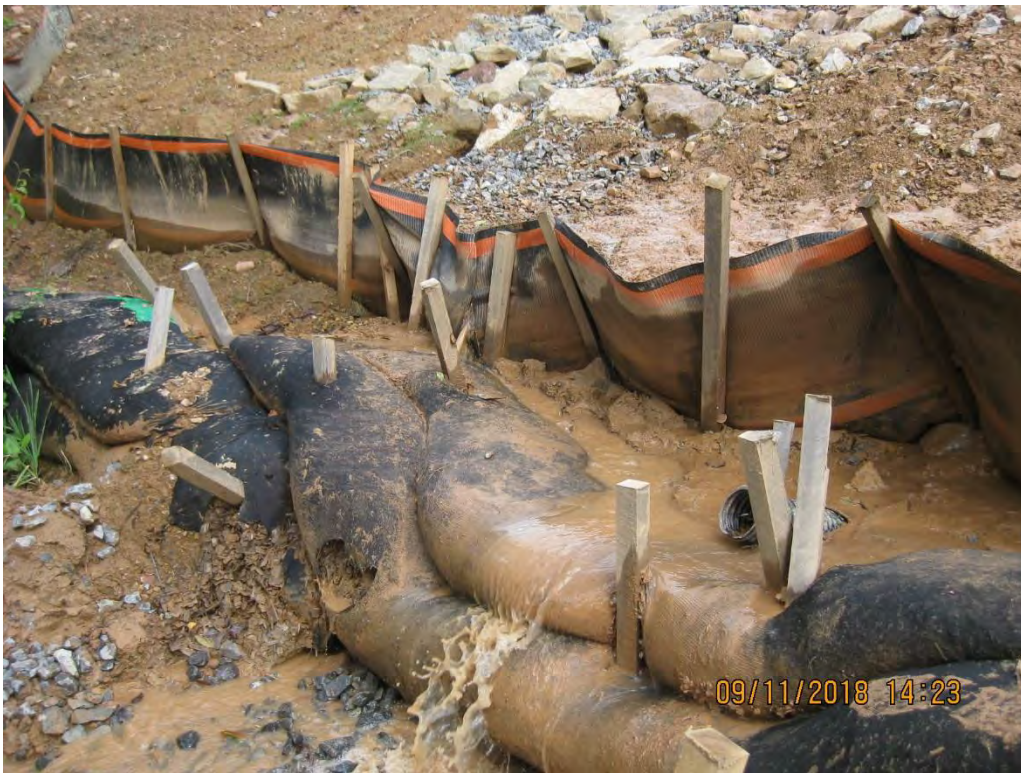
Photo 8: Station 900 (approximately)-Flow below silt fence into sump.

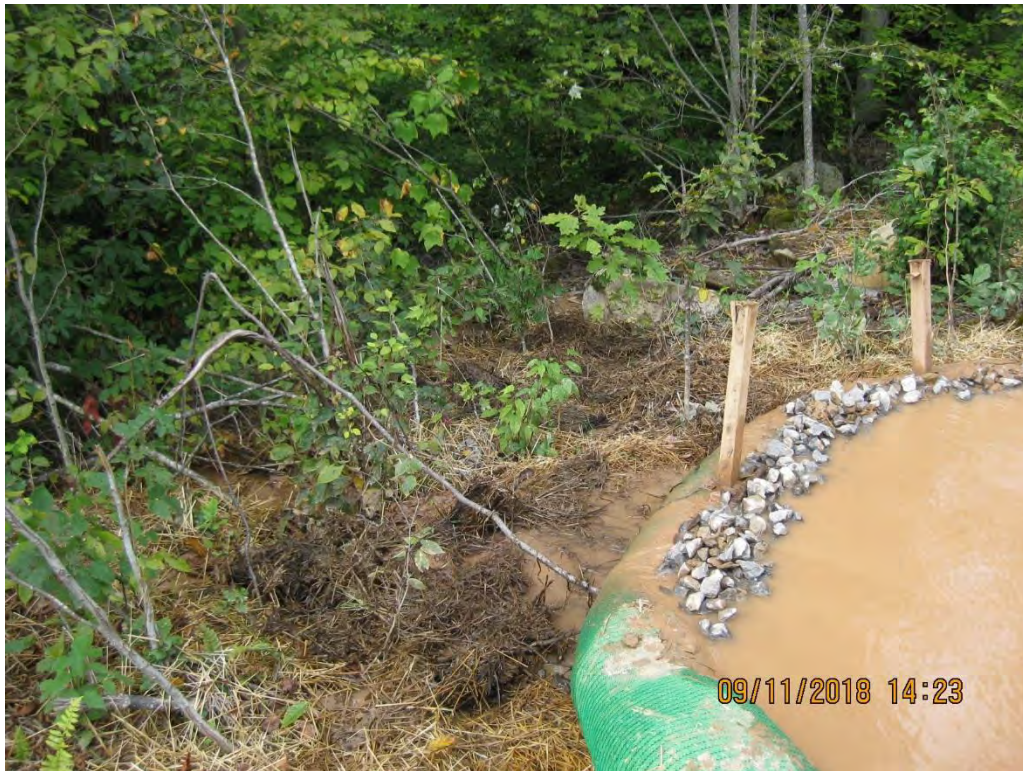
Photo 9: Station 900 (approximately)- outlet of sump below photo 8 with sediment laden water leaving site view down gradient.

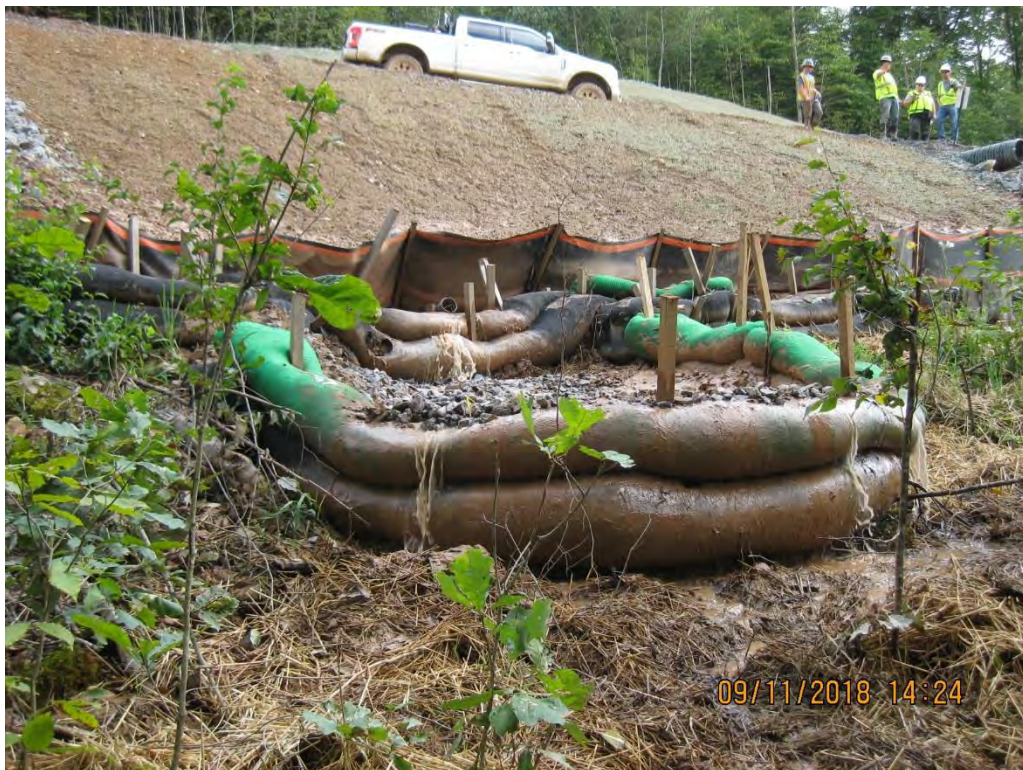
Photo 10: Station 900 (approximately)- upslope view of controls and sediment laden water leaving site.

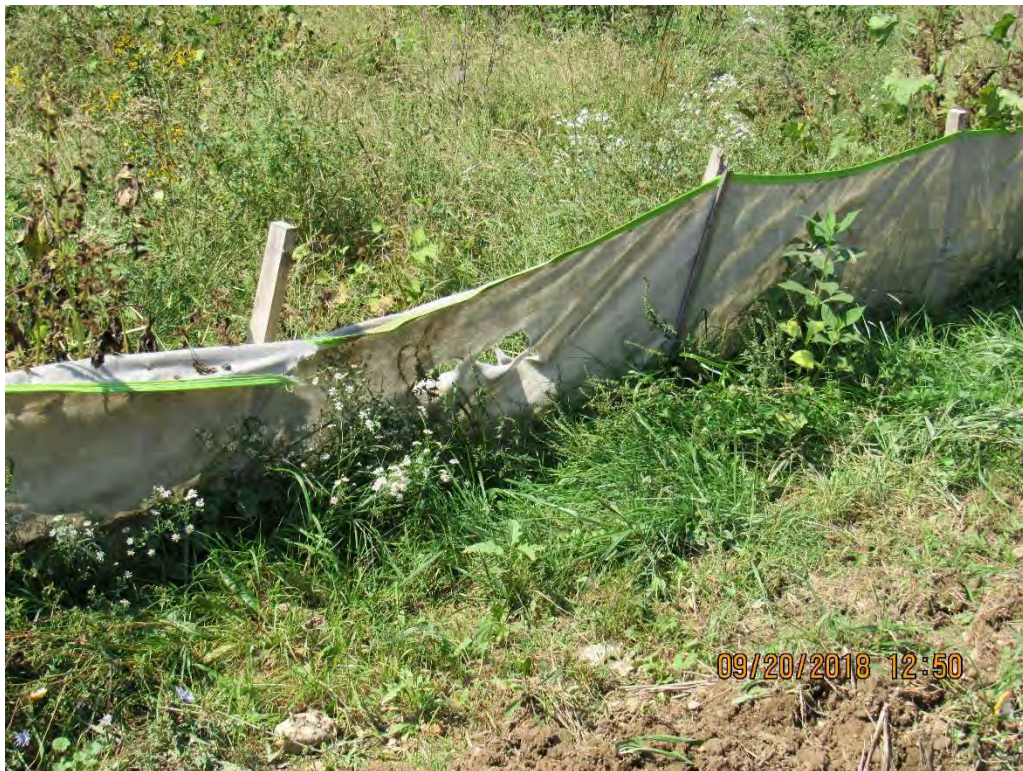
Photo 2: Silt fence needs replaced along access road 231.01 off Painters Run Road near station 10270+49.

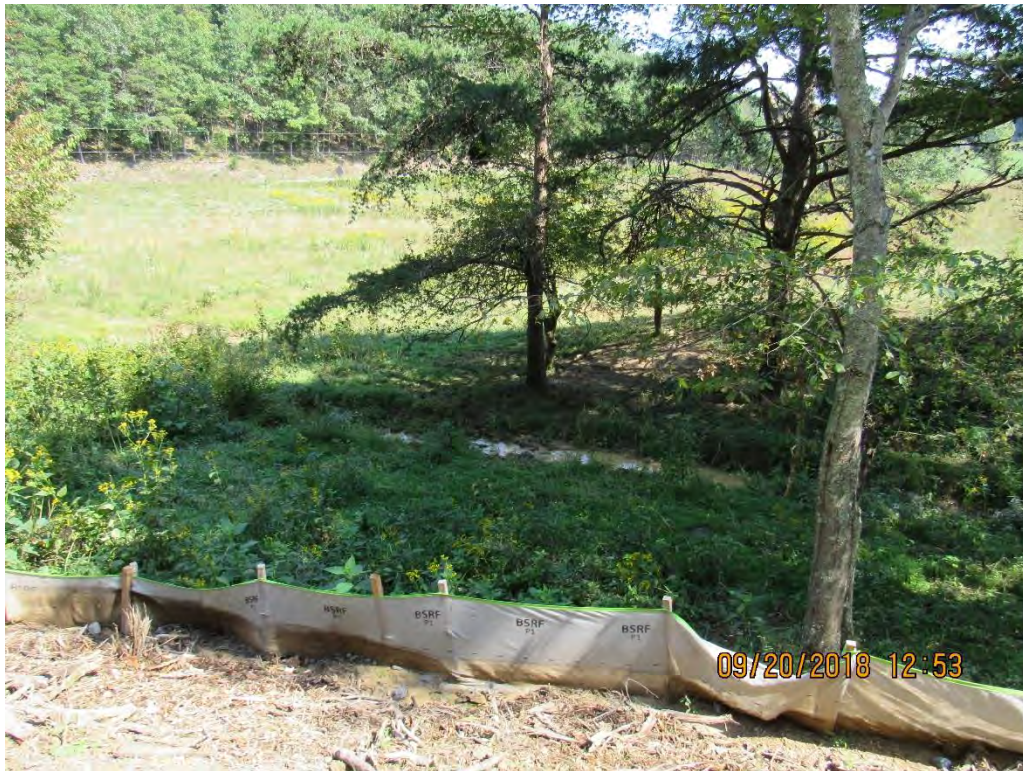
Photo 3: Sediment laden UNT of Painters Run down stream of control failure near station 10270+49

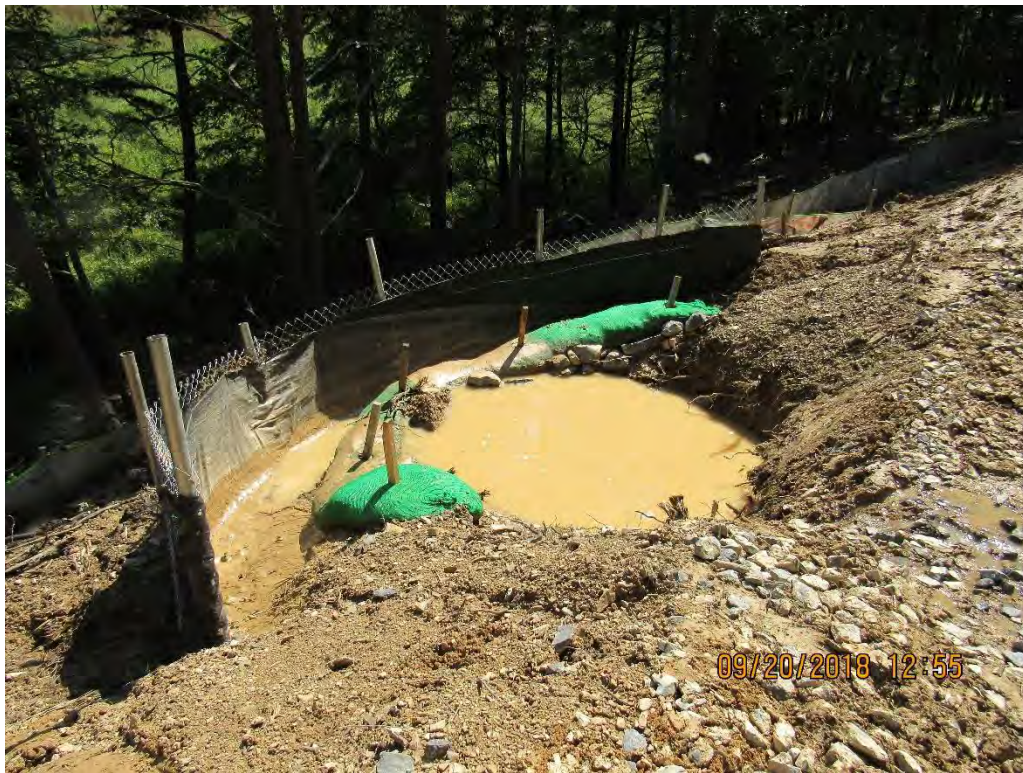
Photo 4: Sump above control failure off access road 231.01 near station 10270+49 Painters Run.

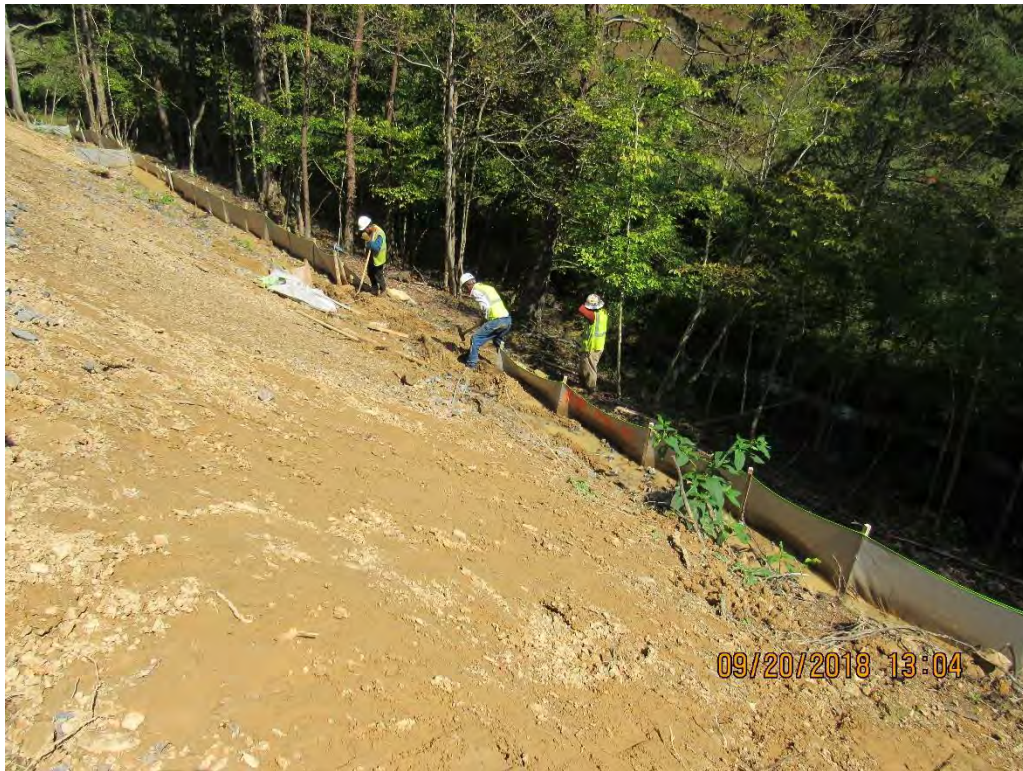
Photo 5: Repairs in progress along access road 231.01 near station 10270+49 Painters Run.

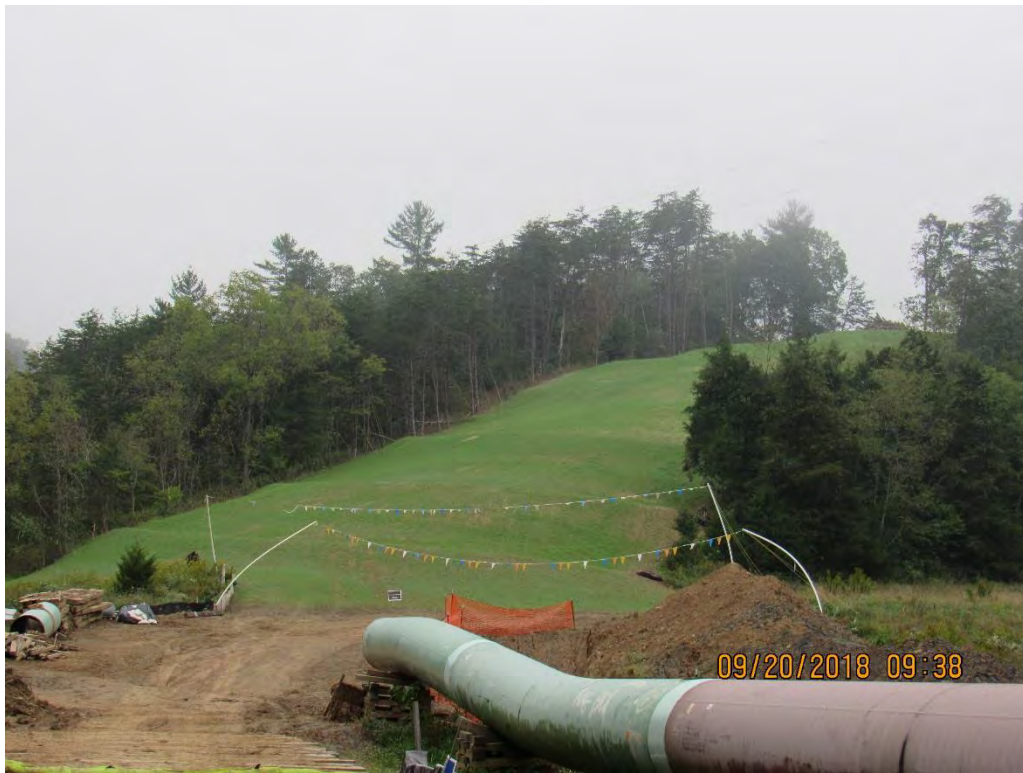
Photo 6: Slope above Slate Run near station 9624 has been reclaimed with some growth.

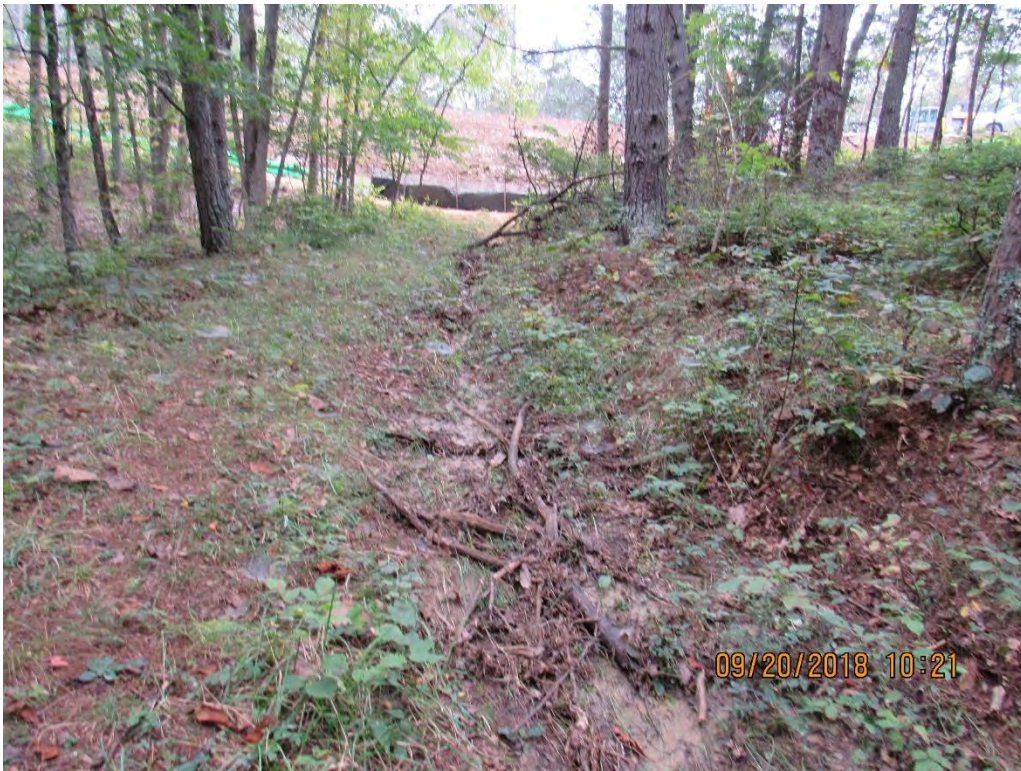
Photo 7: Historic release of controls near station 9617+75 with upgraded controls above Slate Run.

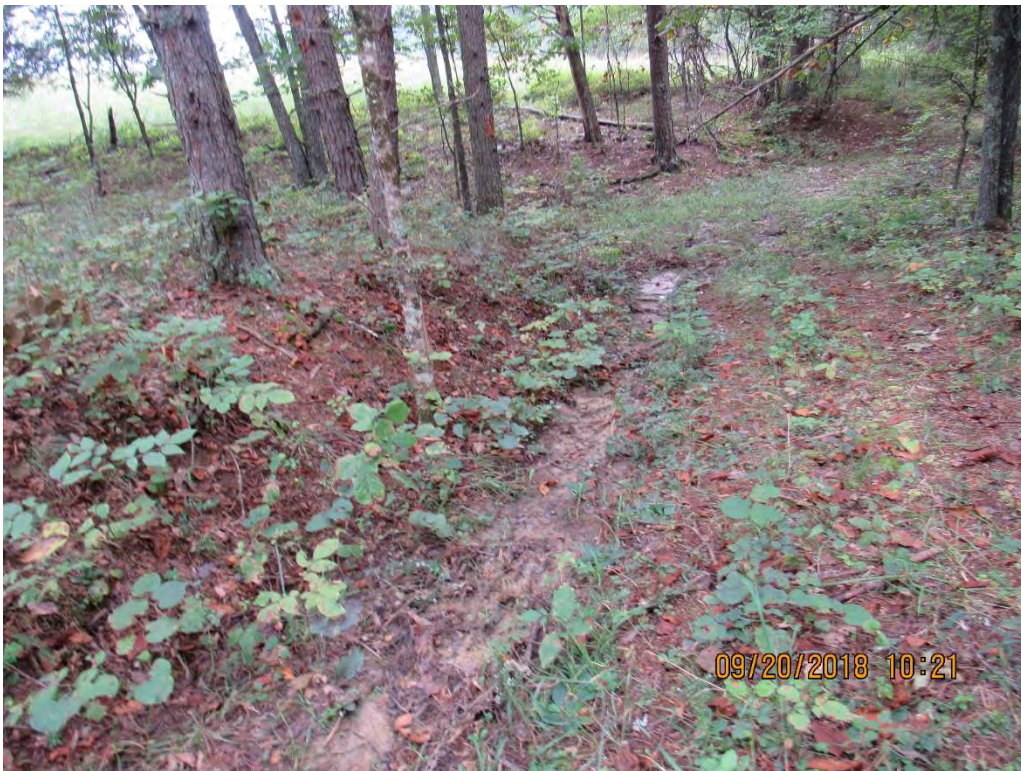
Photo 8: Downslope of historic release of controls near station 9617+75 above Slate Run.

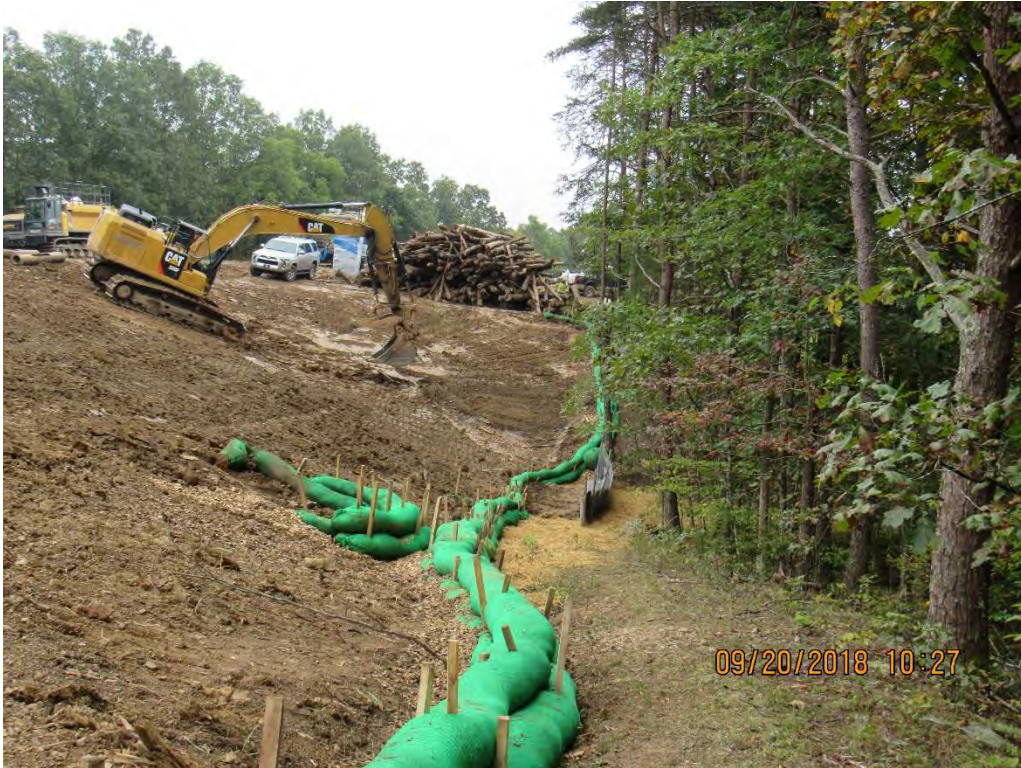
Photo 9: Source of historic release in photos 7 & 8 near station 9617+75. Final reclamation in process above Slate Run.

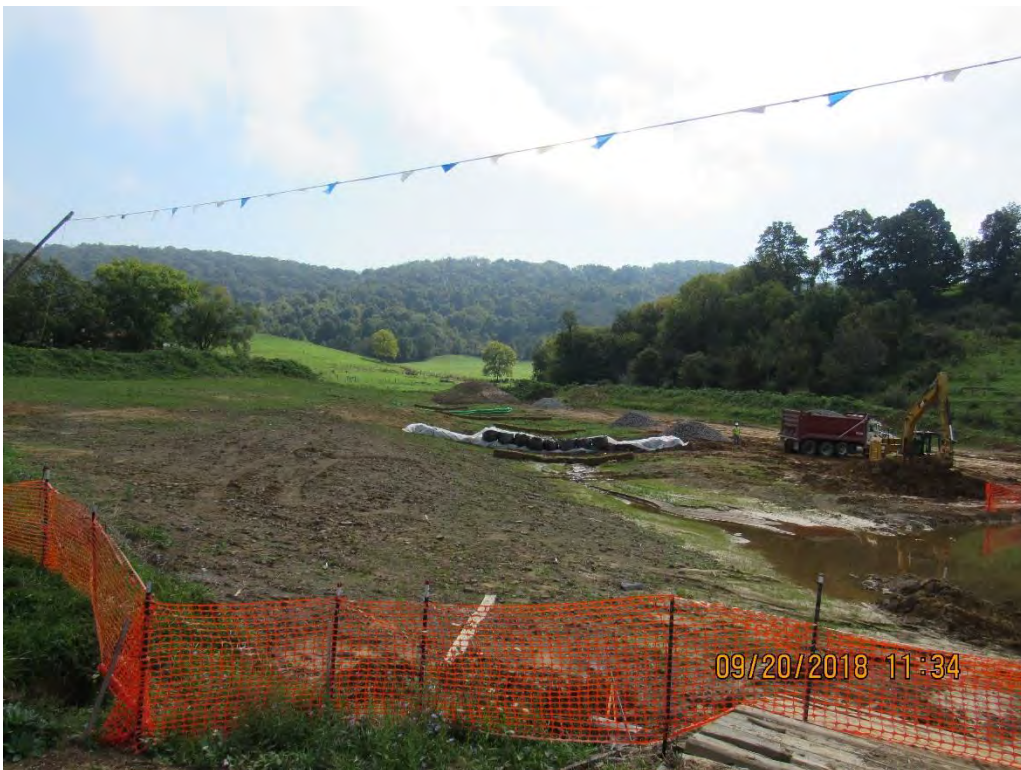
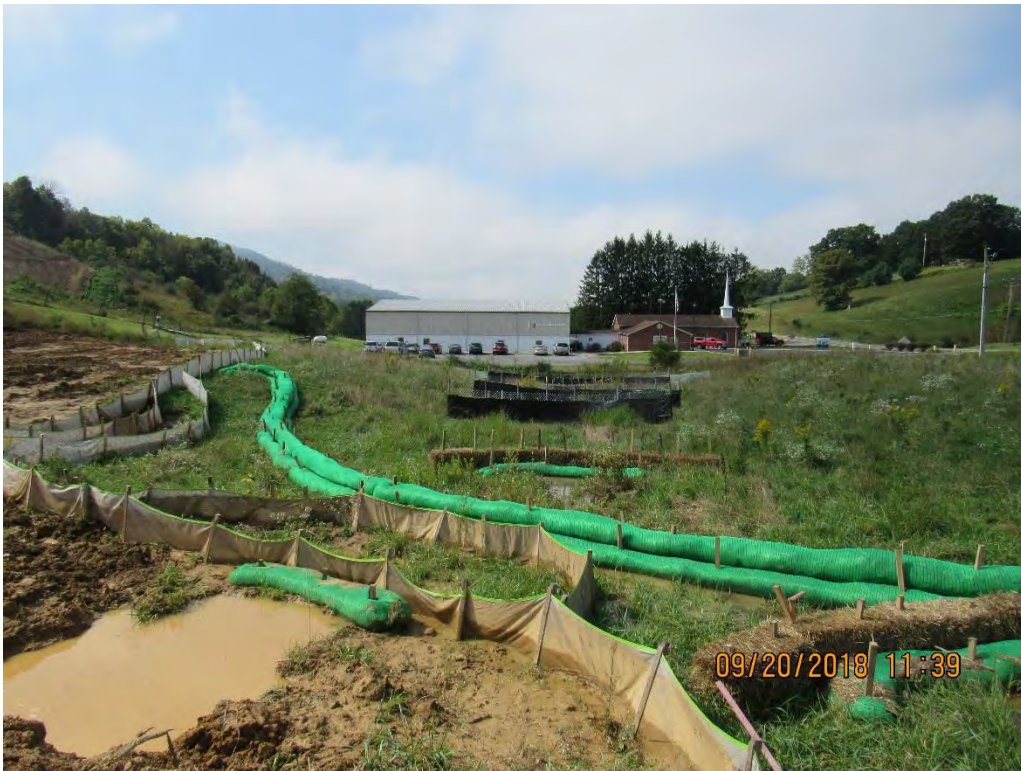
Photo 10: Hurricane Florence storm prep near Lindsie Methodist Church station 10116+46.

Photo 11: Hurricane Florence storm prep near Lindsie Methodist Church station 10116+46.

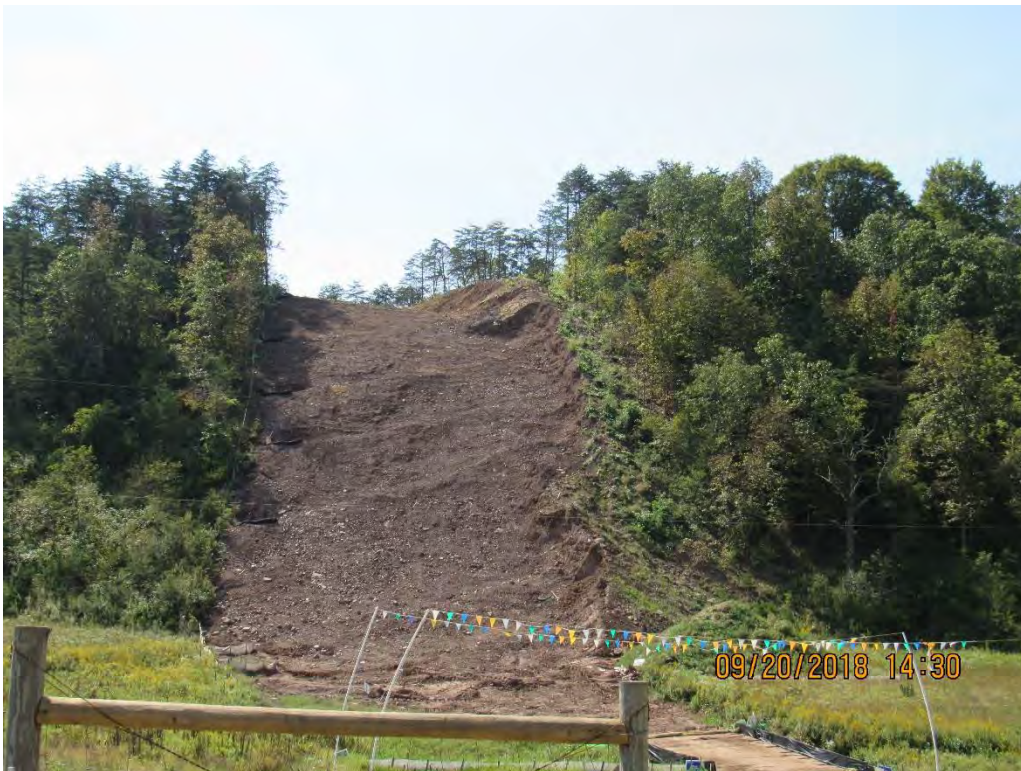
Photo 12: Wayside/Talcott near station 9466+16. Final restoration scheduled within a few weeks, weather depending.

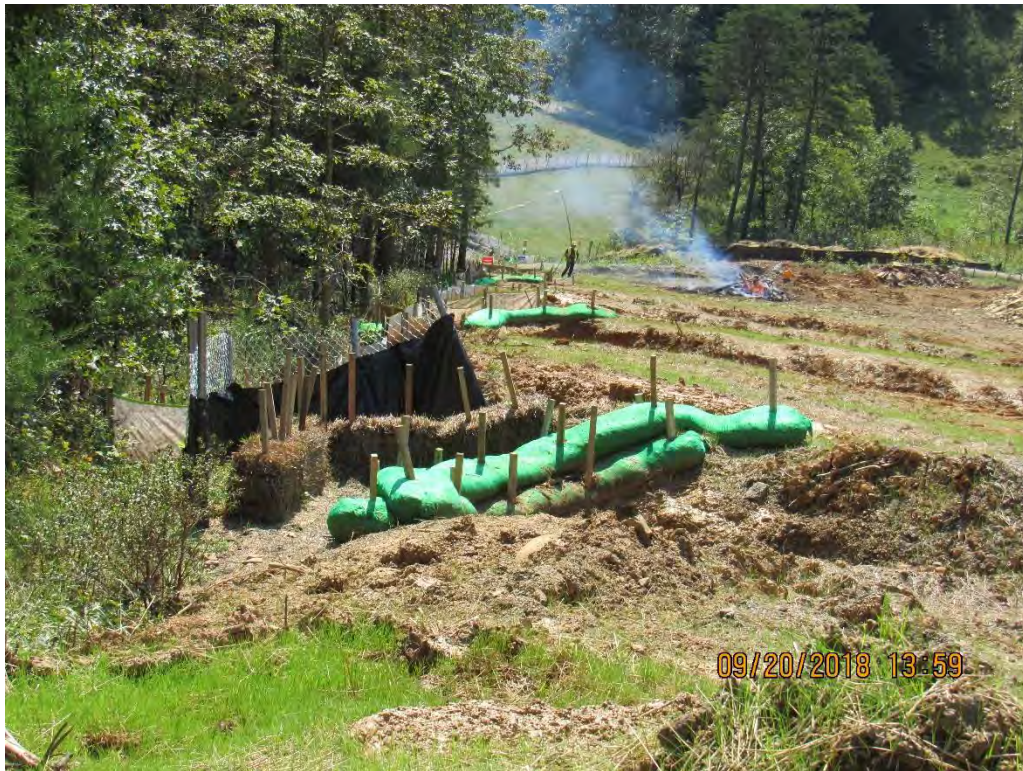
Photo 13: Ellison Ridge crossing near station 9778. Additional controls added due to historic release.

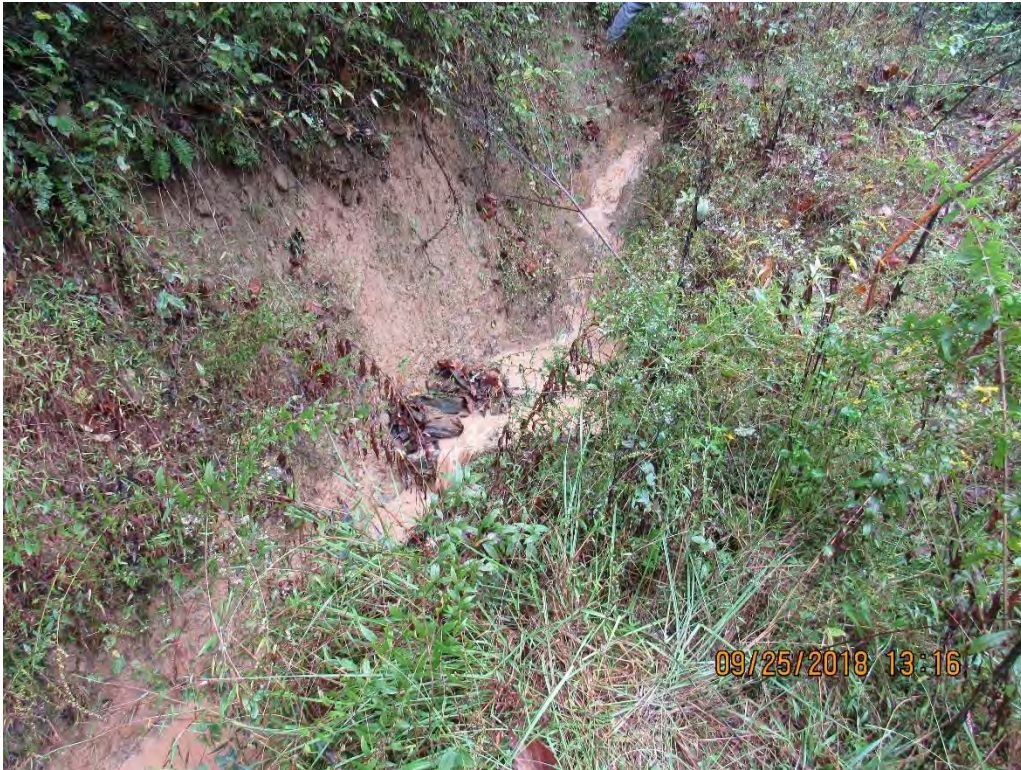
Photo 1: Sediment laden water from sumps near station 3625+00.

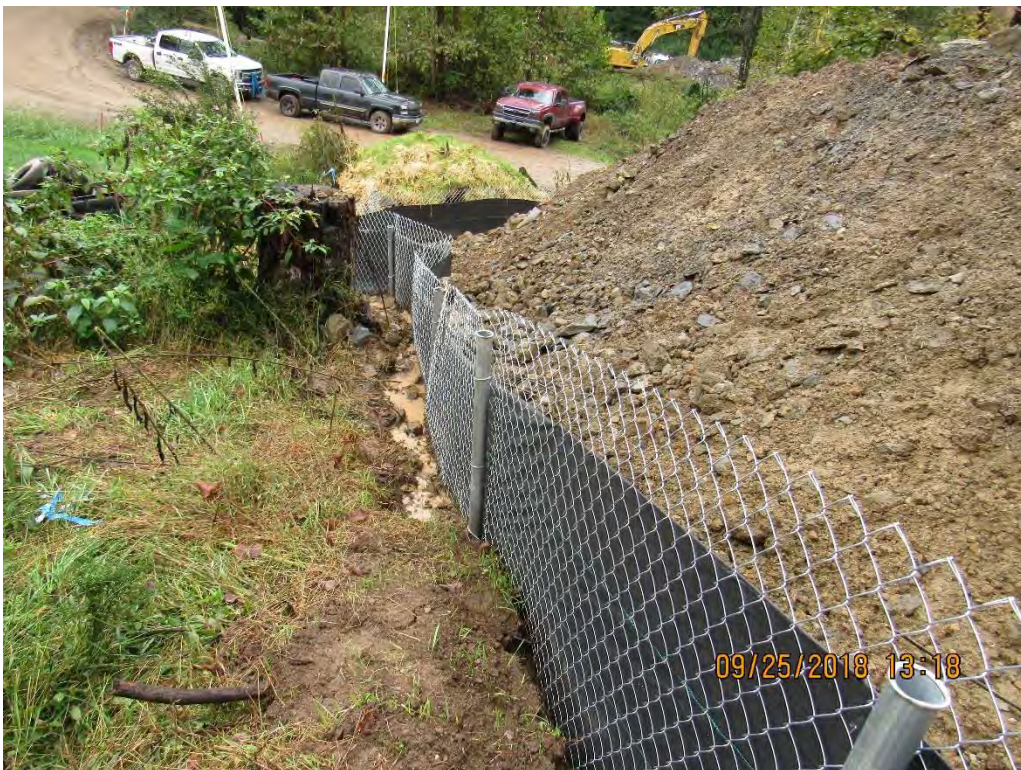
Photo 2: Undermined perimeter controls near 3634+00 which failed allowing sediment laden water to leave site.

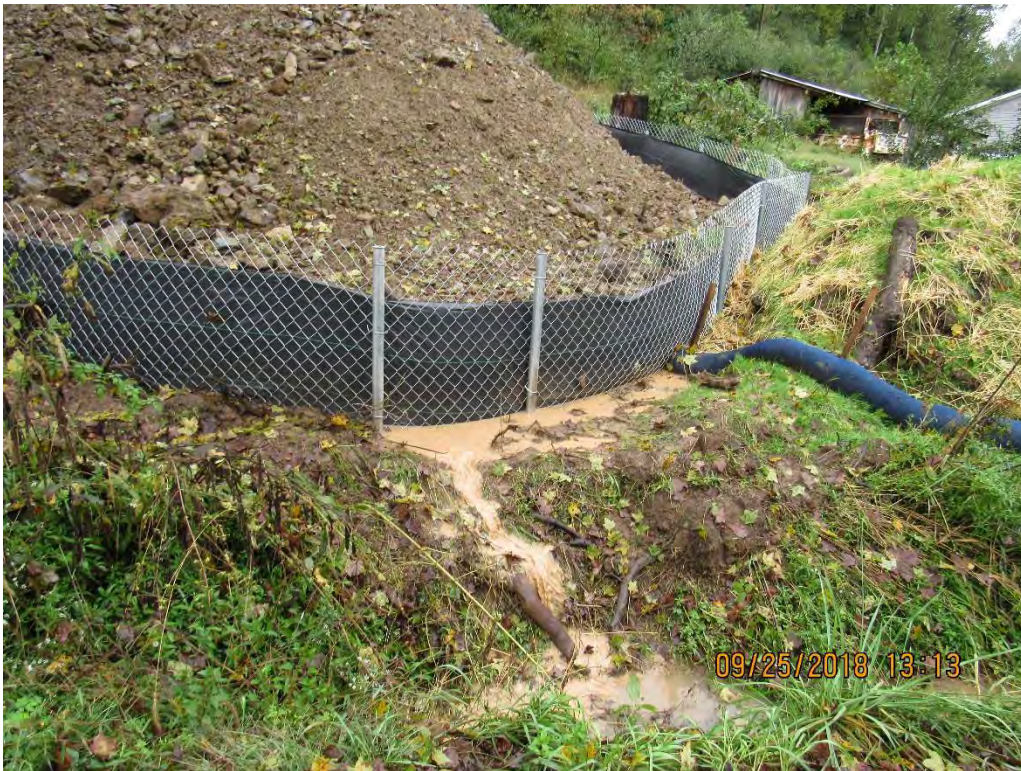
Photo 3: Failure of perimeter controls near 3634+00 allowing sediment laden water to leave site.

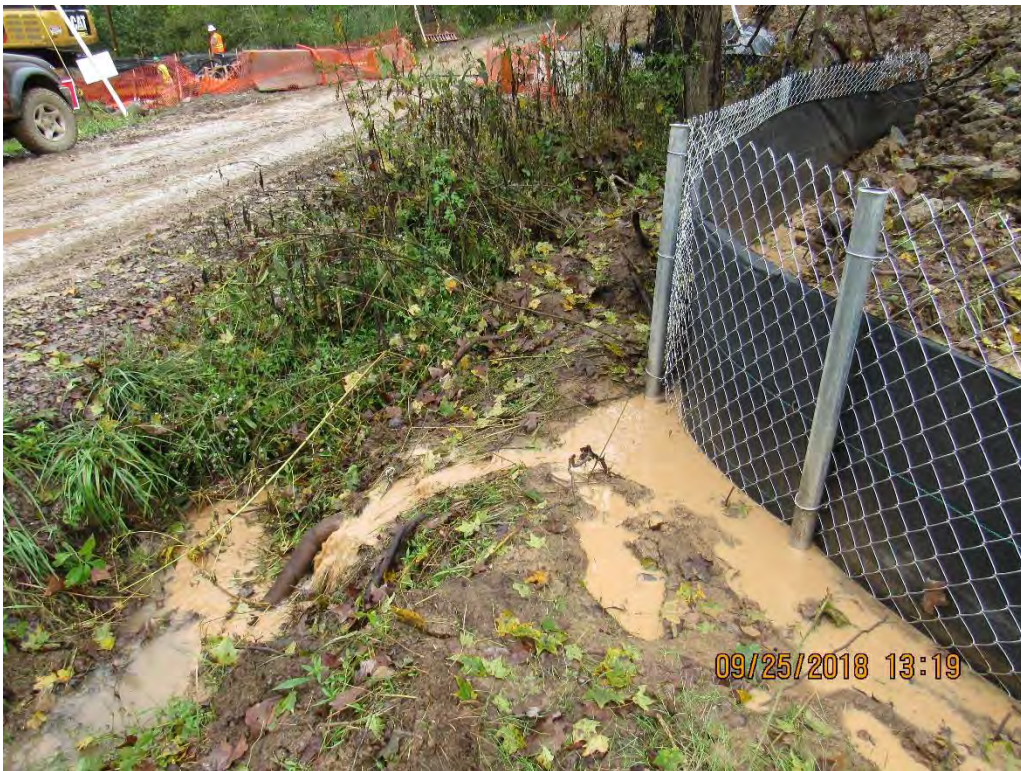
Photo 4: Close-up of failed perimeter controls near station 3634+00 where sediment laden water is entering UNT of Knawls Creek.

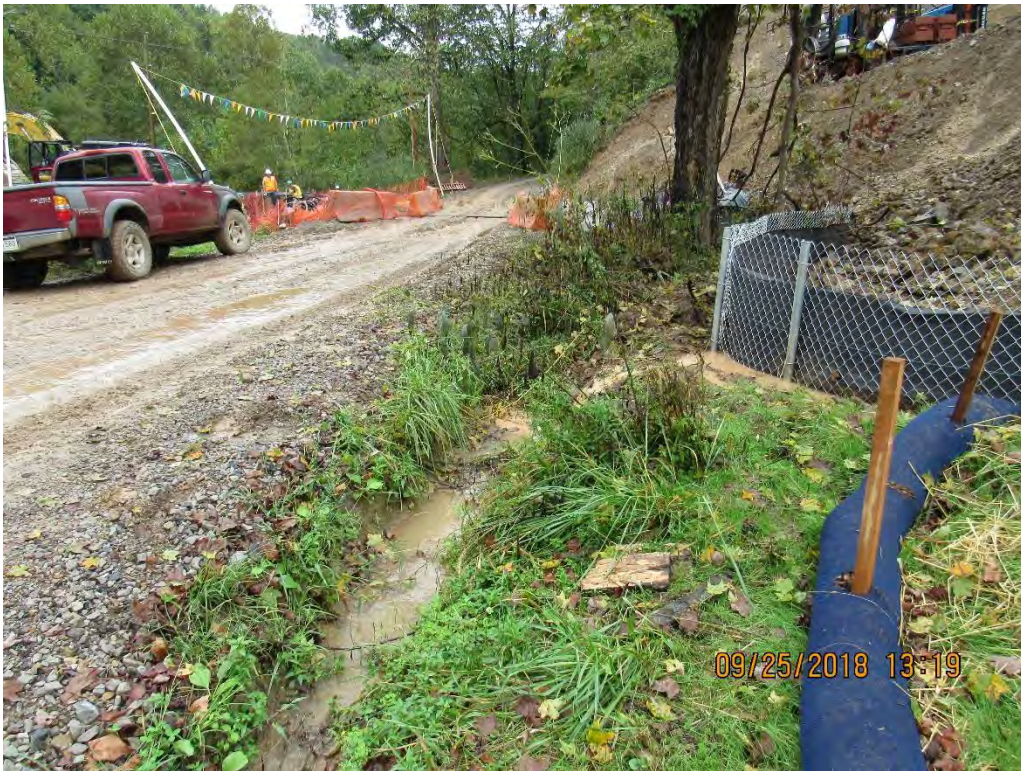
Photo 5: Sediment laden water entering UNT of Knowls Creek near station 3634+00 from failed perimeter controls.

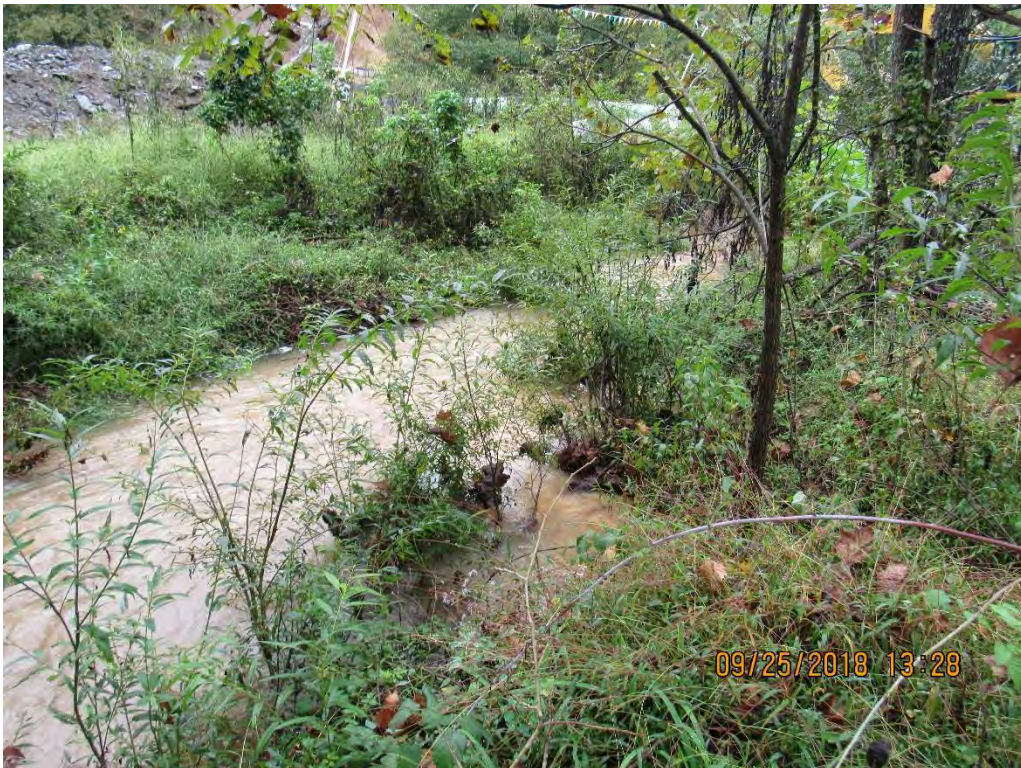
Photo 6: Convergence of UNT of Knowls Creek with sediment laden water mixing with Knowls Creek.

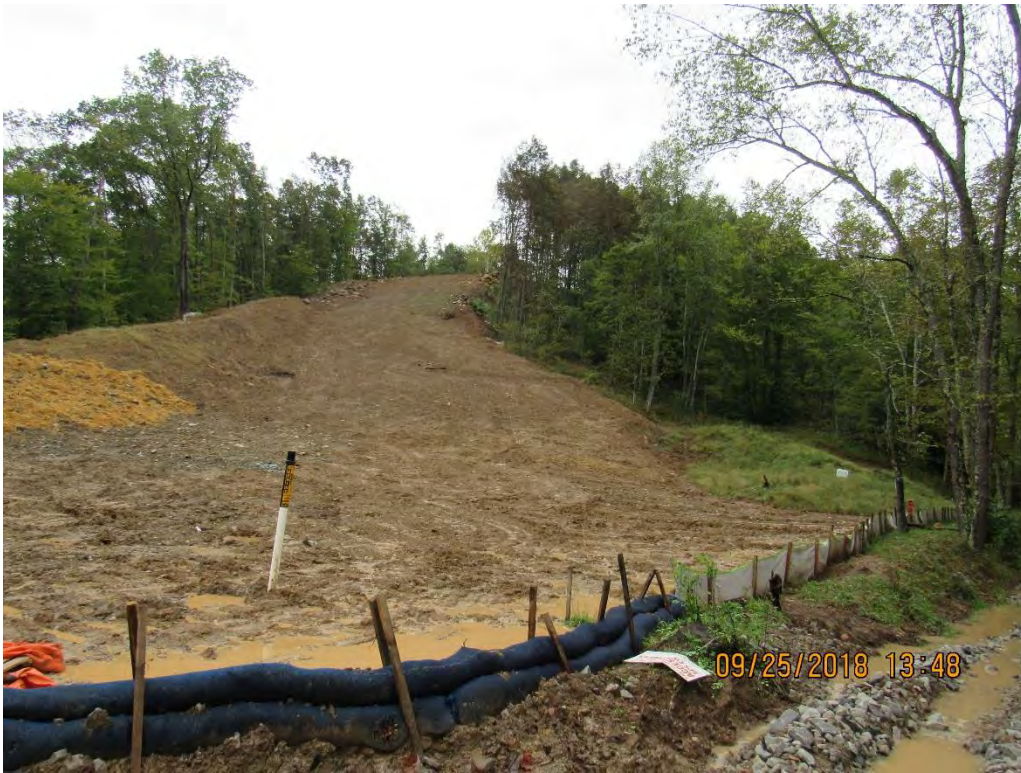
Photo 7: Former area of concern near Barbecue Run at station 3565+00.

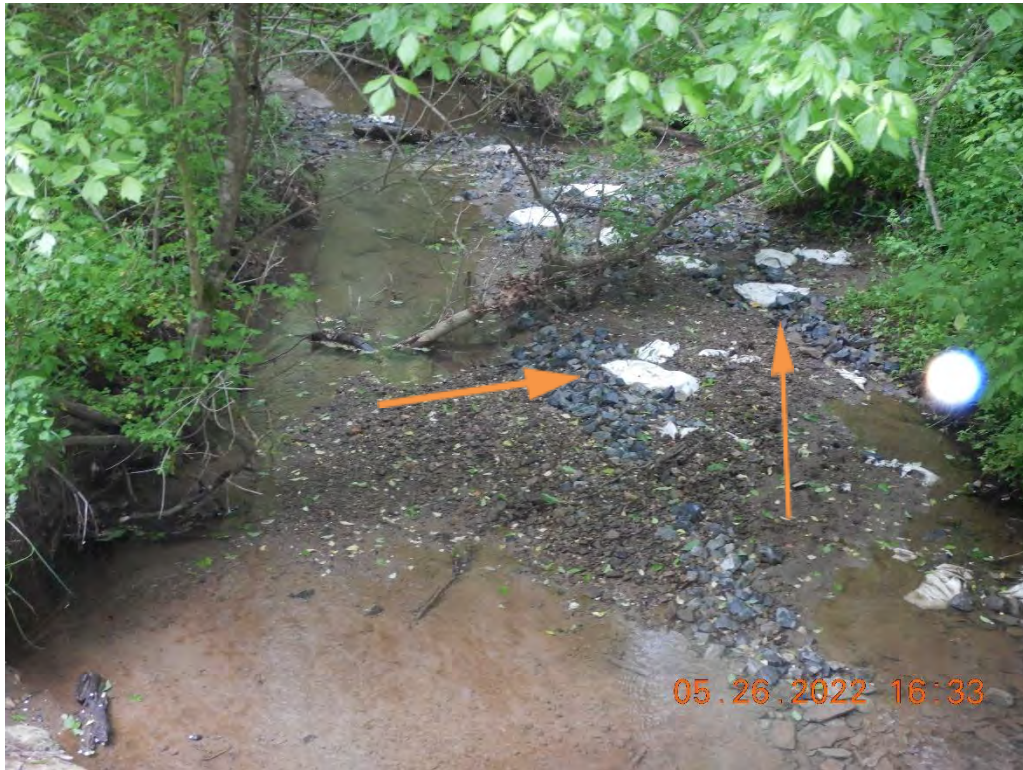
1. (23) – The company failed to remediate or clean up a spill in stream S-VV13B (Second Big Run) that was noted on 5/9/2022 (N 38° 53'54.3", W -80° 34'05.9").

Materials that were washed out during a spill call on 5/9/2022 that have still not been removed from the stream (N 38° 53'54.3", W -80° 34'05.9").

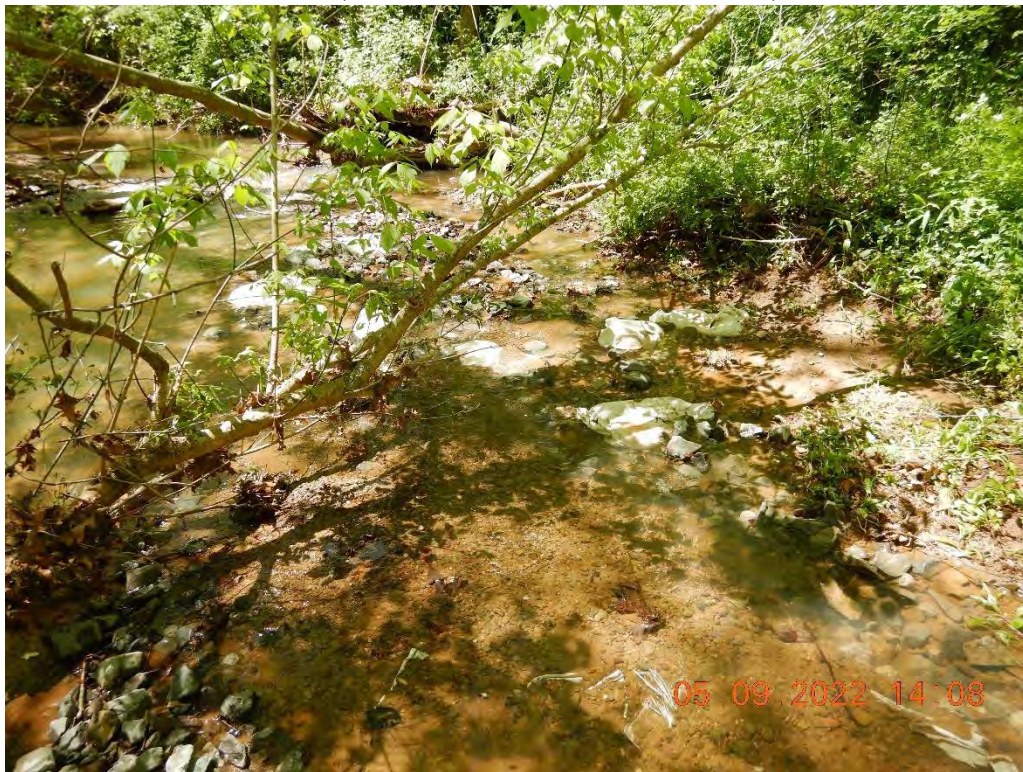
This is a photo taken on 5/9/2022 showing the sandbags and stone in stream S-VV13B (Second Big Run).
