**The Wilderness Society et al. Comments on the
U.S. Forest Service Mountain Valley Pipeline and
Equitrans Expansion Project Draft Supplemental
Environmental Impact Statement (#50036)**

**WEST VIRGINIA DEPARTMENT OF ENVIRONMENTAL PROTECTION
WV OIL AND GAS CONSTRUCTION STORMWATER PERMIT**

FACILITY NAME:	Mountain Valley Pipeline Project			REG. #	EXPIRE DATE:
PERMITTEE	MOUNTAIN VALLEY PIPELINE, LLC			WVR310667	5/13/2018
ADDRESS/PHONE:	Attn: Matt Hoover 625 LIBERTY AVE, ST 1700 PITTSBURGH, PA 15222				
LOCATION:	Wileyville, WV			Entry Date/Time:	4/3/18 8:30am
COUNTY:	Wetzel			Exit Date/Time:	4/3/18 1:37pm
Site Representative /Phone	Matt Hoover Sr. Environmental Coordinator (412) 258-5627			PHOTOS <input checked="" type="checkbox"/>	
CO-PERMITTEE:				ADDRESS:	
SITE OPERATOR:	Precision Pipeline			ADDRESS:	
PERMITTED ACREAGE	4214	WEATHER:	Rain	LAST INSPECTION:	N/A
RECEIVING STREAM(S)	Mobley Run > Ohio River				NOV: 1
Regular Mail <input type="checkbox"/> Certified Mail <input checked="" type="checkbox"/>	Tracking #				
OVERALL FACILITY RATING:	Unsatisfactory		COMPLIANCE OUTCOME	Not Immediately Corrected

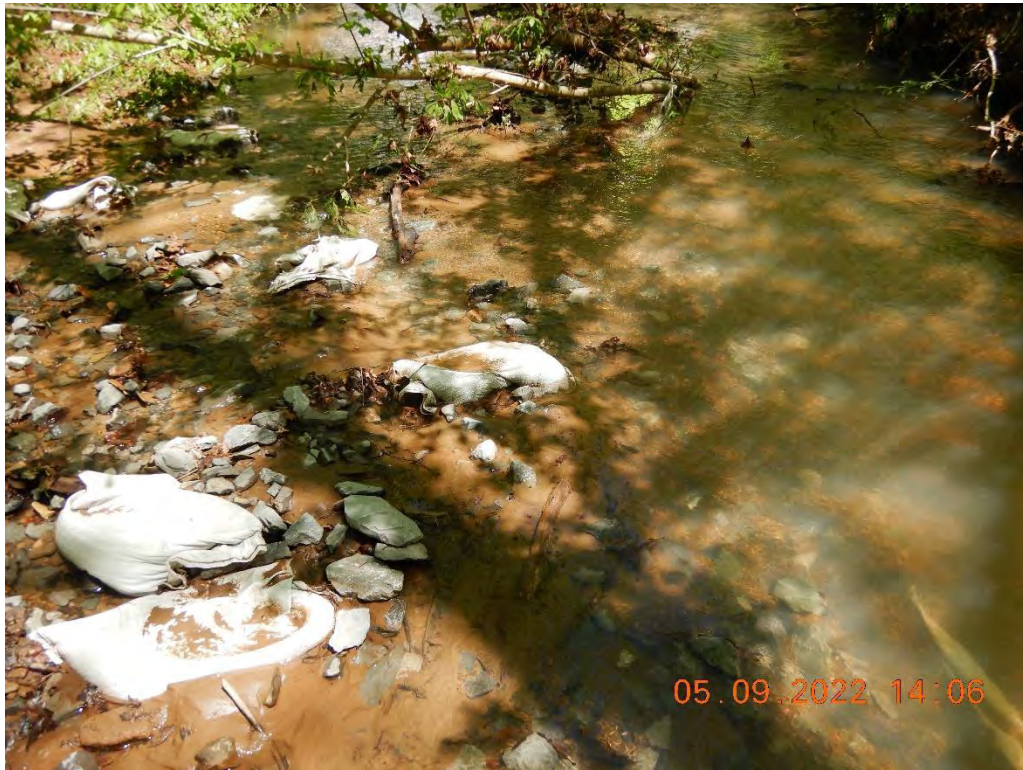
A close-up photo from 5/9/2022 that shows the sandbags and stone in stream.

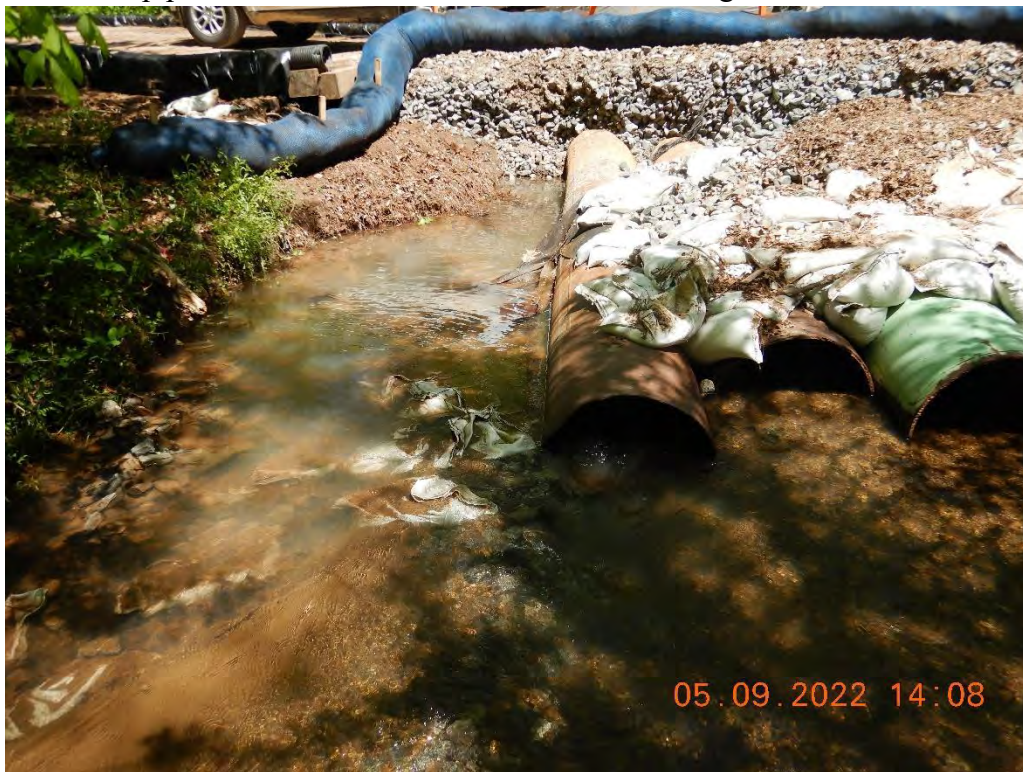
This is a photo showing the flumes that were in place on 5/9/2022.

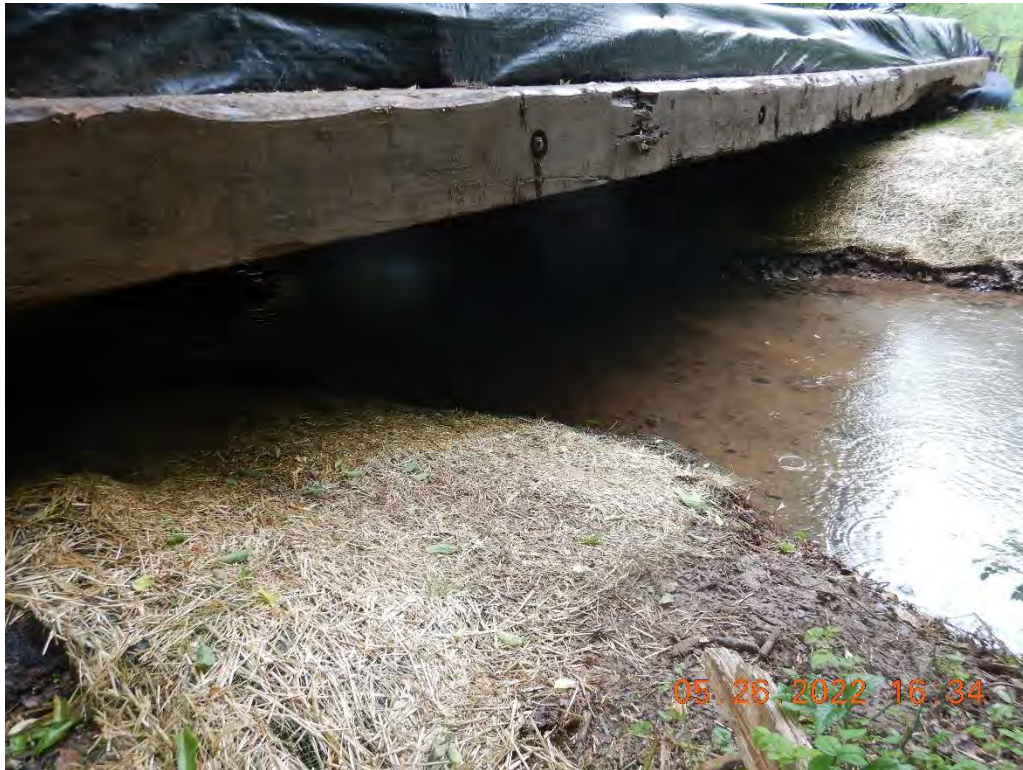
This is a photo showing the air bridge that was installed by the company. The company removed the flumes from the stream to prevent future instances of sandbags and stone from washing downstream.

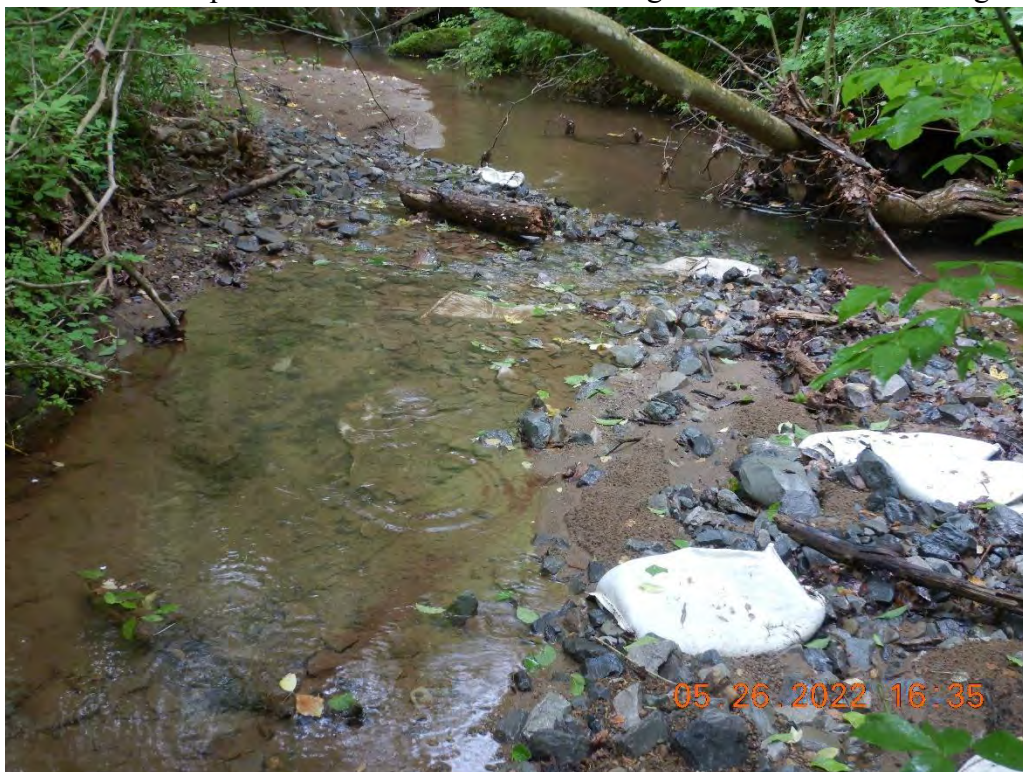
This is a close-up photo showing the sandbags and stone that are still in Second Big Run.

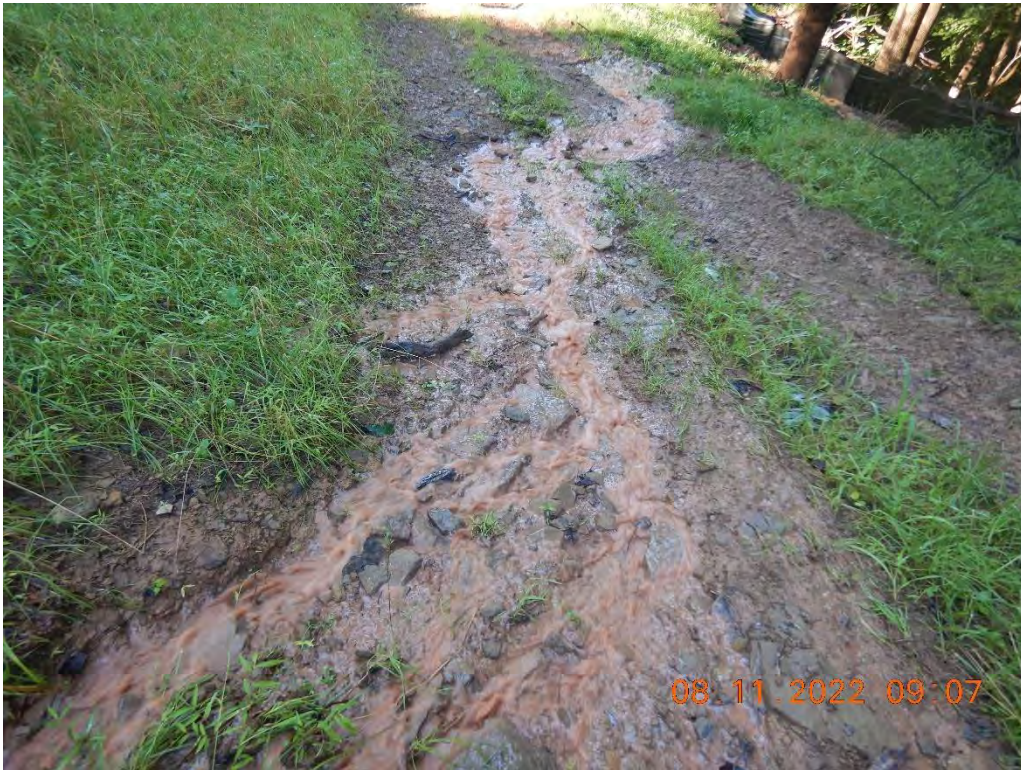
Photo # DSCN2165 – Initial surge of sediment laden water (at or near coordinates 39°29.6430 X -80°31.2104') that initiated this inspection.

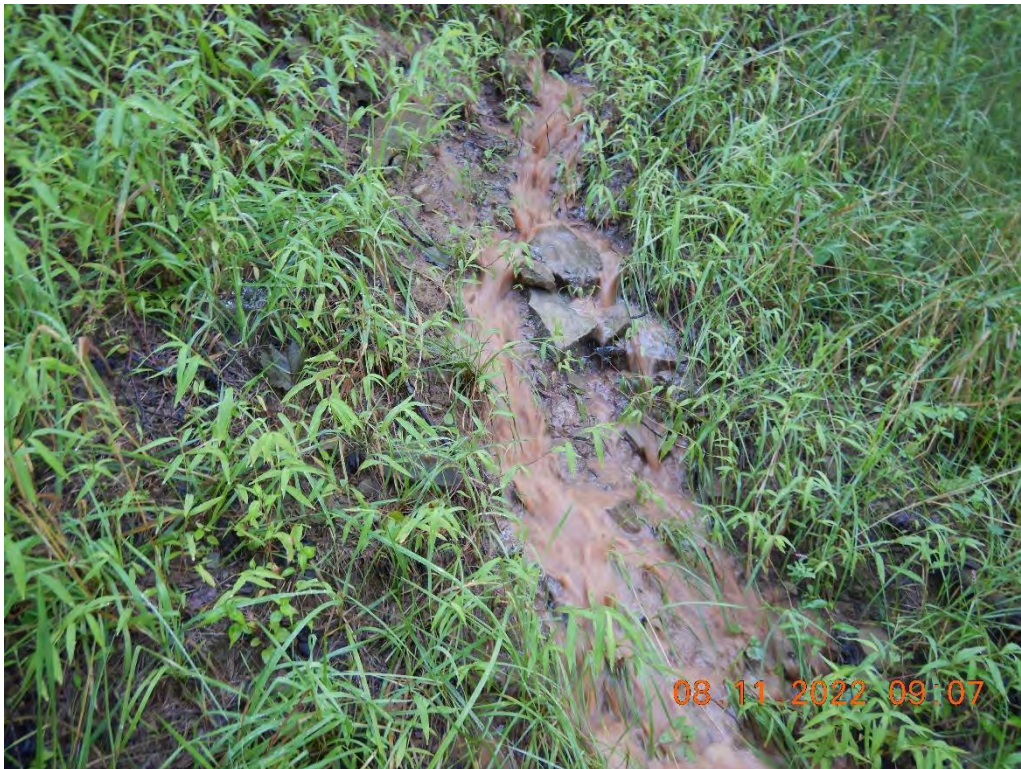
Photo # DSCN2166 – Sediment laden water flowing downslope below and outside of the Mountain Valley Pipeline project.

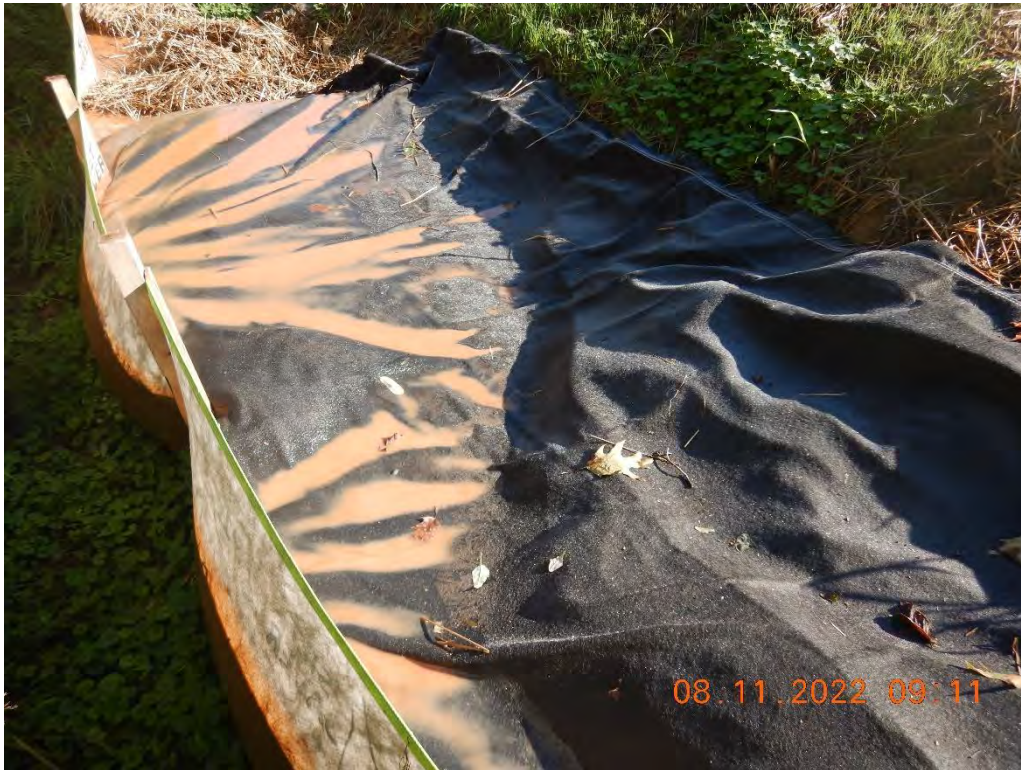
Photo # DSCN2180 – Trench de-watering filter bag located within Mountain Valley Pipeline’s permitted limits of disturbance. Sediment laden water can be seen on top of the filter bag.

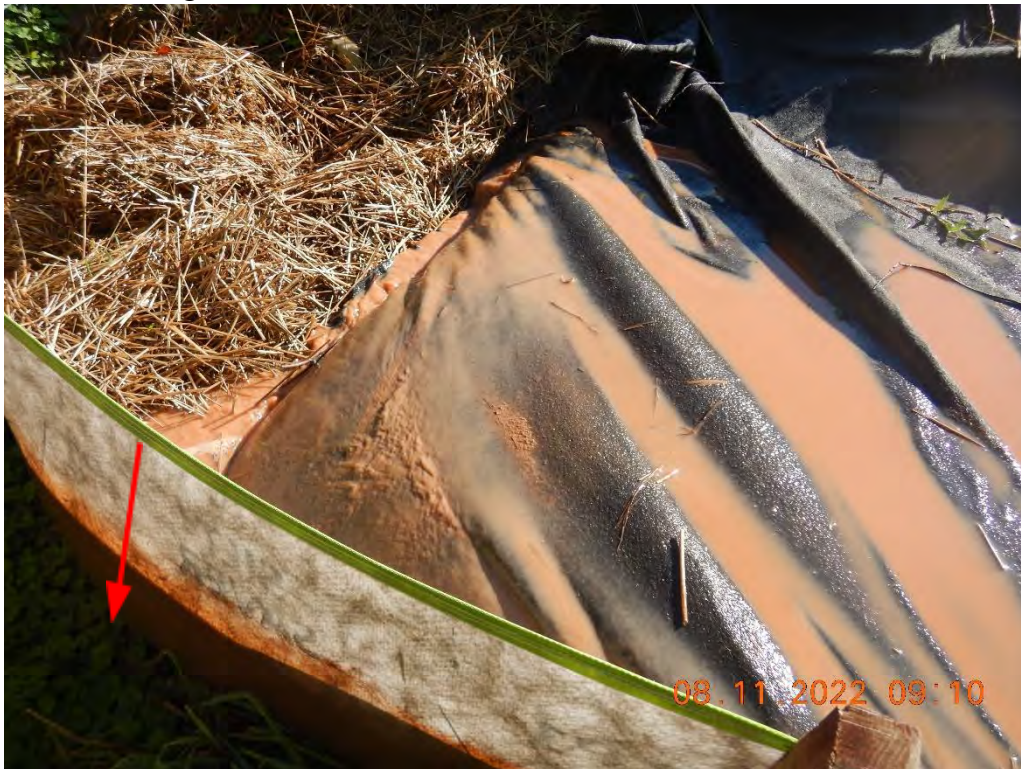
Photo # DSCN2179 – End of the de-watering filter bag opposite the end where the incoming pump water enters. The photograph shows sediment laden water flowing

along the end of the bag after passing through the device. Red arrow indicated the approximate location where sediment laden water is leaving the site.

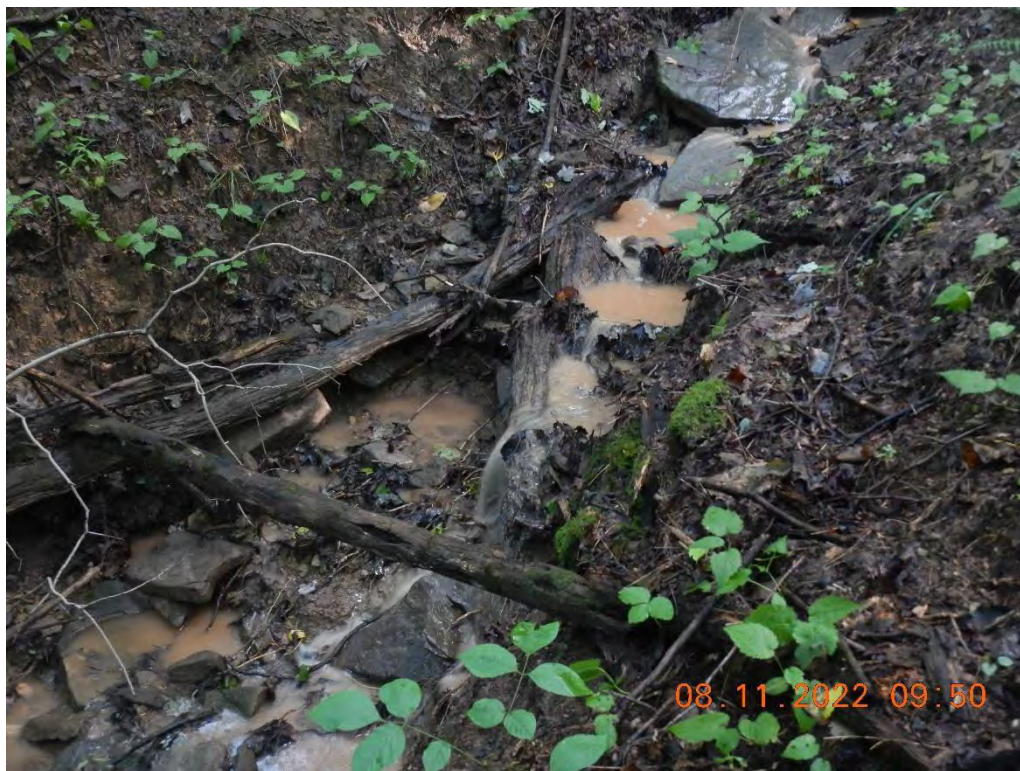
Photo # DSCN2201 – Sediment laden water flowing in an unnamed tributary of Stout Run downstream from the section of stream shown in DSCN2199, above.
