Road	Field Checking Notes
000	Fuels treatment:
	 A mix of young and mature forest; some of the young forest is quite dense but the mature forest is widely spaced Many of the trees are burn scarred but most are alive, green. The downslope is steep in many parts—70 to 80 degrees in certain areas.
	Fall and leave:
	A more severe burn section. Little understory, mostly grass. Most trees are dead.

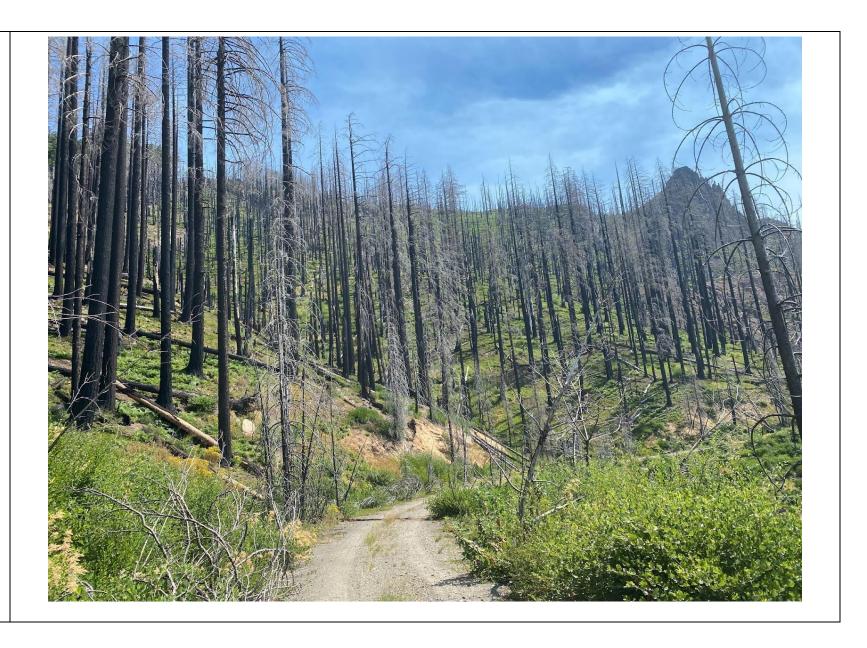
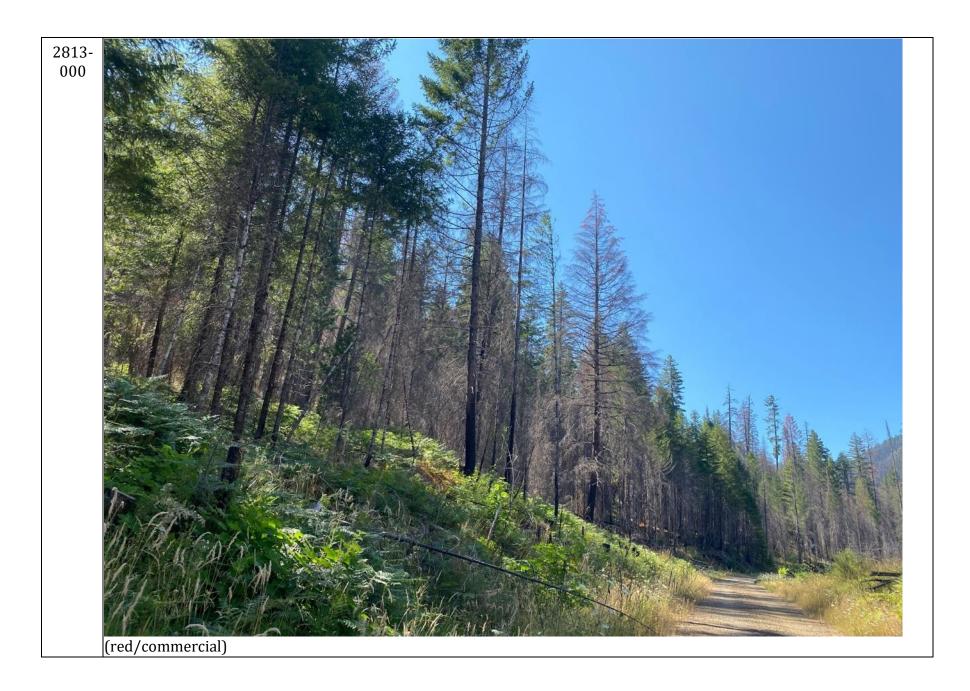
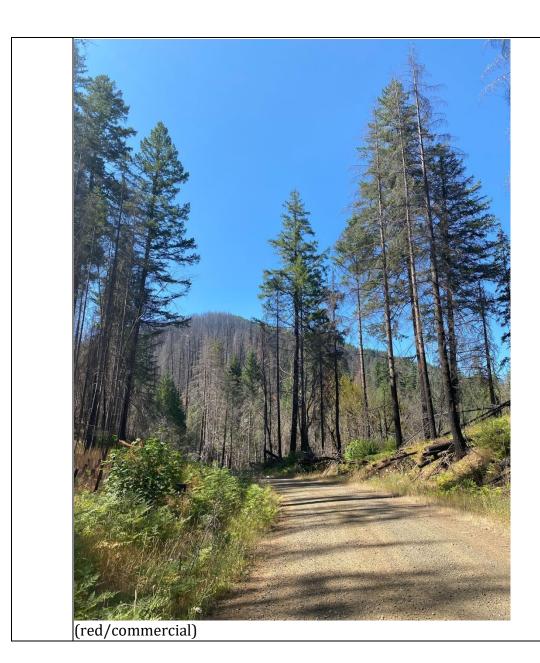
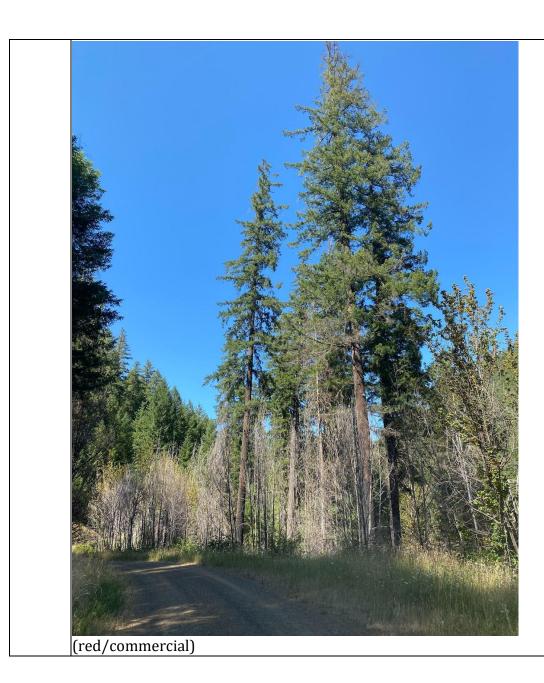
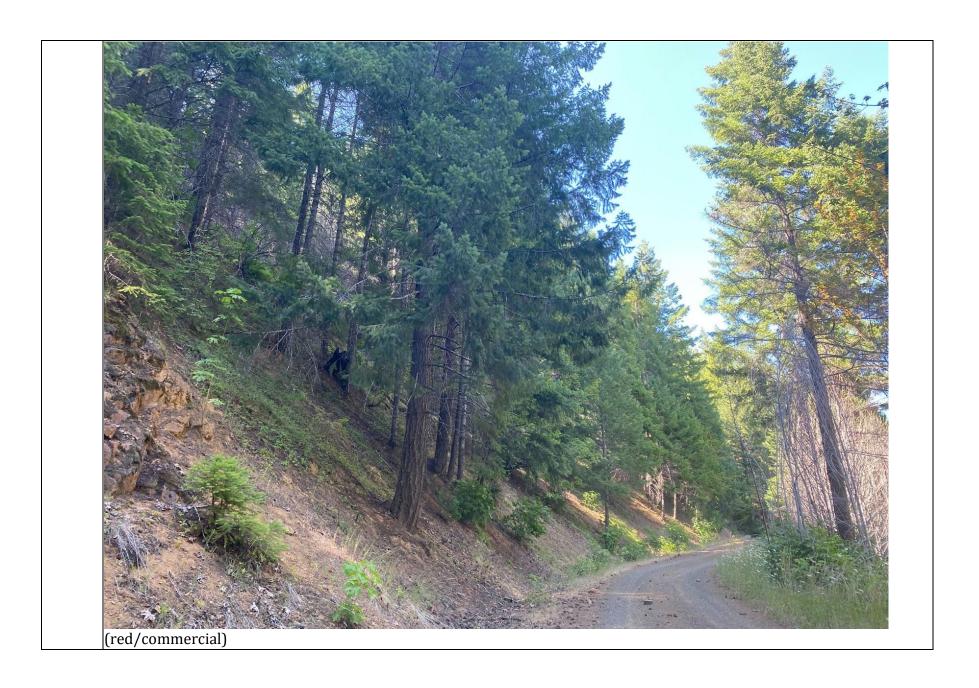
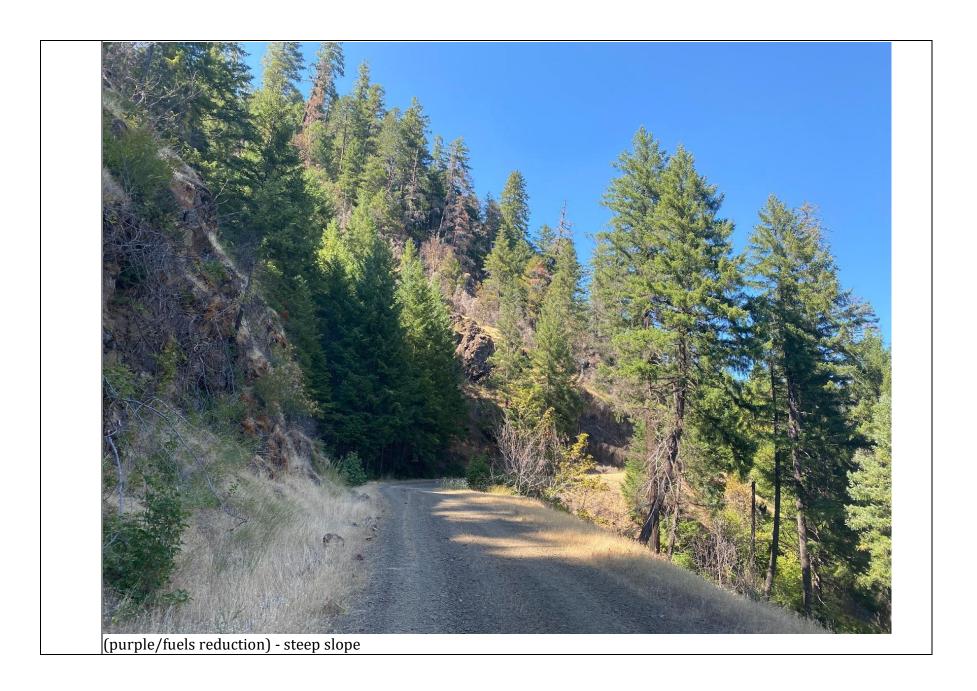
2759-425

Landslide blocks the road leading into 2759-400. High severity, spindly young trees with not much commercial value. Steep, rocky soils susceptible to future landslides. Road gives access to and goes along Cavitt Ridge. Access notes: "Planting Access" and "PODs." The ridge has already burned significantly—how do high severity fire impacted areas play into the PODs model and fire mitigation goals? Other than some potentially interesting rock features for recreational interest, my recommendation would be to remove this road and 2759-426, 400 from the project.
