## RE: CLAIM #24970 - LOSS AND DAMAGE CLAIM FOR WILLIAM BROWN/ELIZABETH GIBBONS PARCEL @2 TRACT "A" OF THE H.E.S. NO. 445 SITUATED IN SECTION 7 T17N; R14E NMPM, (former DEARTH Property) CALF CANYON, SAN MIGUEL COUNTY, NM

CALF CANYON BROWN/GIBBONS PARCEL #2 TRACT "A" OF THE H.E.S. NO. 445 SITUATED IN SECTION 7 T17N; R14E NMPM, SAN MIGUEL COUNTY, NM

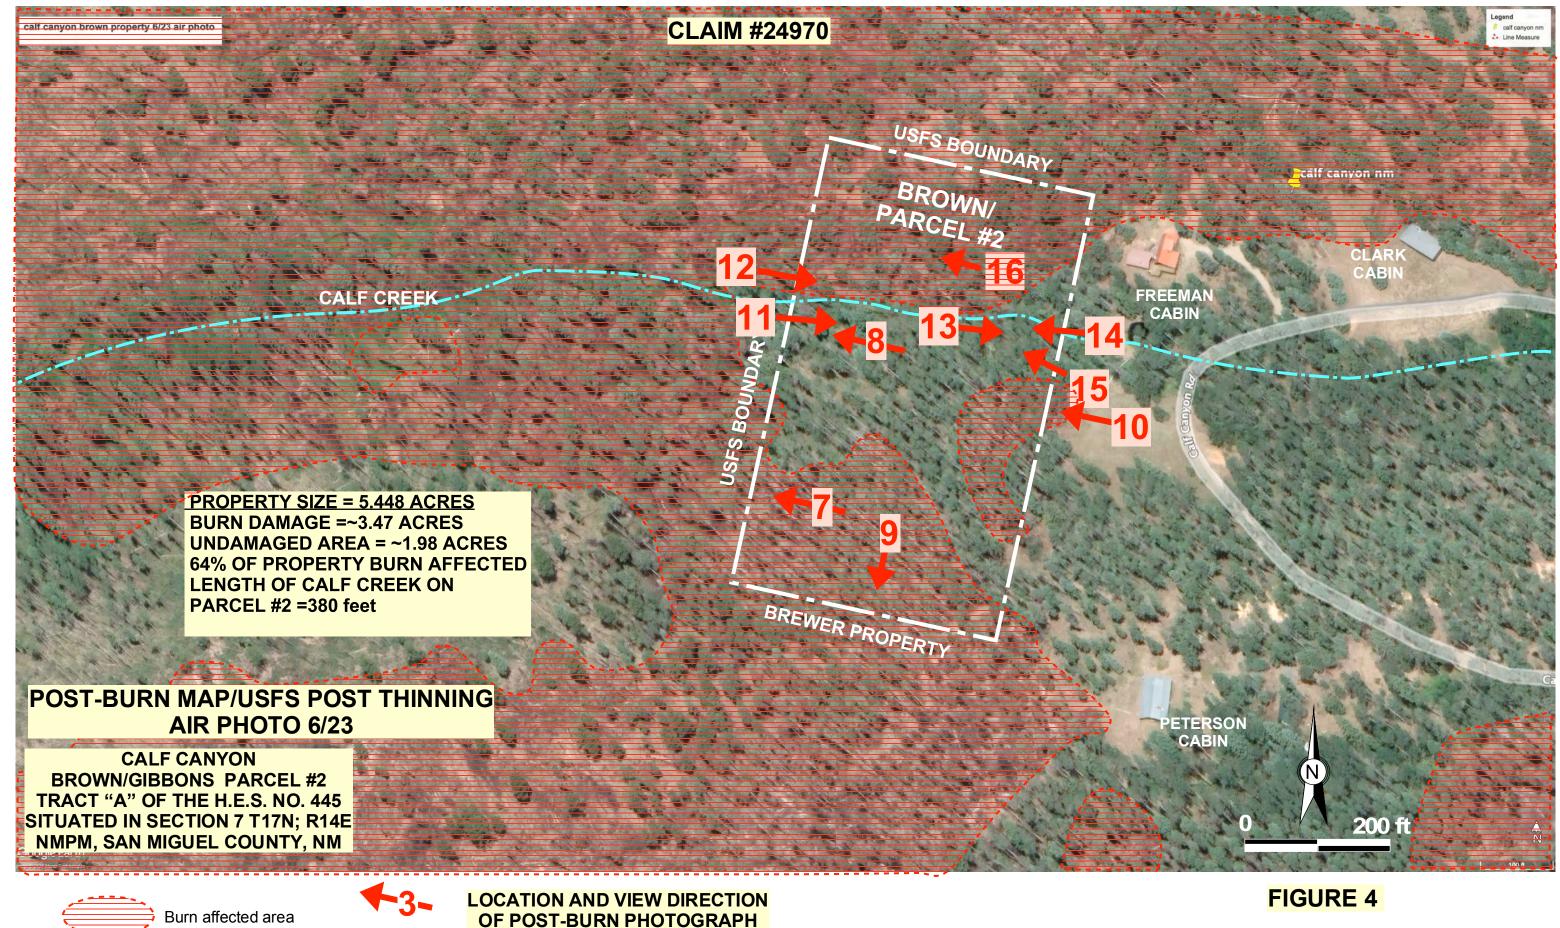
# FIGURE 3

- Pre-fire vegetation and stream conditions are highlighted in Figure 2 (June 2017 aerial photograph) and the photographic log shown in Figure 5.
- Figures 3 and 4 present post-burn aerial photographs (June 2023) highlighting the extent of the burn and the location of post burn/flooding ground photographs which are shown in Figures 6, 7, and 8.
- Approximately 64% of the property was burned by the fire based on air photo data confirmed by ground inspection.
- Extensive erosion occurred along Calf Creek during post fire flash flooding combined with deposition of large gravel bars and wood debris piles. Hydrologic evaluation of flood depositional characteristics indicate water flows on the order of 10<sup>2</sup> greater than normal.
- A small structure on the property was burned and destroyed.

LOCATION AND VIEW DIRECTION OF POST-BURN PHOTOGRAPH
