## **Comment on Plantation Thin & Potential Control Line Treatments EA**

**Collin Neuhauser**

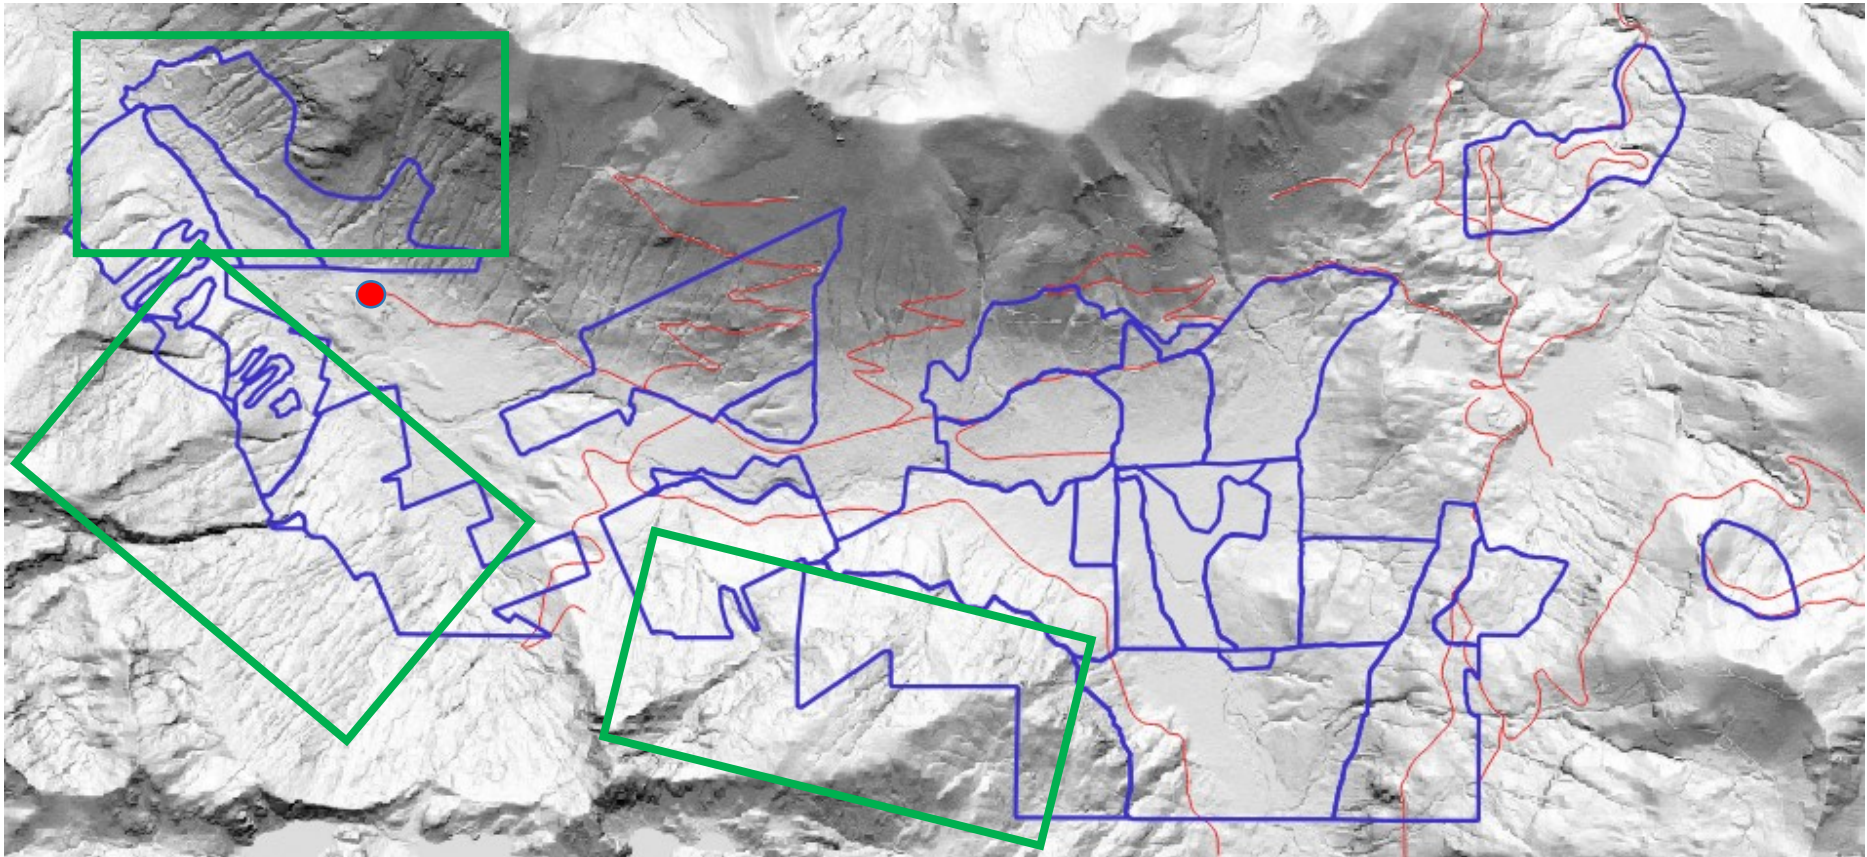
## Upper Green River Watershed

● Severe scotchbroom infestation on Weyerhaeuser land

□ Areas of steep slopes with no existing roads, I would like to see these areas dropped from the EA. The area is prone to landslides

The 26 Road from 2612 junction to 99 junction is in the most need of the pavement reclamation analyzed in the Iron Crystal EA. I would like to see that reclamation paid for through timber sales using the 26 road if another funding source is not available.

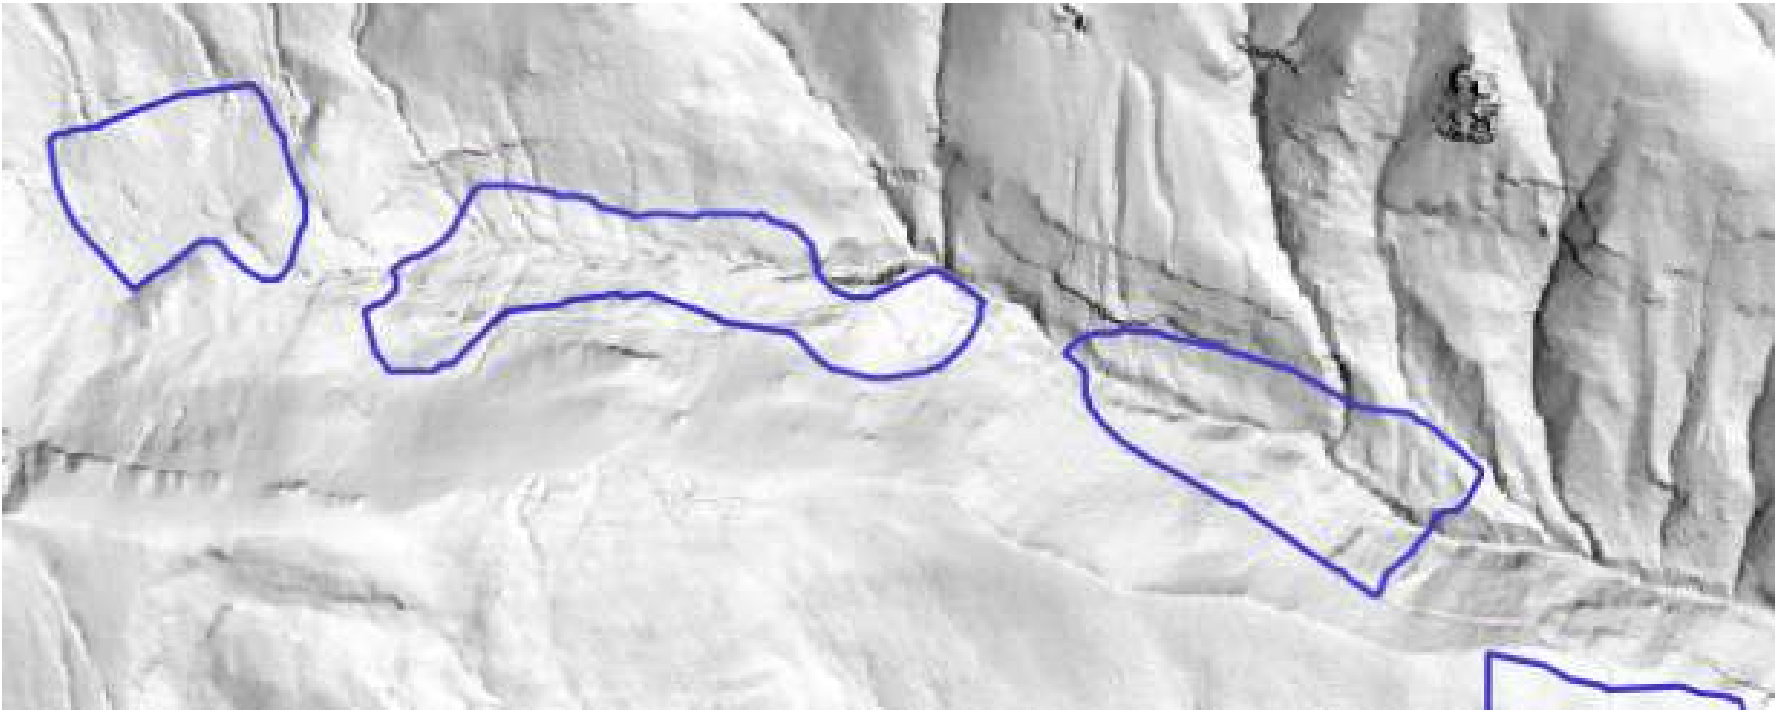
## 1. Crystal Creek

These units in the Crystal Creek watershed straddle the creek and do not make sense to harvest. Rebuilding the road would cause more negative impacts than any positives from the small amount of thinning that would be feasible outside of the riparian reserve. Please consider dropping these units from the EA.

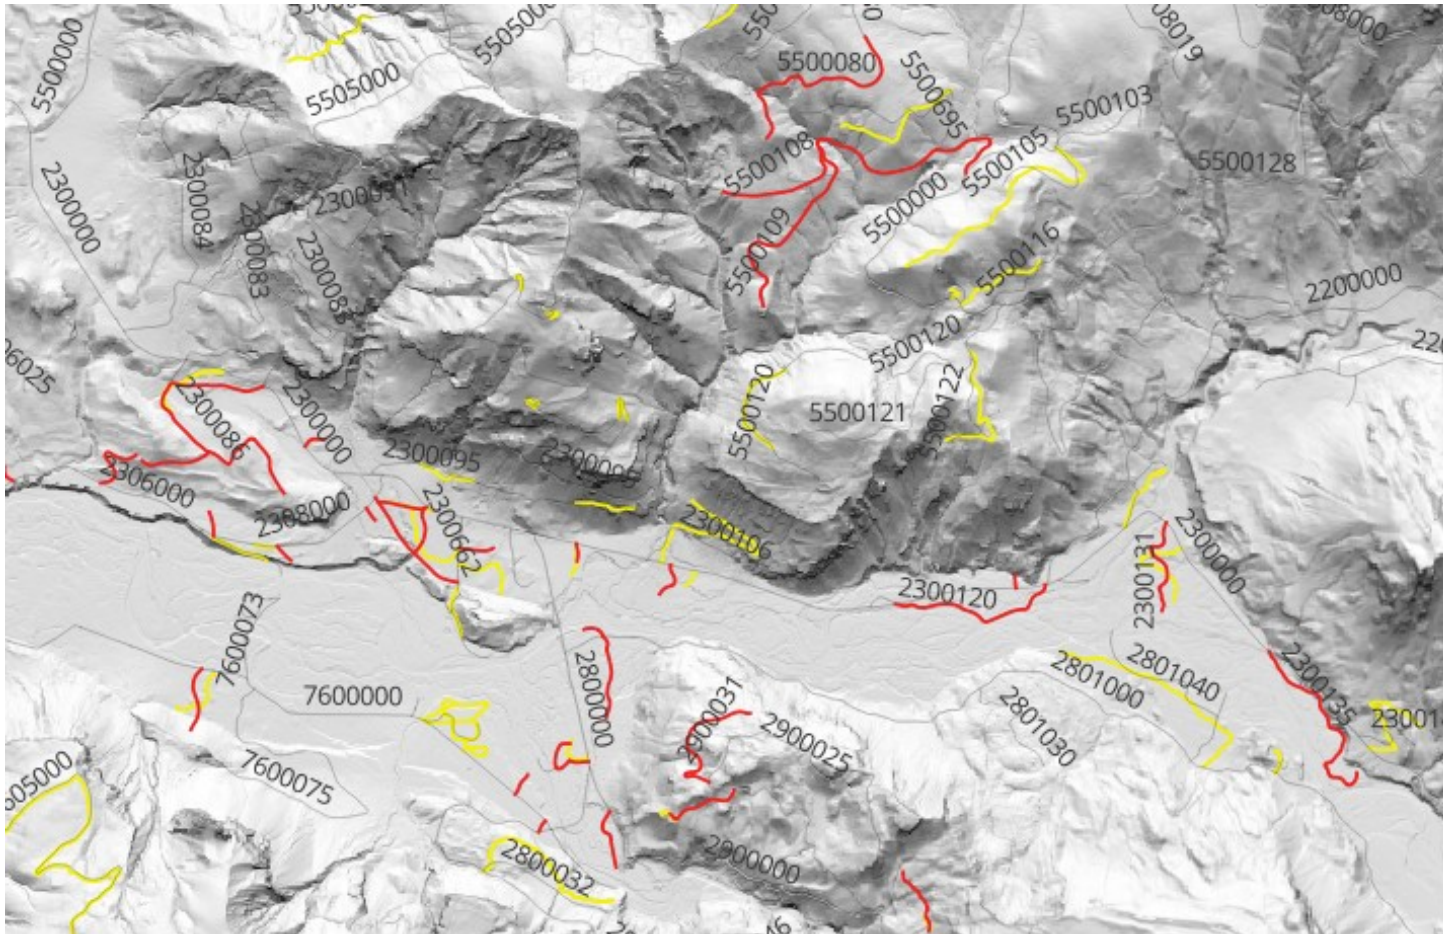
- Red roads are ones that were selected for closure or decommissioning in the Yellowjacket EA.
- Yellow is my mapping of roads that were not accurate in the roads layer.
- I do not think it is okay that EAs are completed without checking the accuracy of the data and correcting mistakes. Roads data can be checked against LIDAR unless the terrain is very flat and stand data can be checked against a combination of LIDAR and historic imagery.

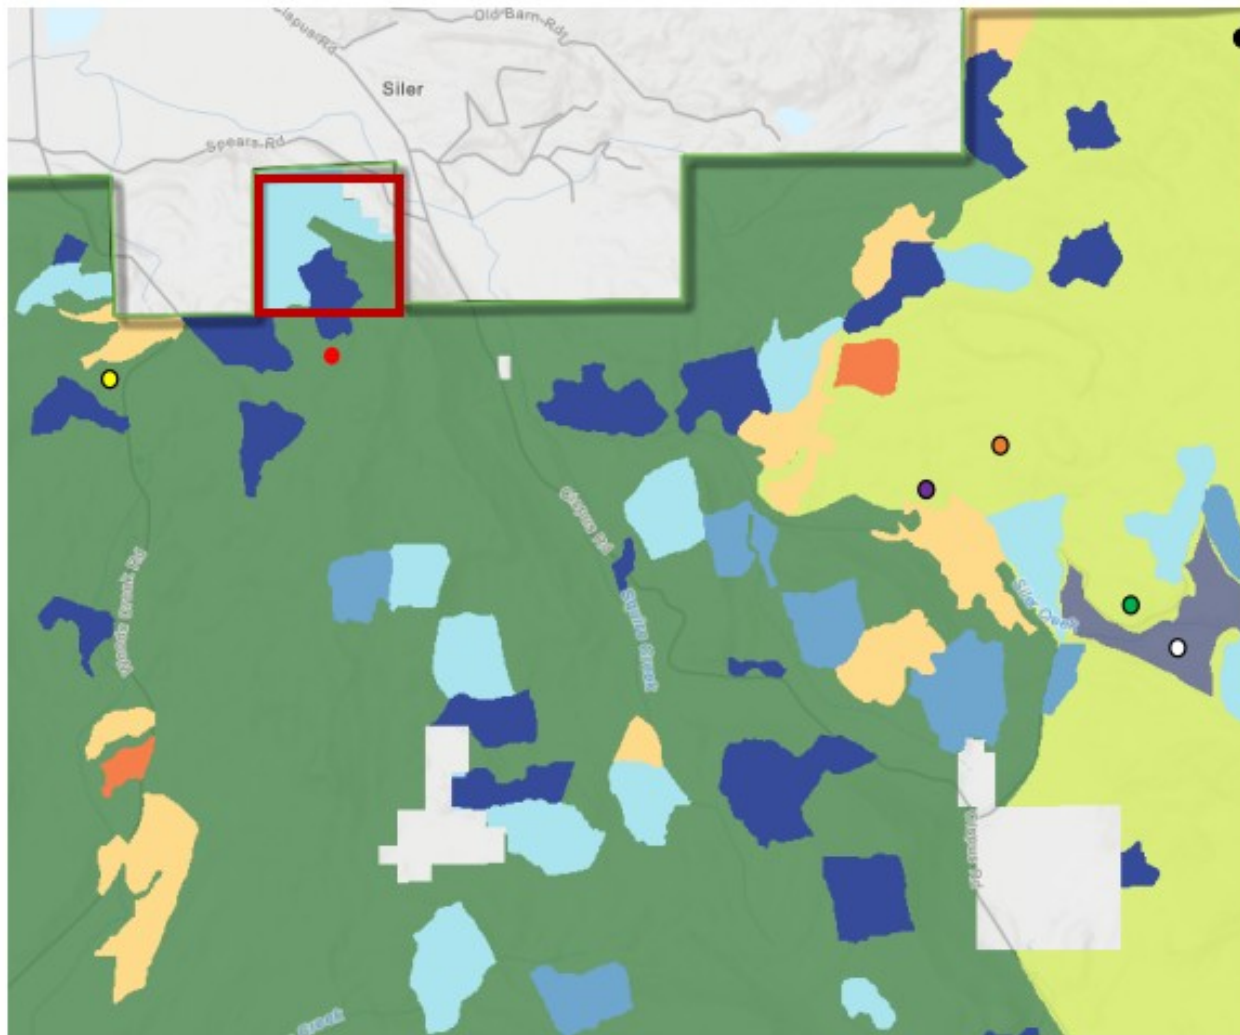
## Siler Creek

This section of the 2303 rd was built in a very wet area and should be considered For decommissioning.

- Just to the east,
- Stand tag 520010 is missing, its origin is 1950.
- Stand tag 528174 is missing, its origin is 1961.
- Stand tag 528074 is missing, its origin is 1961.
- Stand tag 528027 is missing, its origin is 1952
- Stand tag 528516 is missing, its origin is 1952
- Stand tag 528189 is missing, its origin is 1965
- Stand tag 529507 is missing, its origin is 1982
- This stand is not a plantation under 80

The Siler creek area should be prioritized because it has very overstocked douglas fir plantations, is adjacent to a rural community, is a short haul to the mill, there are lots of opportunities for AOP barrier removal, and it is LSR. ML1 roads in LSR should have all of their culverts removed and be decompacted because no further entry will be needed for many.

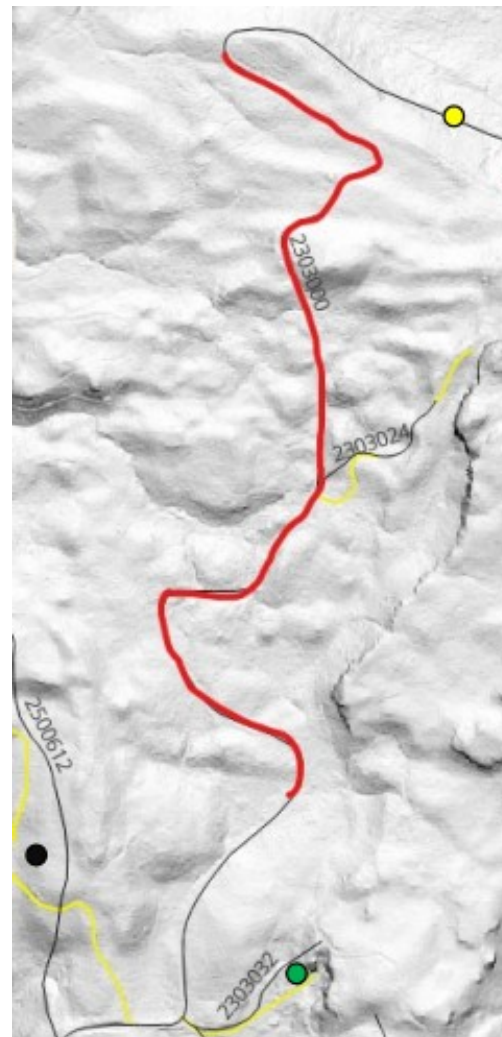
## Siler Creek Continued

- Portion of 2303 that is built through a very wet area. This portion will not be necessary in the future because the area is LSR.
- Landslide location
- Judd Pit. This gravel pit has not been used recently
- The 2500-612 spur should be deleted. It was built as a skid trail

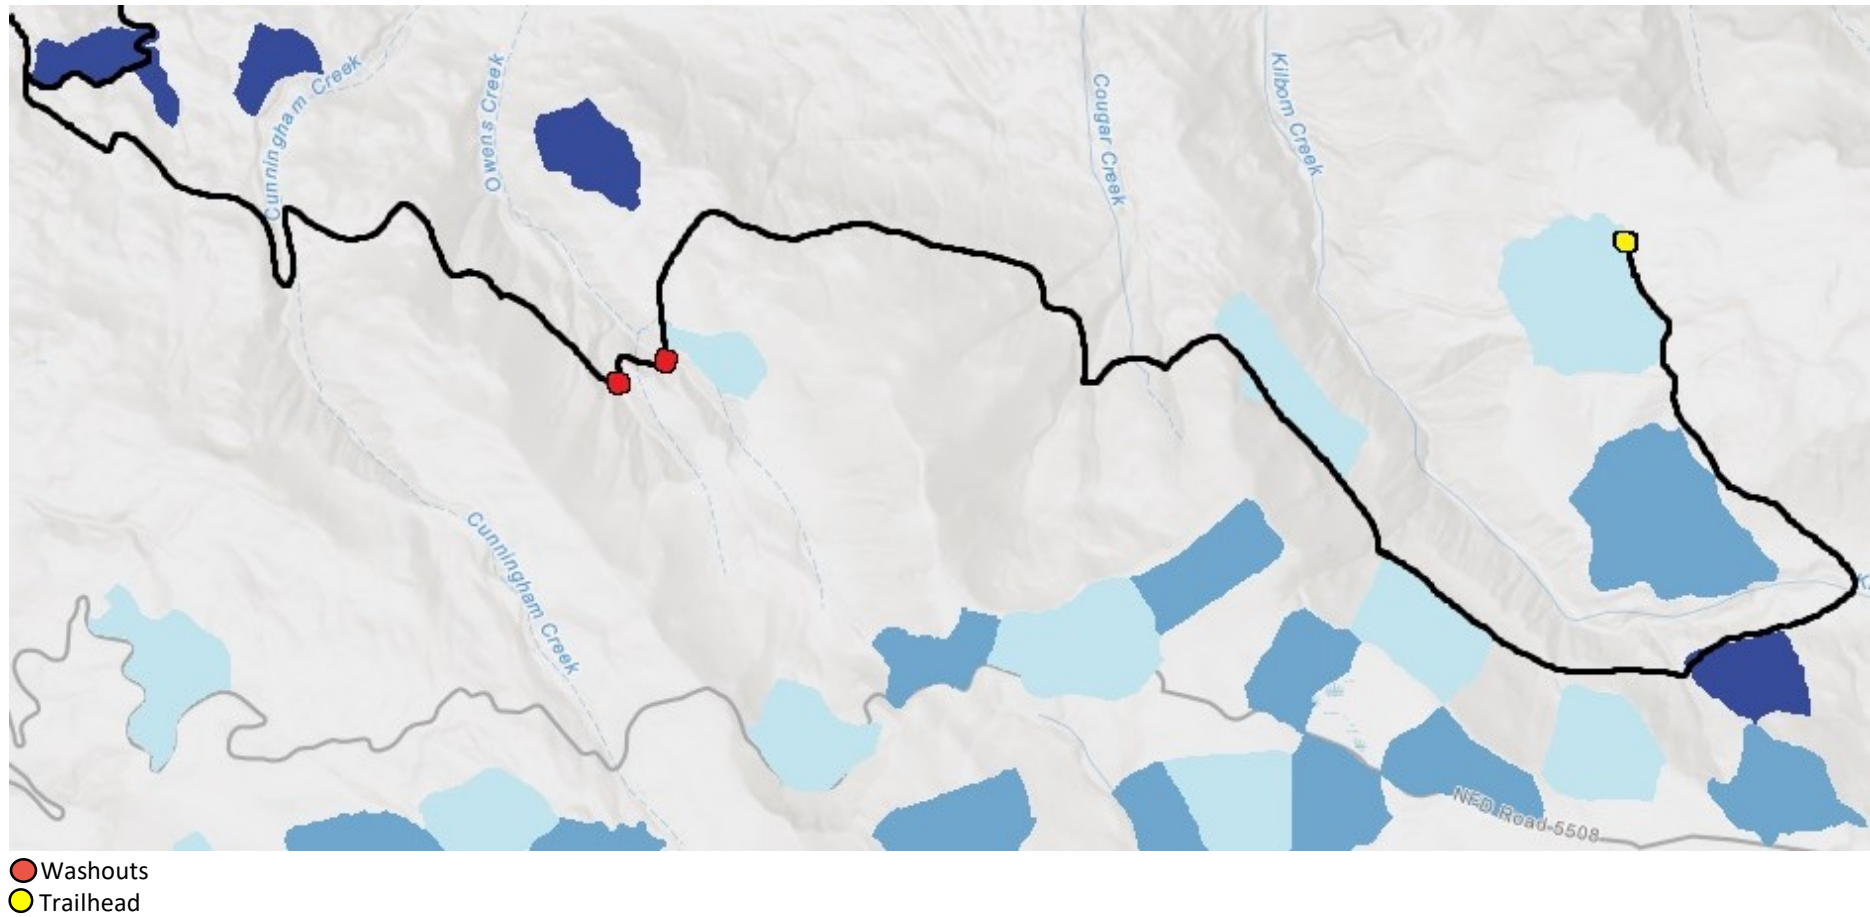
## 2304 Kilborn Creek

The 2304 should be a priority because it gives access to an area where backburns could stop a fire threatening Randle. There is also a trailhead.

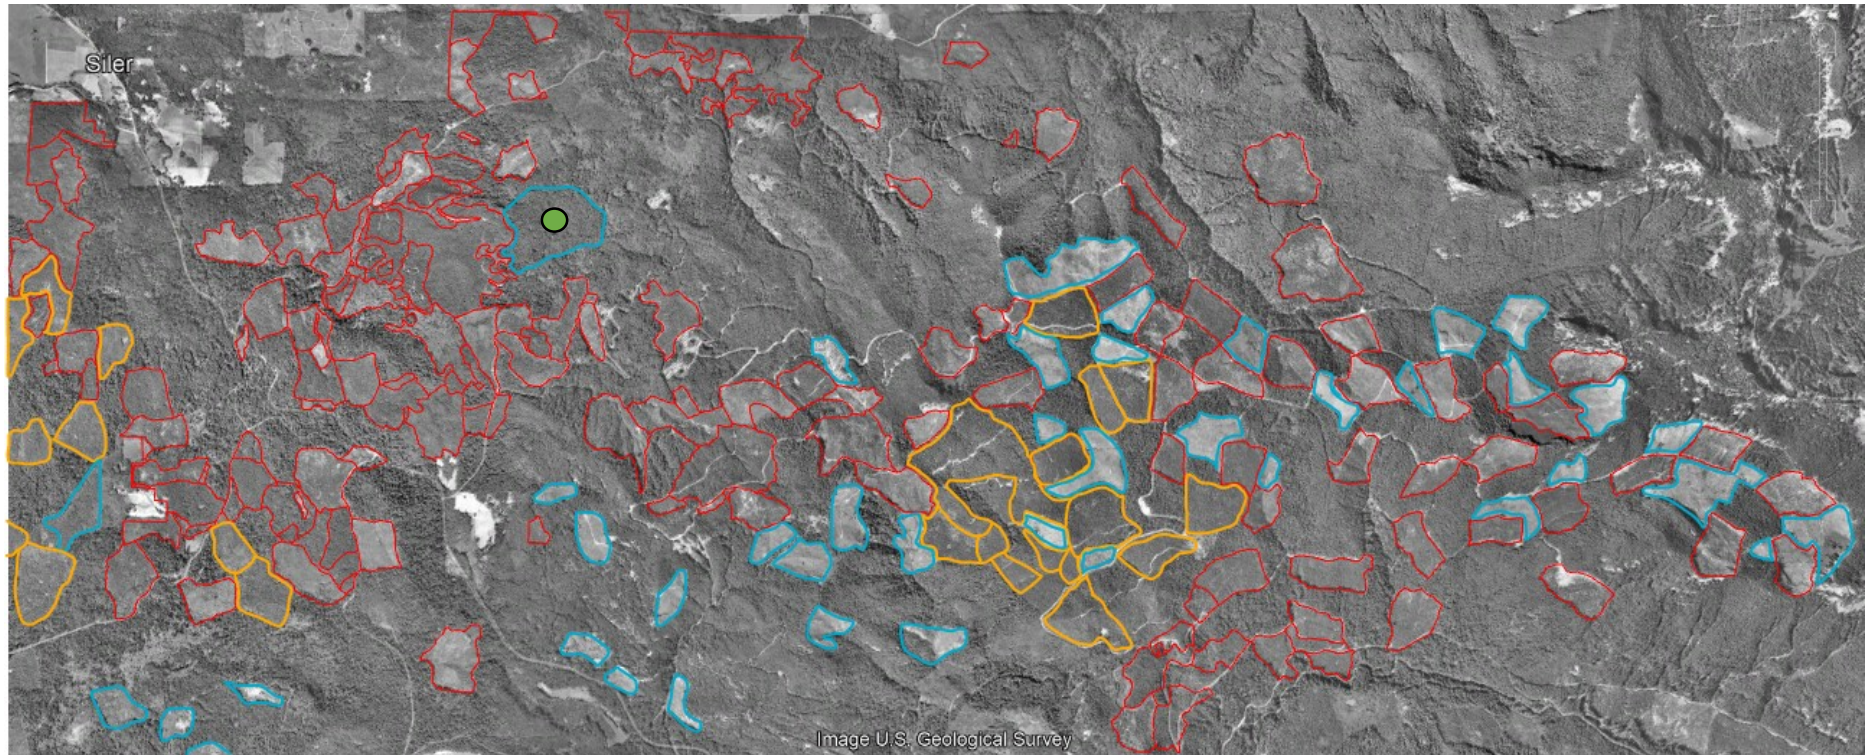
### Siler and Killborn Missing Units Under 80

- Stands under 80 layer
- Stands treated under Kraus Ridge and Yellowjacket EAs
- Stands under 80 missing from layer
- Large stand on 2304-030 spur that is of uncertain age, possibly 1940s-50s origin

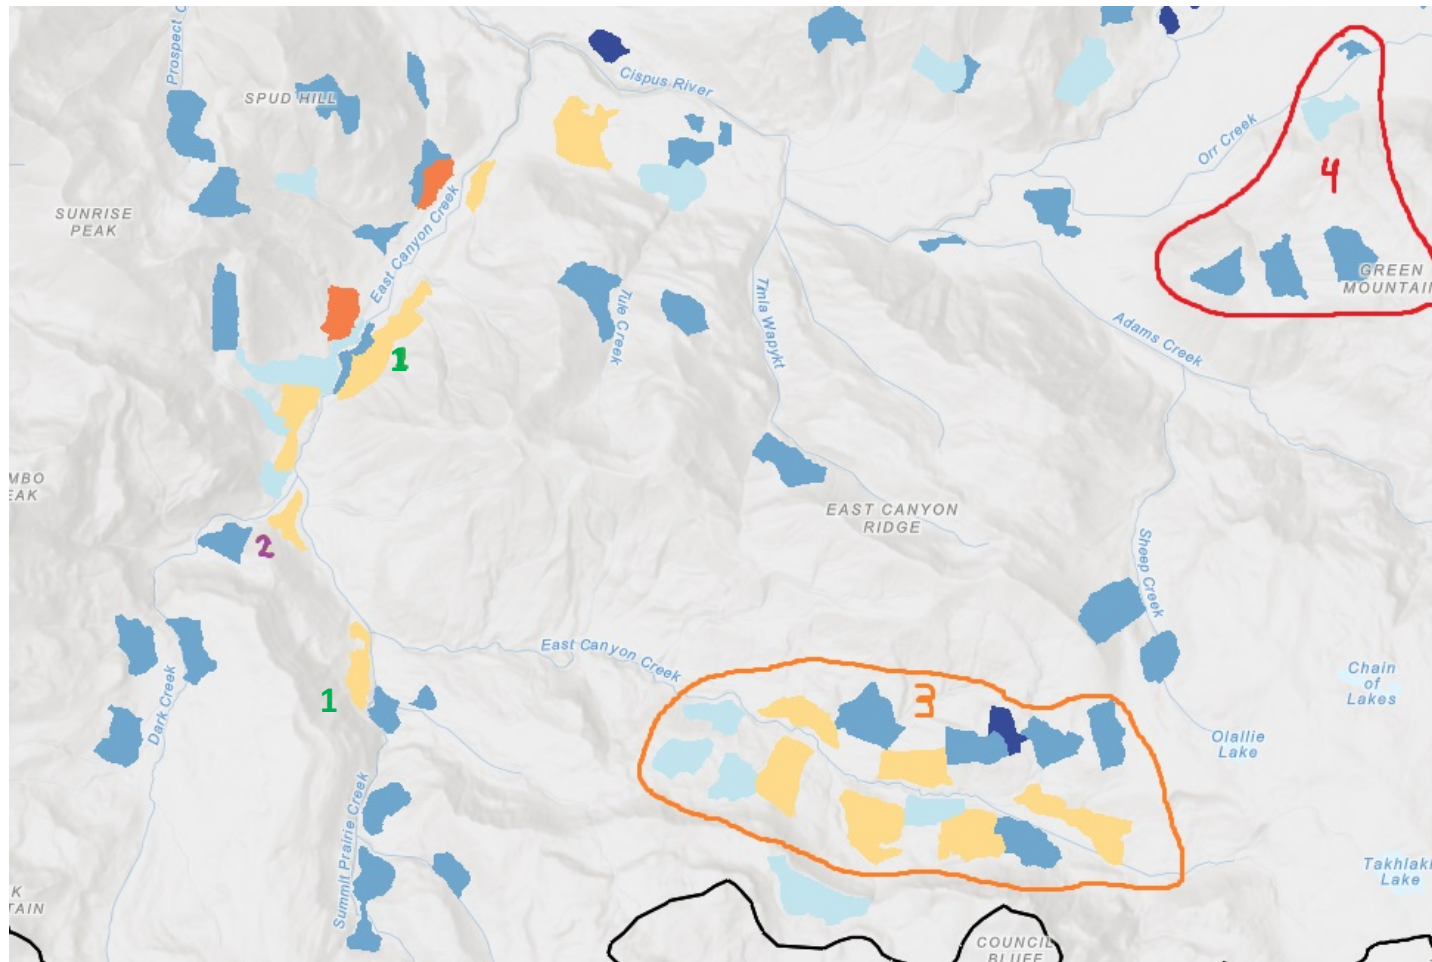
## East Canyon Creek and Green Mountain

1. Stand Tag 539622 does not have access without a long temp road. Is this a good candidate for helicopter logging?

Stand Tag 539464 has a similar situation to the south.

2. Road 2300-245 is decommissioned and there is no crossing over East Canyon Creek. What is the plan for accessing these units? I hope that construction of a new crossing over the creek is unnecessary. Is helicopter logging the best option?

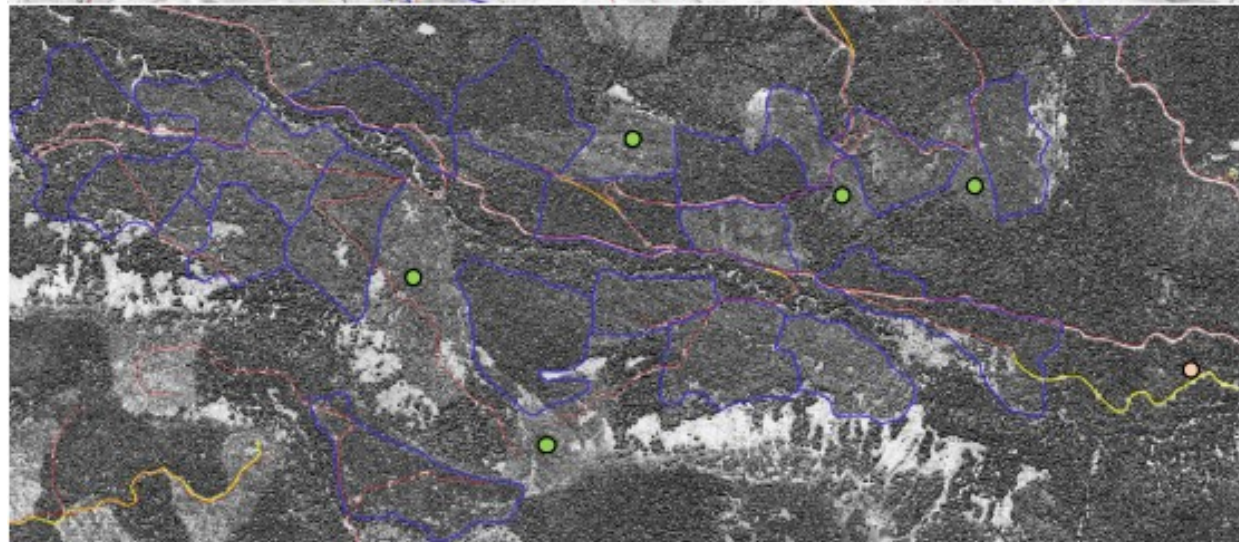
- Plantations that likely should have been included. There may be more out the 2328-021.
- The 2300-306 seems to extend to here. Is this a plantation?

Neither the 292 or 304 spurs will be needed for quite a while after harvest and I think removing the crossings will be beneficial for the creek.

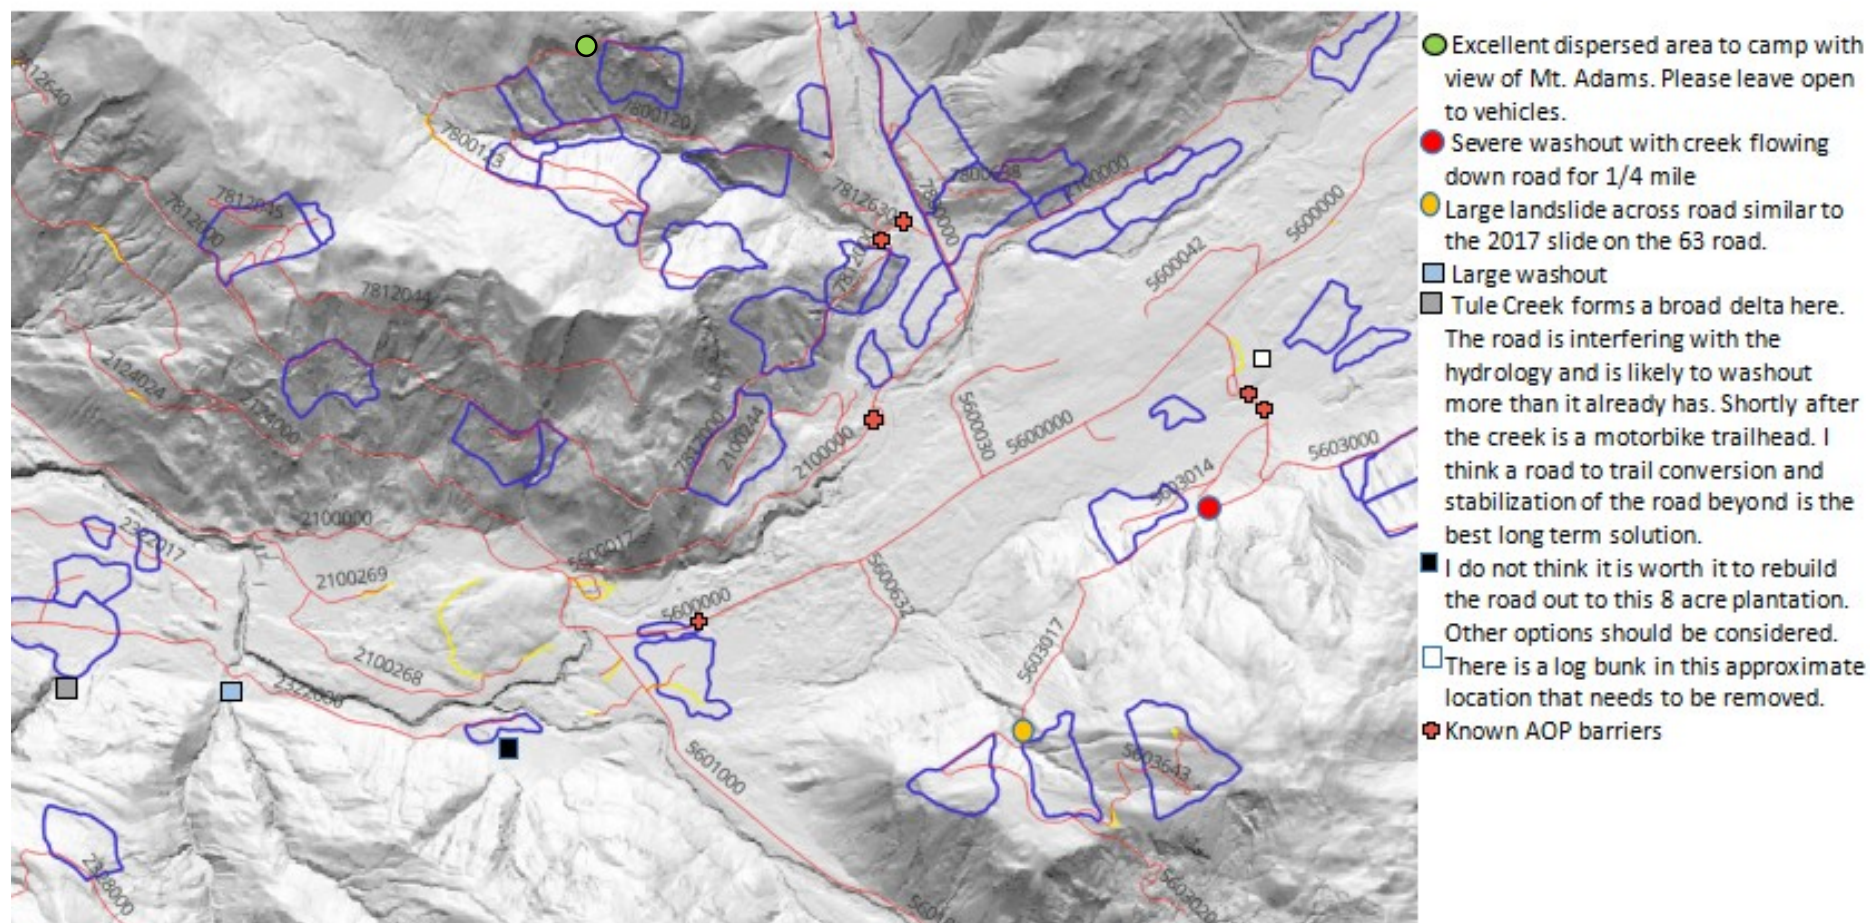
## Green Mountain

I would like to see an analysis of the pros and cons of decommissioning the 5603017. I do not think it is a sustainable road traversing such steep terrain and it is the only road between Orr Creek and the Horseshoe Roadless area. The end of the road should be a road to trail conversion for the 110 motorcycle trail that starts on the 5601.

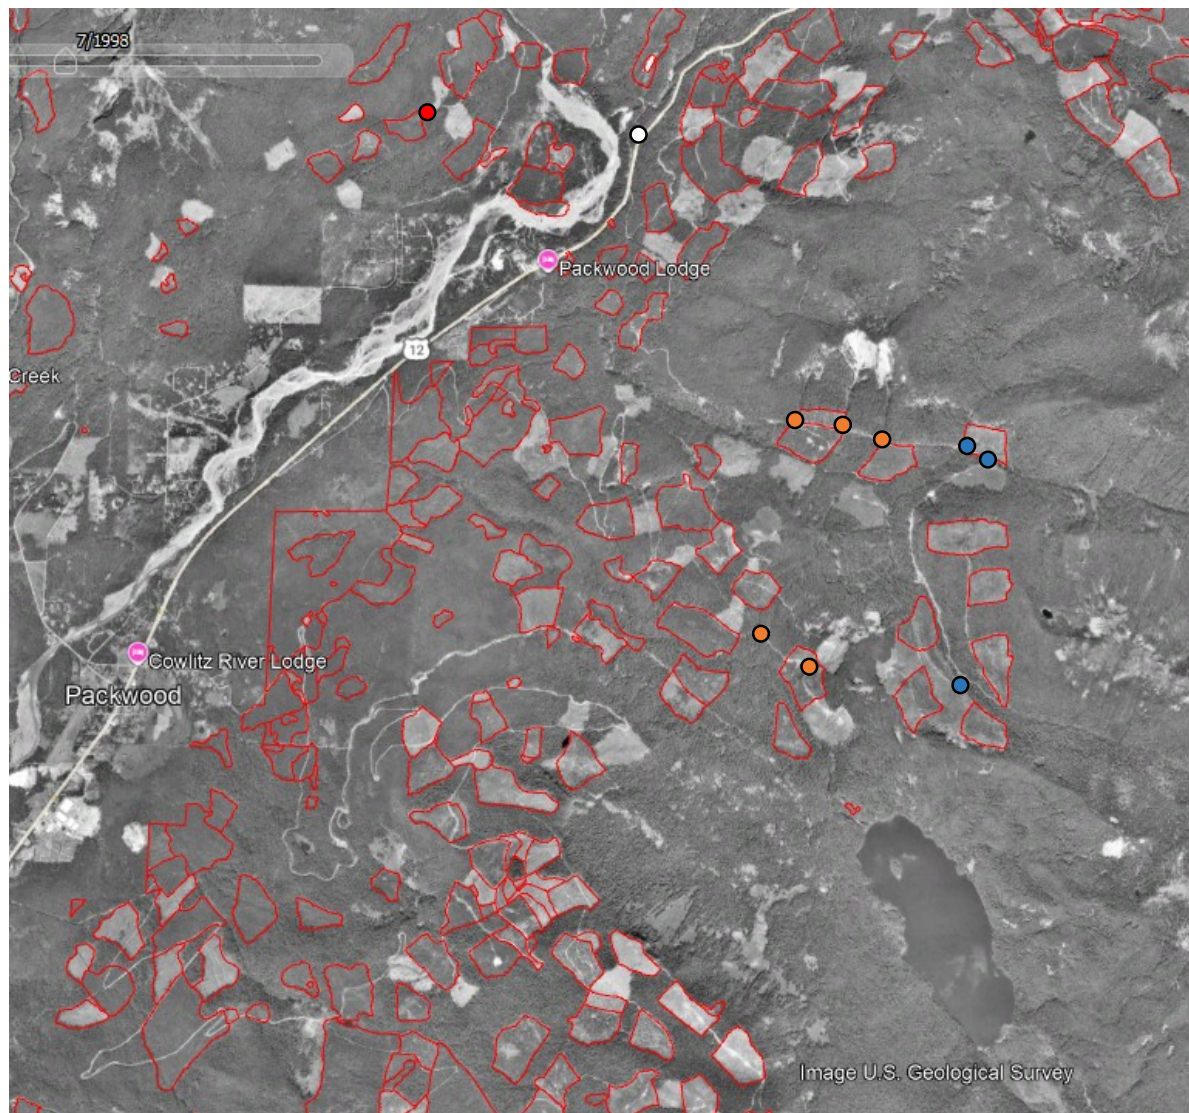
### Packwood Area

- Steep drainages burned in the Goat Rocks fire. These culverts are at high risk of washout due to the burn scars above them. Some have already washed out and others are plugged with debris. I would like to see these culverts removed after timber harvest is complete.
- These are the locations of former log stringers that have collapsed or are unsafe to use. I would like to see the road beyond these decommissioned because it abuts wilderness and is not sustainable to keep.
- Jody's Bridge. I would like to see the plantations beyond thinned via helicopter and culverts on road 1270 removed. I am assuming that it is too expensive to ever replace the bridge.
- Location of culvert that needs to be upsized because it is getting plugged with branches and duff. There was quite a bit of damage when the creek overtopped and ran down the ditch causing a rut at the 5290 junction.

This area has severe infestations of scotch broom that were remapped in 2024. Scotch broom increases fuel loading in thinning units so I would like to see a plan to contract out large scale treatments. District staff will not be able to keep up with the growing infestations. Please see Unit 5 of the Skinner sale and Units 17 and 18 of the PRT Stewardship sale for worst case scenarios of scotch broom invasion of thinning units.

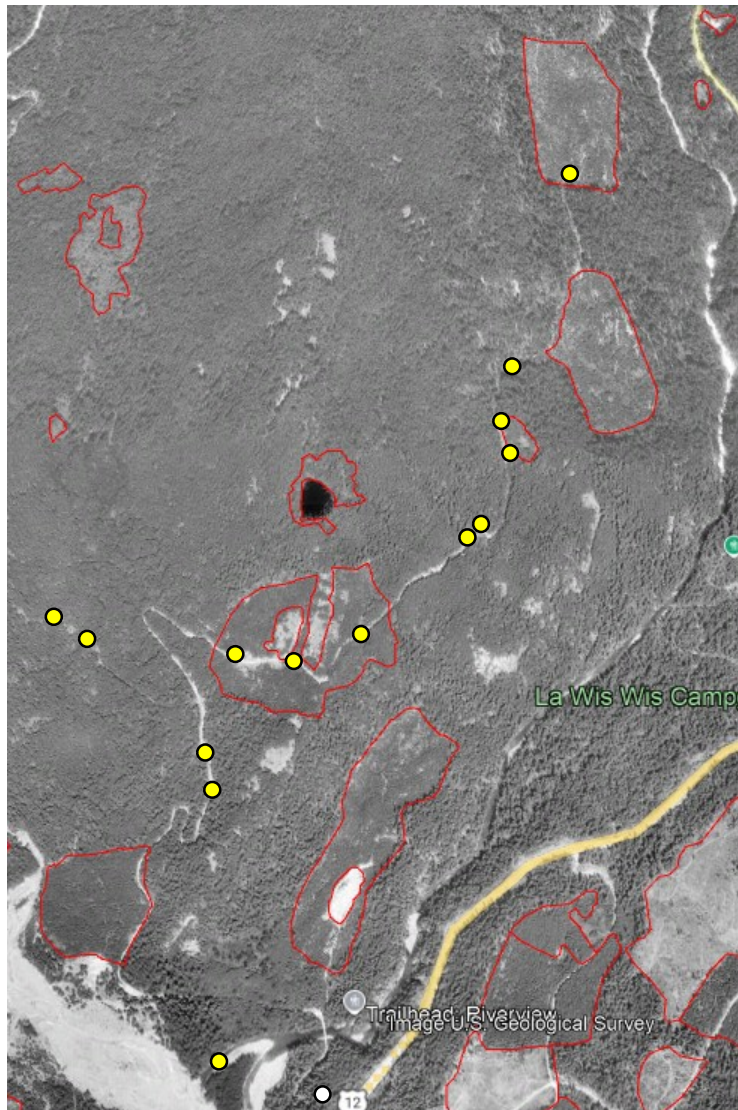
- Culverts identified with LIDAR on 1270 beyond Jody's Bridge that need to be removed

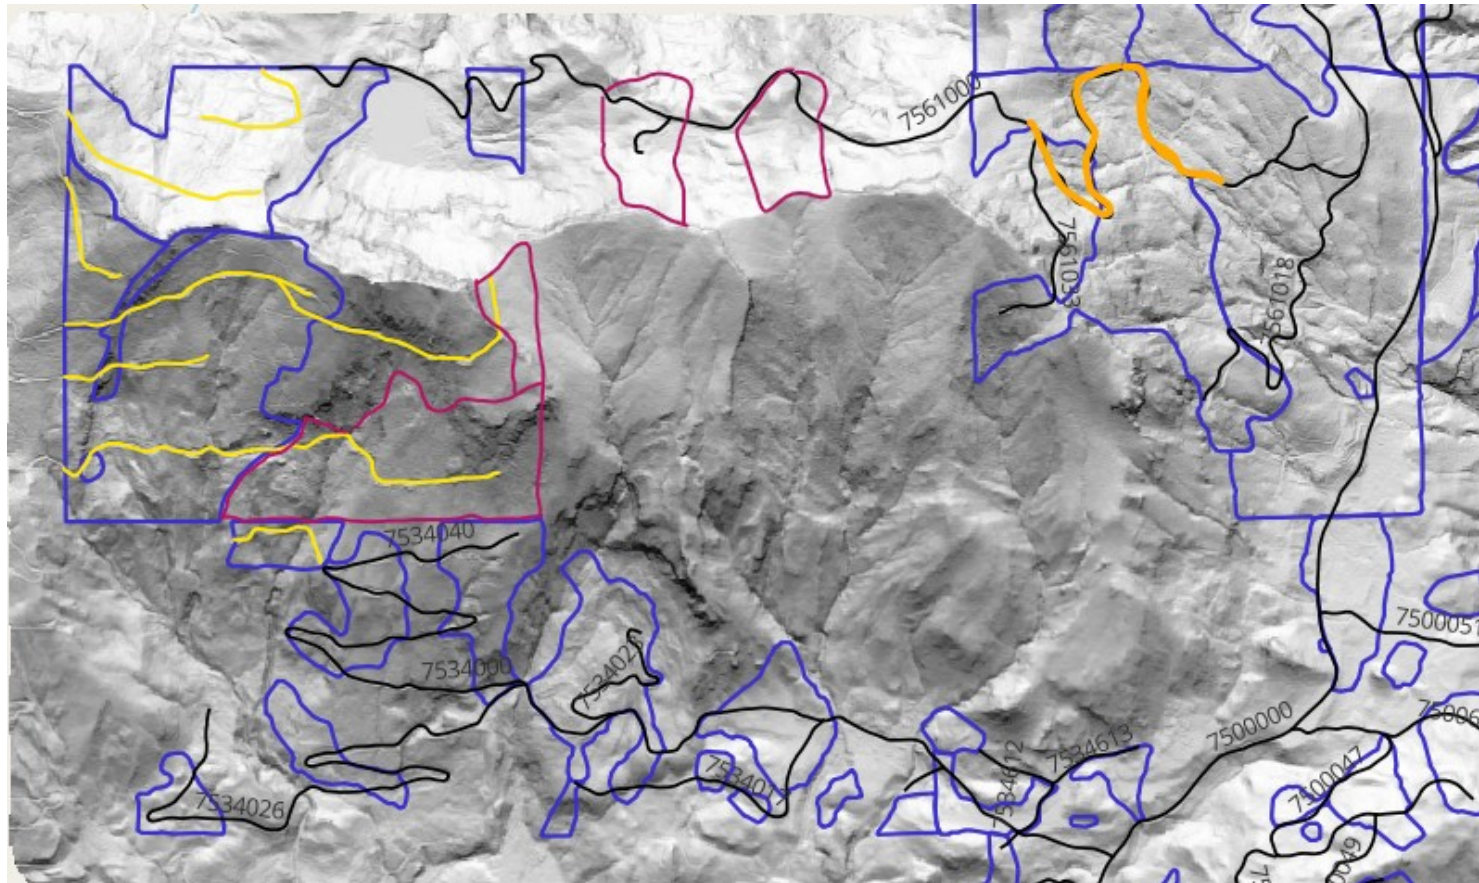
### Watch Mountain Area

- Unmapped roads from land exchange
- Unmapped stands under 80
- Extremely steep portion of 7516 that OHVs are using to reach Watch Lake and private land.

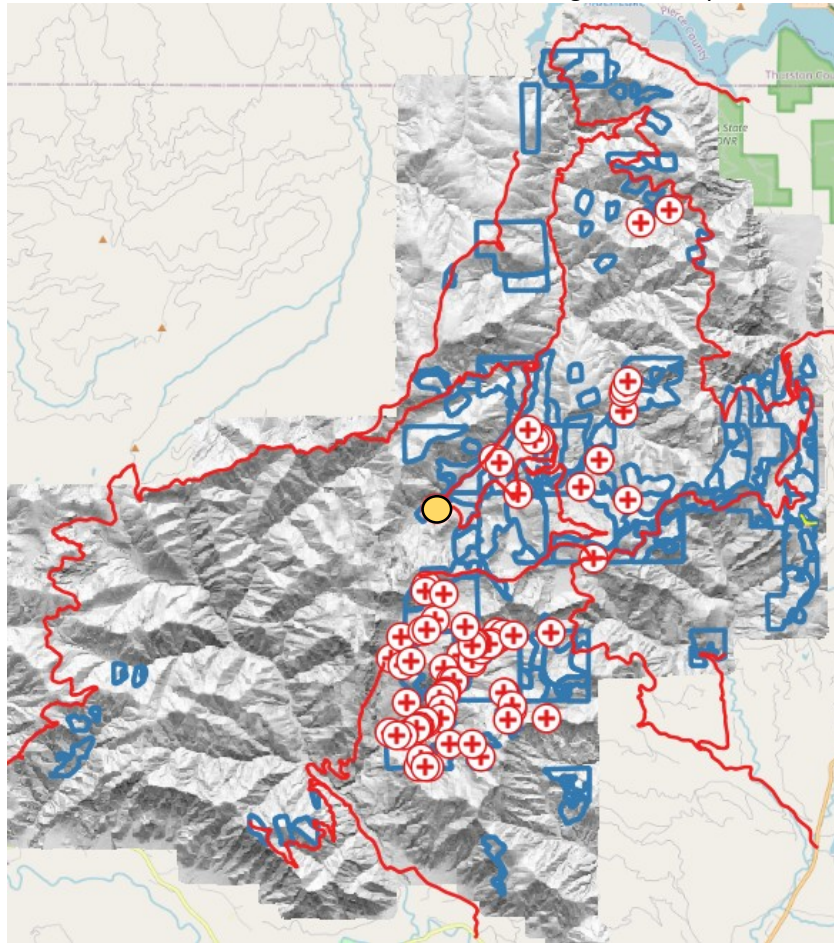
## Mineral Block

Moderate to severe washouts observed via lidar.
-

Primary roads that are currently drivable, almost all others are grown in or washed out.
-

Stands under 80 layer. Some of the stands data is innacurate and many are missing.
-

Failed bridge that needs replacement ASAP. It is a public safety hazard because the public keeps removing the barriers blocking it.

There are so many access issues and innacurate data for the mineral block that I think it should be excluded from this EA. It is also the next area scheduled for analysis after the Skate EA. A lot of road decommissioning needs analysis since this watershed is all LSR. Public access needs to be reestablished on the 7400 and 7200 ROWs.

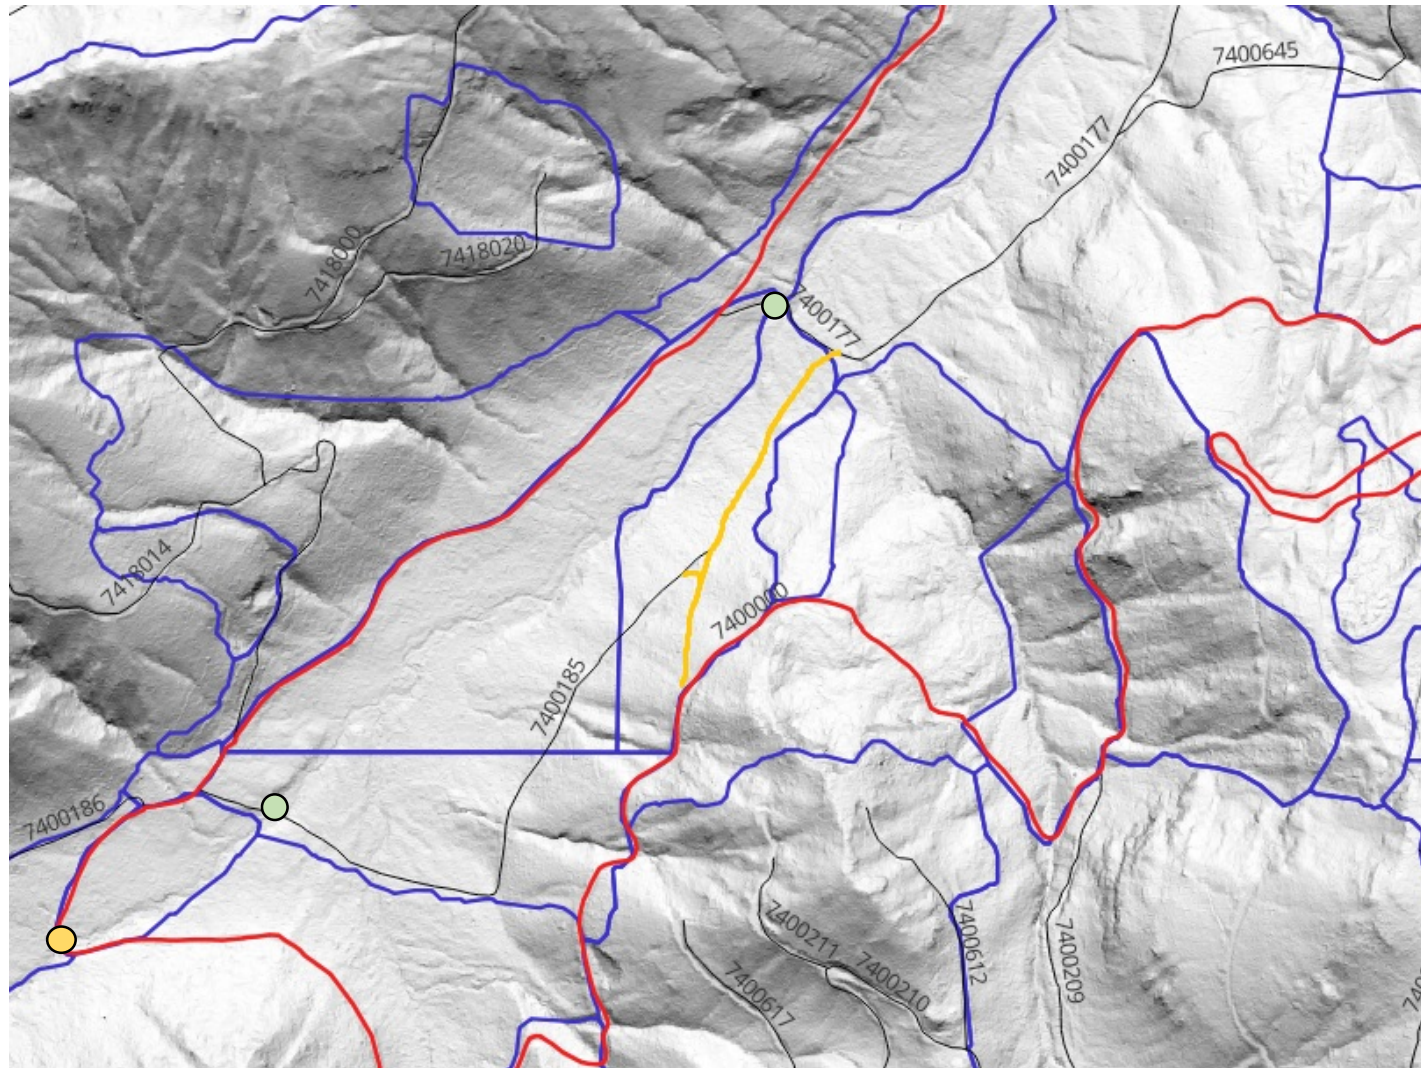
### Mineral Block Continued - West Fork Little Nisqually

- Failed bridge, see above
- Recovered riparian crossings that can be avoided
- Good location for temp road to avoid rebuilding riparian crossings
- Primary roads that are currently drivable, almost all others are grown in or washed out.
- Stands under 80 layer. Some of the stands data is inaccurate and many are missing.

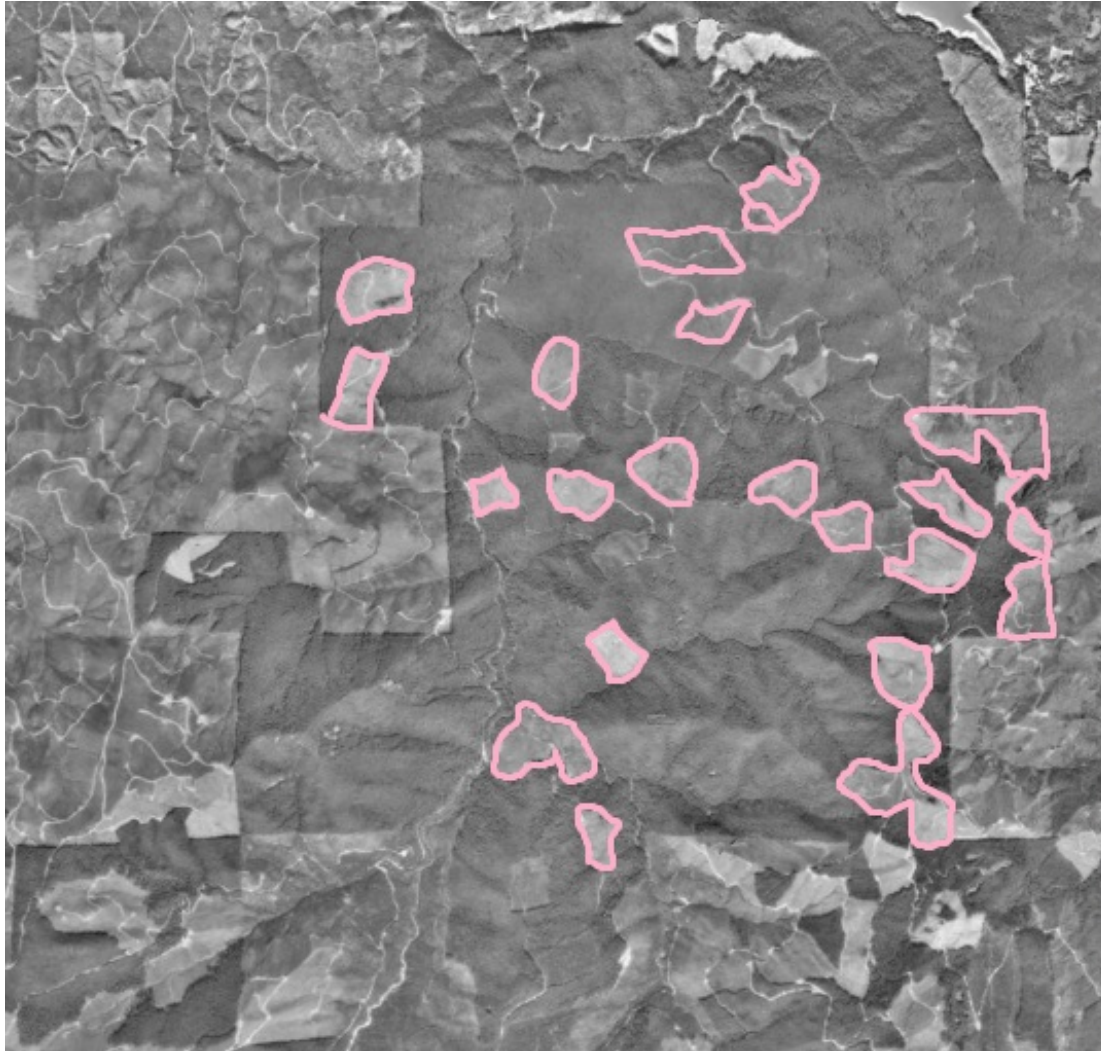
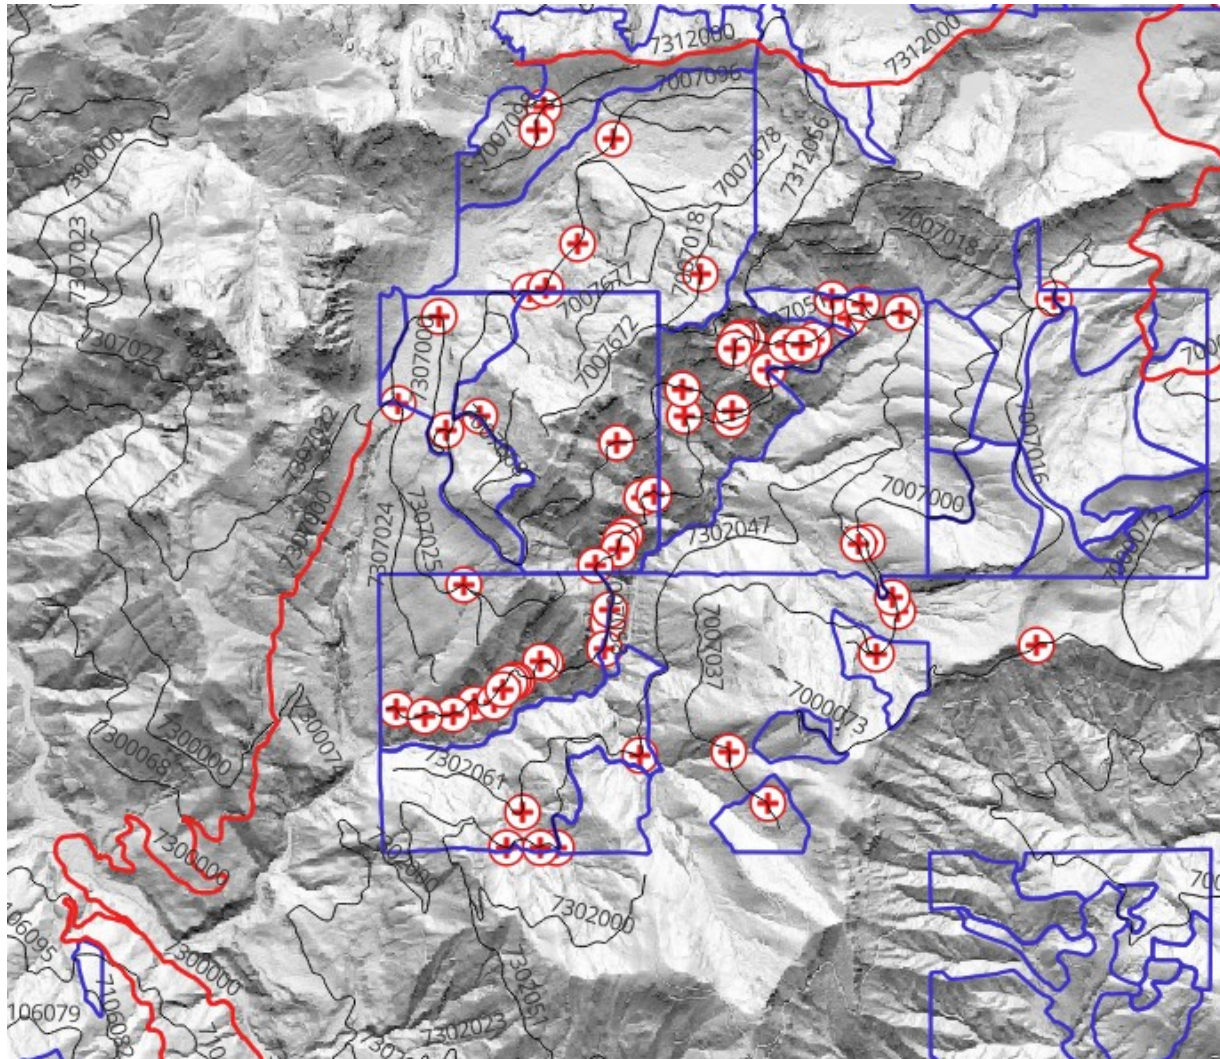
#### **Mineral Block Continued - Lower Little Nisqually**

- I have highlighted plantations that are not in the stands under 80 layer and are not proposed stands in this EA. The imagery is from 1994.
- The North Fork Tilton watershed also has stands that need to be analysed that are not in the stands under 80 layer.
- Stands data desperately needs to be updated alongside roads data to allow for more complete analysis in future EAs.
