## **Comment on Plantation Thin & Potential Control Line Treatments EA**

**Collin Neuhauser**

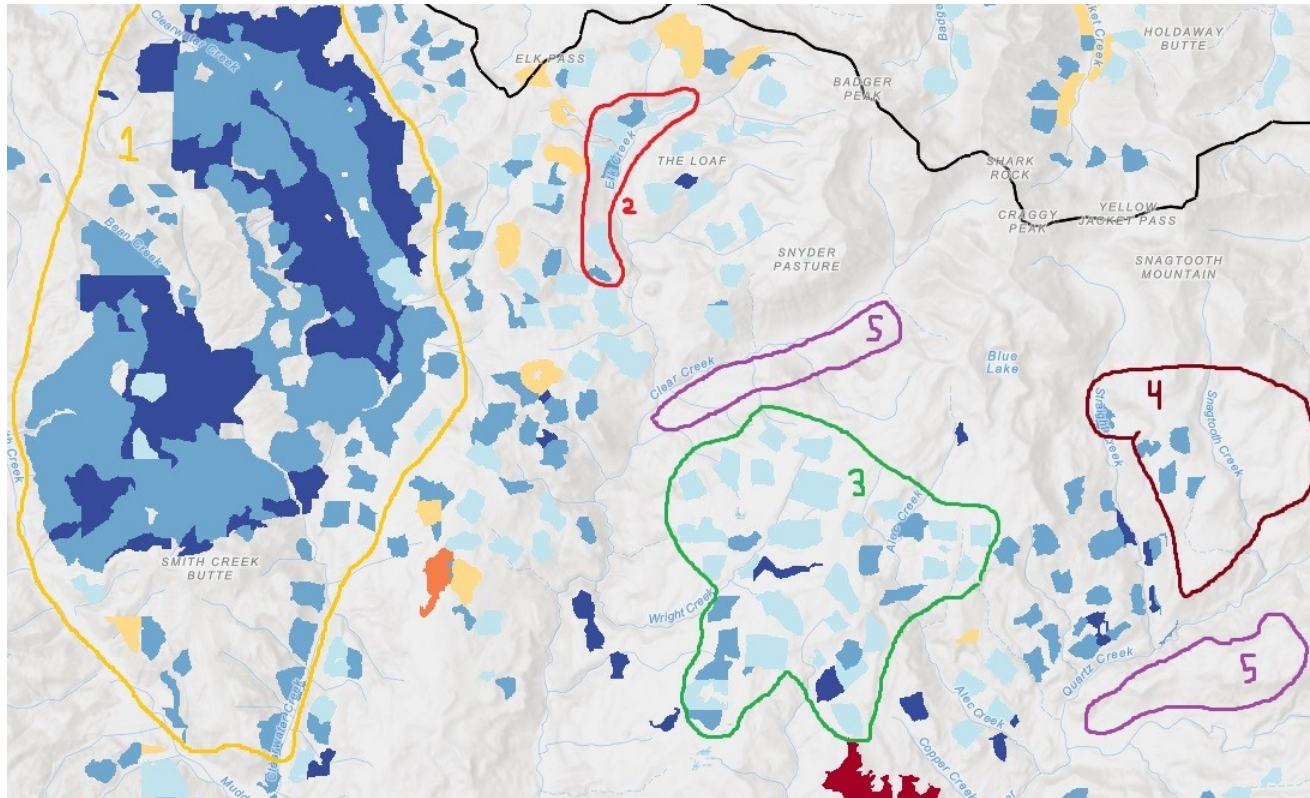
## Area North of Lewis River

1. The Clearwater watershed was going to be covered under the Pool EA. I think the complexity of the area would be better analysed in a watershed level analysis. I would like to see the ridgetop roads become ML2 to allow public access
2. The 2559 along Elk Creek traverses steep terrain and crosses multiple large creeks. Because the area is LSR, I think this road should be decommissioned after the 100 spur. The old bridge abutments and approaches at Elk Creek on the 100 spur should also be removed from the riparian area.
3. This area should be a priority for commercial or precommercial thinning to improve the huckleberry habitat.
4. This area that is blocked by a landslide on the 9341 needs to be analyzed for either reestablishing public access or decommissioning.
5. These areas have plantations that do not appear in the stands under 80 layer. Area 4 also has more stands.

- A major culvert upgrade is needed where the 93 road crosses Platinum Creek. Large woody debris is getting caught at the inlet. I think that a box culvert would be the best option to allow the wood to pass through during storms.
- Culvert upgrades are also needed in the Spencer Creek headwaters. The 93 road is an important corridor to stormproof.
- *Lathyrus sylvestris* needs to be treated along the 93 road to prevent its spread. It has heavily infested the Quartz Creek trailhead.
