Date: July 27, 2007

Participants: Alma Winward  
Don DeLong  
Geoffory Anderson

#### Purpose of Trip:

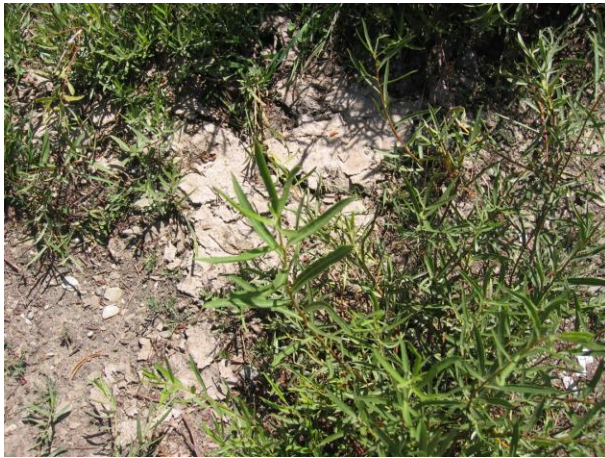
Picture 6. *Salix melanopsis*

At a dispersed camping area in a willow thicket, Alma pointed out a newly classified species of willow (*Salix melanopsis*) (Picture 6). It was apparently broken out from coyote willow (*Salix exigua*). In contrast to serrated leaves of Booth's willow (*Salix boothii* Dorn), as an example, the leaves of *S. melanopsis* have raised points along the margins. As we left this camping area, he also pointed out *Salix lasiandra* (whiplash willow) along the road just east of the turnout to the campsite (Picture 7). This species is tree-like, growing up to 30 feet tall. One or more main stems remain alive and the branches die after several years, to be replaced by new branches. He said this is an important species to many wildlife species.
